ADMINISTRATIVE SERVICES COMMITTEE MEETING AGENDA

AO Boathouse and Rowing Club Recommendation

ALTERNATIVE CONSTRUCTION & ENVIRONMENTAL SOLUTIONS, INC.

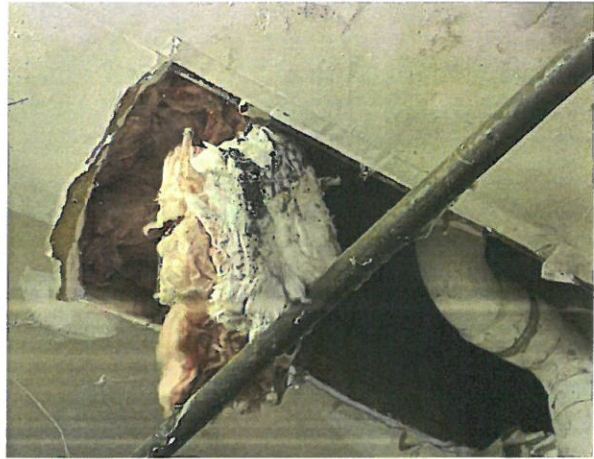
2, Staining Indicative of Mold Colonization on Insulation

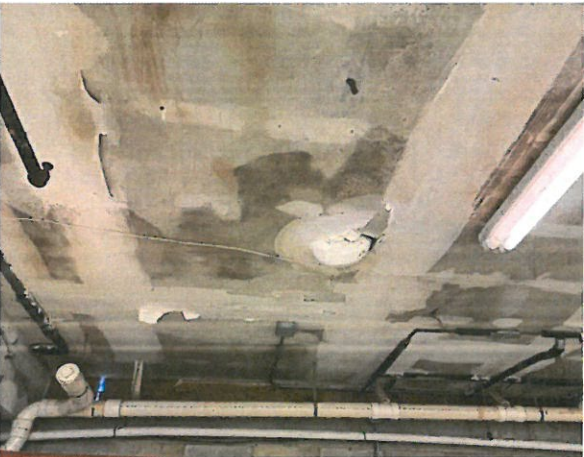
3, Evidence of Water Intrusion and Damage to Drywall

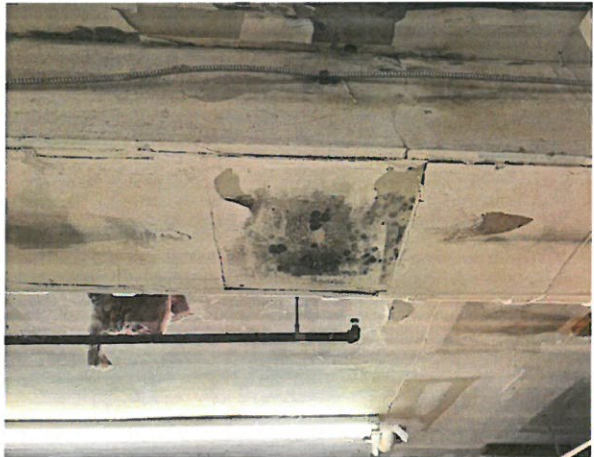
4, Staining Indicative of Mold Colonization Drywall Ceiling

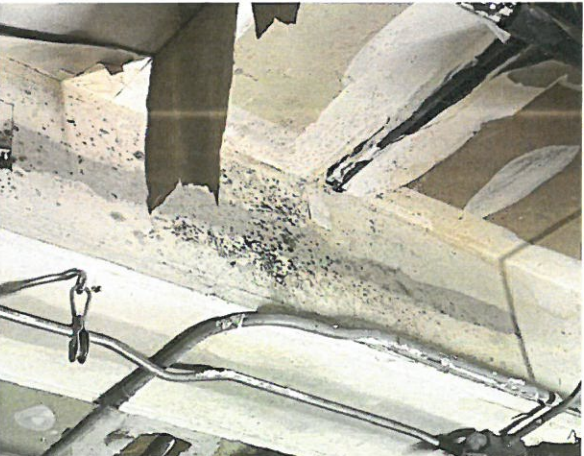
5, Staining Indicative of Mold Colonization on Ceiling Beam

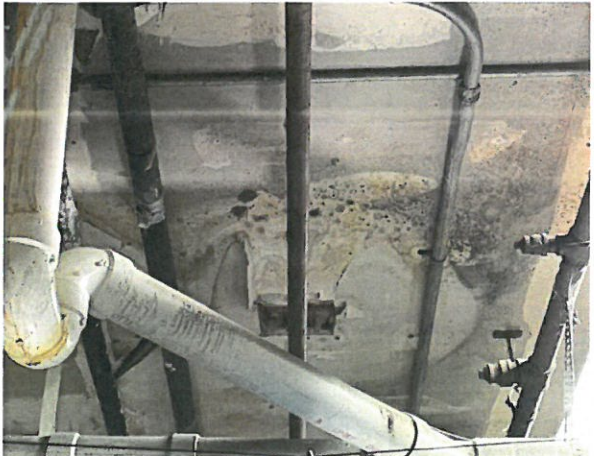
6, Staining Indicative of Mold Colonization Drywall Ceiling

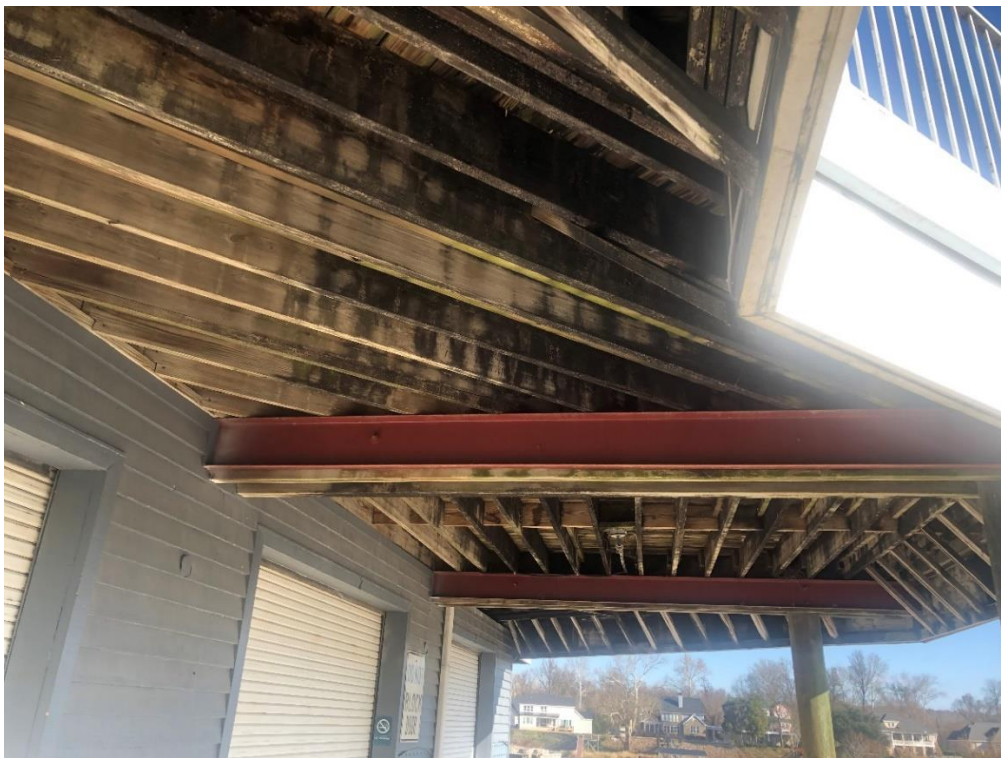
Steel reinforcement of deck girders. Note bad condition of framing beyond the protective building eaves of roof above deck.

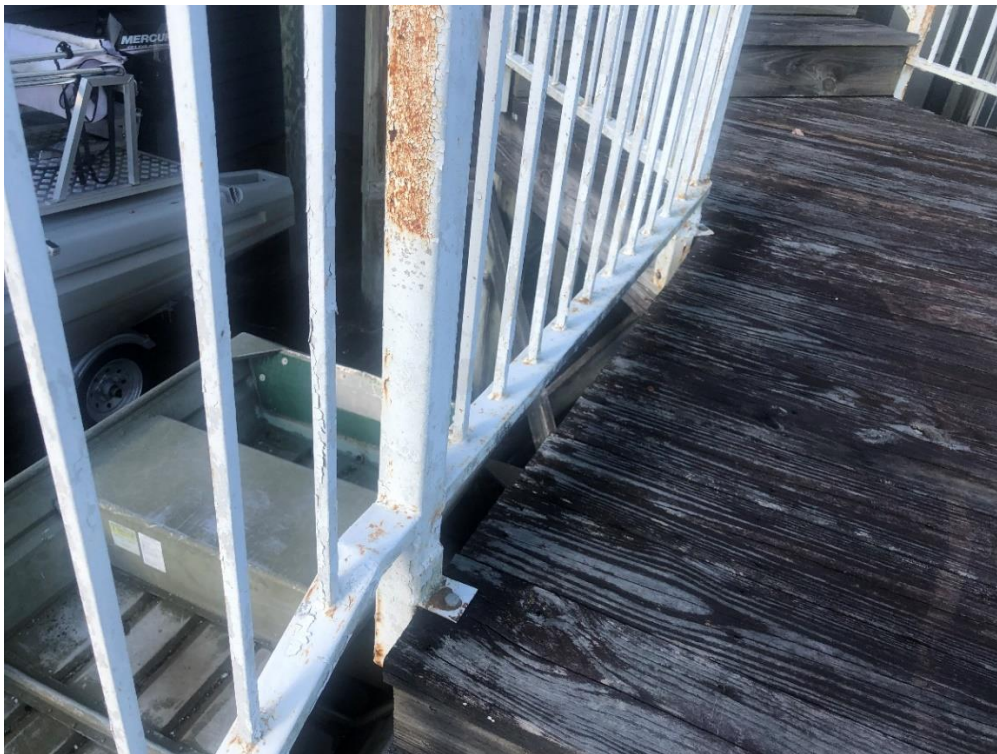
Loose railing due to rotted deck.

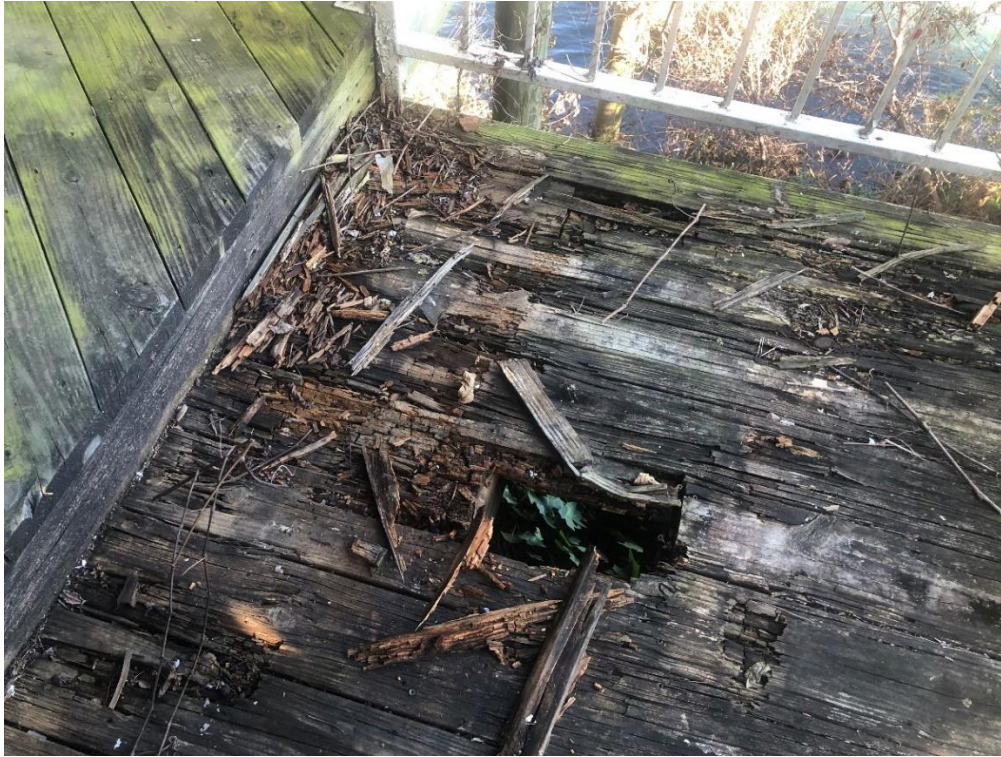
New hole in deck inadvertently created at time of observation.

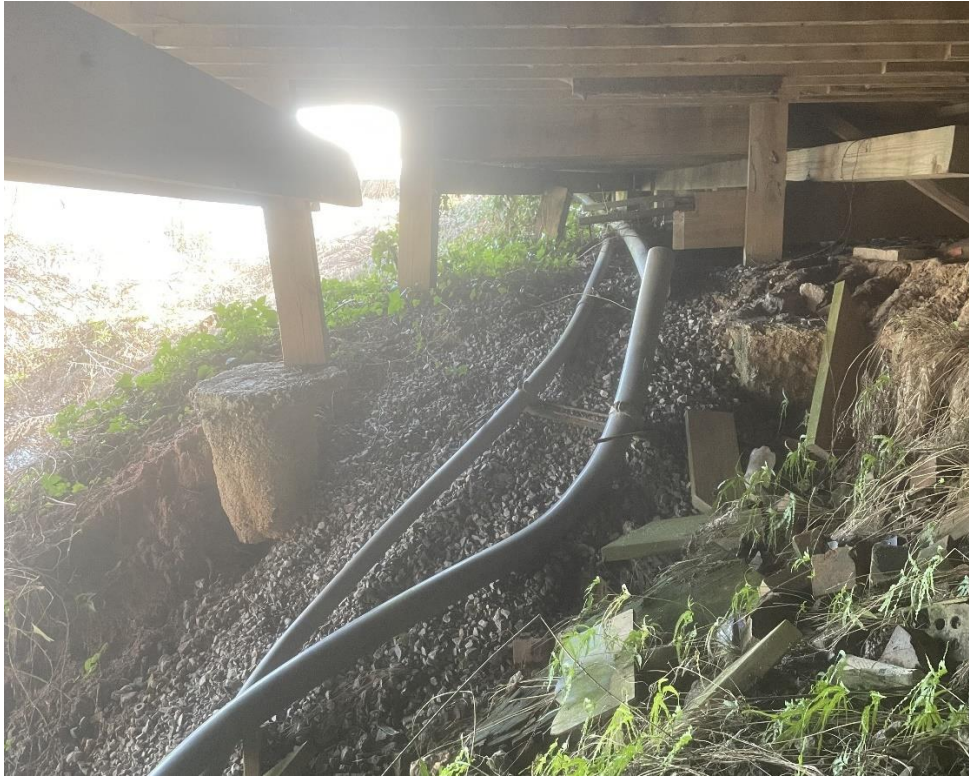
Erosion-compromised (non-pile) deck pier supports.

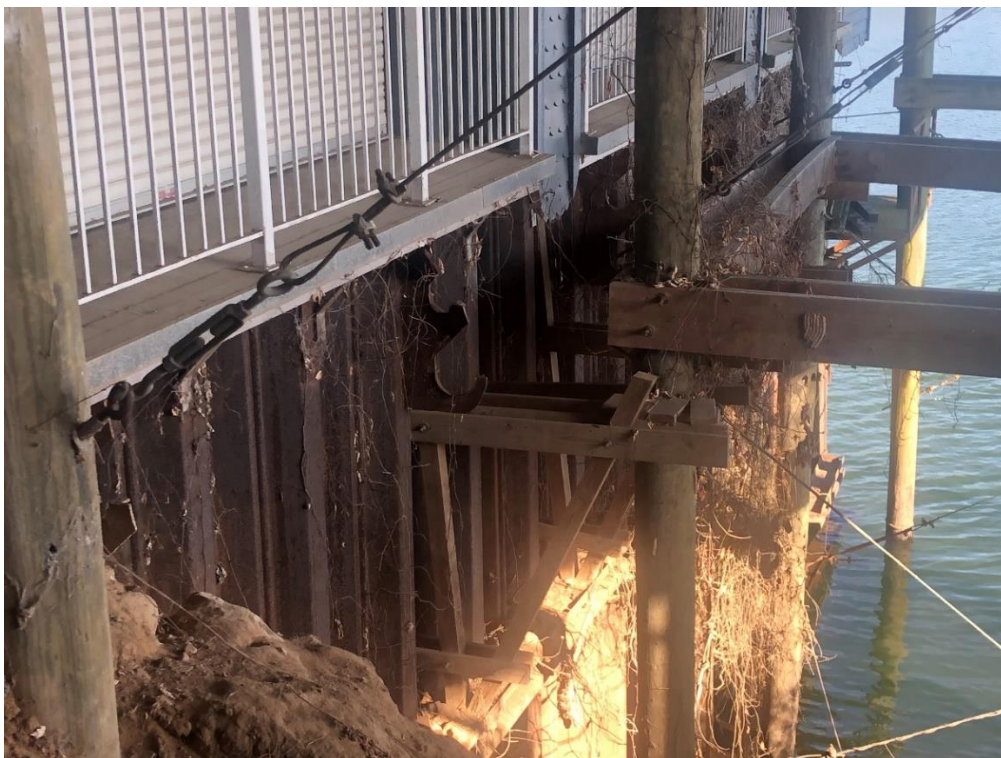
Condition of sheet pile platform and tie-back supports.

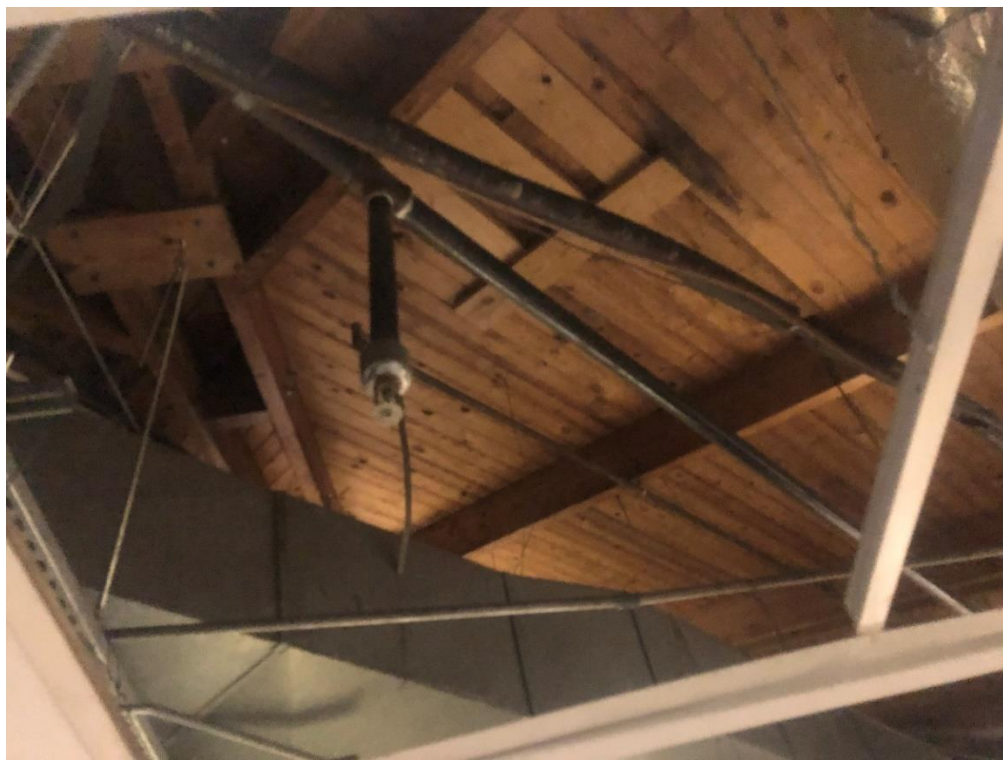
Roof structure above drop ceiling in kitchen. Note previous leaks and repairs.

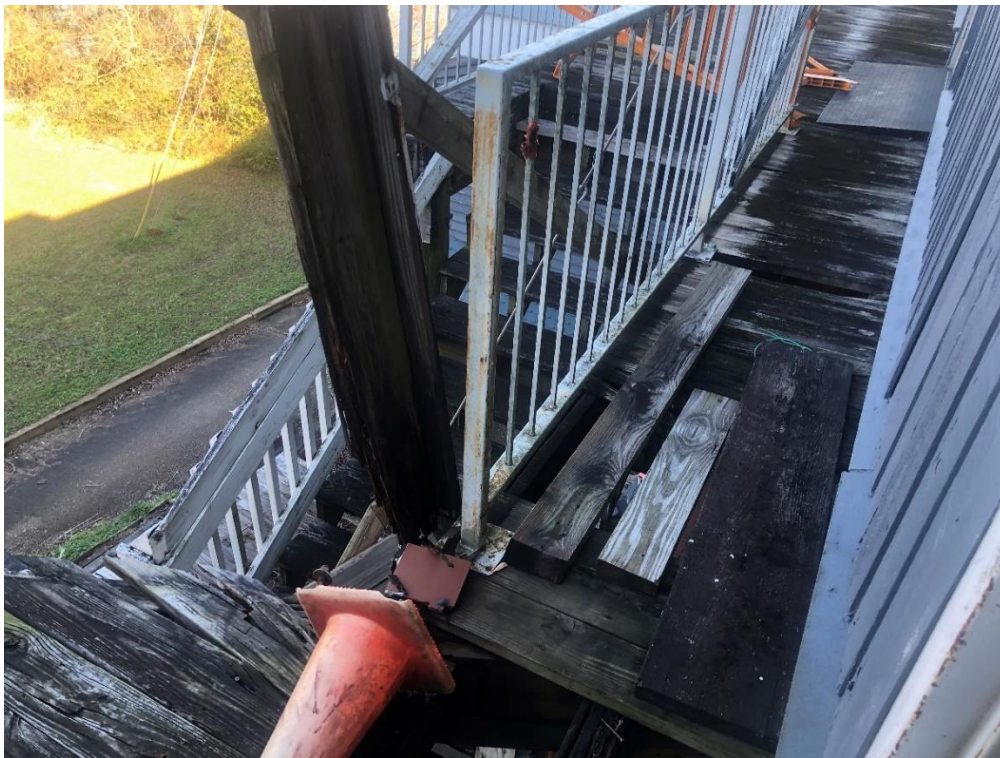
Unpassable condition of West side deck and stairs.

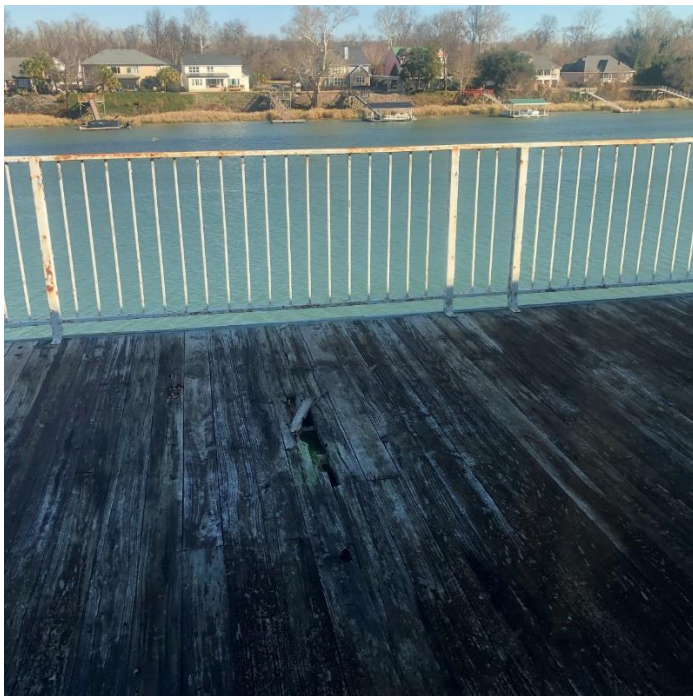
North deck (above water) showing one of many existing holes in decking.

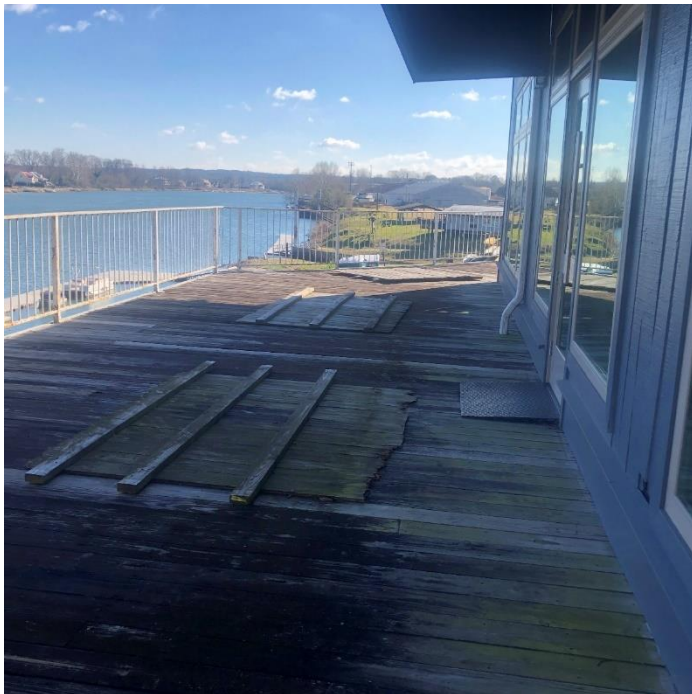
North deck showing previous “repair” attempts.

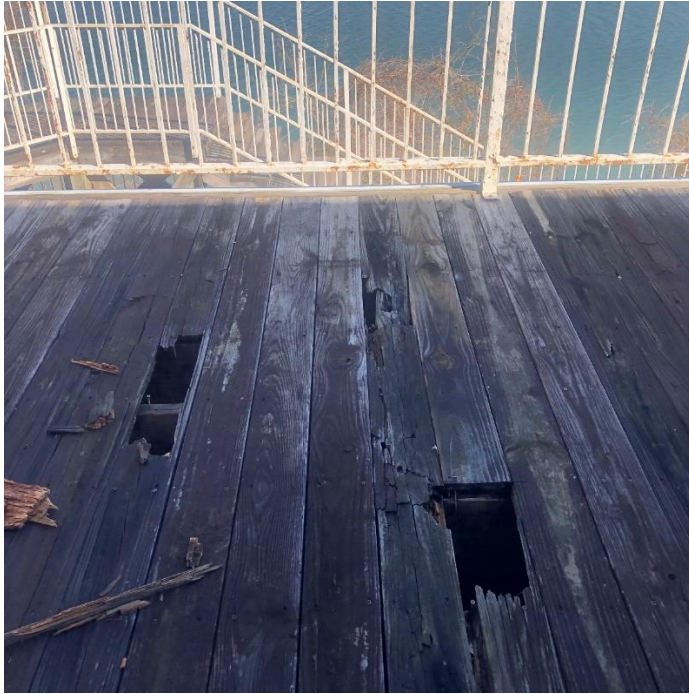
Common existing foot-sized holes in deck.

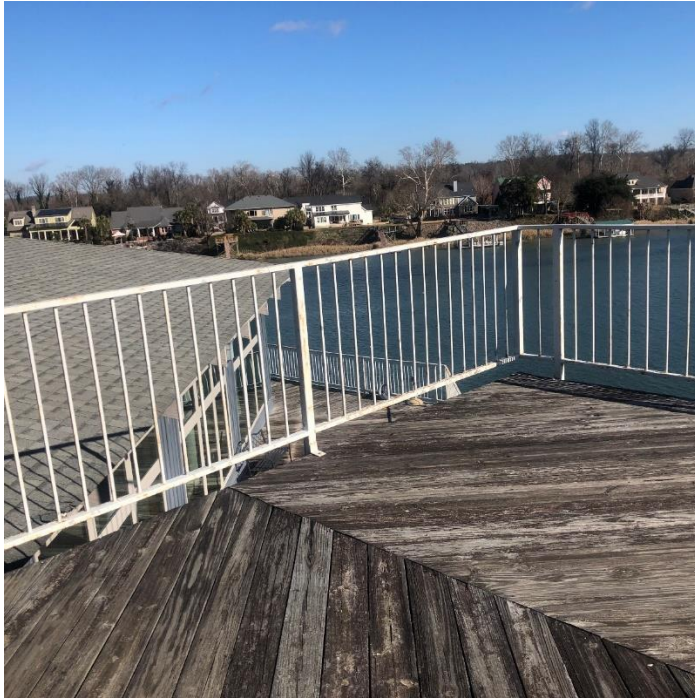
Condition of penthouse deck with roof of River leg to the left.

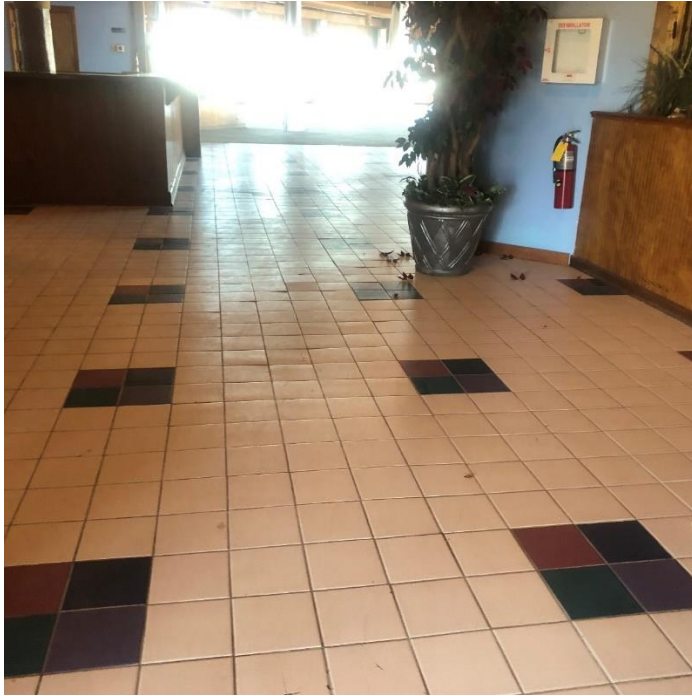
Entry tile floor with minimal cracks.

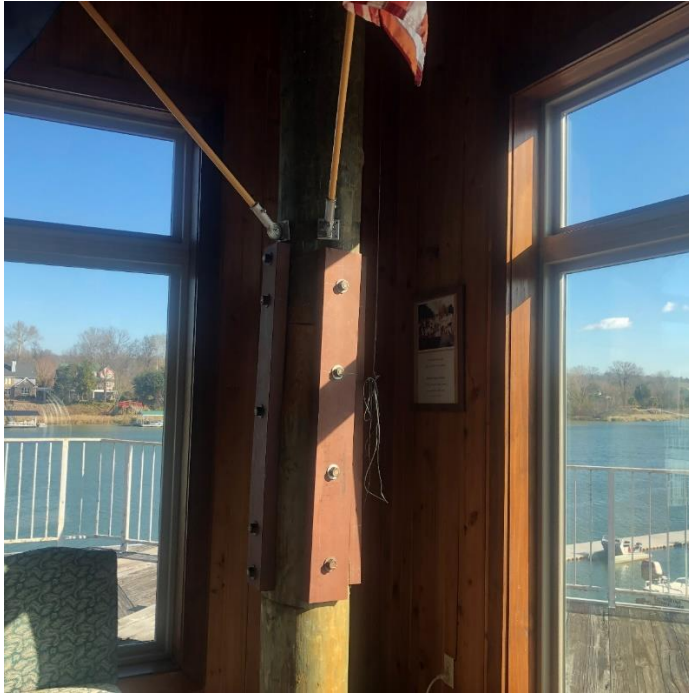
Structural splice at corner pole.
