April 13, 2026 - Historic Preservation Commission Meeting Agenda

April 13, 2026 at 12:00 PM
598 Main Street, Bay St. Louis, MS 39520

7. Motion to conceptually approve demolition of the existing house at 232 Citizen St. (in anticipation of new residence construction; extensive rot, neglect, and termite damage documented; outbuildings and right/rear sections of house may be removed prior to building permit; final demolition approval granted once new house plans are submitted, approved, and building permit paid; new house placement requested forward of existing footprint to allow possible salvage of some portion), submitted by Dianna Webb.

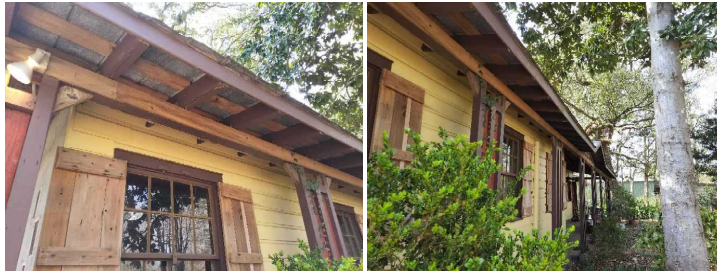
- 3. Acceptable Type: Cement Fiber
- 4. Attention Needed House Numbers Not installed - House numbers missing a number to identify address of home. Recommend correction.
- 5. Attention Needed Trim: Wood - Raw wood was observed in a number of areas around the exterior of the home. Recommend painting / staining to preserve the life of the materials.

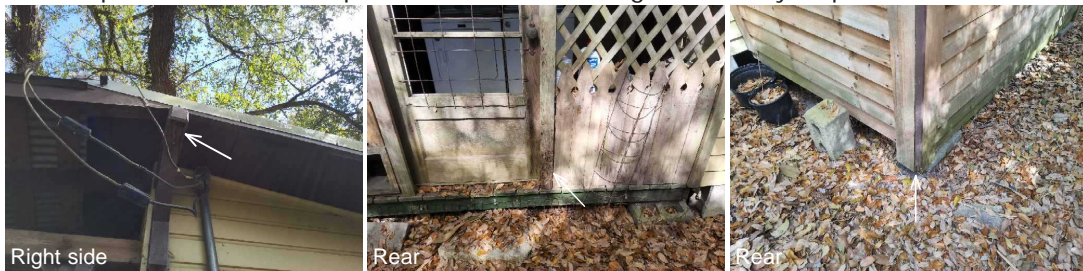
- 7. Major Concern Trim: Wood - Damaged wood consistent with wood destroying insect activity was observed at several areas of the exterior siding and trim. Wood components affected by insect damage may continue to deteriorate if infestation remains active. Recommend evaluation by a licensed pest control professional and replacement of all damaged wood by a qualified contractor.

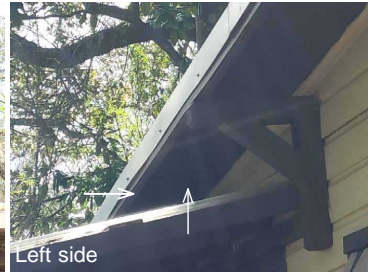
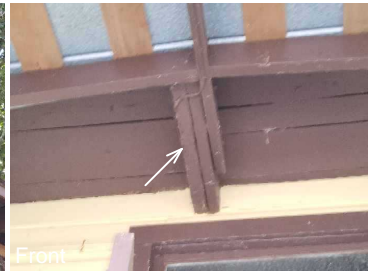
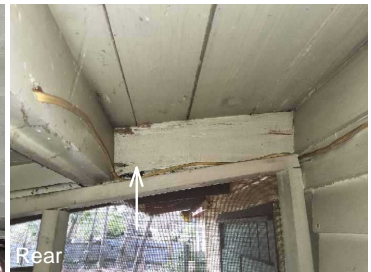
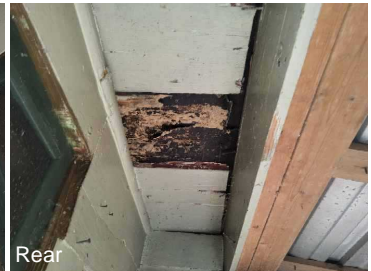
9. Major Concern Fascia / Soffit: Open (Exposed rafter tails), Wood - Fascia observed with wood damage at several locations. Recommend removing / replacing damaged wood. *The inspector was unable to determine if this was from moisture / wood destroying insect.

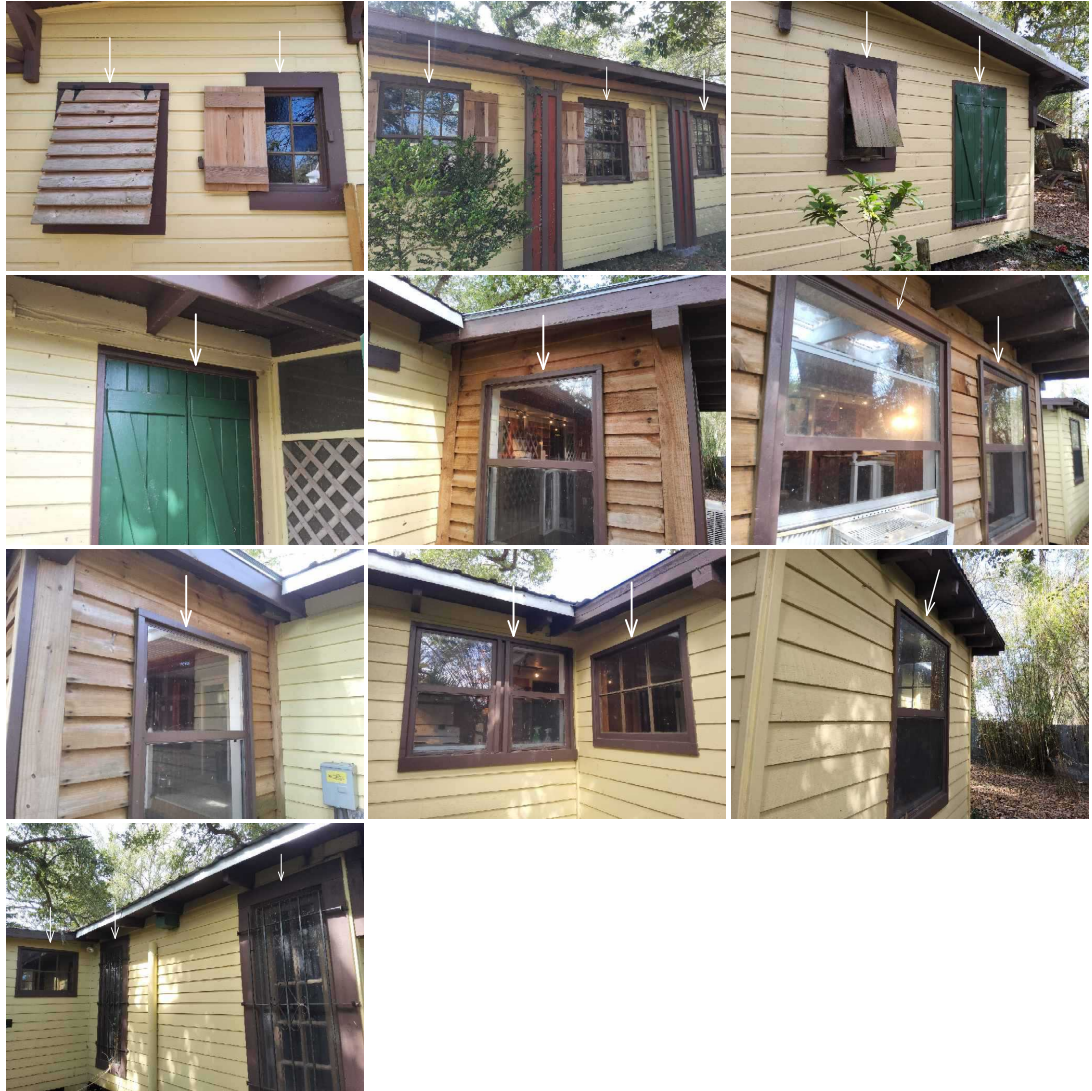
10. Attention Needed Windows: Wood, Metal - Windows appear to be installed without visible head flashing and appear dependent primarily on sealant to prevent water intrusion. Sealant is considered a maintenance component and deteriorates over time. Without proper flashing above the window openings, moisture intrusion into the wall assembly may occur leading to concealed deterioration. Recommend evaluation and correction by a qualified contractor.

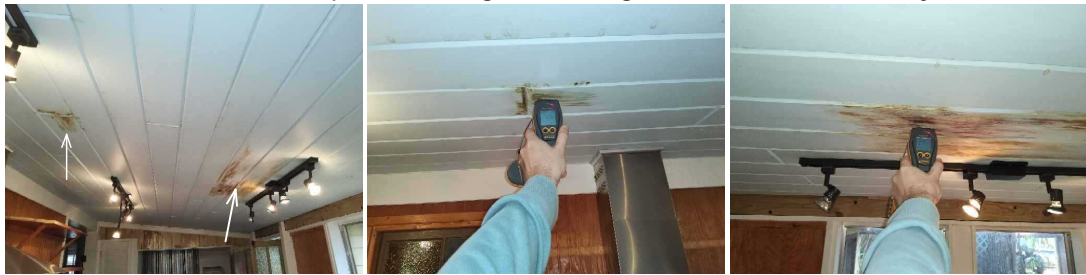
- 2. Acceptable Ventilator: Manufacturer unknown
- 3. Acceptable Disposal: In-Sinkerator
- 4. Acceptable Dishwasher: Samsung
- 5. Not Present Refrigerator: None
- 6. Acceptable Sink: Porcelain Coated
- 7. Acceptable Plumbing/Fixtures: Double Valve Split Fixture
- 8. Acceptable Cabinets: Wood
- 9. Acceptable Counter Tops: Porcelain, Other
- 10. Acceptable Pantry: Single Door
- 11. Acceptable Floor: Wood
- 12. Acceptable Walls: Paneling
- 13. Major Concern Ceiling: Wood - Moisture staining was observed on the kitchen ceiling and elevated moisture readings were detected during the inspection. Elevated moisture levels indicate an active or recent moisture intrusion source. Continued exposure to moisture may lead to structural deterioration and microbial growth. Recommend a qualified contractor locate and repair the source of moisture and replace damaged building materials as necessary.

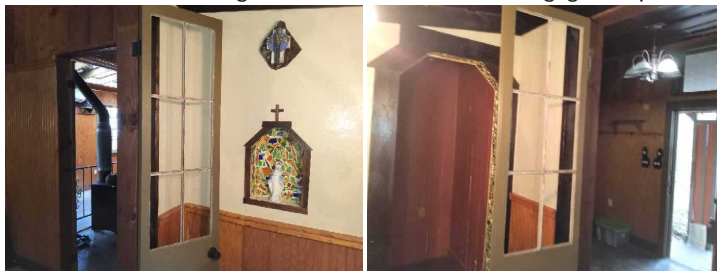
4. Acceptable Ceiling: Metal
5. Attention Needed Doors: Wood with glass - Doors are missing glass panes. Recommend replace.

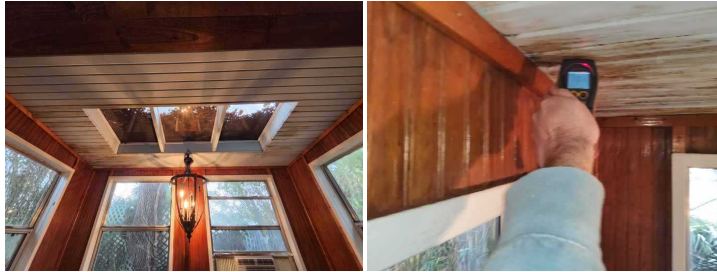
- 25. Major Concern Ceiling: Wood - Moisture stains observed on the ceiling. Upon moisture survey this area tested elevated for moisture. Recommend a licensed contractor remove and replace all damaged wood.

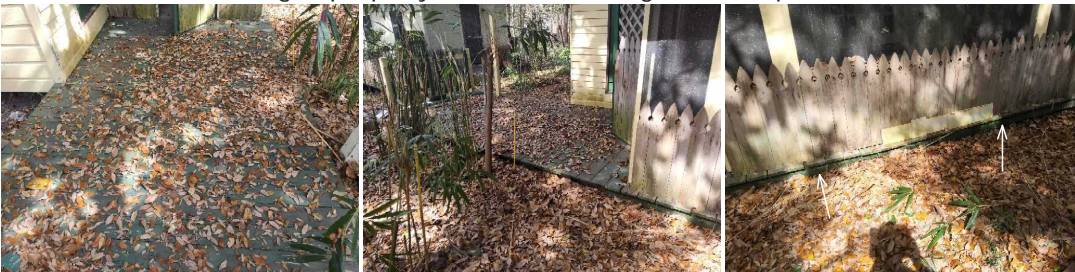
3. Deck: Wood - Damaged wood was observed at the deck framing and portions of the deck appear to be constructed in direct contact with soil. Wood in soil contact is highly susceptible to accelerated deterioration and termite activity. Structural members showing deterioration should be replaced and the deck should be reconstructed so that structural framing is properly elevated above grade and protected from moisture exposure.

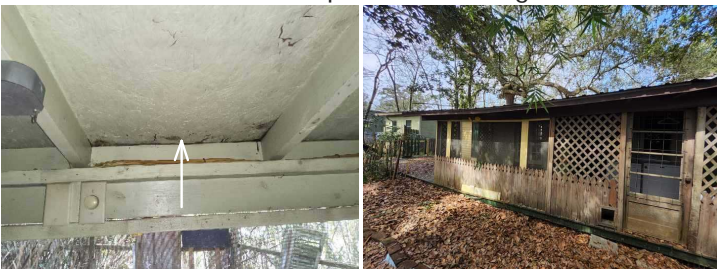
4. Deck Cover: Wood - The deck cover has damaged wood and was observed sagging. Recommend a licensed contractor remove and replace all damaged wood.

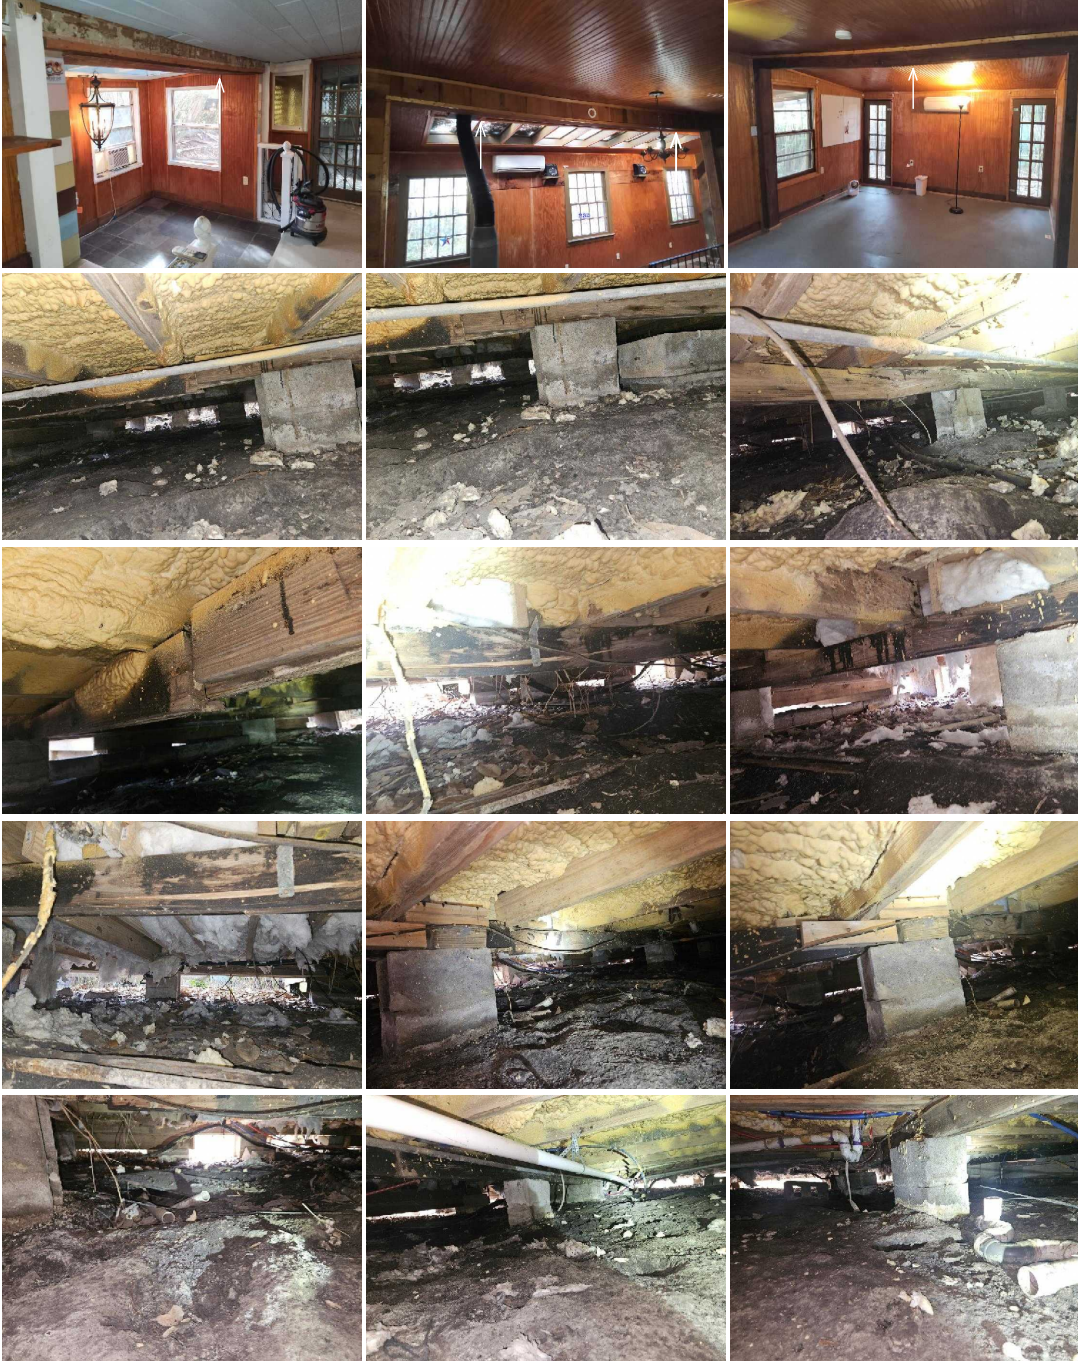
7. Foundation: Pier / Beam
8. Differential Movement: Sloping floors
9. Beams: Wood - Structural beams supporting the floor framing were observed deteriorated, sagging, and in some locations broken or improperly spliced without adequate pier support. Several supporting piers also appear deteriorated from long-term moisture exposure and possible termite activity. These conditions indicate significant structural distress within the crawlspace framing system. Recommend a qualified contractor or structural professional further evaluate the structural support system and repair or replace all compromised beams and piers.

Substantial structural repairs or reconstruction may be required to restore structural integrity.

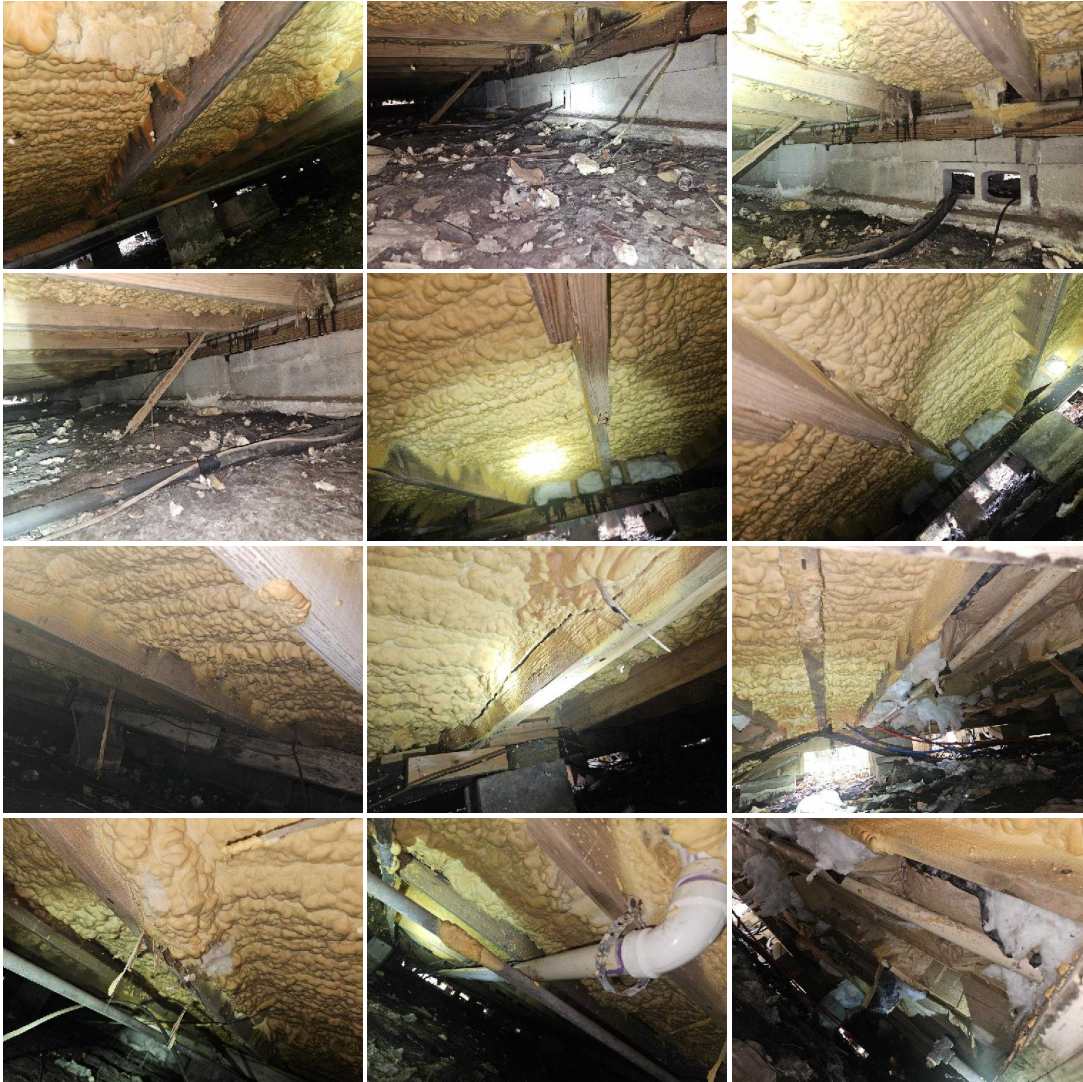
10. Joists/Trusses: Wood - Many floor joists were observed deteriorated and structurally compromised throughout the crawlspace. Several joists appear to have been previously repaired by scabbing additional lumber to damaged members; however, the existing joists and repair members show continued deterioration consistent with moisture exposure and termite damage. Significant sagging of the floor structure was observed in the rear right portion of the home. Recommend a qualified contractor or structural professional evaluate the framing system and replace damaged joists as necessary to restore structural integrity.

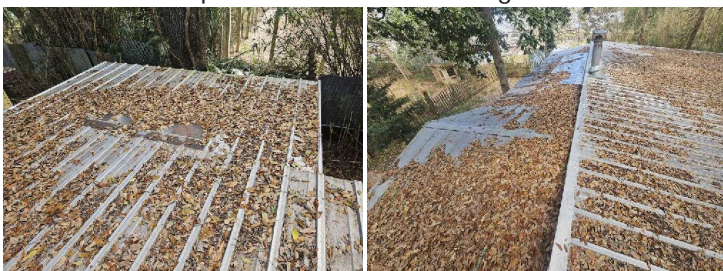
15. Skylights: DIY, Non engineered/ manufactured - Glass panels were installed as makeshift skylights and do not appear to be part of a manufactured skylight system. These panels are not properly flashed and may allow water intrusion into the roof structure. Improvised installations can lead to roof leakage and structural deterioration over time. Recommend removal of these panels and installation of properly manufactured and flashed skylight assemblies or replacement of the roofing materials in these areas.

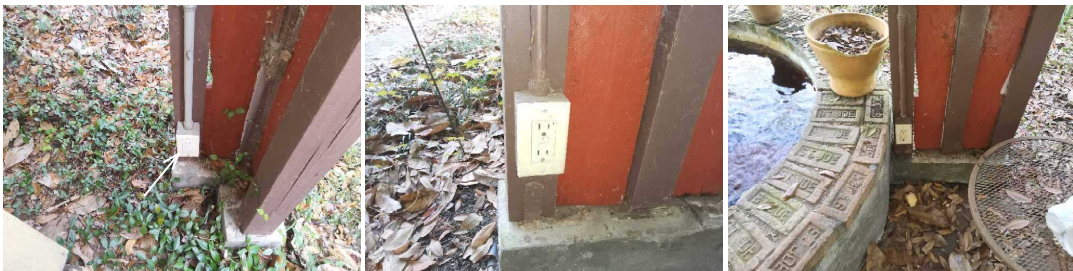
21. Exterior Electric Outlets: 110 VAC GFCI - The GFCI outlet was tripped and will not reset. Recommend a licensed electrician make the needed corrections.

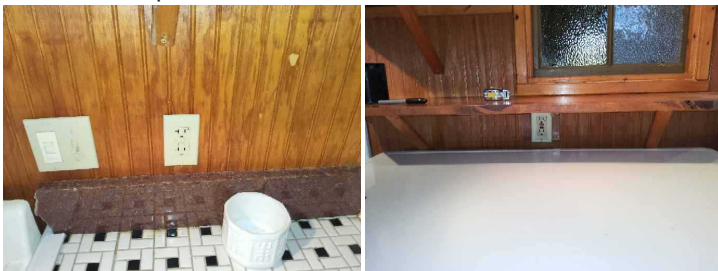
23. Middle Kitchen Electrical: 110 VAC GFCI - GFCI outlets were tripped and will not reset. Recommend a licensed electrician replace the outlets.

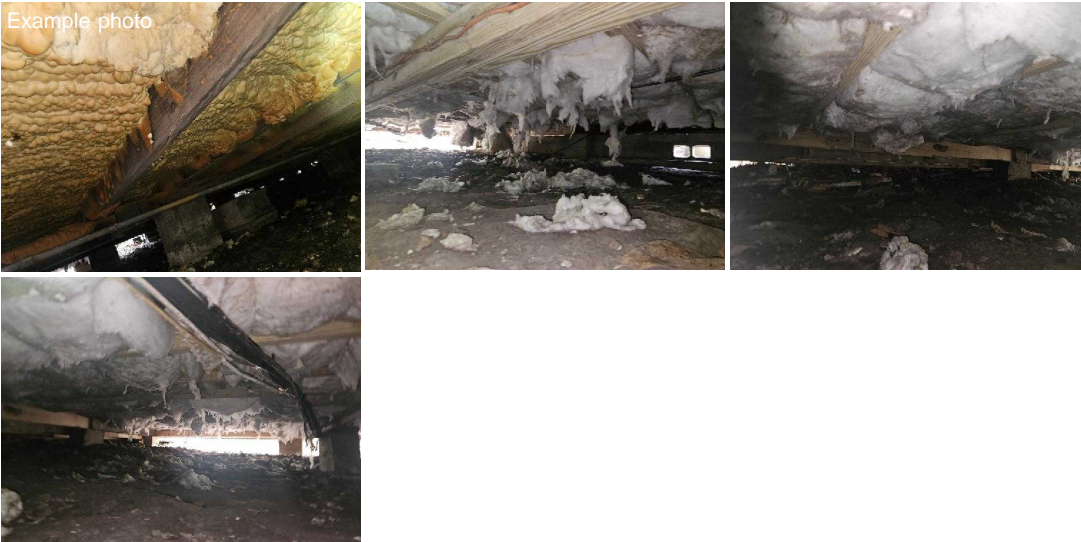
36. All Crawl Space Insulation: Fiberglass batt - The underside of the floor system is insulated with spray foam and fiberglass batt insulation which conceals large portions of the framing system. Evidence of termite damage was observed in accessible areas; however, concealed framing prevents determination of the full extent of deterioration. In the inspector's professional opinion, removal of insulation may be necessary to fully evaluate the structural framing and determine the scope of required repairs.
