PUBLIC ART COMMISSION MEETING

September 09, 2024 at 4:30 PM
Council Chambers: 201 North Broadway, Escondido, CA 92025

3. PUBLIC ART DEACCESSIONING - VINEHENGE

Playground Inspection Report 2023

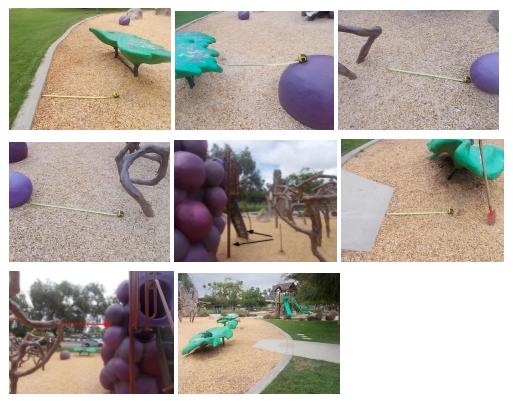
3. The use zones around all structures are non-compliant. The slide, vine climber, and concrete leaf structures are designed for climbing and play. Reference Nature Works Inc. Maintenance Manual Sept. 11 2004. ASTM 9.2.1, 9.2.3 CPSC 5.3.9. **1 Rating.** The large boulders placed close together also represent a fall hazard in the containment area. Recommend the structures/equipment be moved or removed to achieve proper use zones. (Vine climber & Slide 51", Vine climb and bolder 44", vine climb and round grape rock 48". Leaf climber to ADA ramp 32", Leaf to curb 29", Leaf to rocks and boulder up to 52". Stationary structures require a 72 inch use zone.

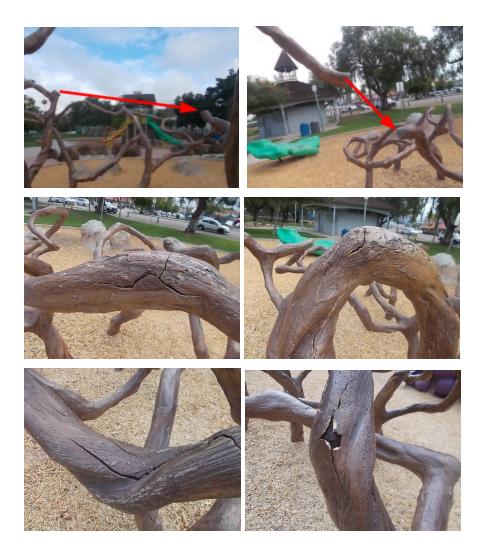
4. Two structural failures of the vine climber have been reported on Jan 26, 2023 and Aug. 22 2022. The current condition of the vine climber reveals complete separation of the climber arm extensions in two locations. Pics below. Movement of the remaining damaged arms and the structure indicates serious structural compromise. There are numerous cracks, some large and deep, that may have allowed water to enter down to the metal infrastructure leading to rust and support structure failure. ASTM 4.1, CPSC 2.5.1. 1 Rating. Recommendation: High priority. Immediately take the play area out of service with approved construction fencing to restrict play activity in the area. Long term engineered structural integrity and safety of the existing structure is a serious concern.

ASTM F1487-21 4.1 General Requirements—Playground equipment shall be manufactured and constructed only of materials that have a demonstrated durability in the playground or similar outdoor setting. Any new materials shall be documented or tested accordingly for durability by the playground equipment manufacturer.
