**Work Session Meeting Agenda**  
**2 Park Drive South, Great Falls, MT**  
**Gibson Room, Civic Center**  
**November 18, 2025**  
**5:30 PM**

# Boston and Montana Barn

Existing Conditions Assessment

Recommendations for Stabilization and Protection

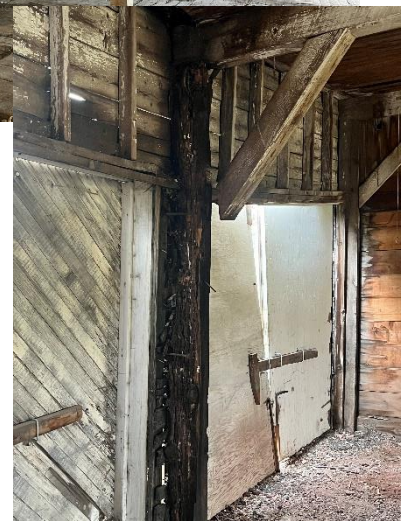
Primary structure is a series of heavy timber columns and beams serving as intermediate bearing for the building. Sizing of these beams and columns are in general accordance with the loading anticipated; however, many of the columns are suffering from dry-rot, and some of them have separations at their connecting points. The original design for the second floor required two parallel rows of columns to support the roof structure. These are all currently absent, resulting in a dangerous structural situation on the northern section. The structure is in danger of collapse.

Building lateral systems at both the roof and the walls are impaired, rendering the building unable to resist wind or seismic forces acting on the building.

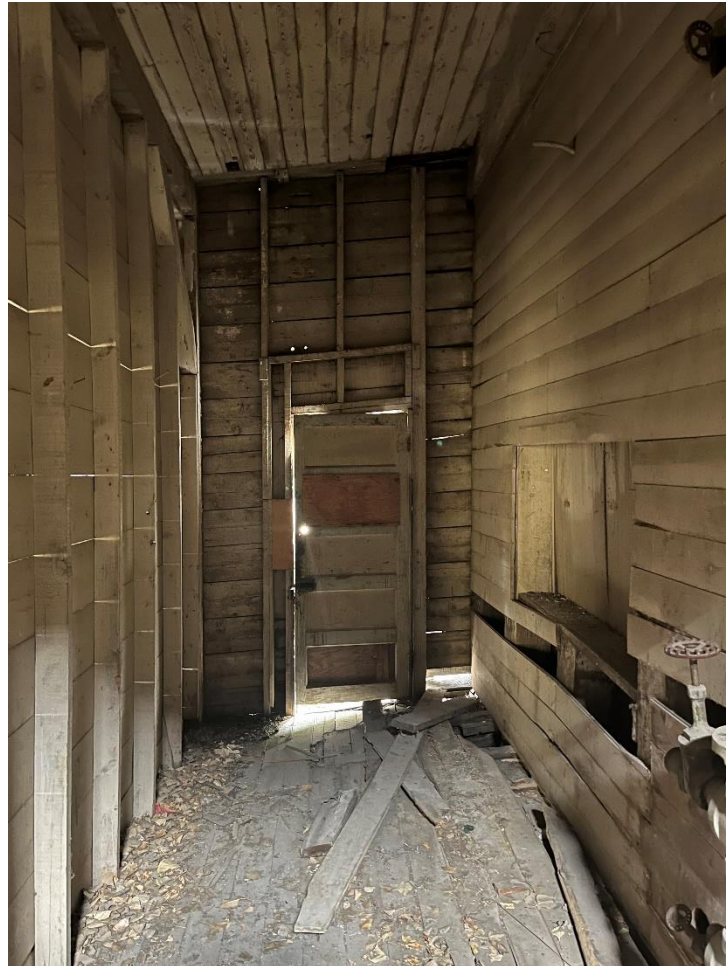
Internal stairwell is stable. Main floor level is not level, but apart from some holes and gaps in the flooring, is in relatively serviceable condition. The second level south section is covered with debris but is primarily stable. Floor in the north section is noticeably out of level, primarily at the north end of the building where the exterior walls have shifted out of plumb.

Foundations in the north section are mostly unobserved due to lack of access to below-floor areas. Foundations in the south section are accessible from openings in the wall along the southeastern corner of the building. Sandstone is weathered and the joints require maintenance, but the stone is in adequate condition.

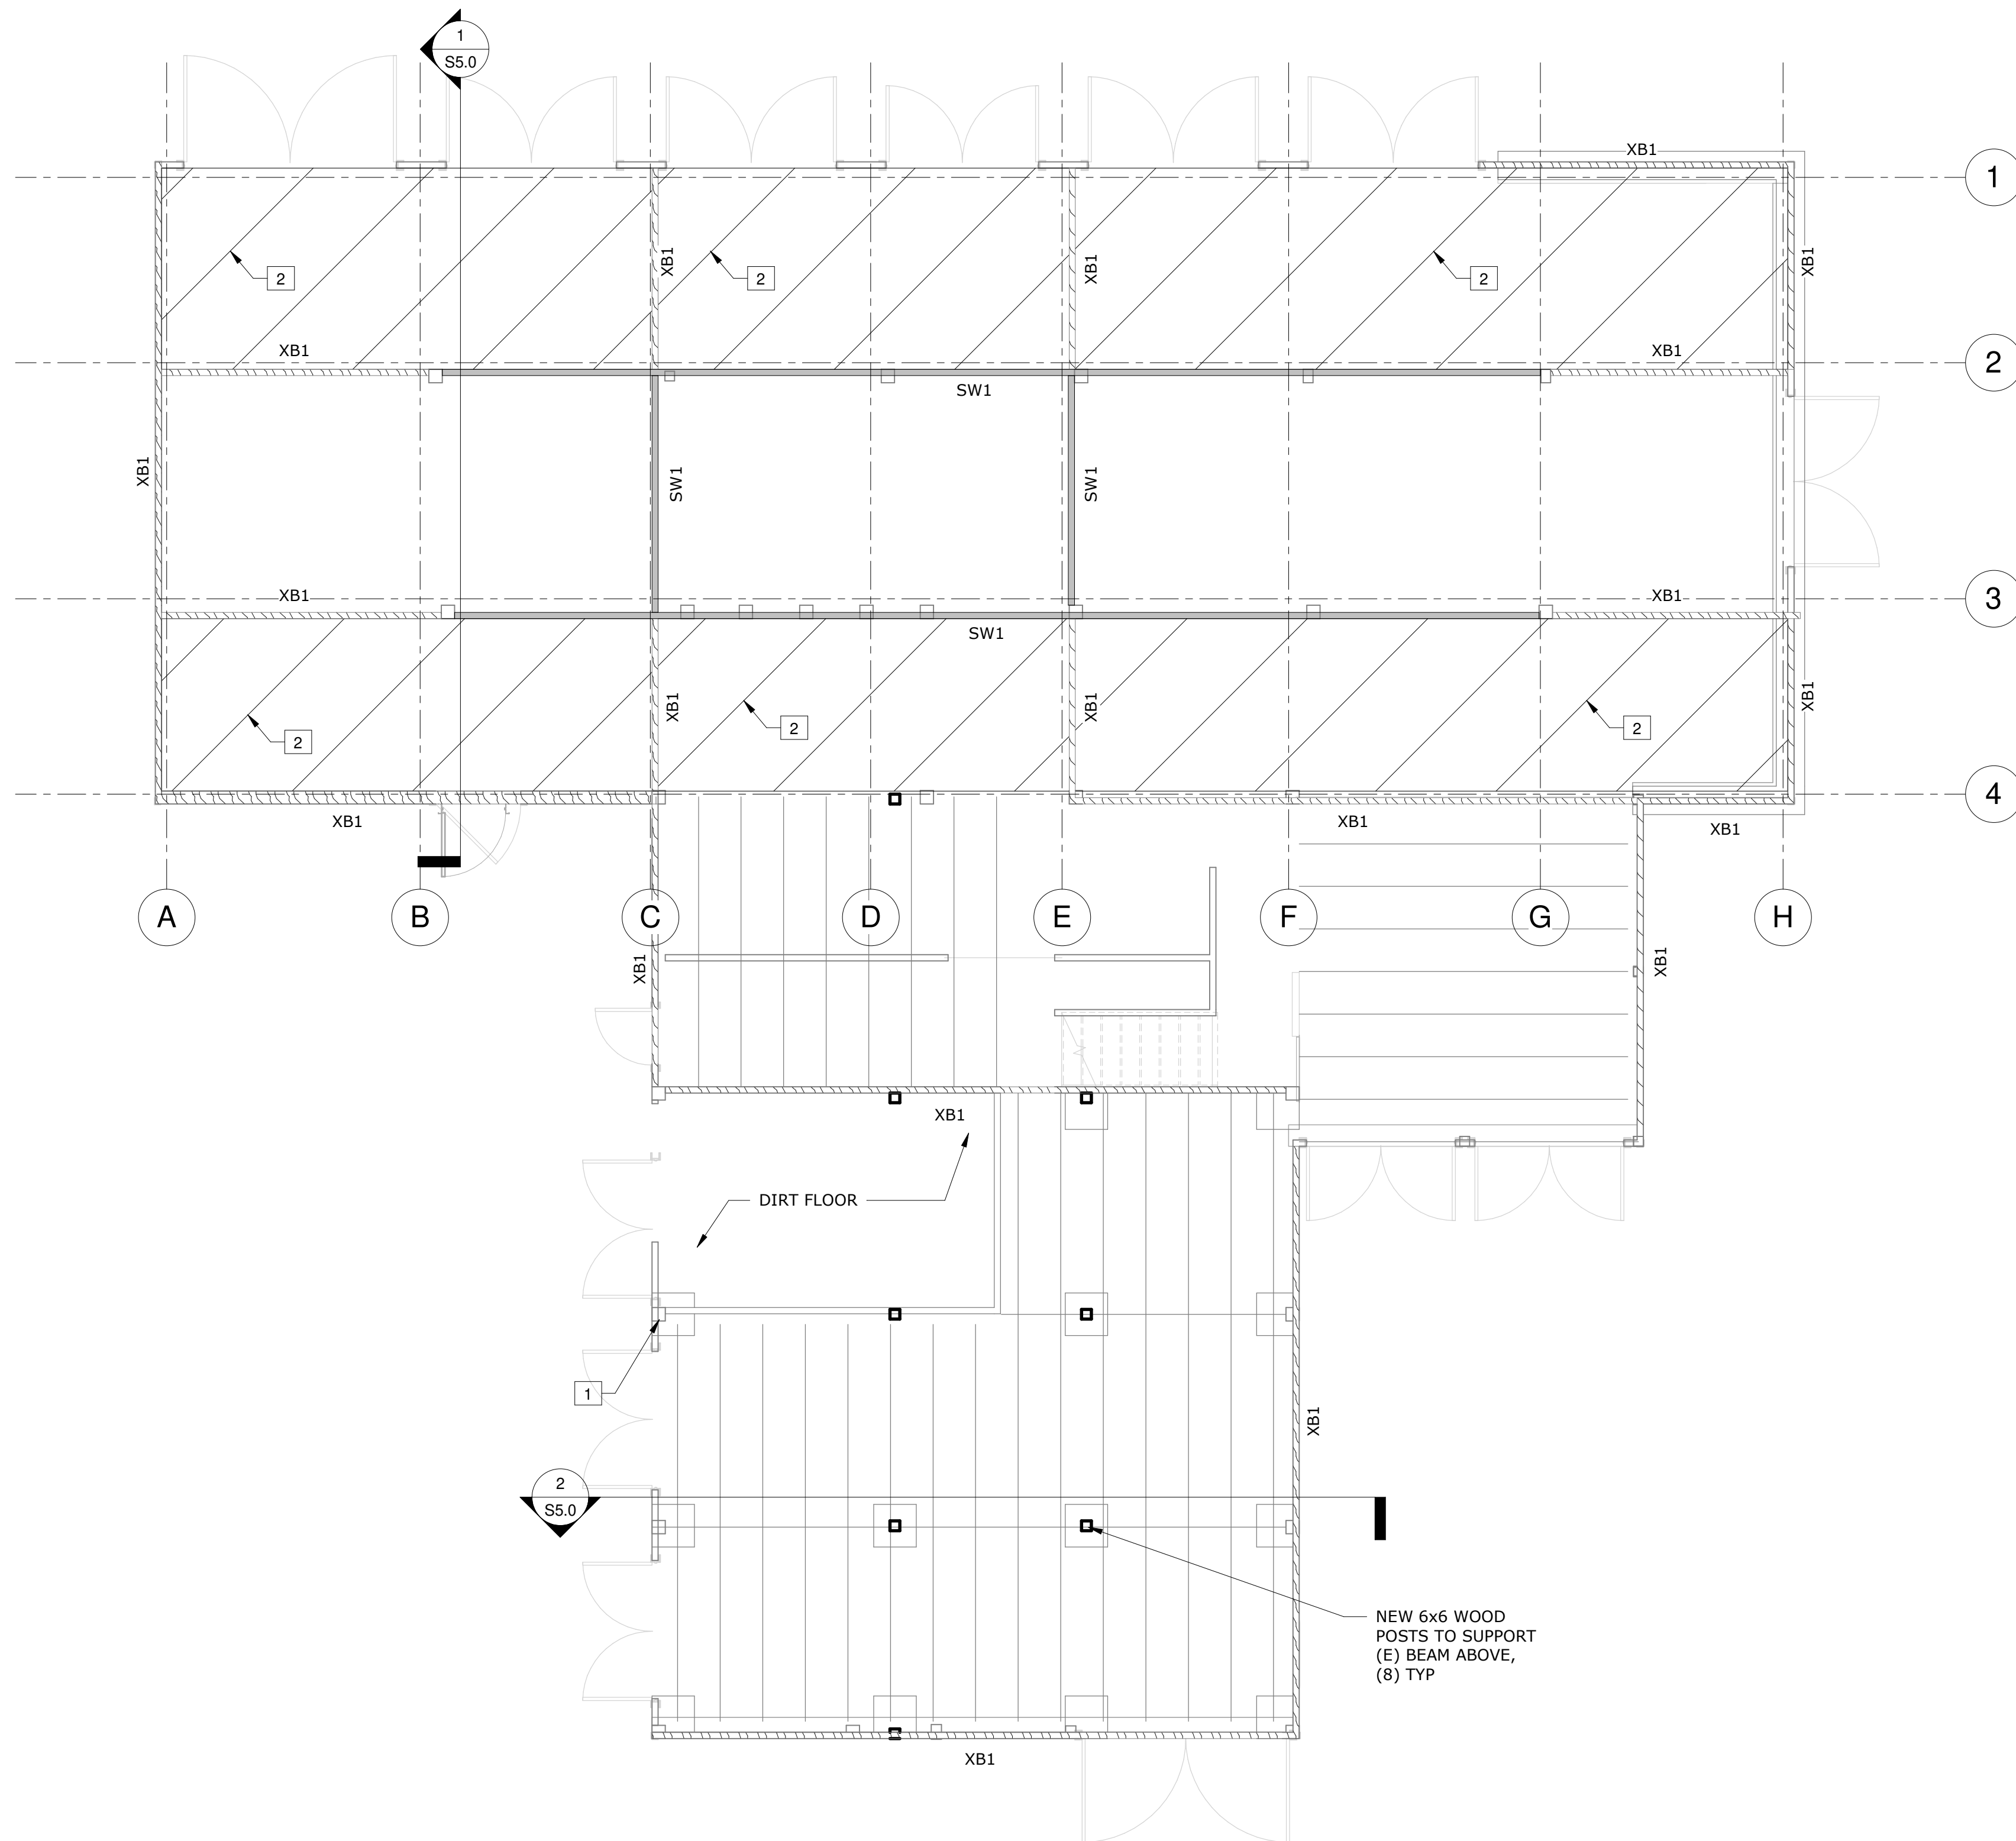
- 1 DETERIORATED POST. REMOVE AND REPLACE PRIOR TO INITIAL BRACING.
- 2 2x4 LAID FLAT @ 4'-0" OC W/ (2) 16d NAILS INTO EA JOIST, MIN (3) JOIST LAP.

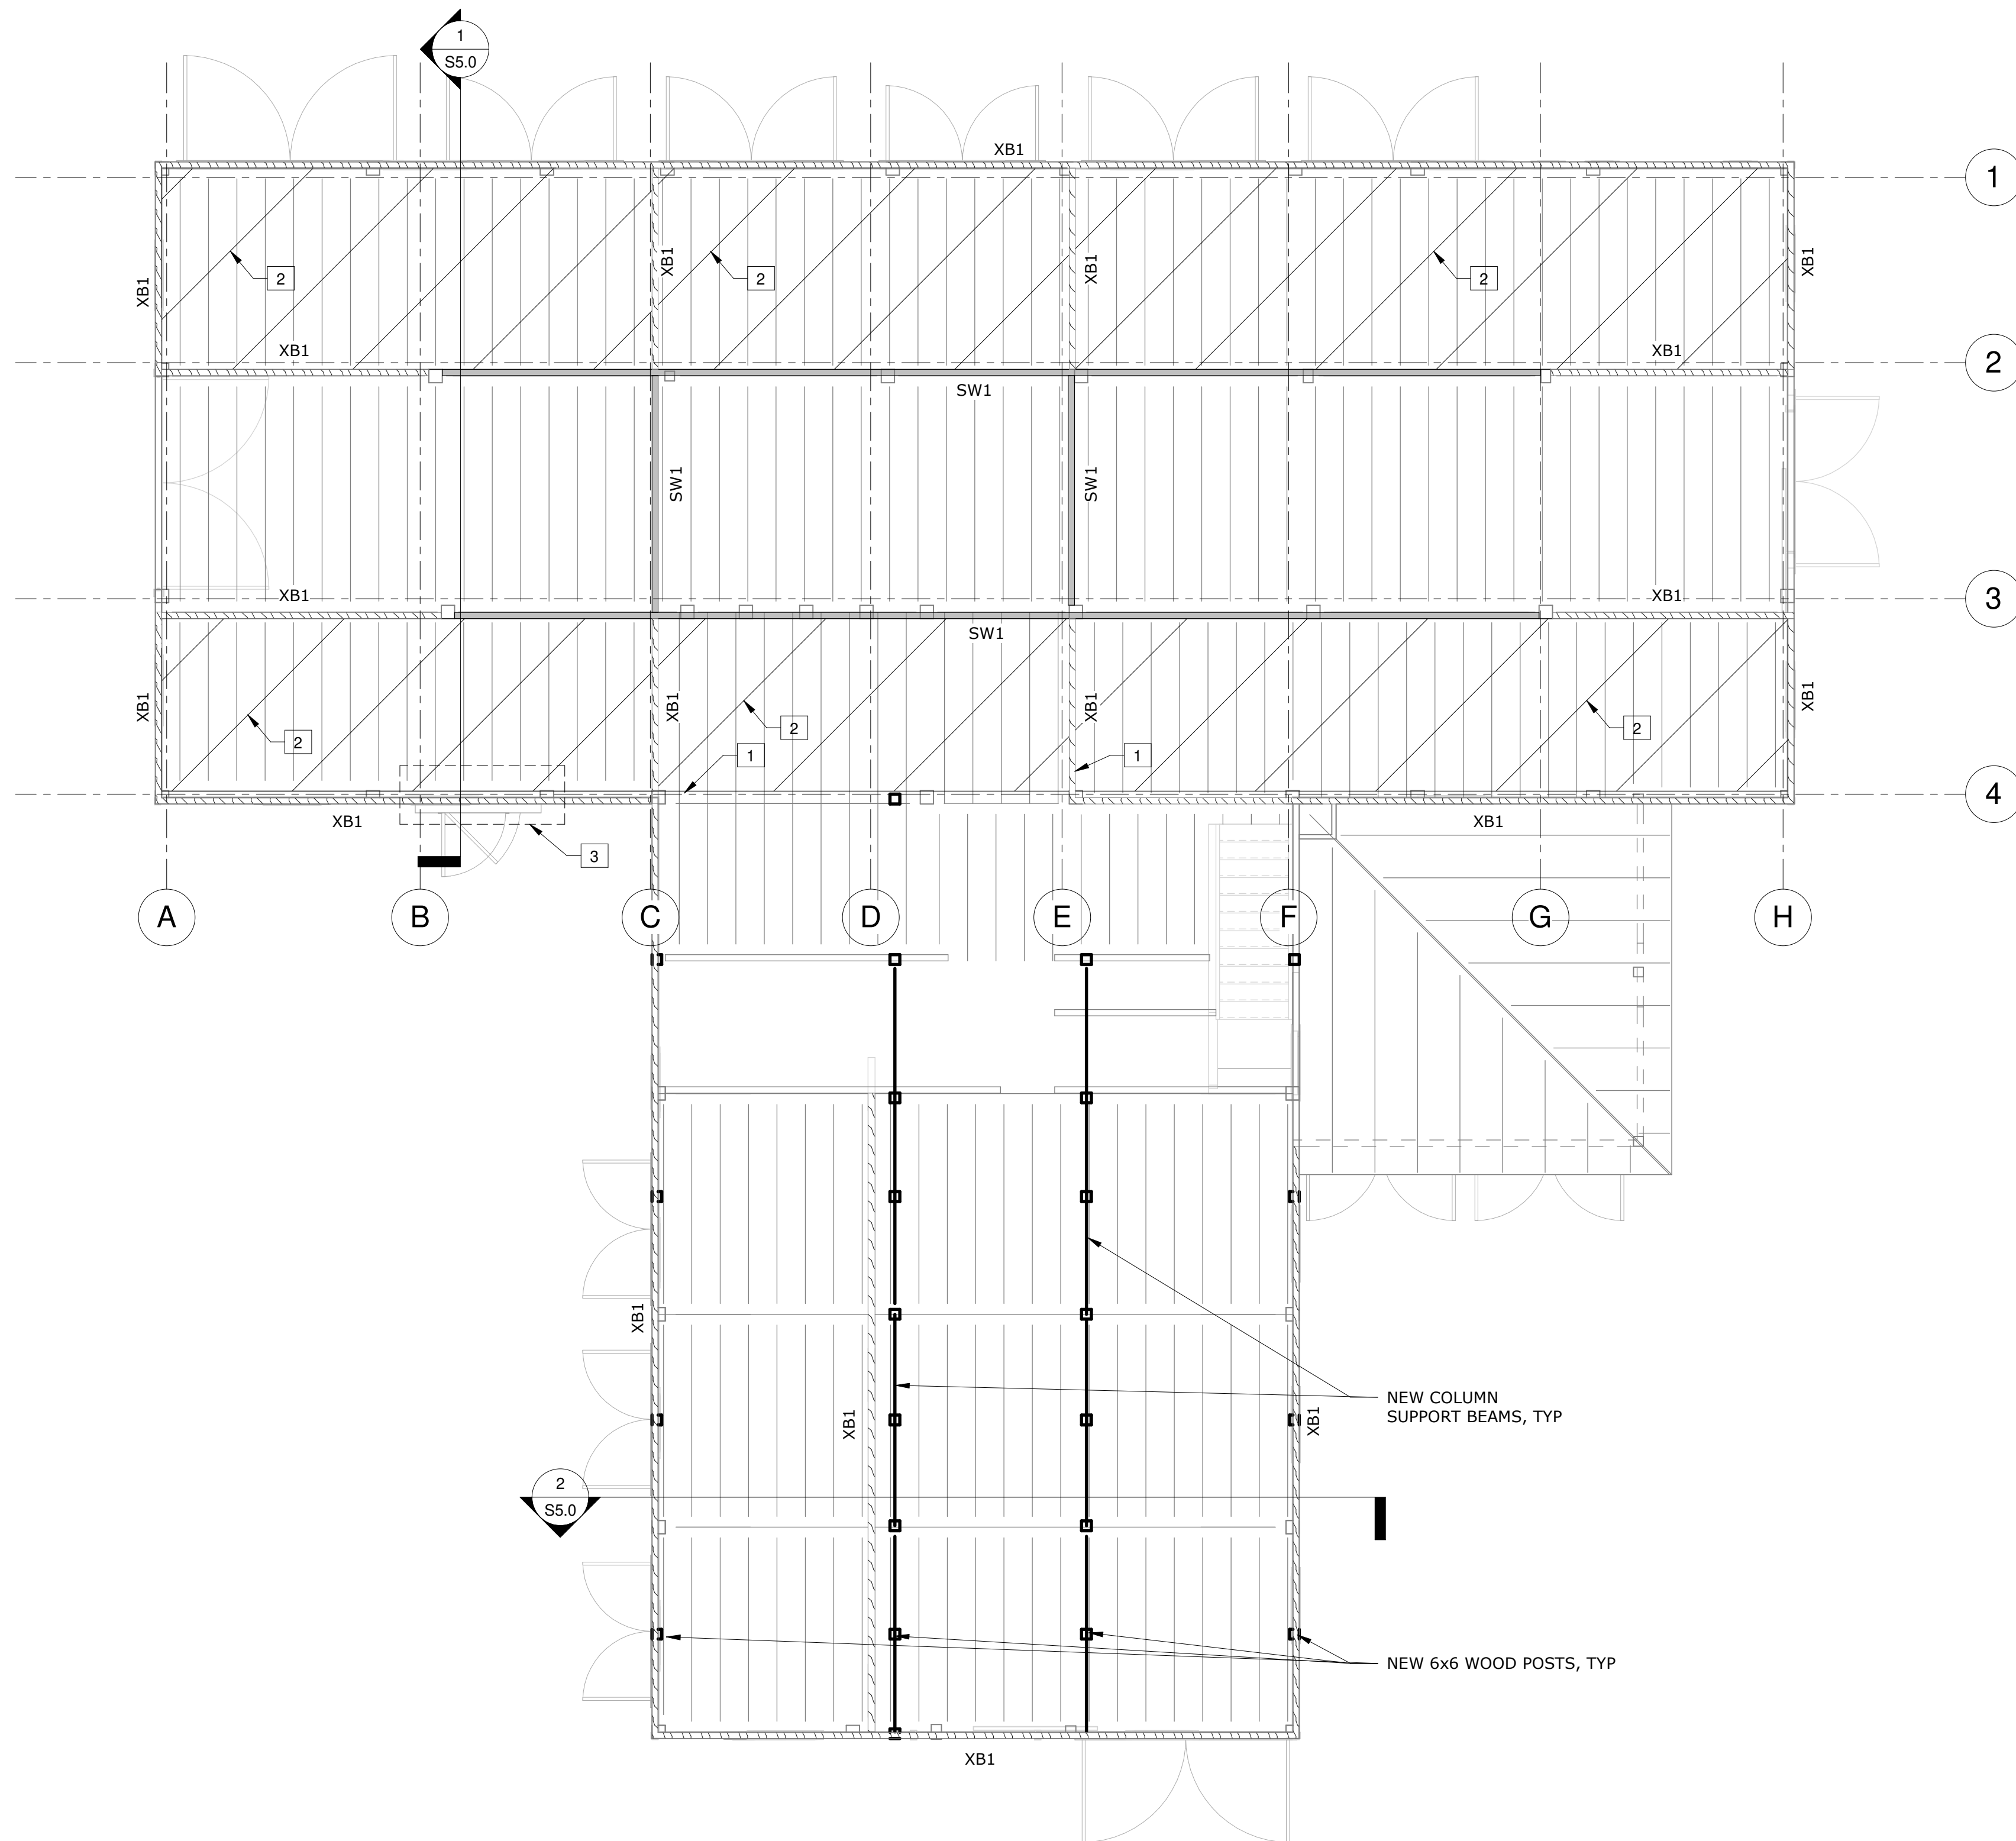
- 1 DAMAGED FLOOR FRAMING MEMBER, REPAIR OR REPLACE.
- 2 2x4 LAID FLAT @ 4'-0" OC W/ (2) 16d NAILS INTO EA JOIST, MIN (3) JOIST LAP.
- 3 FLOOR COLLAPSE AREA. NEW FRAMING & FLOORING REQUIRED.

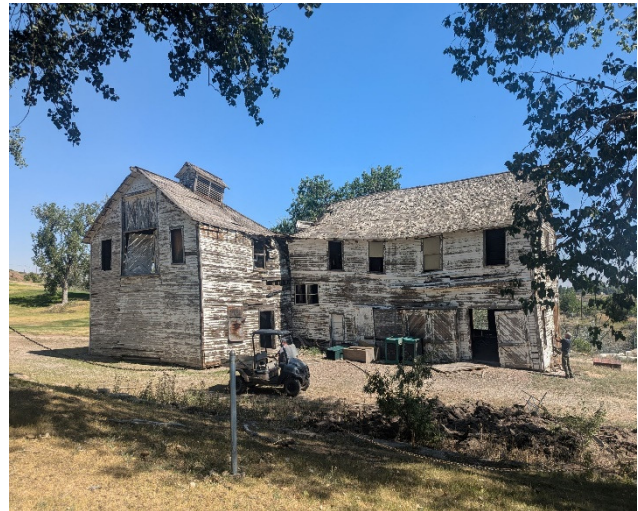
Since the time of the original report, the center of roof at the north section of the building has completely collapsed inward. The roof at the south section is still relatively in the same condition as described in the original report, aside from its connectivity to the north roof, which has completely severed. Though the center of the north roof has completely collapsed and most of the lateral pressure previously incurred to the exterior walls has been relieved, some lateral load from the collapsed material is still being placed against the exterior walls, and affecting their capacity for carrying and resisting load.

Due to the collapse of the primary roof, the second floor surface and framing is now much more exposed to weather conditions, particularly rain and snow. As the building faces more winter conditions it is anticipated that the floor system will see much faster weathering and movement due to exposure

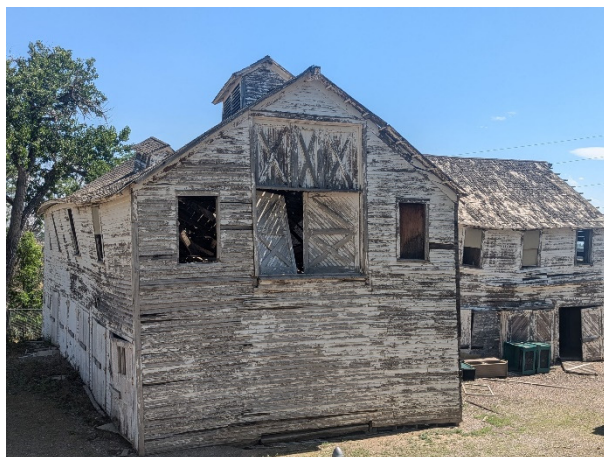
As indicated above, the collapse of the roof has reduced a large amount of lateral pressure on the exterior bearing walls. Currently the north wall is drastically out of plumb and is in danger of separating from the floor framing at second floor. Fallen material is still in some areas leaning against the exterior wall and there is still concern for maintaining the viability of the north wall of the building. Furthermore, the force resistance of that upper level framing is not braced and is compromised in the event of any large wind loads or seismic events.

The entire north roof system will now require full removal and replacement. There is remote possibility that some of the members of the existing roof system could be retained for reuse, but due to their age and the importance of the roof structure, it is recommended that the entire north roof structure be removed and replaced following stabilization of the perimeter bearing walls, restructuring of the window and door headers, and the central core construction.
