NATURAL RESOURCES PRESERVATION ADVISORY BOARD REGULAR MEETING

Wednesday, May 01, 2024 AT 11:00 AM

TOWN OF HIGHLAND BEACH, FLORIDA
3618 S. OCEAN BOULEVARD
HIGHLAND BEACH, FL 33487
Telephone: (561) 278-4548

At the April 16, 2024 Town Commission meeting, a presentation on the 2023 Beach Restoration Feasibility Study (“Study”) was made by Douglas Mann, Lead Coastal Engineer, of Aptim Environmental & Infrastructure, LLC. Note that a video recording of the meeting is available on the Town’s website. The Study includes a site-specific Beachfront Property Evaluation which provides beach and dune observations and corresponding recommendations for each beachfront property (see appendix B of Study). While the Commission did not provide any specific direction to the Board on educational outreach of the Beachfront Property Evaluations to residents, the Town Manager has indicated that such outreach efforts should be pursued by the Board in the form of communication strategies or a plan (e.g. letter, email, etc.). Given the latter, the item has been placed on the Board’s agenda for discussion.

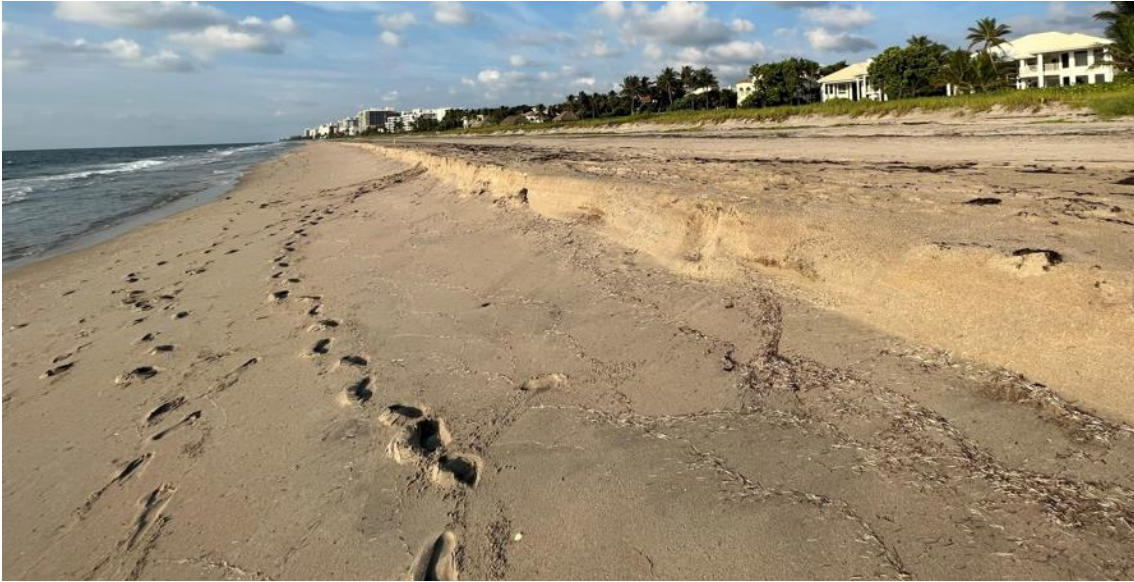
Photo 1. View looking south at the Highland Beach-Delray Beach municipal boundary. The berm has an approximate 20-inch scarp which diminishes to the south.

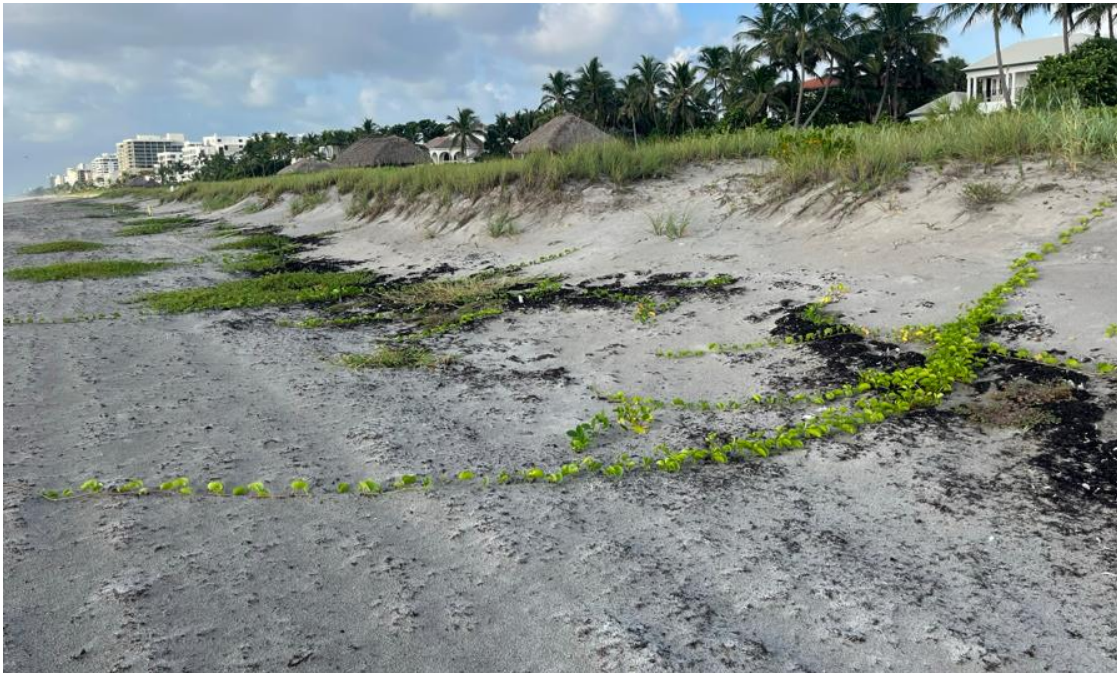
Photo 2. Eroded dune face with historical wrack lines at the toe of the dune.

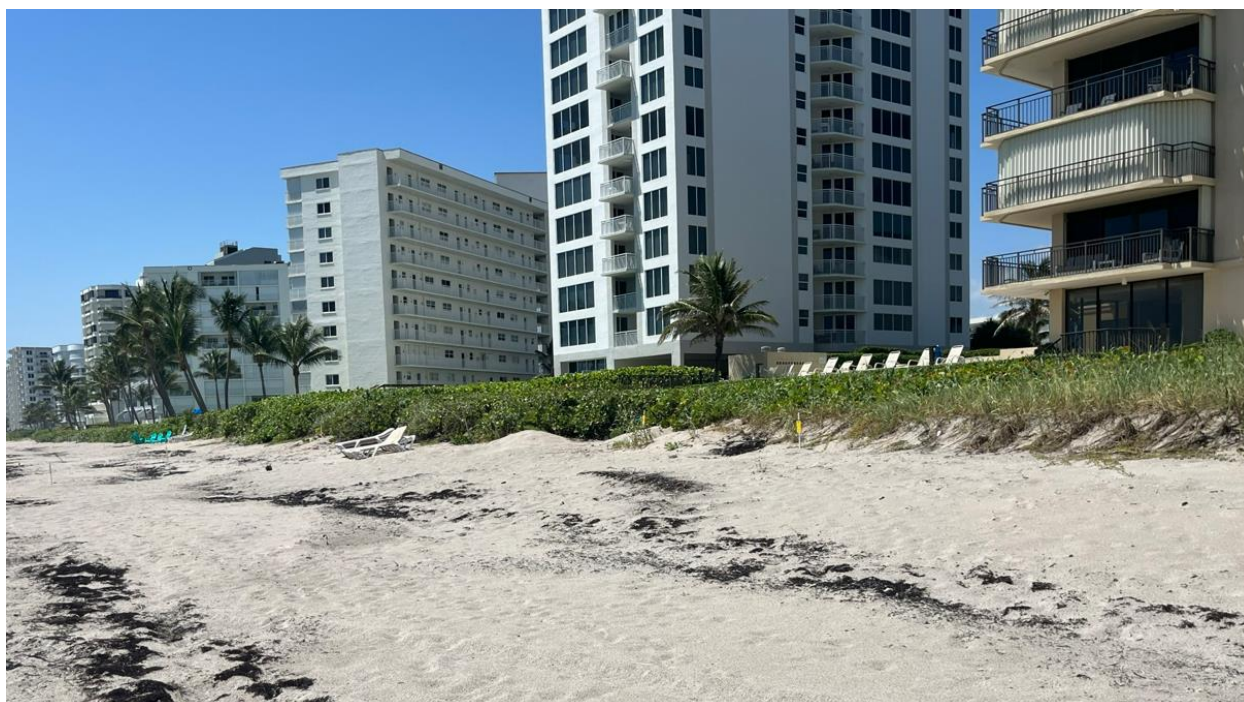
Photo 3. (From right to left) The scarped dune toe in front of Ocean Pines Condo. The scarped dune toe is hidden behind the seagrasses in front of Ocean Dunes Condo.

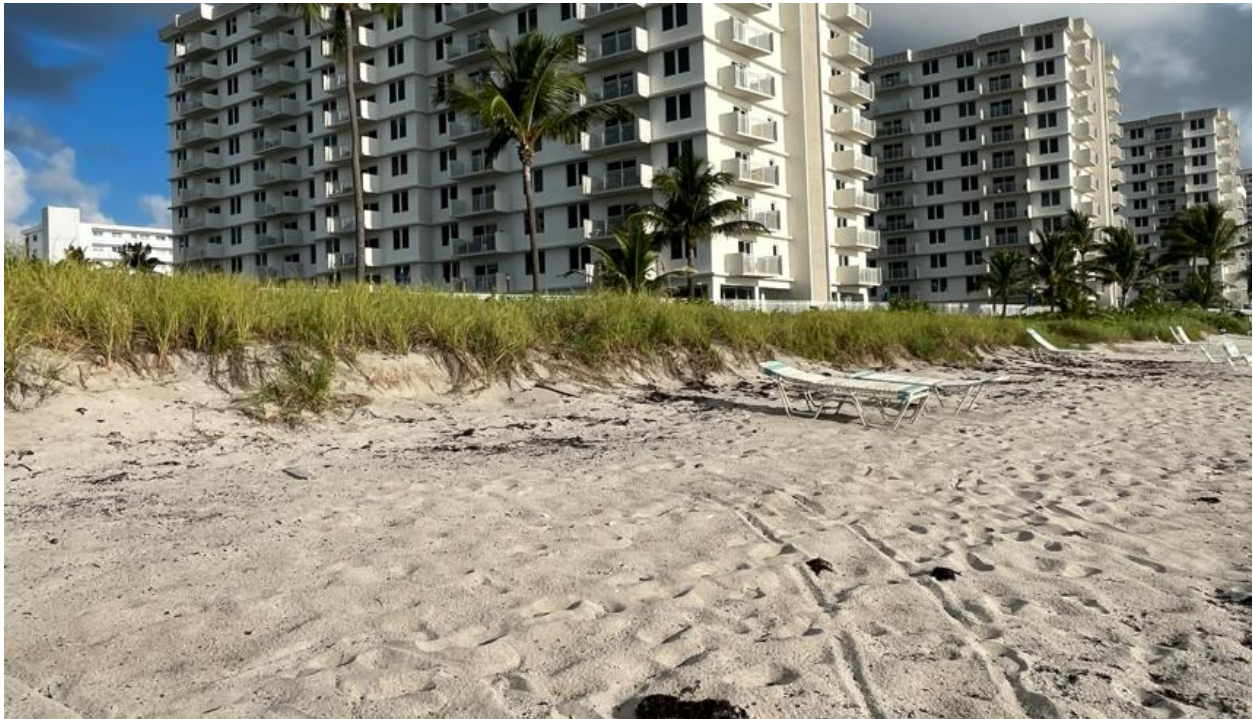
Photo 7. View to the north along the beach in front of the Ambassadors South Condo.
Note the scarped dune face and dune toe.

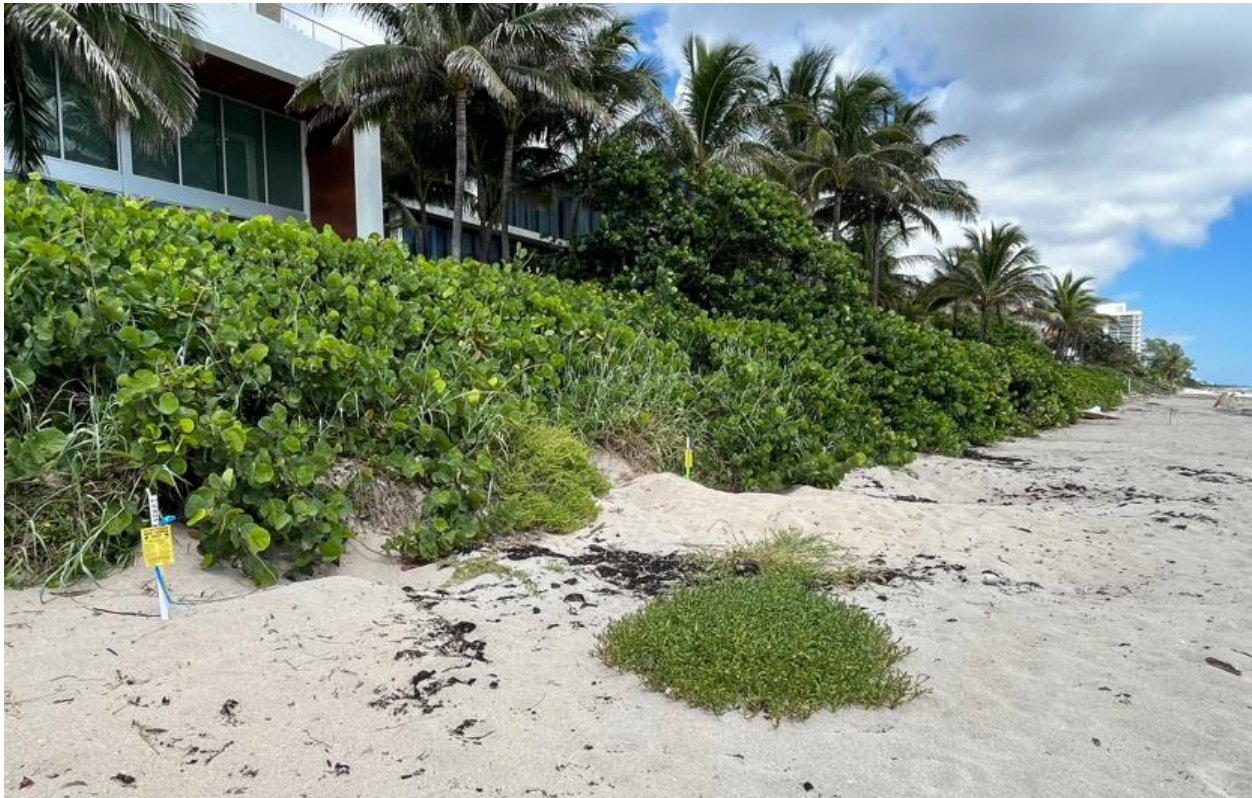
Along this section of the Town's shoreline, sections of the dunes are well vegetated, however, some areas have been undermined at the base of the vegetation and some dune scarps were visible along the shoreline (Photo 8). The elevation of the dune ranges from +15 feet, NAVD to +23 feet, NAVD. Profile R-199 had a lower dune elevation at +12 feet, NAVD, which provides limited protection.

Photo 8. Dune face scarping is resulting in undermining of the dune vegetation₁ in front of 3715 South Ocean Boulevard.

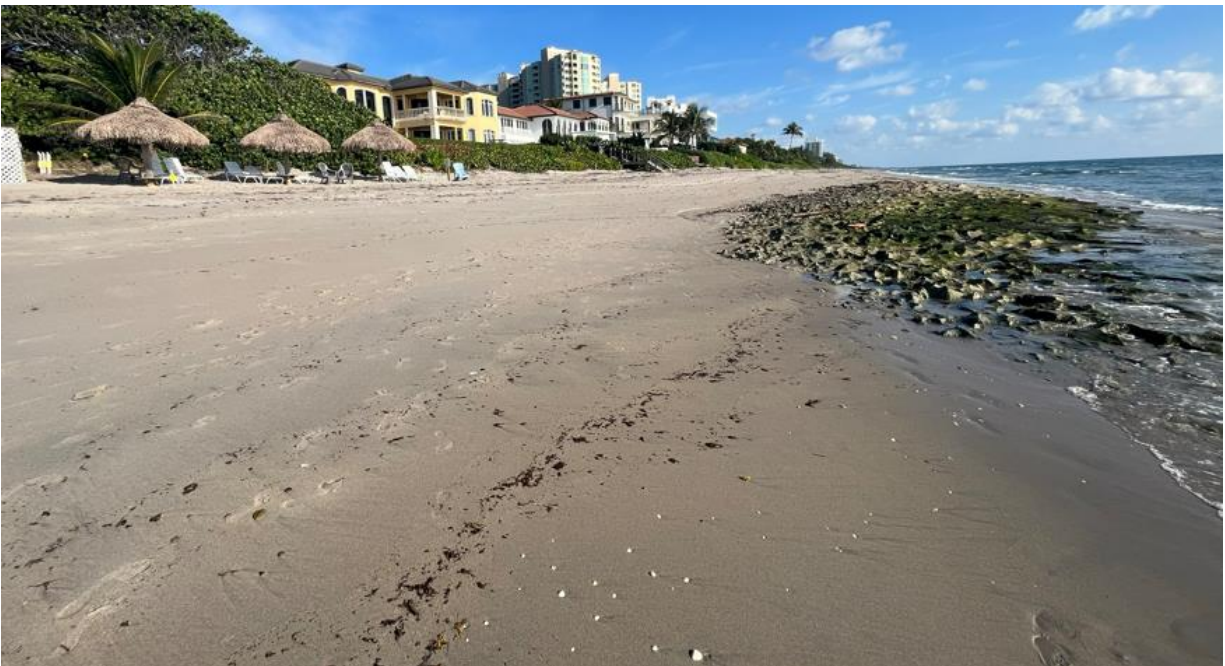
Persistent hardbottom first appears in this reach (Photos 9 and 10). In Photo 9, the outcrop in this area acts as a breakwater, holding the sand up on the adjacent property. In Photo 10, the rock outcrop functions more like a low-profile groin with a wider beach on the north side of the outcrop fronting 4201 and a receded shoreline on the south side of the outcrop, fronting Ocean Place Villas.

Photo 9. Looking north, the exposed hardbottom observed in front of the Regency Highland Club and 3907 South Ocean Boulevard.

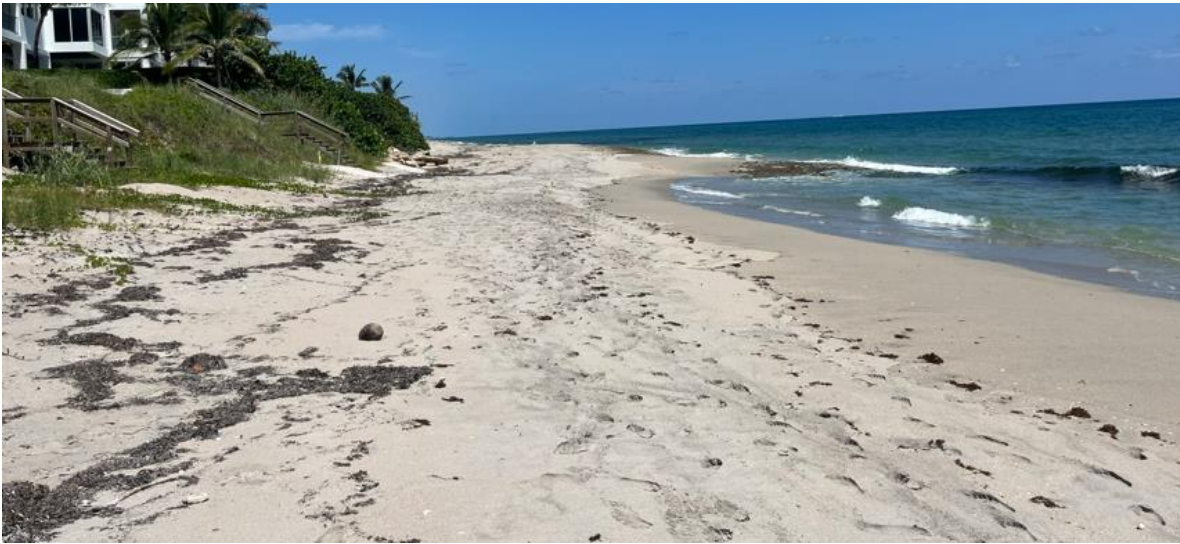
Photo 10. Looking north, the beach narrows to the south of the outcrop, fronting Ocean Place Villas.

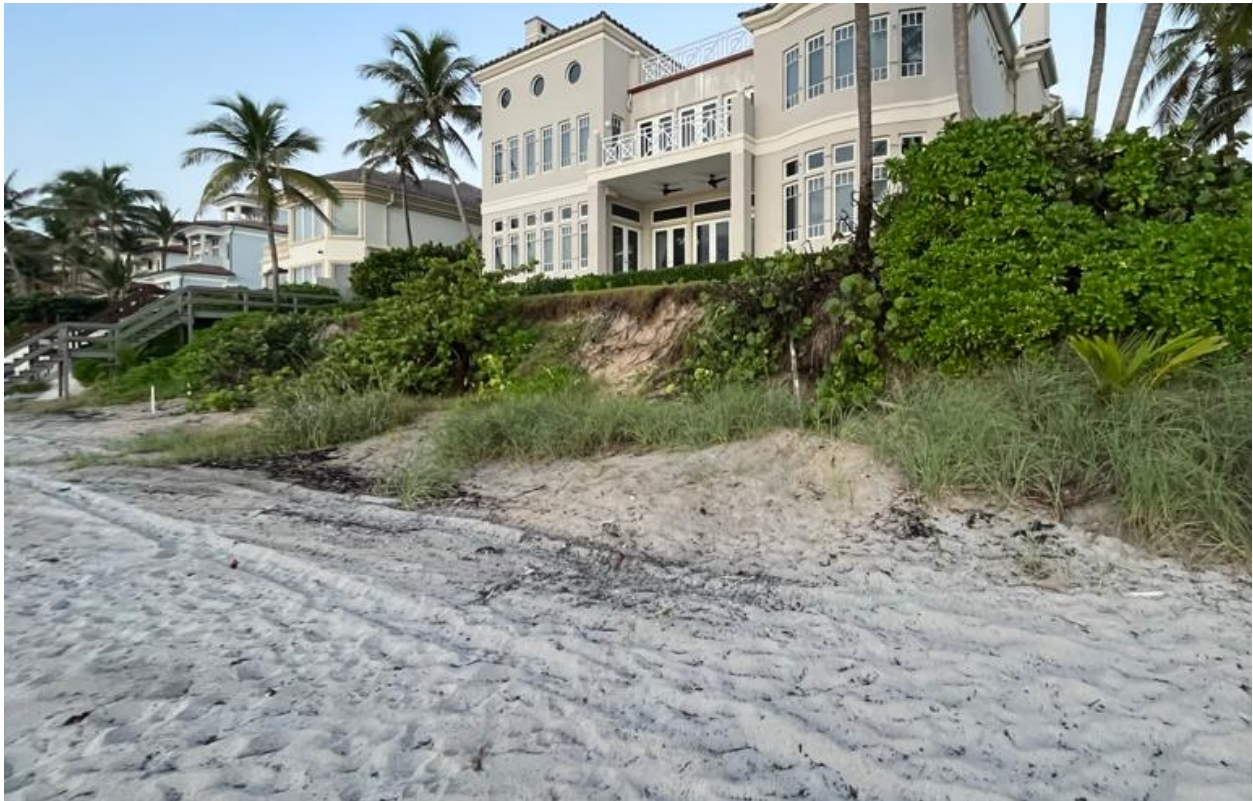
Photo 11. The most significant erosion observed in the Ocean Place Estates.

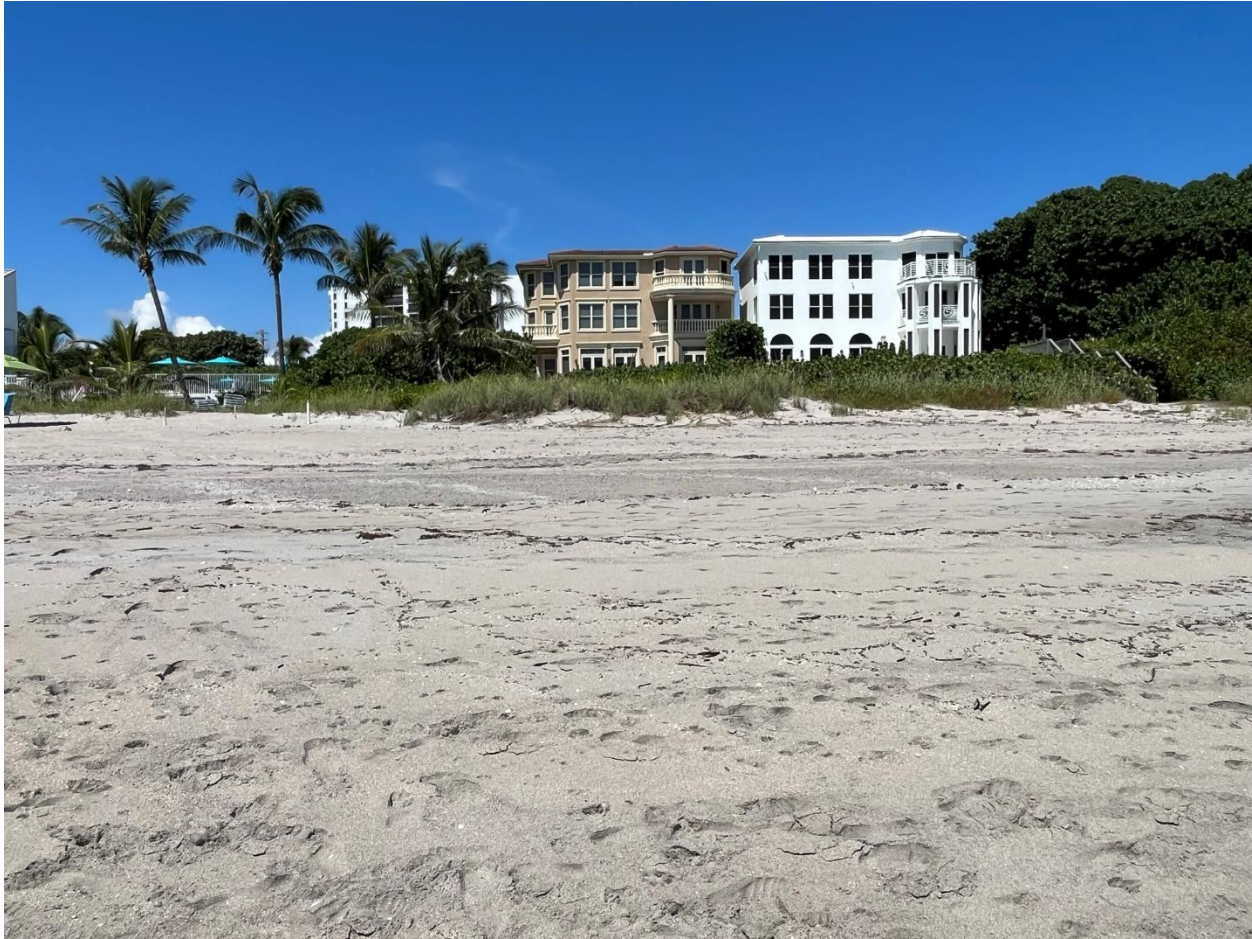
The beach access for the Admiral Walk Towers is at the limits of Highland Beach, with a 100-foot-wide vegetated dune with no structures present on this beach parcel. While the dune is wide in this area, the dune crest is at approximately +10 feet, NAVD (FDEP profile R-204, Appendix A), which is the lowest dune in Highland Beach. The dune crest is at the elevation of 100-year return period storm surge (Photo 14).

Photo 14. West view of the two single family homes and a portion of the Boca Highland Beach Club. Note the elevation of the dune relative to the adjacent Milani Park parcel.

The two single family homes and the Boca Highland Beach Club at the south end of Town have the lowest dune elevations in the Town. For those properties, this alternative is not recommended.

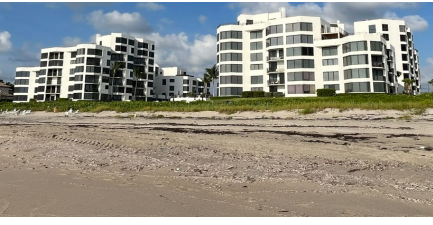
Townhouses of Highland Beach 2575 S Ocean Blvd

<ul style="list-style-type: none"> - Wide beach - Delray gray sands - ~6-8" berm scarp north-to-mid property, & ~8-10" berm scarp mid-to-south property - Historical wrack line at the toe of the dune - Mid-berm has 2 additional wrack line 	<ul style="list-style-type: none"> - Dune crest elevation is ~2.5-3' above berm elevation - The dune in front of the N. building is positioned more landward than the dune in front of the S. building; the southern dune falls in line with adjacent northern properties - Dune crest elevation lower in the middle of the property (~2' above berm) compared to the edges - ~1.5-2' of dune washout/scarp, with a 2H:1V seaward slope - Seaward vegetation up to the dune crest is thinned out, ~5-6' of front dune veg before dense sea grape back dune; especially the south dune - Dune comprised of panic grass, sea oats; sea grape 	No	No	Restore dune toe with 2cy/ft of sand along east dune toe. Revegetate dune toe with pioneer zone dune vegetation.

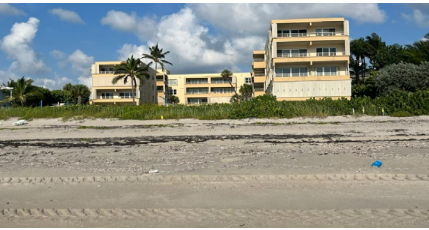
Carlton House 2701 S Ocean Blvd

<ul style="list-style-type: none"> - Wide beach - Delray gray sands - Berm scarp leveled off - Historical wrack line at the toe of the dune - Mid-berm has additional wrack line 	<ul style="list-style-type: none"> - Dune crest elevation is ~1-1.5' above berm elevation from north-to-mid property, and is ~2-2.5' from mid-to-south property - No dune scarp but rather wave runoff to ~2' above the berm, only observed mid-to-south; the northern dune is at a lower elevation and has been washed over, with little/thinned vegetation before back dune - 2H:1V seaward slope where vegetation remains than gradually 3H:1V slope to the toe/wrack line - North property edge has sea grapes rather than a planted dune - Dune comprised of ~5-10' of thinned sea oats before the dense back dune vegetation (sea grape); railroad vines growing in wrack line 	No	No	<p>Restore dune toe with 2cy/ft of sand along east dune toe.</p> <p>Revegetate dune toe with pioneer zone dune vegetation. Consider raising the crest elevation of the dune.</p>

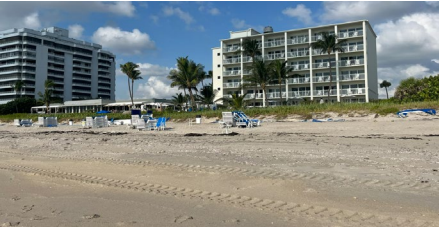
<ul style="list-style-type: none"> - Beach getting thinner - Delray gray sands - Berm scarp leveled off - Historical wrack line at the toe of the dune - Mid-berm has additional wrack line 	<ul style="list-style-type: none"> - Dune crest elevation is ~2-2.5' above berm elevation north of the steps and is ~3-4' south of the steps - North dune has ~2' scarp with a 1H:2V seaward slope and the south dune has ~3' scarp with a 1H:3V slope - Wave runup over parts of the north dune - Areas of thinned/dying vegetation on the seaward slopes - Dune comprised of panic grass, sea oats, with a denser sea grape back dune; the sea grapes along the south end of the property extend seaward to the dune crest 	No	No	Restore dune toe with 2cy/ft of sand along east dune toe. Revegetate dune toe with pioneer zone dune vegetation.

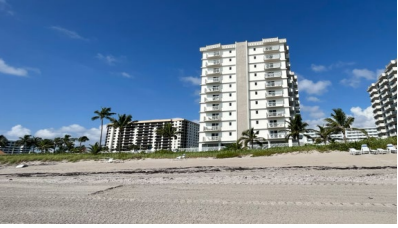
<ul style="list-style-type: none"> - Beach getting thinner - Delray gray sands, traces of Highland shelly brown sands - Berm scarp leveled off - Historical wrack line at the toe of the dune - Mid-berm has additional wrack line 	<ul style="list-style-type: none"> - North dune crest elevation is ~3.5-4' above berm elevation with ~2.5' scarp/runup to base of vegetation - Mid-property dune crest elevation is ~1' above berm, appears to have been washed over; has a wide flat dune crest - South dune crest elevation at 2.5' above berm elevation with a 1H:2V slope; scarp of 2' at base of sea grape - Dune comprised of mainly of sea oats, sea grape, and beach naupaka, with some palm trees - Dune has thinned/dying vegetation at scarp line, exposing base of sea grape/naupaka vegetation 	No	Yes. ~5' tall	Restore dune toe with 2cy/ft of sand along east dune toe. Revegetate dune toe with pioneer zone dune vegetation.

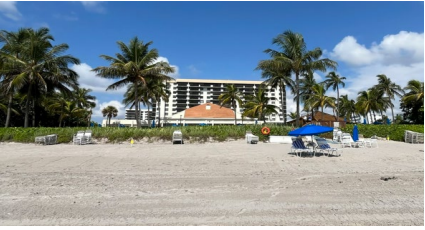
Coronado at Highland Beach Ocean Club 3321 S Ocean Blvd

<ul style="list-style-type: none"> - Beach getting thinner - Delray gray sands, traces of Highland shelly brown sands - Berm scarp leveled off - Historical wrack line at the toe of the dune - Mid-berm has additional wrack line 	<ul style="list-style-type: none"> - Dune crest elevation is ~3-3.5' above berm elevation with ~2.5' scarp/runup to base of vegetation and a 1H:2V slope - No fronting dune to the north - Dune comprised of mainly of sea oats, sea grapes, beach naupaka, and snake grass; ~20' wide - Dune has thinned/dying vegetation at scarp line, exposing base of vegetation 	No	No	Restore dune toe with 2cy/ft of sand along east dune toe. Revegetate dune toe with pioneer zone dune vegetation.
Ridge O 3401 S Ocean Blvd

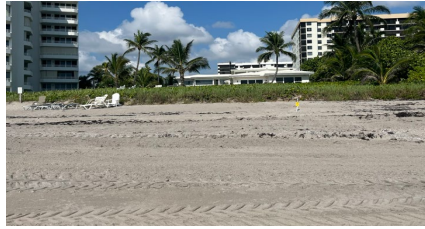
<ul style="list-style-type: none"> - Beach getting thinner - Delray gray sands, traces of Highland shelly brown sands - Berm scarp leveled off - Historical wrack line at the toe of the dune - Mid-berm has additional wrack line 	<ul style="list-style-type: none"> - Dune crest elevation is ~2-2.5' above berm elevation - ~1.5-2' scarp/runup to base of vegetation and a 1H:2V slope - Top of dune comprised of sea oats and sea grape ~50' wide - Dune has thinned/dying vegetation at scarp line 	No	No	Restore dune toe with 2cy/ft of sand along east dune toe. Revegetate dune toe with pioneer zone dune vegetation.

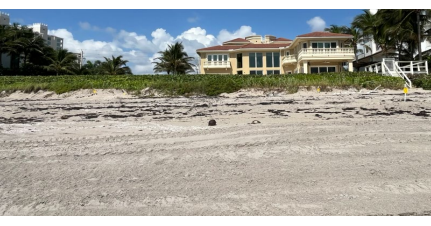
<ul style="list-style-type: none"> - Berm scarp leveled off - Historical wrack line at the toe of the dune extending to mid-berm - Delray gray and Highland brown sands - The beach is more narrow 	<ul style="list-style-type: none"> - North Dune crest elevation is ~1.5-2' above berm elevation with ~1.5' scarp/runup; sea grapes extend out to the dune toe - South of stairs to mid-property, the dune crest elevation is ~2-2.5' above berm elevation with ~2' scarp/runup; most of the front dune has washed out - Mid-to-south property, the dune crest is ~3' above berm elevation, with ~2.5' scarp/runup - The seaward dune has a 1H:1V slope up to crest, and a 2H:1V back slope - Dune comprised of sparse sea oats/grasses on the front dune and dense sea grape vegetation and naupaka 	No	No	Restore dune toe with 2cy/ft of sand along east dune toe. Revegetate dune toe with pioneer zone dune vegetation. Consider removing seagrape/naupaka and installing pioneer zone vegetation.

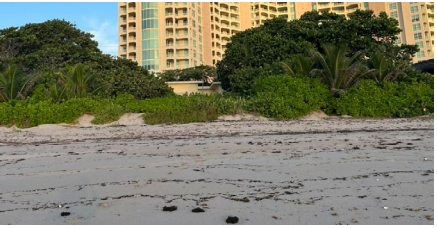
<ul style="list-style-type: none"> - Minor berm scarp, smoothed by runup - Historical wrack line at the toe of the dune extending to waterline - More Highland brown sands and shell hash visible 	<ul style="list-style-type: none"> - Dune crest elevation is ~3-3.5' above berm elevation with ~2-2.5' scarp/runup - The seaward dune has a 1H:1V slope up to crest with level top; scarped areas of dune have 1H:2V slope - Dune sparsely comprised of sea oats with slightly denser sea grape and naupaka vegetation on dune crest 	No	No	Restore dune toe with 2cy/ft of sand along east dune toe. Revegetate dune toe with pioneer zone dune vegetation. Remove exotics. Consider reducing the seagrape and planting pioneer dune vegetation.
3813 S Ocean Blvd

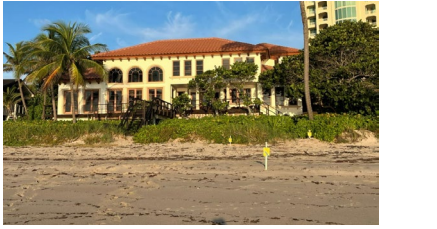
<ul style="list-style-type: none"> - 6-8" berm scarp, smoothed by runup - Historical wrack line at the toe of the dune extending to waterline - More Highland brown sands and shell hash visible - Dune overwalk is ~8' above the berm 	<ul style="list-style-type: none"> - Dune crest elevation is ~3-3.5' above berm elevation with ~2.5-3' scarp; wave runup of dune extends ~5' landward in some areas - The north dune has a 2H:1V slope up to crest with level top; the back dune has 4H:1V slope - The dune, south of the steps, has a 1H:2V slope, with more scarp - Dune sparsely comprised of panic grass, naupaka, and misc. vegetation on dune's scarped slope and dune crest. Denser sea grapes in the back dune 	No	No	Restore dune toe with 2cy/ft of sand along east dune toe. Revegetate dune toe with pioneer zone dune vegetation.

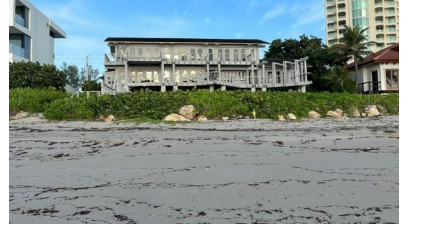
3817 S Ocean Blvd

<ul style="list-style-type: none"> - 8-9" berm scarp - Historical wrack line at the toe of the dune extending to waterline - More Highland brown sands and shell hash visible - Armoring with 2.5-3.5' wide boulders present in front of the dune, more so from north-to-mid property 	<ul style="list-style-type: none"> - Dune crest elevation is ~3-3.5' above berm elevation with ~3' scarp where no armoring is present - The dune has a 2H:1V slope but exhibits a 1H:3V slope where dune scarp is present (mid-south property) - Dune comprised of grasses, sea grapes, naupaka, and misc. vegetation on dune's scarped slope and dune crest 	No	No	Restore dune toe with 2cy/ft of sand along east dune toe. Revegetate dune toe with pioneer zone dune vegetation.
3833 S Ocean Blvd

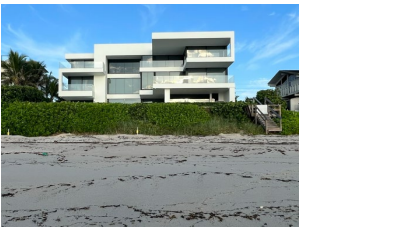
<ul style="list-style-type: none"> - 4-6" berm scarp, smoothed by runup - Historical wrack line at the toe of the dune extending to waterline - More Highland brown sands and shell hash visible 	<ul style="list-style-type: none"> - Dune crest elevation is ~2-2.5' above berm elevation with ~2' scarp/runup to crest - The seaward dune has a 1H:2V slope up to crest - The back dune is 5-6' above berm elevation - Dune comprised of sea oats and grasses fronting a denser sea grape and naupaka back dune 	No	No	Restore dune toe with 2cy/ft of sand along east dune toe. Revegetate dune toe with pioneer zone dune vegetation.

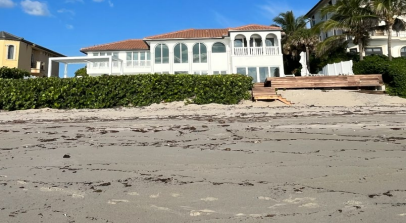
3905 S Ocean Blvd

<ul style="list-style-type: none"> - Berm scarp leveled off - Historical wrack line at the toe of the dune extending to waterline - More Highland brown sands and shell hash visible 	<ul style="list-style-type: none"> - North dune crest elevation is ~3' above berm elevation and is positioned under the deck structure and no vegetation - Mid-to-south dune crest elevation is ~4' with ~2.5-3' scarp/runup to base of vegetation - The seaward dune has a 2H:1V slope up to crest - Dune comprised of sparse grasses and denser sea grape - Only ~20' of vegetation between beach and seaward edge of the patio 	No	No	<p>Restore dune toe with 2cy/ft of sand along east dune toe. Revegetate dune toe with pioneer zone dune vegetation.</p>
3907 S Ocean Blvd

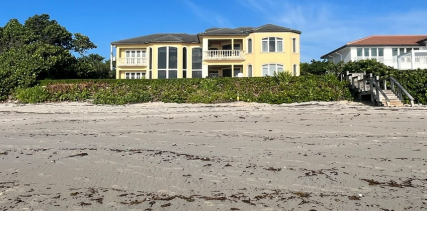
<ul style="list-style-type: none"> - Berm scarp leveled off - Berm appears higher north-to-mid property compared to mid-to-south property - Historical wrack line at the toe of the dune extending to waterline - More Highland brown sands and shell hash visible - Rock outcrop visibility extends into 1-2' deep water of swash zone 	<ul style="list-style-type: none"> - Not much of a pioneer dune present - Dune crest elevation is ~3' above berm elevation with a 2H:1V slope and ~1.5' scarp and at south end of property - Back dune has a 1H:1V slope to crest at ~8' above berm elevation - North-to-mid property, the dune is ~15-20' wide - Mid-to-south property, the dune narrows to ~10' wide - Dune comprised of sea grape and sparse sea oat vegetation 	Yes; on dry beach, acts like groin	No	<p>Restore dune toe with 2cy/ft of sand along east dune toe. Revegetate dune toe with pioneer zone dune vegetation.</p>

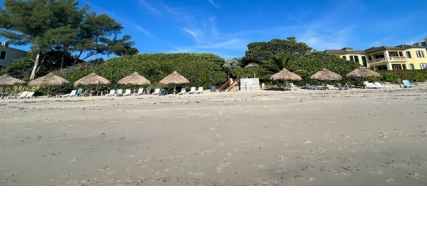
<ul style="list-style-type: none"> - Berm scarp leveled off - Historical wrack line at the toe of the dune - More Highland brown sands and shell hash visible - Rock outcrop visibility extends into 1-2' deep water of swash zone 	<ul style="list-style-type: none"> - North-to-mid property dune crest elevation is ~2.5' above berm elevation sparsely covered with grasses and sea oats - South dune crest elevation is ~3-3.5' above berm elevation with ~2.5' scarp at base of sea grape vegetation - Areas where wave runup occurred on the dune, has a 1H:1V slope but exhibits a 1H:3V slope where dune scarp is present (north-to-mid property) 	Yes; half on dry beach/ partially wet, acts like breakwater	No	<p>Restore dune toe with 2cy/ft of sand along east dune toe. Revegetate dune toe with pioneer zone dune vegetation. Consider moving beach chairs to the berm.</p>

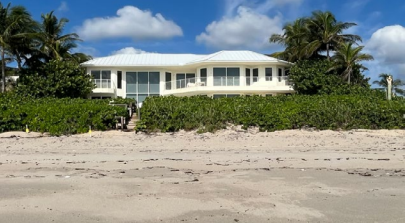
<ul style="list-style-type: none"> - Berm scarp leveled off - Historical wrack line at the toe of the dune extending to waterline - More Highland brown sands and shell hash visible - Rock outcrop visibility only in 2-3' deep water of swash zone 	<ul style="list-style-type: none"> - Front dune crest elevation is ~3-3.5' above berm elevation with ~2-2.5' scarp/runup at base of vegetation - The seaward dune has a 1H:2.5V slope up to crest - Dune comprised of some sea oats with some denser sea grape and naupaka vegetation extending from the back dune to the dune toe - ~40-45' of dune fronting the patio structure 	Yes; visible in 2-3' deep water, from mid-to-south property; no effect.	No	<ul style="list-style-type: none"> Restore dune toe with 2cy/ft of sand along east dune toe. Revegetate dune toe with pioneer zone dune vegetation.

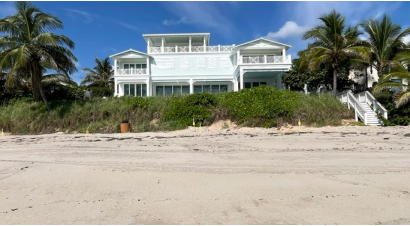
<ul style="list-style-type: none"> - Berm scarp leveled off - Historical wrack line at the toe of the dune extending to waterline - More Highland brown sands and shell hash visible - Rock outcrop visibility only in 1-2' deep water of swash zone 	<ul style="list-style-type: none"> - Pioneer dune has been mostly washed over; some vegetation remains on the slipped seaward face - Dune crest elevation is ~10' above berm elevation with ~3-5' of scarp/runup - ~4.5' of runup behind the beach access steps - Erosion along landward side of steps - The northern dune has a 1H:3V slope up to crest - The southern dune has a 1H:4V slope to from ~5-10' above the berm and then the slope becomes 1H:1V down to the dune toe - Dune comprised of some sea oats with dense naupaka growing mid-property - ~20' of dune fronting the grass yard 	Yes; rocks up on beach and also visible at waterline and shallow water of swash zone; no effect.	No	<ul style="list-style-type: none"> Restore dune toe with 2cy/ft of sand along east dune toe. Revegetate dune toe with pioneer zone dune vegetation.

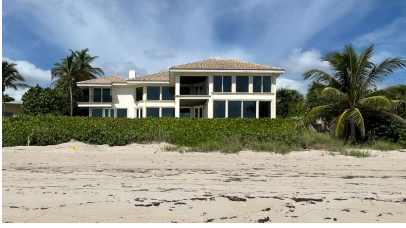
4111 S Ocean Blvd

<ul style="list-style-type: none"> - Berm scarp leveled off - Historical wrack line at the toe of the dune extending to waterline - More Highland brown sands and shell hash visible 	<ul style="list-style-type: none"> - Not much of a pioneer dune present; deflated - Dune crest elevation is ~2.5-3' above berm elevation with ~2-2.5' scarp/runup over the deflated dune to the base of the dense vegetation - Fallen front dune comprised of sea oats - Tall dense back dune, comprised of sea grape and naupaka, is exposed and scarped at the base 	No	No	Restore dune toe with 2cy/ft of sand along east dune toe. Revegetate dune toe with pioneer zone dune vegetation.
4115 S Ocean Blvd

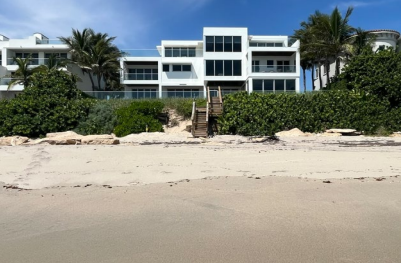
<ul style="list-style-type: none"> - Berm elevation is ~0.5' higher than southern adjacent property - Historical wrack line at the toe of the dune extending to mid-berm - More Highland brown sands and shell hash visible - Visible, partially buried rocks dune toe (Armoring boulders?) 	<ul style="list-style-type: none"> - Not much of a pioneer dune present due to severe erosion, especially at mid-property near the steps - Dune has a 1H:5V slope, with 2' of scarp at the base of the vegetation - Dune comprised sea grape, naupaka, and misc. vegetation - Northern dune vegetation extends seaward ~10' compared to the rest of the dune 	Yes; some rocks buried at the dune toe. Some of the rock outcrop along the north edges of the property act as breakwater for this property. No exposed rocks in the berm fronting property, but another outcrop is exposed along the south property edge.	No	Restore dune toe with 2cy/ft of sand along east dune toe. Revegetate dune toe with pioneer zone dune vegetation.

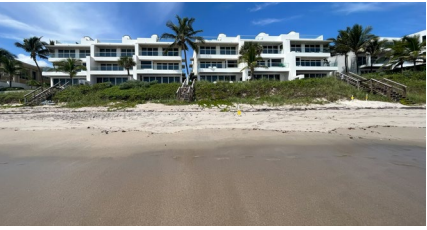
<ul style="list-style-type: none"> - Very narrow beach, <40' from waterline to dune toe -Berm scarp is ~6" at waterline Historical wrack line at the toe of the dune extending to mid-berm - More Highland brown sands and shell hash visible - Northern steps are the most seaward and tapers landward at each location. -Rock outcrop only present at north end of property 	<ul style="list-style-type: none"> - Not much of a pioneer dune present; appears flattened with some grasses only ~2' above berm elevation - The dune appears to be severely eroded, with 4-6' of wave run-up and 2' to 5' scarp in areas - Dune position tapers landward between each walkover staircase; 20' from north-to-mid steps; 10' from mid-to-south steps; 10' from south steps to property line - North dune has a 1H:2V slope, Mid dune has a 1H:3V slope, and South dune has a 1H:5V slope - Dune comprised of sea oats, grasses, sunflowers, and misc. vegetation 	Yes; rock outcrop at north end of property acts as a groin. Visible into 2' deep water	Yes; visible at south property edge. ~10' tall, concrete cap	Restore dune toe with 2cy/ft of sand along east dune toe. Revegetate dune toe with pioneer zone dune vegetation.

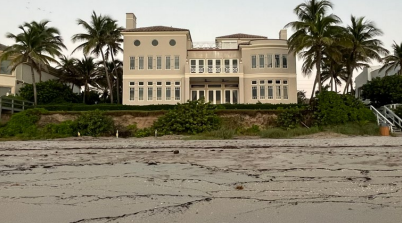
<ul style="list-style-type: none"> - Berm scarp leveled off - Narrow beach - Historical wrack line at the toe of the dune extending to waterline - More Highland brown sands and shell hash visible 	<ul style="list-style-type: none"> - Severe dune erosion present, with scarp of ~10' up to top of dune face - Fallen slope/front dune has elevation of ~1' above berm elevation - Dune is setback 10-15' landward compared to neighbors - Dune comprised sea oat, sea grape and misc. vegetation - Dune slope has 1H:8V slope at it's most extreme sheared face - The seaward face of the home/structure is <10-15' from the scarped dune face 	No	Yes; buried SSP	<p>Restore dune toe with 2cy/ft of sand along east dune toe. Revegetate dune toe with pioneer zone dune vegetation.</p>
2 Ocean Place

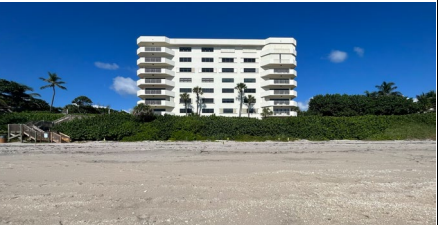
<ul style="list-style-type: none"> - ~4-6" berm scarp, smoothed by run-up - Beach is less narrow at this property - Historical wrack line at the toe of the dune extending to waterline - Highland brown sands with shell hash more prominent 	<ul style="list-style-type: none"> - Dune toe has elevation of ~3' above the berm elevation with ~1.5-2' scarp at the toe of the dune - Back dune has a 1H:2V slope under the vegetation and extends 15-20' above the berm elevation - Wave run-up/scarp is visible up to 2-3' above berm elevation at the base of the vegetation - Dune tapers landward about 10' from the north end to the south end of the property - Dune comprised of sea oats, sea grape, railroad vines, and misc. vegetation 	Yes; flat rocks/ridge is visible in 1-2' deep water; no effect.	No	<p>Restore dune toe with 2cy/ft of sand along east dune toe.</p> <p>Revegetate dune toe with pioneer zone dune vegetation.</p>

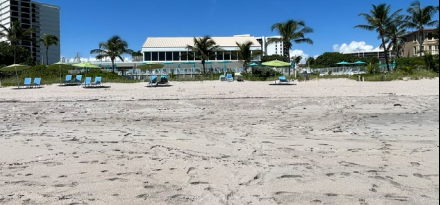
<ul style="list-style-type: none"> - Beach is relatively wide at this property - Historical wrack line at the toe of the dune extending to waterline - Highland brown sands with shell hash more prominent - Nearshore bar extends from Yamato Rock, ~20' from shoreline 	<ul style="list-style-type: none"> - Dune elevation is 1.5-2' above berm elevation with ~1' scarp/wave run-up over the front of dune - Dune is ~30-40' wide from the beach to the seaward edge of the structures - The back dune is a lower elevation than the front dune (appears to be the same elevation as the berm) - Front dune is comprised of sea oats and grasses before a denser sea grape and naupaka back dune 	No	Unknown	<ul style="list-style-type: none"> Restore dune toe with 2cy/ft of sand along east dune toe. Revegetate dune toe with pioneer zone dune vegetation. Consider raising dune crest elevation for increased storm protection.
