City of Homer Agenda

City Council Worksession

TO: Marvin Yoder, City Manager
FROM: Carey S. Meyer, City Engineer
DATE: May 14, 2020
SUBJECT: Seawall Considerations

Subject: Homer Seawall Alternatives Analysis

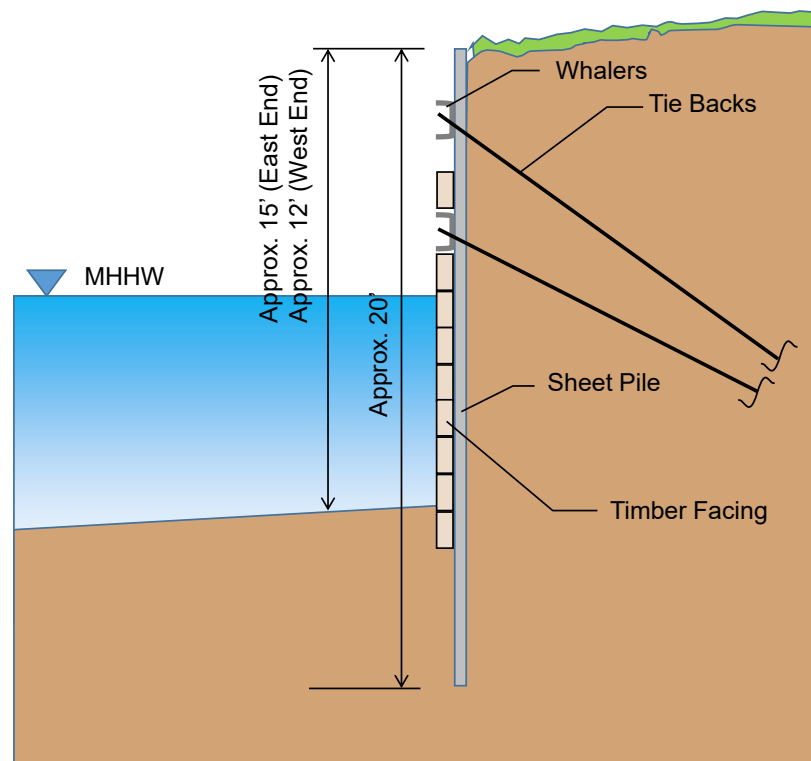
The seawall was constructed in 2002 using fiberglass sheet pile. Based on information provided by the City of Homer, the structure experienced immediate challenges primarily due to several major storm events occurring during construction and has since required continued maintenance to maintain functionality. One issue that was observed early in the project, was the

degradation of the sheet pile material due to abrasion from the beach sediments. Timber paneling was subsequently installed to mitigate the abrasion. A steel whaler (horizontal structural member) was also installed to provide additional structural support for the wall (Figure 2 and Figure 3). Over time, it has been observed that the elevation of the seafloor at the toe of the wall is lowering, noting that the elevation of the toe varies greatly throughout the year (i.e. seasonal variations). Continued lowering of the toe elevation will eventually undermine the seawall and allow retained uplands to slough.

Figure 2. Existing seawall schematic.

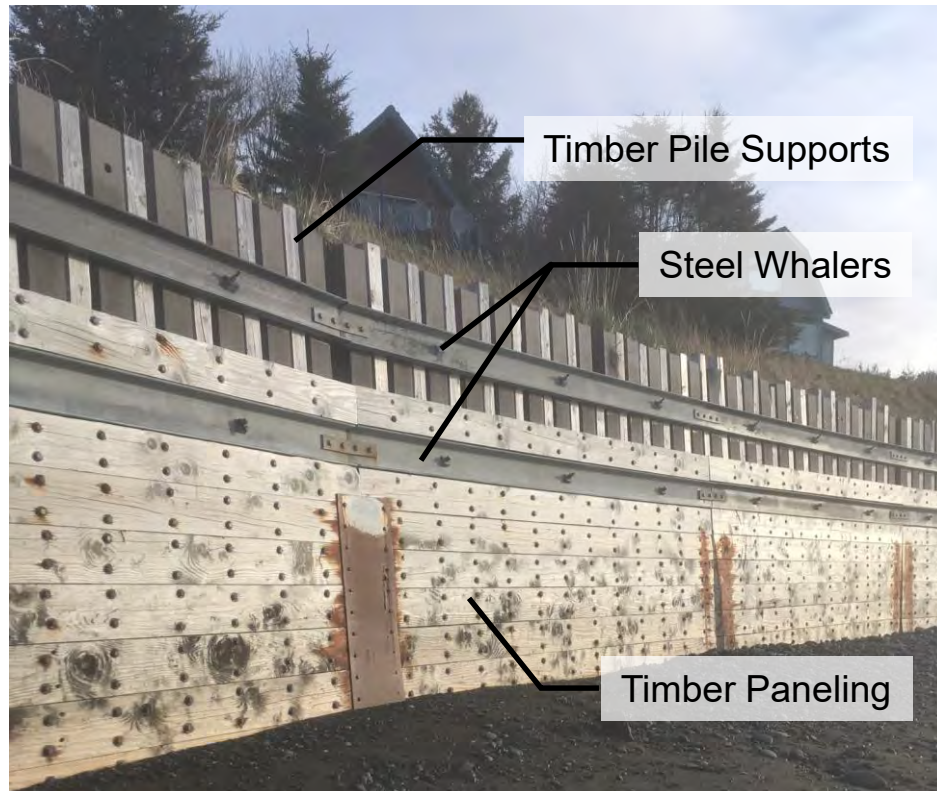
A site visit was conducted on April 25, 2019 with the City of Homer City Engineer to observe the condition of the seawall. During the visit, several sink holes at the top of the seawall were observed. These were generally correlated with local failures of the timber facing at the toe of seawall (Figure 4). Within these local failures, the degrading effects of the prior abrasion were observed. Seawall height, as measured from the beach to the top of the sheet pile, was measured near the culvert drainage located on the east side of the seawall (Figure 1) and was found to be approximately 15 feet. A schematic showing the approximate conditions of the existing seawall is shown in Figure 2. Armor stone was observed on the eastern terminal of the seawall and is shown in Figure 5. Many of the armor stone were observed to have rounded edges indicating recurring movement over time which is assumed to be due to wave action. Based on rough measurements and an assumed density of 160 pounds per cubic foot, stones were found to range from 1,500 lbs. to 7,500 lbs. in weight with most stones weighing less than 2,000 lbs.

Figure 3. Seawall existing condition.

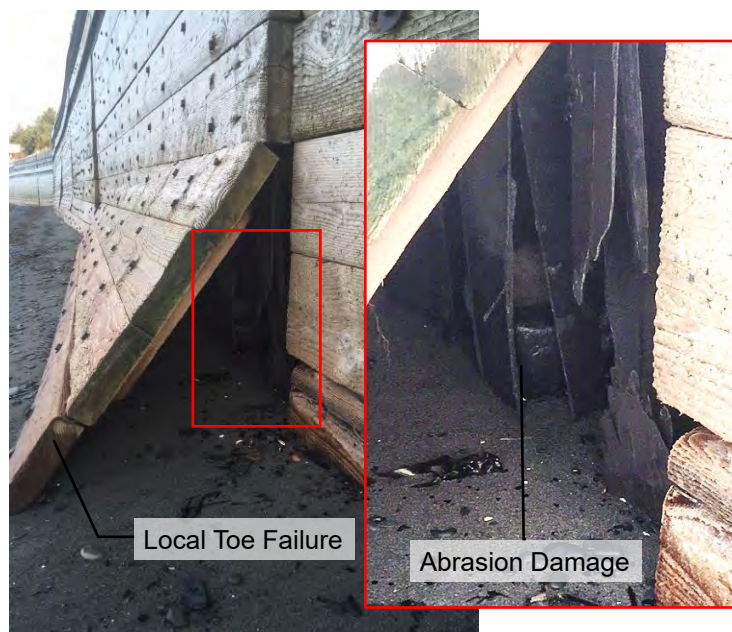
Damage to the wall is a direct result of erosion at the toe of the wall as confirmed by the engineering firm HDR Inc. Erosion of the toe exposes the fiberglass sheet pile (below the protective timber face). This makes it easier for wave forces to get behind the timber panels, breaking them while damaging the sheet pile. Holes in the sheet pile at the bottom of the wall then allow material from behind the wall to escape. The wall is structurally supported by tie-rodged concrete blocks buried behind the wall; these become exposed with the loss of material, damage to sheet pile, and breaking of timber panels (please see attached 'Figure 1' diagram). Protecting the toe of the wall from erosion therefore will extend wall life and significantly reduce maintenance costs.

Figure 4. Example of observed local failure – correlates to sink hole at top of the seawall. Inset shows previous assumed abrasion damage.

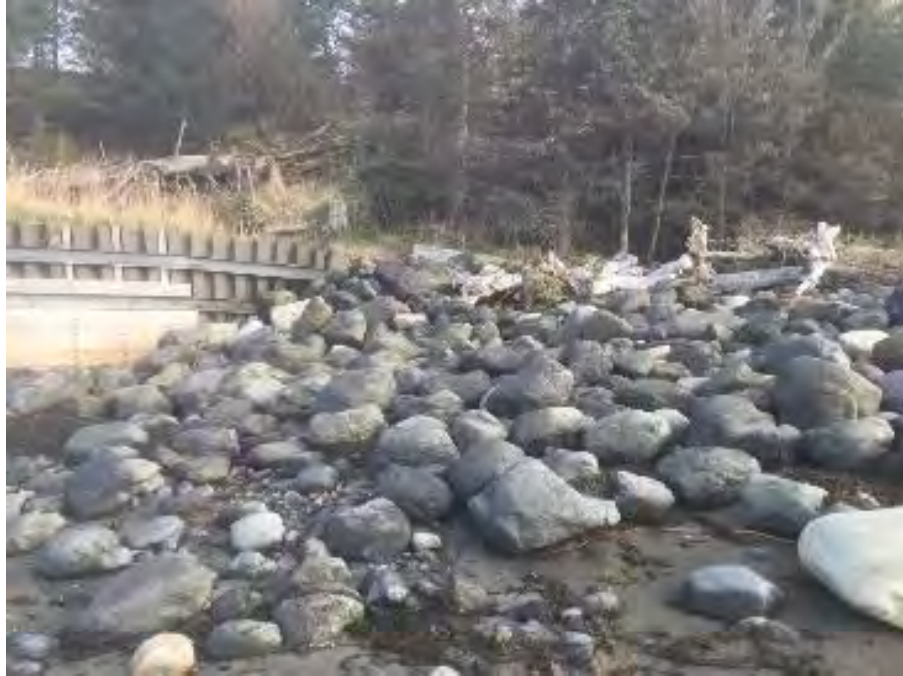
Figure 5. Observed armor stone at east terminal of the seawall.

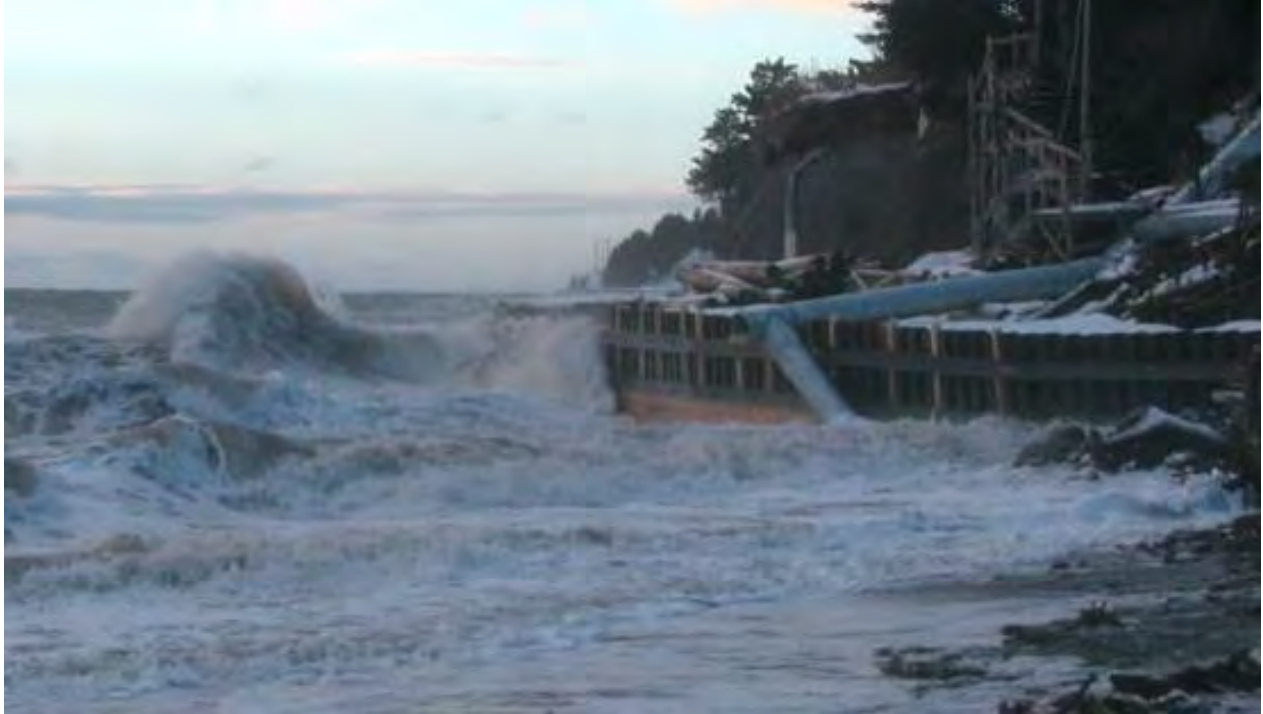
Kachemak Bay is relatively shielded from open ocean swell coming from the Gulf of Alaska. Waves generated at the site are primarily wind-generated waves that have developed within the Kachemak Bay/Cook Inlet water bodies. Because of this, wave directional trends will closely align with wind directional trends shown in Figure 6. Due to the presence of the Homer spit and orientation of the project shoreline, waves traveling from the northeast direction will not be able to develop to any significant size prior to impacting the seawall. However, waves traveling from west southwest can reach a significant size due to the large fetch (>80 miles) and deep water across Kachemak Bay and Cook Inlet. Considering these conditions, it is believed that depth limited storm waves impact the seawall on a regular basis. Figure 7 provides an example of storm conditions during a high tide at the seawall. In addition to the large wind-generated waves impacting the seawall, wave reflection off the seawall likely amplifies the waves just seaward of the structure.

Figure 7. Storm waves impacting existing Homer seawall (photo courtesy of City of Homer).
