Planning Commission Worksession

- A. Presentation on the Landslide Hazard Susceptibility Mapping in Homer, Barrett Salisbury
Attachment from Ed Berg

A Profile of the Coastal Bluff between West Hill Road and Crittenden Drive, Homer, Alaska v1.1

by Ed Berg PhD 12/17/2024

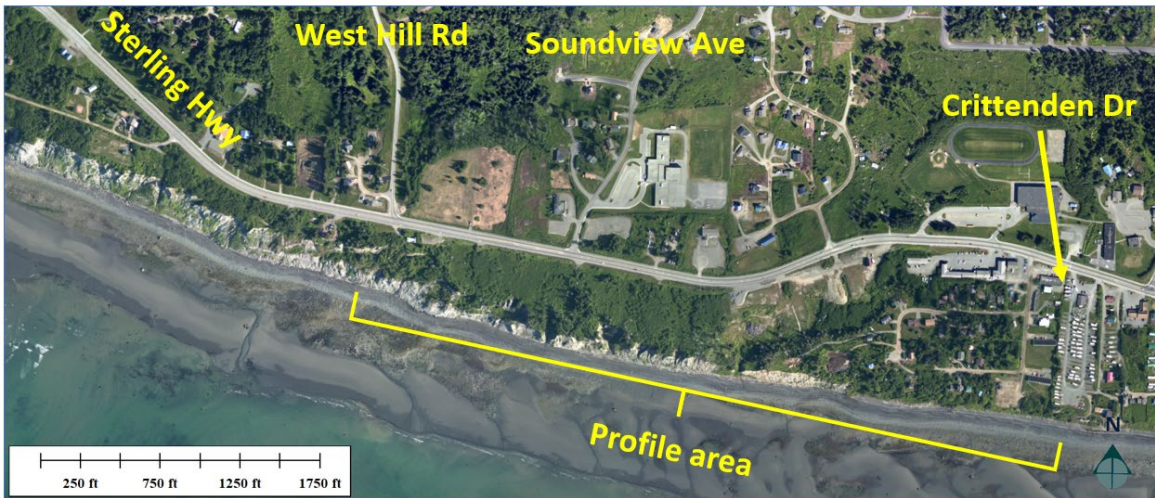
Fig. 1. The profile area. The forest in the western part of the profile area is mostly alder with very little spruce. This was a mature old-growth Sitka/Lutz spruce forest before the 1990s spruce bark beetle outbreak. The site was

logged in the late 1990s and alders have since recruited vigorously. (2015 Hydropalooza NOAA imagery)

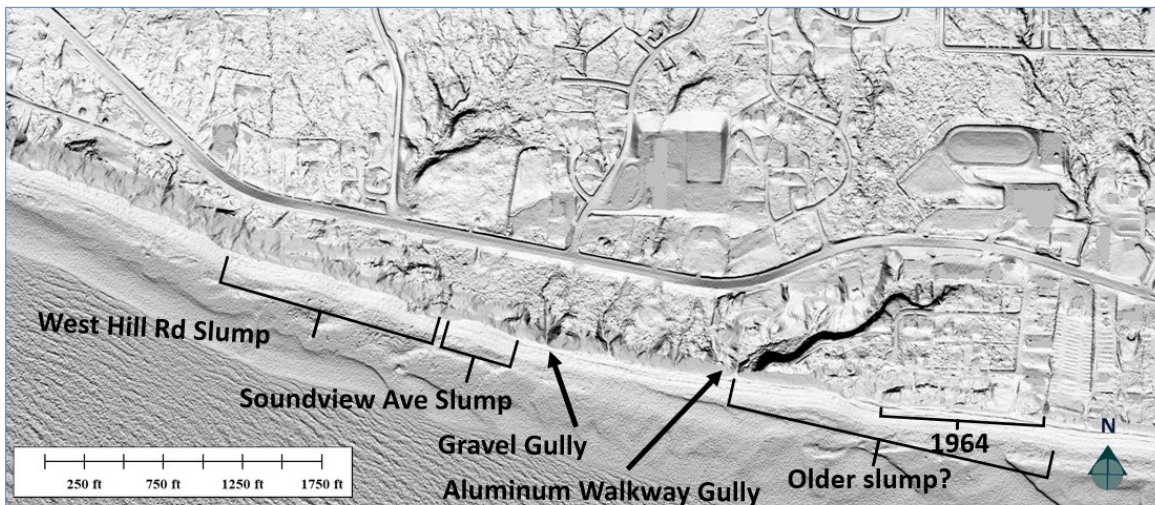
Fig. 2. The profile area (LiDAR). In this 2008 LiDAR bare-earth image the vegetation (trees and shrubs) has been digitally removed to create a view of the lowest visible surface (grass,

moss, forest floor litter, etc.). Buildings have similarly been removed; although described as “bare-earth,” the view is not actually of the mineral soil surface. The unusual character (wide but short) of the Aluminum Walkway Gully is clearly displayed in this image.

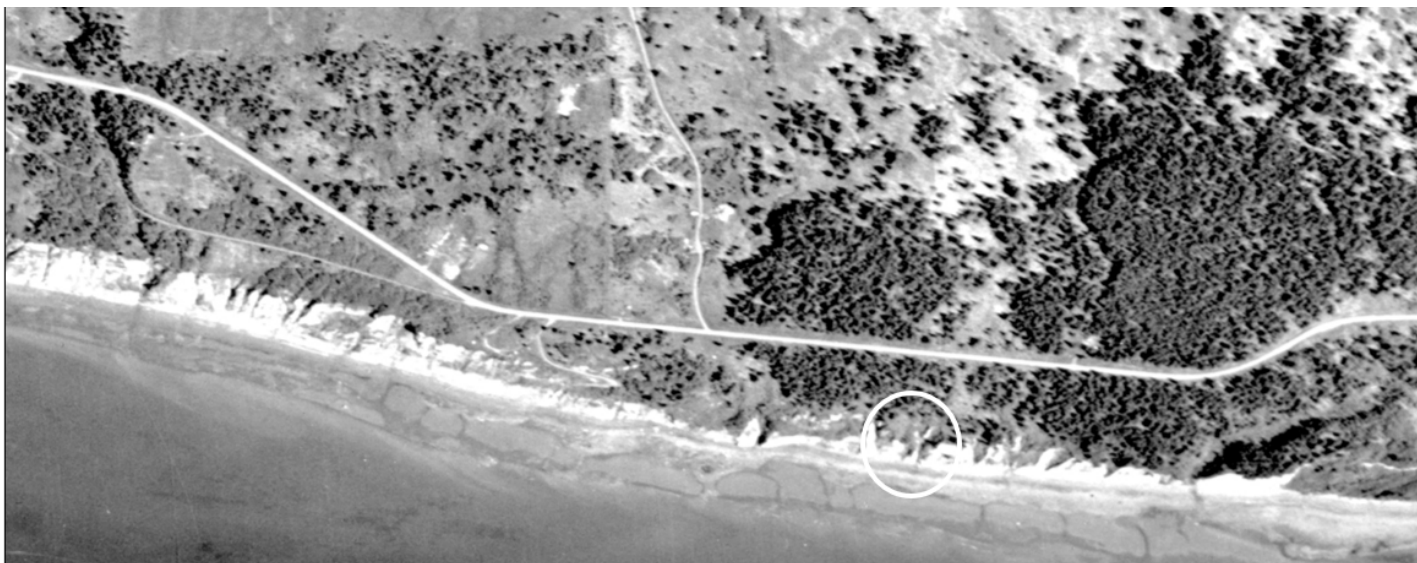
Fig. 3. 1951 aerial photo. This photo shows the newly constructed Sterling Highway. The dark trees are Sitka/Lutz spruce that are growing rapidly after being released from competition by the 1880s death of the dominant trees by spruce bark beetles (Berg et al. 2006). The Individual tree canopies are visible and have not yet closed. The fine gray texture is grass. Few alders are visible. The West Hill Rd and Soundview Ave Slumps can be seen and Gravel Gully is also present (circled).

Bluff collapse. Two massive slope failures dominate the western section of the profile: the West Hill Rd Slump and the Soundview Ave Slump. These slumps are failures of glacial materials that slid off the top of the Beluga Formation bedrock (sandstone and coal) and have been removed from the beach by surf erosion. These are not recent slumps; they are clearly visible (and not fresh) in the 1951 aerial photograph.

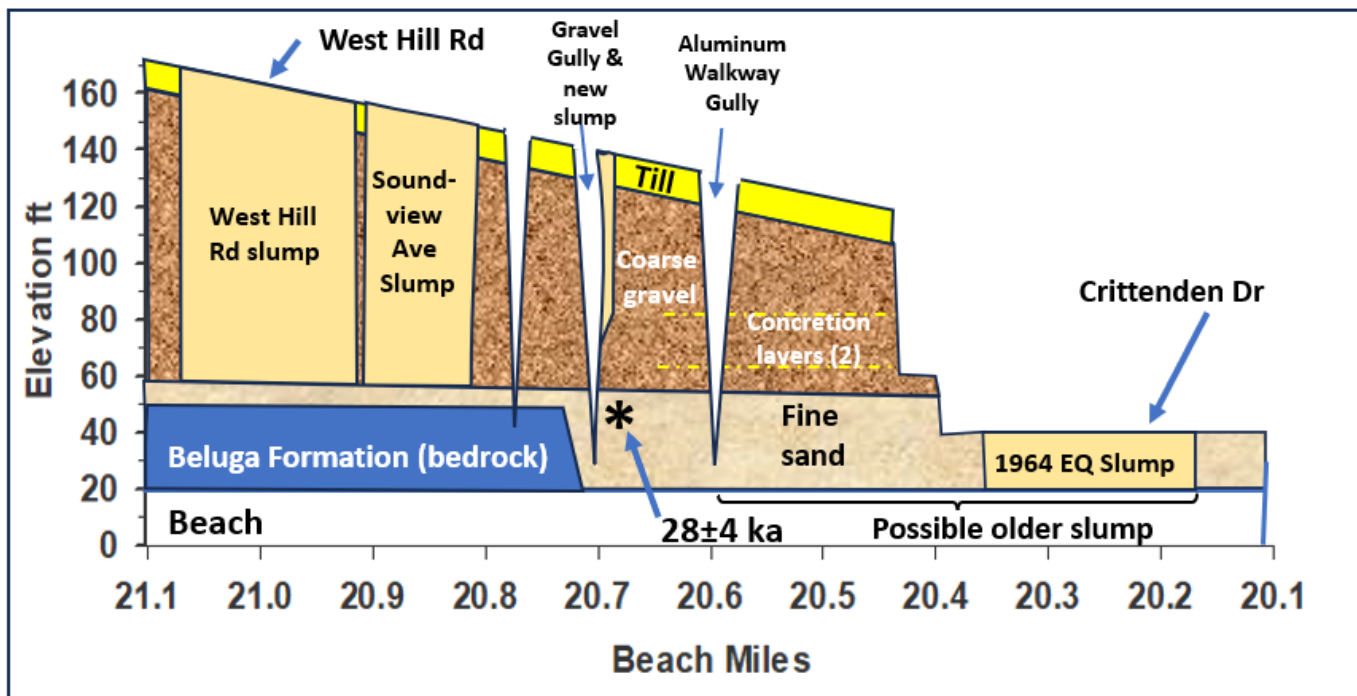
Fig. 4. Bluff Stratigraphy. This diagram shows details of the three layers of glacial material that overlie the bedrock of the Miocene-age Beluga Formation (sandstone, mudstone (shale), and coal). The steepness of the bluff and the thick cover of soil (colluvium) and vegetation tend to obscure the view of these features from the beach. Geologic mapping is by the author. The subsurface depth of the Beluga Formation bedrock east of the indicated terminus is unknown and has not been determined to the best of the author's knowledge: the next beach outcrop is along the east shore of Kachemak Drive. Elevations (mean sea level) are from 2008 LiDAR imagery. Distances are from Google Earth 2024 imagery. The Luminescence Lab at Utah State University (2020) determined the fine sand date of $28,000 \pm 4000$ years (28 ± 4 ka), using Optically stimulated luminescence (OSL) dating. The scale of miles along the beach starts at Kachemak Celo at the head of Kachemak Bay. (Graphic by the author)

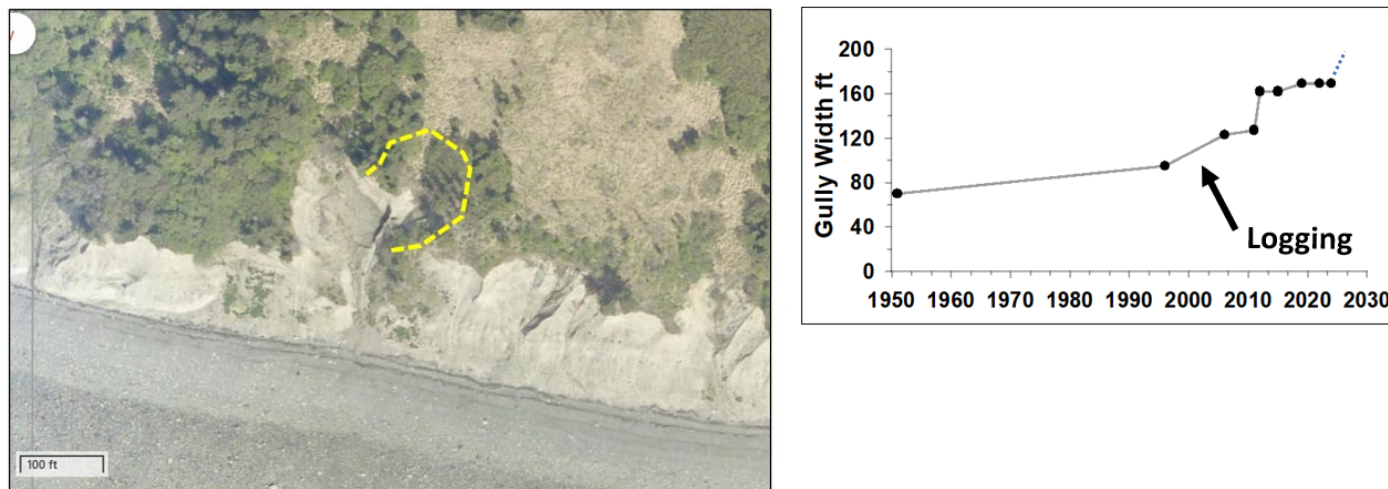
Gravel Gully and 1990s logging. Gravel Gully is a small steep-walled canyon, probably of recent origin, that provides a unique window into the hydrology of this coastal bench. Its three glacial strata (till, coarse gravel, and fine sand) are well displayed without any colluvium or vegetation. Fig. 5 shows the gully expansion after logging, and hydrology is a likely cause of this expansion. Foresters have long recognized that logged areas on poorly drained soils often become swampy (paludified) when the trees are no longer available to convey (transpire) soil moisture to the atmosphere. The swampy forest of the Calvin and Coyle Trail is an excellent example of such paludification following the death of the trees (albeit by spruce bark beetles, rather than logging).

Fig 5. Gravel Gully. This notch in the bluff expanded significantly after the bench was logged in the late 1990s. The dashed line indicates a recent slump (KPB imagery 2020-21). Gully widths were measured on the 1951 aerial photograph and Google Earth 1996-2024. The width after the most recent (October 2024?) slump has not been determined.

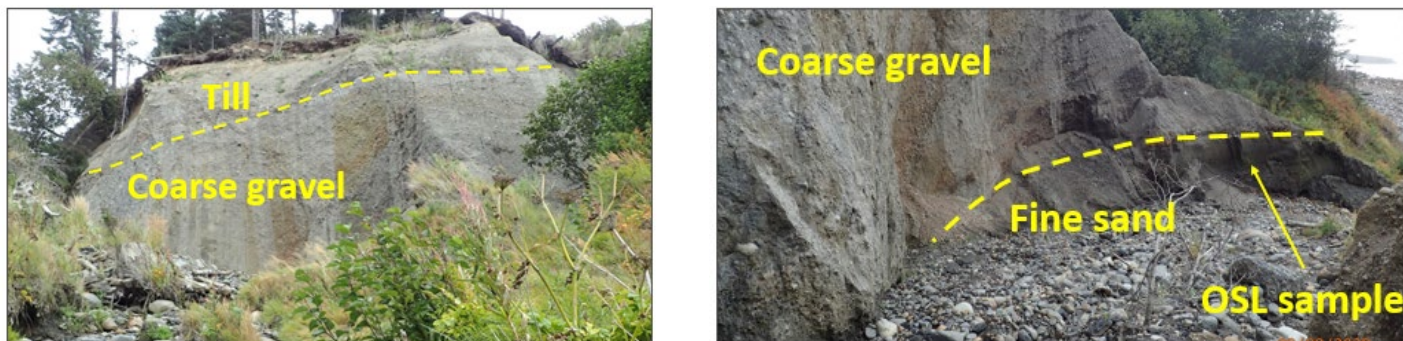
Fig. 6. Gravel Gully. (Left) A vertical wall of coarse gravel with a cap of glacial till. The view is looking north, up the gully. (Right). A massive (unlayered) fine sand underlies the coarse gravel. The OSL date of the sampled fine sand is 28 ± 4 ka; the gravel is estimated to be 25-20 ka (see below). This site is now partially buried under recently slumped material. A very recent (October 2024?) slump has widened the east side of the gully, and stream erosion is actively transporting material to a new delta on the beach. The north headwall of the gully is unchanged from 1951 to 2024, indicating that the gully is expanding laterally, rather than cutting further north into the bluff. The view is south, down the gully to the beach. (Photos are by the author 9/8/2020).

The coarse gravel in this bluff site is dirty gravel, with lots of silt. It is not like a bag of well-washed marbles. In Fig 6 the eroded gravel in the streambed has been washed by streamflow and the fines (sand, silt, and clay) have been transported to the beach and beyond. The dense appearance of the gravel wall, however, is due to the matrix of fines that supports the larger rocks.

If the bluff gravel was well-washed (like a bag of marbles), groundwater would drain freely through it, and slumping would be less of a concern. Dirty gravel, however, retains groundwater and raises the water table and hence raises the risk of slumping.

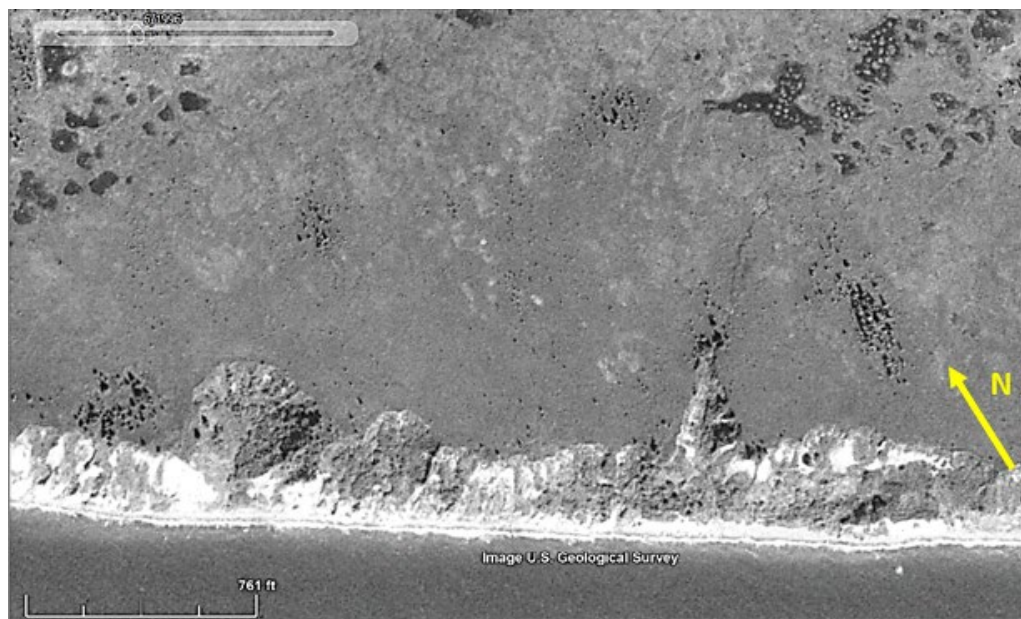
Fig. 7. Coastal bluff slumps along the coast north of Diamond Creek. Black areas are open water in wetlands. The bedrock of the Sterling Formation (mudstone, sandstone, and coal) forms the base of the bluff. Bluff height is ~1180 ft. Slumps are numbered northward from Diamond Creek (Berg 2024). The image is Google Earth 1996. The view is looking northeast.

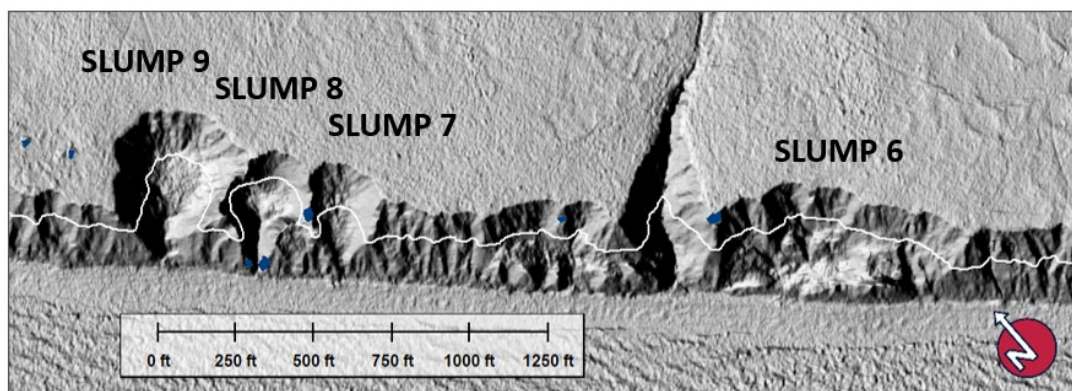
Fig. 8. As above, bare-earth LiDAR image. The white line shows the top of the Sterling Formation bedrock (elevation 110 ft). The slumps occur in both the overlying glacial lakebeds and the upper bedrock.
