## **Historic Resources Advisory Committee Agenda**

February 22, 2024 at 5:00pm

# STRUCTURAL CONDITION SURVEYS

Project Number I1817.23001; RSI-3411

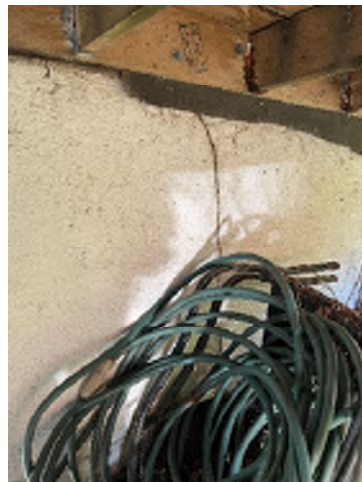
**Figure 1-2.** Large Concrete Crack on the South Wall.

The foundation is in fair condition for a structure that is 113 years old. There are issues that need to be addressed, including concrete cracks and a lack of reinforcement. A large concrete crack exists on the north and south sides of the building. Minimal cracks to the finishes inside the residence were seen. Buildings constructed in the early 1900s do not have the same standards for code minimums that we do today. Reinforcement in the concrete walls is unlikely and would not meet the current minimum standards. Reinforcements were not observed during the inspection. Water frequently flows in the basement on the residence's north side at the foundation crack's location. The bottom of the trim in the basement is rotten, indicating water has previously reached it. At a minimum, the cracks can be sealed to help minimize water infiltration and a water proof membrane can be installed on the outside of the foundation. Full repair would include replacement of the foundation, which would include installing a properly reinforced foundation with a modern water proofing system.

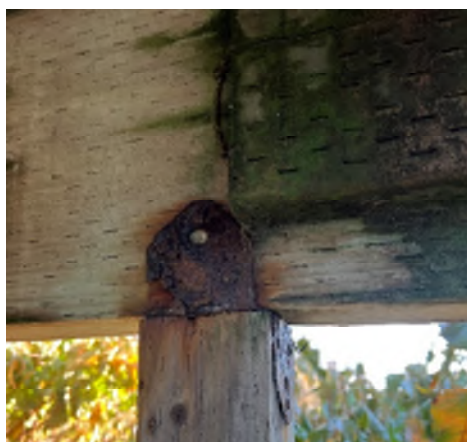
**Figure 1-3.** Rusty Hardware Connections on the Deck Framing.

This building is generally in fair condition for its age. Rusty hardware at post and beam connections, chipped paint, some rot, and significant moss growth exist. The extent of the rot below the siding on the east side of the building is unknown.

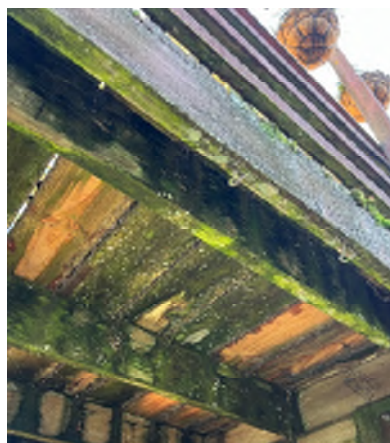
**Figure 1-4.** A Significant Amount of Moss on the West Side of the Deck Framing.

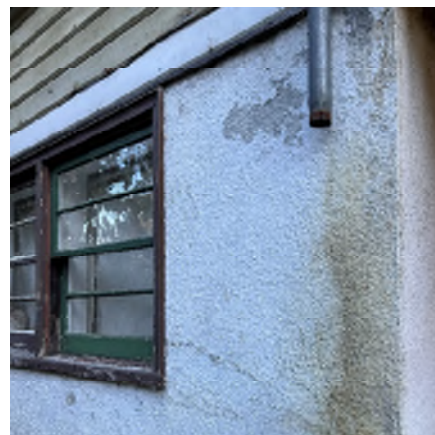
**Figure 1-6.** The Drainpipe Ends Abruptly in Mid-Air and Does Not Direct Water Away From the Foundation.

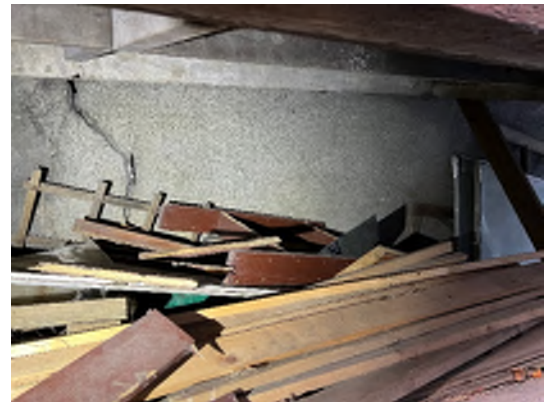
**Figure 1-12.** A Large, Deep Concrete Crack on the North Wall. No reinforcement is observed.

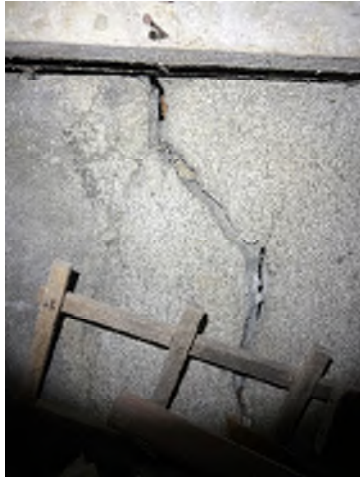
**Figure 1-13.** Visible Wood Framing in the Deep Crack Where Water Infiltrates the Basement.

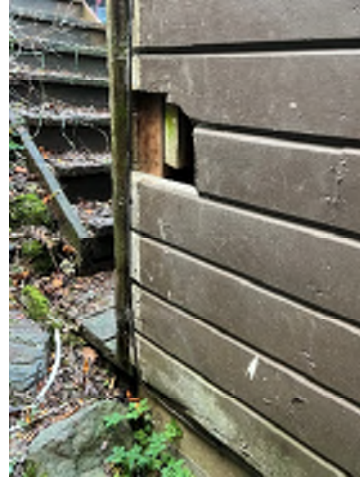
**Figure 1-14.** A Hole in the Siding That Can Allow Water or Animals in the Wall Cavity.

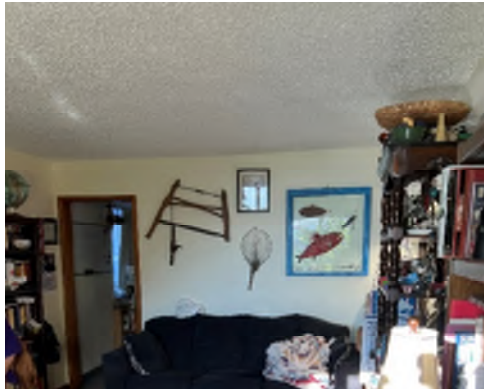
**Figure 1-21.** Very Few Sheetrock Cracks Were Observed on the Main Level.

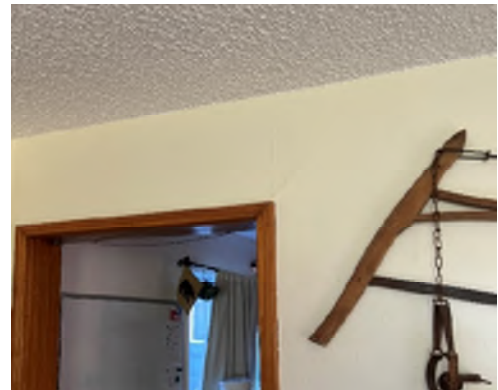
**Figure 1-22.** A Diagonal Crack Above the Door Frame.

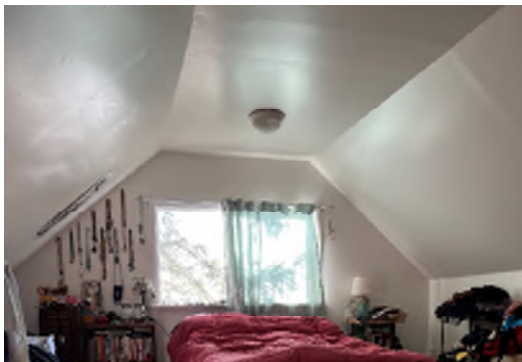
**Figure 1-23.** The Wood Framing Is Not Visible at the Edges Because the Upper Level Is Fully Finished.

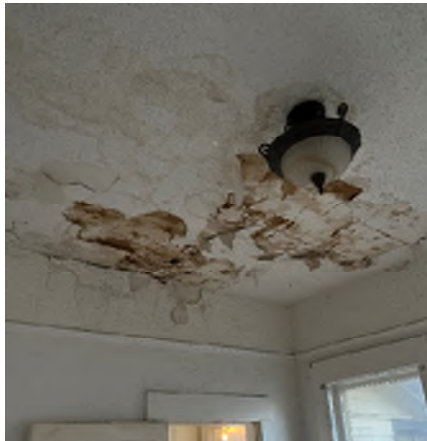
**Figure 2-17.** Significant Water Damage to the Ceiling Below the Roof Leak. The light fixture was not tested because of signs of water infiltration.

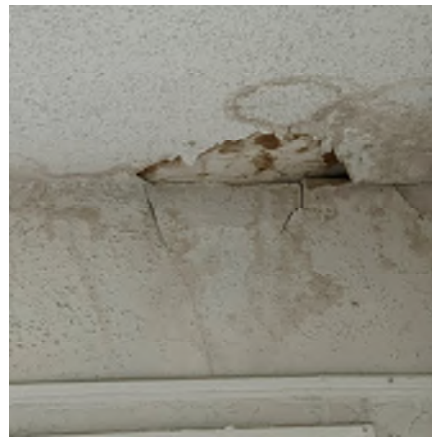
**Figure 2-18.** Ceiling Paint Is Cracked and Falling From the Wall Due to Water Infiltration. How extensive the water damage is or if there is mold is unknown without a destructive investigation.

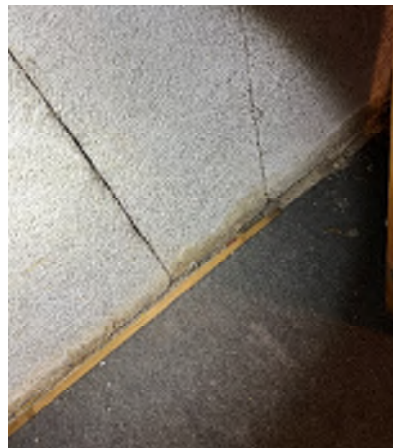
**Figure 2-30.** Bottom of the Wall Panel Has Water Damage.

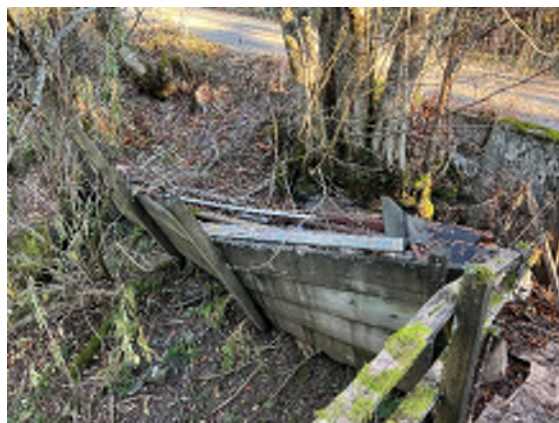
**Figure 3-8.** Failed Wooden Retaining Wall.

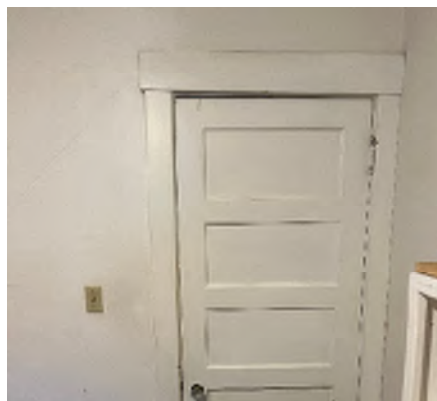
**Figure 3-23.** Door Does Not Sit Square in the Door Frame.

Many settlement indications exist, including a noticeable floor slope from east to west on the main level, long lateral cracks across east to west walls, a door not sitting square in the frame, and the concrete basement wall that has cracked and shifted. Because of the age of the building and the many unknowns concerning how the foundation was constructed. The foundation is at the end of its useful life.

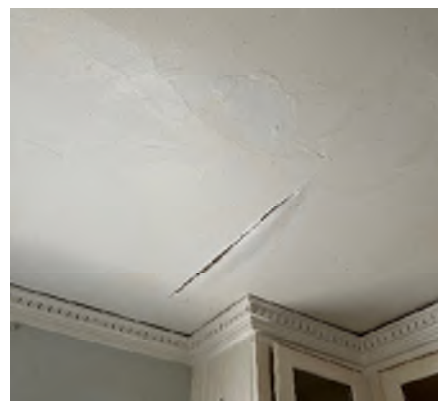
**Figure 3-24.** Sheetrock Cracks and Water Damage on the Ceiling.

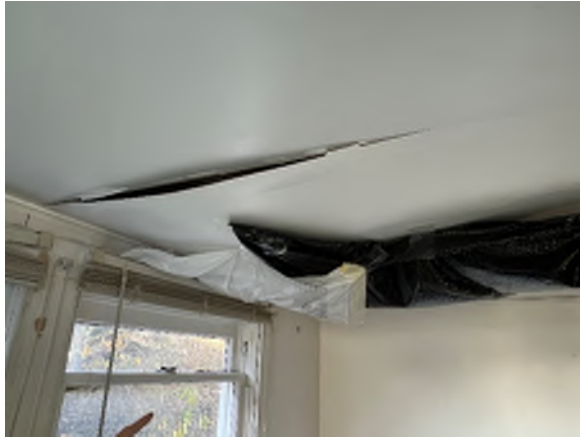
**Figure 3-31.** Ceiling Damage From a Roof Leak.

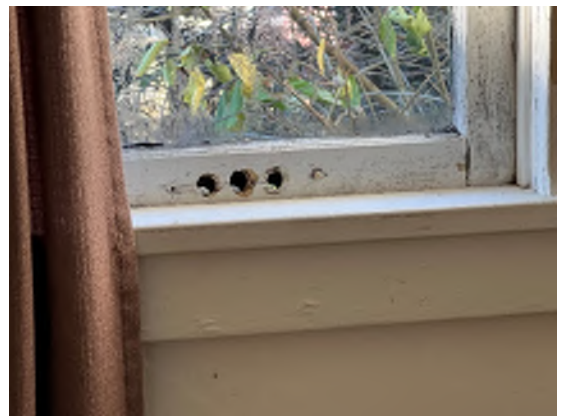
**Figure 3-34.** Mold and Holes in the Windowsill. The holes can lead to water infiltration.

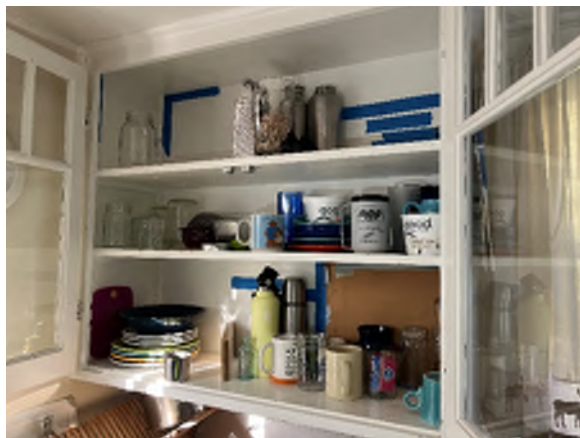
**Figure 3-35.** Blue Tape Where the Tenant Found Cracks.

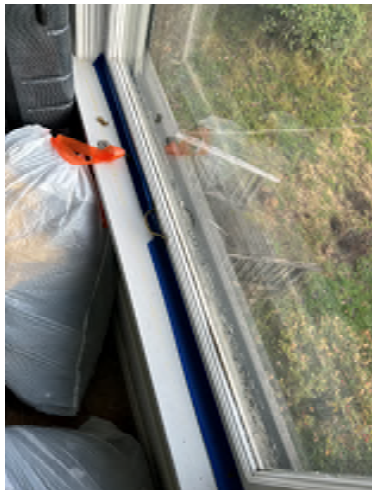
**Figure 4-17.** Deteriorating Windowsill.

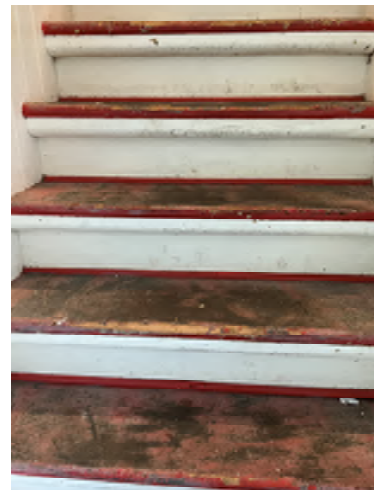
**Figure 4-18.** Steps Leading to the Second Floor Are in Poor Shape.

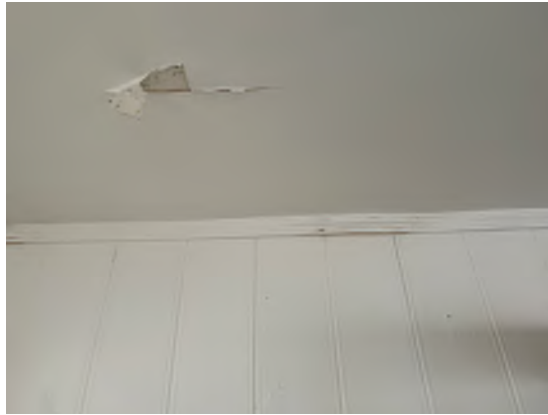
**Figure 4-19.** Peeled Paint With Signs of Water Damage on the Ceiling and Cracking in the Trim and Wallboards.

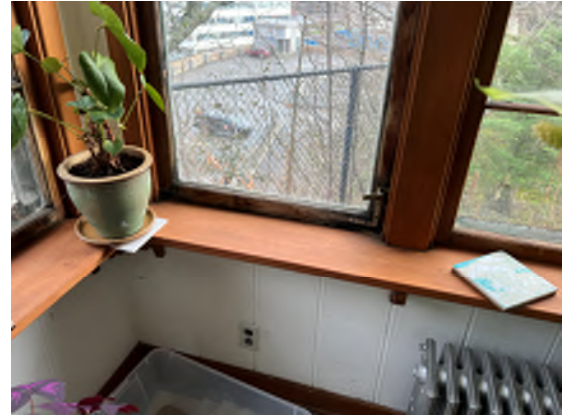
**Figure 4-20.** Rotting Window Frame.

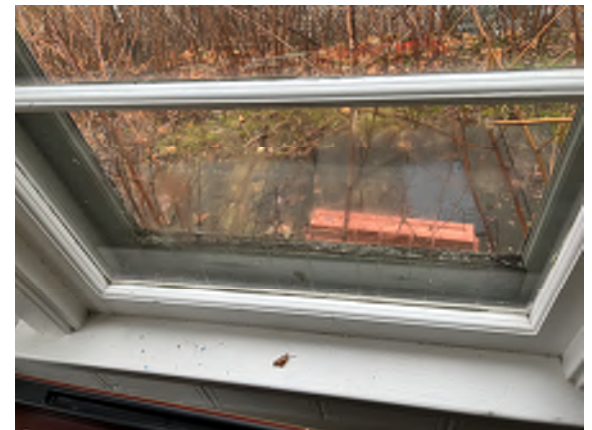
**Figure 4-22.** Rotting Storm Window and Window Frame.

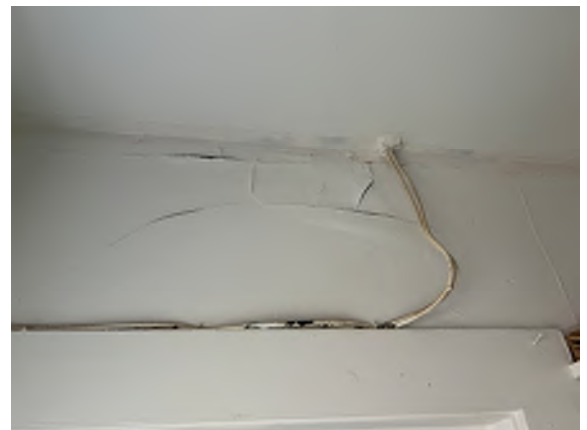
**Figure 4-24.** Cracked and Bubbled Paint likely from Water Infiltration.

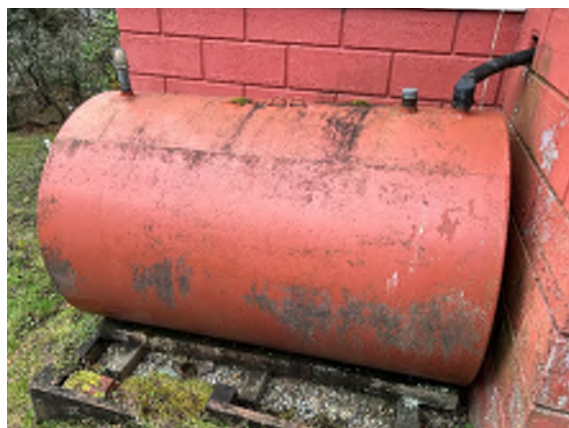
**Figure 5-3.** Cracking in the Concrete Wall. The tank is not seismically anchored and the framing is rotten.

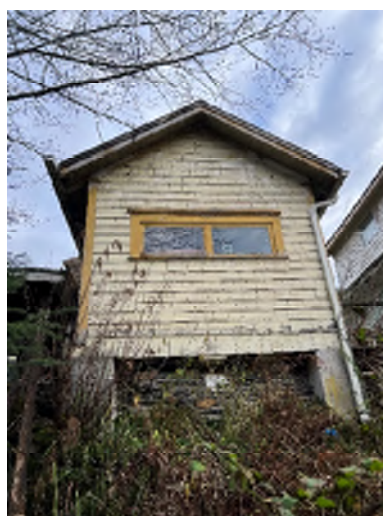
**Figure 5-16.** West Side of Garage. Paint on the siding has significantly deteriorated.

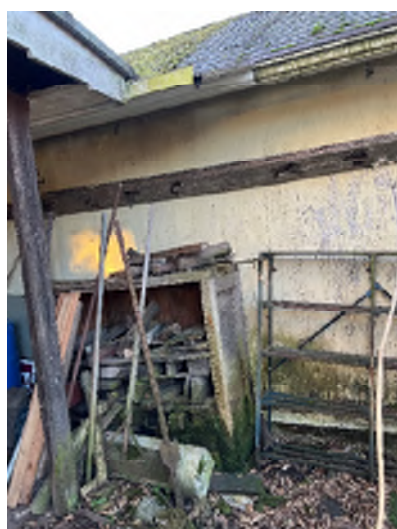
**Figure 5-17.** Gutter Drainage Splashed on the Garage and Caused Significant Moss to Grow and the Plywood to Rot.

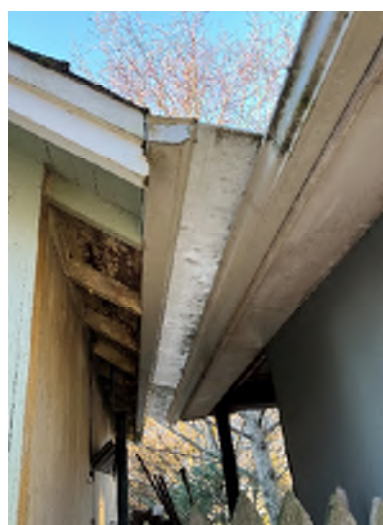
**Figure 5-18.** Deterioration Under the Eave.

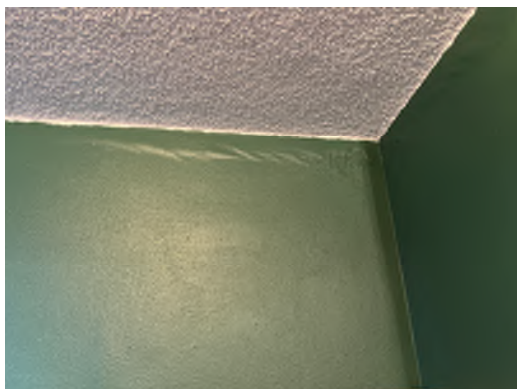
**Figure 5-21.** Bubbled Paint.

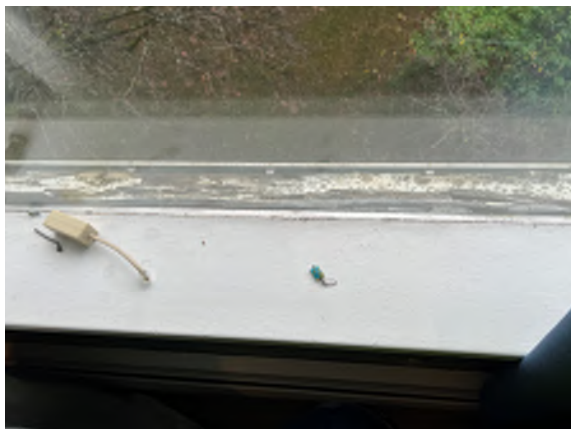
**Figure 5-23.** Deteriorating Windowsill.

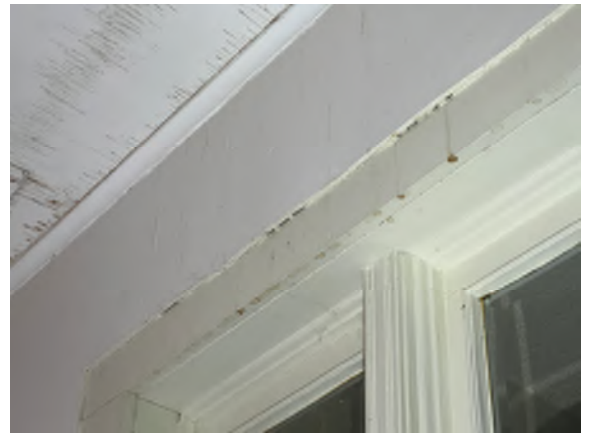
**Figure 5-26.** Indications of Water Damage on Windowsill.

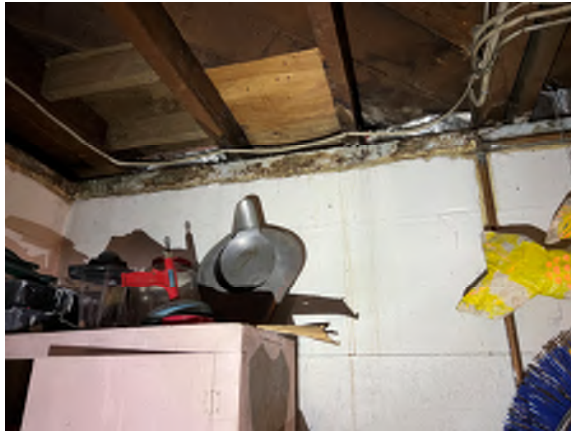
**Figure 5-31.** Water-Damaged Insulation and Water Marks Running Down the Concrete Basement Wall.

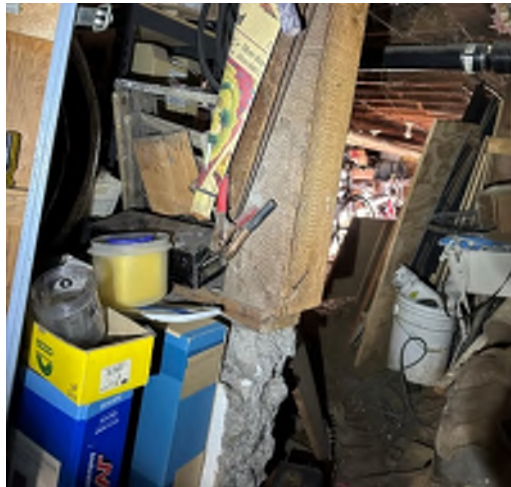
**Figure 6-24.** Wood Post Supported Eccentrically by Stem Wall With a Chunk of Concrete Missing Directly Below the Post.

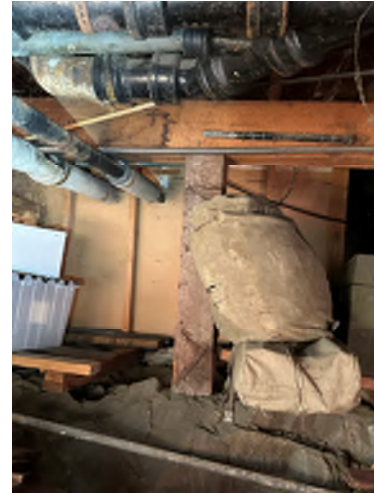
**Figure 6-25.** No Lateral Restraint/Connection From Beam to Column. The wood column is placed directly on top of the rock.

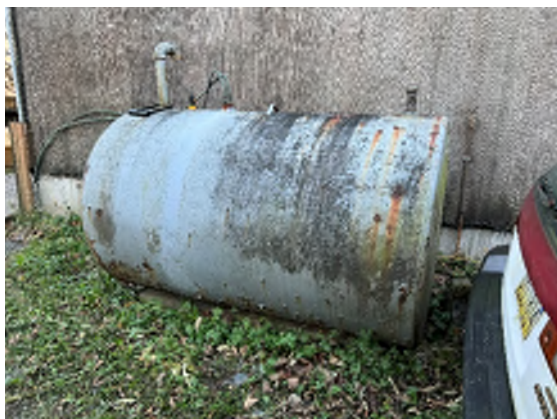
**Figure 7-7.** A Rusted Tank That Is Not Seismically Secured.

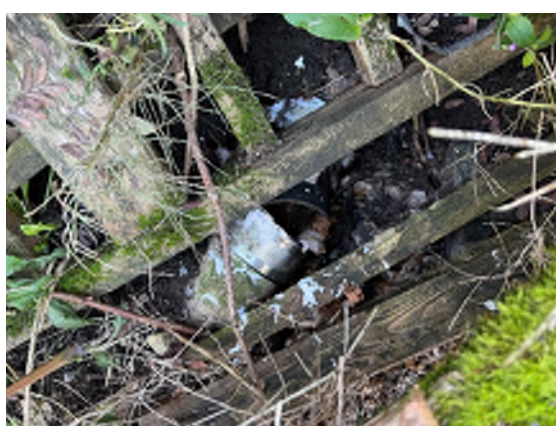
**Figure 7-12.** A Broken Pipe Below the Pile of Wood That May Be a Sewer Pipe.

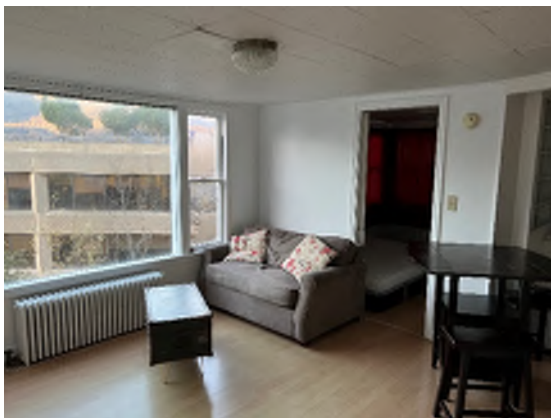
**Figure 7-41.** Finishes Appeared to Be in Good Condition.

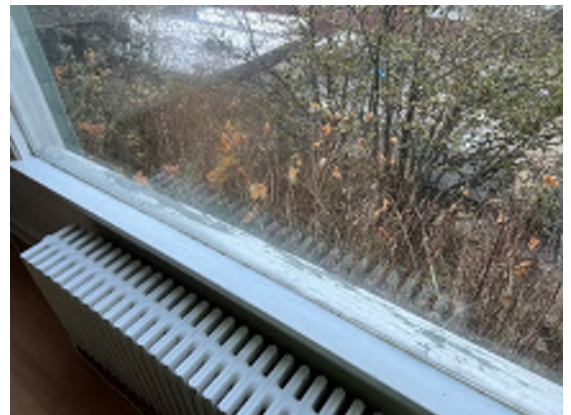
**Figure 7-42.** The Window Frame Has Some Deterioration.

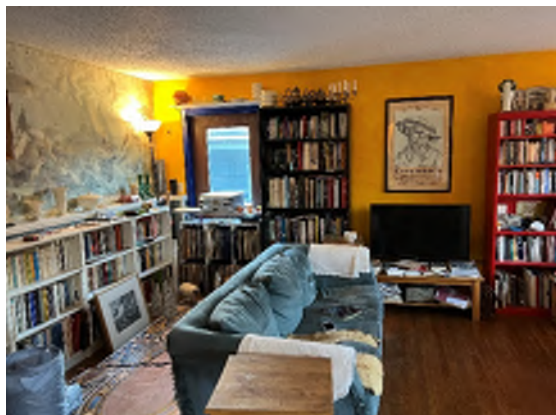
**Figure 7-43.** More Finishes Appeared to Be in Good Condition.

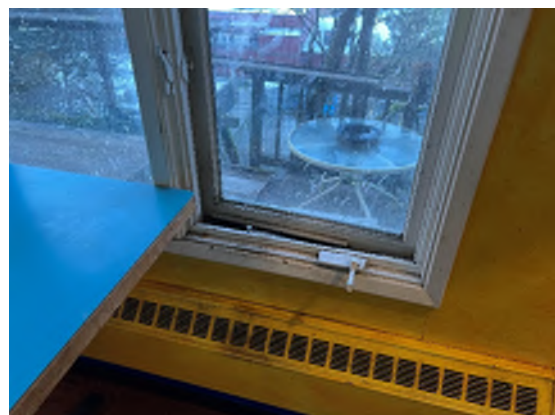
**Figure 7-44.** One Window No Longer Opens Properly.
