HISTORIC RESOURCES ADVISORY COMMITTEE - SPECIAL MEETING AGENDA

March 20, 2024 at 12:00 PM

STRUCTURAL CONDITION SURVEYS

Telephone Hill is located in downtown Juneau, Alaska. This neighborhood consists of historic homes that were built between 1882 and 1947. The City and Borough of Juneau owns this neighborhood and is exploring potential options for redeveloping the land. RESPEC Company, LLC (RESPEC) was retained to provide a structural condition survey of each of the seven residences.

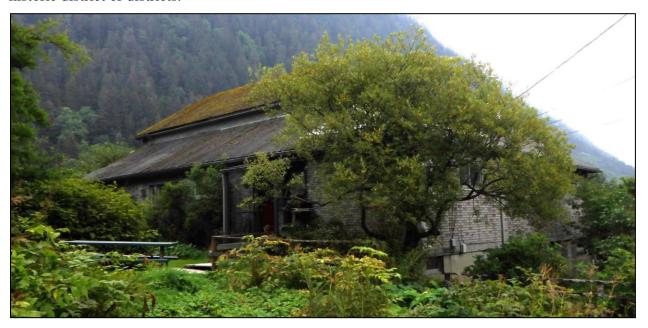
During the 2023 site visit, the Edward Webster House (JUN-00070) (Figure 5) was found to be standing but appeared to have been heavily modified, with modern doors, windows, and siding. The building also appeared to have been divided into apartments. Additional research would be required to determine how much the building has been altered since its period of significance, if it is eligible for listing on the NRHP, and if it is a contributing or non-contributing element to a historic district or districts.

Figure 5. Looking east from Dixon St. at the Edward Webster House (JUN-00070) in 2023 (NLURA Photograph).

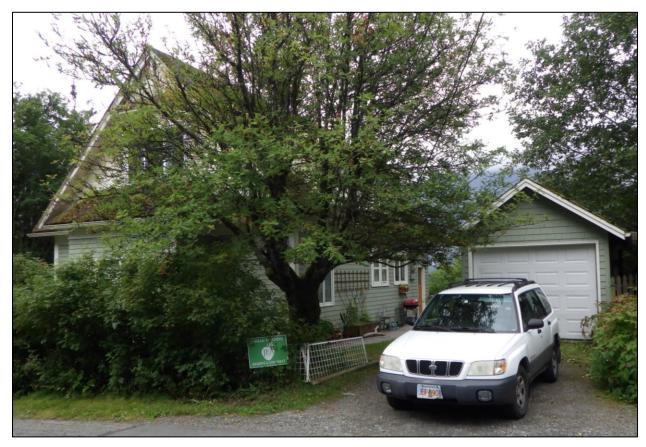
During the 2023 site visit, the Bosch/Carrigan House (JUN-00291) was found to be standing and retained windows, doors, siding, and fenestration consistent with its date of construction. A small garage located on the north side of the house had a modern garage door, but otherwise had an appearance consistent with the age of the house. Additional research would be required to determine how much the building has been altered since its period of significance, if it is eligible for listing on the NRHP, and if it is a contributing or non-contributing element to a historic district or districts.

Figure 6. Looking southwest from Dixon St. at the Bosch/Carrigan House (JUN-00291).

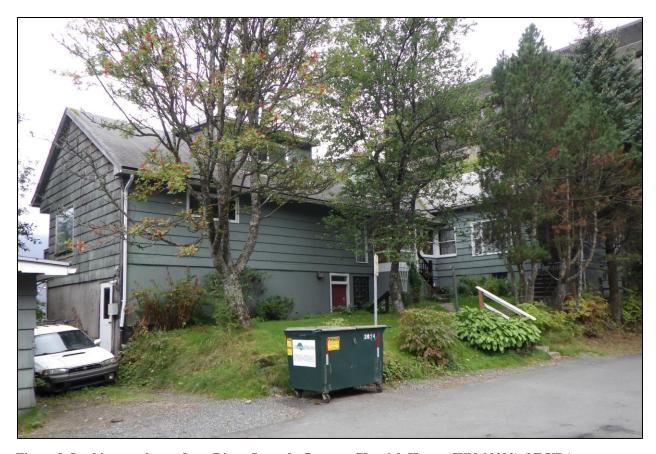
During the 2023 site visit, the Peterson/Kasnick House (JUN-00292) (Figure 8) was found to be standing and retained windows, doors, siding, and fenestration consistent with its date of construction. A small garage (Figure 9) located on the south side of the lot had an appearance consistent with the age of the house. Additional research would be required to determine how much the building has been altered since its period of significance, if it is eligible for listing on the NRHP, and if it is a contributing or non-contributing element to a historic district or districts.

Figure~8.~Looking~northwest~from~Dixon~St.~at~the~Peterson/Kasnick~House~(JUN-00292)~(NLURA~photograph).

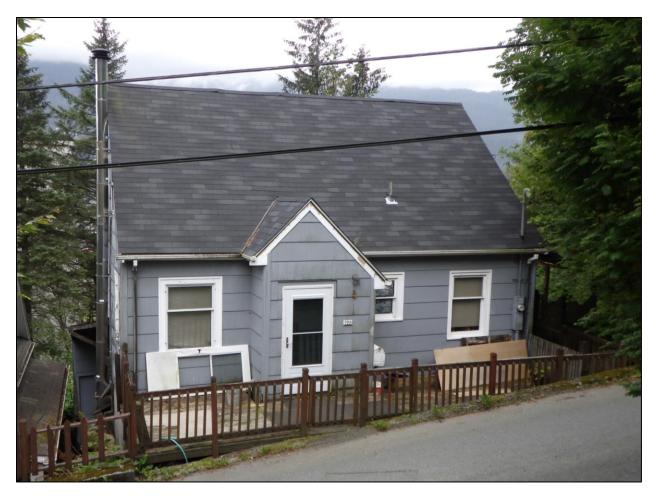
During the 2023 site visit, the Martin/Johnston House (JUN-00294) was found to be standing and retained windows, siding, and fenestration consistent with its date of construction, though the door appears to be modern. Additional research would be required to determine how much the building has been altered since its period of significance, if it is eligible for listing on the NRHP, and if it is a contributing or non-contributing element to a historic district or districts.

Figure 11. Looking west from Dixon St. at the Martin/Johnston House (JUN-00294) (NLURA photograph).

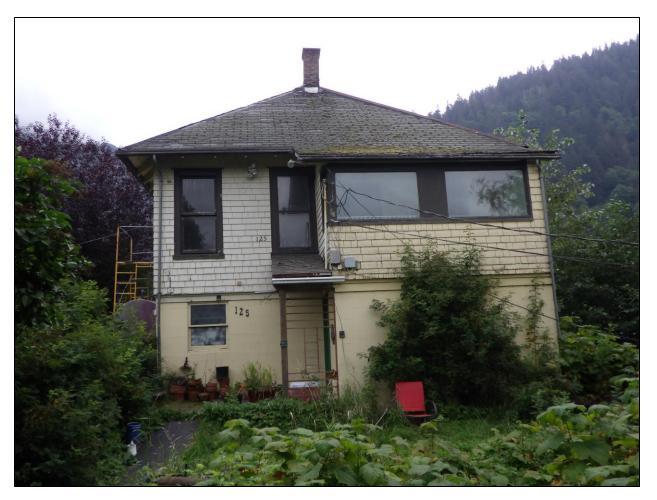
During the 2023 site visit, the Webster/Hurley House (JUN-00295) (Figure 12) was found to be standing and retained windows, doors, siding, and fenestration consistent with its date of construction. Additional research would be required to determine how much the building has been altered since its period of significance, if it is eligible for listing on the NRHP, and if it is a contributing or non-contributing element to a historic district or districts.

Figure 12. Looking east from Dixon St. at the Webster/Hurley House (JUN-00295) (NLURA photograph).

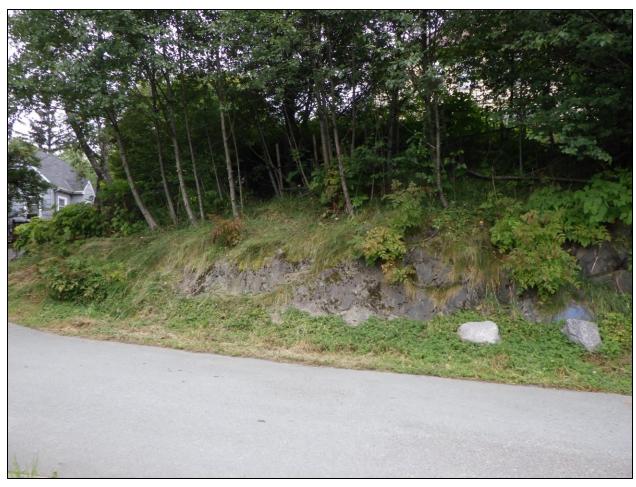
During the 2023 site visit, the Alexander House (JUN-00976) was found to have been demolished (Figure 16). No additional research is recommended for this building as it lacks the integrity required for listing on the NRHP.

Figure 16. Looking north at the former location of the Alexander House (JUN-00976) showing the site is demolished (NLURA photograph).

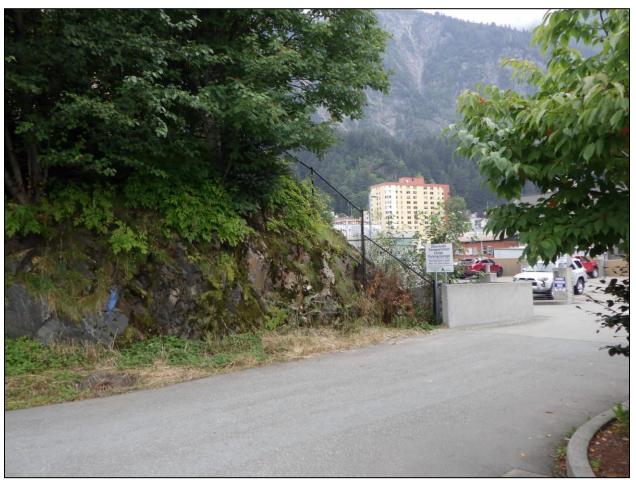
During the 2023 site visit, the Percy Reynolds House (JUN-00977) was found to have been demolished (Figure 17). No additional research is recommended for this building as it lacks the integrity required for listing on the NRHP.

Figure 17. Looking northwest at the former location of the Percy Reynolds House (JUN-00977) showing the site is demolished (NLURA photograph).

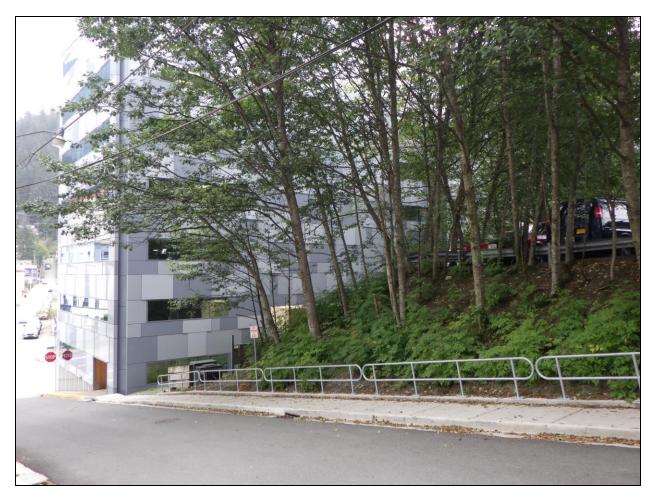
During the 2023 site visit, the Engstrom Building (JUN-00981) was found to have been demolished (Figure 18). No additional research is recommended for this building as it lacks the integrity required for listing on the NRHP.

Figure 18. Looking roughly east from West 3rd St. at the former location of the Engstrom Building (JUN-00981) showing the site is demolished (NLURA photograph).

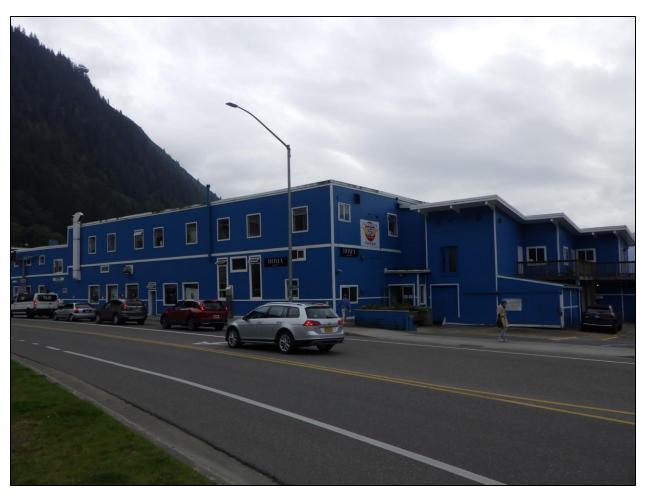
During the 2023 site visit, the Pacific Coastal Steamship Wharf (JUN-00120) was still standing and in the condition described on the AHRS card (Figure 20). No additional research is recommended for this building as it has been determined not eligible for listing on the NRHP.

Figure 20. Looking southeast at the Pacific Coastal Steamship Wharf from Egan Ave. (JUN-00120) (NLURA photograph).

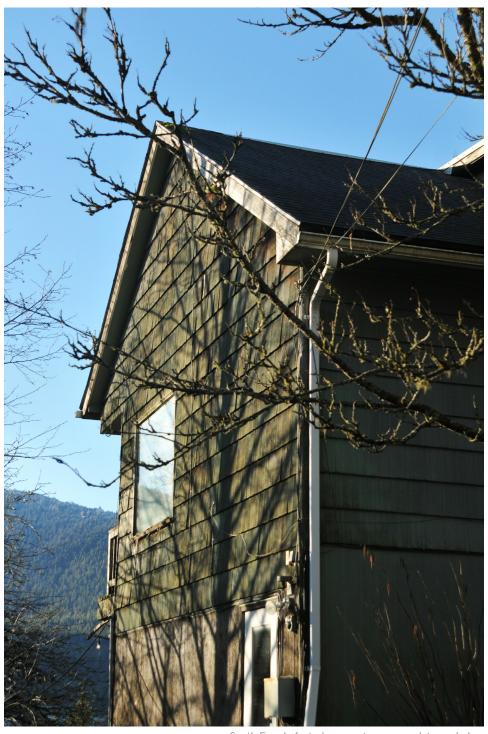
South Facade featuring a contemporary picture window and an entrance to one of the three basement units. Shake-Shingle siding covers the entire residence. Peterson-Kasnick House, 2023

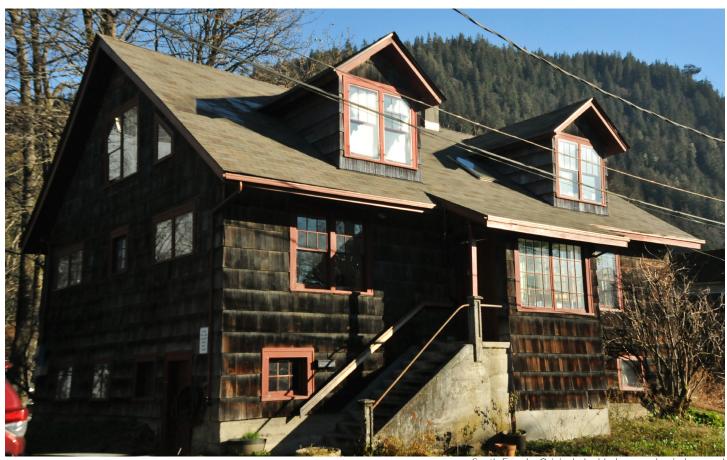
South Facade. Original, double-hung sash windows and original cedar shake siding retained. Wooden gutter has been replicated and replaced in the 1980s.

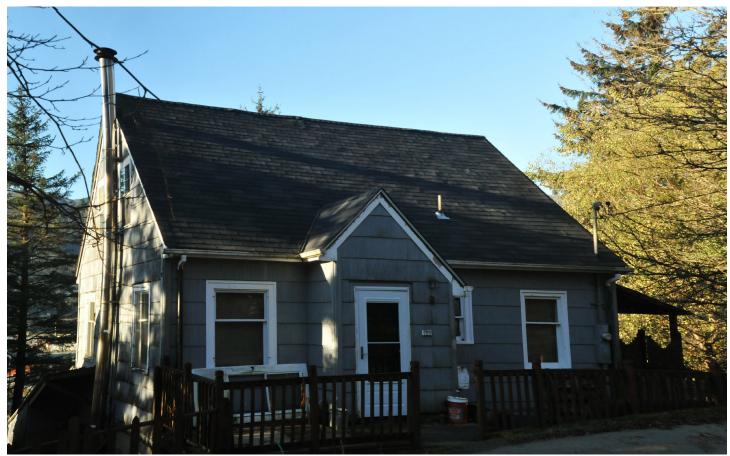
East Facade. Contemporary windows replace originals. Contemporary wooden deck added.

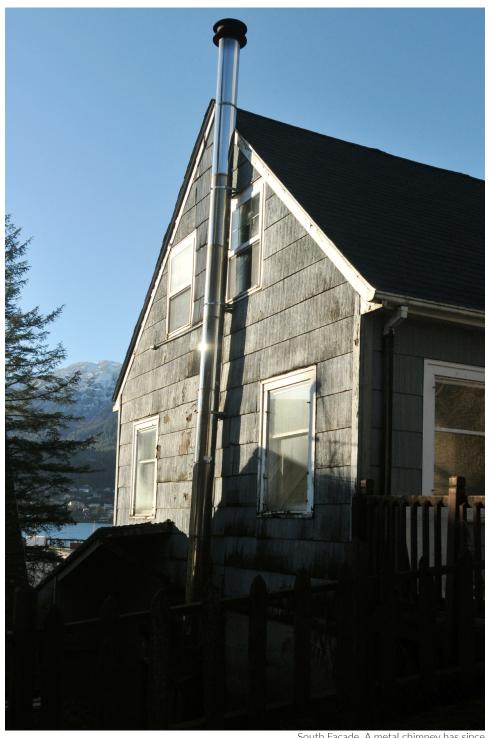
South Facade. A metal chimney has since replaced the original cement block chimney.
