BOARD OF PUBLIC WORKS

AGENDA

Subject: Notice of Noncompliance (NON) for June 27, 2024, Inspection at the Closed CE Land Landfill, City of Kaukauna, Outagamie County, License No. 0073

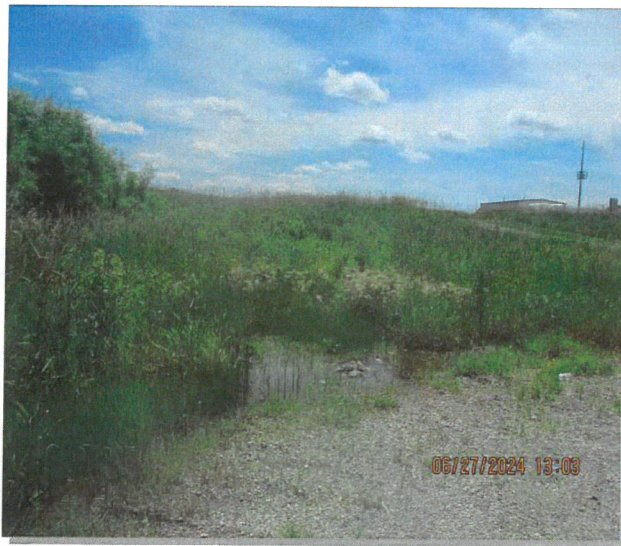
Photo # 105801 Photo 2 of 30

- b. The department observed areas of ponding water on or in close proximity to the North Passive Vent (NPV) trench. The areas of ponding water are recommended to be graded to promote storm water drainage away from the NPV to ensure the trench continues to function as intended.

Ponding water on ground surface over NPV trench. Low spots collecting ponding water on and immediately near the passive gas vent trench should be regraded to preventing ponding water and ensure passive gas vent trench is functioning as intended.

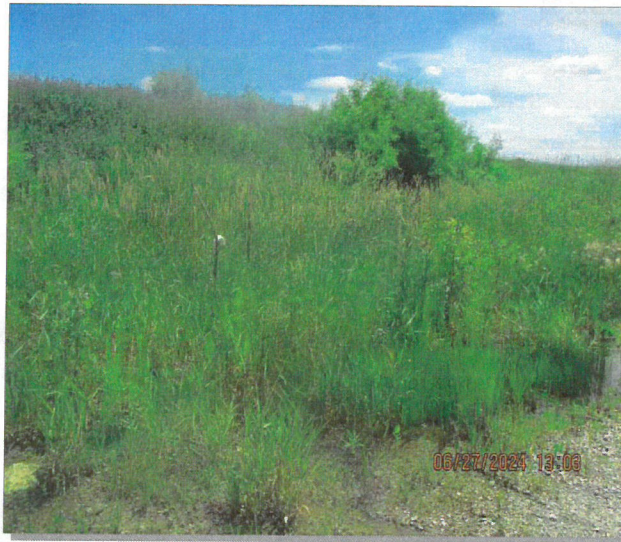
Photo # 105802 Photo 3 of 30

Ponding water on ground surface over NPV trench. Low spots collecting ponding water on and immediately near the passive gas venting trench should be regraded to prevent ponding water and ensure the passive gas vent trench is functioning as intended. Woody vegetation establishing near passive gas vent trench (bottom left of photo) should be removed to prevent damage to the trench from the tree roots.

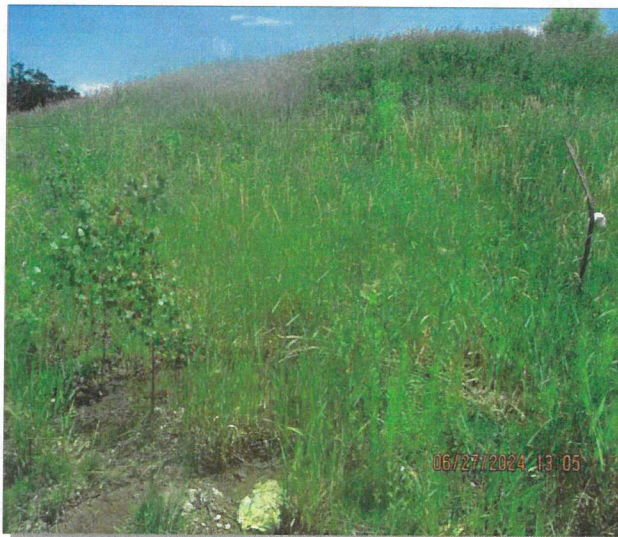
Photo # 105803 Photo 4 of 30

Passive gas vent trench with ponding water on ground surface over passive gas vent trench on northern side of landfill on King's Plat property. Low spots collecting ponding water on and immediately near the passive gas venting trench should be regraded to preventing ponding water to ensure passive gas vent trench is functioning as intended. Woody vegetation establishing near passive gas vent trench (bottom left of photo) should be removed to prevent damage to the trench from the tree roots.

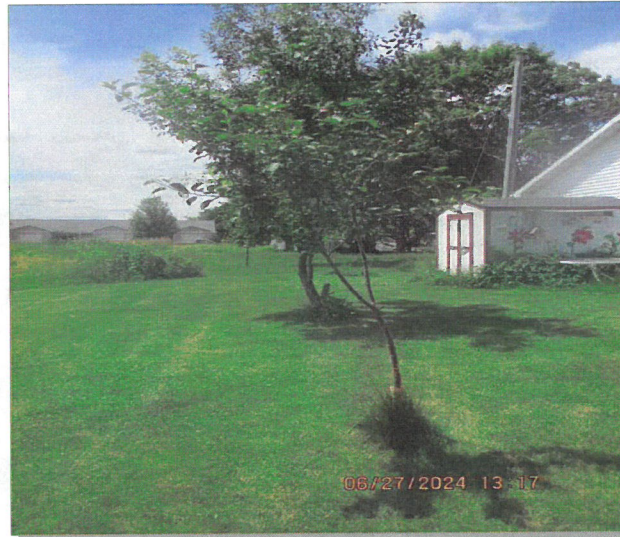
Photo # 105832 Photo 6 of 30

- c. The department observed woody vegetation is on or in close proximity to the NPV trench and 20th Street vent. The woody vegetation is recommended to be removed to prevent damage from the tree roots to the passive gas vent trenches to ensure the trenches continue to function as designed.

Woody vegetation planted immediately near or on the 20th Street trench, near gas probe GP-5. Woody vegetation establishing near passive gas vent trench should be removed to prevent damage to the trench from the tree roots.

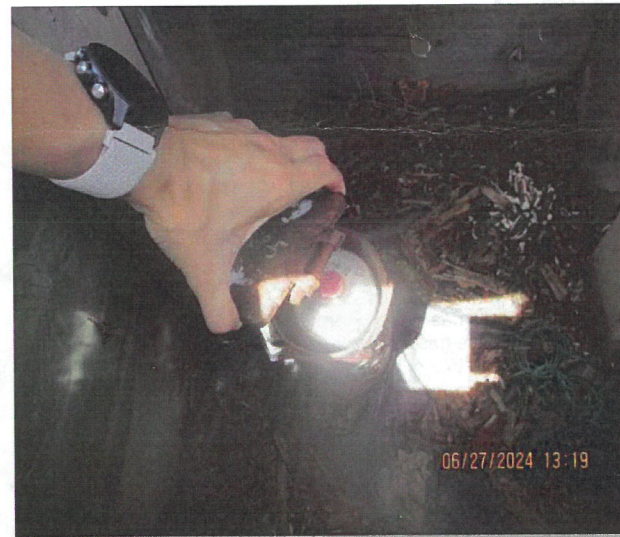
Photo # 105833 Photo 7 of 30

- abandonment and replacement of the monitoring devices or contact the department to schedule a meeting to discuss alternative actions.
- b. Gas probe GP-5 was observed to not be lockable due to the hinges on the protective cover rusting through. The lockable cover to gas probe GP-5 needs to either be repaired or replaced, in accordance with s. NR 507.13, Wis. Adm. Code. Provide the department photo documentation of the repair or request an alternative timeline for repairs by **October 3, 2024.**

Gas probe GP-5 labeled. Hinge to the lockable cover on the device is rusted through, not allowing the gas probe to be properly locked. The cover on the gas probe needs to be replaced to allow the device to be properly locked.

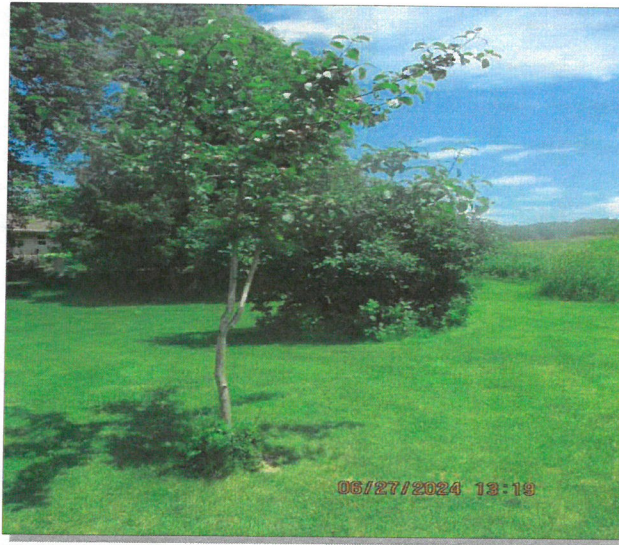
Photo # 105834 Photo 8 of 30

Woody vegetation planted immediately near or on the passive gas vent trench near gas probe GP-5 on the northern side of King's Platt property. Woody vegetation establishing near passive gas vent trench (bottom left of photo) should be removed to prevent damage to the trench from the tree roots.

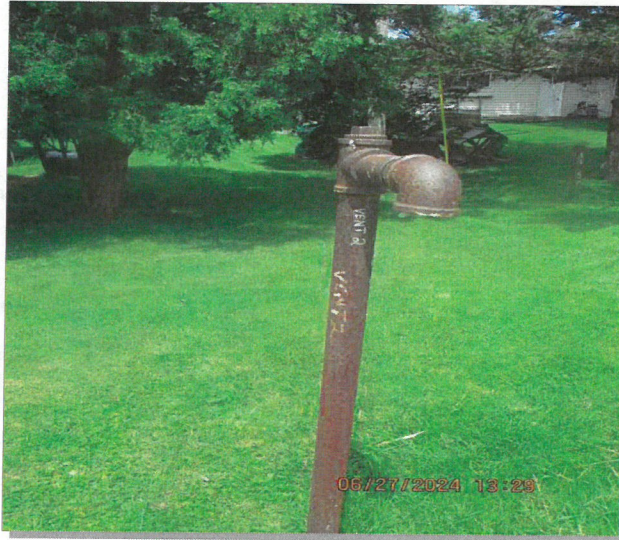
Photo # 105835 Photo 9 of 30

Passive gas vent 2. The DNR recommends that the opening to the passive gas vent is covered with a mesh material to prevent insects from inhabiting the passive gas vent.

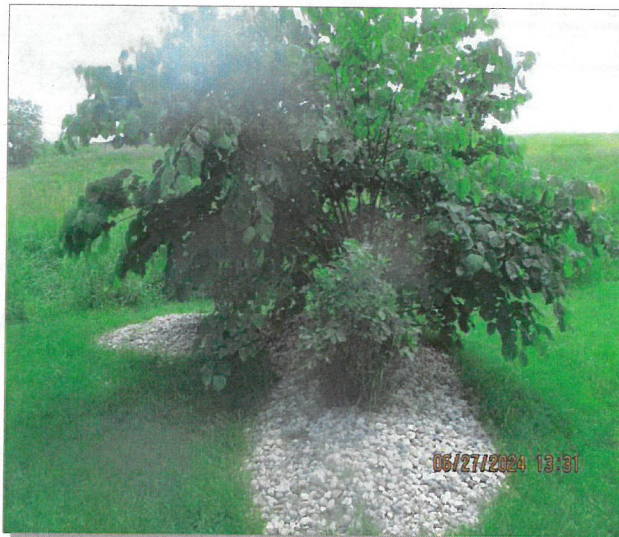
Photo # 105836 Photo 10 of 30

Woody vegetation established near gas probe GP-7. Woody vegetation should be removed if it is on or immediately near the passive gas venting trench to prevent damage to the trench due to the tree roots.

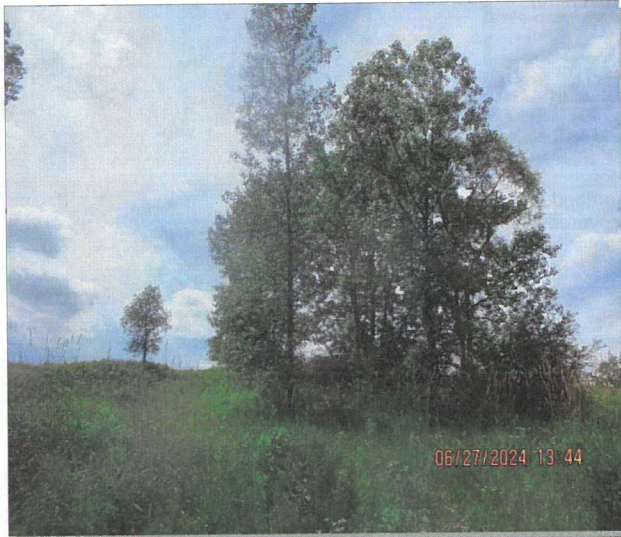
Photo # 105838 Photo 12 of 30

- c. During the inspection, woody vegetation was observed growing on the eastern side/sideslope of the landfill, along the public access trail. The department could not determine if the woody vegetation was on the final cover. If on the final cover, the woody vegetation needs to be removed to prevent damage to the landfill cover. Please evaluate if the woody vegetation is on the final cover and provide documentation of the evaluation to the department in writing by **October 3, 2024.** If determined to be on the landfill cover, please include next steps to remove woody vegetation on the east side of the landfill.

Woody vegetation established on east side of CE Land property, west of the public trail. Woody vegetation needs to be removed if the woody vegetation is within the limits of waste of the landfill.

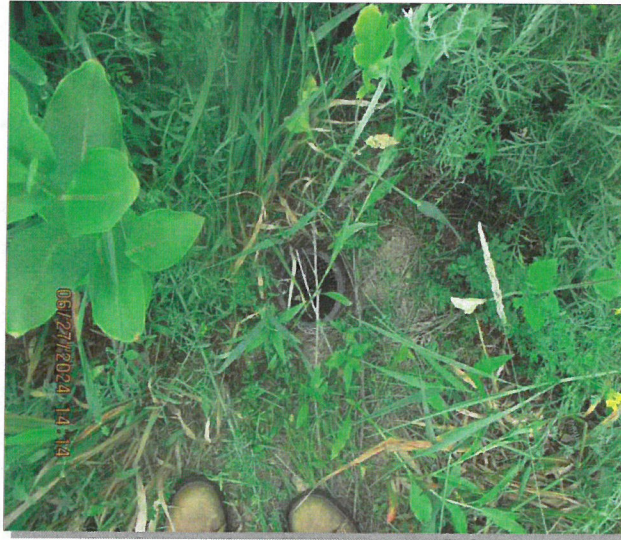
Photo # 105841 Photo 15 of 30

Unidentified broken pipe located adjacent to passive gas vent SPV-5. Pipe penetration needs to be identified and properly repaired or abandoned depending on what the device is identified to be.

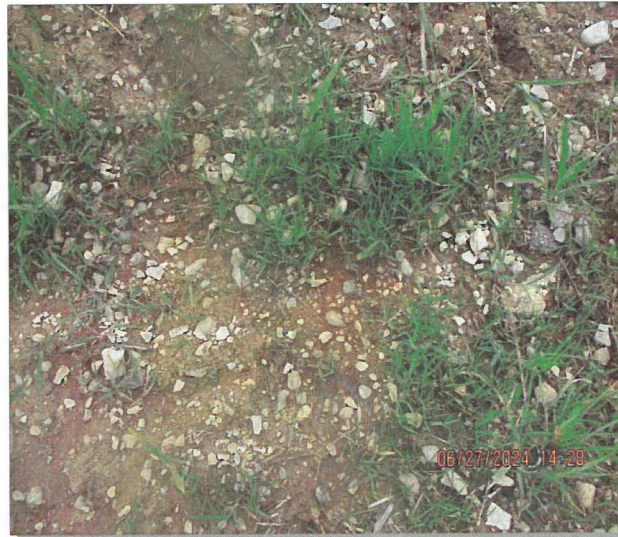
Photo # 105844 Photo 18 of 30

During the inspection, a bare spot located east of the northern most Coffee Hill condominiums contained rust colored staining on the soil surface that has the potential to be caused by a leachate release or gas stress. The department recommended adding clean fill to the area and vegetating as an initial step to remediating the area. If additional fill does not prevent future seeps or new seeps form, additional actions may be needed to remediate leachate/gas releases.

Close up of approximate 3-foot diameter bare spot located east of the northernmost condominiums with indications of rust colored staining that could be caused by gas and/or leachate. The DNR discussed adding additional clean fill over the area and stabilizing (vegetating) the added soils.

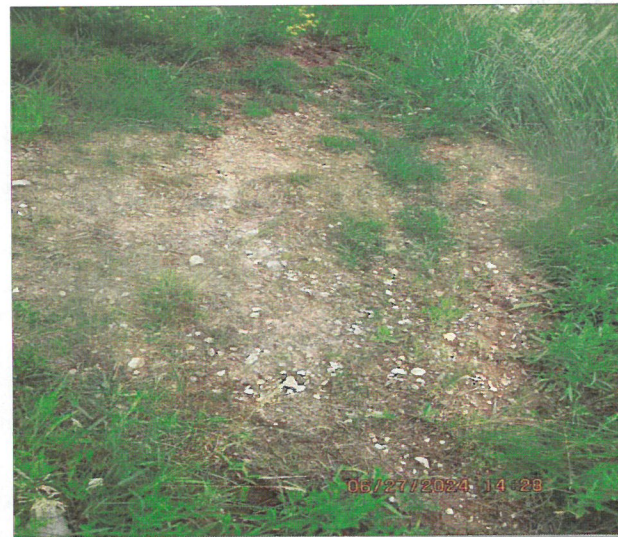
Photo # 105845 Photo 19 of 30

Close up of approximate 3-foot diameter bare spot with indications of rust colored staining that could be caused by gas and/or leachate. The DNR discussed adding additional clean fill over the area and stabilizing (vegetating) the added soils.

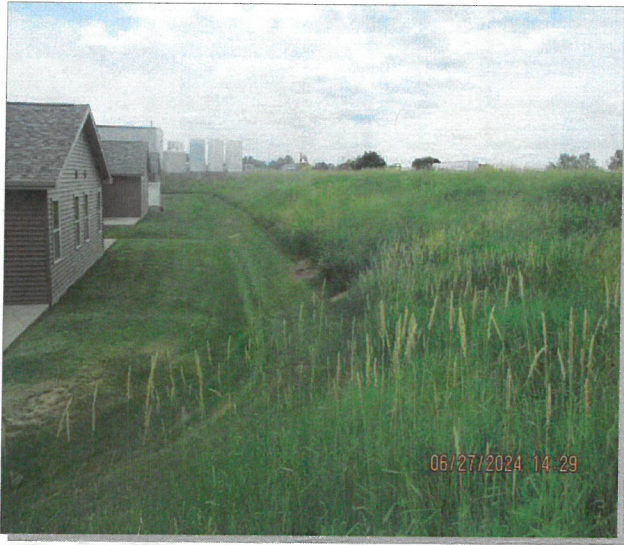
Photo # 105846 Photo 20 of 30

- b. Four bare spots located on the sideslopes of the landfill adjacent to the northernmost Coffee Hill condominiums were observed during the inspection. The bare spots need to be stabilized to prevent erosion of cover soils. Please provide photo documentation of the repairs completed or a response to the department in writing by **October 3, 2024** for next steps to correct the bare spots located near the Coffee Hills condominiums.

- ii. The cause of the bare spots located on the sideslope of the landfill adjacent to the northernmost Coffee Hills condominiums needs to be determined. If topsoiling and seeding the bare spots does not result in vegetation establishment, additional measures will be needed to determine the cause of the stressed vegetation and measures needed to vegetate the bare spots. The department recommends performing a surface emission scan for landfill gases to determine if the bare spots are caused by gas stress.

Southern boundary of landfill and Coffee Hills condominiums. Three bare spots observed on the sideslope between the landfill and condominium (center of photo).

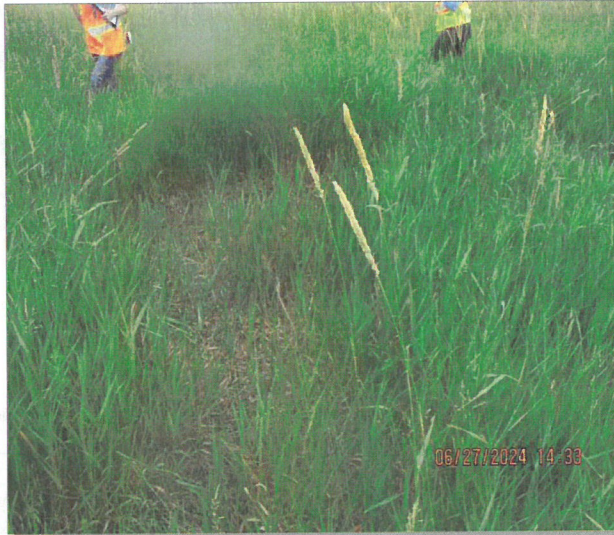
Photo # 105850 Photo 24 of 30

Stressed vegetation/ponding water area located in the central portion of the landfill (closer to western side of landfill).

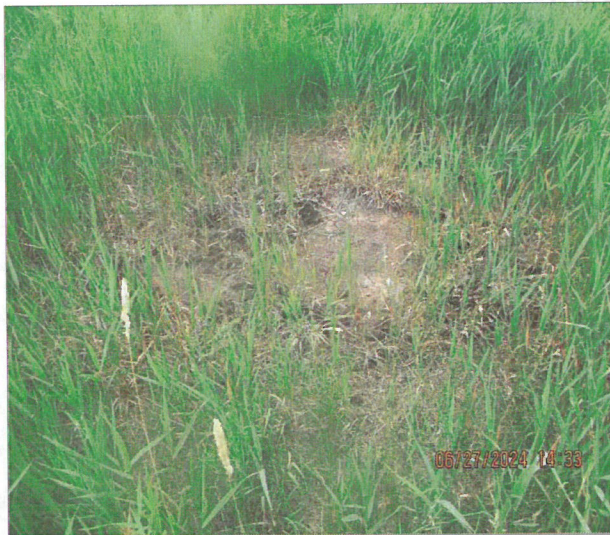
Photo # 105851 Photo 25 of 30

- a. During the inspection the department observed multiple areas of ponding water located in the northwest portion of the landfill. The ponding water areas need to be graded to allow for positive storm water runoff off the final cover. Due to the extent of the bare spots, the department recommended a topographic survey to ensure that the grading work will not redirect the storm water to other low areas of the final cover. Please provide a response to the department in writing by **October 3, 2024** for next steps to correct the ponding water areas.

Ponding water located in the central portion of the landfill (closer to western side of landfill). Area needs to be graded to prevent ponding water.

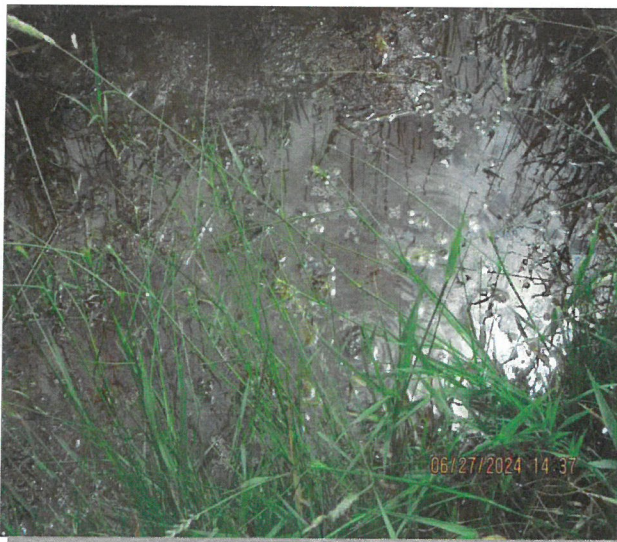
Photo # 105852 Photo 26 of 30

- a. During the inspection, the department observed two areas of potential gas stress related to noncompliance item numbers 2a and 2b, discussed above.
 - i. An area of ponding water located in the northwest portion of the landfill, adjacent to the mowed trail on the south side, was observed bubbling. At the time of the inspection, the department discussed adding additional clean fill to the area to prevent the gas from migrating through the final cover.

Gas observed actively bubbling in ponding water located adjacent to the mowed trail (south side), in northwestern portion of landfill. Area needs to be graded to prevent ponding water. Additional measures may be needed to mitigate gas.

The department additionally recommends that due to the current use of the landfill as a public park, measures should be taken to ensure that the bubbling water, and all areas specifically used for public recreation, are not emitting landfill gas at concentrations that may cause negative affects to citizens utilizing the park (i.e., explosion hazard from open flames/grilling activities).

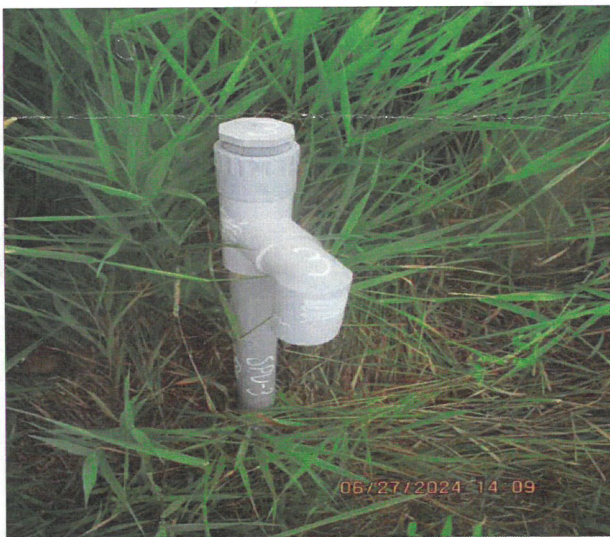
- c. Two passive gas vents along the Southern Passive Vent (SPV) trench require repair, including SPV-5 which was observed to be broken and uncovered at the ground surface and SPV-3 that was observed to be broken and unstable/wobbly. Provide the department photo documentation of the repairs or plan outlining a timeline for the repairs to the department by **October 3, 2024.**

Passive gas vent SPV-3 broken (not viewable in photo) and unstable/wobbly
