# Town of Lake Park, Florida

## Historic Preservation Board Meeting Minutes

23-002: QUASI-JUDICIAL PUBLIC HEARING ON A PETITION TO RESCIND THE LOCAL HISTORIC DESIGNATION, GRANTED IN 1998, FOR THE ARNOLD BUILDING LOCATED AT 918 PARK AVENUE, LAKE PARK, FLORIDA, 33403 (8PB9607), AND TO REMOVE IT FROM THE HISTORIC DESIGNATION SURVEY AND FLORIDA MASTER SITE FILE.

# STRUCTURAL ASSESSMENT

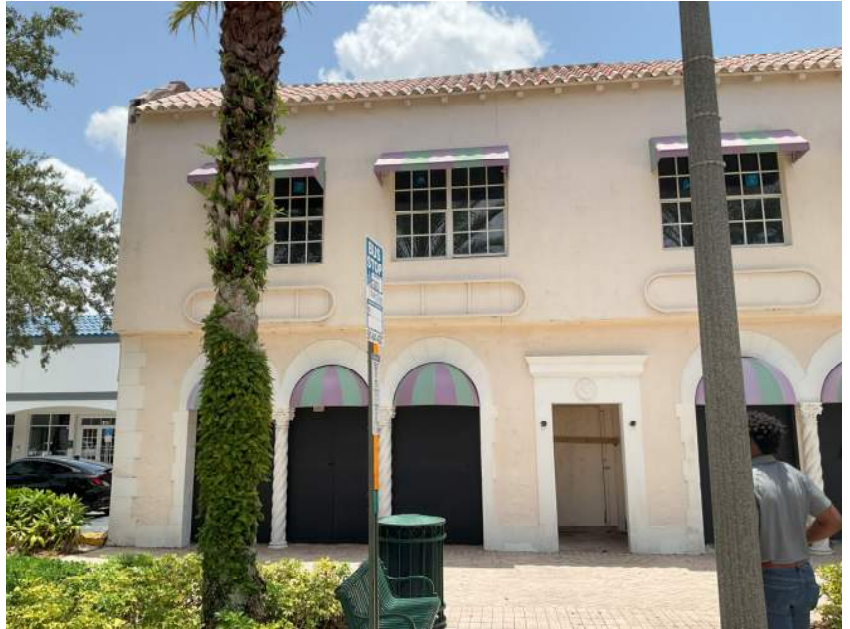
Photo No. 002  
Date Taken: 07/10/2023  
File Name: 20230710\_173333447  
Description: Cracked stucco at top of Northeast corner of building

Comments: Cracked stucco allows for water infiltration, allowing for structural water damage to wood framing members

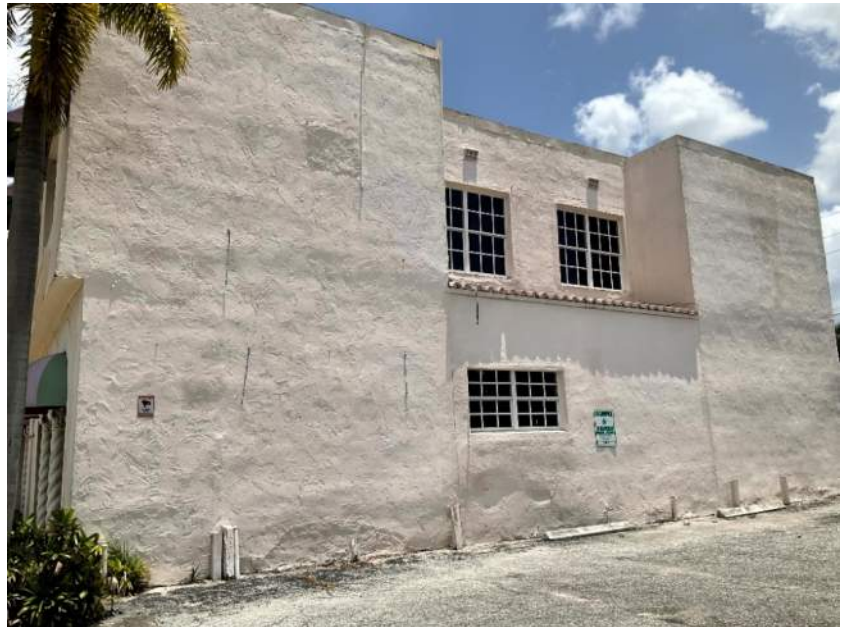
Photo No. 010  
Date Taken: 07/10/2023  
File Name: 20230710\_174453683  
Description: Large indentation on stucco finish

Comments: Presumed vehicle impact. Wall framing needs to be inspected for damage.

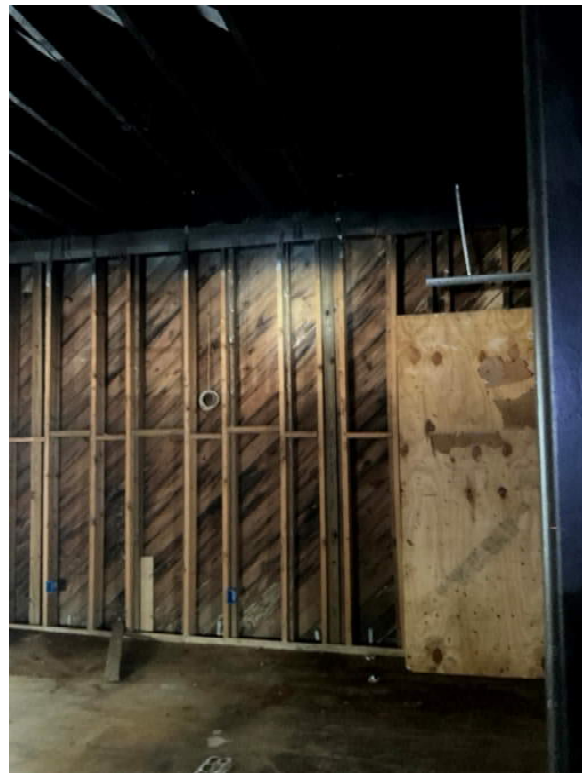
Photo No. 029  
Date Taken: 07/10/2023  
File Name: IMG\_7974  
Description: Interior front wall at  
Northeast side of building

Comments: Missing sheathing, missing  
headers over arched  
openings

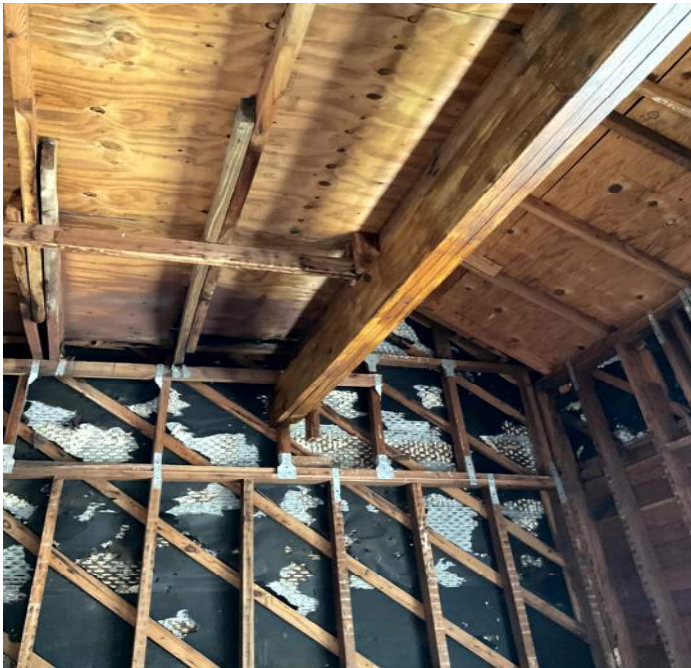
Unconventional top of wall framing  
PHOTO NO. 20230710\_182333863

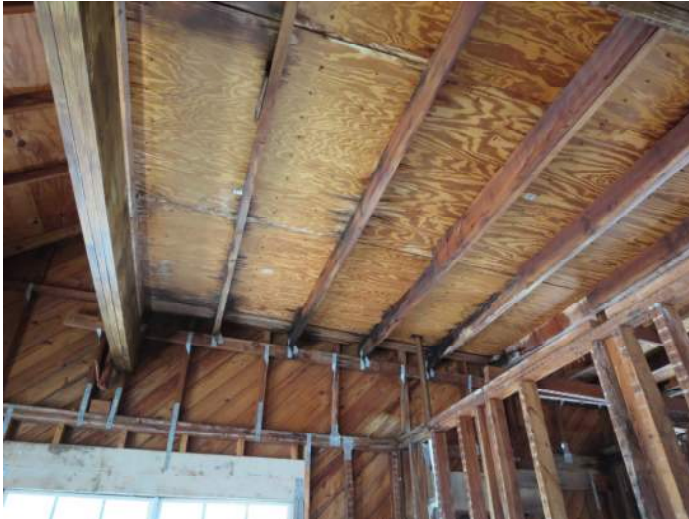
Roof framing and water stains at roof deck sheathing  
PHOTO NO. IMG\_7999
