Town of Lake Park, Florida

Special Call Historic Preservation Board Meeting

HPB 24-001: QUASI JUDICIAL HEARING TO CONSIDER A REQUEST FOR A SPECIAL CERTIFICATE OF APPROPRIATENESS TO ALLOW THE REPLACEMENT OF A ROOF FOR A LOCALLY HISTORICALLY DESIGNATED HOME LOCATED AT 250 FORESTERIA DRIVE

STRUCTURAL ASSESSMENT

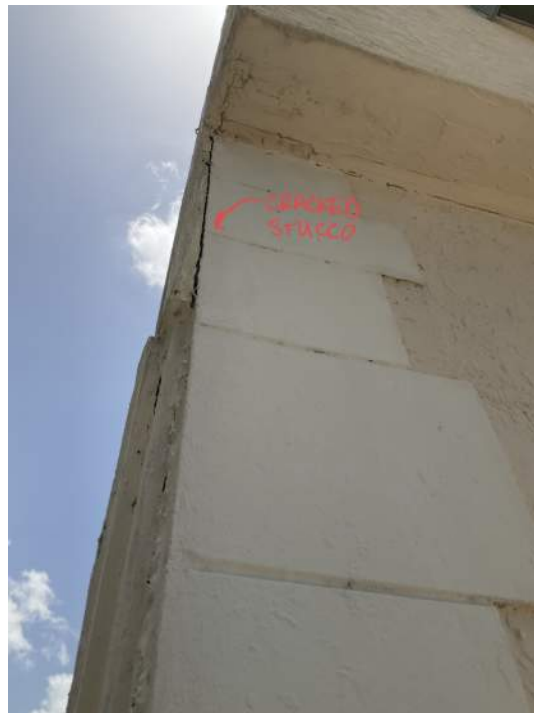
Photo No. 002
Date Taken: 07/10/2023
File Name: 20230710_173333447
Description: Cracked stucco at top of Northeast corner of building

Comments: Cracked stucco allows for water infiltration, allowing for structural water damage to wood framing members

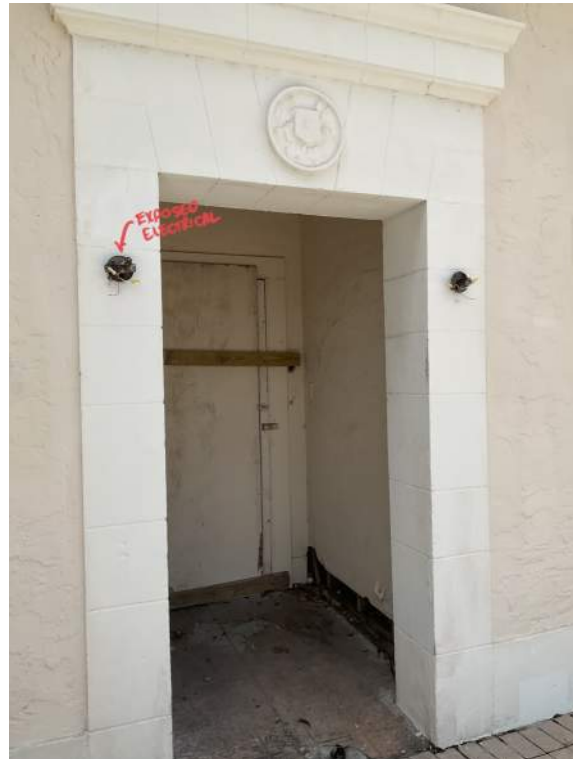
Photo No. 003
Date Taken: 07/10/2023
File Name: 20230710_173546857
Description: Entrance doorway

Comments: Exposed electrical wires on the exterior of the building should be capped.

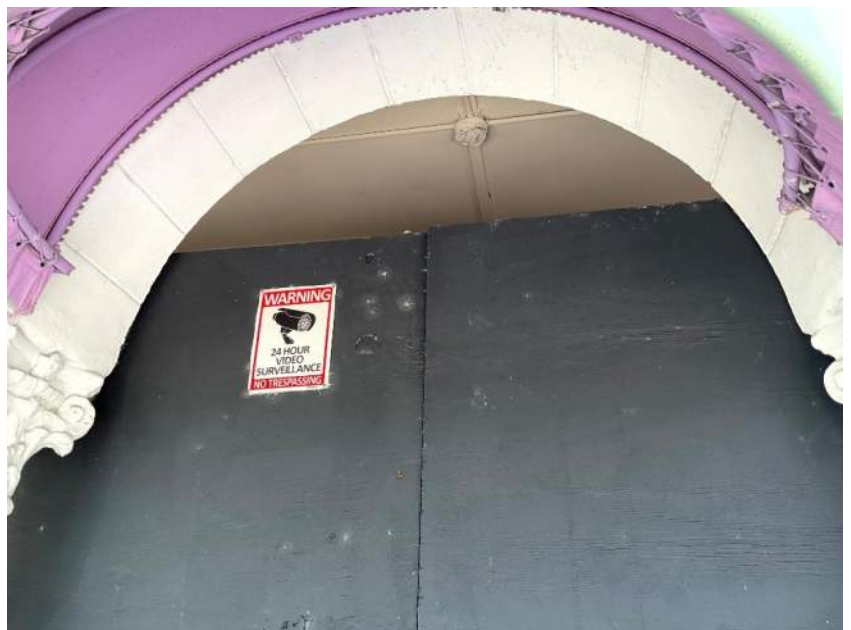
Photo No. 004
Date Taken: 07/10/2023
File Name: 20230710_173527910
Description: Boarded storefront openings.

Comments: Boards do not fully enclose the openings allowing for water and pest infiltration into the building.

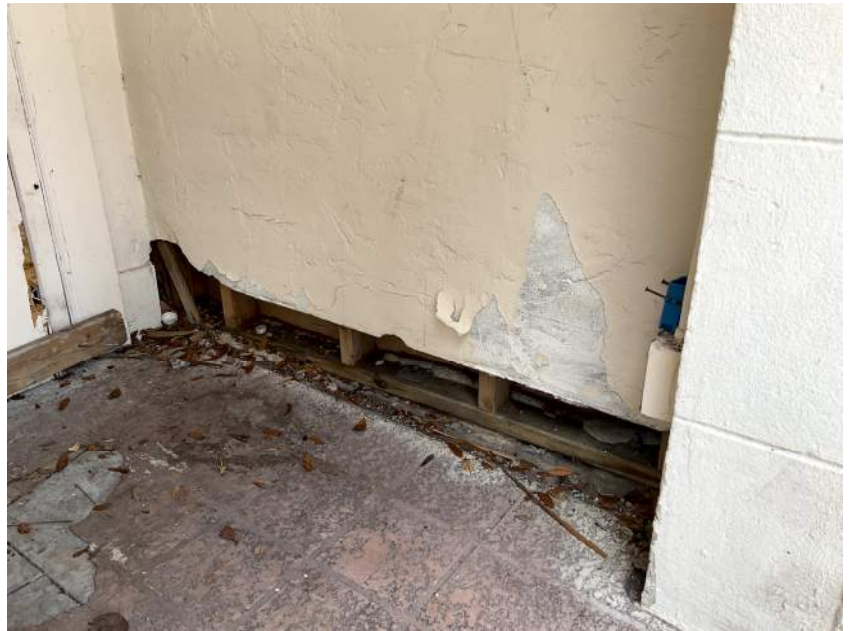
Photo No. 007
Date Taken: 07/10/2023
File Name: 20230710_173938121
Description: Front entrance vestibule with spalled stucco and exposed framing

Comments: Spalled stucco finish allows for water and pest infiltration into the building.

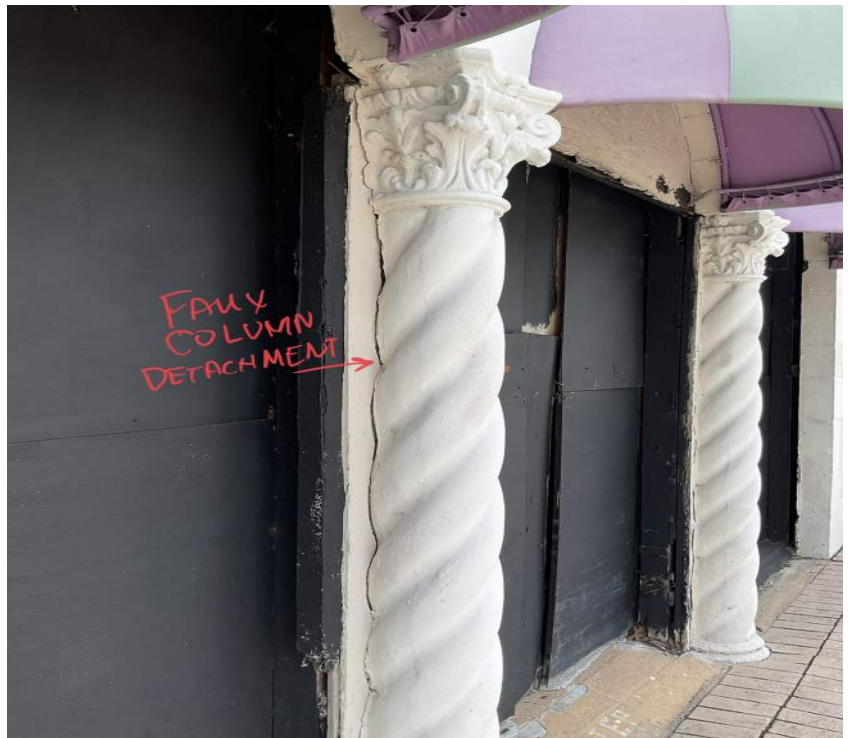
Photo No. 008
Date Taken: 07/10/2023
File Name: 20230710_173954446
Description: Detached faux column

Comments: Susceptible to falling and injuring a pedestrian.

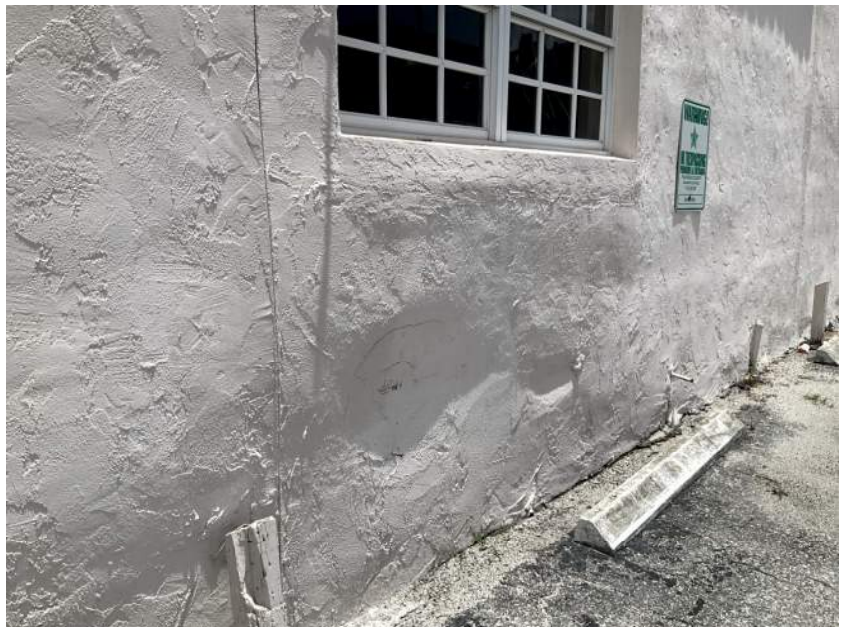
Photo No. 010
Date Taken: 07/10/2023
File Name: 20230710_174453683
Description: Large indentation on stucco finish

Comments: Presumed vehicle impact. Wall framing needs to be inspected for damage.

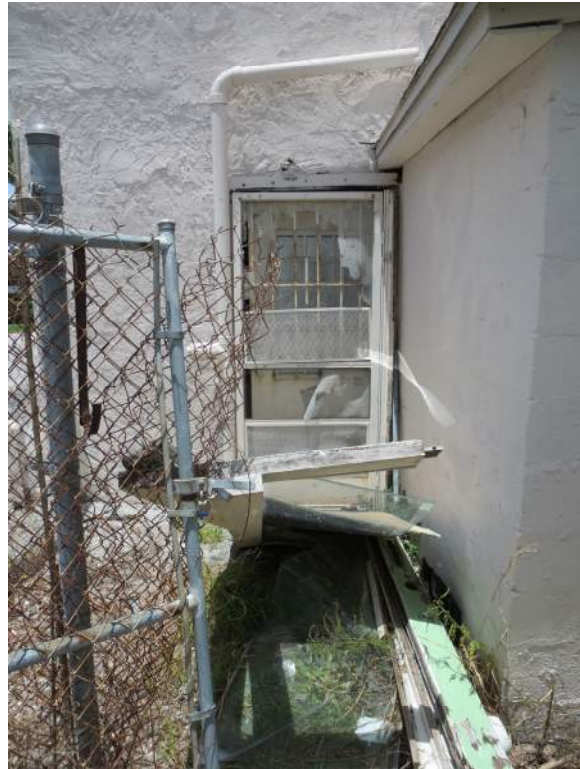
Photo No. 013
Date Taken: 07/10/2023
File Name: IMG_7937
Description: Broken screen door and exposed door frame at Southwest corner of building

Comments: Dangerous debris needs to be removed

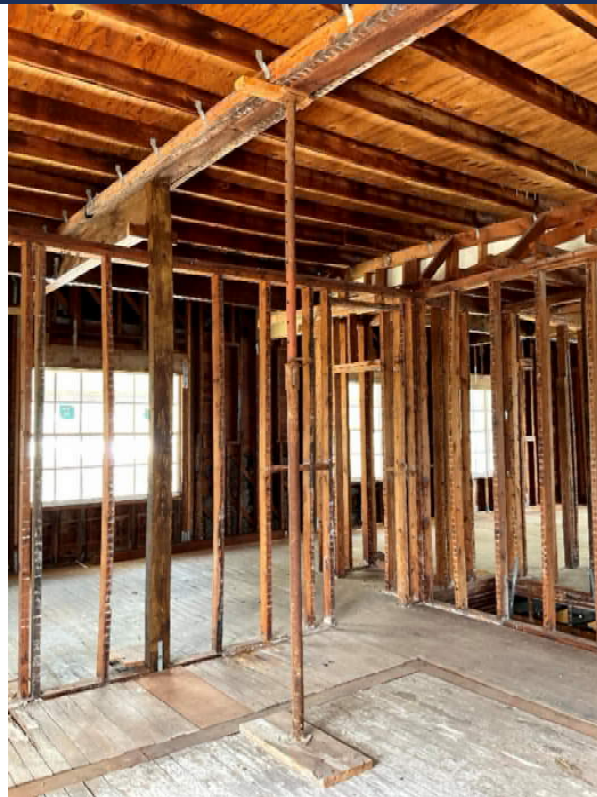
Photo No. 031
Date Taken: 07/10/2023
File Name: 20230710_183906548
Description: Roof framing temporarily shored

Comments: Near the Northwest corner of the 2nd floor a shallow roof girder is temporarily shored

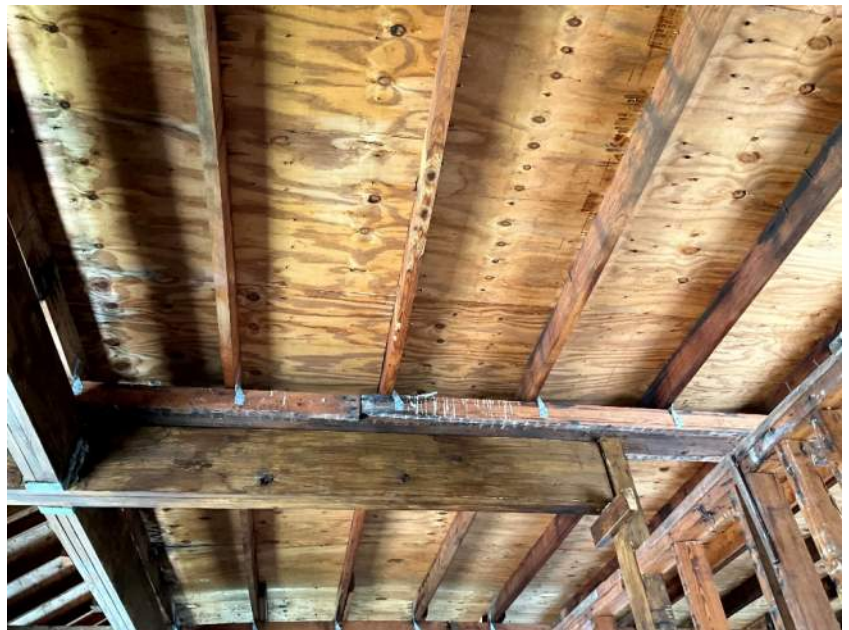
Photo No. 032
Date Taken: 07/10/2023
File Name: 20230710_182541168
Description: Roof framing girder bearing over nailed stub

Comments: Framing of girder is unconventional and needs to be analyzed. Water stains on roof deck sheathing.

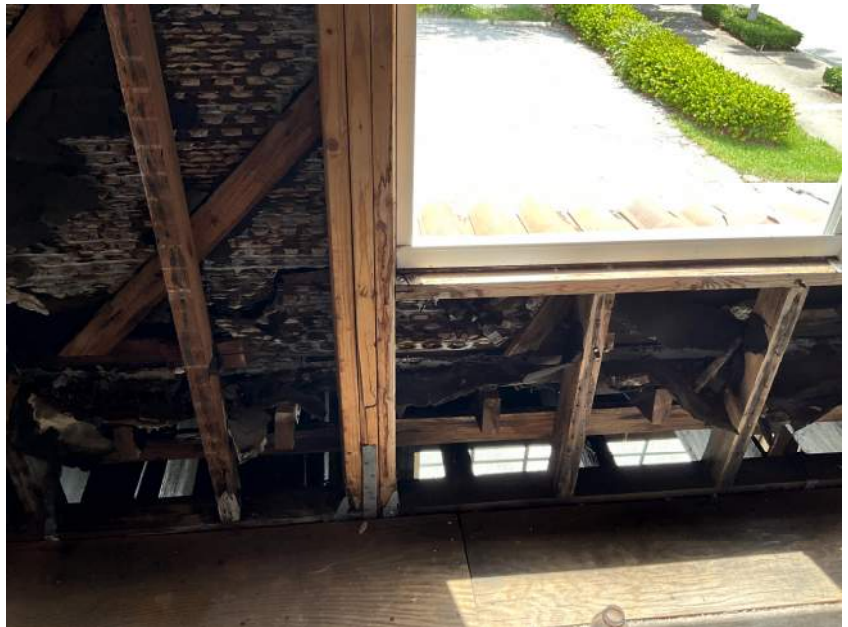
Photo No. 034
Date Taken: 07/10/2023
File Name: 20230710_183718585
Description: Window vertical framing at West side of building

Comments: Roof and 2nd floor wall framing bearing over unblocked floor joists

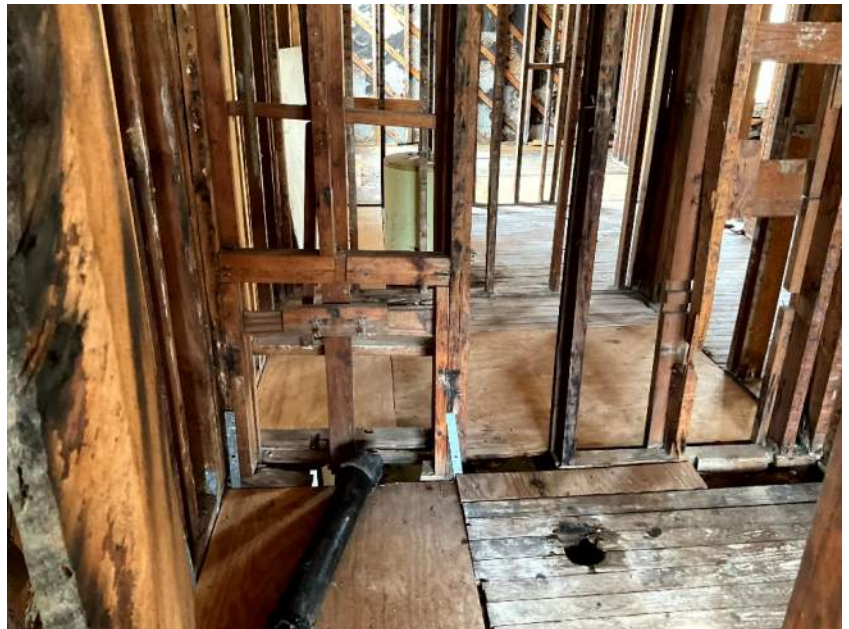
Photo No. 035
Date Taken: 07/10/2023
File Name: 20230710_183145784
Description: Decayed wood framing and discontinuous deck framing
Comments:

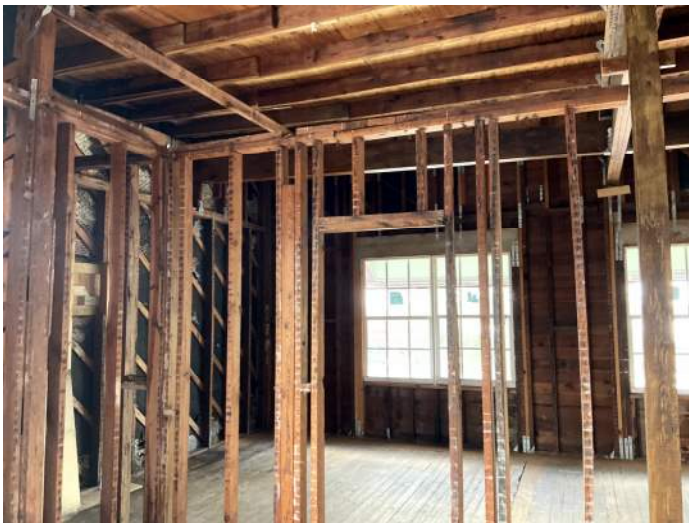
Missing header over arched openings
PHOTO NO. 20230710_181658453
