# City Council Study Session Agenda

Monday, February 28, 2022 at 5:30 PM  
27400 Southfield Road, Lathrup Village, Michigan 48076

# Sanitary Sewer System City of Lathrup Village

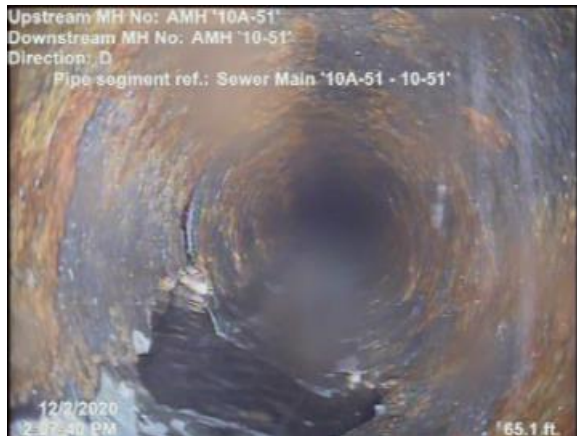
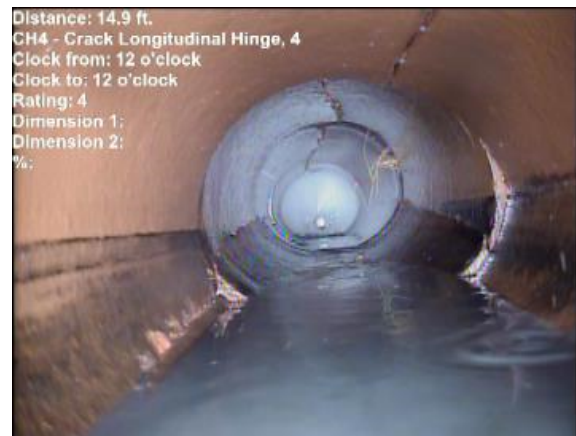
Broken and cracked sewers to be lined:

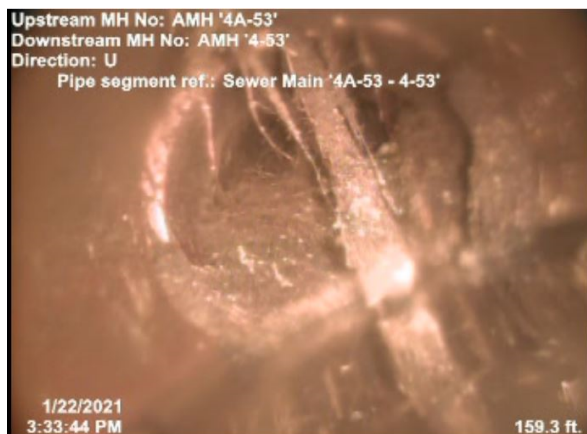
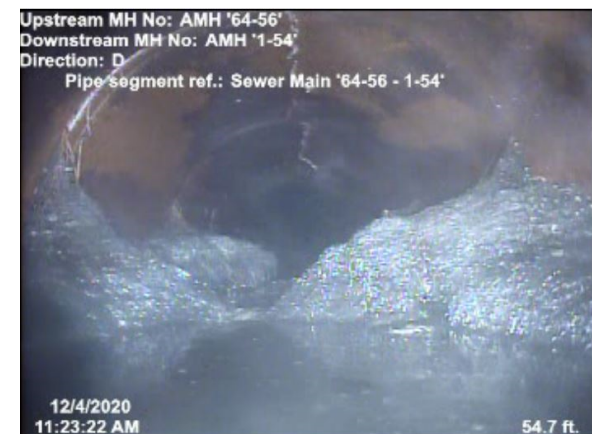
Sewer root intrusions:

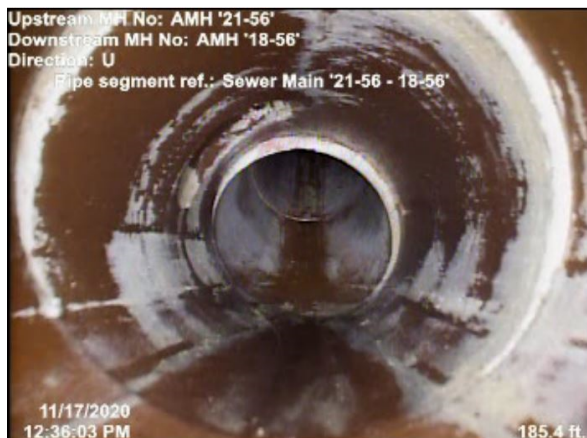
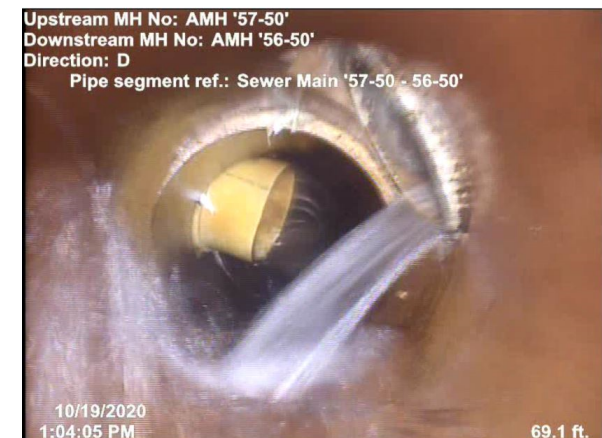
Dead end sewers and protruding taps:

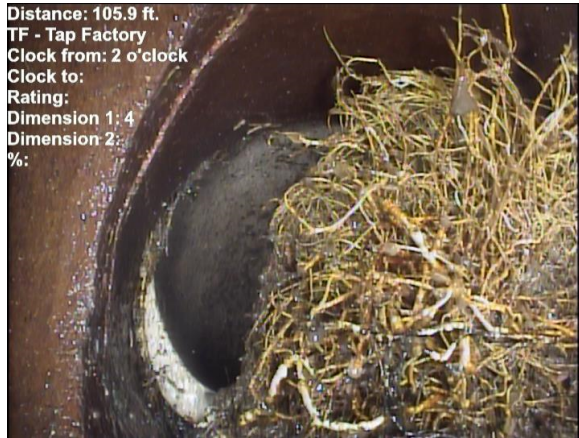
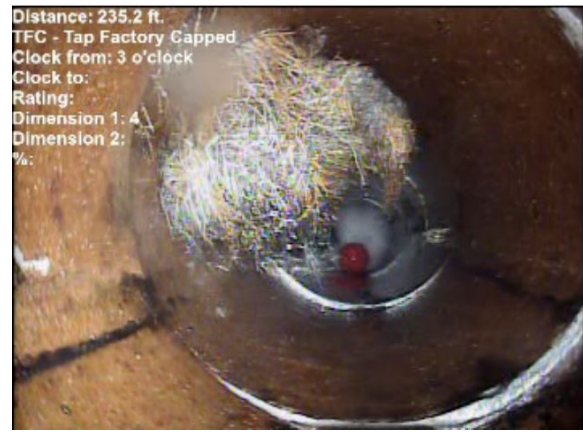
### Residential service lead roots:

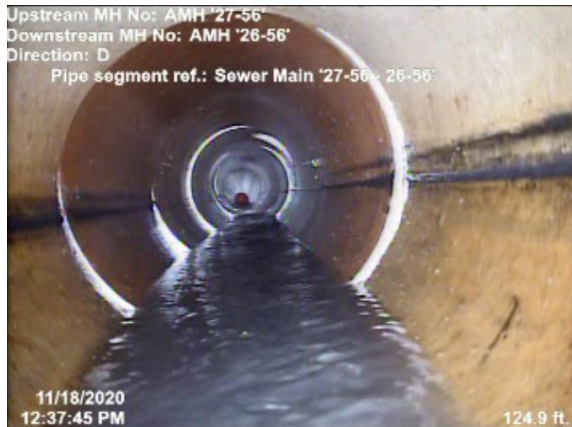
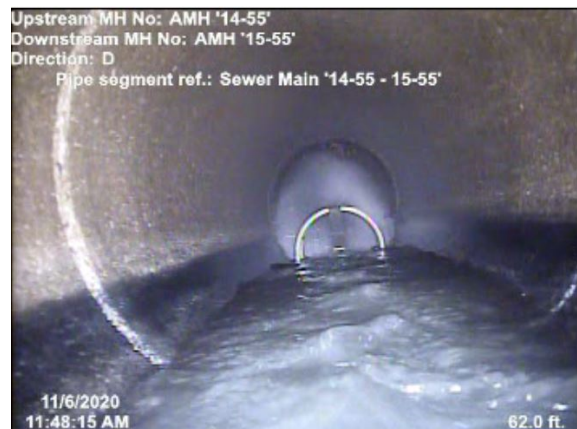
- The existing 24" sewers along both Evergreen and WB 11 Mile were assessed as good condition. However, these sewers had between 6 - 10 inches of debris in the pipe bottom which significantly reduces the flow capacity.

### Sewers with a lot of debris (black parallel lines):

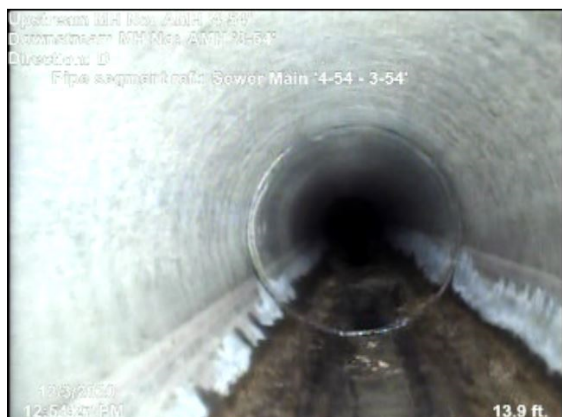
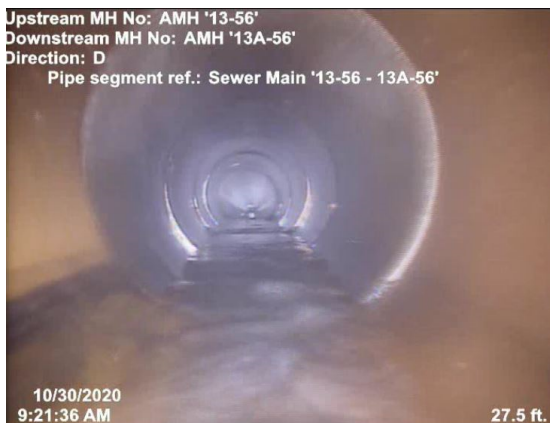
### Sewers in good condition:

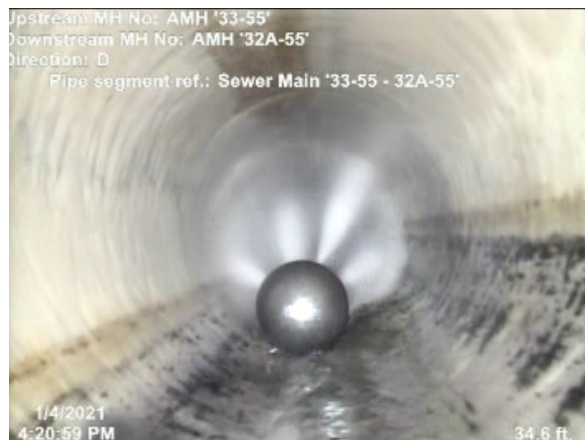
Sewers previously lined with Cured-In-Place-Pipe:
