**Item:** Sandalwood Stormwater Evaluation

**DAM AND CULVERT REPORT  
FOR  
SANDALWOOD TOWNHHOMES**

**SHOAL CREEK TRIBUTARY 4.1**

### APPENDIX A - Visual Existing Condition on Dam

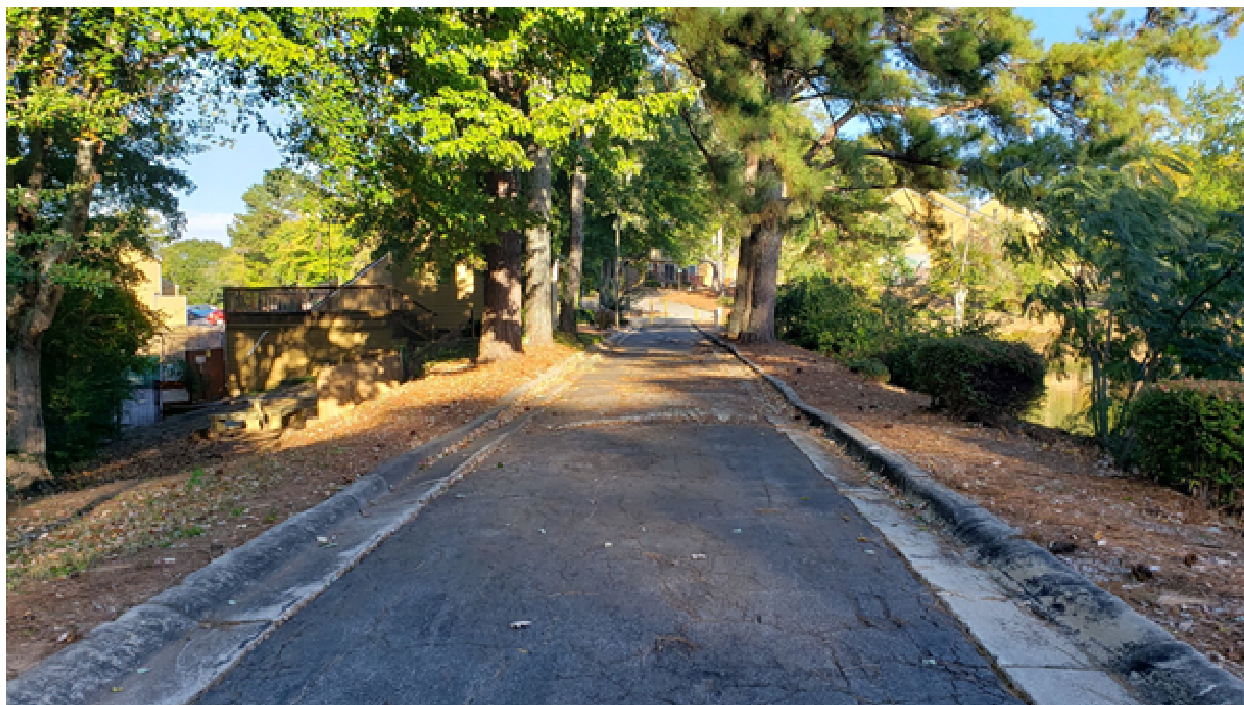
The top of the dam is comprised of a 13' back-to-back road with curb and gutter.

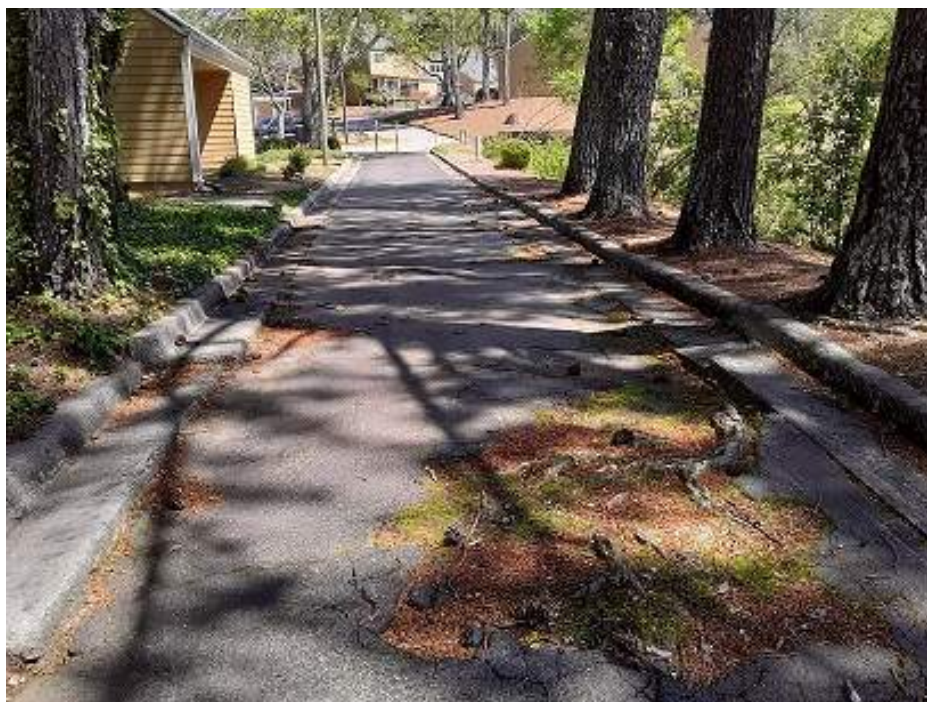
Over the years several large trees have grown up along the road causing root intrusion into the paving and buckling of curb and gutter.

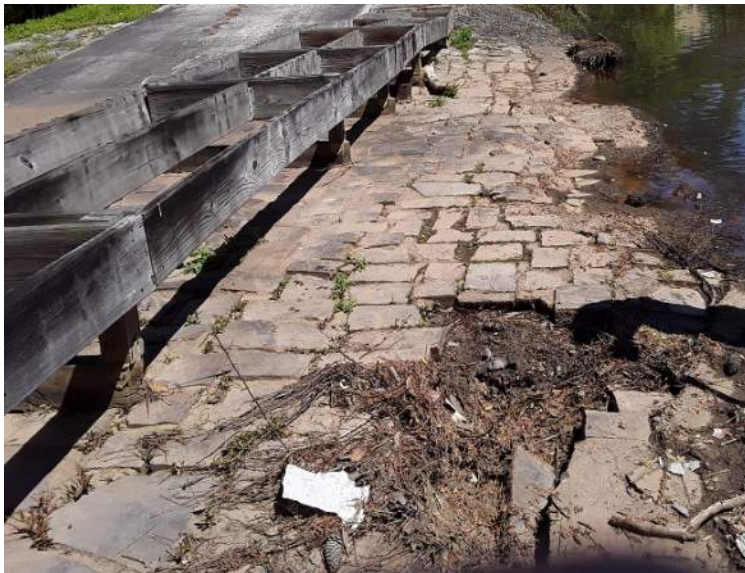
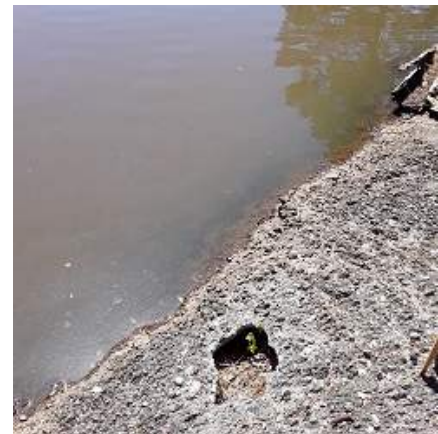
Some damage to the weir, consisting of a small hole in the concrete and the collapsing of the grouted block section of the roadway could be observed.

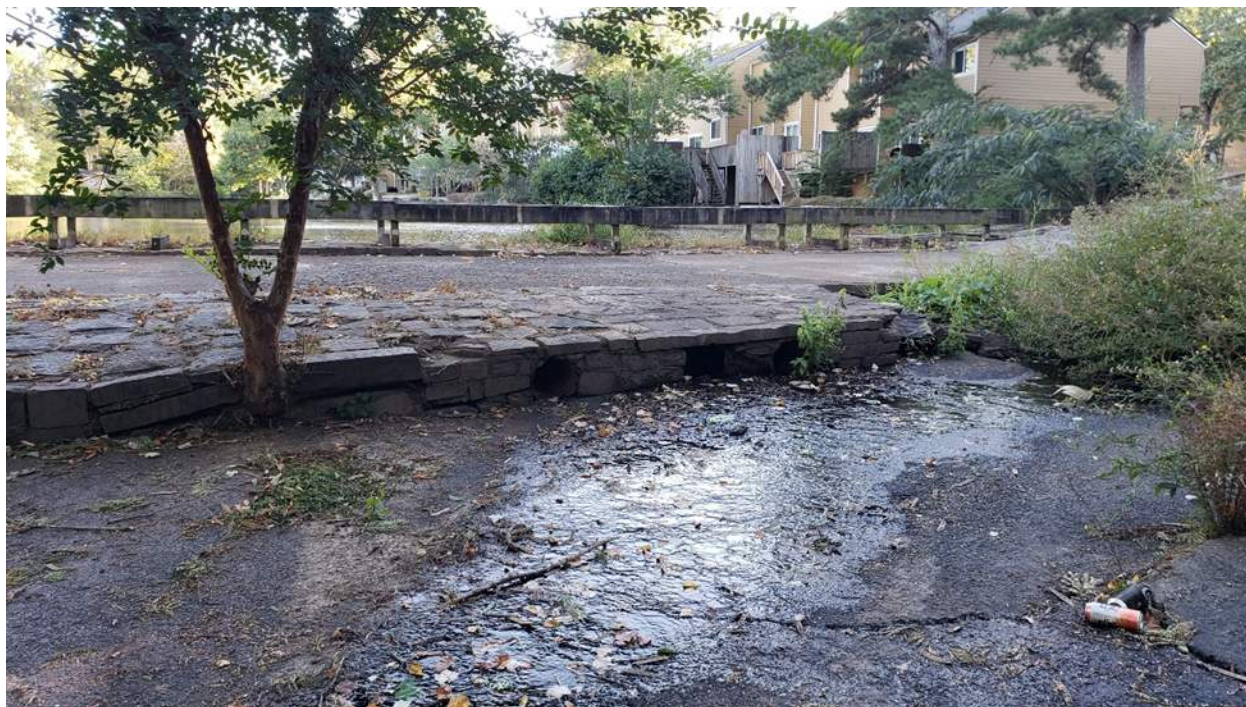
At the time of observation, runoff was exiting the lake through one or two of the existing 12" pipes that convey the base flow underneath the weir. The upstream location of the pipes could not be located. Because only 2 were functioning, it is assumed that the remainder are blocked by sediment.

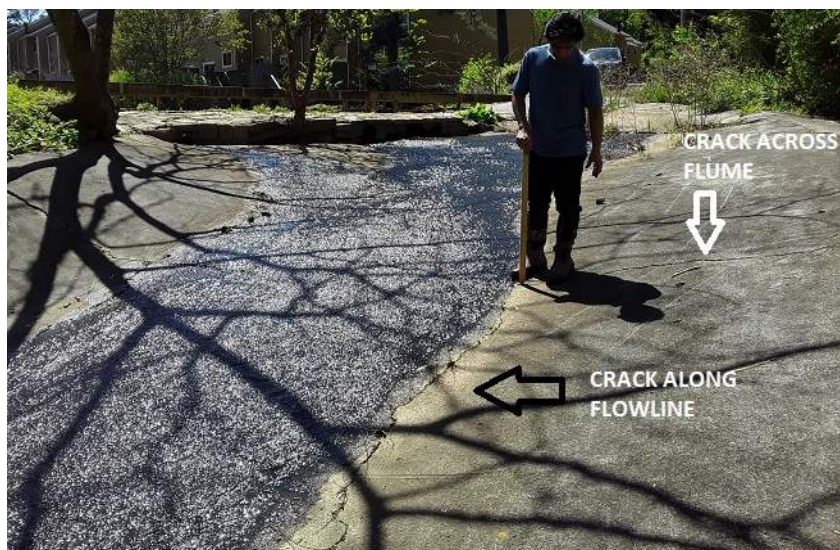
The weir section discharges to a wide concrete flume approximately 2' deep. Cracking can be seen across the flume and along the edge of the flow path.

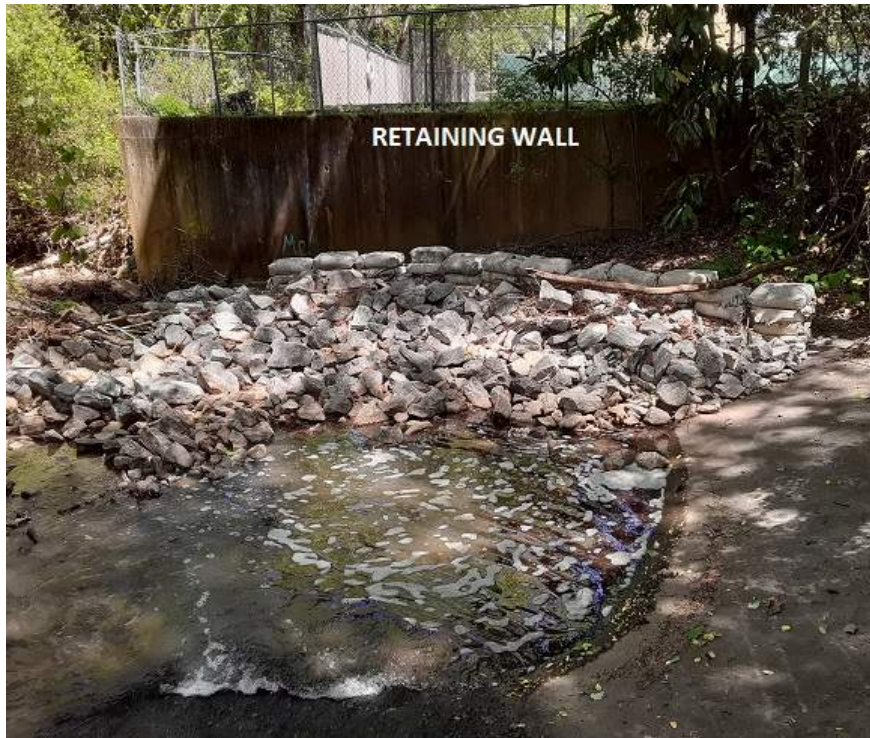
At the bottom, there is a rip rapped basin backed up by stacked cement bags to protect the retaining wall that supports the pool.

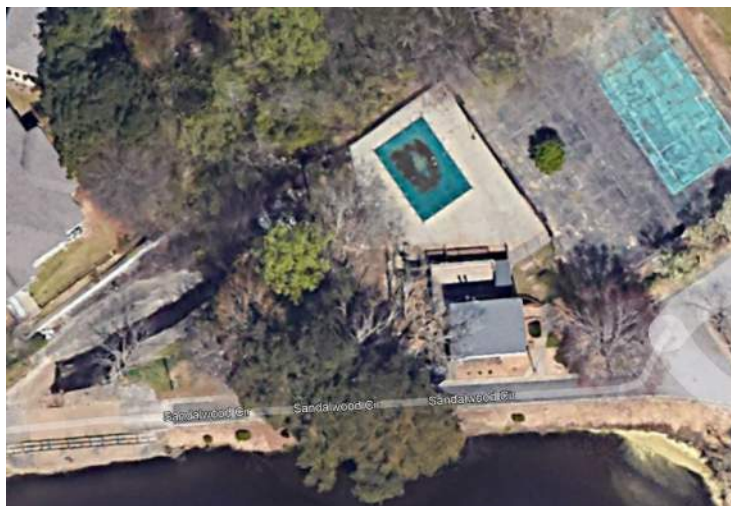
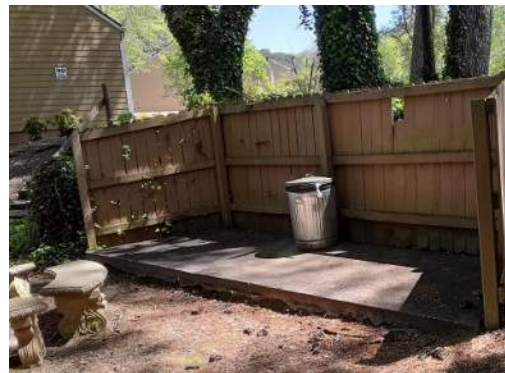
A tennis court, clubhouse and pool are located on the back side of the dam. There is a small area dug into the embankment that is used for garbage can storage. The remainder of the back side of the dam consists of small woody vegetation and mulch with some small to medium trees. No seepage or animal burrows were observed.

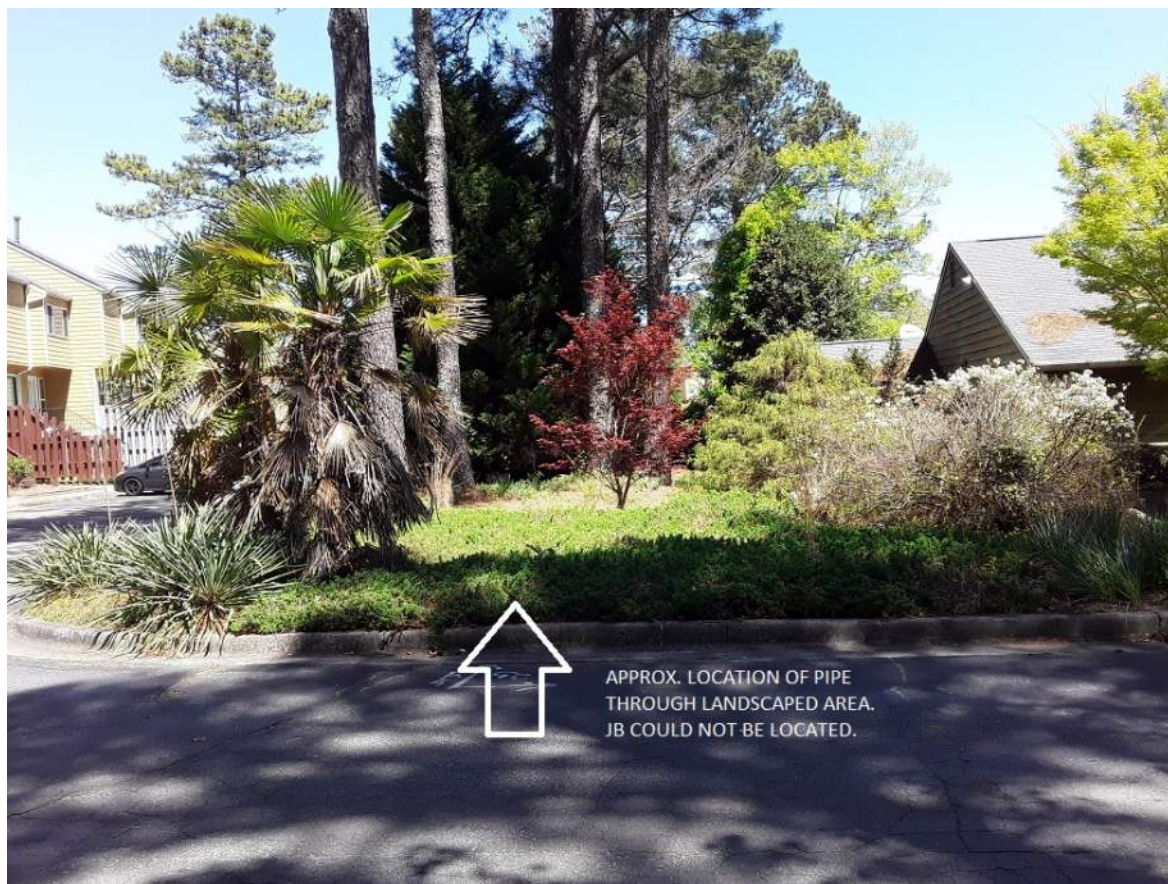
If the pipe is installed between the curb and the condo units corresponding to the GIS, there are at least 5 large pine trees and a Cedar tree located above the pipe. (See Photo below)

*Looking downstream*

Generally, the 42-year-old 48" diameter corrugated metal pipe appears to be in good condition; however, corrosion is beginning to form at the flow line throughout the pipe and lining or reapplying a protective coating should be planned. The undermining of the outlet headwall should be repaired, possibly by hand placed, grouted rip rap similar to the downstream headwall of the southern 84" CMP (See Photo 1 Page C-33). Additional rip rap should be placed beyond the repair. Trees should be removed from the proximity of the upstream headwall and grout reinstalled around the pipes. It is also recommended that the gas pipe penetrations and the damaged section be repaired so that sediment cannot escape into the pipe.

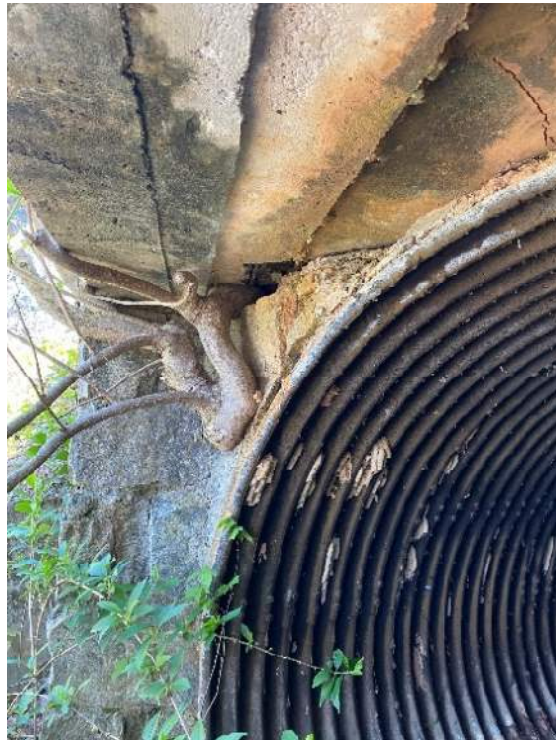
**Picture 2:** A tree is causing cracks in downstream headwall.

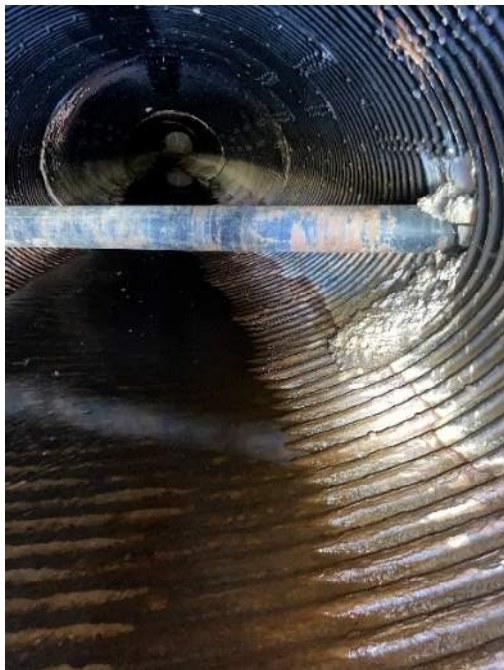
**Picture 3:** The invert of the pipe was somewhat corroded but solid. The crossing pipe  $\pm 25'$  from downstream headwall appears to be a water or sewer pipe. Penetrations appear to be sealed with concrete. Spillage present.

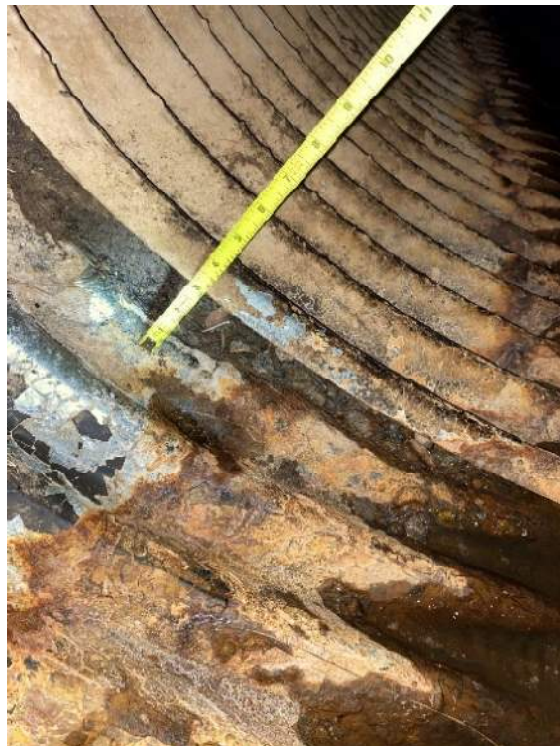
**Picture 4:** 3" gap at joint.

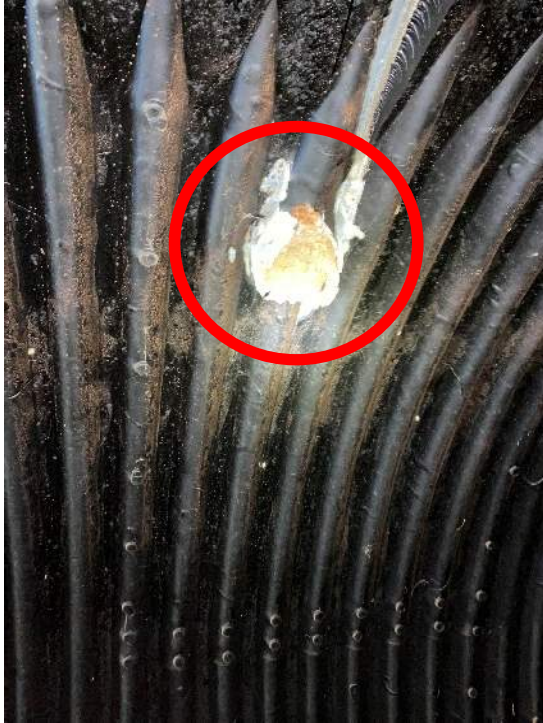
**Picture 5:** Small round rupture about 4" wide about 60 feet from downstream headwall. Possibly from repair work. No sediment visible.

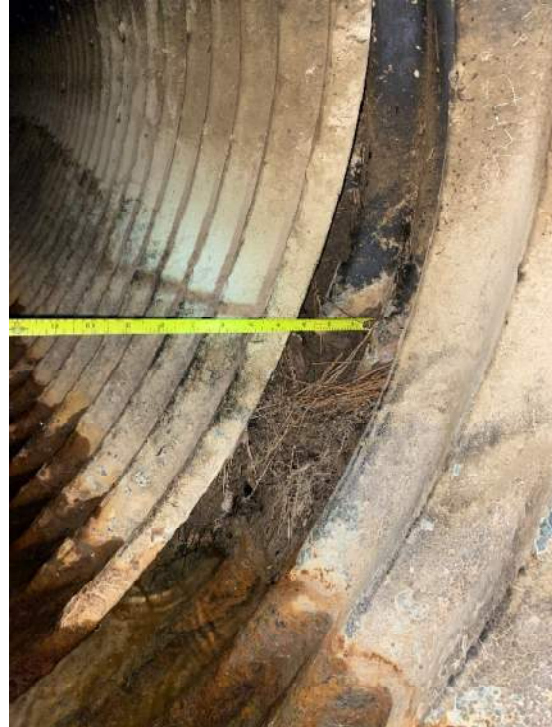
**Picture 6:** 3" gap at joint. Sediment present.

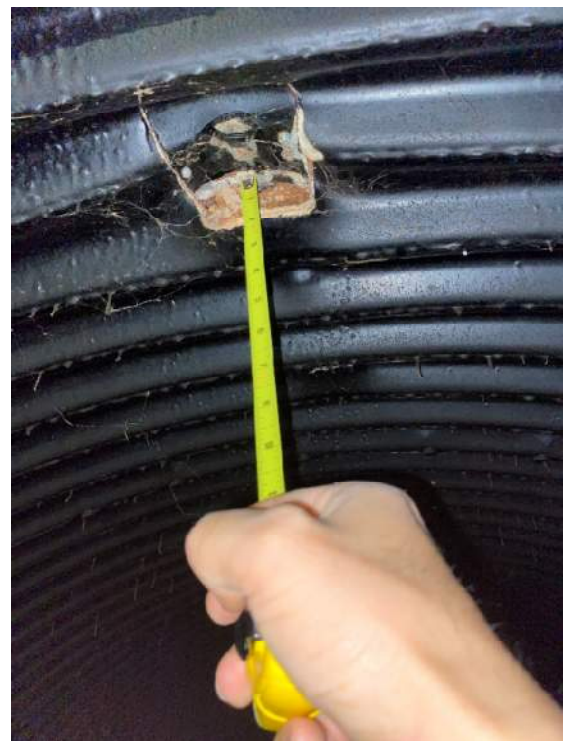
**Picture 8:** A rupture on the pipe about 4" wide and 6" long. Sediment is visible.

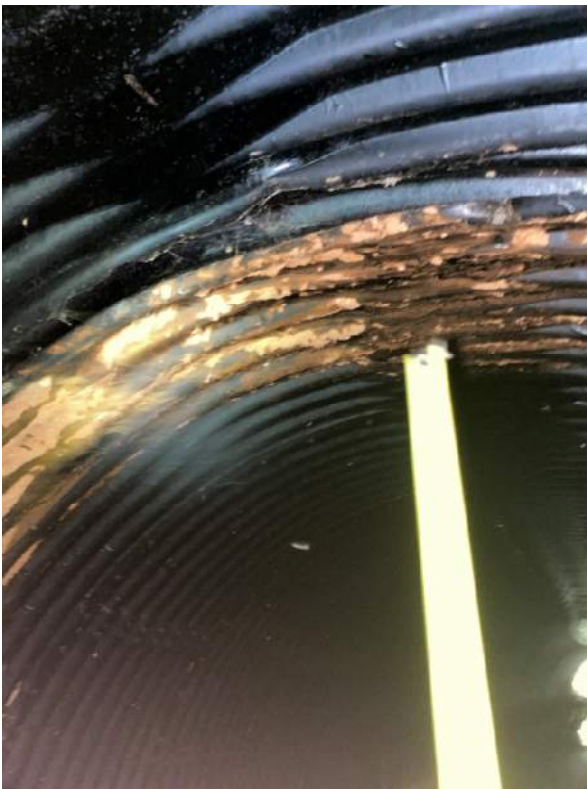
**Picture 11:** Corrosion on top of pipe.

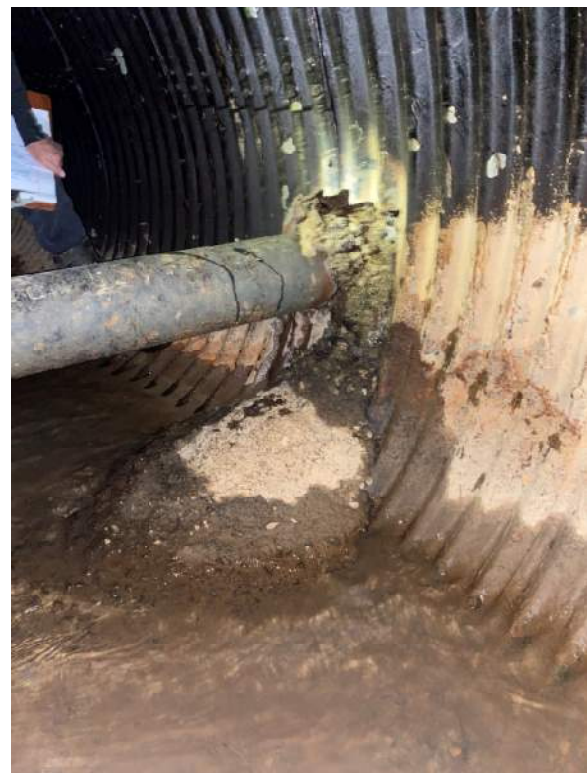
**Picture 12:** Water pipe crossing  $\pm 30'$  from upstream headwall. Penetration sealed with concrete. Spillage present.

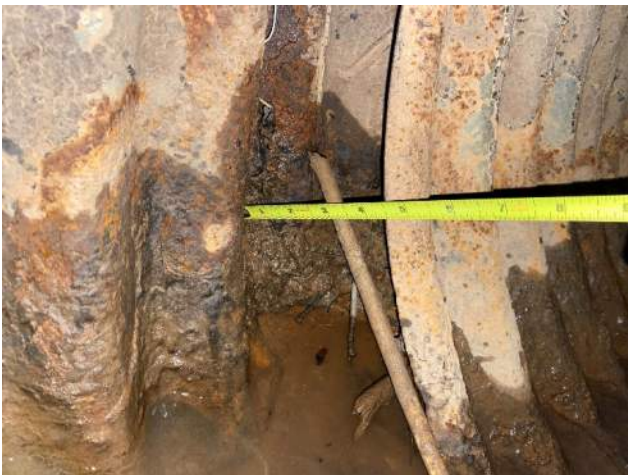
**Picture 15:** Gap shown on picture 14 at pipe joint. Some sediment is infiltrating.

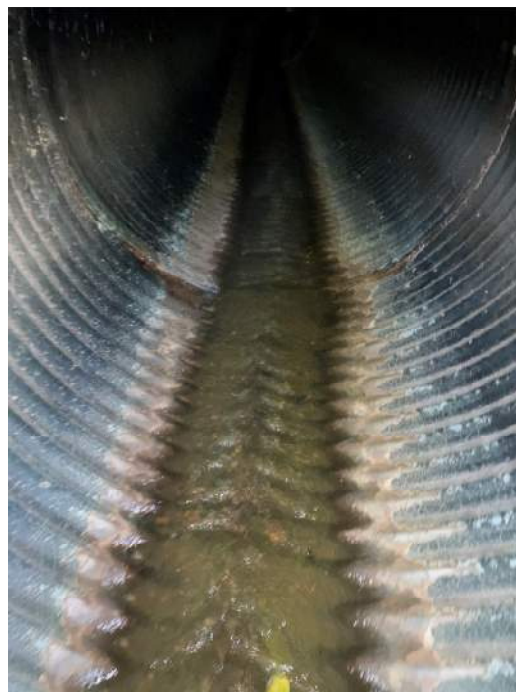
**Picture 2:** Bottom is slightly corroded but solid.

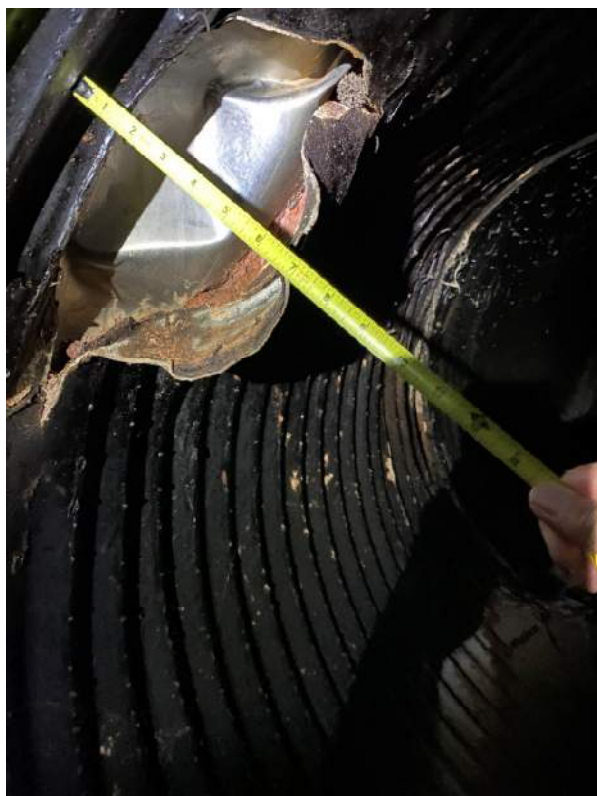
**Picture 3:** The pipe is damaged 10' from upstream headwall. 5" bulge and sediment noticeable.

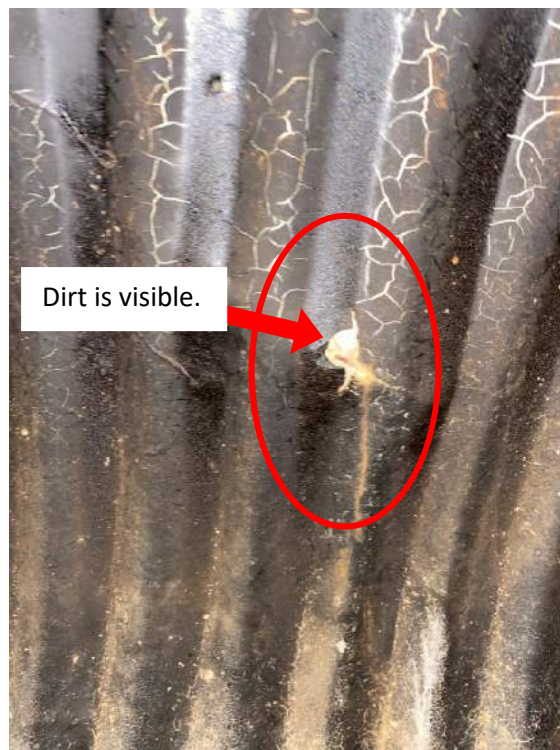
**Picture 4:** Small rupture close to upstream headwall. Small traces of dirt.

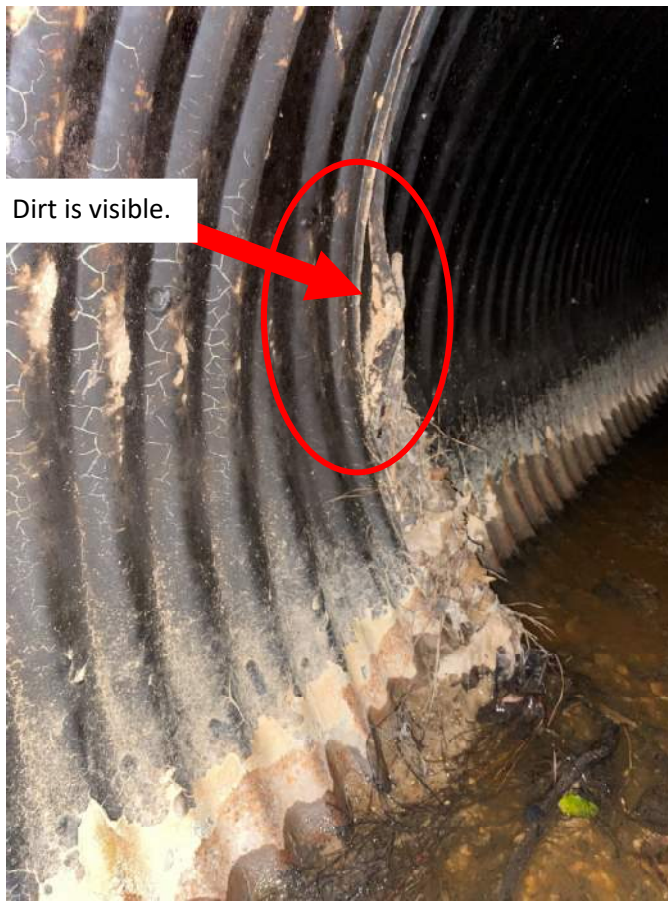
**Picture 5:** Gap at pipe joint  $\pm 20'$  from upstream headwall. Small traces of dirt.

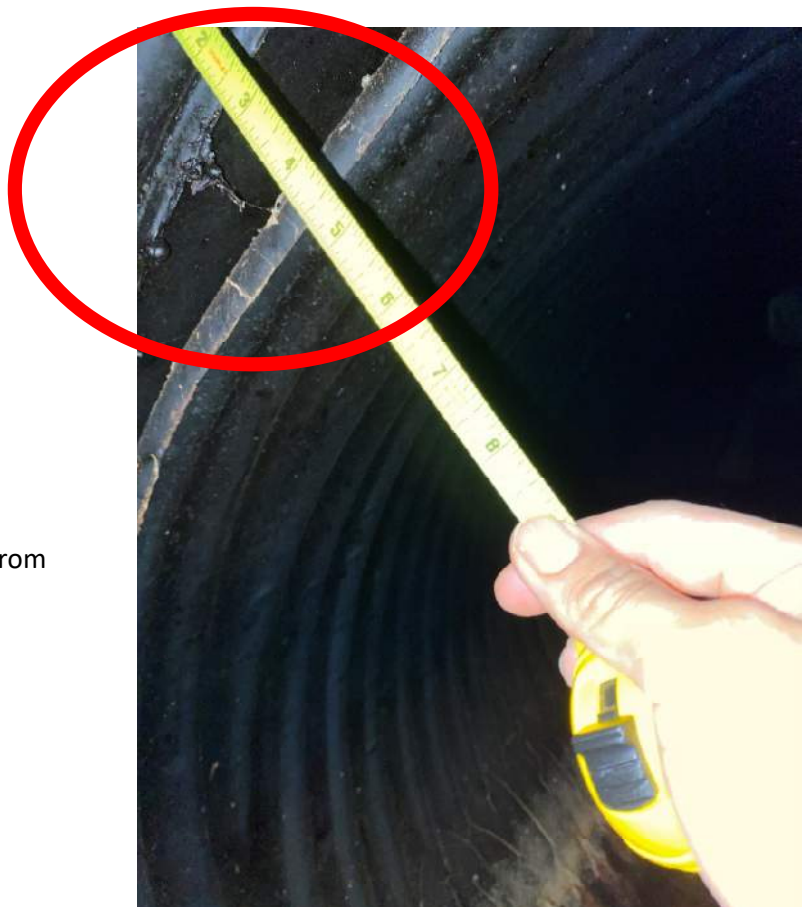
**Picture 6:** 4" gap at pipe joint  $\pm 30'$  from upstream headwall.

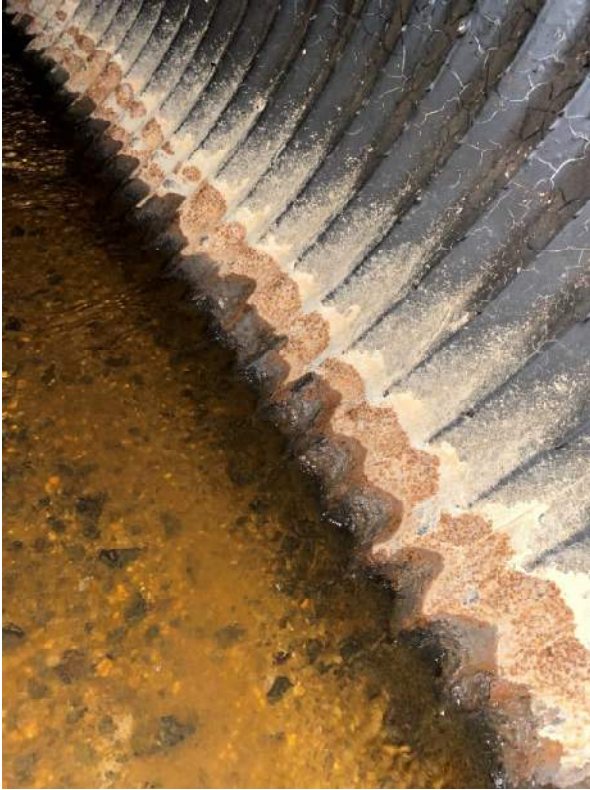
**Picture 7:** Corrosion along flowline but invert of pipe is solid.

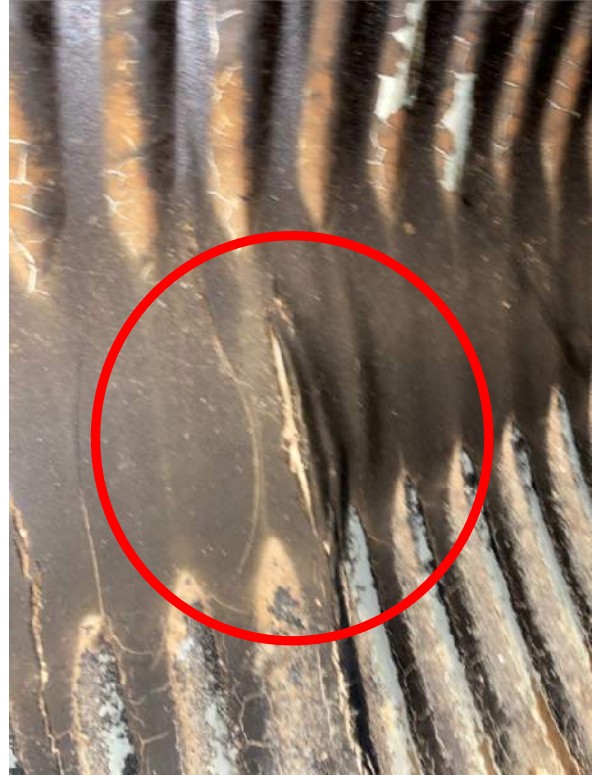
**Picture 12:** Small crease on pipe that seems to be cracked close to downstream headwall.

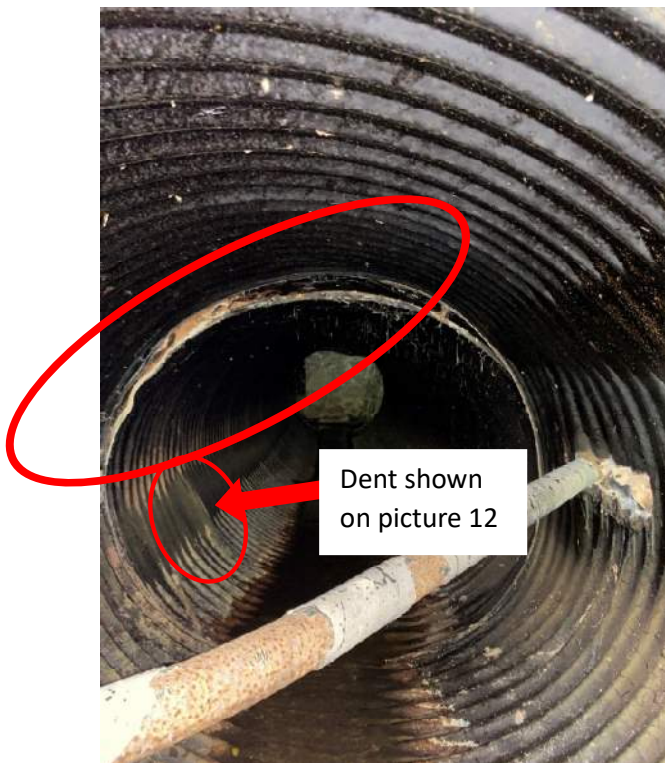
**Picture 13:** Gap at pipe joint. Sediment is visible.

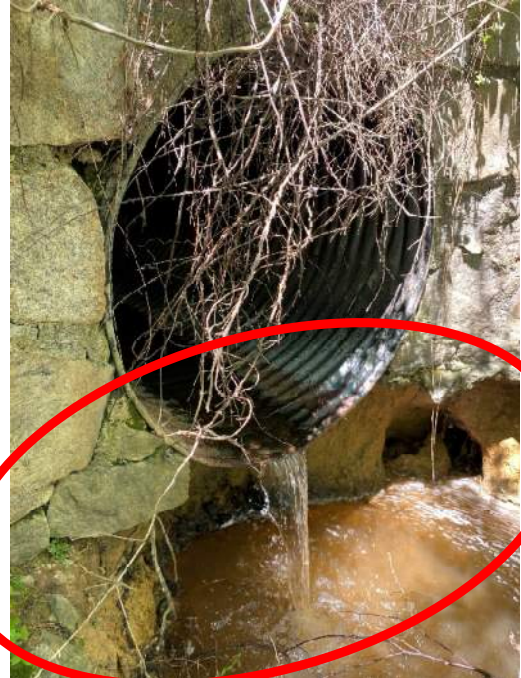
**Picture 14:** Undermining at downstream headwall. The grout at joints is loosening and falling out in headwall. Rip-rap recommended.
