STORMWATER AUTHORITY AGENDA

STORM WATER MASTER PLAN & CAPITAL IMPROVEMENT PROGRAM

CITY OF LAWRENCEVILLE
GWINNETT COUNTY, GEORGIA

Hussey Gay Bell Project No. 22-0006-C
OCTOBER 2023

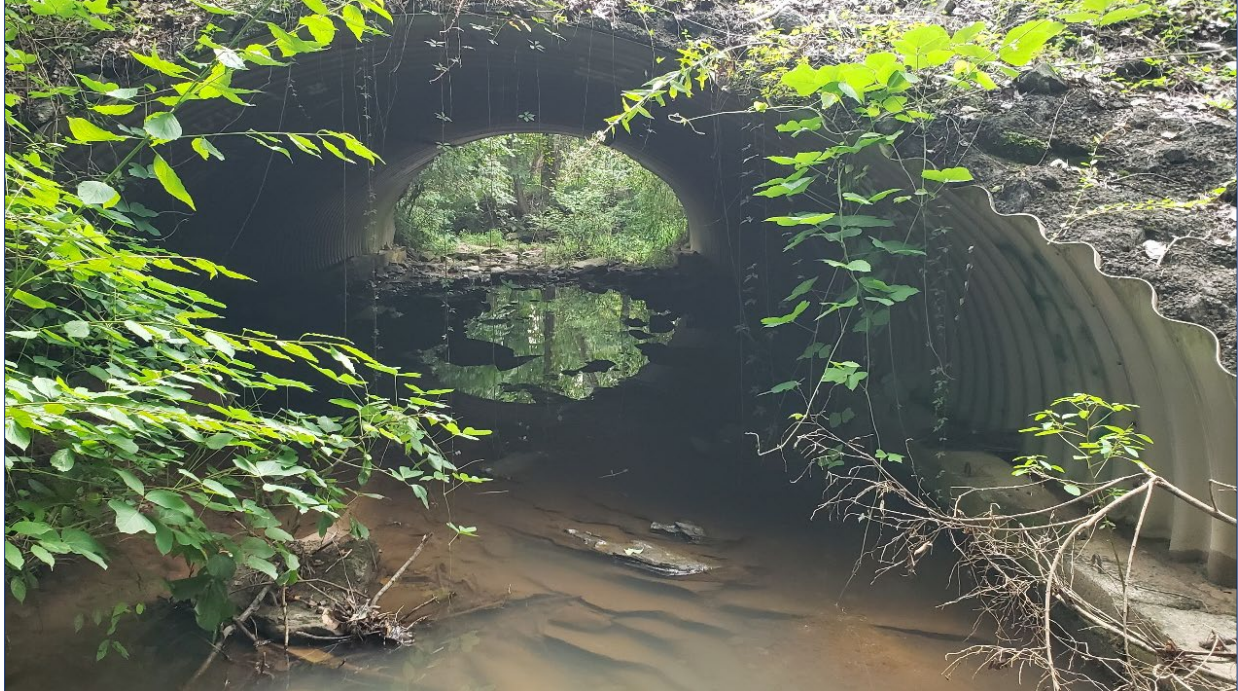
The culvert shown above is listed as an 84”x240” elliptical CMP that is part of a double barrel road crossing of Sarah Lane in the Pew Creek basin. It has an approximate watershed basin of 1,140 acres for storm water conveyance.

The pipe culverts that were recommended for repairs in the 2018 study have been reviewed in the field as part of the SWMP. The results of the review are provided in Appendix C.

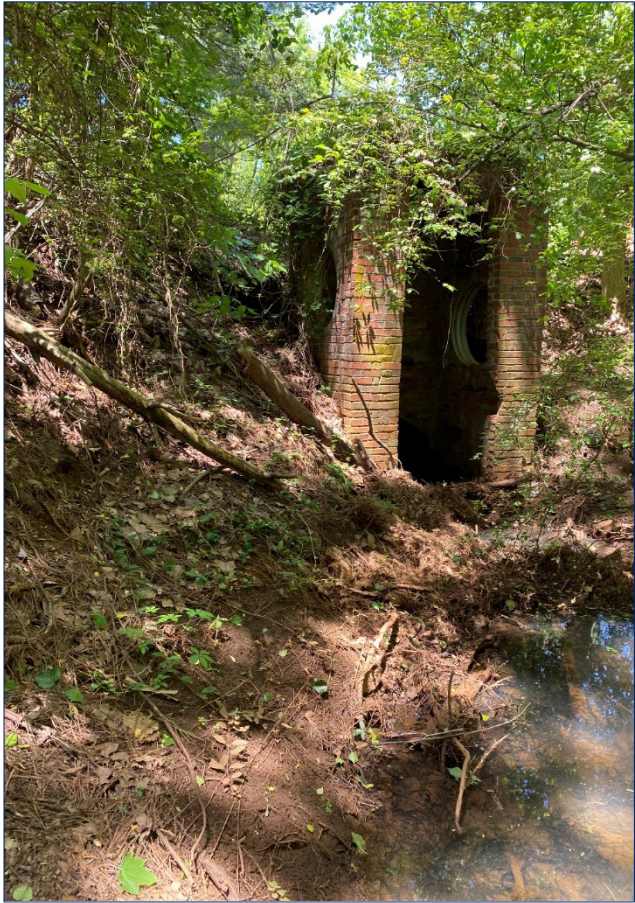
The pond shown at left has an outlet control structure that is in disrepair, has invasive growth, and can no longer function as designed.

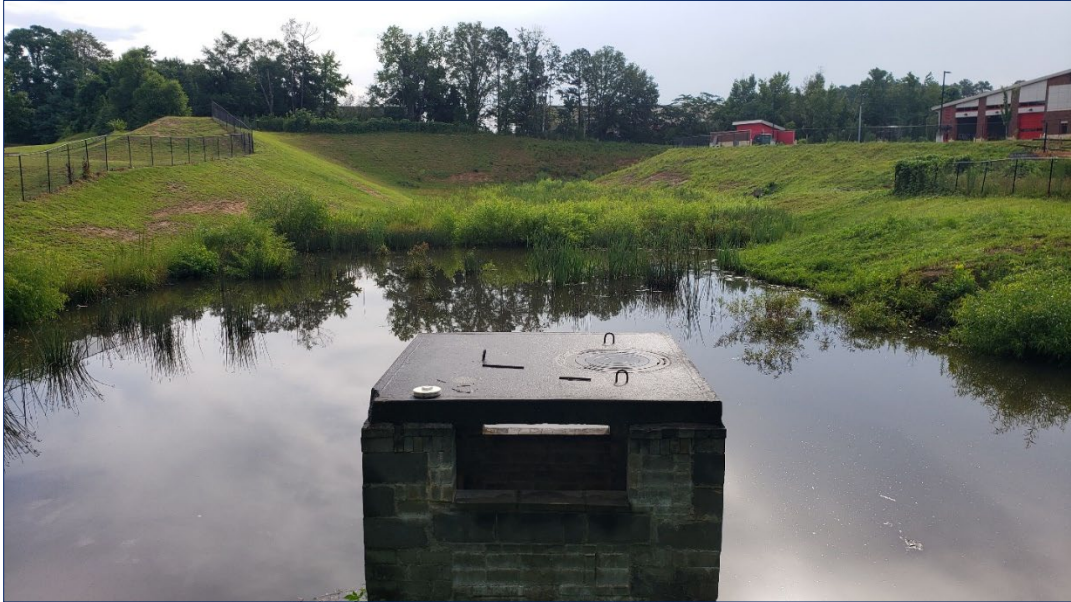
The pond, below, is well maintained and is able to treat the storm water runoff as well as detain water in the event of heavy rainfall.

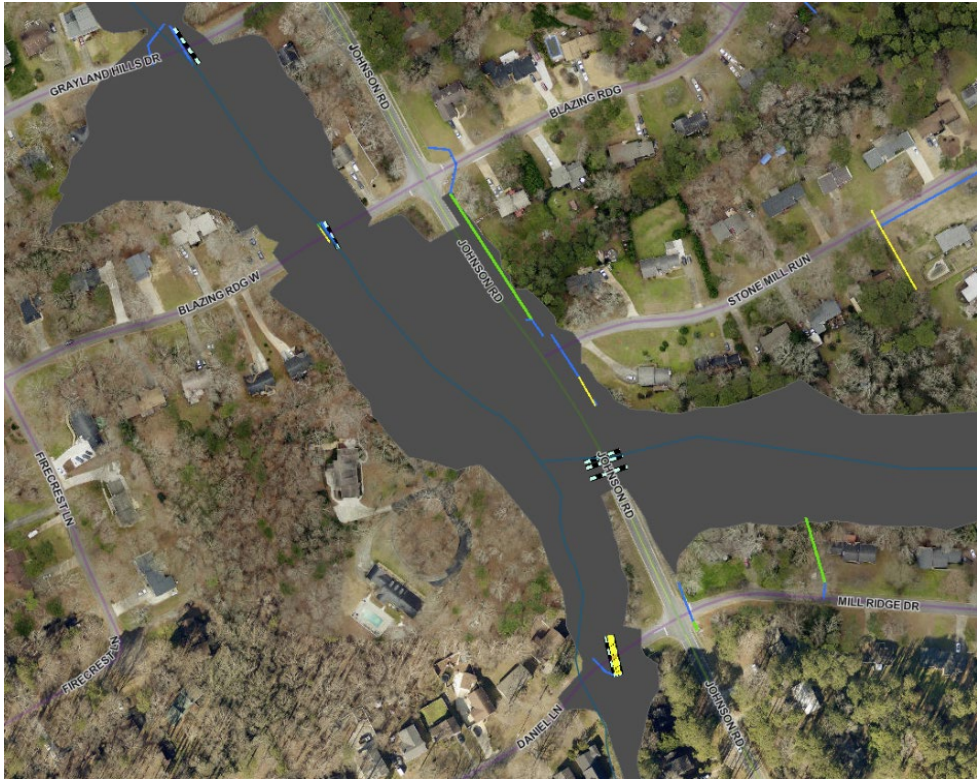
1-Blazing Ridge, 5-Daniel Lane and 8-Grayland Hills Dr.

No.	Street Name	Comment
1 A	Blazing Ridge W	96” CMP with moderate corrosion. Backwater does not appear to place houses within the flood plain.
2	Carithers Rd.	Shows on Gwinnett flood map. Drainage area less than 100 acres.
3 A	Channel Dr.	(2) 60” RCP. Upstream houses do not appear to be within the 100-year boundary.
4 I	Clearsprings Dr.	(2) 54” CMPs with moderate-severe corrosion. Eleven upstream houses are within the 100-year flood boundary.
5 I	Daniel Lane at Johnson Rd. and Mill Ridge	(3) 48” CMP with moderate to severe corrosion. One house may be within the 100-year flood plain due to backwater.
6	Dogwood Dr.	There are multiple private driveway culverts that may be contributing to backwater in road. No houses appear to fall within the 100-year flood limit.
7	Forest Valley Rd.	Flooding appears to be a result of culvert under Scenic Hwy. – study by Gwinnett County. Maple Wood Dr. also overtops. Four houses appear to be within the 100-year backwater from Scenic Hwy.

8 I A	Grayland Hills Dr.	72” CMP with moderate to severe corrosion, backwater appears to place four houses in the 100-year flood plain.
9	Grizzly Pkwy. near Spring Cir. and Northdale Rd.	Grizzly Pkwy. was constructed after the flood study was completed. Update study. Northdale Rd. overtops – Gwinnett Study.
10 I A	Gwinnett Dr. – near Nash	The 36” CMP (moderate to severe condition) under Gwinnett Drive and connecting downstream pipes through school property are undersized. Flows overtopping the Gwinnett Dr. travel through the school’s parking lot. One building falls within the 100-year flood zone. Significant base flow through system.
11 A	Gwinnett Dr. near Stone Mountain St.	Culverts under Gwinnett Dr. appear undersized. Fairly recently culvert replacement/relining occurred in this area. 3-4 commercial buildings appear to be within the flood plain limit.
12	Harris Dr.	The downstream ditch is full of water year-round and does not drain. Two houses, downstream of crossing, appear to be in the 100-year flood limit and backwater from Industrial Park Dr.

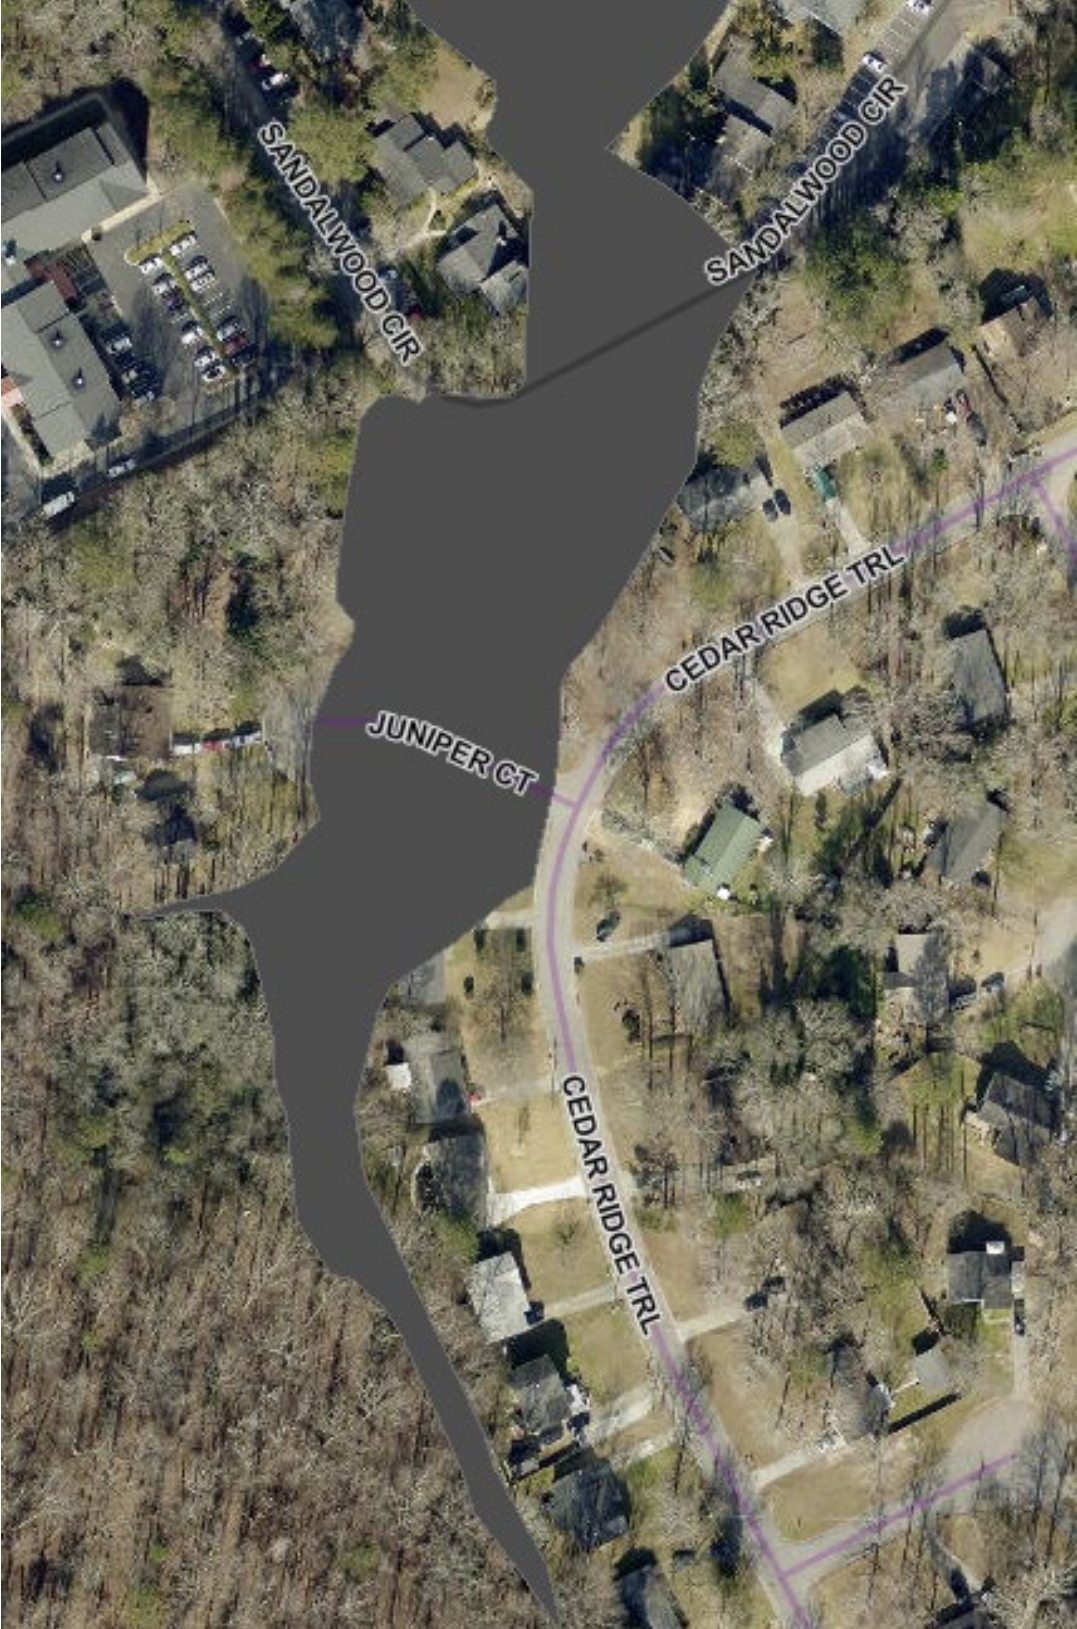
17-Juniper Ct. and 28-Sandalwood Cir.

* 15 A	Hurricane Shoals – 316	Upstream buildings appear to be outside of the flood limits.
* 16	Hurricane Shoals – Old Norcross	One upstream commercial building appears to be within the 100-year flood plain.
17 IA	Juniper Ct.	The 66” CMP under Juniper has significant sediment buildup and corrosion. Additionally, the downstream channel is full of water and sediment and does not drain. The downstream private piped system is inadequate for a 100-year storm. Four houses appear to be within the 100-year flood limit. This location require further detailed study to determine the best solution. Immediate clearing of downstream channel is recommended.
*18 I	Lakeview Road (City Park)	No buildings within the 100-year flood limit. Maintenance for culvert is in question. GIS shows city-maintained road within Rhodes Jordan Park.
*19	Langley Dr.	Backwater from culvert under Langley and/or contributing upstream pipe systems results in one or two upstream office buildings within the flood plain. Portions of the upstream area may have been developed after flood study was completed.

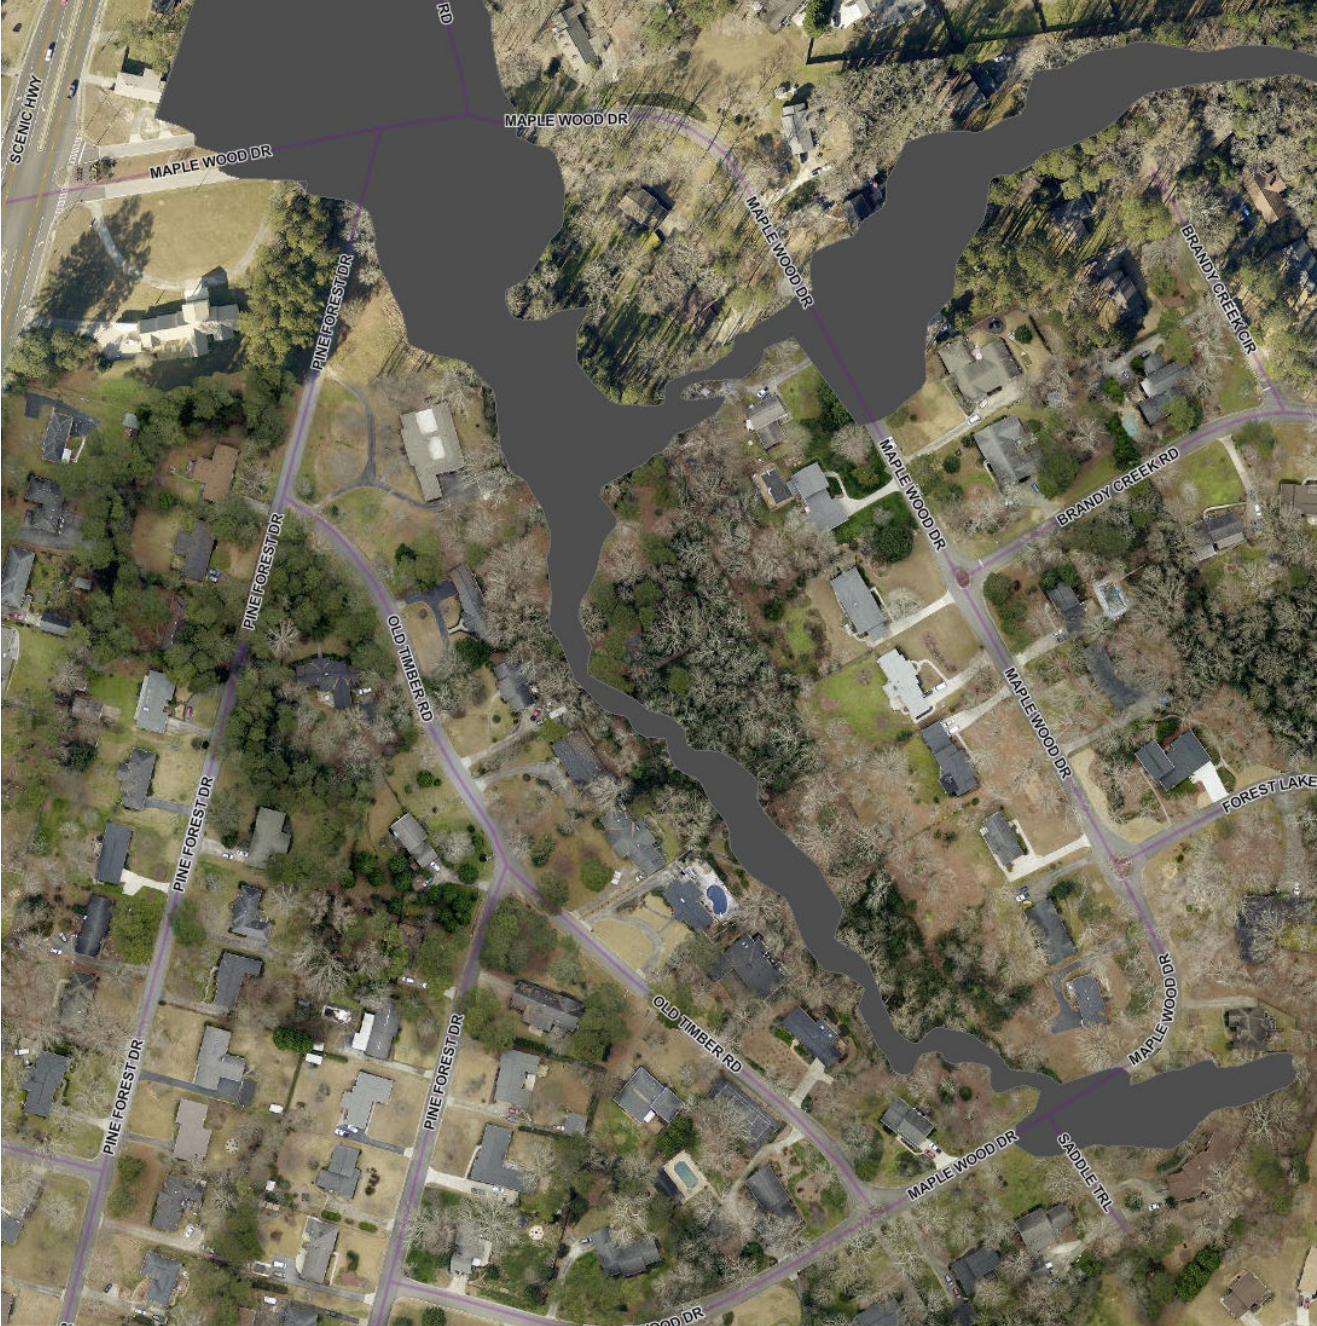
20-Maplewood Dr. – three (3) crossings

20	Maplewood Dr. (3 crossings)	48” HDPE north of Brandy Creek Rd. intersection appears to be undersized resulting in two houses being within the flood boundary. The 48” CMP crossing near Saddle Trail appears undersized; however, no houses appear to be within the flood limit as a result. See Forest Valley Rd. for the third crossing.
21	Paper Mill Rd. – near Paper Mill Dr.	Two 36”h x 54”w Elliptical RCPs appear undersized. No upstream houses adversely affected.
22 IA	Pike Park Dr.	Two 72” CMP in poor condition. One commercial building is near the flood boundary.
23 A	Private drive at Mulberry Place Apartments	No buildings appear to be affected by the undersized culvert.
24	Nash St. (Update required)	Nash St. is shown in the flood plain; however, the flood study was done prior to Nash St. extension to Gwinnett Dr. Refer to Gwinnett Dr. – near Nash St. for description.

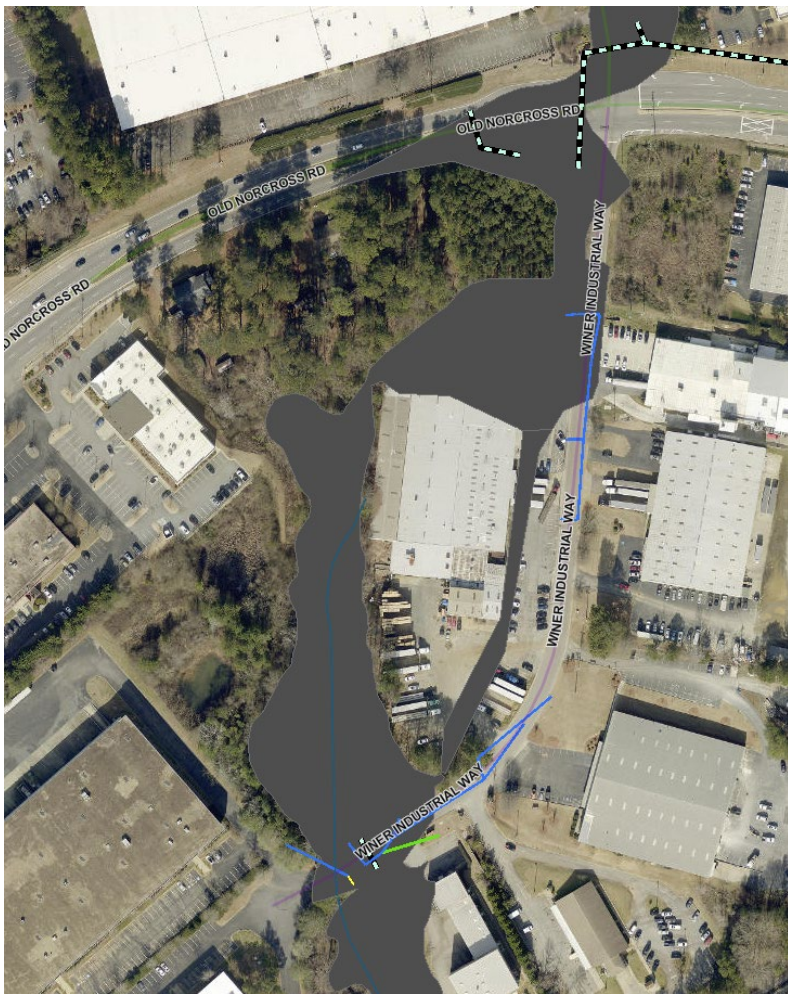
37- Winer Industrial Way

**36	Sugarloaf Pkwy. near Scenic Hwy.	100-year backwater does not appear to encroach on upstream buildings.
37 A	Winer Ind. Way	84" CMP moderate corrosion – commercial building within the 100-year flood plain.

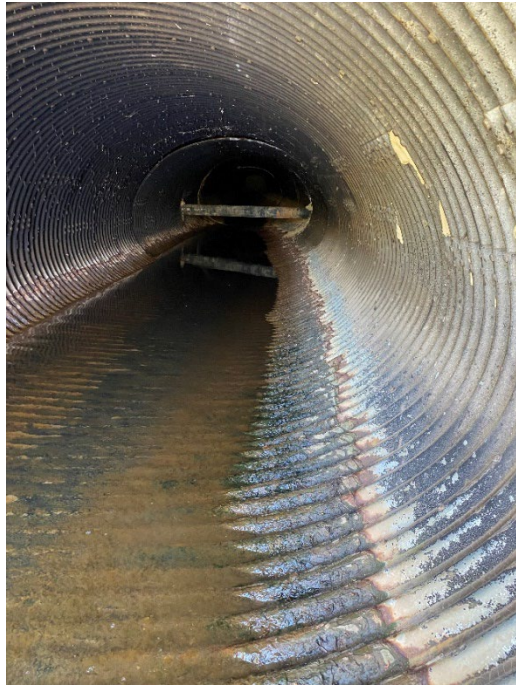
View of interior of pipe. Corrosion evident at interface of baseflow (water), air and steel pipe. An obstruction (gasline) is evident in this photograph.

downstream end of the pipe. Thus, if a pipe is listed as poor condition, it is important to collect more information on that pipe. A closed-captioned television (CCTV) inspection of the pipe will be necessary to obtain more reliable information and is less expensive than other methods of evaluating pipe conditions between structures.
