## CITY COUNCIL WORK SESSION

March 03, 2026 at 5:00 PM

B. Review Sanitary Sewer Televising Results

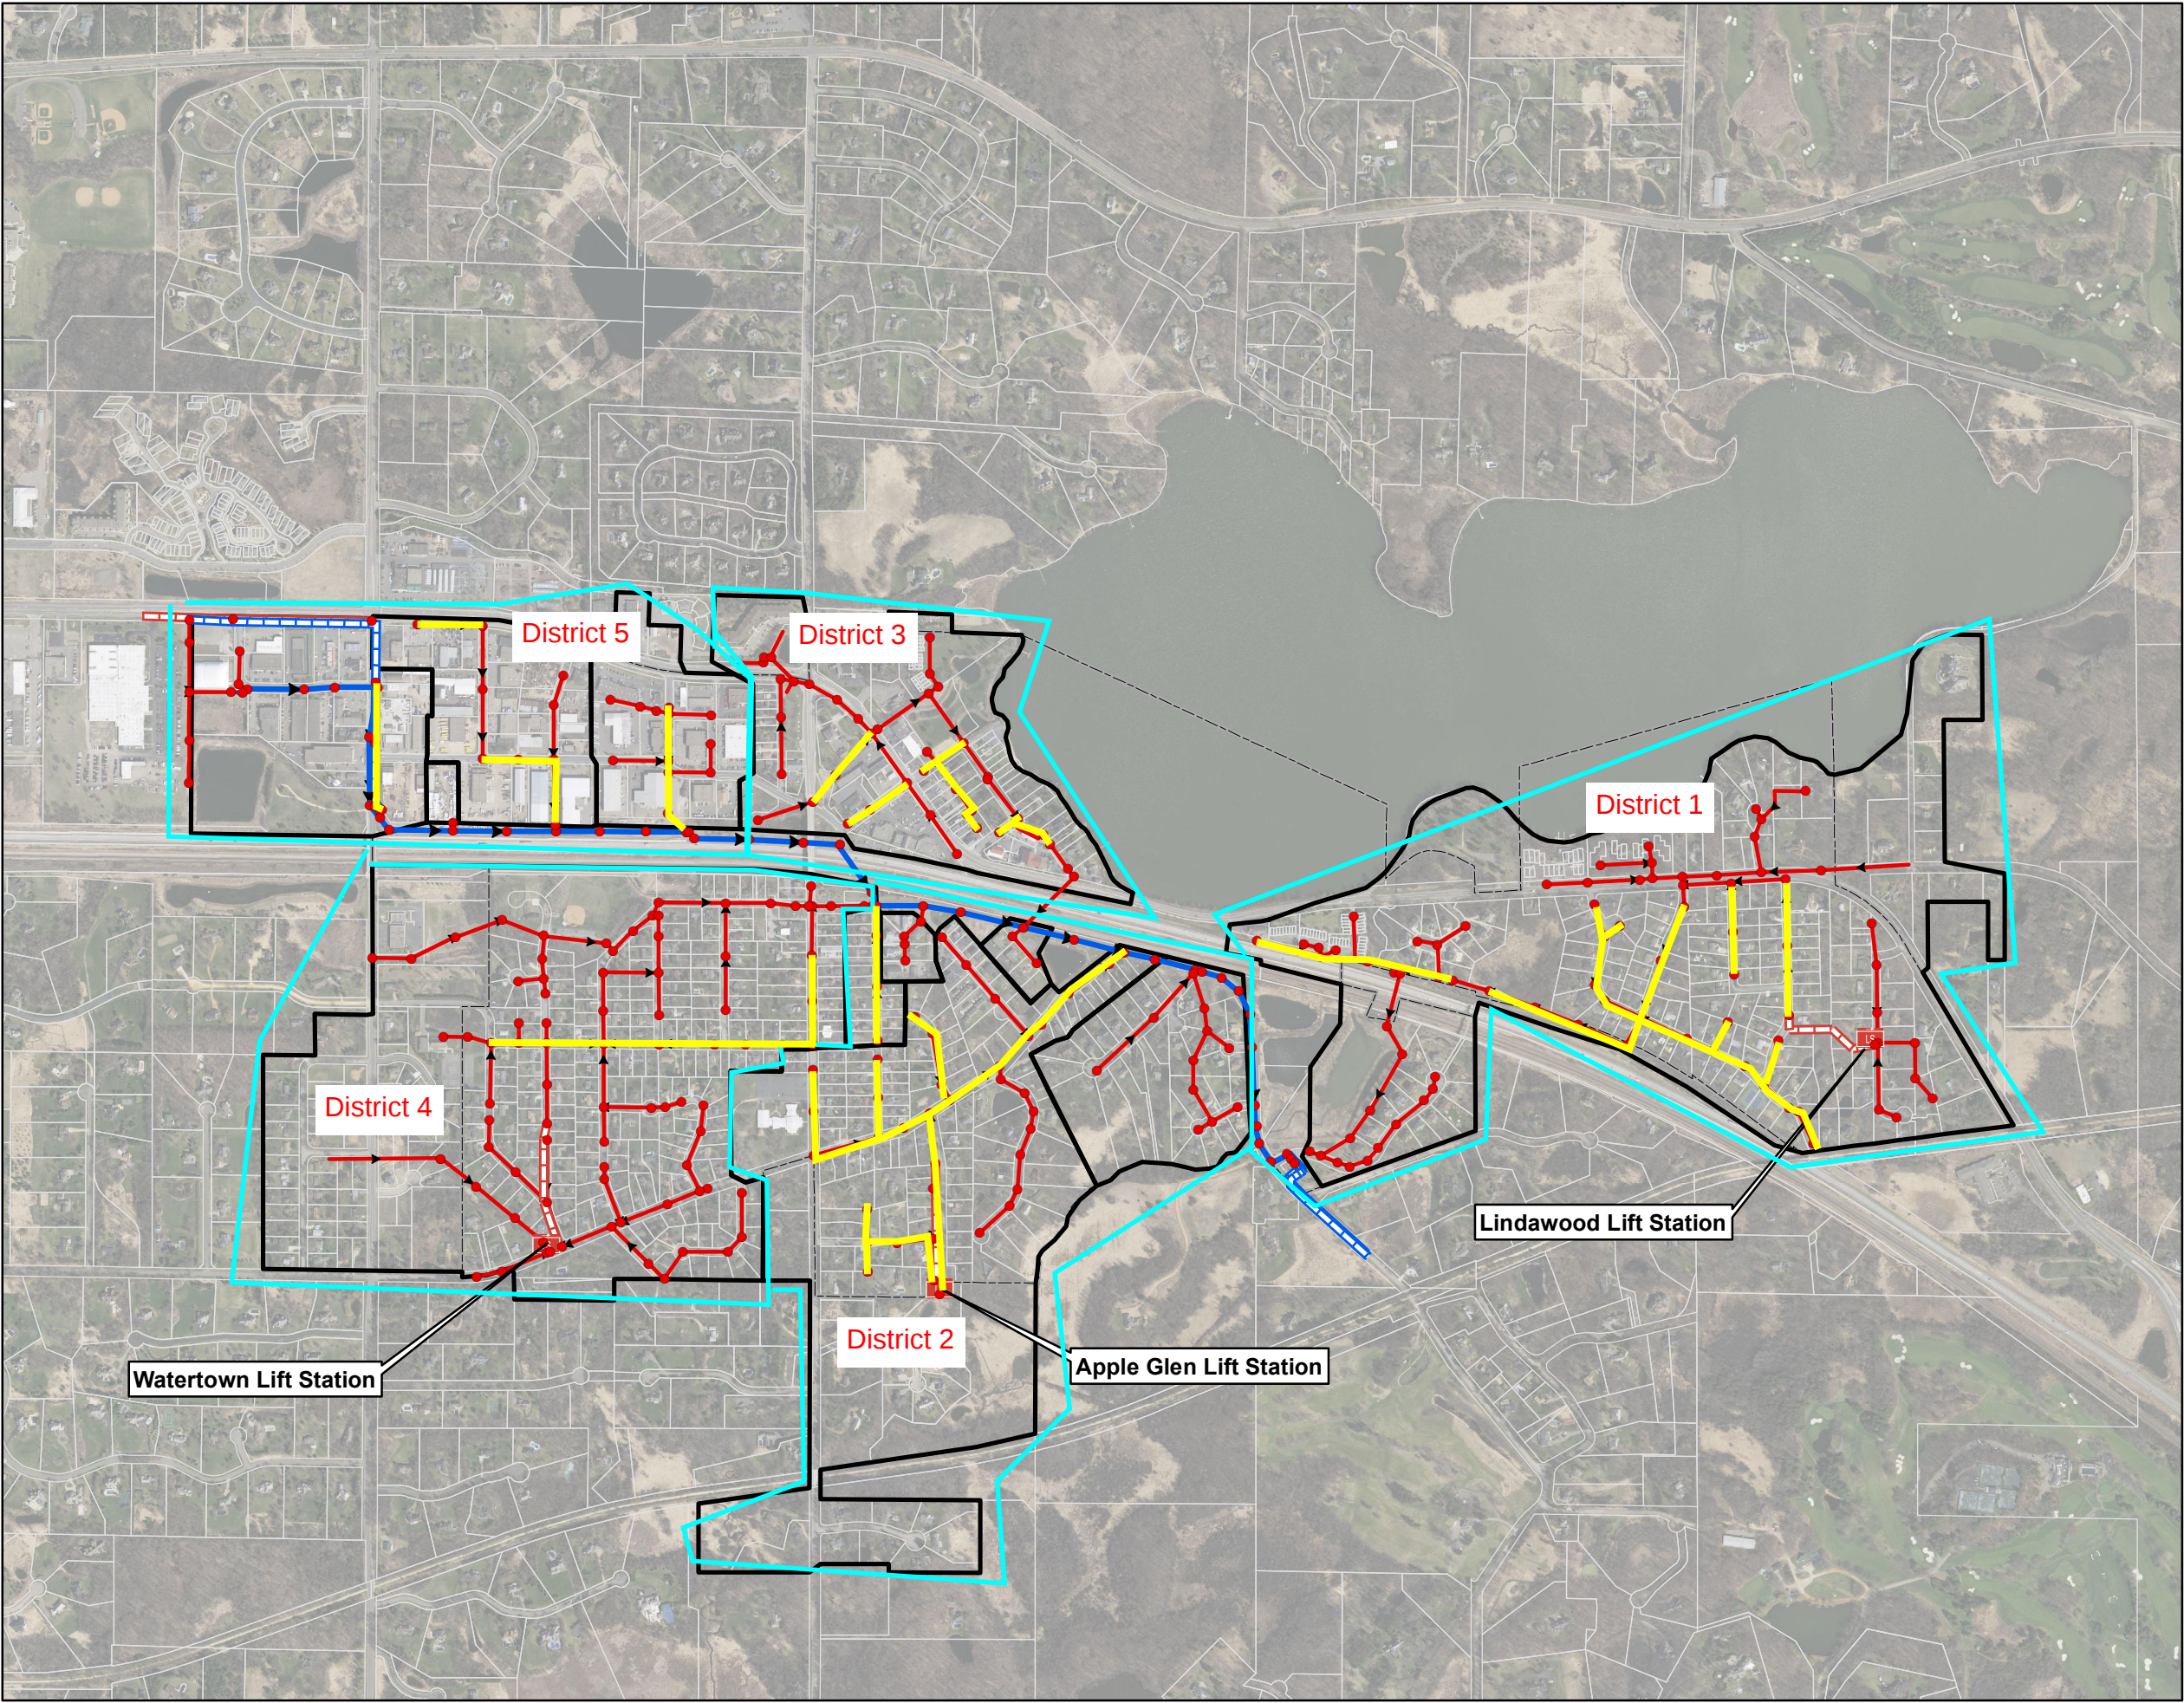
Sanitary  
Sewer -  
District 1

2K to 3K: Service 260' dripping leak, service 275' running leak, service 277' 4 running leaks, service 314' running leak, service 315 dripping leak, and service 354' running leak.

2K to 18C2: Infiltration gushing at 18C2 MH and roots growing in pipe

1K to 4-C: Standing Water from 1K to 30' towards 4-C

5-C to 6-C: possible running leak at service 35'

113 to 4-C: 20' multiple cracks, 40% water level sag at 118' Clay Pipe

4-C to 162-S: 20% water

HIGHER WATER LEVELS, CONSISTENT WITH AREA

MINOR SAG 63' FROM 155S

MINOR SAG 28' FROM 156S

STANDING WATER RIGHT OUTSIDE OF 9C
