**TOWN OF LOS GATOS
HISTORIC PRESERVATION COMMITTEE
JANUARY 28, 2026
110 EAST MAIN STREET
TOWN COUNCIL CHAMBERS
4:00 PM**

2. Consider a Request to Remove a Pre-1941 Property from the Historic Resources Inventory for Property Zoned R-1:10. **Located at 8 Central Court.** APN 529-35-034. Exempt Pursuant to CEQA Section 15061(b)(3). Request for Review PHST-26-001. Property Owner: William Holt and Elizabeth LaSorsa. Applicant: Joel Stieber. Project Planner: Sean Mullin.
3. Consider a Request for Approval to Construct a New Second-Story Addition and Exterior Alterations to an Existing Pre-1941 Single-Family Residence on Property Zoned R-1D. **Located at 34 Pleasant Street.** APN 529-26-018. Exempt Pursuant to CEQA Guidelines, Section 15301: Existing Facilities. Minor Residential Development Application MR-25-003. Property Owner: Michael Hyman. Applicant: Maia Gendreau. Project Planner: Ryan Safty.

FOUNDATION INSPECTION AND CONDITION ASSESSMENT
8 Central Court, Los Gatos, CA

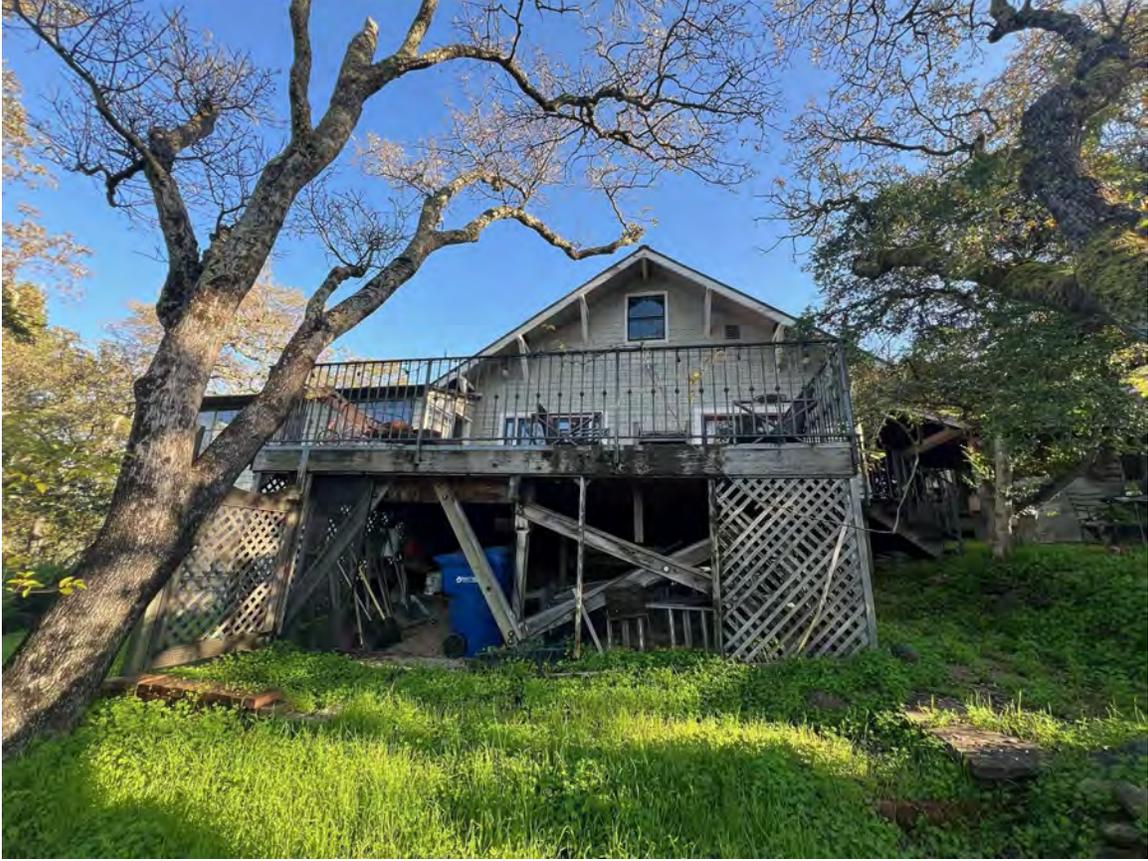
Southwest Corner looking East (house is on the left, outbuilding constructed in 2000 on the right)

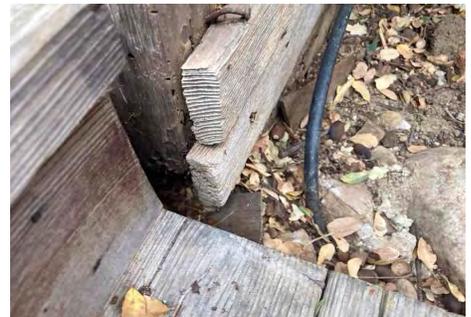
Photo 58

1. The wood members under the left front corner and various areas show evidence of water damage. We recommend the services of a licensed structural pest control operator for investigation of this condition. (See Photo 58) (See Photo 59)

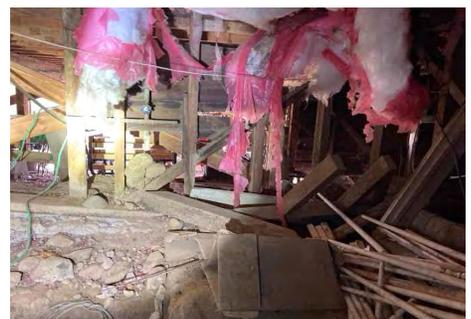
Photo 43

2. Wood/soil contacts at the crawl space should be eliminated. This condition is conducive to rot and wood boring insect activity. We recommend a minimum clearance of six inches be maintained between the soil and the bottom of the wood line. (See Photo 43)

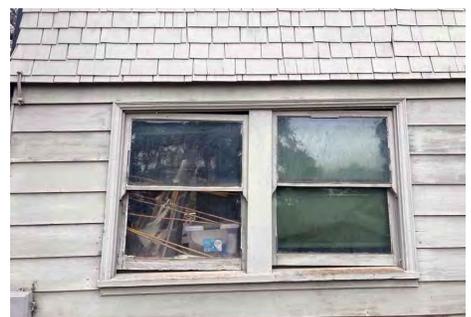
Photo 17

3. Substantial interior floor sloping, drywall cracking and/or exterior cracking was observed in the structure. This implies that structural movement of the building may have occurred. The rate of movement cannot be predicted during a one-time inspection. A structural engineer should be consulted for further evaluation of this condition. (See Photo 17) (See Photo 37)

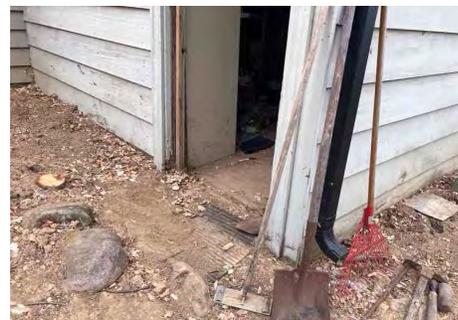
Photo 14

4. The foundation for the addition is wood mudsill. This is not considered a true foundation as this term applies to present building standards. The mudsill for conventional foundations is the first wood member, usually a 2"x 6" or 2"x 8" treated lumber, to be placed over the top of the concrete foundation stem wall, it is then secured to the foundation with anchor bolts. In this case, there is not a concrete foundation, only wood directly in contact with the soil. This exposes this structure to various forms of wood damaging organisms and activity. Additionally, there is no method that will effectively secure this structure for earthquake safety. A structural pest control operator and a licensed foundation specialist should be consulted. (See Photo 14)

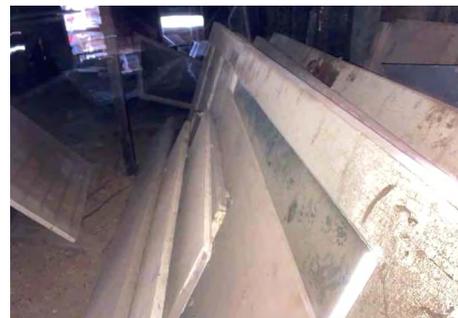
Photo 41

5. Personal storage was blocking access to the basement/crawl space area. Therefore, the back area is considered inaccessible and was not fully inspected. With access and an opportunity for a complete inspection, conditions in need of attention may be discovered. Ideally, the personal belongings should be removed so the area may be inspected. (See Photo 41) (See Photo 42)

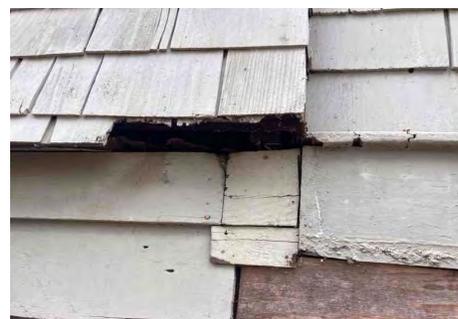
Photo 20

6. Shingle siding is missing and/or loose from the exterior wall. We recommend they be replaced to restore both cosmetic appearance and maximum protection for the underlying surface. (See Photo 20)

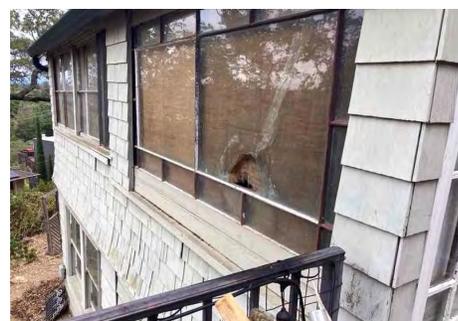
Photo 04

7. Cracked or broken exterior window glass at the back wall and various areas should be replaced. (See Photo 4) (See Photo 5) (See Photo 25)

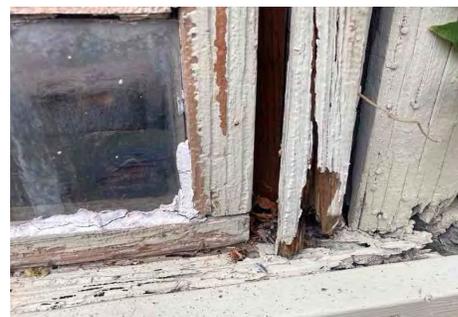
Photo 28

8. The window at the front and right side wall shows evidence of water damage to the sill/jamb. We recommend the advice and services of a general contractor and/or structural pest control company regarding repairs. (See Photo 28) (See Photo 53)

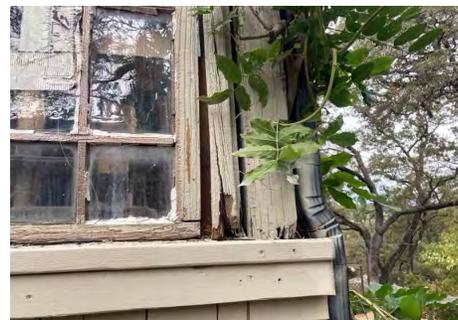
Photo 27

9. The window frames/sash at the right side wall shows evidence of water damage. We recommend the advice and services of a general contractor and/or structural pest control company regarding repairs. (See Photo 27) (See Photo 31)

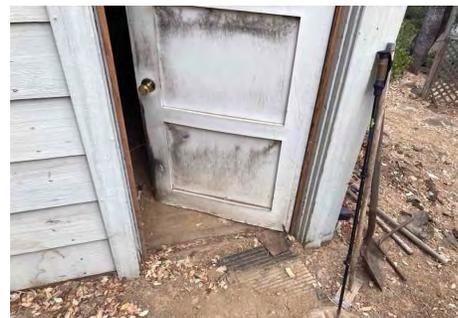
Photo 10

10. Water damage was noted at the back storage shed door. We recommend the services of a licensed general contractor and/or structural pest control company regarding repairs. (See Photo 10)

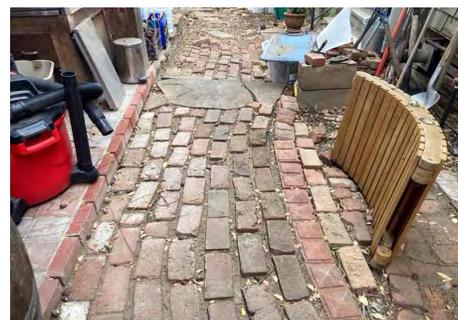
Photo 55

11. The cracked and heaved walkway section(s) at the front present a trip hazard. This condition should be corrected for improved safety. (See Photo 55)

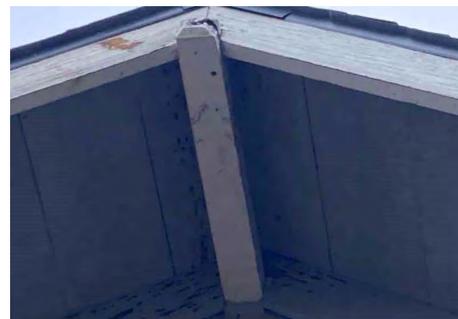
Photo 03

12. Mechanical damage was observed to the roof eaves/sheathing at the left side. We recommend the services of a licensed general contractor and/or structural pest control company. (See Photo 3)

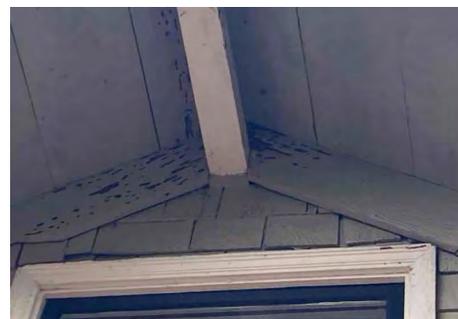
Photo 02

13. Mechanical damage was observed to the rafters at the left side and various areas. We recommend the services of a licensed general contractor and/or structural pest control company. (See Photo 2) (See Photo 29)

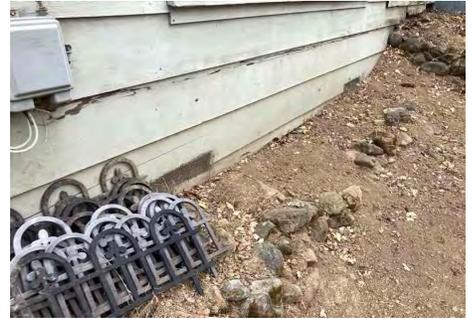
Photo 06

14. Wood/soil contact at the base of the wood siding at the front and various areas should be eliminated. If rotted or damaged siding is found consult a licensed structural pest control operator regarding repairs. (See Illustration 3S) (See Photo 6) (See Photo 7) (See Photo 57)

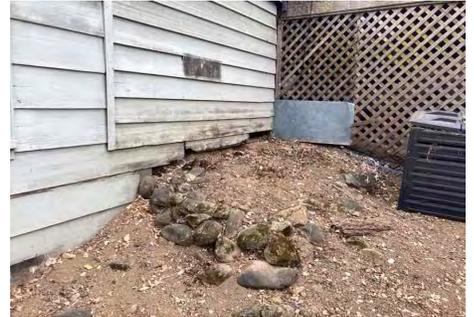
Photo 16

15. Water damage was observed to the wood siding at the front and various areas exterior walls. We recommend the services of a licensed general contractor and/or structural pest control company. (See Photo 16) (See Photo 26) (See Photo 54)

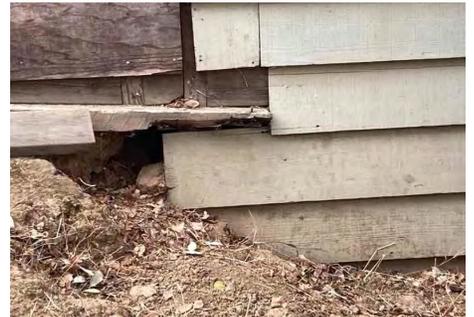
Photo 19

16. Water damage was observed to the exterior trim at the back and left rear corner. We recommend the services of a licensed general contractor and/or structural pest control company. (See Photo 19) (See Photo 21)

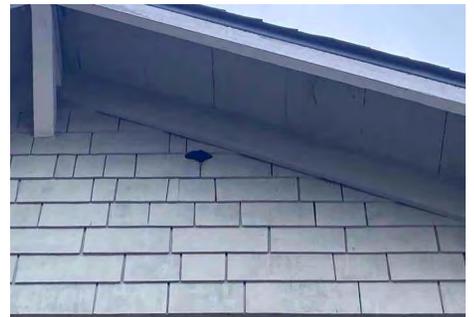
Photo 18

17. There is an opening or hole in the siding at the right side and various areas of the rear exterior wall. We recommend this area be repaired or replaced to eliminate moisture or rodent entry. (See Photo 18)

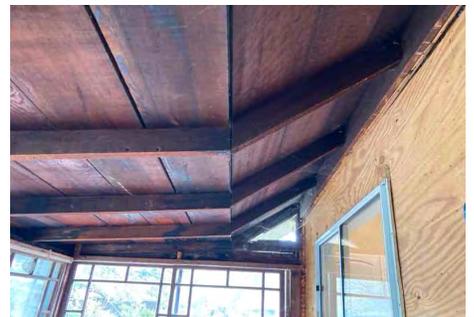
Photo 39

18. The patio cover is improperly constructed. The existing configuration indicates improper design and/or workmanship and is a major safety issue should the patio cover give way due to lateral forces or seismic activity. We recommend the patio cover be removed or replaced according to local building codes. (See Photo 39)

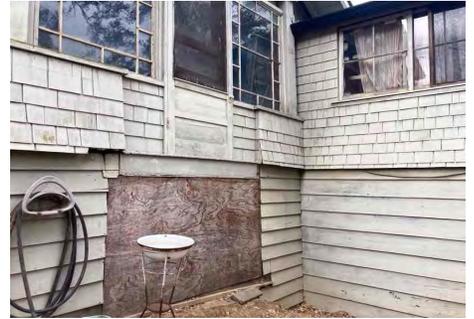
Photo 22

19. The installation of a proper porch, step, landing or deck at the exterior door should be considered for additional safety. (See Photo 22)

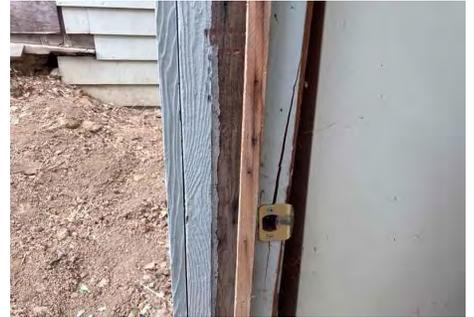
Photo 12

20. The jamb is cracked, split or damaged at the back storage shed door. We recommend it be repaired or replaced. (See Photo 12)

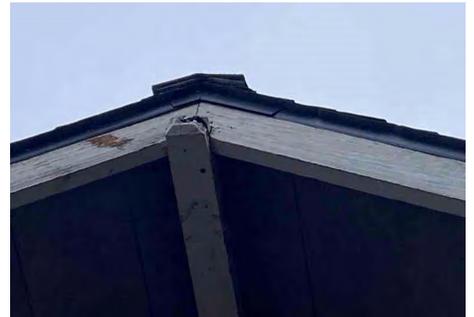
Photo 01

21. Mechanical damage was observed to the beam ends at the left and right side. We recommend the services of a licensed general contractor and/or structural pest control company. (See Photo 1)

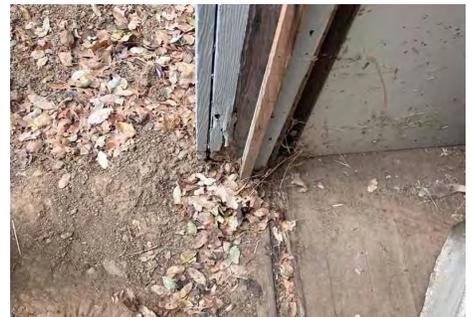
Photo 11

22. Water damage was noted at the back storage shed door jamb. We recommend the services of a licensed general contractor and/or structural pest control company. (See Photo 11)

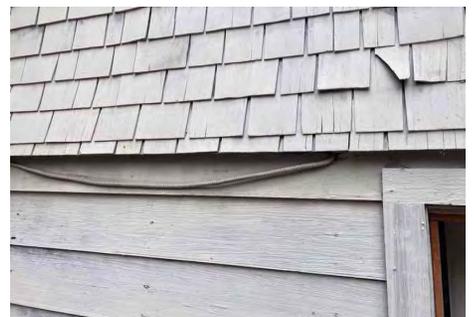
Photo 09

23. The exterior metal conduit and/or connectors installed at the back is not designed for use where exposed to weather. We recommend that the conduit and/or connectors be removed and approved exterior conduit, boxes and/or fittings be installed (See Photo 9)

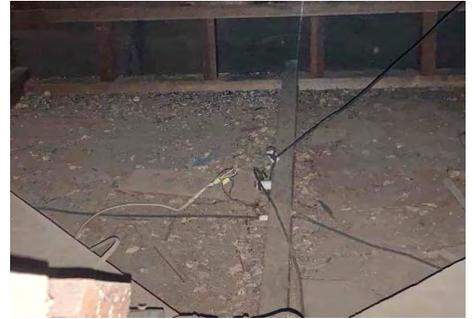
Photo 33

24. Running splices, which are improper connections outside of a junction box, were observed in the attic. We recommend connections be joined with approved connectors inside a junction box to prevent accidental contacts or mechanical damage. (See Photo 33) (See Photo 47)

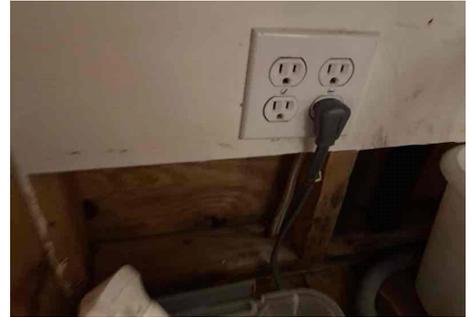
Photo 40

25. Exposed wiring inside the kitchen cabinet should be relocated, covered or protected by rigid conduit. (See Photo 40)

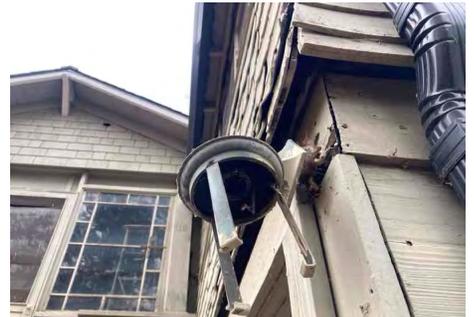
Photo 08

26. The loose light fixture in the back storage shed should be repaired or replaced. (See Photo 8)

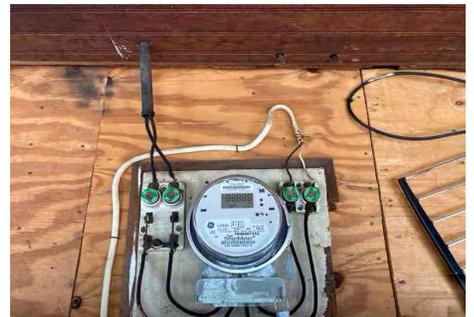
Photo 38

27. The branch/auxiliary panel cover plate (sometimes called the "Dead Front") is missing. It should be replaced. (See Photo 38)

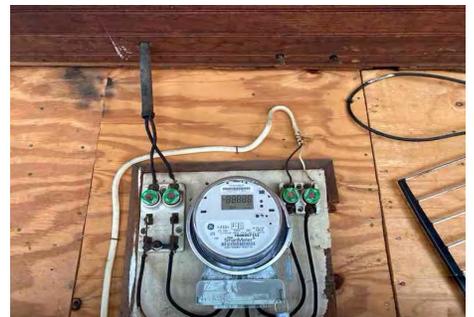
Photo 38

28. We found exposed wiring at the sun room. Even if insulated, we recommend all wiring be encased in conduit or otherwise protected in accordance with present standards. (See Photo 38)

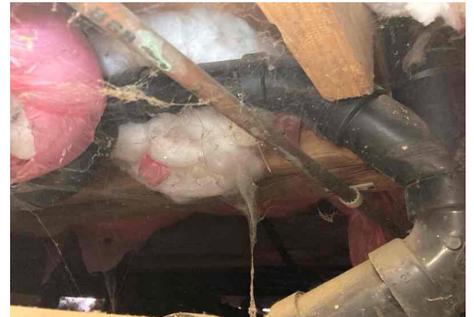
Photo 49

30. The drain system adjacent to the laundry area and master bathroom shower was improperly installed. We recommend the drains be reconfigured according to industry standards. (See Photo 49) (See Photo 51)

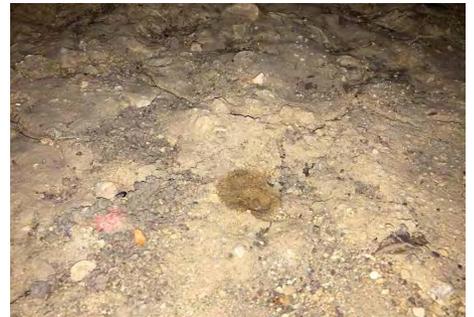
Photo 52

31. The plastic/metallic waste piping is leaking at the front bathroom toilet. We recommend all leaks be repaired. (See Photo 52)

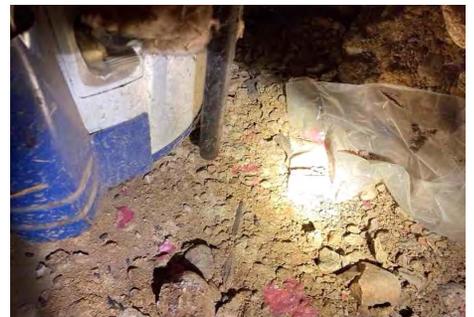
Photo 45

32. The temperature and pressure relief discharge pipe for the water heater is improper. We recommend the installation of a proper discharge pipe to an approved location. (See Photo 45)

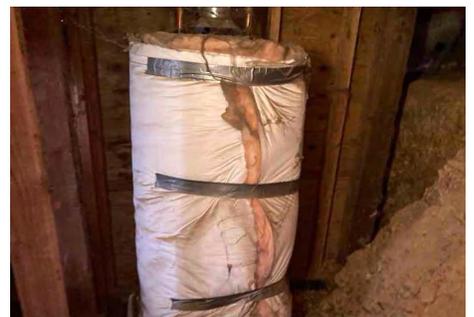
Photo 46

33. The water heater was not strapped. All water heaters (gas or electric) in seismic zones should be properly anchored or strapped in the upper and lower section of the tank to resist movement during earthquake conditions. Specifically California state code is as follows.

1. All water heaters gas or electric must be strapped.
2. Tanks up to 52 gallons require two straps, one in upper one-third and one in the lower one-third of the fixture. Water heaters with a capacity of 52 or above require three, one in upper one-third, one in middle and one in lower one-third are required. There are cases where there is an exception to this rule, we recommend consulting the local building authority regarding the adequacy of the seismic restraints for the water heater at this property.

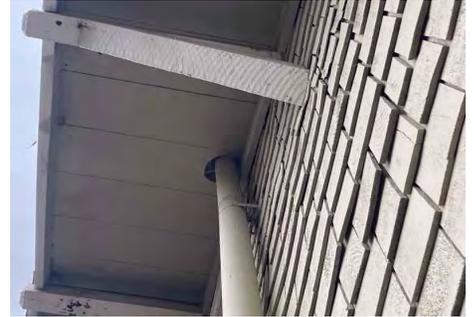
Photo 30

4. Straps must wrap around the body of the water heater and any gaps between the wall and tank should be blocked to prevent movement.
 5. Straps should be secured to adjacent wall or stud and from opposing directions
 6. Straps should be secured to the wall or studs using 1/4" diameter by 3" long lag bolts with washers. (See Illustration 8E) (See Photo 46)
34. There is insufficient clearance between the water heater exhaust flue and combustible materials. This condition should be corrected. (See Illustration 8C) (See Photo 30)

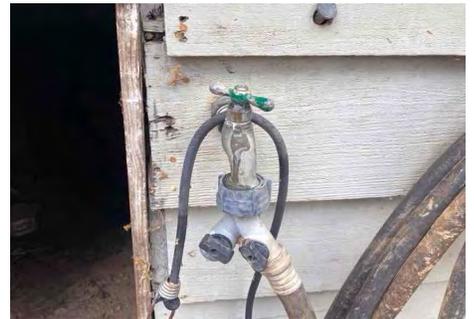
Photo 23

35. The exterior hose bib at the back is leaking. We recommend all leaks be repaired. (See Photo 23)

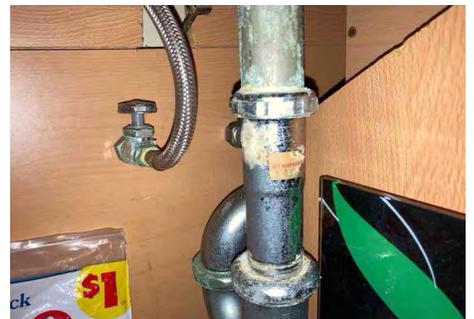
Photo 35

36. There is evidence of heavy corrosion and rust, but no leakage on the exterior of the exposed and accessible metal drain piping in the front bathroom. This piping should be monitored for leakage and repaired as necessary. Upgrading this piping and connections should also be considered. (See Photo 35)

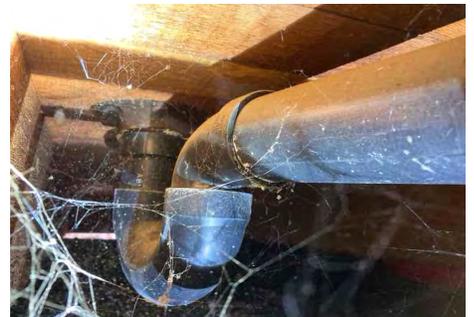
Photo 50

37. There is a cracked and leaking Plastic drain pipe at the front bathroom stall shower. This is a potential health hazard. We recommend the piping in question be repaired or replaced. (See Photo 50)

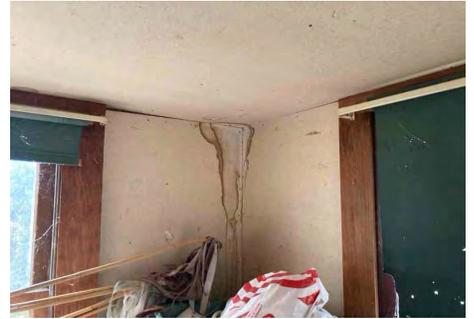
Photo 15

38. The ceiling at the back shed and side shed shows evidence of water stains. It is recommended that the source of these stains be identified and corrected and the surface be refinished. (See Photo 15)

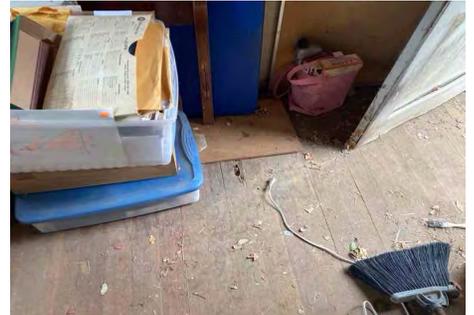
Photo 13

39. Damage to the front bathroom and bathroom storage shed hardwood flooring was observed. The extent of damage is difficult to predict without removing floor coverings. It is recommended that the source of the damage be identified and corrected by the appropriate trades. (See Photo 13) (See Photo 34)

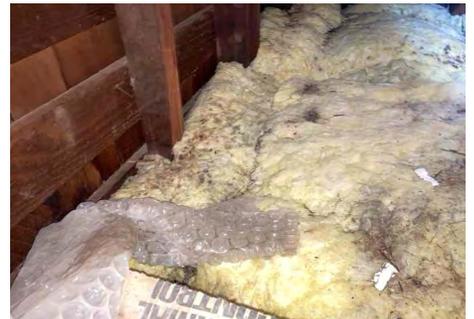
Photo 32

40. Evidence of vermin activity was observed within the structure. It is likely this evidence will extend into inaccessible areas. The owner is advised to contact the appropriate trade for further evaluation and remedial measures if necessary. (See Photo 32)

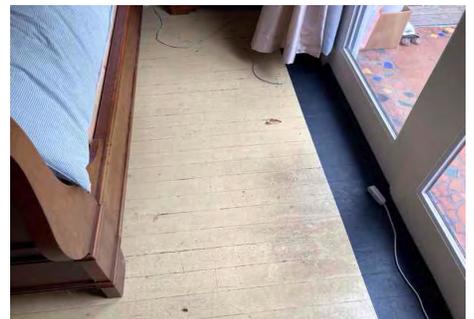
Photo 36

41. Minor water damage to the master bedroom hardwood flooring was observed. It is recommended that the source of the damage be identified and corrected, and the surface be repaired and refinished to restore its appearance. (See Photo 36)
