CITY OF MERCER ISLAND **REVISED**

CITY COUNCIL REGULAR VIDEO MEETING

TITLE:	AB 6002: Draft ADA Transition Plan	<input checked="" type="checkbox"/> Discussion Only <input type="checkbox"/> Action Needed: <input type="checkbox"/> Motion <input type="checkbox"/> Ordinance <input type="checkbox"/> Resolution
RECOMMENDED ACTION:	Receive report. No formal action required.

City of Mercer Island ADA Transition Plan

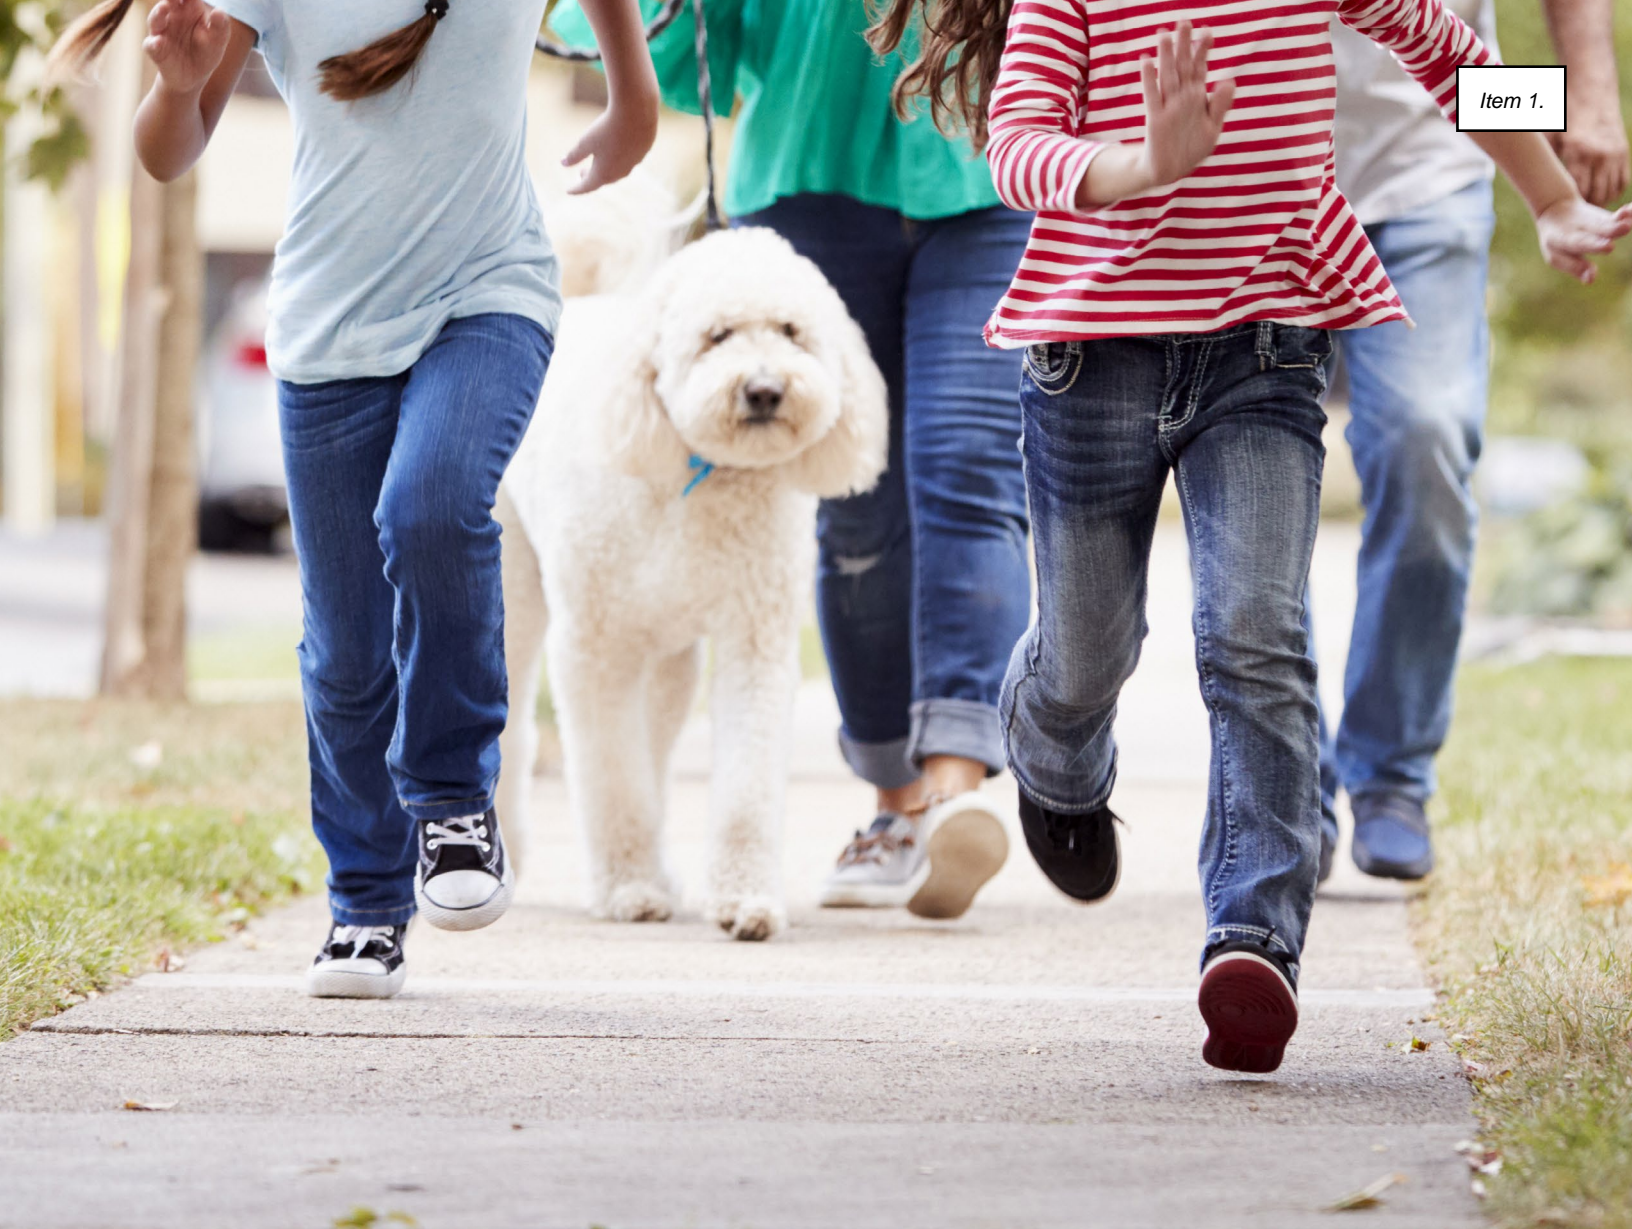
Approximately 34 miles of sidewalk were inventoried with approximately 98% not meeting ADA standards (see Table 2-2 and Figure 2-12). Grinding, patch repair, and full reconstruction are potential solutions for removing the sidewalk barriers depending on the severity of the barrier.

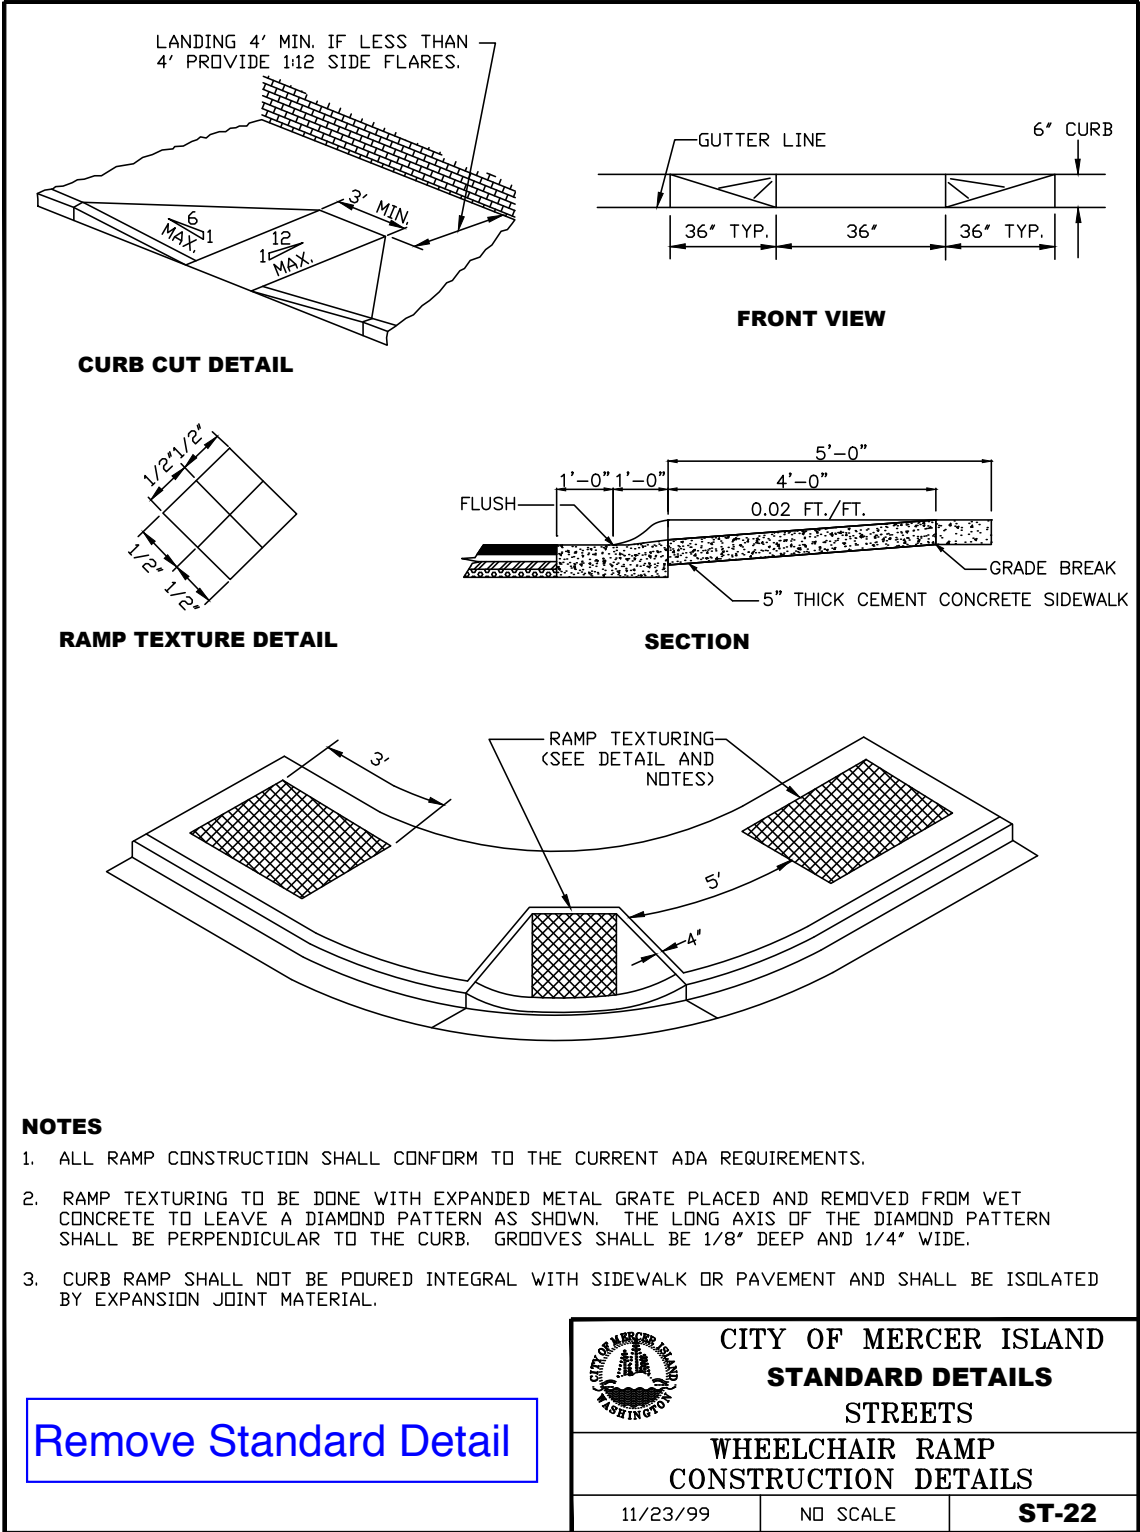
Remove Standard Detail

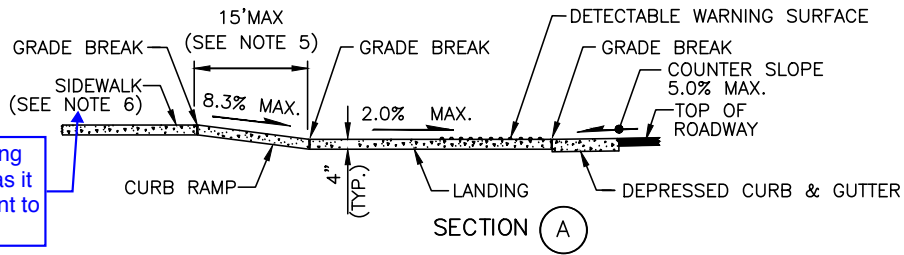
Recommend removing reference to note 6 as it doesn't seem relevant to the sidewalk.

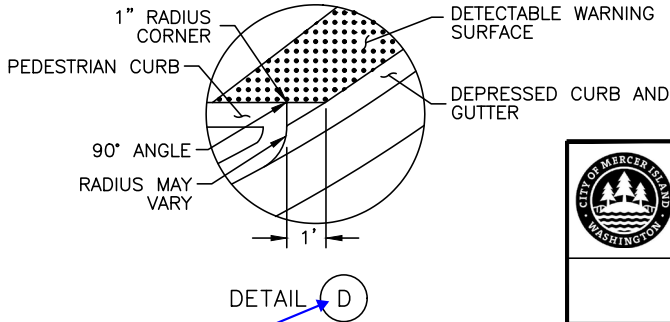
Suggest changing to "B".

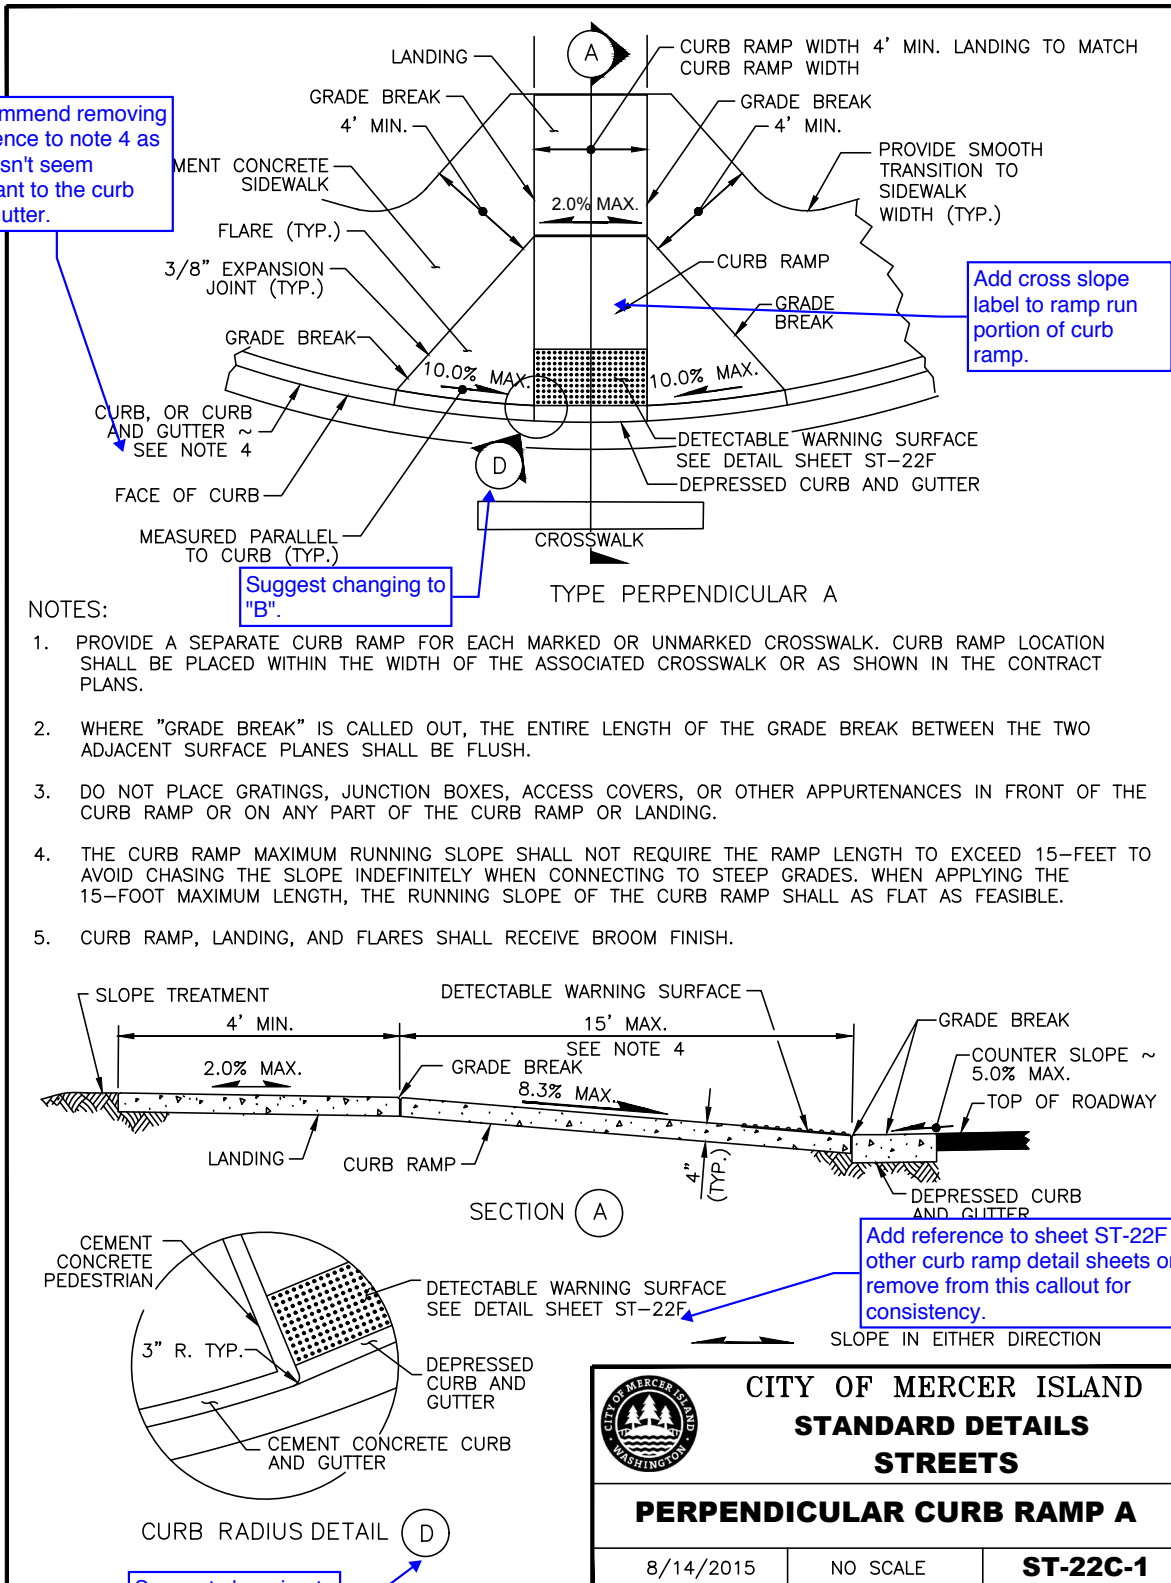
Recommend removing reference to note 4 as it doesn't seem relevant to the curb and gutter.

Add cross slope label to ramp run portion of curb ramp.

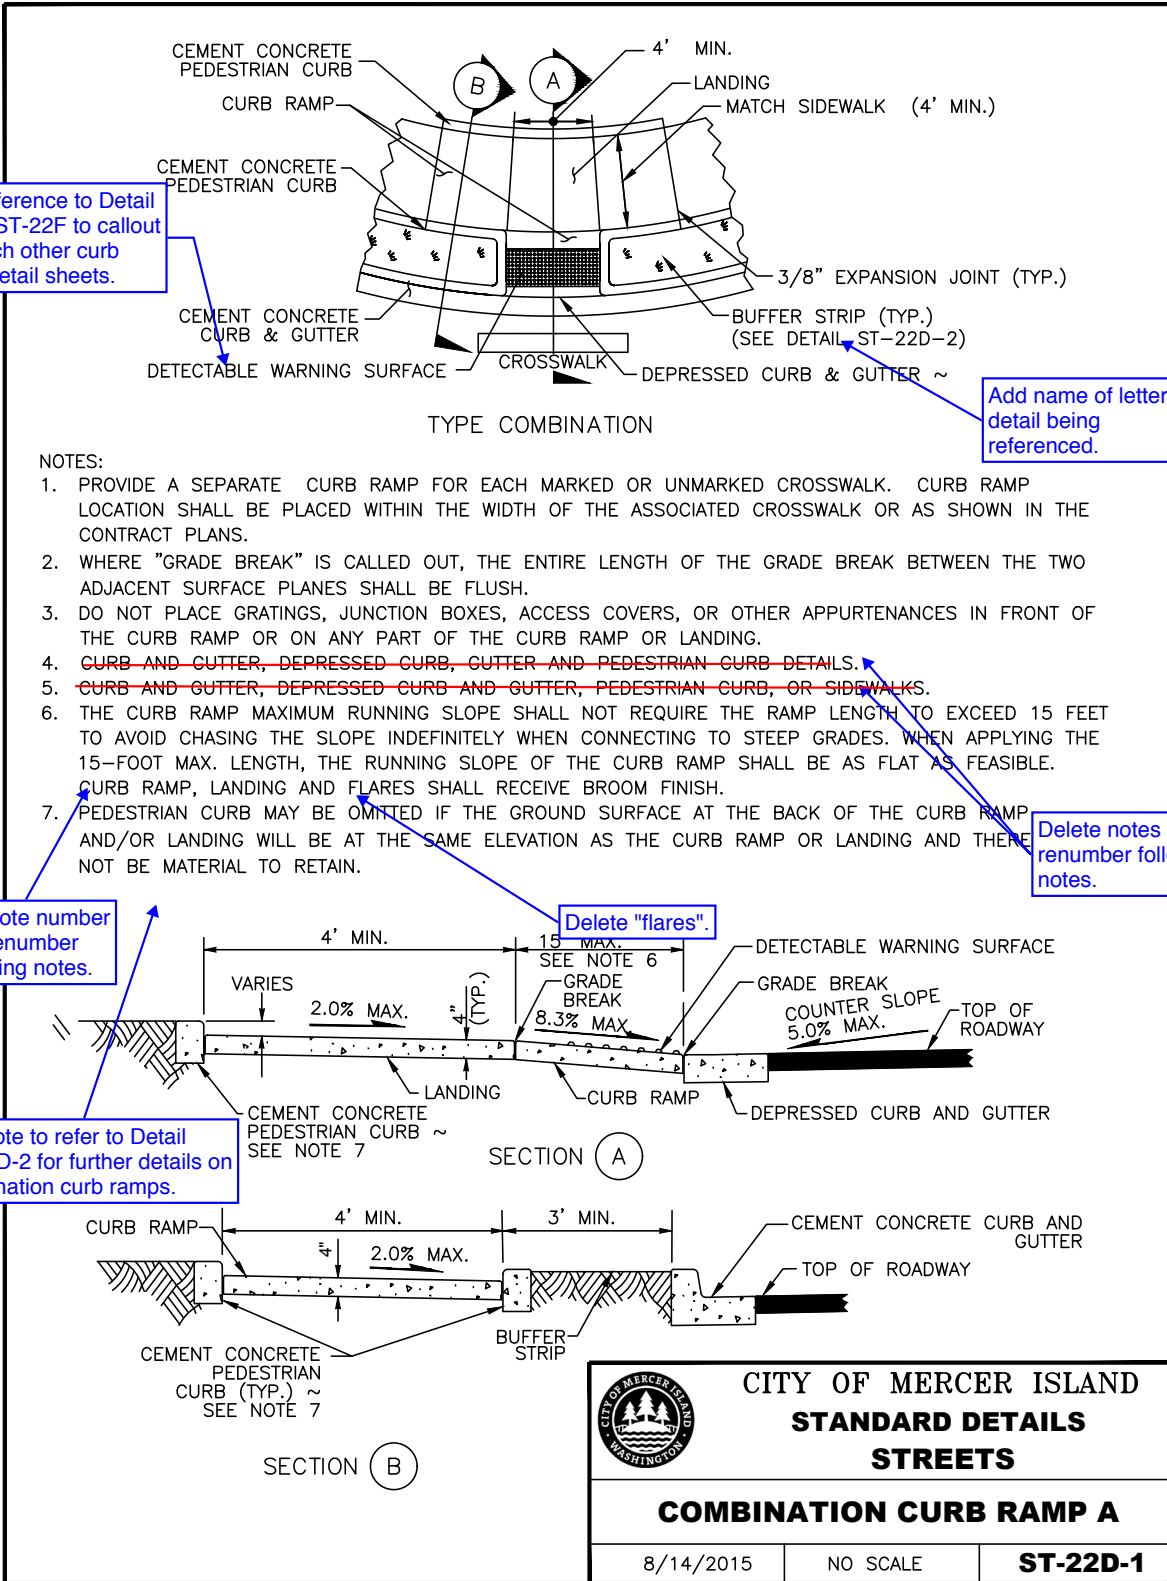
Add reference to Detail Sheet ST-22F to callout to match other curb ramp detail sheets.

Add name of letter of detail being referenced.

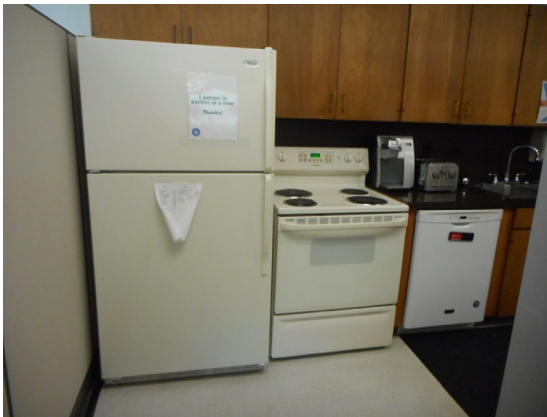
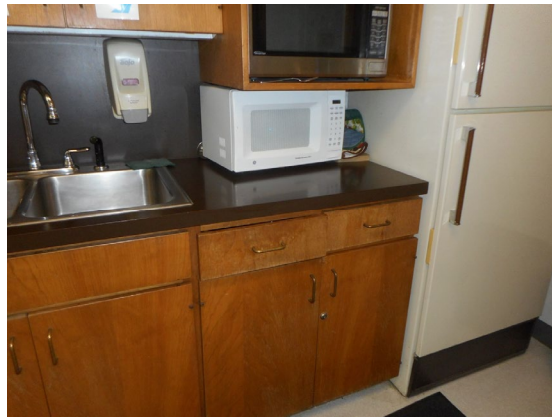
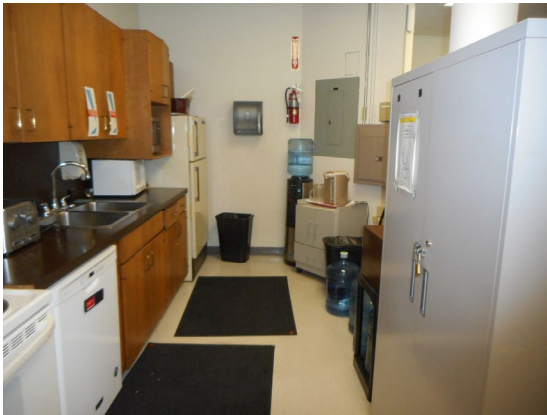
Maintenance Building

- Upper Left: Kitchen range has controls that require a reach over the burners. Kitchens with cooktops require an adjacent work surface with knee & toe space.
- Upper Right: Sink is 36" AFF (34" max. required). Outlets and switches mounted above countertop are not accessible for a side reach due to countertop height & depth.
- Lower Left: Metal cabinets and water bottles block the required turn-around space. Paper towel dispenser and fire extinguisher are mounted too high.

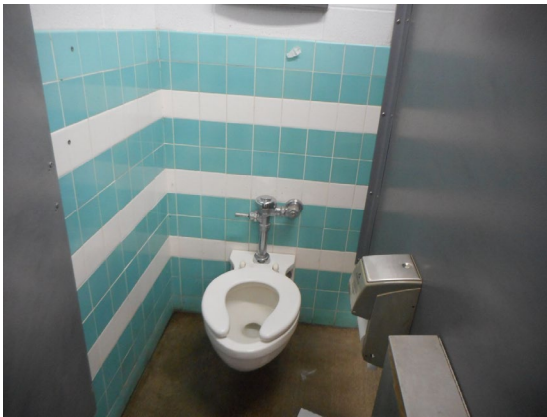
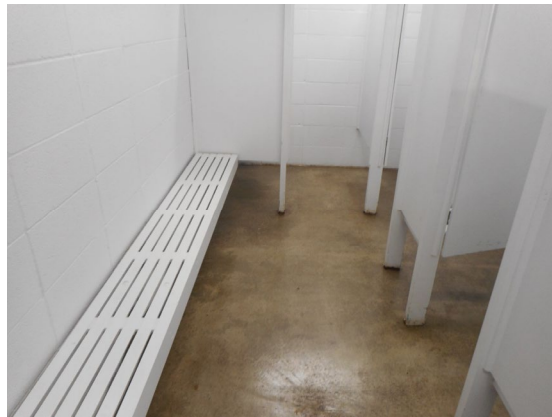
Groveland Beach Park

Upper Left: Restrooms are substantially non-compliant. Accessible stall in the Women's restroom is too small, grab bars are missing, flush control is incorrectly located. The Men's restroom lacks a turn-around.
