AGENDA
Historic Preservation Commission Meeting
Tuesday, June 18, 2024
Town Hall / Council Chambers - 302 Pine St Minturn, CO

- A.** Ordinance 16 - Series 2024 An Ordinance Amending the Town's Historic Register to Add 478 Eagle River Street - Harris

Review the landmark designation nomination of 478 Eagle River Street based on the criteria outlined in the Minturn Municipal Code Sec. 19-3-20, citing findings of fact, and forwarding a recommendation of approval, approval with conditions, or denial to the Minturn Town Council.

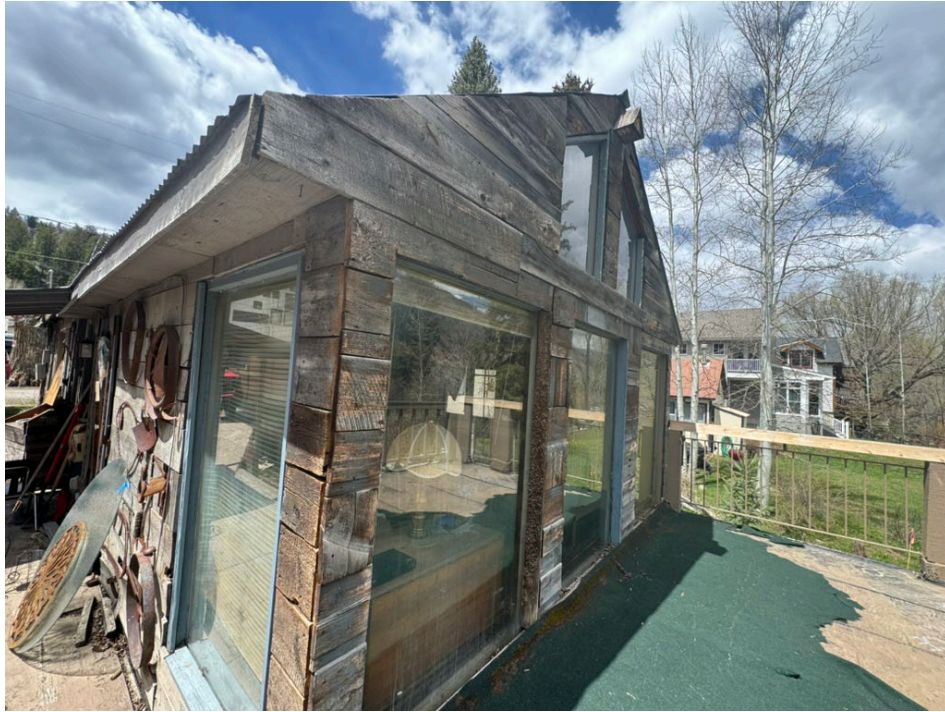
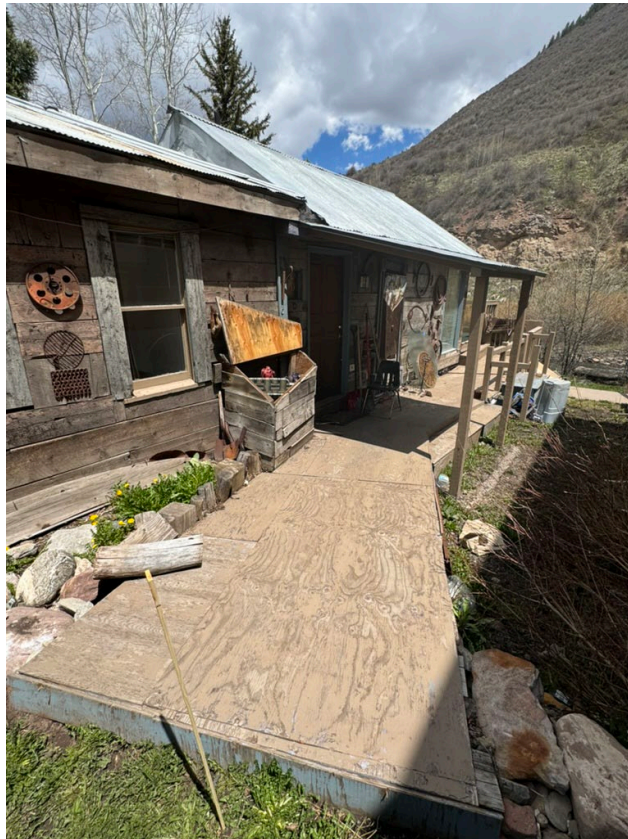
(Details 3 and 4) South addition and plywood decking.

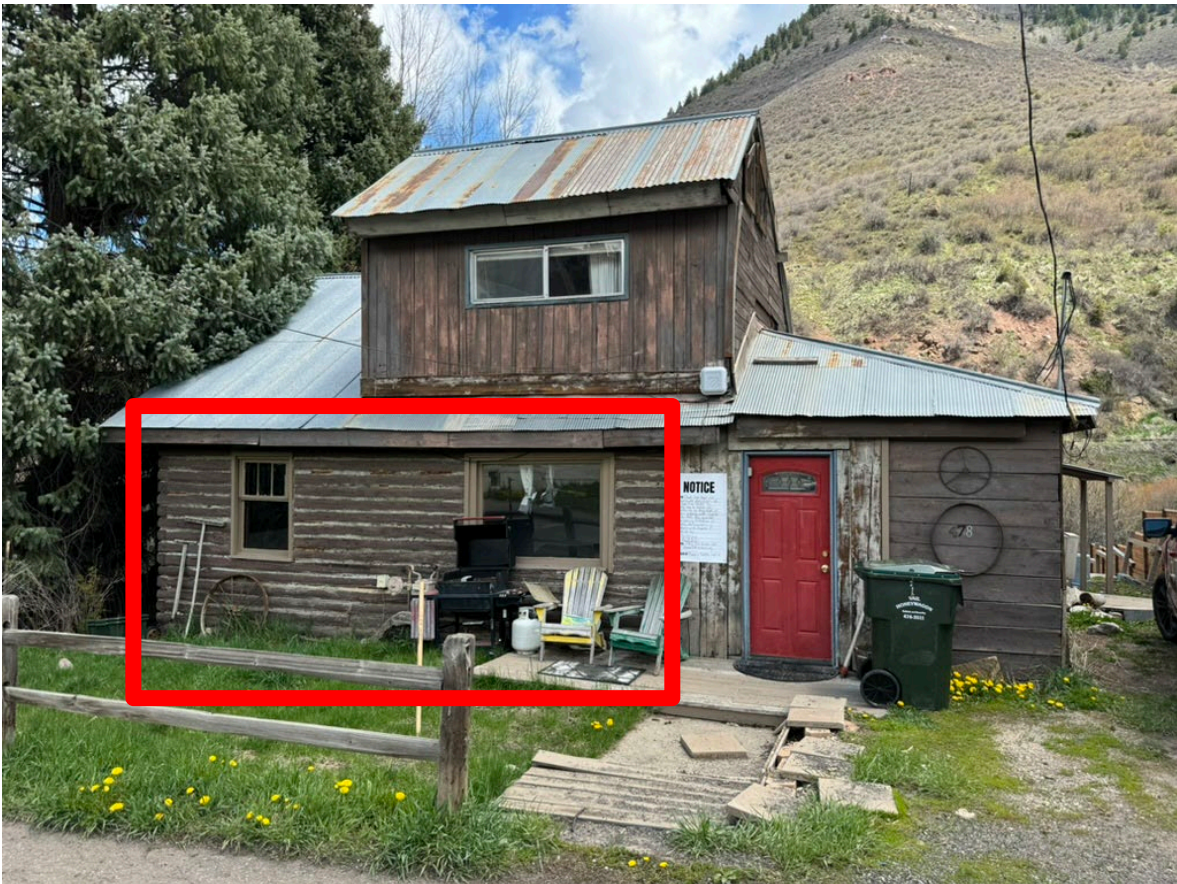
(Detail 5) Original cabin call out (red box). All other Structure components are later additions.

This curved log design is not clearly detectable along additional facades, signifying no clear delineation between what may have been an original section of the Structure and additions/renovations over the course of history. Therefore, there is no way to separate the qualifying and non-qualifying components of the Property and the Property as a whole is not eligible for historic designation.

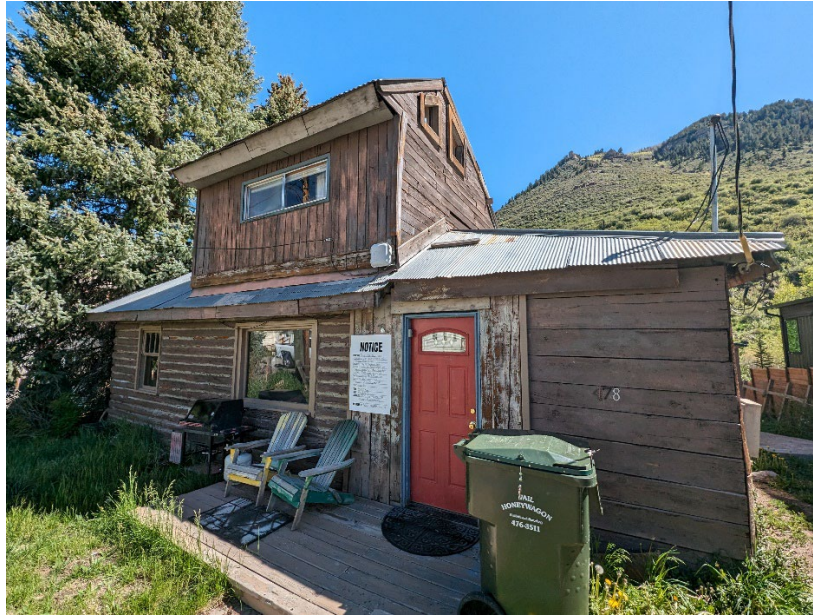
The Structure’s exterior along the street frontage is primarily made of wood, a portion of which is log construction but primarily wood board siding, that is described in the Inspection Report as decaying and requiring attention to restore structural integrity. The Structure’s lack of primarily log construction alone is a major deficiency in identifying the structure as exemplifying the Rustic style architecture, as is the lack of a stone chimney, paned windows and overhanging roof on some of the additions. The Rustic style typically employs a cohesive siding material throughout, and as evidenced by the photos provided herein, the Structure instead has a hodgepodge of different siding material (including extensive use of styrofoam, mis-matched boards, and tree-like adornments).

(Detail 7) Structure west façade.

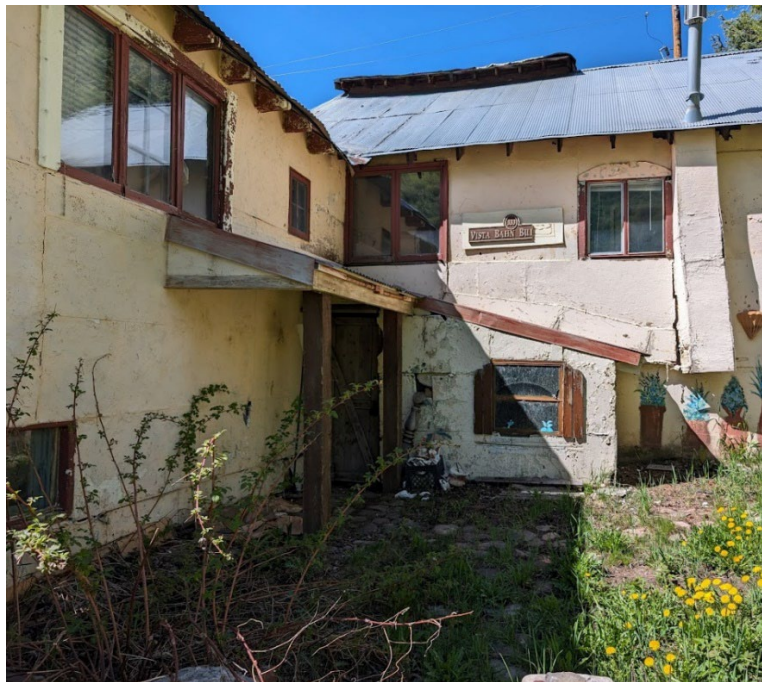
Elsewhere, the wood siding is missing from the Structure on multiple exterior facades, and still others are made of a decaying foam-like material reflected in the image below.⁵

(Detail 8) East and north facades, rear additions, and faux-Italianate components.

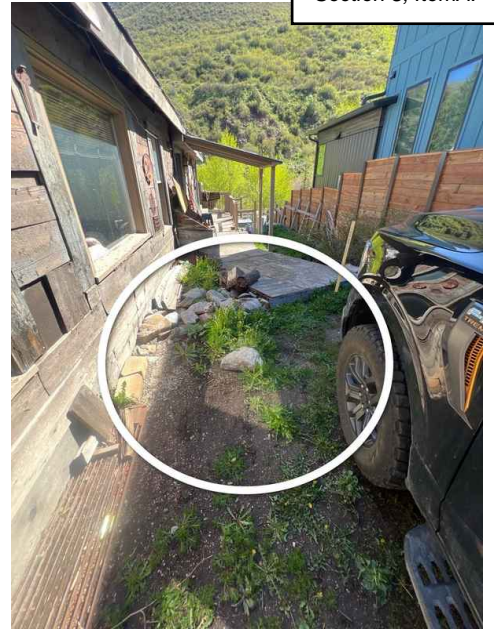
3.5.1 Walkways Condition

DAMAGES STAIR BOARD

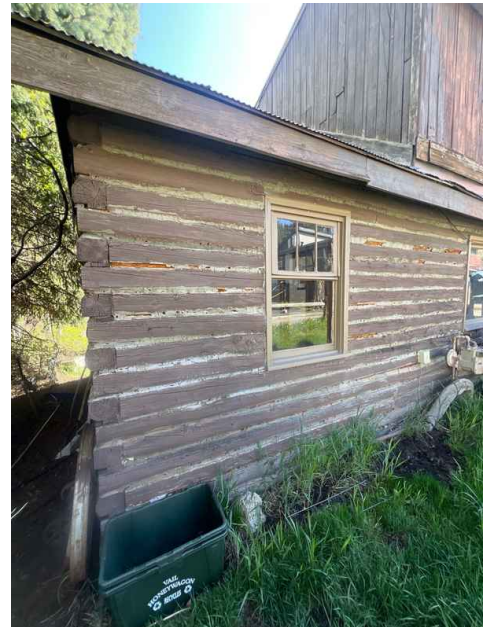
4.1.2 Structural

OLD BUILDING METHODS

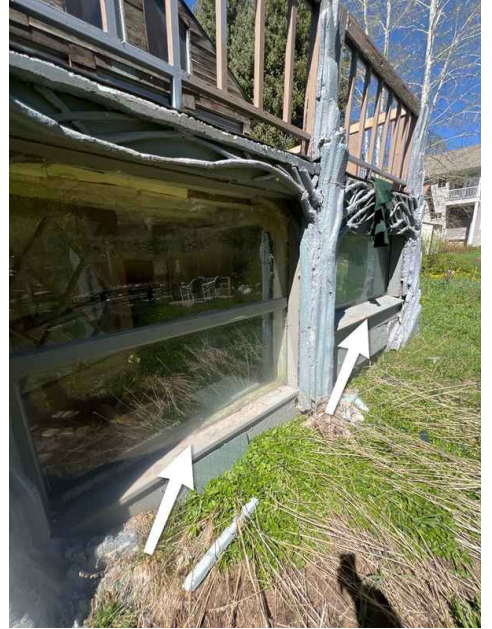
4.7.2 Trim

DETERIORATED TRIM

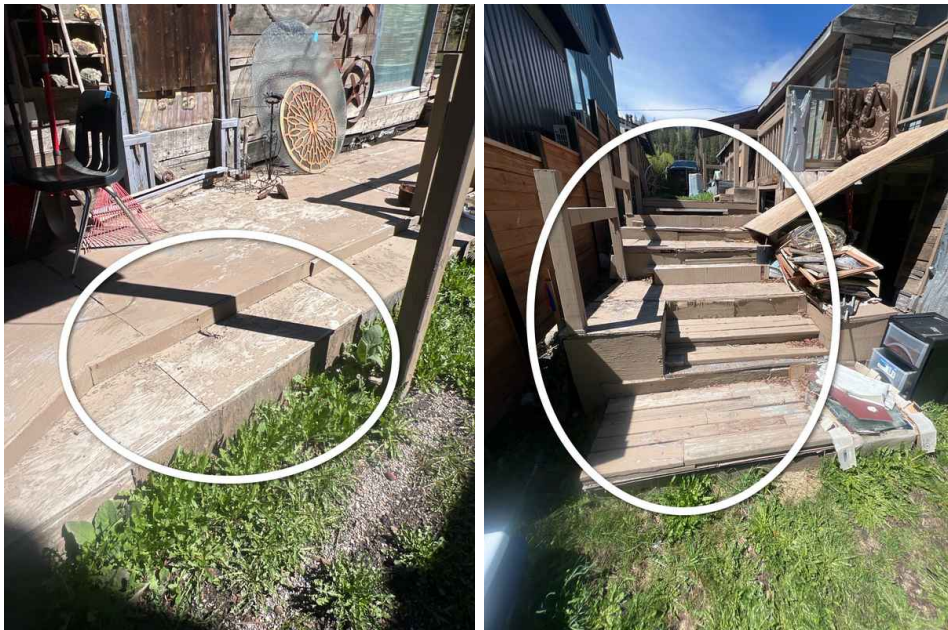
6.8.2 Deck steps

DAMAGED OR DETERIORATED**SEVERAL**

The steps were generally deteriorated and/or structurally damaged, making them potentially hazardous to a person who might use them. We recommend further review for a better understanding of replacement costs/repairs and present condition.

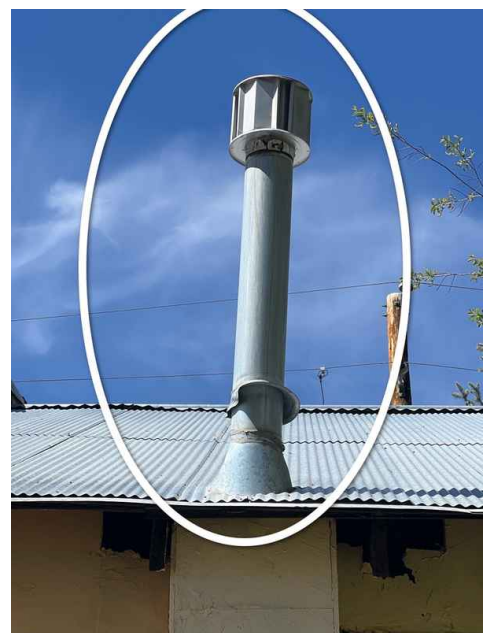
9.4.1 Metal roofing material condition

DAMAGED ROOF PANELS

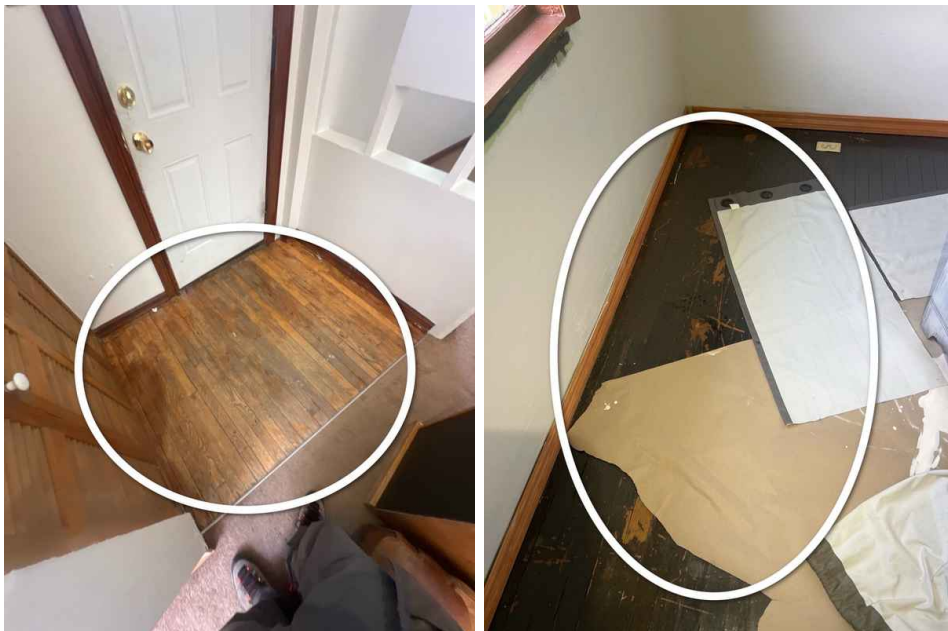
10.7.4 Floors

TRIP HAZARD

An elevation change of fewer than 4 inches was observed. This creates a trip hazard and should be corrected before personal injury results. We recommend that the lip be corrected as necessary.

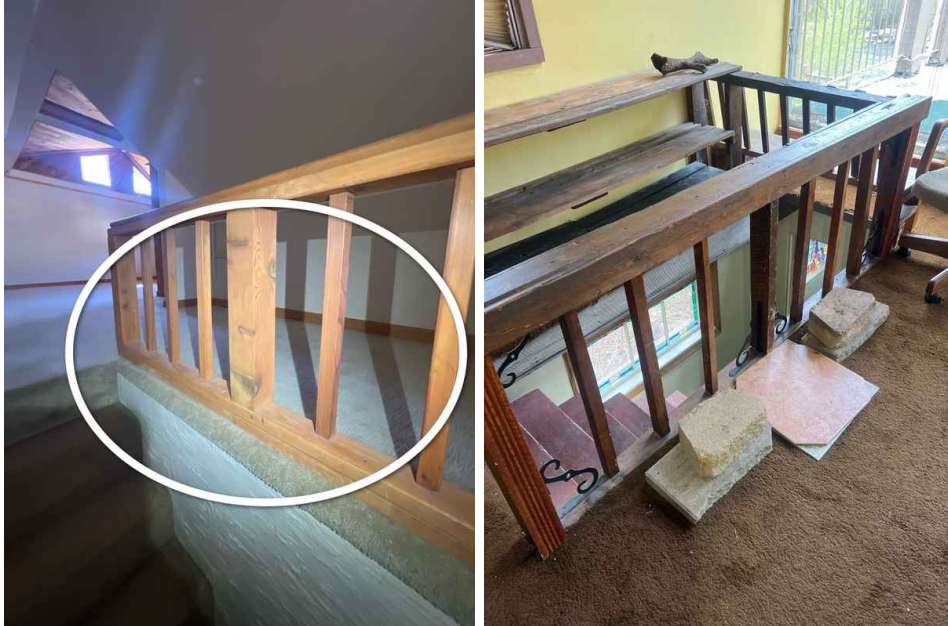
16.5.2 Railings

NO GUARD RAIL

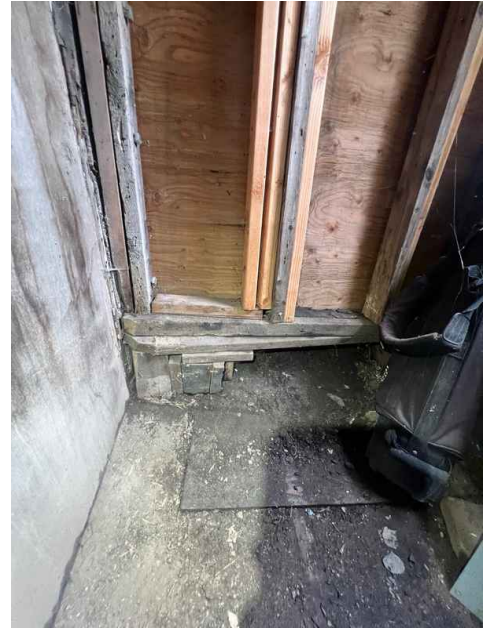
24.4.4 Foundation walls

DETERIORATED WALLS

The wood foundation walls are significantly bowing in towards the home. Damaged foundation plywood, moisture and soil intrusion, and drywall damage are visible. We suggest a further review by a qualified professional or structural engineer to evaluate this condition.
