City Council Public Hearing Agenda

1. Public Hearing - Proposed Sale of City Owned Property 401 Virginia Street
 - a. Opening of Public Hearing
 - b. Introduction
 - c. Testimony in Favor
 - d. Neutral Testimony
 - e. Testimony Opposed
 - f. Close the Public Hearing

401 Virginia Street New Meadows, Idaho 83654

Company Information

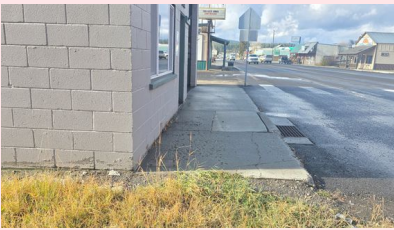
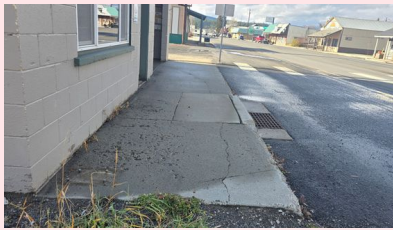
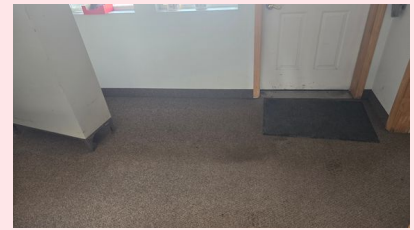
⚠️ **G-1 Grounds:**

The front concrete is sloping toward the building - see north side. Standards recommend a quarter inch per foot slope away from the building or better to prevent water draining toward the building. Signs of water drainage toward the building and moisture intrusion were evident as rust on the entry door and carpet stains. Concrete replacement and/or a water collection drain installation is recommended. Have this further evaluated and repaired as recommended by a qualified contractor.

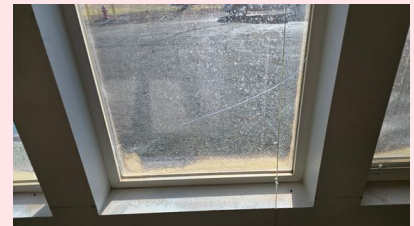
⚠️ **E-5 Exterior:**

South and west windows have failed vacuum seals. Cracked glass also noted at one of the rear windows. This presents as visual irregularities between the double pane glass which cannot be cleaned without glazing replacement. I list as a major concern due to the cost of replacing multiple windows. Hire a glass replacement company to further evaluate and replace windows with lost seals.

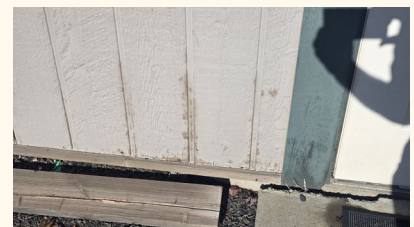
failed paint & water damage

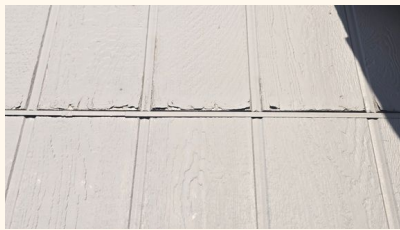
failed paint

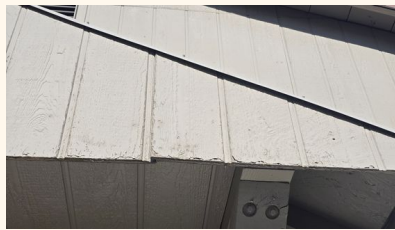
failed paint

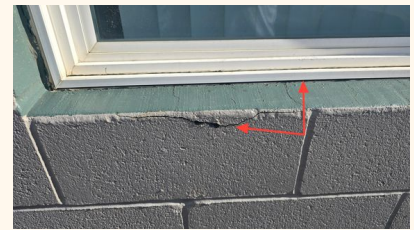
failed paint

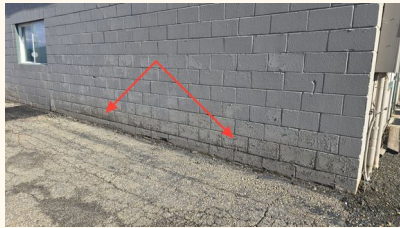
masonry sealant needed

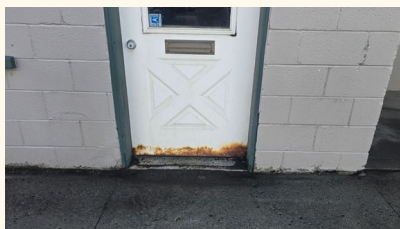
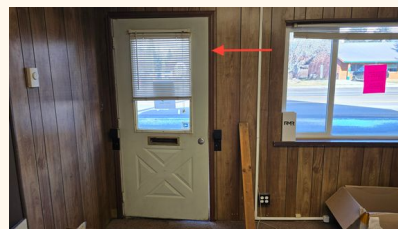
✂ E-3 Exterior:

The northeast steel door exterior is rusting and should be replaced. Additionally, this door was not square and contacts the door frame when operated.

out of square - hits frame

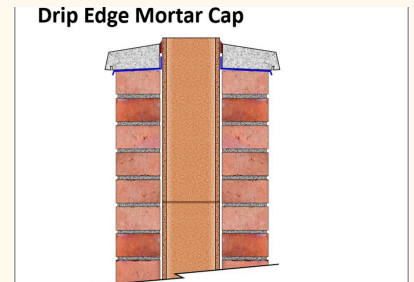
✂ RG-1 Roof & Gutters:

simple metal cap

**(RG-1) Recommended Repair:** The unused concrete chimney should be capped to prevent water and ice from entering and damaging the masonry. Hire a mason to further evaluate and install a masonry or metal chimney cap.

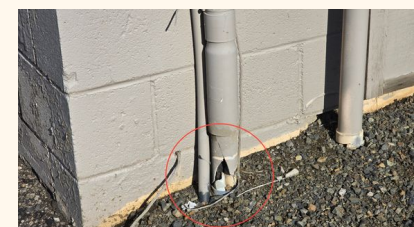
✂ ESD-1 Electric Service & Distribution:

The conduit for the electric service lateral is broken where it meets the asphalt. This has exposed the conductors and could pose a safety hazard. Hire a licensed electrician to make repairs.

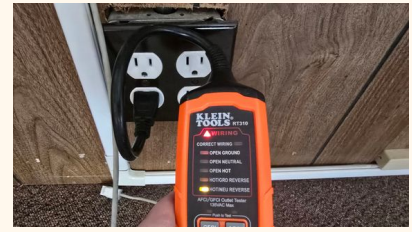
✂ EDFW-1 Electric Distribution & Finish Wiring:

Reverse polarity was noted at the electrical receptacle at the front office wall. This is when the hot and the neutral have been wired backwards. This should be corrected by a licensed electrician.

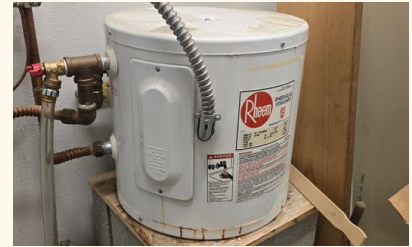
✂ P-4 Plumbing:

This is the original water heater manufactured in 2001. According to industry standards, this water heater has entered a less reliable phase of its service life. There is staining indicating the water heater has developed leaks. Recommend replacement for ongoing reliability.

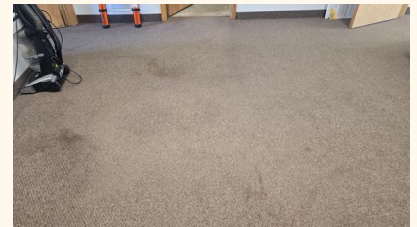
✂ I-1 Interior:

The wall to wall carpeting is likely original and showing signs of age indicating it should be updated. See attached photos showing localized staining and wear.

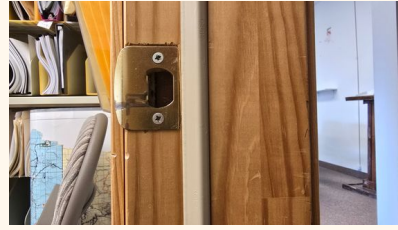
✂ I-2 Interior:

The east office door was not latching correctly and requires the strike height to be adjusted so the door latches closed.

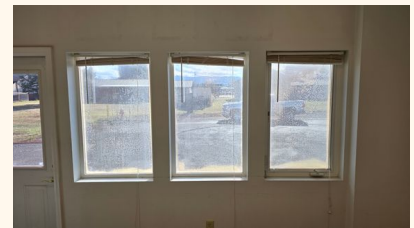
I-3 Interior:

As mentioned above and previously in the exterior chapter, several windows appeared to have failed vacuum seals. Hire a glass replacement company to further evaluate and replace windows with lost seals.

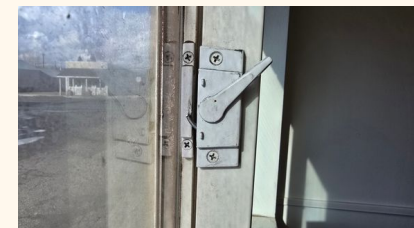
I-4 Interior:

The west window lock was inoperable. I was unable to align and engage the locking mechanism. This should be repaired as it poses a security risk.

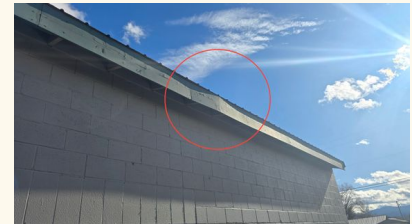
🔧 E-2 Exterior:

Warped fascia at west side observed. This appears to be mainly a cosmetic issue at this time. Recommend repair/replacement prior to having the exterior painted. A relief cut and new fasteners may suffice.

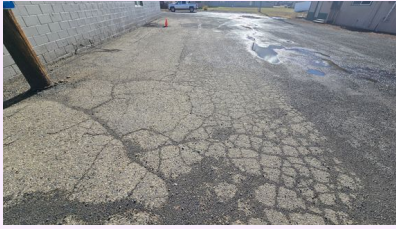
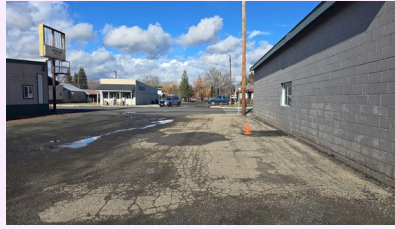
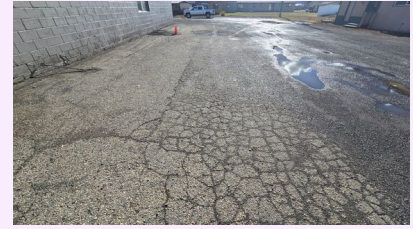
🏠 G-2 Grounds:

Asphalt areas were seen to be in poor overall condition with significant cracking, deterioration and undefined areas. While the lot is in useable condition, a logical improvement would be new asphalt parking areas with painted yellow lines for vehicle parking. Blue paint and decals should be displayed for the handicapped parking stall. These spaces should be marked with a wheelchair

symbol and are often wider to accommodate mobility devices.

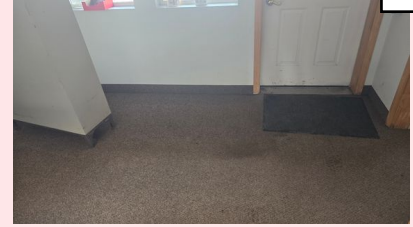
Site Drainage: Negative Grade, Grade slopes toward foundation

⚠ (G-1) Major Concern: The front concrete is sloping toward the building - see north side. Standards recommend a quarter inch per foot slope away from the building or better to prevent water draining toward the building. Signs of water drainage toward the building and moisture intrusion were evident as rust on the entry door and carpet stains. Concrete replacement and/or a water collection drain installation is recommended. Have this further evaluated and repaired as recommended by a qualified contractor.

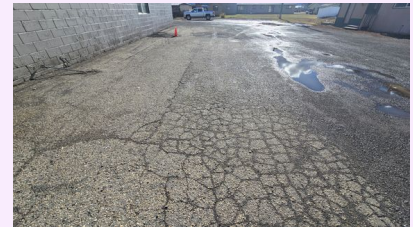
Driveway: Parking Lot: Asphalt, Gravel, Asphalt: Poor overall condition

**(G-2) Suggested Improvement:** Asphalt areas were seen to be in poor overall condition with significant cracking, deterioration and undefined areas. While the lot is in useable condition, a logical improvement would be new asphalt parking areas with painted yellow lines for vehicle parking. Blue paint and decals should be displayed for the handicapped parking stall. These spaces should be marked with a wheelchair symbol and are often wider to accommodate mobility devices.

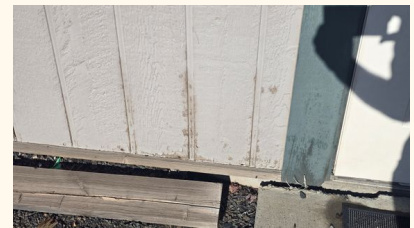
failed paint & water damage

**(E-1) Recommended Repair:** The wooden portions of the exterior siding and trim needs to be re-painted to preserve and maintain the siding system. Any water damaged siding should be replaced as needed prior to prep and paint. Specialized paint is required for concrete block. Budget for re-painting the exterior in the near term. Examples of specific observations noted during inspection include:

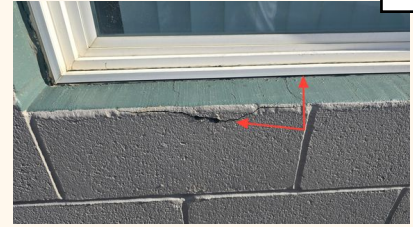
failed paint

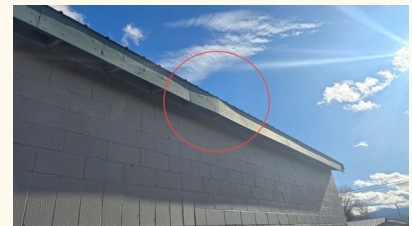
(E-2) Suggested Cosmetic Repair:

Condition: Overall appearance and condition good, Warped fascia (west side)

Warped fascia at west side observed. This appears to be mainly a cosmetic issue at this time. Recommend repair/replacement prior to having the exterior painted. A relief cut and new fasteners may suffice.

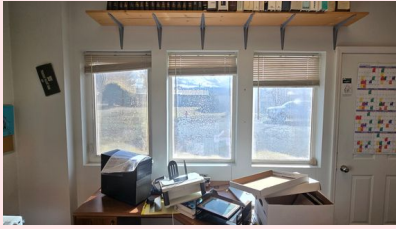
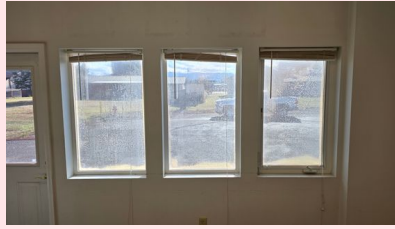
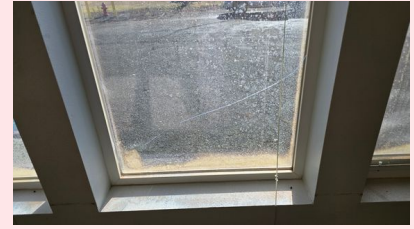
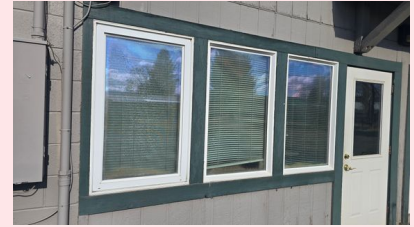
Condition / Observations: Several failed insulated glass units (IGU'S), One failed insulated glass unit (IGU)

⚠️ (E-5) Major Concern: South and west windows have failed vacuum seals. Cracked glass also noted at one of the rear windows. This presents as visual irregularities between the double pane

glass which cannot be cleaned without glazing replacement. I list as a major concern due to the cost of replacing multiple windows. Hire a glass replacement company to further evaluate and replace windows with lost seals.

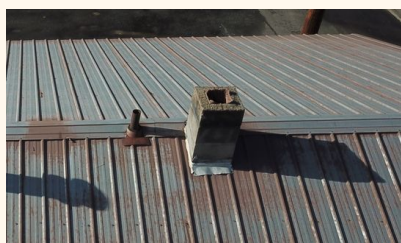
simple metal cap

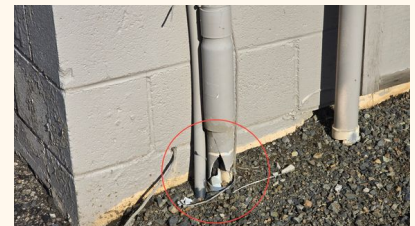
🔧 (ESD-1) Recommended Repair:

The conduit for the electric service lateral is broken where it meets the asphalt. This has exposed the conductors and could pose a safety hazard. Hire a licensed electrician to make repairs.

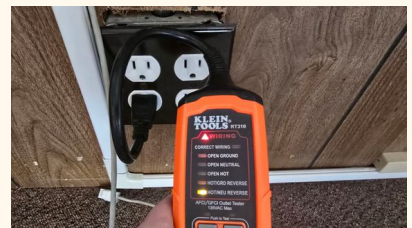
🔧 (EDFW-1) Recommended Repair:

Reverse polarity was noted at the electrical receptacle at the front office wall. This is when the hot and the neutral have been wired backwards. This should be corrected by a licensed electrician.

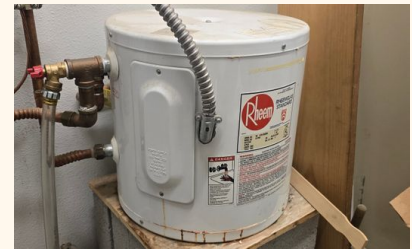
This is the original water heater manufactured in 2001. According to industry standards, this water heater has entered a less reliable phase of its service life. There is staining indicating the water heater has developed leaks. Recommend replacement for ongoing reliability.

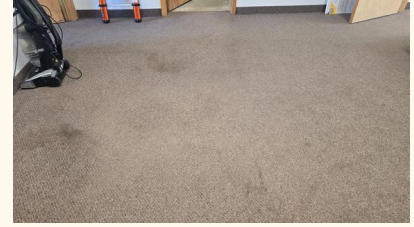
✂ (I-1) Recommended Repair: The wall to wall carpeting is likely original and showing signs of age indicating it should be updated. See attached photos showing localized staining and wear.

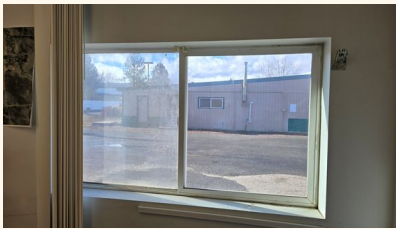
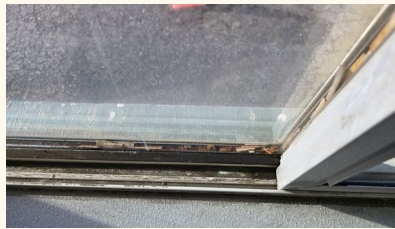
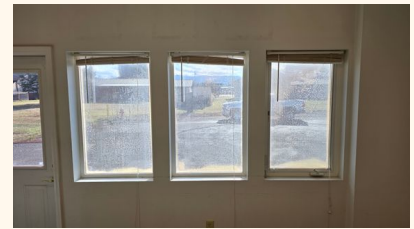
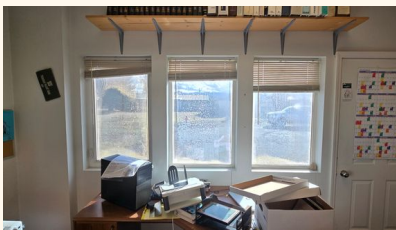
🔧 (I-3) Recommended Repair: As mentioned above and previously in the exterior chapter, several windows appeared to have failed vacuum seals. Hire a glass replacement company to further evaluate and replace windows with lost seals.

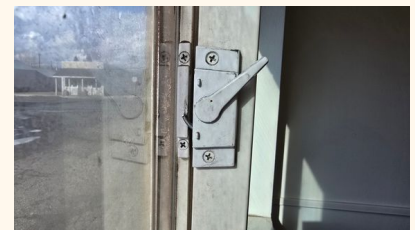
🔧 (I-4) Recommended Repair:

The west window lock was inoperable. I was unable to align and engage the locking mechanism. This should be repaired as it poses a security risk.

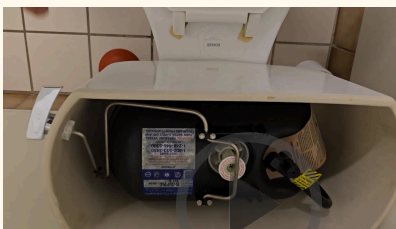
**(WB-1) Recommended Repair:** The Sloan® Pressure Vessel inside the womans bathroom toilet tank was not functioning normally and requires repair or replacement. Hire a licensed plumber to further evaluate and repair as recommended.
