**CITY OF NOVI**  
**Administrative ePacket**  
**December 05, 2024**

[PCCP Water Main Inspection Results - Croy](#)

# Condition Assessment Report

The City of Novi (Novi) contracted Pure Technologies, a Xylem brand (Pure Technologies), to conduct a condition assessment of the 36-, 30-, and 24-inch Novi Road PCCP Water Transmission Main located in Novi, Michigan. The Novi Road PCCP Water Transmission Main consists of prestressed concrete cylinder pipe (PCCP), specifically lined cylinder pipe (LCP).

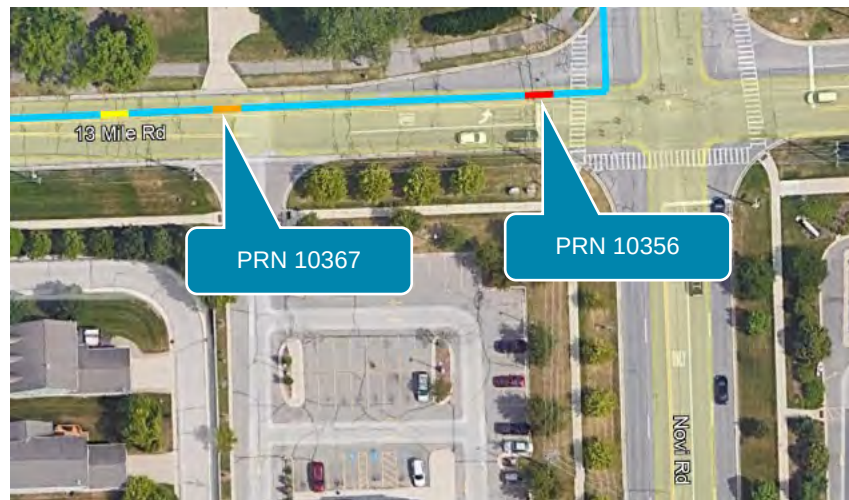
Electromagnetic analysis of the data obtained during the 2020 inspection determined that a total of eight (8) pipes displayed electromagnetic anomalies consistent with prestressing wire damage. Of those eight (8) distressed pipes, four (4) pipes (Pure Reference Number 10324, 10327, 10356, and 10367) with broken wire wraps ranging from 10 to 30 as well as across entire length were repaired with carbon fiber reinforced polymer (CFRP) in March 2024. The locations of four (4) CFRP repaired pipes along the transmission are shown in Figures 1.4 and 1.5.

Figure 1.4: CFRP repair pipes – PRN 10356 and PRN 10367.

Structural Technologies to perform an internal repair method called Carbon Fiber Reinforced Polymer (applied by hand inside the pipe) to strengthen the pipe segment. The same repair method was used on GLWA's water mains on 14 Mile Road.

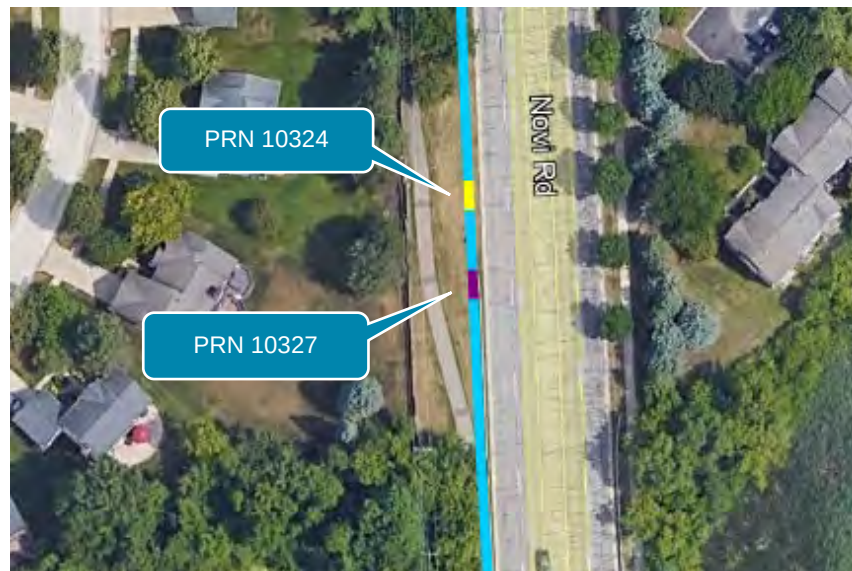
Figure 1.5: CFRP repair pipes – PRN 10324 and PRN 10327.

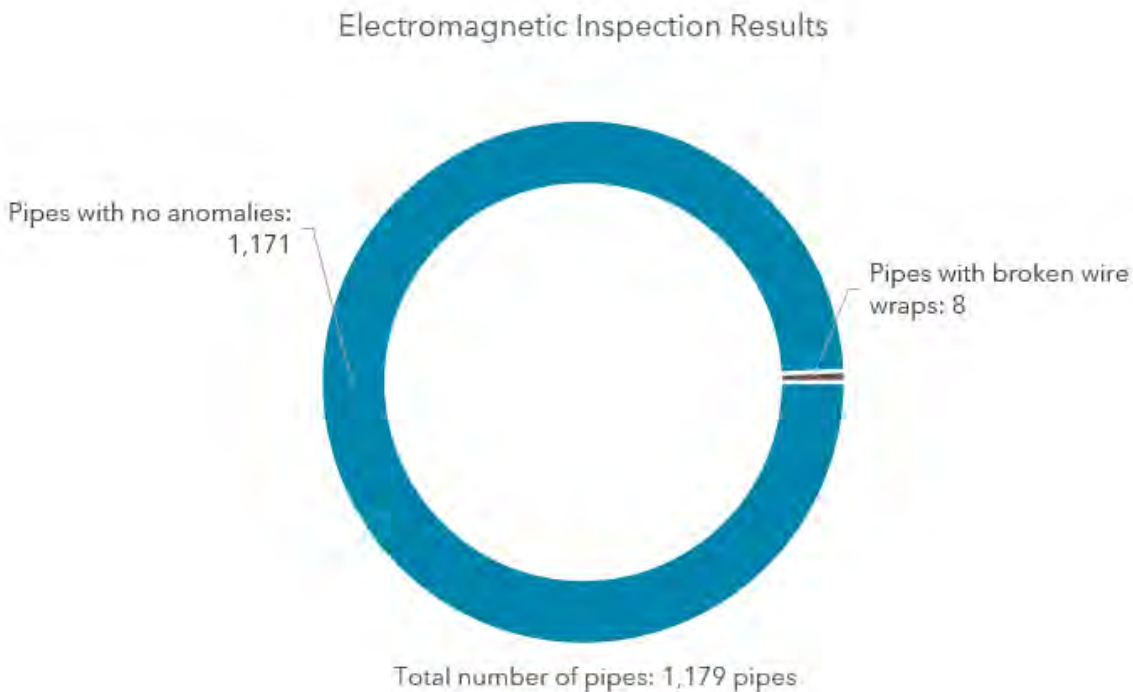
Electromagnetic analysis of the data obtained during the 2020 inspection determined that a total of eight (8) pipes displayed electromagnetic anomalies consistent with prestressing wire damage. Of those eight (8) distressed pipes, four (4) pipes (Pure Reference Number 10324, 10327, 10356, and 10367) were repaired with carbon fiber reinforced polymer (CFRP) in March 2024. Analysis of the data obtained during the 2024 inspection determined that zero (0) pipes displayed electromagnetic anomalies consistent with prestressing wire damage. A summary of inspection results is presented in Table ES.2. A complete discussion of the electromagnetic results is presented in Section 5.

Figure 3.2: Prestressing wire wrap findings for the Novi Road PCCP Water Transmission Main.

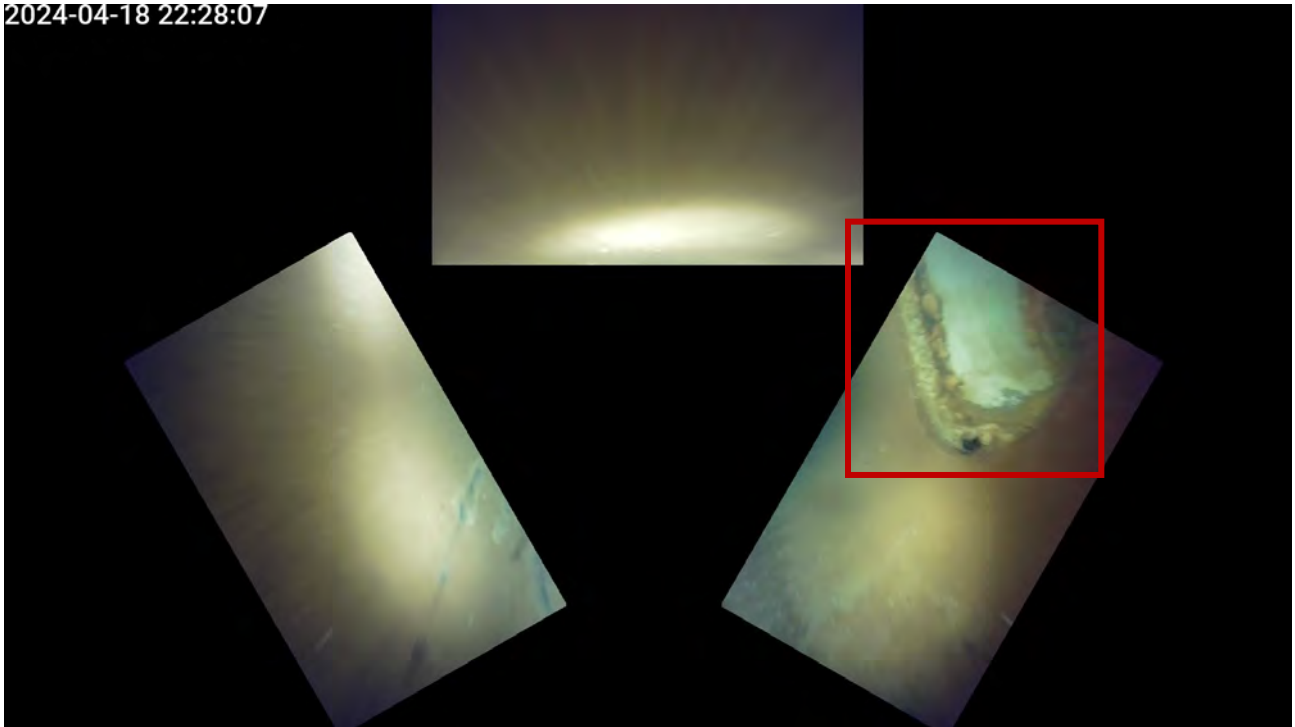
Figure 6.1: Hydrant outlet in Pure Reference Number 11546

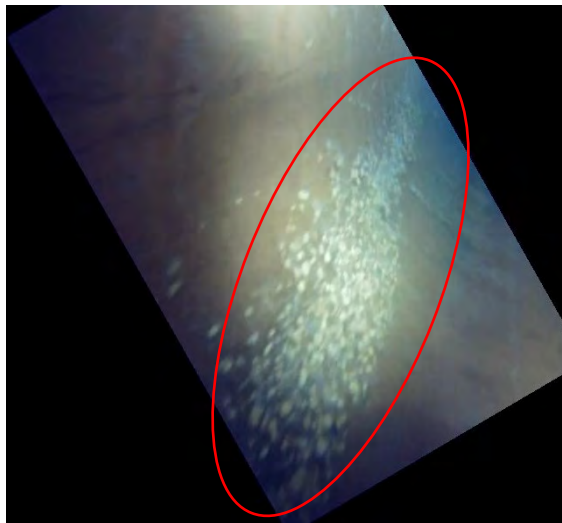
In addition to the leak location, several other observations were reviewed. Discoloration was noted in PRN 11173, as shown in Figure 6.2. Material buildup was observed in PRN 11169, 11289, and 11577, examples of which are shown in Figure 6.3. A possible protrusion into the pipe was observed in PRN 11194, illustrated in Figure 6.4. A visual anomaly was observed in Pure Reference Number 11506, seen in Figure 6.5. Details of video review are included in Appendix H.

Figure 6.2: Discoloration seen on Pure Reference Number 11173

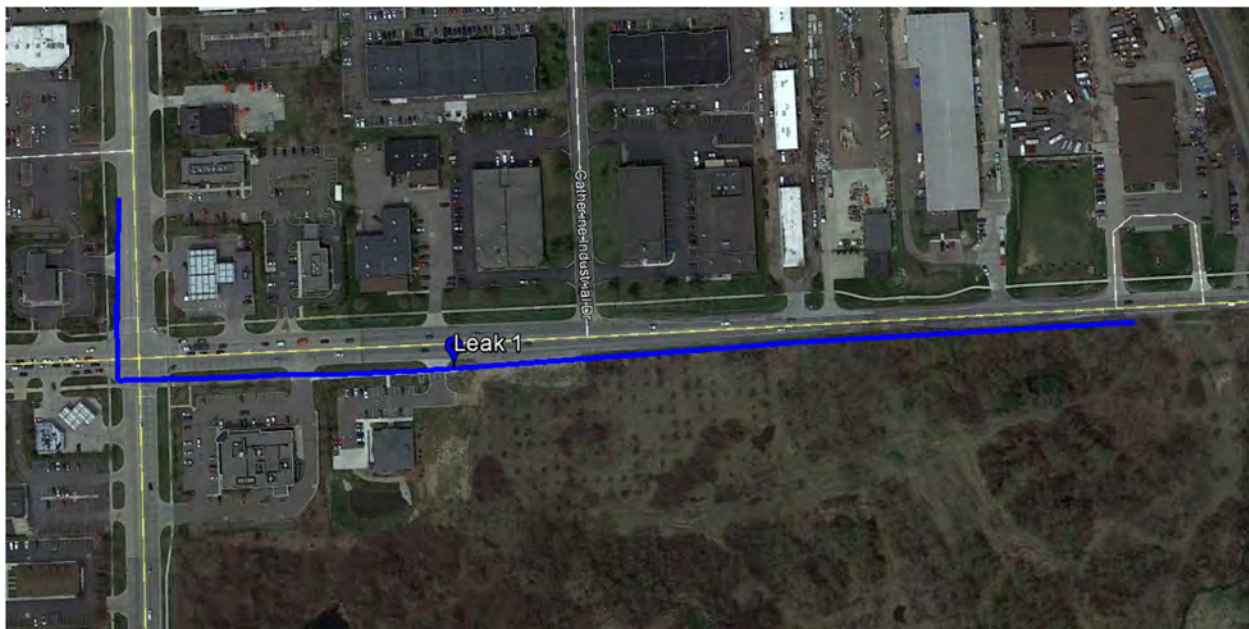
Figure 3.2: General Layout of Novi East Inspection with leak locations mapped

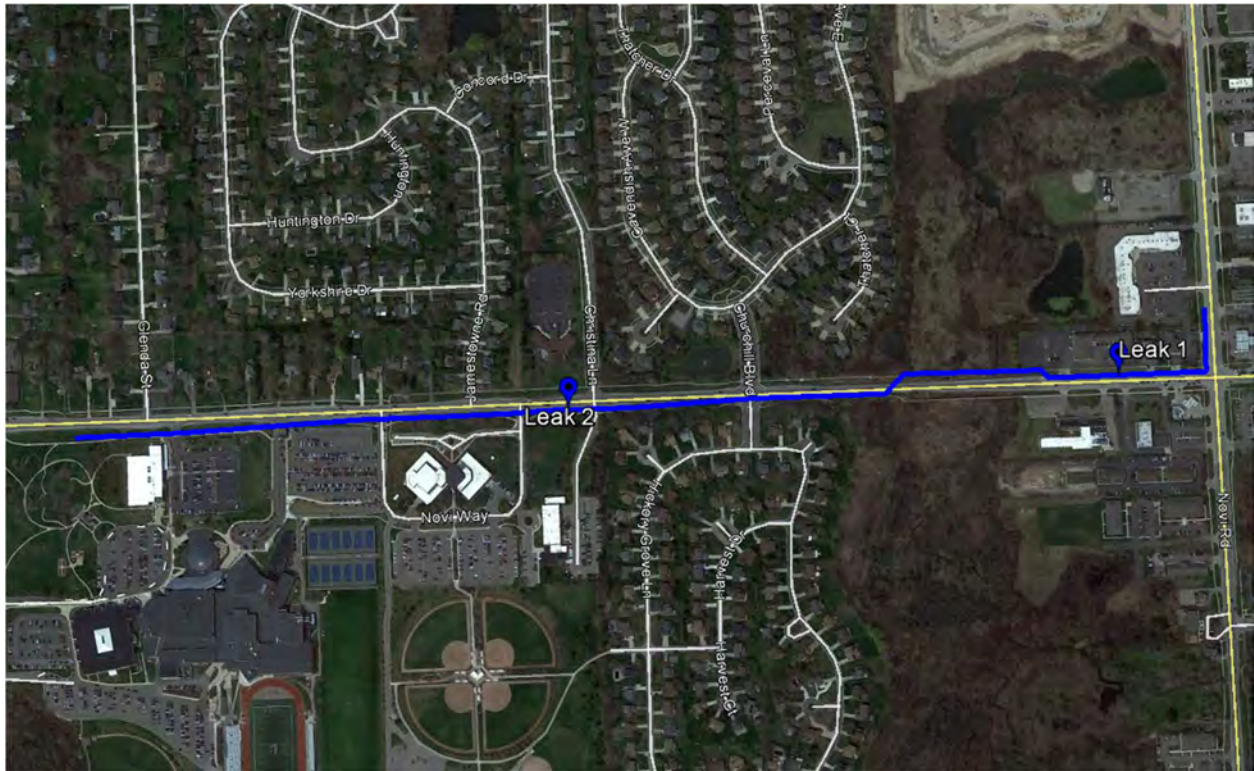
*Figure 3.4: General Layout of West Inspection with leak locations mapped*

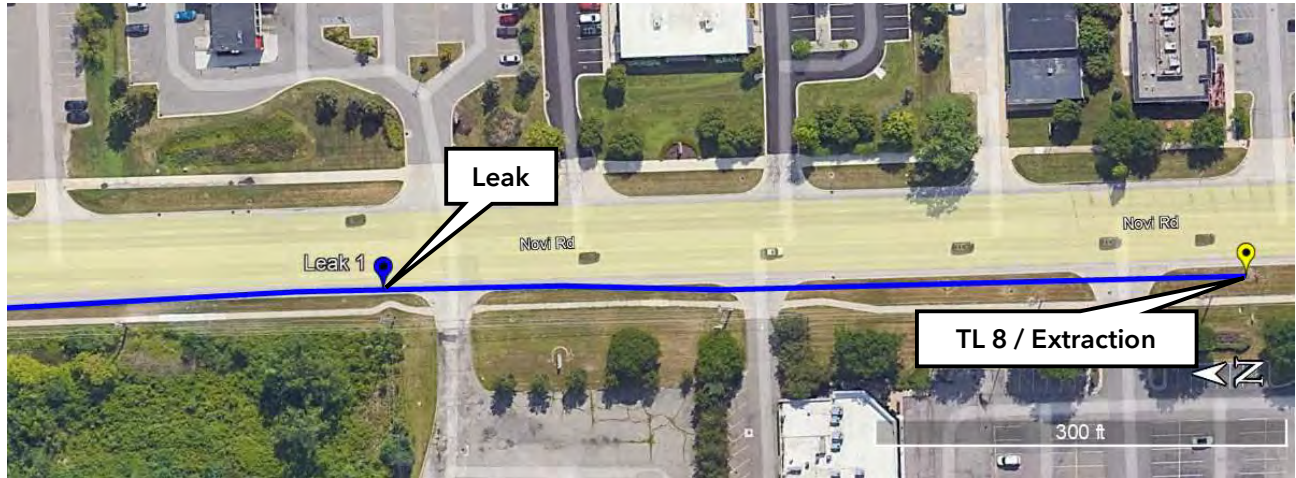
Figure 3.1: Aerial View of Novi Road PCCP Water Transmission Main with Location of Leak

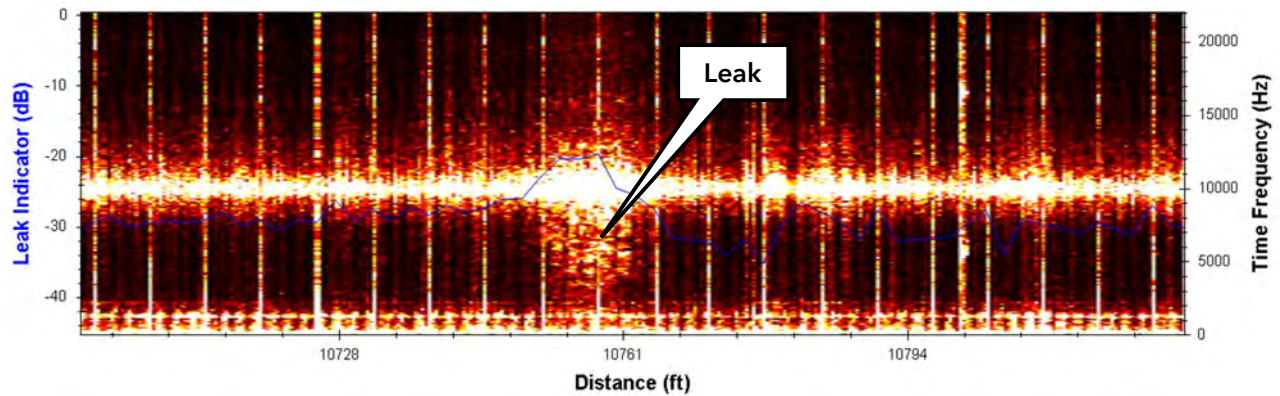
Figure 3.2: Acoustic Intensity of Leak #1

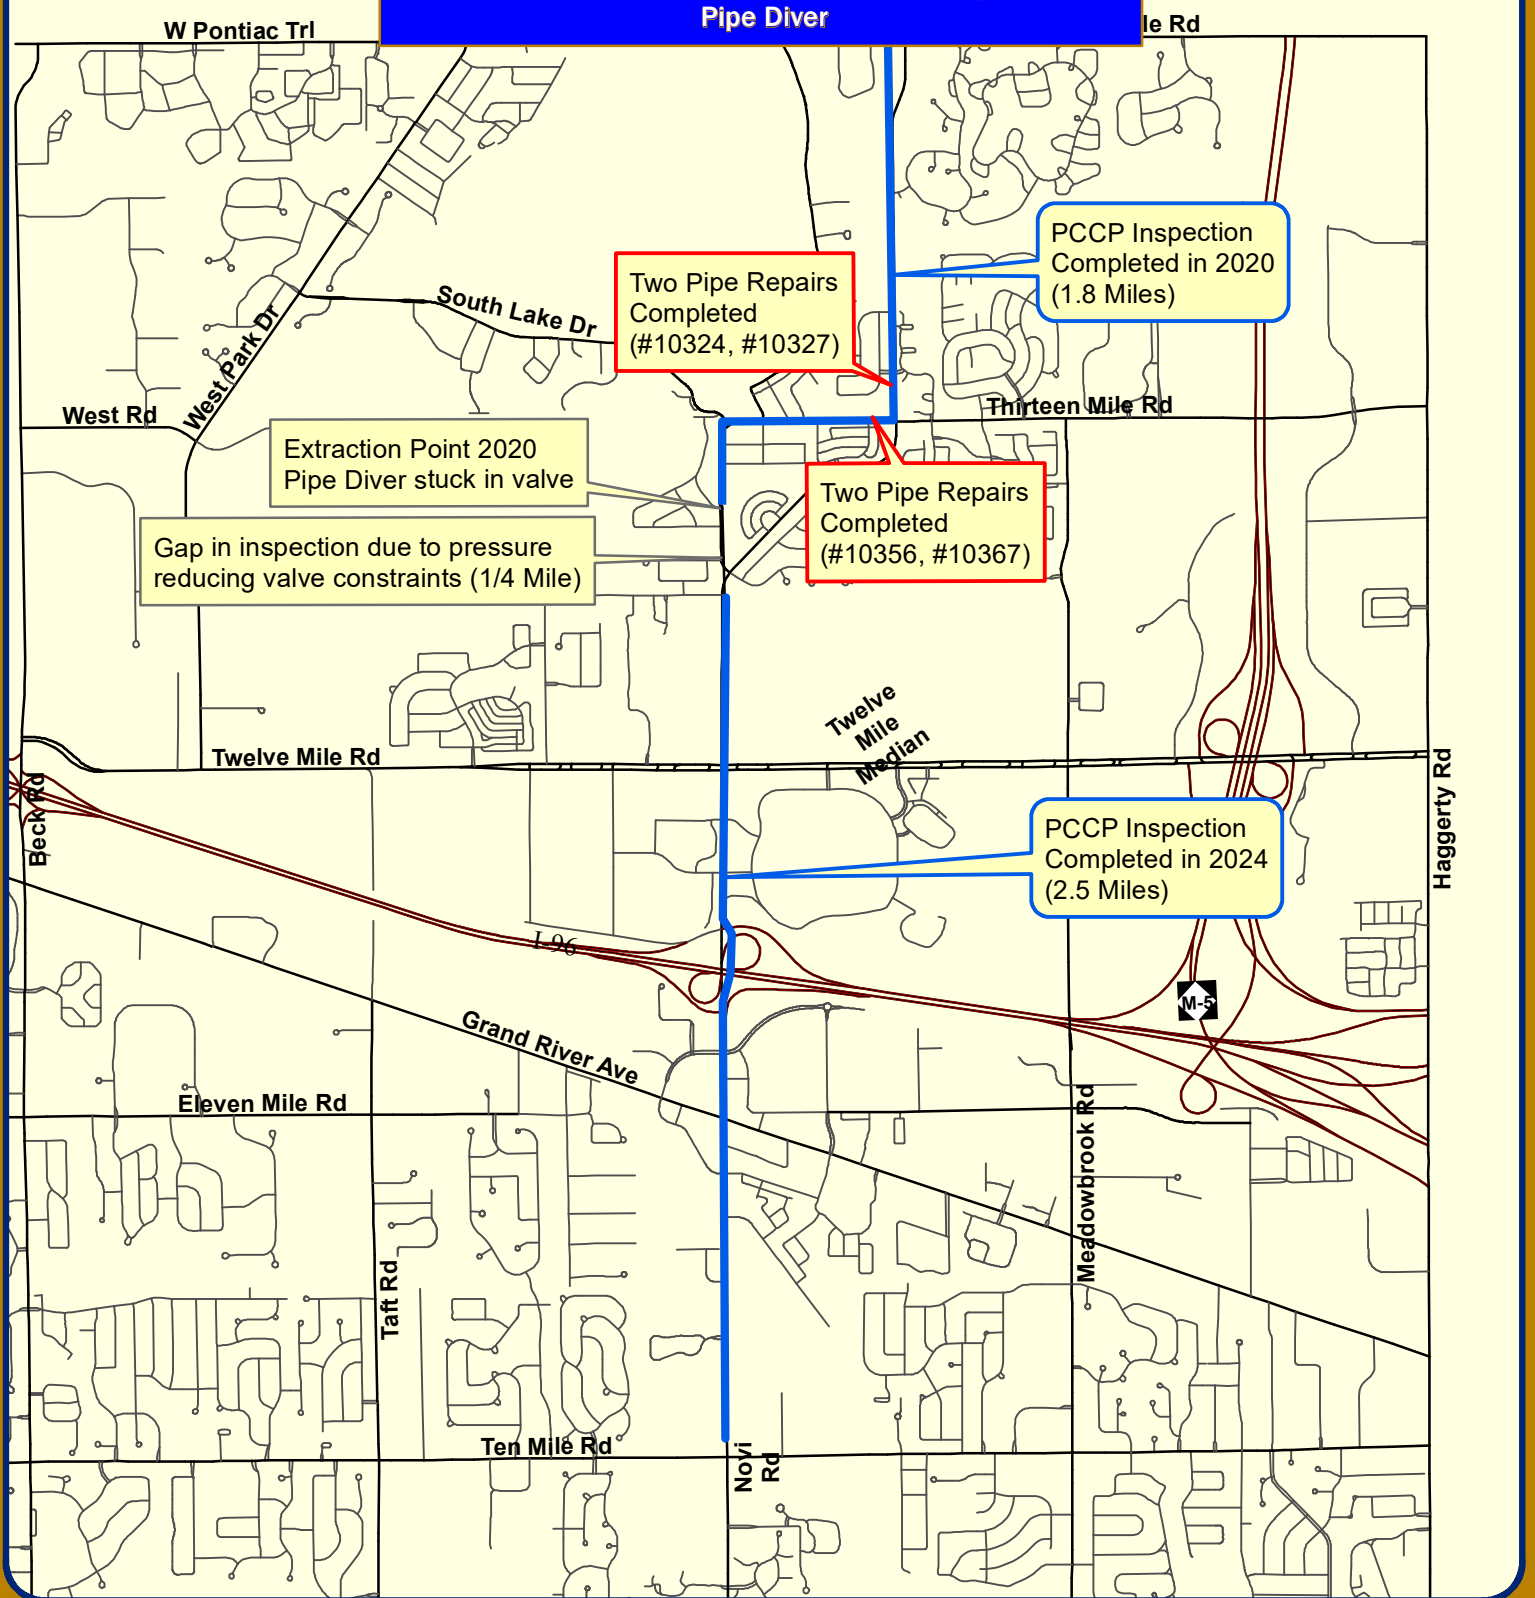
The attached map shows the PCCP water main inspected along Novi Road and the location of the repairs. It should be noted that approximately 1,483 feet of pipe north of the Novi Rd/Old Novi Rd intersection could not be inspected due to the pressure reducing valve which regulates pressures between districts. Staff will continue to monitor and inspect Novi's PCCP assets as needed.
