# Preliminary Engineering Report

## Downtown Sidewalks

**PROJECT # 23-1206**  
July 24, 2024

City of Oelwein  
20 2nd Avenue SW  
Oelwein, Iowa 50662

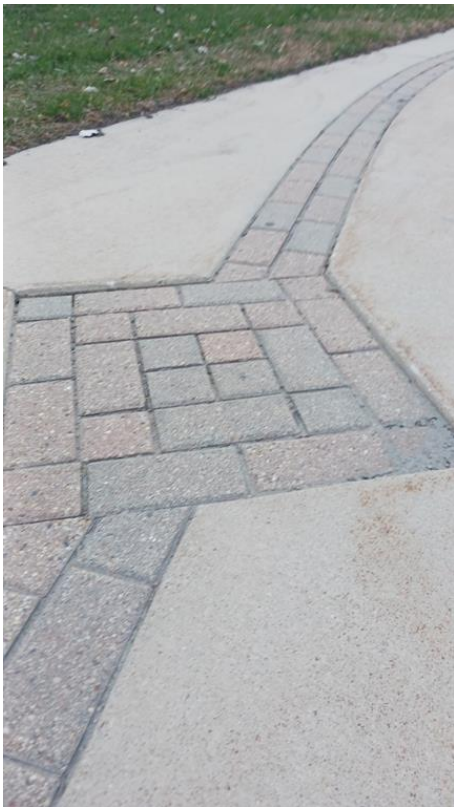
Another common deficiency is vertical displacement of greater than one-quarter inch. This typically occurs at the paver/PCC interface as pavers appear to have settled relative to the adjacent PCC. Portions of the curvilinear paver band are lower than the adjacent PCC, the decorative diamonds are commonly lower than adjacent surfacing, and curb ramp pavers have settled around the perimeter of the intersection. The vertical offset is commonly 0.5" plus. There are multiple PCC panels throughout the project area that have vertically shifted as well.

Paver settling, greater than 0.25"

Pavers were an important component of the 2005 project and add to the aesthetic value of the downtown area. They looked great for the first years after construction. Now, the pavers are settling and causing trip hazards with vertical displacement over 0.25" being very common throughout the downtown area. The original plans indicated a PCC base with sand setting bed between the PCC base and paver. In theory, this creates a stable base that will keep pavers from settling or moving. In reality, the pavers have moved. Removal/replacement of sidewalk sections for recent utility repairs have shown that some portions of the paver band have a PCC base but others do not. Portions without the PCC base can be expected to settle and shift. Portions with the PCC base should only show paver settling if the sand setting bed has worked its way out of the pavers, through joints. This is not expected but may be taking place. Additionally, it appears PCC sections on either side of the pavers are shifting in many locations. In general, pavers adjacent to PCC slabs for streets and sidewalks are hard to keep elevation matched over time. The frost action we see in our climate tends to cause displacement. The pavers can be removed, the base corrected, and the pavers replaced. This would not correct the cross slopes greater than 2% and would likely address the vertical offset for a few years but not long term.

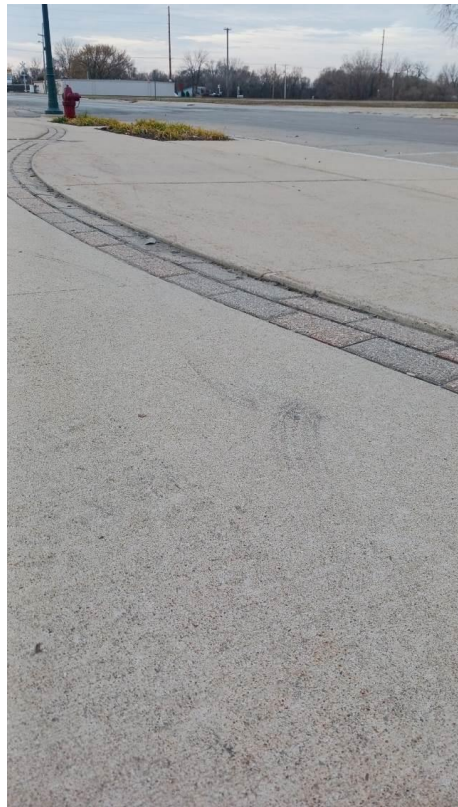
Pavement settling along paver band

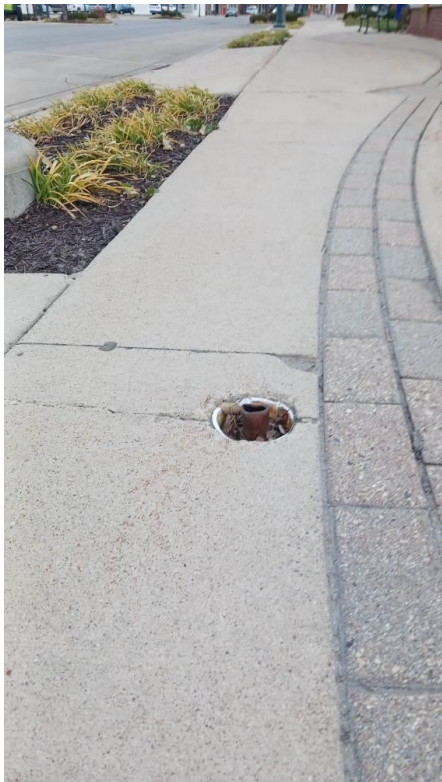
Curb stop boxes for water services were typically sleeved when the 2005 PCC sidewalk was constructed. Many of the boxes are either lower or higher than the adjacent surface. Those higher are likely pushed up by frost and then do not lower on their own. All of these can be a tripping or falling hazard. Any holes within the sidewalk should be 0.5" or less in size. Many curb stops are missing the curb box lid, which leaves a hole in the sidewalk of 4"+/- diameter.

Curb stop box protruding with opening around box

Curb stop boxes are recommended to be placed within a standard valve box riser (poured into the PCC) with standard valve box lid. This eliminates the box being above or below sidewalk elevation and open holes around the boxout. These are easily added during construction and provide great long-term protected access.

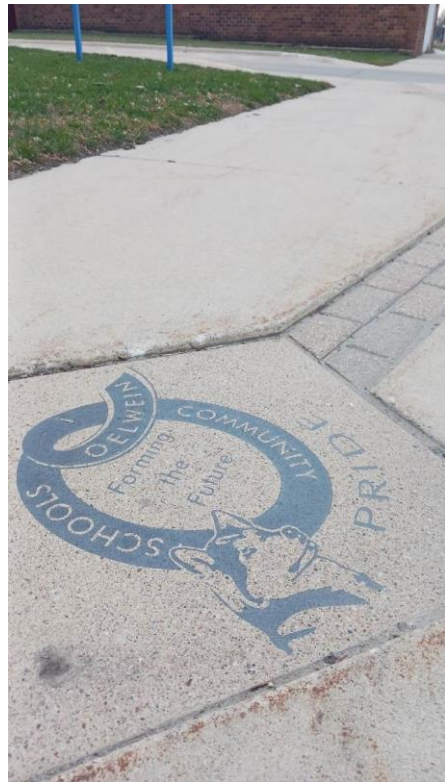
Paver and diamond settling, greater than 0.25"

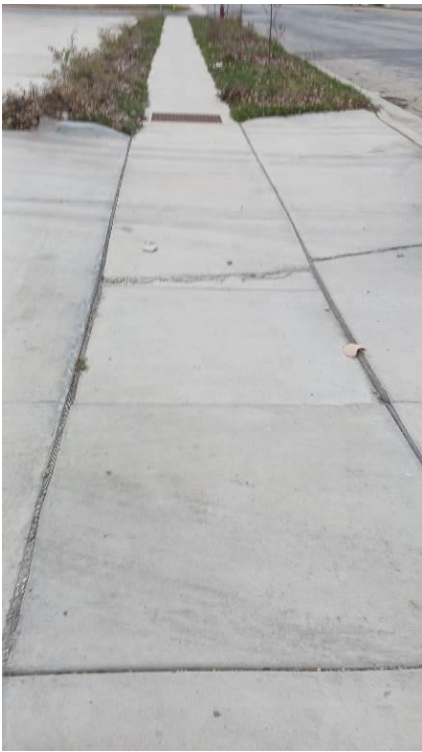
Some PCC panels are cracked, but not more than would be expected for the age of the PCC. Older sections commonly have more cracks than the 2005 sections. The cracks are problematic only when vertically separated – otherwise, they are just a visual deficiency. Currently, there is significant

Crack with vertical displacement

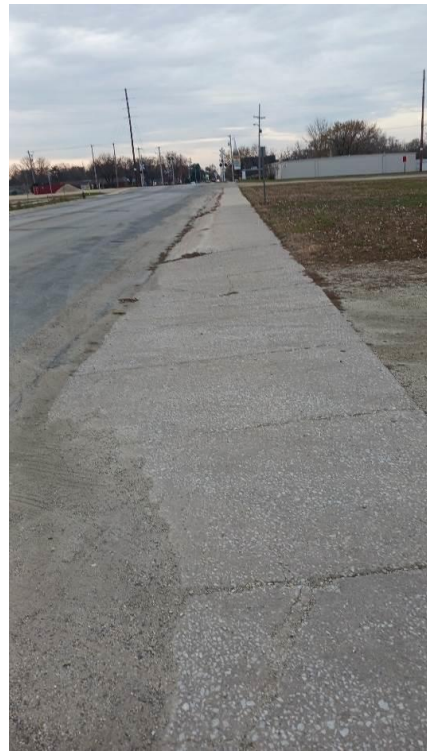
The majority of sidewalks within the project area have a cross slope greater than 2%. While portions of the cross section can be greater than 2%, there should be a minimum 3' (recommended 5') wide section that is continual in the running direction of the sidewalk that has 2% or less cross slope to meet Americans with Disabilities Act accessibility requirements. Most sidewalk portions were constructed with a straight grade from the building to the curb, without the 'flatter' section at 2% or less. Cross slopes were field checked with a digital level. Cross slopes are commonly between 2% and 3%, clearly over the 2% maximum, with several areas exceeding 3%. The 2005 project plans indicate the new sidewalk cross slope to be 2% +/-, indicating that slopes over 2% were expected with the project. Older sidewalk sections typically have portions greater than 2% cross slope. A section of new (fall 2023) sidewalk was also found to have a cross slope greater than 2% due to constructing with a uniform cross slope. The only appreciable section without deficiency is that adjacent to the south side of the event center parking lot.

Cross slope greater than 2%

A continual accessible pedestrian path of minimum 3' width at 2% or less cross slope will be best achieved by replacement of the existing sidewalk. Creating this path will minimally require the majority of the PCC cross-section to be replaced. Leaving the remainder after the 1.5% portion does not make sense from a visual perspective and would cause three cross slopes per cross section vs two if fully reconstructed. The typical design strategy for sidewalks in a downtown setting where the sidewalk must meet the existing building and the existing curb is to create a minimum 5' wide section with a cross slope of 1.5%, commonly at the building side of the sidewalk. The remaining sidewalk section would match the curb height and be at a variable slope, allowed to be greater than 2%. The replacement could come in a variety of options. Pavers could be a portion of the project but would have the same ongoing issues as currently exist and will have additional maintenance. Using standard PCC for the sidewalks will provide the longest-lasting and lowest maintenance surface. There are options to upgrade PCC aesthetics with the common ones being integral coloring (colored throughout the PCC thickness), stamping, and joint treatment, such as tooled joints.

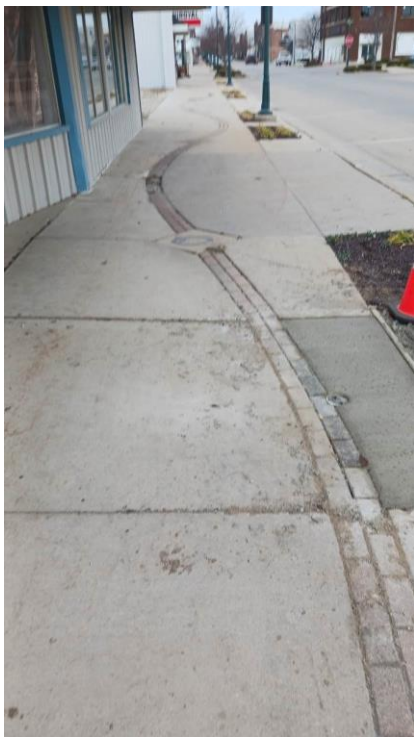
A few portions of sidewalk show settling, which leads to a low point within the sidewalk that does not drain. This ultimately leads to cracking of the PCC and quick deterioration along with icing in the winter months. Causes may be from inadequate compaction of utility trenches or coal vaults or general lack of compaction.

Settling of sidewalk creating a low point without drainage

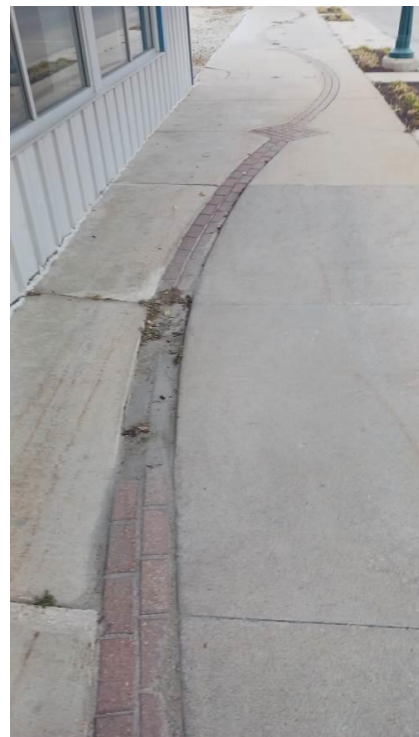
Paver band setting greater than 0.25

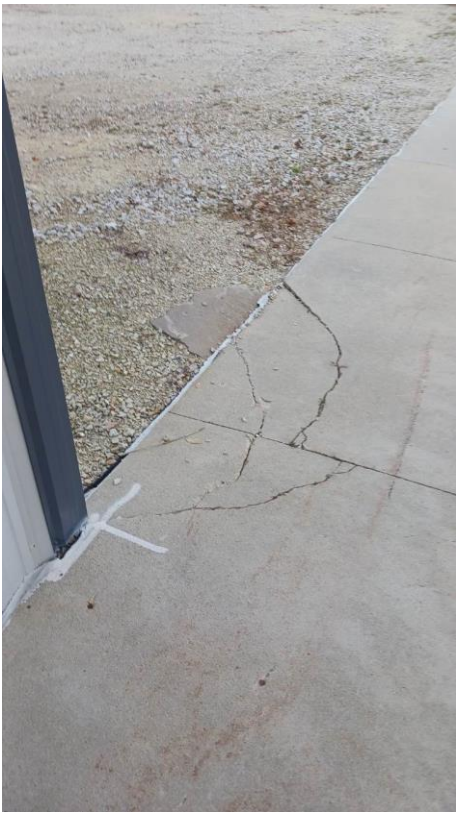
Severely broken PCC

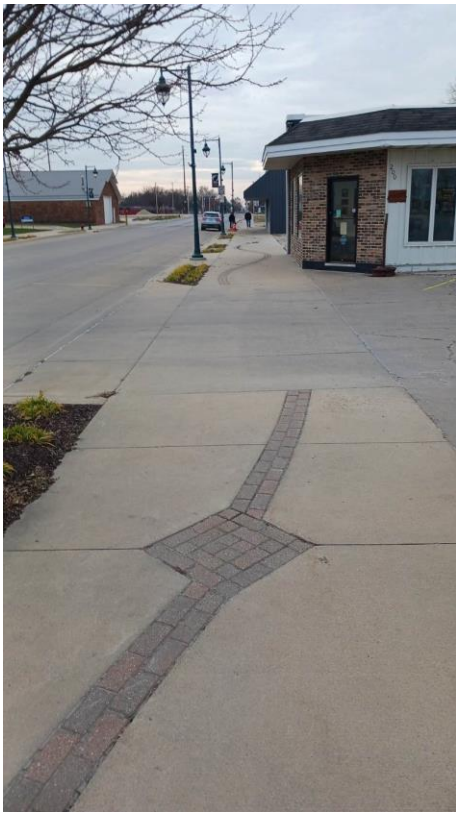
Paver settling greater than 0.25"

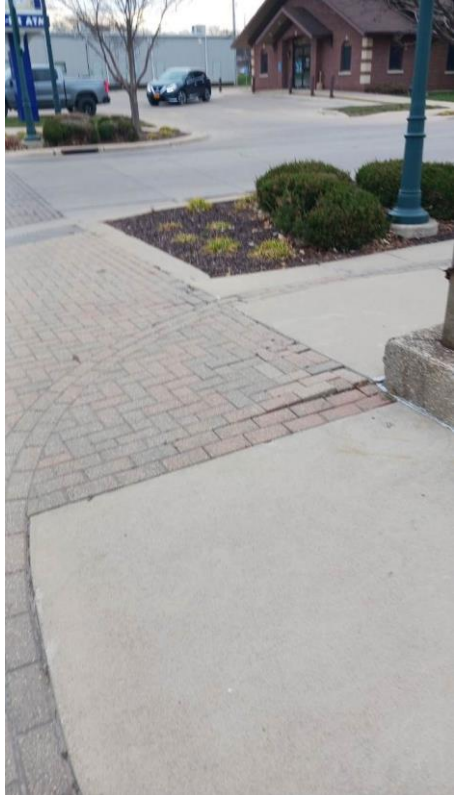
Heaving pavers with vertical displacement greater than 0.25"

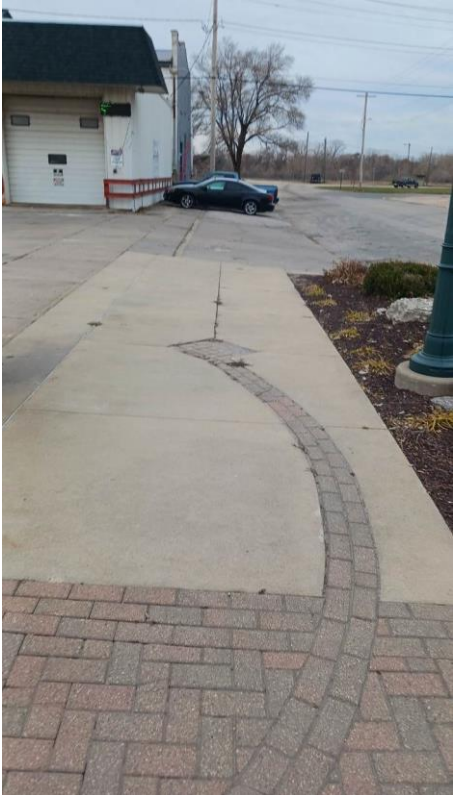
Cross slope greater than 0.25"

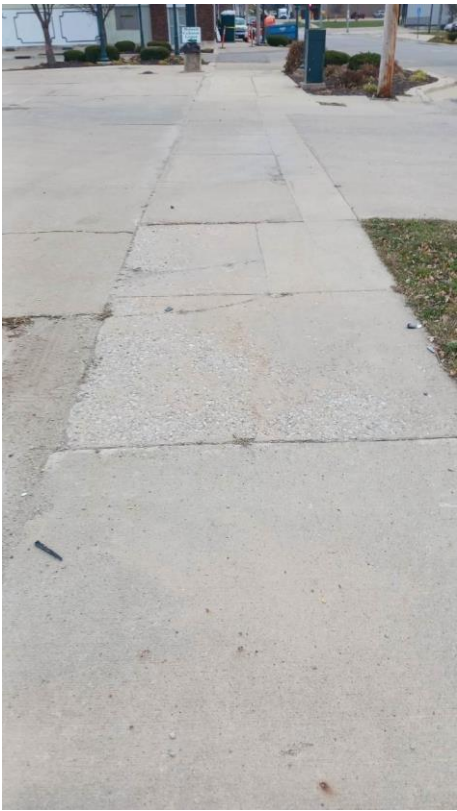
PCC displacement greater than 0.25"

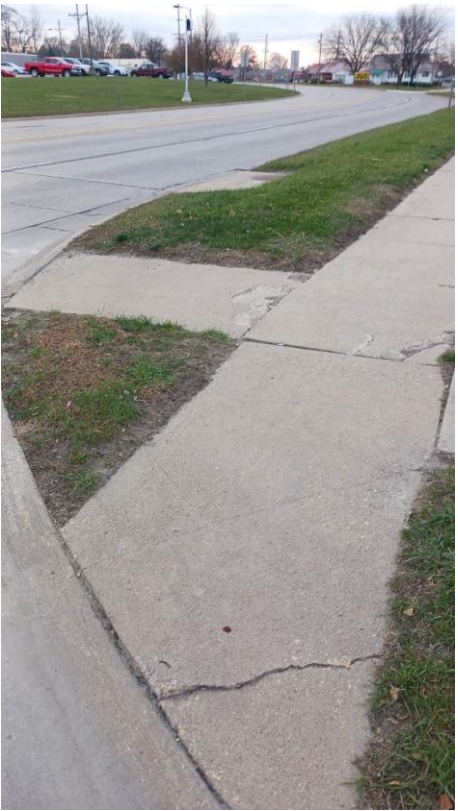
Curb ramps within older sidewalk sections do not meet current requirements of curb height (0.5"), do not have detectable warning panels, or have excessive slope. There are few curb ramps within the project area that would be considered fully compliant.

Non-compliant pedestrian ramp

Detectable warning panels, required at pedestrian curb ramps, are recommended to be heavy-duty cast iron, placed into the PCC sidewalk. This material is virtually indestructible and will not settle or move like paver panels.

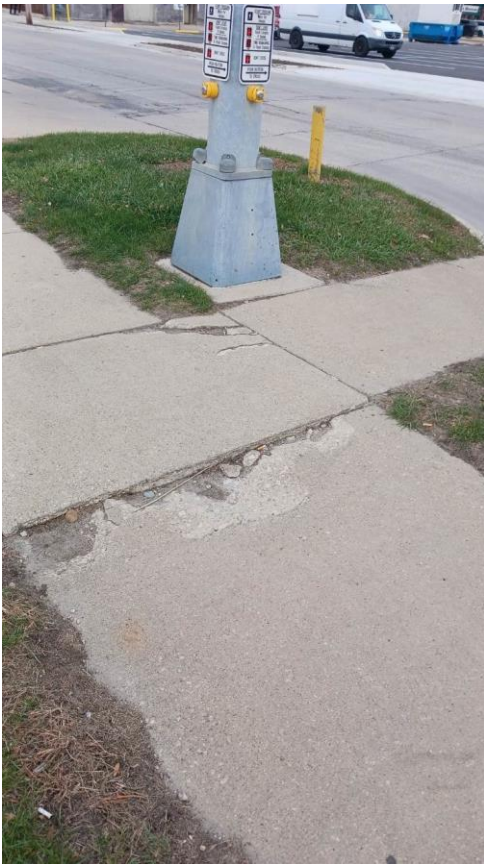
Broken/missing PCC with vertical displacement greater than 0.25"

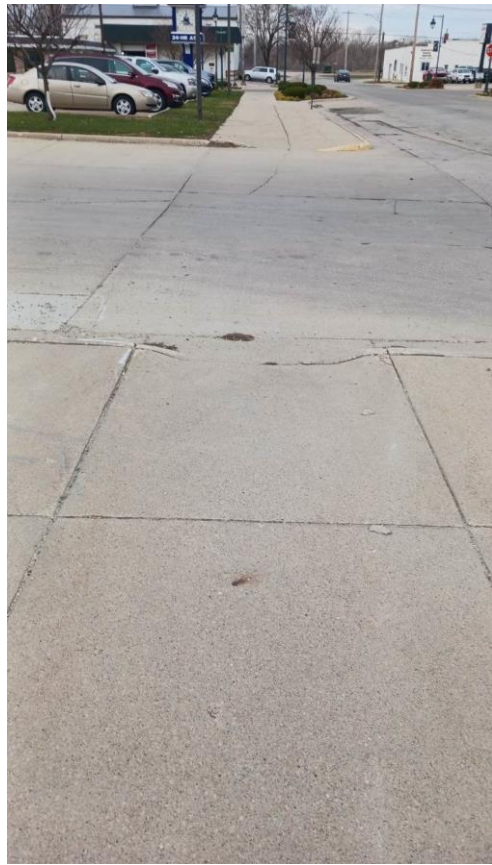
Non-compliant pedestrian ramp

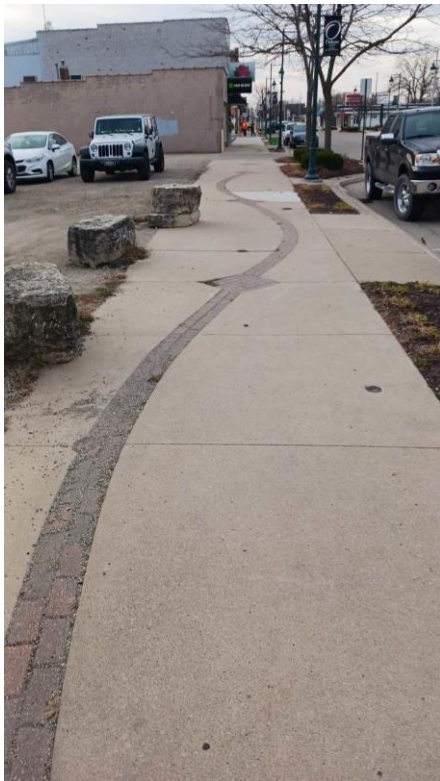
Paver band and diamond settling

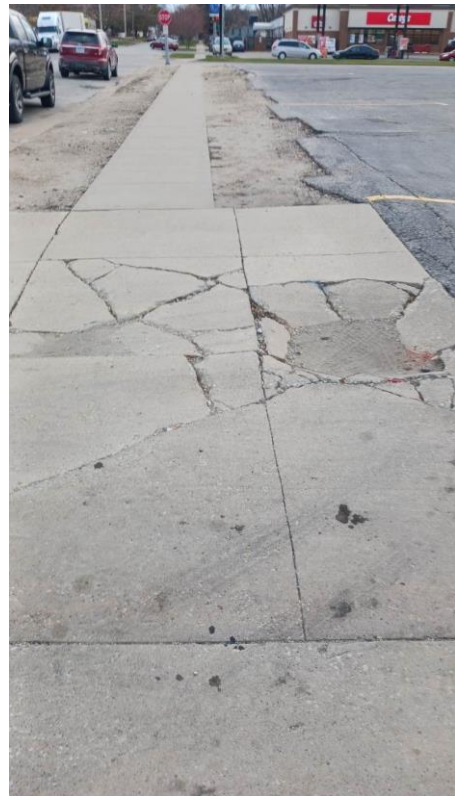
Severely broken PCC

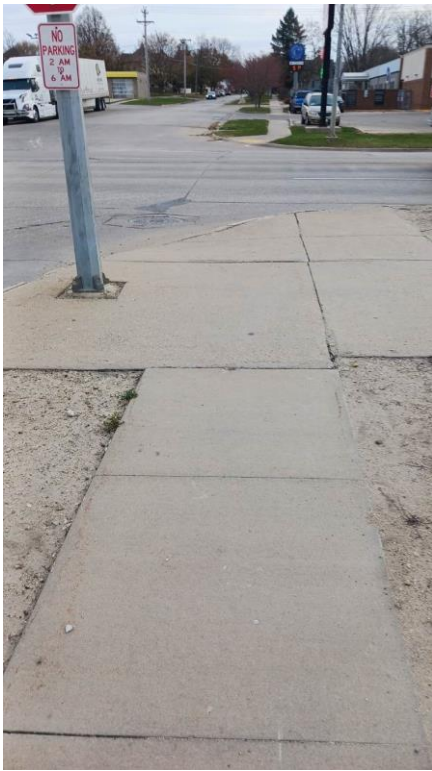
Non-compliant curb ramp

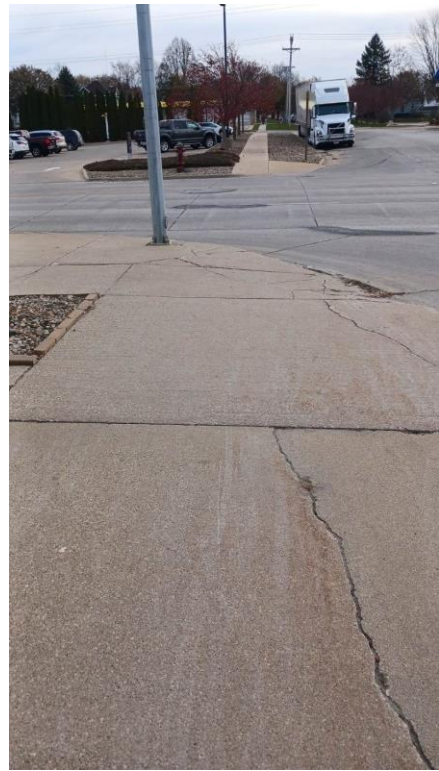
Non-compliant curb ramp

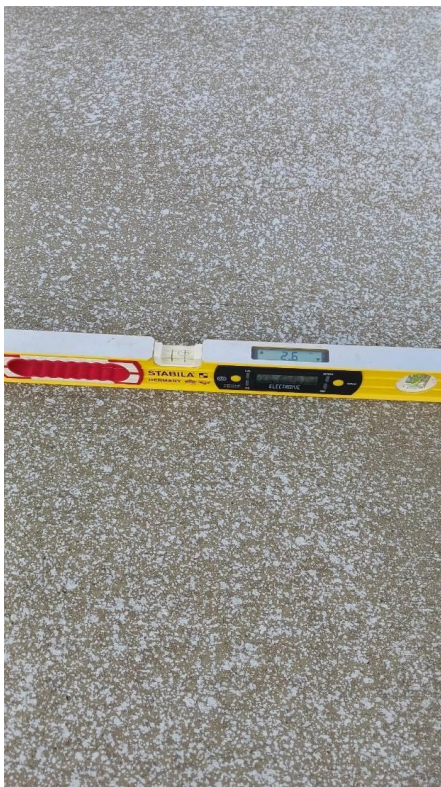
Cross slope greater than 2%

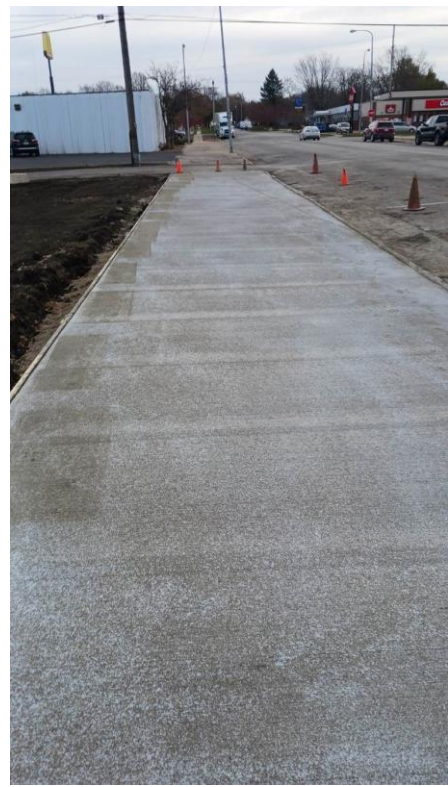
New sidewalk with greater than 2% cross slope

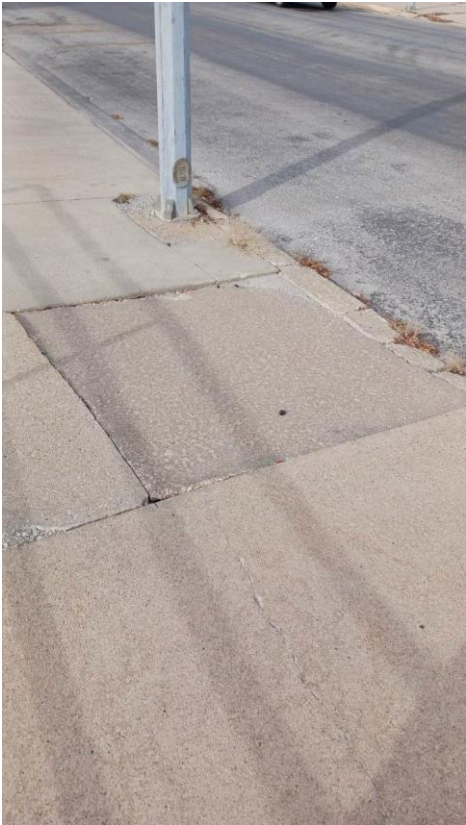
Settled PCC panel

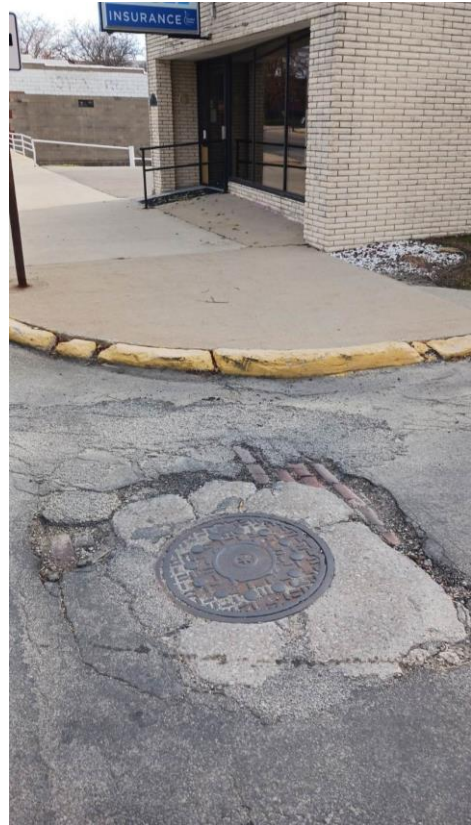
Non-compliant curb ramp

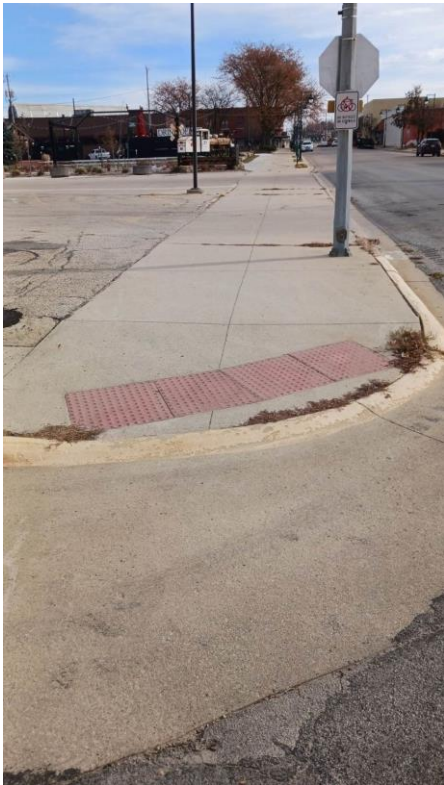
Curb height greater than 0.5"

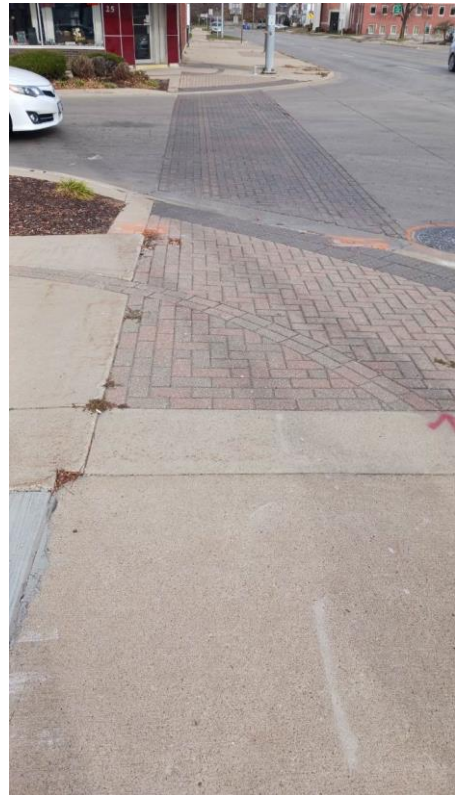
Curb ramps within the 2005 project area, aside from the significant vertical offsets mentioned above, meet slope requirements. The detectable warning pavers have settled relative to the curb in many locations, leading to a vertical offset greater than 0.25". Detectable warning paver movement is a common issue when used as their location sees occasional vehicle turning traffic, which tends to cause movement.

Settled pavers around curb ramp perimeter

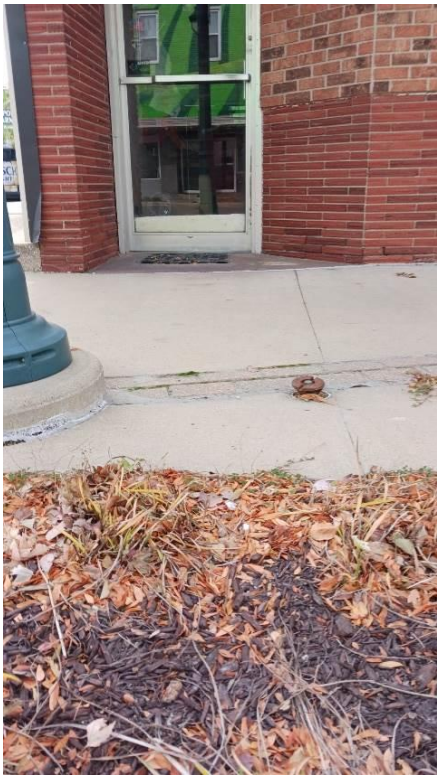
Protruding curb stop

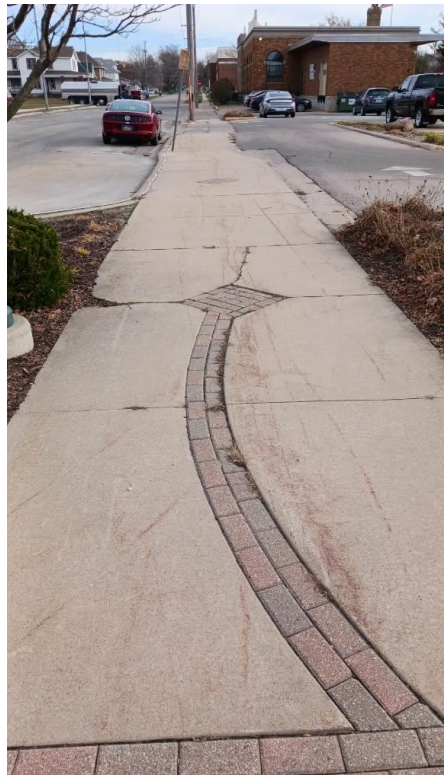
Paver and diamond settling

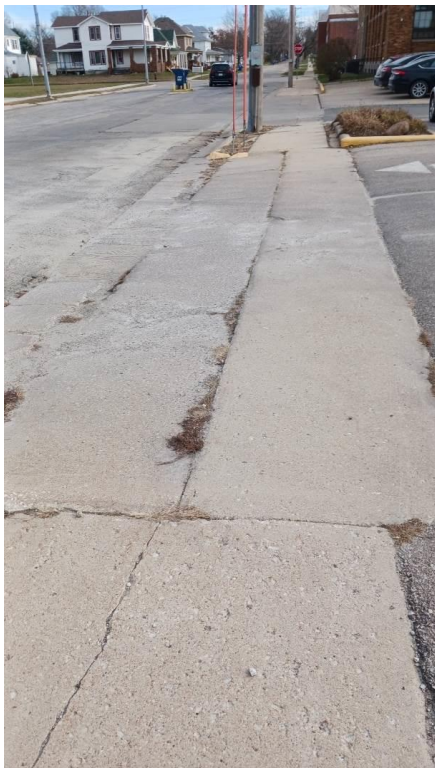
Panel displacement

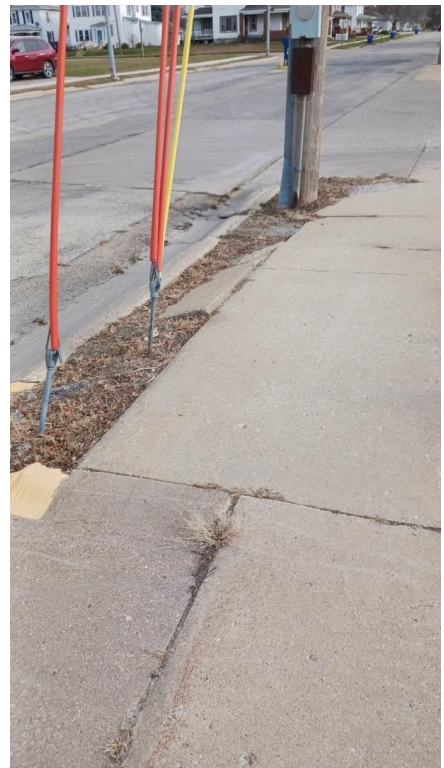
'Curb' within pedestrian walkway

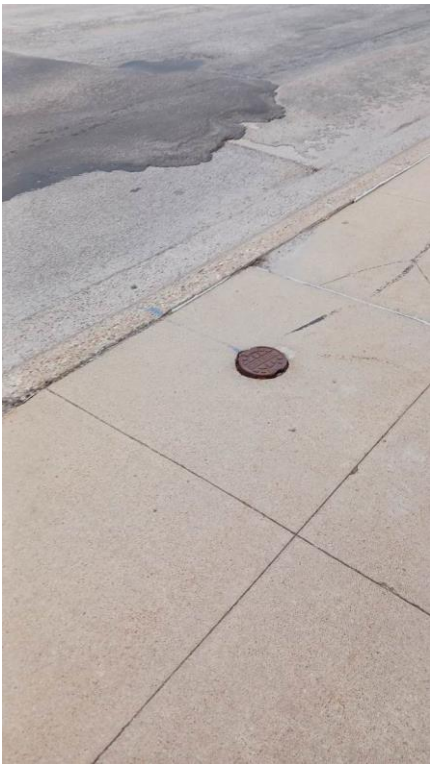
Protruding water valve

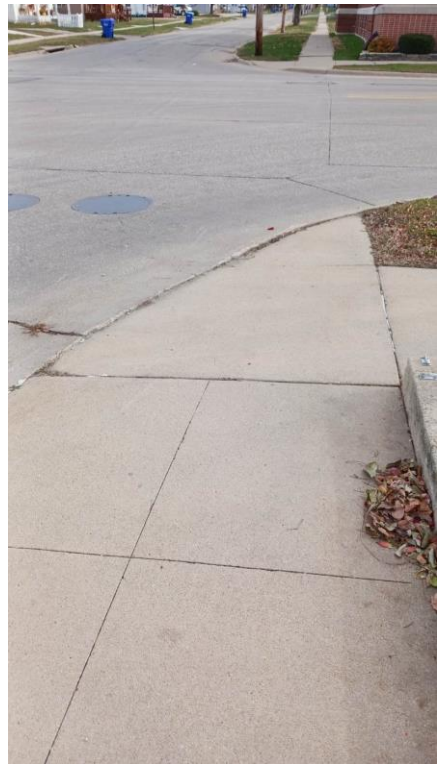
Non-complaint pedestrian curb ramp

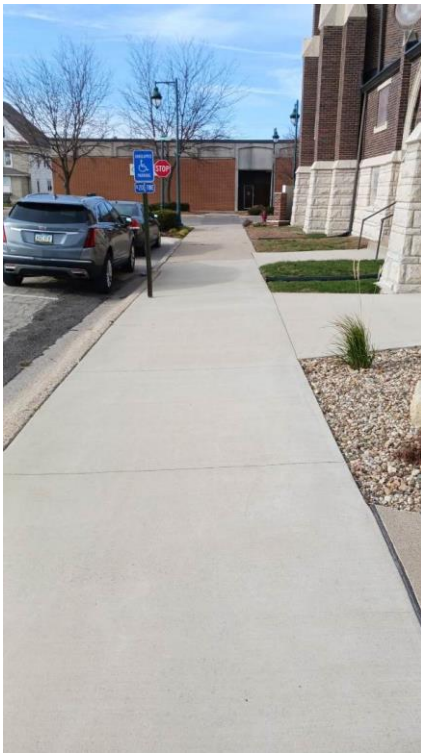
Cross slope in excess of 2%

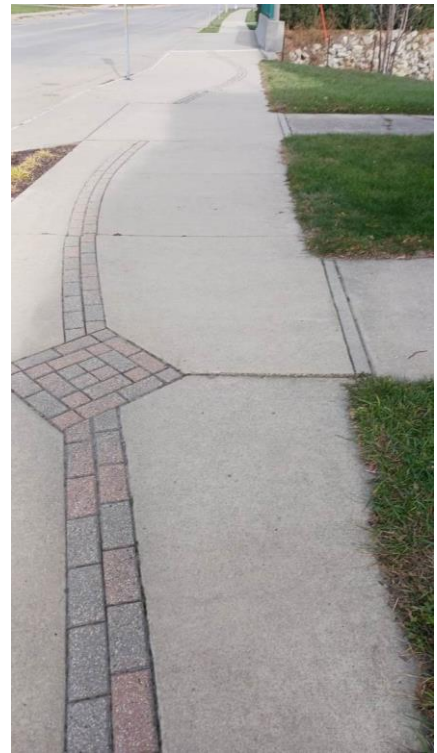
PCC displacement across paver band

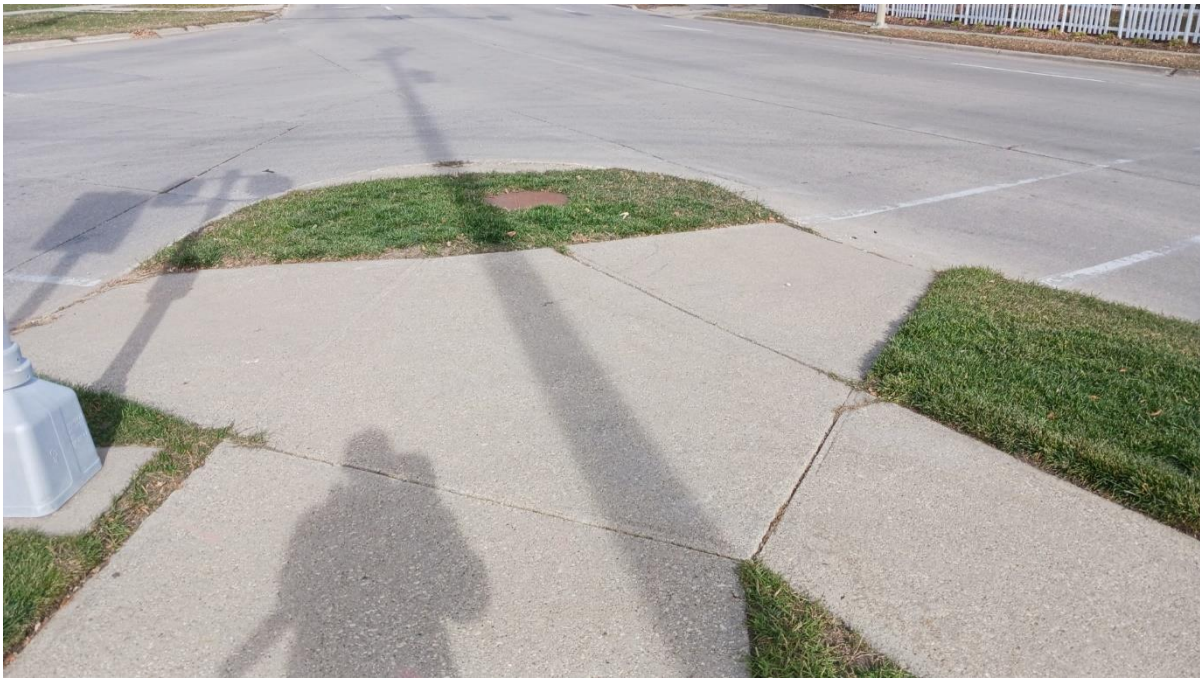
Non-compliant pedestrian curb ramp

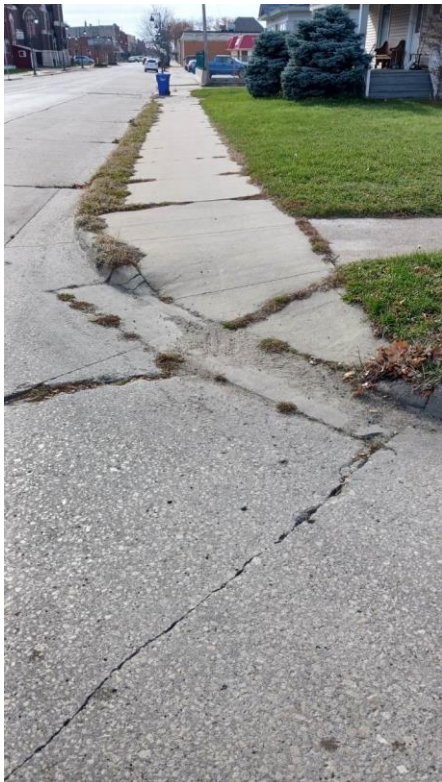
Non-compliant pedestrian curb ramp

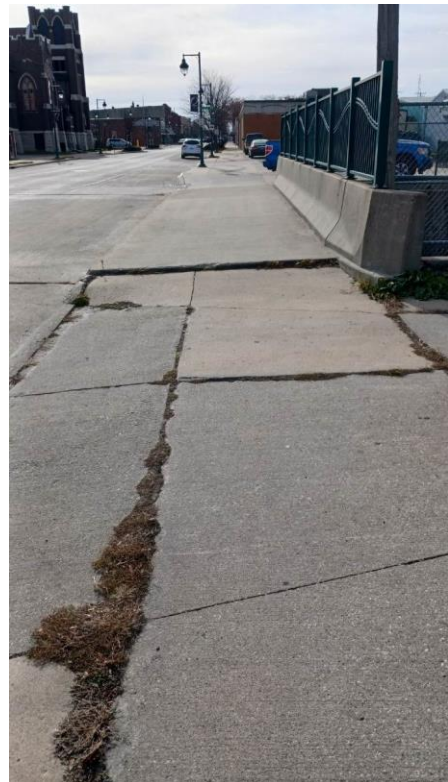
Vertical PCC displacement greater than 0.25" and cross slope greater than 2%

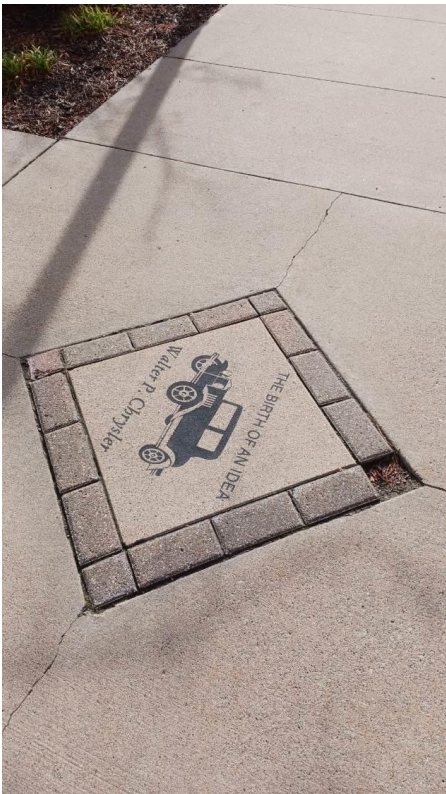
Missing paver causing trip hazard

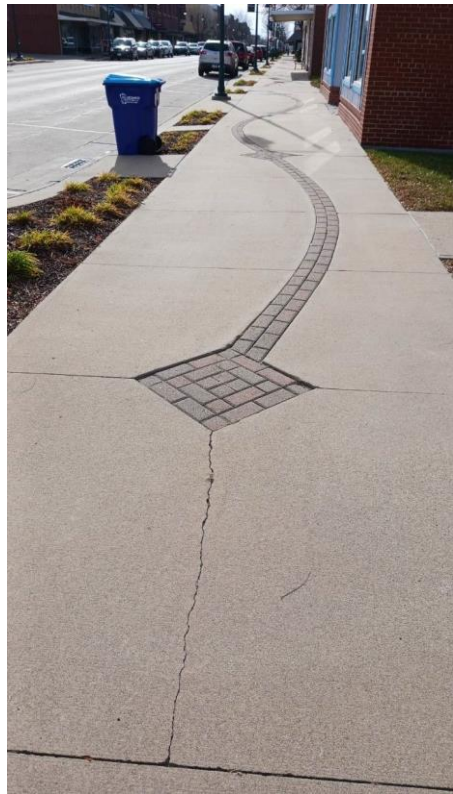
Settled pavers and diamond along with crack from end of diamond

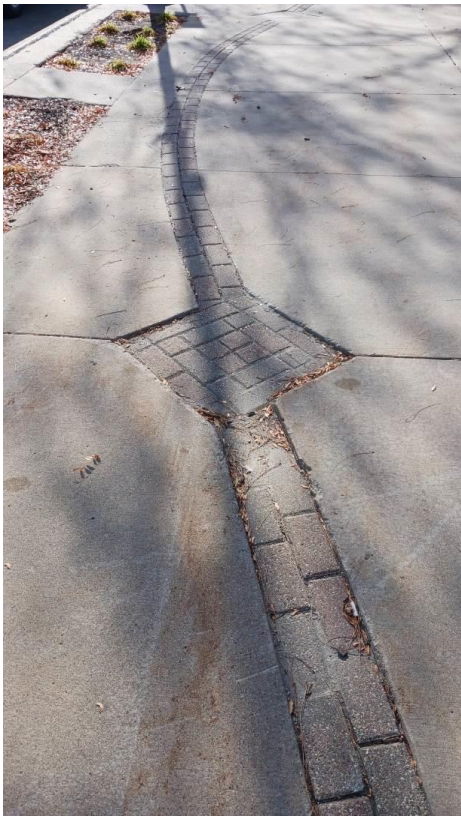
Settled pavers and diamond

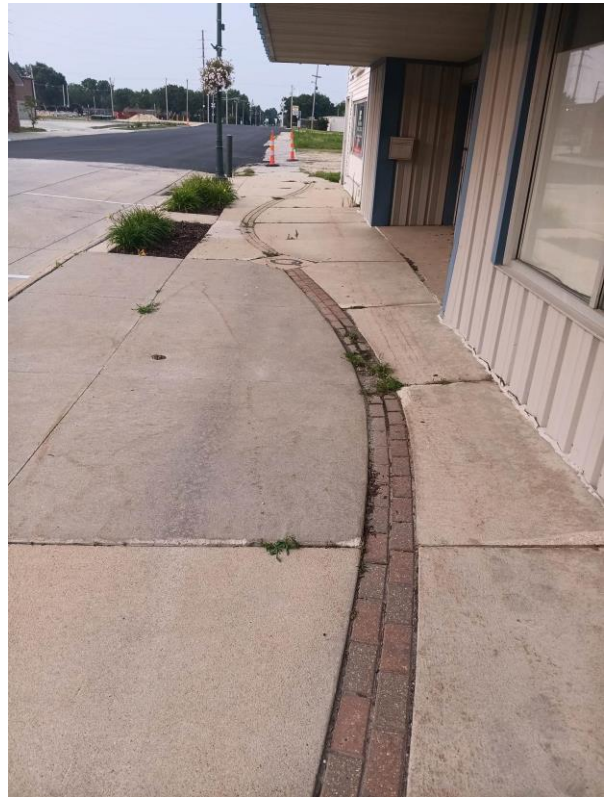
vegetation growing in joints between pavers as well as some PCC joints throughout the project area. This is caused by organic debris settling in the joints. It takes very little organic material for vegetation to grow, especially when there are frequent rain events as we have had this spring and summer. This makes the area look very rough and can promote further joint deterioration.

Vegetation in joints

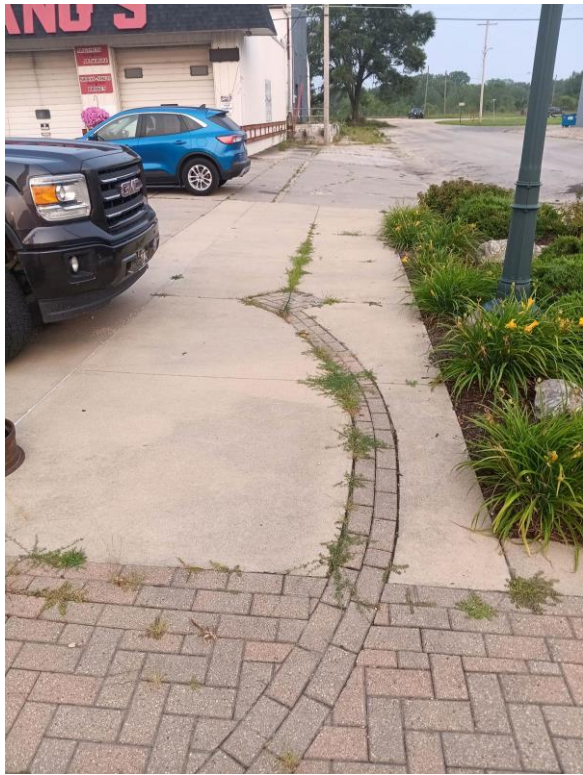
Vegetation in joints
