## PEDESTRIAN AND BICYCLE ADVISORY COMMITTEE MEETING AMENDED AGENDA

May 08, 2025 at 11:30 AM

# DIVISION AVE. RSA • ANNUAL AVERAGE DAILY TRAFFIC (AADT)

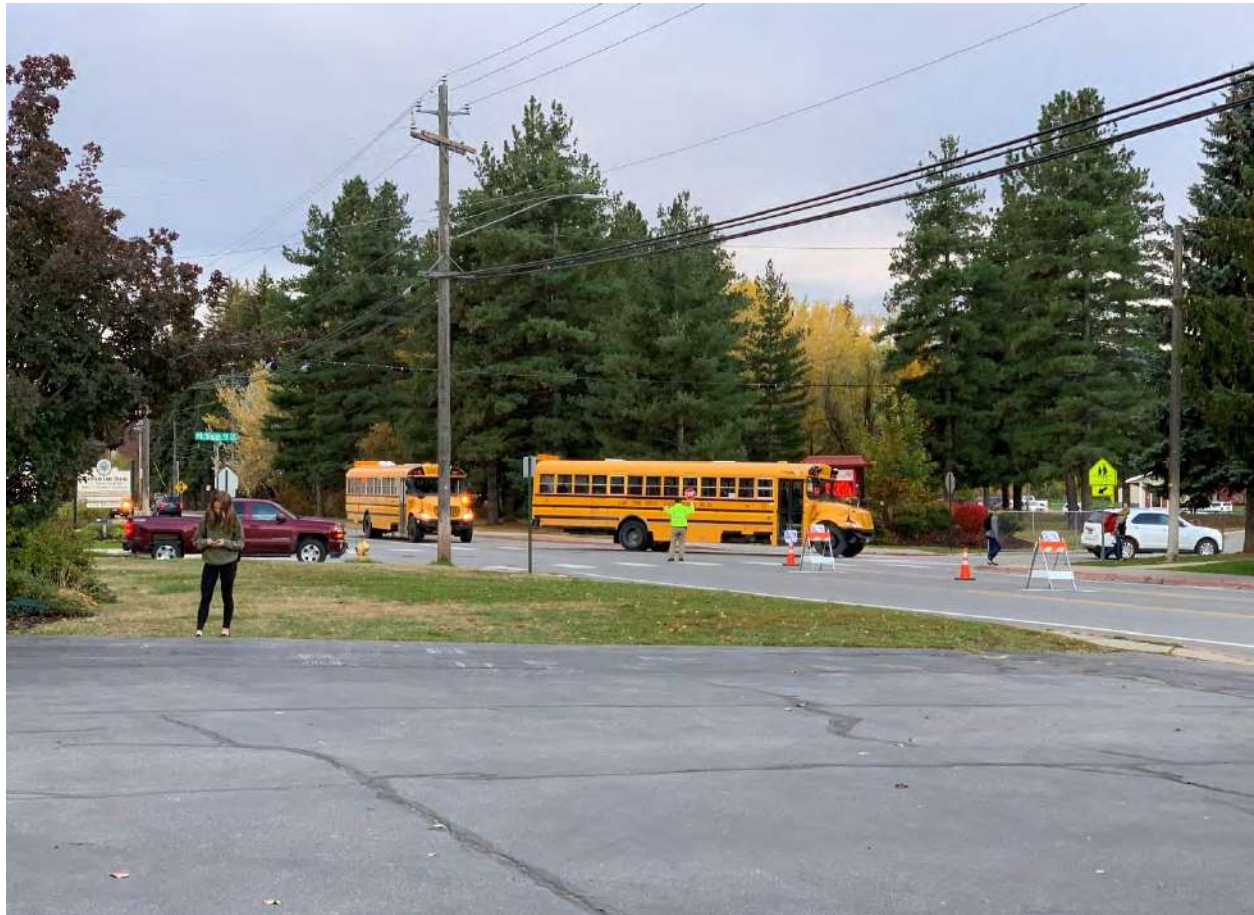
Observation 1: Significant traffic peaks at school start and end times (Photo: Fehr & Peers).

Traffic was observed to exhibit significant peaking characteristics at school start & end times. The City has made incremental improvements to this area to improve safety and address citizen complaints.

During the school start peak period, a trained crossing guard closes the southbound left turn lane on Division Avenue and directs traffic at Michigan Street. The crossing guard was observed to be effective in managing both vehicle and pedestrian traffic to reduce pedestrian/vehicle conflicts during the AM peak.

No additional traffic or pedestrian control was observed during the school closing peak.

Due to the effectiveness of the crossing guard during the school opening peak period, the City is recommended to coordinate with the school district to implement a similar crossing guard in the school closing peak to provide additional protection to pedestrians and reduce pedestrian/vehicle conflicts.

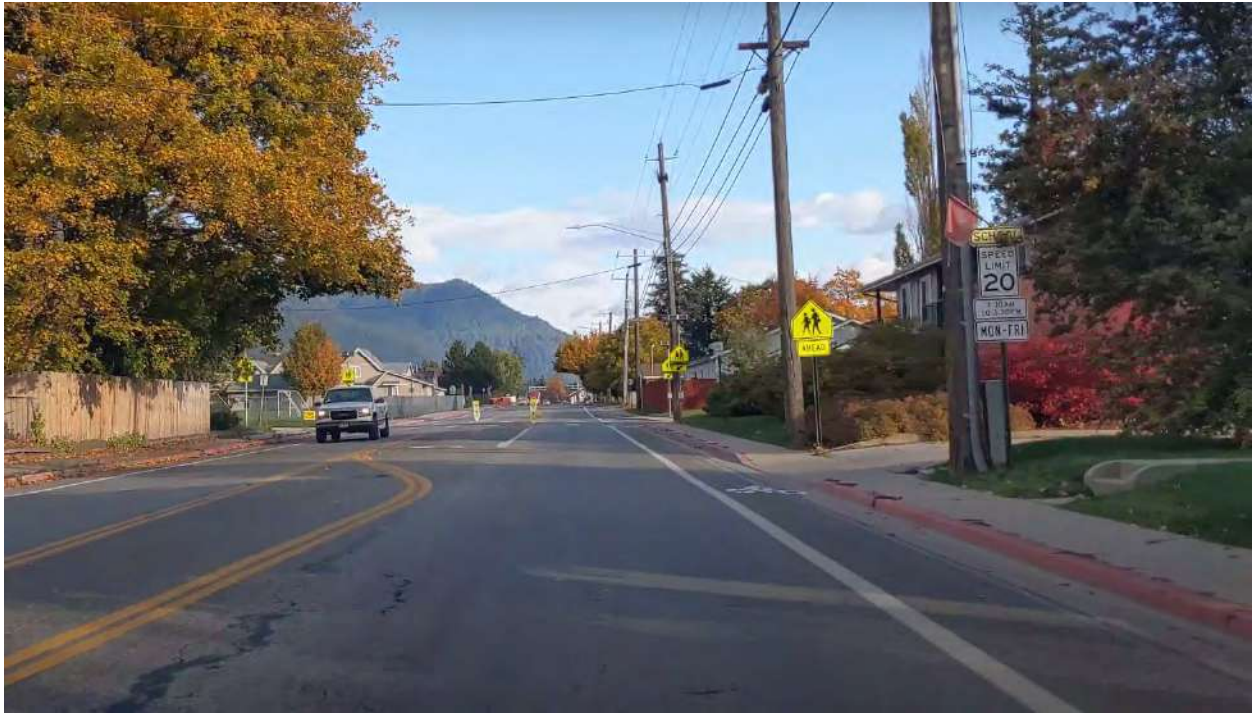
Observation 4: School zone signs posted for 20mph with low compliance (Photo: Fehr & Peers).

The RSA team observed that school zone signs along Division were posted to reduce the speed limit to 20mph. The speed limit along the rest of Division Avenue is 25mph, so the school zone only reduces the speed limit by 5mph. Furthermore, the school zone speed limit is active from 7:30 AM to 3:30 PM, even during periods when the school is not starting or ending. The law enforcement representative on the RSA team noted that the minor reduction in speed limit and broad time that the school speed limit is in effect has resulted in low compliance, but the increased police presence has helped.

### **Recommendation 4: Increase School Zone Sign Visibility, Limit Restrict Time Active**

The school zone speed limit is 20mph (5mph lower than the normal speed limit on Division Avenue) and active from 7:30 AM to 3:30 PM. To increase compliance with the school zone speed limit, the RSA team

recommends adding flashing lights to the school zone speed reduction signs (see **Figure 7** for example); the flashing lights should be either automatically scheduled, or manually activated by a crossing guard. The RSA team also recommends that the school zone speed limit reduction should only active during school opening and closing peak periods, when students are likely to be present. If speeds continue to be an issue during the school opening and closing peak period, then reducing the school zone speed limit to 15mph (10mph lower than the normal speed limit) would be appropriate. Police presence to enforce the speeds should continue to be a priority.

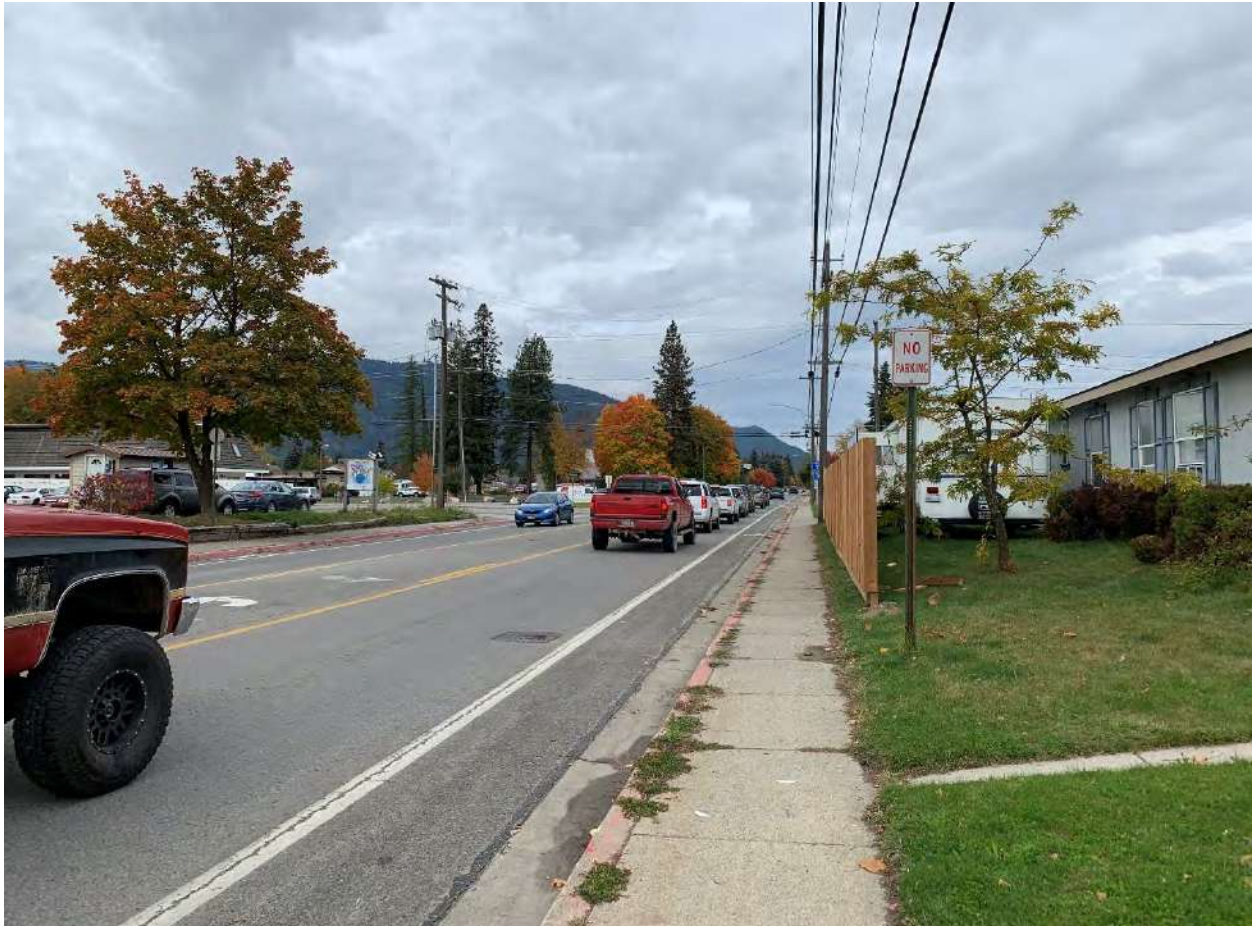
Observation 5: Long northbound queues at Division Avenue & Pine Street during school closing peak (Photo: Fehr & Peers).

Northbound left-turning vehicles were observed driving along the two-way left-turn lane along Division Avenue far in advance of the intersection at Pine Street to illegally get around northbound through/right-turn queue. Law enforcement staff on the RSA team reported that this has caused crashes at this location.

**Recommendation 5: Reconfigure Northbound Approach at Division Avenue & Pine Street**

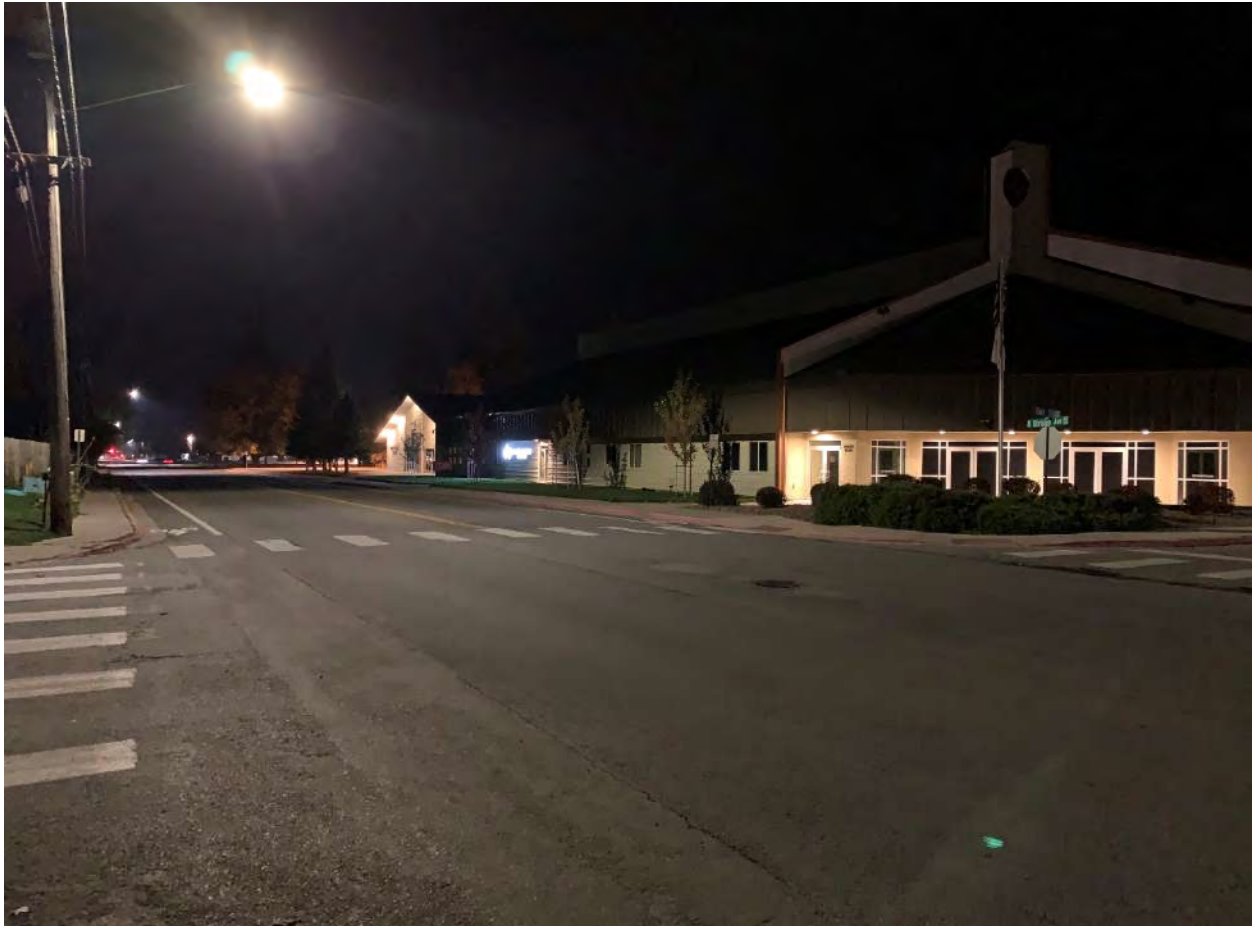
Observation 6: Street lighting observed to be sparse for pedestrians. (Photo: Fehr & Peers).

Division Avenue was not observed to be continuously lit at night. Crosswalks were lit from one corner of each intersection. However, lighting was observed to be sparse in some sections, especially for pedestrians and cyclists on the multi-use path along the west side of Division Avenue.

**Recommendation 6: Perform a Lighting Inventory and Add Lighting as Needed**

Fehr & Peers recommends performing a lighting study to determine where additional lighting is needed along Division Avenue, especially for pedestrians and cyclists on the multi-use path. The study should aim to provide sufficient lighting for the multi-use path, sidewalk, and crosswalks along Division Avenue.

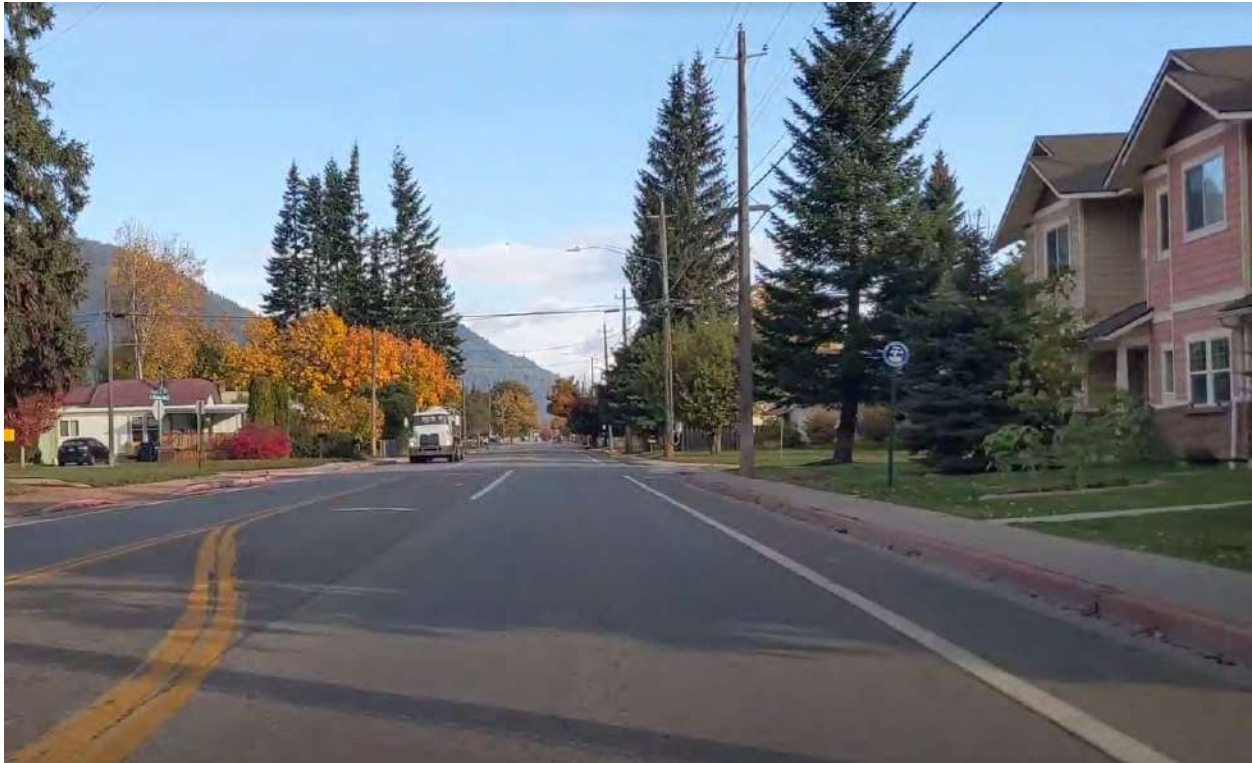
Observation 8: Substandard bus stop (Photo: Fehr & Peers).

The northbound bus stops on Division Avenue were observed to lack pedestrian amenities such as waiting areas, bus shelters and benches.

**Recommendation 10: Provide Bus Benches or Bus Shelters at Bus Stops**

Fehr & Peers recommends providing pedestrian amenities such as concrete waiting areas, benches and/or shelters for transit users. The southbound bus stop near the library between Cedar Street and Oak Street currently provides a bus shelter with a bench that could serve as a template for other bus stops along the corridor. Depending on the location of the bus stop, relocating the bus stop poles may also be necessary to adequately provide space for a bench or shelter.

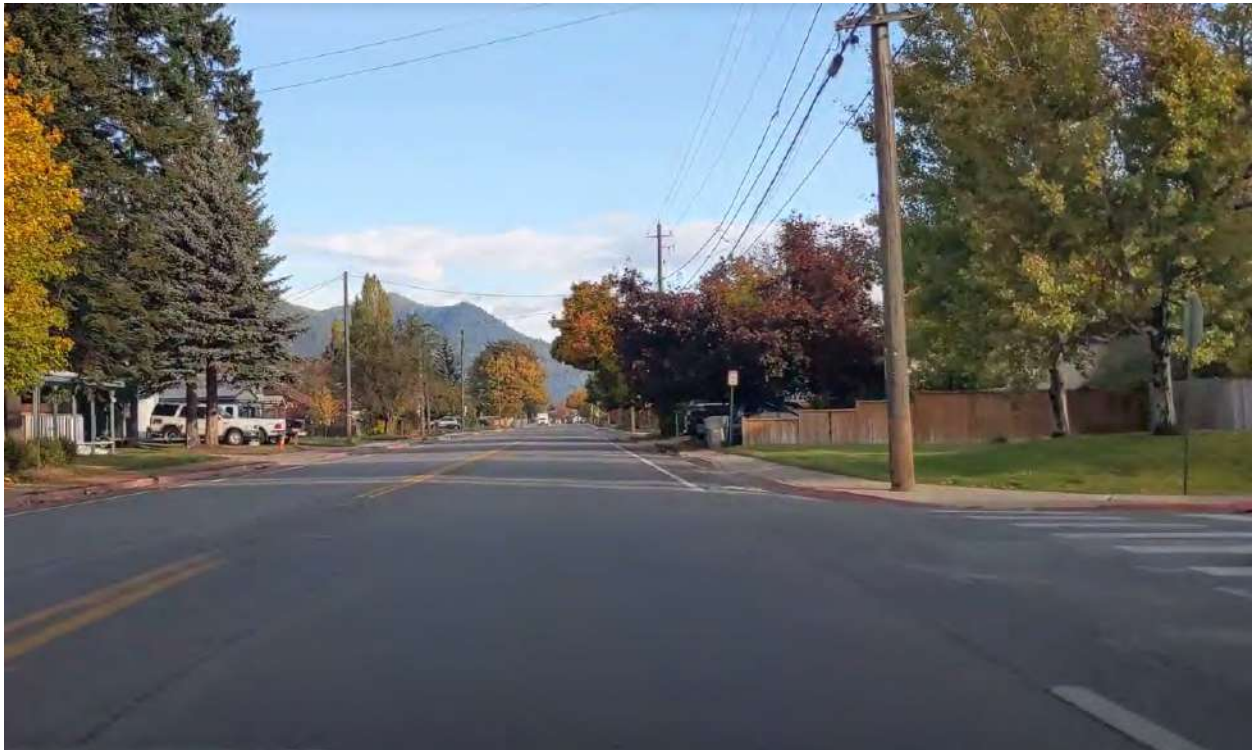
Observation 10: Power pole in the center of sidewalk at Division Avenue & Fir Street (Photo: Fehr & Peers).

As shown in Observation 10, a power pole is placed in the center of the sidewalk on the northeast corner of the intersection at Division Avenue & Fir Street. This pole is obstructing the walkway and is preventing the sidewalk from being ADA compliant. Similarly, a pole obstructs the sidewalk the northeast corner of the intersection at Division Avenue & Larch Street.

**Recommendation 11: Relocate the Power Poles in the Sidewalk at Division Avenue & Fir Street and at Division Avenue & Larch Street**

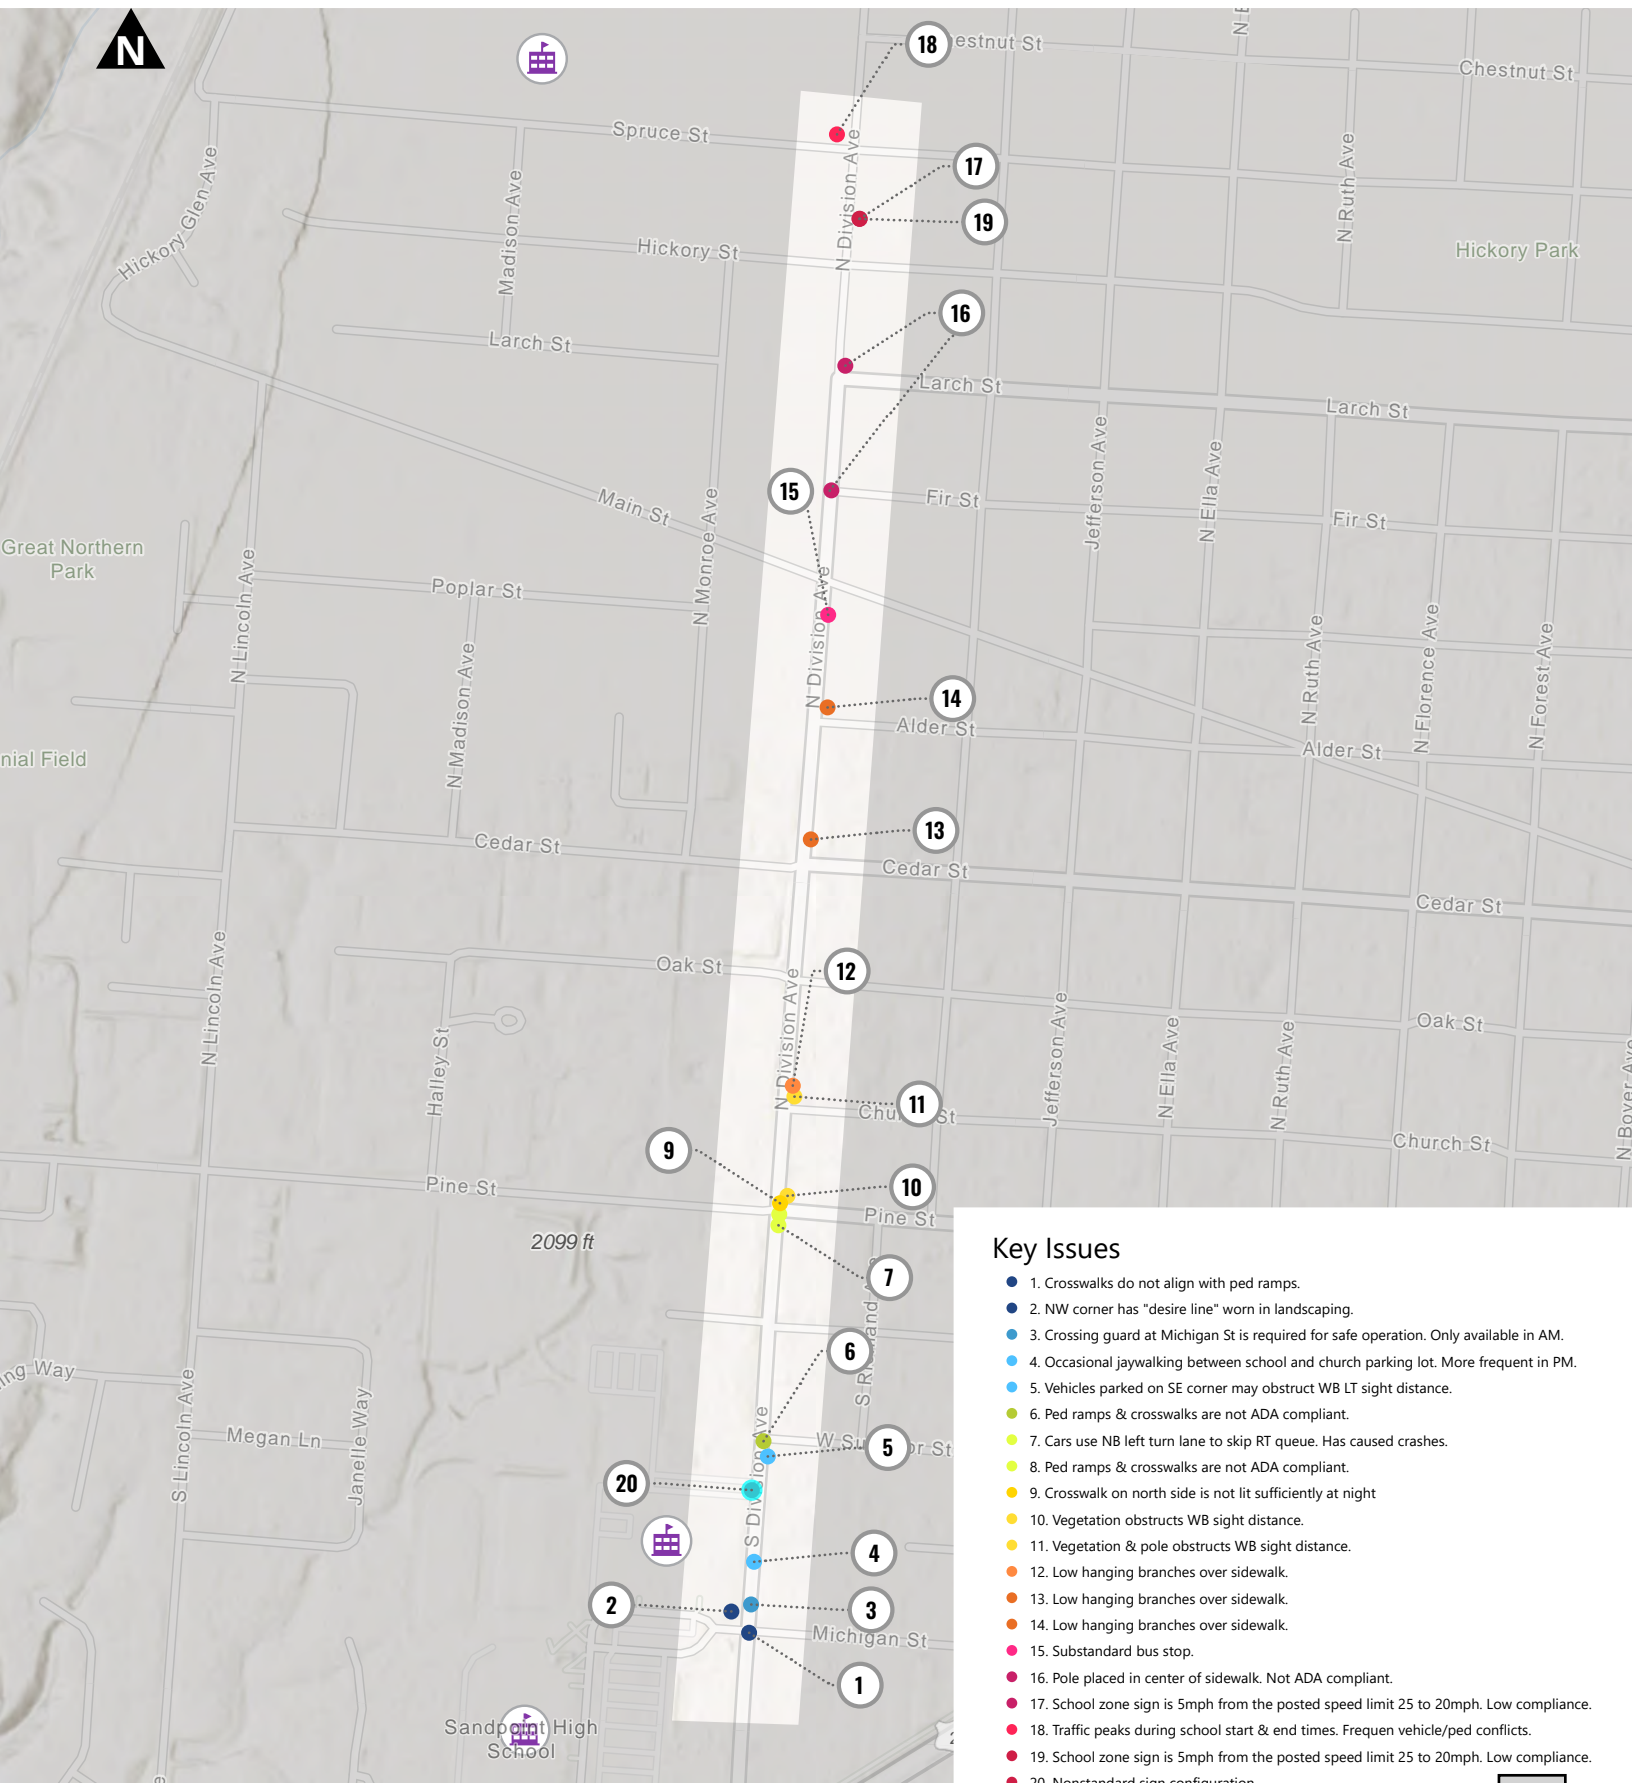
# DIVISION AVE. RSA • KEY ISSUES

- 1. Crosswalks do not align with ped ramps.
- 2. NW corner has "desire line" worn in landscaping.
- 3. Crossing guard at Michigan St is required for safe operation. Only available in AM.

- 6. Ped ramps & crosswalks are not ADA compliant.
- 7. Cars use NB left turn lane to skip RT queue. Has caused crashes.
- 8. Ped ramps & crosswalks are not ADA compliant.
