## **CITY COUNCIL REGULAR MEETING**

**SUBJECT:** Main Drain Condition Assessment

**TECHNICAL MEMORANDUM 3.0R1  
SUMMARY REPORT**

**CITY OF SONORA**  
**MAIN DRAIN FIELD INSPECTION AND CONDITION ASSESSMENT**  
**TECHNICAL MEMORANDUM 3.0R1**  
**SUMMARY REPORT**  
**October 2023**

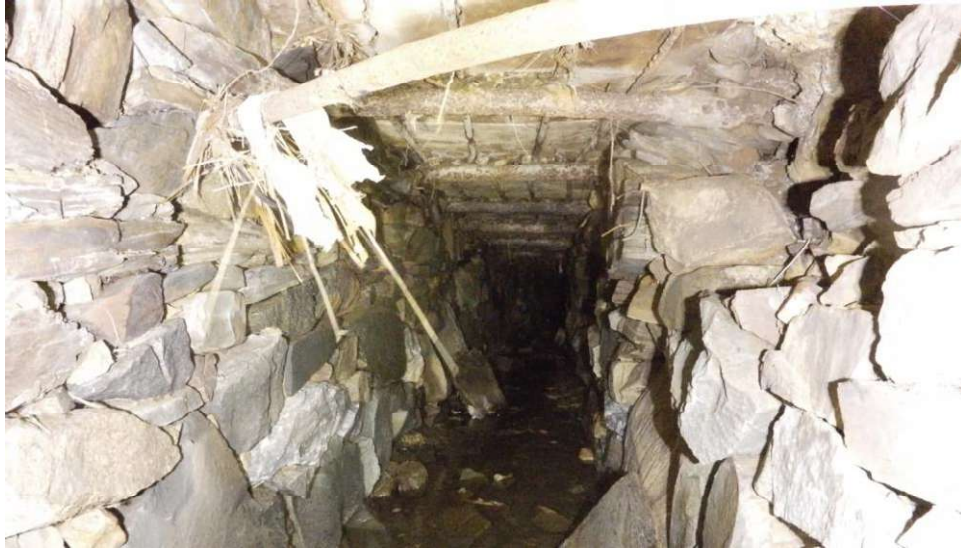
The drone inspection from Entry 1 to Entry 2 was approximately 100 ft long. Pipe crossings and pipe inlets were noted throughout the segment. About 40 ft from Entry 1 and 20 ft from Entry 2 there were minor rock collapsed areas. The collapse is near the top section of the wall and stones were missing.

**Minor rock collapse about 40 ft from Entry 1**

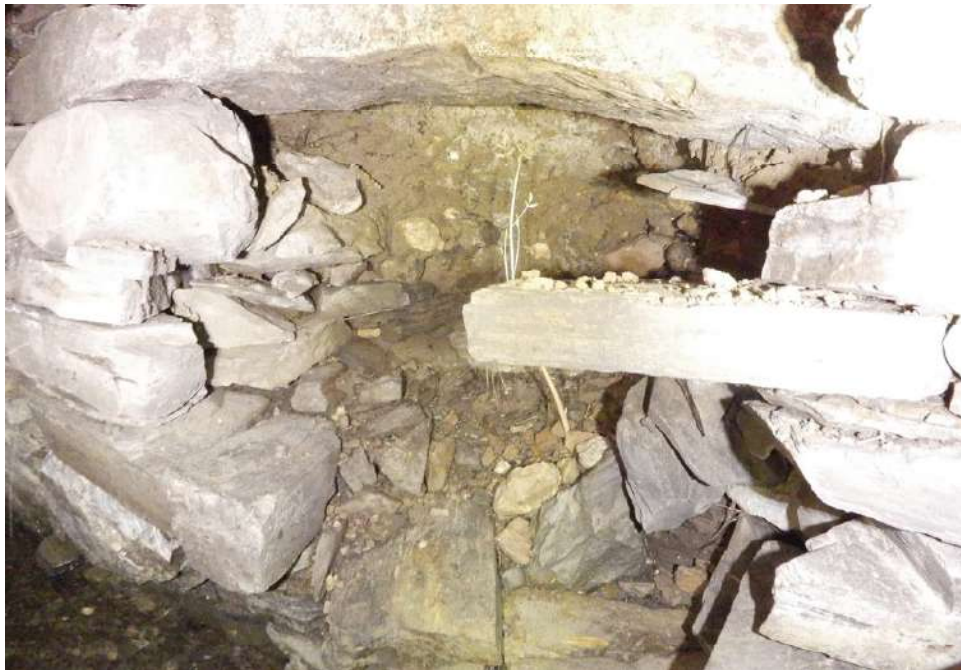
**Minor rock collapse 20 ft from Entry 2**

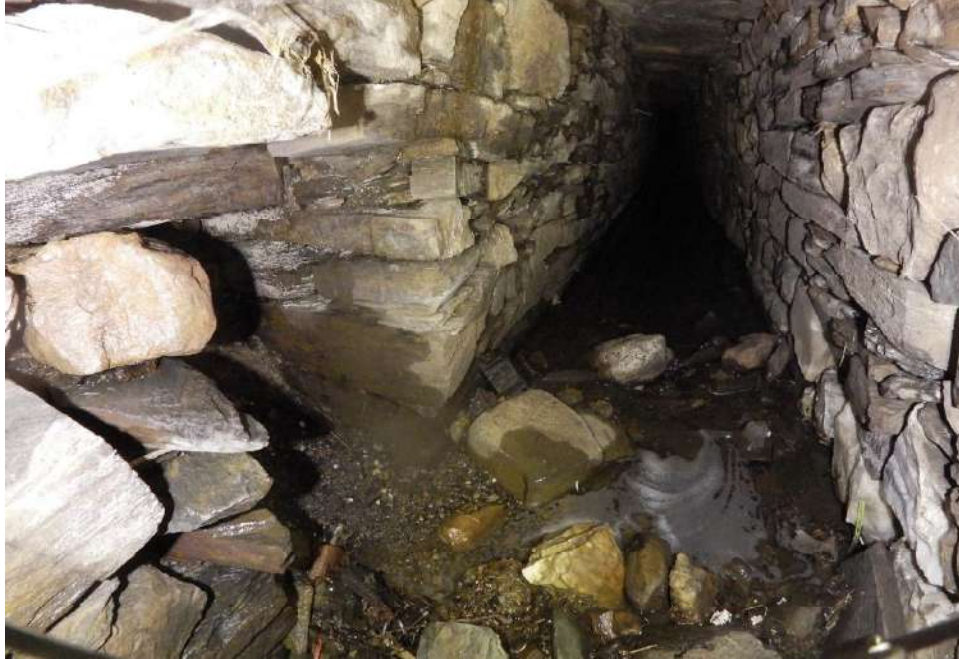
The inspection area from Entry 2 to Entry 3 was approximately 73 ft long. The section included pipe inlets near the ceiling, HDPE pipe connecting to the drainage inlet, and cracks on the stone ceiling. A noteworthy section of the tunnel was the minor rock collapse 65 ft from Entry 3. The collapse was near the bottom half of the wall and segments of stones were missing.

**Minor rock collapse 65 ft from Entry 3**

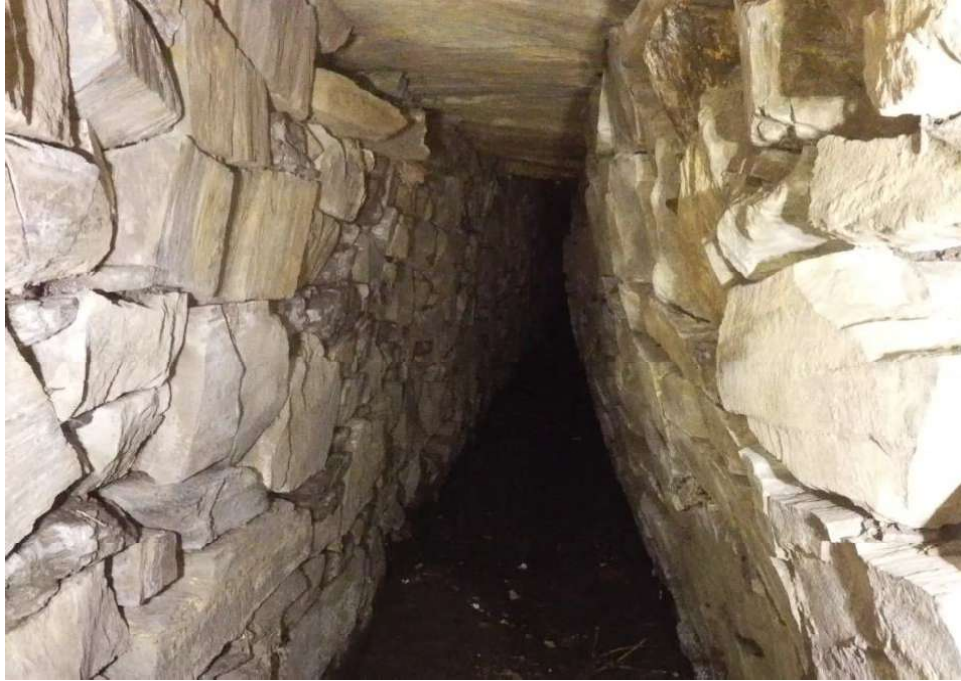
Inspection area from Entry 3 to Entry 4 was approximately 47 ft long. The stone tunnel section contained inlets near the ceiling and began to narrow at 30 ft from Entry 3. The drone could not fit through the narrow area and had to turn around. An additional stone tunnel was discovered 2 ft from Entry 4. The additional stone tunnel was significantly smaller than the main drain tunnel being about 1 ft by 1 ft. The additional stone tunnels appeared to serve drainage facilities along Washington Street.

**Narrow rock tunnel area 30 ft from Entry 3**

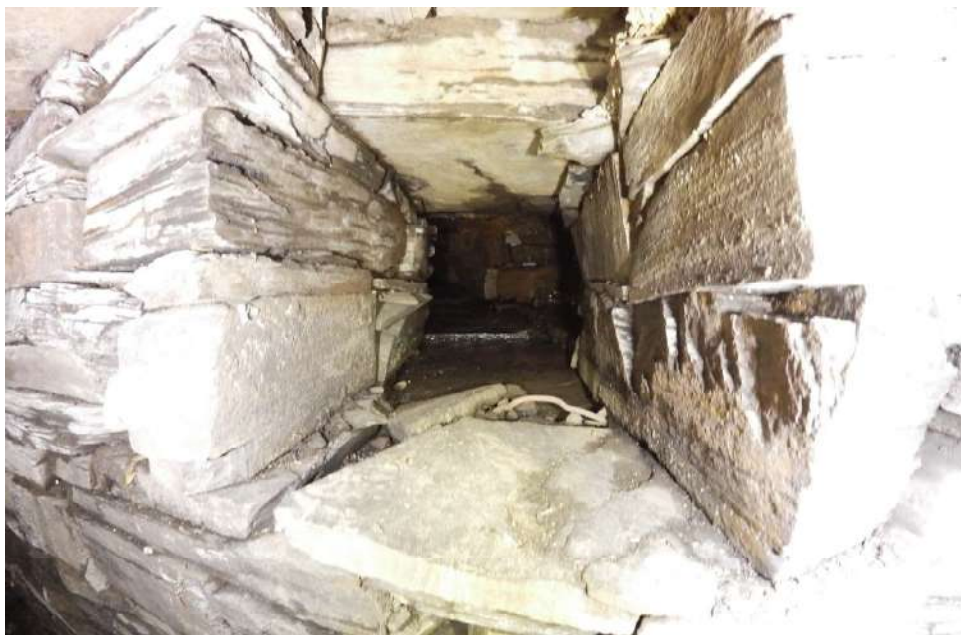
**Entrance of an additional rock tunnel (1 ft x 1 ft) 2 ft from Entry 4**

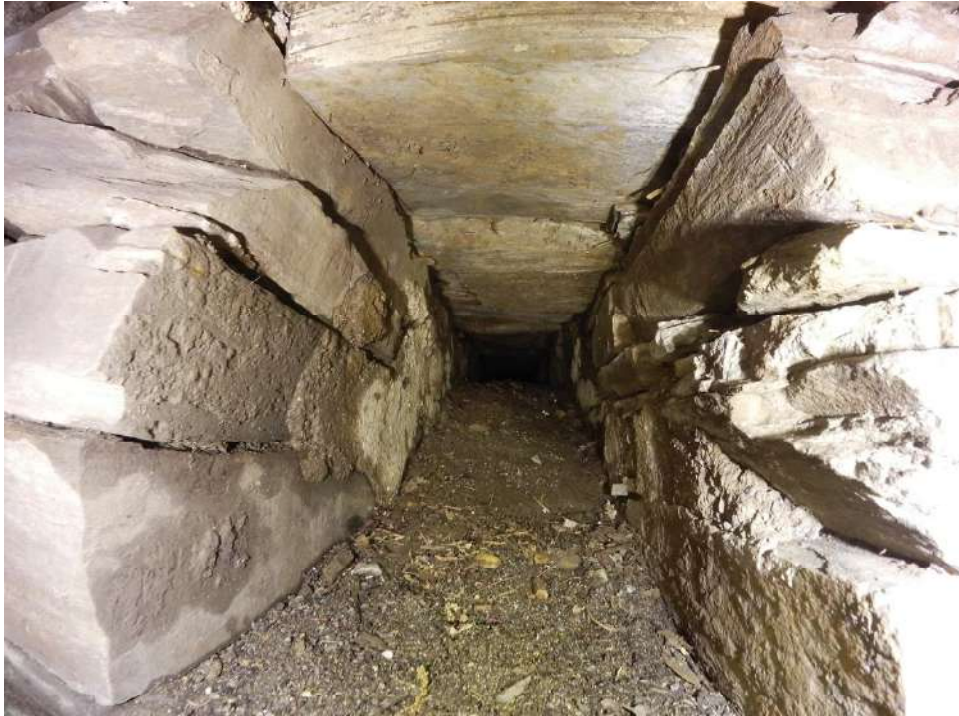
The segment between Entry 4 and Entry 5 was approximately 85 ft long. There was an additional rock tunnel at the beginning of the entrance, about 1 ft in from the manhole. The rock tunnel was 1 ft by 1 ft. A rock collapse was evident about 85 ft from Entry 5.

**Entrance of an additional rock tunnel (1 ft x 1 ft) 2 ft from Entry 4**

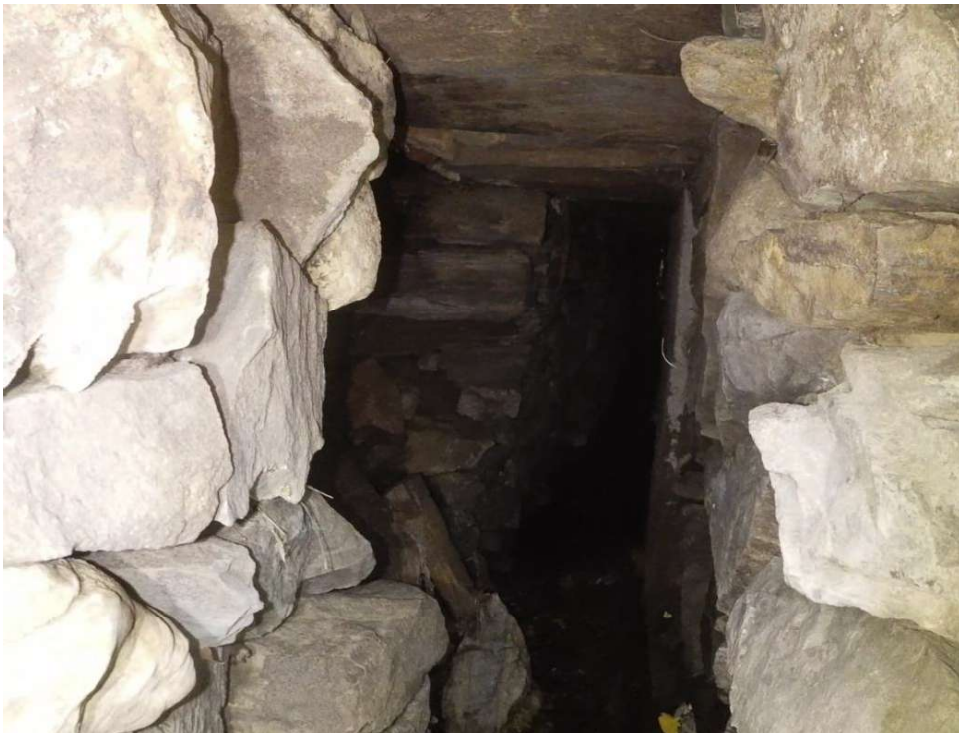
**Minor rock collapse 85 ft from Entry 5**

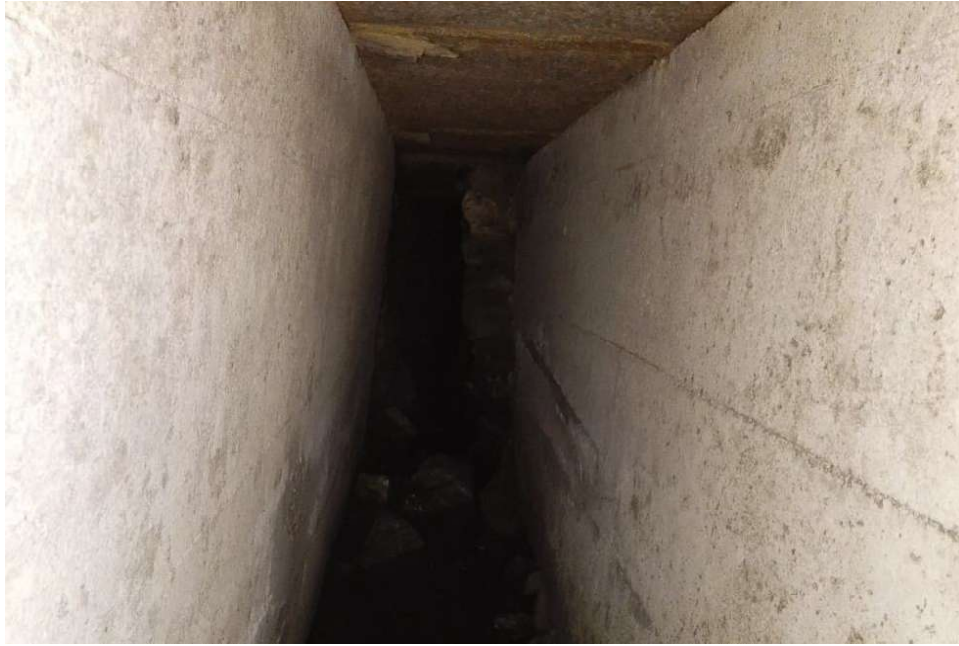
The segment between Entry 5 to Entry 6 was approximately 60 ft long. For a section of 20 ft from Entry 6, there are two sections sprayed with gunite forming a box culvert. An additional rock tunnel was found 12 ft from Entry 6.

**Gunite area around stone tunnel creating box culvert south of Entry 6**

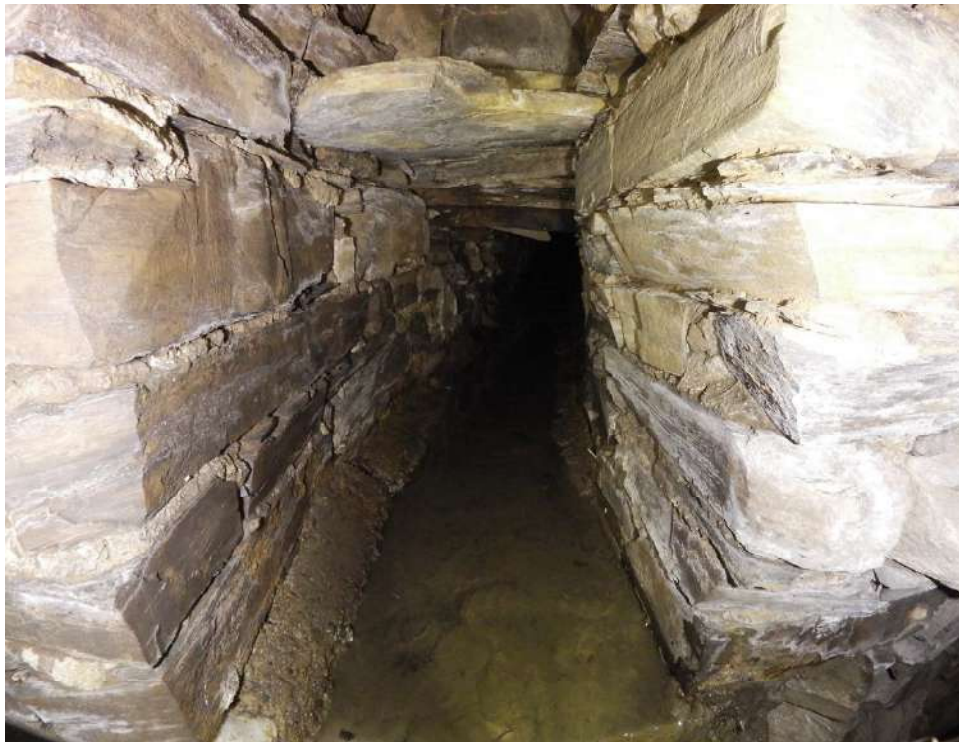
**Entrance of an additional rock tunnel (1 ft x 1 ft) 12 ft from Entry 6**

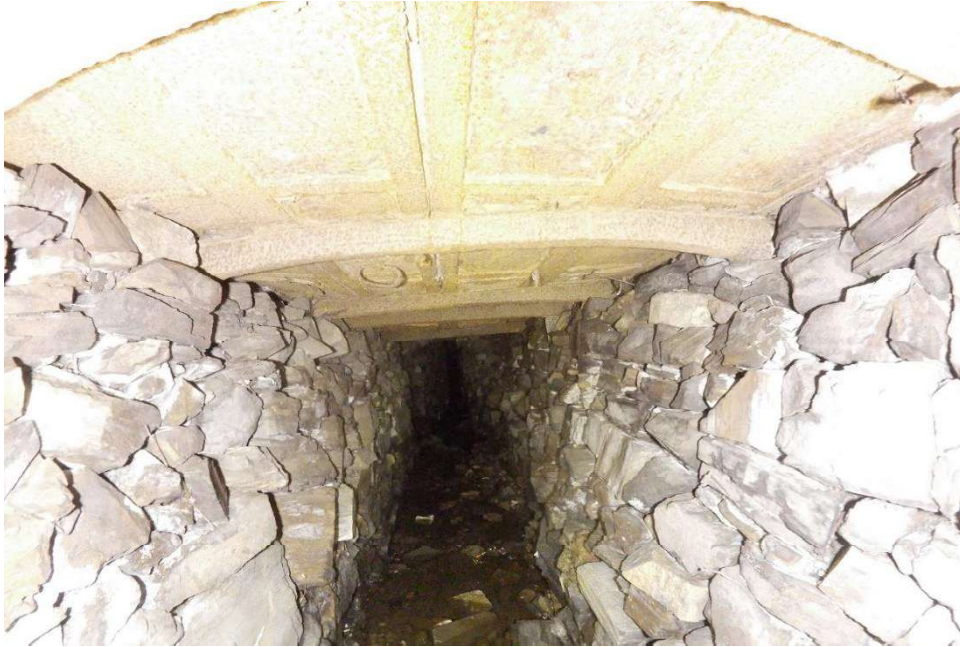
The inspection between Entry 6 and Entry 7 was approximately 80 ft long. The section contained pipe inlets, CMP pipes, and steel doors. About 30 ft from Entry 6 there are rusted/deteriorating steel doors on the ceiling of the tunnel. At 75 ft from Entry 7 there is a crack in the ceiling.

**Rusted steel doors 30 ft of Entry 6**

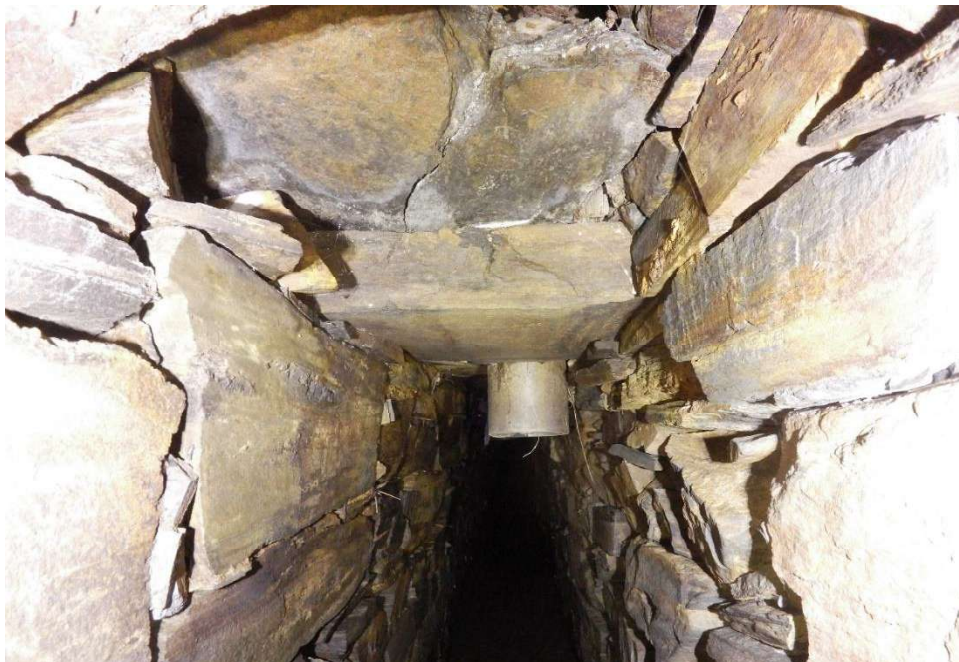
**Crack on ceiling 75 ft from Entry 7**

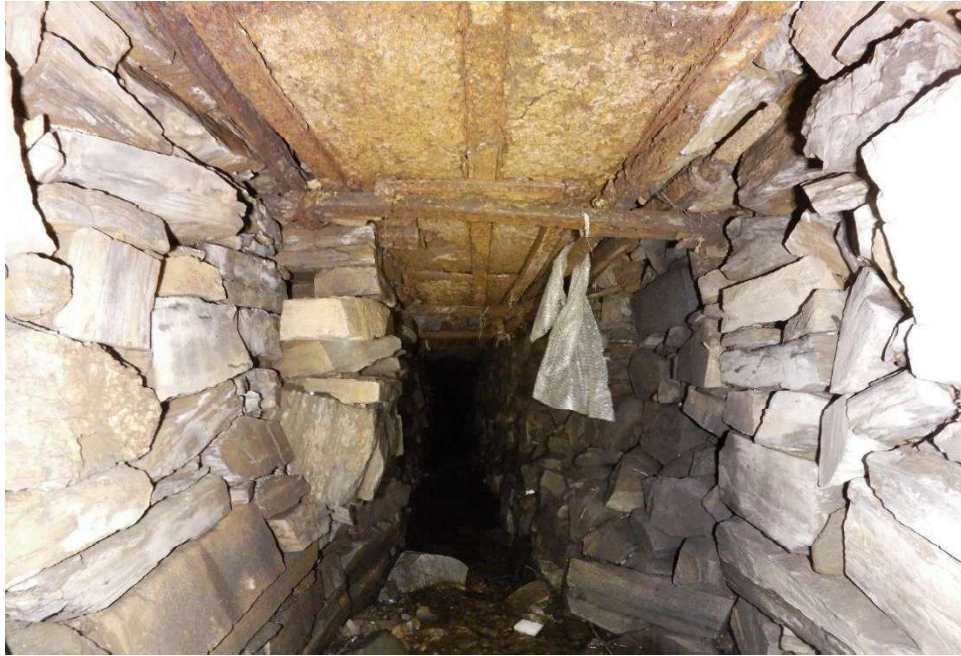
The section between Entry 7 and Entry 8 was approximately 90 ft long. This section consisted of additional rusted steel doors, metal culverts along the ceiling, and tight sections that have gunite around the surface. Significant sections of the steel surface has deteriorated due to the abundance of rust damage. The Entry 8 is covered in gunite all over the stone walls. The gunite starts 1 ft from Entry 8 and continues for about 15 ft.

**Rusted steel doors 1 ft from Entry 7**

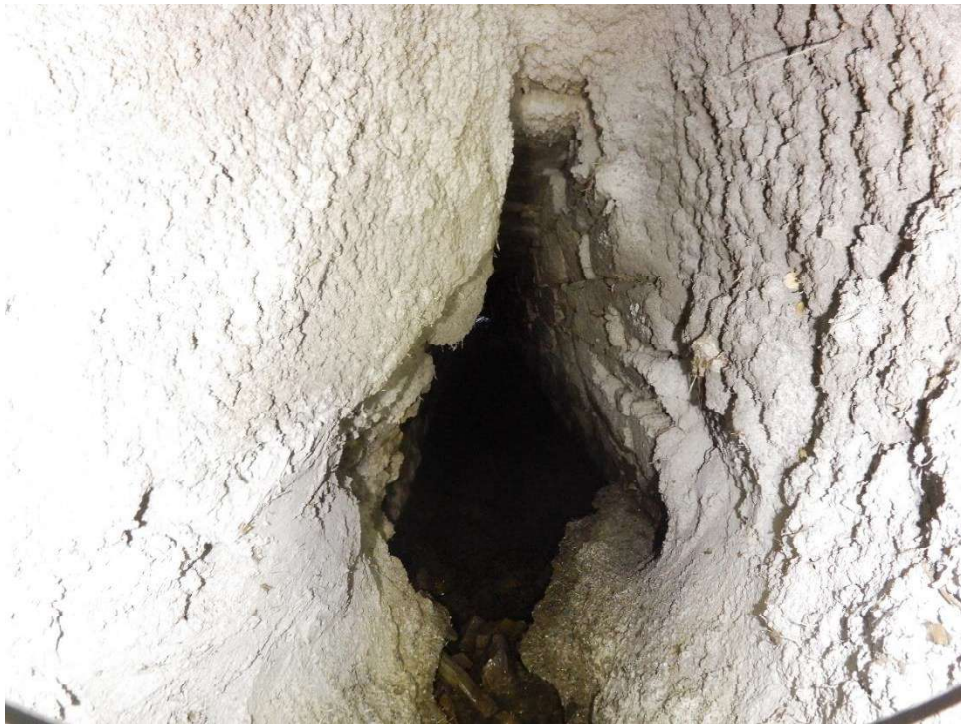
**Gunite surface 1 ft south from Entry 8**

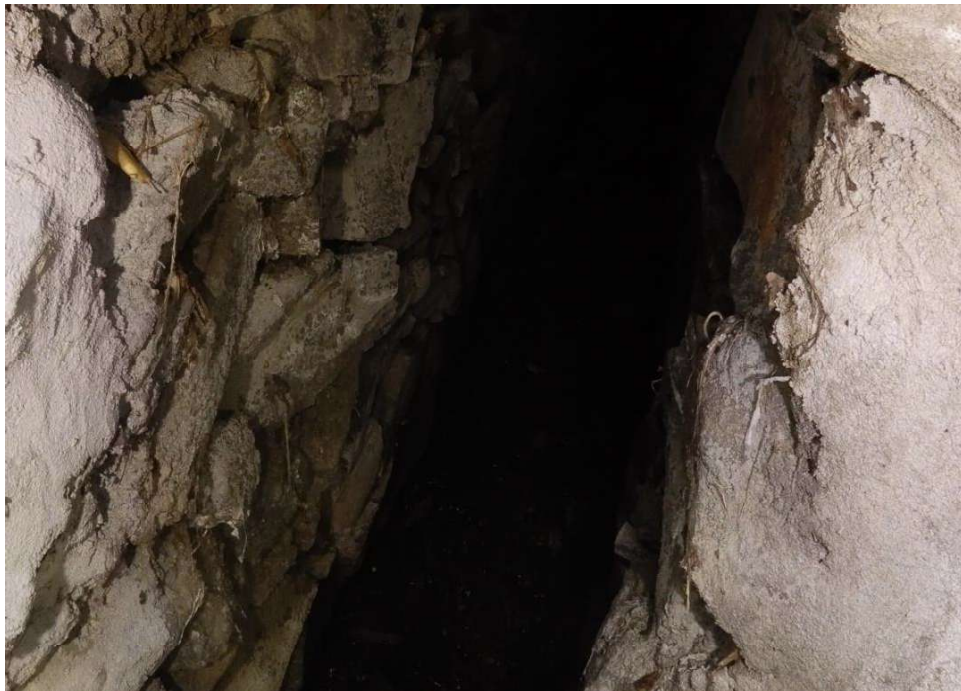
**Gunite on stone wall surfaces 1 ft from Entry 8**

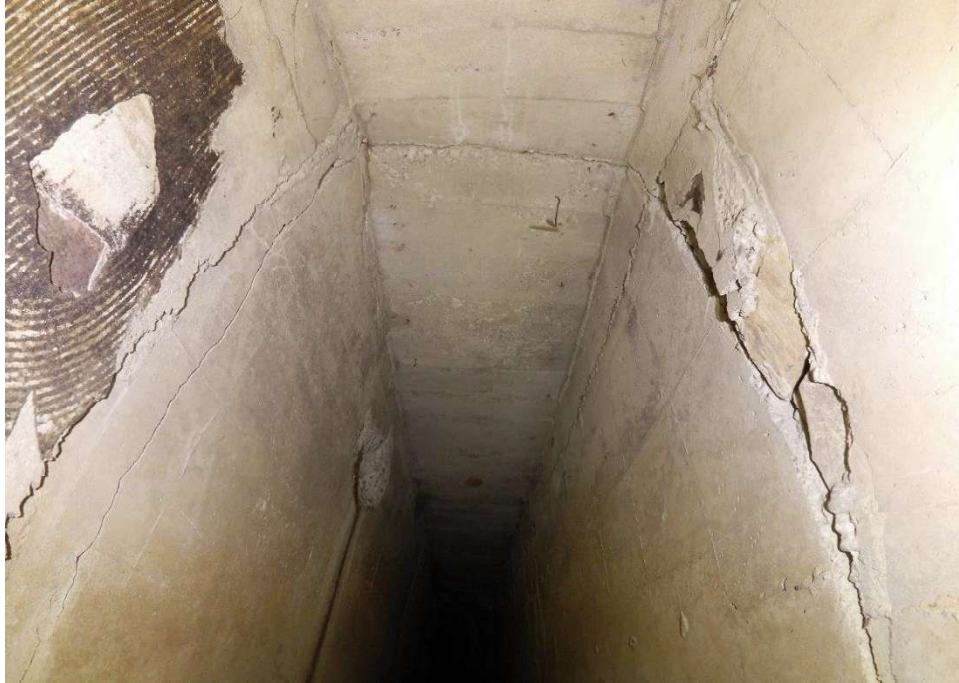
The section between Entry 9 to Entry 10 was approximately 92 ft long. This section consisted of a box culvert, timber wood on the surface, and a major stone tunnel collapse. The box culvert extended for about 26 ft starting 1 ft from Entry 10. Moist timber with water stains was on the surface 36 ft from Entry 10. The major stone tunnel collapse extended about 10 to 12 ft starting 65 ft from Entry 10. Stones covering the floor, the west wall, and the lid of the tunnel are missing and the soil is exposed.

**Box culvert 1 ft from Entry 10**

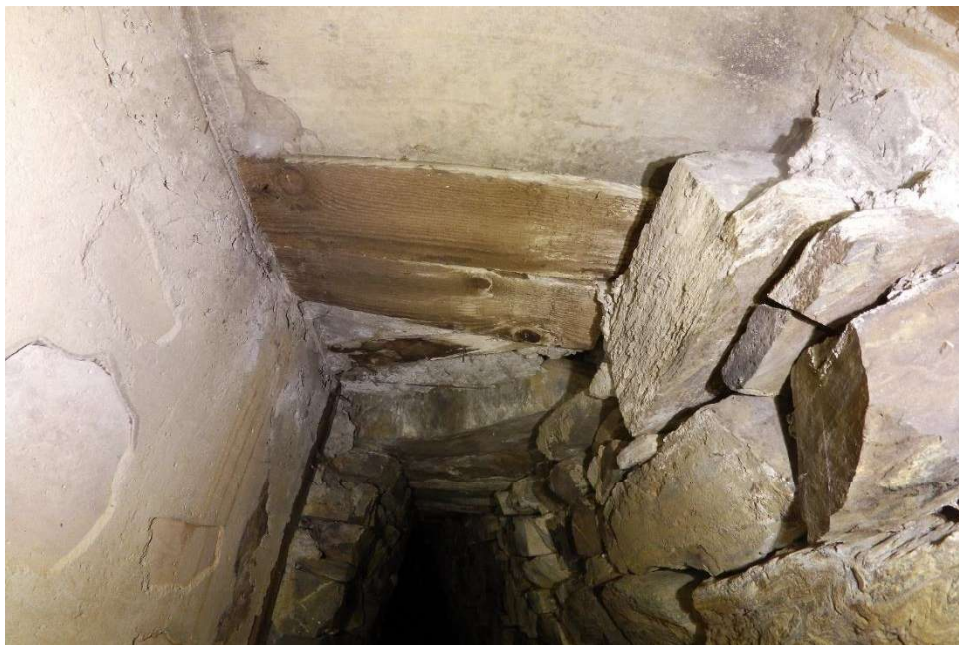
**Moist timber with water stains on ceiling 36 ft from Entry 10**

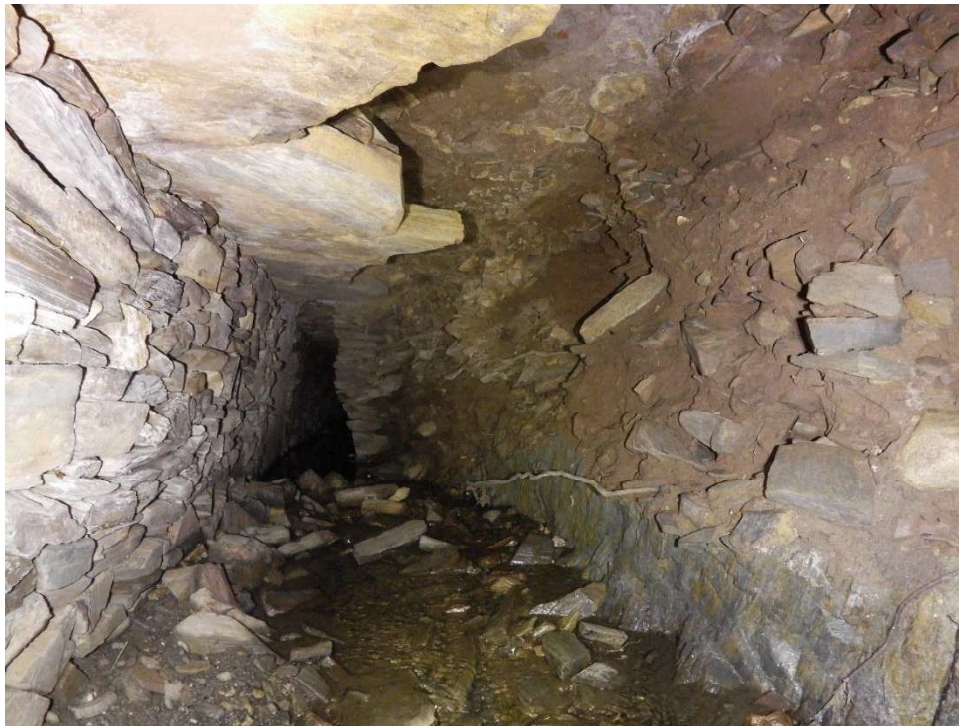
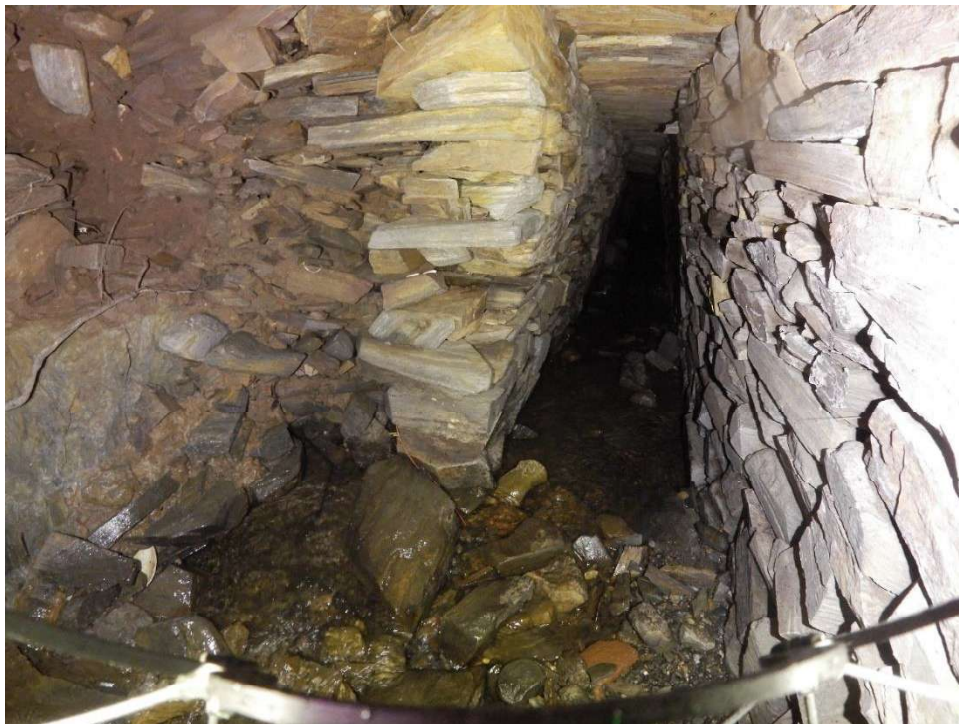
The first four of these collapse areas are minor in nature. The fifth collapse area is of concern because this section of failed tunnel is approximately 10 to 12 ft and the west wall and lid of the tunnel at this location are missing. It appears that only the arching effect of the soil above the tunnel is supporting Stockton Street/ SR-49. At this same location, settlement in the roadway above the tunnel can be seen and has been previously marked by the City as a location of potential tunnel failure. Because Caltrans currently has ongoing construction activities, including the use of heavy machinery and trucks occurring directly adjacent to this section of failed tunnel, a letter was forwarded to Caltrans on 2 June 2023, recommending the portion of the road above this section of collapsed tunnel be blocked off from traffic and this location of the tunnel be exposed and repaired in the very near future.

**Major stone tunnel collapse 65 ft from Entry 10**
