## **Design Review Committee Agenda**

**Monday, August 11, 2025 at 5:00 PM**

**[Approve, with conditions, a Design Clearance for the demolish, remodel, and reconstruction of the Kingdon Hall of Jehovah's Witnesses located at 40 Gold Dust Trail](#)**

DATE: August 11, 2025

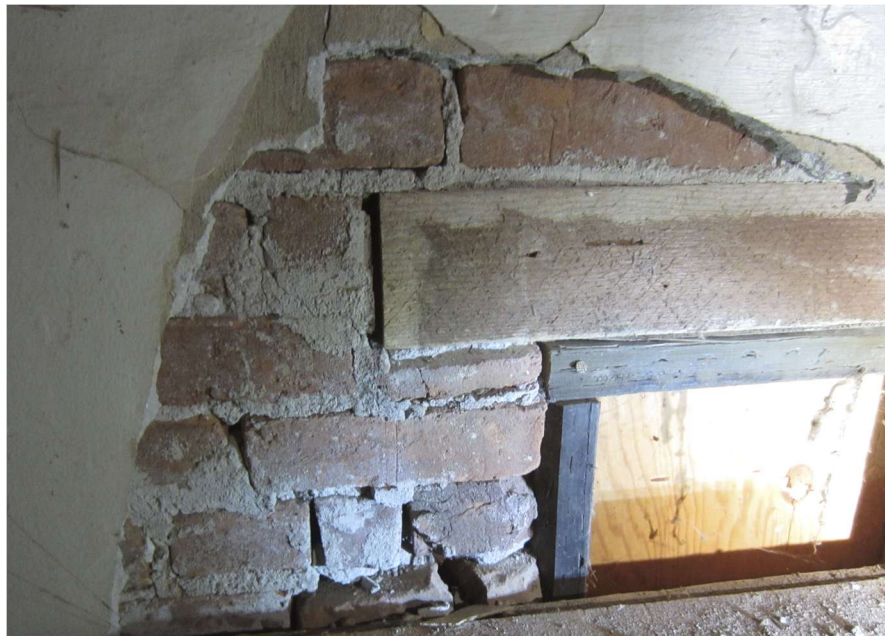
Figure 9 – Moisture affecting plaster and mortar

- The interior surfaces of the brick walls are plastered, with notable areas of scaling resulting from moisture migration.
- In certain wall sections below the floor framing, the mortar has deteriorated to the extent that individual bricks can be shifted or removed by hand.

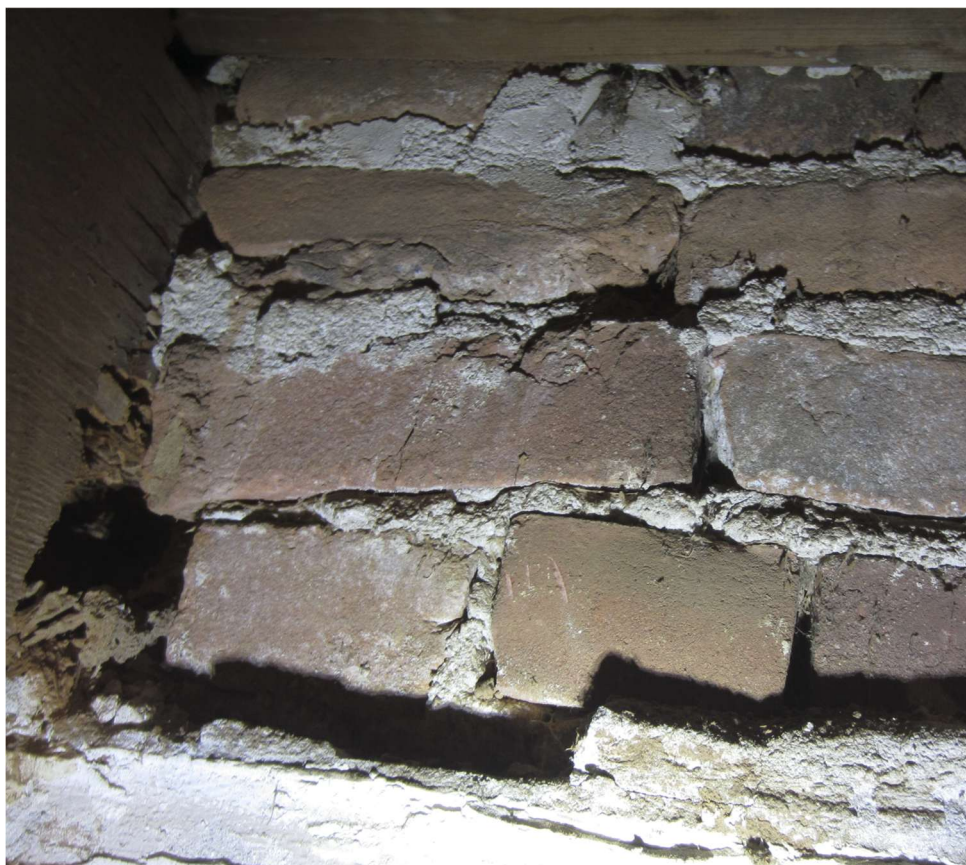
Figure 10 -Dry rot at embedded beams

- Roof framing: Dry rot has been observed where the framing connects to the walls.
- Unreinforced Masonry (URM) Walls: Approximately 25% of the mortar on the south, west, and north walls is chalky and can be easily removed.

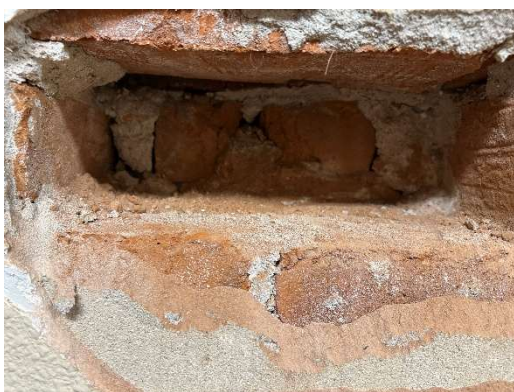
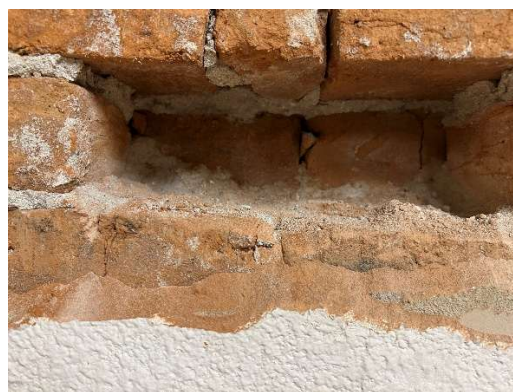
Figure 11 – Mortar and Brick Review – Interior Brick Condition

- Mortar quality and workmanship are inconsistent. Variations in lime content have resulted in some mortar being soft to the touch. Additionally, mortar application is uneven, with some bricks exhibiting poor coverage (Figures 9-12).

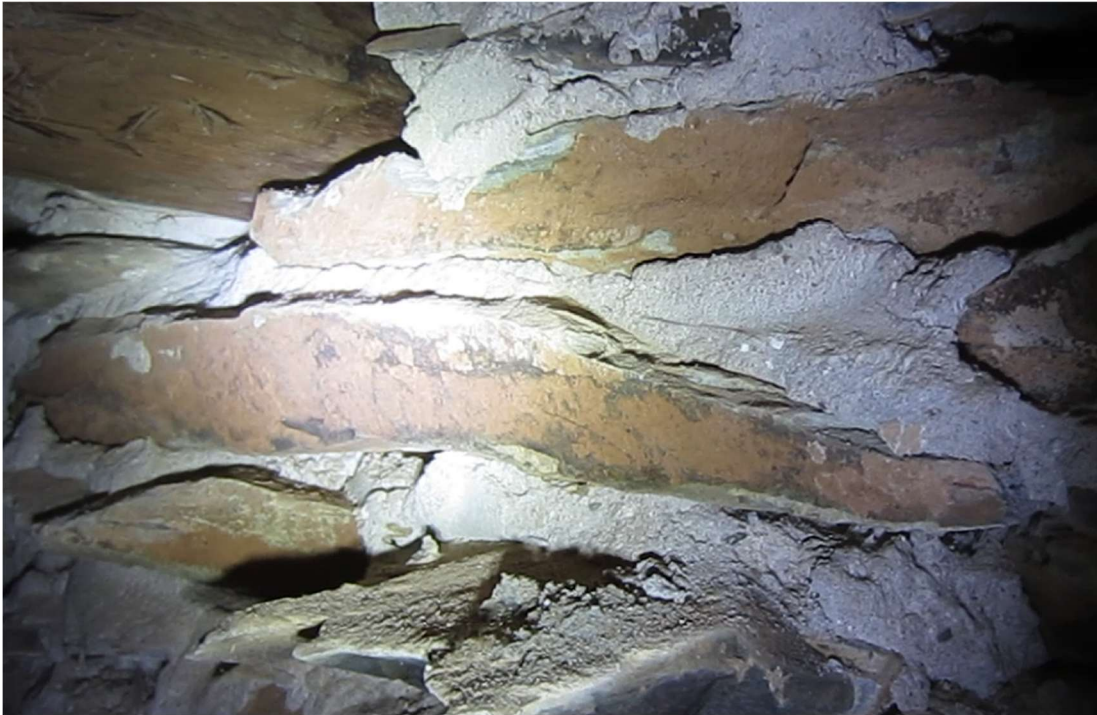
Figure 12 – Foundation Stacked Stone - Moisture affected mortar strength

- e. Foundation- the foundation consists of mortar stacked rock to the floor joist level. The mortar within approximately a foot within the floor level from the surrounding grade level is in poor condition, and in some areas completely eroded.

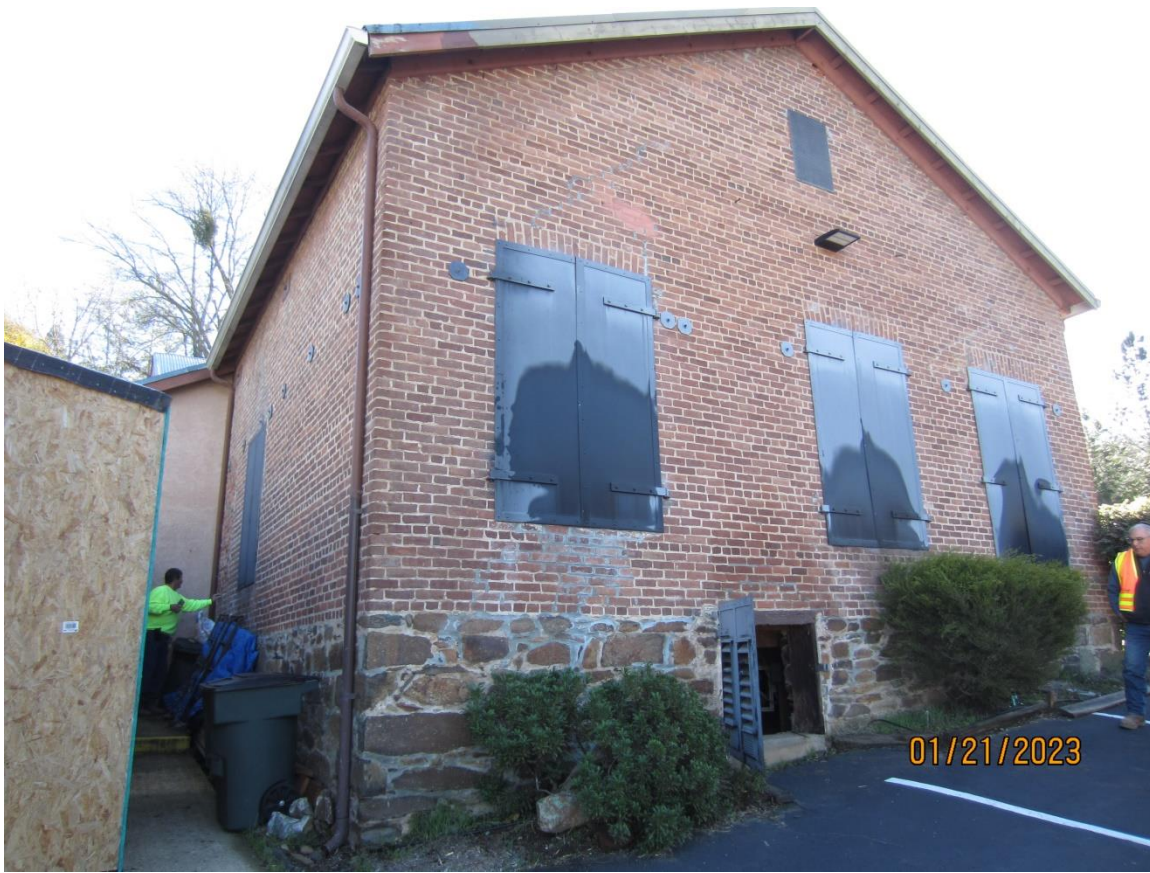
At gable end walls at Lines A and B no wall anchorage was observed at the attic level (See Pics 1, 17).

Pic 1- West wall of URM building with access door to crawl space and added anchors each side of existing wall openings.

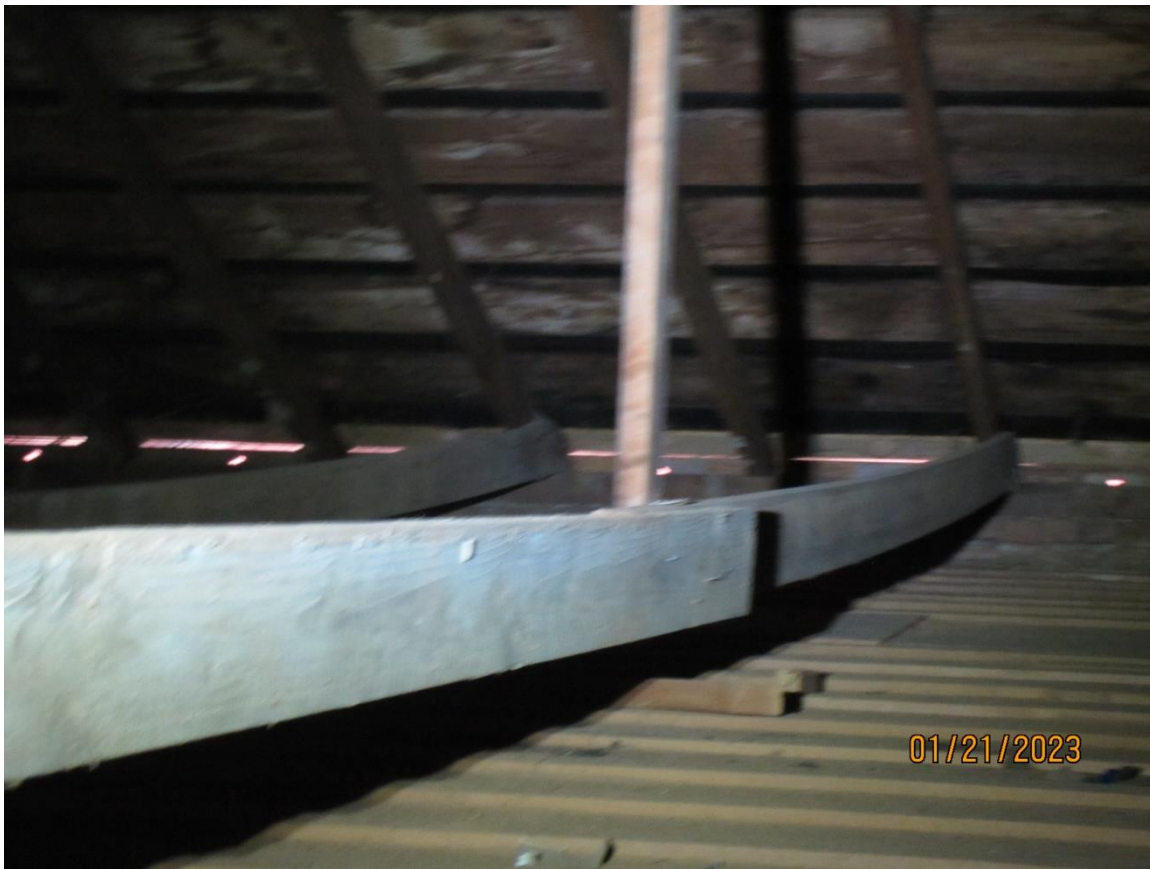
Pic 3 – Sagging collar tie at roof rafters. King Post added at mid-span

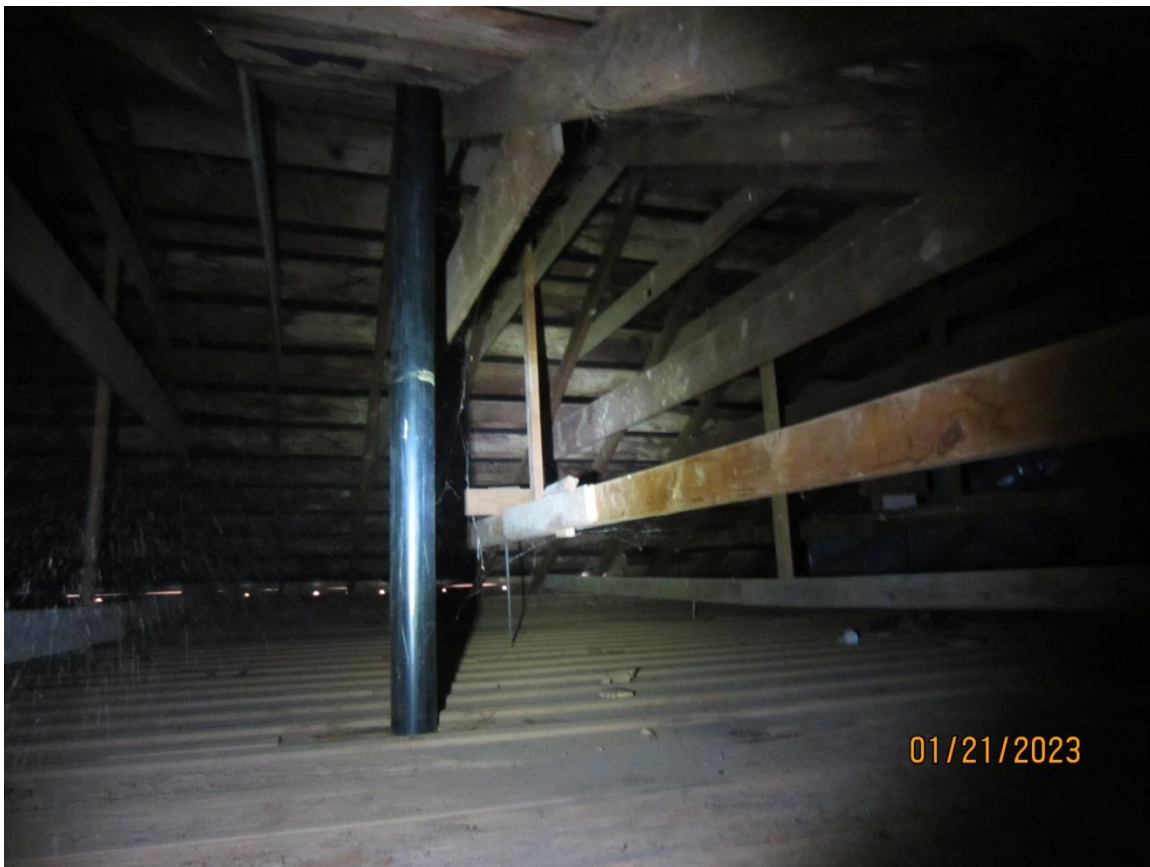
Pic 4 – Collar ties are varying elevations at roof rafters

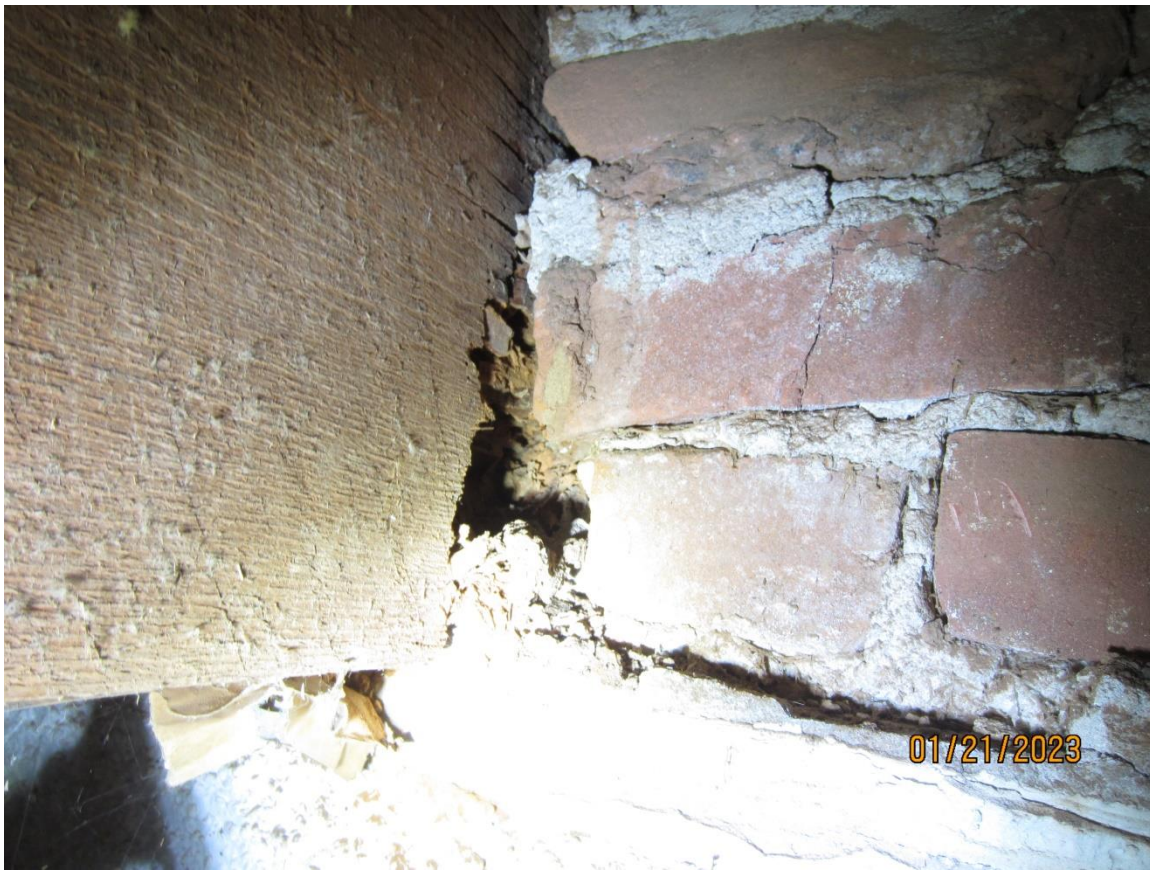
Pic 11 – Dry rot at embedded 2"x11.25" attic floor joists

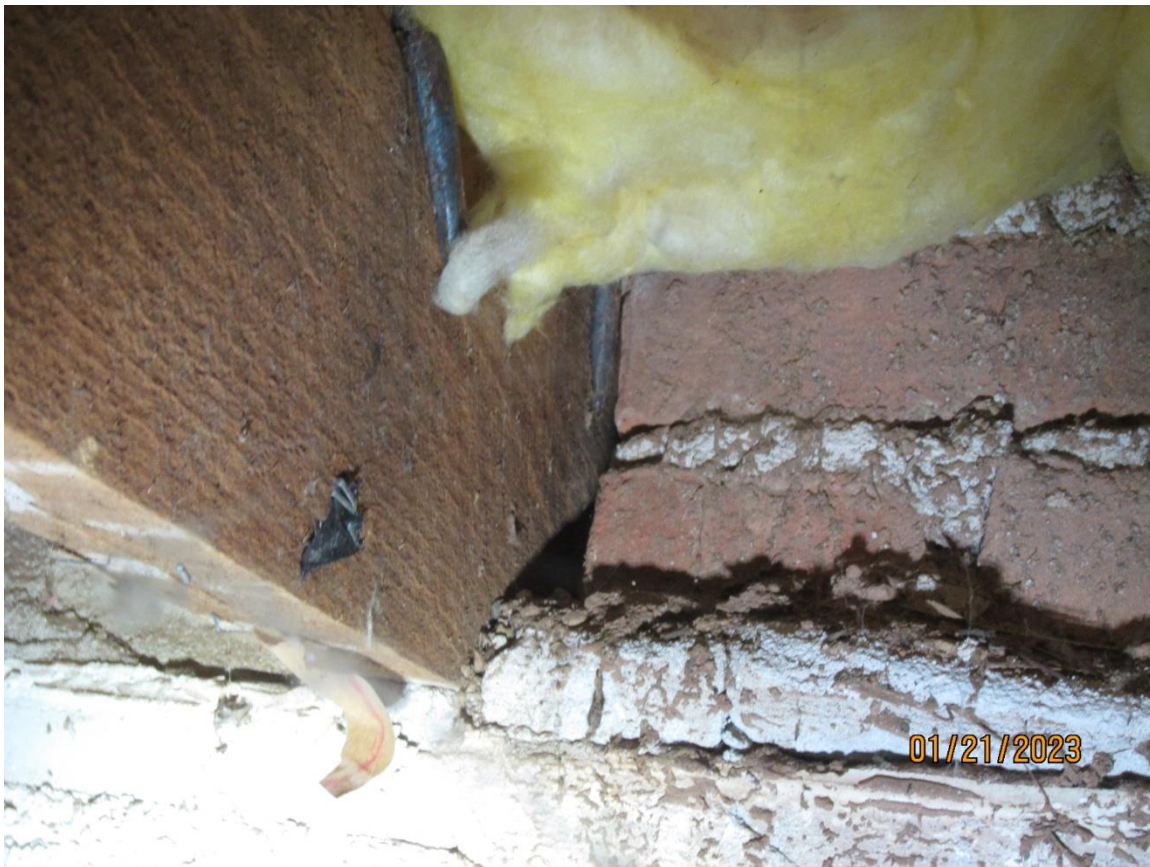
Pic 12 – Dry rot at embedded attic floor joist

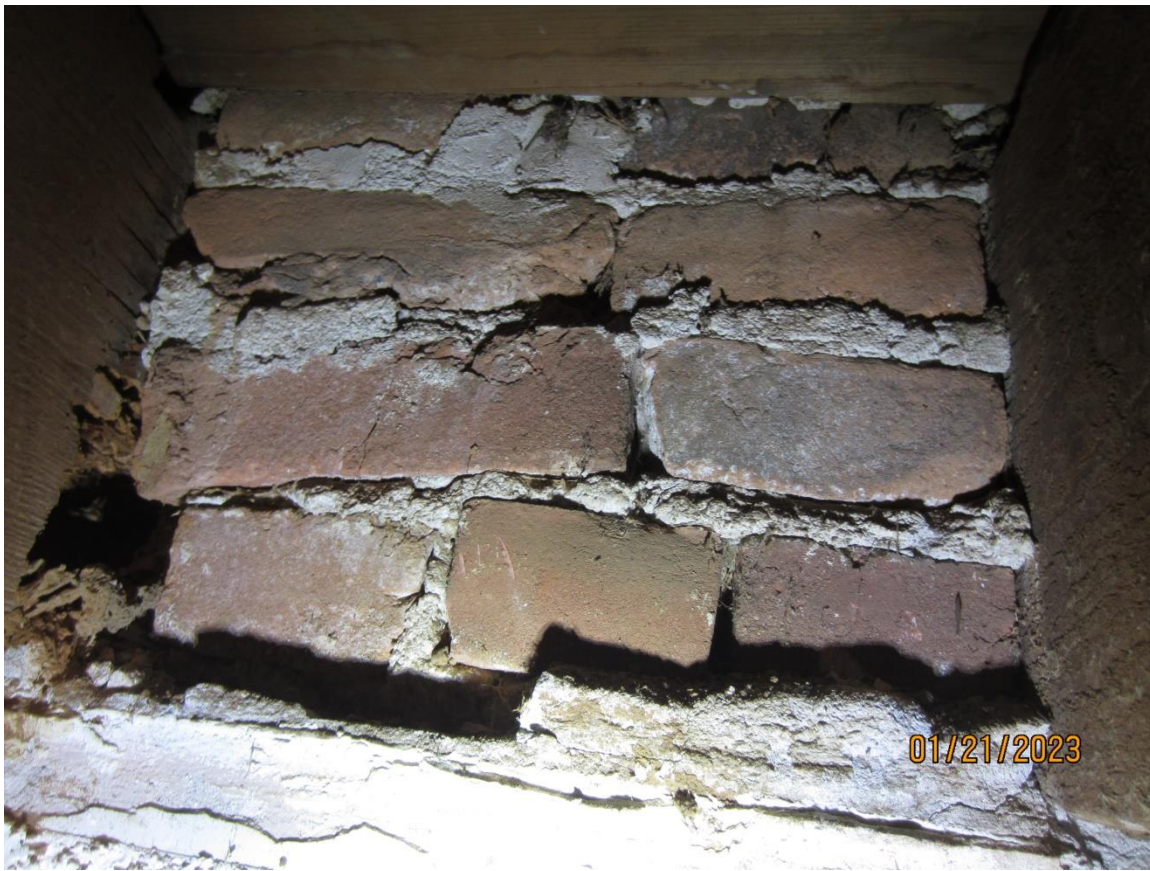
Pic 13 – Dry rot at embedded attic floor joist

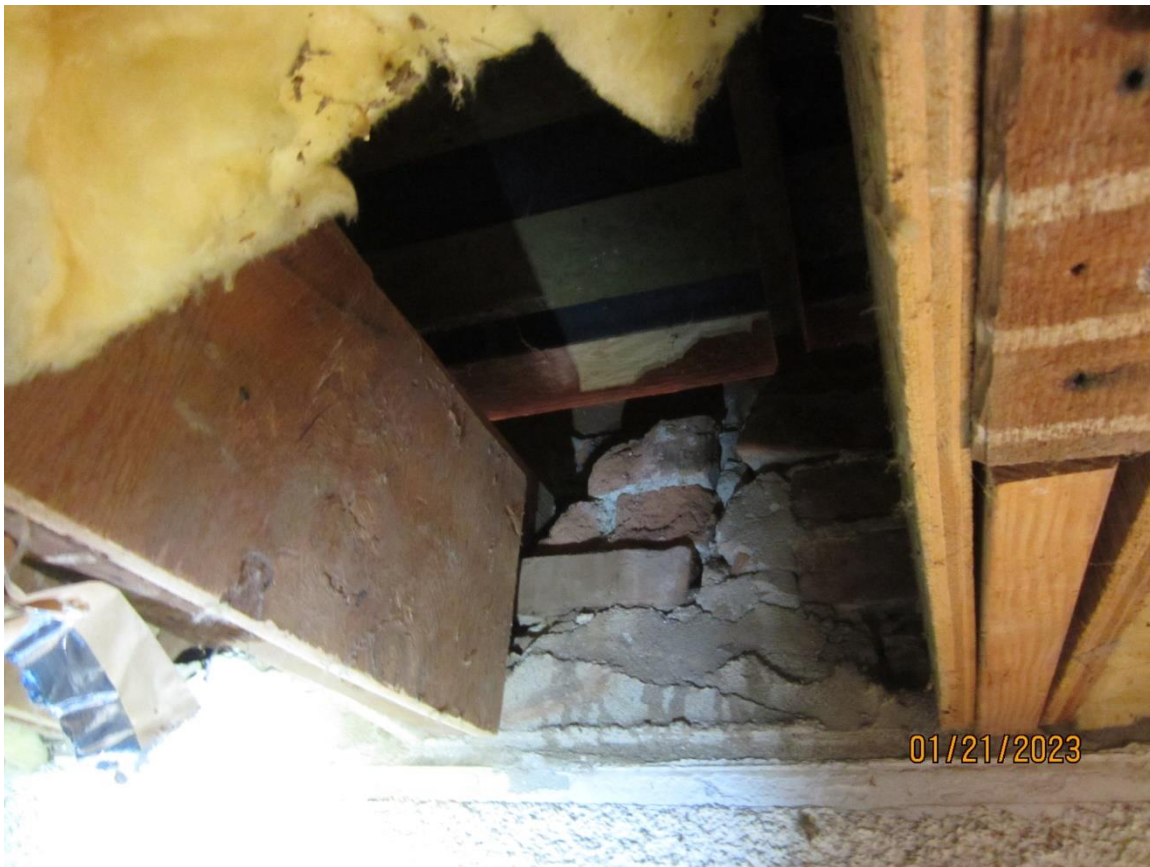
Pic 14 – Weak mortar and loose bricks at attic ceiling joist repair locations.

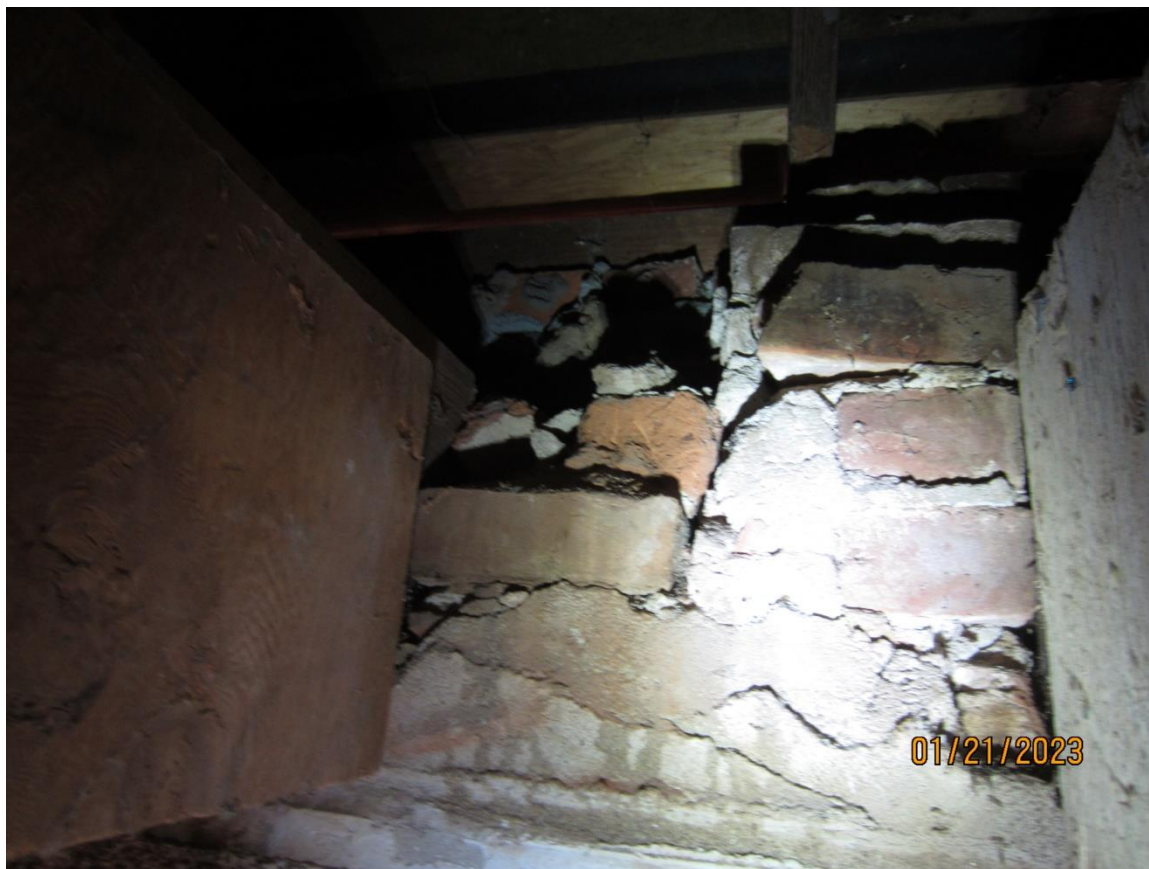
Pic 15 – Loose bricks and weak mortar at attic floor joist repair location

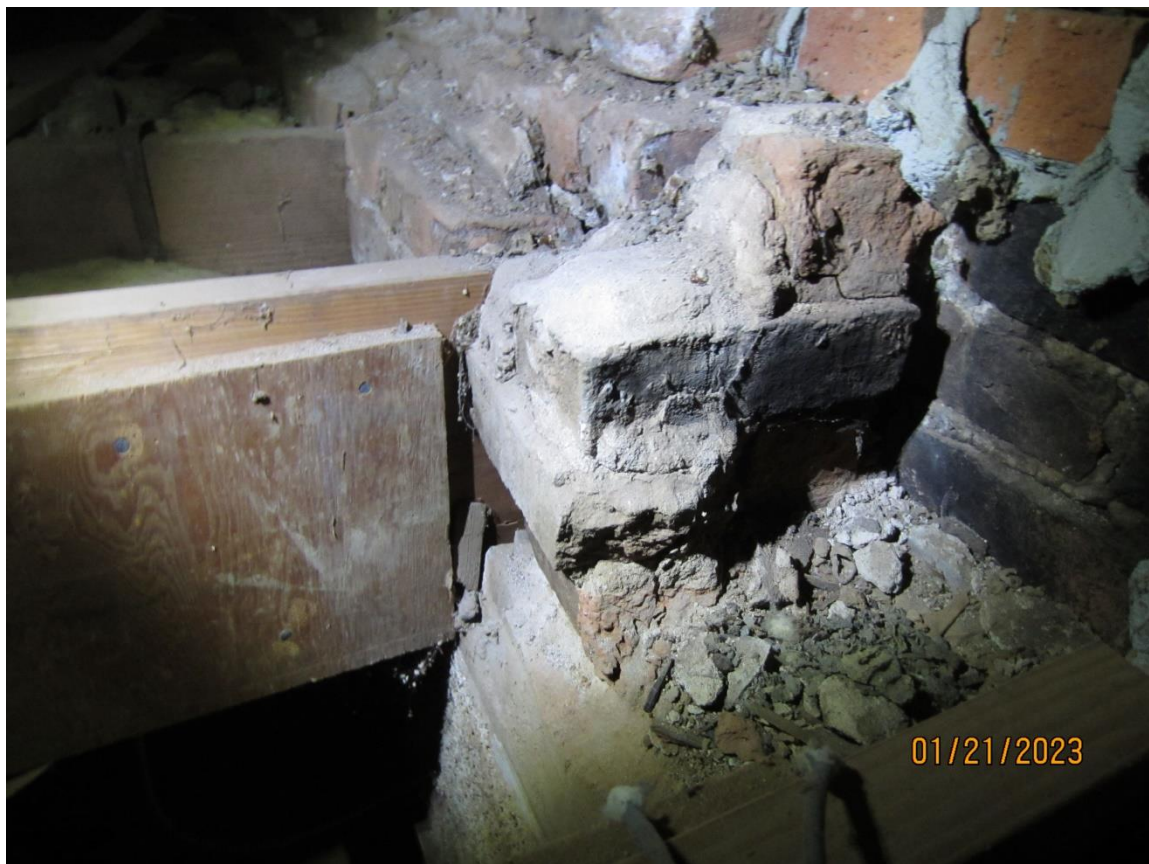
Pic 16 - Loose and missing bricks. Exposed brick head for interior two wythes of wall.

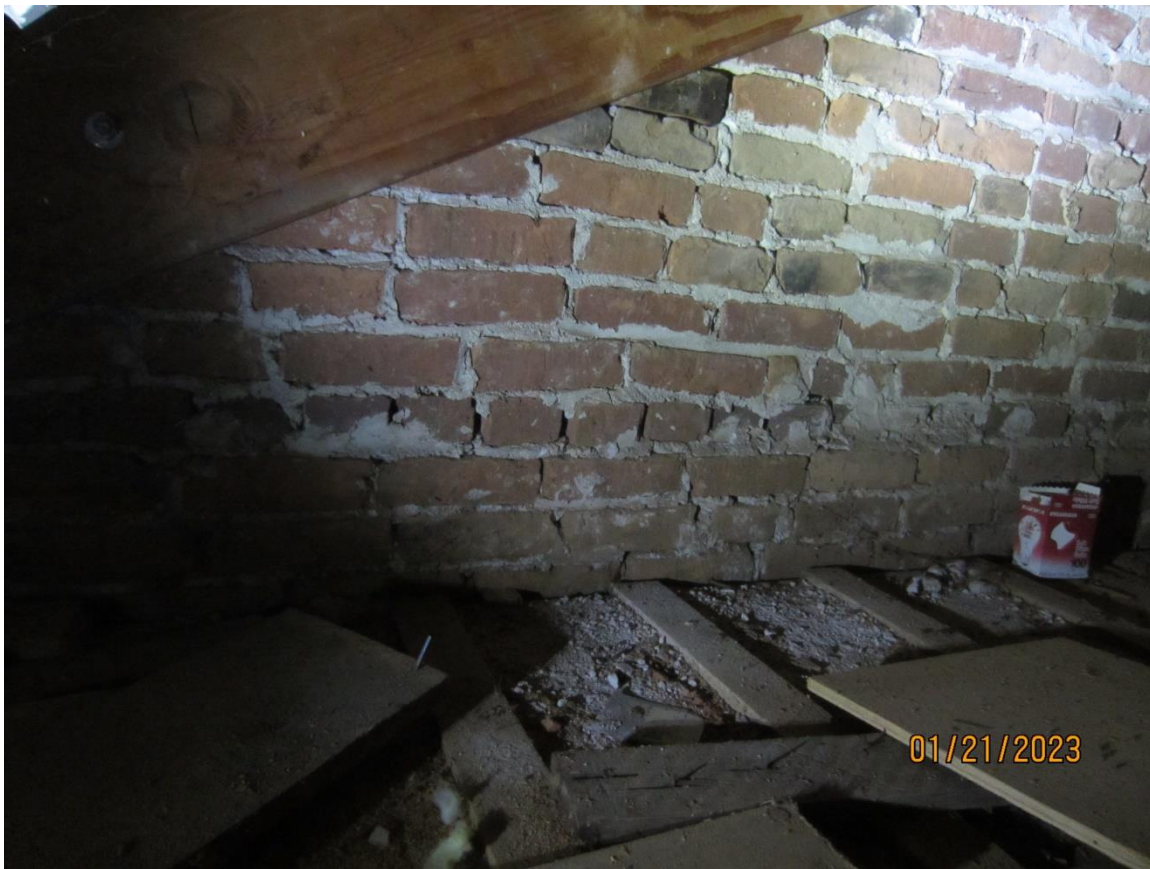
- b. Wall Anchorage- There is a lack of adequate anchorage at 4-foot on center at the floor and roof levels. The specified anchorage at the ceiling level at the interior is concealed and could not be confirmed; however, the exterior anchors exceed the minimum spacing requirement. Therefore, it is concluded that the lack of sufficient wall anchorage poses a significant stability deficiency. [ASCE 41-17 5.7.1]

Pic 17 - No wall anchorage at Line B (East Wall) at attic floor level. Attic floor boards removed.

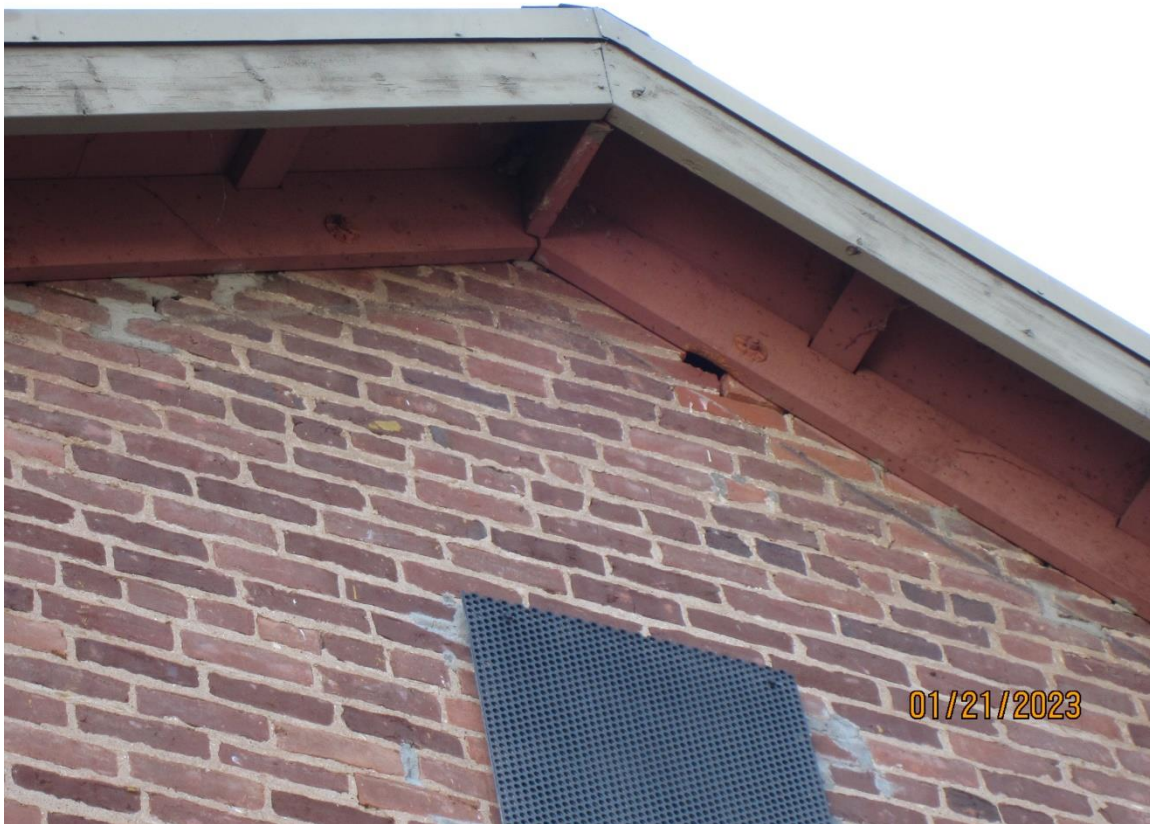
Pic 18 – Loose and missing bricks at west wall gable

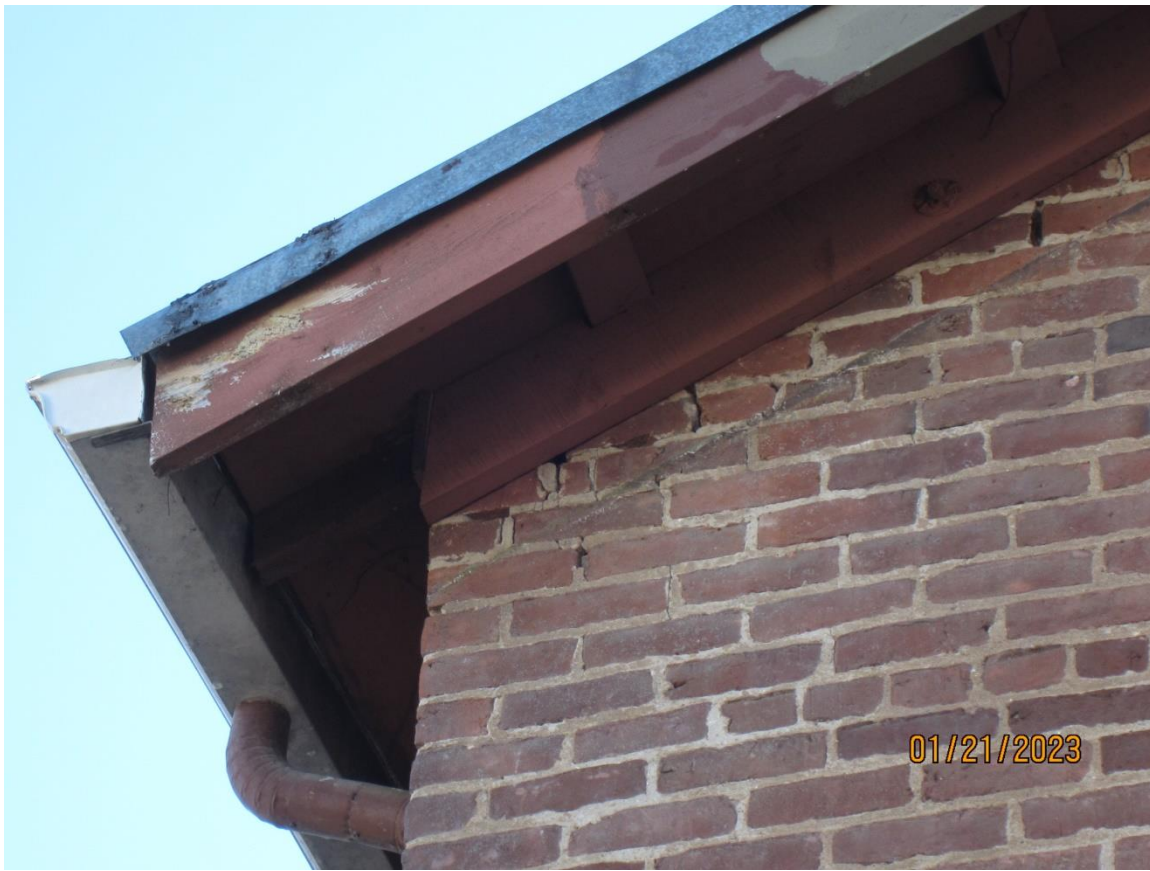
Pic 19 – Loose bricks at top of wall support on north end of west wall

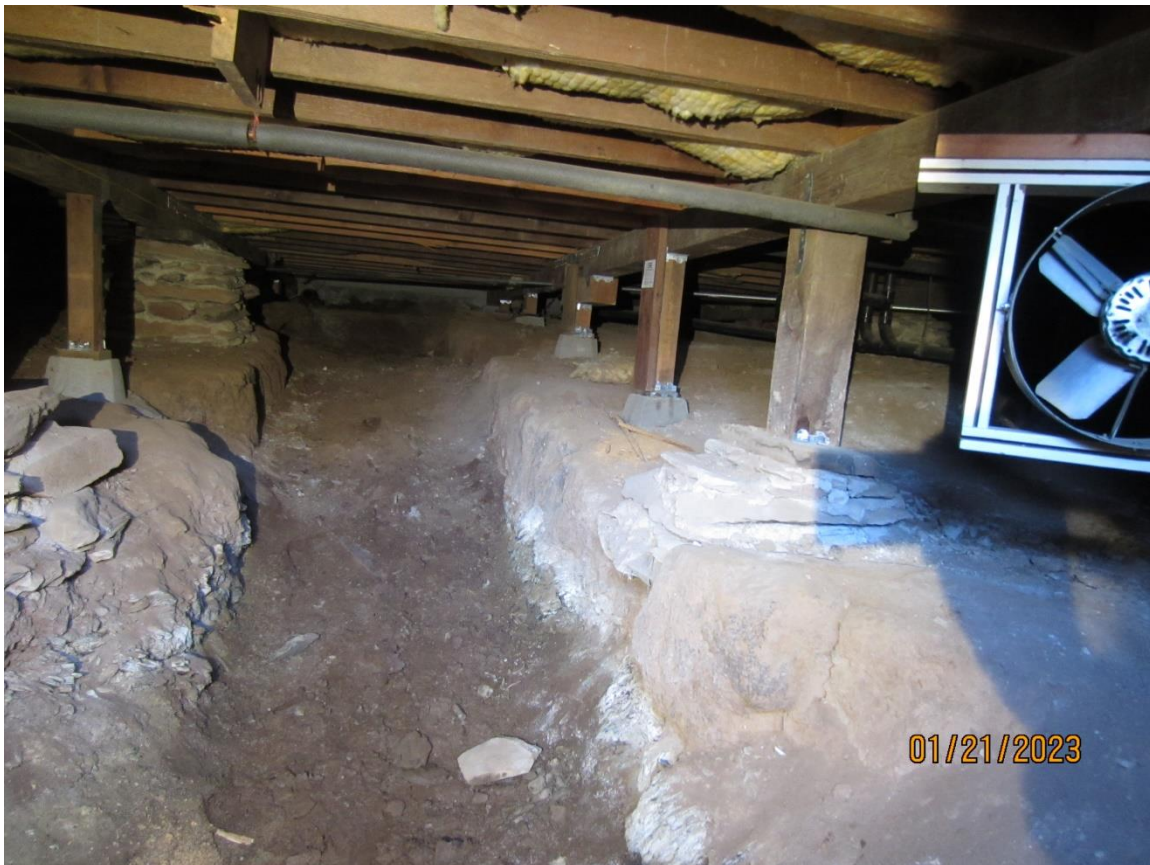
Pic 20 – Drainage trench sloping from east to west toward crawl space access door.

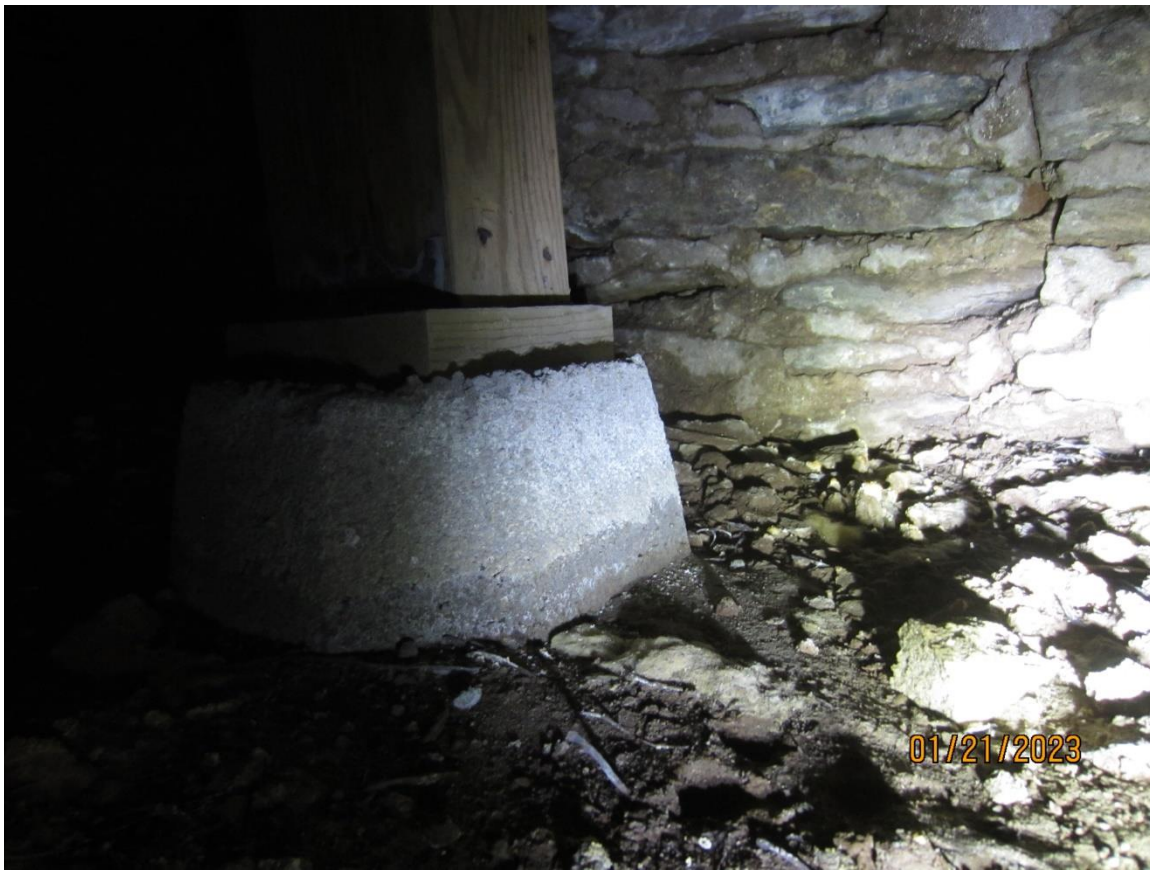
Pic 21 – Moisture at pier block and stacked shale foundation wall at Gridline 2.

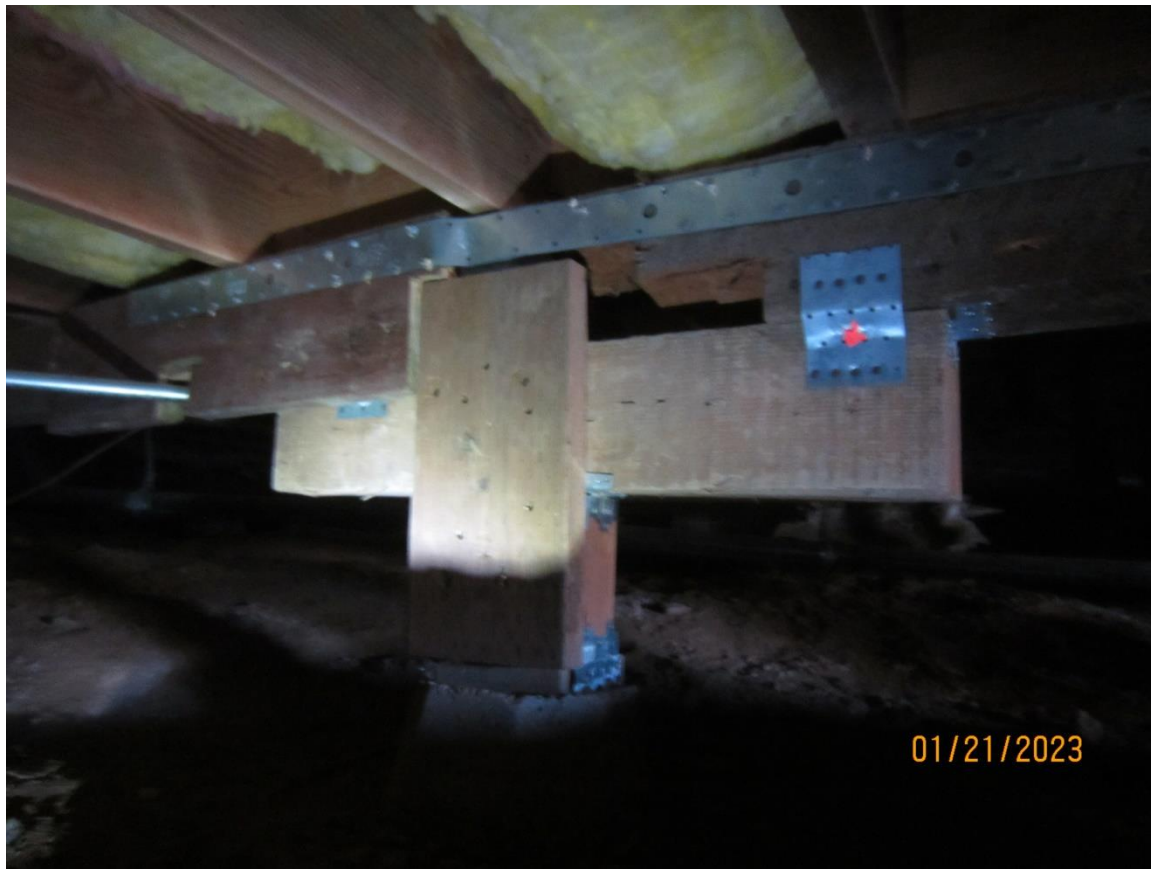
Pic 27 – Beam splice and dry rot repair over pier block (teter-totter method)
