Weddle Covered Bridge (Sweet Home, OR)

JANUARY 31, 2023

Oregon Transportation Professionals, LLC
202 DEANN DRIVE, UNIT #2
INDEPENDENCE, OR 97351
(503) 932-3093

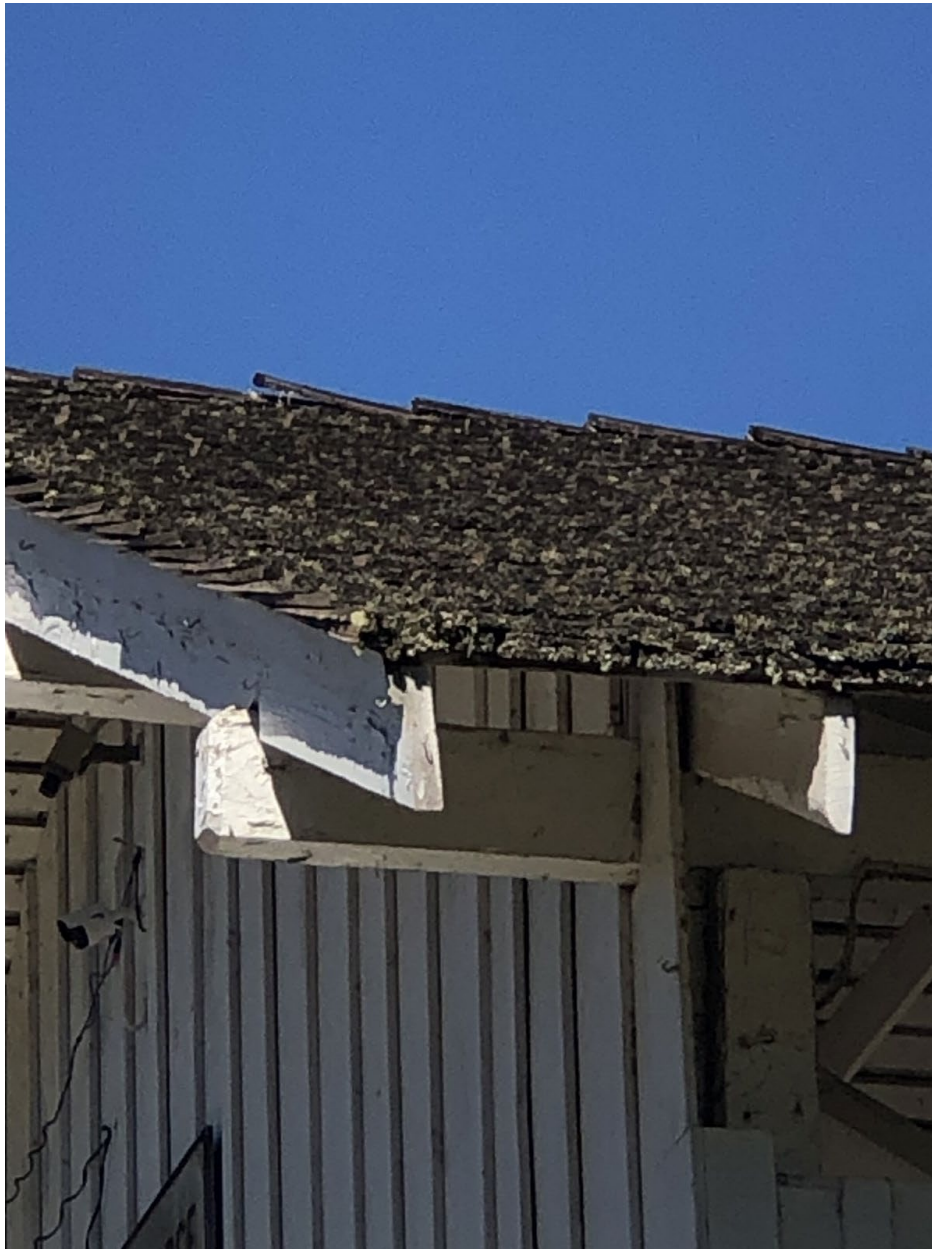
The roof appears to have widespread surface decay replacing the shingles is recommended. Based on appearance, the shakes were installed in 1990 with the covered bridge which would age them 32 years. A replacement should be planned considering cedar shake roof usually lasts around 30 years.

Figure 2 – Cedar shake roof should be replaced soon.

Element	Location	Covered Bridge Housing Roof
963a	Covered Bridge Housing	Roof is 95% effective, however decay is widespread so replacement is recommended.

Recommendation #1 – Replace the truss roofing to mitigate moisture penetration to structural members of the bridge. Cedar shake roofs usually last 20 - 30 years. Alternative composite roofing shingles that look like cedar shake are available for additional longevity to preserve structural members. Maintenance Priority = Routine High (next 2-3 years), est. \$12,000.

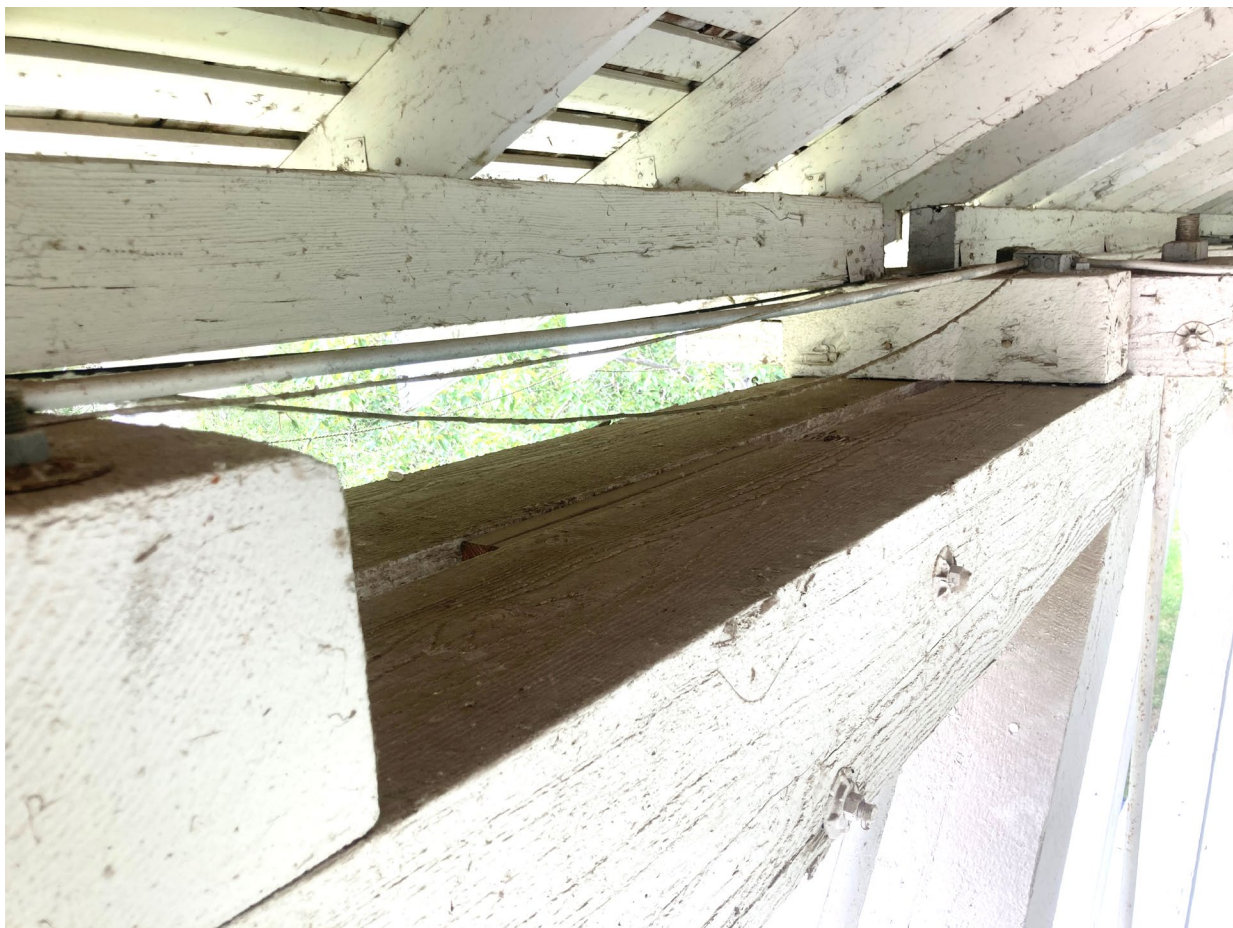
Fortunately, the roof is still effective, and no leaks were observed at the time of the inspection. The top chord is in good shape without signs of advancing decay. While the roof is the primary moisture barrier, the secondary preservation system is a good coat of paint.

Figure 3 - Unpainted top chord

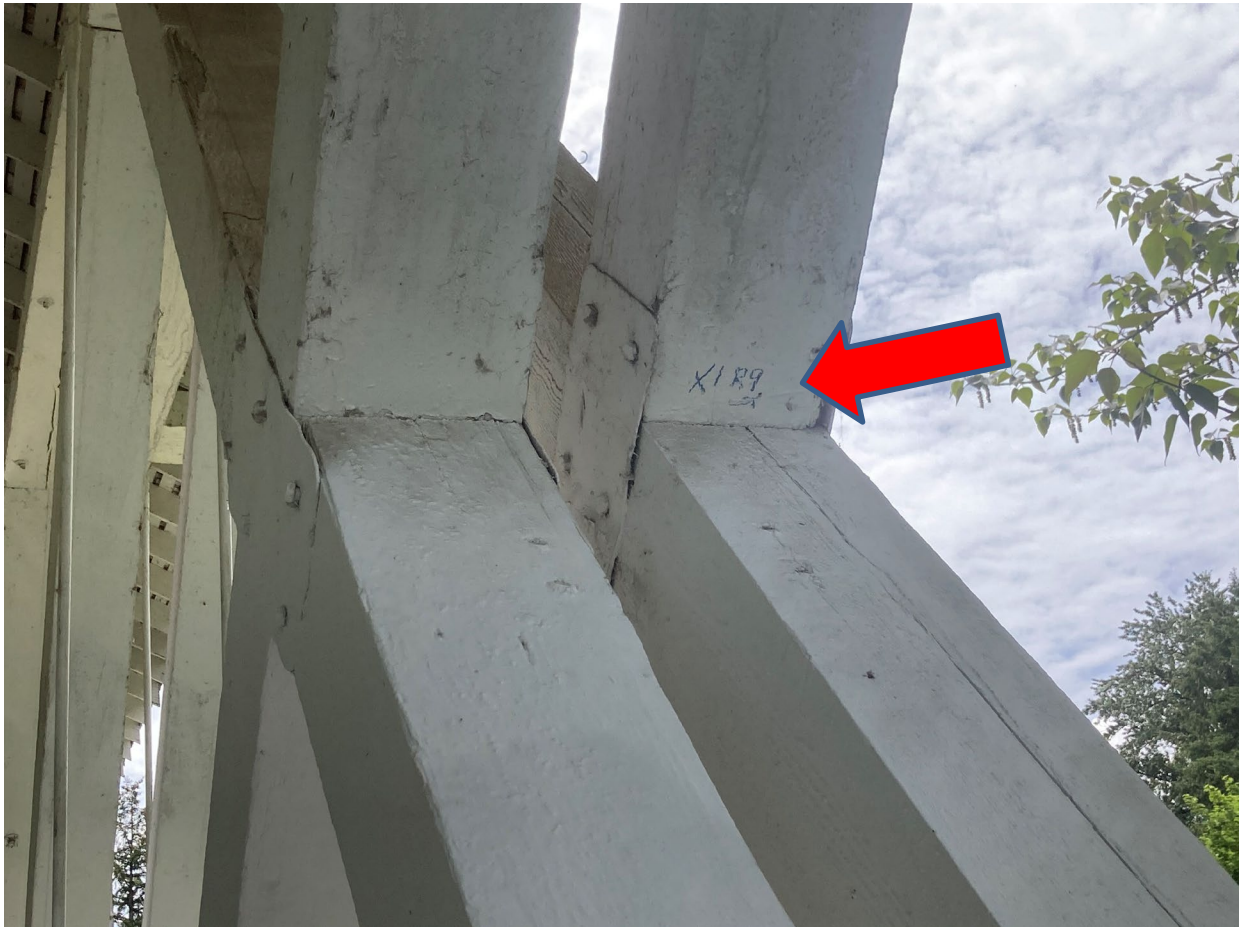
The downstream diagonals have areas of moderate to heavy decay present. L3U4 (Right) a 10"x10" downstream diagonal has minor decay in right member which should be monitored in the future if the decay spreads. The Left member has major decay (9") localized at the brace. While not designed as a tension or compression member, the bracing serves to provide rigidity against buckling.

Figure 4– Downstream L3U4 (Left) 9" of Major Decay

Element	Location	Truss Downstream Diagonals
135	L0U1	No defects noted.
135	L1U2	Suspect Decay on Left (L ₁ X10) (R ₁ X10).
135	L2U3	Suspect Decay both sides (L ₁ X10) (L ₁ X10 Starting on Left).
135	L3U4	Decay on Right bottom (R1 R2X8). CS4 Decay Left above brace (X1R9).
135	U3L4	Distortion, Decay Left.
135	L4U5	Decay Right (X10) R CS2 8'.
135	U4L5	Decay Right below brace (X10), Left missing 3 bolts (X10).
135	U5L6	Decay Left Middle (X10).
135	U6L7	CS3 Decay Left (R5X5).
135	U7L8	L CS2 10'.

Recommendation #4 – Repair CS3/CS4 timber truss members. Maintenance Priority = Urgent (next 1-2 years), est. \$10,000.

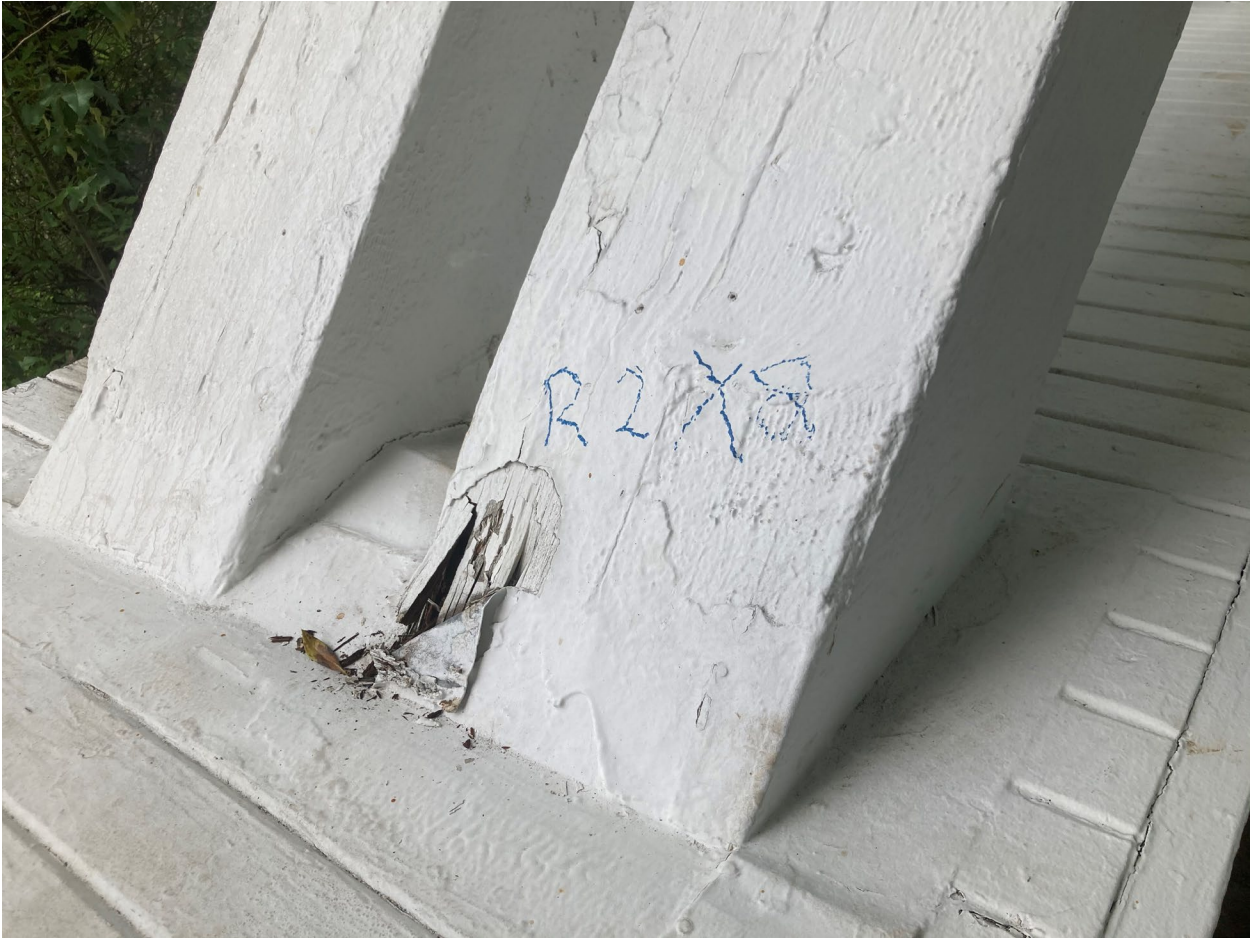
Figure 5 – Downstream L3U4 (right) 2” of minor decay

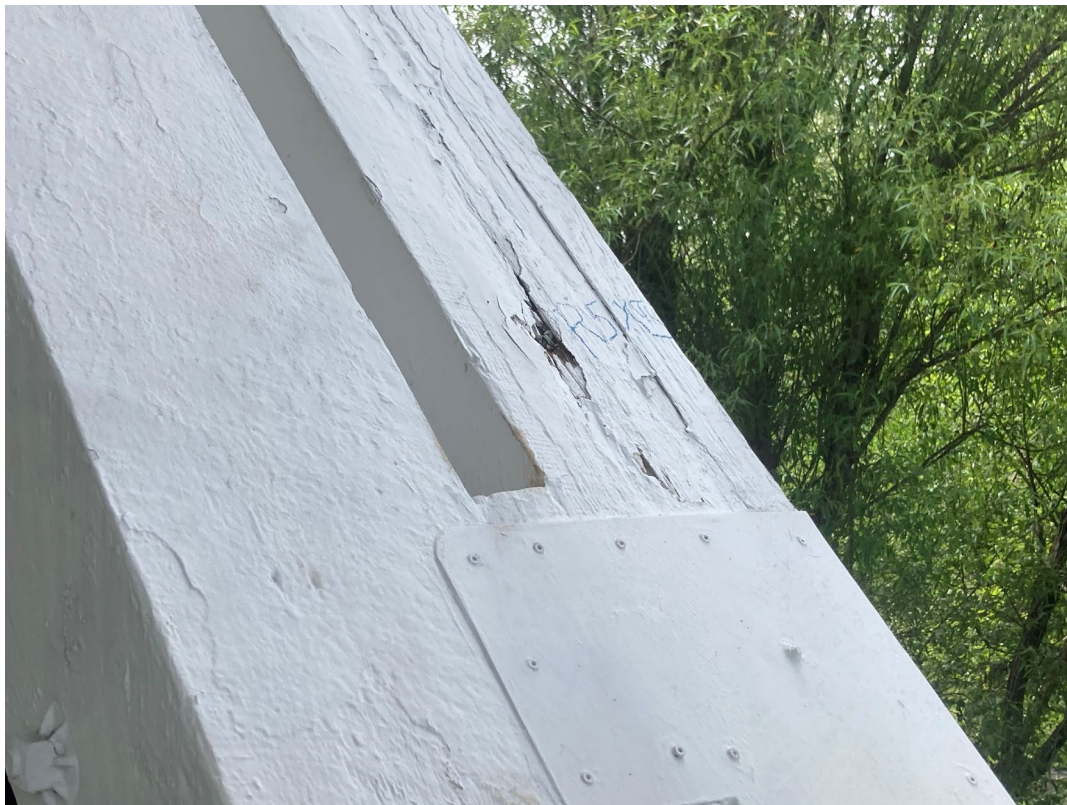
Figure 6 - Downstream U6L7 (Left) 5" Moderate Decay

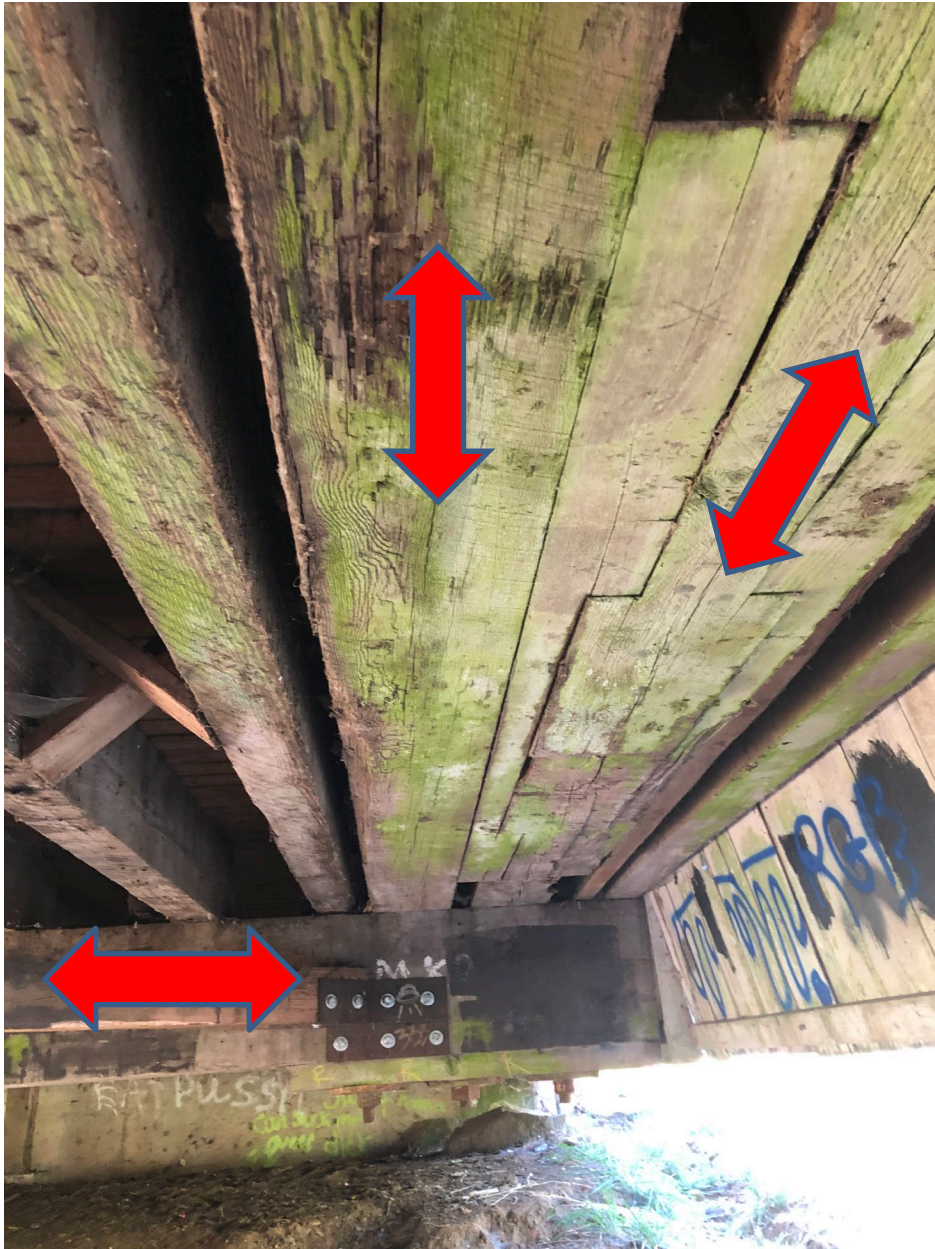
The bottom chord also has decay throughout with moderate decay on top of the bottom chord along the downstream side of the bridge. All of the bottom chords are 12"x12". L1L2 and L6L7 have 3" of moderate decay. L2L3 has 6" of decay. And 6" of decay centered in bottom chord towards FB2 and 6" at the top FB3.

Figure 7 - Bottom chord L2L3 and Floor beam 2

Element	Location	Bottom Chord Downstream
135	L0L1	No defects noted.
135	L1L2	3' CS3 Section loss near FB1
135	L2L3	4' CS3 Section loss near FB2. 4' CS3 Section loss near FB3.
135	L3L4	No defects noted.
135	L4L5	No defects noted.
135	L5L6	No defects noted. Anchor rod broken and bolt missing at connection.
135	L6L7	5' CS3 section loss near mid length.
135	L7L8	No defects noted.

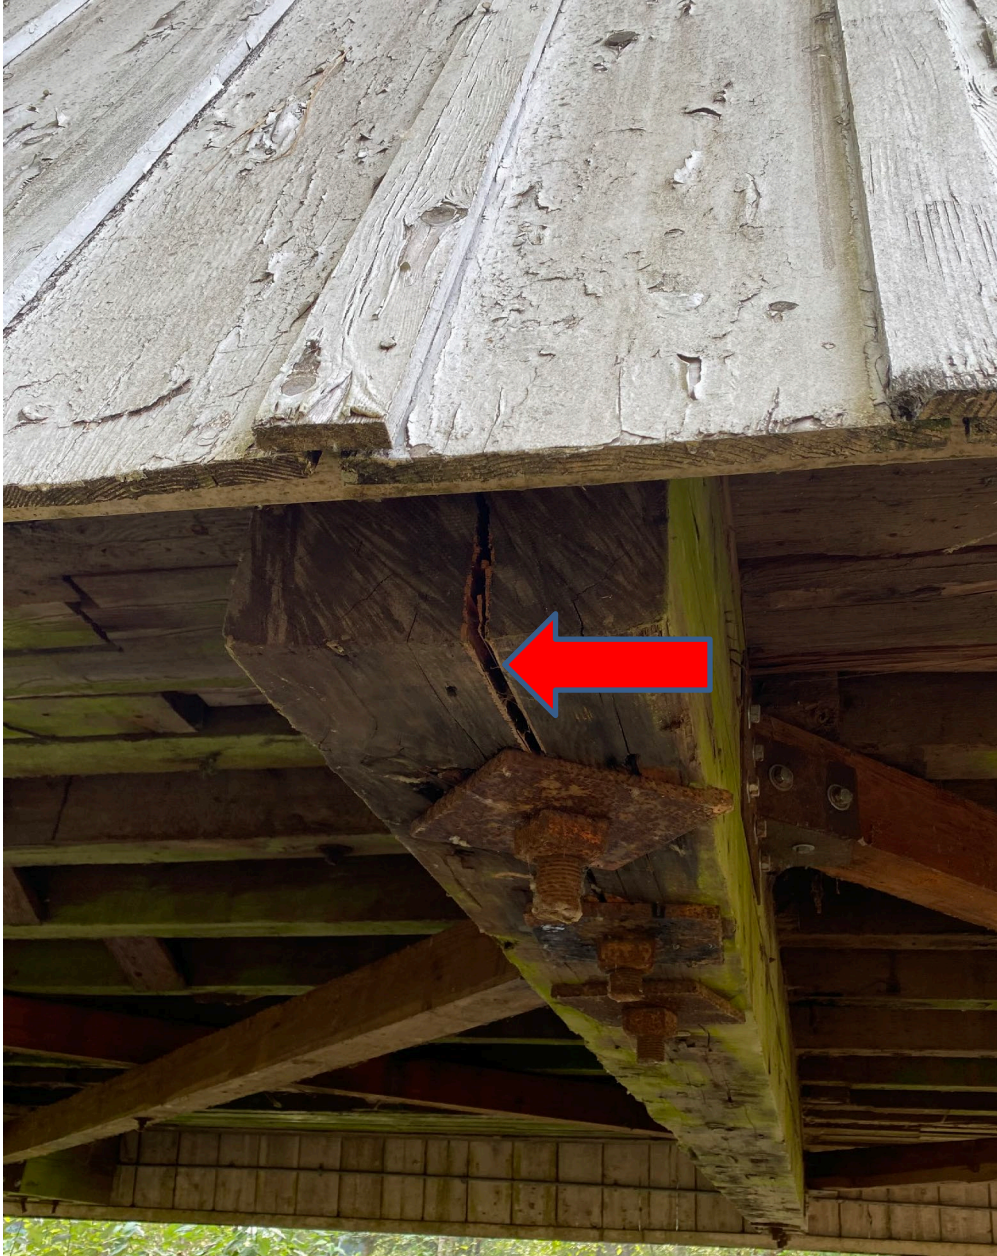
Figure 8 – Split at end of Floor Beam 3

Floor beam 3 has a split at both ends that will need to be monitored. We recommend repair with a fish plate to stabilize the split.

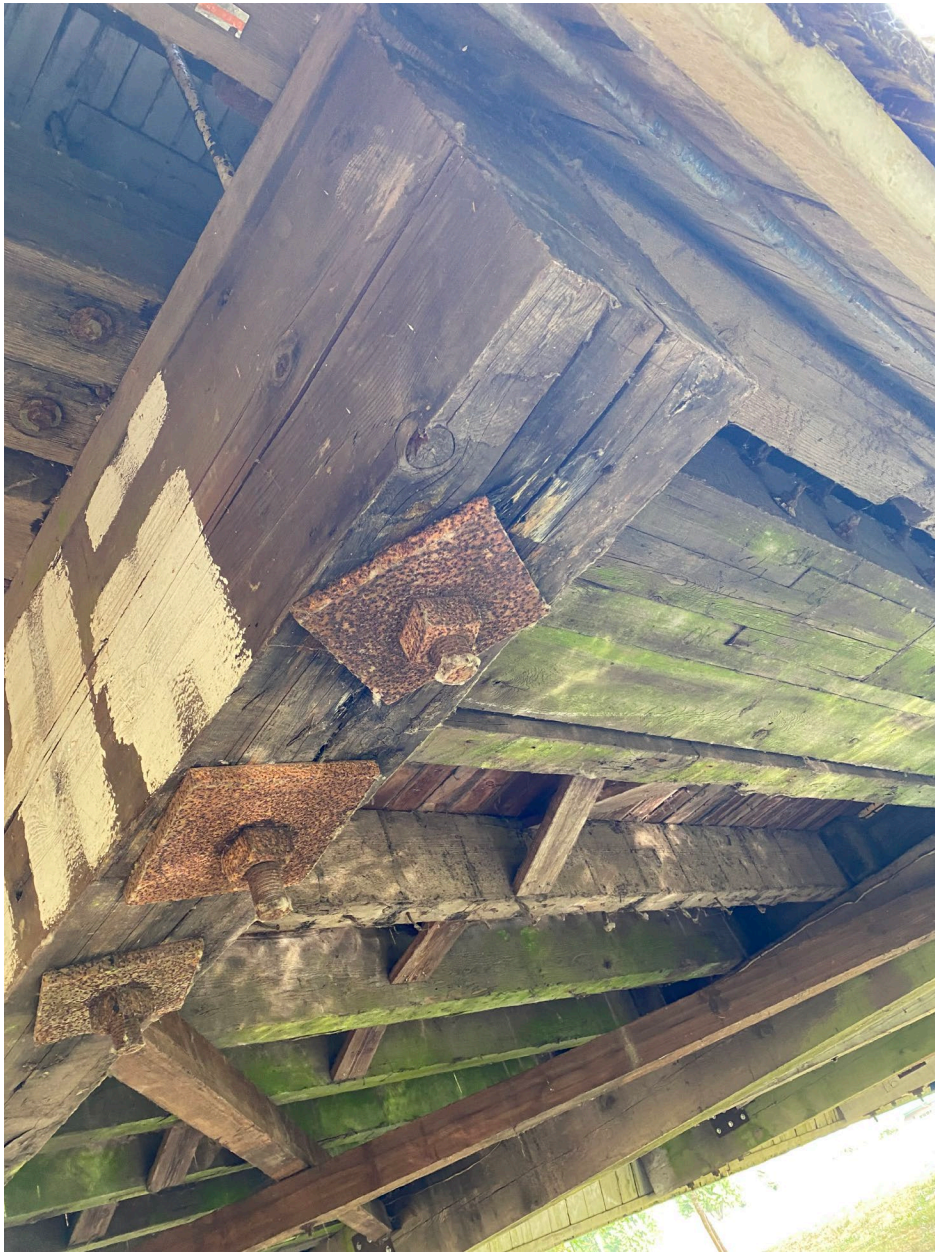
The steel rods and anchor plates have mild surface corrosion and pitting. They need to be painted to prevent future section loss. The section loss is within tolerable limits.

Figure 9 – Pitting on tie rod anchors

Recommendation #7 – Clean and paint pitted plates at bottom connection of steel cables. Maintenance Priority = Routine Schedule (next 2-3 years), est. \$2,000.

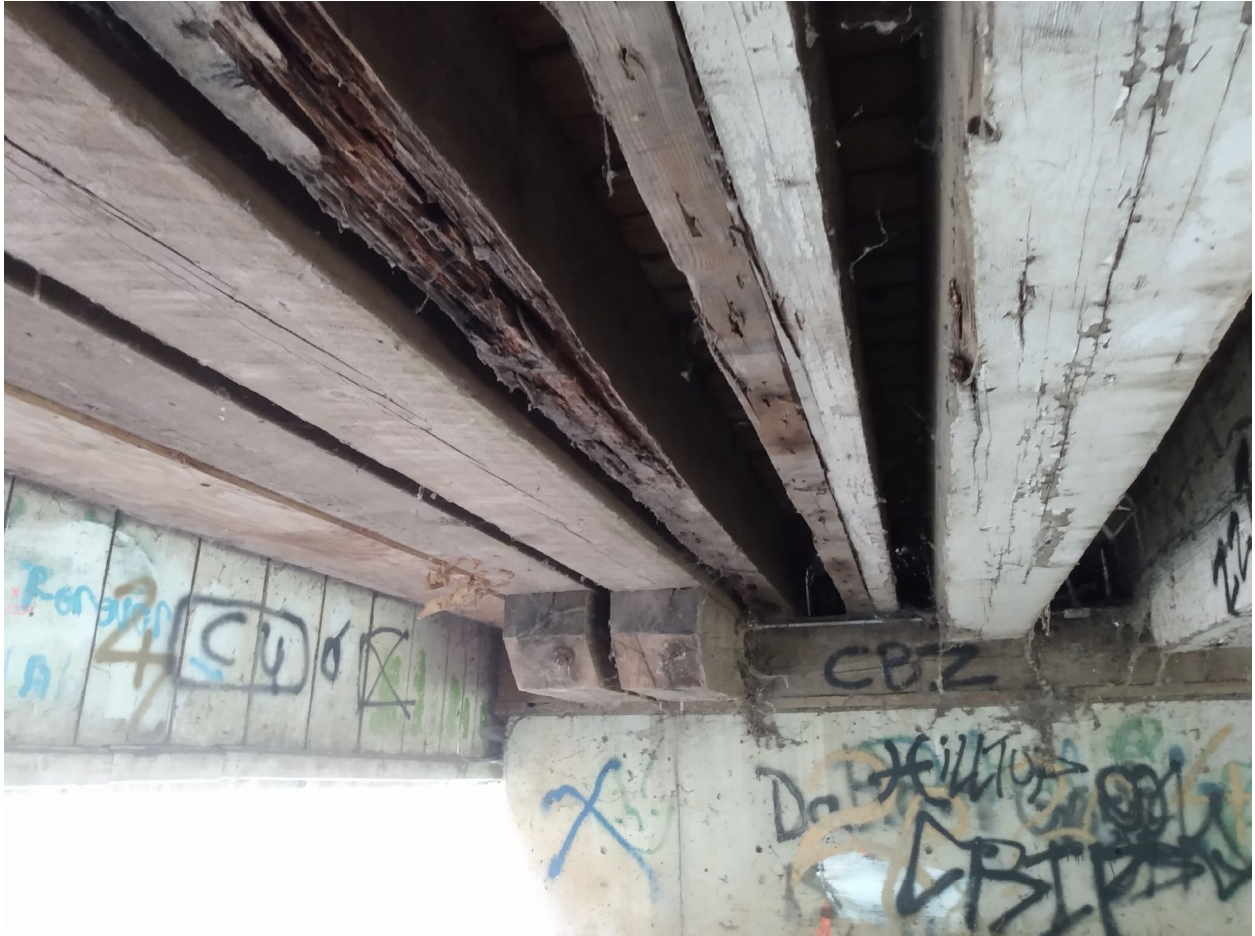
Most of the stringers are in satisfactory condition. There are stringers with heavy decay, splits, and checking. Major decay was found in stringers: S6 in bay 1, and S1,5,6 and 8 in Bay 8. Moderate decay was found in Bay 3, 4 and 5. Specific stringers are specified in maintenance recommendations.

Figure 10 - Bottom chord and stringer 1, 2 and 3

Recommendation #3 – Replace CS4 timber stringers: Bay 8 Stringer 1,5,6,8, and Bay 1 stringer 6. Monitor or replace CS3 timber stringers: Bay 1 Stringer 5, Bay 2 Stringer 5, Bay 3 Stringer 1, Bay 4 Stringer 4,7, 8, Bay 5 Stringer 1,3,5,7, Bay 7 stringer 3, and Bay 8 Stringer 10. Insert shims for timber stringers: Bay 3 Stringer 2 and 7, and Bay 4 Stringer 5. Maintenance Priority = Routine High (next 2-3 years), est. \$19,000.

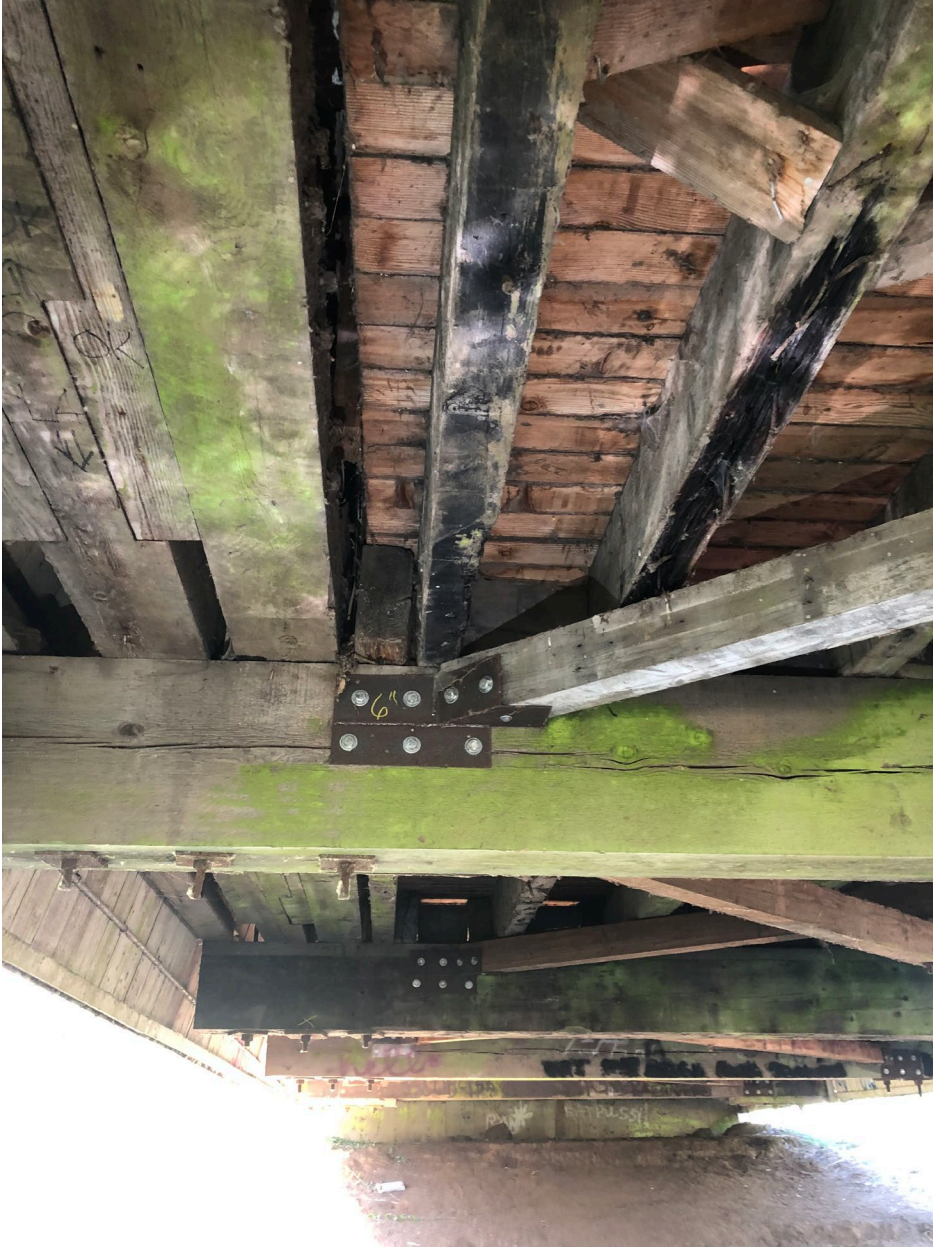
Figure 11 - Surface decay and fire damage to Bay 5 Stringers 7 & 8

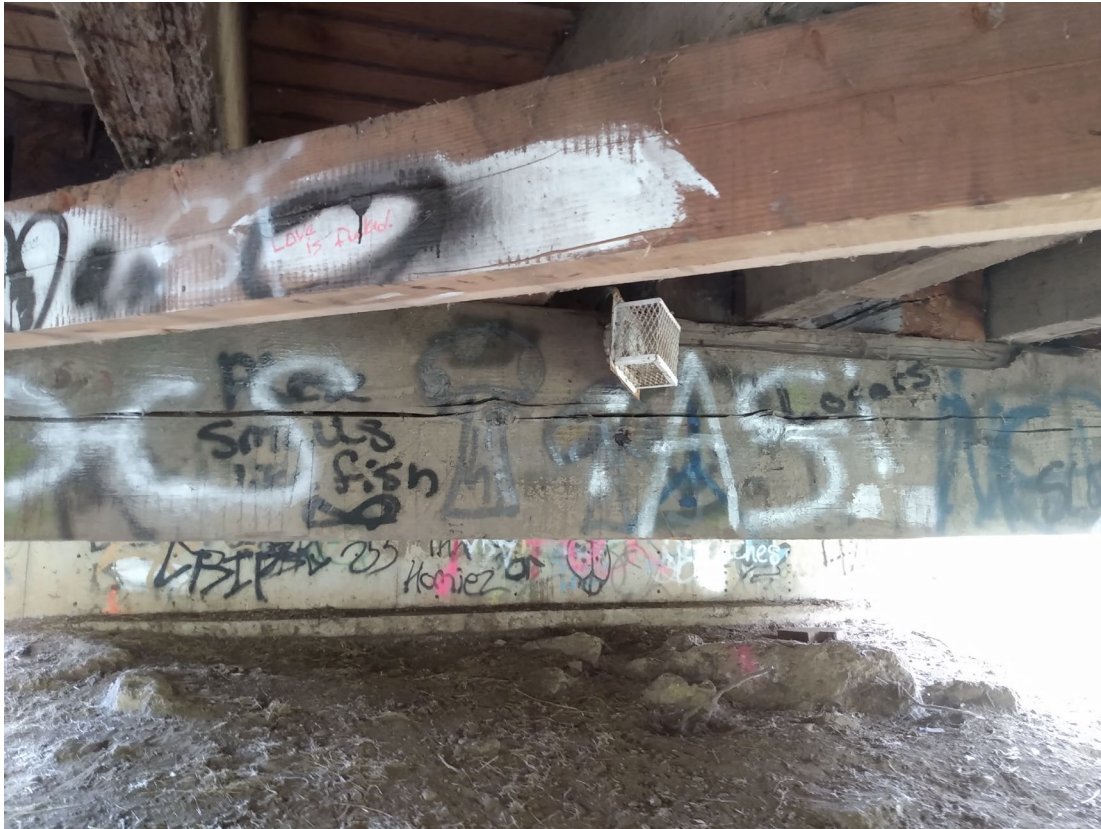
Figure 12 - Bent 2 scour – monitor scour after peak rainfall events.

Bent 2 has some scour with no undermining and appears to be in a stable condition. Monitoring the scour is critical. Erosion around the substructure may cause structure instability and should be prevented. Maintenance recommendations have been included with a monitoring program to continually reevaluate the stability of the substructure.

Recommendation #12 – Monitor the bridge ends after significant storms or flooding events to make sure the substructure fully supports the bridge ends. The bridge should have the concrete blocks fully bearing on the ground without any deflection to the structure. Immediately halt traffic using the bridge until the bridge abutments are stable and fully supported. Maintenance Priority = Monitor, est. \$250/year.

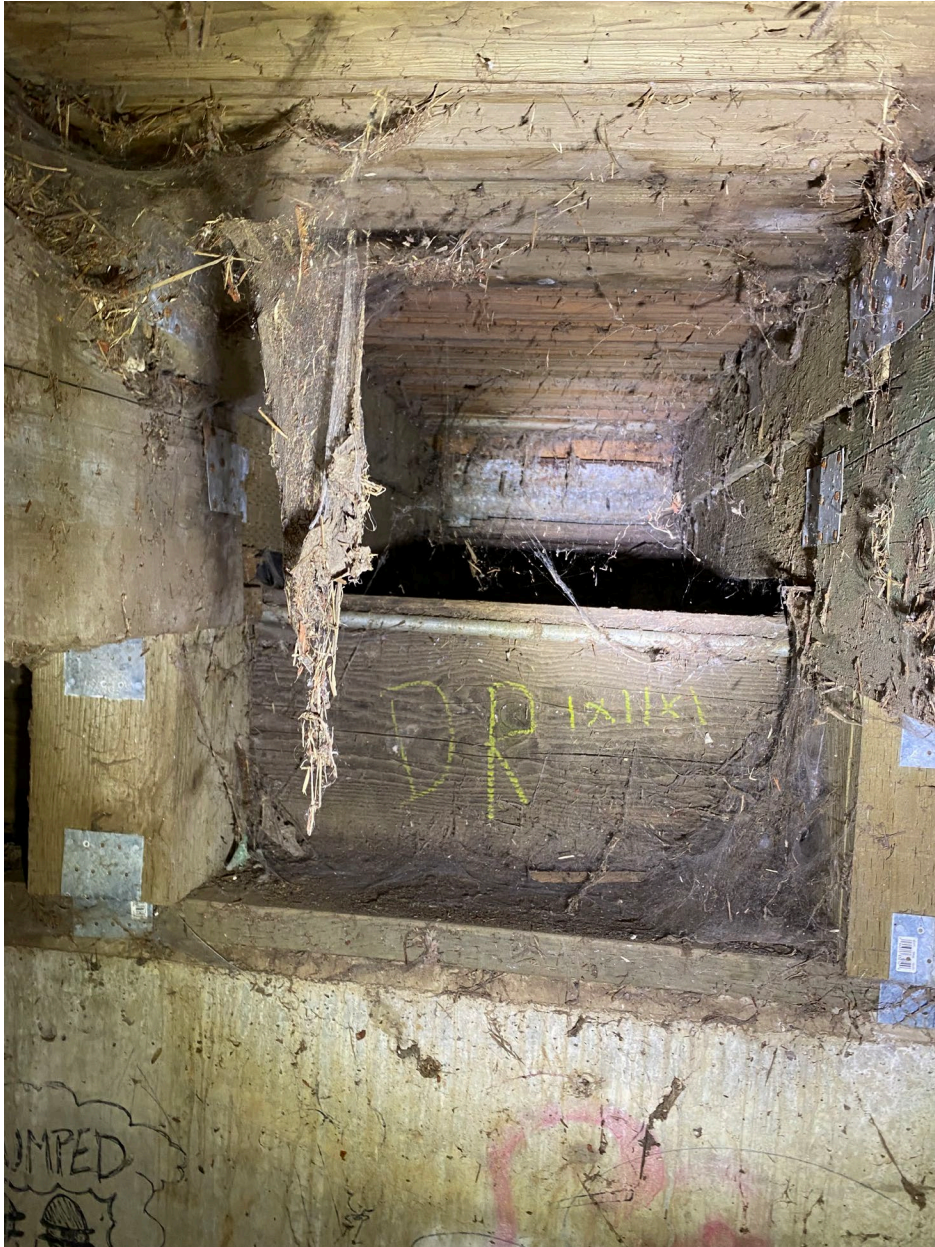
Figure 13 – Bent 1 backwall is a 1” shell with 11” of decay.

Element	Location	Concrete Abutment
215	Bent 1	1' CS2 crack. Timber sill on abutment has CS4 section loss full length.
215	Bent 2	1' CS3 crack D/S. Timber sill on abutment has CS2 check full length. Bumper board rotted. Footing is exposed.

Recommendation #10 – Replace bumper boards on both sides of the bridge. Approach at both ends of decayed boards at the ends of the bridge. The timber sill/backwall is also needs to be replaced due to decay. Maintenance Priority = Routine High (next 2-3 years), est. \$3,000.

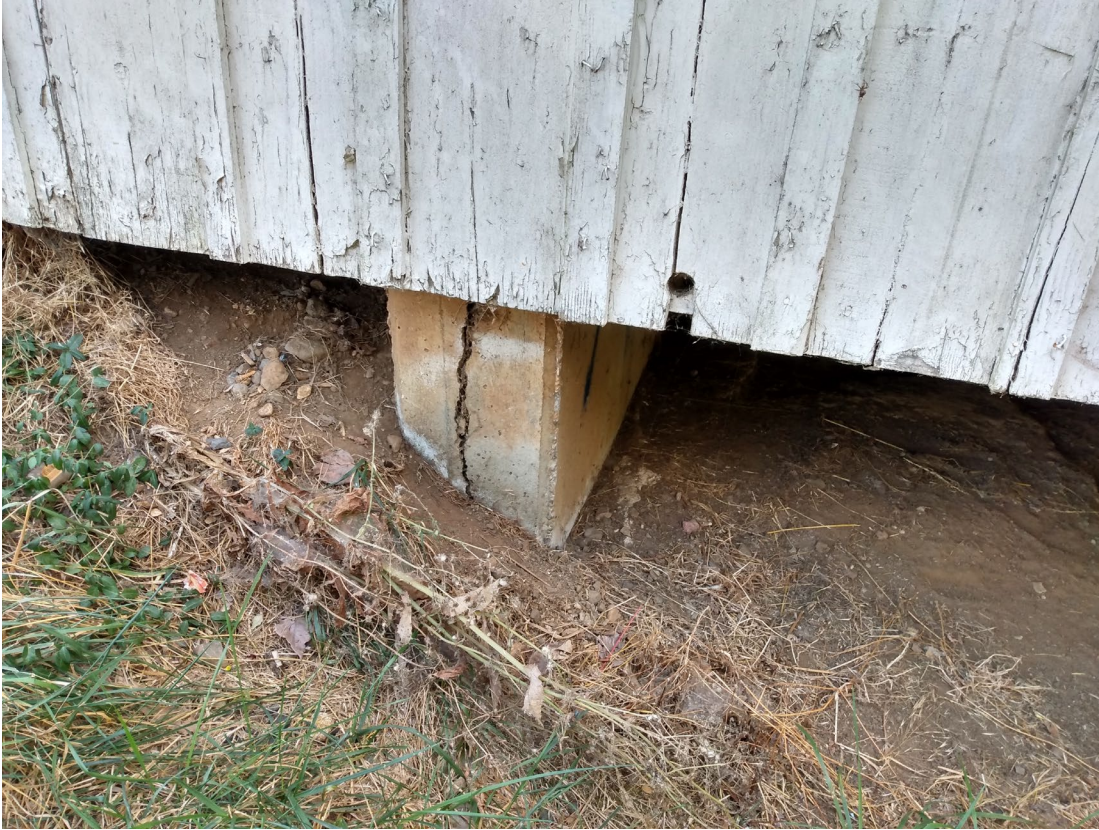
Figure 14 – Crack present in Bent 2 appears stable but should be monitored.

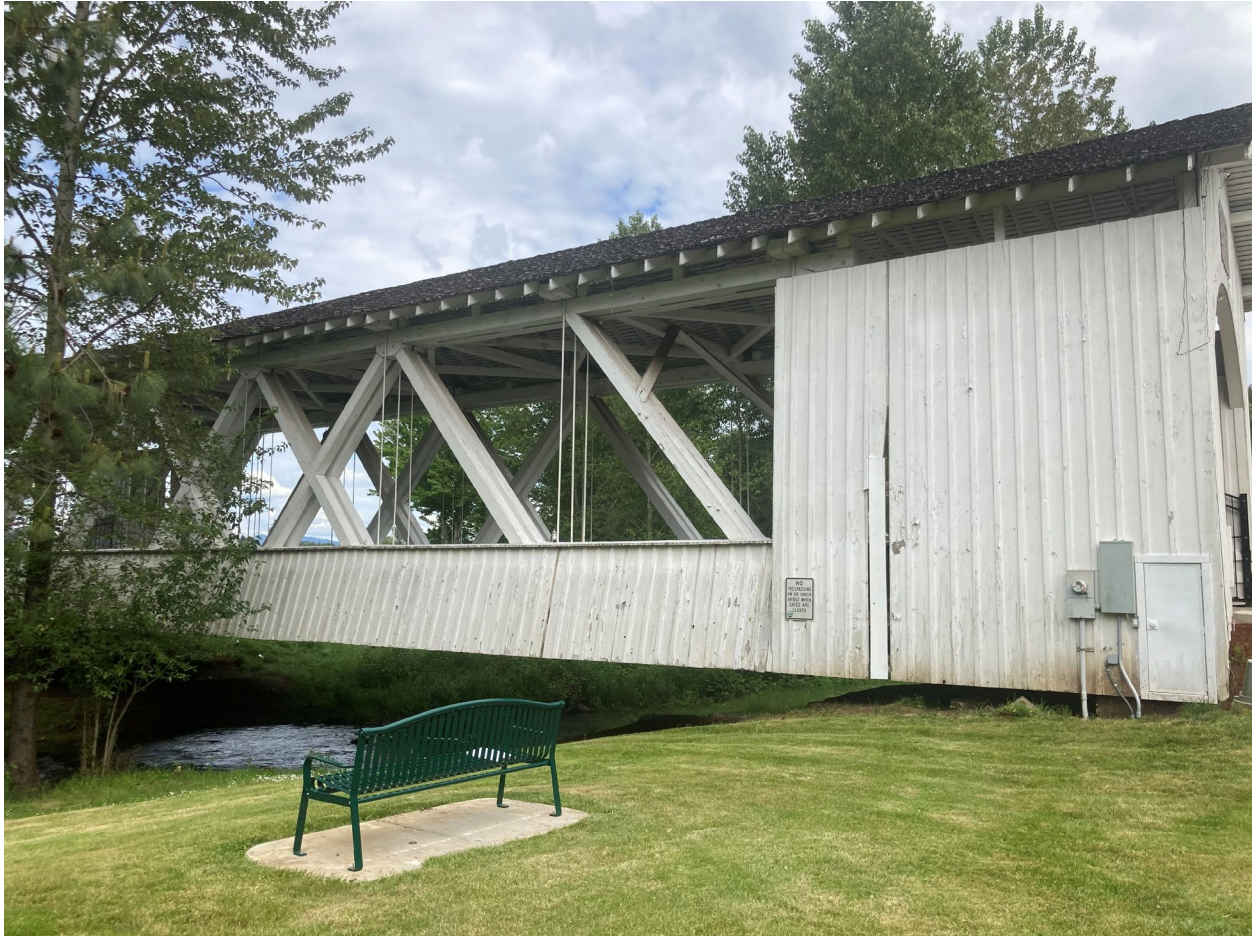
The painting system on the outside of the house is approaching the end of its useful life. Repainting of the bridge within the next five years will extend the life of the exterior siding and more importantly protect the interior truss members. As a protective system, paint repels damaging moisture that leads to timber decay. The inside portion has some life left but the top of the top chord is unpainted.

Figure 15 – Outside paint condition

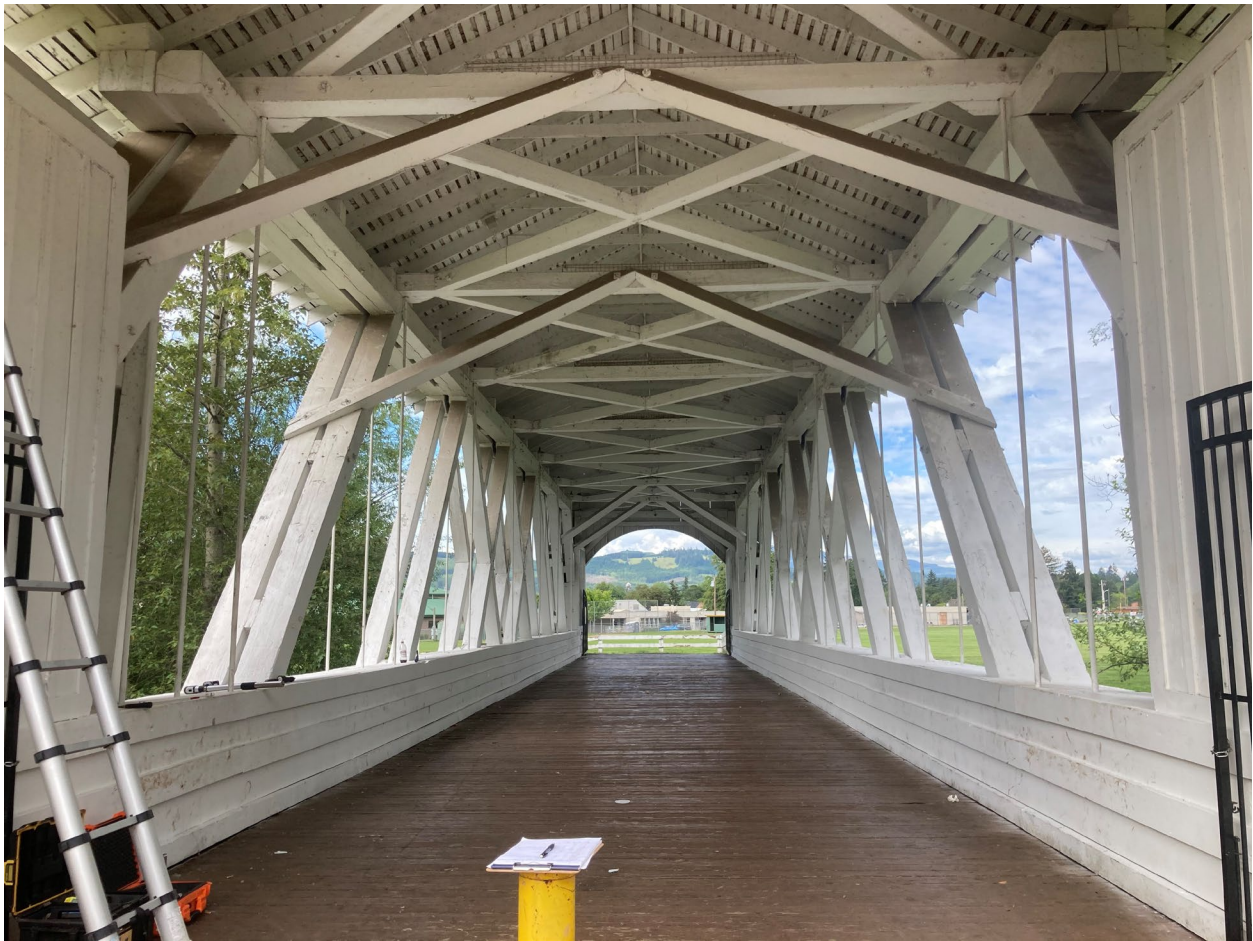
Figure 16 – Inside Paint condition
