**CITY COUNCIL WORK SESSION  
MEETING AGENDA**

TO: City Council  
FROM: Lisa Parks, City Administrator  
DATE: March 11, 2025  
SUBJECT: Davis Meeker Oak Tree Risk Assessment Final Report Briefing

The City of Tumwater contracted with Todd Prager and Associates LLC to perform a Level 3 Advanced Tree Risk Assessment for the Davis-Meeker Oak, a 66-inch diameter (DBH) Oregon white oak (*Quercus garryana*) and City of Tumwater-designated heritage tree. The advanced assessment included a thorough climbing inspection of the tree, sonic tomography testing at eight locations on the main stems of the tree, and a root crown excavation. The assessment also included a review of historic site conditions. The new information was used to categorize risk using the International Society of Arboriculture's tree risk assessment process. Based on that process, all but one tree part was rated as *low* risk, and one tree part was rated as *moderate* risk during the next three-year timeframe.

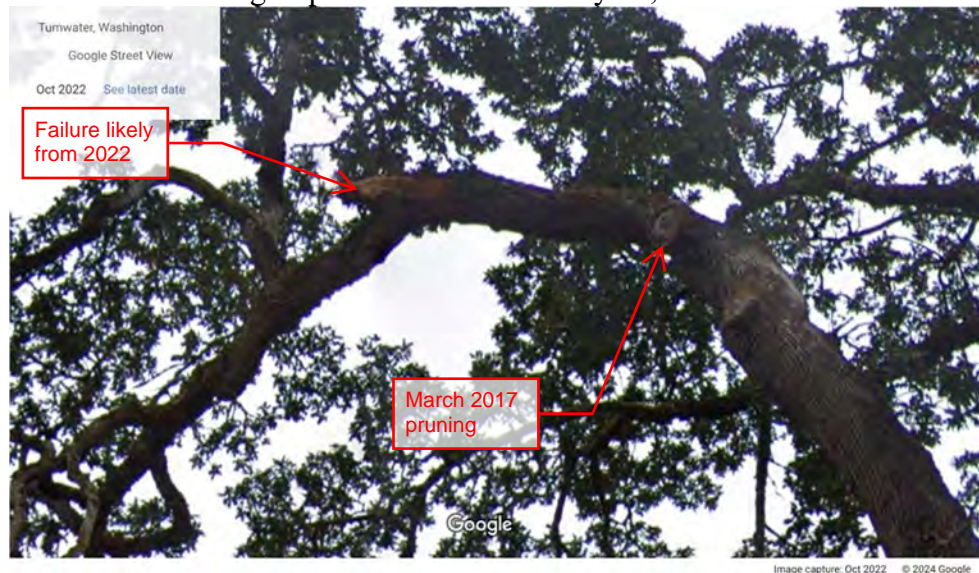
- There is a relatively recent branch failure, likely from 2022. Google street view shows the torn branch first appearing in October 2022. City of Tumwater records document removing of parts of the tree on July 16, 2022.

**Figure 4 October 2022 view of branch over Old Highway 99.**

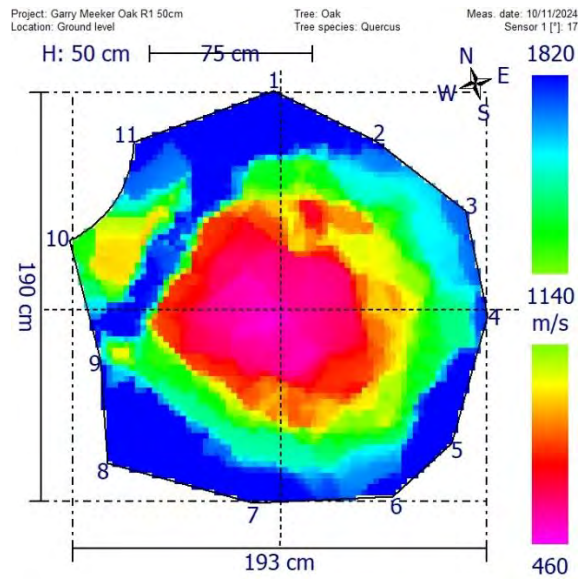
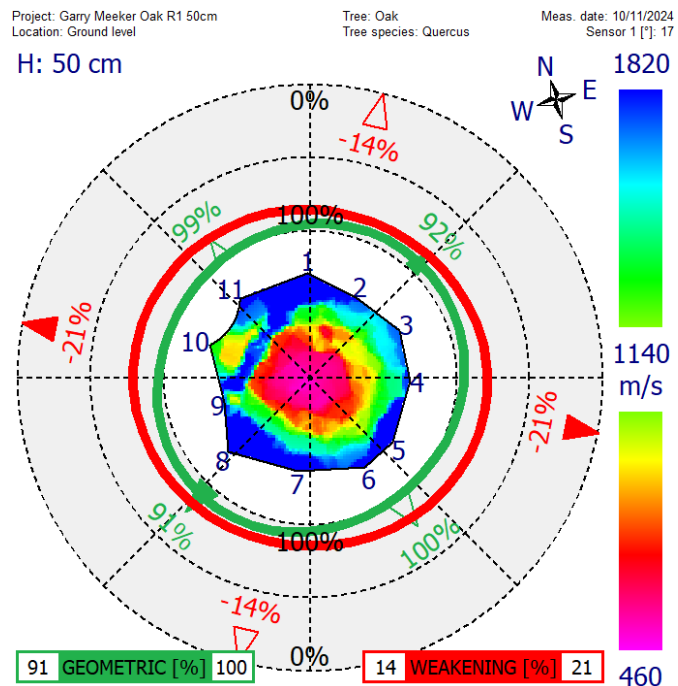
At this level there is significant compromised wood throughout the stem. The wood decay fungi that is affecting this tree has created a significant amount of compromised wood.

At this level there is between 14% and 21% strength loss depending on direction.

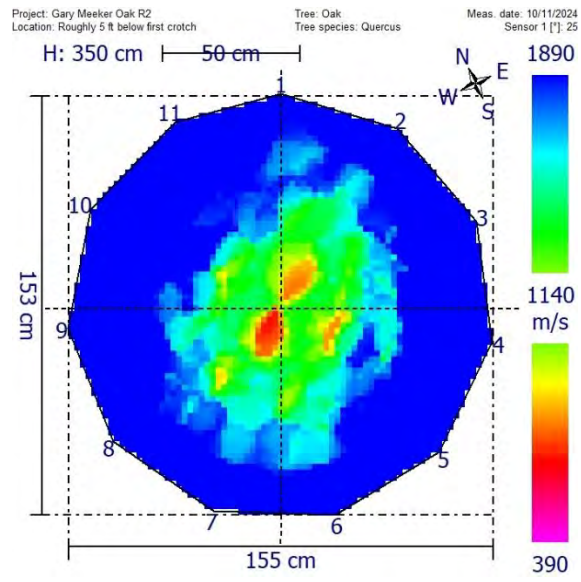
At this level there is a small amount of compromised wood in the center of the stem. The green indicates where the co-dominant inclusion is causing a weak attachment point.

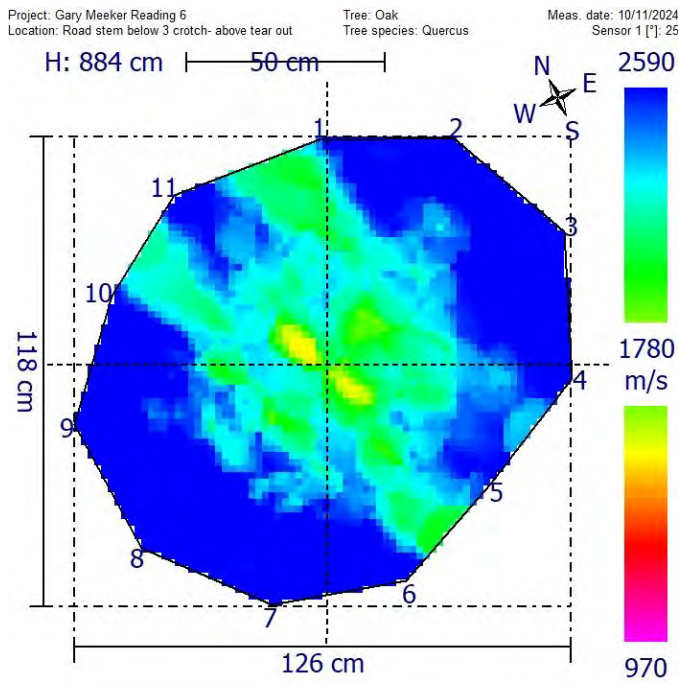
At this level there is included bark throughout the center of the stem, where the three stems connect.

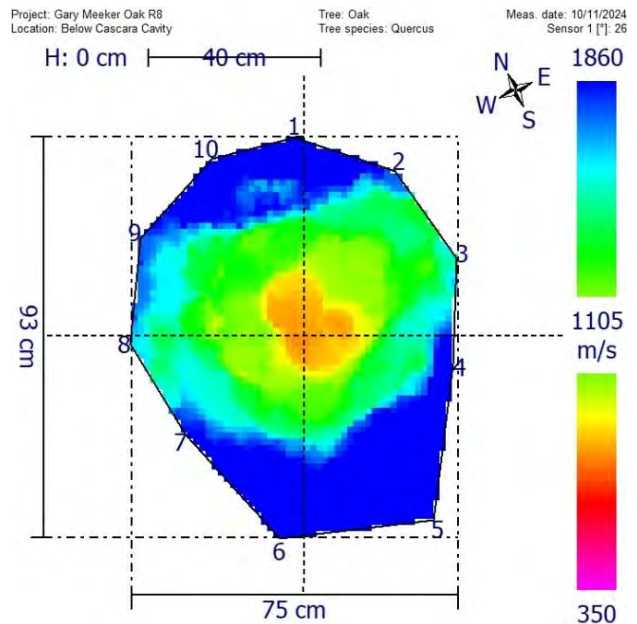
At this level there is less dense wood in the center of the stem. The center yellow spot indicates where the cavity above extends too.

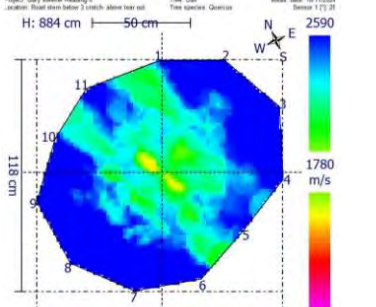
<p>At this level there is no sign of compromised wood.</p> <p>At this level there is no strength loss.</p>
6	884 cm/ 29 ft	Stem 1, below 2 <sup>nd</sup> codominant union, above SE branch failure (Jan. 2012)

<p>At this level there is likely included bark within the center of the stem, where the codominant stems connect.</p> <p>At this level there is between 2% and 8% strength loss. This is minimal strength loss.</p>

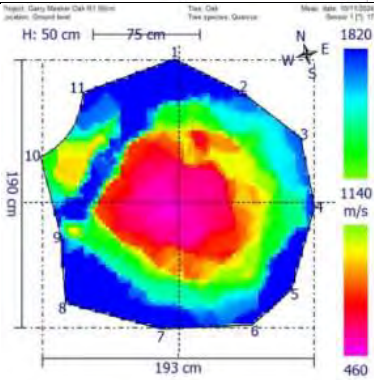
<p>At this level there is significant compromised wood throughout the stem. A wood decay fungi has created a significant amount of compromised wood and hollow trunk.</p> <p>At this level there is between 14% and 21% strength loss depending on direction.</p>
<p>1</p> <p>50 cm/ 1.6 ft</p>	<p>Main stem near ground level.</p>

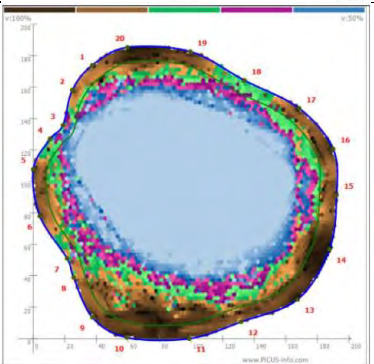
<p>Tree Solutions sonic tomography reading. Conclusion was that there is sufficient wood to support existing tree. The sonic tomography strength limit appears to have been set at approximately 80 percent hollow, or approximately 4-inches (10 cm) of sound wood based on the tree's diameter at the measurement point.</p>

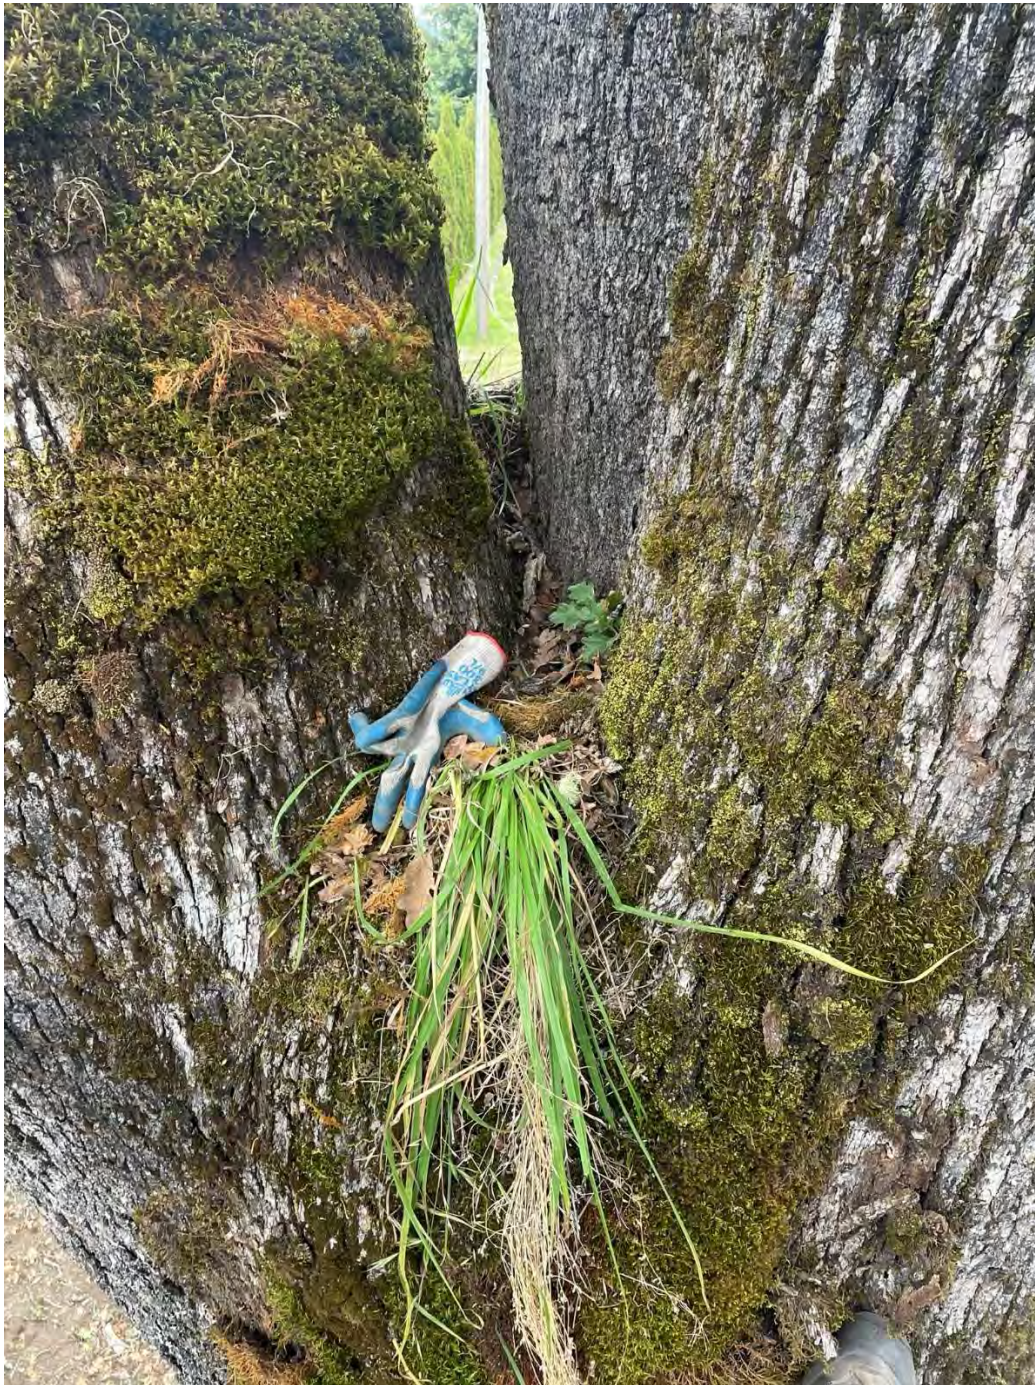
Figure 2 Debris accumulation and plant growth between codominant stems.

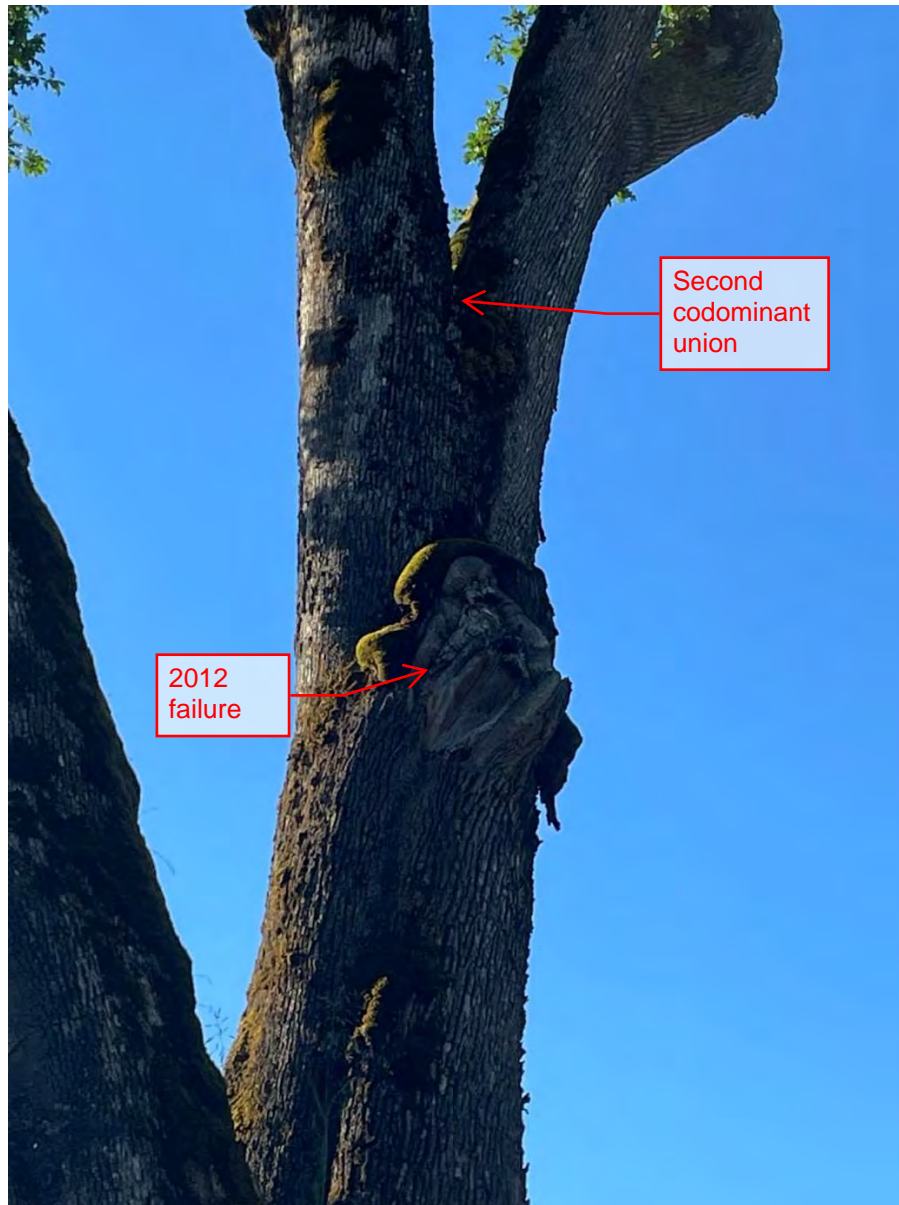
Figure 3 2012 failure and the second codominant union related to the following series of photos.

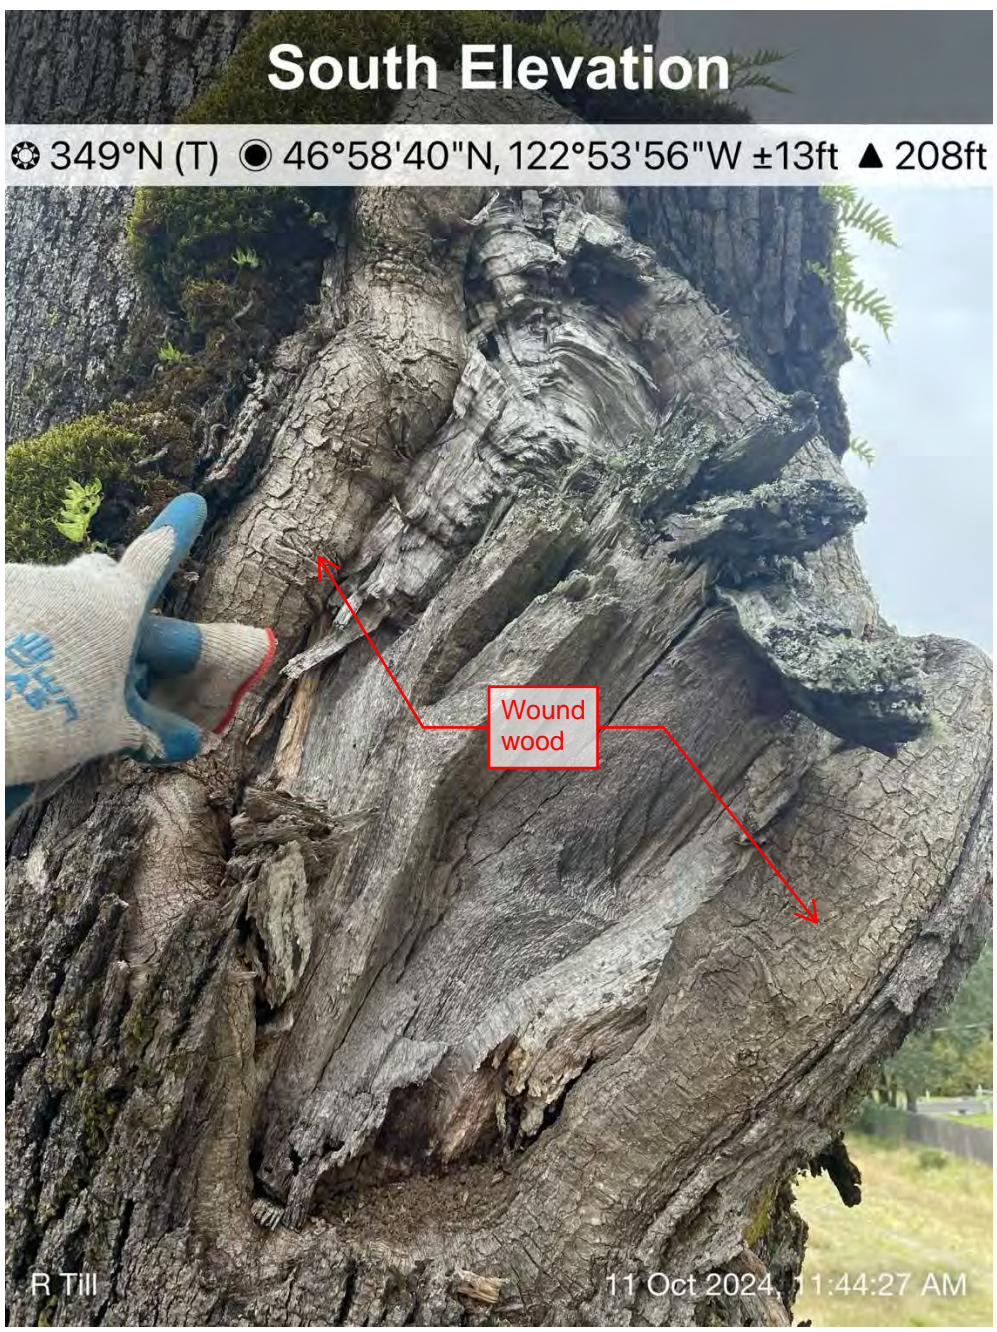
Figure 4 Failure on southeast side of central stem at 26 feet.

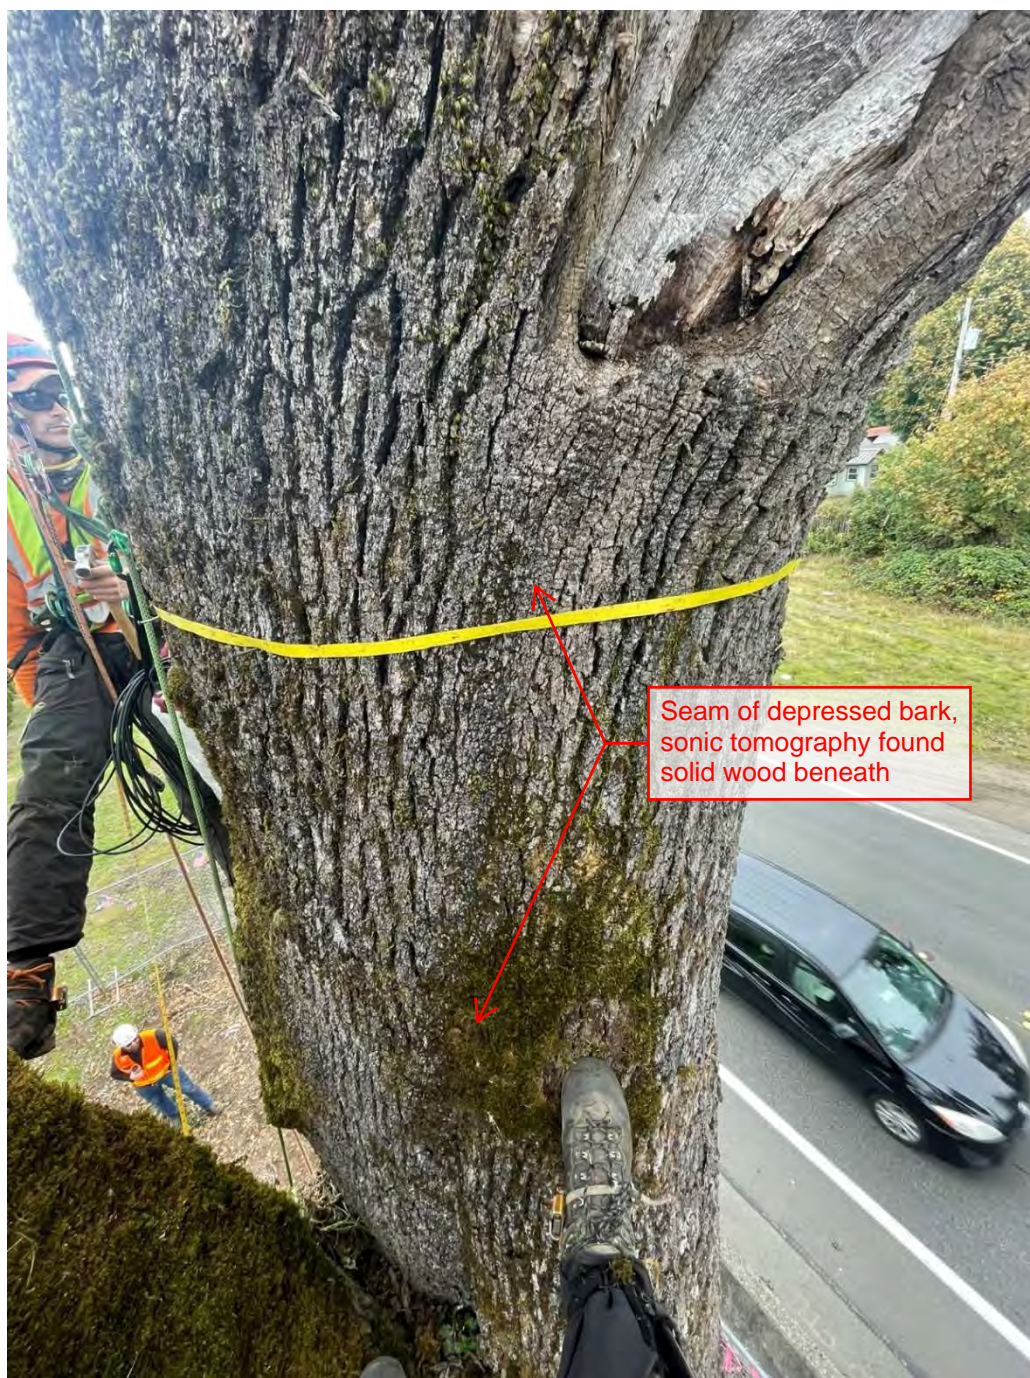
Figure 5 Seam below 2012 failure. Sonic tomography found solid wood down into codominant union.

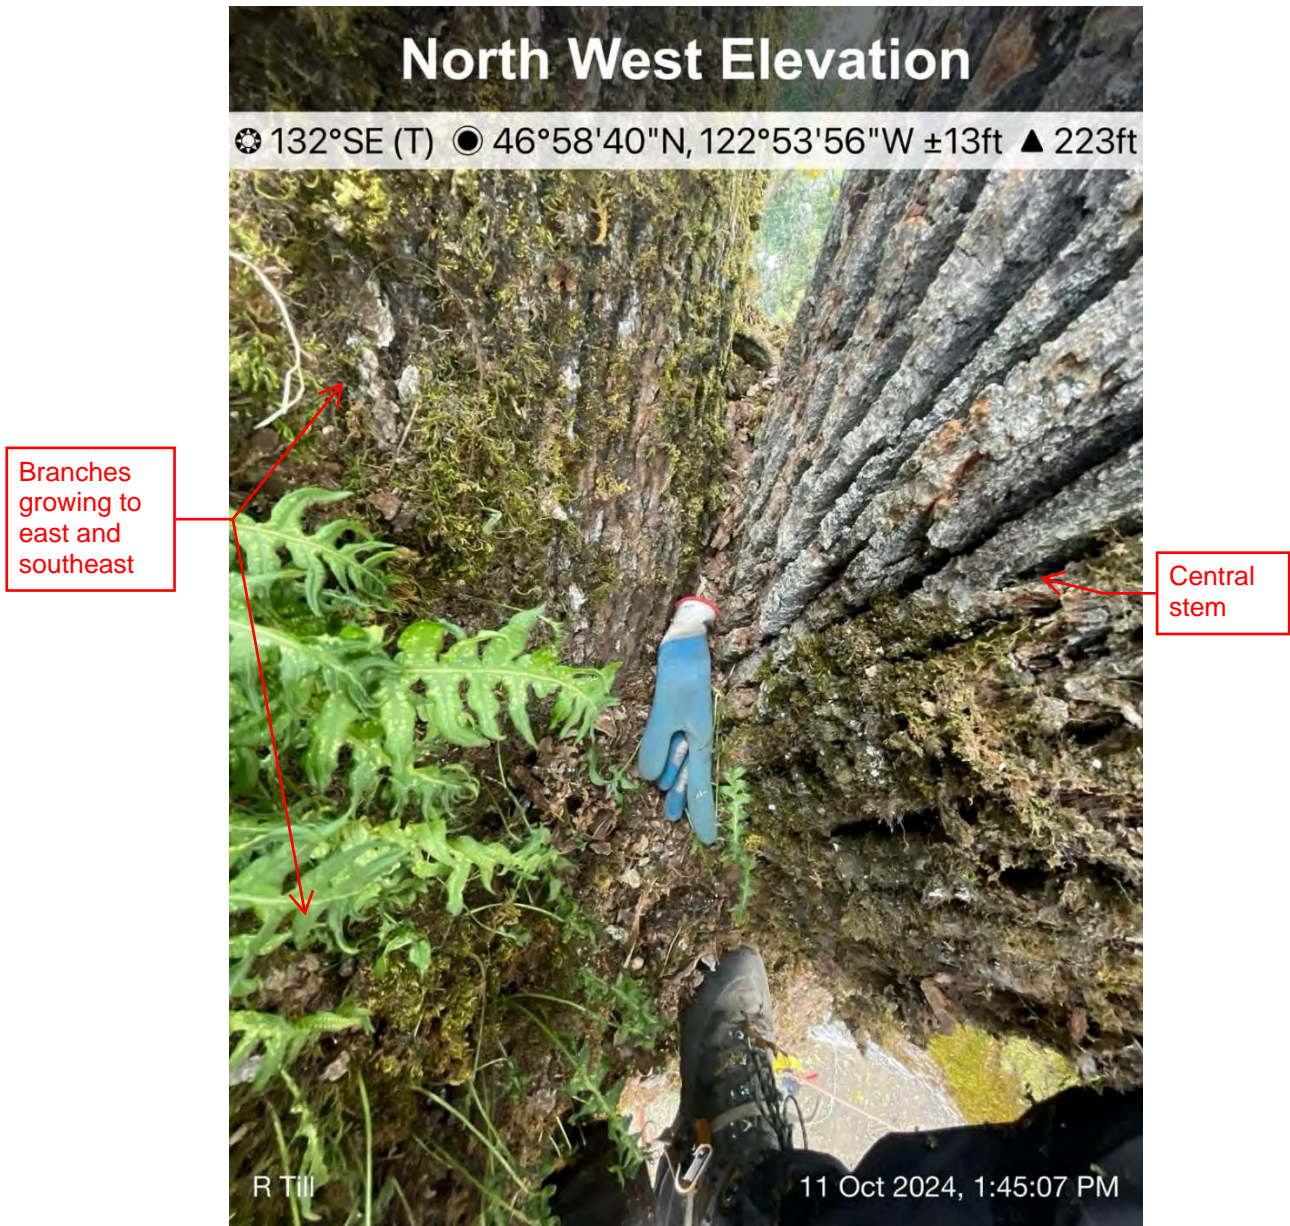
Figure 6 View directly down into second codominant union. Two stems over the road are on the left and central stem to the right. Union has included bark. Probing did encounter solid resistance beneath debris.

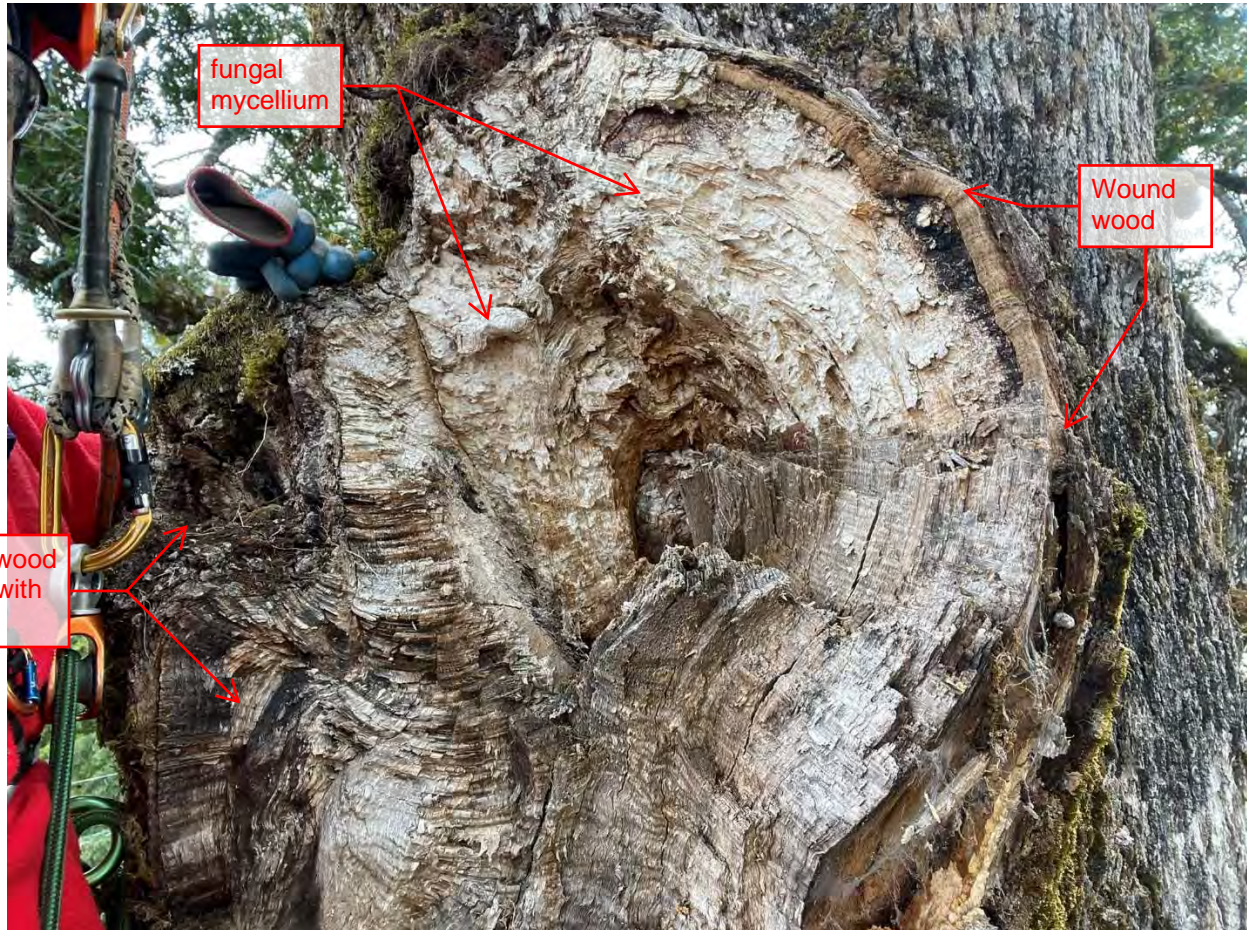
Figure 11 Wound wood on the top-right margin is positive response from tree. The fungal mycelium sampled from this location was identified as a *Stereum* species, which primarily consumes dead sap wood.

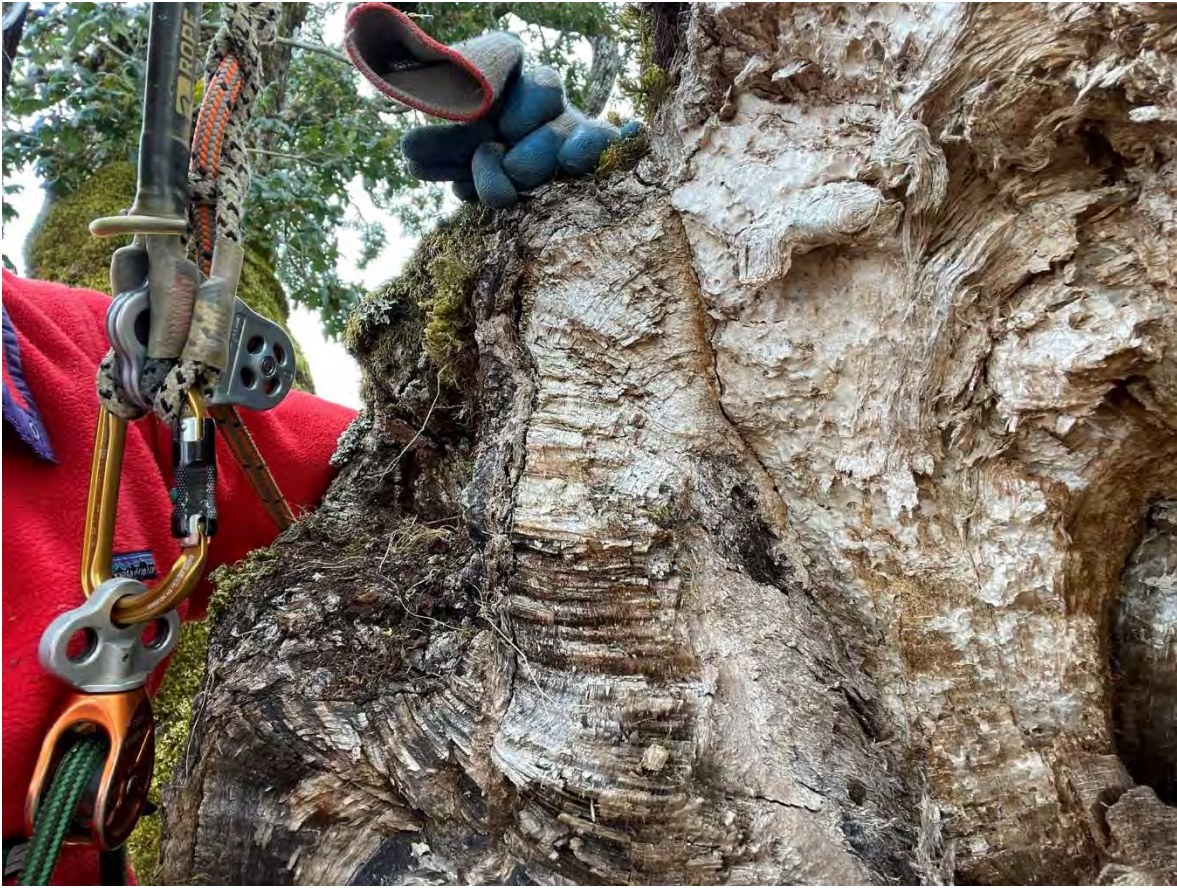
Figure 12 Left margin of 2023 failure and adjacent historic wound.

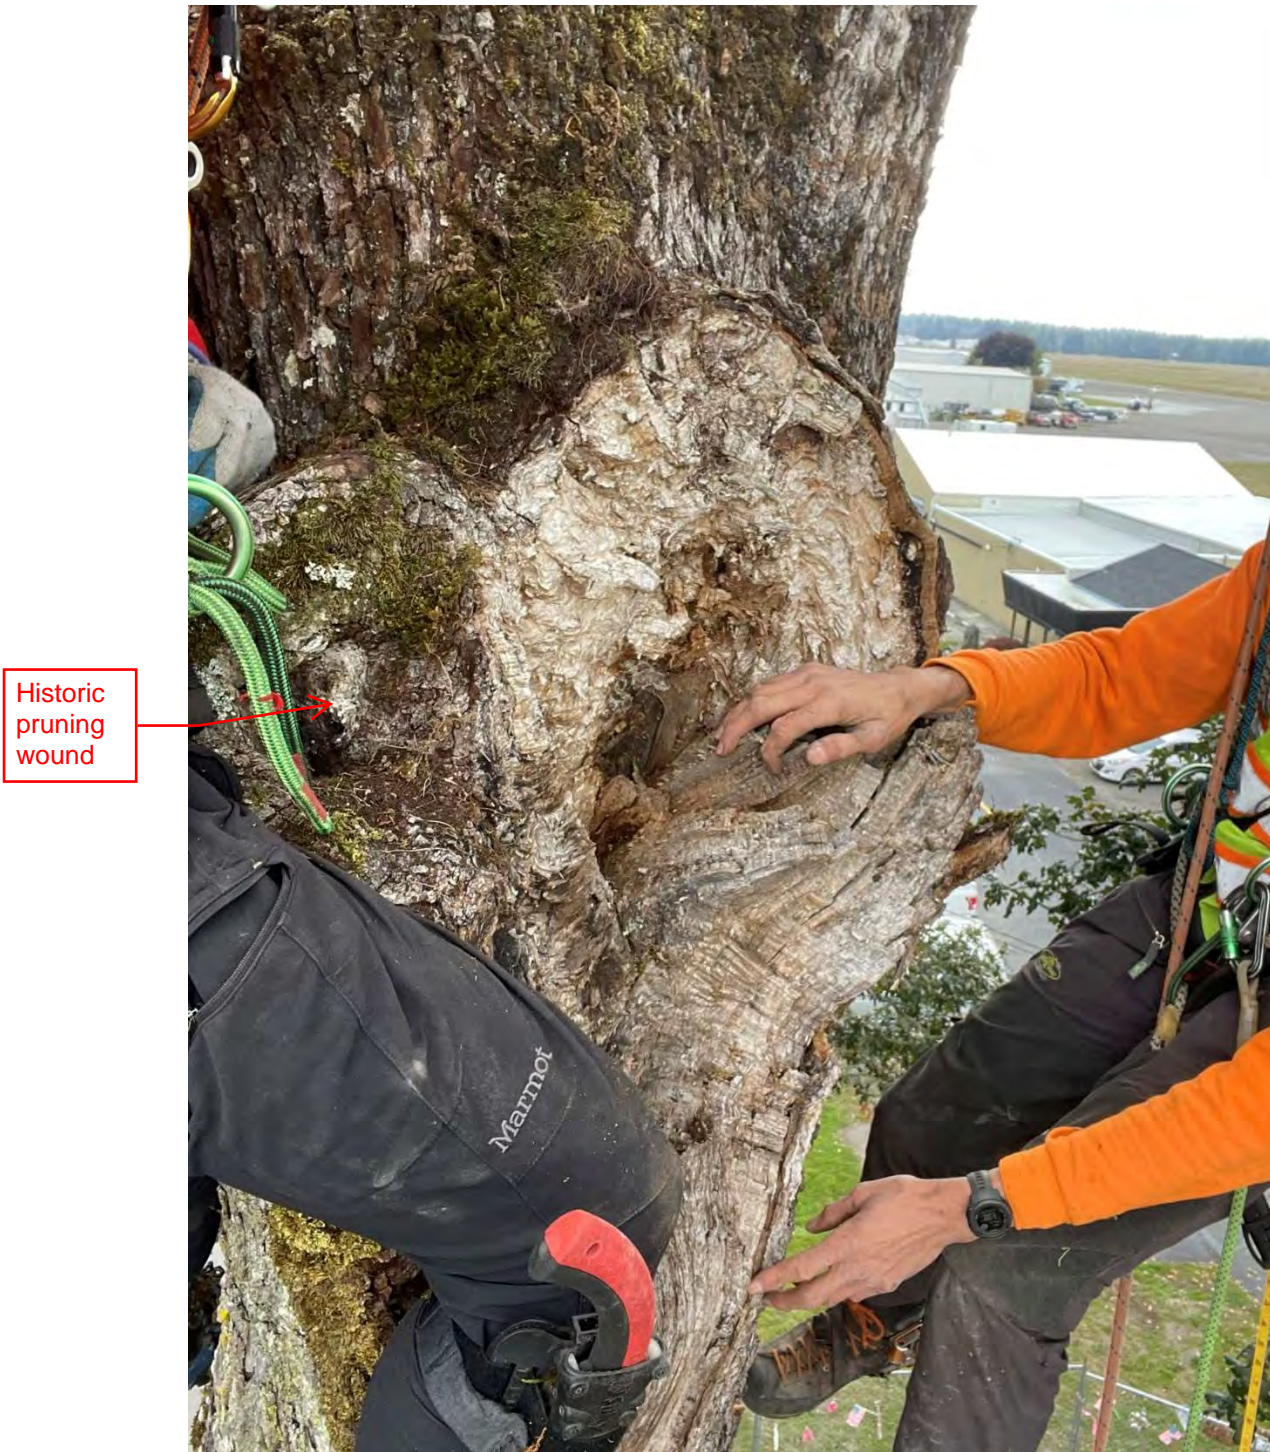
Figure 13 Additional view of 2023 failure and historic pruning wound.

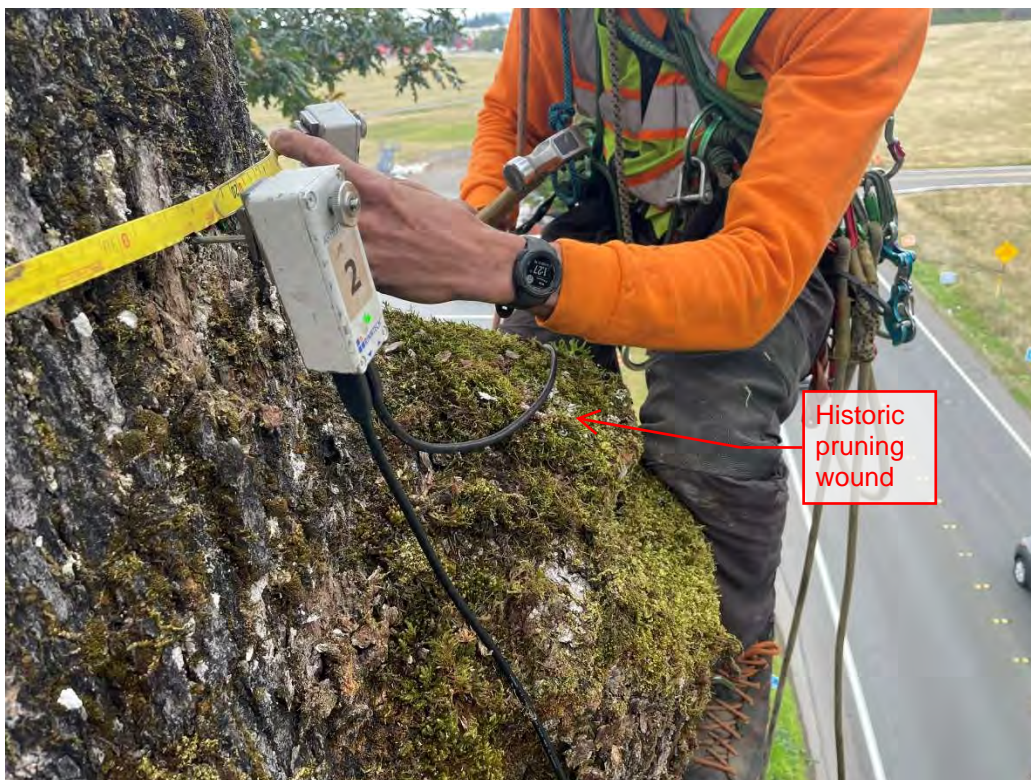
Figure 14 Historic pruning wound (covered in moss directly below watch) approximately 1 foot above the 2023 failure and below the Kestrel cavity.

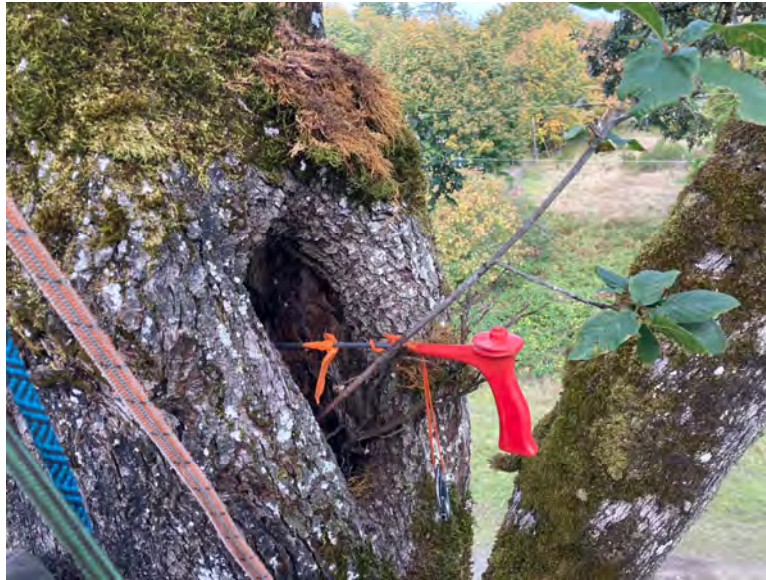
Figure 15 Photo depicting depth of cavity and cascara (*Frangula purshiana*) growing from cavity.

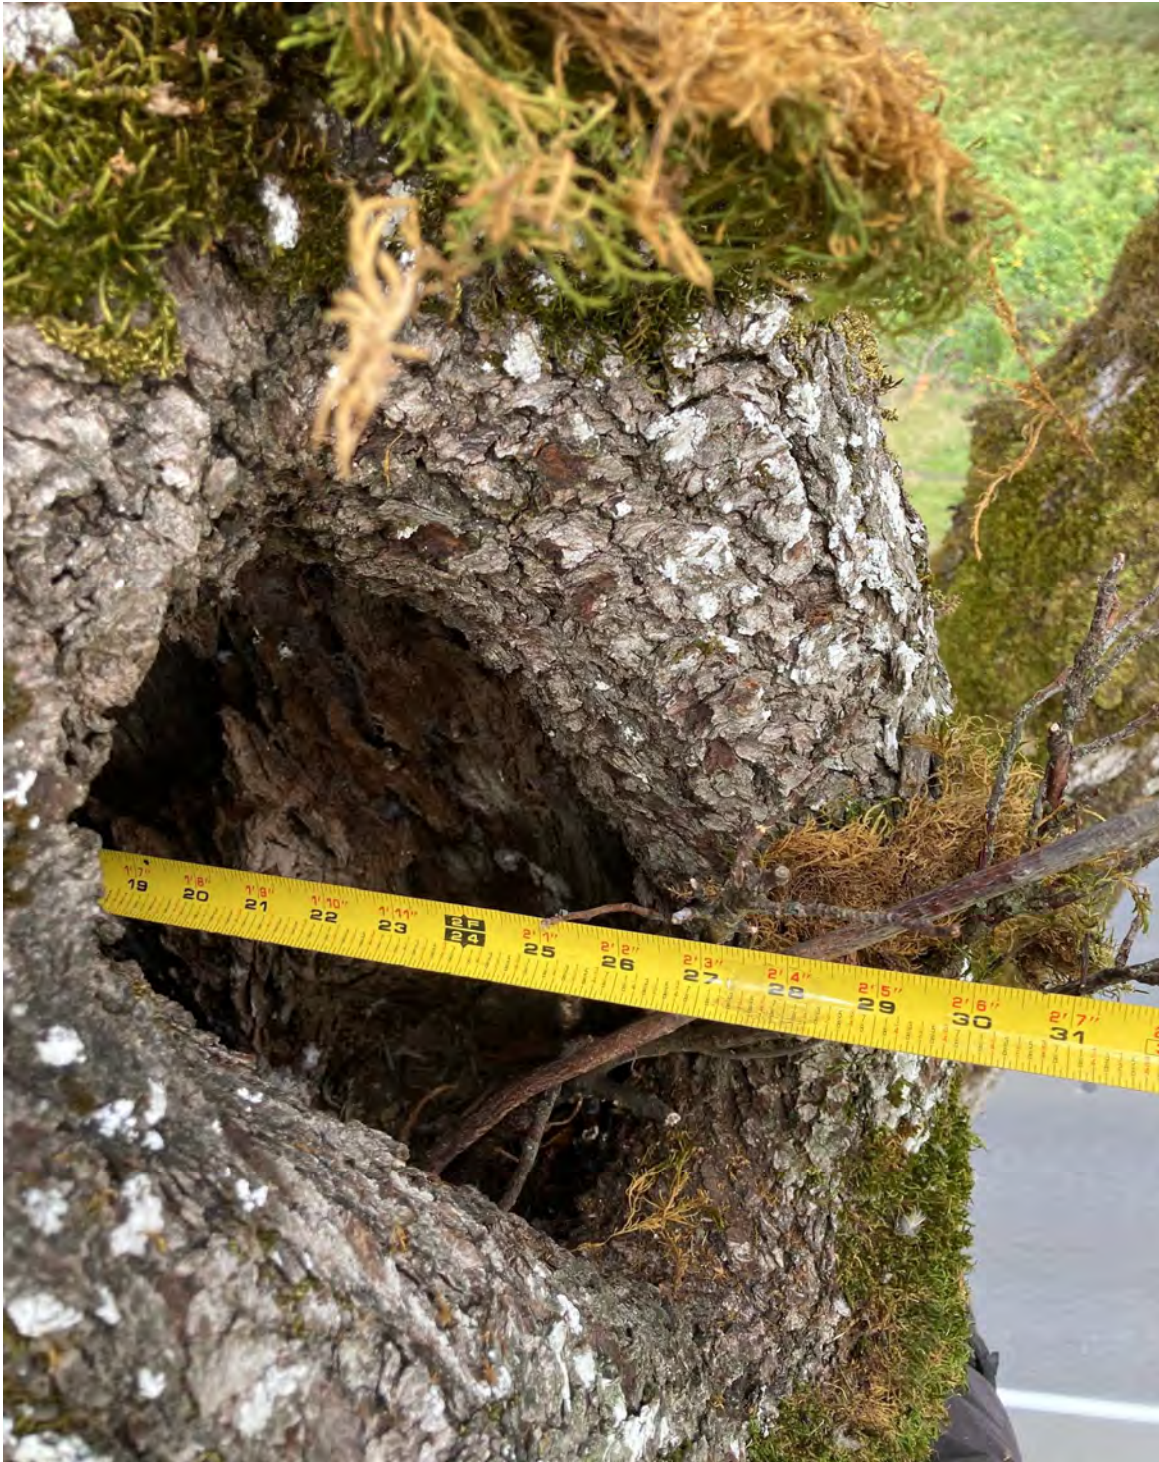
Figure 17 Depth measurement at approximately 25 inches.

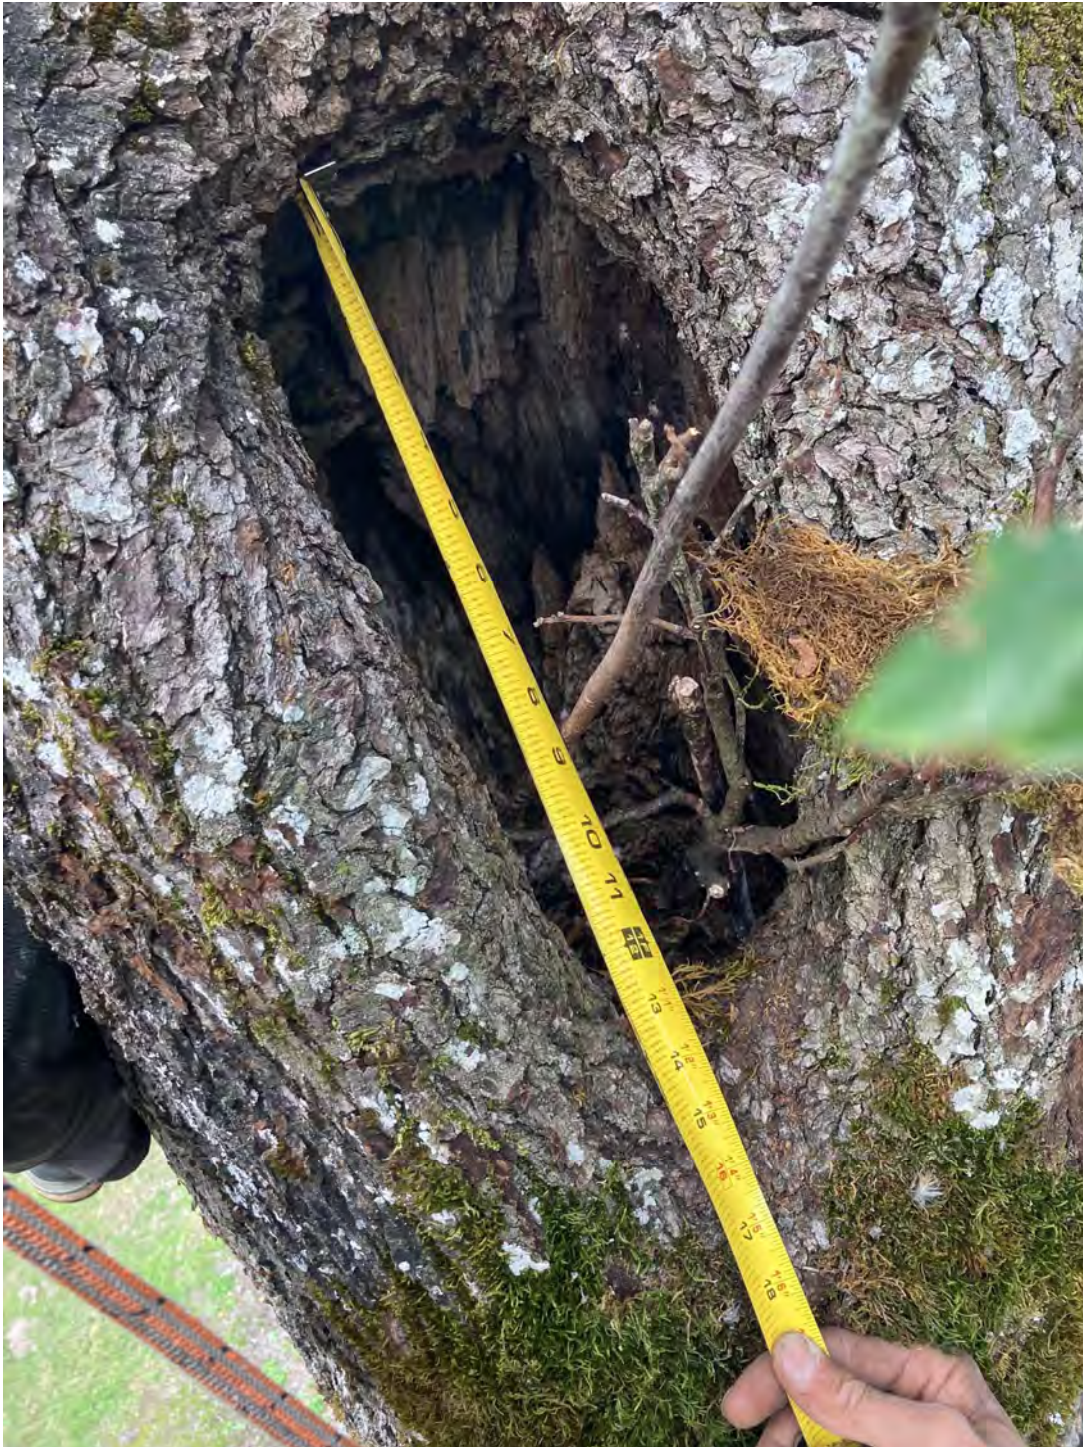
Figure 19 Depth measurement at approximately 24 inches to interior edge of cavity.

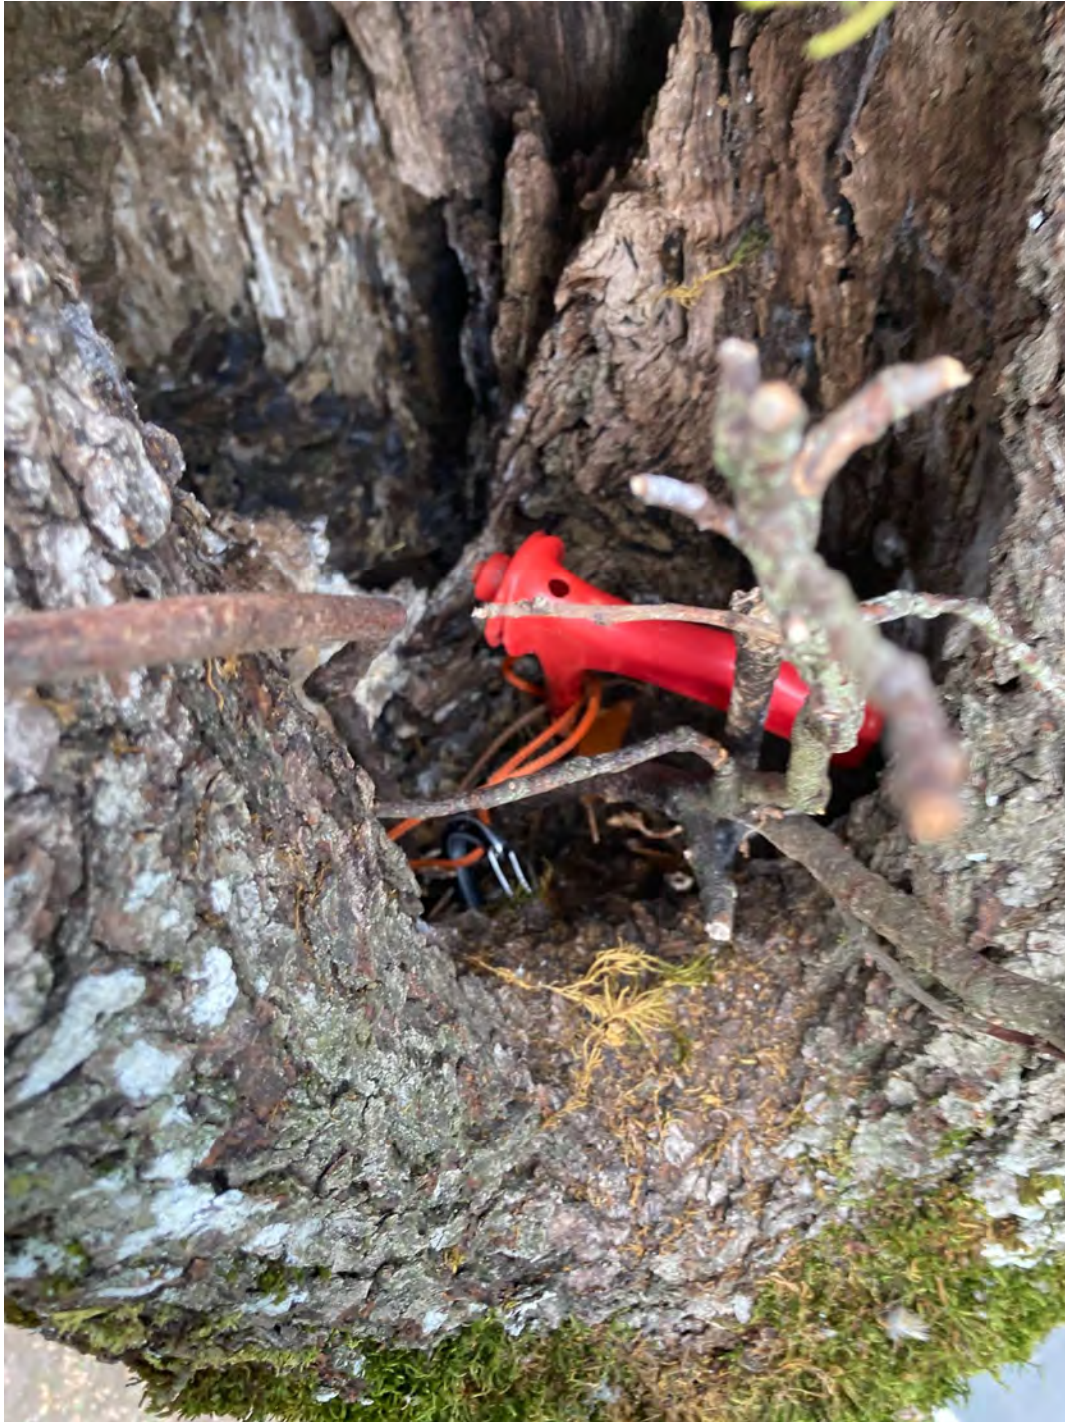
Figure 23 Probe inserted down into cavity in a central column of decay.

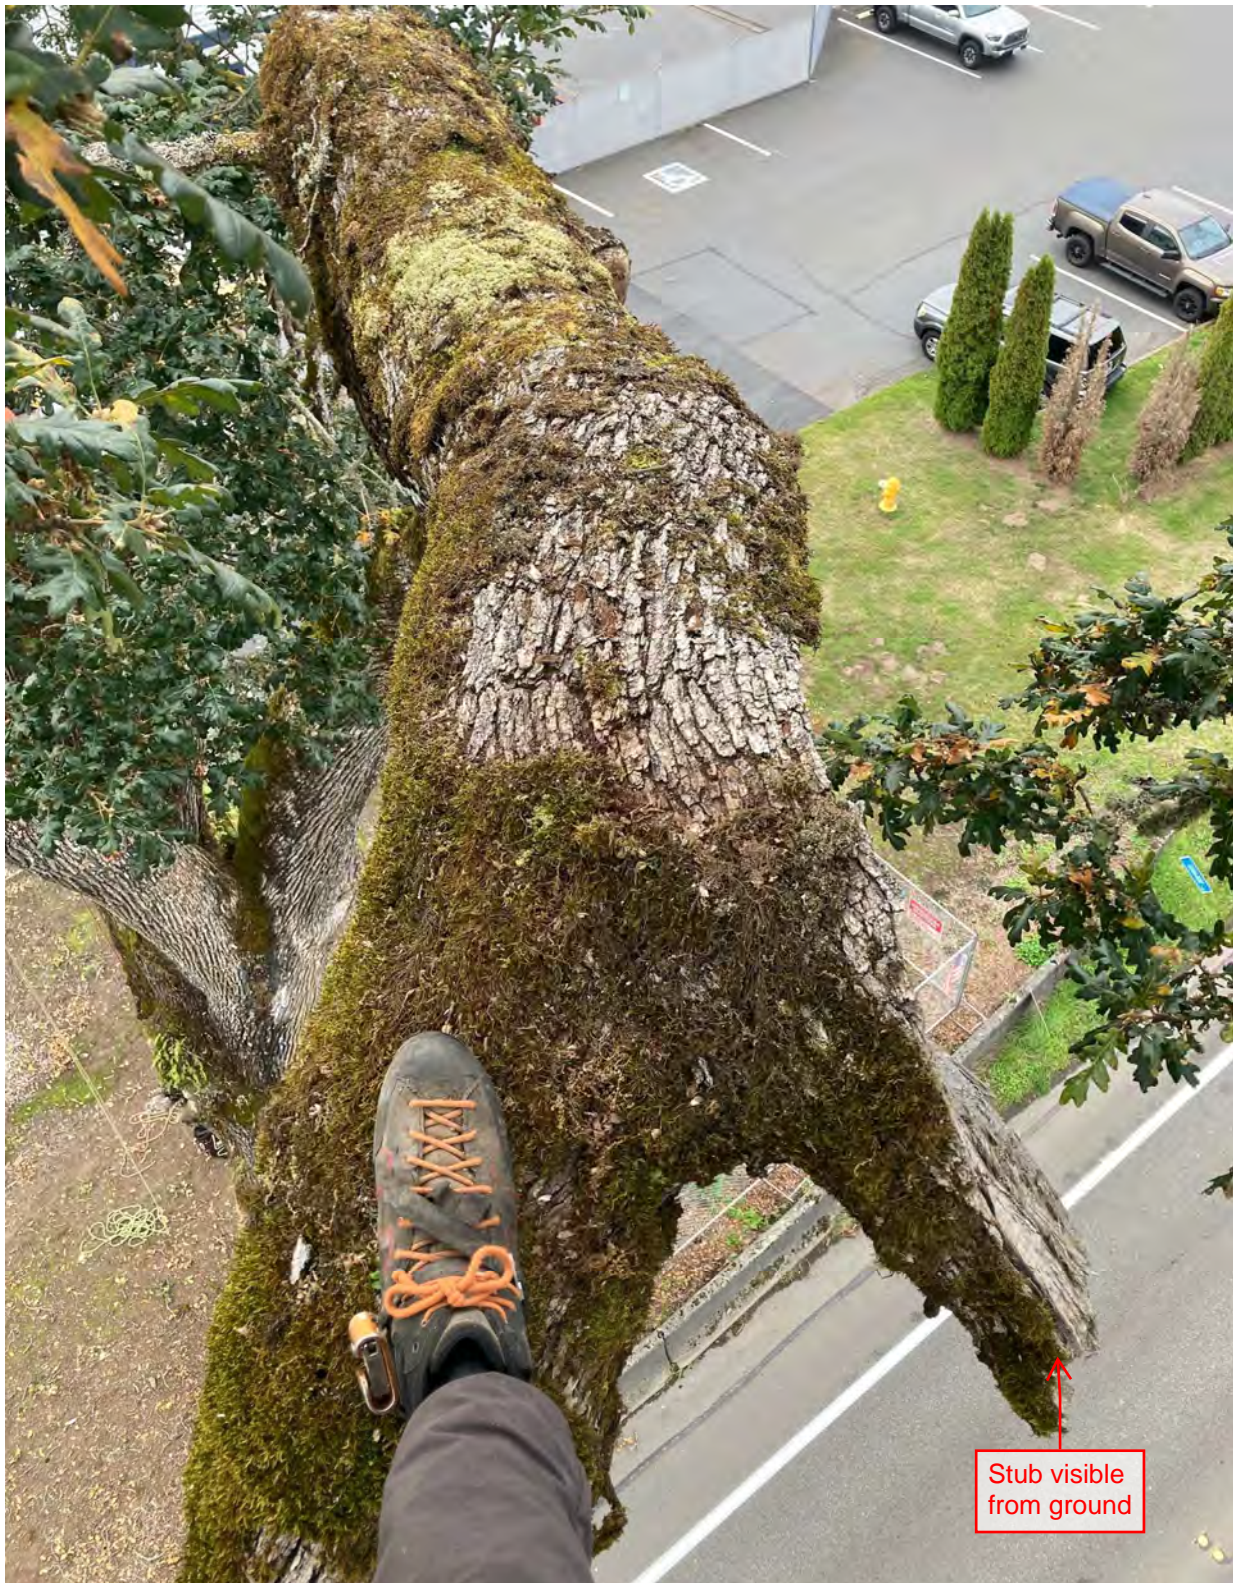
Figure 26 View from above failure showing extent of sound wood supporting remaining stem.
