**CITY COUNCIL WORK SESSION  
MEETING AGENDA**

TO: City Council  
FROM: Lisa Parks, City Administrator  
DATE: March 11, 2025  
SUBJECT: Davis Meeker Oak Tree Risk Assessment Final Report Briefing

The City of Tumwater contracted with Todd Prager and Associates LLC to perform a Level 3 Advanced Tree Risk Assessment for the Davis-Meeker Oak, a 66-inch diameter (DBH) Oregon white oak (*Quercus garryana*) and City of Tumwater-designated heritage tree. The advanced assessment included a thorough climbing inspection of the tree, sonic tomography testing at eight locations on the main stems of the tree, and a root crown excavation. The assessment also included a review of historic site conditions. The new information was used to categorize risk using the International Society of Arboriculture's tree risk assessment process. Based on that process, all but one tree part was rated as *low* risk, and one tree part was rated as *moderate* risk during the next three-year timeframe.

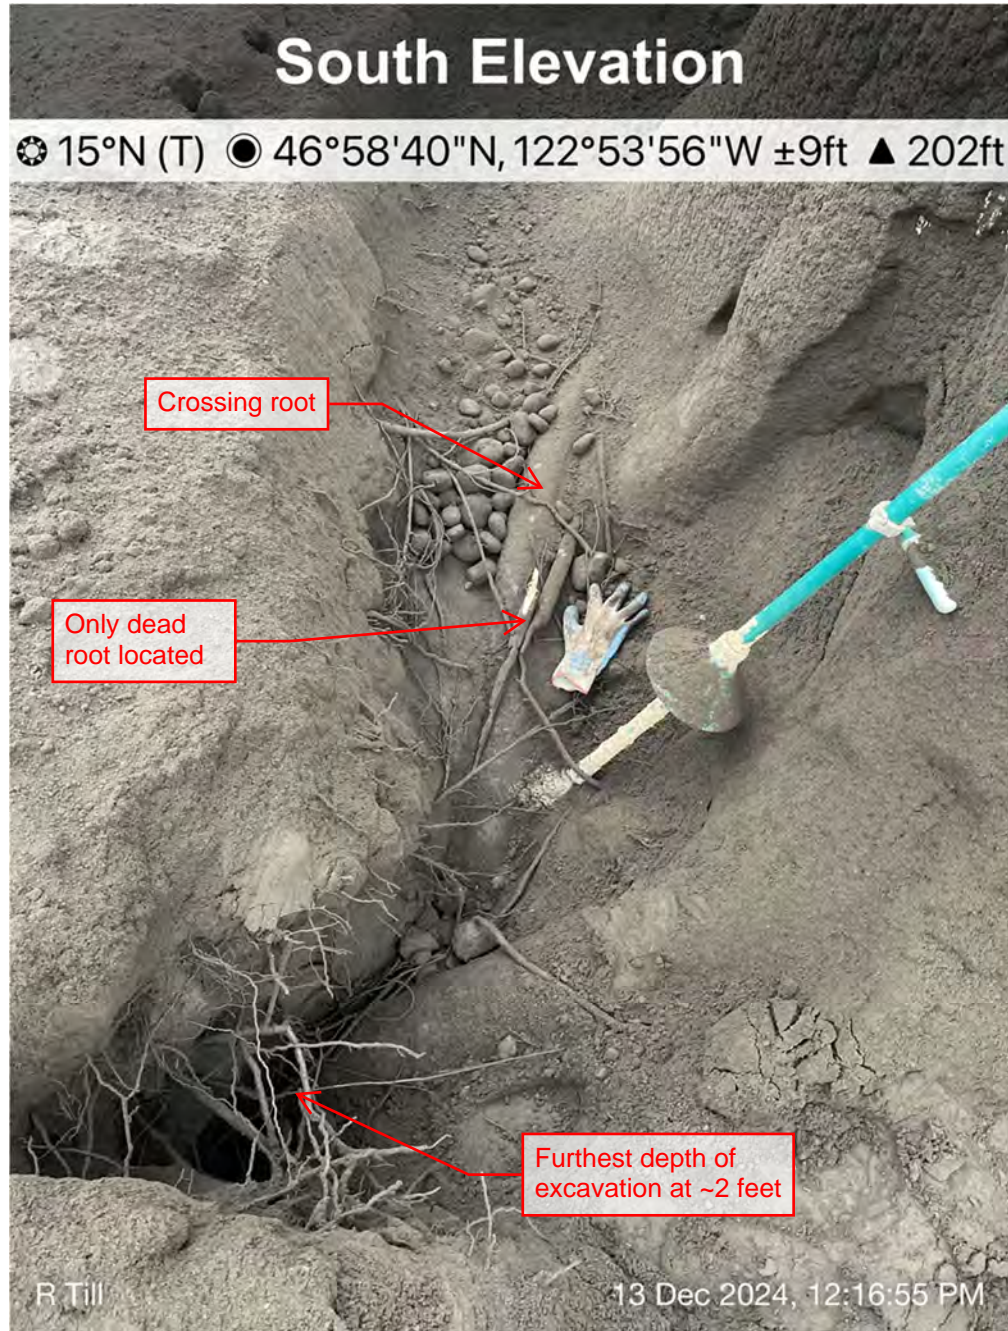
Figure 4 Traced one buttress root and did not locate any signs of concern. One, ~1-inch diameter dead root was located (visible to the left of the glove). One ~4-inch root crosses a primary buttress root, which could limit buttress root expansion.

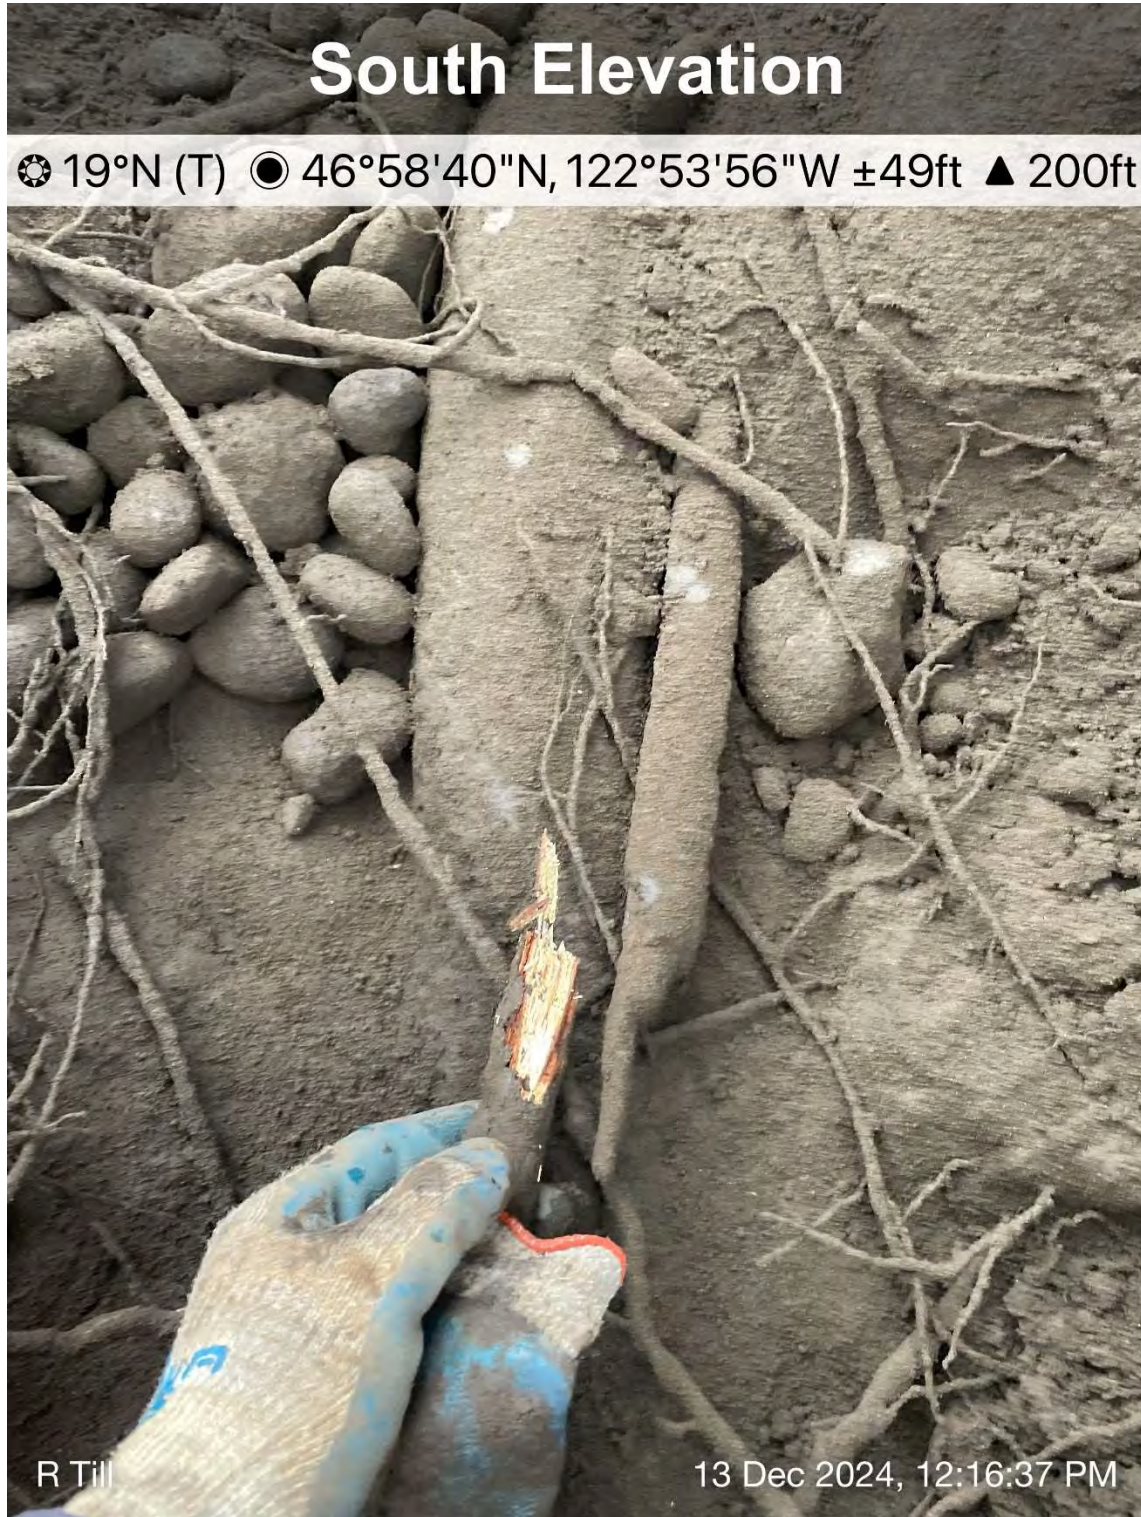
Figure 5 Dead root and crossing root.

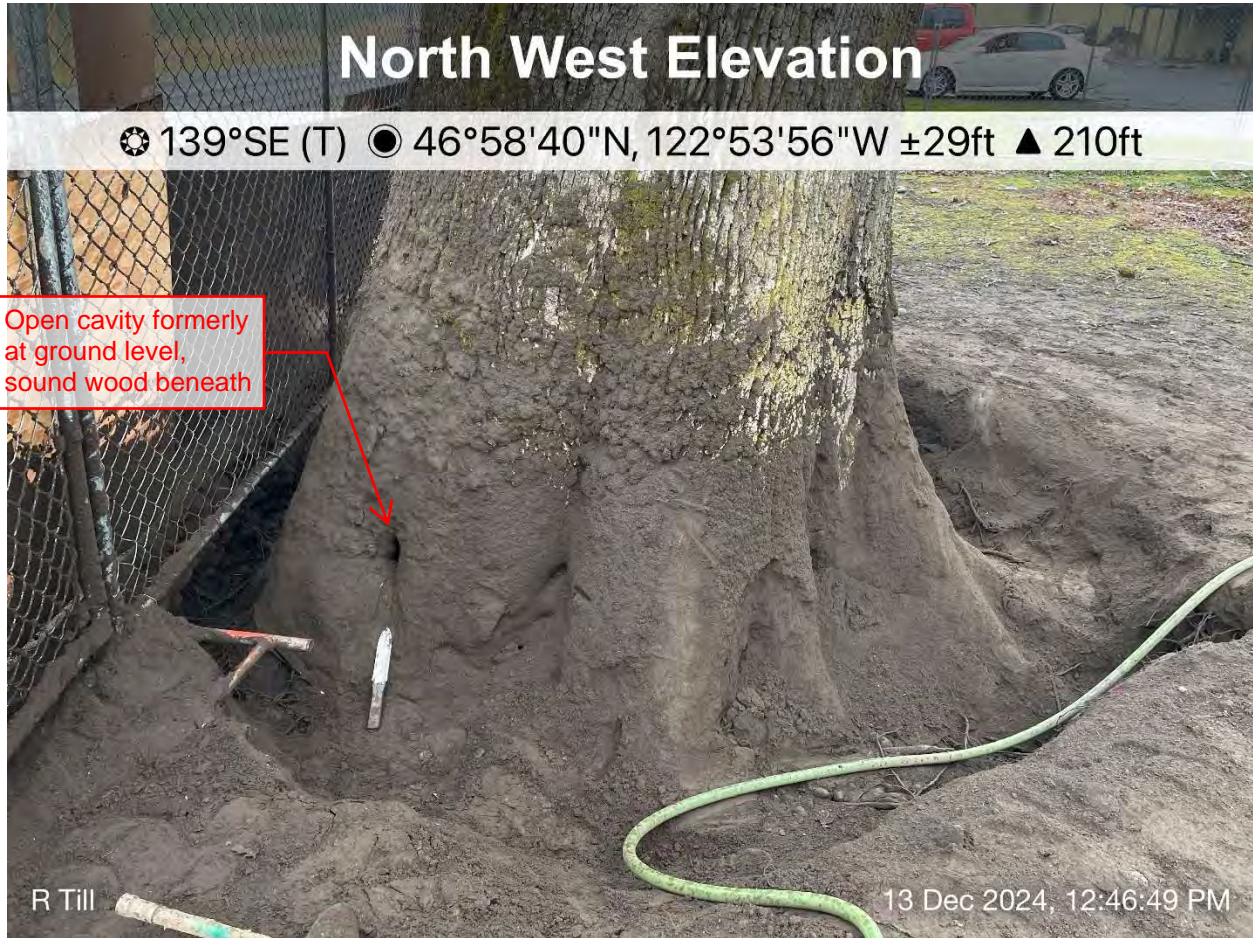
Figure 6 View from northwest. Wood below the cavity is sound. Hand inspected cavity and substantial wood present. Probes creases/sinuses between buttress lobes and did not identify signs of decay.

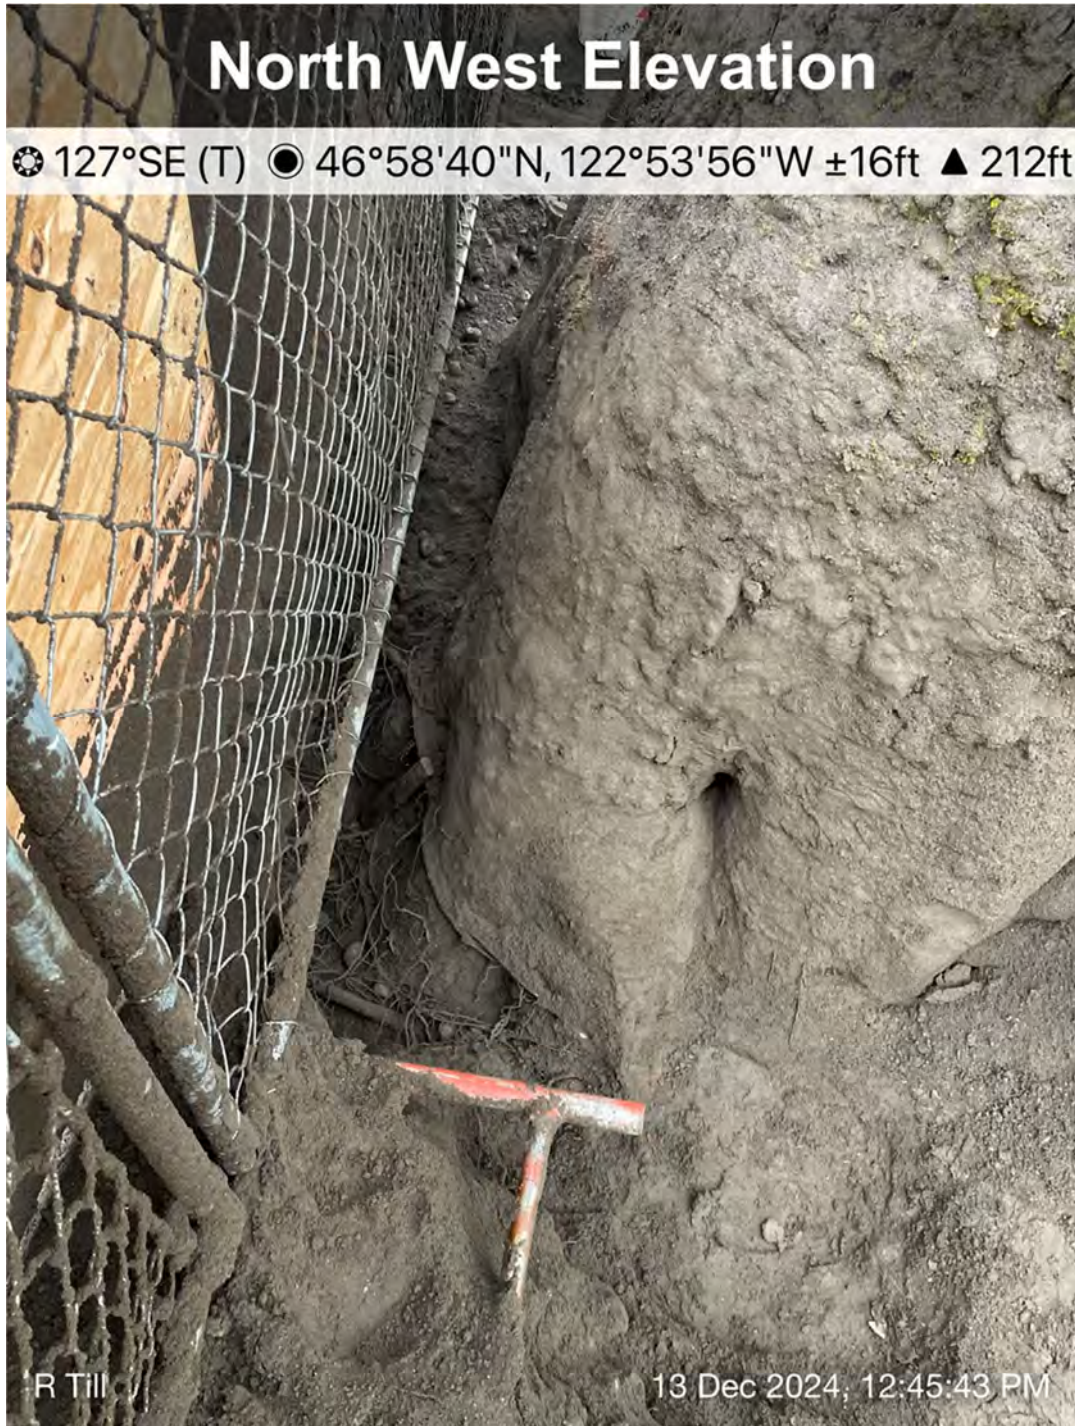
Figure 7 Street side excavation uncovered sound wood and adventitious roots. Buttress flare was not as pronounced, but otherwise no concerning signs. Depth of excavation was hindered by fence.
