**HISTORIC PRESERVATION COMMISSION
MEETING AGENDA**

TO: Historic Preservation Commission
FROM: Chuck Denney, Parks and Recreation Director
DATE: April 18, 2024
SUBJECT: Davis/Meeker Oak Tree

RE: Meeker Oak Risk Assessment

Re: Sonic Tomography of One Garry Oak Tree

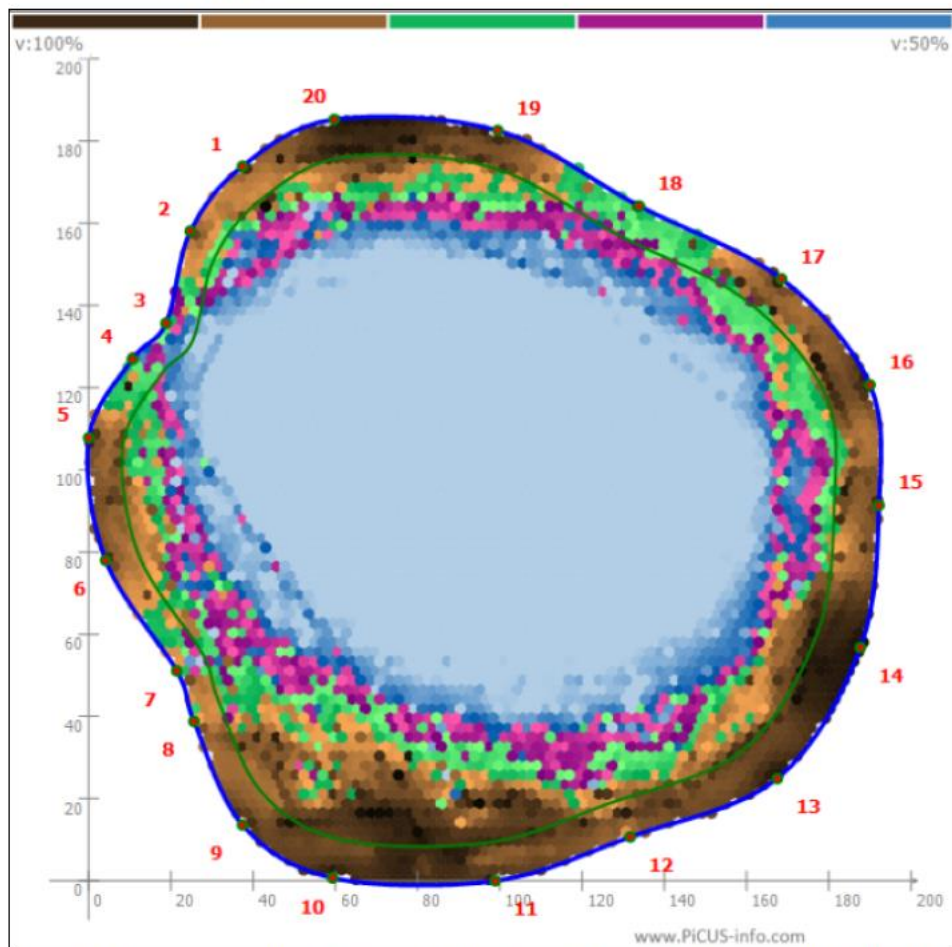
I used a PiCUS sonic tomograph to obtain a tomogram 50 centimeters above the tree base. I selected this height based on soundings of the trunk which indicated the most extensive decay was located low in the trunk. I used the PiCUS Q74 program to analyze the data and obtain a rough estimate of the remaining sound wood shell wall required to maintain tree stability, indicated by the green line in Figure 1 in Appendix A.

The tomogram indicates there is slightly more sound wood than is required to support the tree. However, due to the extent of the decay and thin shell wall around measuring points 3, 4, and 18 it is my opinion that this tree should be managed as a veteran tree and have retrenchment pruning performed to reduce the tree height and spread by approximately 15 feet. Reducing the tree height and spread will result in lowered wind loads acting on the trunk and branch unions resulting in a lower likelihood of failure.

Figure 1. Sonic tomogram of the subject tree. North is located at measuring point 1, and the side of the tree towards the highway is along measuring points 17, 18, and 19. The blue areas indicate decay or a decay cavity, and the brown areas indicate sound wood. The purple and green areas indicate early or spreading decay. The green line is the calculated shell wall of sound wood required for the tree to remain stable.

If this tree is retained, it should be reassessed with sonic tomography in five years to determine if the decay is continuing to spread and what the remaining shell wall is at that time. Additionally, 4 to 6 inches of wood chip mulch should be added within the dripline of the tree to improve soil conditions. The wood chip mulch should be kept 12 inches from the base of the tree.

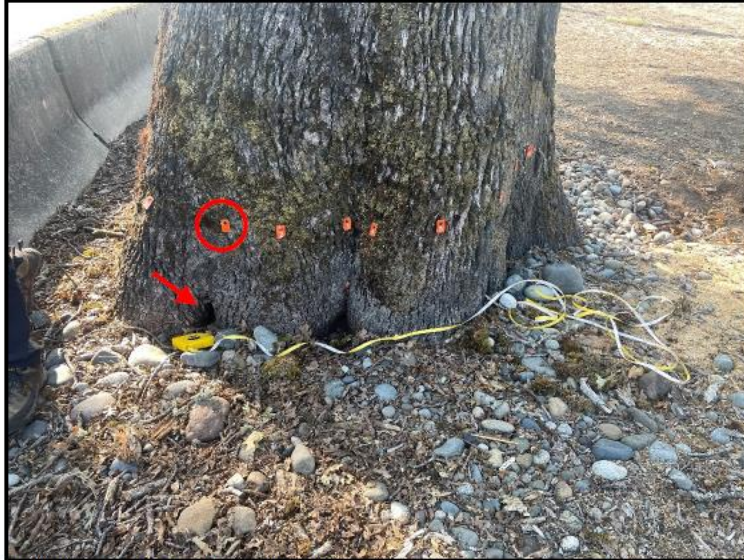
Photograph 1. Measuring point 1 is circled in red. An opening into the decay cavity is indicated by the red arrow.

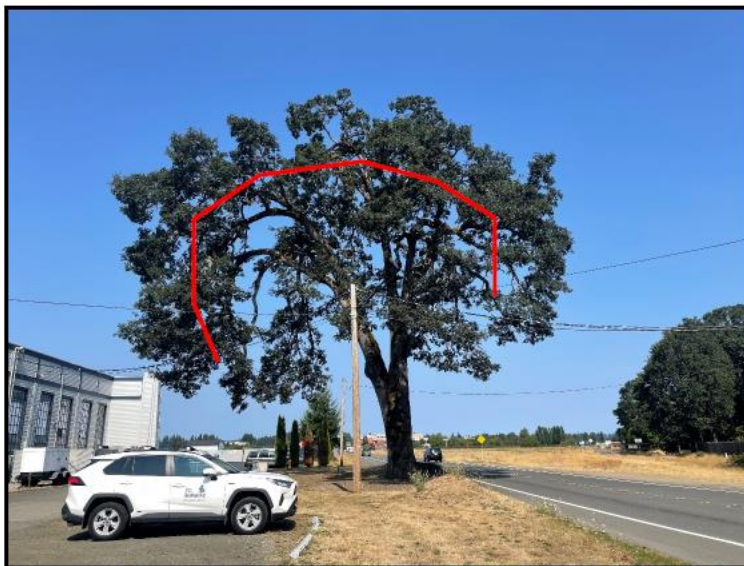
Photograph 2. The crown of the subject tree viewed from the southeast. The red line indicates approximately 15 feet of crown reduction.
