**HISTORIC PRESERVATION COMMISSION  
MEETING AGENDA**

**Thursday, March 21, 2024  
6:30 PM**

Staff requests that the Commission consider and approve a recommendation to the Tumwater City Council for de-listing the Davis/Meeker Oak from the City's Historic Register.

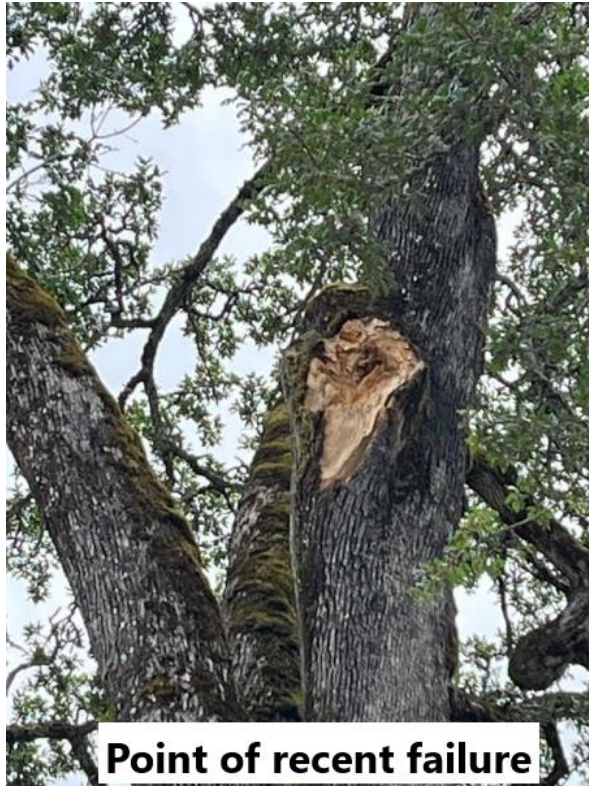
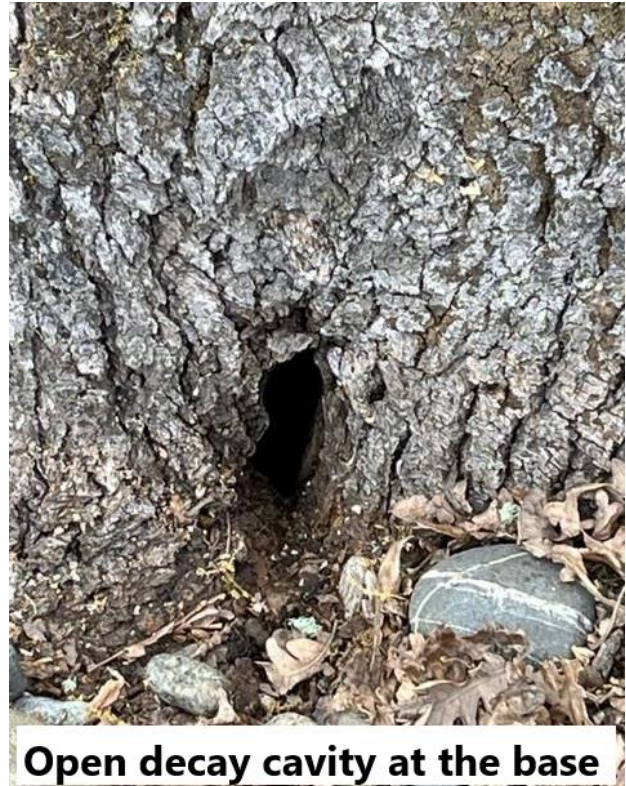
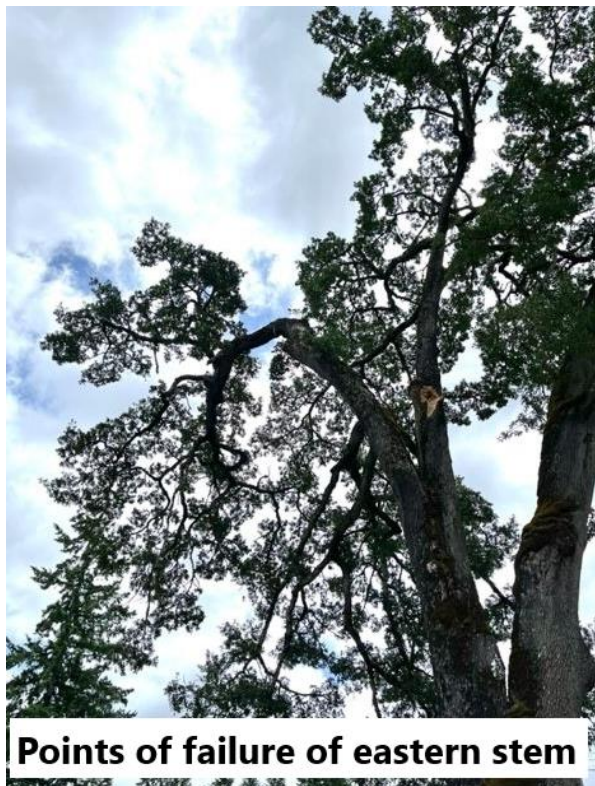
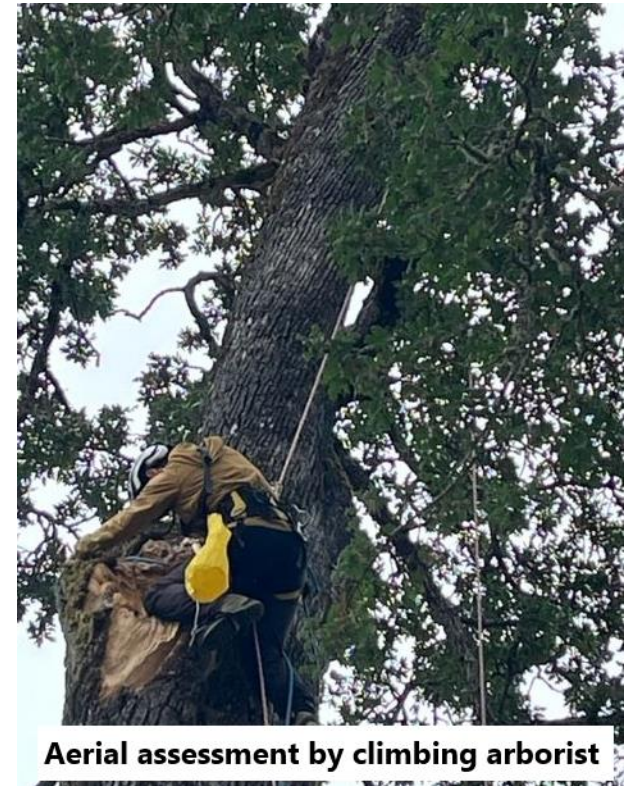
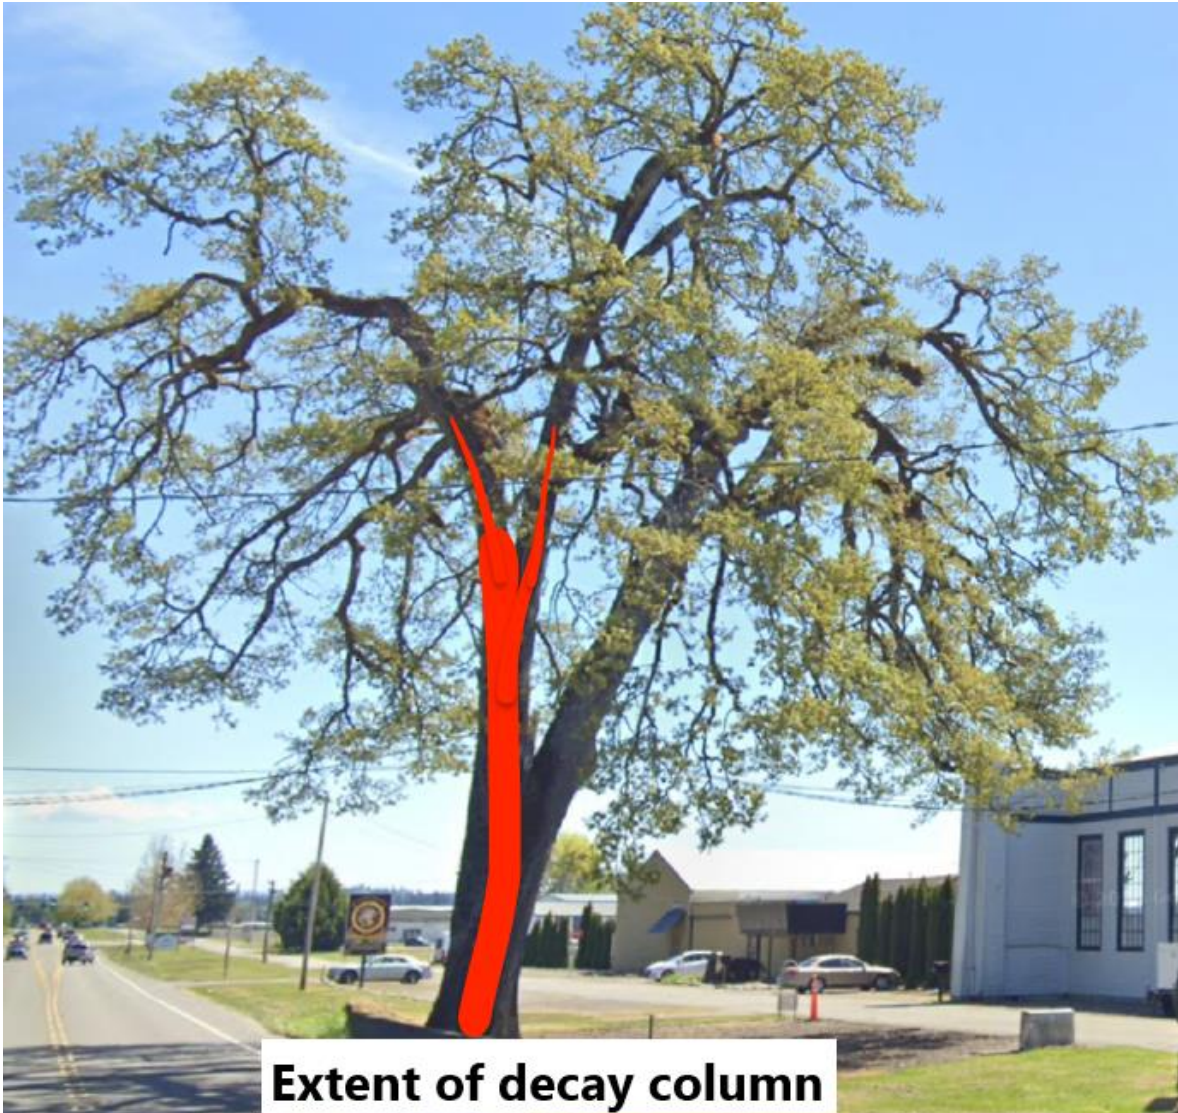
## Photos

An aerial assessment was conducted by Amanda Hancock (ISA Certified Arborist TX4155AU & TRAQ) with Waxwing Tree Specialists on June 29, 2023. This inspection found extensive white rot decay within the large scaffold that recently experienced failure at the union (see photo). Further examination determined that the main stem's decay column continues upward into the eastern co-dominant stem and large diameter scaffold branches (see attached diagram). The west facing co-dominant stem contains solid healthy interior wood upward into the large scaffold branches overhanging the drive and aircraft hangar.

With the exception of the recent large branch failures, the Meeker Oak appears to be in very good health. The crown density, leaf color, leaf size and internode growth all indicate a vigorous tree. However, there are structural concerns associated with the significant decay found in the stem base, lower main stem, east facing co-dominant stem and large scaffold branches. Probable future failures include large diameter scaffold branches from the east facing co-dominant stem and the entire west facing co-dominant stem at the union. The associated inclusions and stress loads will contribute to future failures. Structural support systems in conjunction with pruning were considered but the extent of decay in the main stem and upper east side of the canopy removes that as a mitigation option in my opinion.

Based on my findings and information I have been provided, I am recommending removal.
