## **Watertown Rock River Seawall**

### **Wall Condition Assessment and Feasibility Study**

**City of Watertown  
Watertown, Wisconsin**

**July 2026**

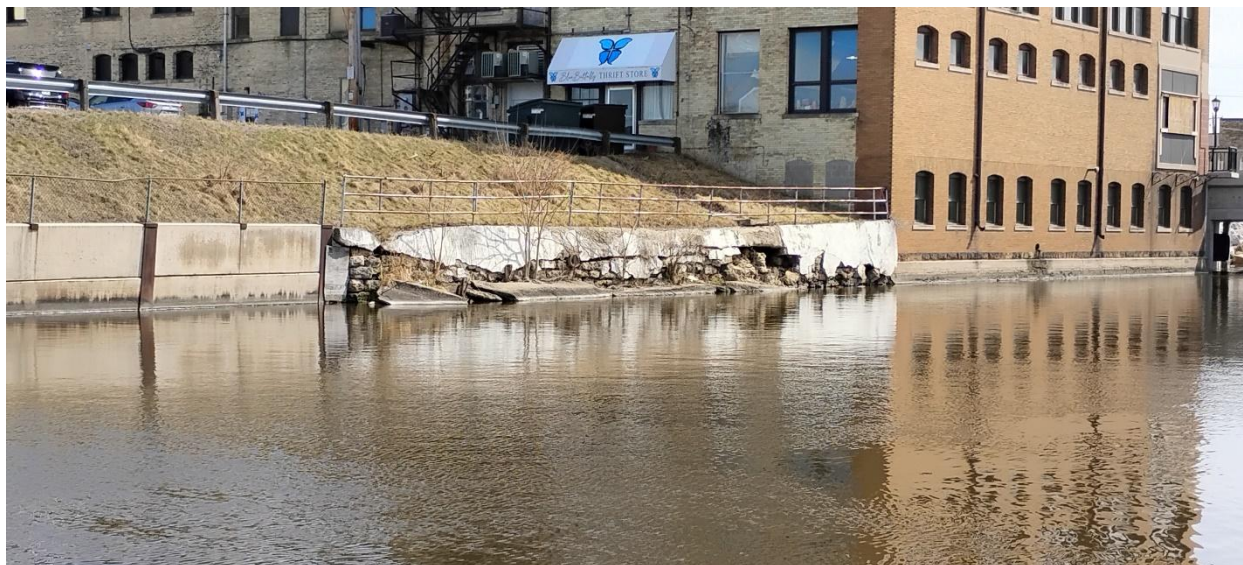
Section A is comprised of a limestone masonry gravity wall with a concrete cap (see Figure 2) approximately 77 feet long and 8.5 feet tall. The retained fill is sloped (3.1H:1.0V) up to the adjacent parking lot. A plaster overlay of sorts was applied on the exposed face of the wall at some point, though most of it has failed, thereby exposing the original masonry. Almost no mortar exists between joints, and a significant void, measuring approximately 4 feet high by 8 feet wide and 5 feet deep, has formed below the concrete cap where the surface drain extends from the adjacent parking lot, as shown in Figure 3. City personnel stated that water was observed actively seeping from the void, most likely coming from an abandoned water main that terminated behind the wall. Since addressing the leaking watermain, the seepage has ceased, but this most likely explains the cause for the size of the void.

**Figure 2. View of Section A looking southeast.**

Overall, Section A is in a critical condition. Given its proximity to the adjacent building and parking lot and given the impact to these structures should the wall completely fail, this section is considered the highest risk compared to other sections of the wall.

Given the proximity of Section A to the parking lot and adjacent building, complete failure of this wall section would have the greatest impact; as such, its replacement or remediation should be highest

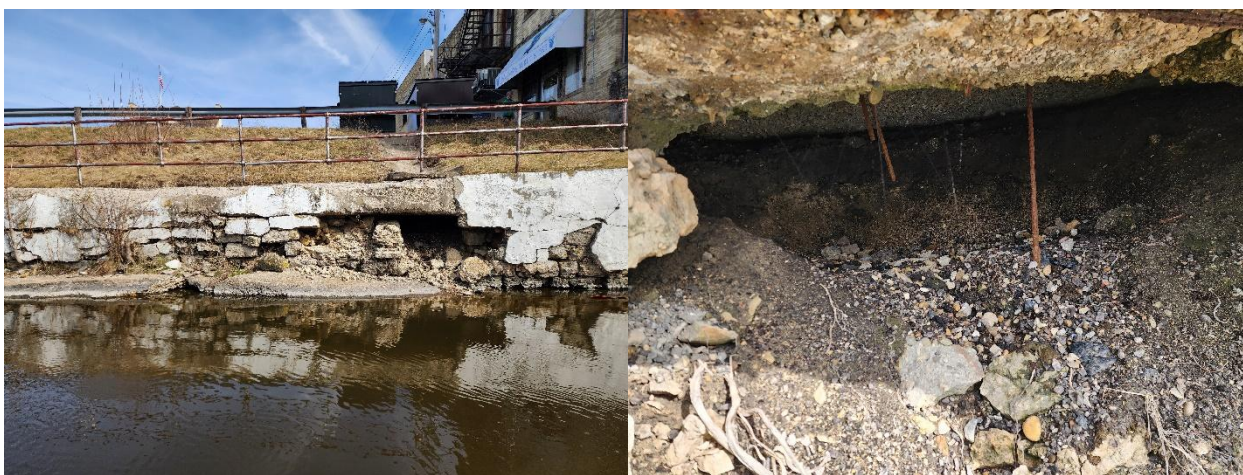
Additionally, the drainage from the parking lot meant to be carried by the surface drain may be finding its way to the backside of the wall, also attributing to the loss of material and the large void.

**Figure 3. Location of void below surface drain (left) and depth of void (right).**

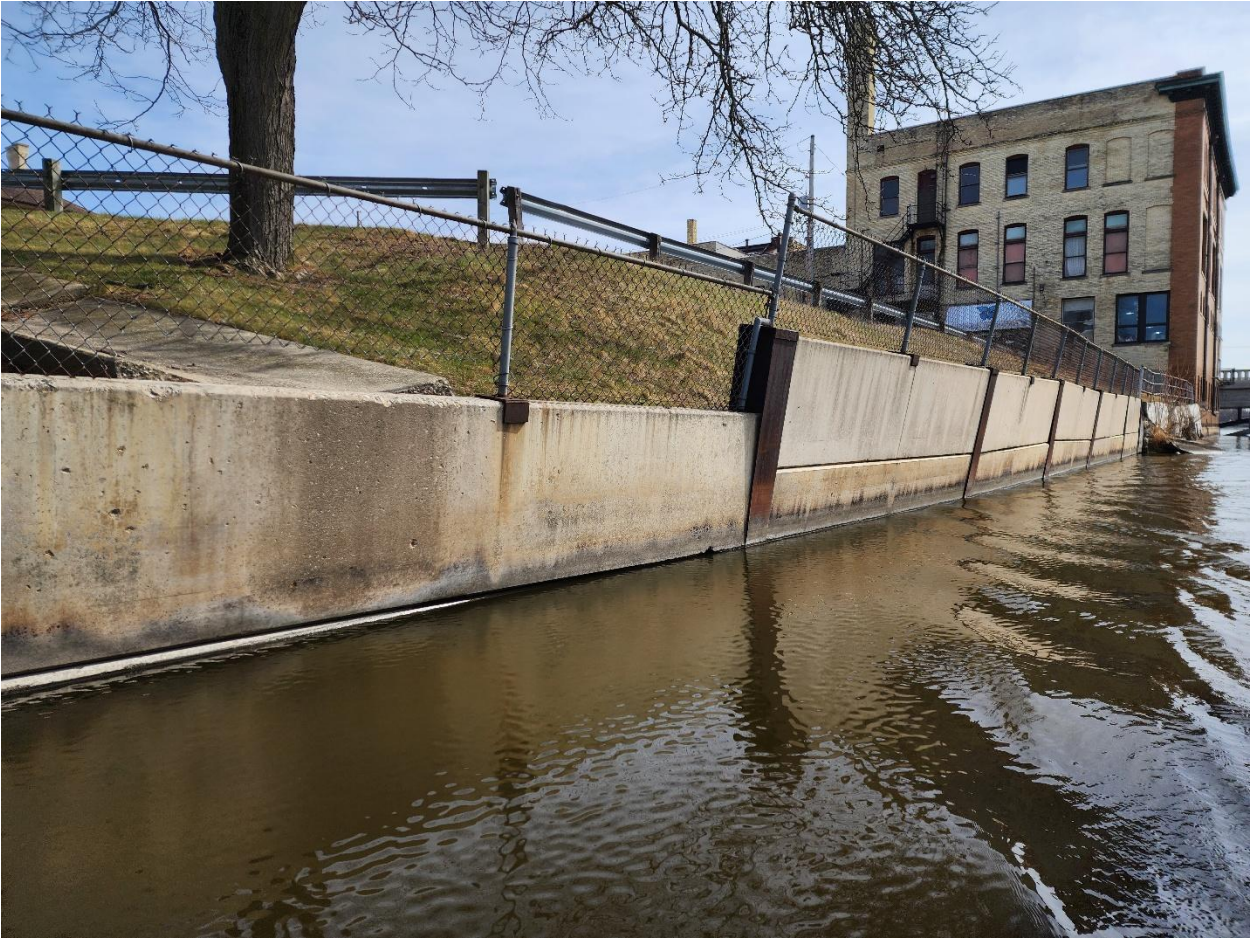
The top of the Section B wall has deflected approximately 24 inches towards the river, leaving several voids between the soil and wall and areas of very loose soil. Figure 4 demonstrates the extent of deflection in Section B. Although plans or design computations for this section are not available, it is assumed the excessive deflection is due to insufficient embedment into competent subgrade and/or bedrock.

Figure 4. View of extreme deflection in Section B.

Overall, the structural elements of Section B are in fair condition, but due to the deflection of the wall, the condition of the wall is considered poor-to-critical.

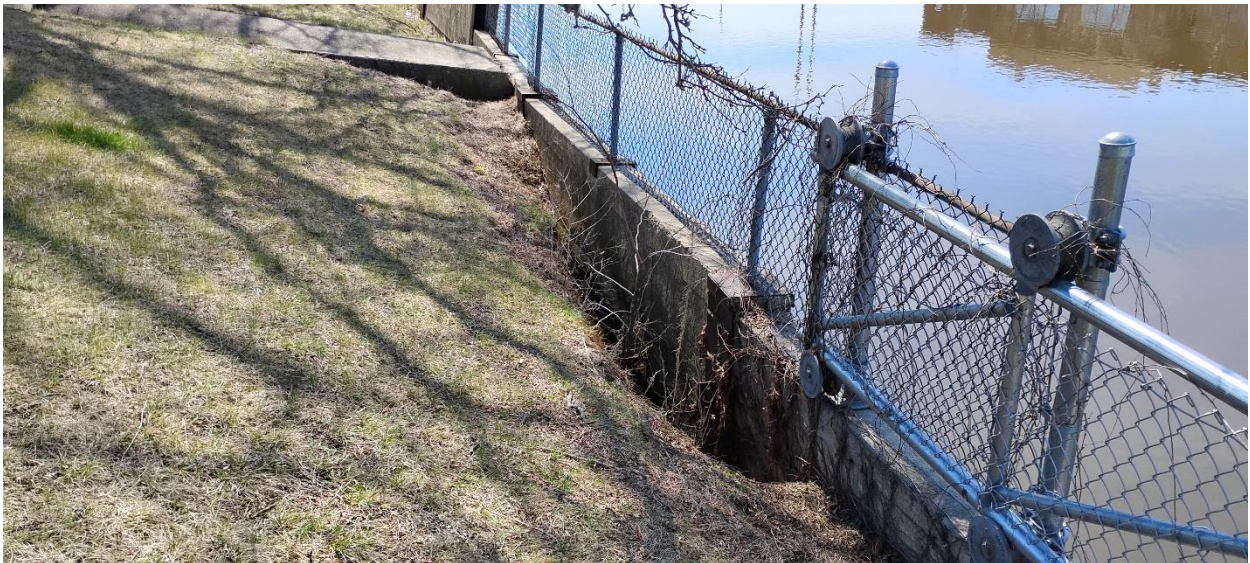
Section C experienced similar deflection as Section B, with large voids between the backfill and wall as seen in Figure 5. As mentioned in Section A, runoff that spills over the surface drain into the retained fill may be contributing to the loss of material behind the wall. The inspection also did not note any presence of geotextile on the backside of the precast panels; geotextile would help prevent the migration of soils through the panel joints.

**Figure 5. Lost fill in Section C. Surface drain from parking lot seen near top of photo.**

Similar to Section B, the structural elements of Section C are in fair condition, but overall, the wall is in poor-to-critical condition due to the deflection and the loss of soils behind the wall.

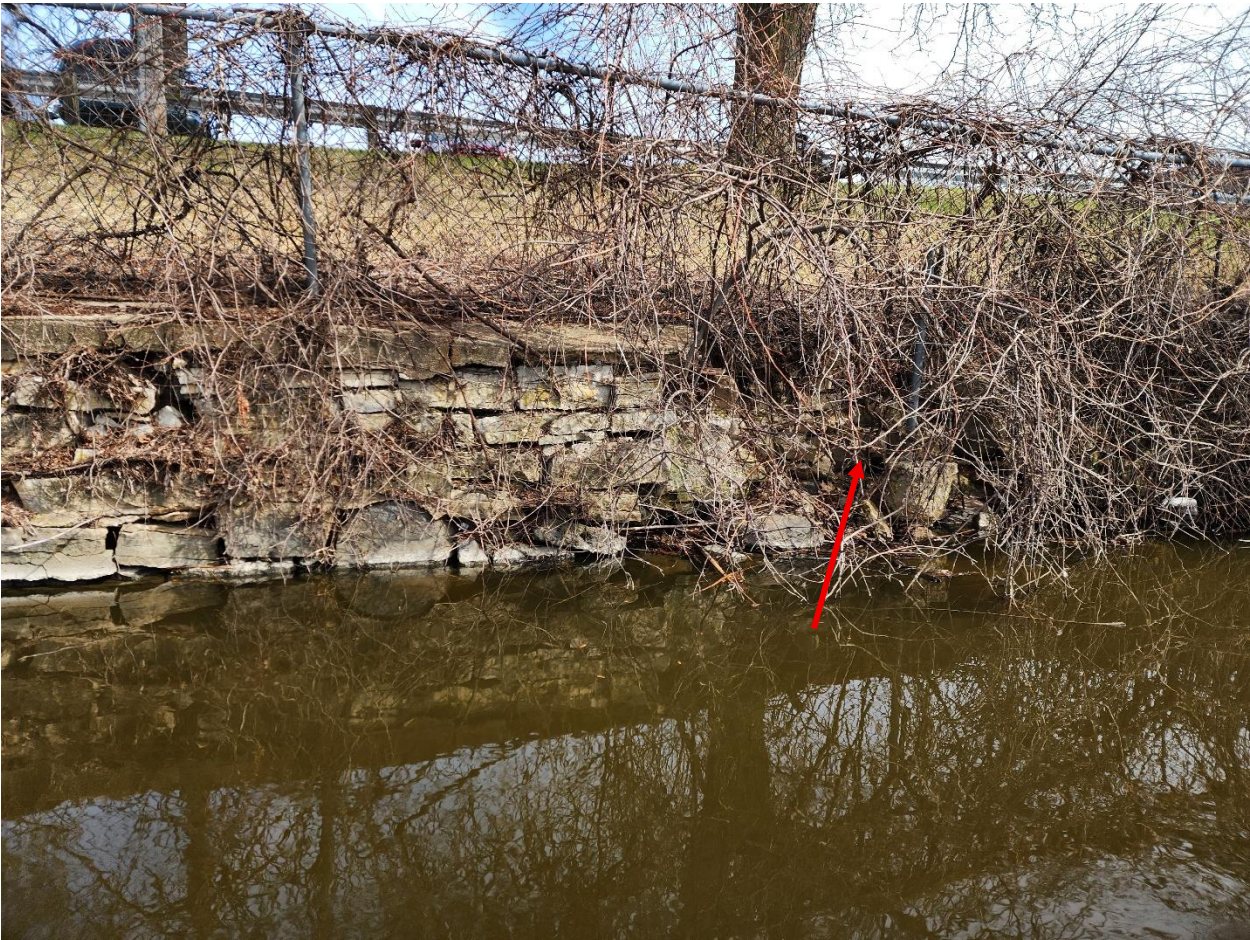
Most of Section D is covered in vegetation, which makes monitoring the condition of this section difficult from land. However, several sections of Section D were noted to have masonry completely absent and retained fill exposed. Overall, Section D is in poor-to-critical condition.

**Figure 6. Failed portion of Section D.**

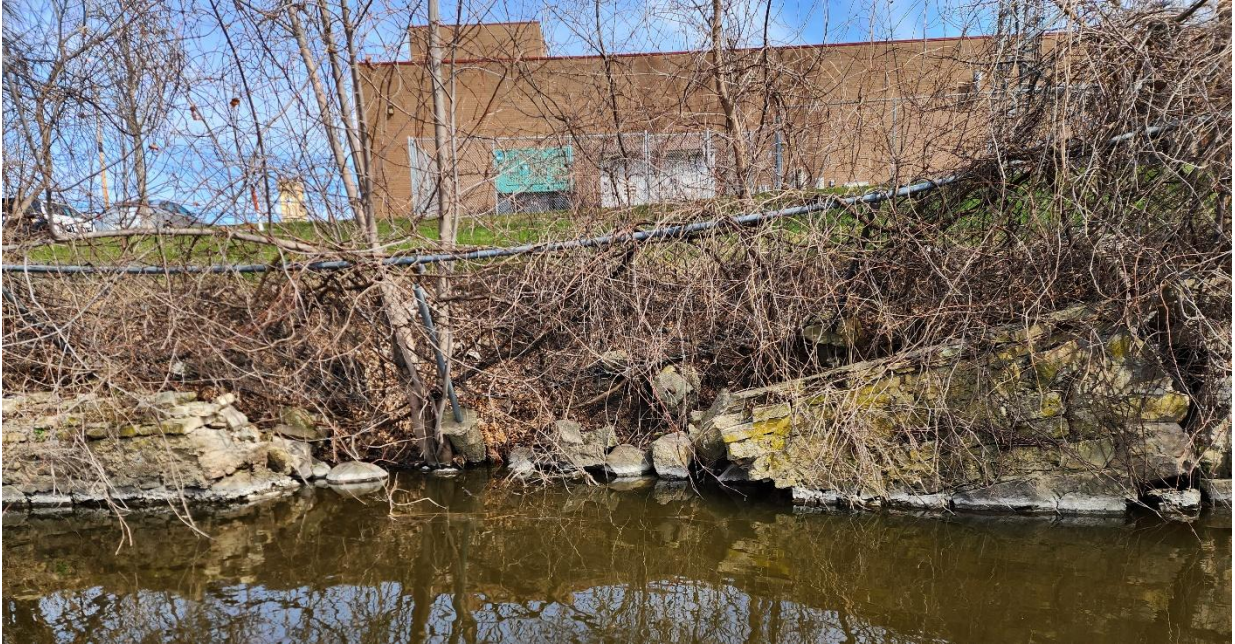
Section E extends from the north end of Section D to the Cady St bridge. It consists of an identical composition as Section D (irregular, angular fieldstone with concrete cap and chain-link fence). Like Section D, no mortar is visible between the joints, and several portions of fieldstone have completely failed as shown in Figure 7.

Overall, Section E is in poor-to-critical condition.

**Figure 7. Failed segment of wall along Section E.**

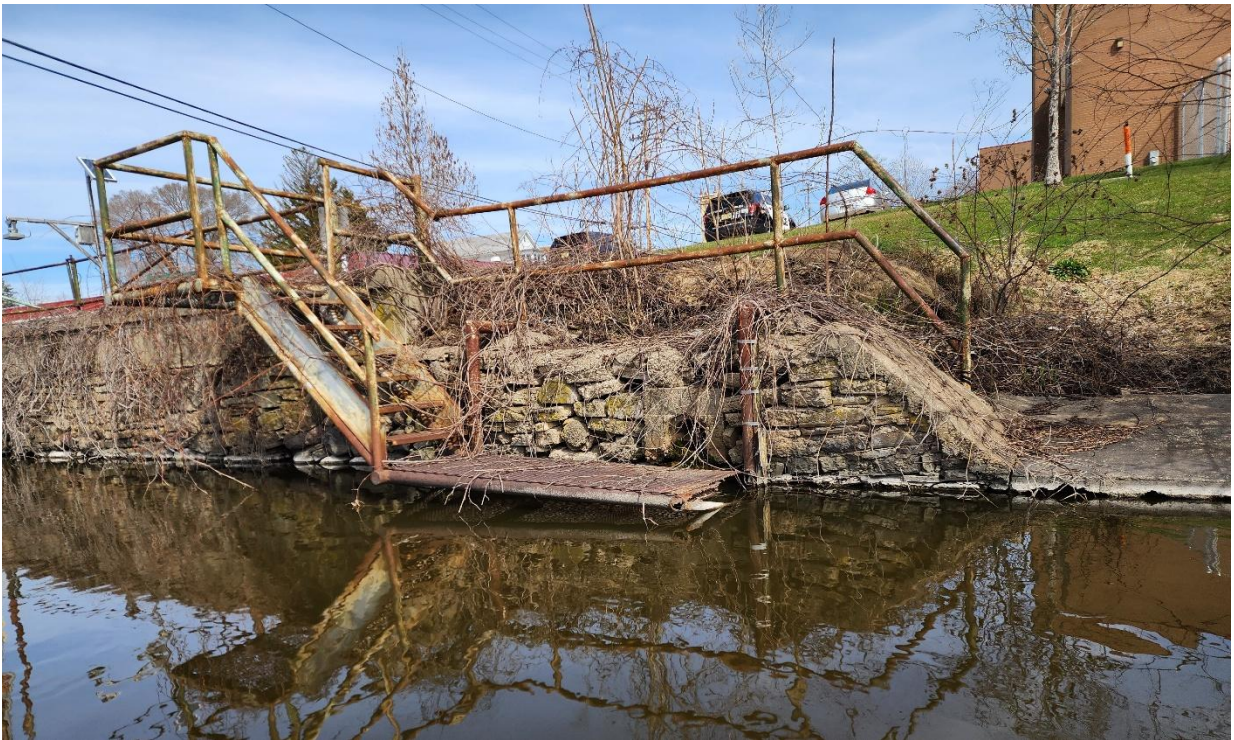
**Figure 8. Old boat launch along Section E.**

What appears to be an old boat launch is located near the north end of Section E (see Figure 8). If no longer in use, the steel platform and stairs should be removed for safety concerns.

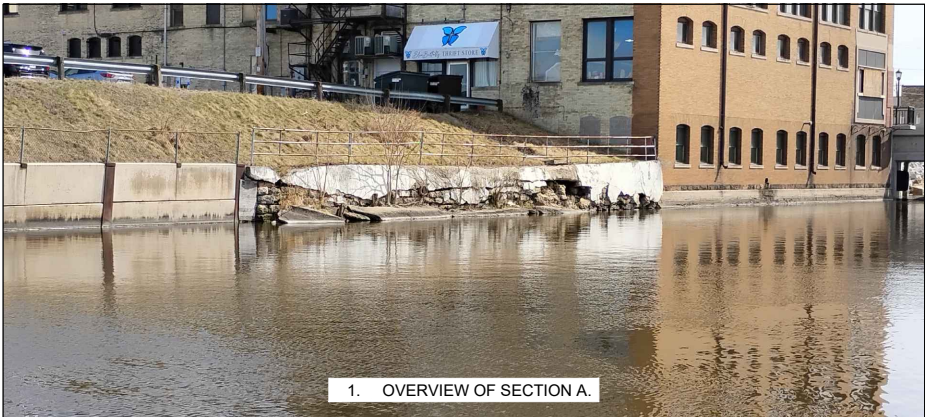
1. OVERVIEW OF SECTION A.

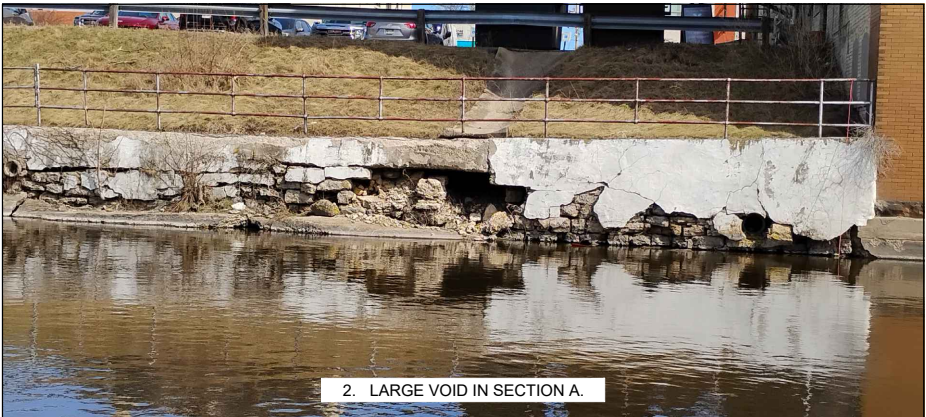
2. LARGE VOID IN SECTION A.

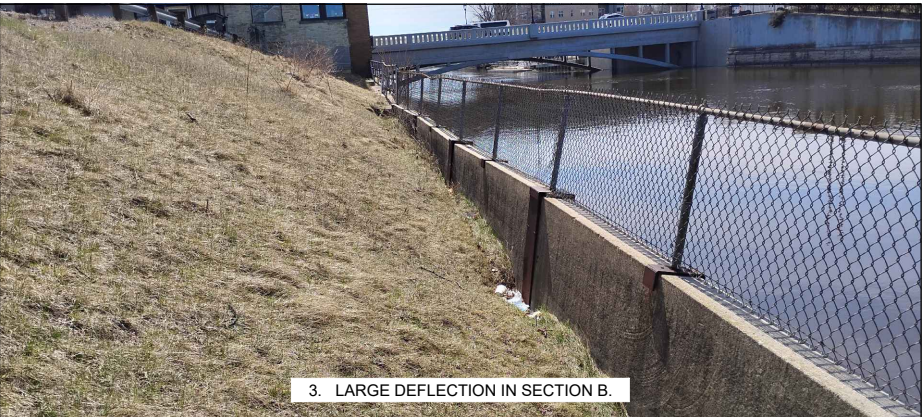
3. LARGE DEFLECTION IN SECTION B.

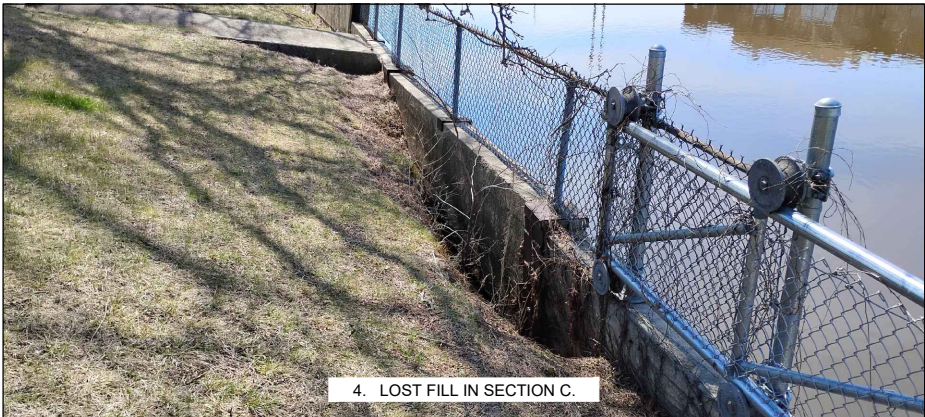
4. LOST FILL IN SECTION C.

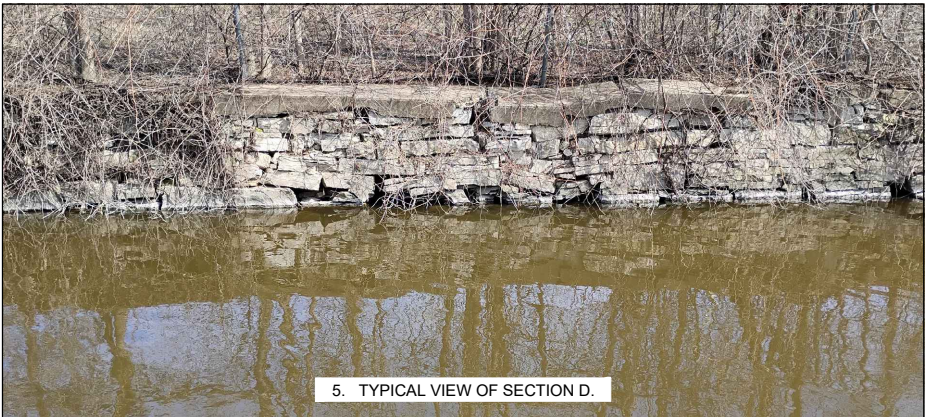
5. TYPICAL VIEW OF SECTION D.

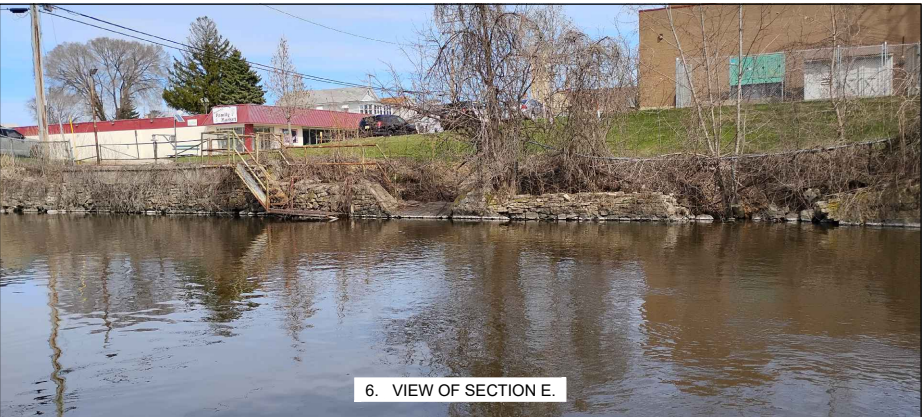
6. VIEW OF SECTION E.
