White Salmon Tree Board Meeting

Tree Assessment

May 2022

In May 2022, Treecology Consulting Group (TCG) conducted a risk assessment, and site evaluation for one street tree at 218 Jewett Blvd. in White Salmon, WA. The tree was assessed on May 20, 2022 by Ruth Williams, International Society of Arboriculture (ISA) Board Certified Master Arborist #WE-7317-BM, ISA Tree Risk Assessment Qualified. The results of this assessment are documented in this report. The goal of this assessment is to provide strategies to manage the tree and site that may impact people and property, and to guide long-term tree care decisions. Considerations include tree health, safety, and site history.

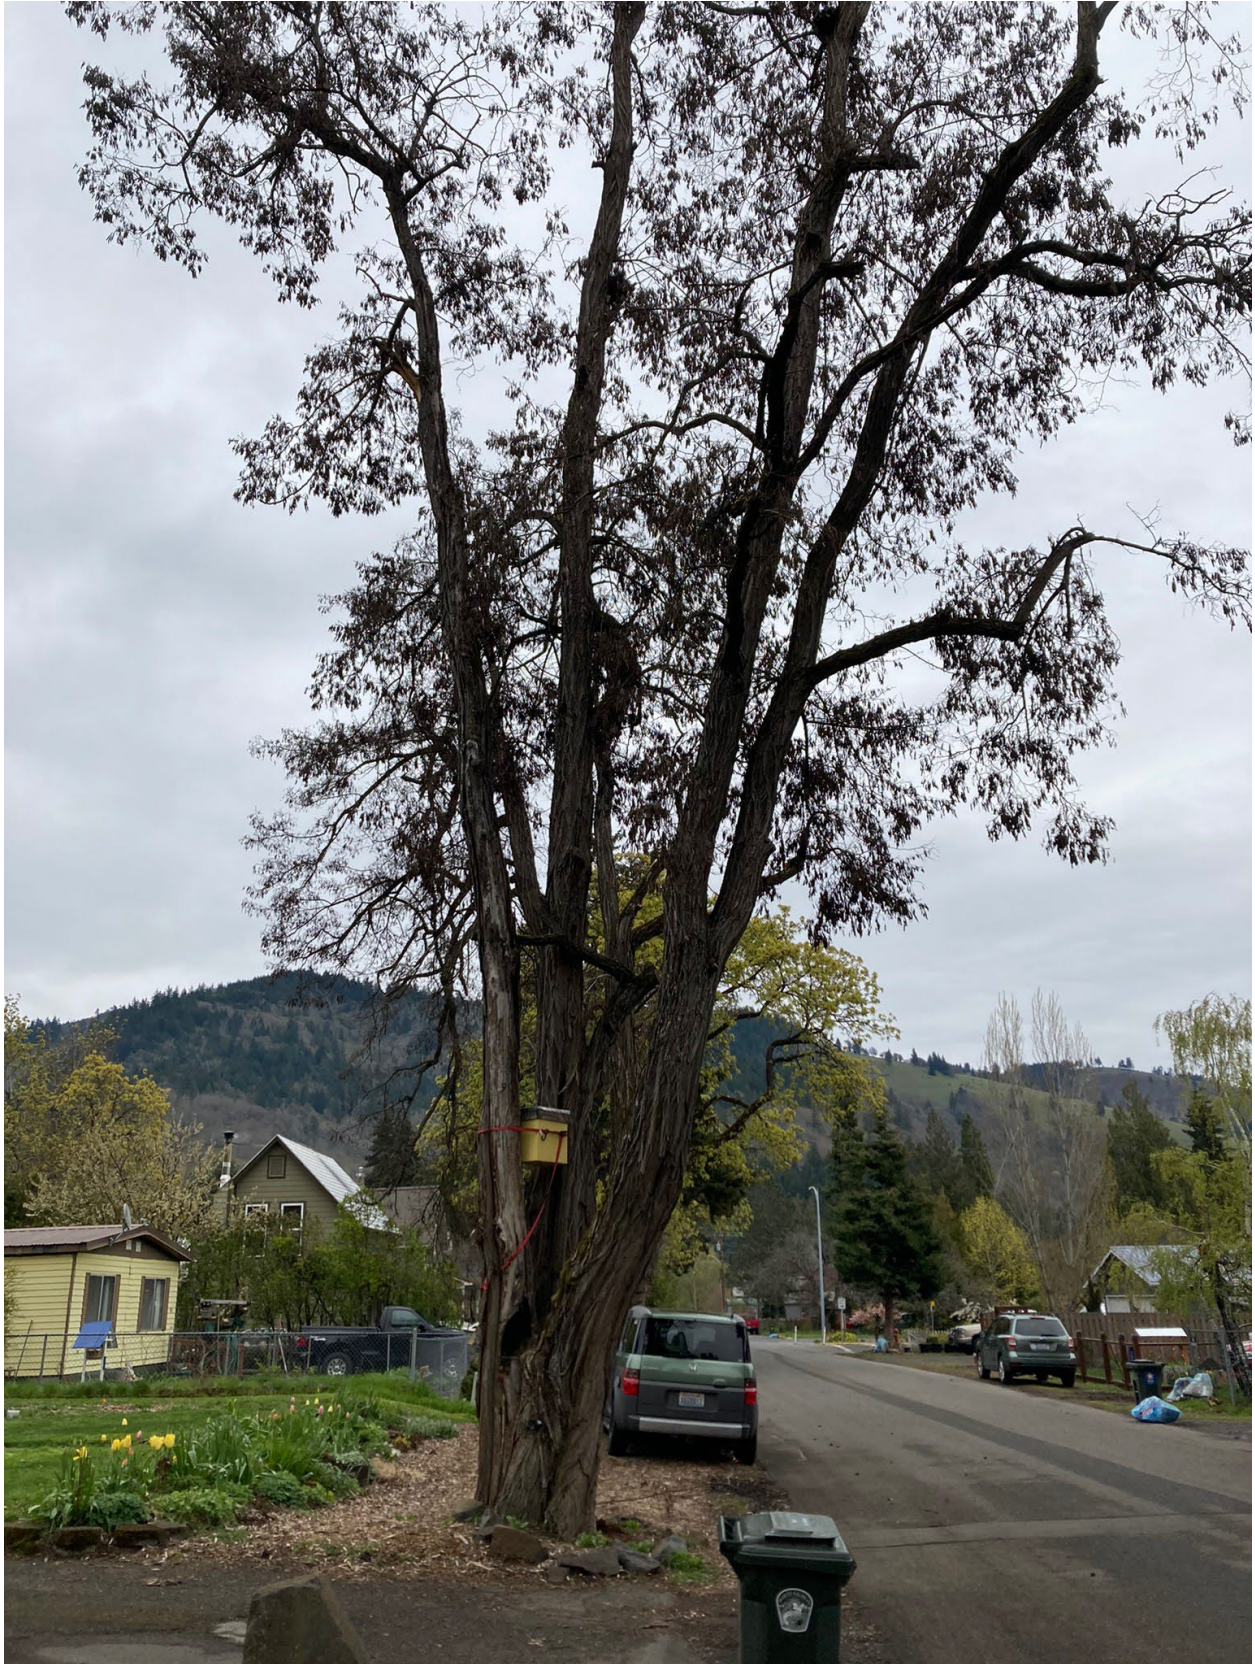
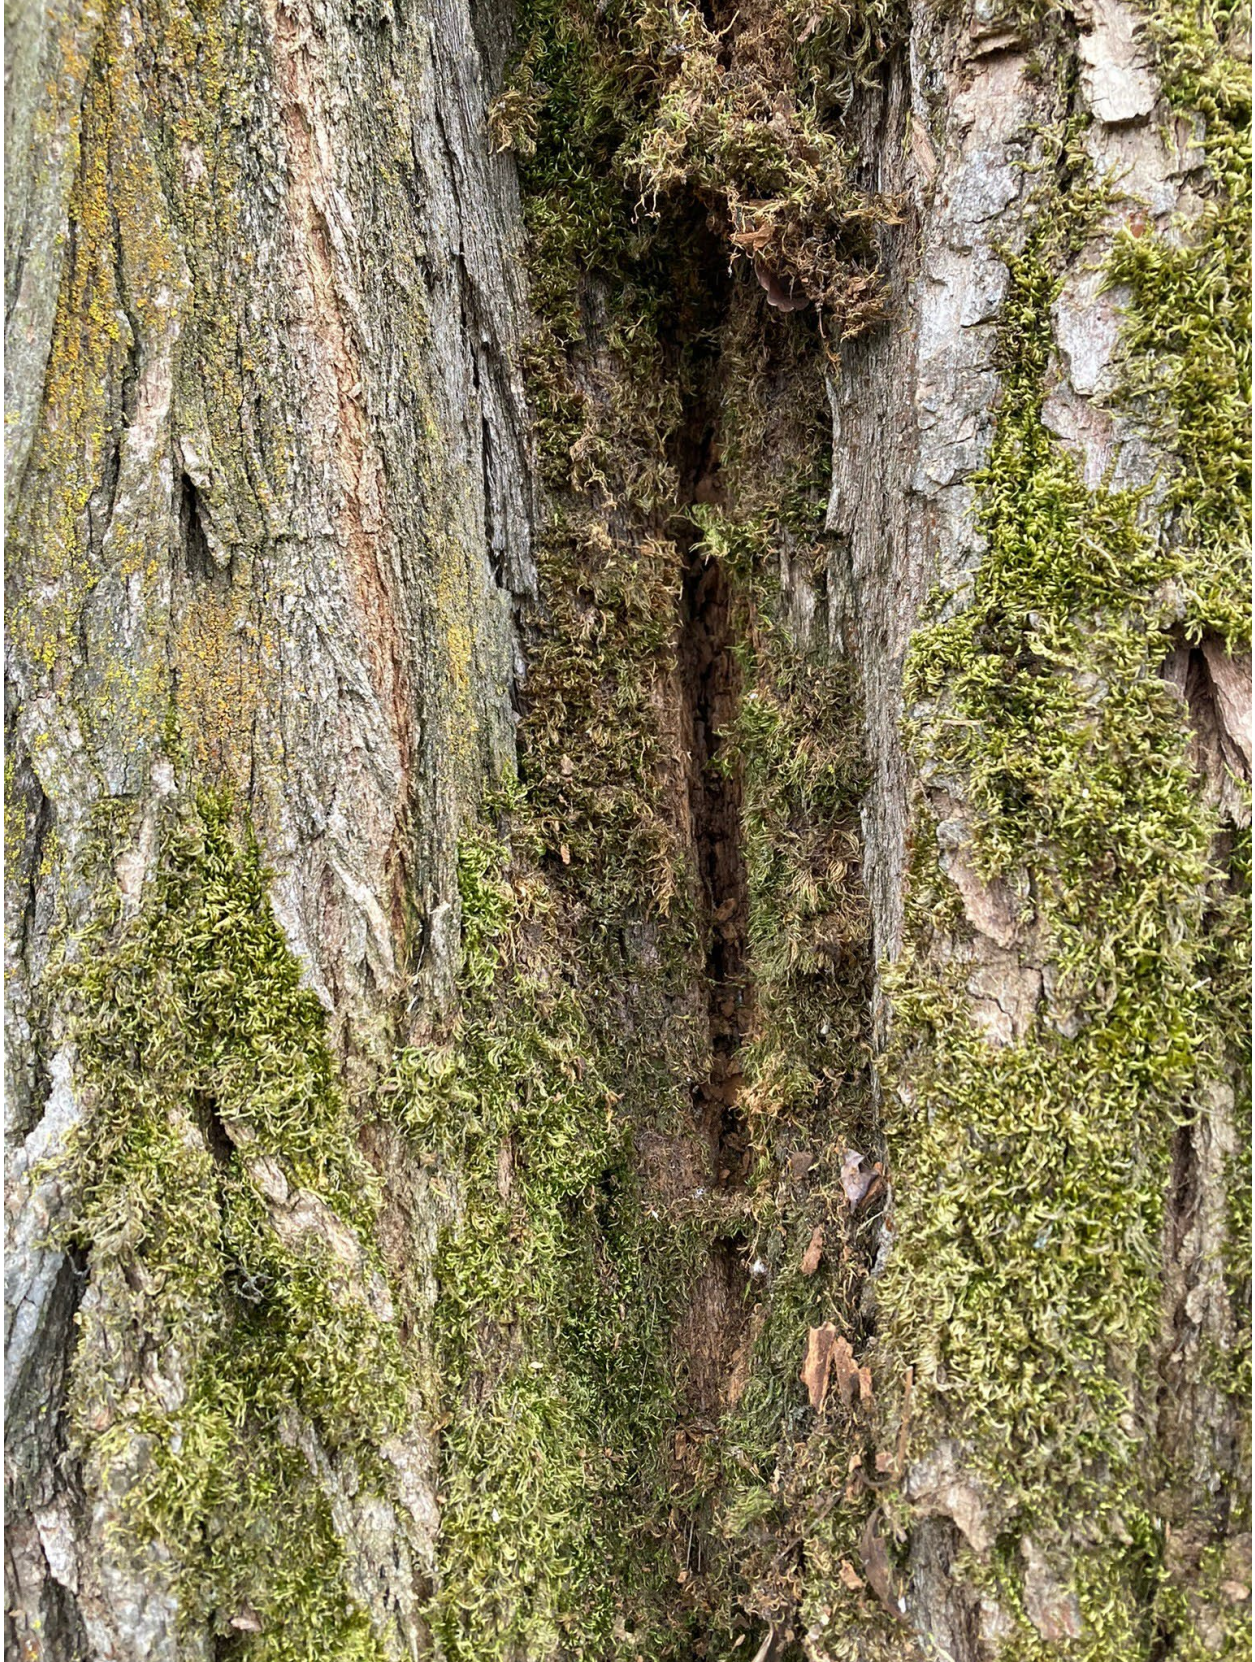
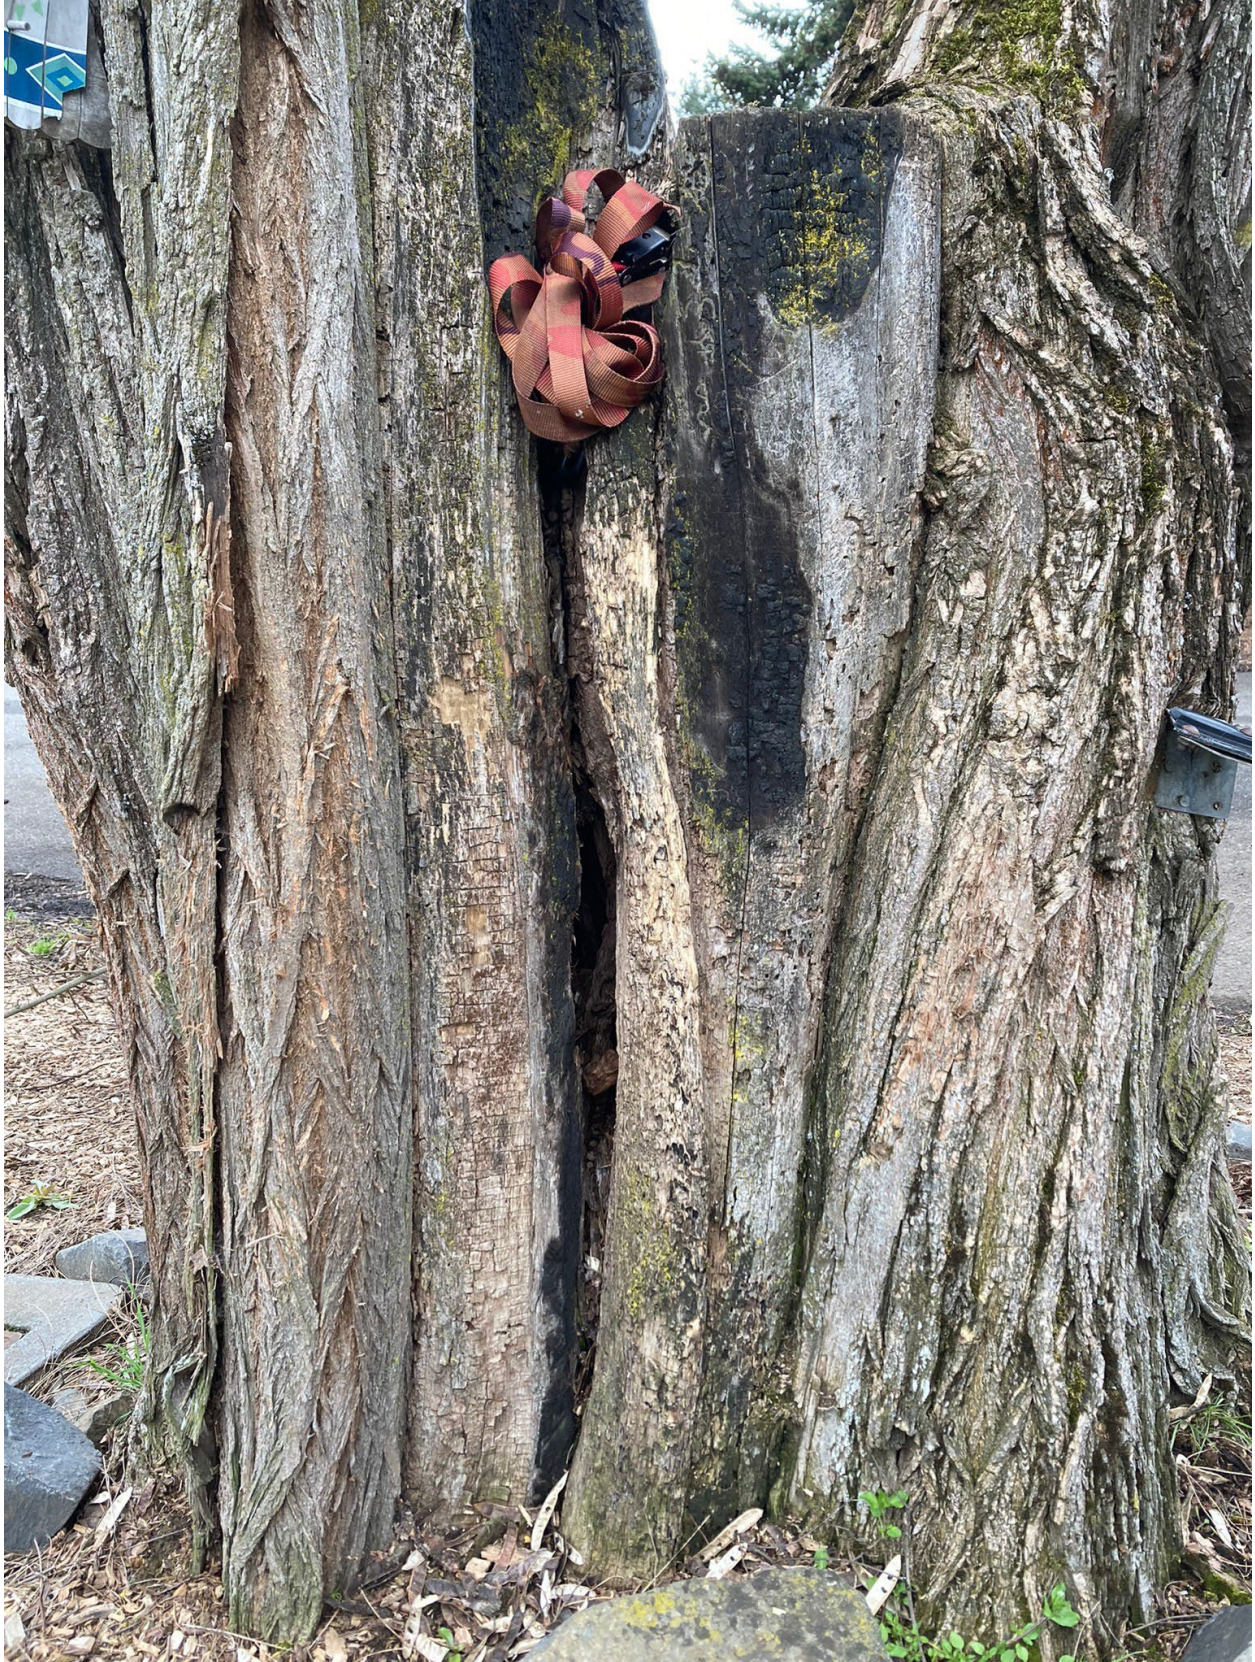
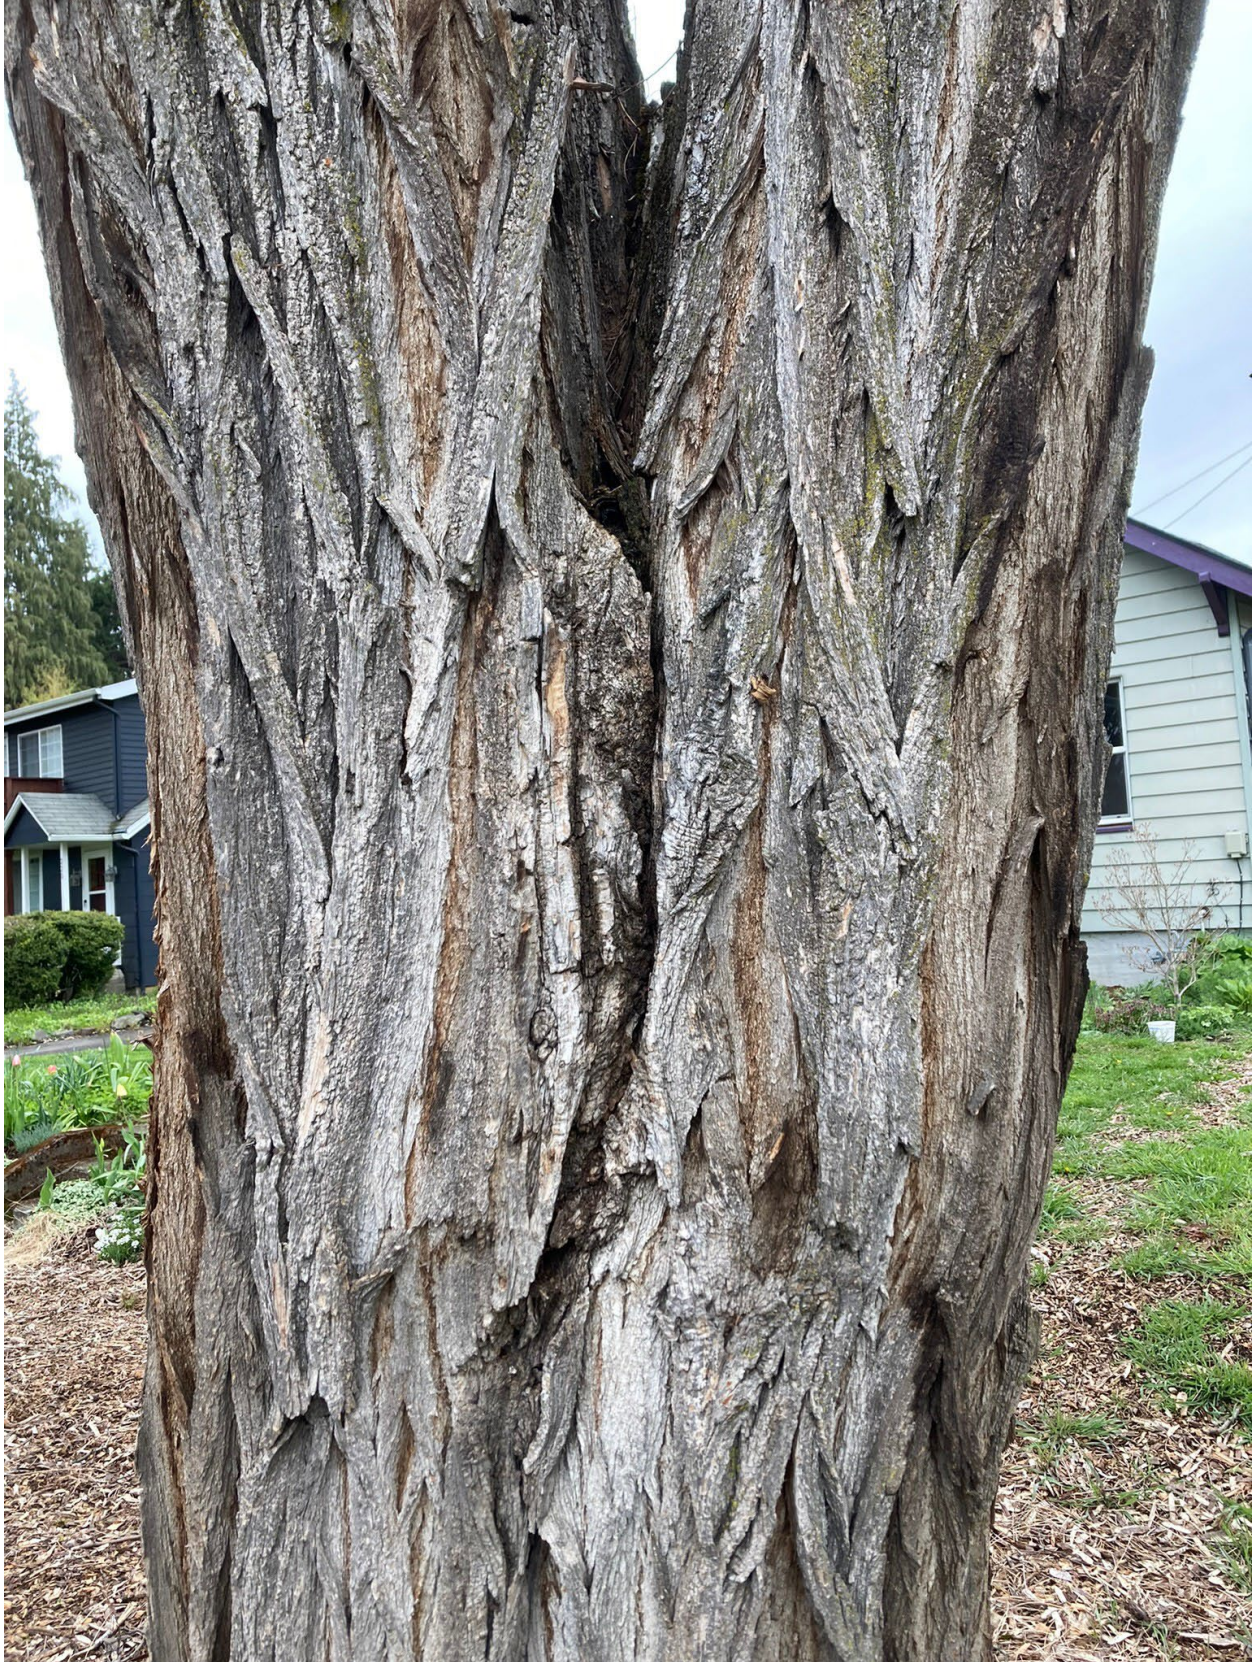
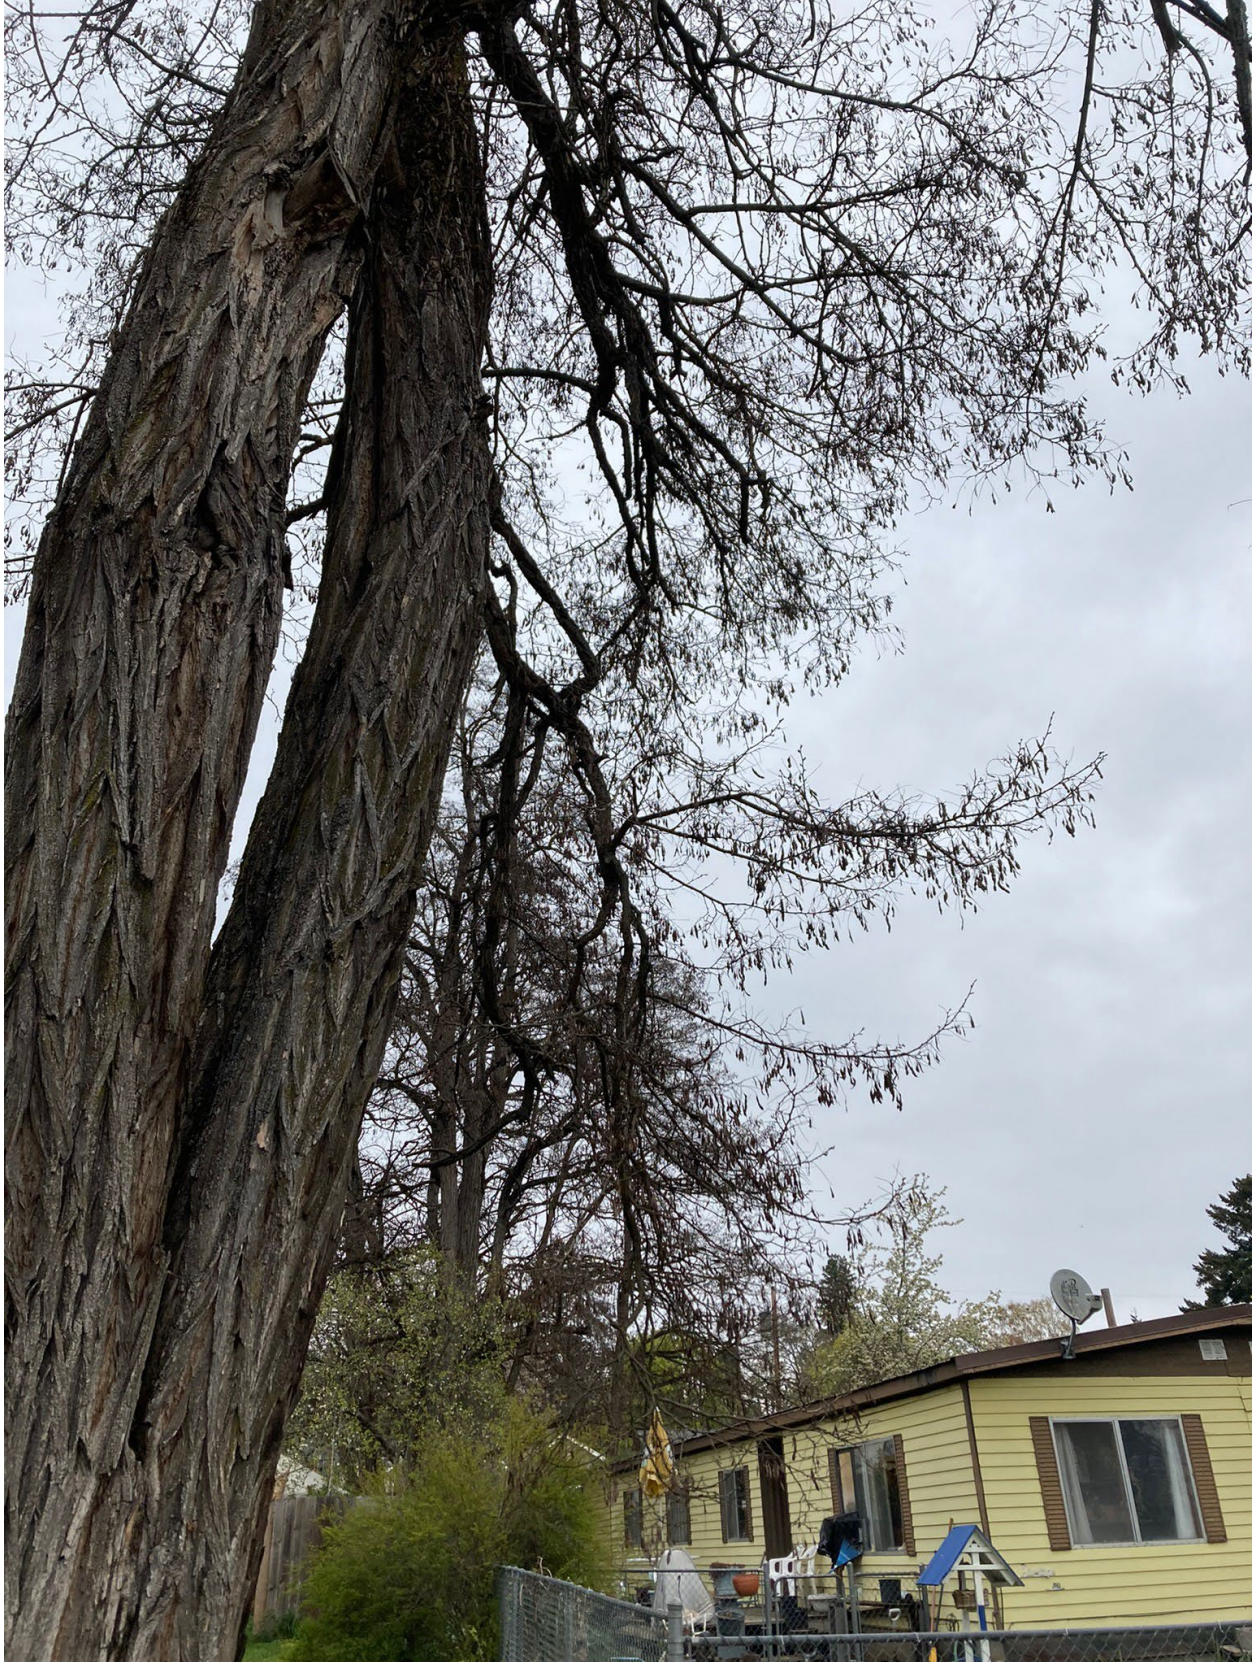
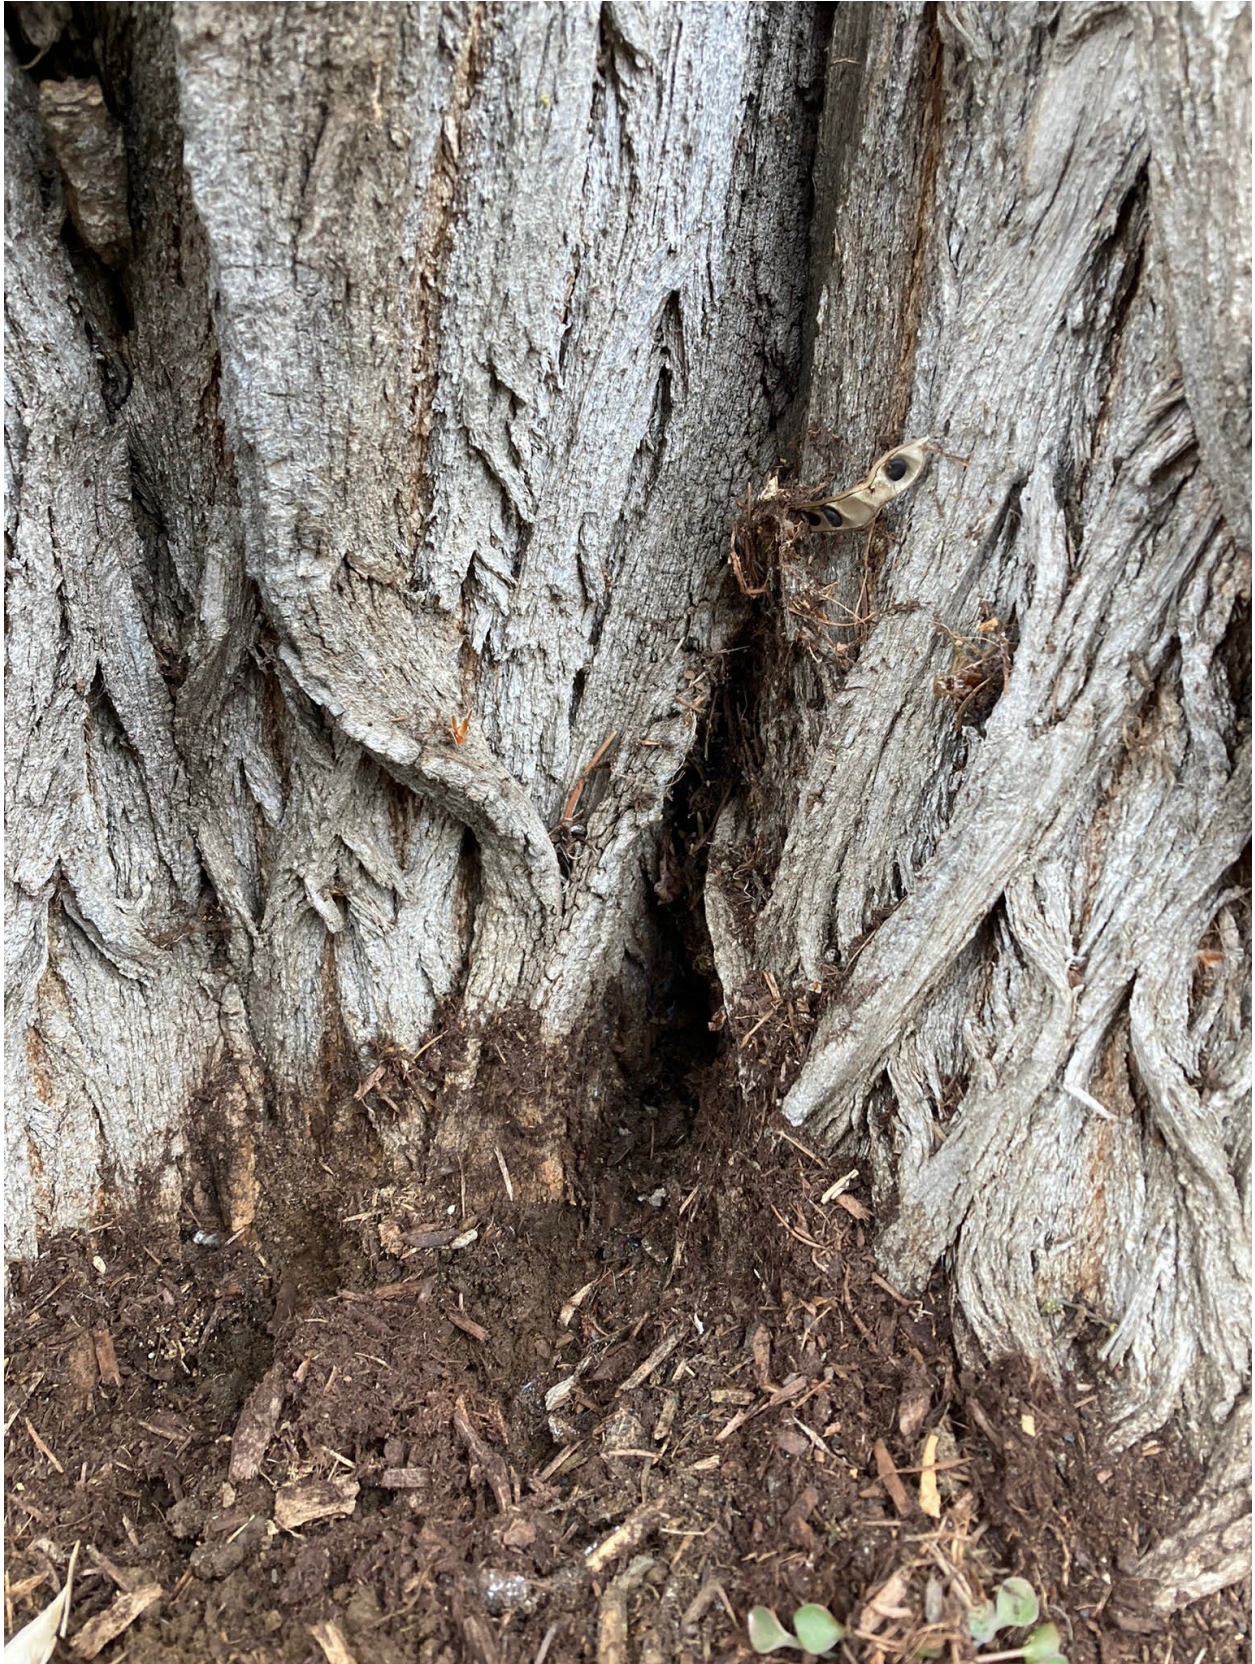
Klickitat Tree Photographs 244 E Green Street Trees

DESCRIPTION	AMOUNT
Two Black Locust trees. Location: In front of 244 Green st. In the city's right of way. Tree # 1: The western tree. DBH 46" Height 40ft The tree shows to have defects in the trunk. Common with these trees. The full circumference of the trunk is not always connected as is the case with this tree. I suspect it dose not have much sound wood holding it together. I recommend removal.	0.00T
Tree # 2: the eastern tree. DBH 34" Height 40ft This tree is in better condition then it's companion. Although it dose show the same poor structure as tree #1 it is not as advanced in its decay and or degradation of its trunk structure. It did loose many branches last winter. Even with this loss of crown weight I don't believe this tree would be wise to keep in the long run, due to it proximity to the road and large scaffolding branch extending towards a residence. I recommend removal.	
<hr/>

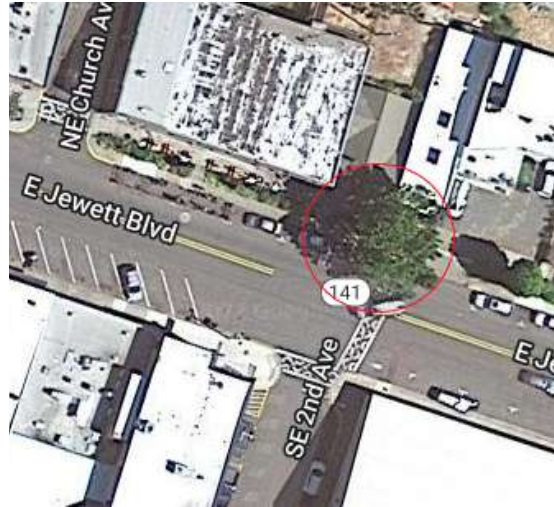
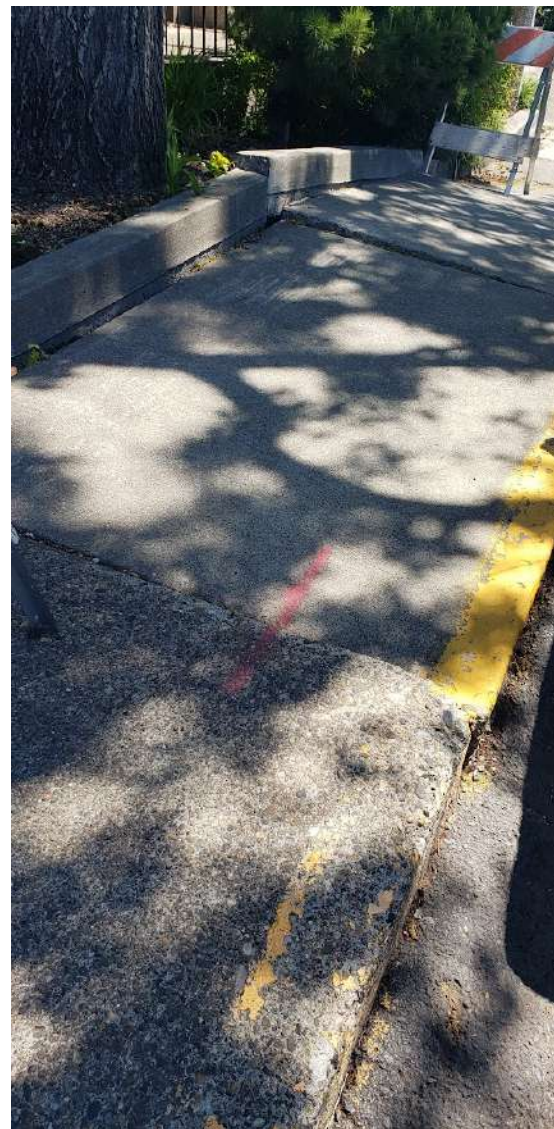
The adjacent pavement appeared new, as though it had been replaced recently. However, the new panels had already lifted unevenly creating a potential trip hazard, and eliminating ADA accessibility compliance. The pavement adjacent was within 6" of the tree trunk.

The adjacent retaining wall and upper sidewalk should be monitored for cracking. They are currently in good condition, however, with the hillside condition, and unknown hydrology, it is possible tree roots can extend uphill if a water source and air are present.

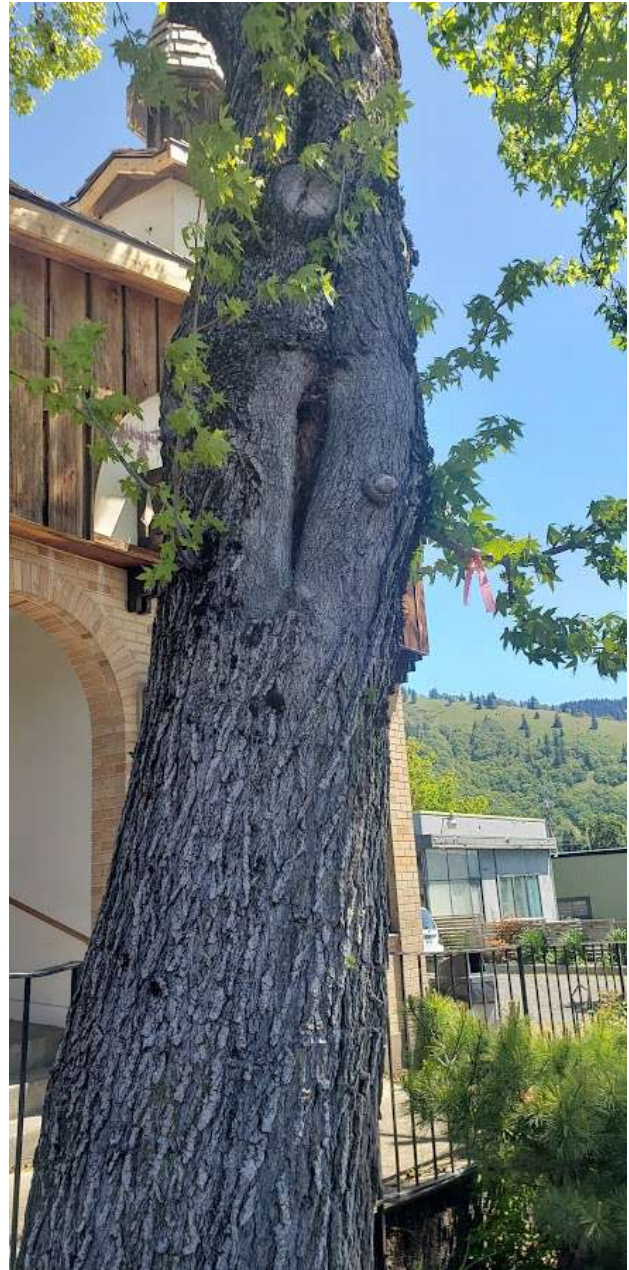
This tree is an open-grown tree with two prior limb failures. One was on the south side (photo, right), toward the street several years ago, and the wound has mostly sealed over. The outer 2-3" of wood beneath the wound is spongy and delayed. Minor epicormic sprouts are present near this wound. A second wound is visible on the north side, higher in the canopy. It looks recent, within the past 3 years. These wounds are consistent with the species that tends to have moderately brittle branches, and tends to fail where included bark is present.

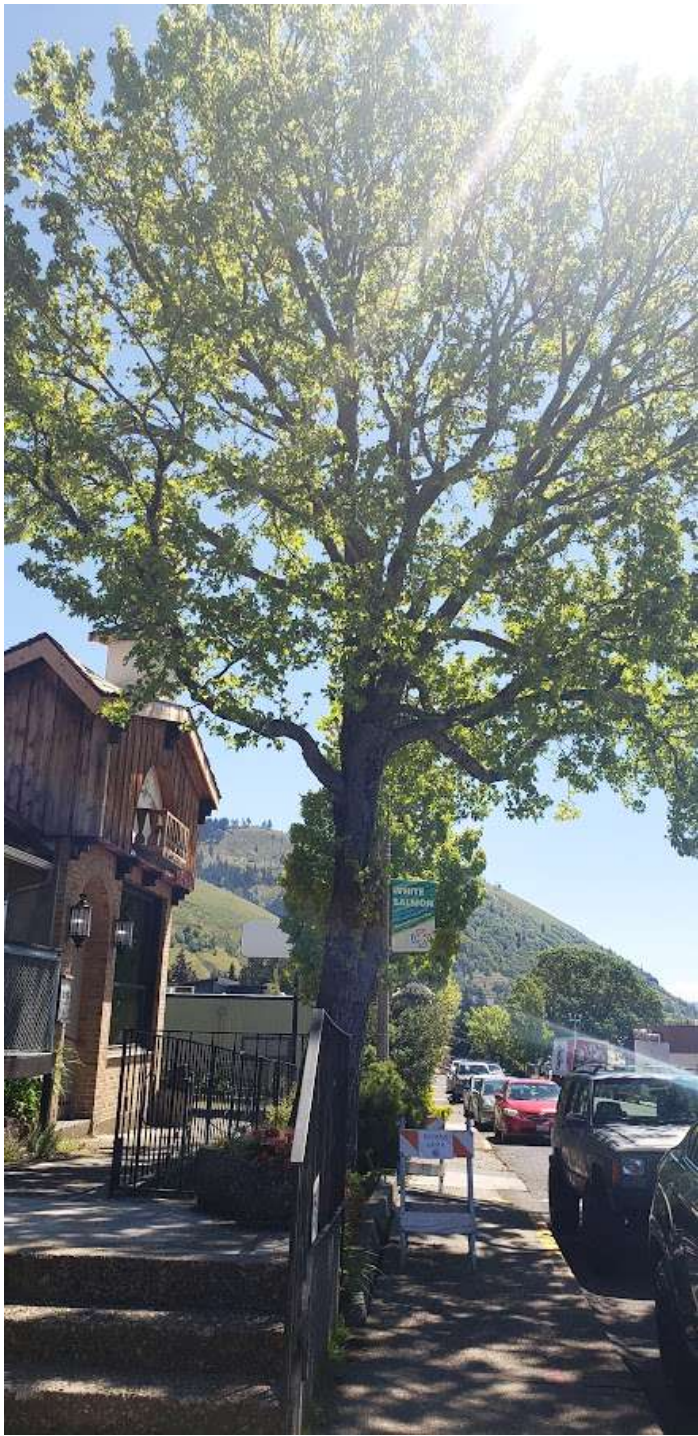
Photo 1. View facing east showing site, upper and lower sidewalk

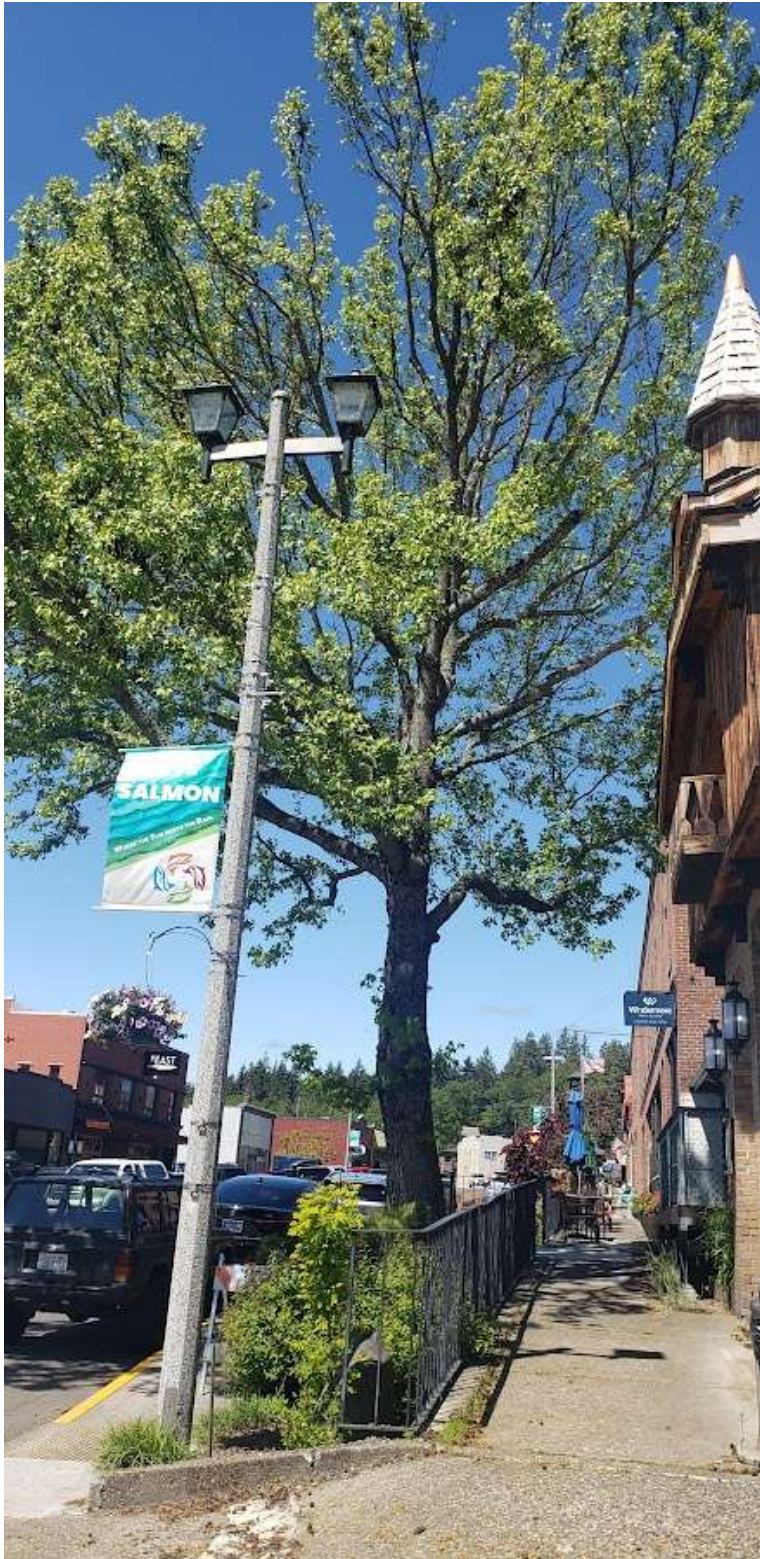
Photo 2. View facing west showing site, upper and lower sidewalk

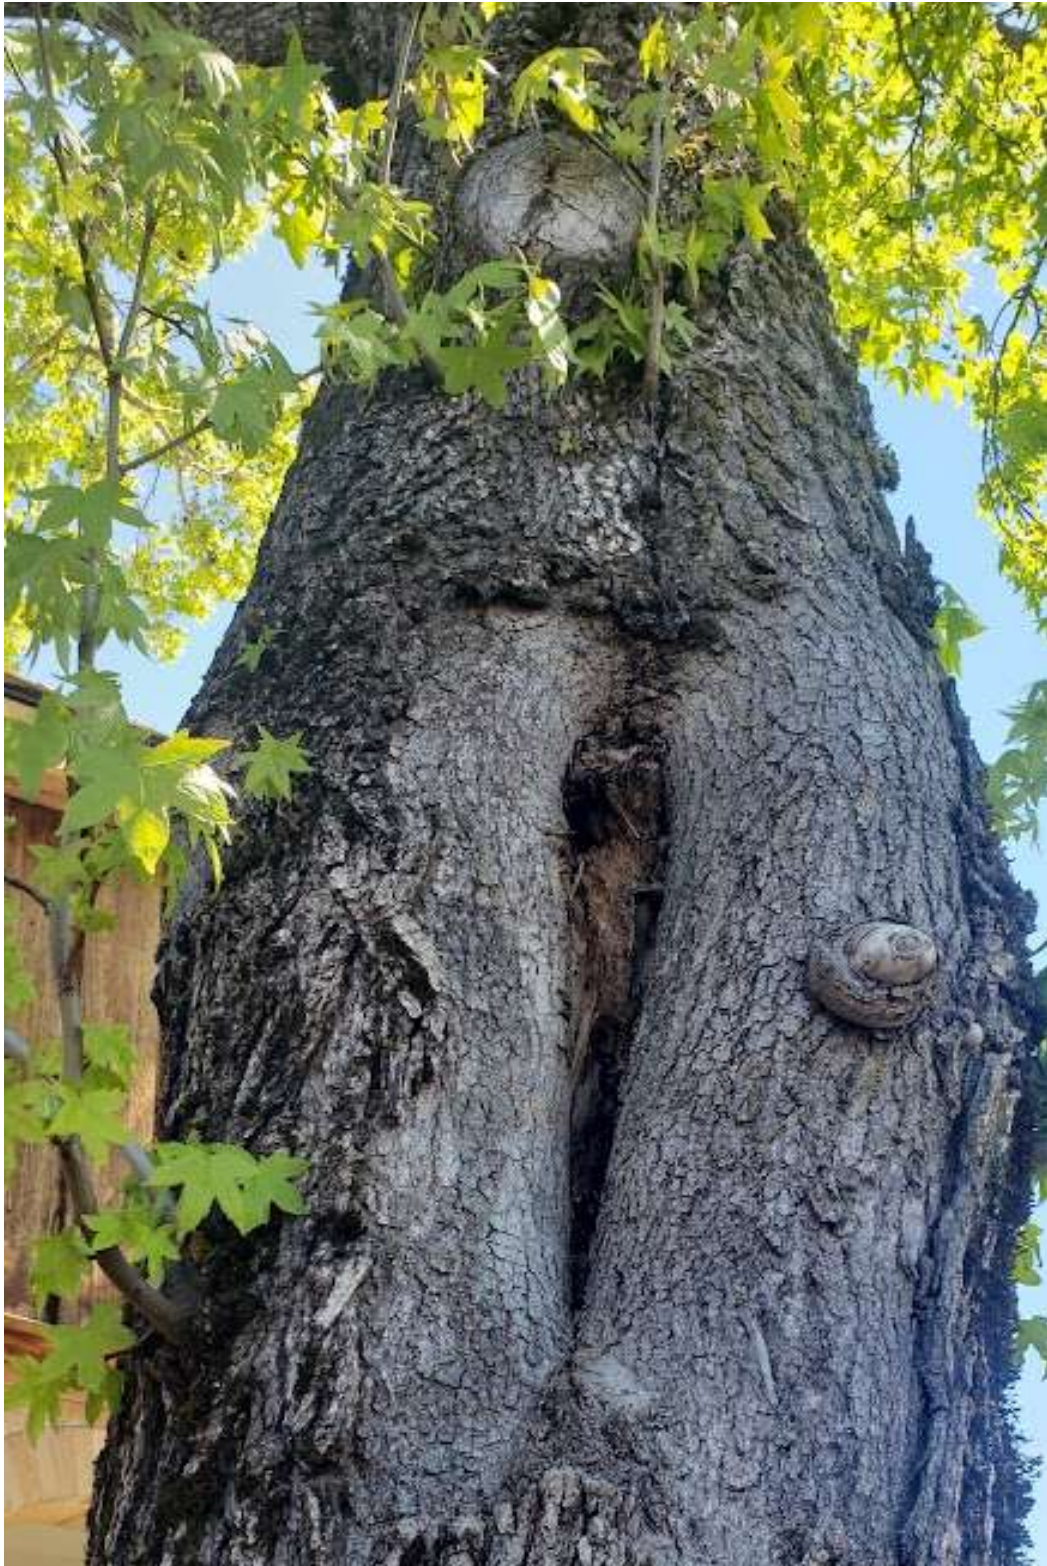
Photo 3. Close view of south trunk wound/ previous branch failure
