White Salmon Tree Board Meeting

August 01, 2022 – 5:30 PM

Tree Assessment

May 2022

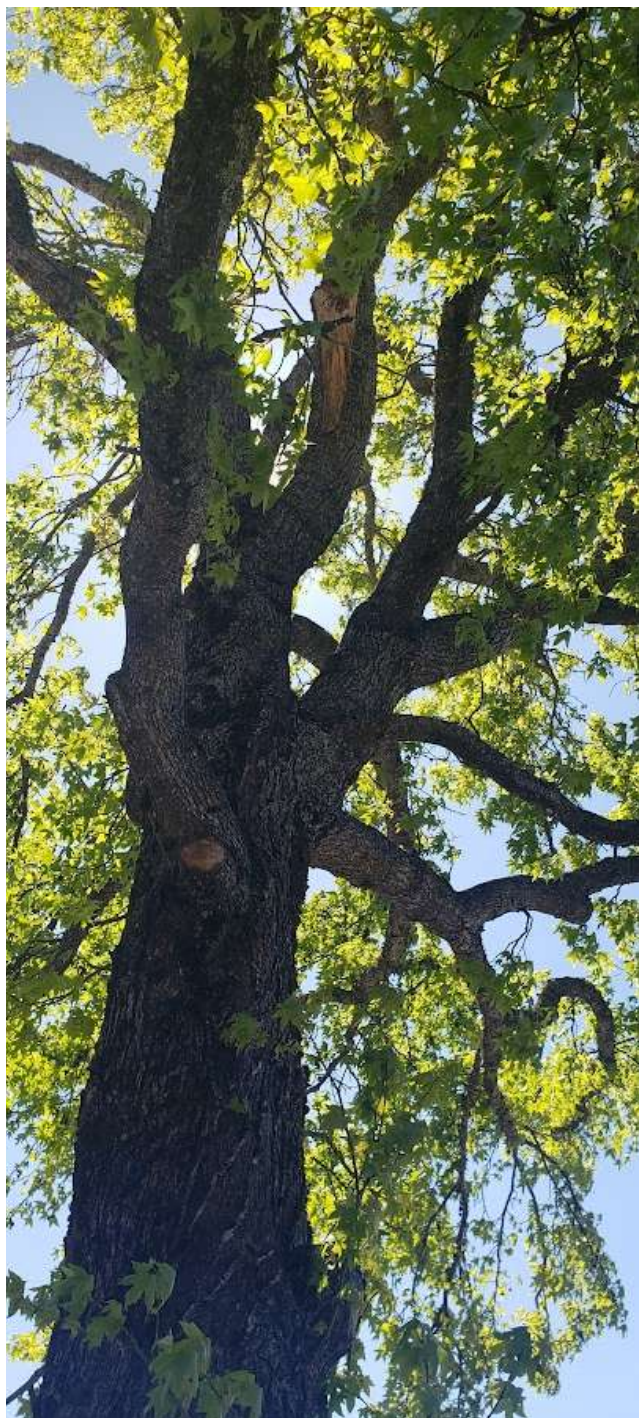
This tree is an open-grown tree with two prior limb failures. One was on the south side (photo, right), toward the street several years ago, and the wound has mostly sealed over. The outer 2-3" of wood beneath the wound is spongy and delayed. Minor epicormic sprouts are present near this wound. A second wound is visible on the north side, higher in the canopy. It looks recent, within the past 3 years. These wounds are consistent with the species that tends to have moderately brittle branches, and tends to fail where included bark is present.

North side limb failure

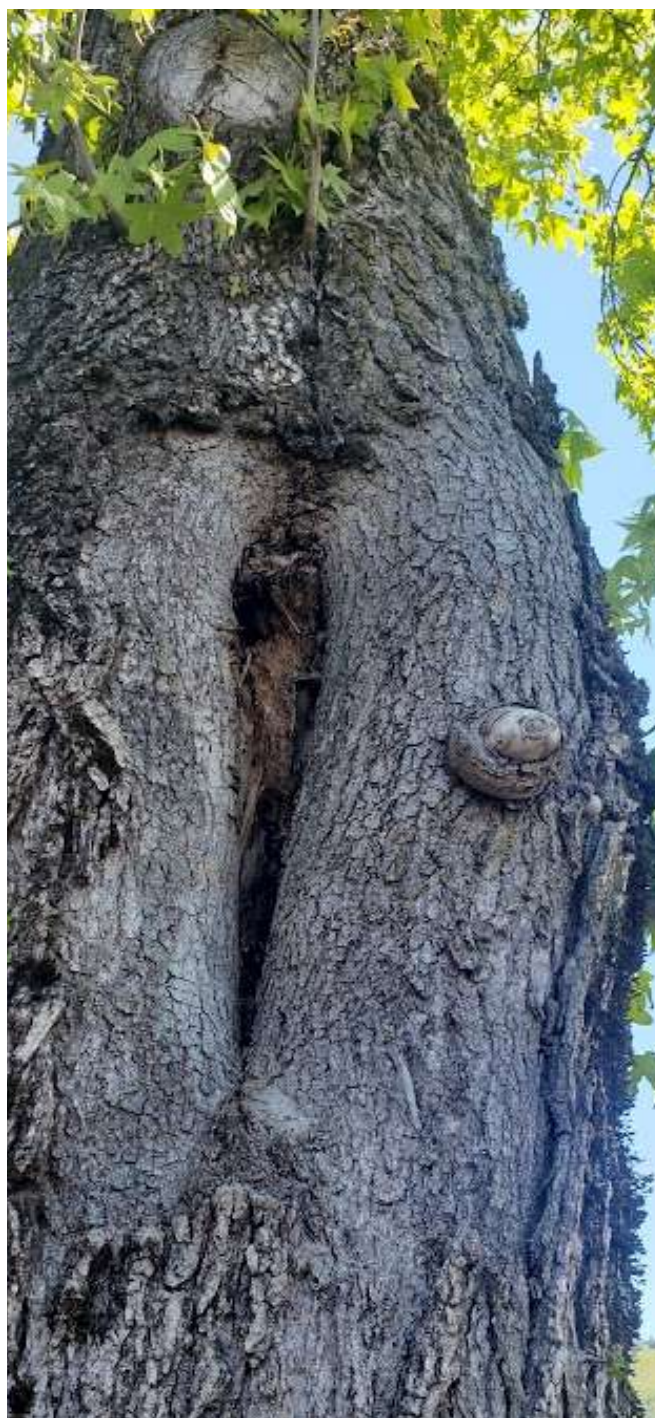
South side limb failure (close up) shows decay/splintered wood indicating prior failure, not pruning wound. Smaller pruning wound above is sealed.

- Pruning: routine end-weight reduction/clearance pruning (cuts largely below 3" diameter in the upper outer ⅓ of the canopy) and aerial inspection for hidden defects every 3-5 years will decrease the likelihood of future limb failure, resulting in a residual risk rating of low. This should be conducted within the next 1-2 years. The tree must be pruned up to 8 feet above sidewalks for clearance and 14 feet above any roadways. The tree should be monitored, and an arborist consulted if changes are noticed in vigor or lean, and after significant storms. The adjacent retaining wall and upper sidewalk should also be monitored for cracking.

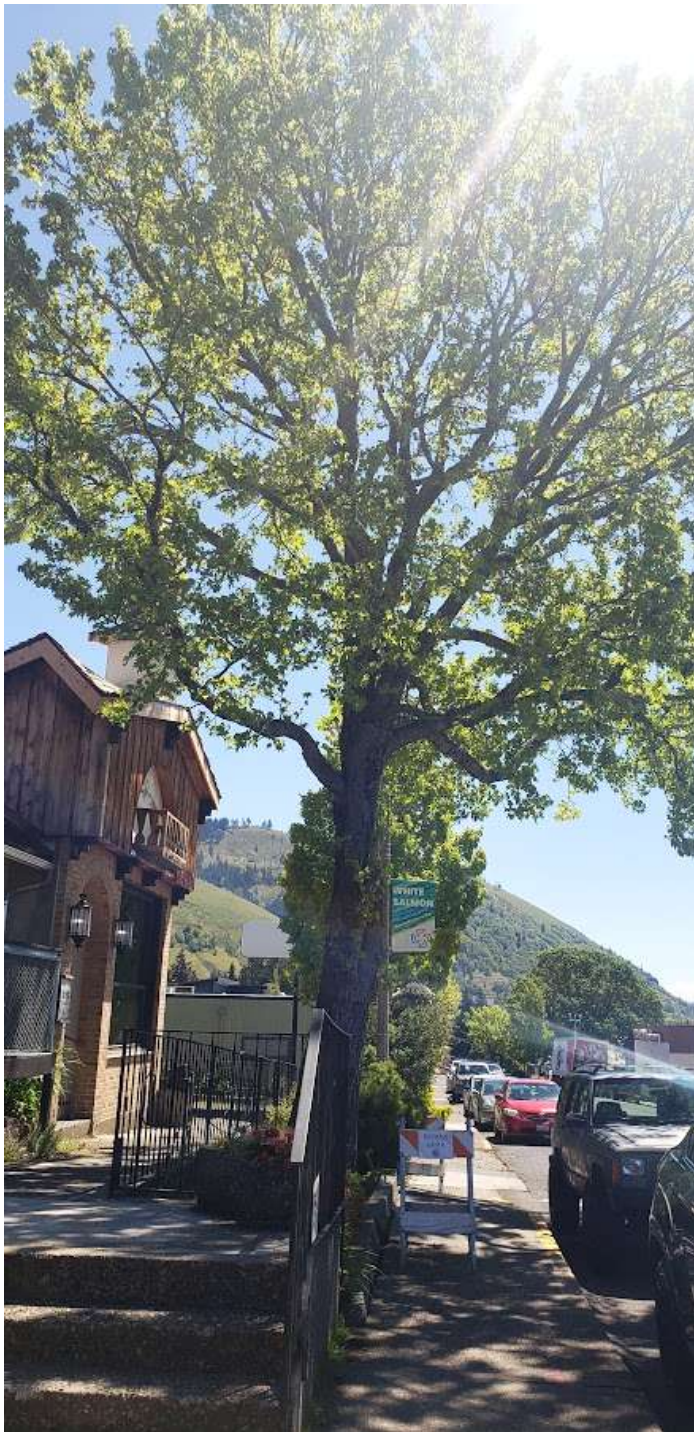
Photo 1. View facing east showing site, upper and lower sidewalk

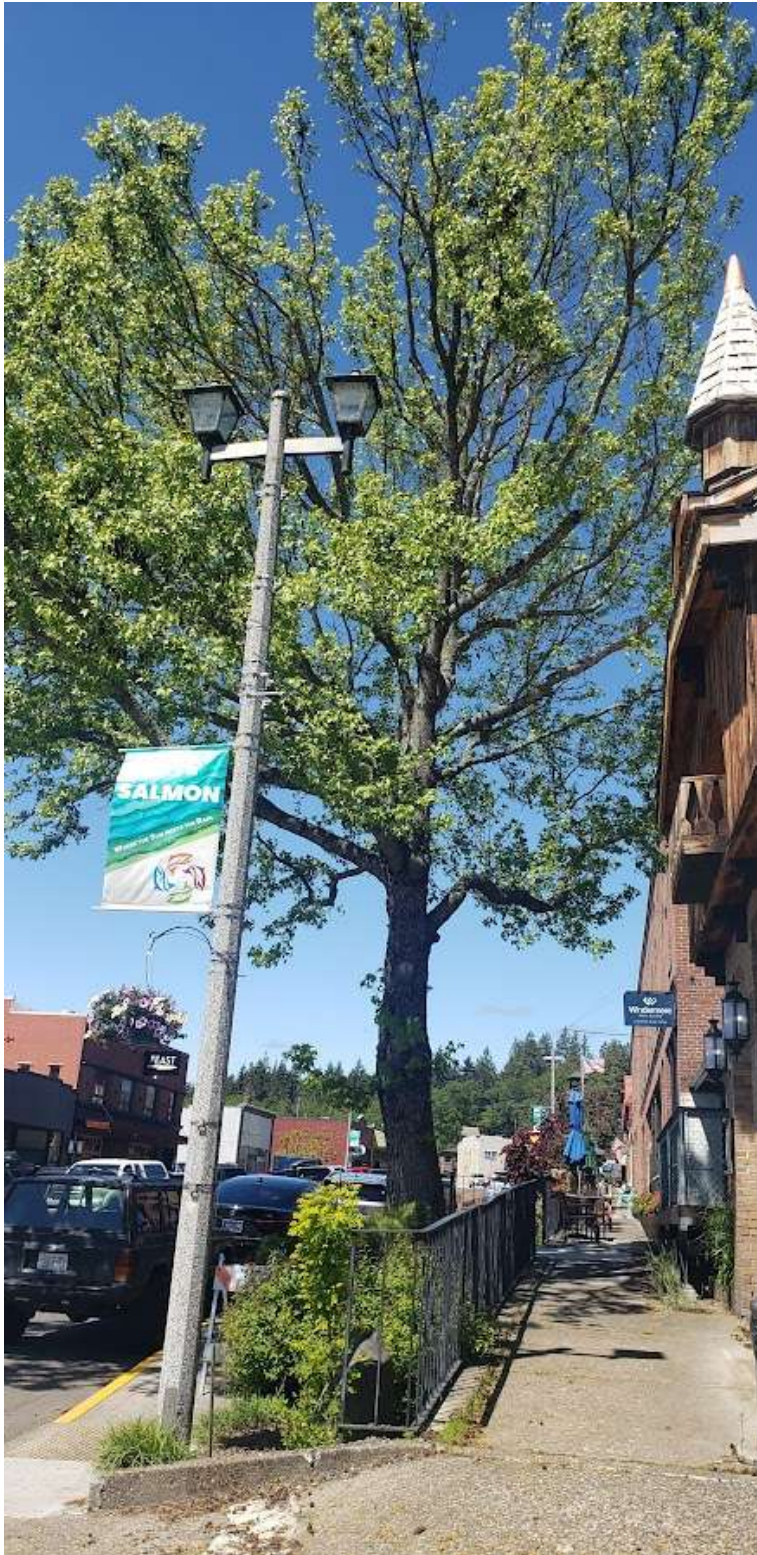
Photo 2. View facing west showing site, upper and lower sidewalk

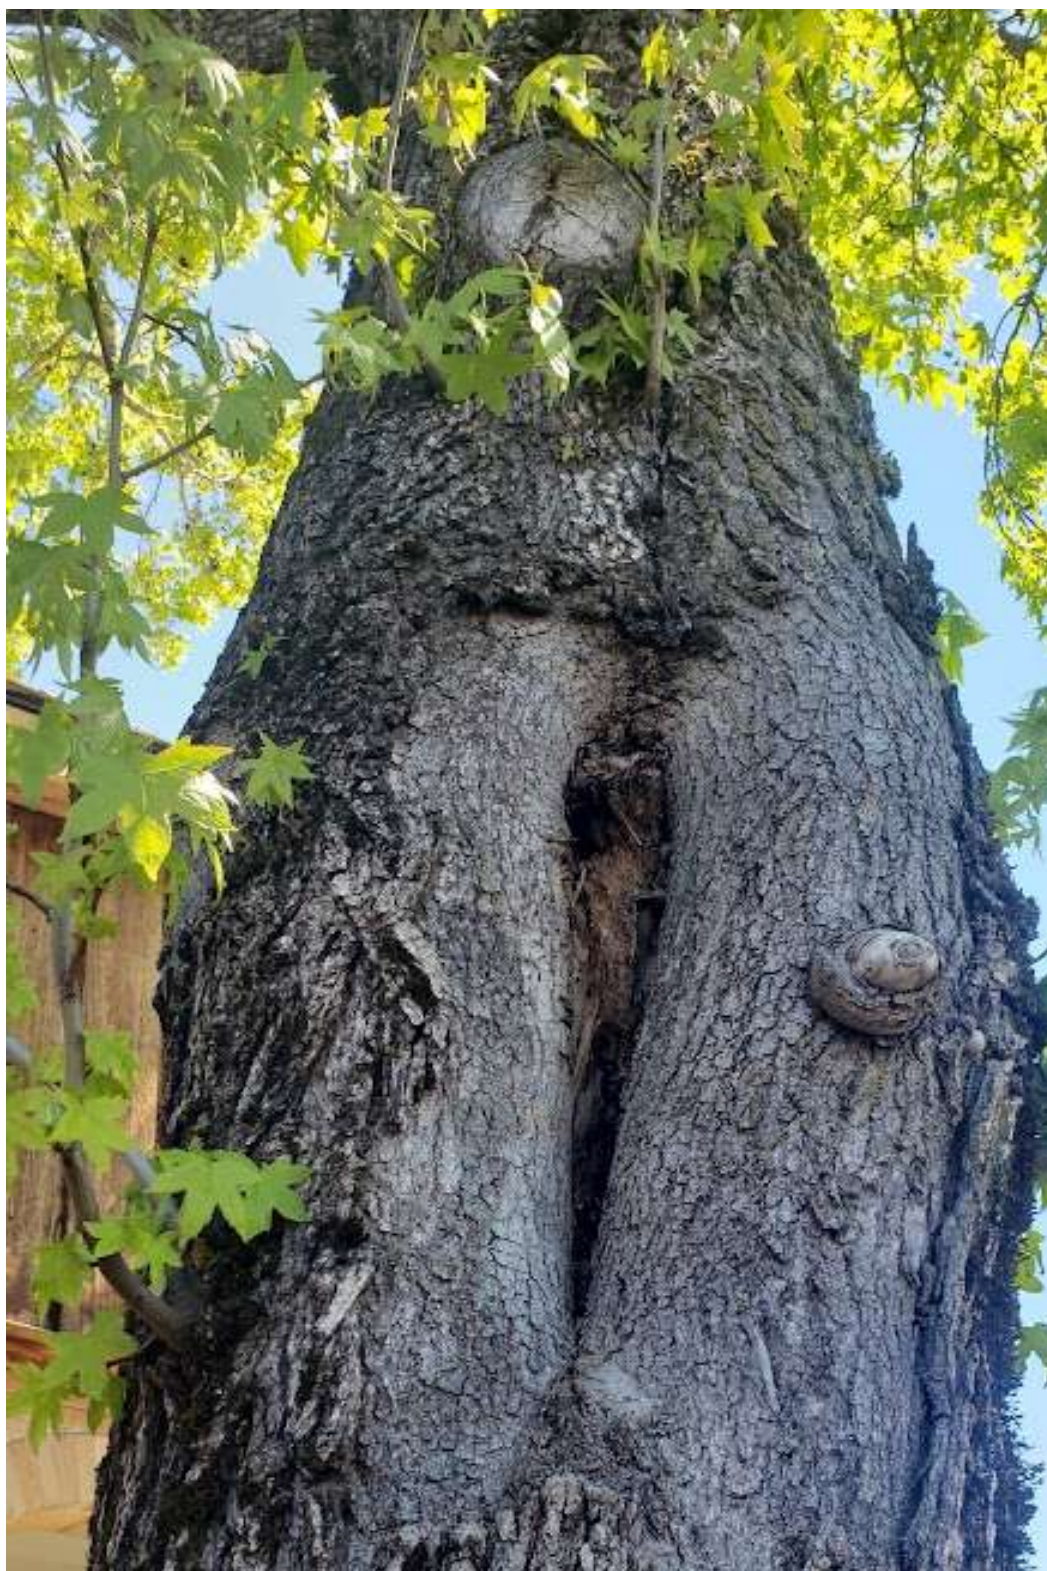
Photo 3. Close view of south trunk wound/ previous branch failure

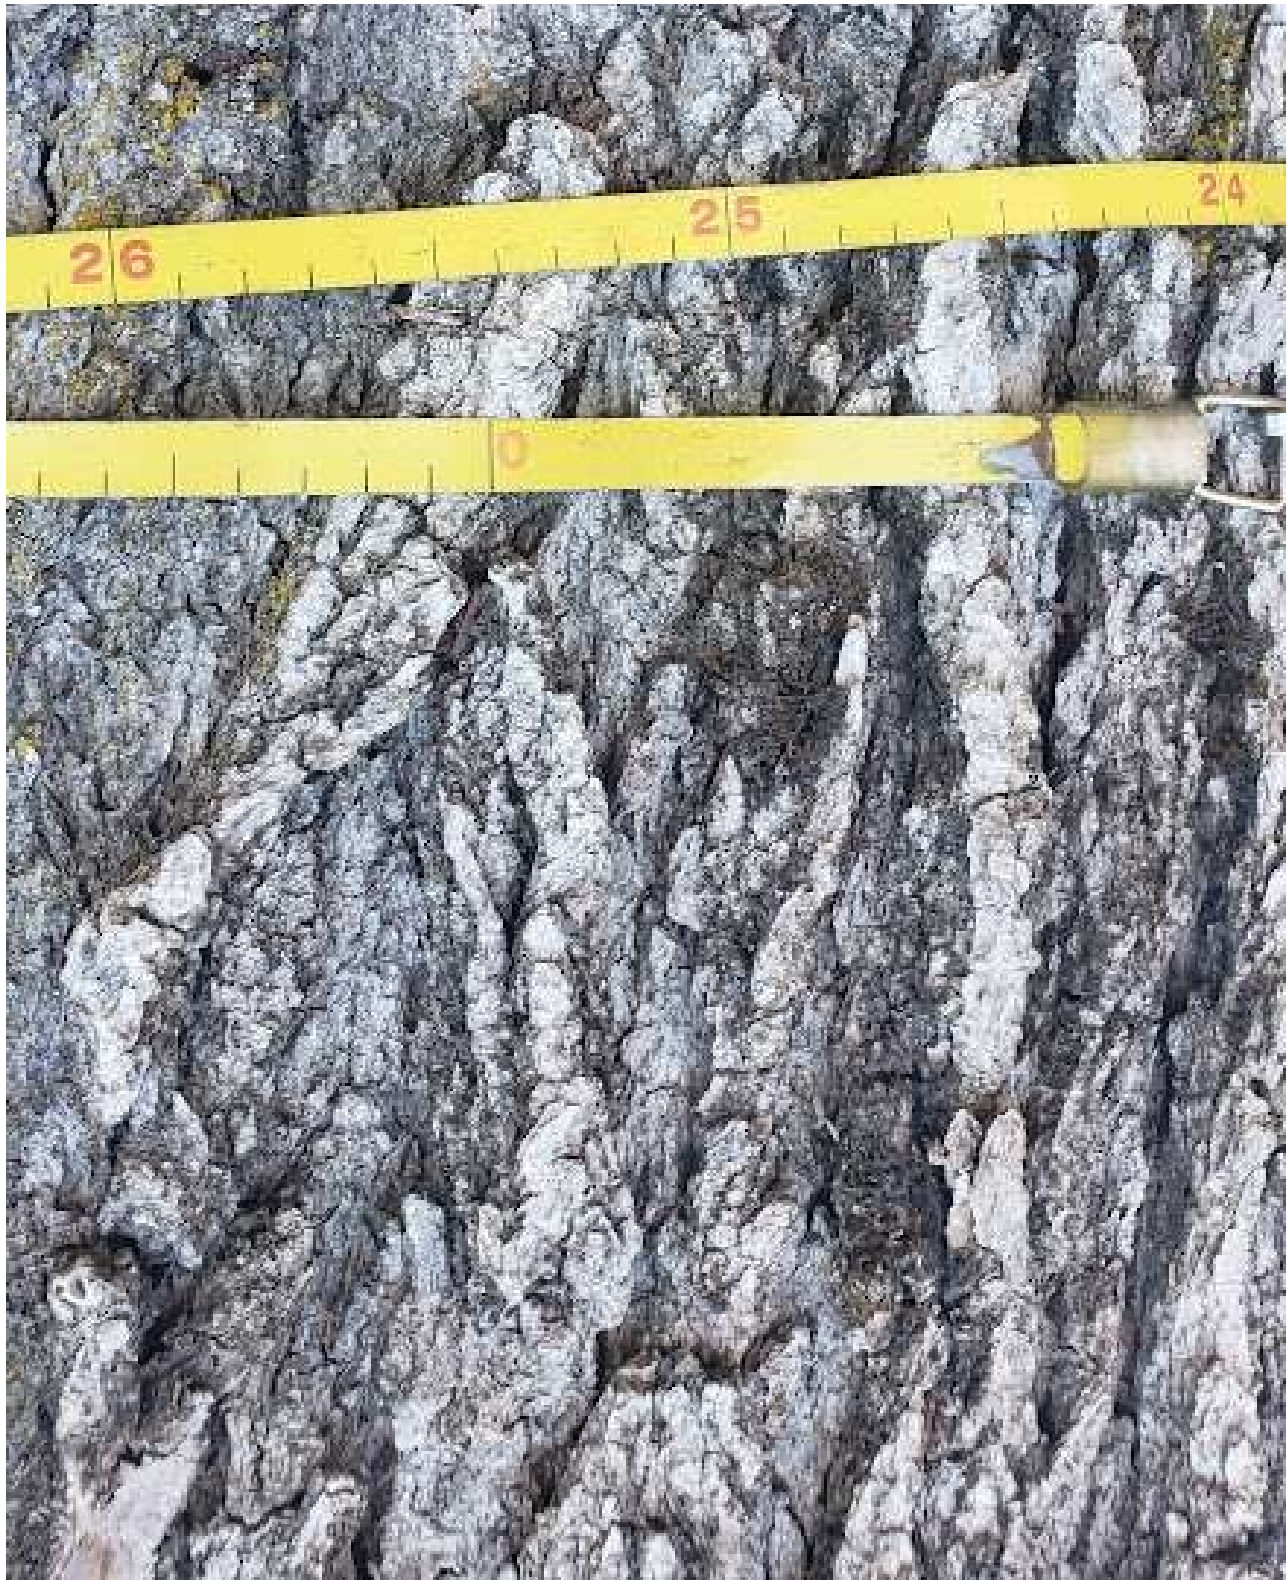
Photo 4. DBH tape on trunk showing over 25" DBH May 20, 2022

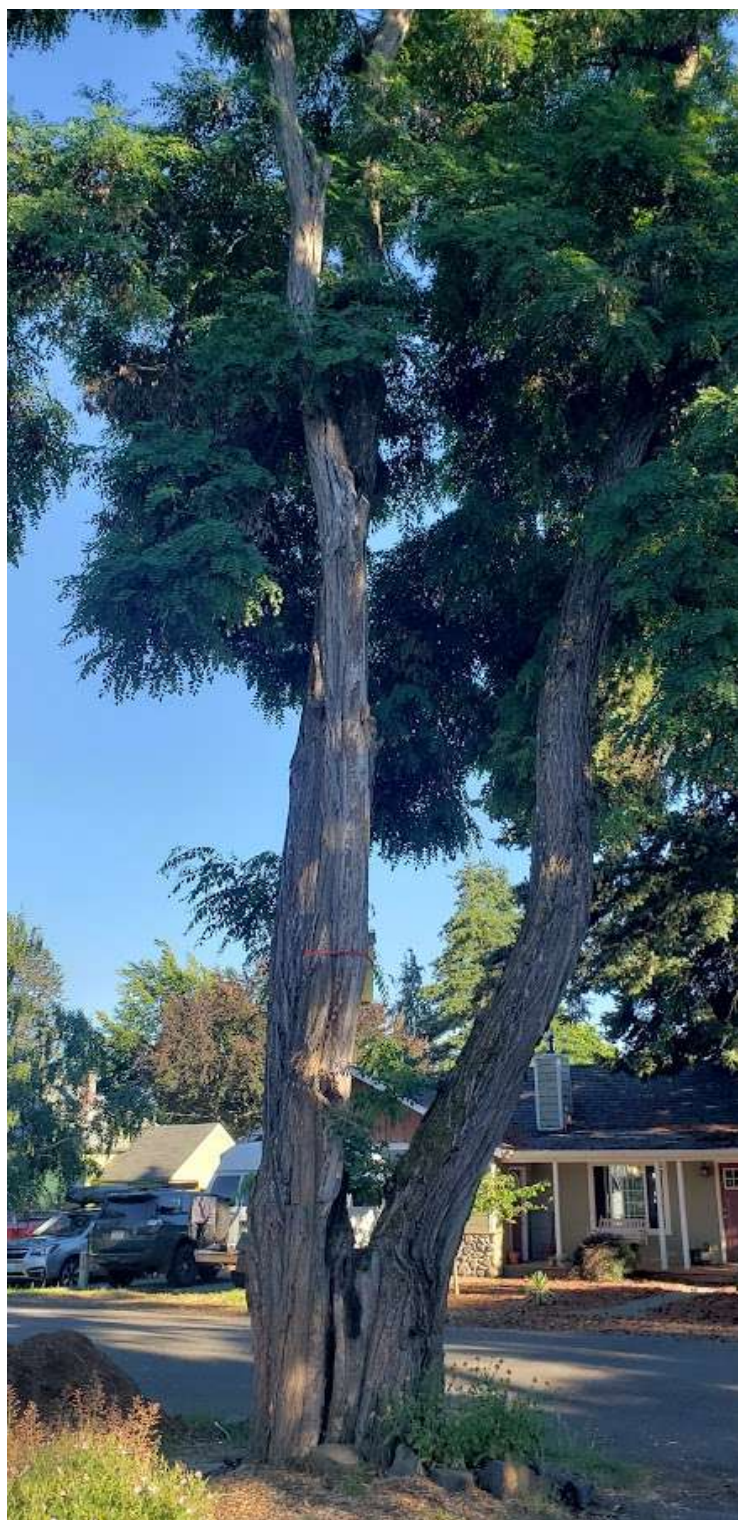
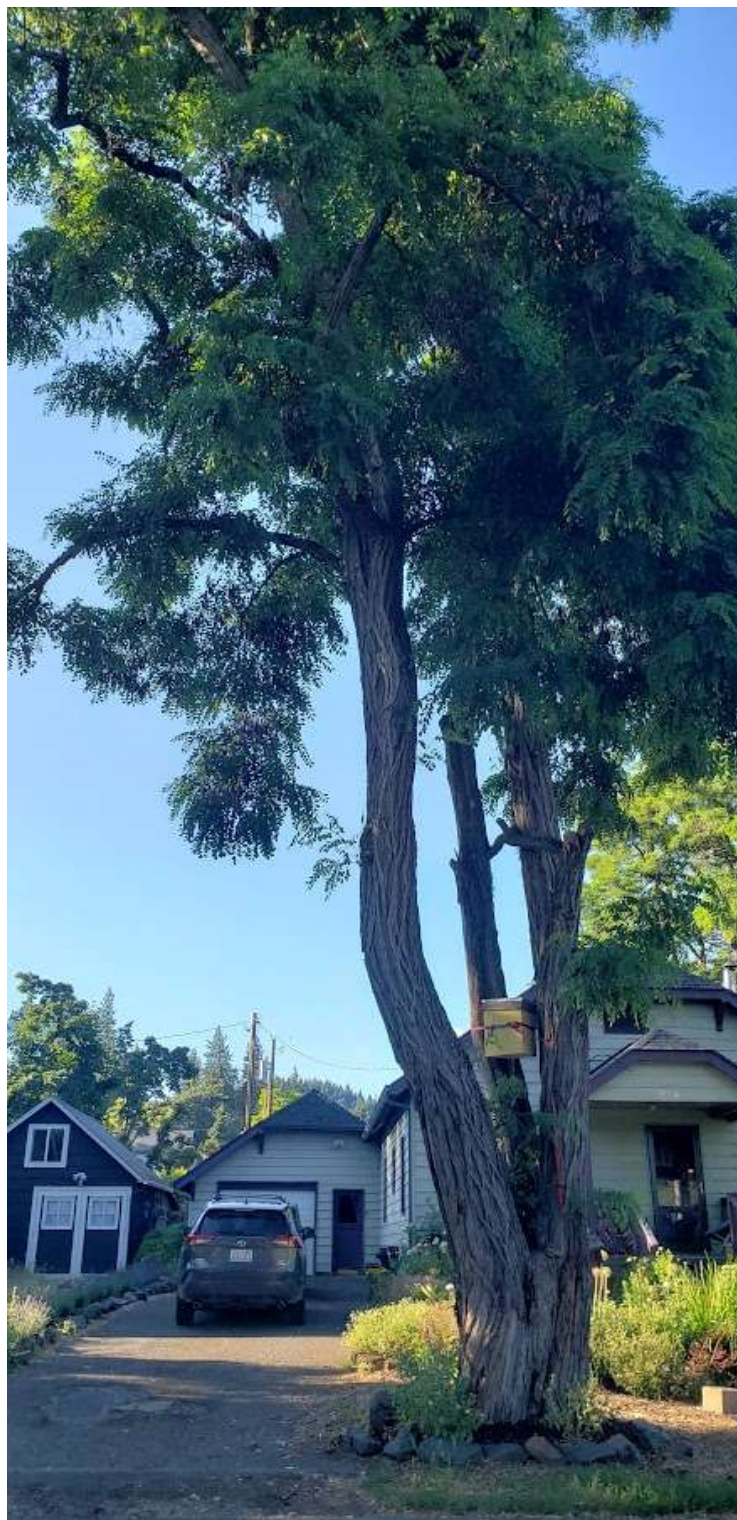
Tree #1 viewed from the north (left) and south (right)

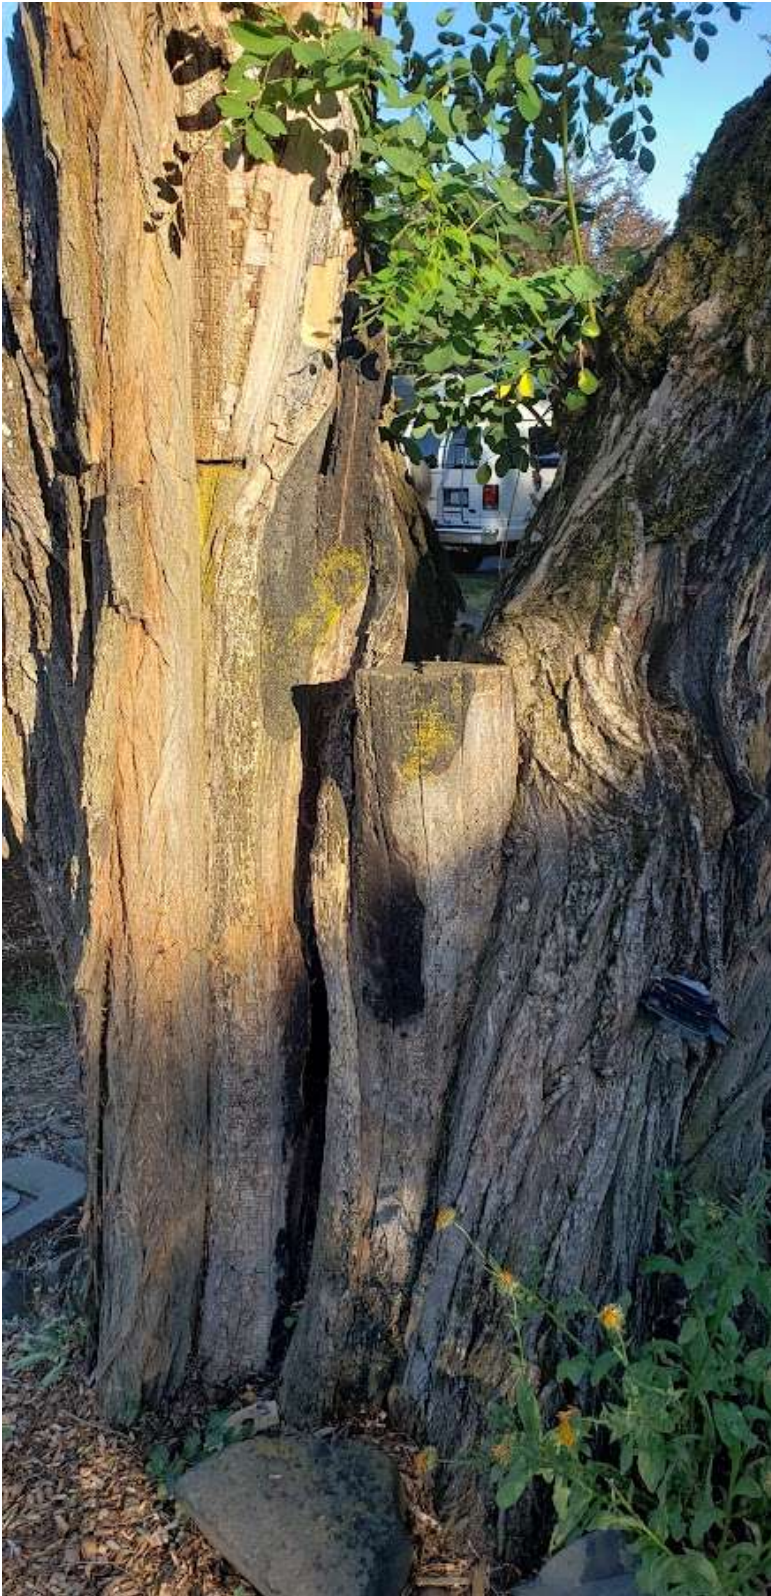
-
- Tree #1 is a mature 44" DBH *Robinia pseudoacacia* that is 73' tall and 35' from the primary target (residence at 244 NE. Green), and about 2' from the secondary target (driveway with frequent vehicle parking). One stem lost much of the living tissue on the interior side of the limb. There is a cavity between the three stems, and charred wood as from a fire. One prior limb failure was documented. The tree has healthy, vigorous foliage. The overall condition is poor.
 - Tree #2 32" DBH *Robinia pseudoacacia* that is 62' tall and approximately 35' from the primary target (residence at 244 NE. Green). The tree is codominant with two major stems. The tree has healthy vigorous foliage. The overall condition is fair.

Tree #1 prior leader failure, 15" dead center, column of decay, fire.

- Tree #1 is high risk based on the ISA TRA methodology. The tree risk mitigation recommendation is removal. Pruning and cabling were considered and are discussed further in this report.
- Tree #2 is low risk. Routine end weight reduction pruning is recommended.

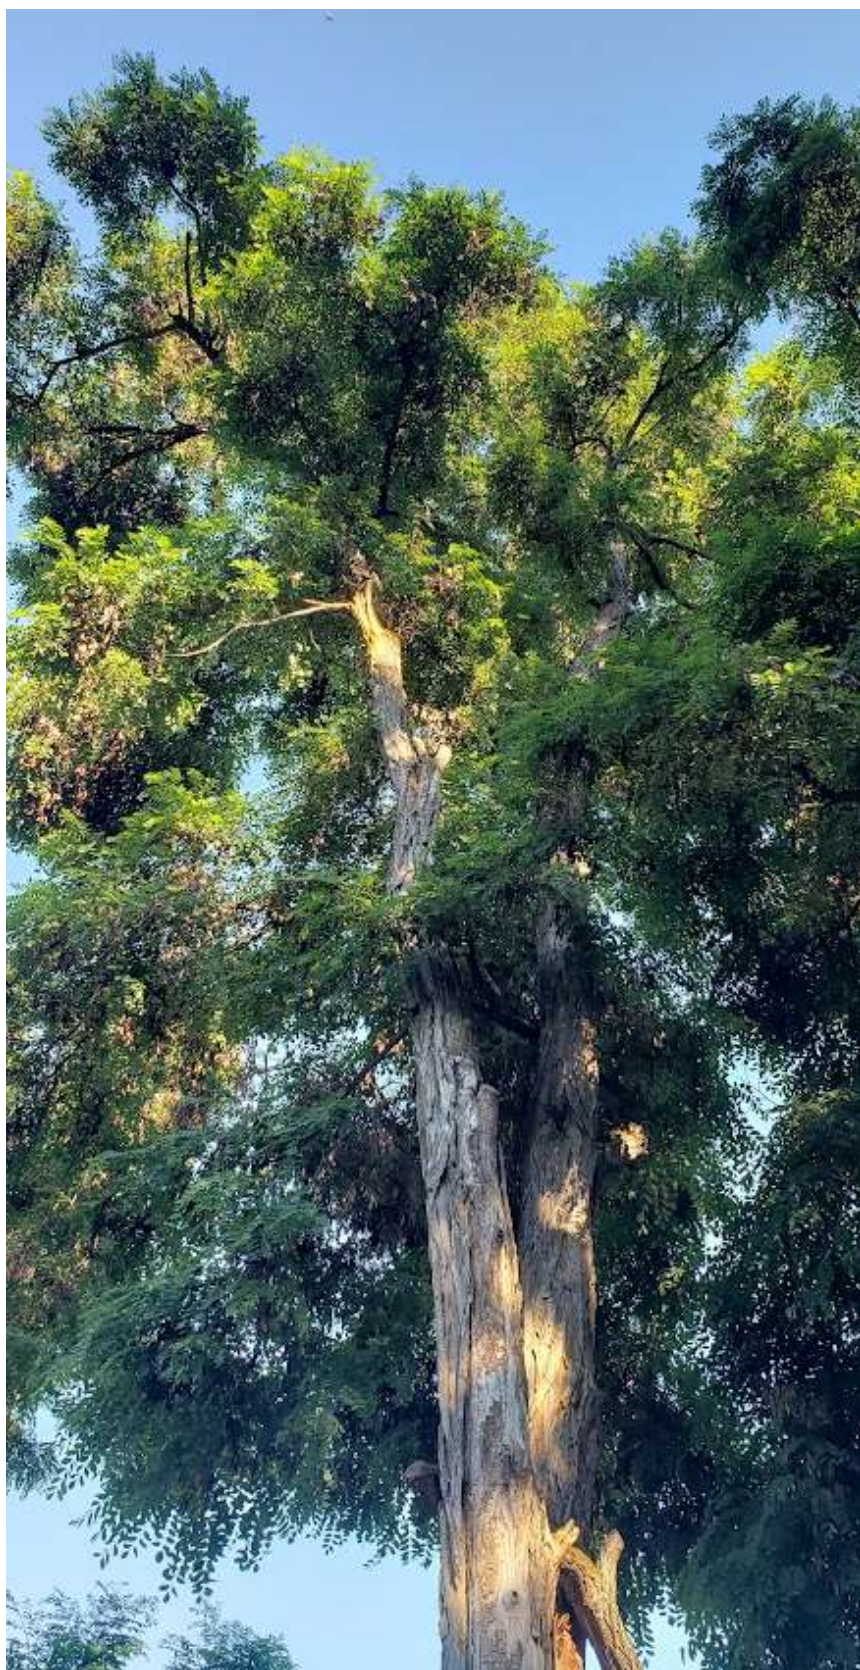
Tree #1 North leader missing 50-70% live tissue on the interior side, recent limb tear-out in upper canopy.

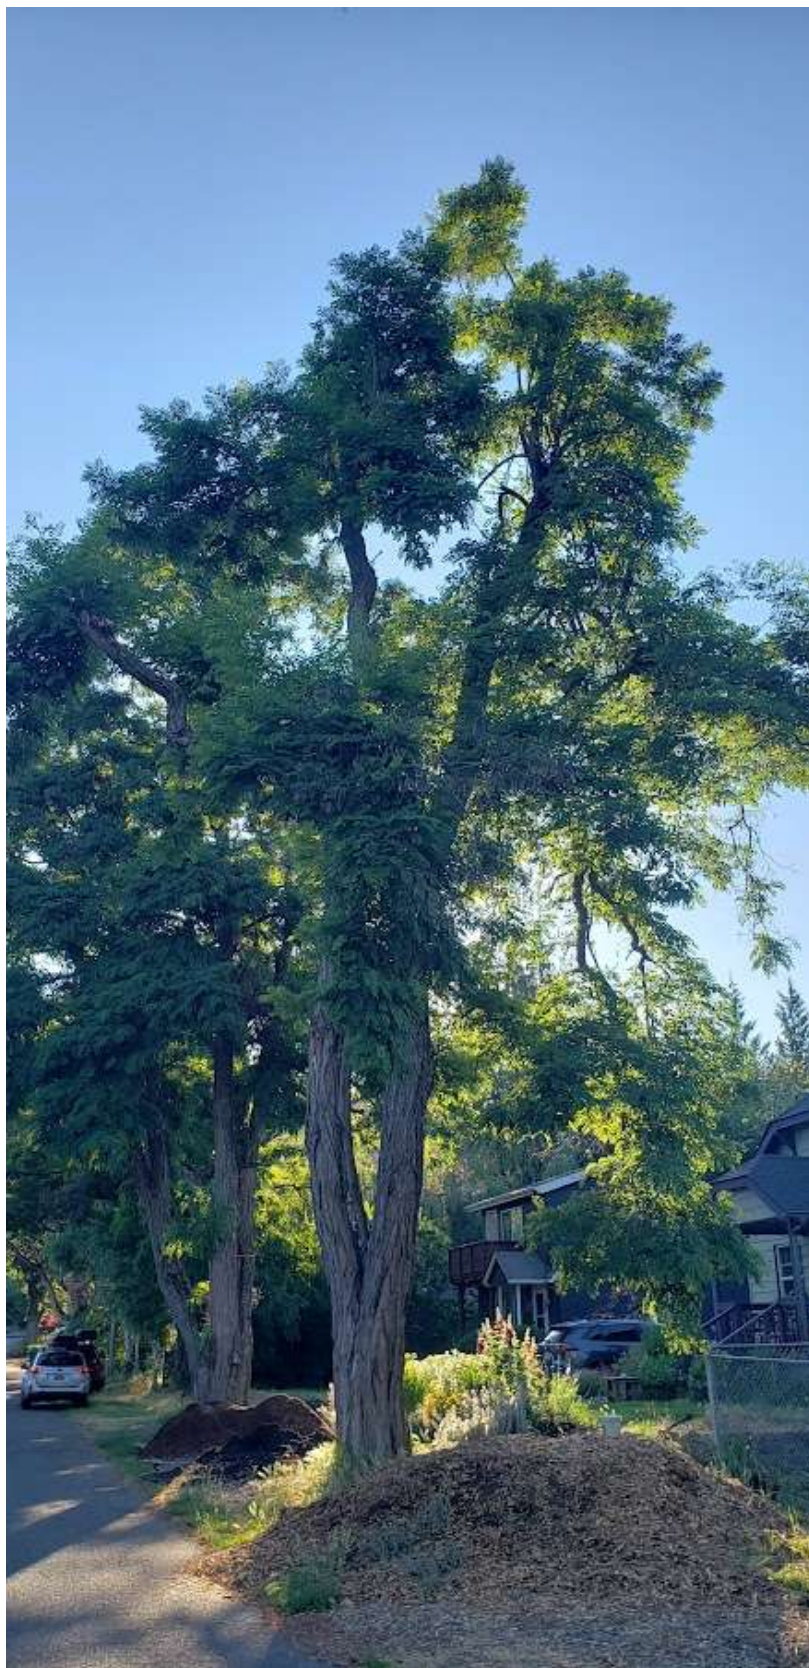
Tree #2 is low risk in a 5 year timeframe. Routine end weight reduction pruning can help reduce the likelihood of branch failure. Routine pruning is conducted on a 6-8 year interval.

Tree #2 is low risk.

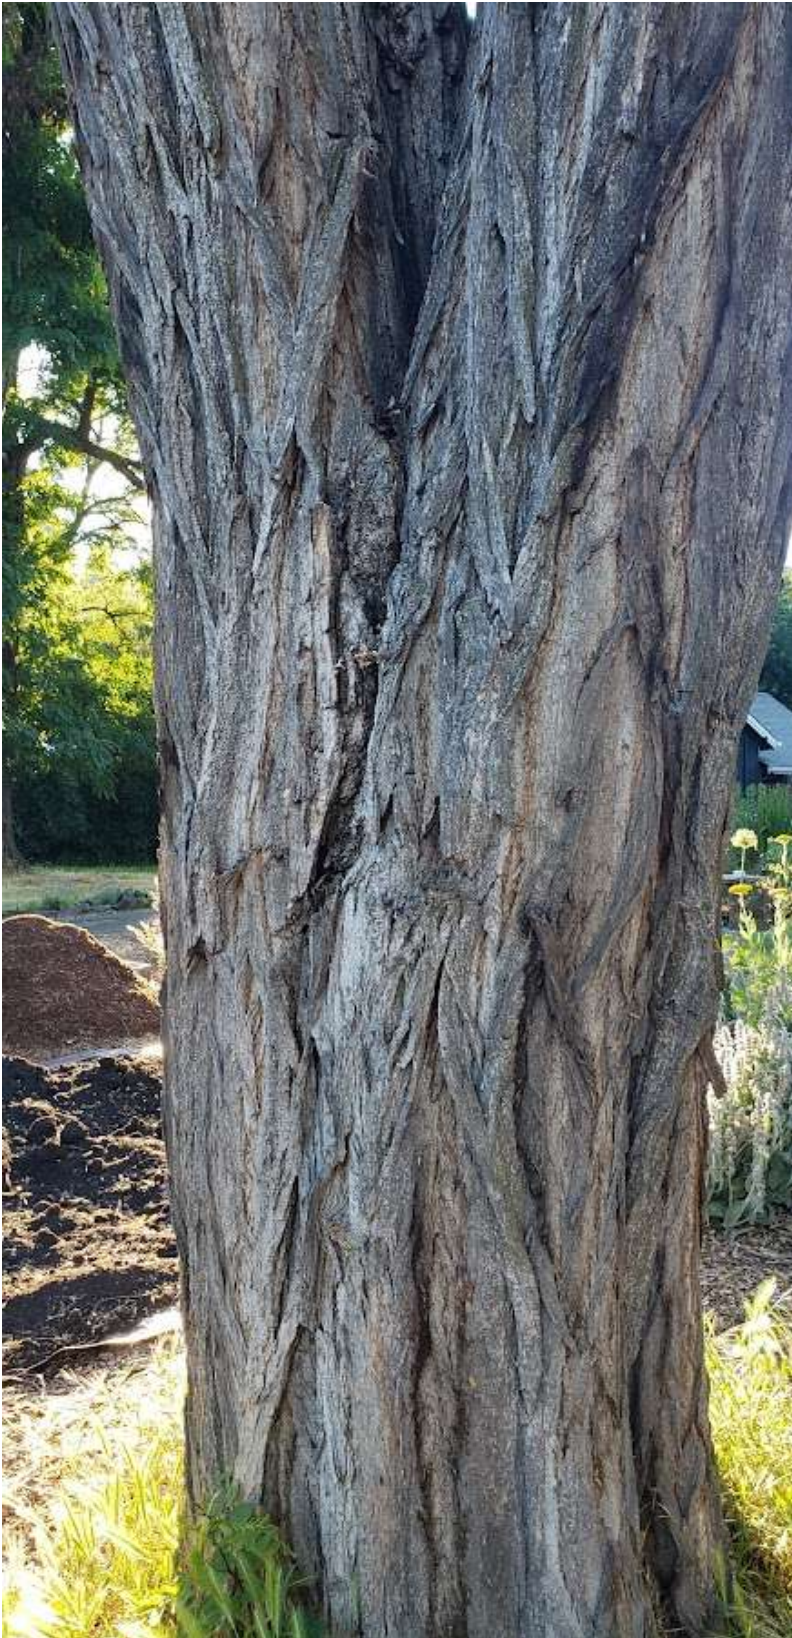
Tree #2 has included bark evident from one side.

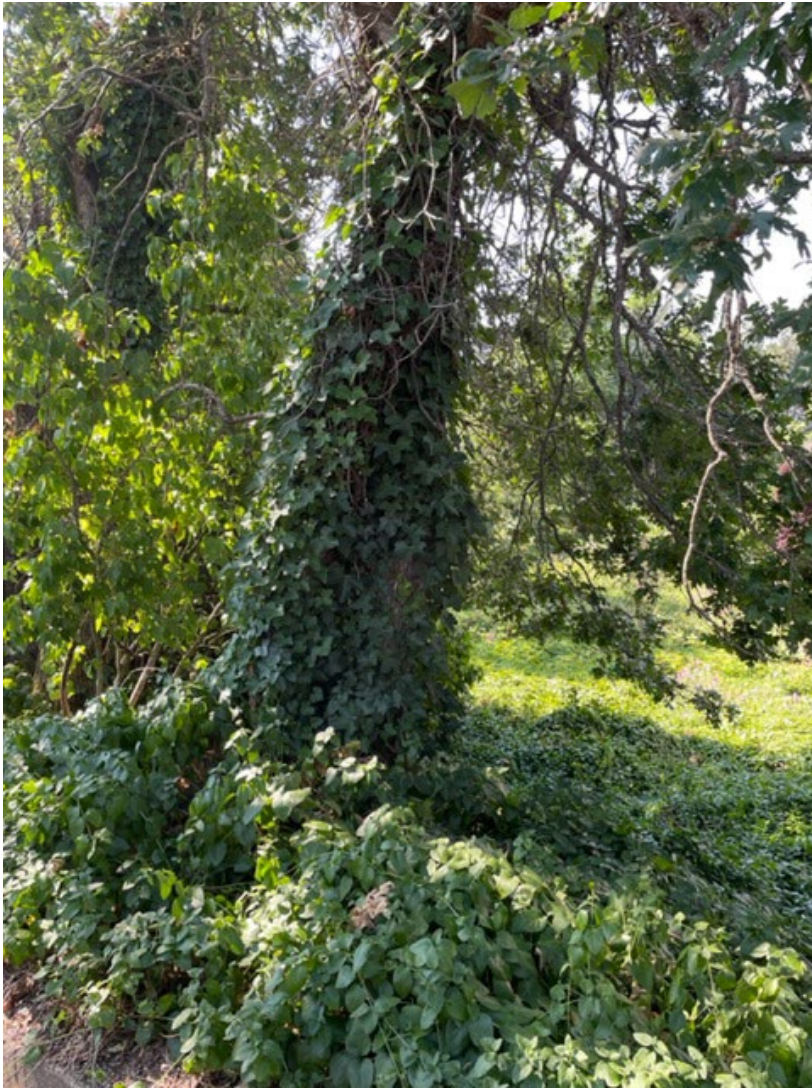
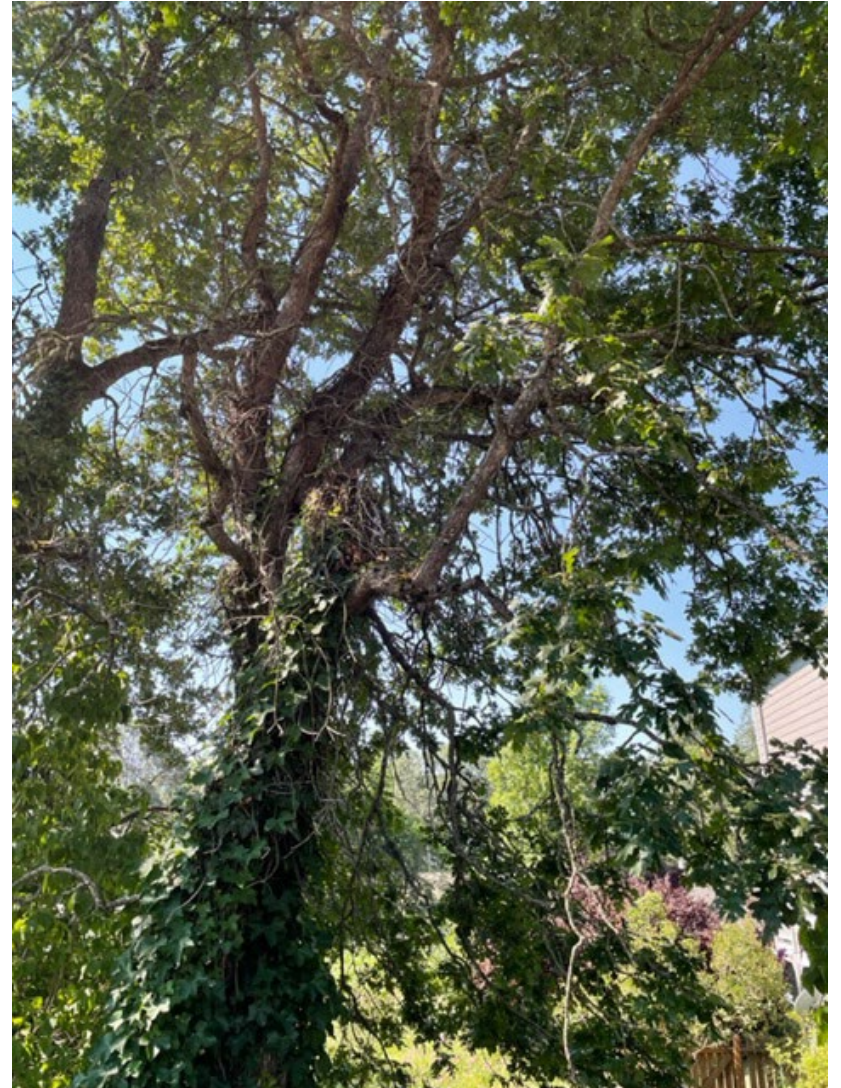
Two oak trees twisted together

Staff recommends the two trees be allowed to remain in place and that they be placed in the city's tree inventory. The trees should be assessed by an arborist when the next round of tree maintenance is scheduled, and any necessary maintenance performed at that time.

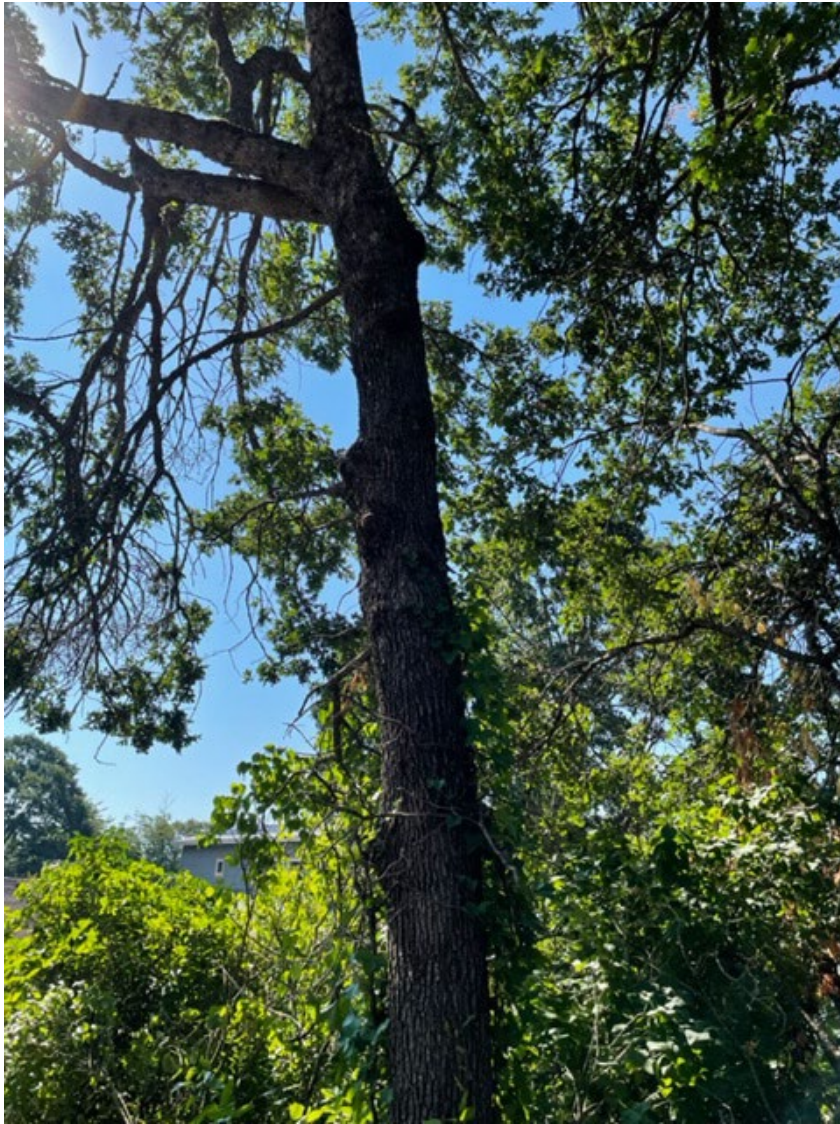
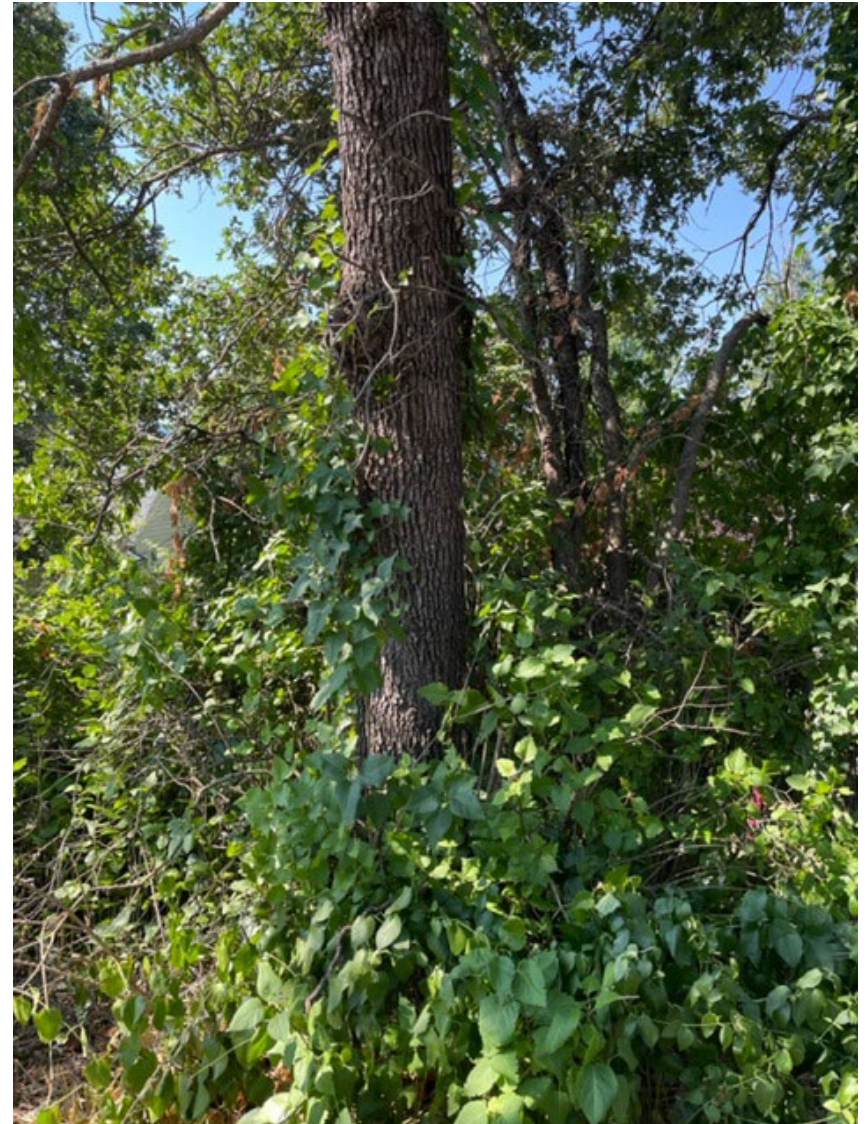
Oak tree located at east of twisted oak trees.
