CITY AND BOROUGH OF WRANGELL BARGE RAMP CONDITION ASSESSMENT

MARCH 2025

Subject: Wrangell Barge Ramp – Condition Assessment

WRANGELL BARGE RAMP CONDITION ASSESSMENT

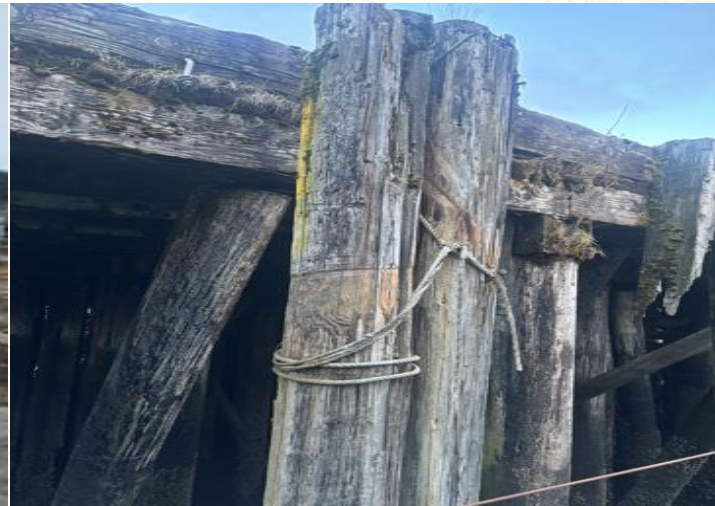
Figure 5 Mill dock Clean up

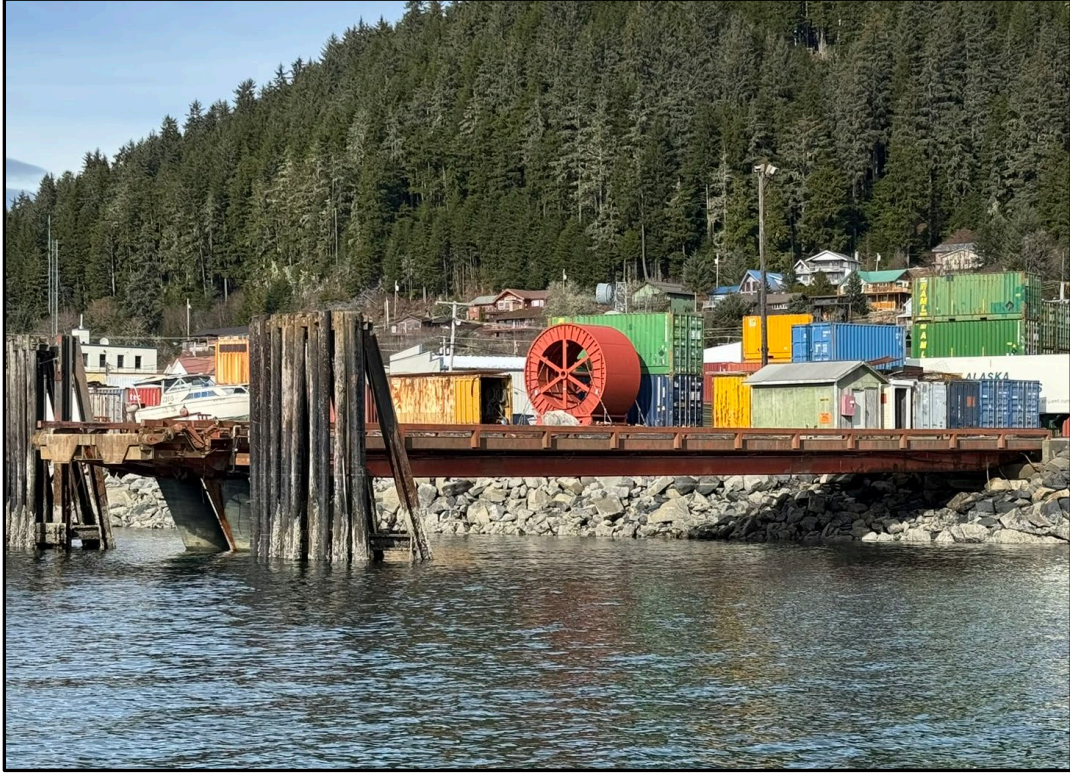
FIGURE 1. Overall view (south side looking north) of barge ramp.

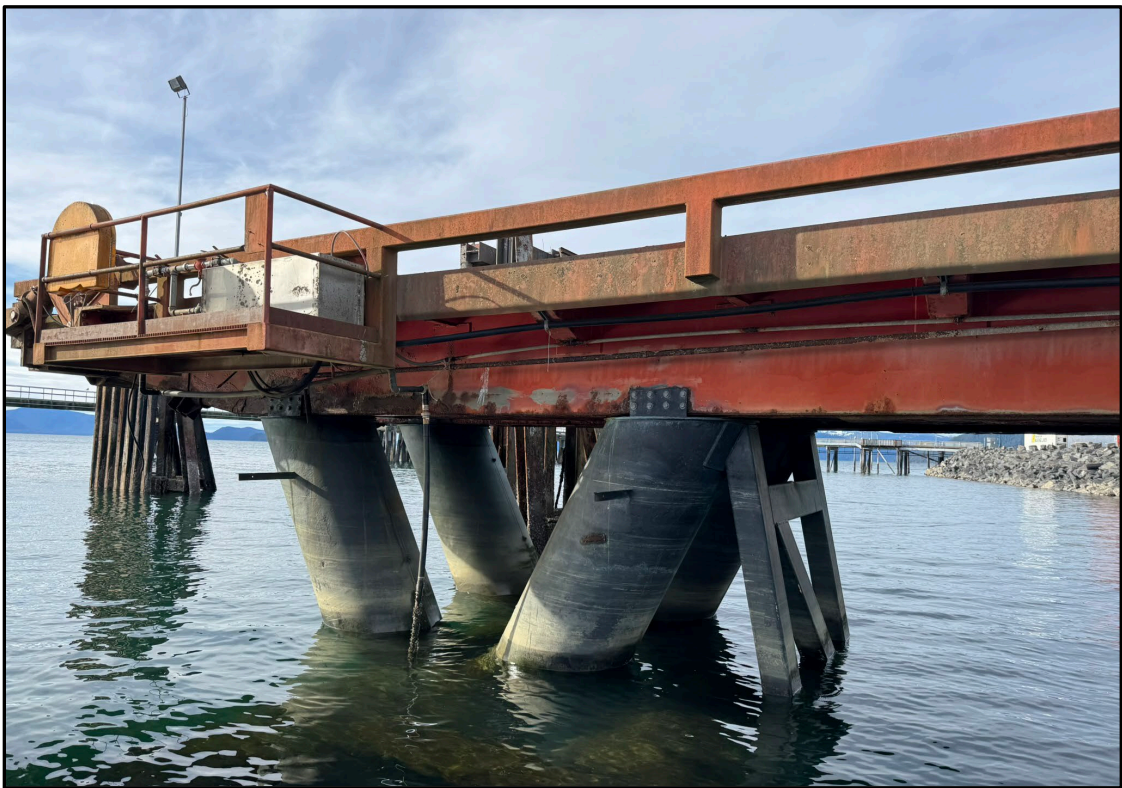
FIGURE 4. Floatation tank operation platform and ramp connection struts (south side).

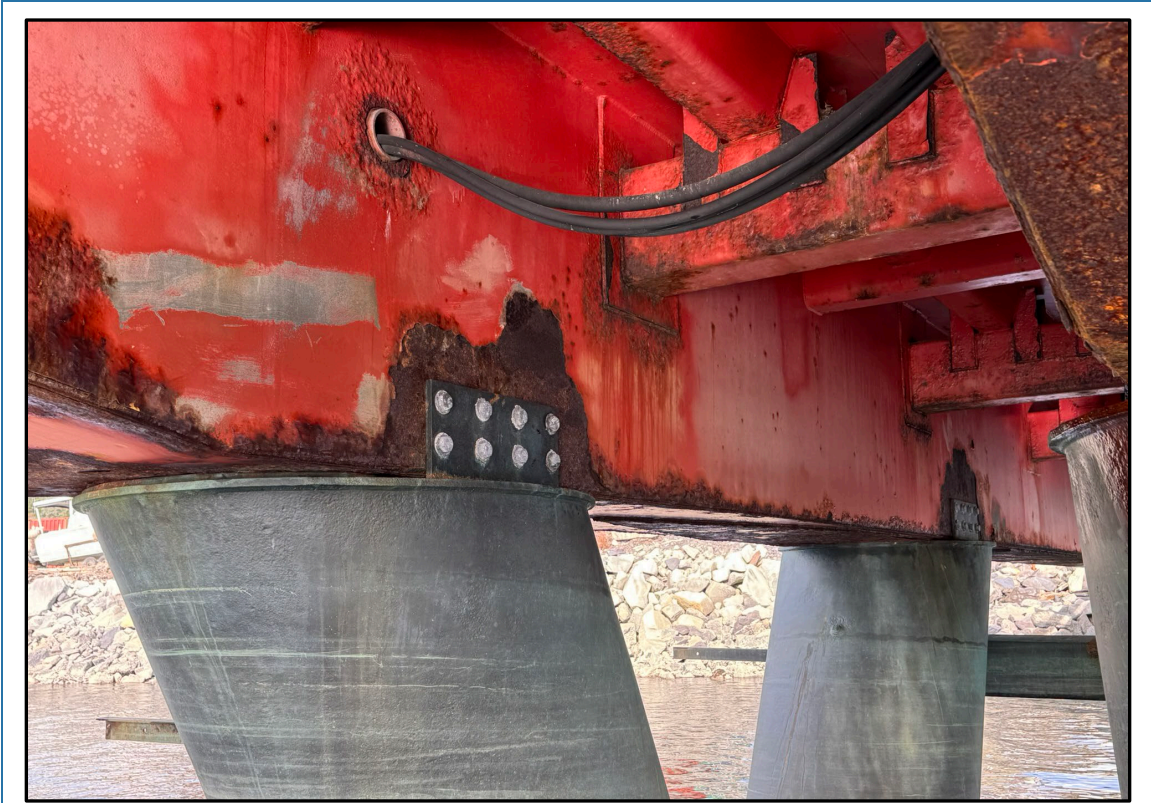
FIGURE 5. Flotation tank connection plates with new bolts.

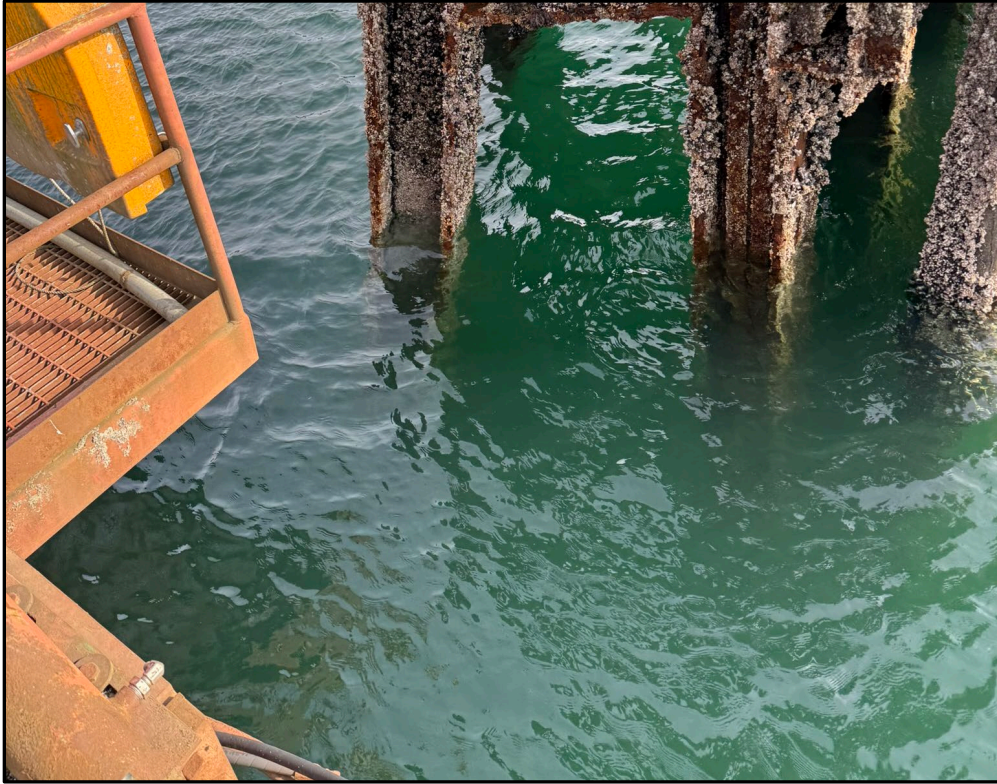
FIGURE 7. Tether cable missing/detached from barge ramp on south side.

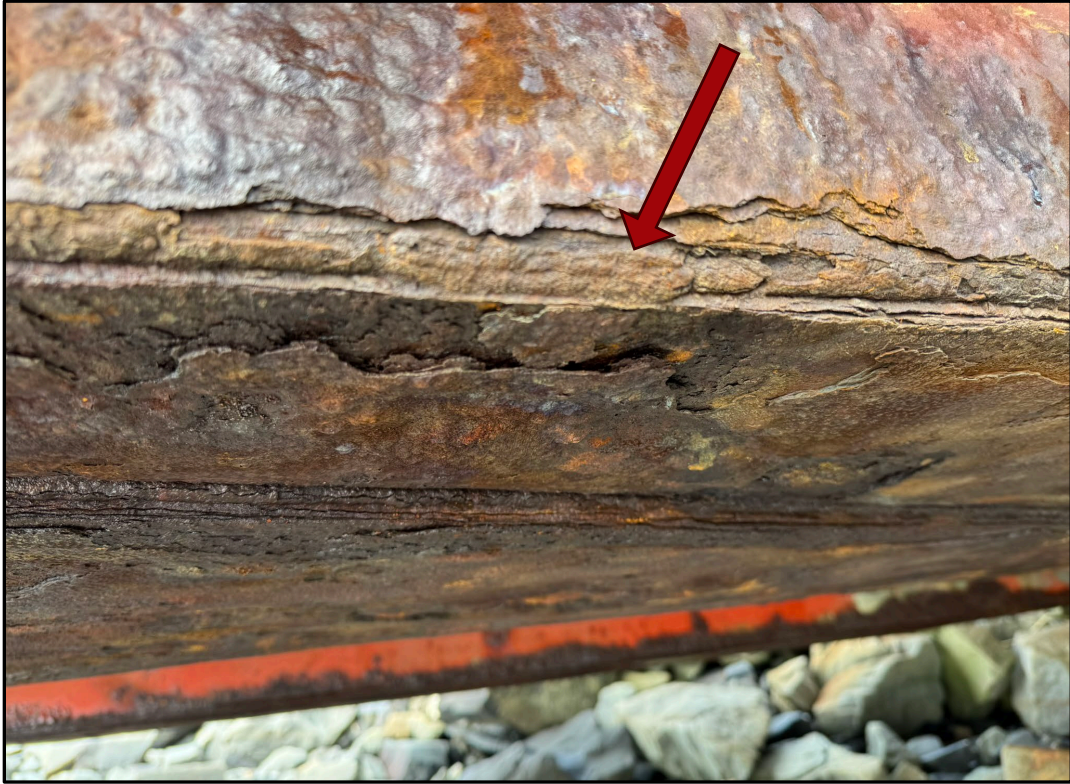
FIGURE 11. Corrosion and loss of weld material along bottom flange edge at web junction.

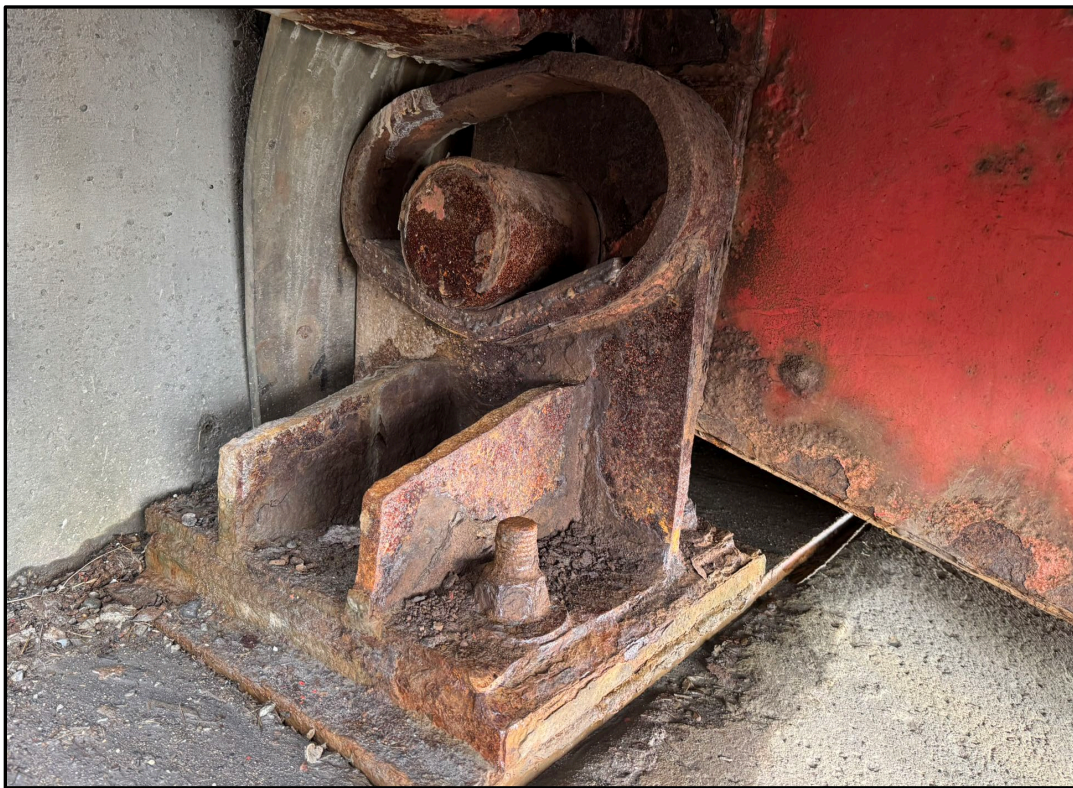
FIGURE 12. Corrosion at abutment bearing assembly; deformed/repairs saddle bearing.

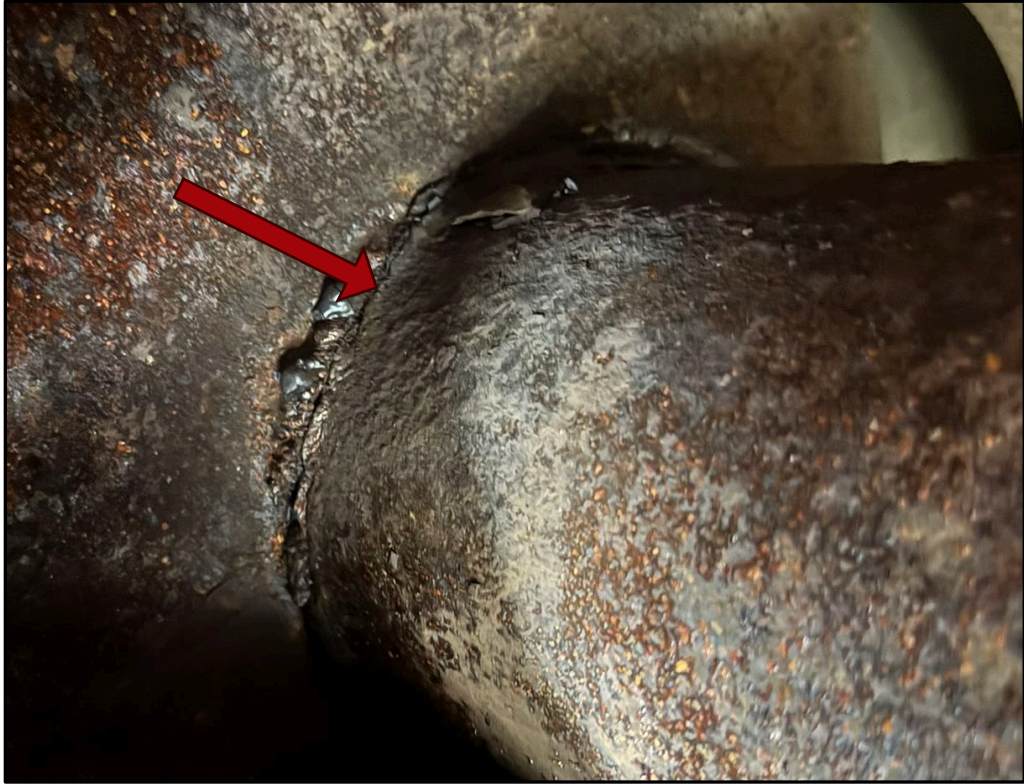
FIGURE 13. Cracked repair weld at abutment bearing pivot pipe.

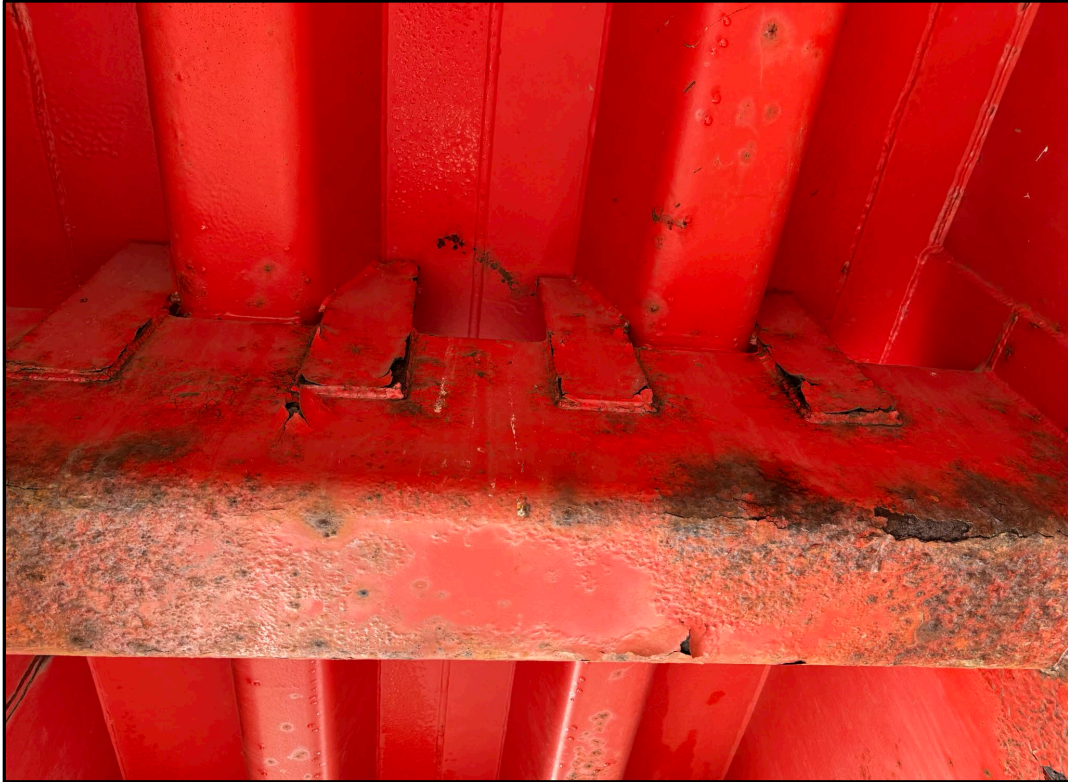
FIGURE 14. Typical coating failure and advanced corrosion of ramp floor beam.

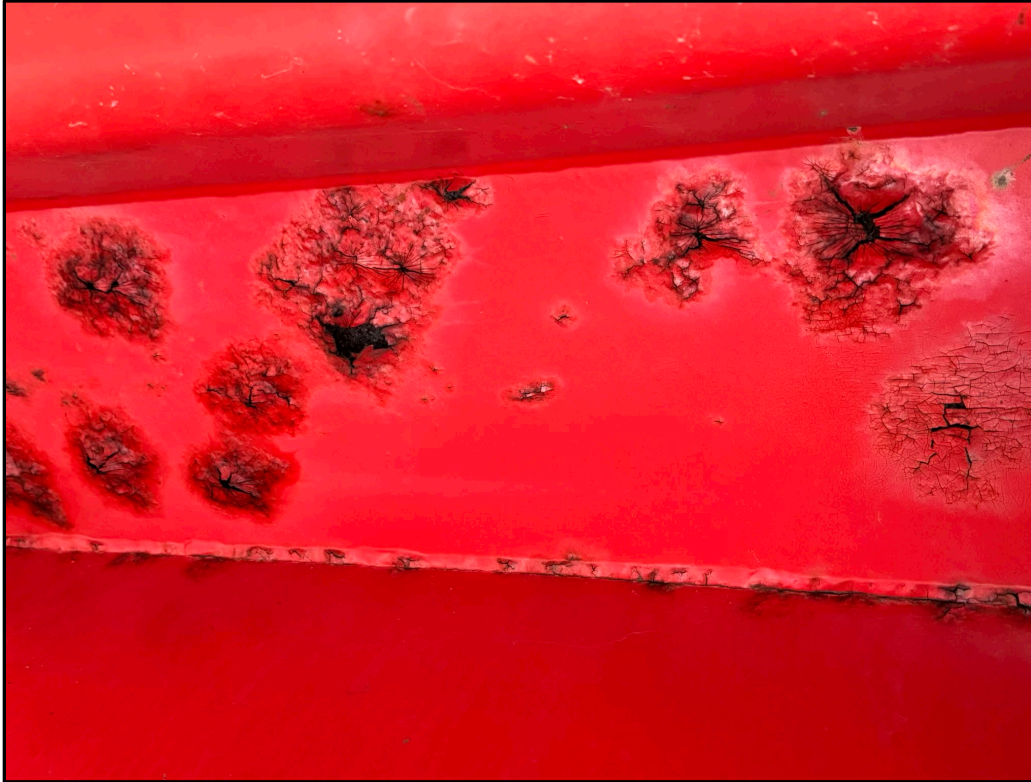
FIGURE 16. Typical blistering of deck plate (underside) between deck ribs.

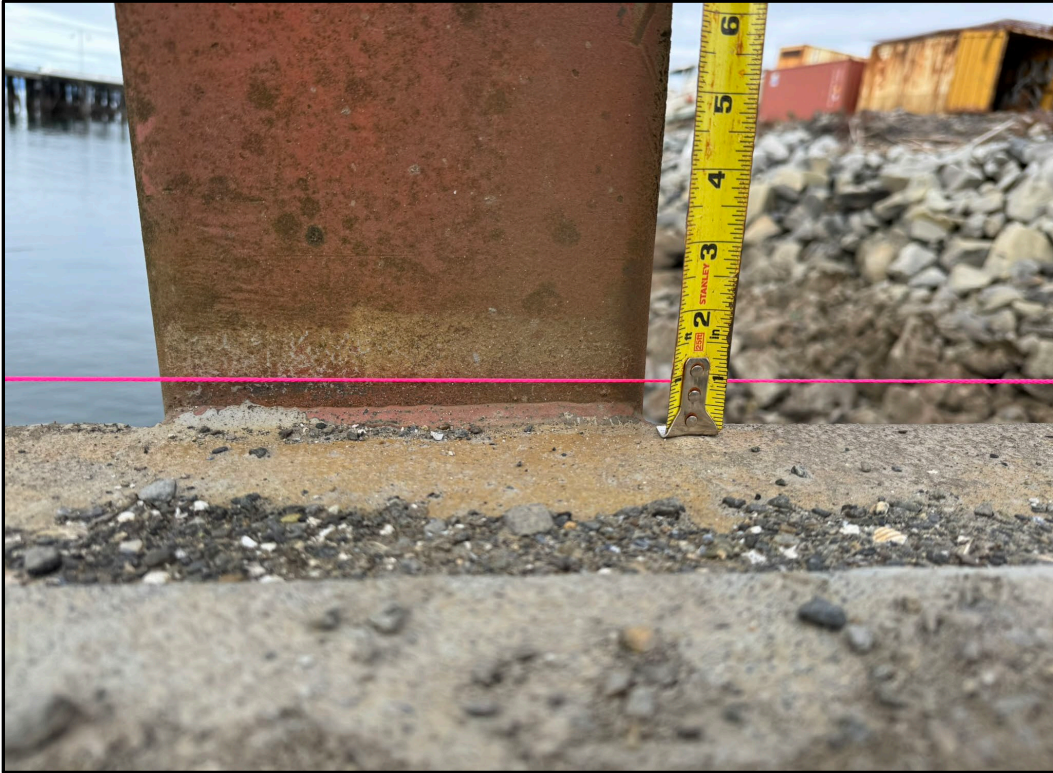
The current overall condition of the barge ramp is poor. It is over 40 years old and time, the elements, and the inherent nature of freight handling operations have all continued to contribute to significant deterioration. Protective coatings for the structural steel are either completely gone or in poor condition, causing significant corrosion of the steel. In addition, the profile of the barge ramp indicates it is bent, likely due to being overloaded.

FIGURE 17. Sag at mid-span of the barge ramp (i.e. ramp bent due to overloading).

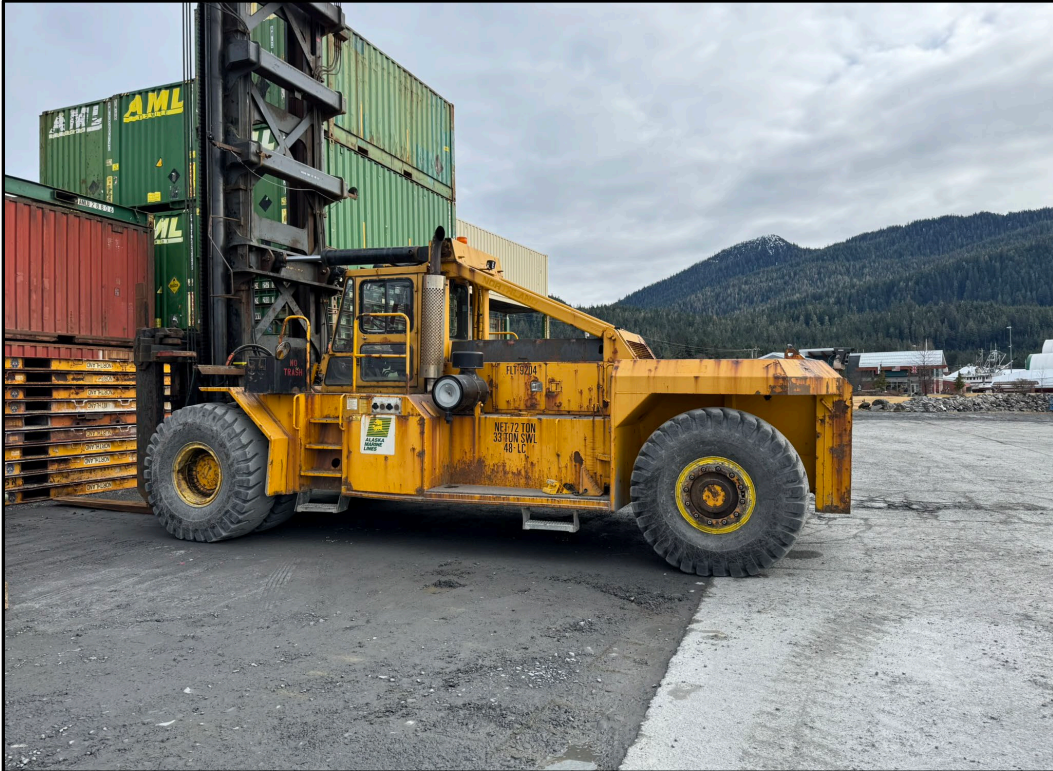
FIGURE 18. Forklift used for handling freight; 77 ton weight; 33 ton safe working load.

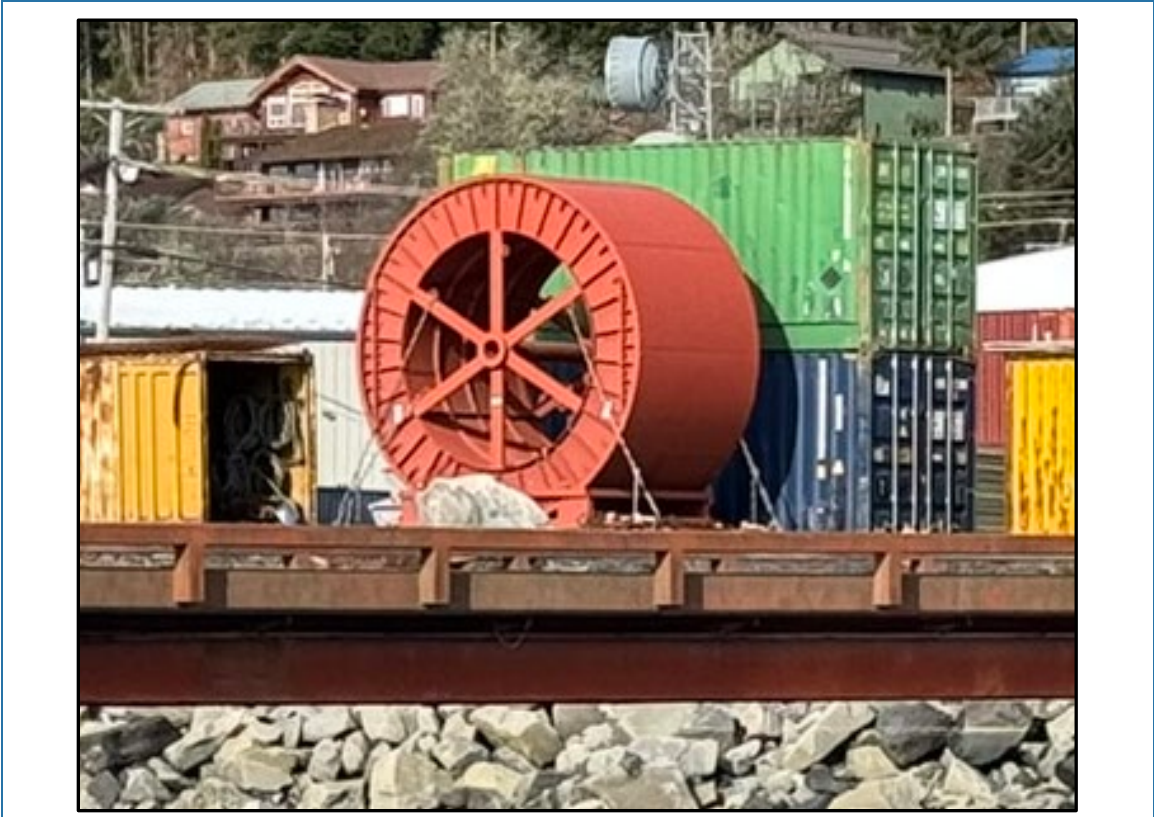
FIGURE 21. Steel electrical cable spool; weight estimated to be over 40 tons.

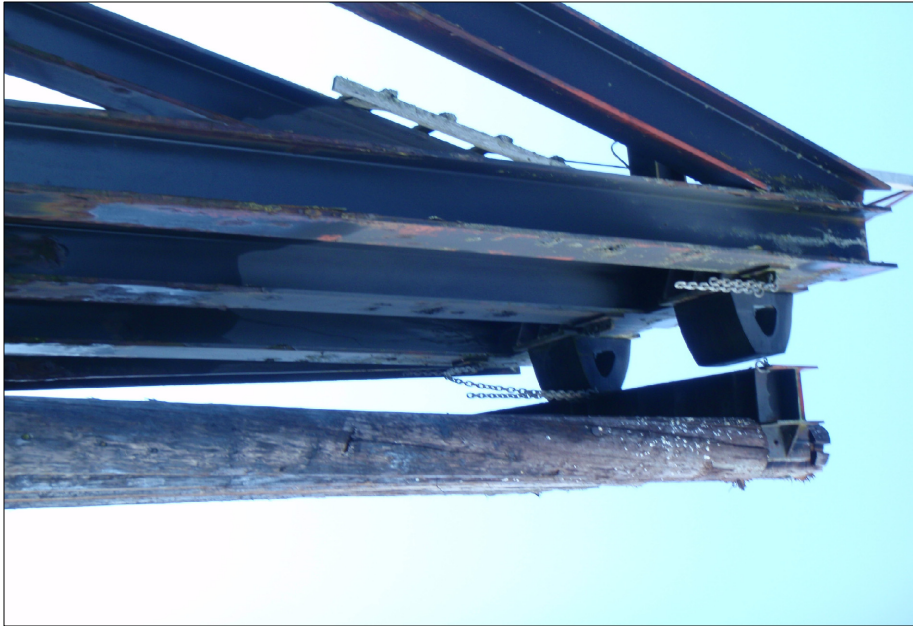
Broken stay chains at Dolphin "D".

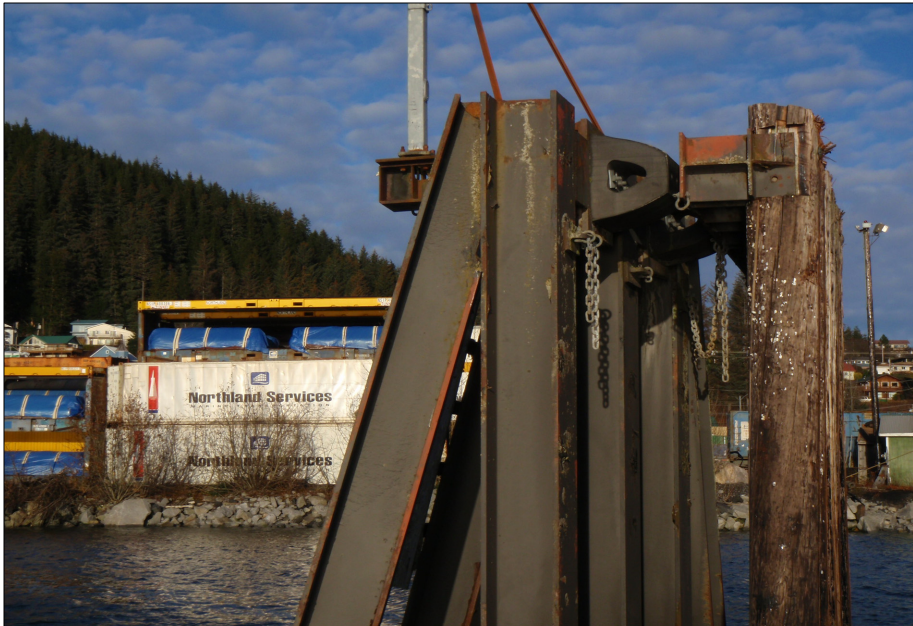
Broken stay chains at Dolphin "D".

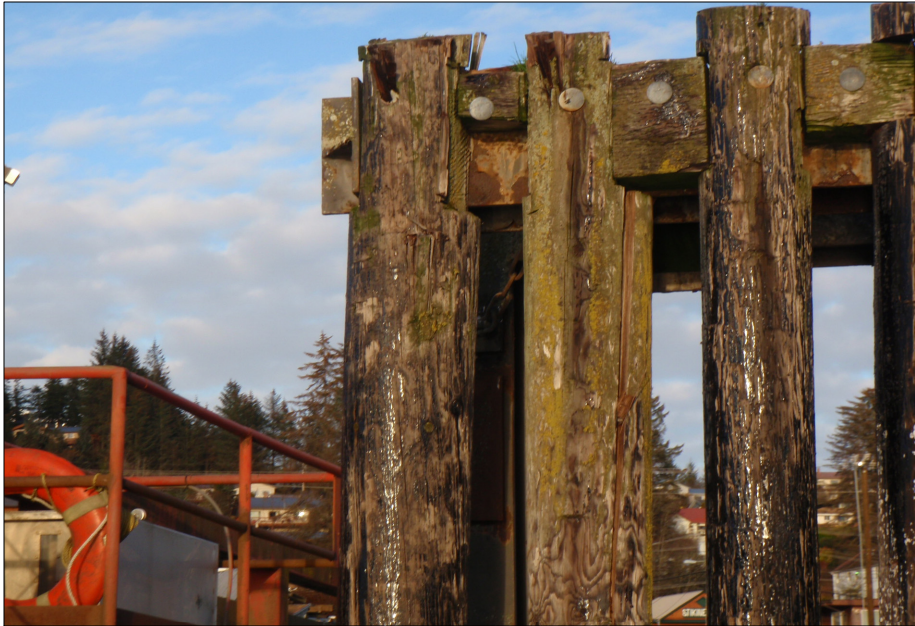
Broken fender pile at Dolphin "F".

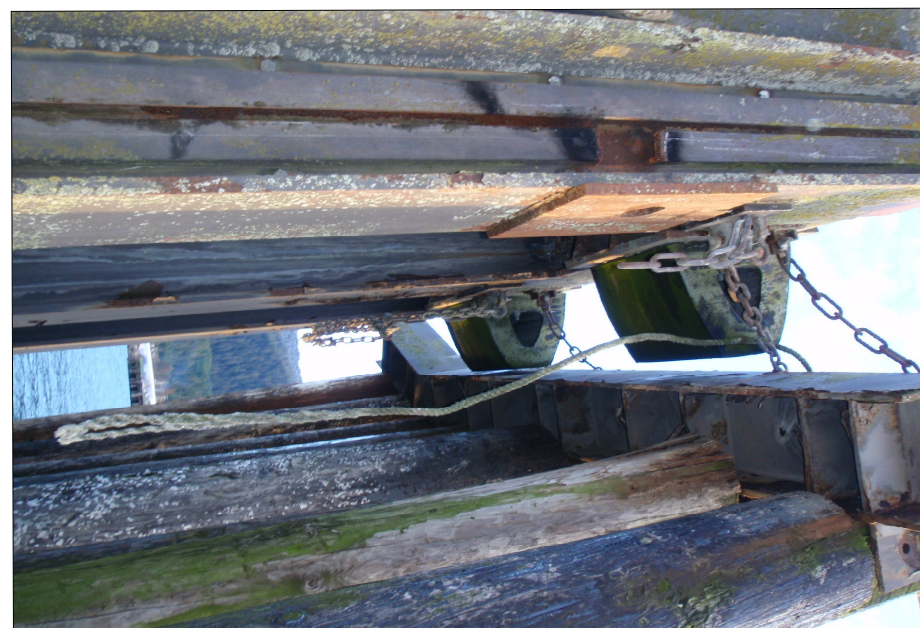
Broken stay chains at Dolphin "F".

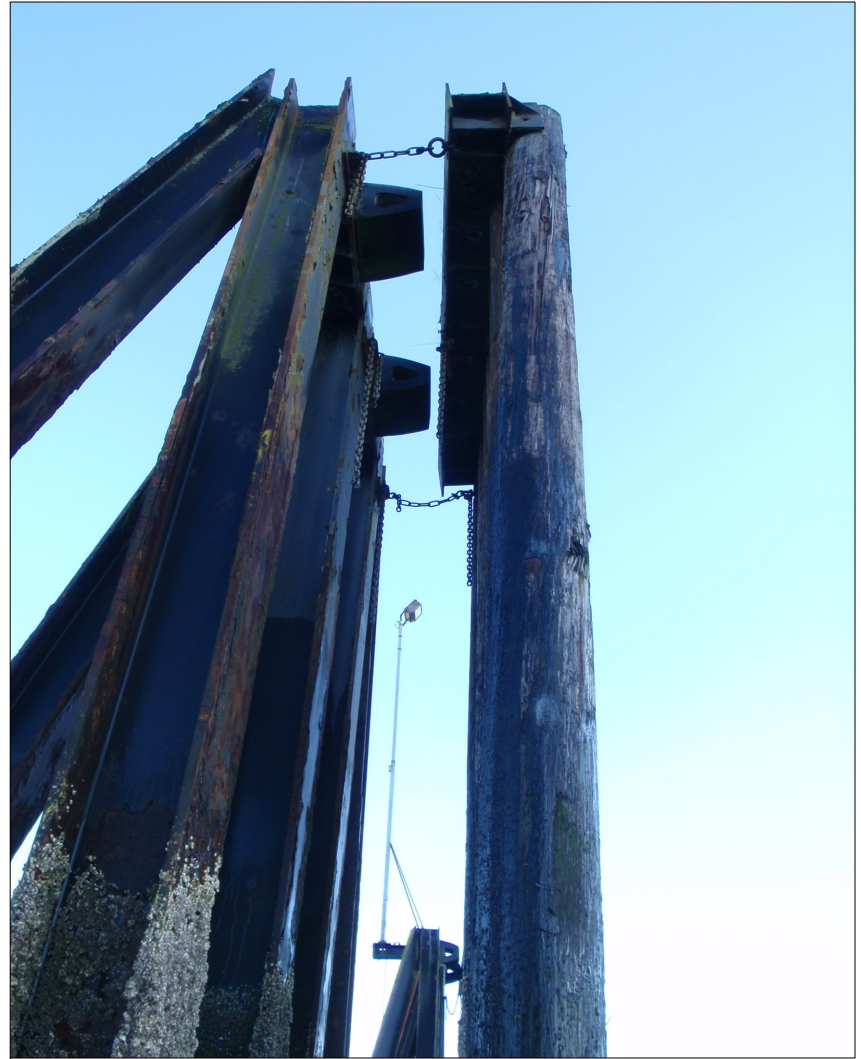
Broken stay chains at Dolphin "C".

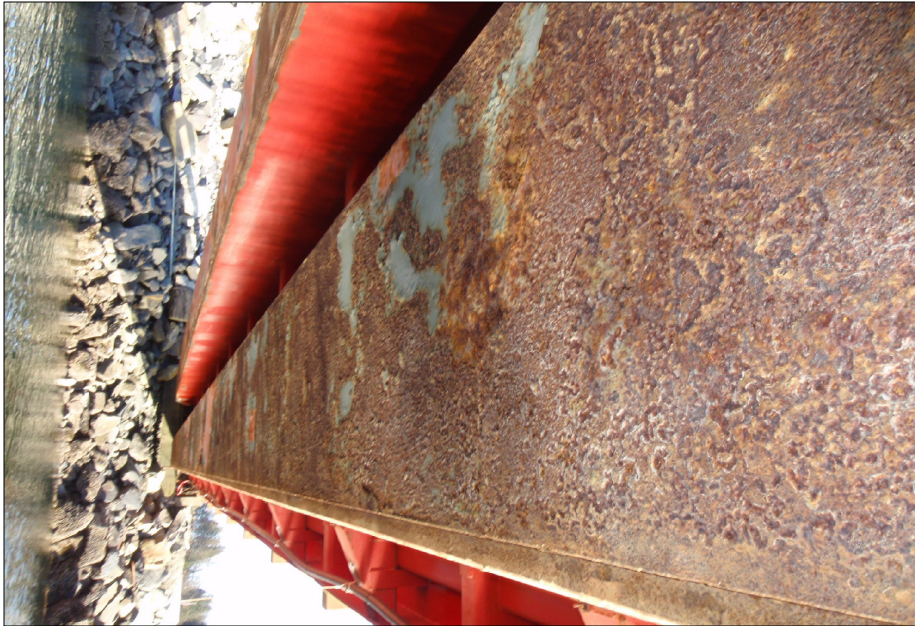
Ramp box-girder bottom flange corrosion.

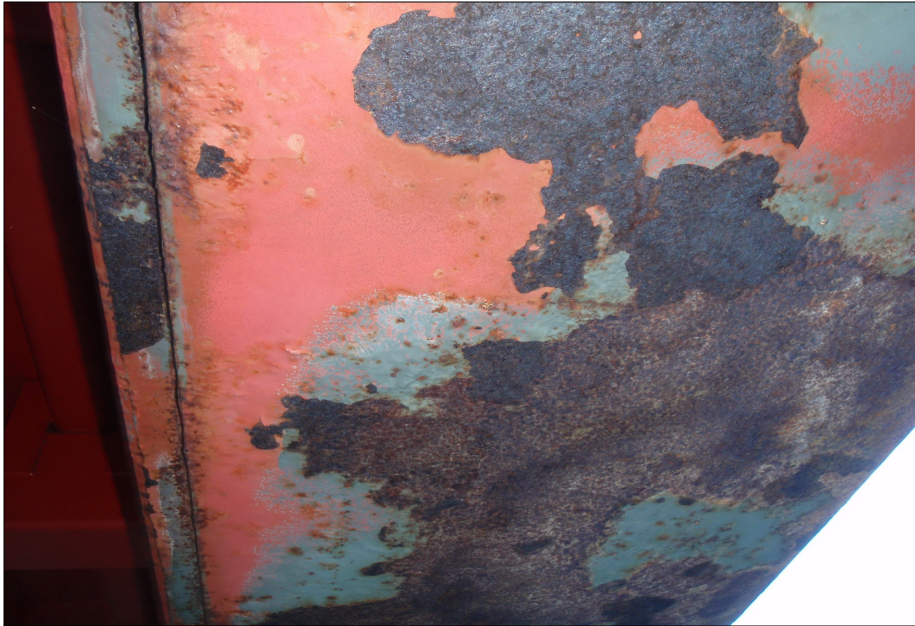
Typical coating failure/corrosion of girder bottom flange.

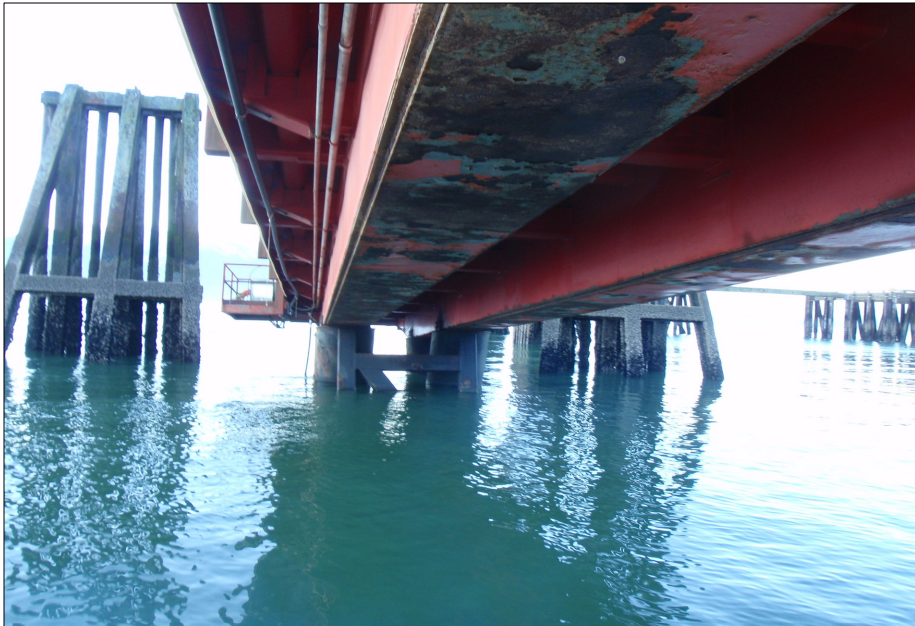
54 Ramp box-girder bottom flanges; coating failure, minor corrosion, typical.

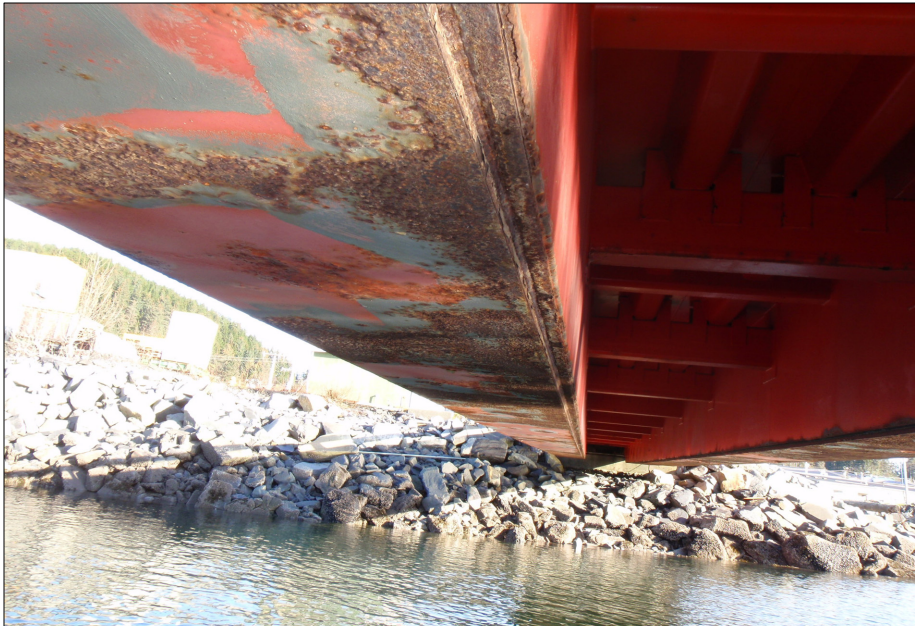
Ramp box-girder bottom flanges; coating failure, minor corrosion, typical.

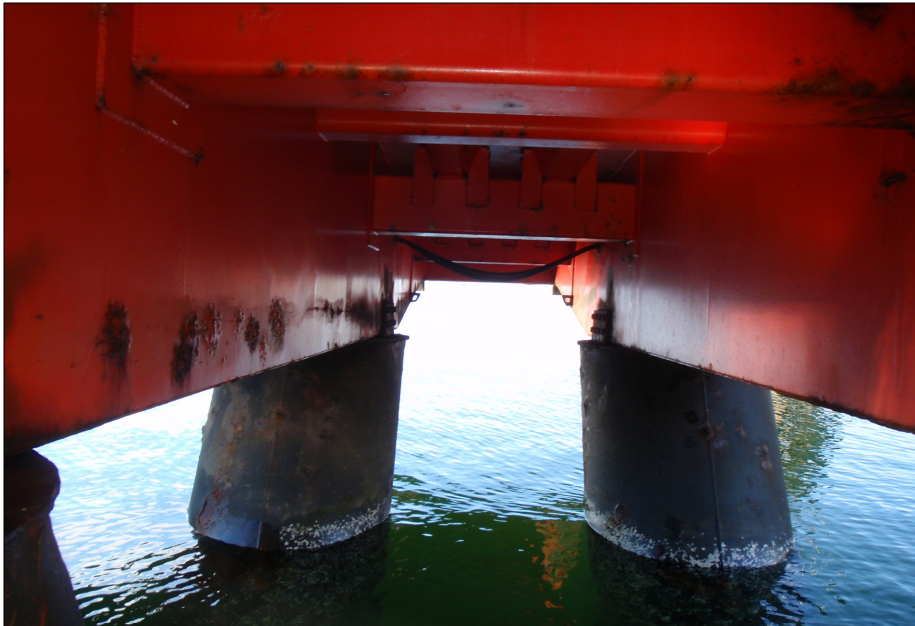
Typical coating failing/minor corrosion of ramp tank support strut.

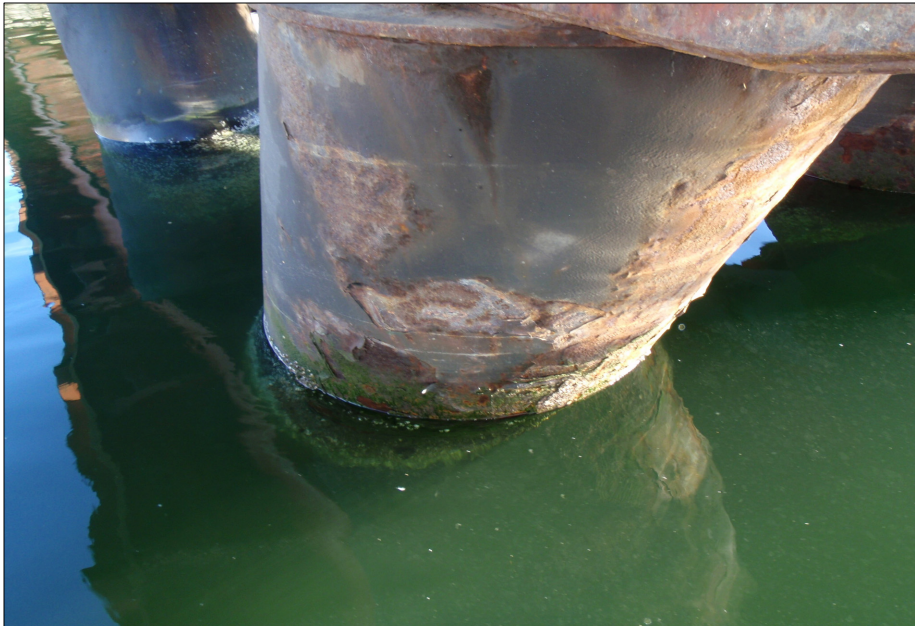
Coating failure/corrosion at ramp/support tank connection assemblies.

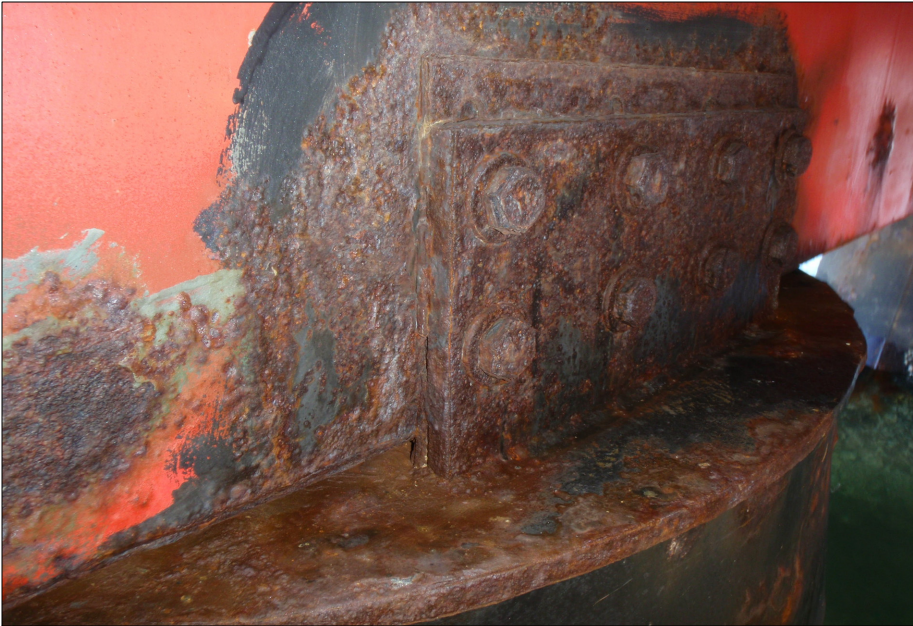
Coating failure/corrosion at ramp/support tank connection assemblies.

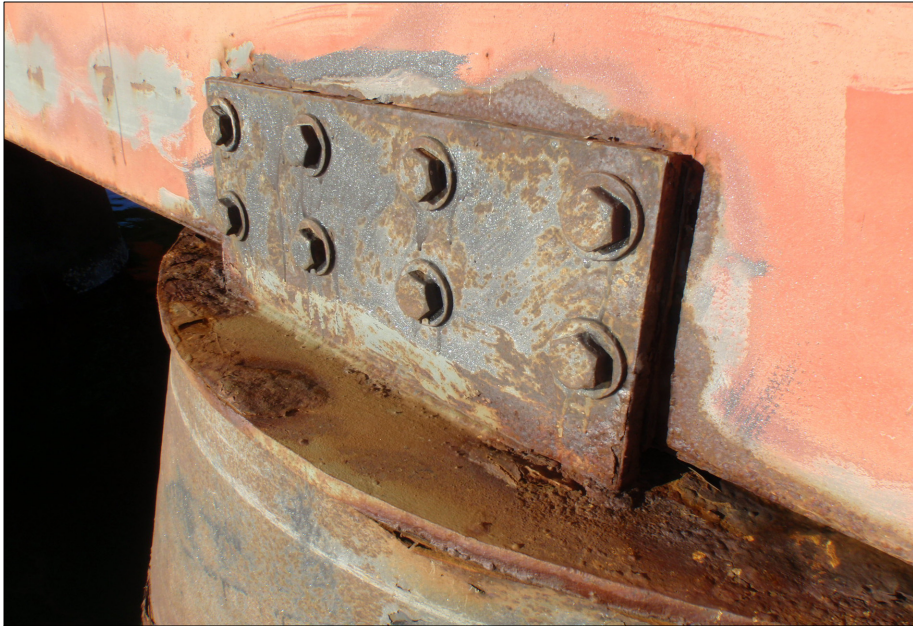
Coating failure/corrosion at ramp/support tank connection assemblies.

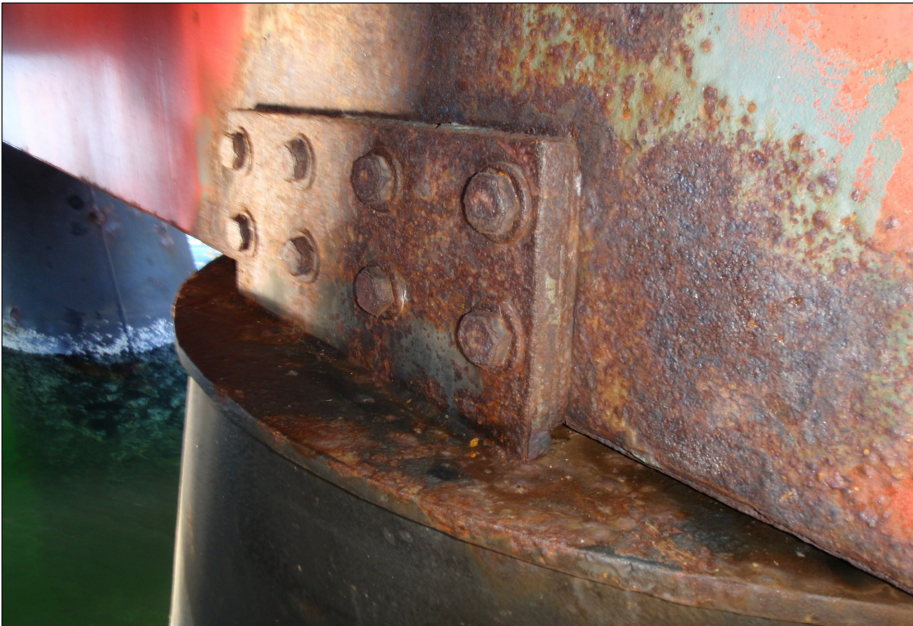
Coating failure/corrosion at ramp/support tank connection assemblies.

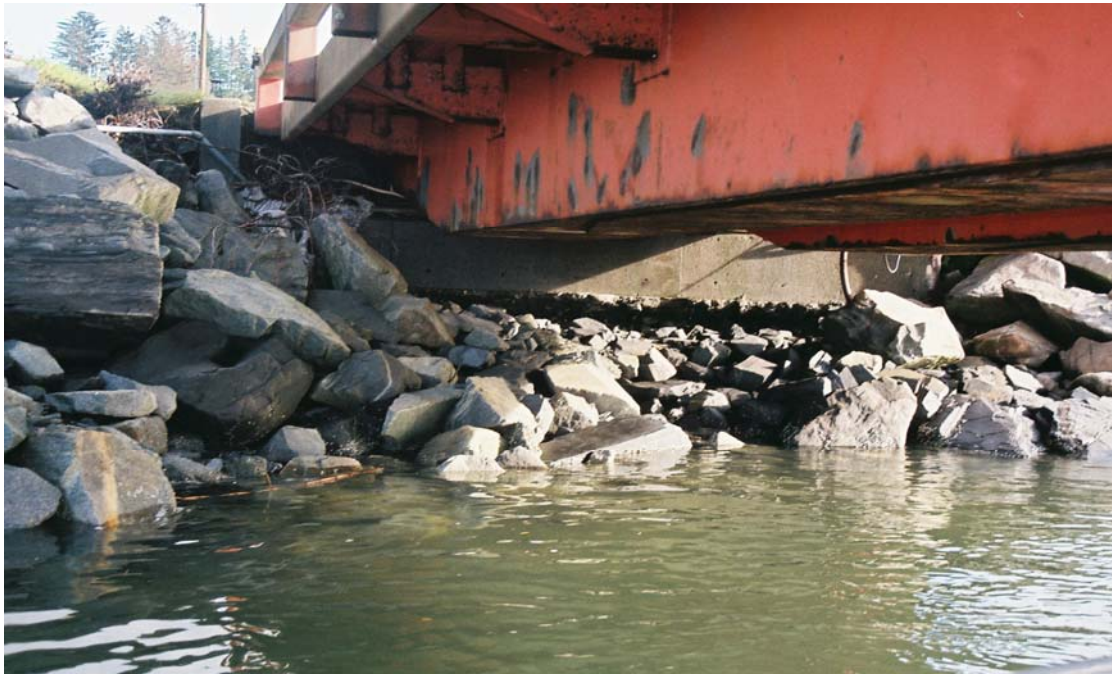
PHOTO No. 3: Transfer Span Bridge Seat – Note the undermining of the concrete bridge seat. Also note the localized failure of the painted coating on the transfer span members.

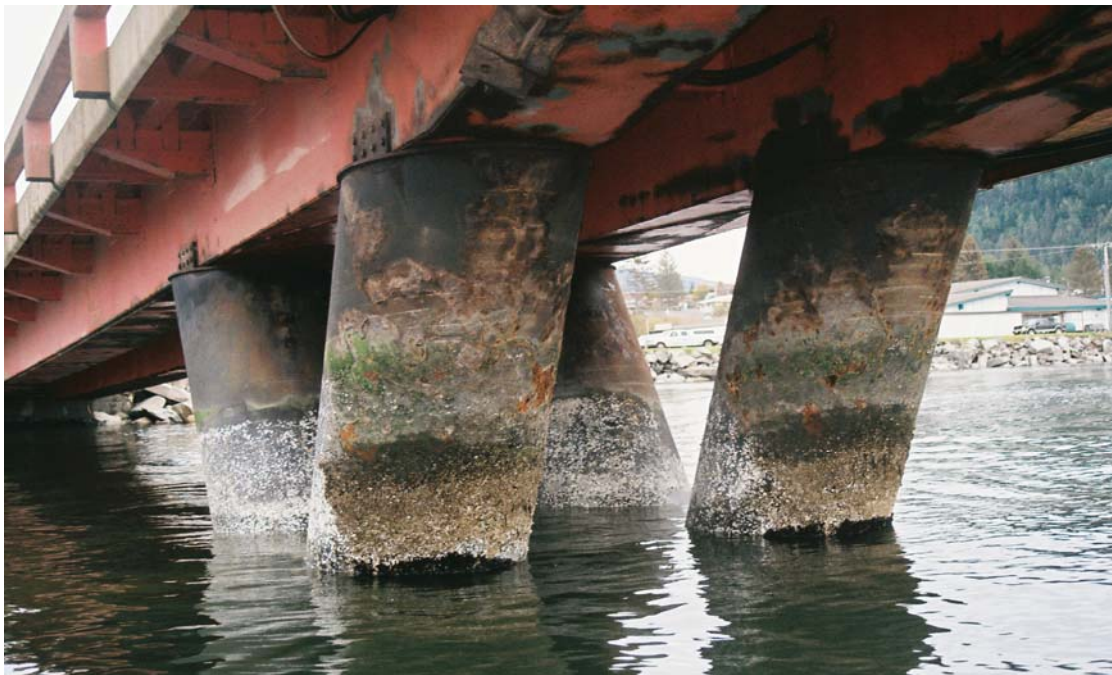
PHOTO No. 4: Floatation Tank Pipe Struts – Note the deterioration and failure of the protective black epoxy coating on these members in the splash zone.

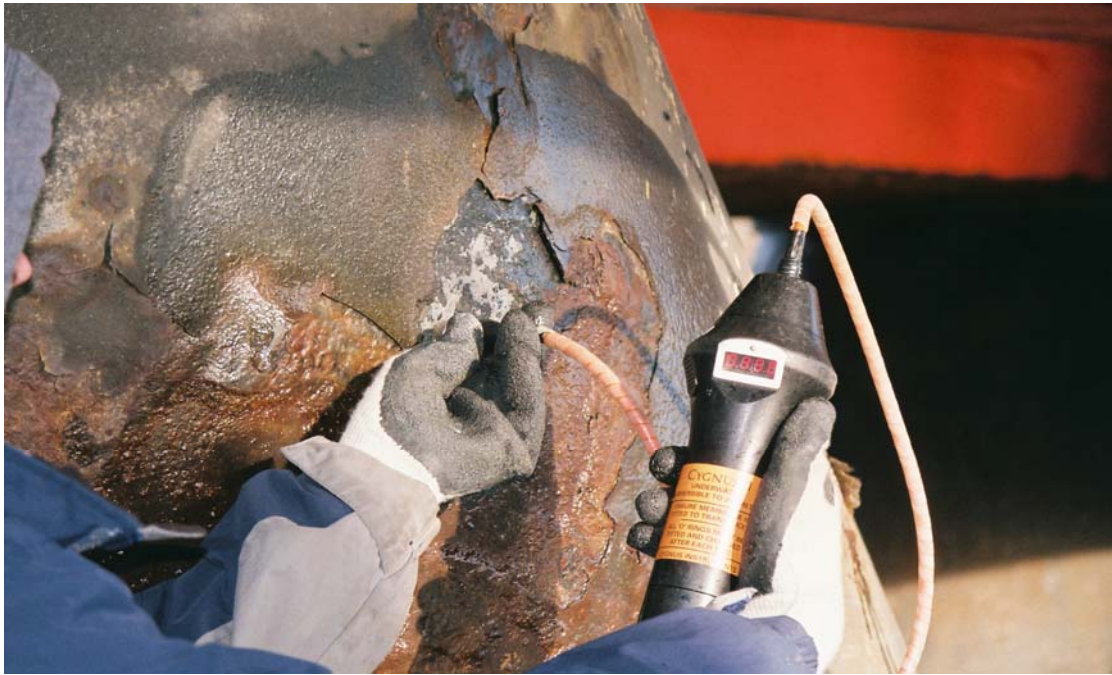
PHOTO No. 5: Southern Floatation Tank Pipe Strut – Note the coating failure and corrosive scale evident in the splash zone. Level III ultrasonic thickness measurements found the remaining thickness to be 0.357 inches.

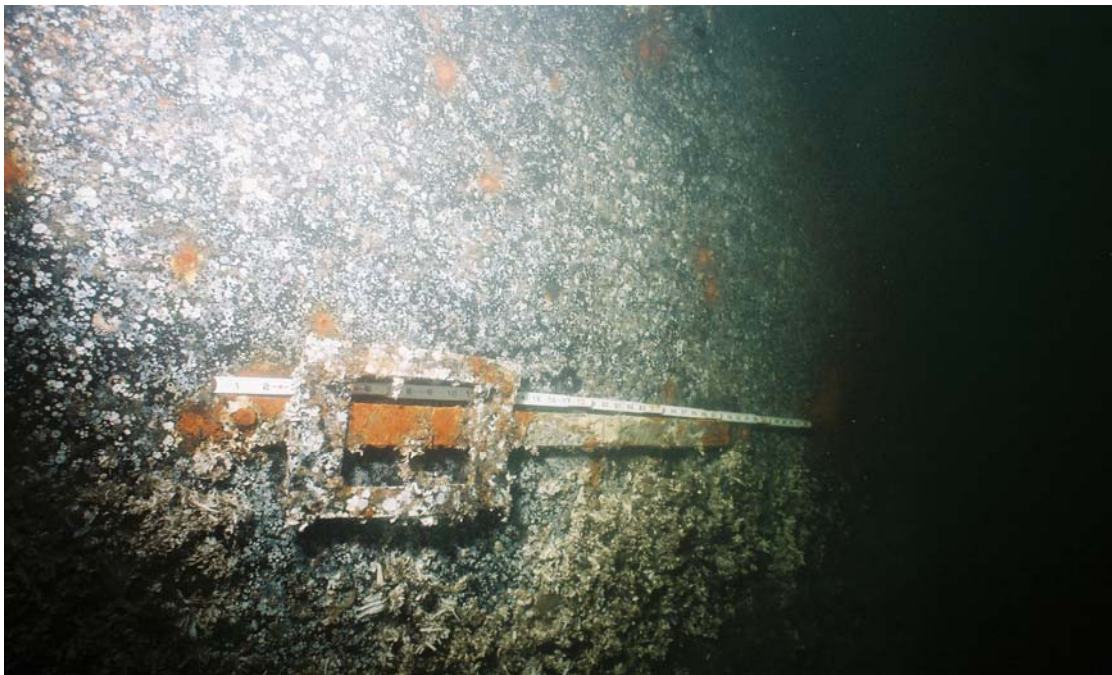
PHOTO No. 6: Floatation Pontoon Cathodic Protection Anode Bracket – Investigation of the Floatation Tanks noted this anode bracket on the north end of the larger 9 ft. diameter tank. Note the ruler lying along the top of the anode attachment bracket. The anode has been completely consumed.
