CITY AND BOROUGH OF WRANGELL BARGE RAMP CONDITION ASSESSMENT

MARCH 2025

Subject: Wrangell Barge Ramp – Condition Assessment

WRANGELL BARGE RAMP CONDITION ASSESSMENT

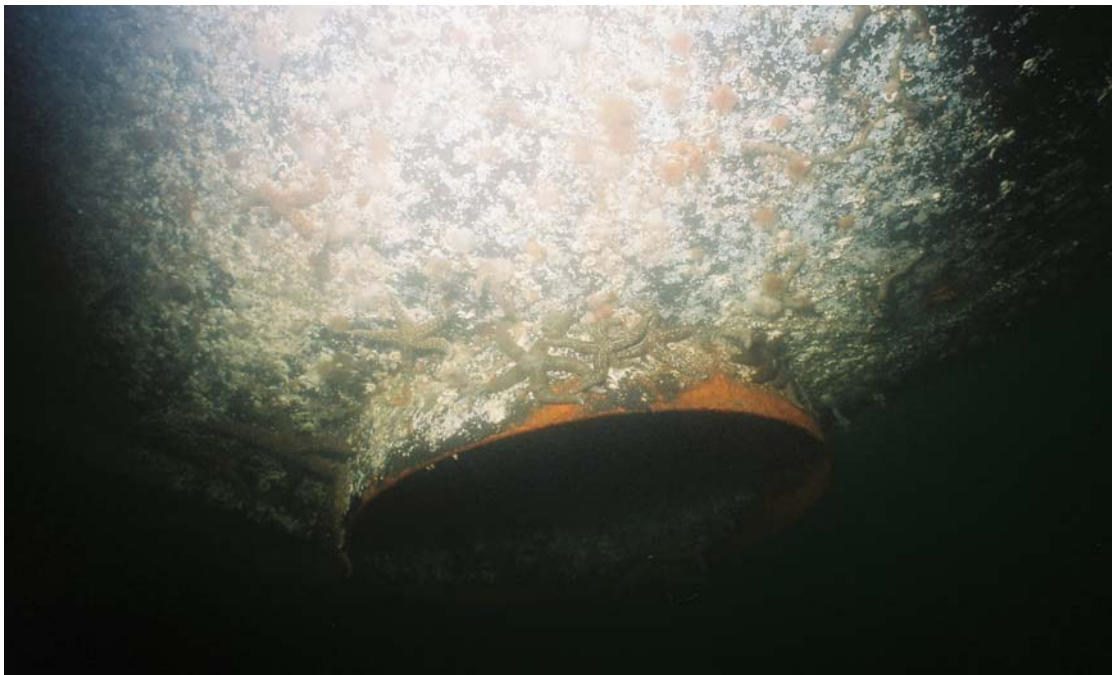
PHOTO No. 8: Floatation Tank Exhaust Port – Note the coating deterioration and minor surface corrosion on the bottom of one of the three exhaust ports located on the bottom of the 9 ft. diameter tank. Also note the good condition of the coating on the bottom of the tank.

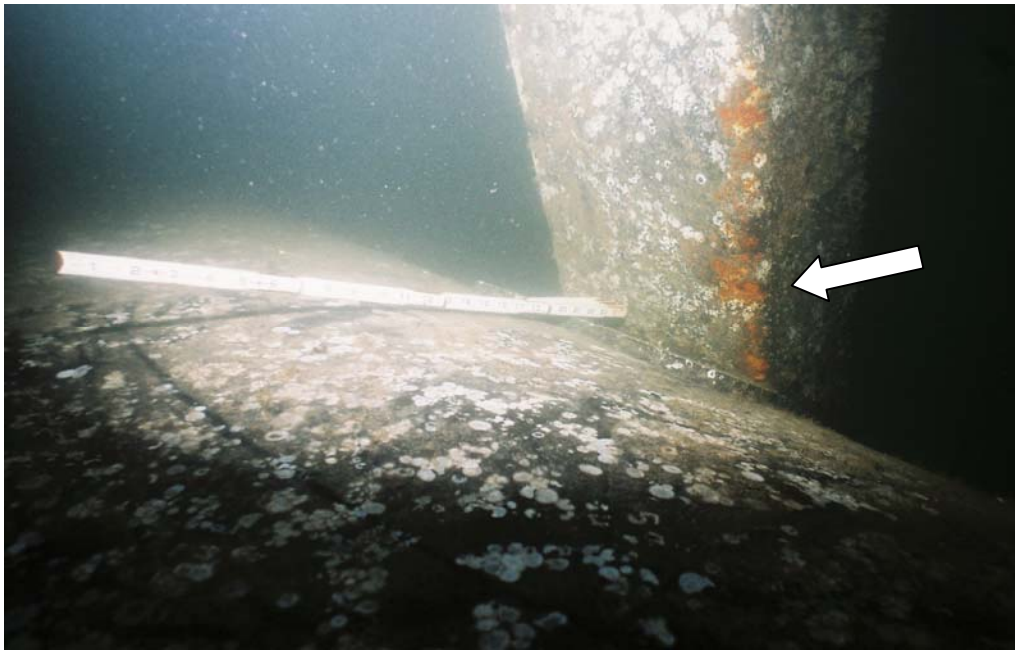
PHOTO No. 9:
Seven Foot Diameter Floatation Tank – Note the good condition of the welded connection between the square tubular strut and the floatation tank. Also note the good condition of the epoxy coating on the top of the pontoon and the localized coating failure on the strut.

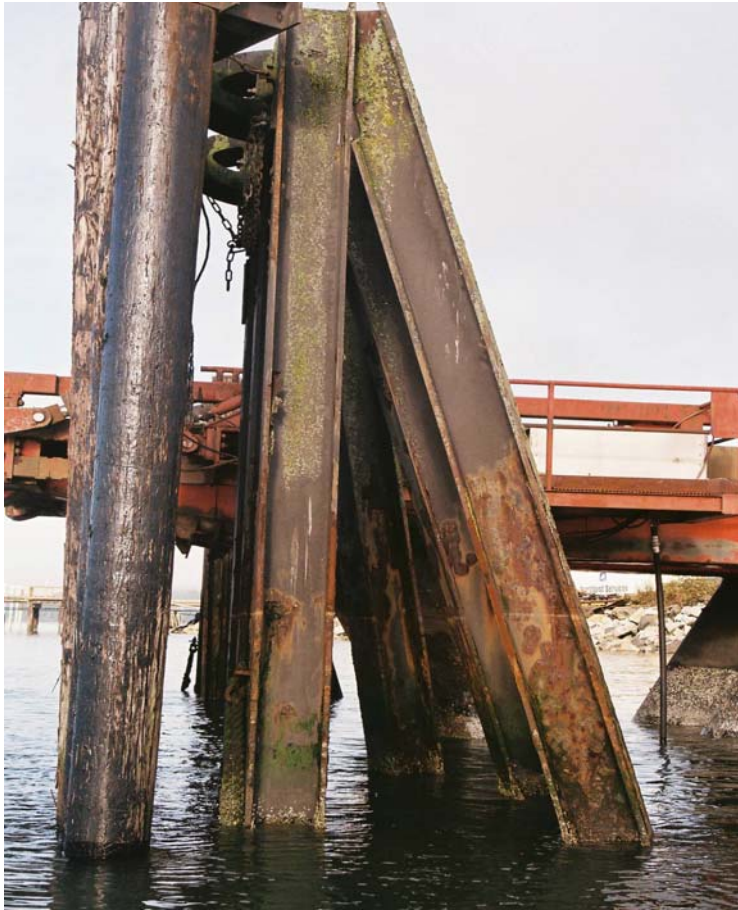
PHOTO No. 11: Breasting Dolphin F – Note the good condition of the epoxy coating at the tops of the piles and the localized coating deterioration in the splash zone. Overall these piles have been estimated to retain 75% of their coating in the combined top and splash zone.

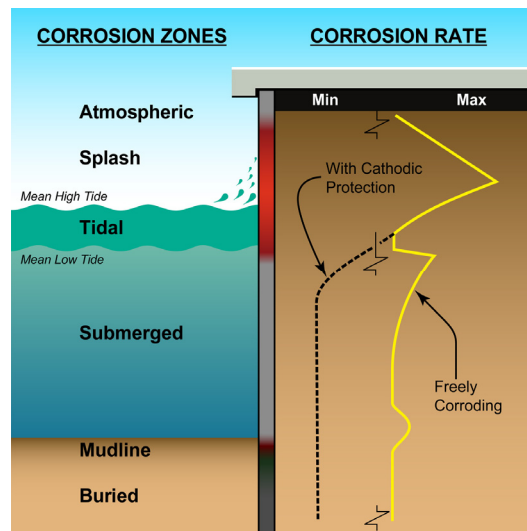
In general among all piles, the worst corrosion was seen in the few feet above high tide, referred to as the splash zone. A schematic drawing of the several tidal zones and the associated corrosion rates appears in the Figure 1. The splash zone receives frequent exposure to salt spray from the ocean. Seawater contains chloride ions, which are a corrosion accelerator for steel structures. As this area is directly exposed to the air, there is plenty of oxygen from the air, which combined with the chloride ion exposure makes this a highly corrosive environment.

Note that the corrosion rate diminishes as you move down into the tidal zone. The reason for the decline in corrosion rate is reduced oxygen availability. In the tidal zone, the piles are submerged for part of each day. Although seawater contains oxygen, it does not provide it to the steel surface for corrosion as readily as atmospheric exposure. Also at about mean tide level, marine growth becomes prevalent. Marine growth, such as barnacles, mussels, algae, and other microbes are oxygen consumers, so at the level of the steel the amount of available oxygen is markedly reduced from much higher levels available in the open ocean. This reduction in oxygen reduces the corrosion rate of the piles.

Figure 1 – corrosion rates versus exposure

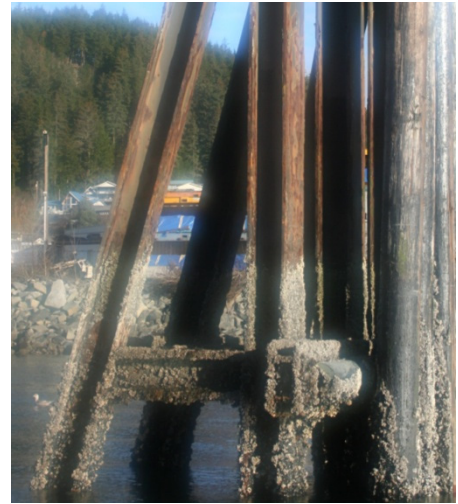
The H-piles on the breasting dolphins are found in both vertical and battered orientations and are all type W14x159. Nominal thicknesses of W14x159 piles are 1.190" for the flanges and 0.745" in the web. The H-piles still had tightly adhering coating throughout much of the lower tidal zone with failure of the coating in the upper tidal and splash zones (see Figure 2).

Figure 2 - coating failure in the splash zone

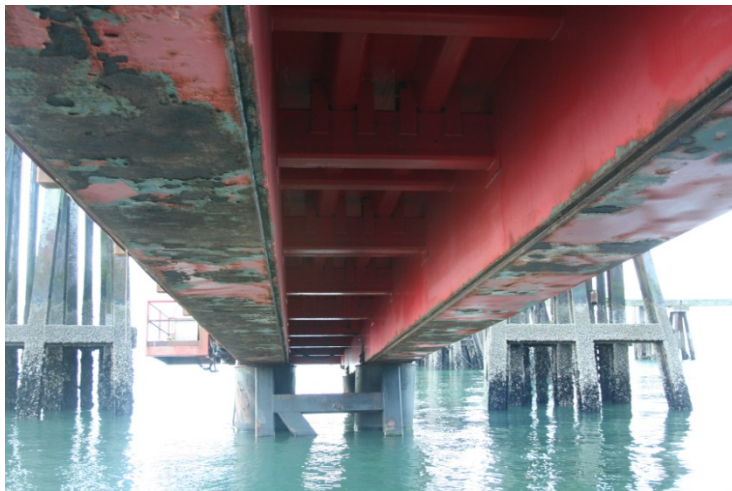
Figure 3 - coating failure along the barge ramp girder soffits

Since it is a floating structure, much of the length of the two box girder flanges constantly sit in or near the splash zone, causing accelerated corrosion on these areas. The coating has largely deteriorated in this area (see Figure 3). The nominal thickness of the box girder flange is 0.75" in most areas with a small reinforced
