* Those who are unable to appear during a meeting but who still wish to share public comment may submit such comments in written form to the City Clerk at least 4 hours in advance of the meeting.

* Individuals with disabilities may request necessary reasonable accommodations by submitting requests to the City Clerk, preferably at least 24 hours in advance.

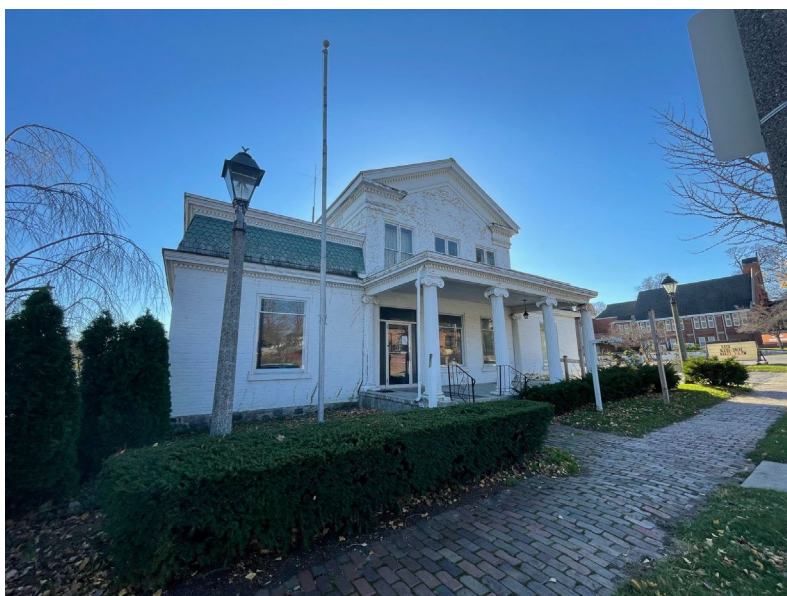
The City shall review all proposals through the City Commission appointed RFP Committee (“Committee”). The Committee may request written clarification from respondents, and will forward all proposals and non-binding recommendations on proposals to the City Commission for final consideration and award of bid and request to enter into a Purchase Agreement and the Historic Preservation and Conservation Easement Deed (Attachment 1), which includes the Ross-Sanders Historic Building Elements document (Attachment 2). The City of Buchanan reserves the right to terminate the RFP process at any point prior to the approval of a proposal.

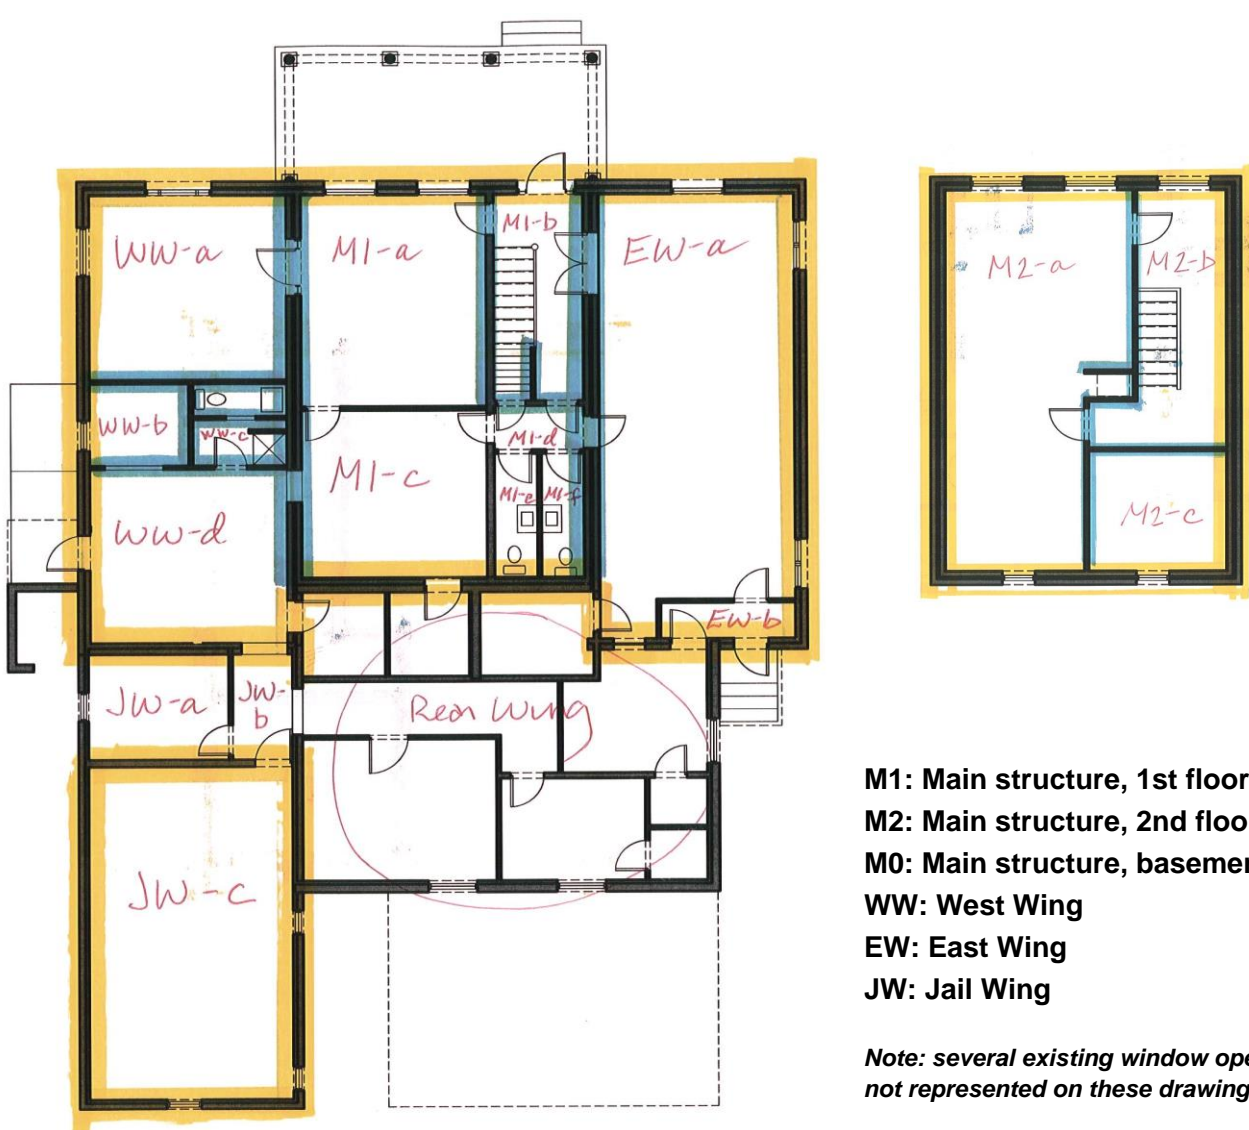
ROSS-SANDERS HOUSE EXTERIOR

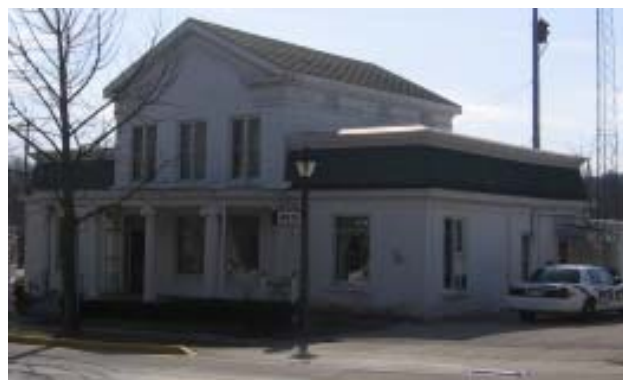
Fig 1: North elevation

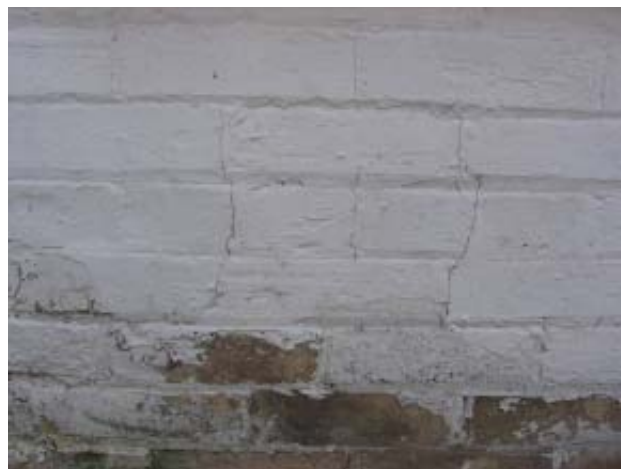
Fig 2: Cracking in exterior brick north wall west wing

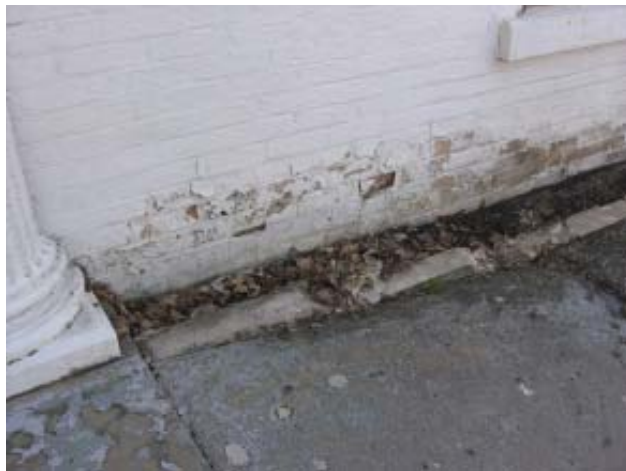
Fig 3: Deteriorating exterior brick north wall west wing

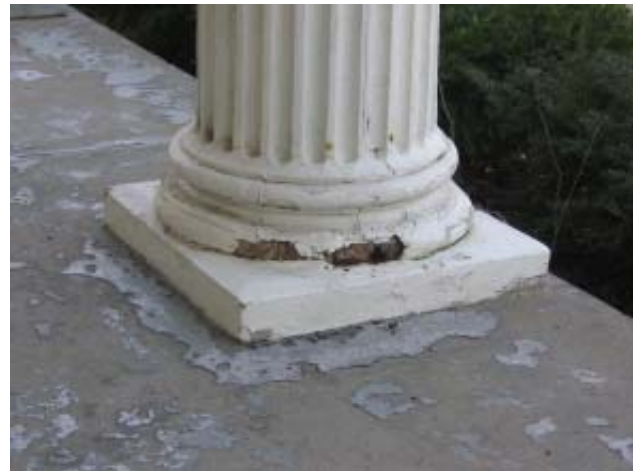
Fig 4: Deteriorating column bases at north porch

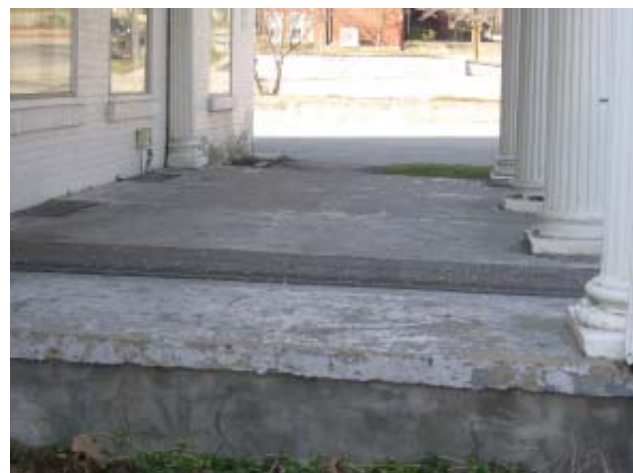
Fig 5: Concrete slab of north porch

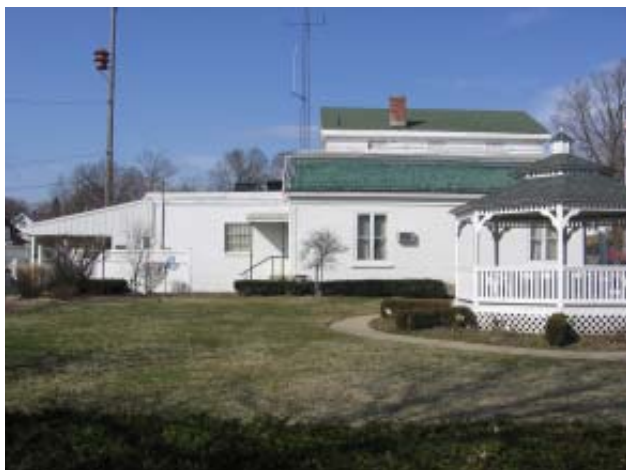
Fig 6: East elevation

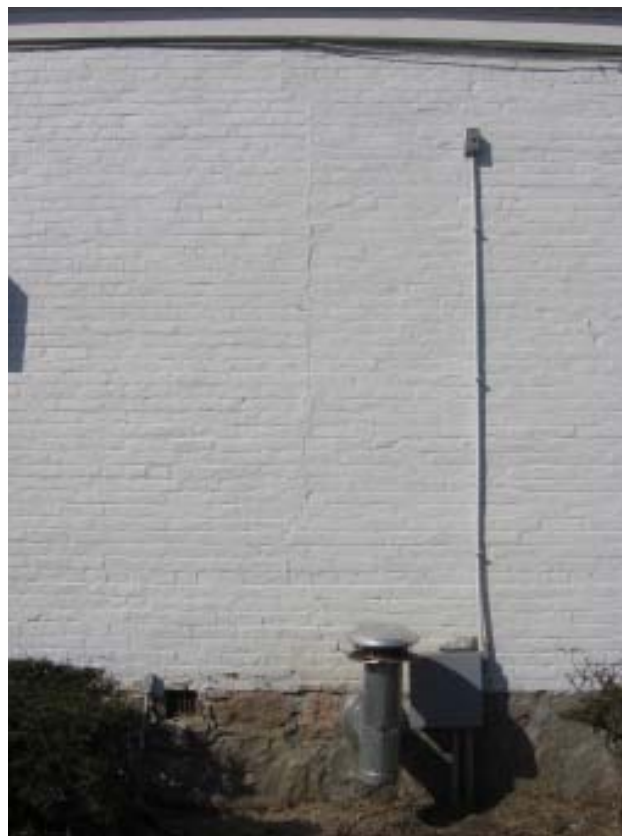
Fig 7: East elevation - Vertical cracked joint

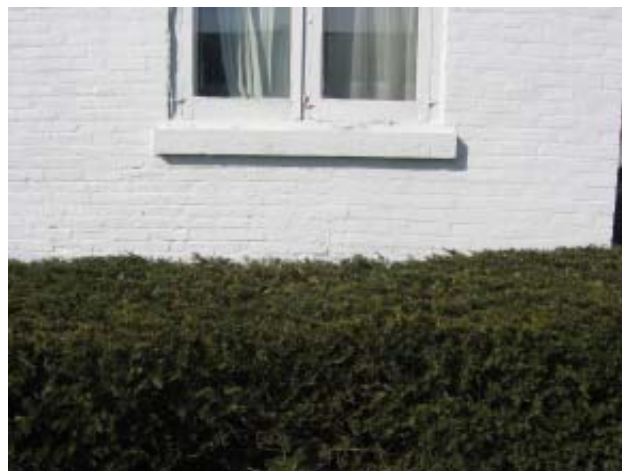
Fig 8: East elevation - Cracking below window

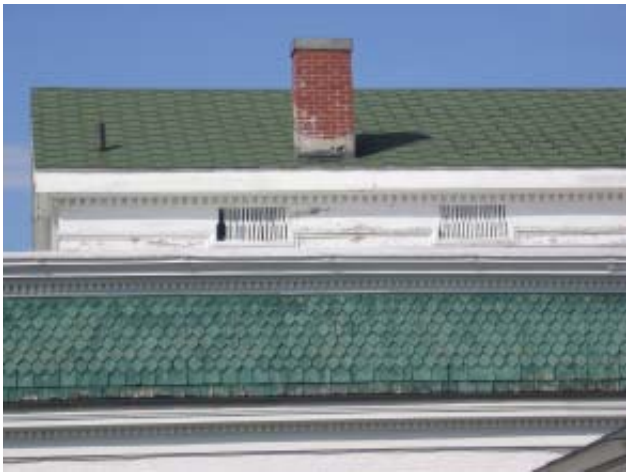
Fig 10: East elevation - Missing iron bar

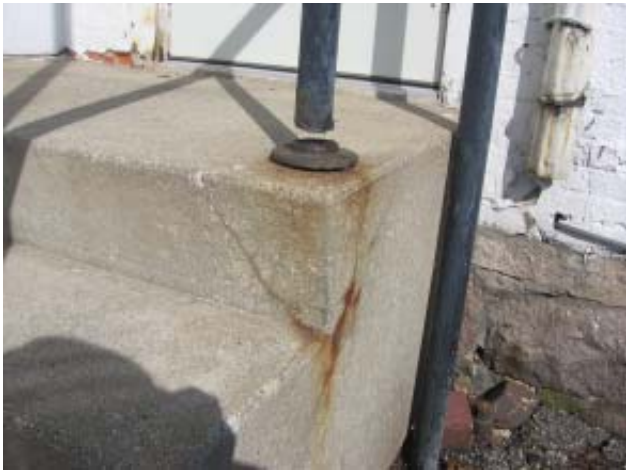
Fig 11: East elevation - Handrail support with no bearing

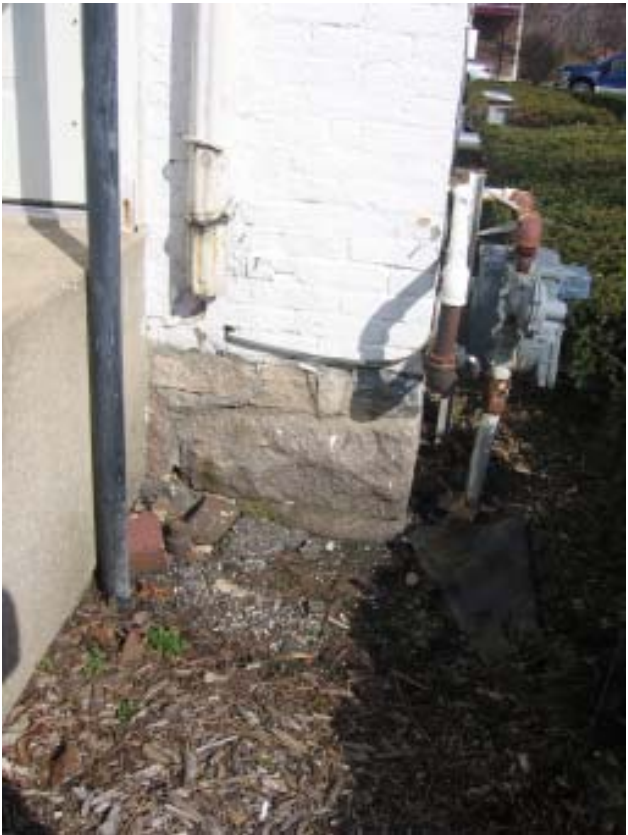
Fig 9: East elevation - Downspout discharging directly against foundation

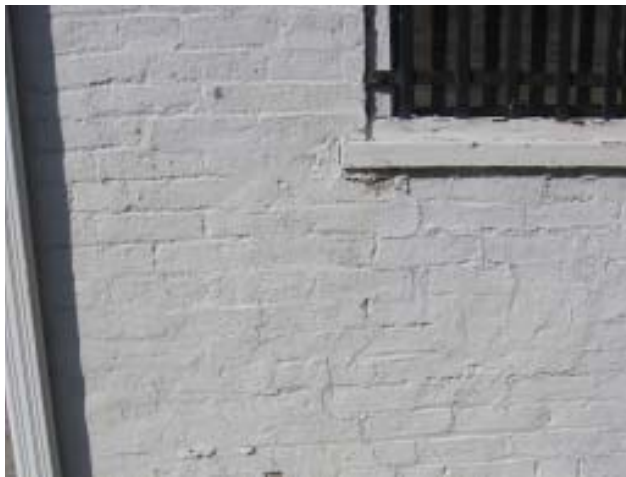
Fig 12: East elevation - Mainly vertical step crack

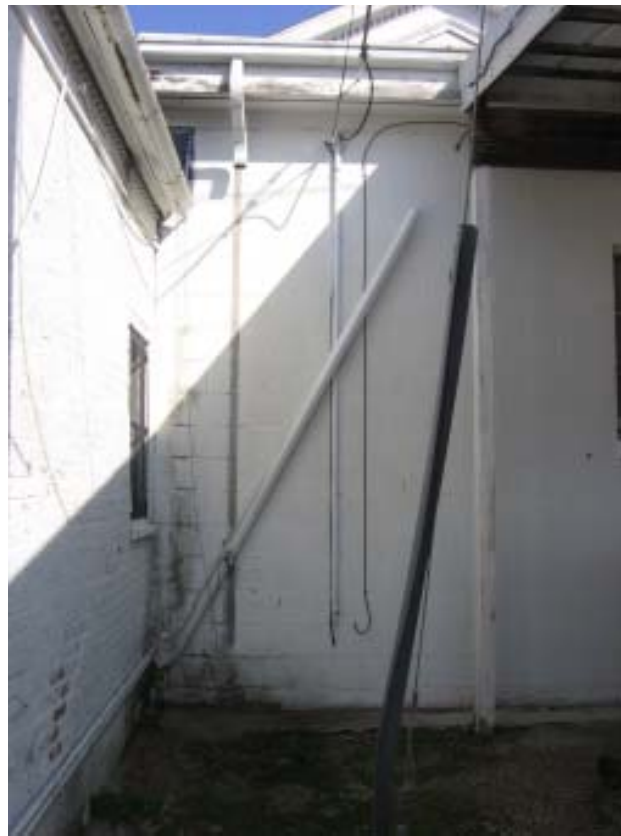
Fig 13: South elevation - Downspouts at corner of 1949 Addition and Jail

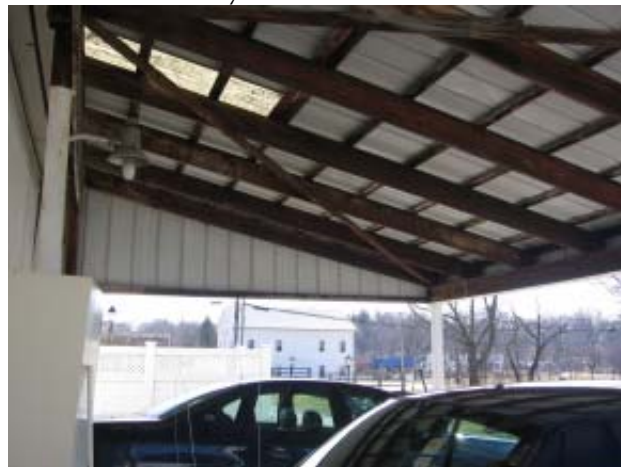
Fig 14: Carport overall

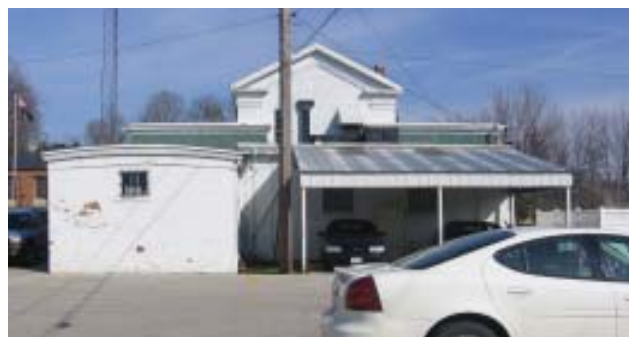
Fig 19: South elevation

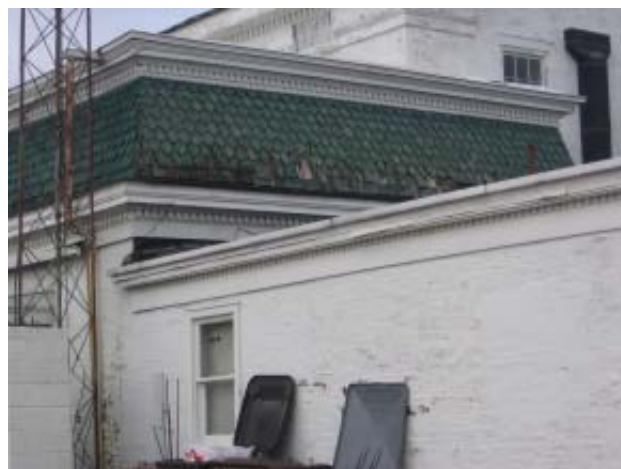
Fig 20: South elevation - Deteriorated shingles

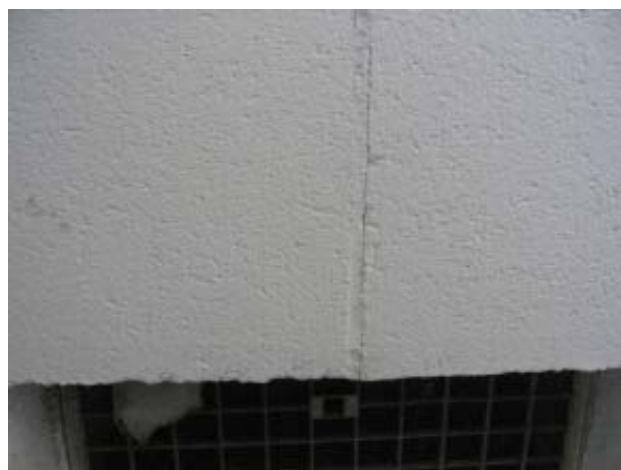
Fig 21: South elevation - Cracked cmu over vent

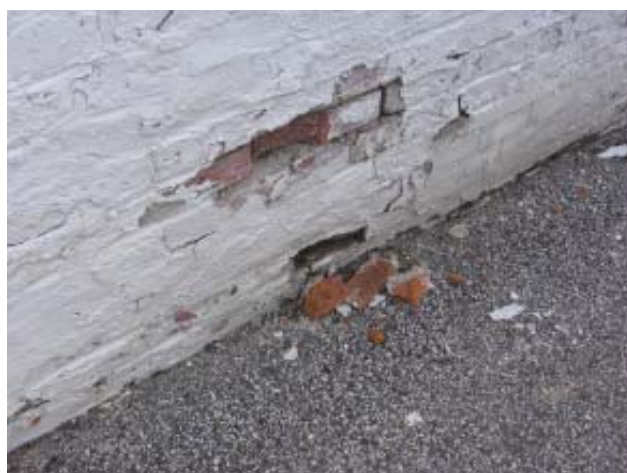
Fig 22: West elevation - Severely deteriorated brick

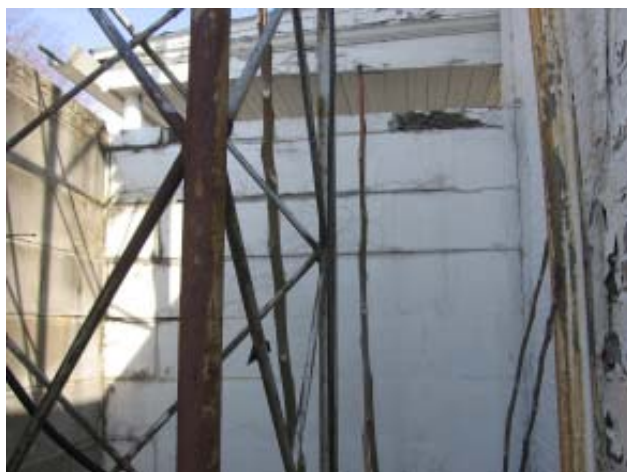
Fig 23: West elevation - Deterioration of top courses of antenna enclosure cmu walls

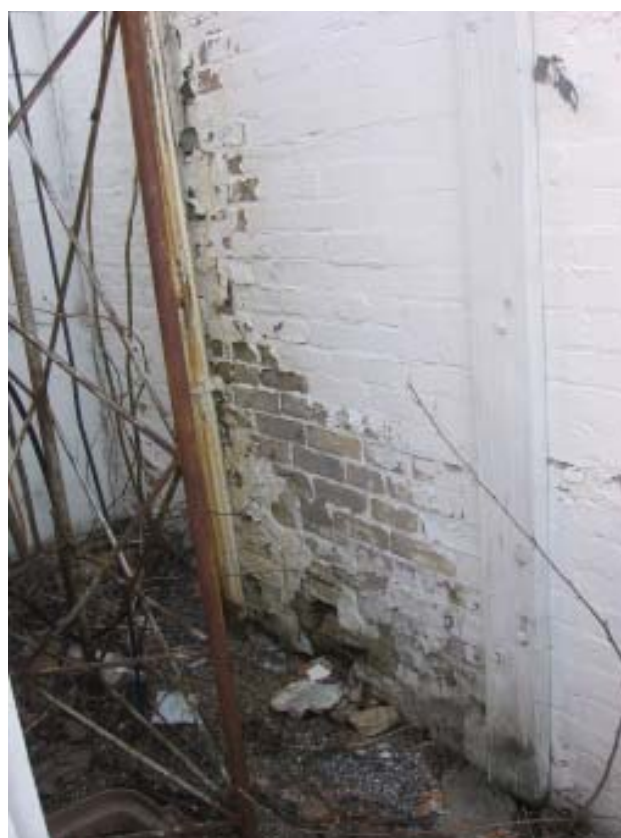
Fig 24: West elevation - Deterioration of brick at antenna enclosure

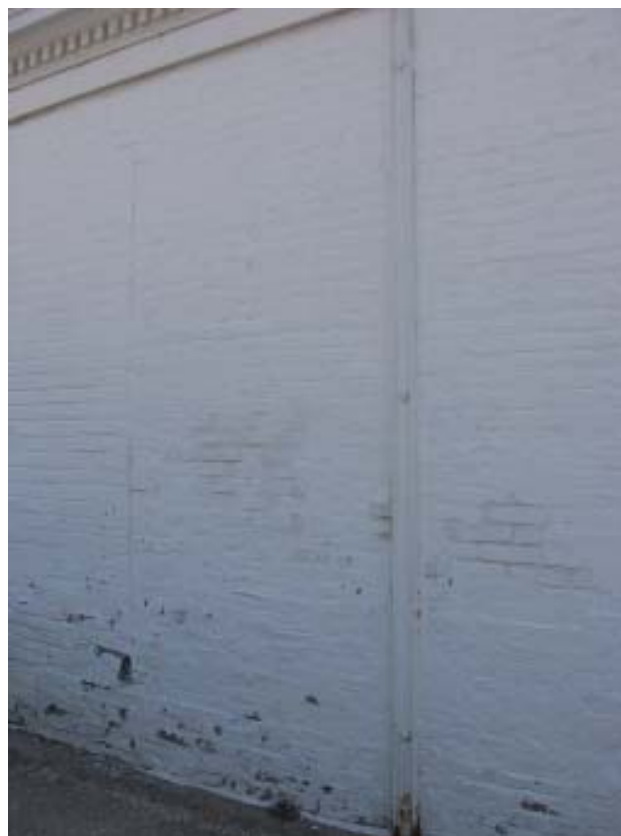
Fig 25: West elevation - Existing channel brace

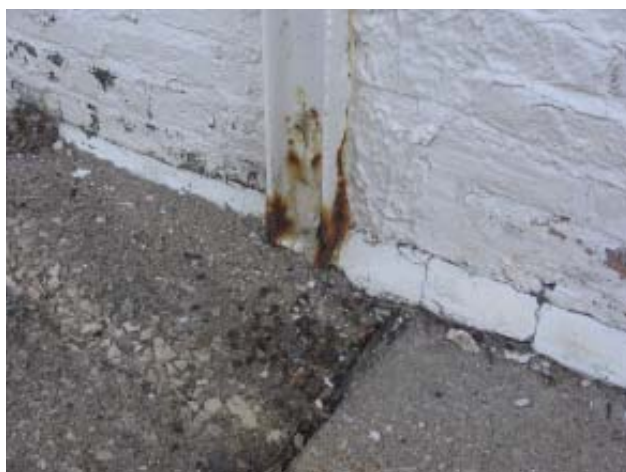
Fig 26: West elevation - Existing channel brace rusting

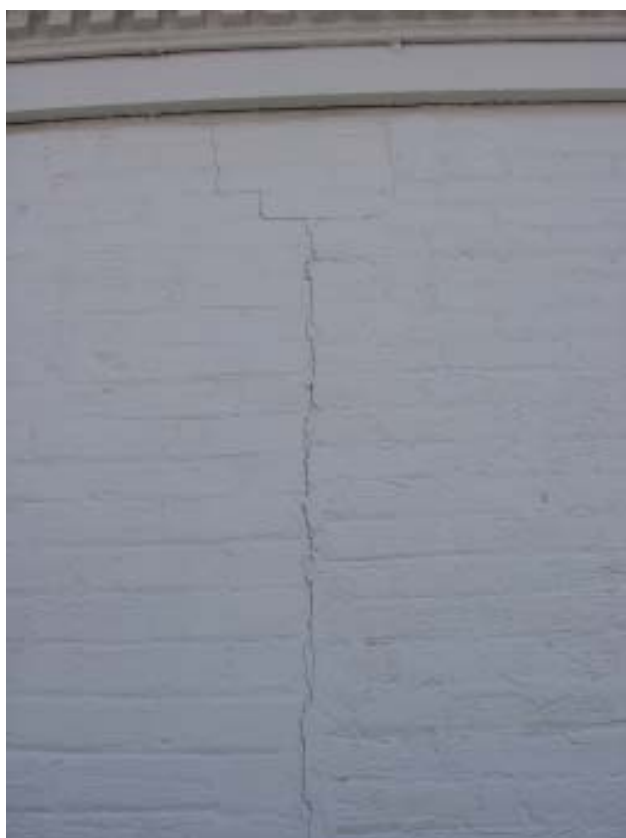
Fig 27: West elevation - Vertical crack at construction joint

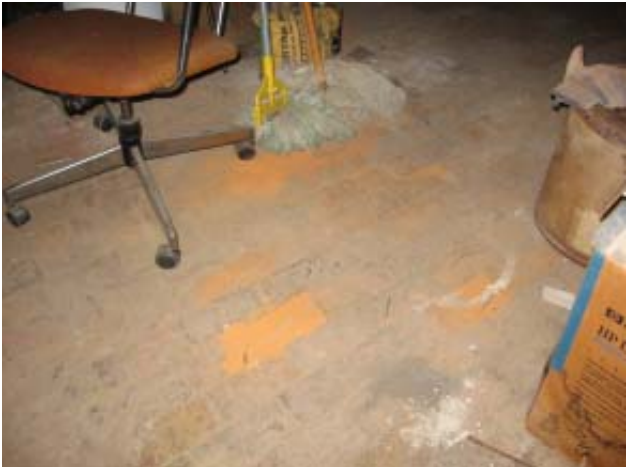
Fig 28: Basement - Deteriorated floor pavers

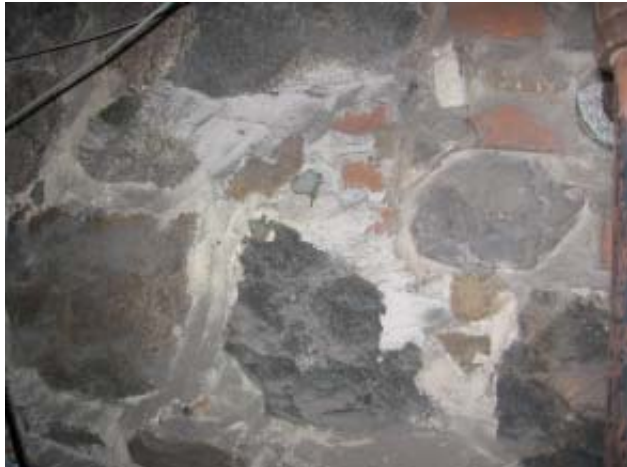
Fig 30: Basement - Cut stone masonry walls repointed

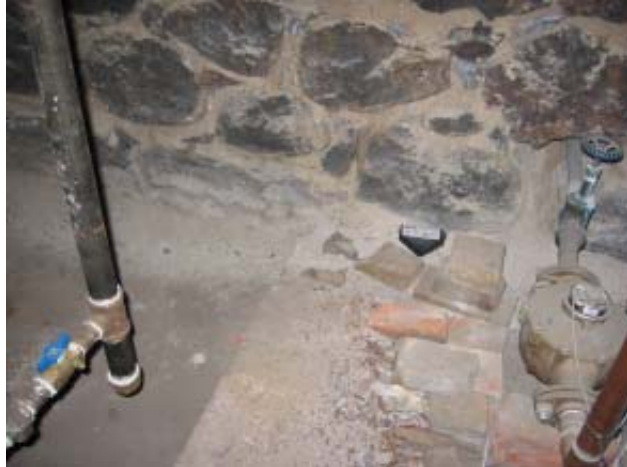
Fig 31: Basement - Mortar dust at base of south wall

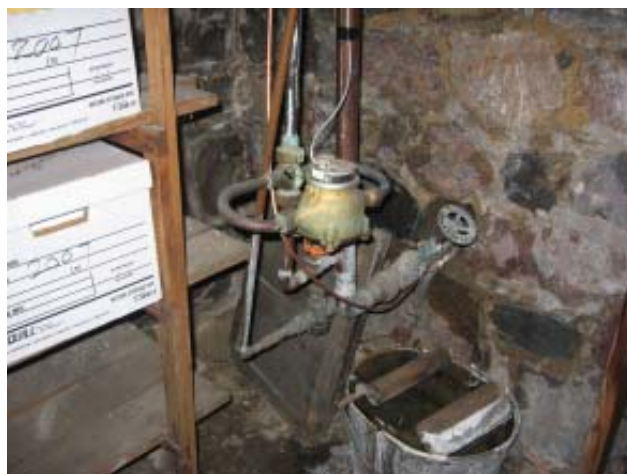
Fig 32: Basement - Leak near a utility meter captured into overflowing bucket below

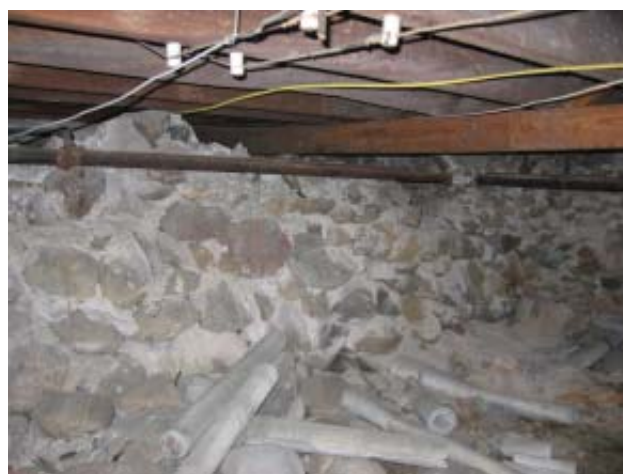
Fig 34: East Crawl Space - Stone masonry walls, excessive masonry dust presumed asbestos insulation

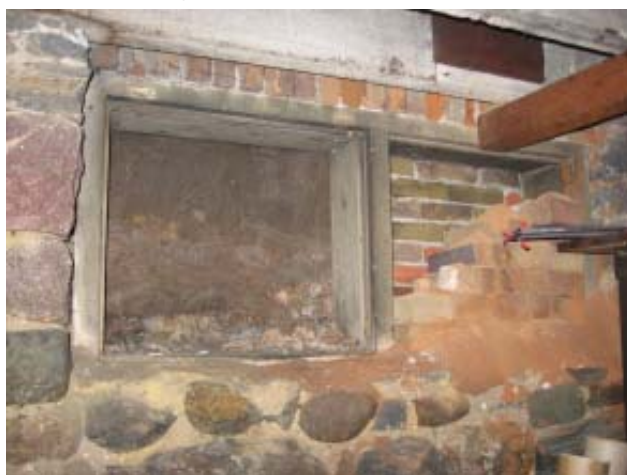
Fig 33: Basement - Window infill and deteriorating brick at north wall

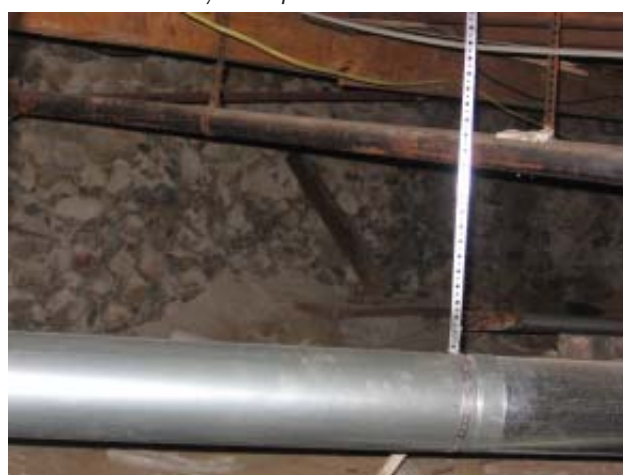
Fig 35: East Crawl Space - Wood bracing system along east exterior wall, excessive mortar dust pile

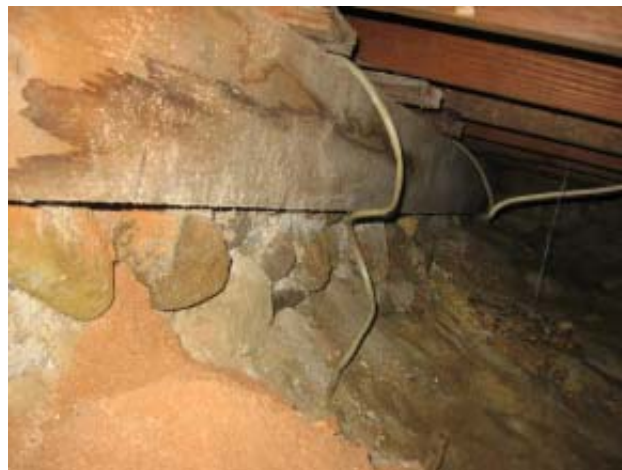
Fig 38: West Crawl Space - Excessive brick masonry dust at base of walls; loose stones in foundation wall

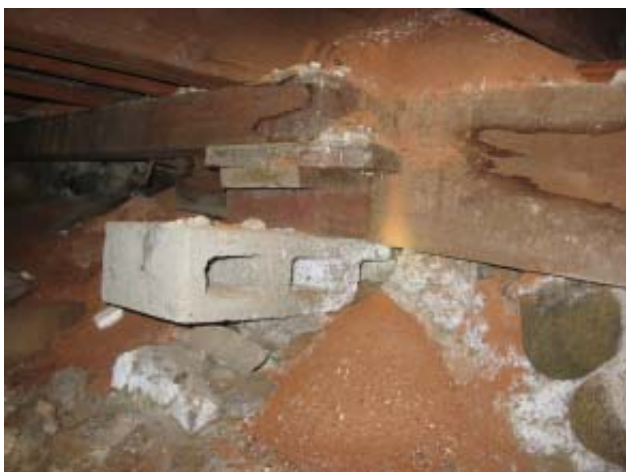
Fig 37: West Crawl Space - Excessive brick masonry dust at base of walls

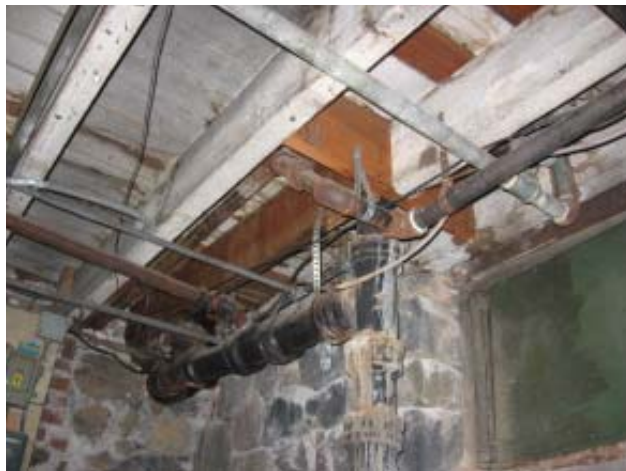
Fig 40: First Floor Structure - Floor infill at previous floor opening in southeastern corner

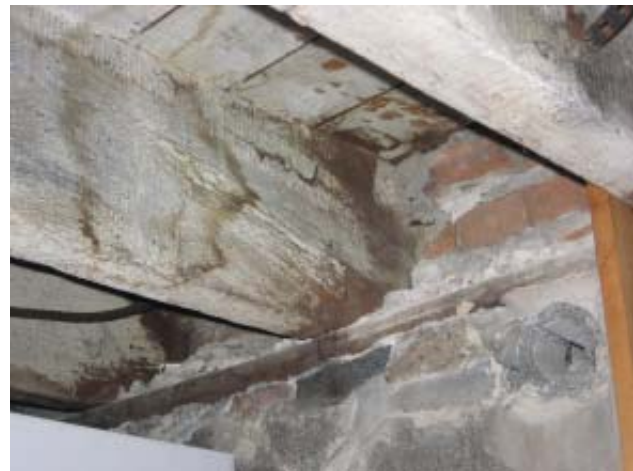
Fig 43: First Floor Structure - Cracked floor joist in northwest corner

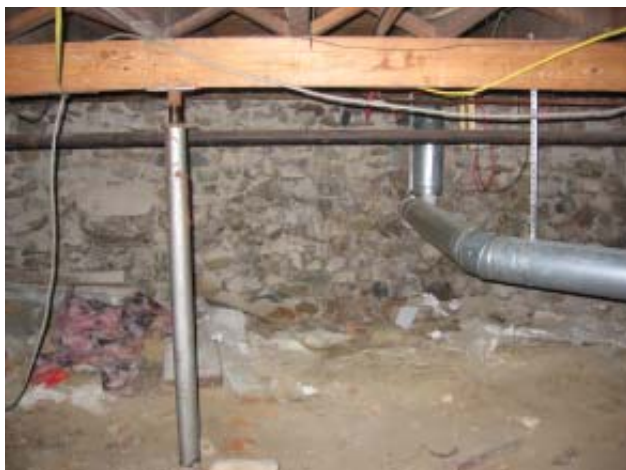
Fig 44: First Floor Structure - Visual curvature in center beam in east wing

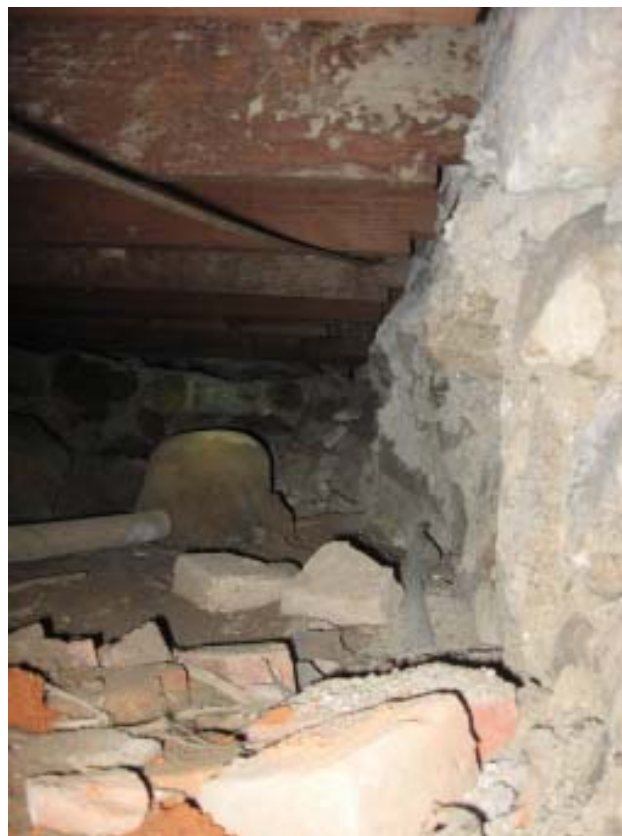
Fig 45: First Floor Structure - Notched joists at east bearing in west wing

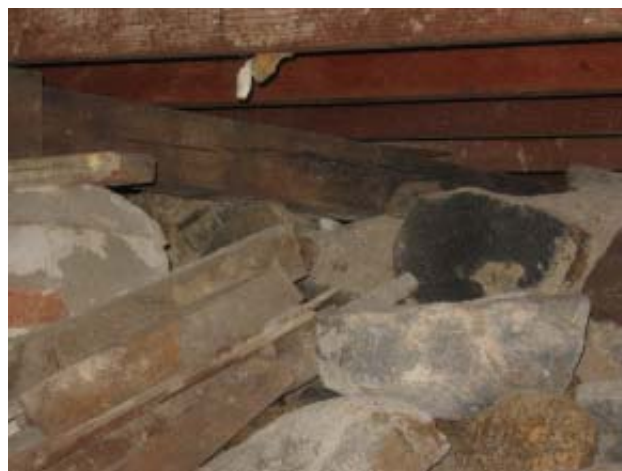
Fig 46: First Floor Structure - Deteriorated center beam in west wing

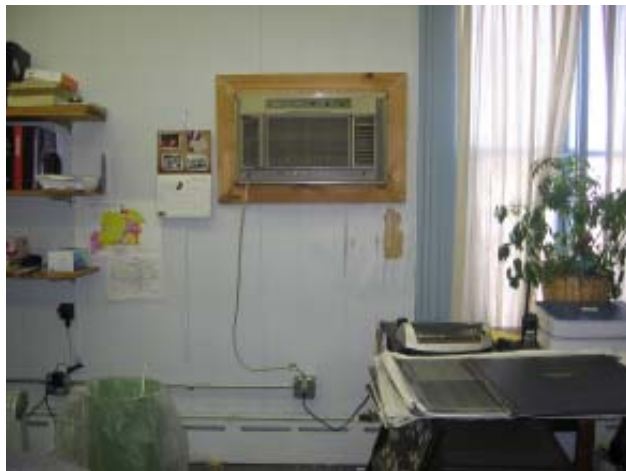
Fig 47: First Floor Level - Water damage below air conditioning unit in east exterior wall

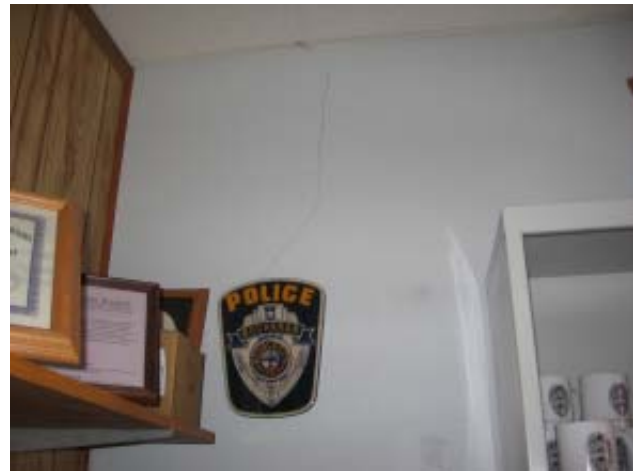
Fig 49: First Floor Level - Crack in west wall, north end of west wing

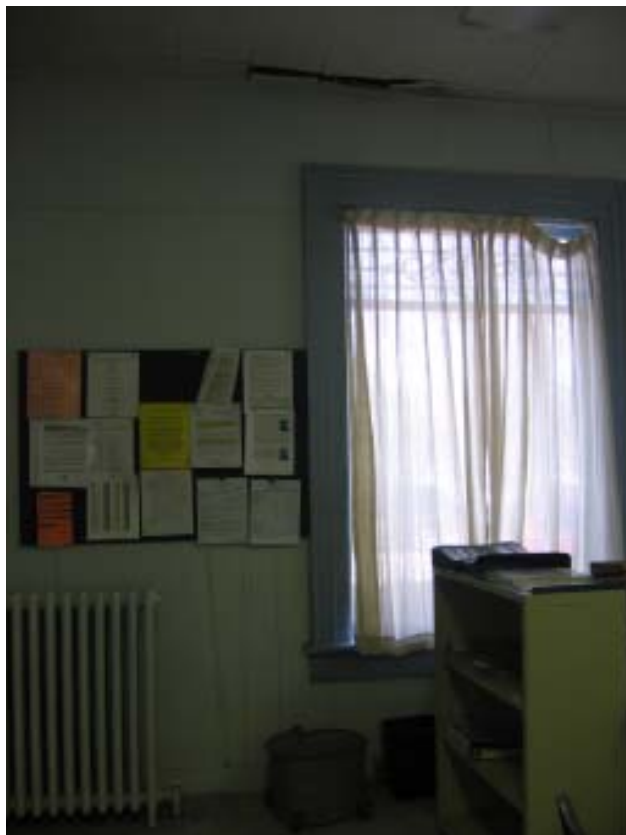
Fig 48: First Floor Level - Water damage at north wall of the east wing

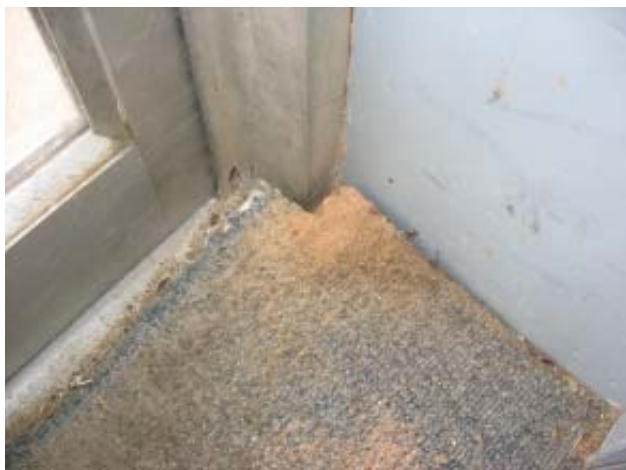
Fig 50: First Floor Level - Brick dust at man door in west wing

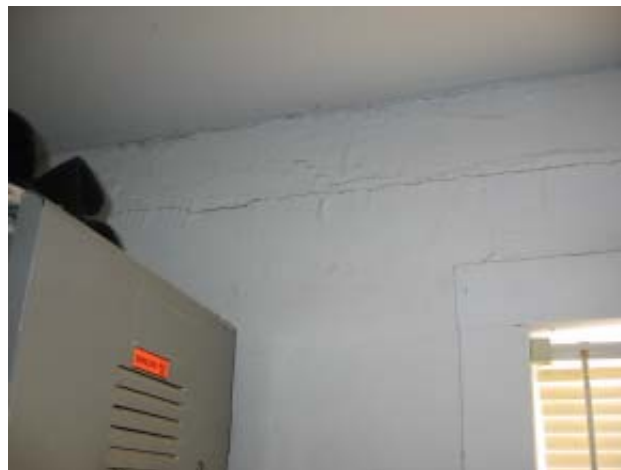
Fig 51: First Floor Level - Horizontal crack at top of jail west wall

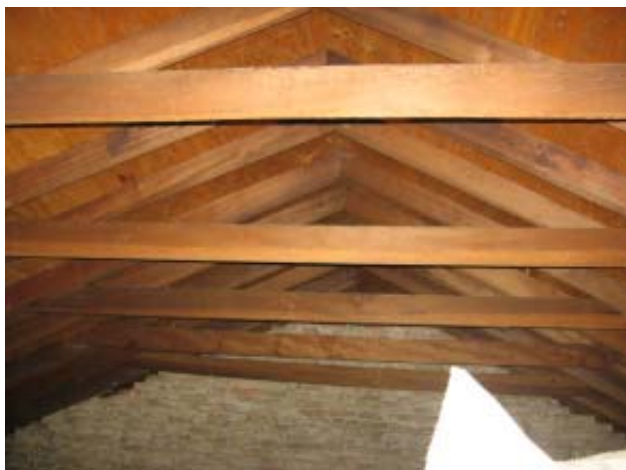
Fig 53: Attic and Roof Structures- Butt jointed rafters and collar ties in central attic

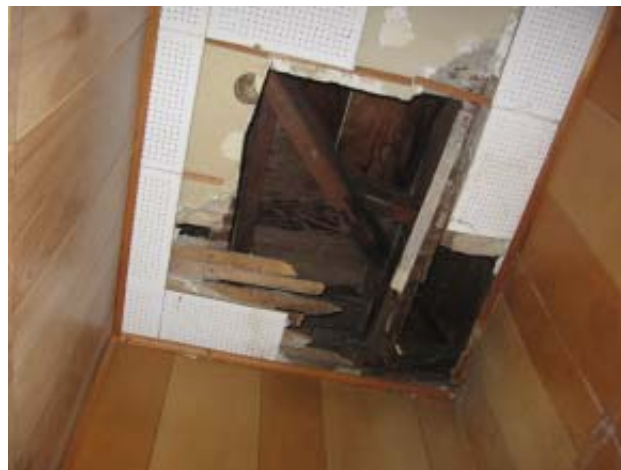
Fig 54: Attic and Roof Structures- Water staining in southeast corner of the east wing

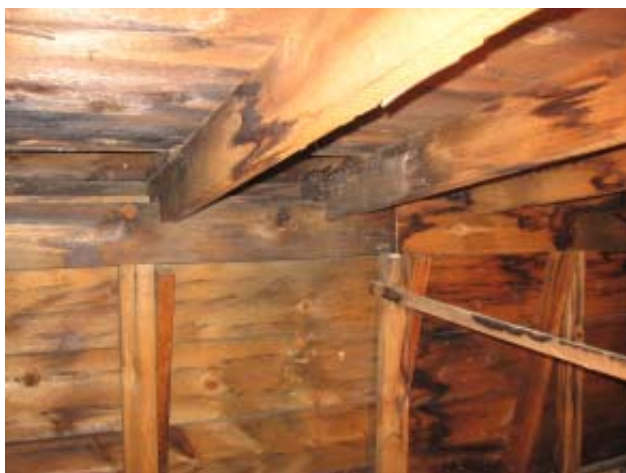
Fig 59: Attic and Roof Structures- Mansard roof construction details, note water staining in wood members in west wing

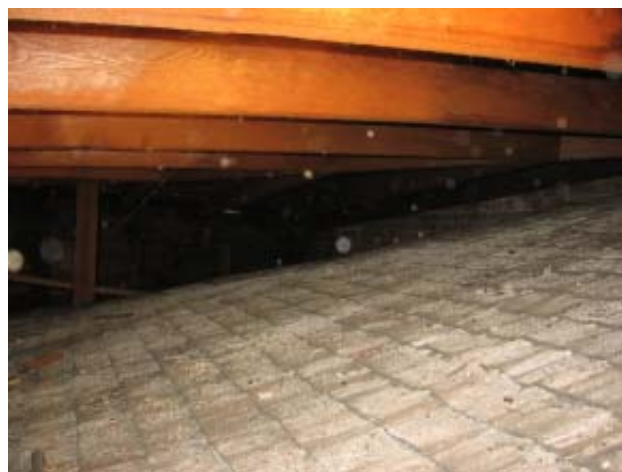
Fig 60: Attic and Roof Structures- Long span rafter splitting in west wing

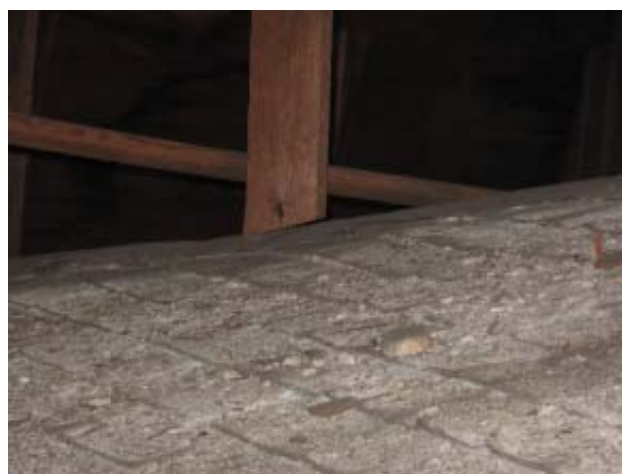
Fig 61: Attic and Roof Structures- Gap observed between bottom of stud supporting hip ridge and top of original hipped roof in west wing

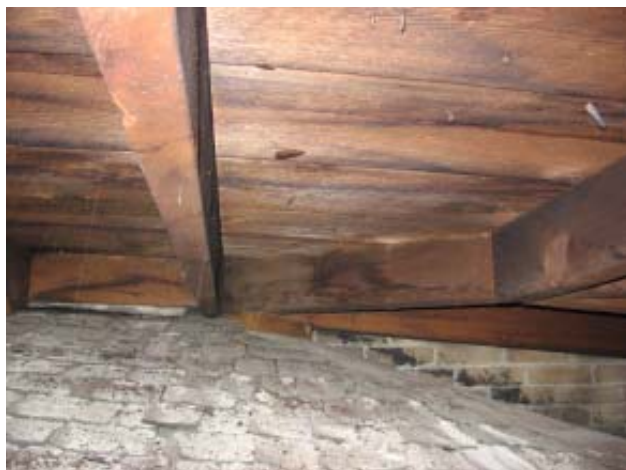
Fig 62: Attic and Roof Structures- Ledger board at masonry wall supporting rafters in west wing

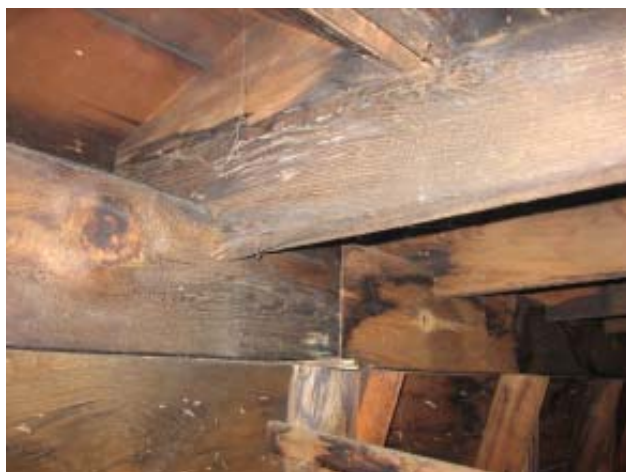
Fig 63: Attic and Roof Structures- Extensive water damage at mansard wall framing in west wing

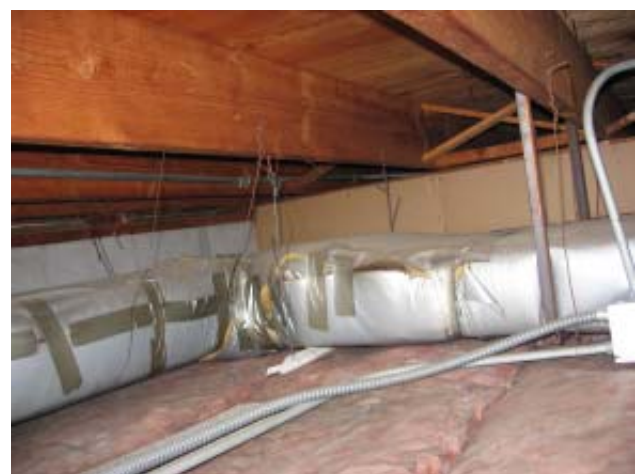
Fig 64: Attic and Roof Structures- Rafters over 1949 addition in good condition

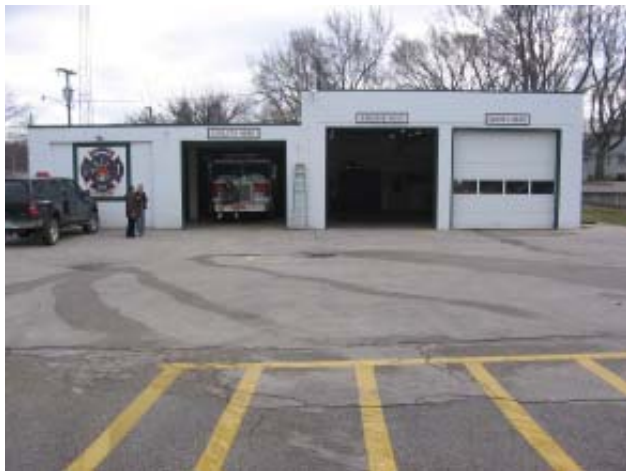
Fig 65: Garage- North elevation

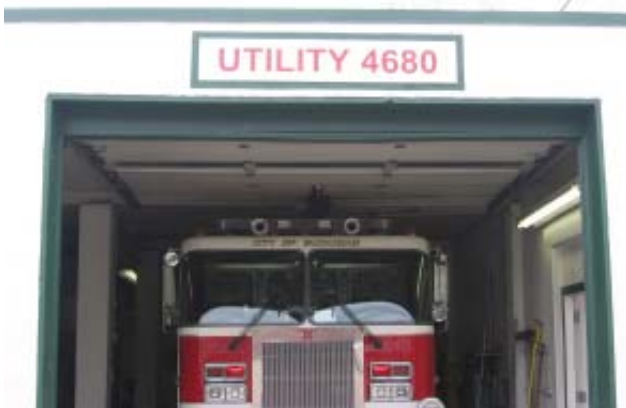
Fig 66: Garage- North elevation, visual sag in lintel

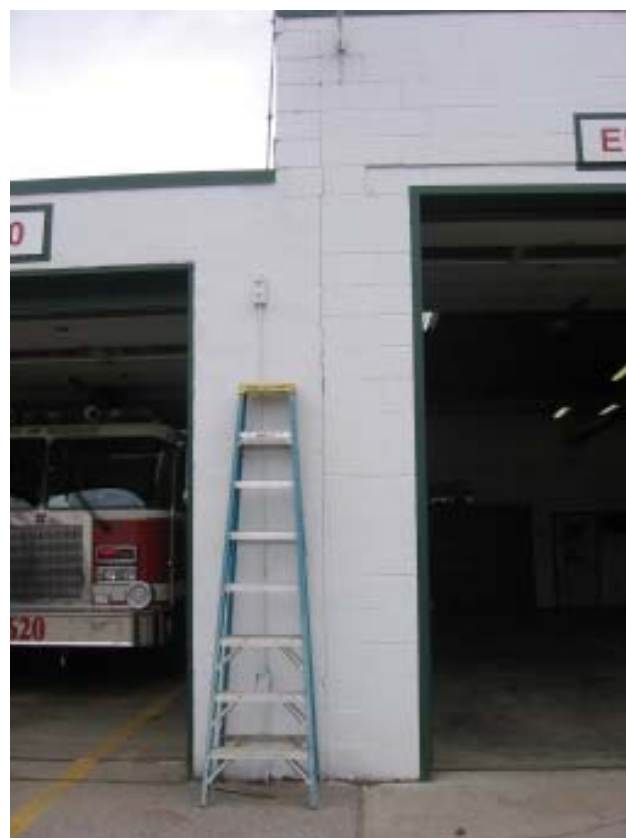
Fig 67: Garage- North elevation, vertical crack at joint between original and addition constructions

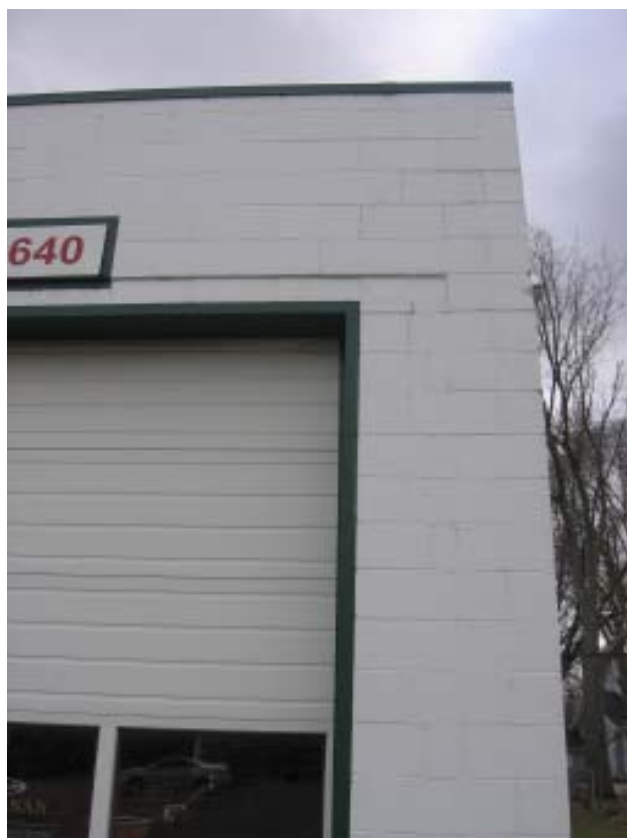
Fig 68: Garage- North elevation, step cracking at lintel bearing and western corner of wall

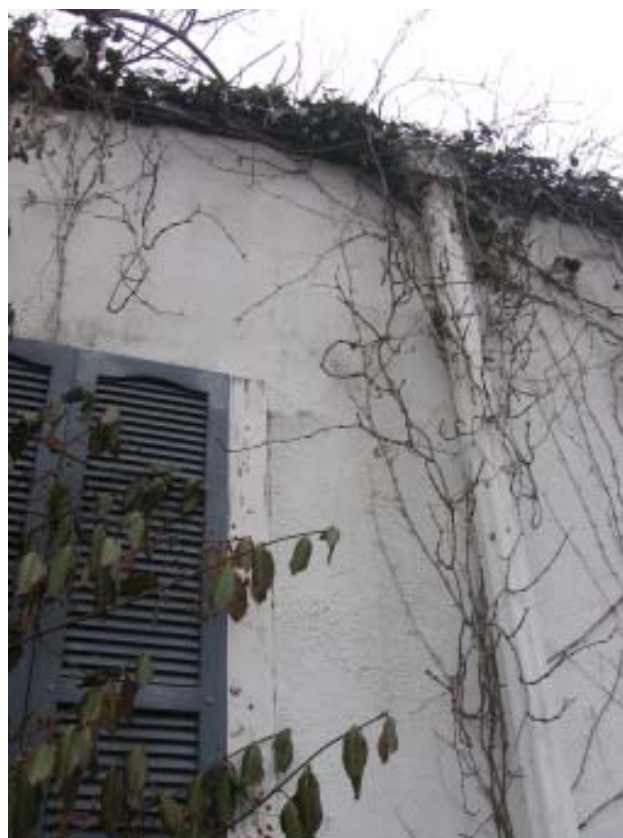
Fig 69: Garage- East elevation, heavy vegetation growth in gutter system

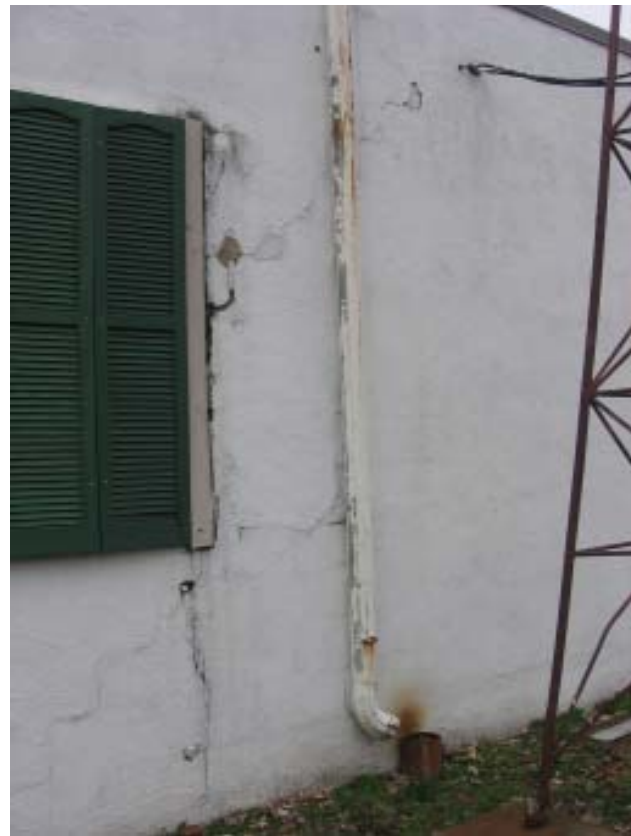
Fig 71: Garage- East elevation, downspout discharging against exterior wall and step cracking in masonry

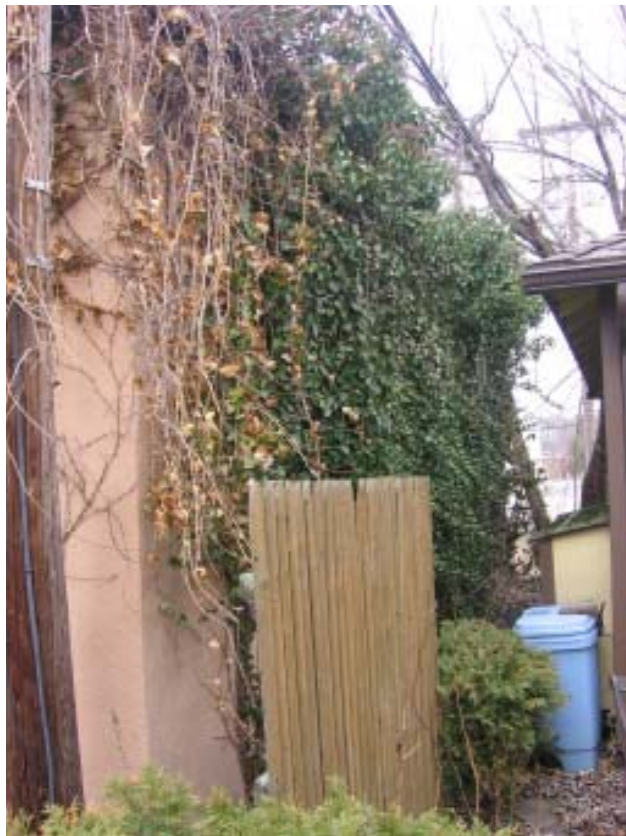
Fig 72: Garage- South elevation, heavy vegetation on wall prohibiting inspection of wall
