* Those who are unable to appear during a meeting but who still wish to share public comment may submit such comments in written form to the City Clerk at least 4 hours in advance of the meeting.

* Individuals with disabilities may request necessary reasonable accommodations by submitting requests to the City Clerk, preferably at least 24 hours in advance.

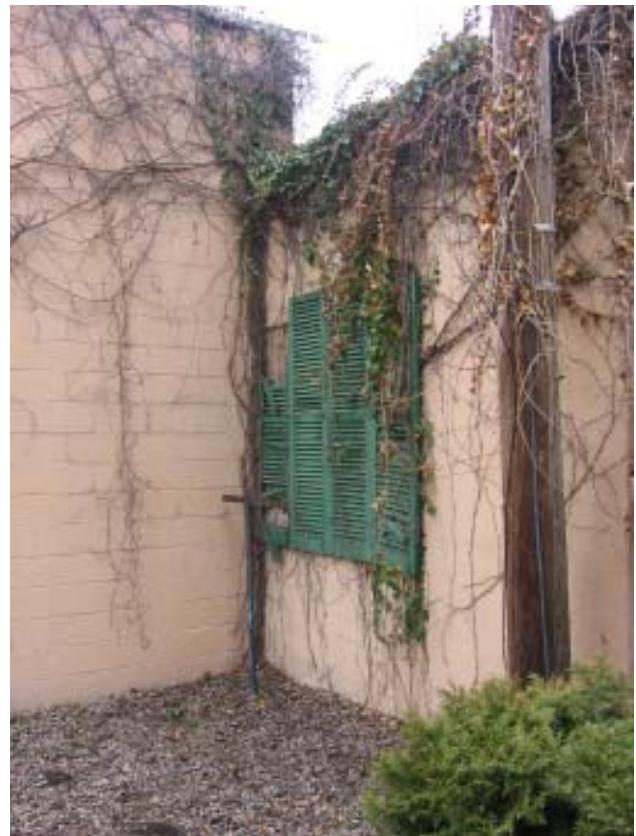
Fig 73: Garage- South elevation, south wall of addition and west wall of original building

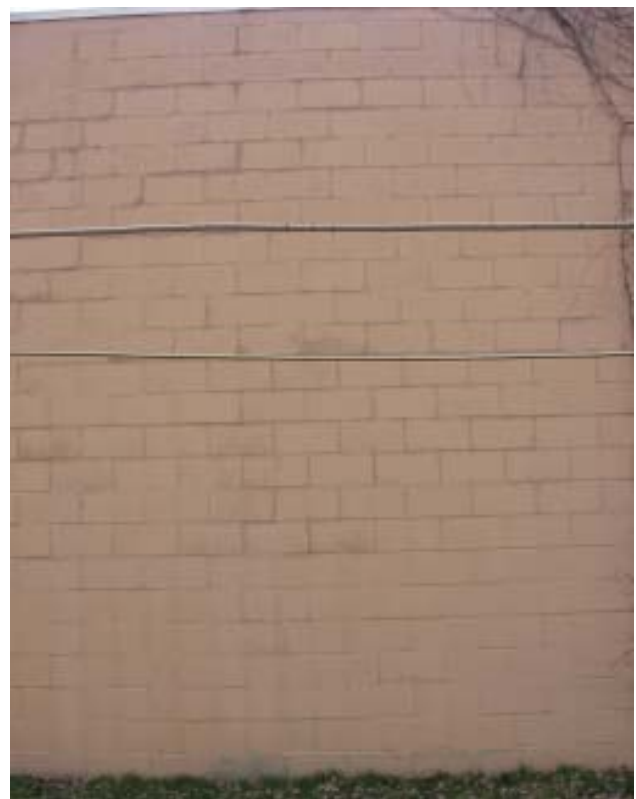
Fig 74: Garage- South elevation, south wall of addition cracking and moisture shown

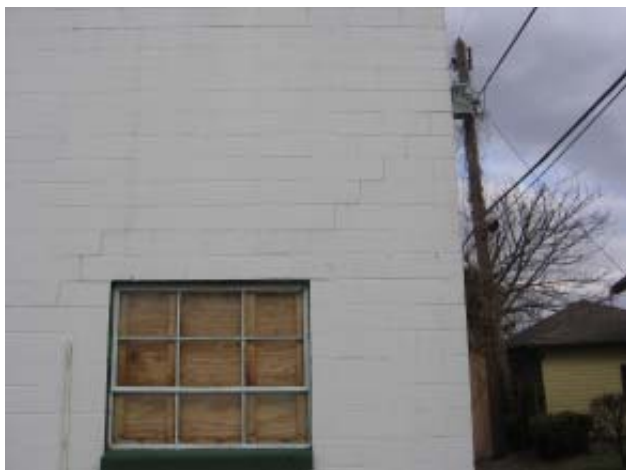
Fig 75: Garage- South elevation, step cracking south of southern window

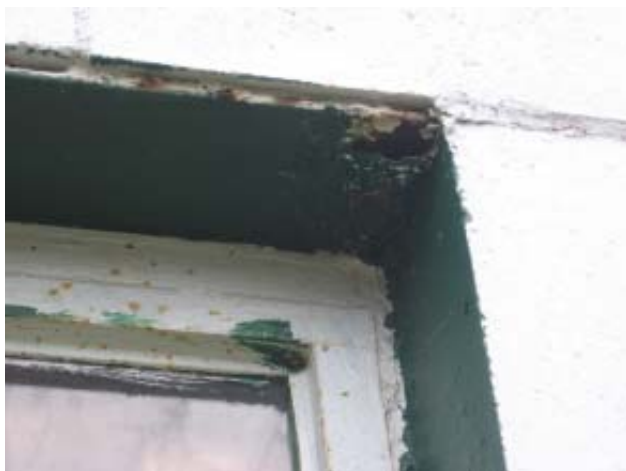
Fig 76: Garage- South elevation, rusting of steel lintel at man door

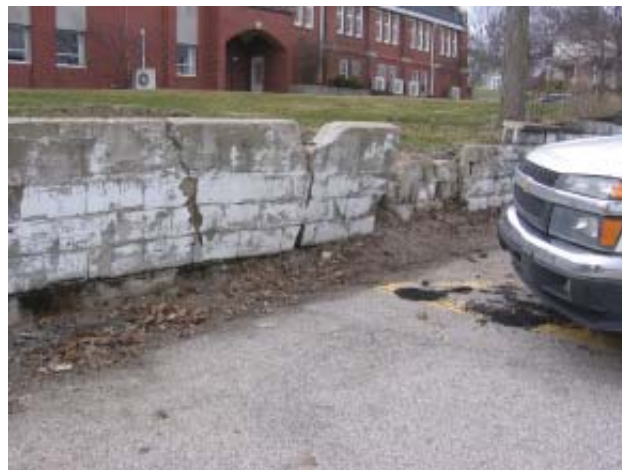
Fig 77: Failing retaining wall at west edge of property

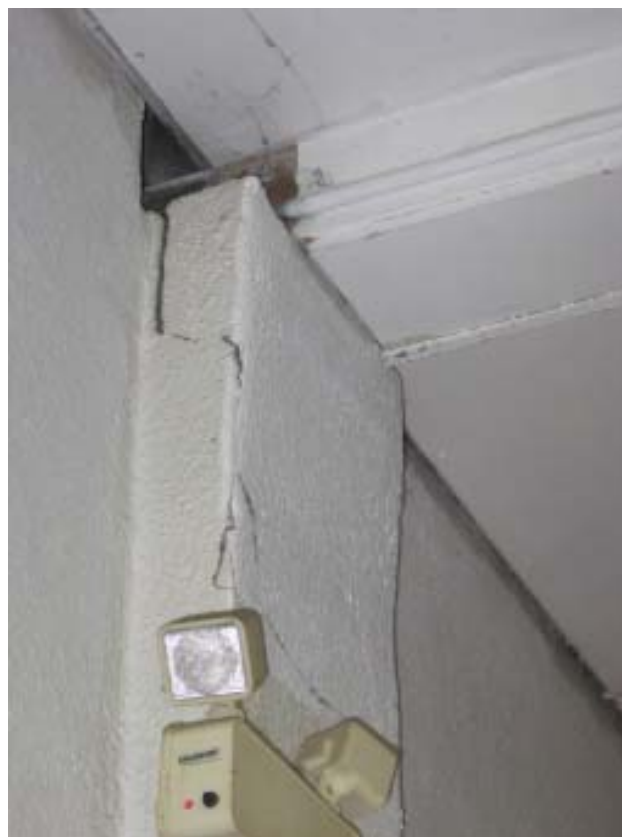
Fig 78: Garage - Masonry pier for roof beam bearing is cracked and rotating inward

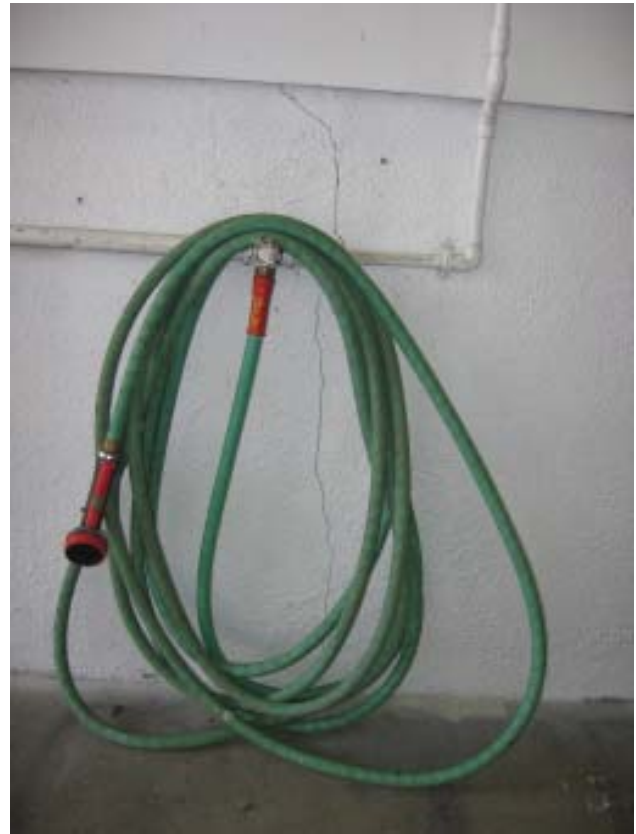
Fig 80: Garage - Vertical masonry crack in common wall between original and addition buildings

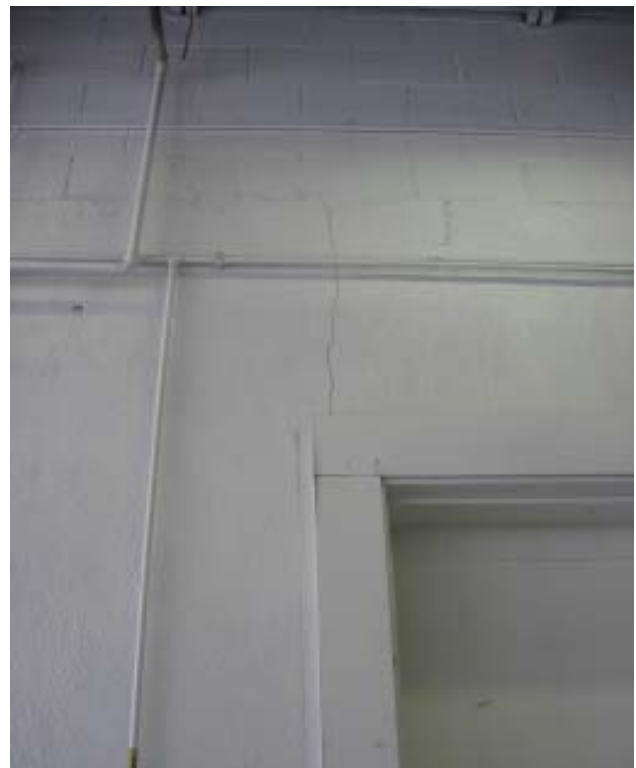
Fig 81: Garage - Vertical masonry crack in common wall between original and addition buildings; note stucco is discontinuous at new addition wall coursing

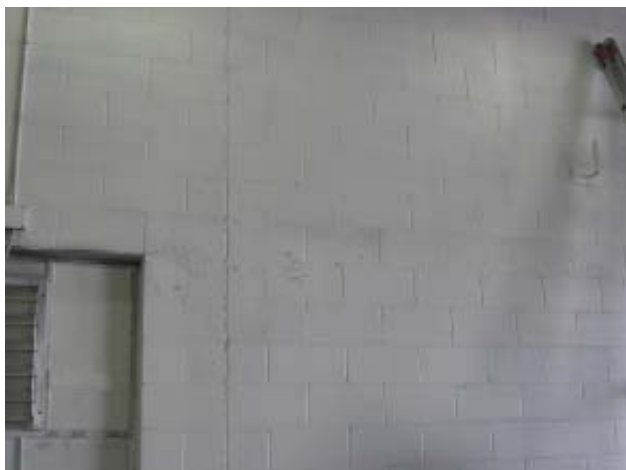
Fig 82: Garage - Vertical masonry crack in expansion joint on both interior and exterior surfaces of west wall

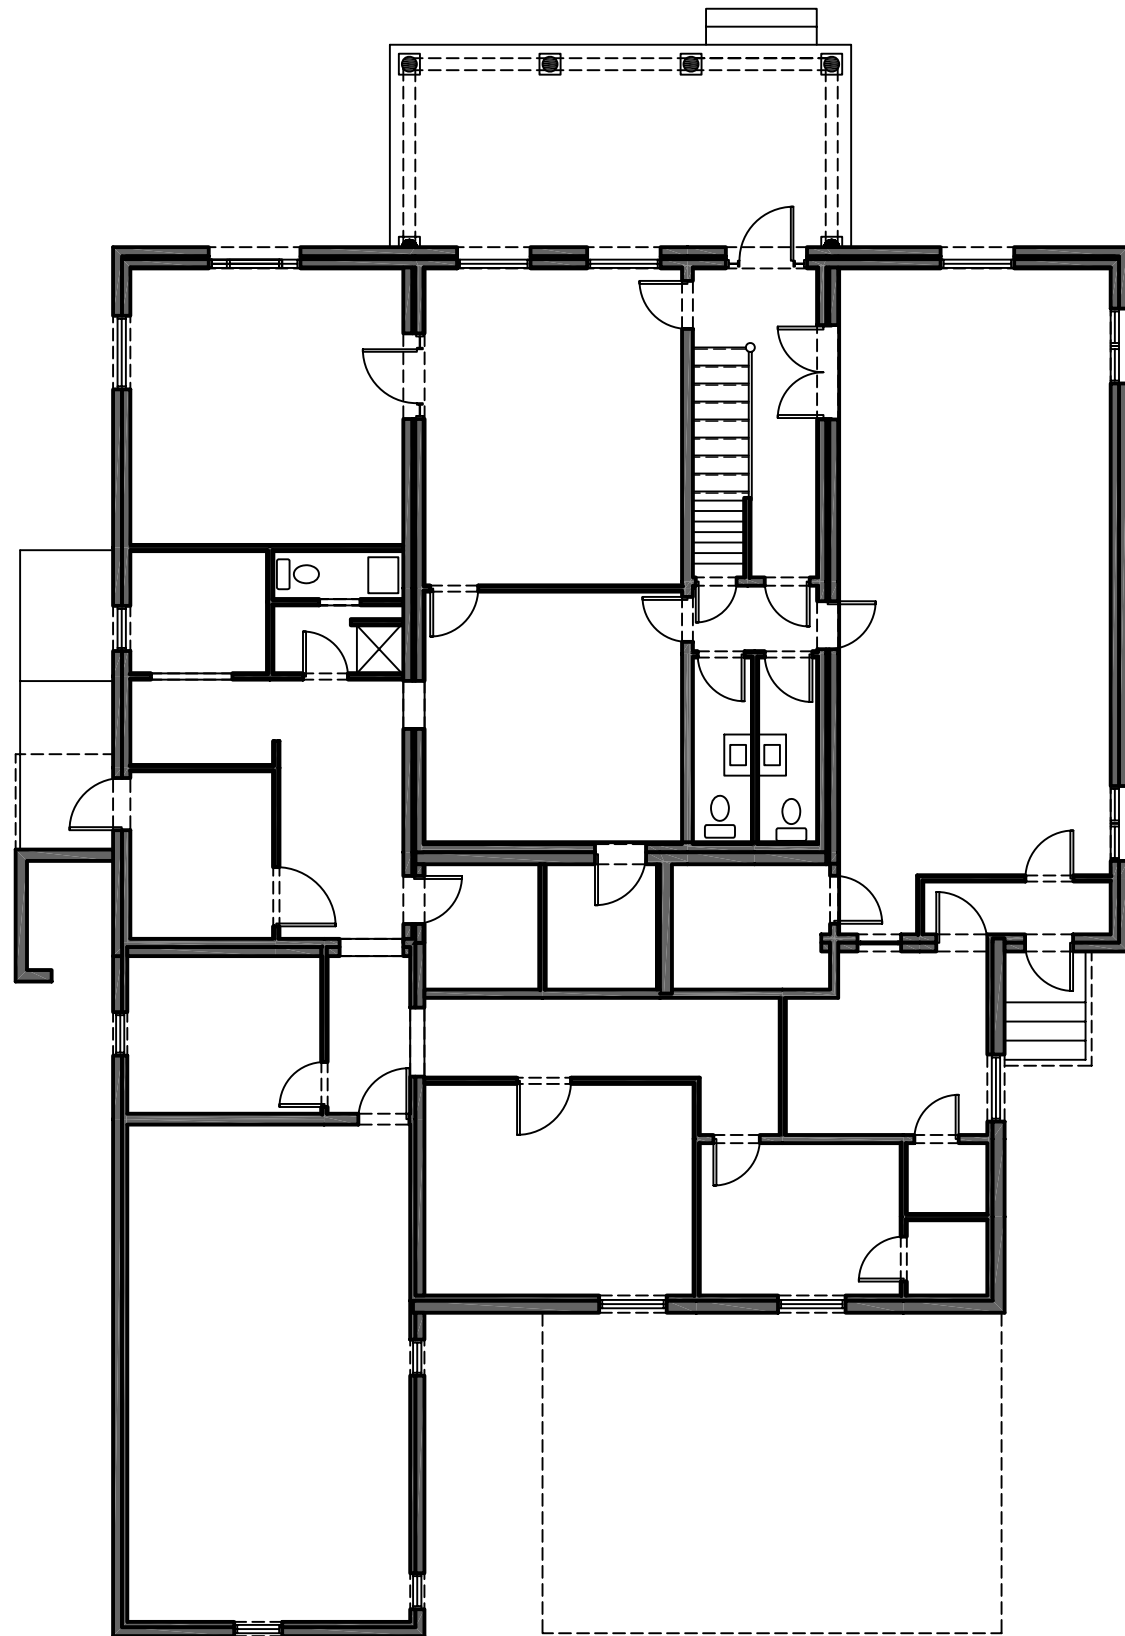
<p>Fitzpatrick Structural Engineering, P.C. PO Box 1506 • ANN ARBOR, MI • 48106 734-769-0320 • WWW.FSEPC.NET</p>	<p>Ross-Sanders House and Garage Buchanan, Michigan Structural Conditions Assessment Report</p> <p>MAIN HOUSE - BASEMENT PLAN</p>	<p>JAN. 28, 2013</p> <p>by: CLE</p> <p>Sheet 1 of 8</p>
---	--	---

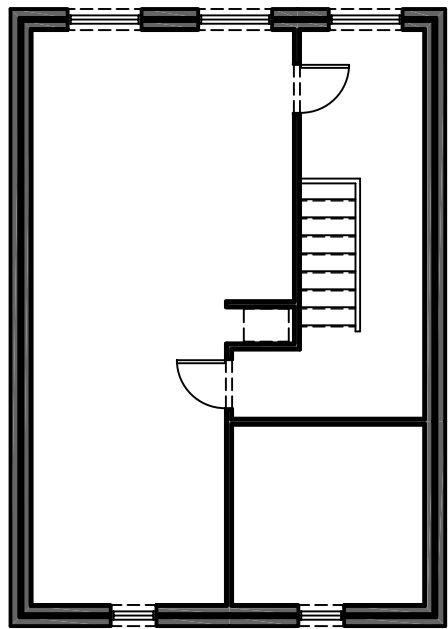
North
PLAN LAYOUT
Scale: 3/32" = 1'-0"

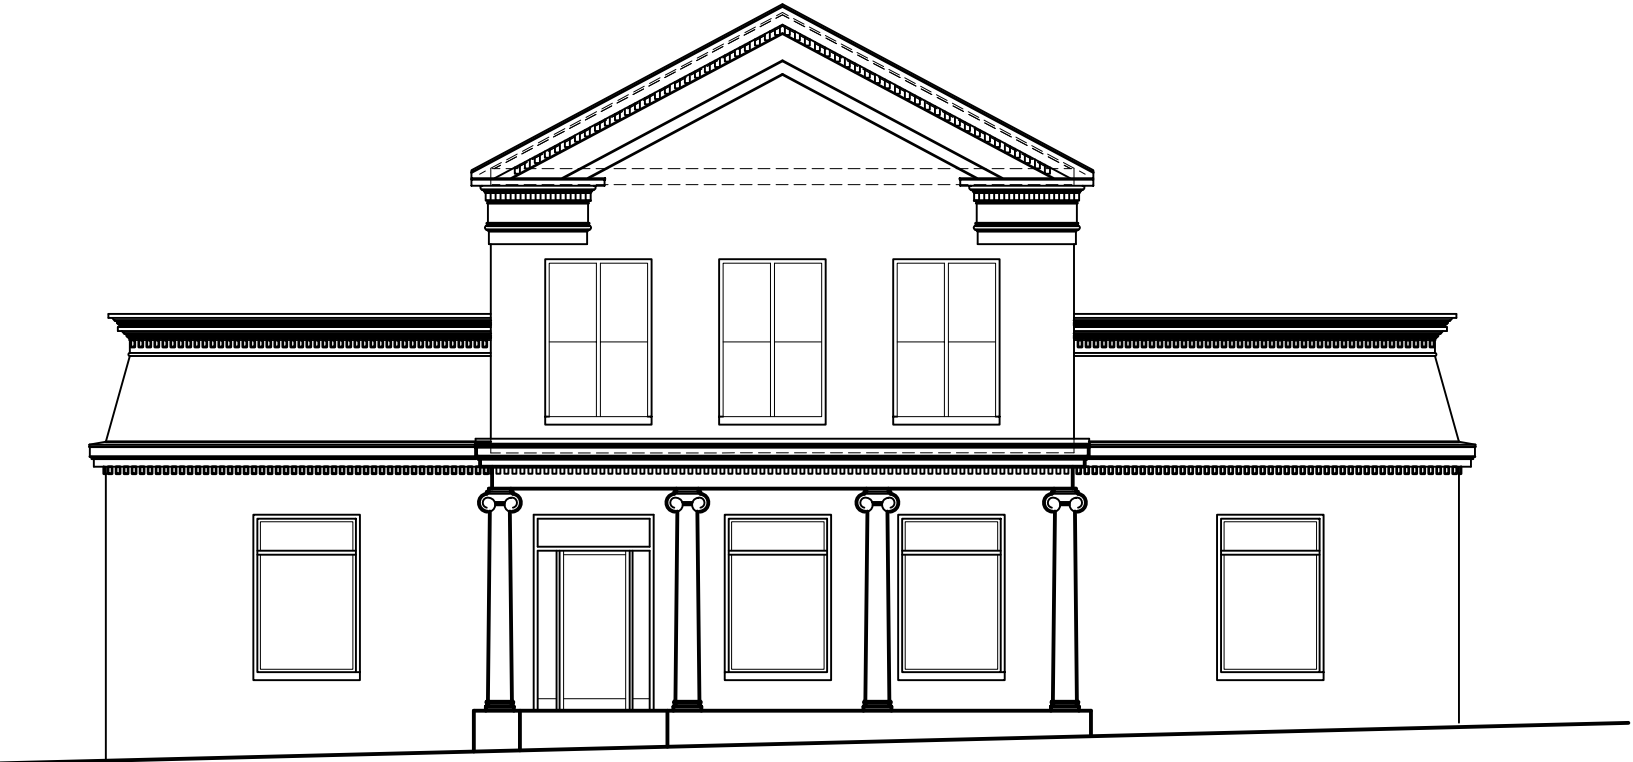
NORTH ELEVATION
Scale: 1/8" = 1'-0"

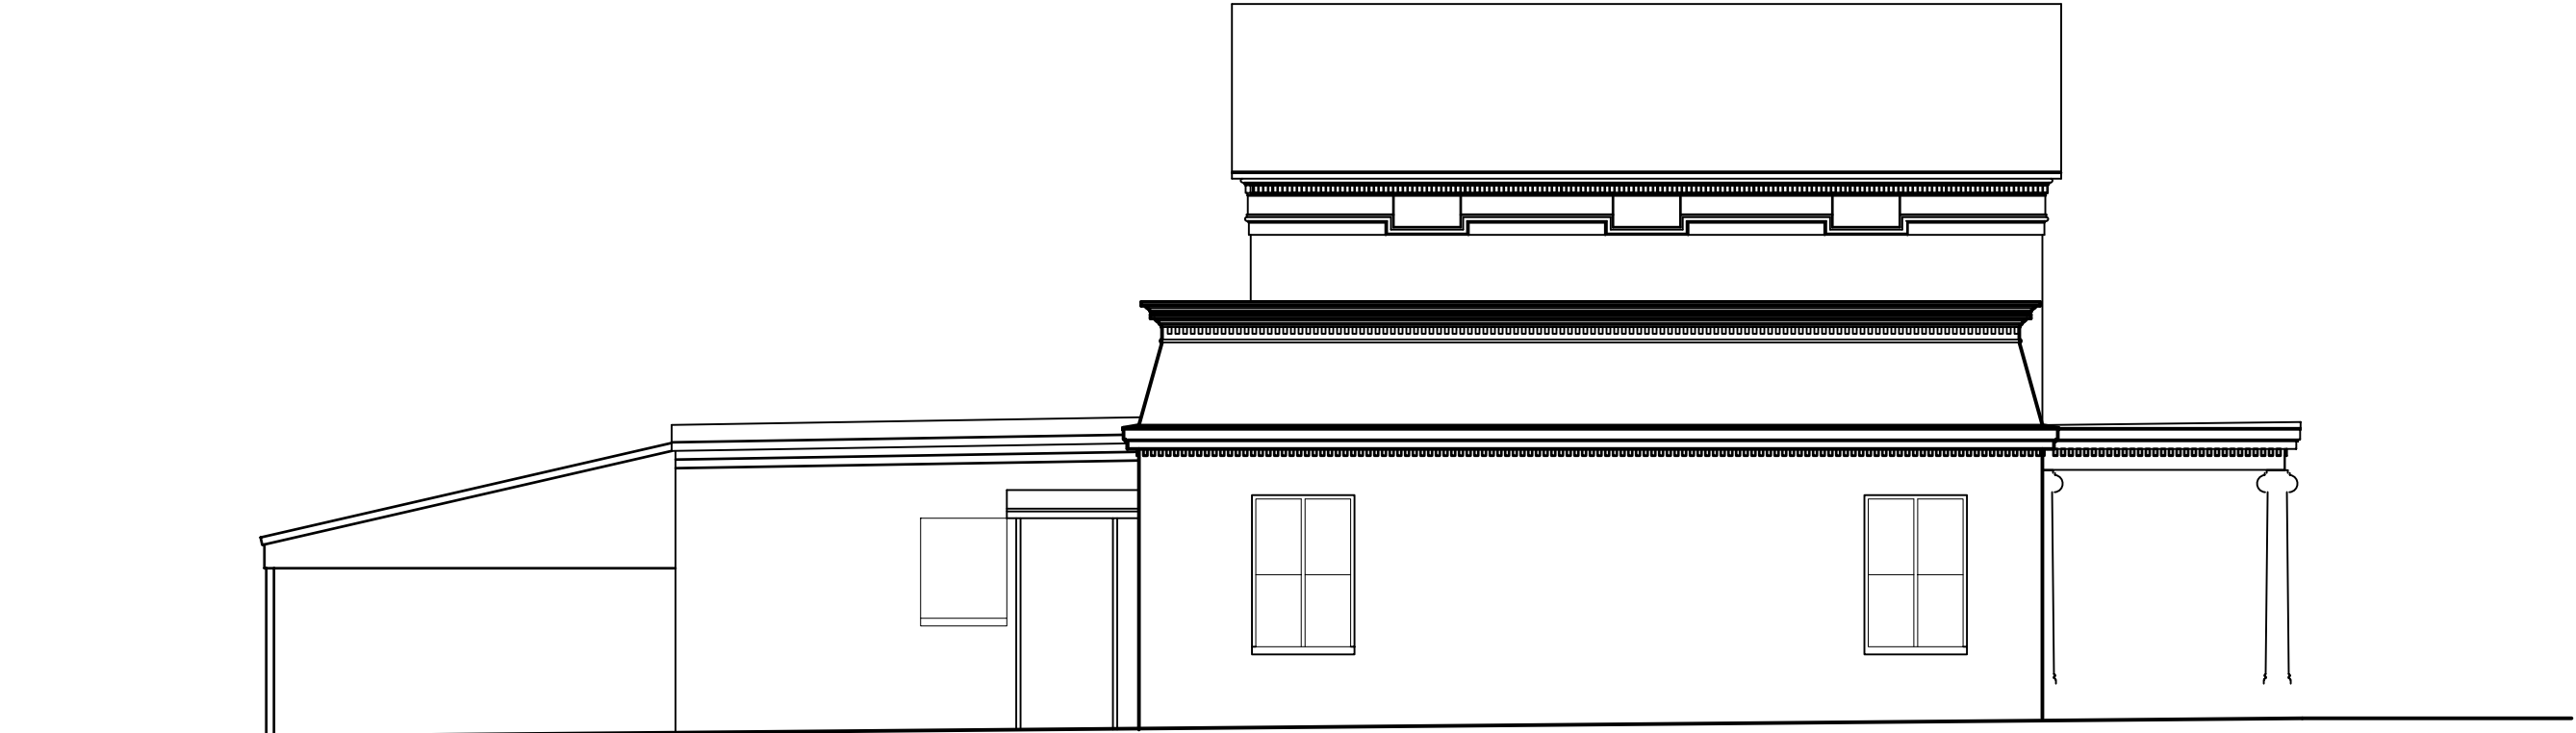
EAST ELEVATION
Scale: 1/8" = 1'-0"

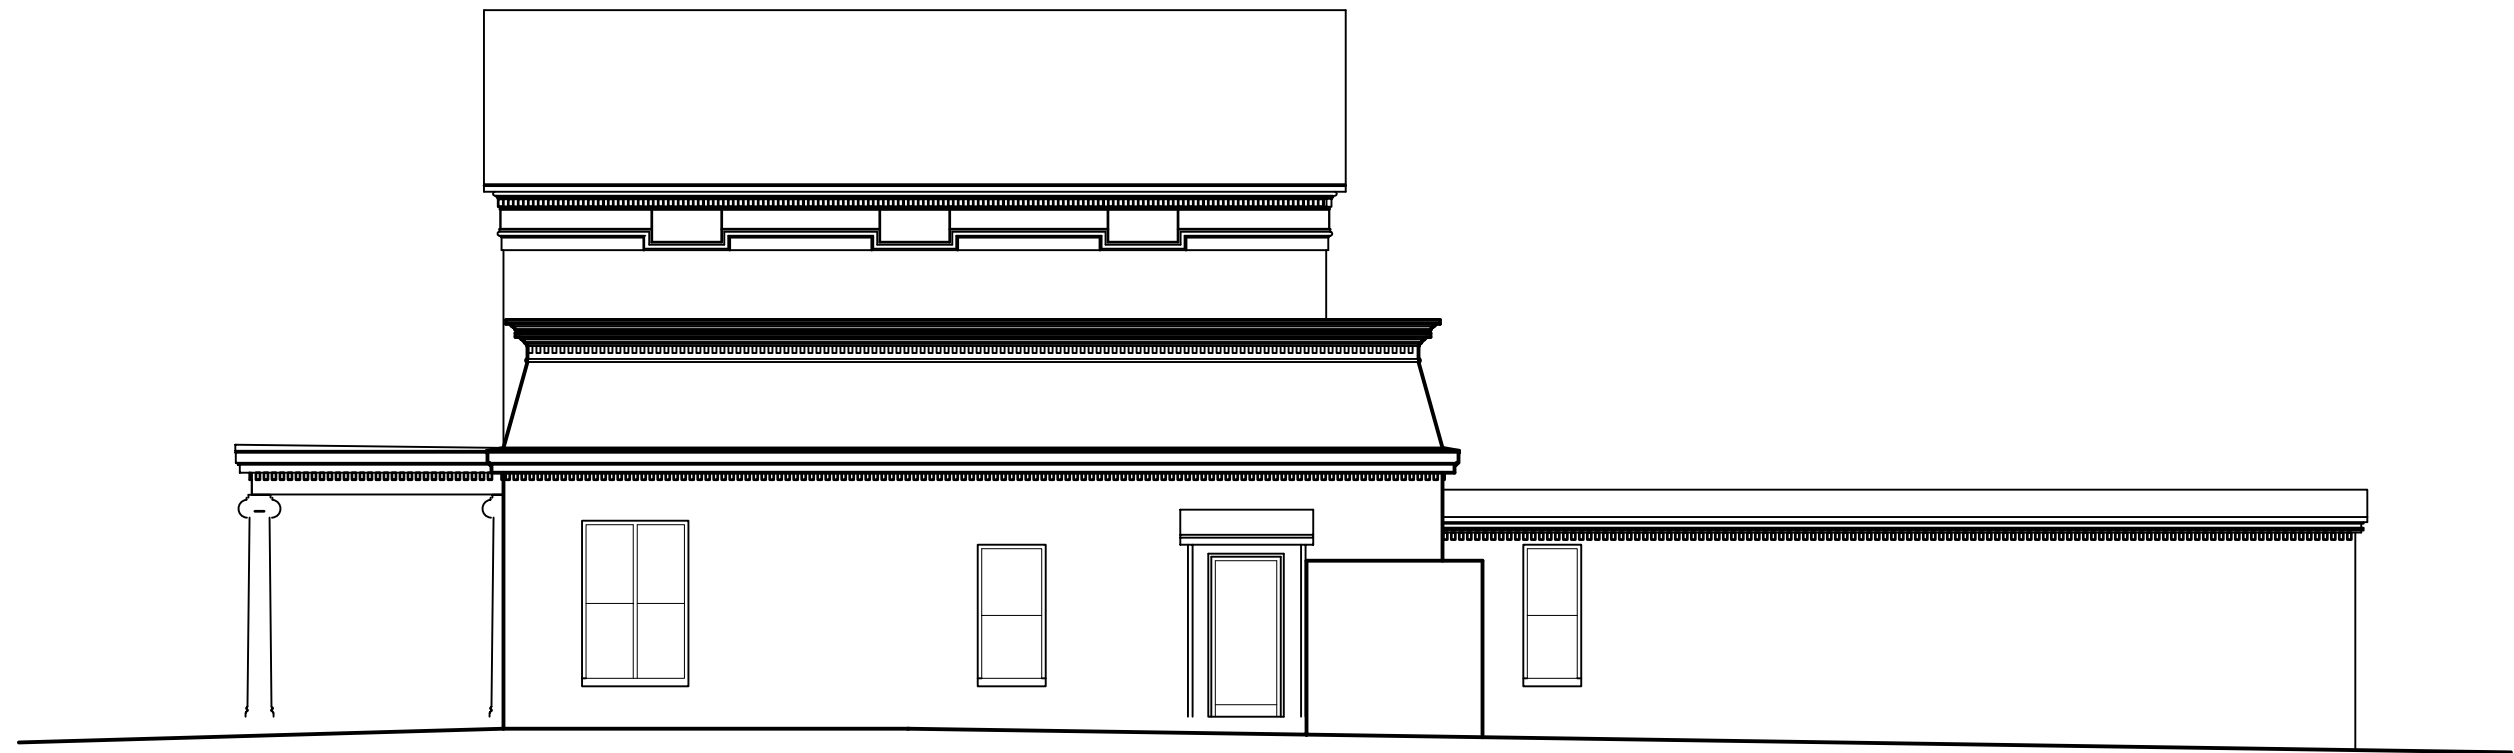
WEST ELEVATION
Scale: 1/8" = 1'-0"

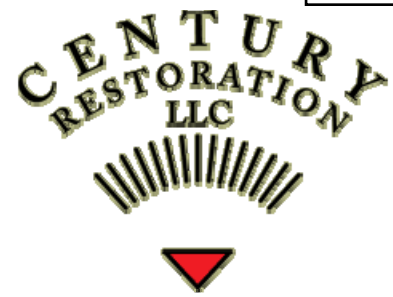
Please refer to Century Restoration LLC's full report for detailed breakdown.

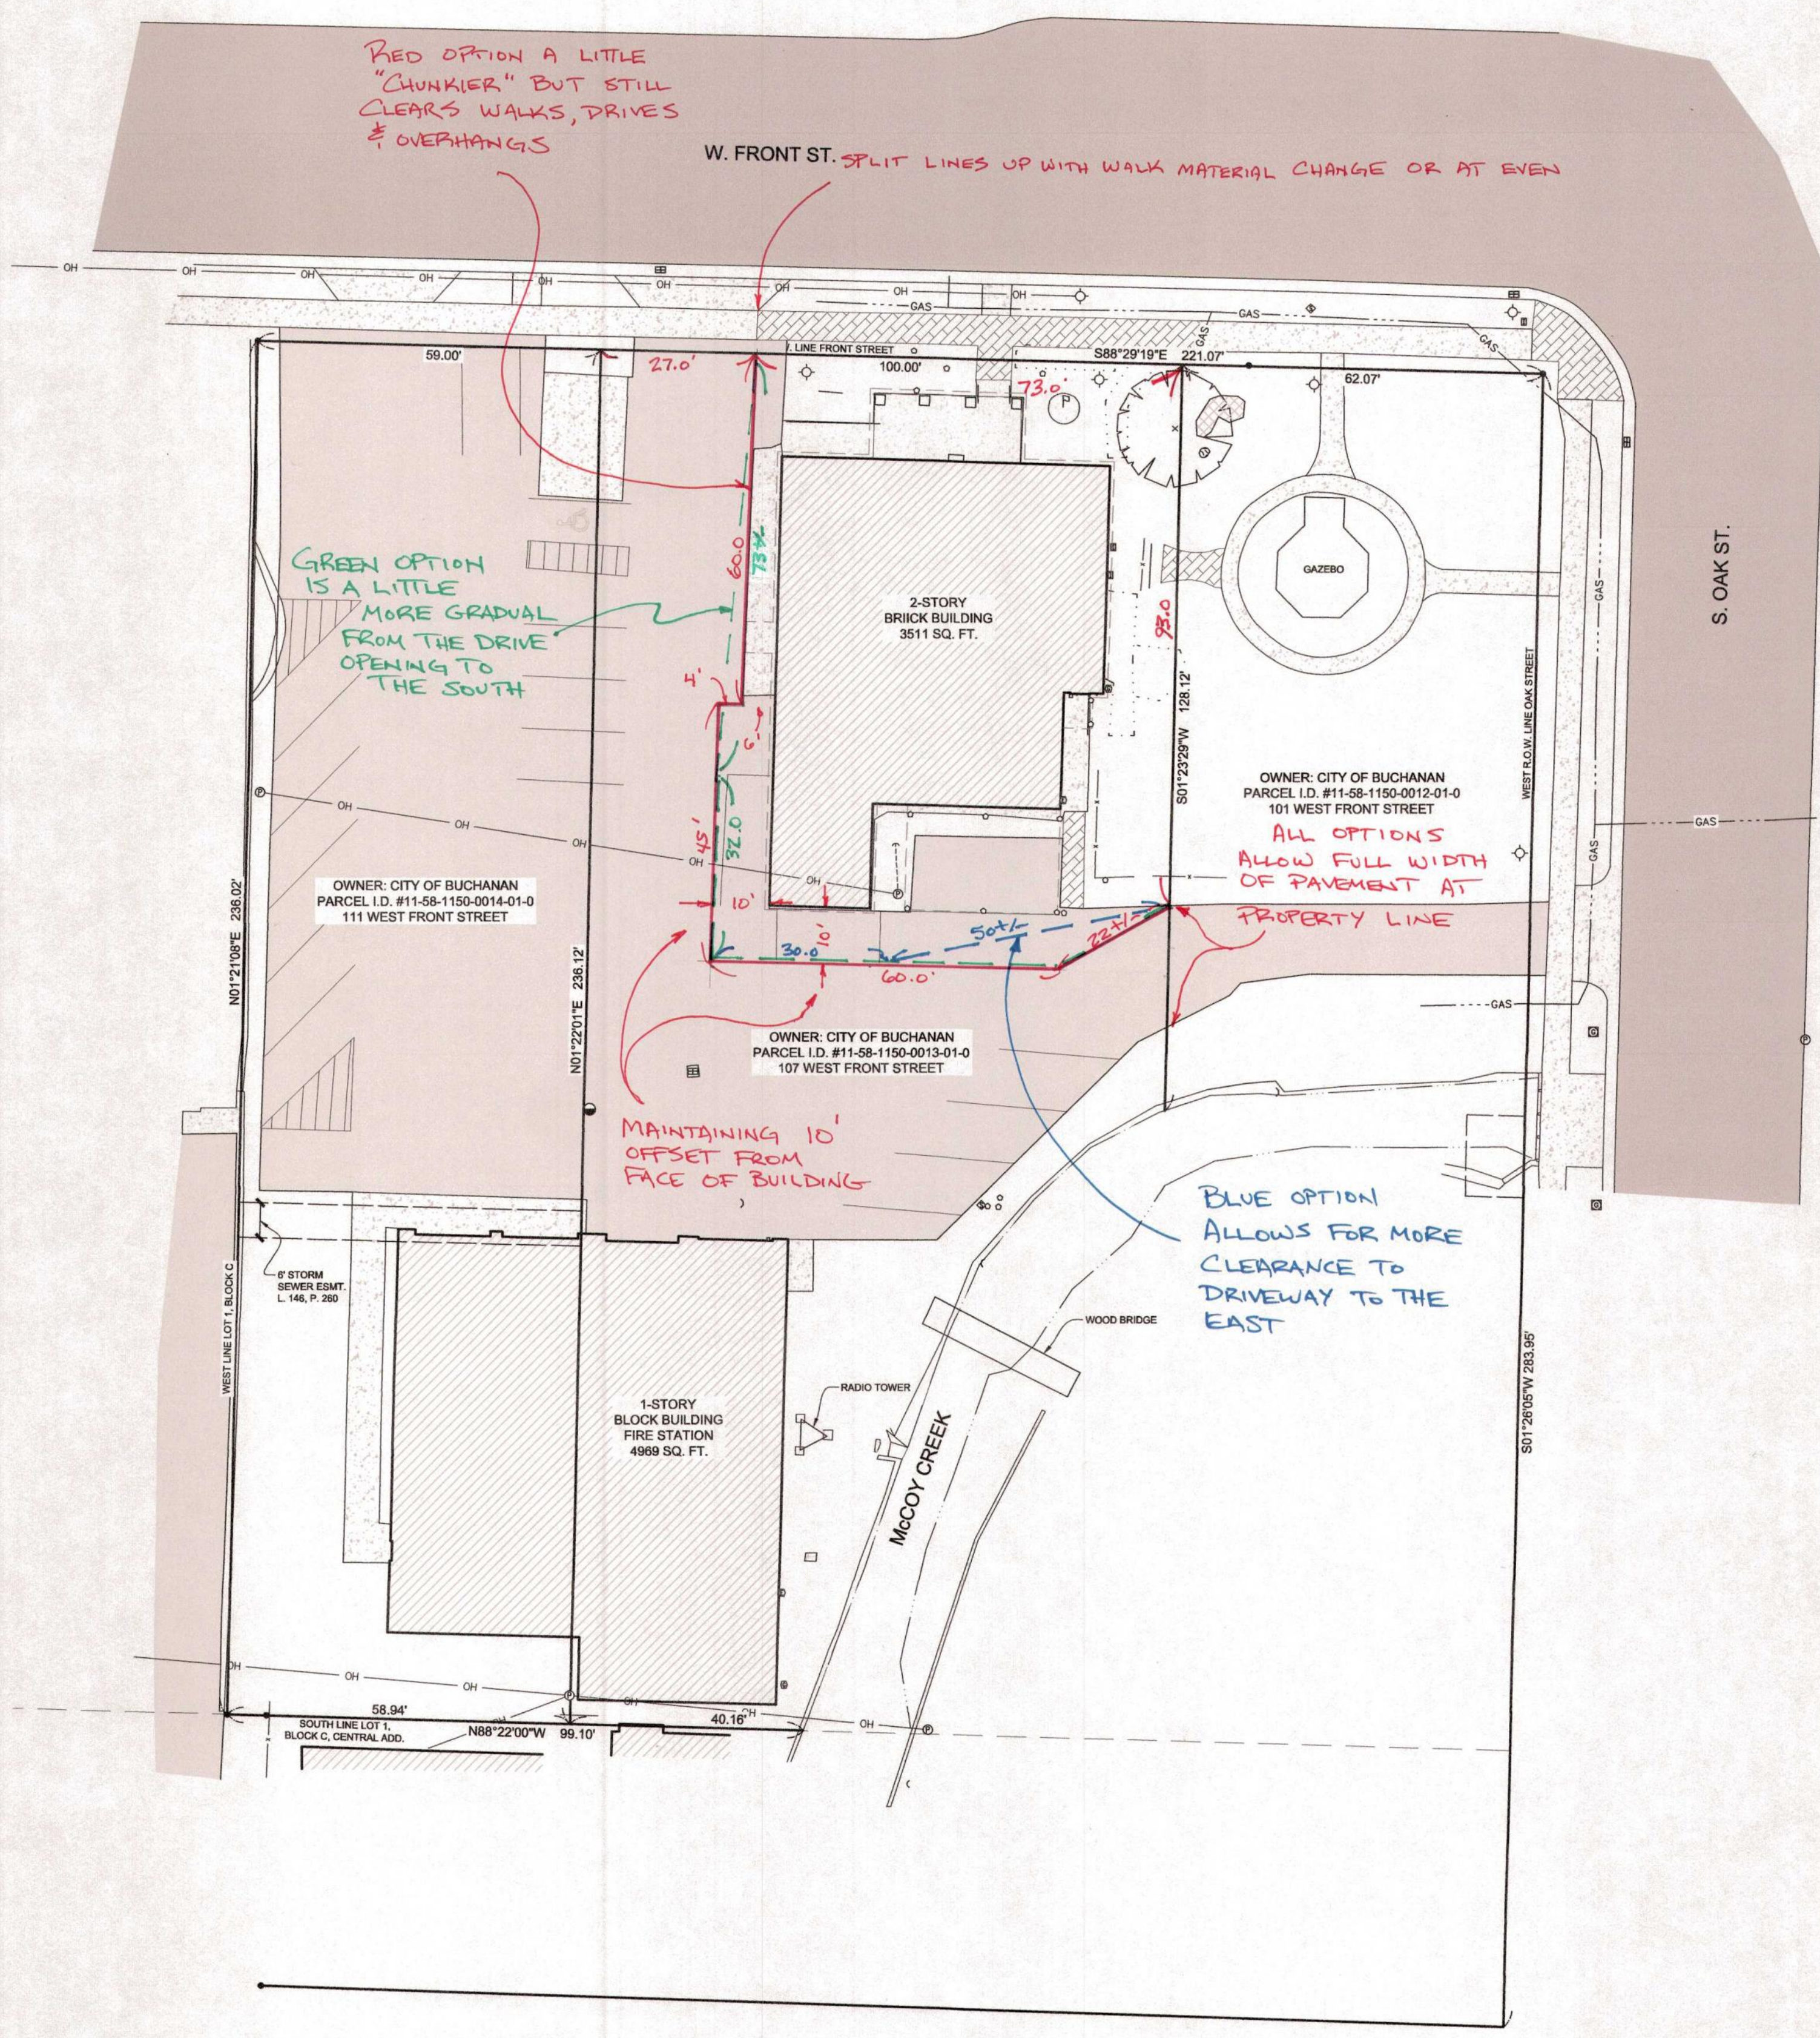
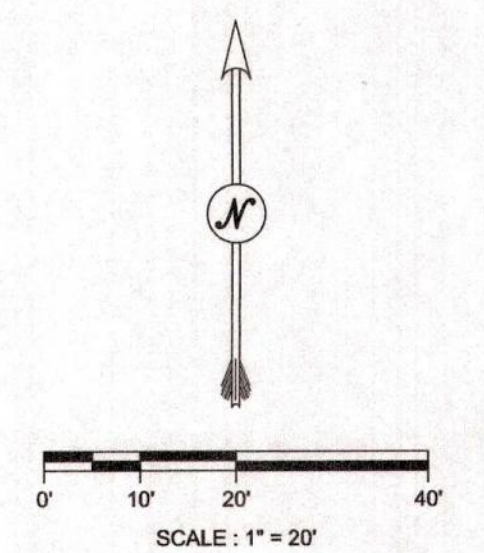
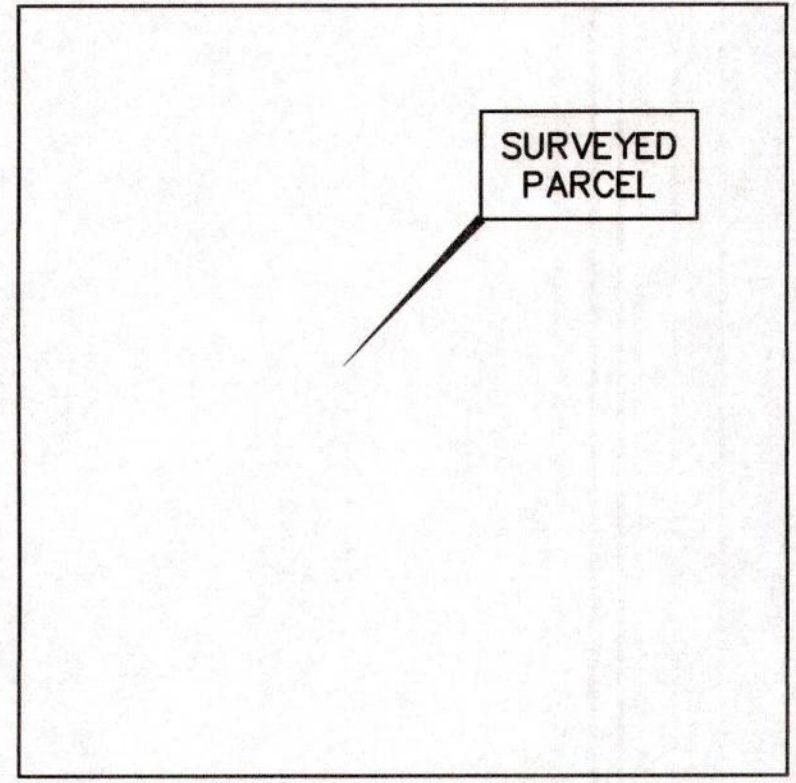
- LEGEND**
- DECIDUOUS TREE
 - ROCK
 - ⊠ FLAG POLE
 - ⊞ IRRIGATION CONTROL BOX
 - ⊕ SIGN
 - ⊞ CATCH BASIN - RECTANGULAR FRAME
 - ⊞ CATCH BASIN - ROUND FRAME
 - ⊞ CULVERT
 - ⊞ LIGHT POLE
 - ⊞ UTILITY POLE
 - ⊞ GUY ANCHOR
 - ⊞ GAS METER
 - ⊞ MARKER - GAS
 - ⊞ POST
 - ⊞ MAILBOX
 - ⊞ FOUND IRON
 - ⊞ HANDICAP PARKING SPACE
 - VEGETATION LINE
 - FENCELINE
 - GAS MAIN
 - BUILDING OVERHEAD
 - EDGE OF WATER
 - ASPHALT
 - CONCRETE
 - BUILDING
 - GRAVEL
 - BRICK WALK
 - LANDSCAPING
