2. Discussion and possible approval of HGA's Add Services Proposal 03 – Existing Precast Plank Repairs Engineering Services

Re:      Dodgeville Public Library Addition and Renovation  
HGA Add Services Proposal 03 – Existing Precast Plank Repairs Engineering Services  
HGA Commission Number: 3757-004-00

**DODGEVILLE  
PUBLIC  
LIBRARY -  
RENOVATION**

**S210**  
© COPYRIGHT HAMMEL, GREEN AND ABRAHAMSON, INC.

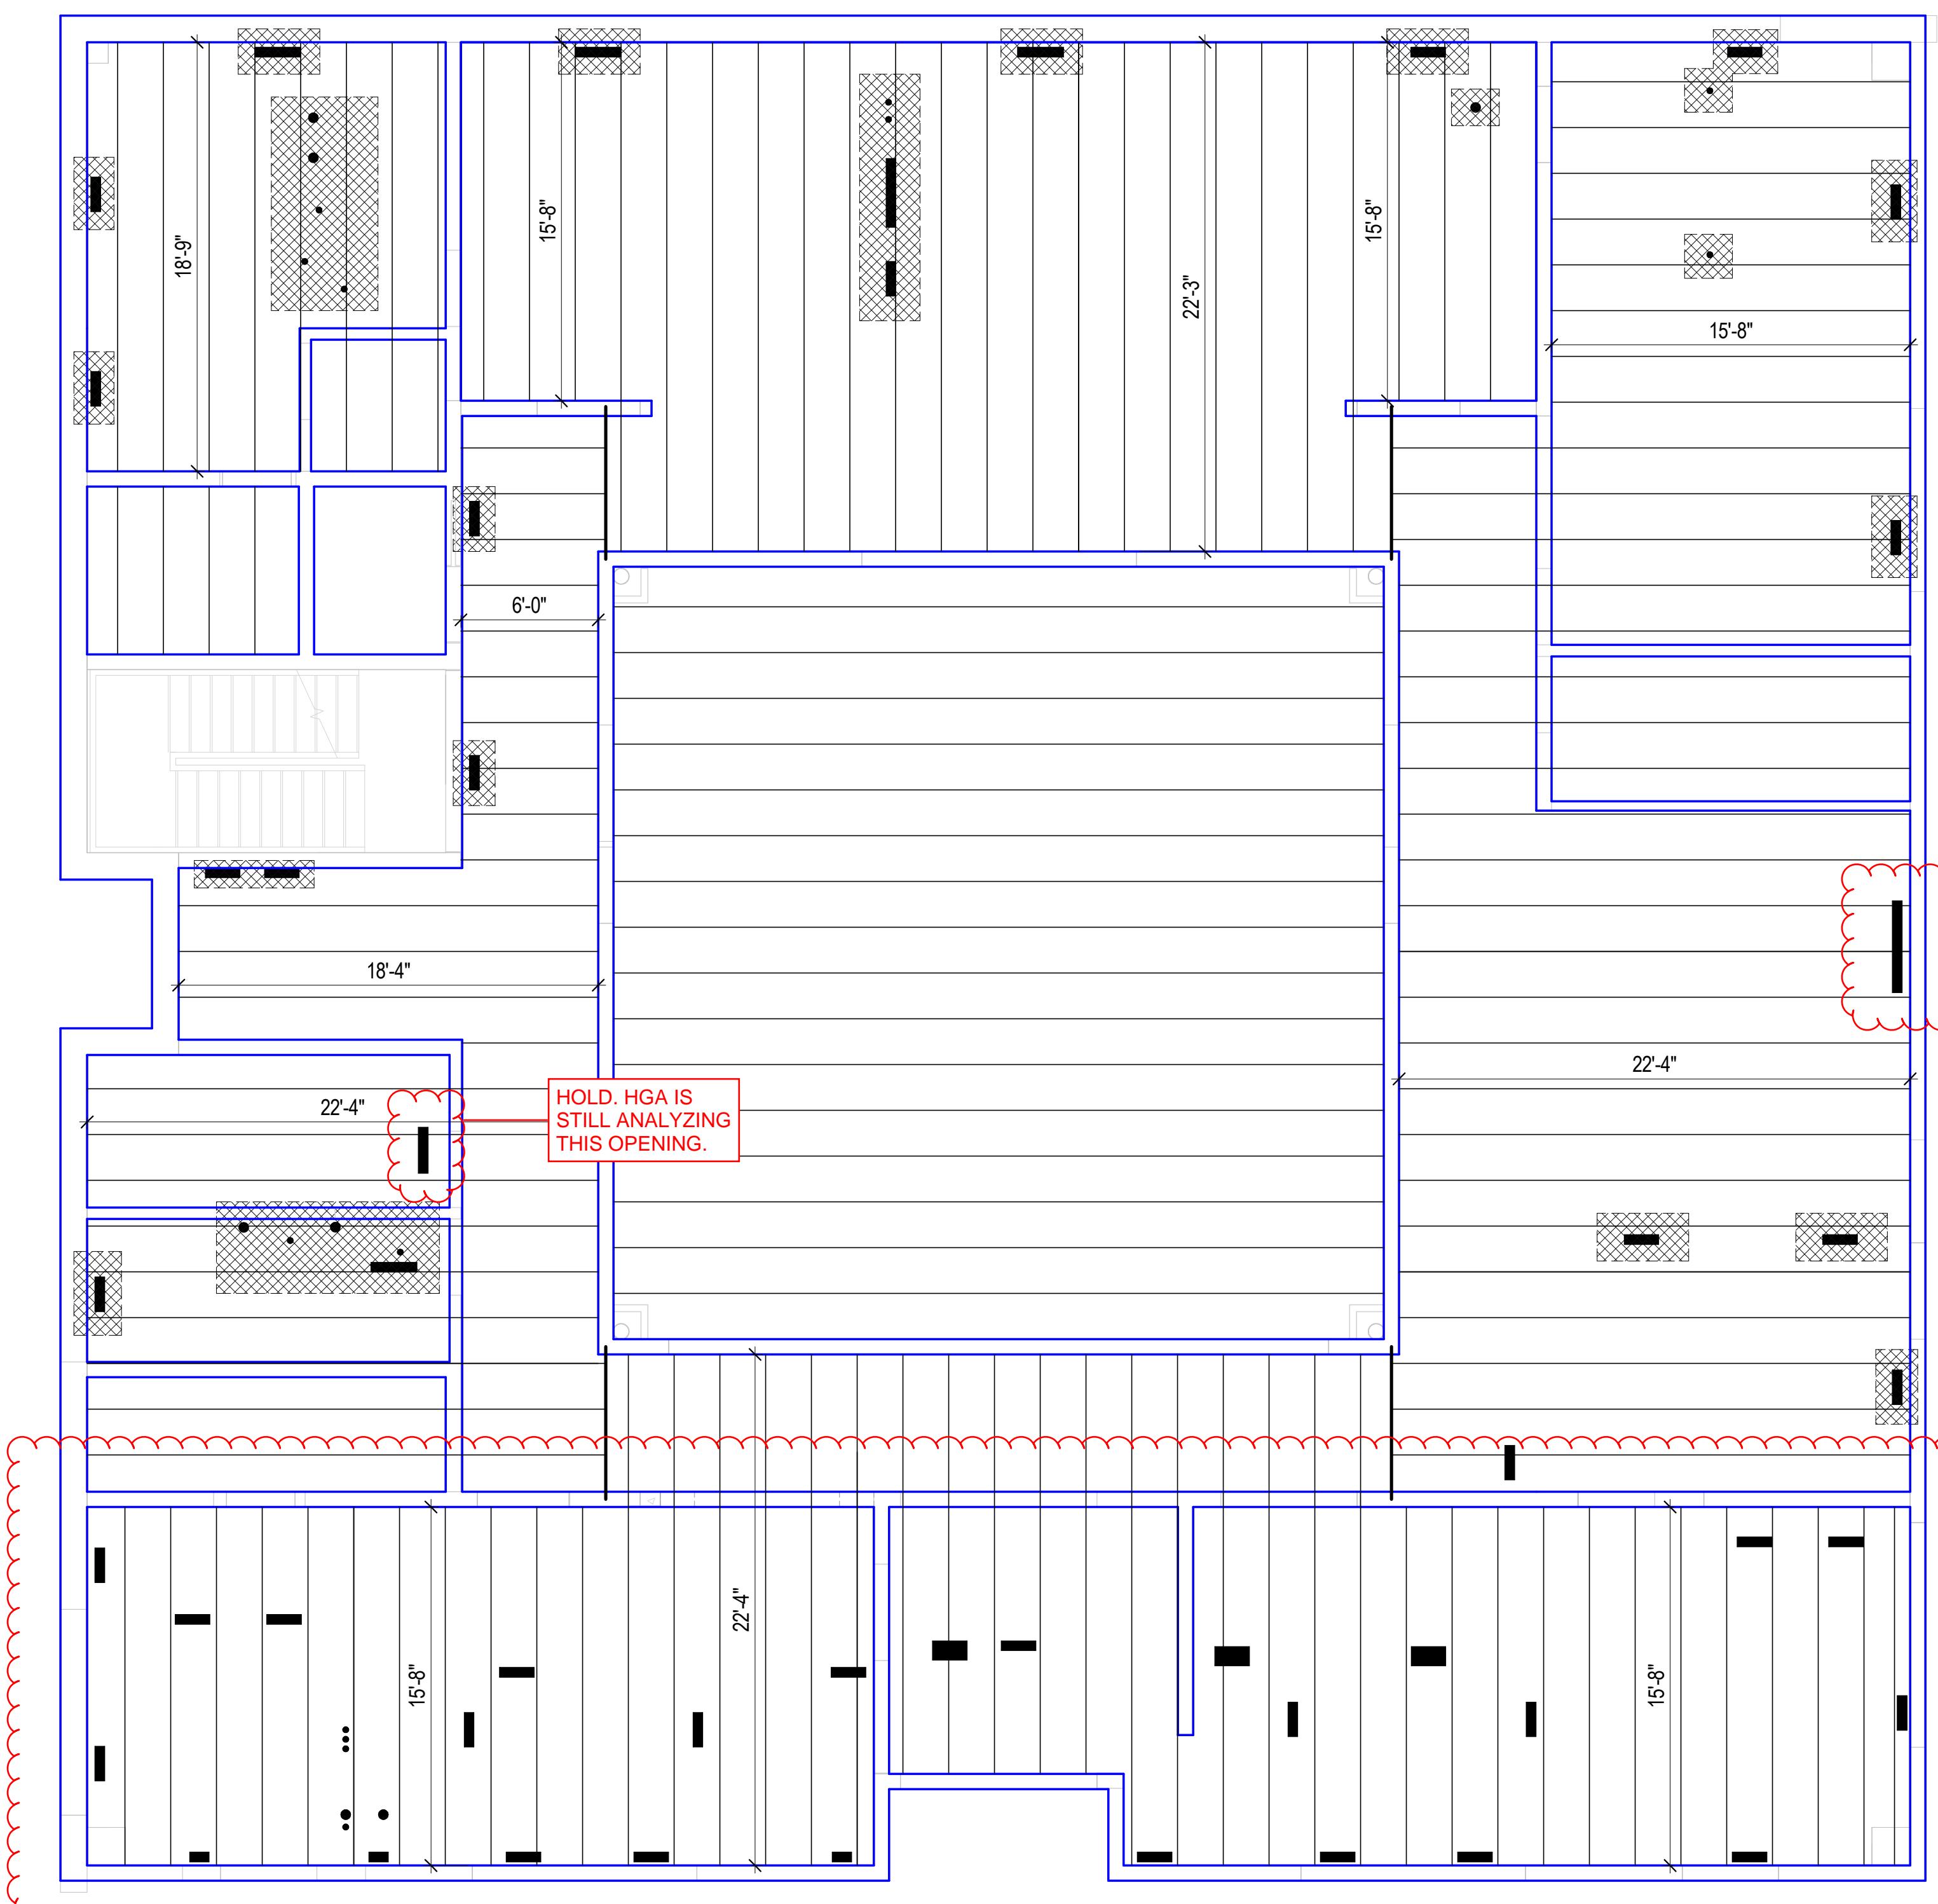
1 EXISTING OPENINGS IN PRECAST PLANK  
3/16" = 1'-0"

As the contractor removed the existing ceiling, chases, ductwork and equipment numerous holes that were cored and cut into the existing precast concrete plank were exposed. HGA Structural Engineer, Ben Shook, visited the job site on December 4, 2025 and documented the size and locations of sixty-nine (69) holes through the existing precast slab, see attached Precast Plank Opening Locations Sketch. This Add Service will provide structural engineering sketches that document the repairs and repairs required to infill, repair or reinforce these plank holes. The Add Service for Existing Precast Plank Repairs Engineering Services will provide the following:

Finding unknown conditions in concealed areas of an existing building are always unfortunate. The smaller holes through the precast plank were able to be addressed with a simple infill detail, however, the larger openings that were cut through the plank compromised the loading capacity of the floor and required an engineered reinforcement solution to meet the requirements for library floor loading.

- OPENINGS IN EXISTING PRECAST PLANK ARE SHOWN BY ■■■■■
- AYOUT OF EXISTING PRECAST PLANK IS APPROXIMATE. VERIFY IN FIELD.
- SIZE AND LOCATION OF EXISTING OPENINGS ARE APPROXIMATE. VERIFY IN FIELD.
- OPENINGS IDENTIFIED BY ■■■■■ REQUIRE NO STRUCTURAL MODIFICATIONS AND CAN BE INFILLED USING DETAIL S210 (OR LEFT OPEN IF THEY ARE BEING USED FOR CURRENT MEP PIPING OR CONDUITS).
