Subject: Notice of Noncompliance (NON) resulting from site visit for the closed CE Land Landfill located at 512 East Ann Street, City of Kaukauna, Outagamie County, Wisconsin, DNR License No. 0073

COMPLIANCE MONITORING
AND EVALUATION FORM

SITE PHOTOS

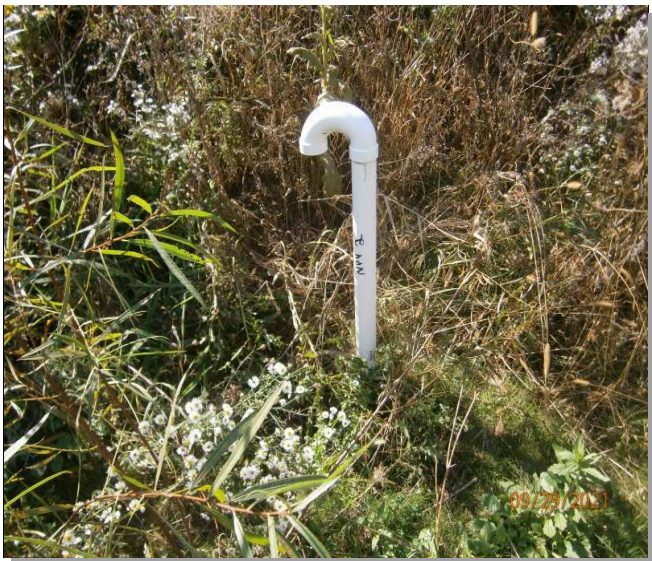
Photo # 82601 Photo 1 of 10

Photo Description
example of passive gas vent

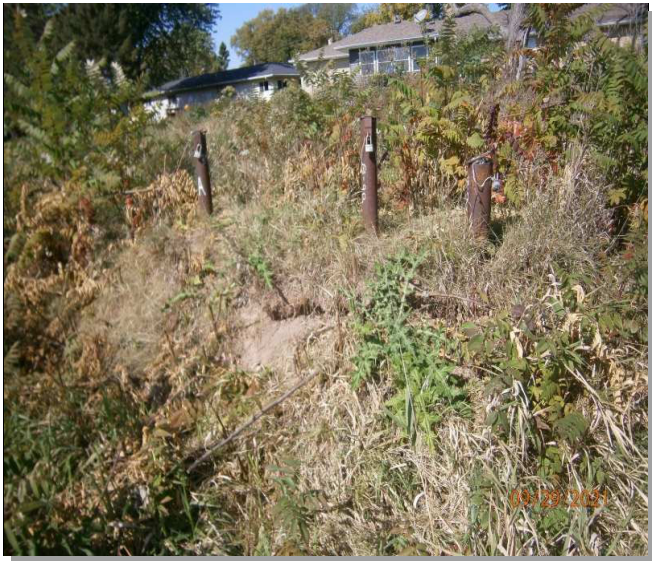
Photo # 82602 Photo 2 of 10

Photo Description
example of monitoring wells that are locked, labeled, and secured

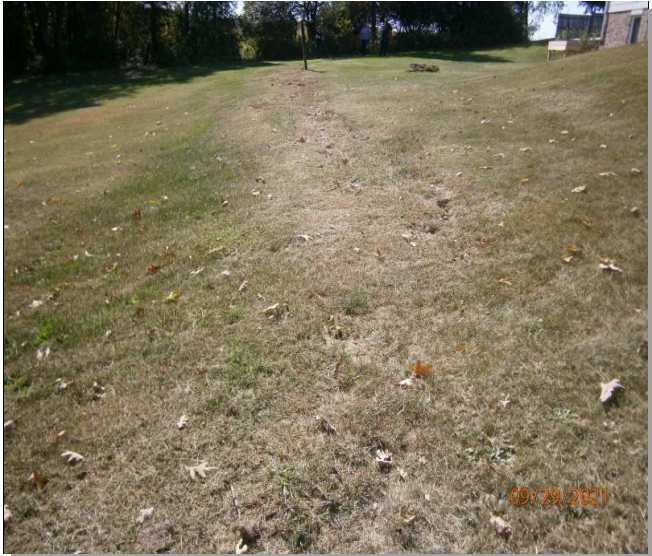
Photo # 82603 Photo 3 of 10

| E. The finished surface of the disposal area is covered with a minimum of 6 inches of topsoil. Verhagen trench appears to be lacking vegetation along trench line (on the Vantoll/Armstrong property); it is unclear if the area is lacking topsoil or if there is a gas migration issue; additional follow up is needed | CA | 506.08(3)(d) |

Photo Description
Area lacking vegetation on area where gas cut-off trench is located on Vantoll/Armstrong property

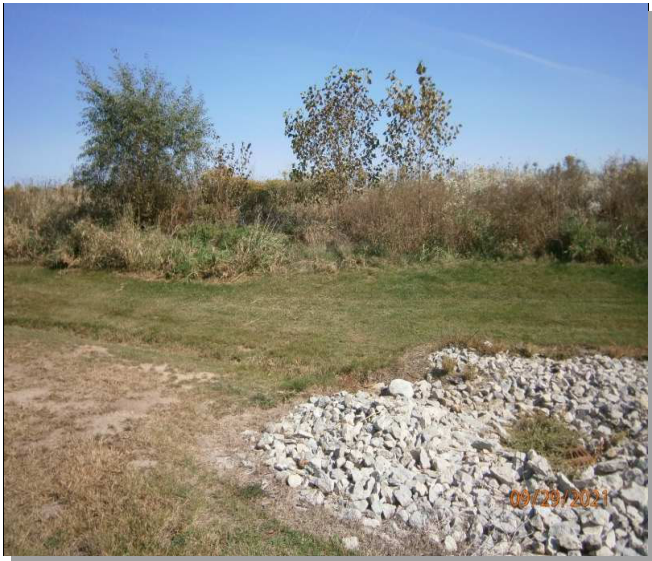
SITE PHOTOS

2. Section NR 506.08(4), Wis. Adm. Code, requires vegetation approved by the department. During the inspection, woody vegetation was noted growing on the final cover area of disposed waste along the southwestern perimeter berm of the landfill along the Coffee Hill condo development.

| F. Vegetation established to minimize erosion (e.g. no bare spots or woody vegetation). areas on the western portion and on top of the perimeter berm have new growth trees that need to be cut to ground level and steps taken to prevent new tree growth; remaining areas with woody vegetation have DNR approval and these areas include the Kaukauna preserve area; Laur portion; and Vantoll/Armstrong private property - in these areas, tree health should be monitored and dying trees should be cut to ground level | X | 506.08(4) |

Photo Description
CE Land new tree growth; example of woody vegetation on perimeter berm along condo association side

Action needed: On the perimeter berm, please cut woody vegetation to ground level so as not to disturb the berm material and in-place waste, add at least 2-feet of compacted earth and at least 6-inches of topsoil, seed, fertilize, and mulch the finished surface. Unless otherwise approved by the department in writing, seed mixtures and sowing rates shall be those specified for right-of-ways in accordance with section 630, Wisconsin Department of Transportation standard specifications for highway and structure construction.

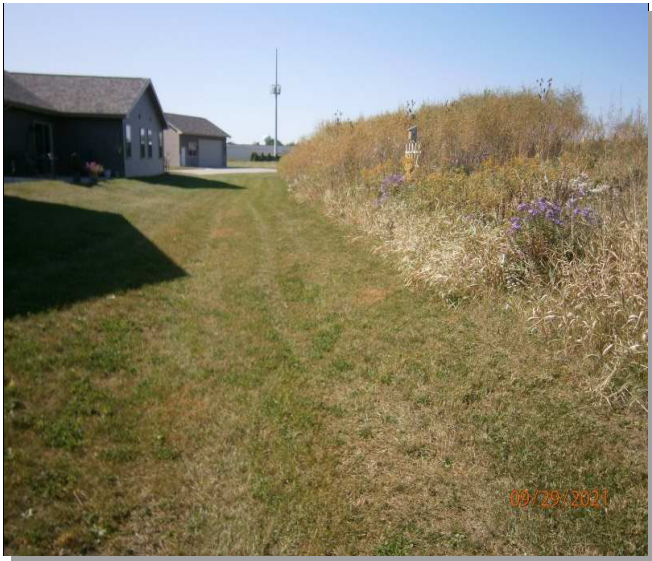
Photo # 82609 Photo 9 of 10
Photo Date & Time 09/29/2021 00:00
Photo Direction W
Photographer HRONEK, SALLY

Photo Description
Condo side slope with willow tree growth; no stressed vegetation in lawn area
