### STORMWATER BOARD REGULAR MEETING AGENDA

Wednesday, May 22, 2019  
3:30 PM

**Item:** Creekwood Cove [1271-1331] & Cottonwood Cove [342-307]. Eleven lots impacted.

**Item:** 920 Lauren Kay Court

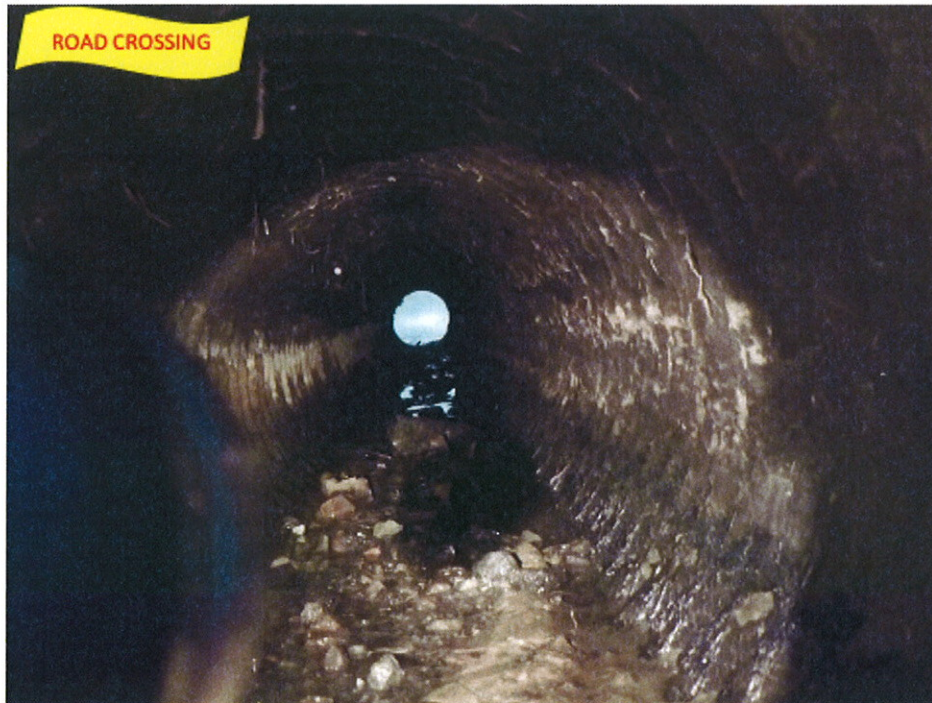
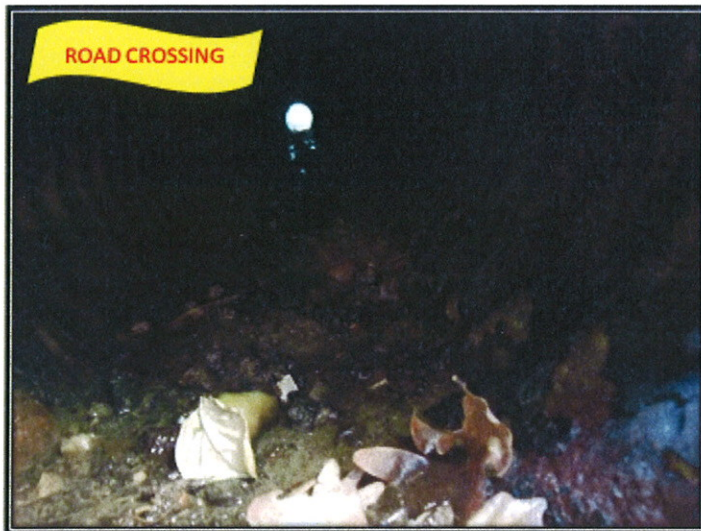
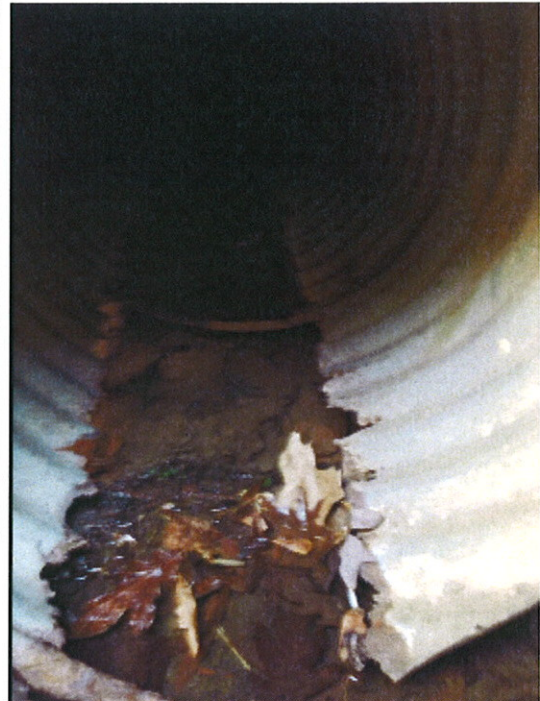
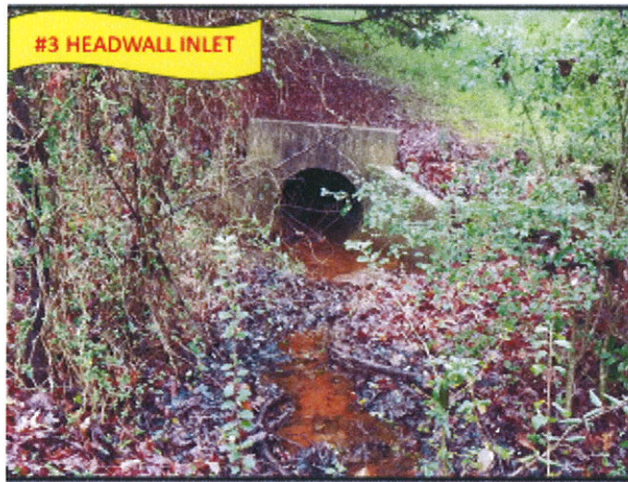
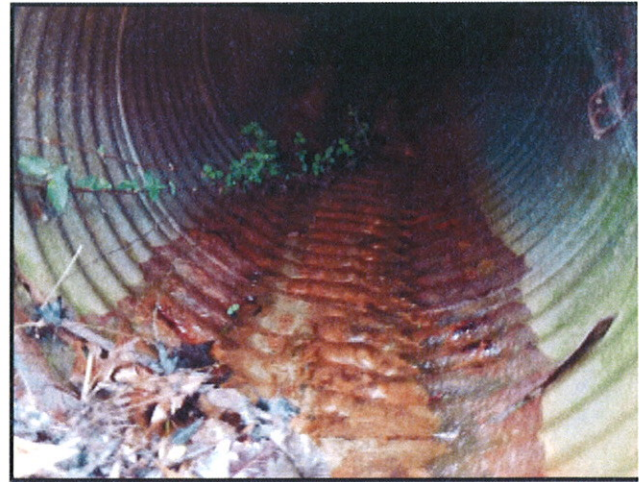
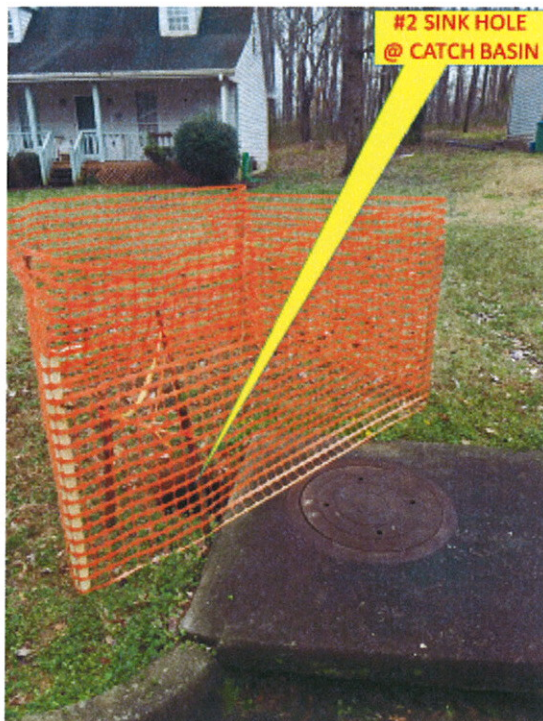
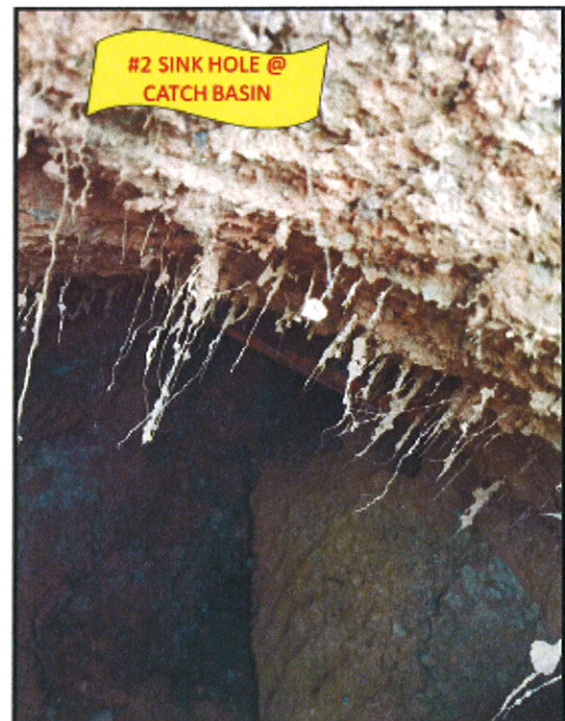
PICTURES TAKEN:

**Summary:** Developer of St. Lawrence Plantation piped a ditch along the front of eleven lots in Unit One and Unit Two of the subdivision. Street drainage was tied into the longitudinal pipe at two locations. The original pipes are rusted out and in need of replacing.

CB #1- 18" CMP pipe TO CB #2 (downstream) (32') street crossing

- 1) Pipe seems rushed out, debris in pipe.
- 2) Joints are poor but No infiltration.

- 3) 2 x black 6" roof drain pipes is coming into CB # 2 and is poorly grouted in.  
This is where the sinkhole is and complain from the owner.
- 4) CB # needs re-grouting and inverts

**CB # 2- 24" CMP pipe TO JB # 4 (downstream) (33.5')**

- 1) Pipe bottom completely rusted out, debris and boulders in pipe, water infiltration from the bottom into the pipe.
- 2) Joints are OK and No infiltration.
- 3) **JB #4** needs invert & grouting.
- 4) Outgoing pipe CMP 42" rusted out at the bottom and needs replacement.
- 5) Incoming 30" CMP pipe from **Headwall # 3** to **JB #4** is completely rusted out at the bottom and needs replacement.

**JB # 4 - 30" CMP pipe TO HW # 3 (upstream) (Total length 238')**

- 1) Pipe rusted out, debris and boulders in pipe- water flow constantly through the pipe.
- 2) At 22' pipe oval shape with low spot holding water.
- 3) Pipe low at some places with about 4"-6" standing water in pipe.
- 4) At 40' pipe separation – elevation dropped about 6" Joints are very bad with infiltration at the joint.
- 5) Headwall in fair shape.

**JB # 4 - 42" CMP pipe TO MH # 5 (downstream) (Total length 205')**

- 1) Pipe bottom completely rusted out, debris and boulders in pipe- water flow constantly through the pipe. From 0' to end Joints very bad with infiltration at about every joint.
- 2) Start from 18' on- big boulders in pipe.
- 3) At 60' pipe oval shape – low spot with lots of gravel & big boulders, bottom completely rusted out.

- 4) **MH #5** in fair shape, needs invert pour.

**MH # 6 - 48" CMP pipe TO MH # 5(upstream) (Total length 221')**

- 1) 6" Pipe black roof drain squeezed in to the MH #6.
- 2) Pipe bottom completely rushed out, debris and boulders in pipe- water flow constantly though the pipe.
- 3) At 117' very bad joint pipe damage with no infiltration.
- 4) From 120' to 160' pipe completely crushed in about 60%.
- 5) From 180' to 190' major damage to the roof of the pipe during construction pipe crushed in about 20%.
- 6) Pipe low at some places with about 3"-6" standing water in pipe
- 7) Pipe has an oval shape at places.
- 8) Joints are very bad with infiltration.
- 9) Joints are damage during construction and in very bad shape.
- 10) **MH #6** in fair shape, needs invert pour and re-grout.

**MH # 6 - 48" CMP pipe TO MH# 7 (178') (downstream)**

- 1) Pipe bottom rusted out.
- 2) At 17' Pipe damage at the roof.
- 3) At 65' Pipe damage at the roof.
- 4) Joints are bad with minor infiltration.
- 5) Joints are damage during construction.
- 6) **MH #7** in fair condition needs invert, grouting & cleanout.

**JB # 8 - 48" CMP pipe TO MH# 7 (194') (downstream)**

- 1) From 0' to 8' big boulders in pipe.
- 2) At 37' – 67' pipe damage at the roof 20%.

- 3) Joints are bad with minor infiltration.
- 4) Pipe bottom looks good.
- 5) No debris after 10' and - water flow constantly through the pipe.
- 6) From 92' to 130' bottom rusted out, bad joints, damage pipe during construction, big boulders and pipe sagging and low spot holds water.
- 7) At the MH #7 a 6" black roof drain pipe is inserted in the pre-cast structure from the right side.
- 8) **MH #7** in fair condition needs invert , grouting & cleanout-

**JB # 8 - 54" CMP pipe TO HW # 9 (84') (downstream)**

- 1) Pipe bottom rusted out no debris in pipe.
- 2) Joints are bad all the way to the outfall with roots infiltration, joints were damaged during construction.
- 3) Pipe in fair condition from 10' to End.
- 4) Sand & gravel about 6" thick close to the outfall

**CB # 10 - 18" CMP pipe TO MH # 11 (70') (downstream)**

- 1) Pipe bottom look good no debris in pipe.
- 2) Joints looks OK with minor infiltration.
- 3) Pipe sag 15% from 40' to End **MH #11** with 4" standing water in it.

- To table this project at the next storm water utility meeting for discussion after we have all the info from the CCTV inspection report on this entire system.
  - To request Engineering Dep. to send out bids to repair AFTER CCTV inspection were done and determine the total scope of work & cost est. to replace the deteriorated storm pipe system.
-

(REPLACE WITH 18" RCP)

**(REPLACE WITH 24" HDPE)**

**(REPLACE WITH 30" HDPE)**

**(REPLACE WITH 42" HDPE)**

**(REPLACE WITH 48" HDPE)**

**(REPLACE WITH 18" HDPE)**

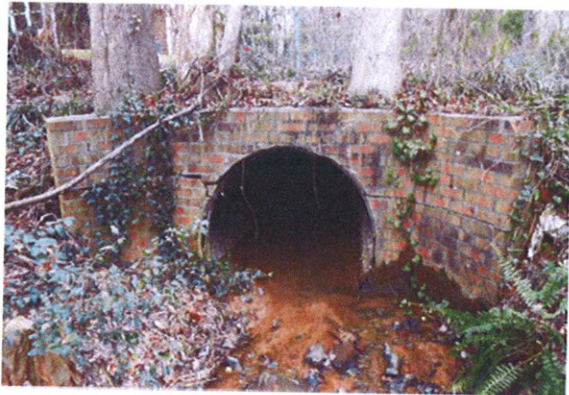
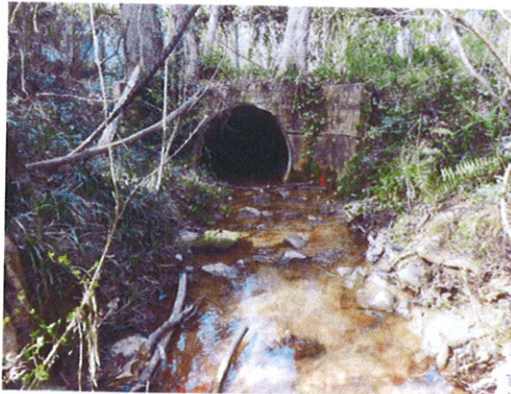
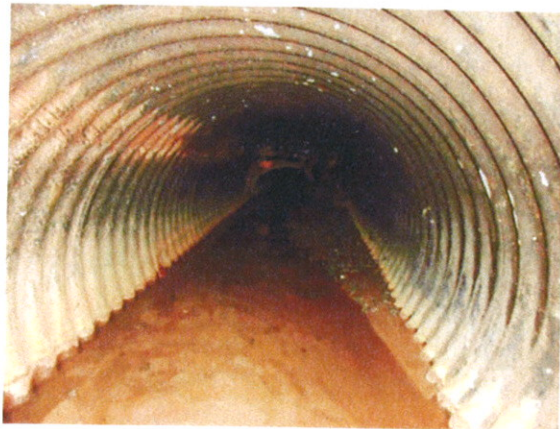
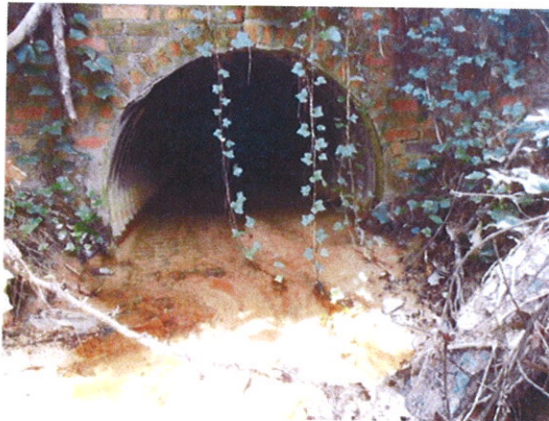
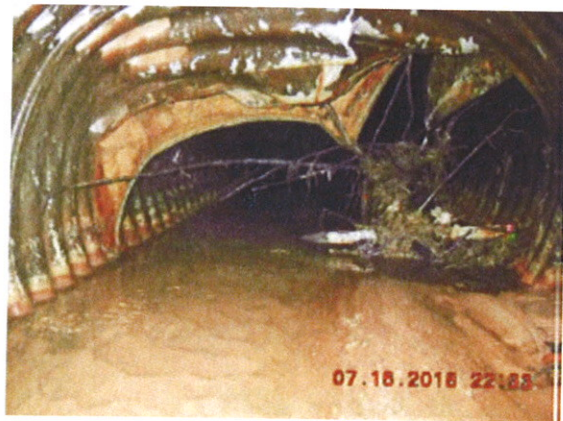
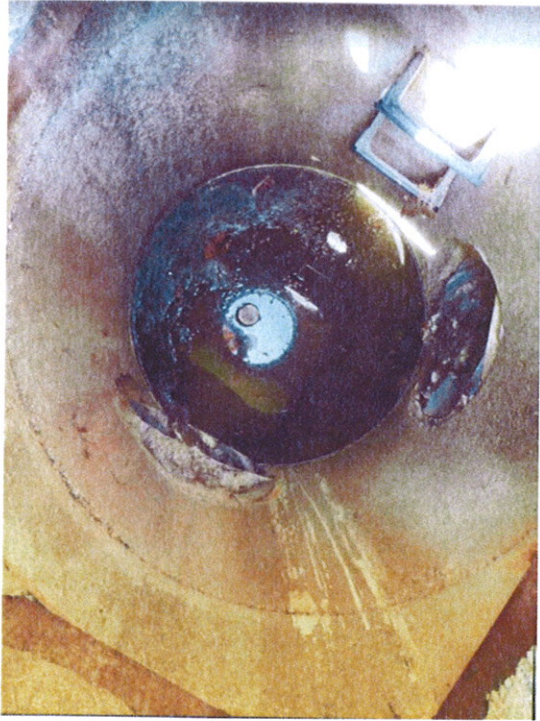
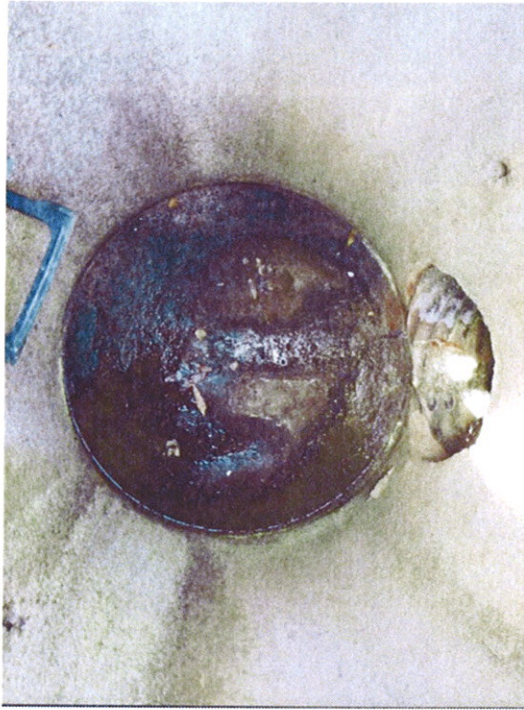
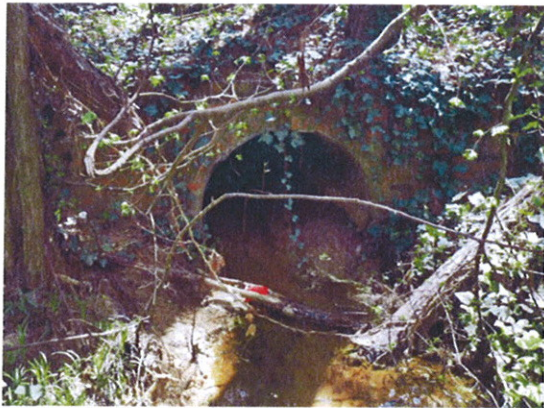
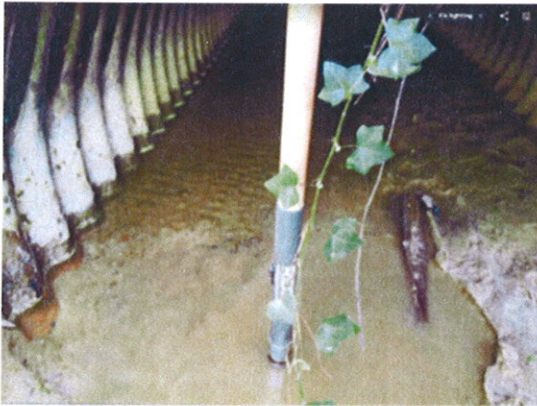
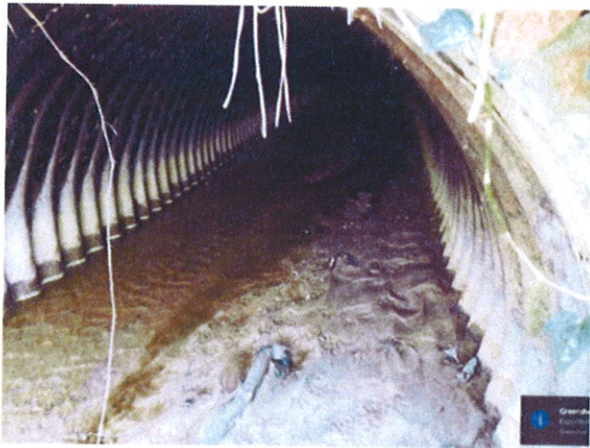
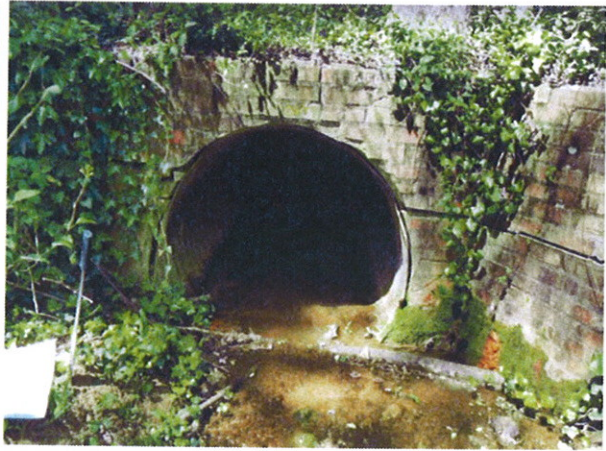
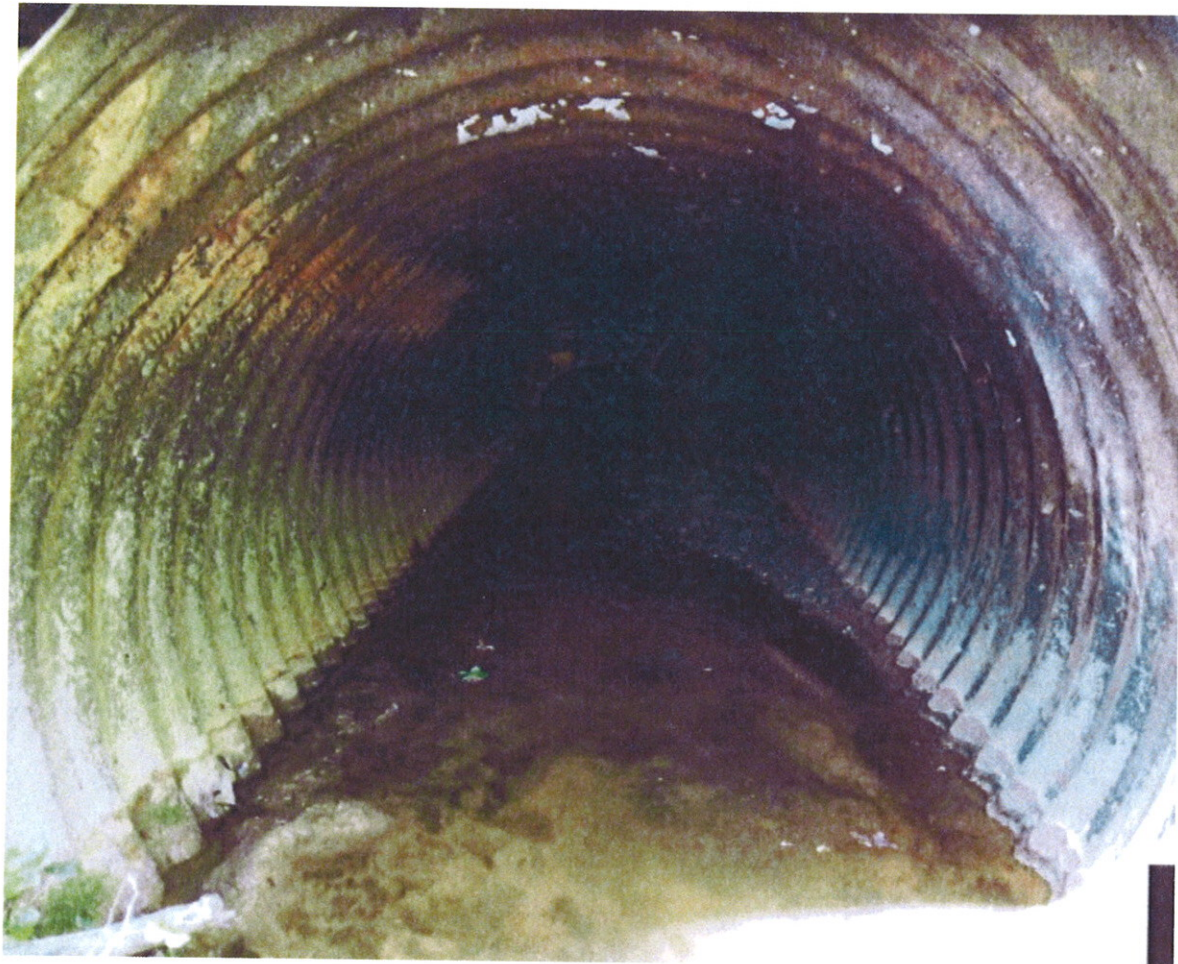
**PICTURES TAKEN:**

**Summary:** Quick overview – 260' of CMP which includes two headwalls and one JB is rusted out and failing.  
Replace with 210' of HDPE out of street, 50' of RCP under street and two JB's; one at each end of the RCP.  
Estimated cost \$100,000.00
