## **HISTORICAL COMMISSION SPECIAL MEETING AGENDA**

**7:00 PM - Monday, August 08, 2022**

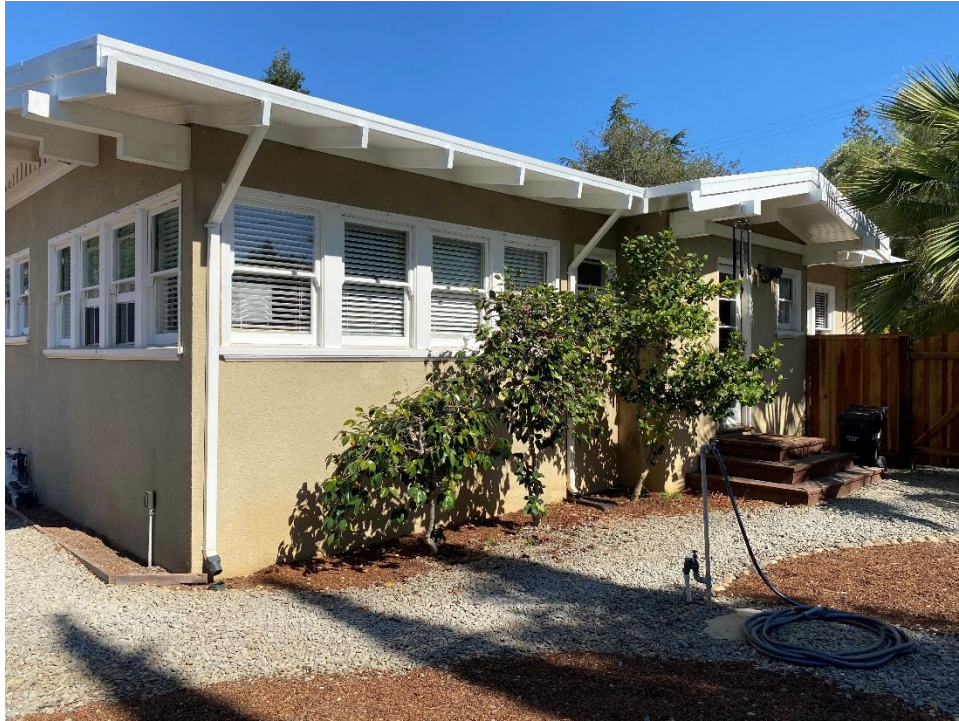
**Figure 31. West elevation, facing southeast.**

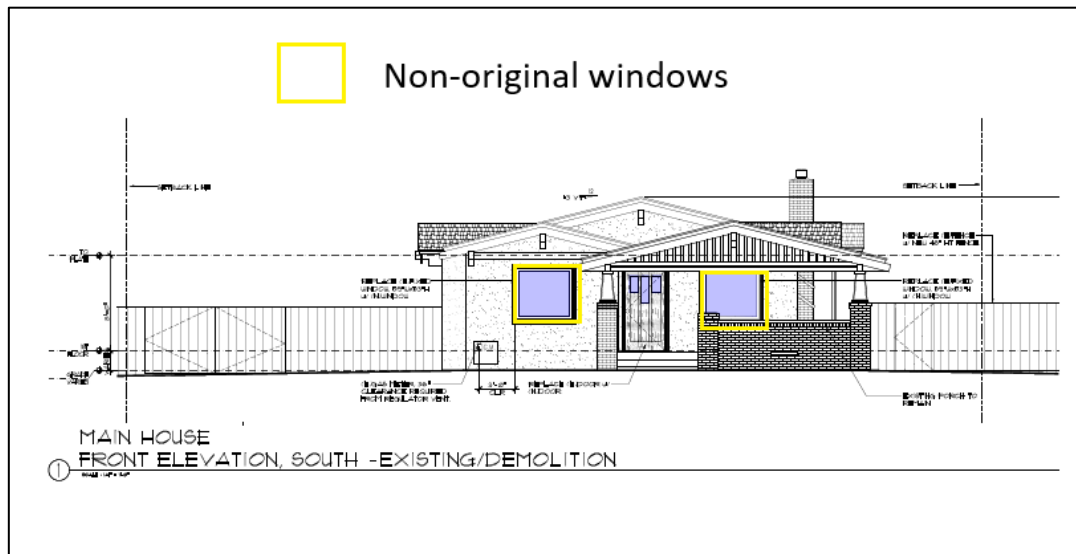
Figure 39. Primary façade (south elevation) showing the non-original windows outlined in yellow (Brownhouse Design; dated 5/27/2022).

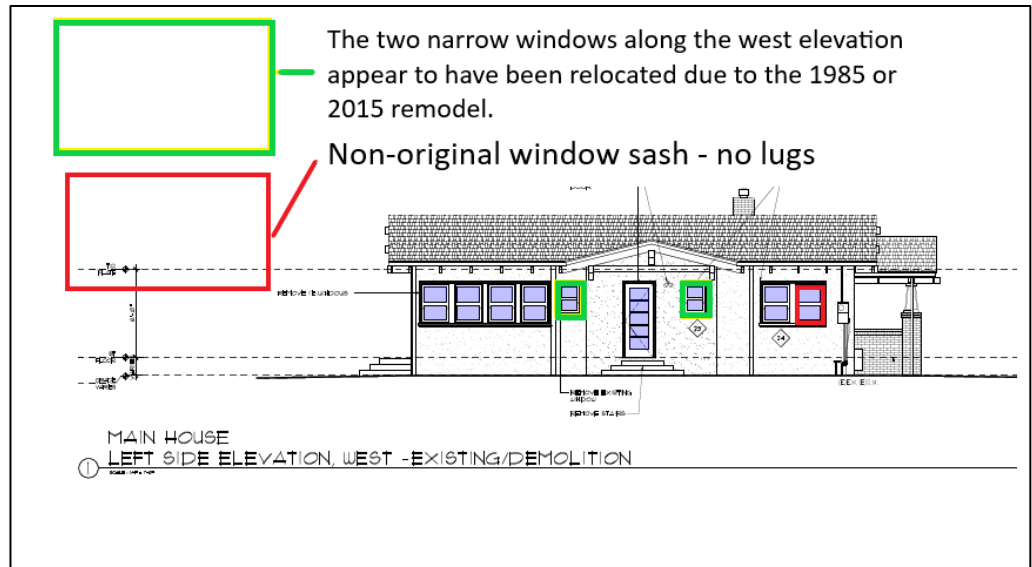
Figure 42. West elevation showing a non-original window sash (outlined in red) and two narrow wood windows (outlined in green) that appear to have been relocated due to remodeling (Brownhouse Design; dated 5/27/2022).

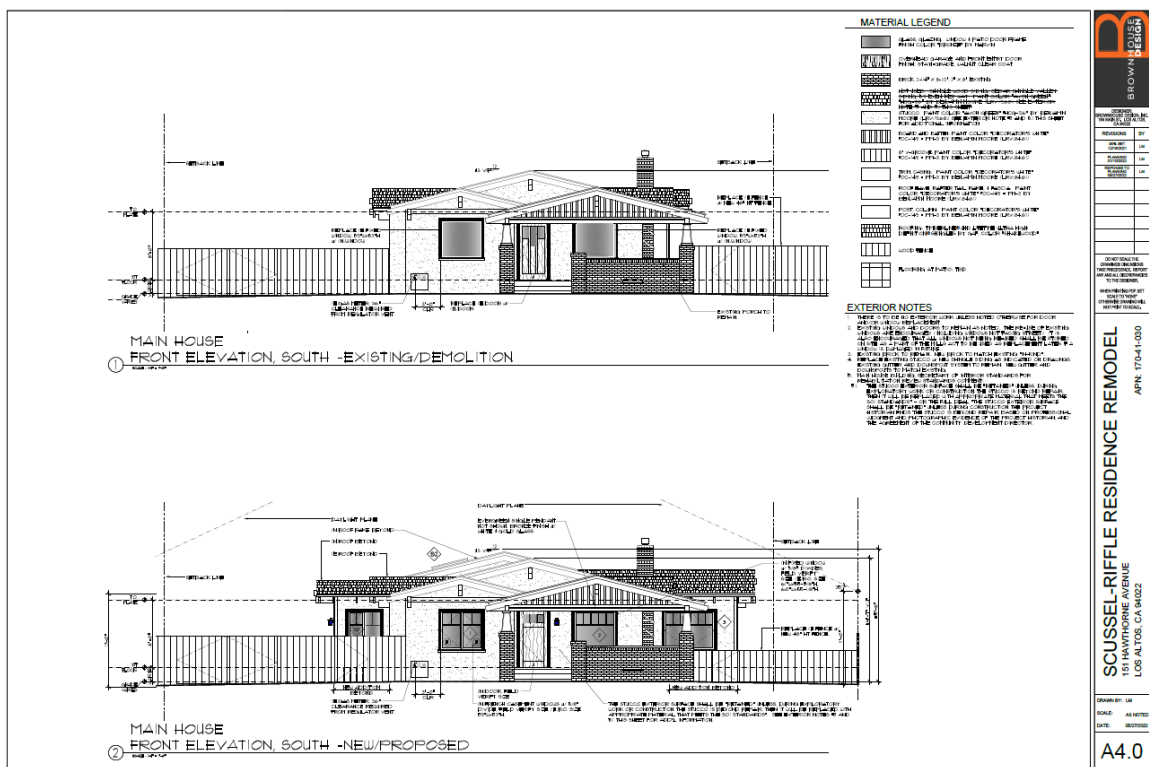
**Figure 43. Existing and proposed primary façade (south elevation) of the ca. 1922 house, showing changes to the windows and front door and the side gable additions (Brownhouse Design; dated 5/27/2022).**

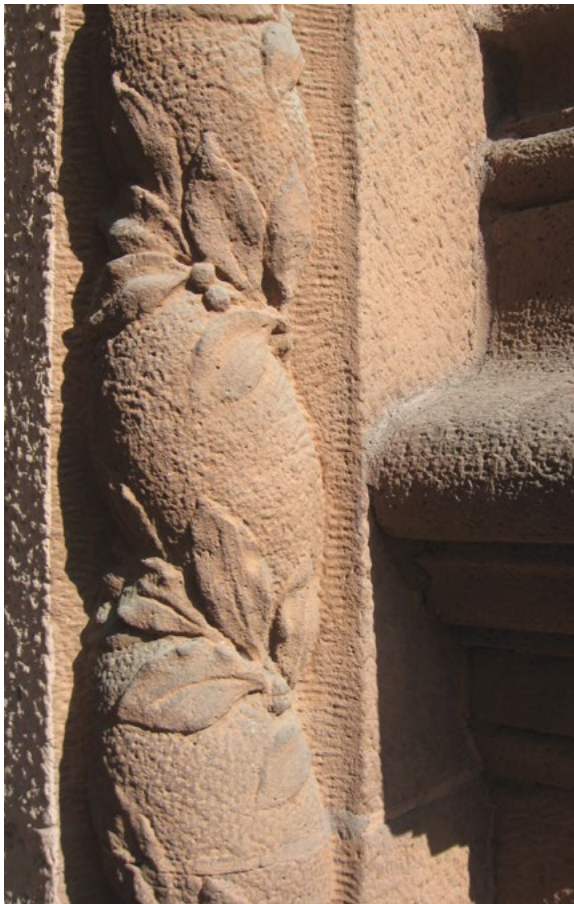
While masonry is one of the most durable historic building materials, it is also very susceptible to damage by exposure, improper maintenance or repairs, abrasive cleaning, or the application of non-permeable coatings.

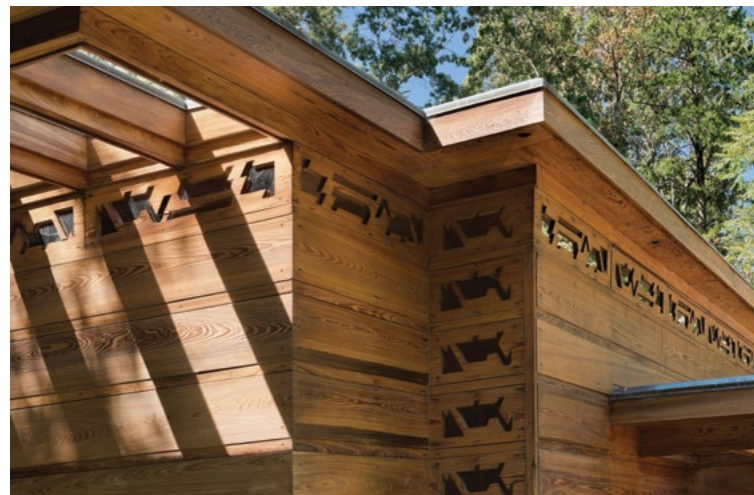
Many historic buildings have wood structural systems and features, such as stairs or columns. The majority of both practical and decorative features, particularly on the interior, are made of wood, such as flooring and paneling.

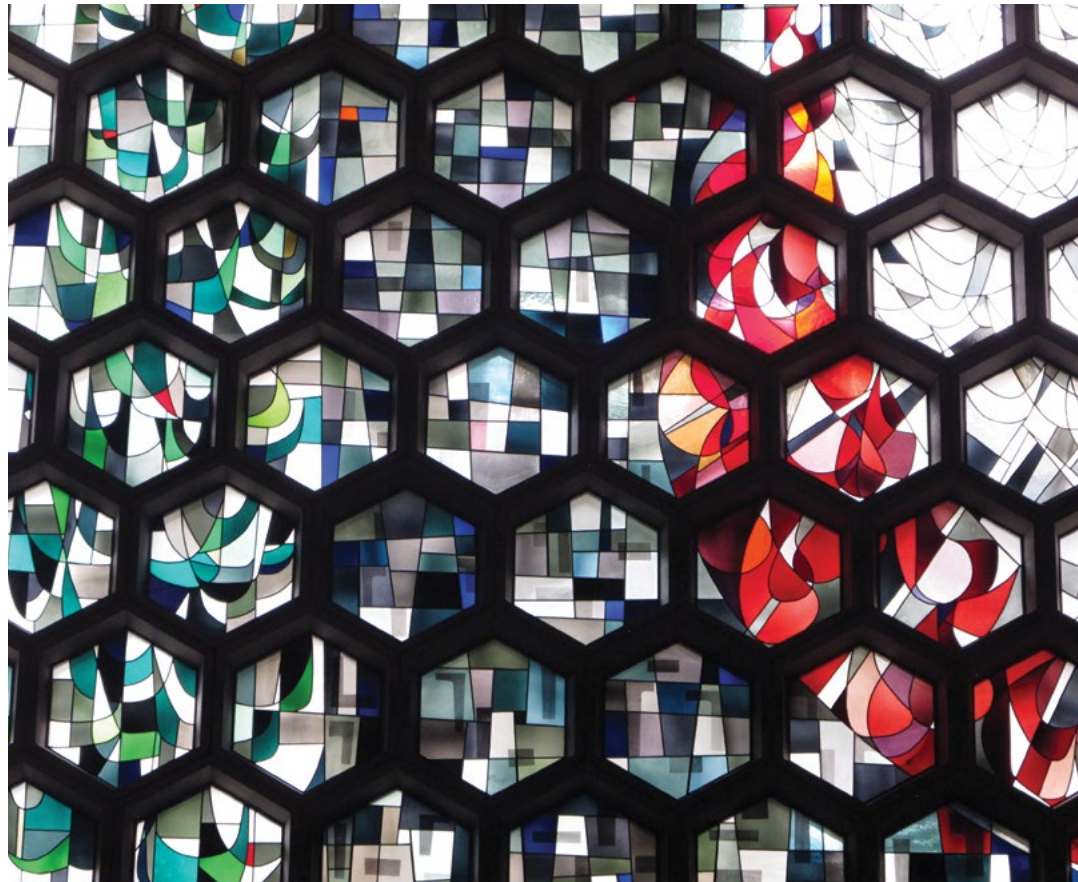
century, architects began using glass curtain walls in Art Moderne-style architecture and, most notably, the International Style. *Tempered glass* is a hardened or toughened glass which began to be used in building construction around 1940. By the middle of the 20th century, glass as a cladding system became synonymous with curtain wall systems.

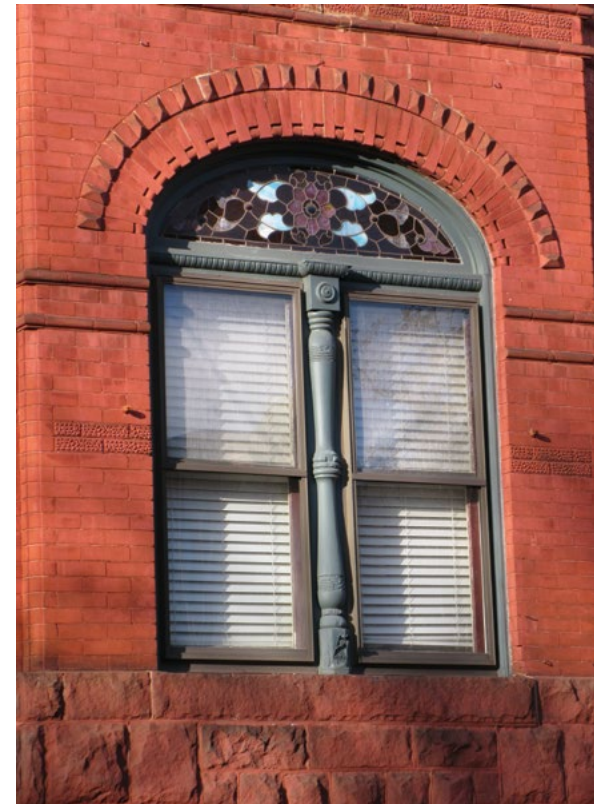
## Entrances and Porches

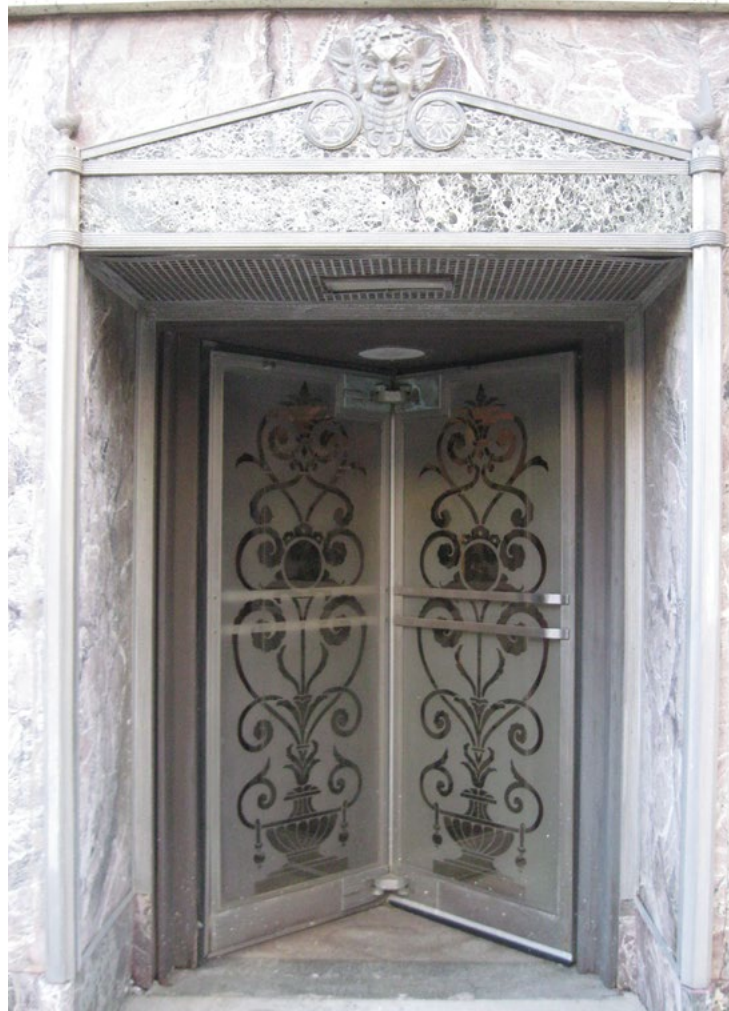
ally, entrances and porches were integral components of a historic building's design; for example, porches on Greek Revival houses, with pediments and Doric or Ionic columns, echoed the architectural elements and features of the building itself. Center, single-bay porches or arcaded porches are evident in Italianate-style buildings of the 1860s. Doors of Renaissance Revival-style buildings frequently featured entablatures or pediments. Porches characterized by lathe-turned porch posts, railings, and balusters were especially prominent and decorative features of Eastlake, Queen Anne, and Stick-style houses. Deep porches on bungalows and Craftsman-style houses of the early 20th century feature tapered posts, exposed posts and beams, rafter tails, and low-pitched roofs with wide overhangs.

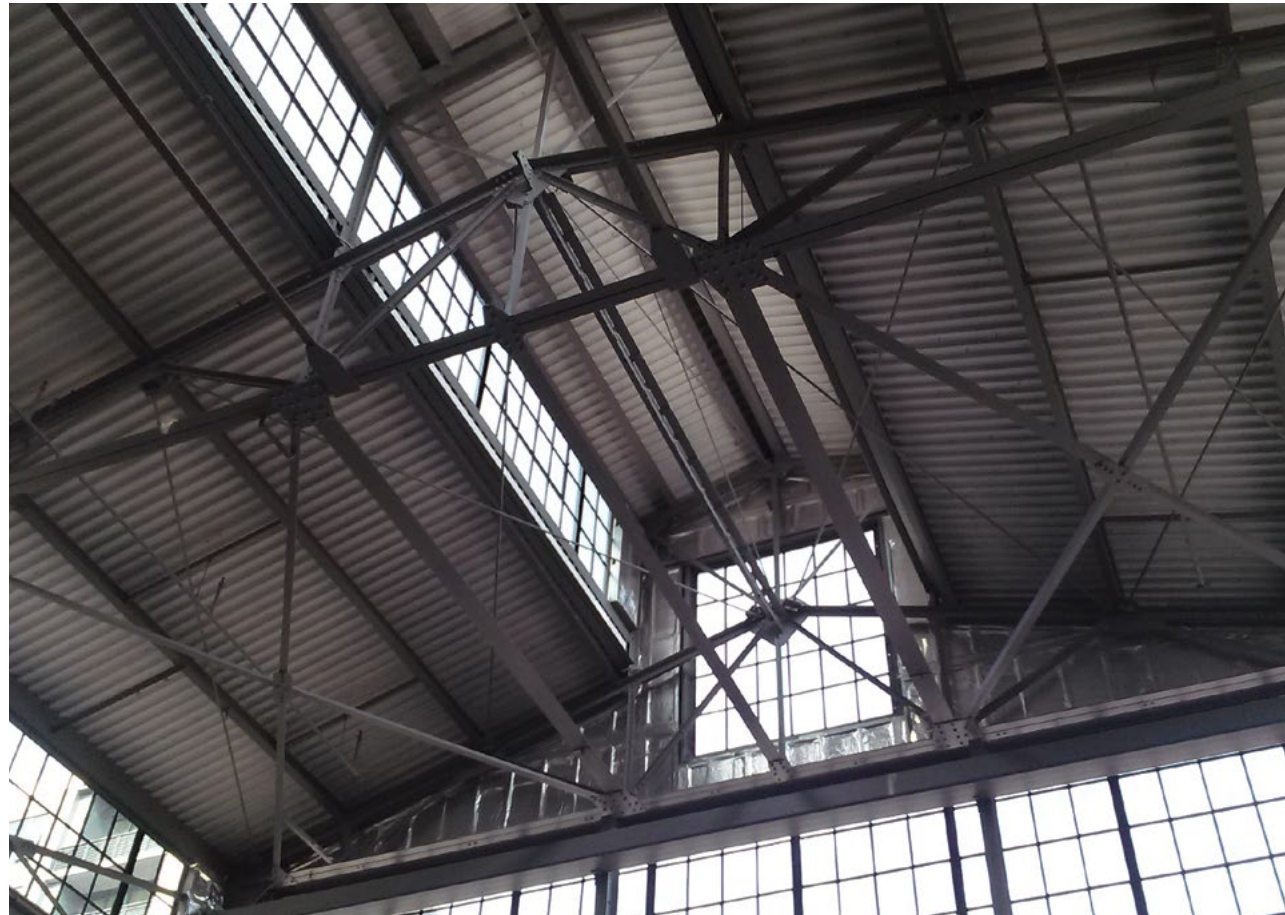
beams, vigas, and outriggers, or masonry foundation walls), they are likely to be important in defining the building's overall historic character. A concealed structural system, although not character defining, may still be significant as an example of historic building technology.

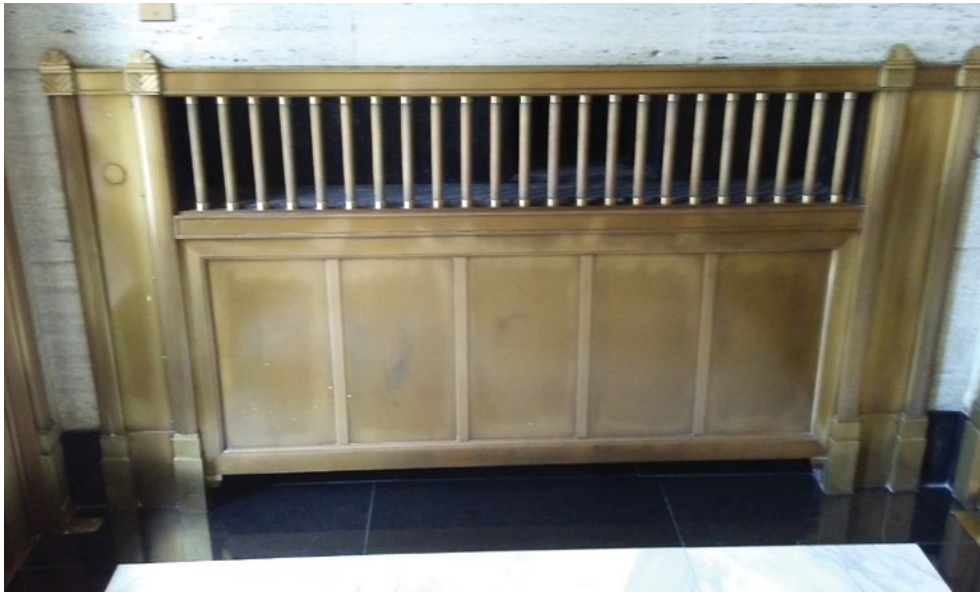
provided both heat and cooling in many buildings. In the late 20th century, as HVAC systems increased in efficiency, they decreased in size, with smaller components, such as split ductless systems with wall-mounted air handlers, cassette ceiling-mounted diffusers, or high-velocity mini duct systems. These systems can be especially useful for retrofitting historic buildings because they are small and unobtrusive. Heat pumps, another late-20th century invention, can help to supplement existing HVAC systems.

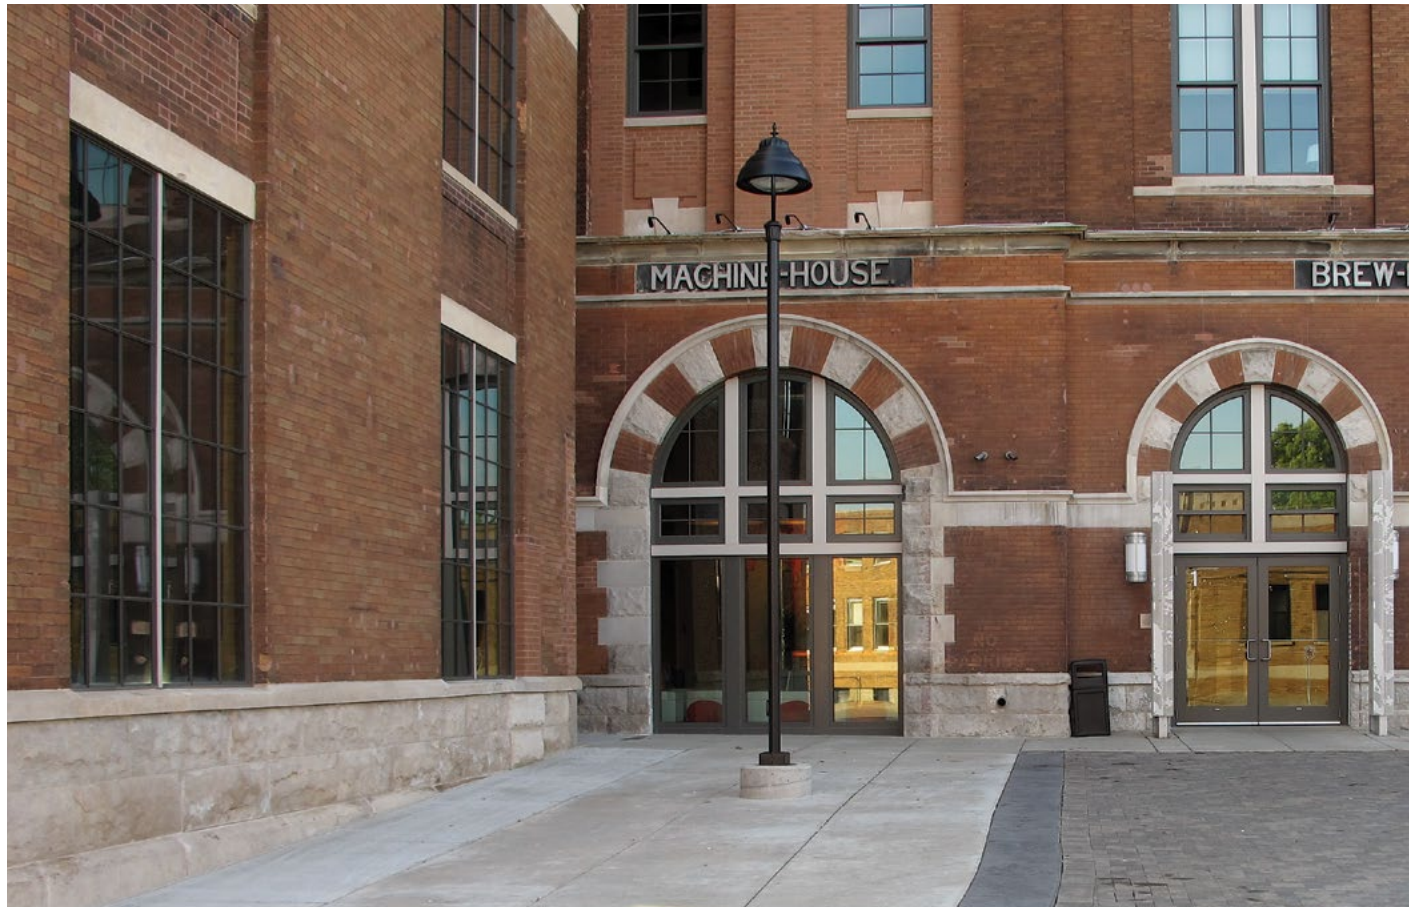
It is often necessary to make modifications to a historic building to make it compliant with accessibility code requirements. Federal rules, regulations, and standards provide guidance on how to make historic buildings accessible. Work must be carefully planned and undertaken in a manner that results in minimal or no loss of historic exterior and interior character-defining spaces, features, or finishes. The goal should be to provide the highest level of access with the least impact to the historic building.

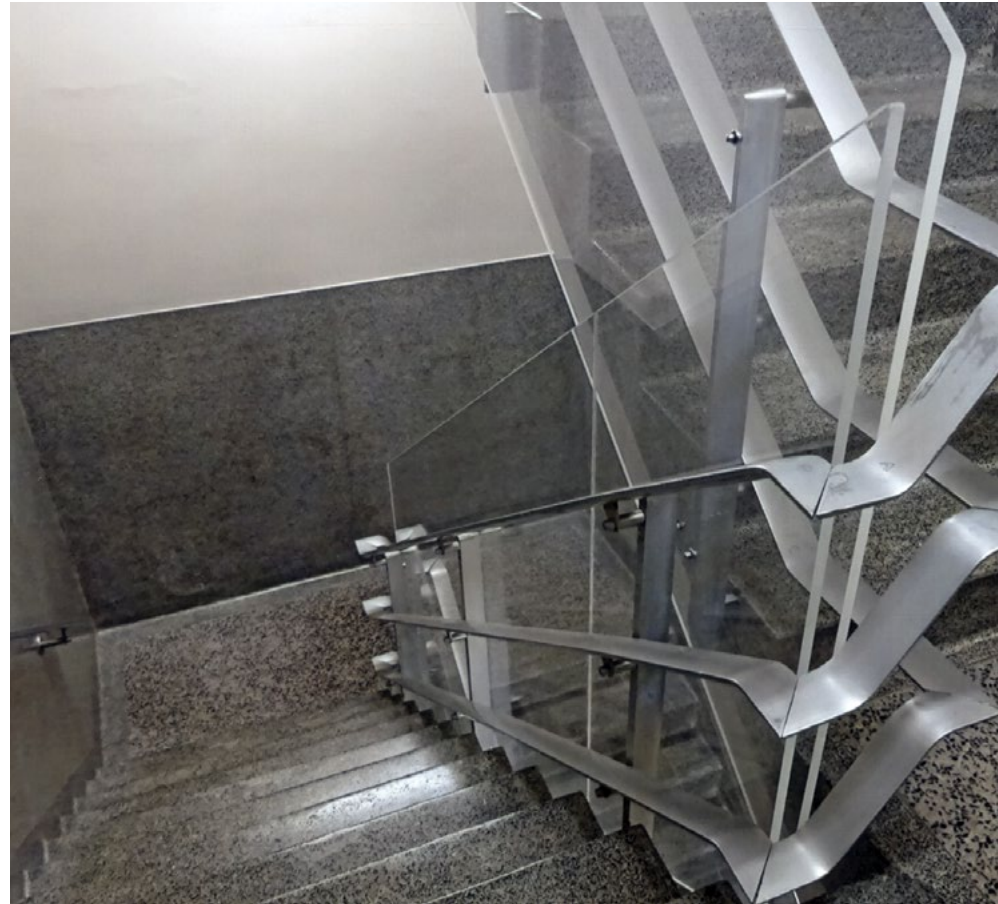
## Resilience to Natural Hazards

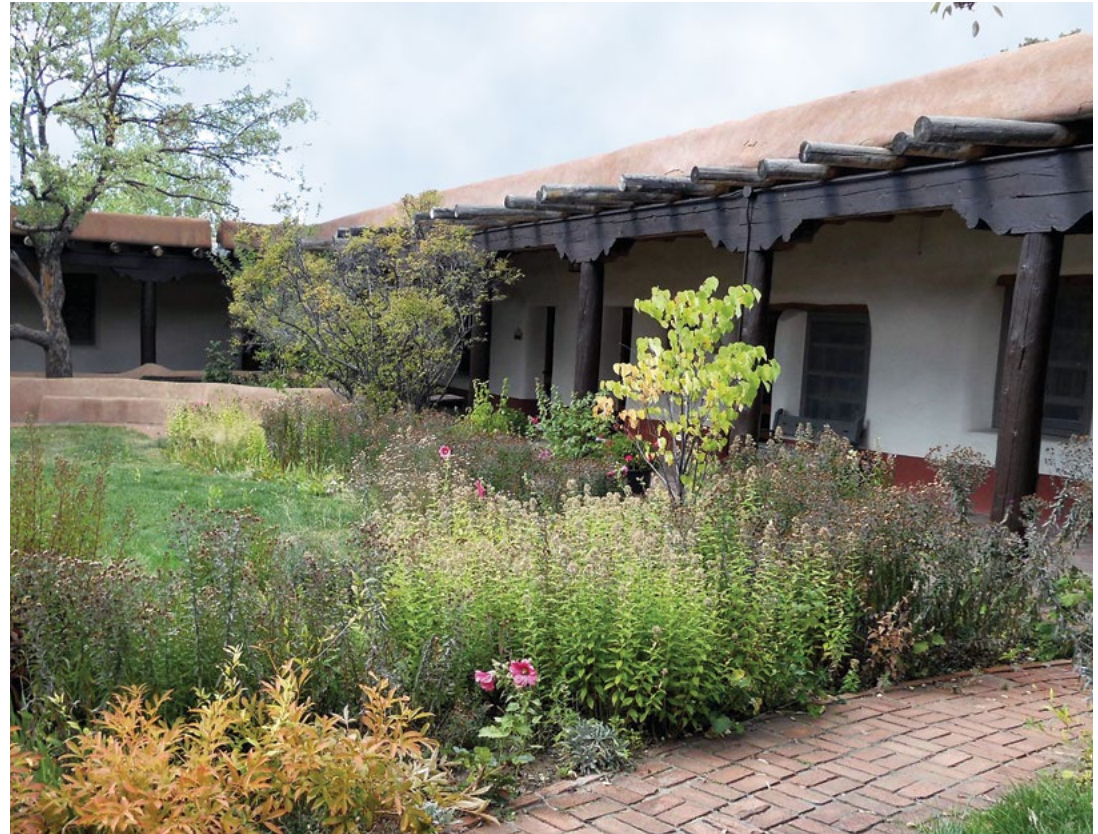
### Standards for Preservation

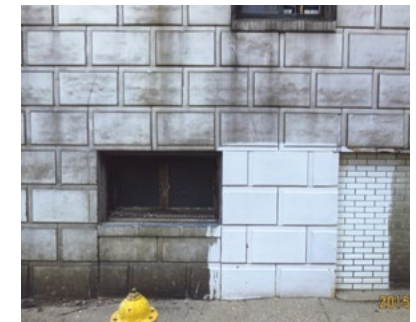
[1] A test patch should always be done before using a chemical cleaner to ensure that it will not damage historic masonry, as in this instance, terra cotta.

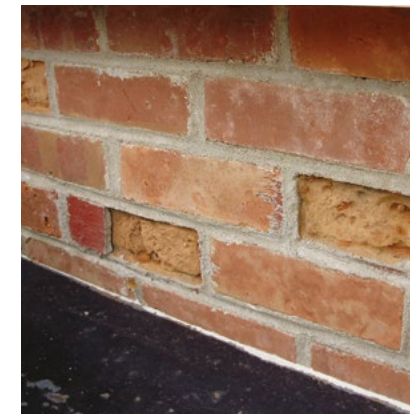
[2] **Not Recommended:** The use of inappropriate Portland cement mortar to repoint these soft 19th-century bricks has caused some of them to spall. *Photo: Courtesy Nebraska State Historic Preservation Office.*

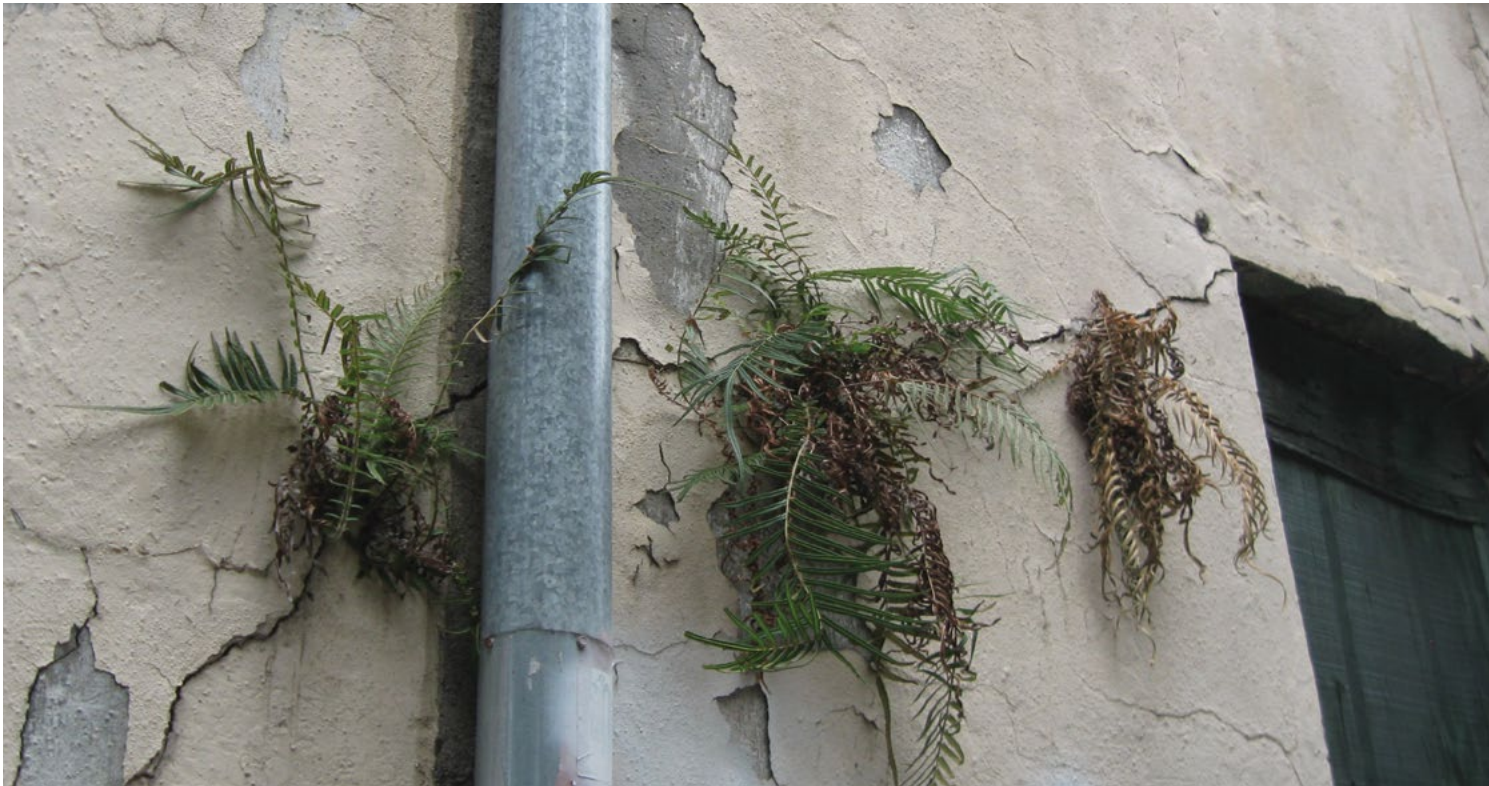
[3] **Not Recommended:** Cracks in the stucco have not been repaired, thereby allowing ferns to grow in the moist substrate which will cause further damage to the masonry.

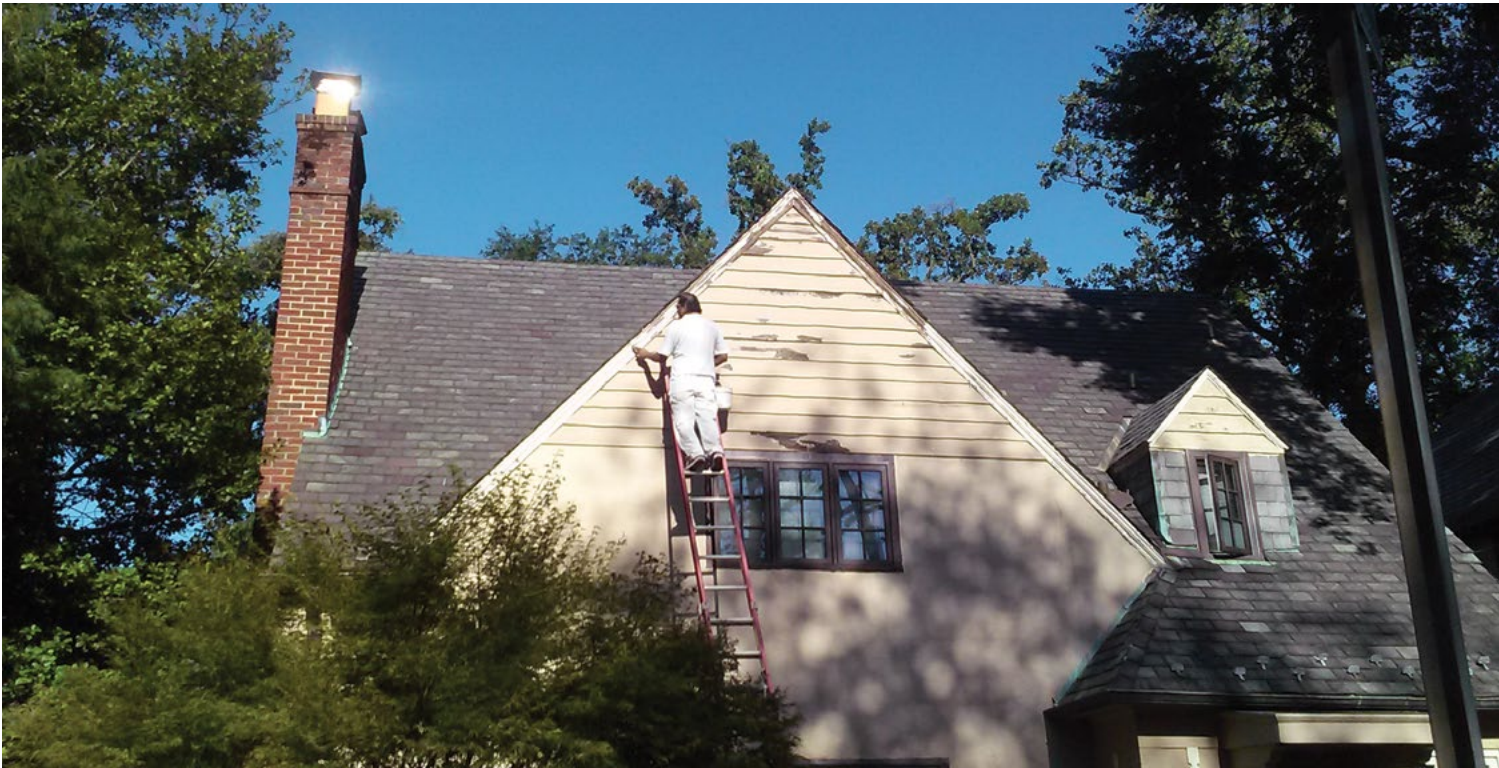
[4] Hand scraping to remove peeling paint from wood siding in preparation for repainting is an important part of regularly-scheduled maintenance.

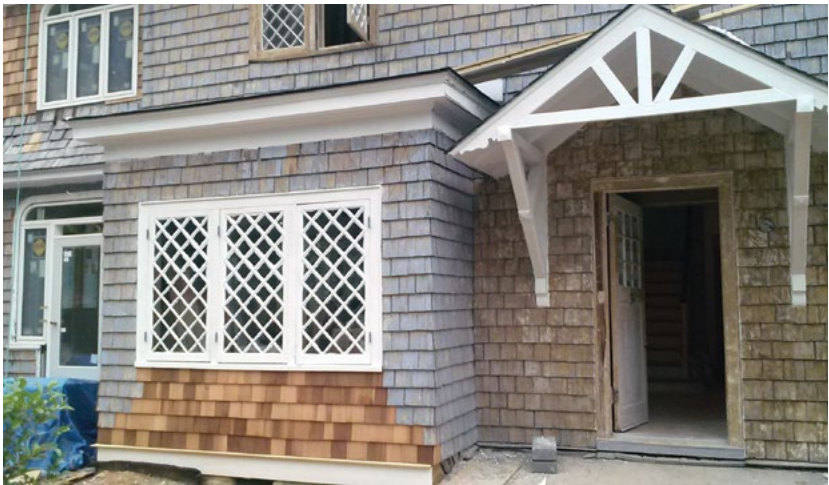
[5] Rotted wood shingles have been replaced in kind with matching wood shingles.

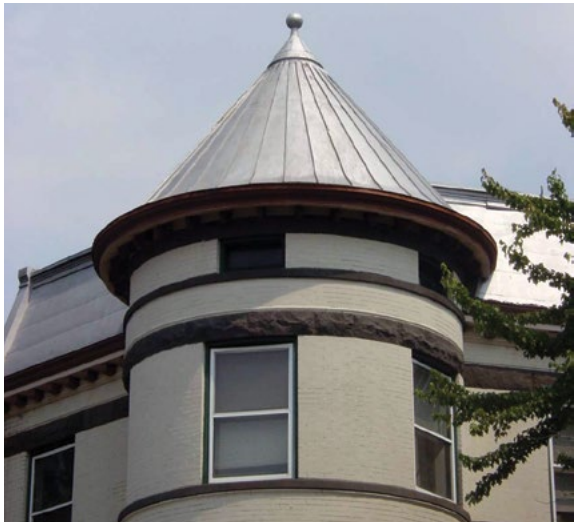
**METALS: WROUGHT AND CAST IRON, STEEL, PRESSED METAL, TERNEPLATE, COPPER, ALUMINUM, AND ZINC**

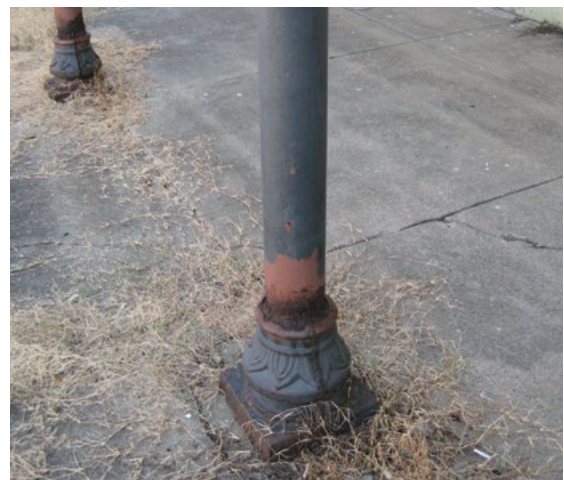
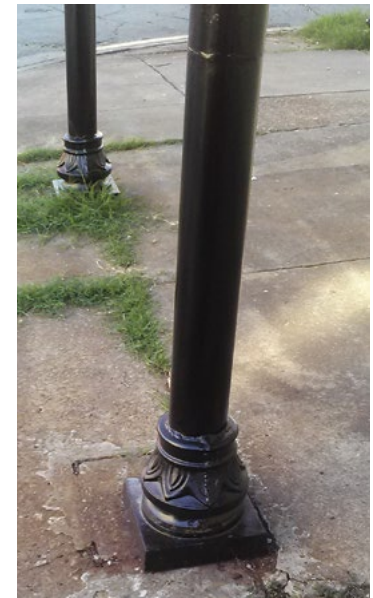
[7] (a) After the damaged portions of the base were repaired, (b) the cast-iron columns were cleaned and repainted to protect the metal from rusting.

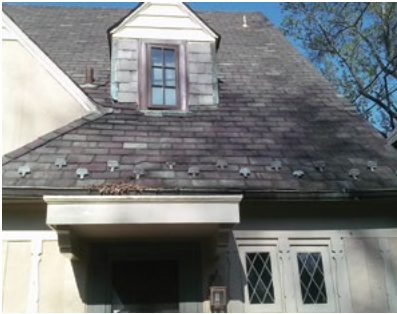
[8] Regular maintenance includes removing leaves that can clog gutters and cause water damage to the exterior and interior walls of a house.

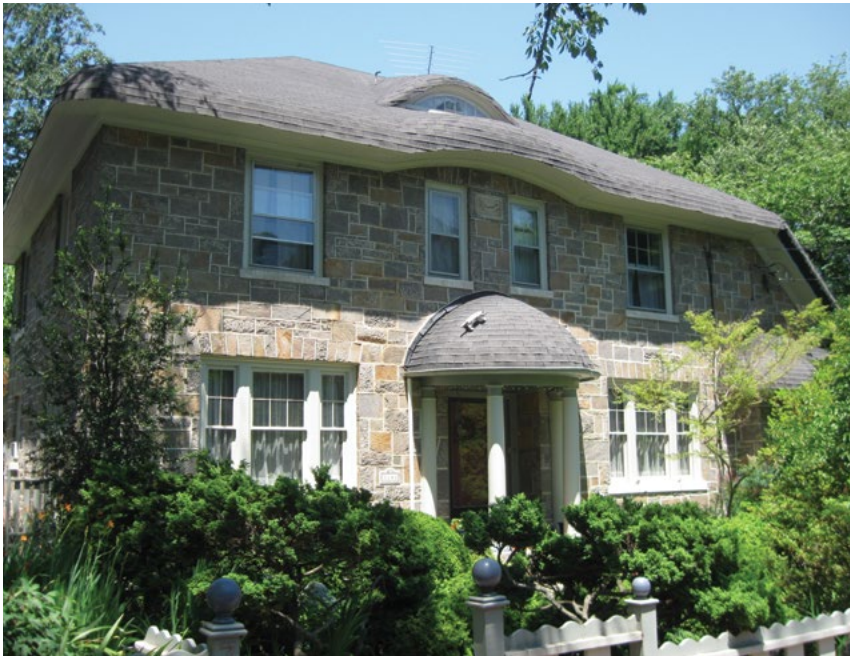
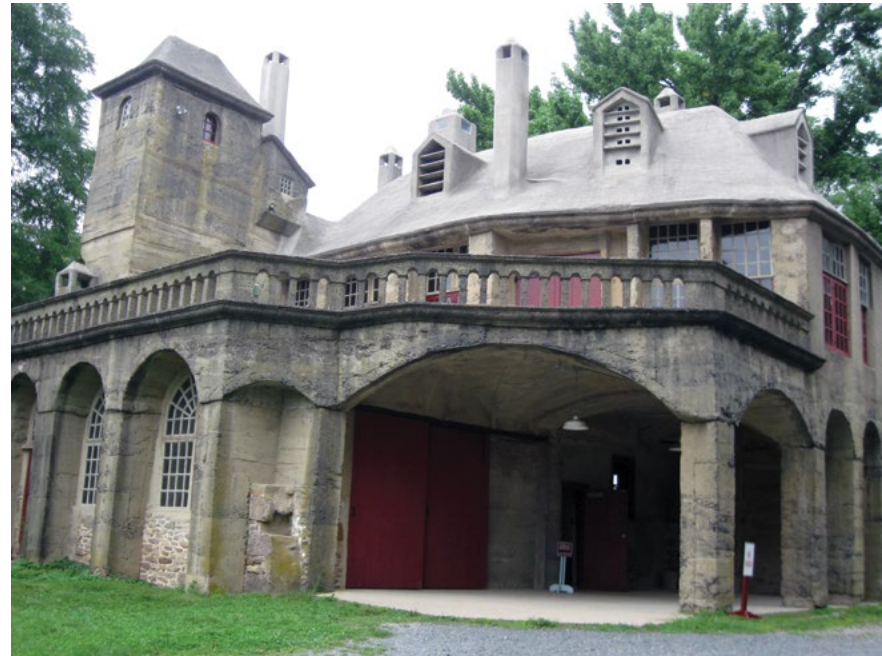
[9] Distinctively-shaped roofs are important in defining the historic character of these early 20<sup>th</sup>-century structures: (a) an asphalt shingle roof on a house; (b) and a concrete roof on Fonthill, Doylestown, PA (1908-1912), designed and built by Henry Chapman Mercer.

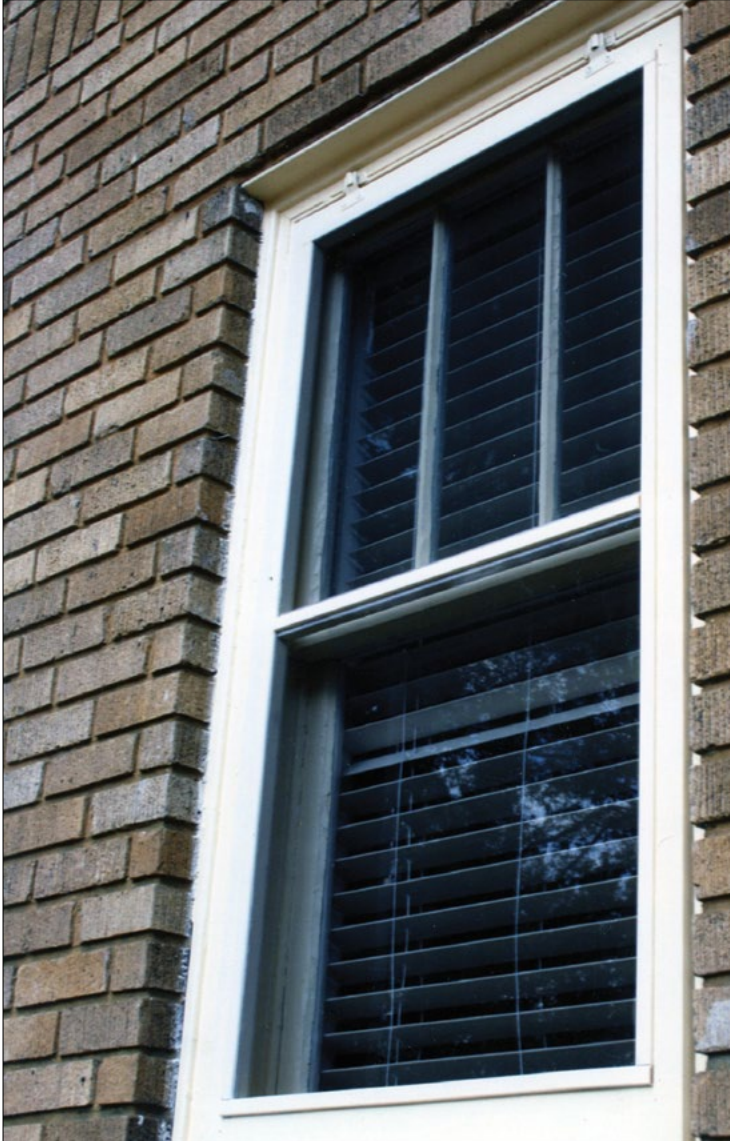
[10] Historic exterior storm windows preserve and help to insulate wood windows.

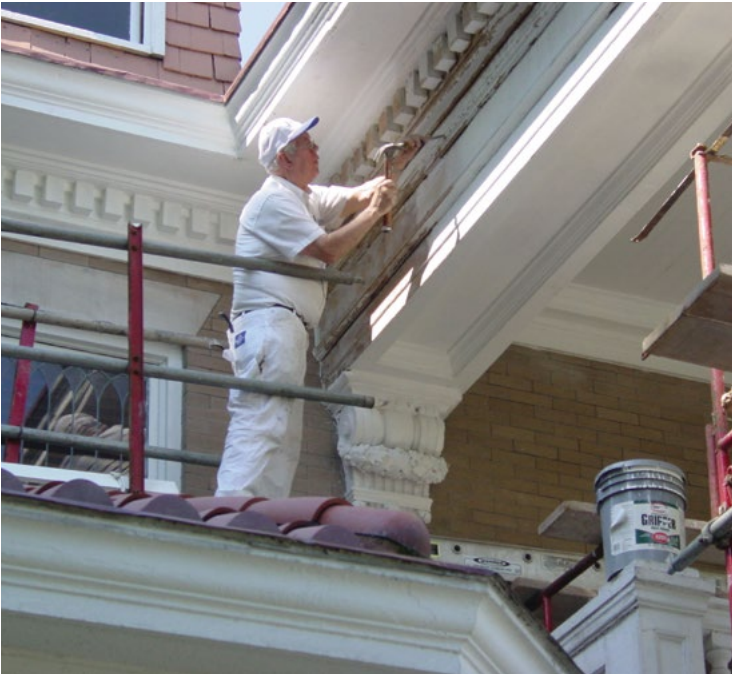
[12] Repair and limited replacement in kind to match deteriorated wood porch features is always a recommended preservation treatment.

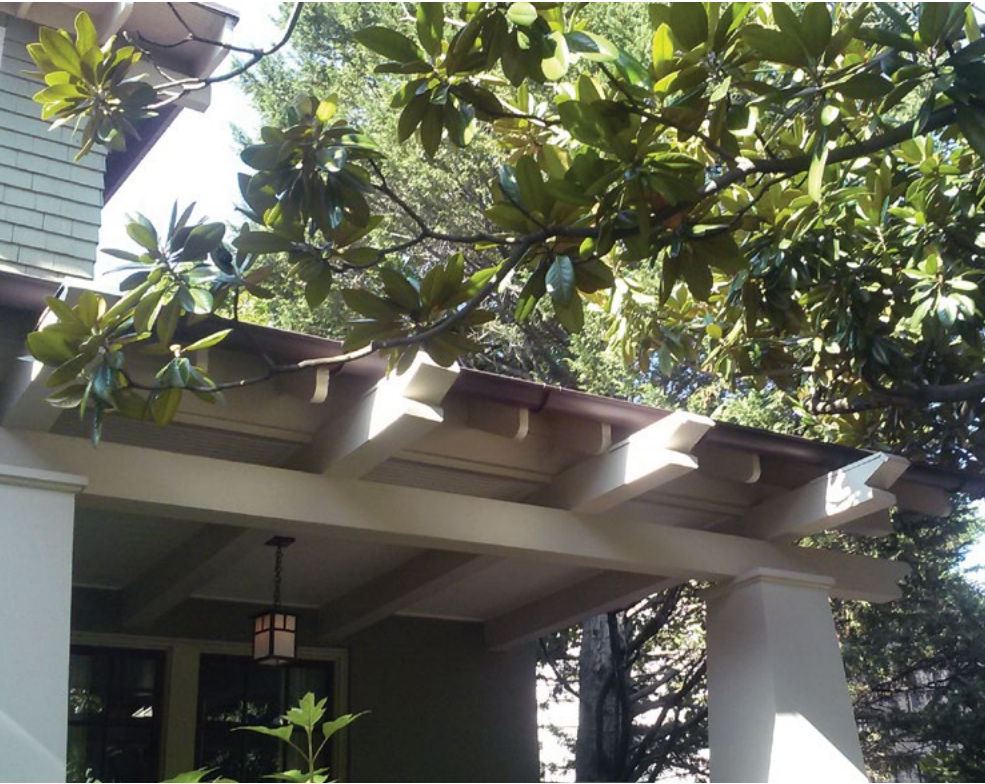
## ENTRANCES AND PORCHES

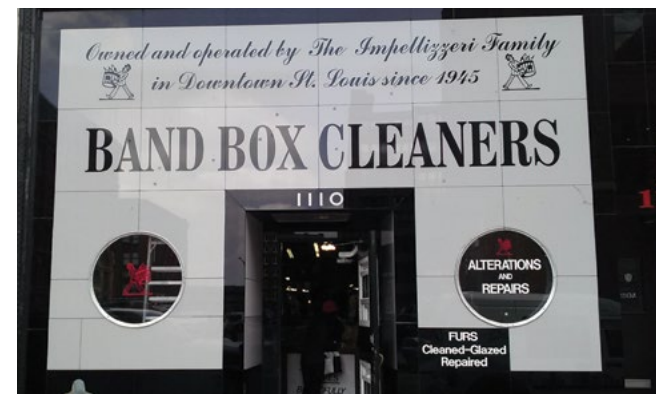
[14] The signage is an original and integral part of this historic Carrara glass storefront.

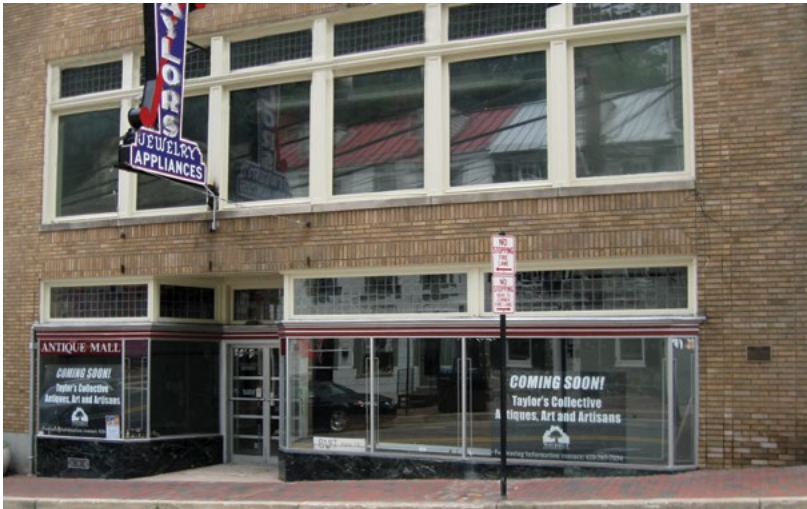
[15] Regular maintenance has helped to preserve this historic storefront, which retains all of its character-defining features, including the granite bulkhead, multi-paned transom glazing, and recessed entrance.

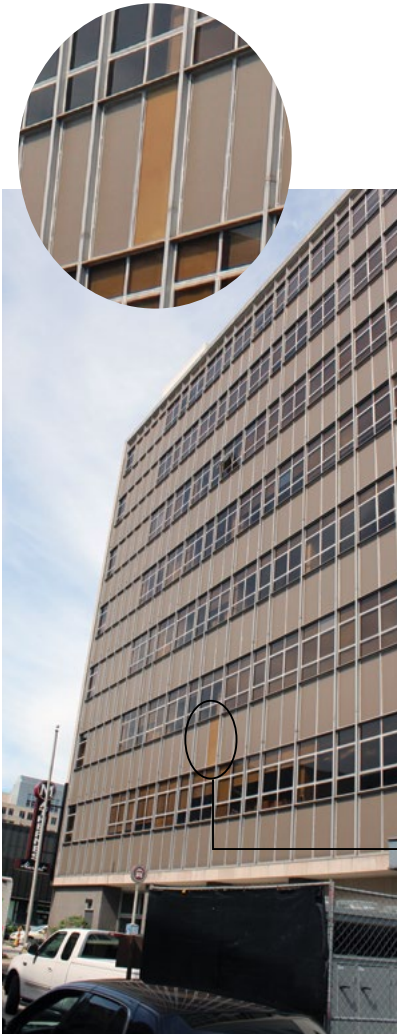
[16] Plywood provides temporary protection for an opening where a damaged spandrel panel was removed until a matching replacement panel can be installed.

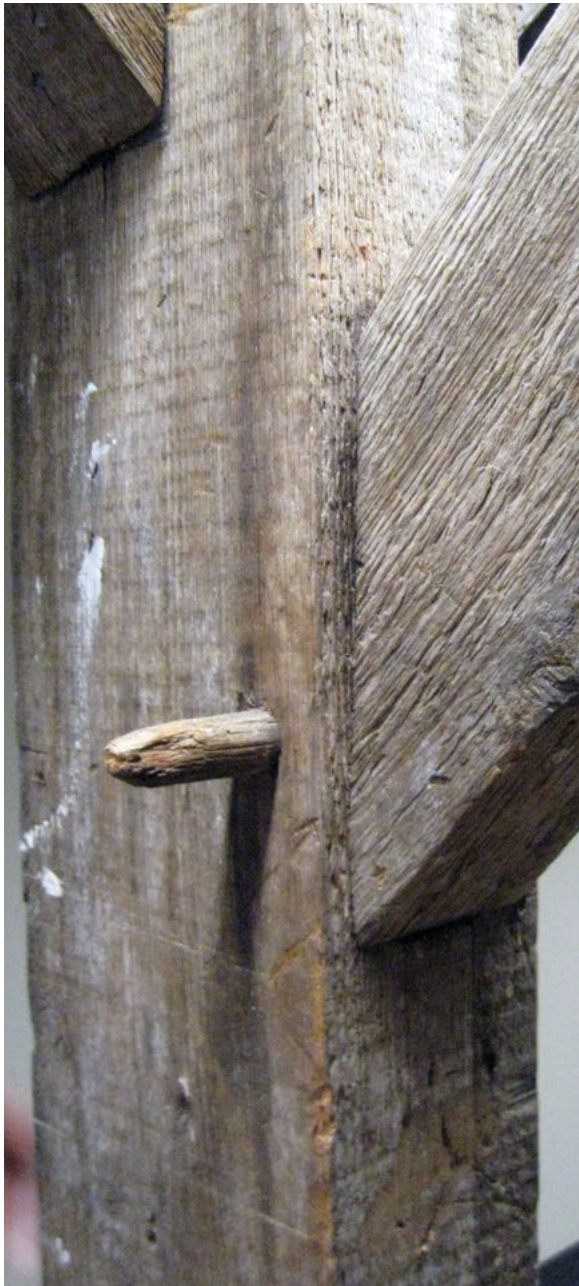
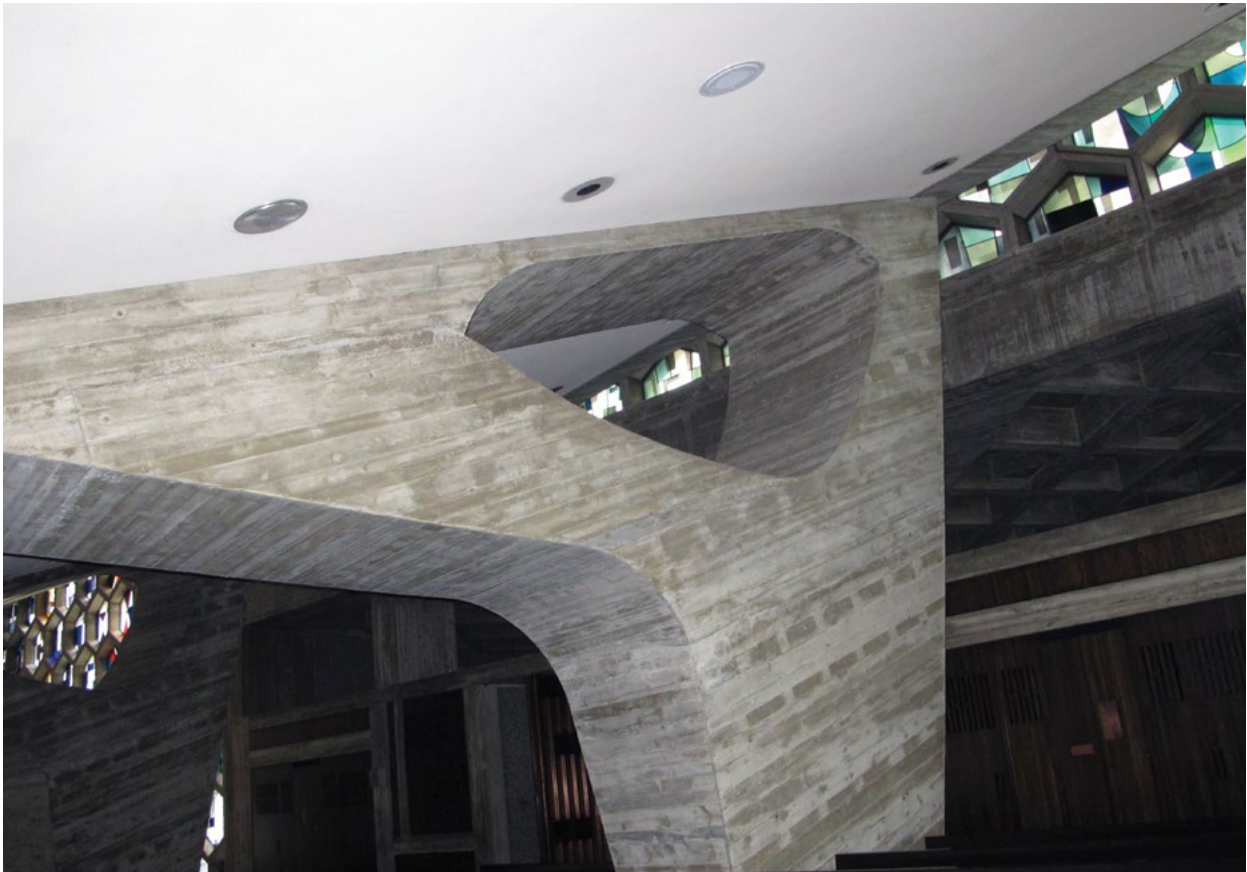
[17] Distinctive examples of traditional construction techniques should be preserved, such as this wooden peg, which is part of the structural system of this late-19th-century warehouse.
