## **HISTORICAL COMMISSION SPECIAL MEETING AGENDA**

**7:00 PM - Monday, August 08, 2022**

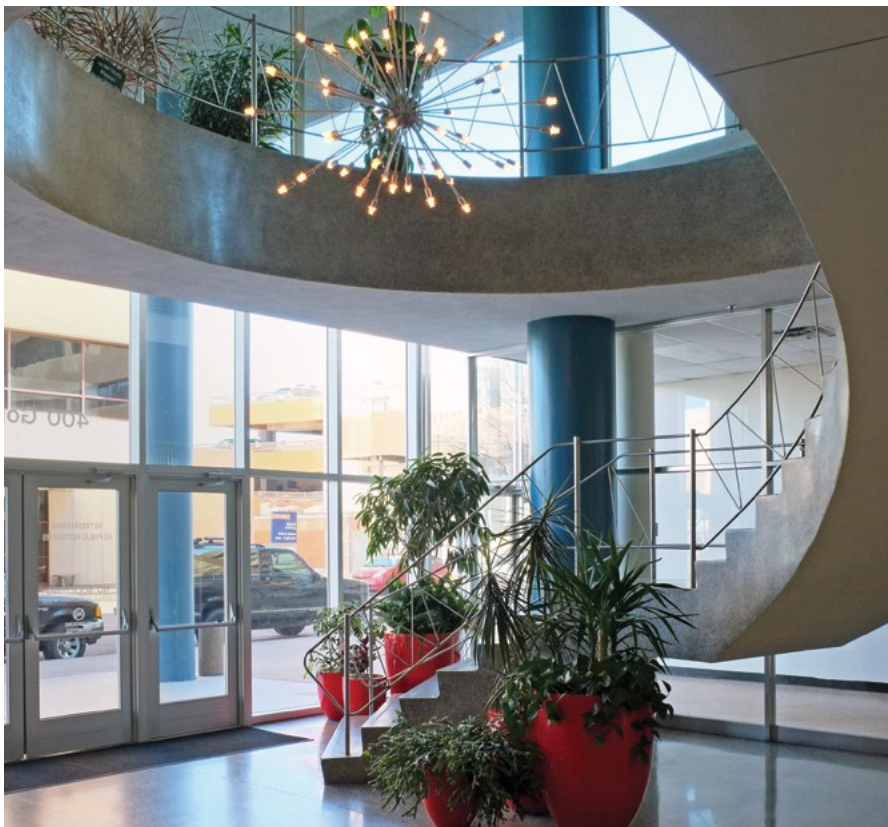
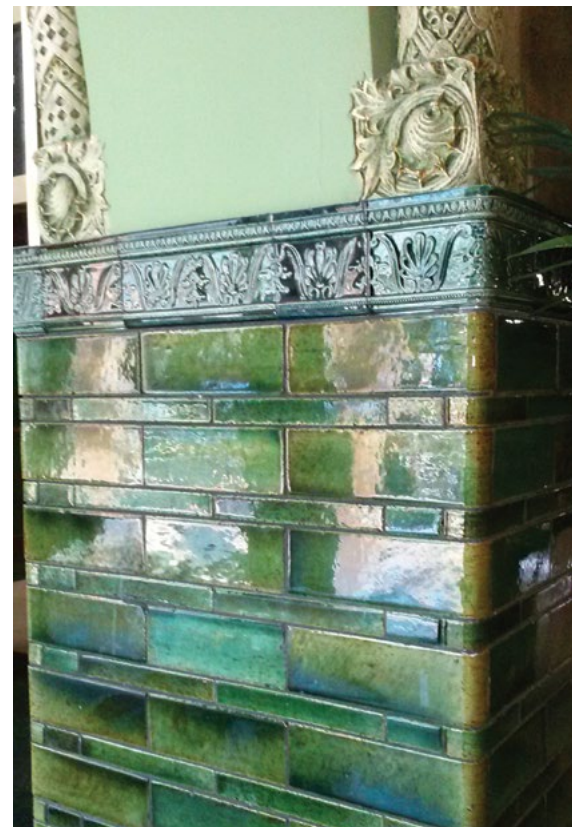
[19] The sweeping staircase with its metal railing, chandelier, and terrazzo floor in the lobby of the 1954 Simms Building, Albuquerque, NM, are character-defining features. *Photo: Harvey M. Kaplan.*

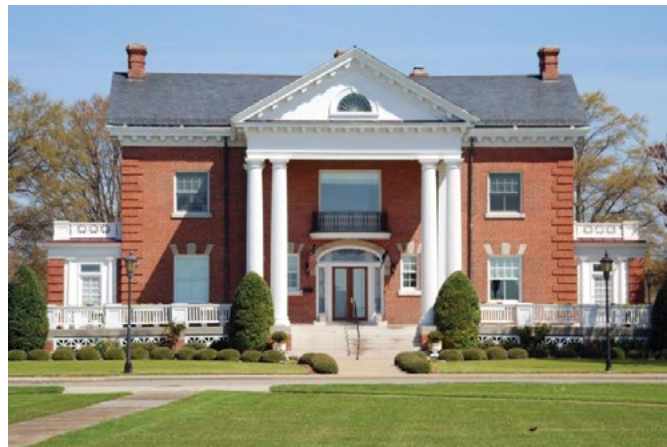
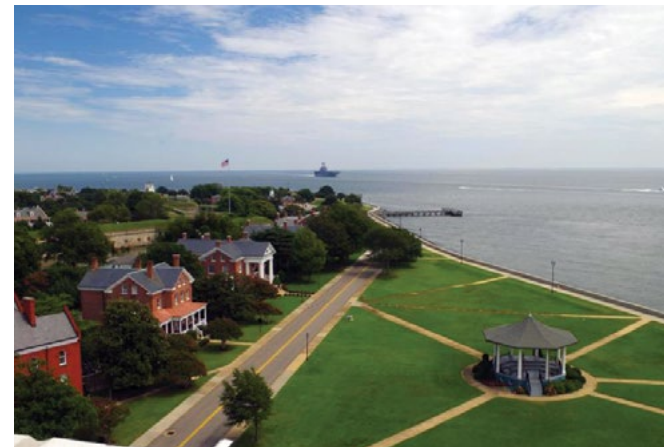
## SETTING (DISTRICT / NEIGHBORHOOD)

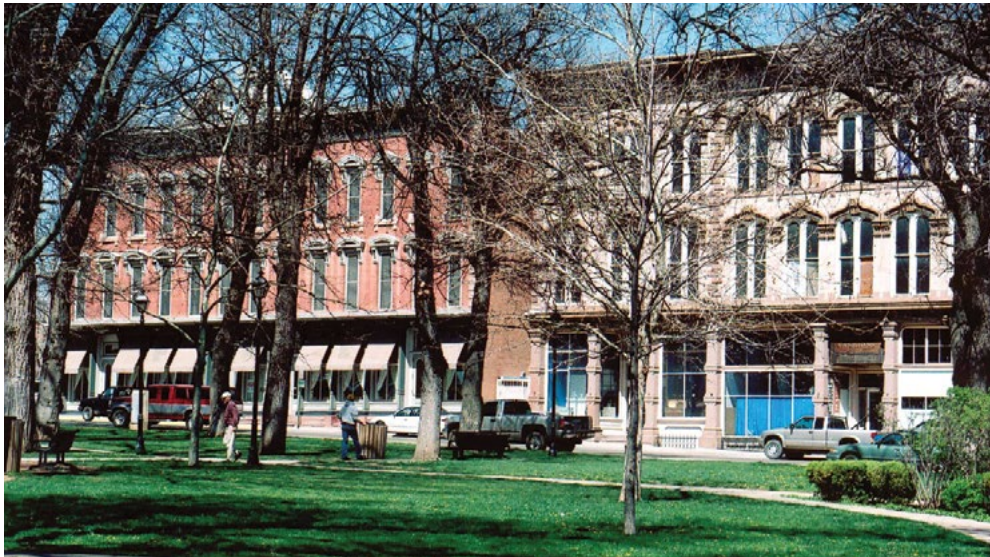
[23] The city square is important in defining the character of the historic setting in this small town.

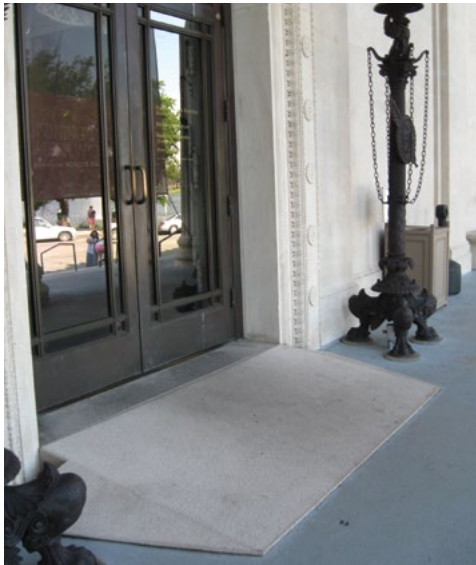
[27] The access ramp at the left of the entrance is concealed by a hedge which minimizes its visibility and impact on the character of the historic apartment building.

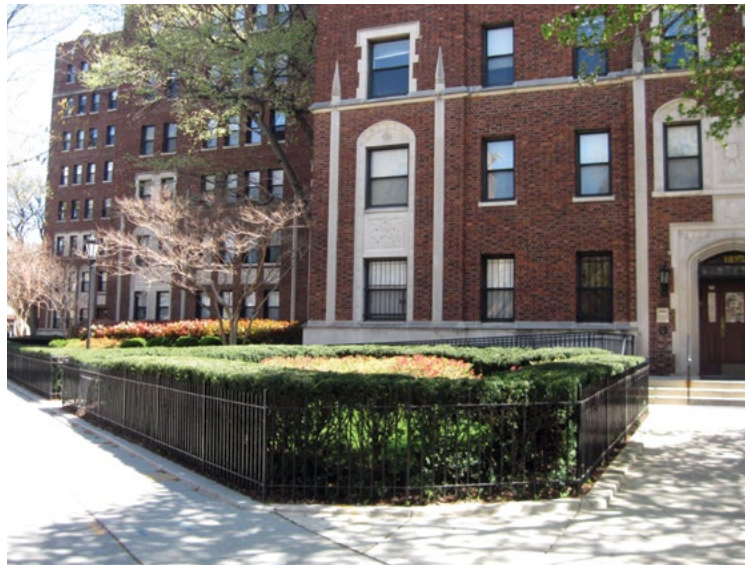
## CODE-REQUIRED WORK

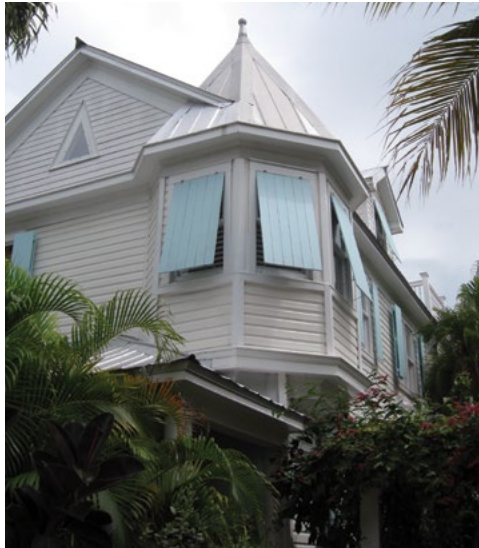
[30] Historic window shutters still serve their original function as protection in hurricane-prone areas.

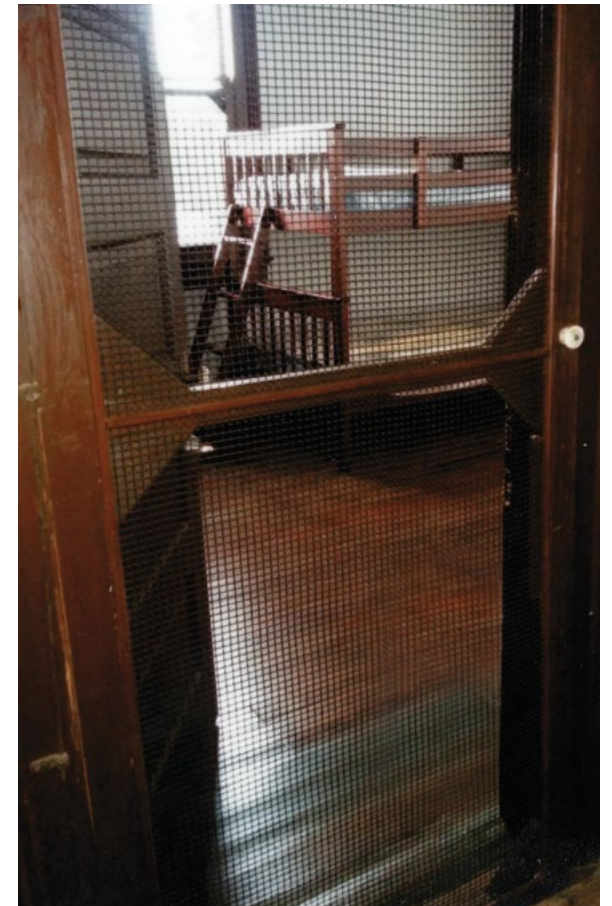
[31] An interior screen door at the entrance to individual apartments is a historic feature traditionally used to help circulate air throughout the building.

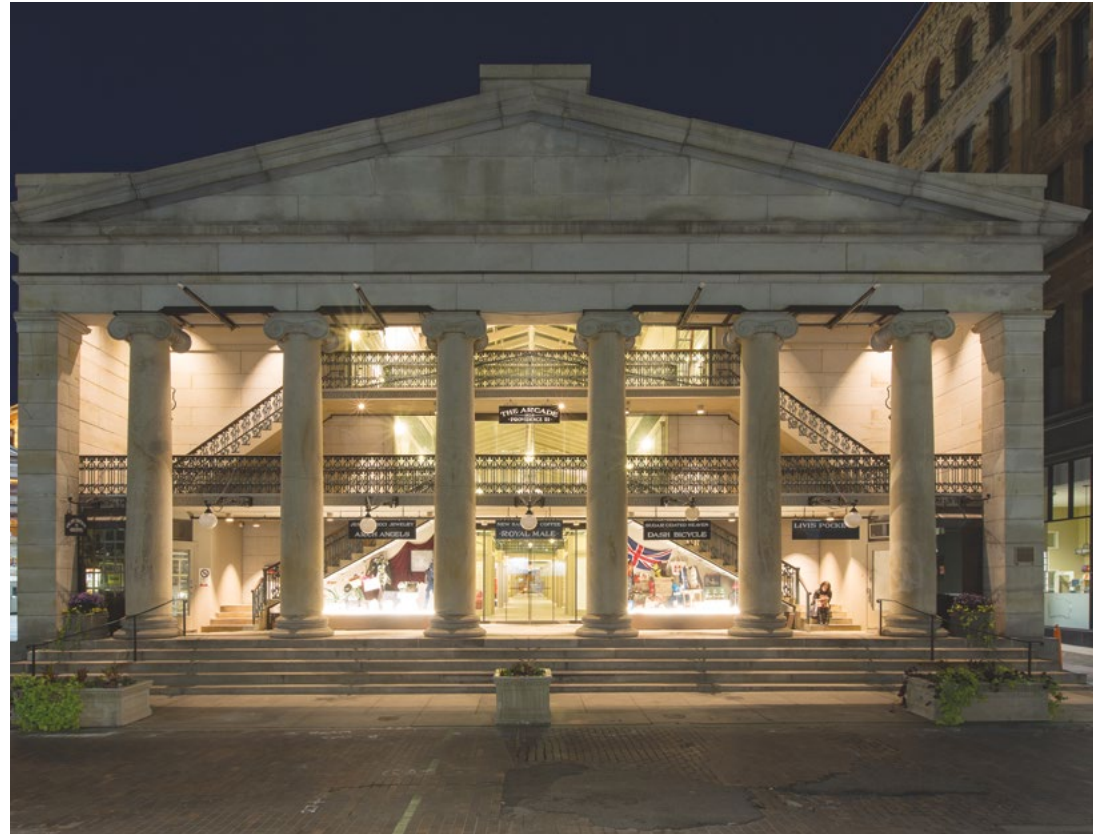
## Standards for Rehabilitation

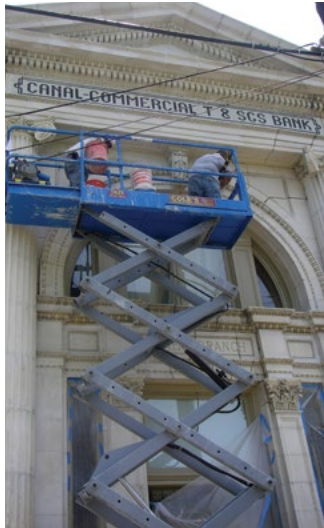
[1] An alkaline-based product is appropriate to use to clean historic marble because it will not damage the marble, which is acid sensitive.

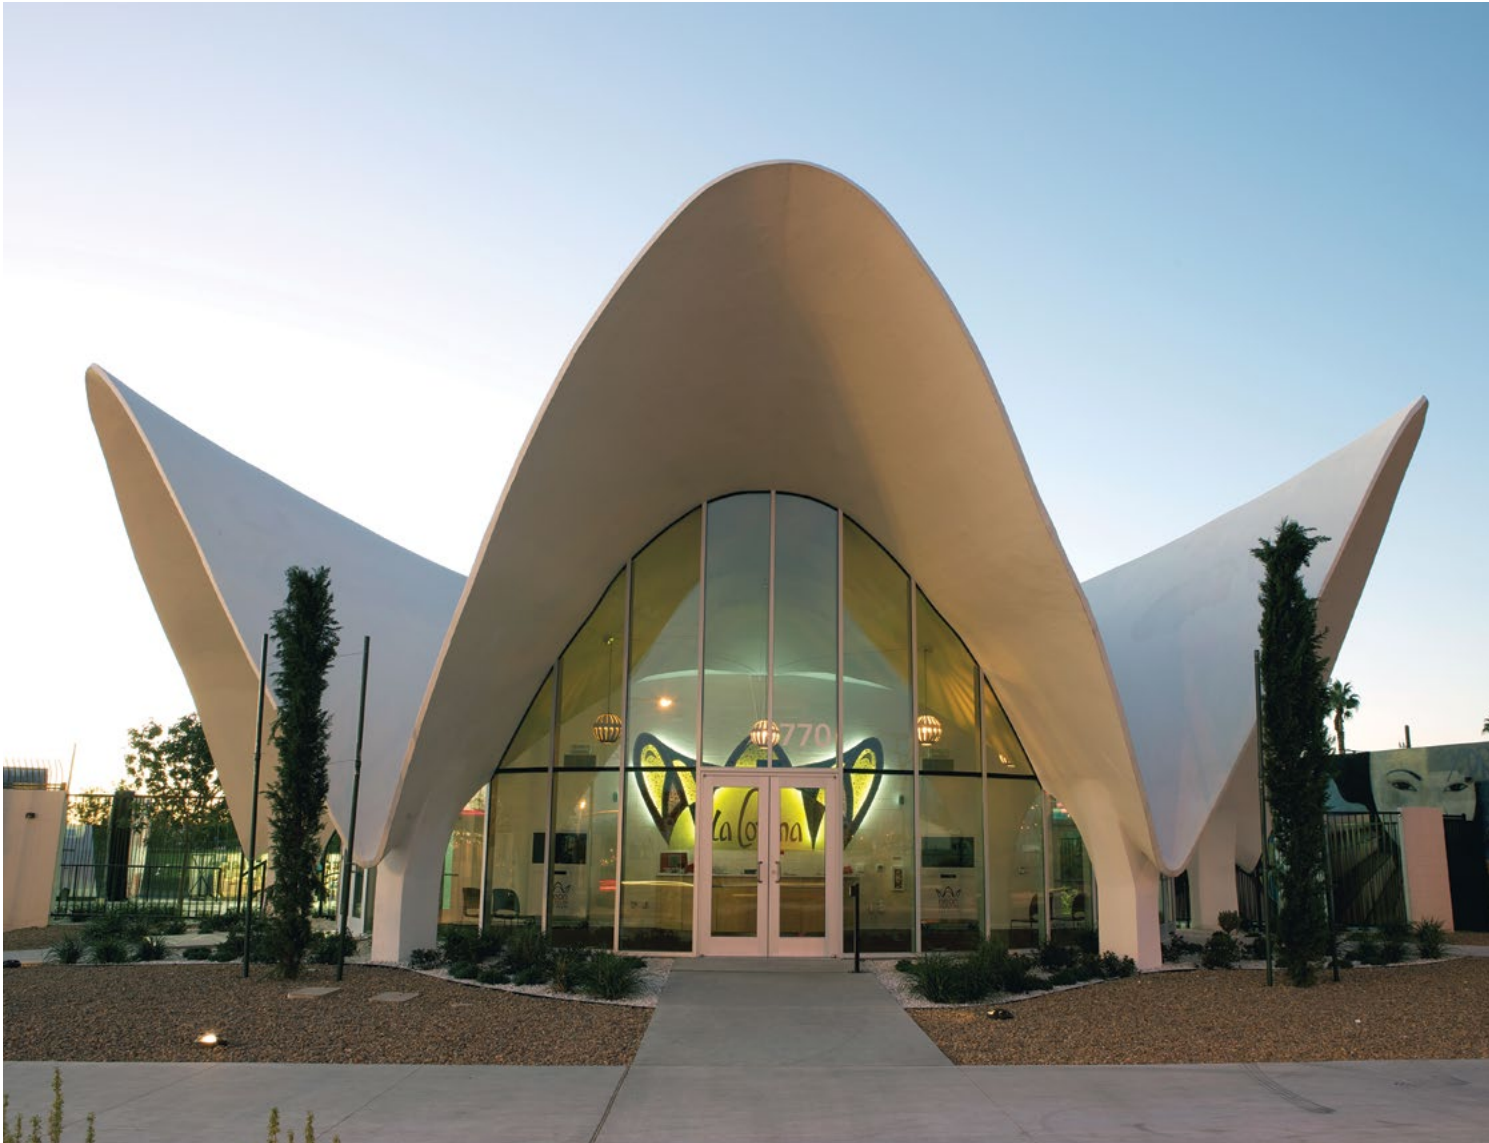
[2] Mid-century modern building technology made possible the form of this parabola-shaped structure and its thin concrete shell construction. Built in 1961 as the lobby of the La Concha Motel in Las Vegas, it was designed by Paul Revere Williams, one of the first prominent African-American architects. It was moved to a new location and rehabilitated to serve as the Neon Museum, and is often cited as an example of Google architecture. *Credit: Photographed with permission at The Neon Museum, Las Vegas, Nevada.*

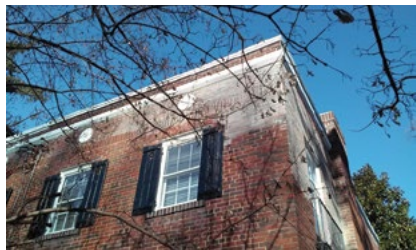
**[3] Not Recommended:**  
The white film on the upper corner of this historic brick row house is the result of using a scrub or slurry coating, rather than traditional repointing by hand, which is the recommended method.

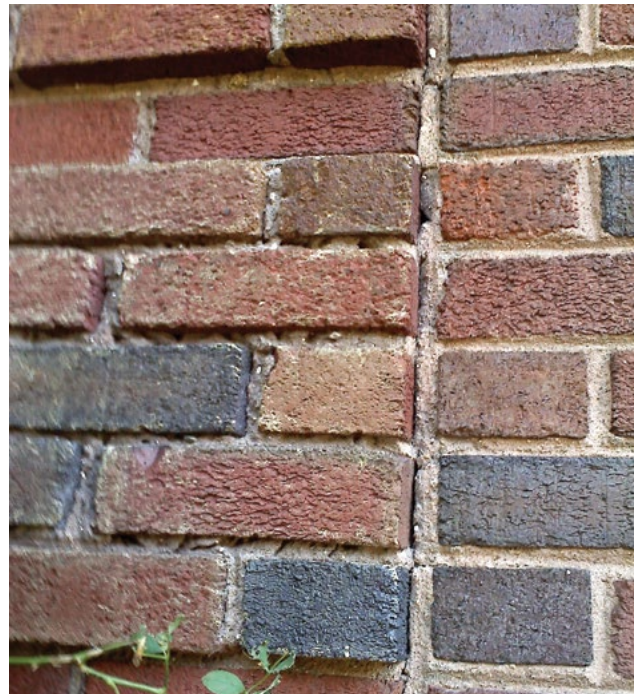
## MASONRY: STONE, BRICK, TERRA COTTA, CONCRETE, ADOBE, STUCCO, AND MORTAR

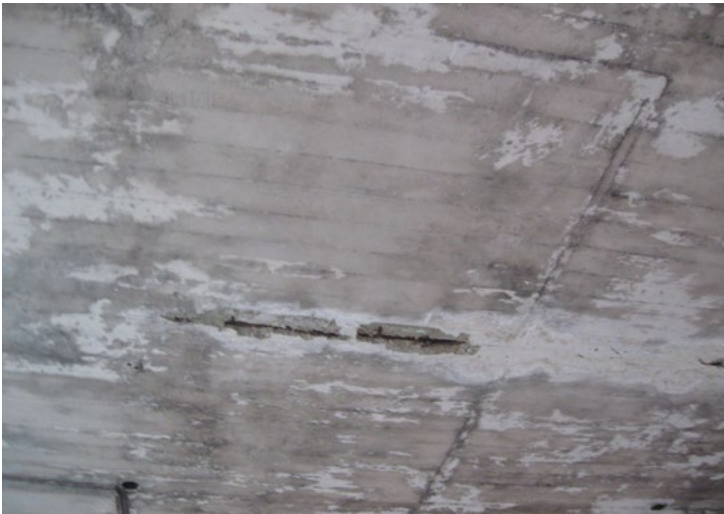
[5] Rebars in the reinforced concrete ceiling have rusted, causing the concrete to spall. The rebars must be cleaned of rust before the concrete can be patched.

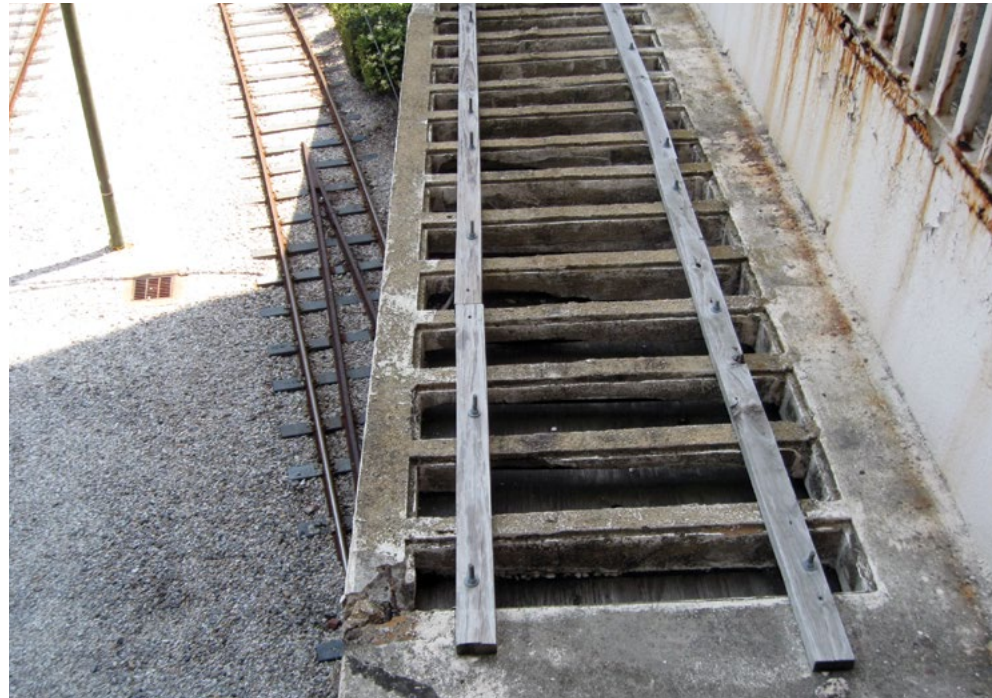
[6] Some areas of the concrete brise soleil screen on this building constructed in 1967 are badly deteriorated. If the screen cannot be repaired, it may be replaced in kind or with a composite substitute material with the same appearance as the concrete.

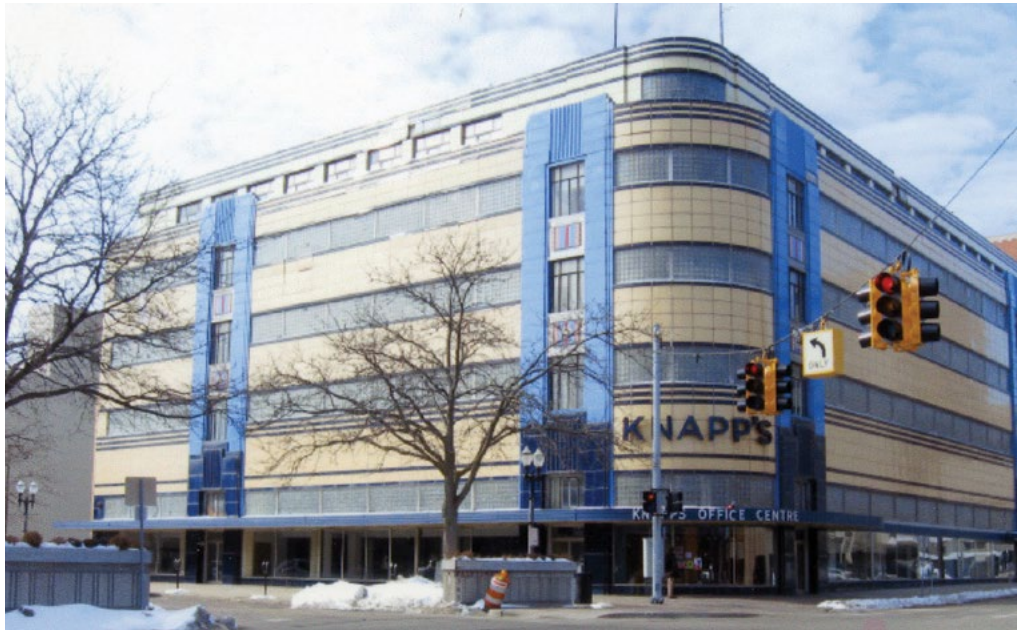
[7] (a) J.W. Knapp's Department Store, built 1937-38, in Lansing, MI, was constructed with a proprietary material named "Maul Macotta" made of enameled steel and cast-in-place concrete panels. Prior to its rehabilitation, a building inspection revealed that, due to a flaw in the original design and construction, the material was deteriorated beyond repair. The architects for the rehabilitation project devised a replacement system (b) consisting of enameled aluminum panels that matched the original colors (c). Photos and drawing (a-b): Quinn Evans Architects; Photo (c): James Haefner Photography.

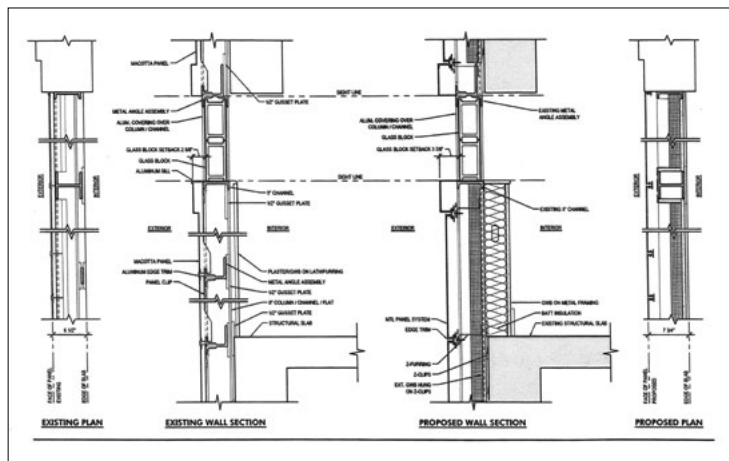
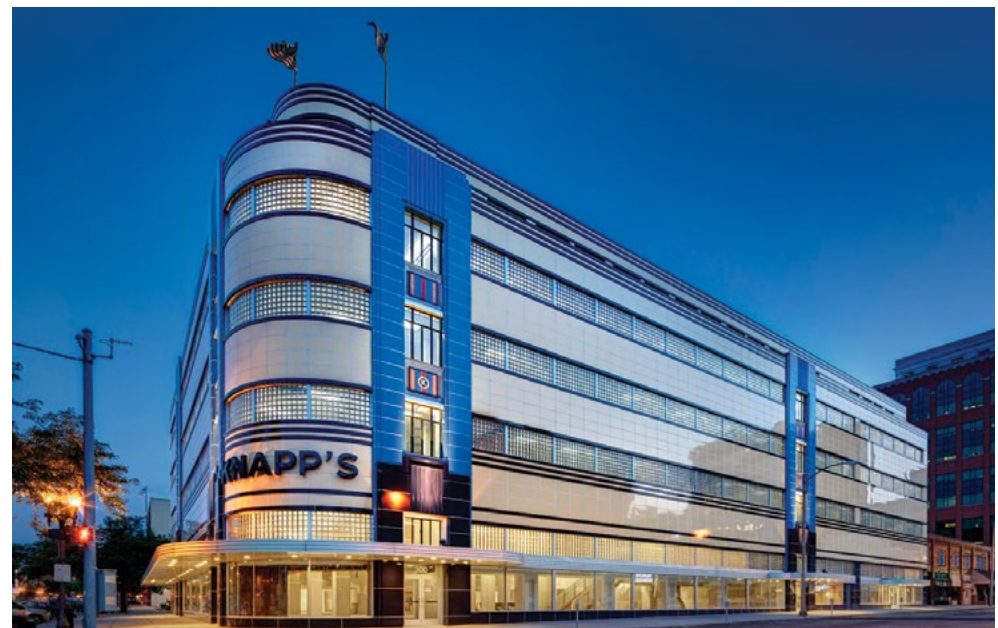
## MASONRY: STONE, BRICK, TERRA COTTA, CONCRETE, ADOBE, STUCCO, AND MORTAR

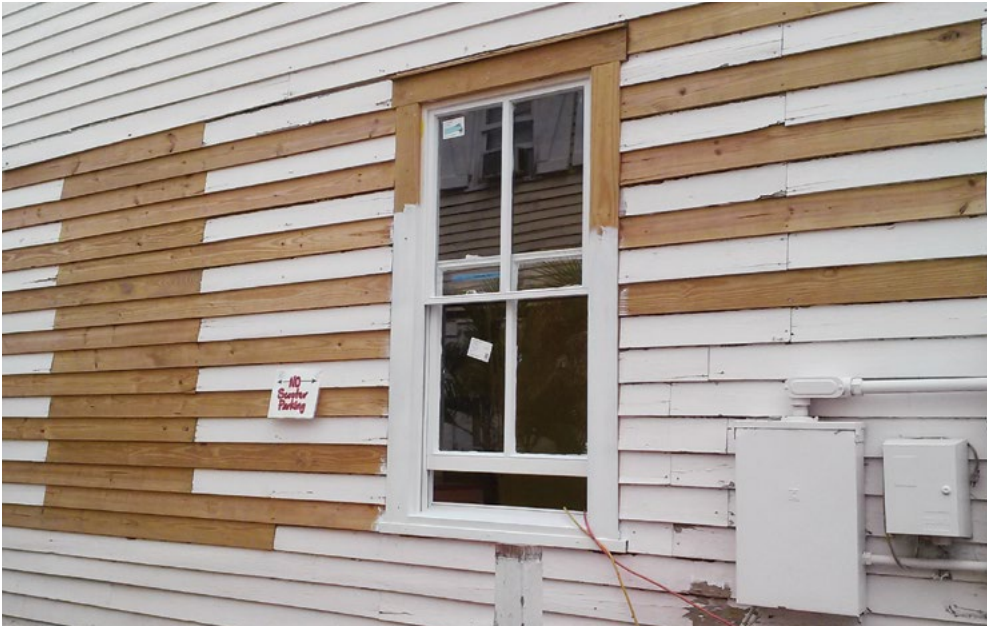
[8] Rotted clapboards have been replaced selectively with new wood siding to match the originals.

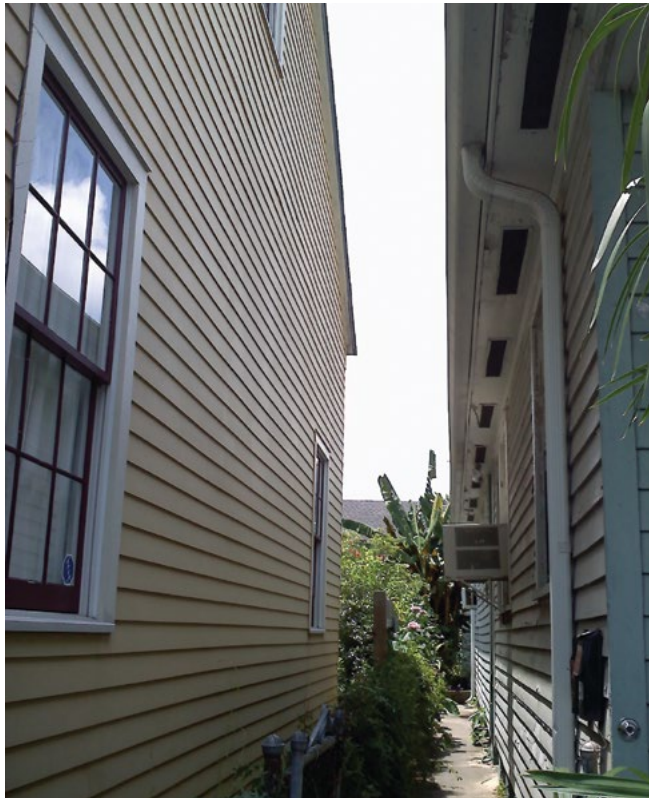
[9] Smooth-surfaced cementitious siding (left) may be used to replace deteriorated wood siding only on secondary elevations that have minimal visibility.

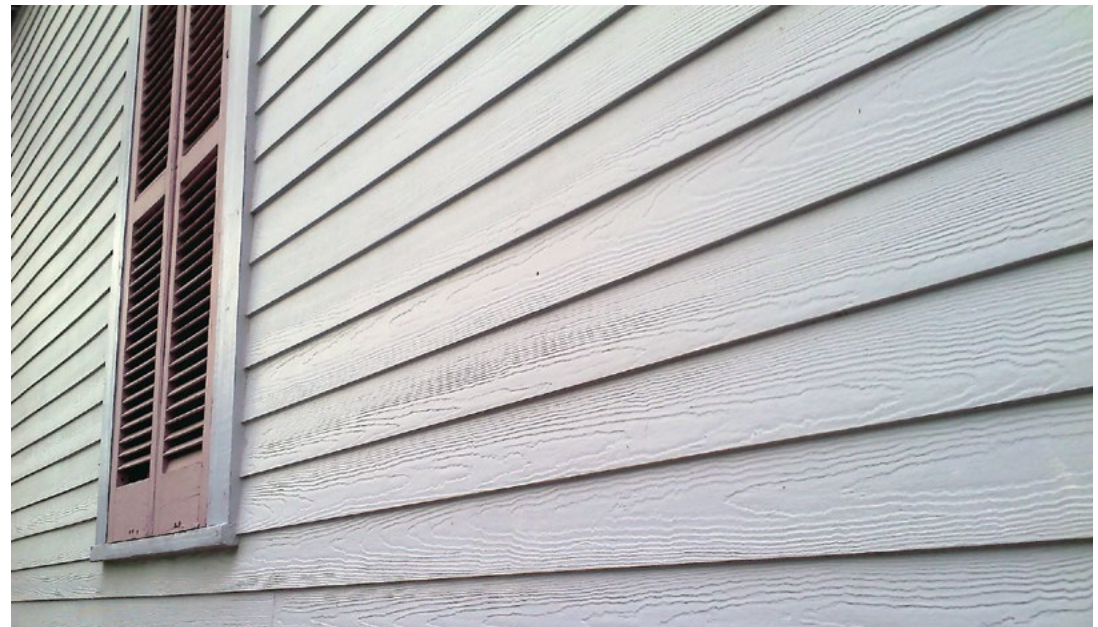
**WOOD: CLAPBOARD, WEATHERBOARD, SHINGLES, AND OTHER FUNCTIONAL AND DECORATIVE ELEMENTS**

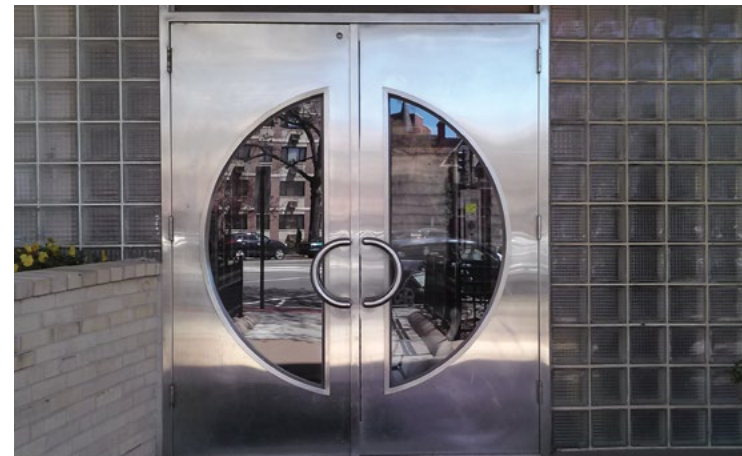
**METALS: WROUGHT AND CAST IRON, STEEL, PRESSED METAL, TERNEPLATE, COPPER, ALUMINUM, AND ZINC**

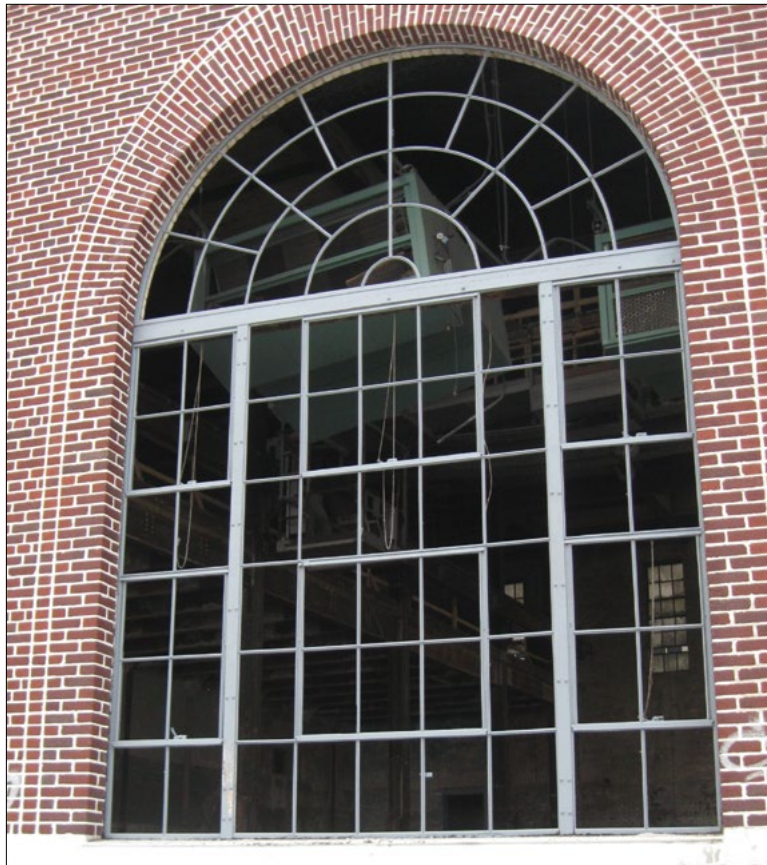
[12] This historic steel window has been cleaned, repaired, and primed in preparation for painting and reglazing.

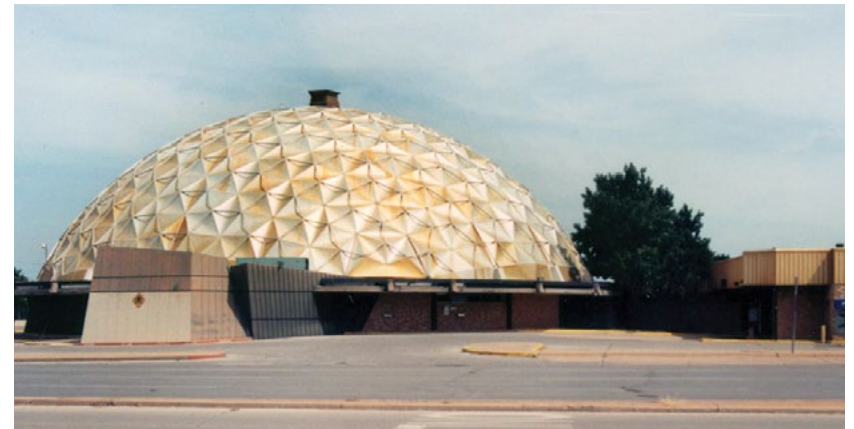
[13] The gold-colored, anodized aluminum geodesic dome of the former Citizen's State Bank in Oklahoma City, OK, built in 1958 and designed by Robert Roloff, makes this a distinctive mid-20th century building.

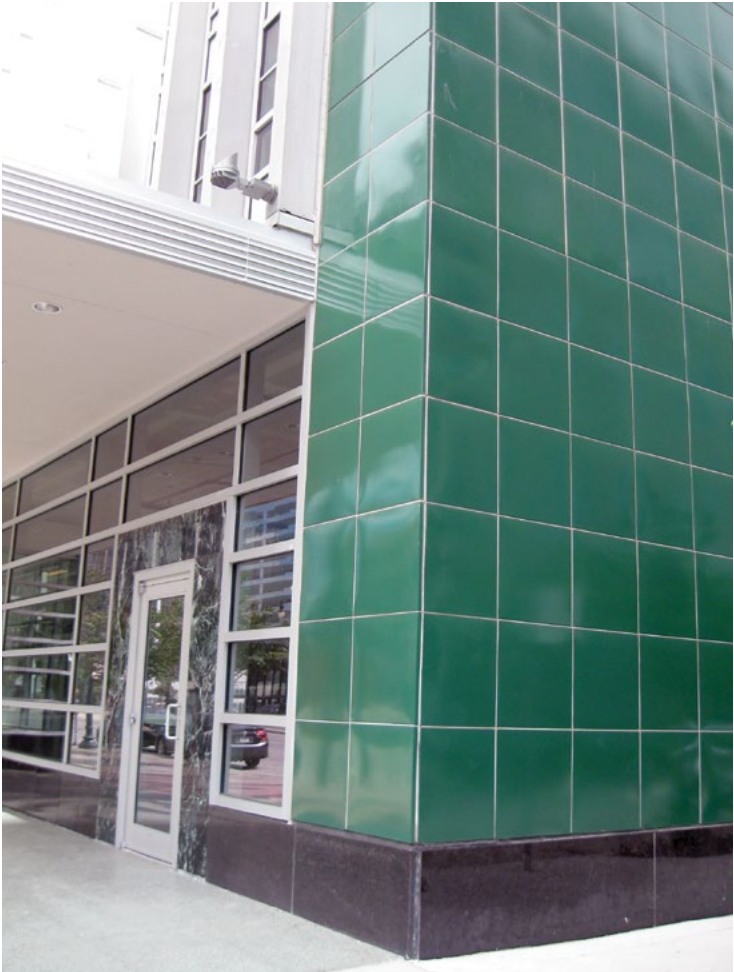
[15] New enameled-metal panels were replicated to replace the original panels, which were too deteriorated to repair, when the storefront of this early 1950s building was recreated.

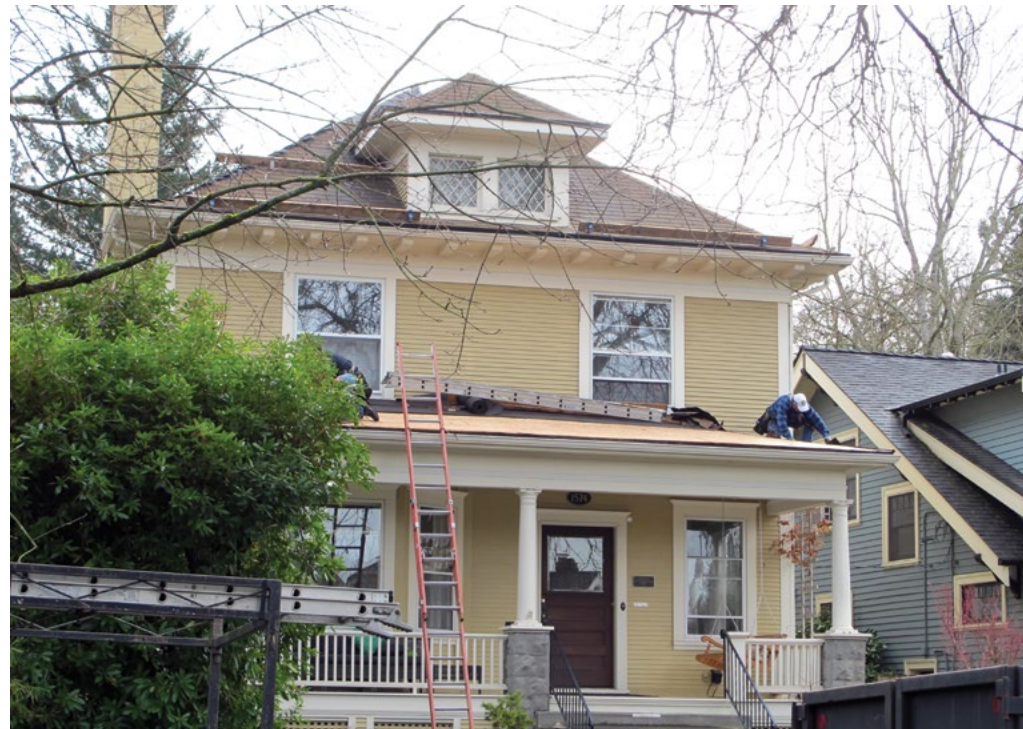
[16] The deteriorated asphalt shingles of this porch roof are being replaced in kind with matching shingles.

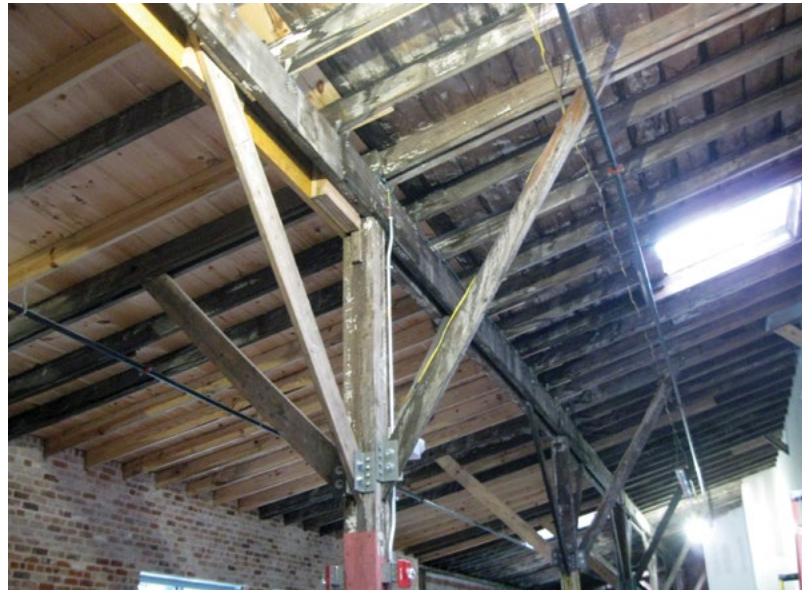
[17] New wood elements have been used selectively to replace rotted wood on the underside of the roof in this historic warehouse.

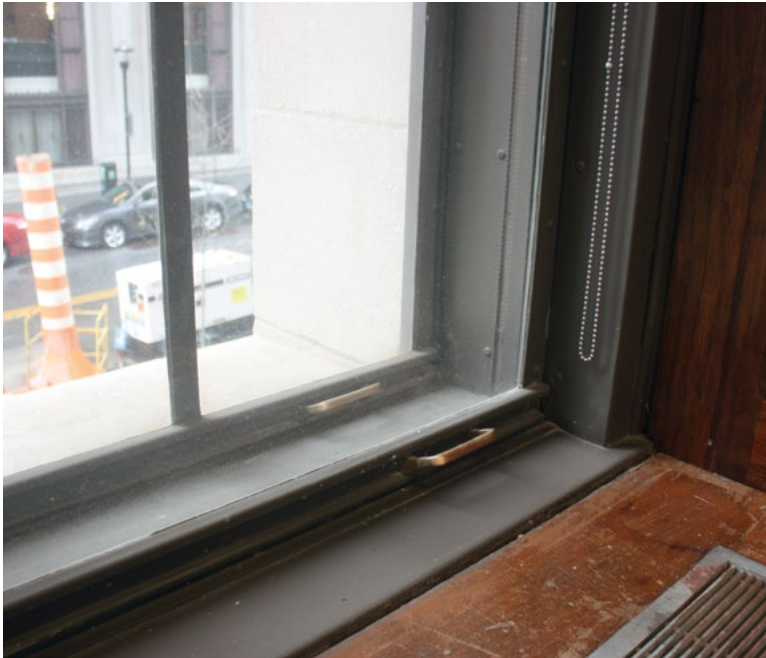
[18] The historic metal storm windows in this 1920s office building were retained and repaired during the rehabilitation project.

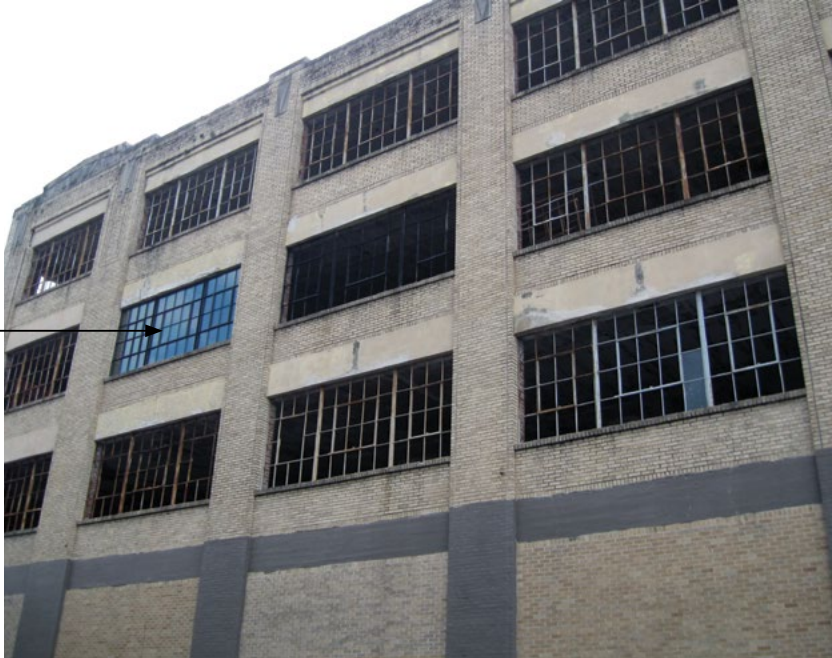
[19] Installing a mockup of a proposed replacement window can be helpful to evaluate how well the new windows will match the historic windows that are missing or too deteriorated to repair.

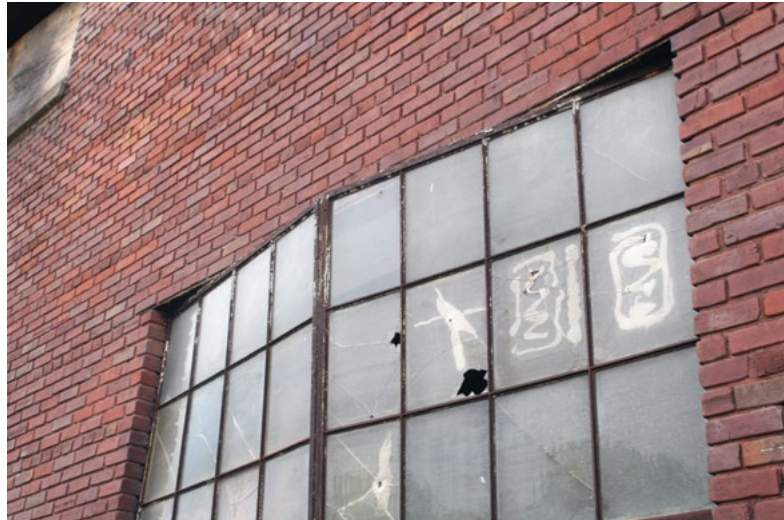
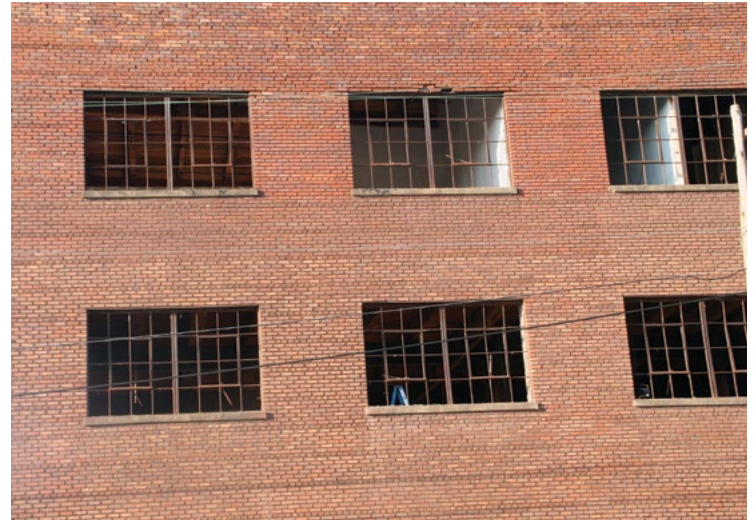
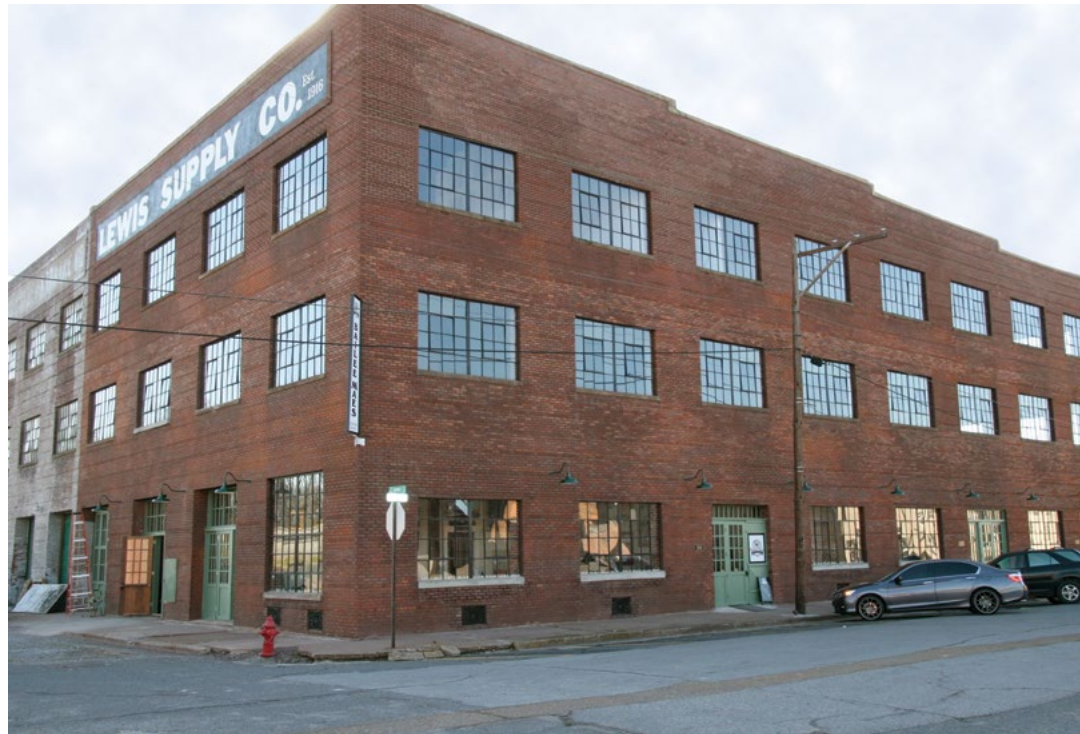
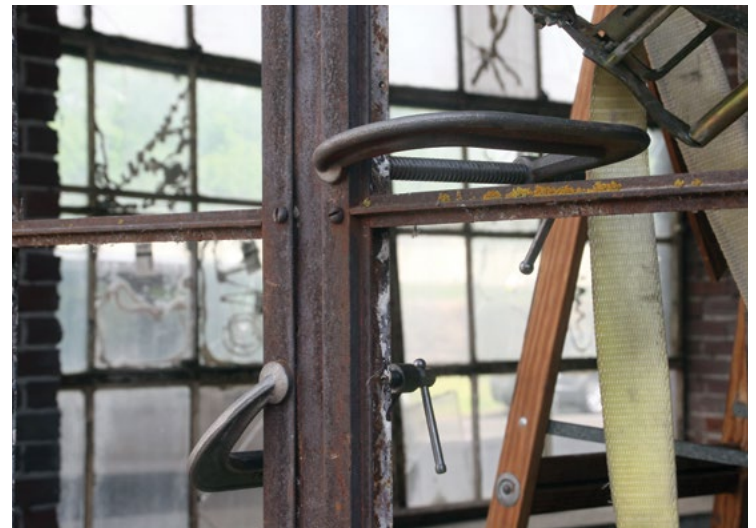
[20 a-d] The original steel windows in this industrial building were successfully repaired as part of the rehabilitation project (left).

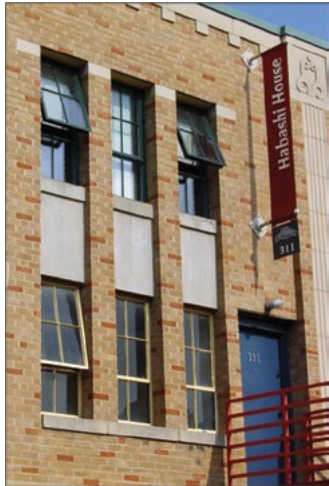
[21] The windows on the lower floor, which were too deteriorated to repair, were replaced with new steel windows matching the upper-floor historic windows that were retained.

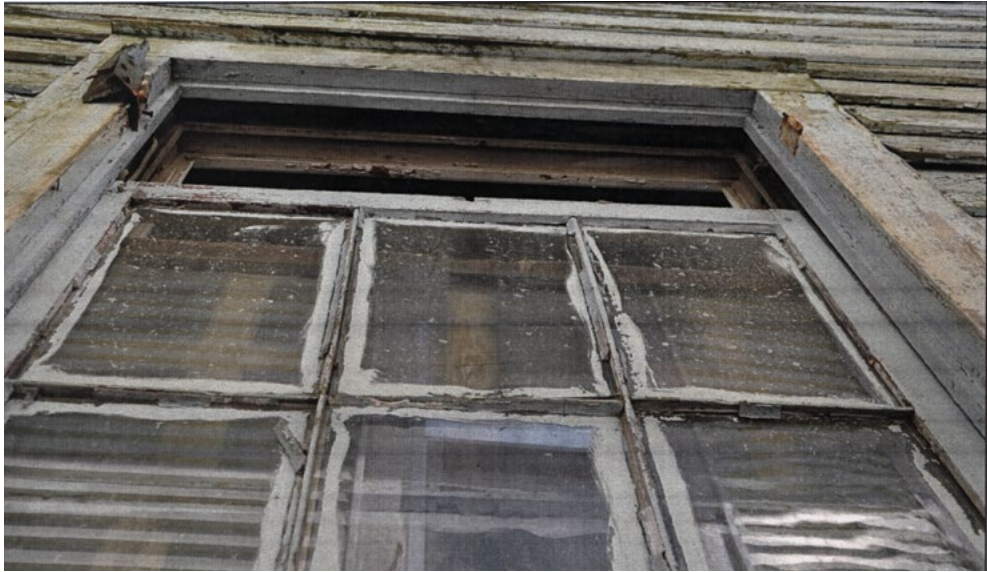
[23] (a) This deteriorated historic wood window was repaired and retained (b) in this rehabilitation project.

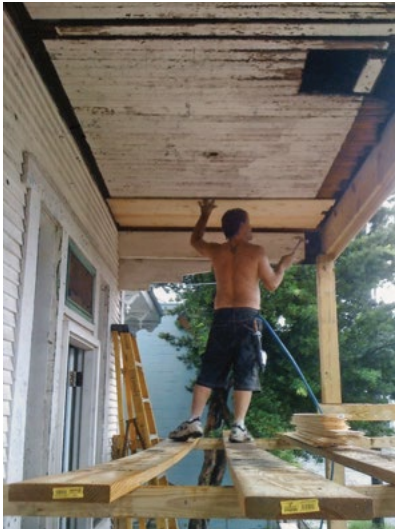
[24] Rotted boards in the beaded-board porch ceiling are being replaced with new matching beaded board.

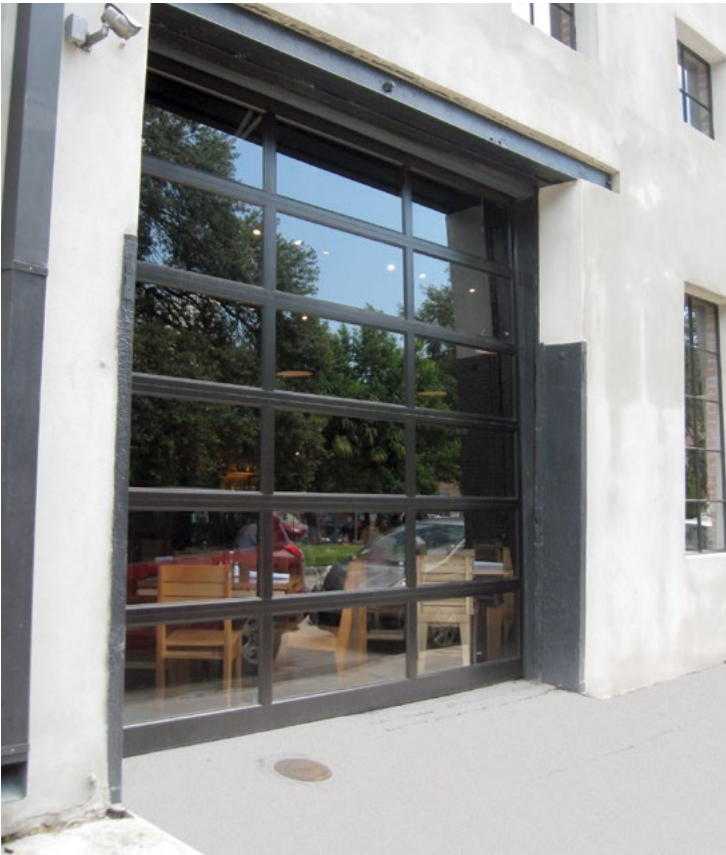
[25] The new infill designs for the garage door openings in this commercial building (a) converted for restaurant use and in this mill building (b) rehabilitated for residential use are compatible with the historic character of the buildings.

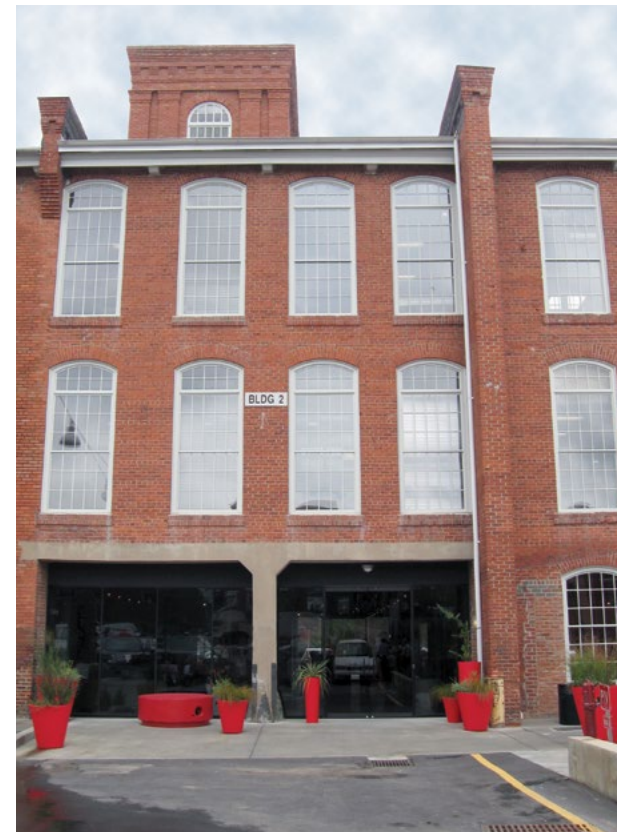
## ENTRANCES AND PORCHES

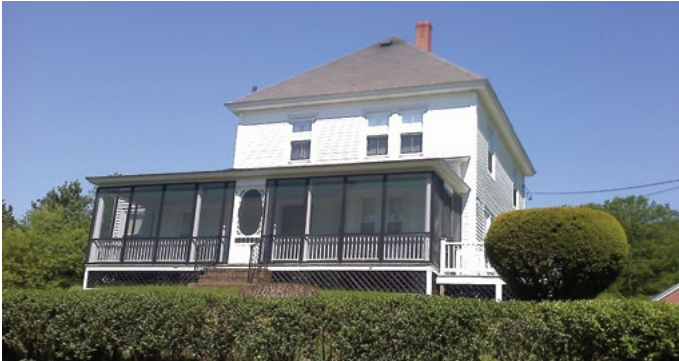
[26] **Not Recommended:** Installing a screened enclosure is never recommended on a front or otherwise prominent historic porch. In limited instances, it may be possible to add screening on a porch at the rear or on a secondary façade; however, the enclosure should match the color of the porch and be placed behind columns and railings so that it does not obscure these features.

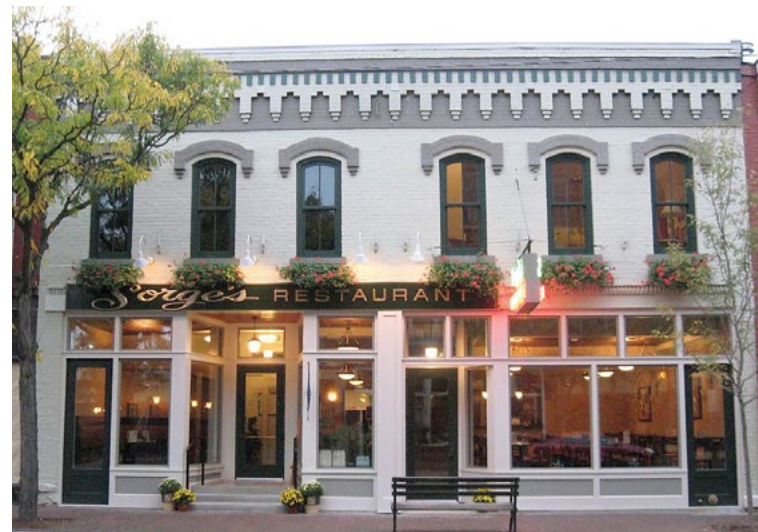
[28] This new storefront, which replaced one that was missing, is compatible with the historic character of the building.

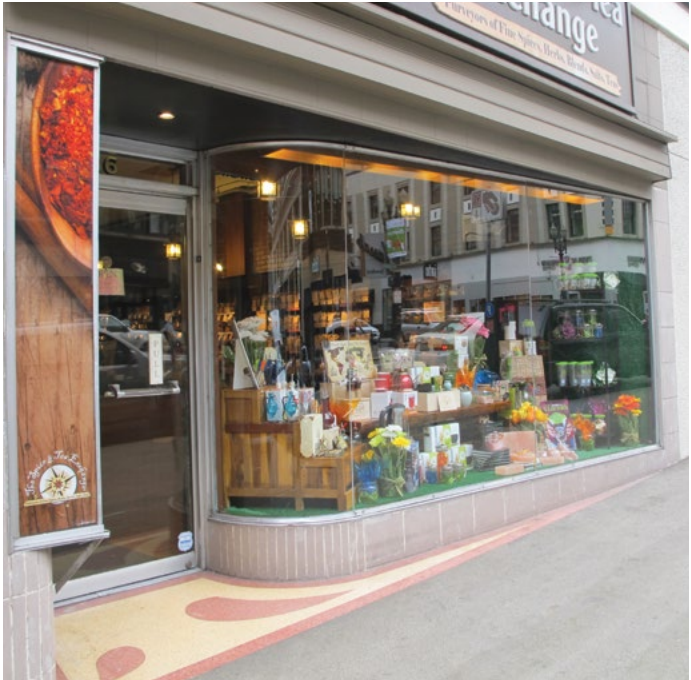
[27] This original c. 1940s storefront, with its character-defining angled and curved glass display window and recessed entrance with a decorative terrazzo paving, is in good condition and should be retained in a rehabilitation project.

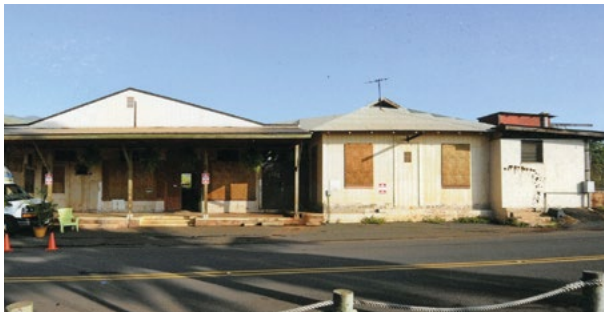
[29] The rehabilitation of the 1910 Māālaea General Store (a), which served the workers' camp at the Wailuku Sugar Company on the Hawaiian island of Maui, included the reconstruction of the original parapet (b).
