## **HISTORICAL COMMISSION SPECIAL MEETING AGENDA**

**7:00 PM - Monday, August 08, 2022**

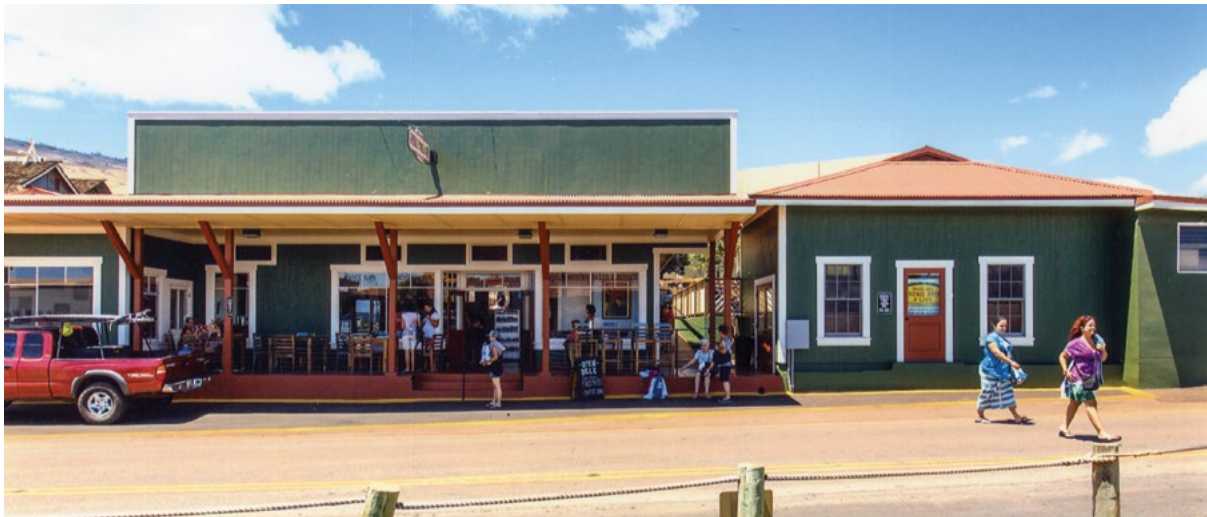
[29] The rehabilitation of the 1910 Māālaea General Store (a), which served the workers' camp at the Wailuku Sugar Company on the Hawaiian island of Maui, included the reconstruction of the original parapet (b).

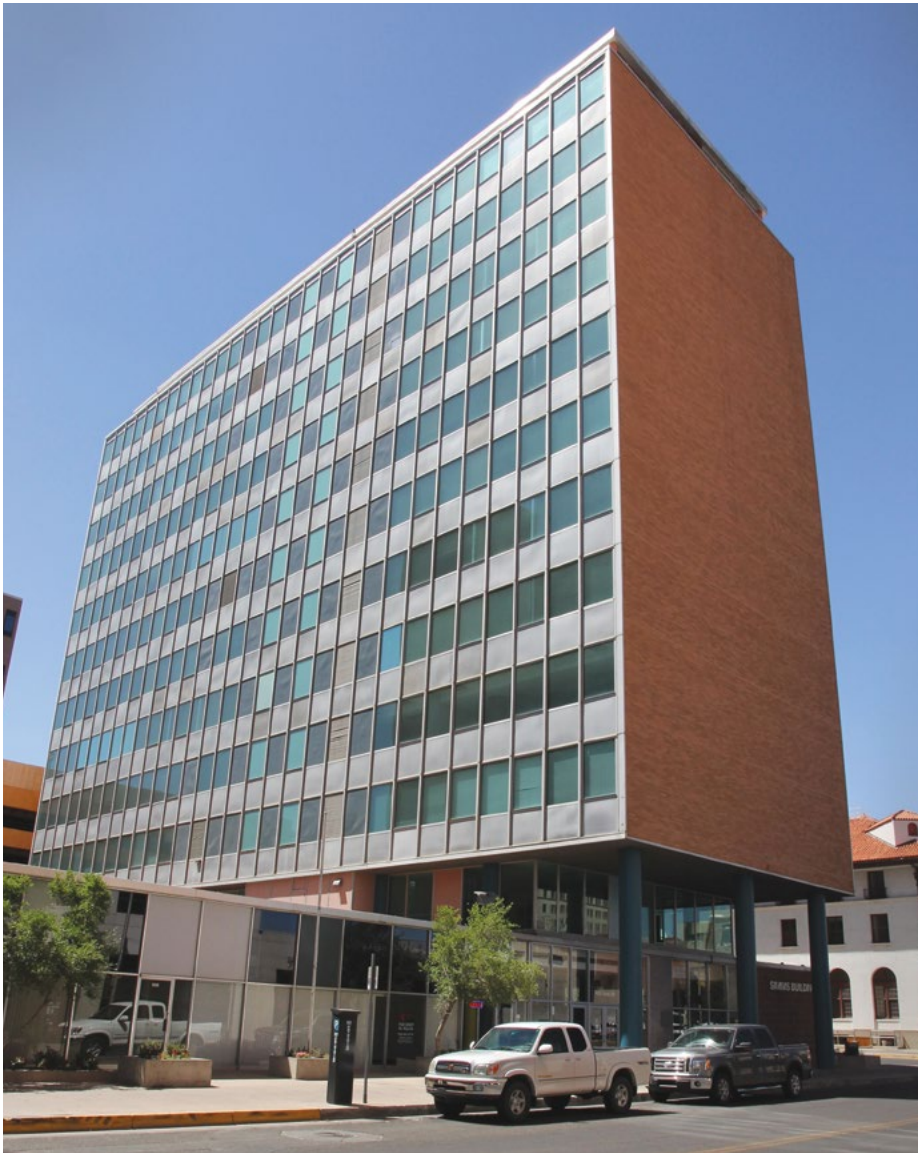
[30] Rather than replace the original curtain wall system of the 1954 Simms Building in Albuquerque, NM, with a different color tinted glass or coat it with a non-historic reflective film, the HVAC system was updated to improve energy efficiency. Photo: Harvey M. Kaplan.

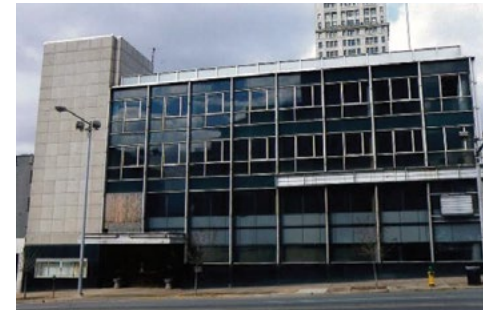
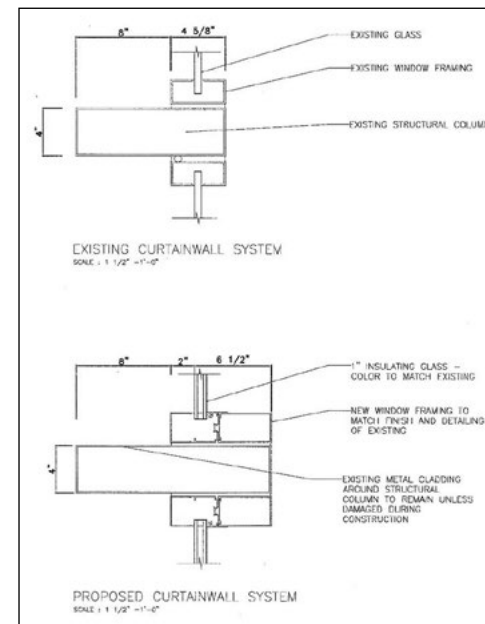
[31 a-c:] (a) The rehabilitation of the First Federal Savings and Loan Association building in Birmingham, AL, constructed in 1961, required replacing the deteriorated historic curtain wall system because the framing and the fasteners holding the spandrel glass and the windows had failed. (b) Comparative drawings show that the differences between the replacement system, which incorporated new insulated glass to meet wind-load requirements, and the original system are minimal. (c) The replacement system, shown after completion of the project, has not altered the historic character of the building.

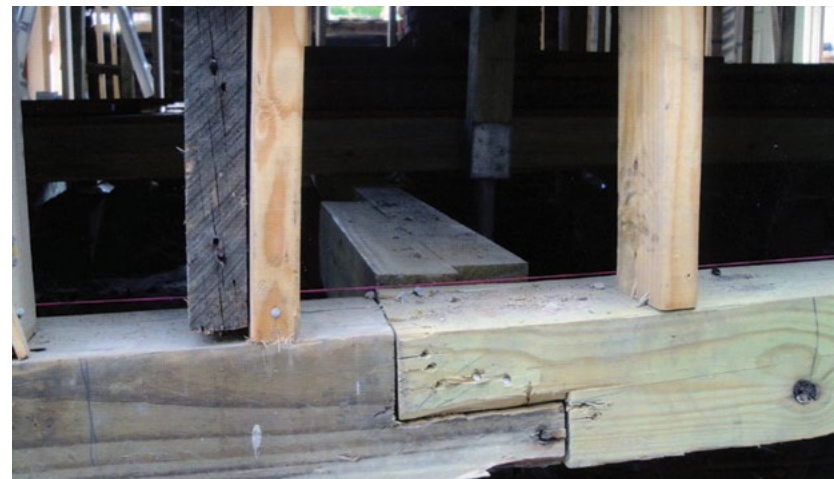
## STRUCTURAL SYSTEMS

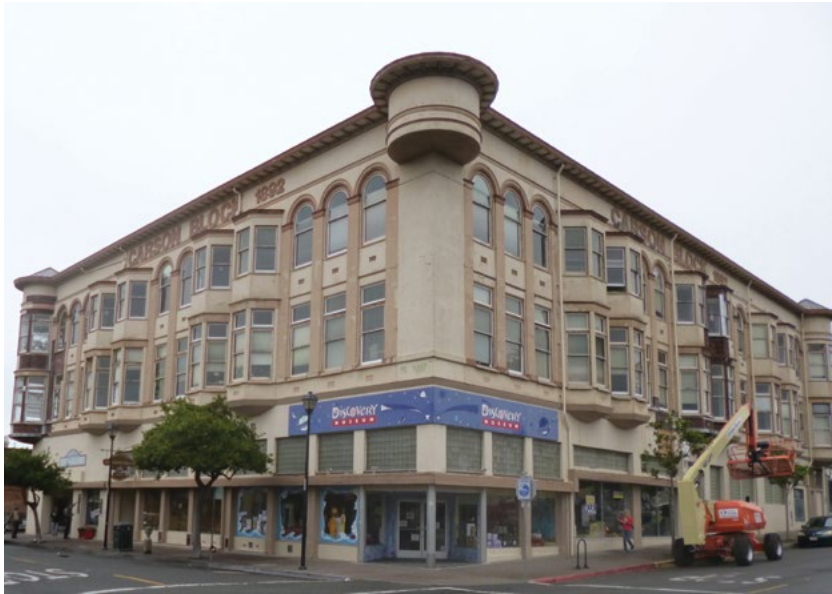
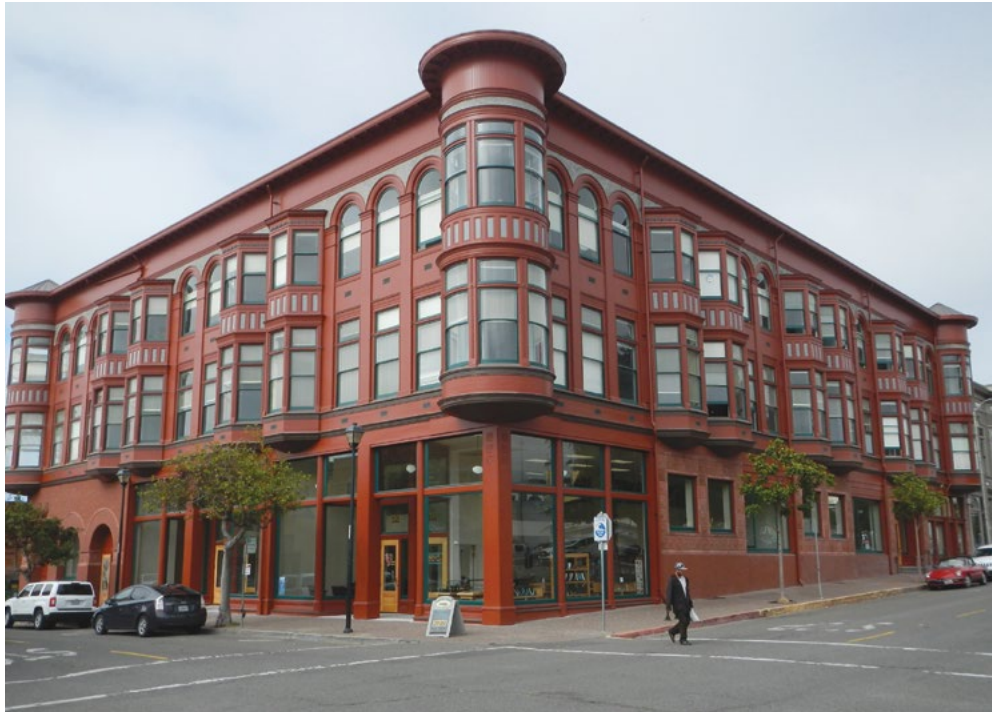
[32] (a-b) The rehabilitation of the 1892 Carson Block Building in Eureka, CA, for its owner, the Northern California Indian Development Council, included recreating the missing corner turret and sensitively introducing seismic reinforcement (c) shown here (opposite page) in a secondary upper floor office space. Photos: Page & Turnbull.

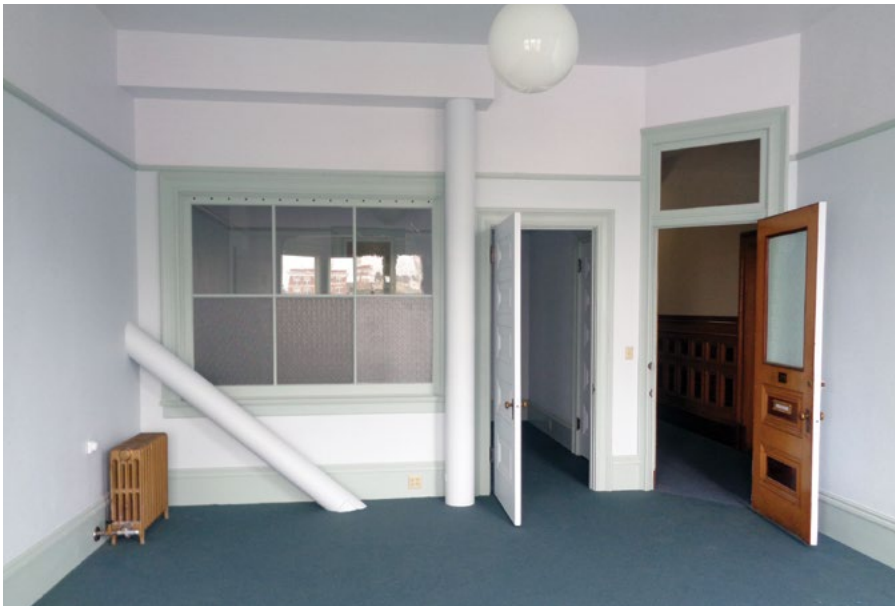
## STRUCTURAL SYSTEMS

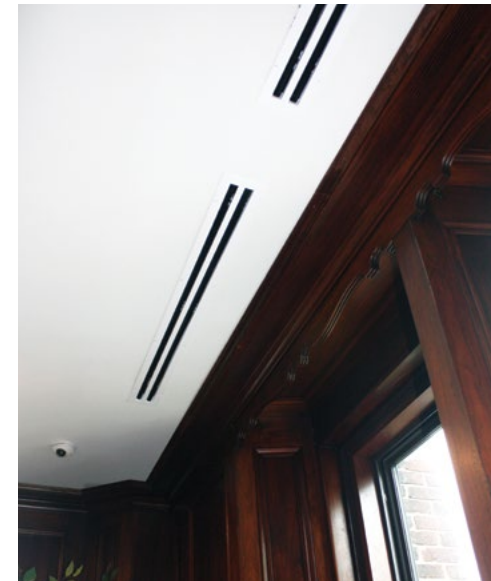
## INTERIOR SPACES, FEATURES, AND FINISHES

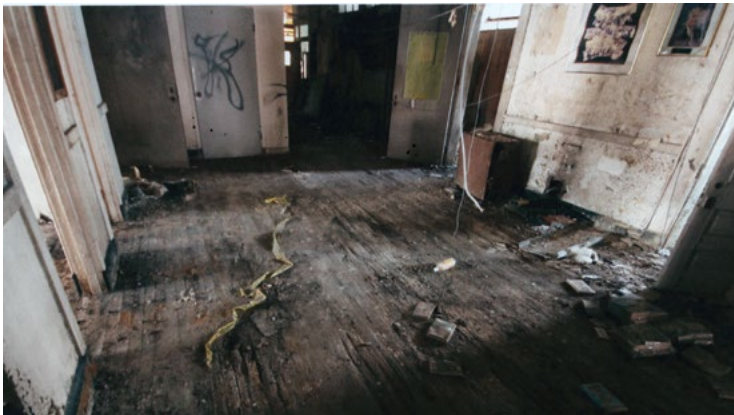
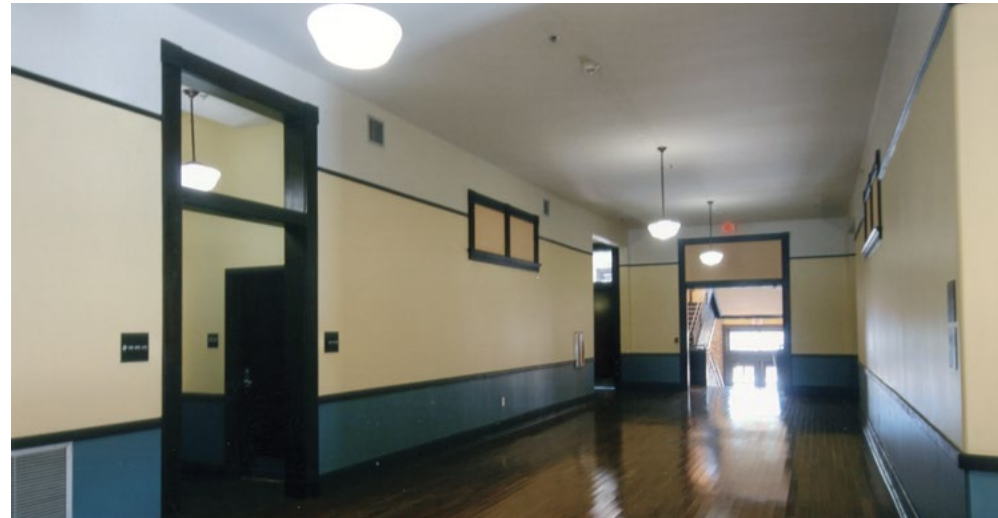
[35] (a) Although deteriorated, the historic school corridor, shown on the left, with its character-defining features, including doors and transoms, was retained and repaired as part of the rehabilitation project (b).

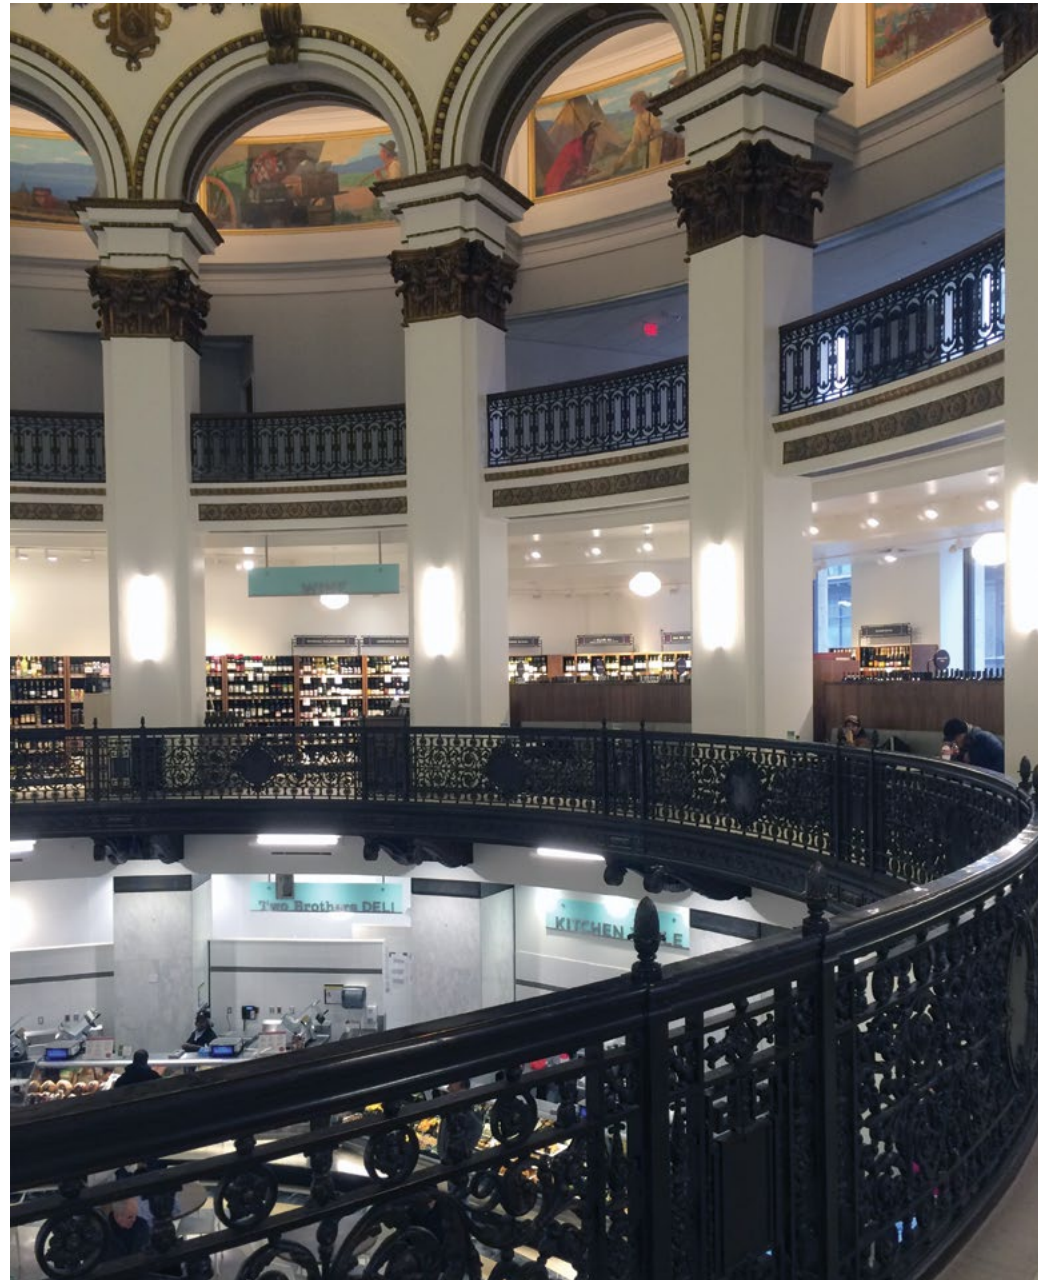
[36] The elaborate features and finishes of this historic banking hall in the Union Trust Company Building, in Cleveland, OH, were retained and repaired as part of its conversion into a food market.

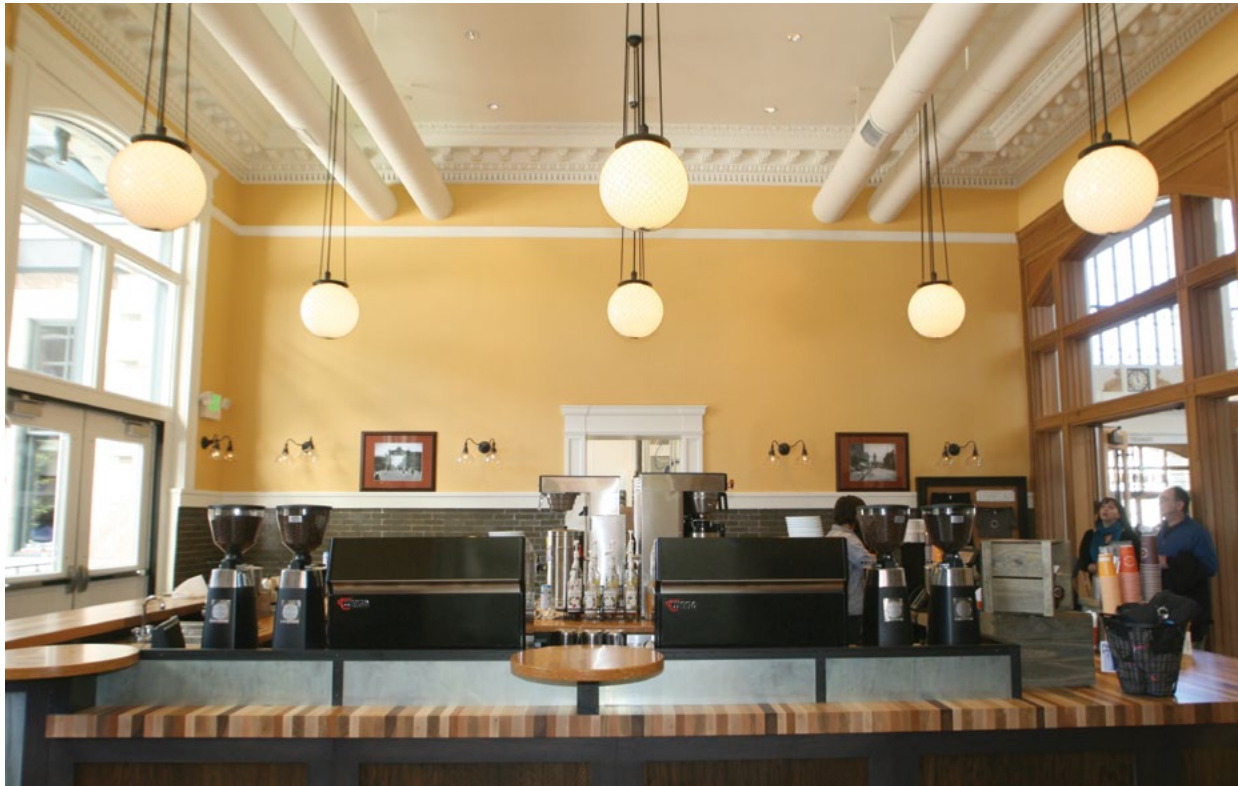
[37] Exposed and painted ducts were appropriately installed here in a retail space in Denver's historic Union Station after considering other options that would have impacted the ceiling height, or damaged or obscured the ornamental plaster crown molding. *Photo: Heritage Consulting Group.*

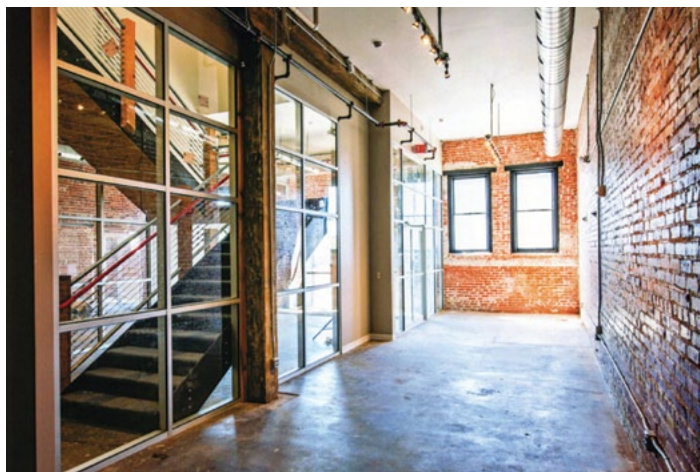
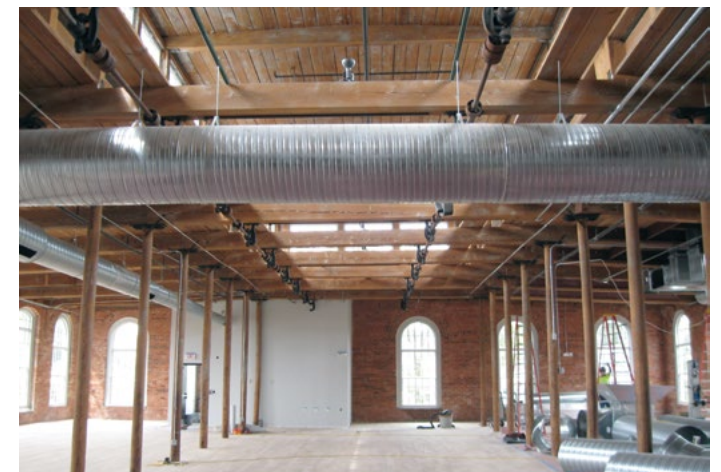
[39] Leaving the ceiling structure exposed and installing exposed ductwork where it does not impact the windows, are appropriate treatments when rehabilitating an industrial building for another use.

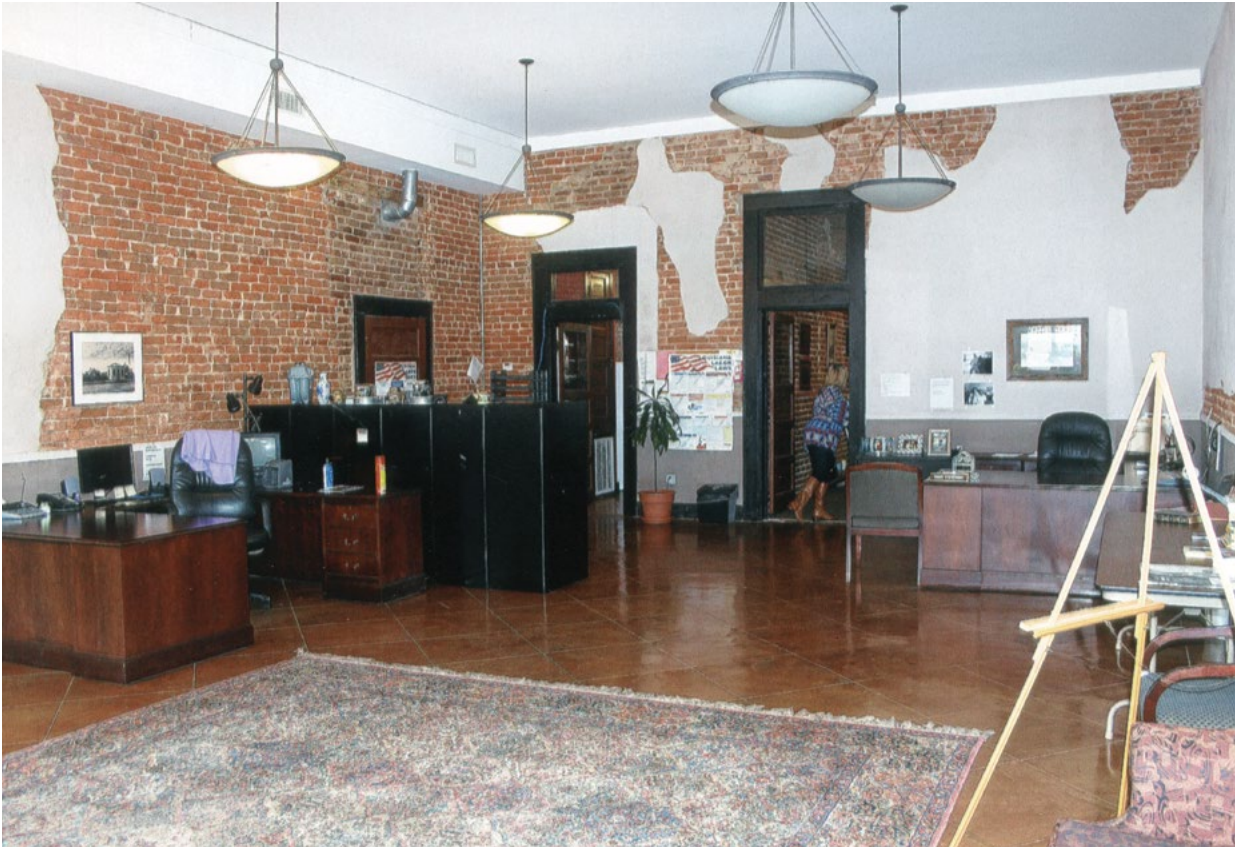
**[41] Not Recommended:**  
Leaving fragments of deteriorated or "sculpted" plaster is not a compatible treatment for either finished or unfinished interior spaces.

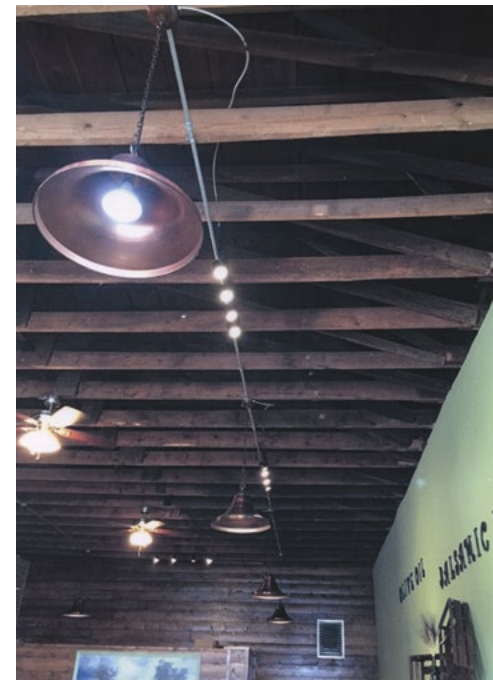
**INTERIOR SPACES, FEATURES, AND FINISHES**

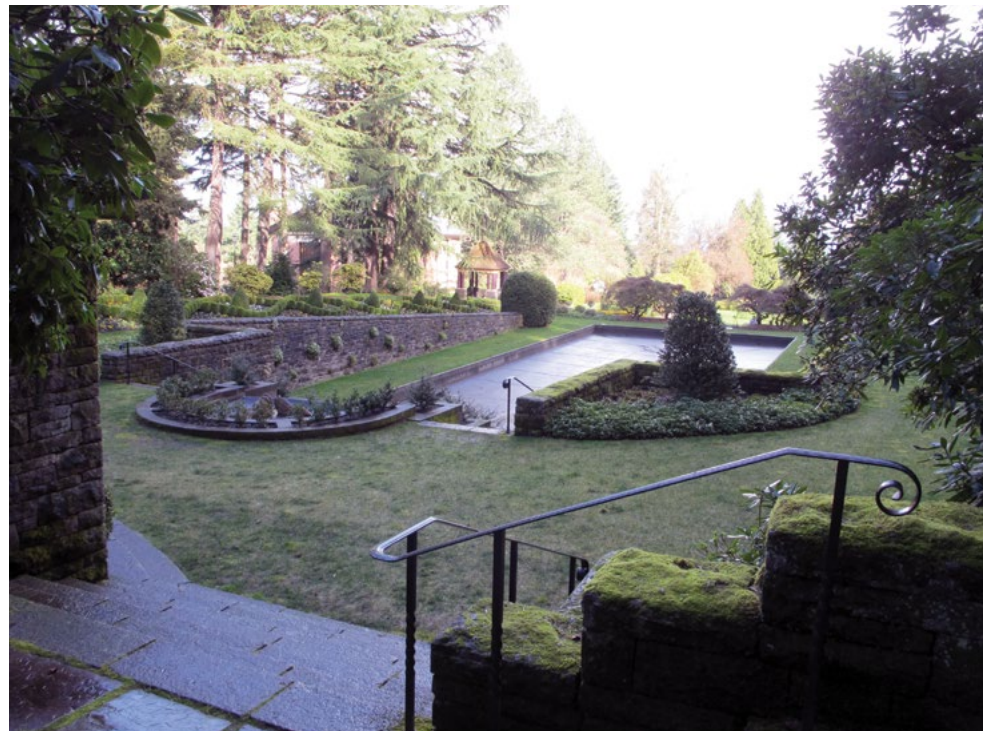
[42] This garden is an important character-defining landscape feature on this college campus.

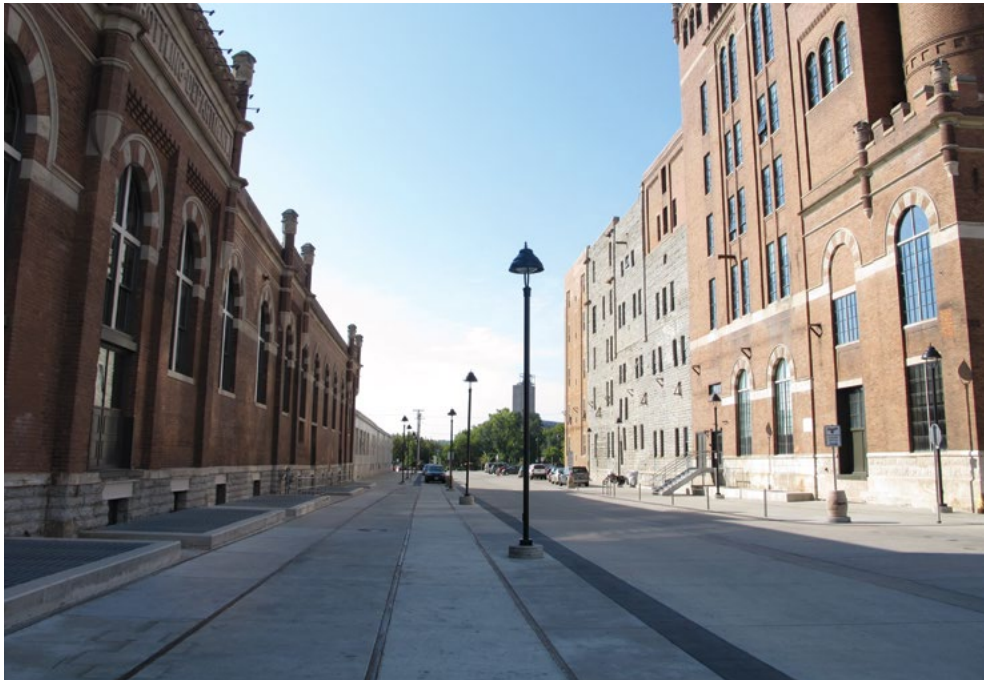
[43] The industrial character of the site was retained when this brewery complex was rehabilitated for residential use.

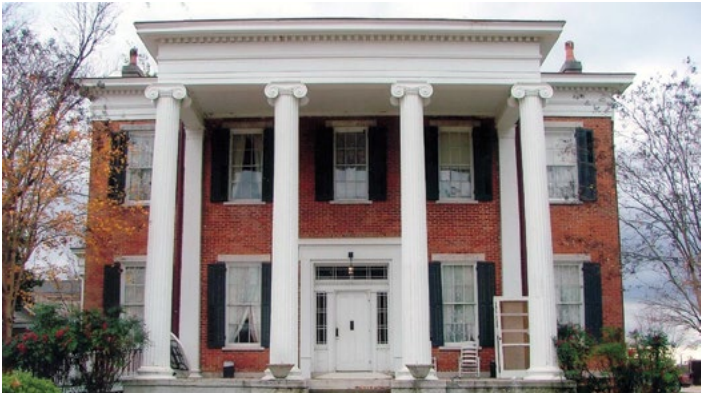
[44] **Not Recommended:** (a-b) The historic character of this plantation house (marked in blue on plan on opposite page) and its site was diminished and adversely impacted when multiple new buildings like this (#3 on plan) were constructed on the property (c).

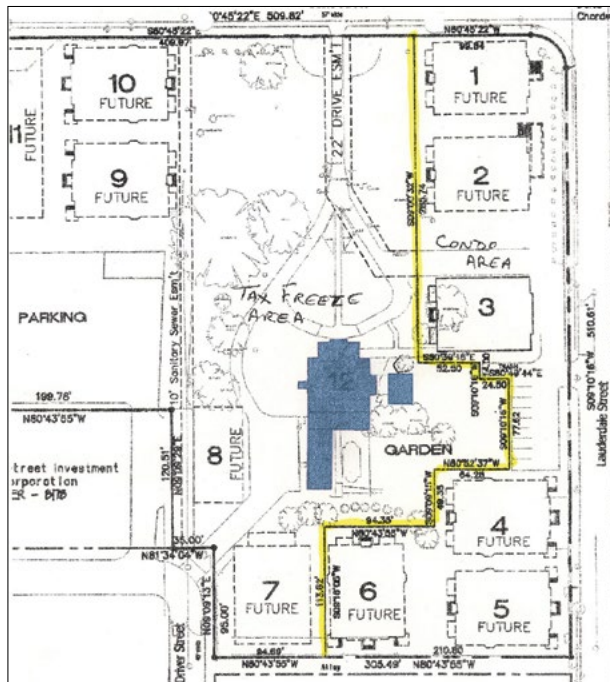
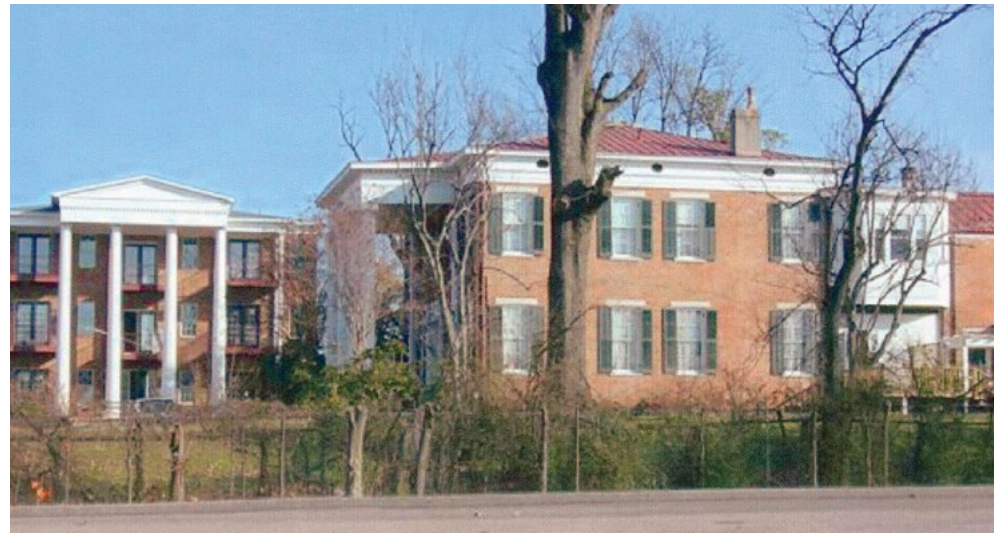
Adding conjectural landscape features to the site (such as period reproduction light fixtures, fences, fountains, or vegetation) that are historically inappropriate, thereby creating an inaccurate appearance of the site.

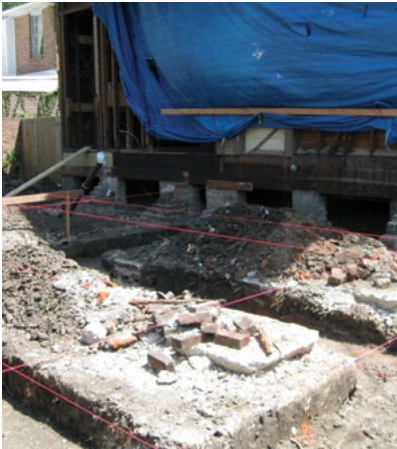
[45] Undertaking a survey to document archeological resources may be considered in some rehabilitation projects when a new exterior addition is planned.

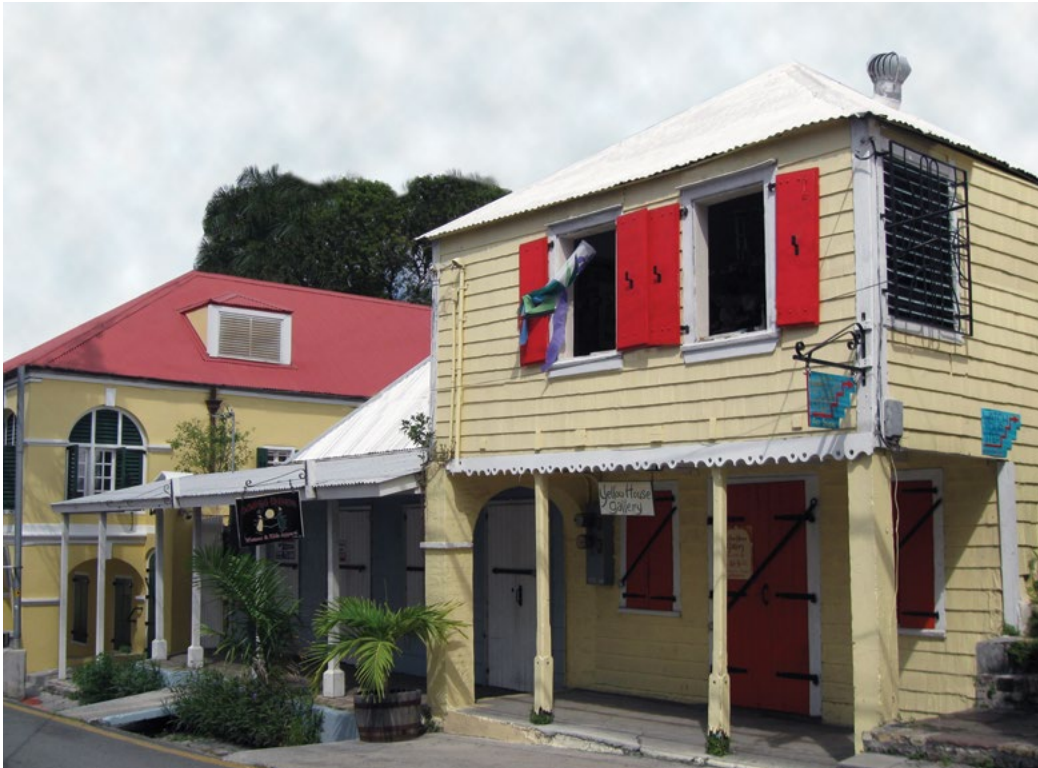
[46] The varied size, shapes, and architectural styles of these historic buildings are unique to this street in Christiansted, St. Croix, USVI, and should be retained in a rehabilitation project.

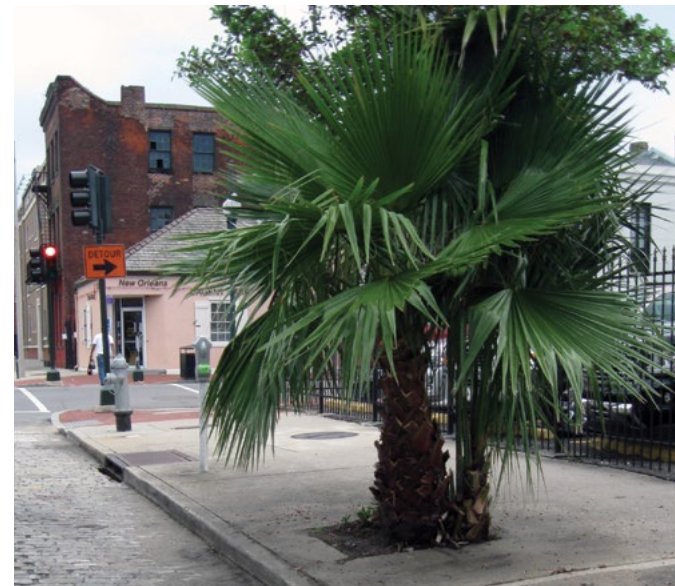
**SETTING (DISTRICT / NEIGHBORHOOD)**

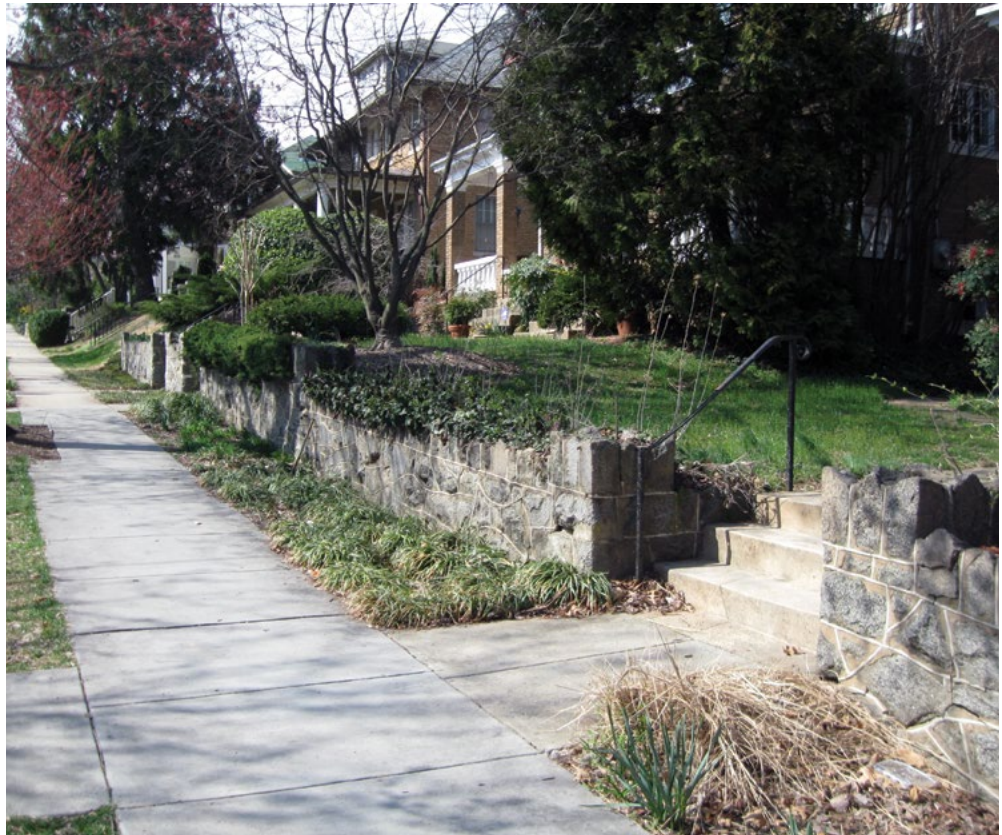
## SETTING (DISTRICT / NEIGHBORHOOD)

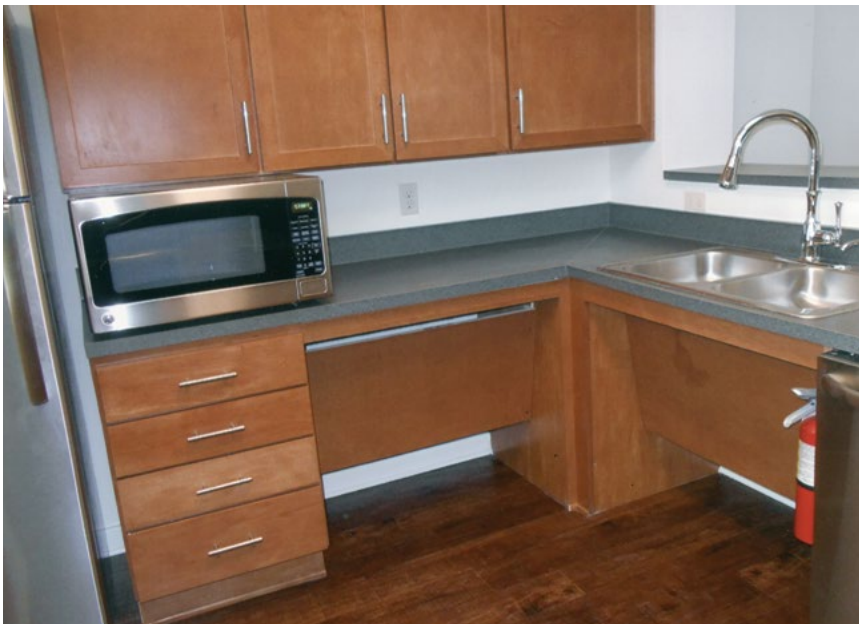
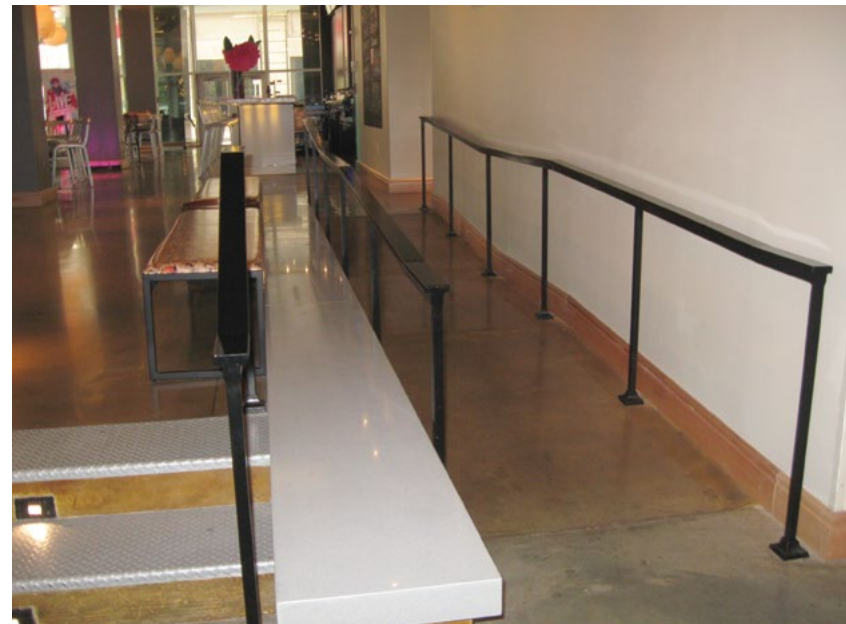
**CODE-REQUIRED WORK**

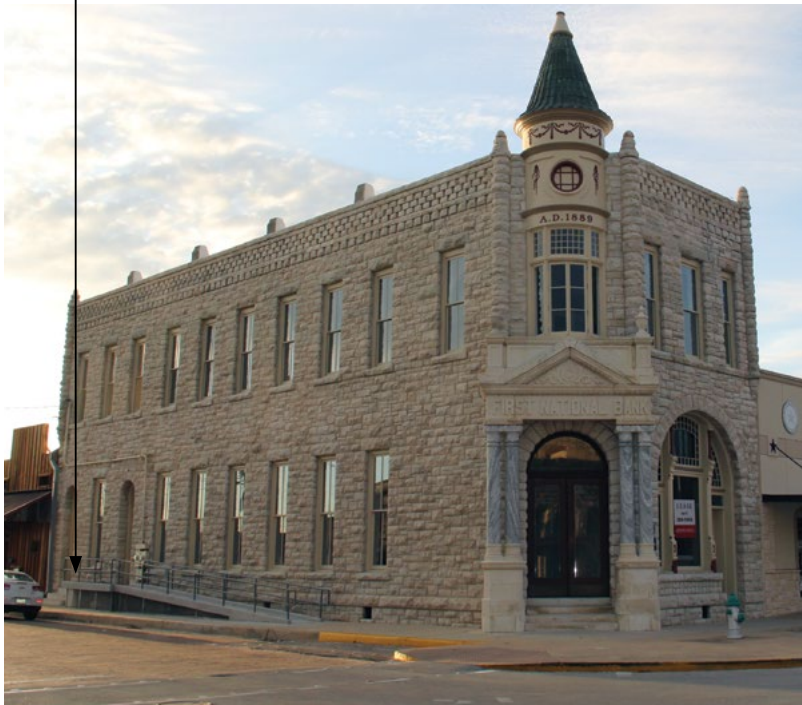
[53] This entrance ramp (right) is compatible with the historic character of this commercial building.

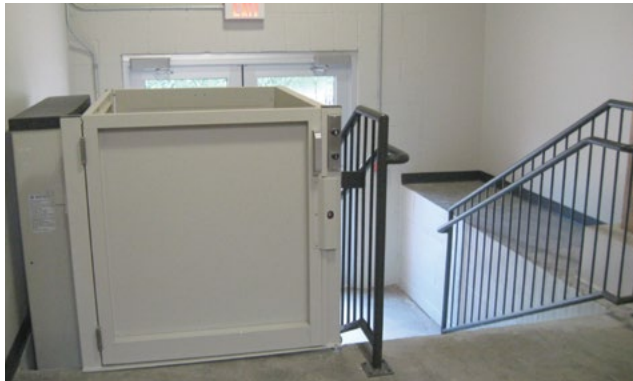
[55] The lift is compatible with the industrial character of this former warehouse.

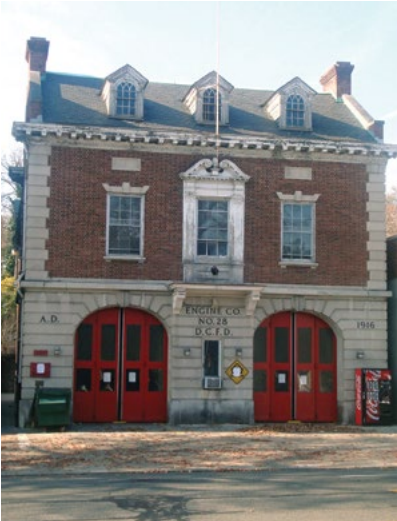
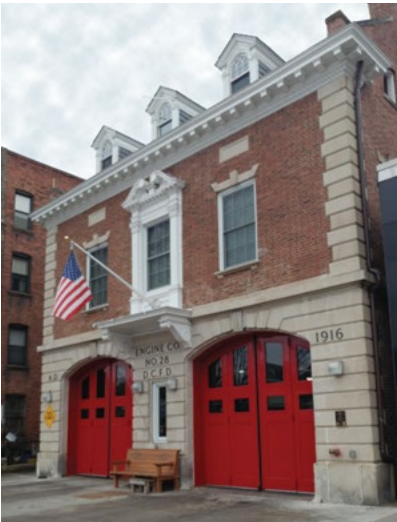
[56 a-b] In order to continue in its historic use, the door openings of this 1916 Colonial Revival-style fire station had to be widened to accommodate the larger size of modern fire trucks. Although this resulted in some change to the arched door surrounds, it is minimal and does not negatively impact the historic character of the building. (a) Above, before; Photo: Fire and Emergency Medical Services Department (FEMS), Washington, D.C.; below, after.

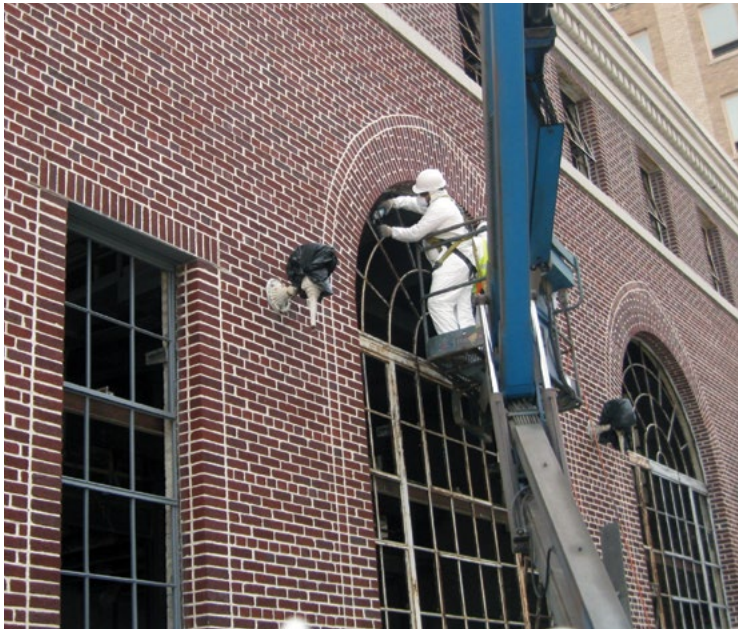
[57] Workers wear protective clothing while removing lead paint from metal features.

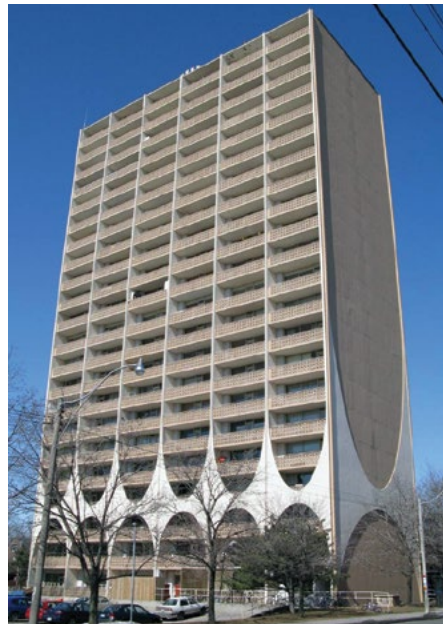
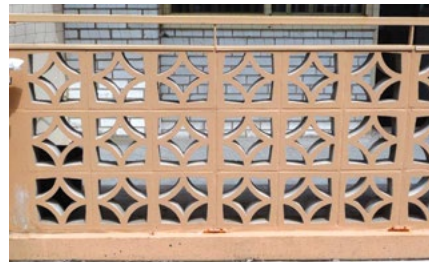
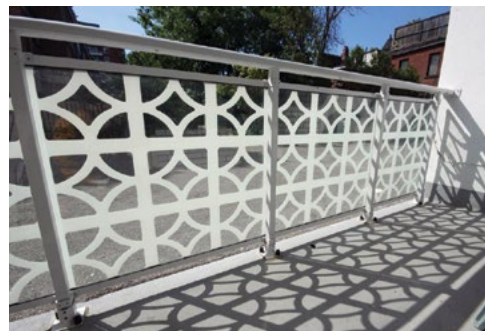
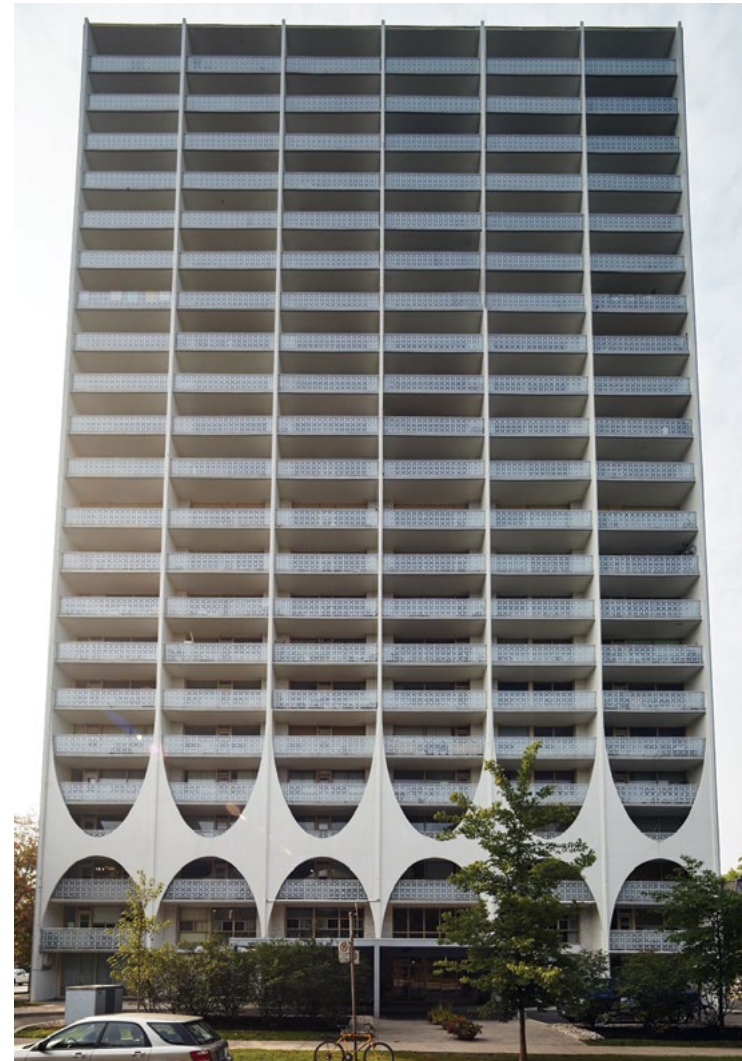
[59] (a-b) The decorative concrete balcony railings on this 1960s building did not meet life-safety code requirements. They were replaced with new glass railings with a fritted glass pattern matching the original design—a creative solution that satisfies codes, while preserving the historic appearance of the building when viewed from the street (c-d). Photos: (a, b, d) ERA Architects, Inc.; (c) Nathan Cyprys, photographer.

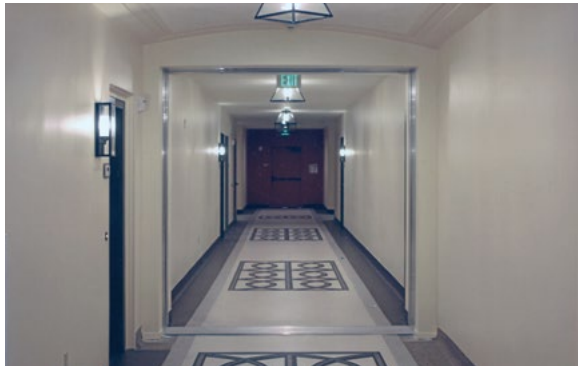
[58] Fire doors that retract into the walls have been installed here (not visible in photo) preserve the historic character of this corridor.

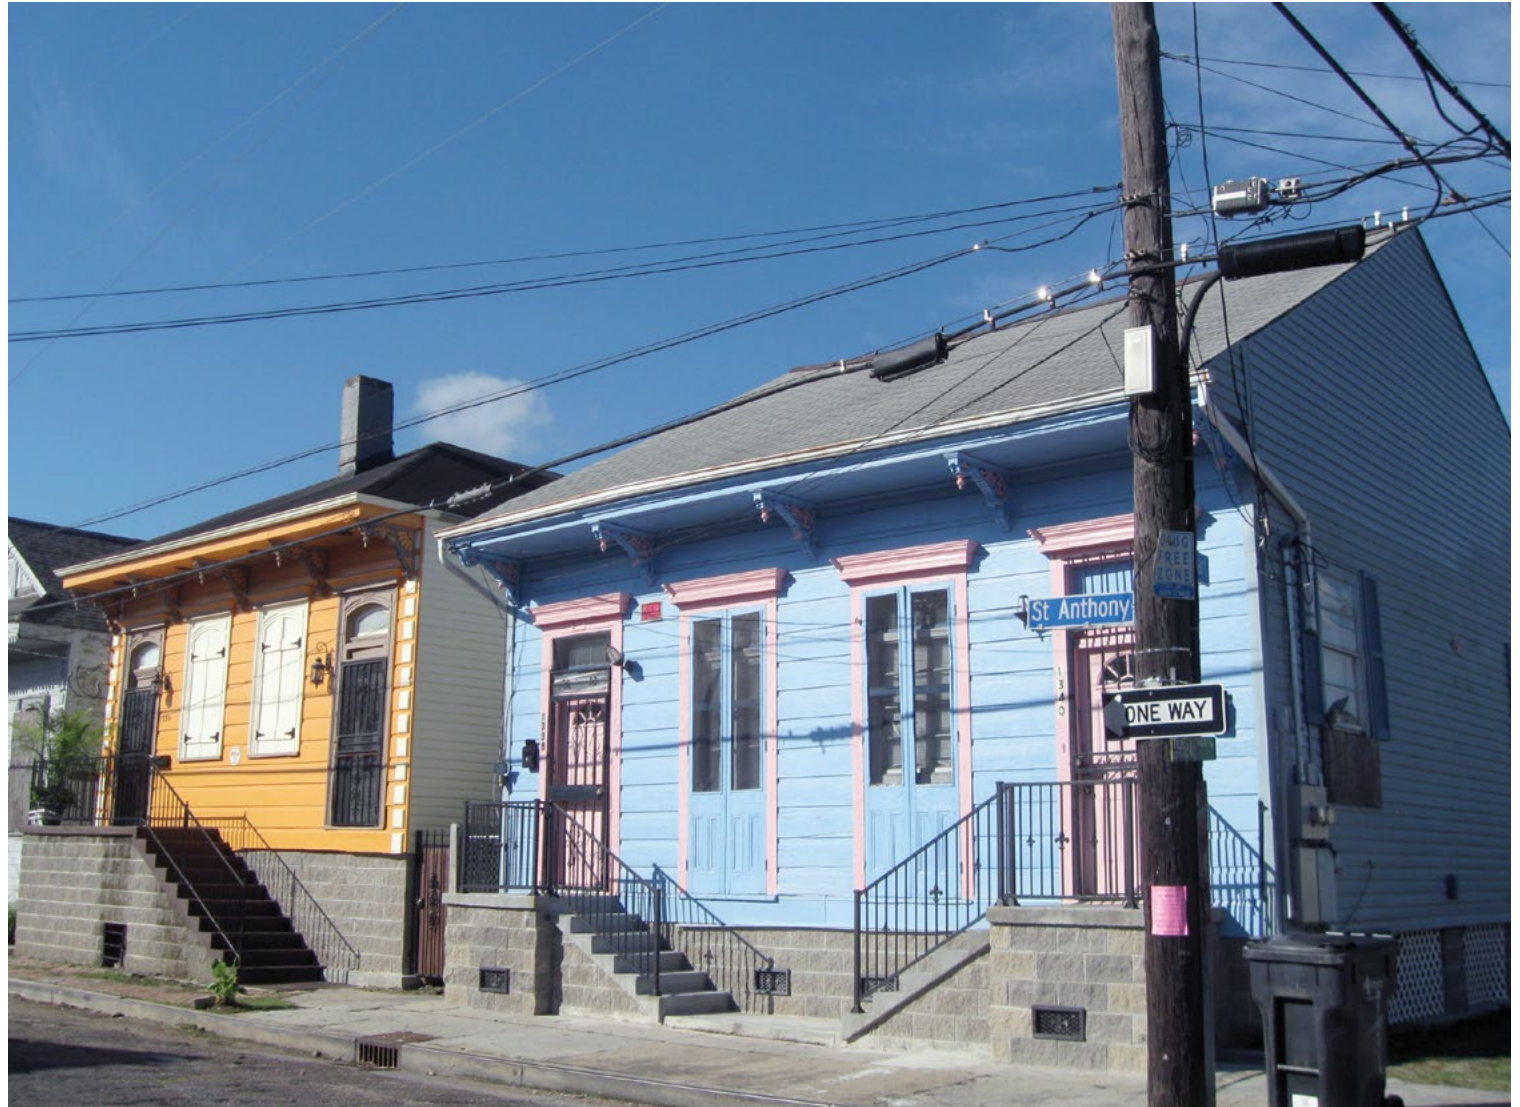
[60] In some instances, it may be necessary to elevate a historic building located in a floodplain to protect it. But this treatment is appropriate only if elevating the building will retain its historic character, including its relationship to the site, and its new height will be compatible with surrounding buildings if in a historic district. The house on the right, which has been raised only slightly, has retained its historic character. The house on the left has been raised several feet higher, resulting in a greater impact on the historic character of the house and the district.
