## **HISTORICAL COMMISSION SPECIAL MEETING AGENDA**

**7:00 PM - Monday, August 08, 2022**

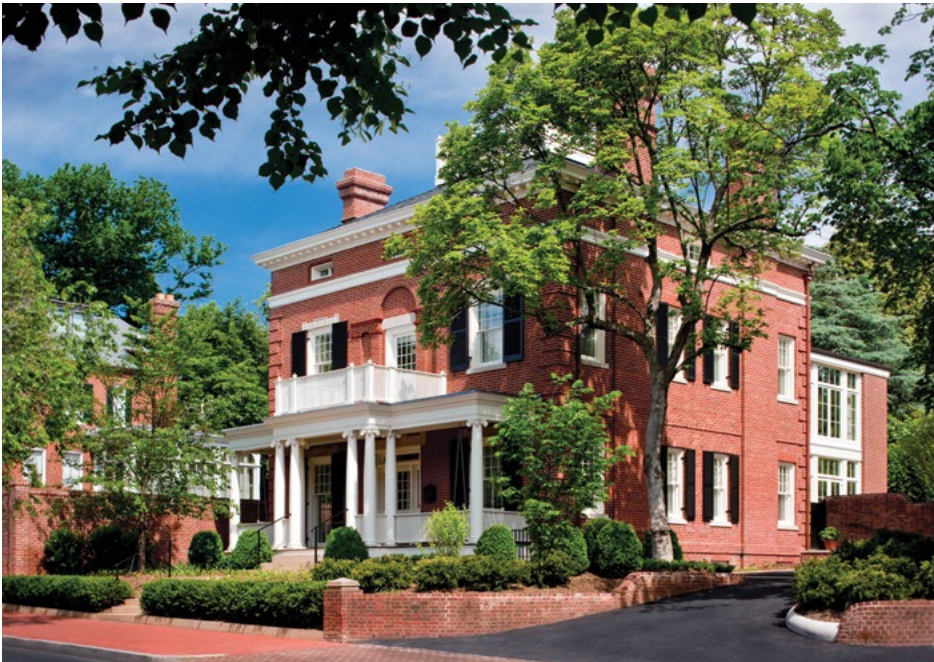
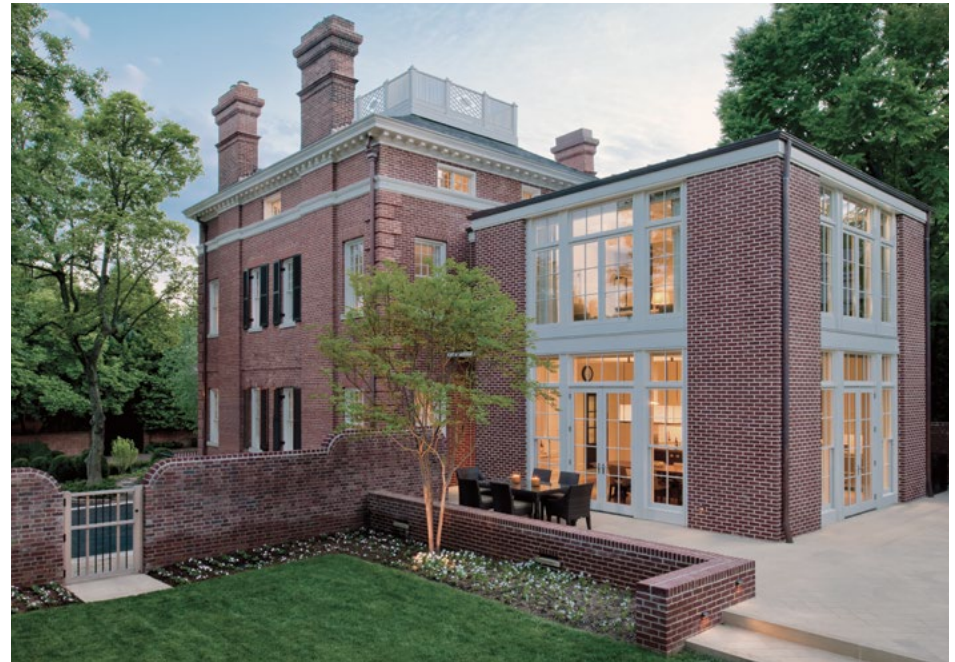
## NEW EXTERIOR ADDITIONS TO HISTORIC BUILDINGS AND RELATED NEW CONSTRUCTION

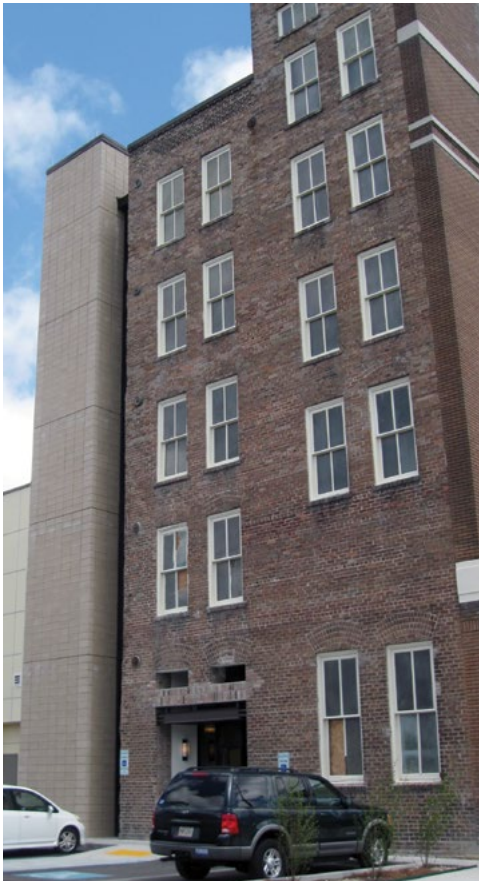
[62] The stair tower at the rear of this commercial building is a compatible new addition.

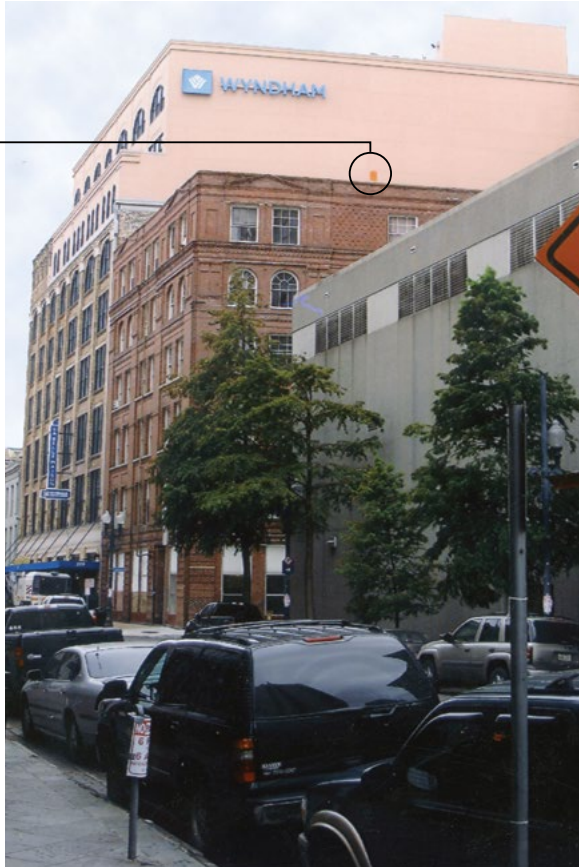
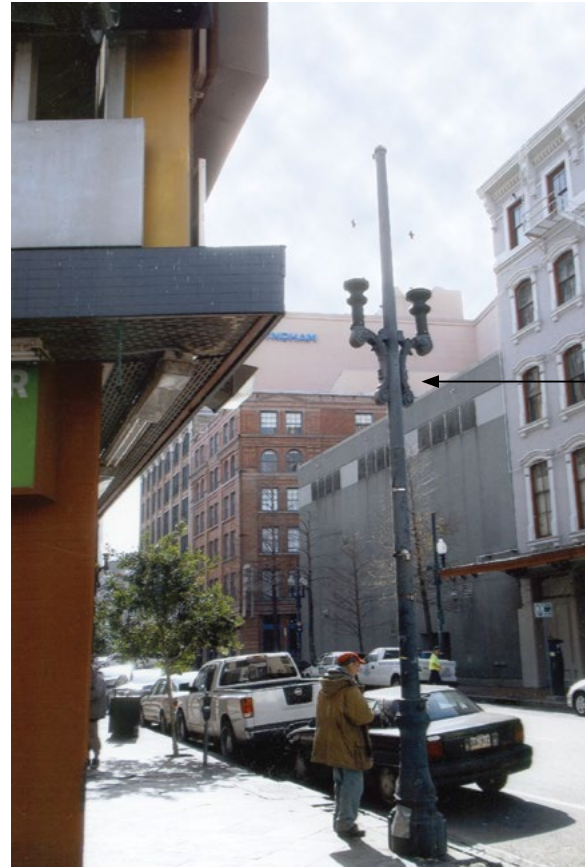
## NEW EXTERIOR ADDITIONS TO HISTORIC BUILDINGS AND RELATED NEW CONSTRUCTION

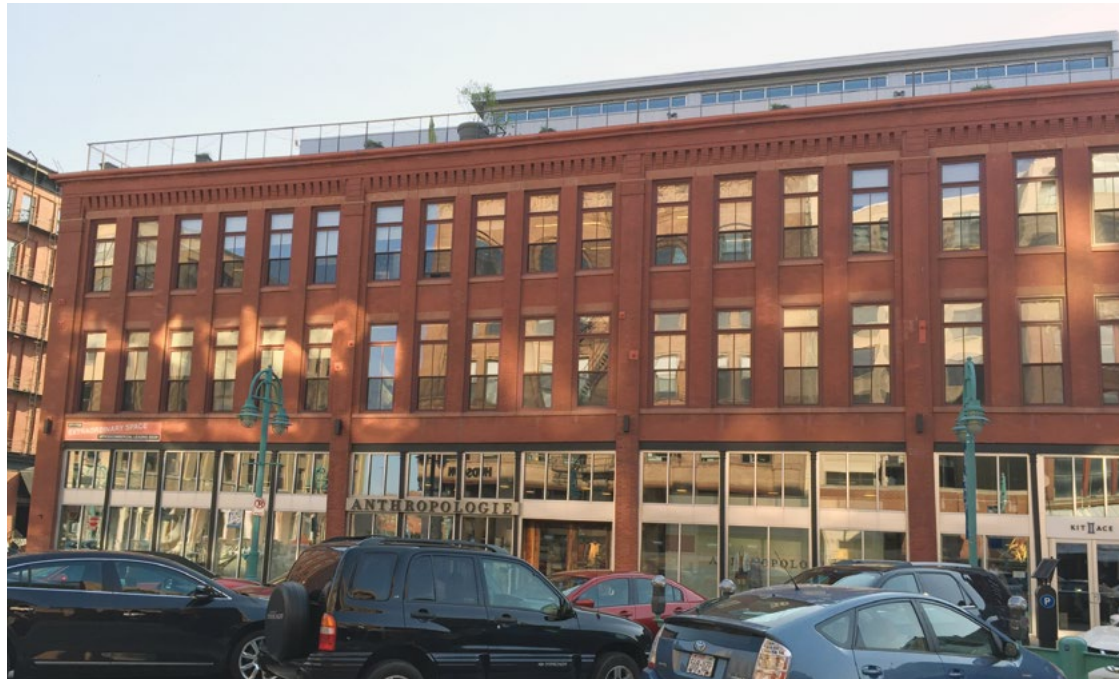
[64] **Not Recommended:** It is generally not appropriate to construct a rooftop addition on a low-rise, two- to three-story building such as this, because it negatively affects its historic character.

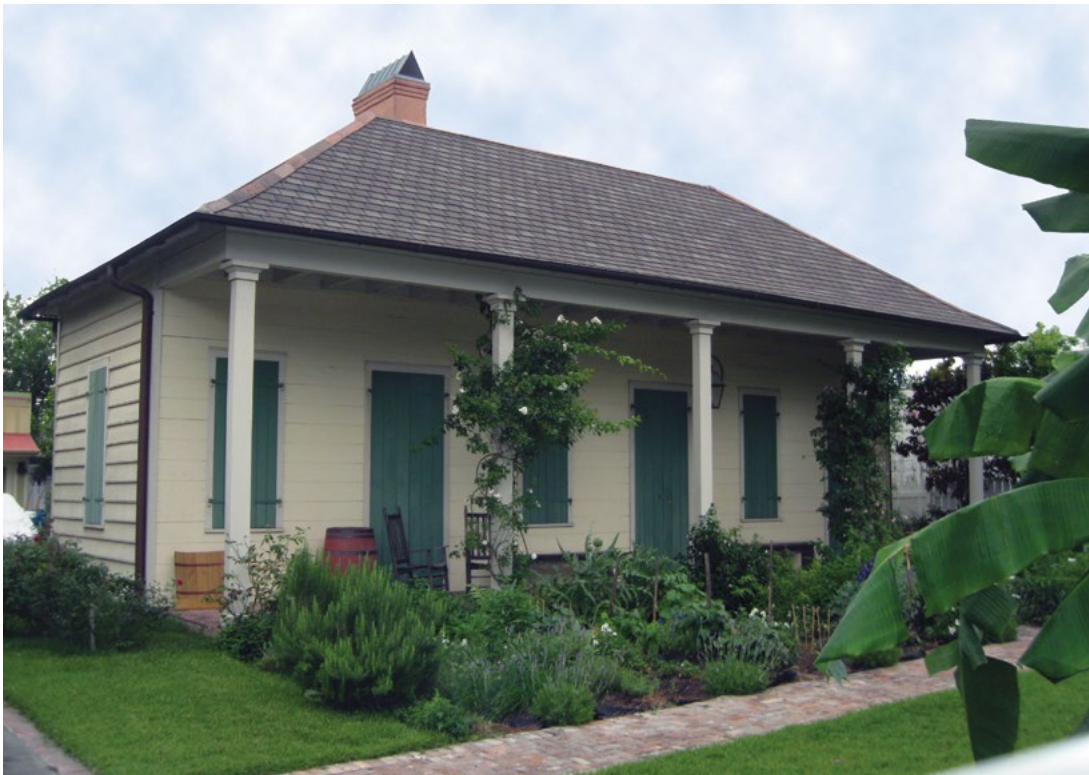
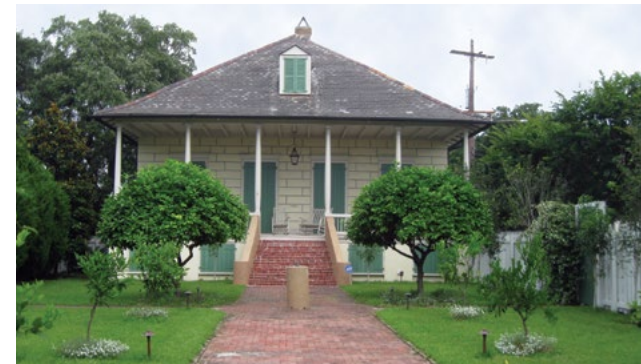
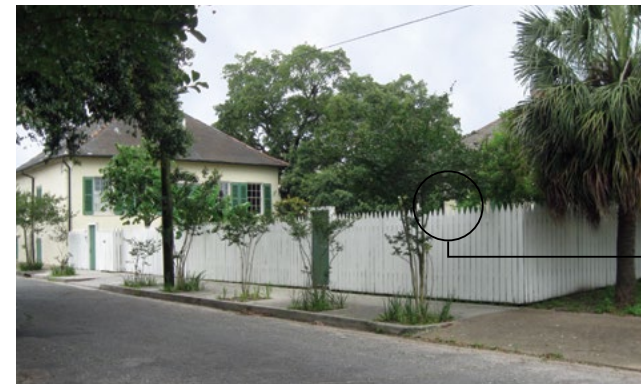
[65] (a) This (far left) is a compatible new outbuilding constructed on the site of a historic plantation house (b). Although traditional in design, it is built of wood to differentiate it from the historic house (which is scored stucco) located at the back of the site so as not to impact the historic house, and minimally visible from the public right-of-way (c).

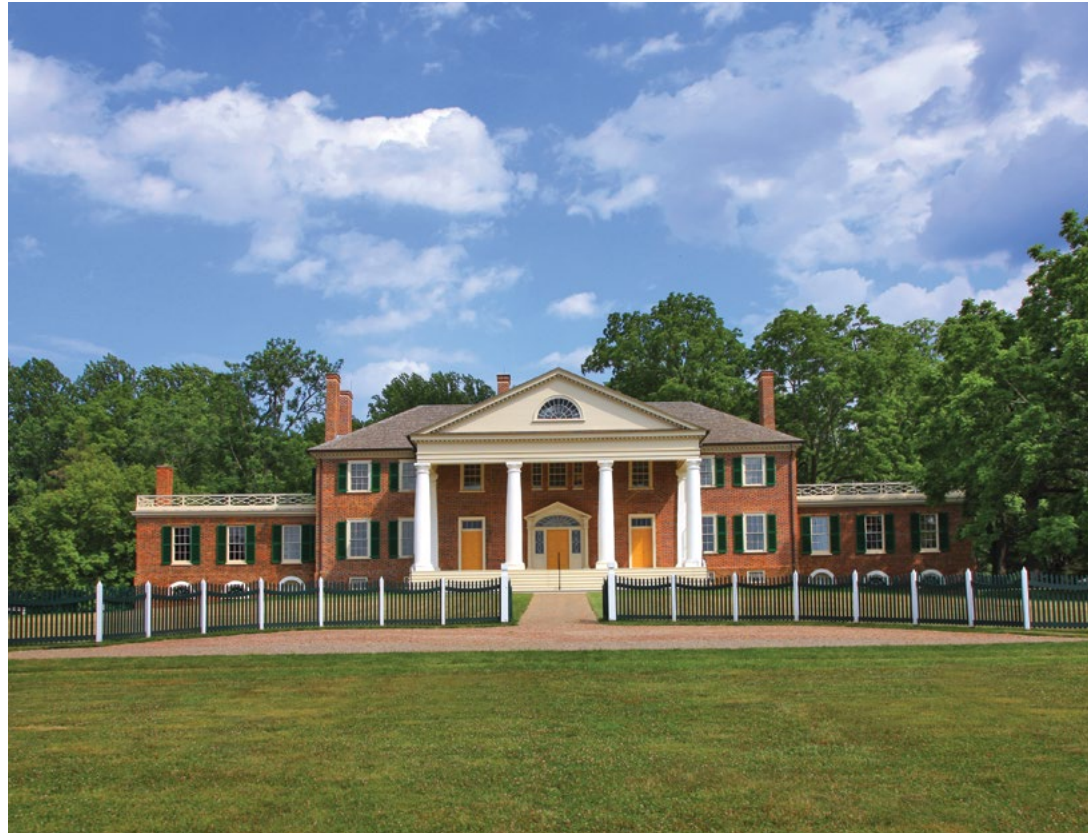
## Standards for Restoration

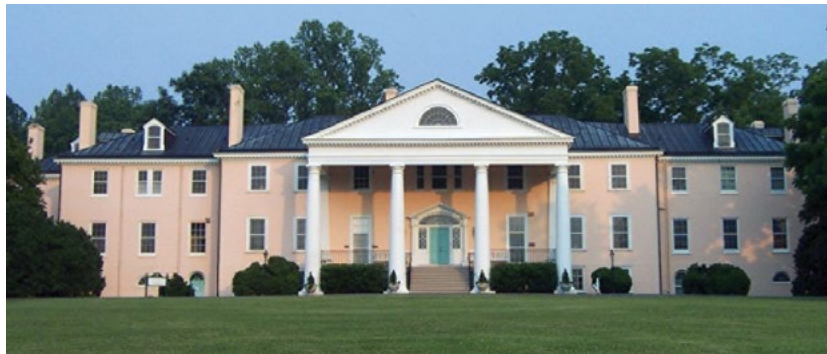
[1] (a) When it was acquired by the National Trust for Historic Preservation in the 1980s, Montpelier in Montpelier Station, VA, the home of James and Dolley Madison, had been much altered and enlarged since it was first constructed. Based on historical documentation and research, Montpelier was accurately restored to its 1820s appearance when the president and his wife lived there (b). Photos: Courtesy of The Montpelier Foundation.

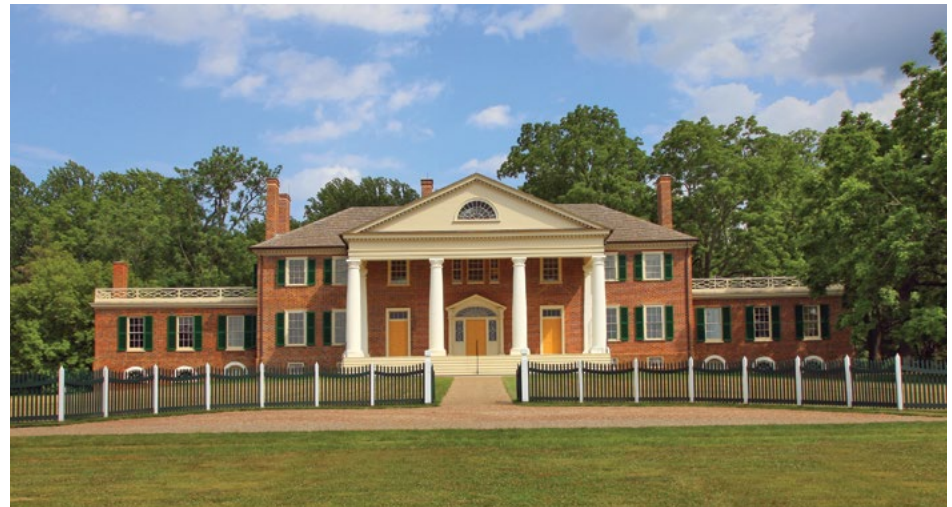
## MASONRY: STONE, BRICK, TERRA COTTA, CONCRETE, ADOBE, STUCCO, AND MORTAR

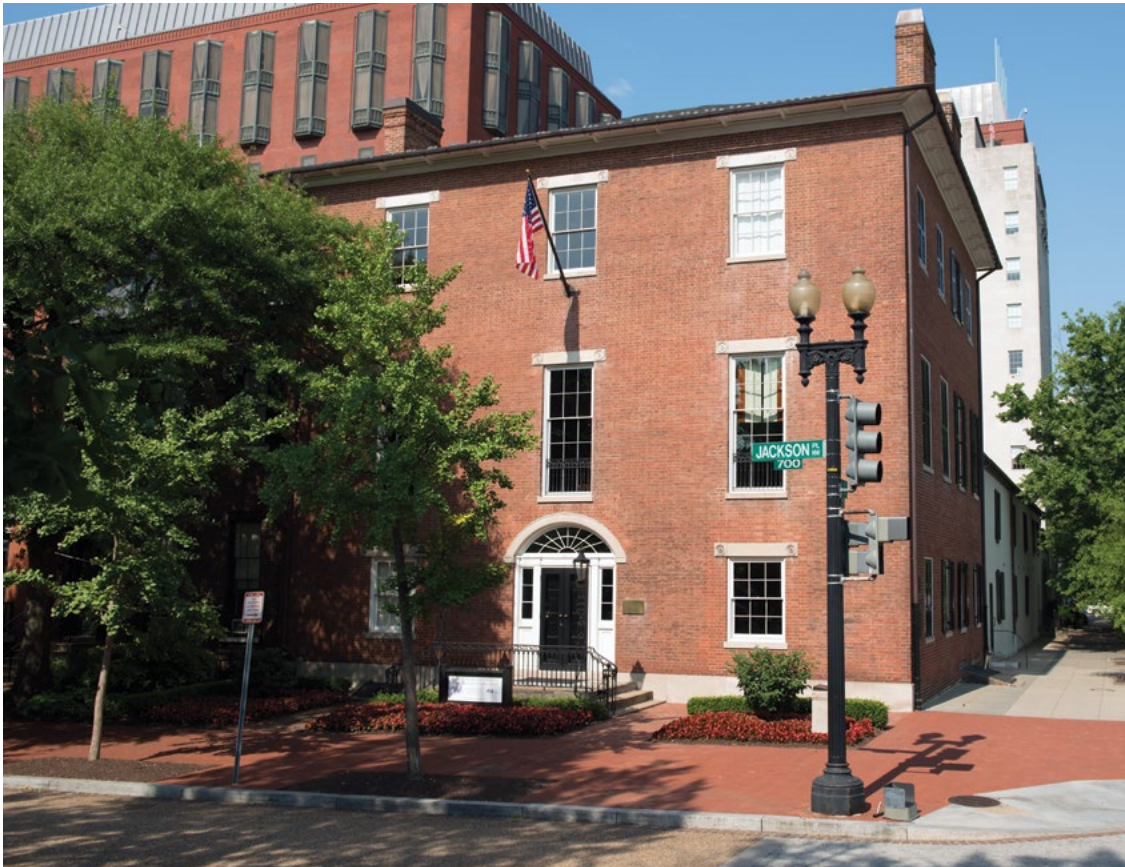
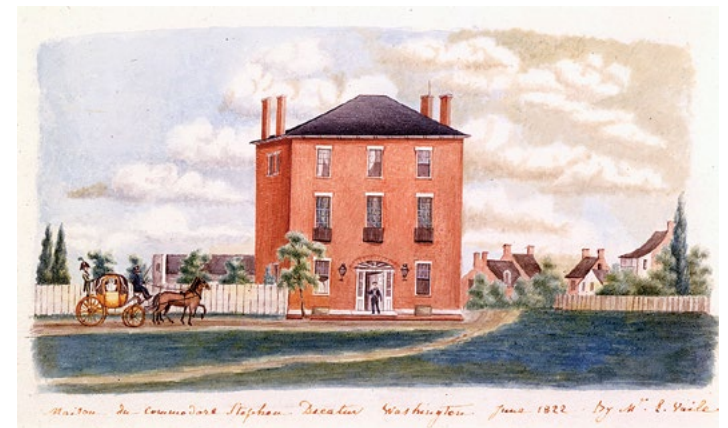
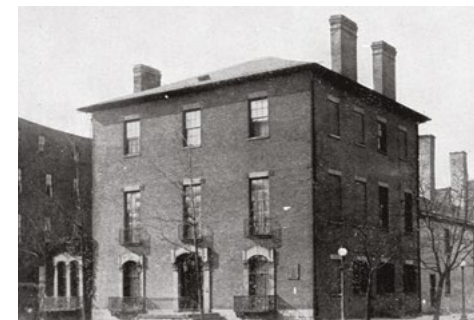
**MASONRY: STONE, BRICK, TERRA COTTA, CONCRETE, ADOBE, STUCCO, AND MORTAR**

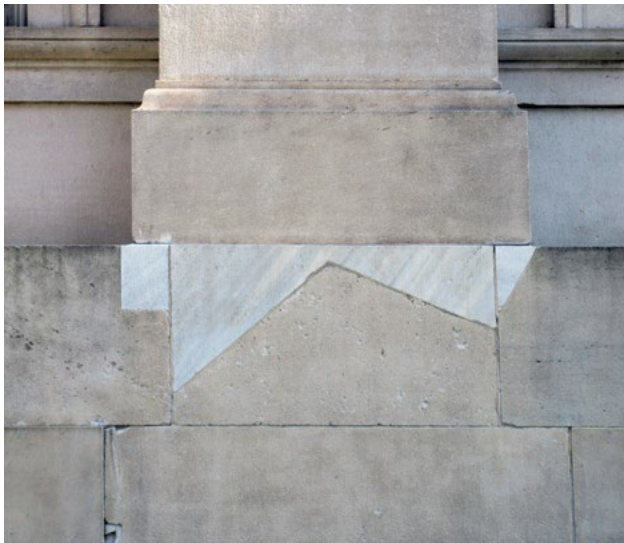
[3] **Not Recommended:** Although the Dutchman stone repair has been well executed, the replacement stone is not a good color match.

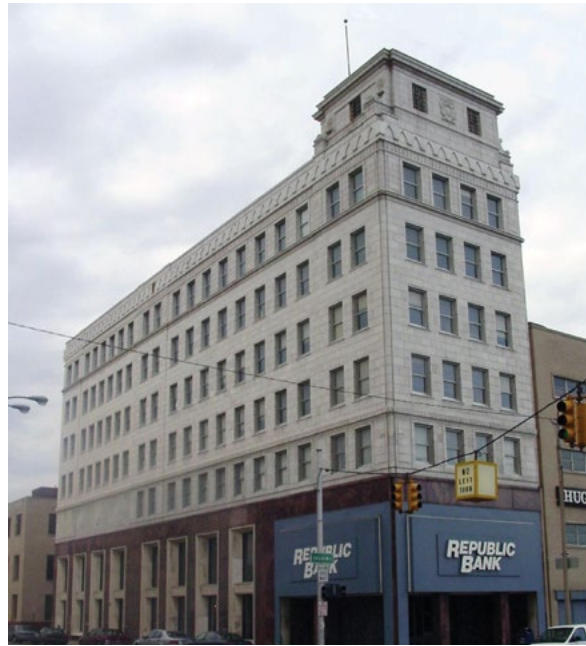
[4] (a) Over the years terra-cotta cladding had been replaced on the lower floors of this early-20<sup>th</sup> century bank building with a storefront and incompatible windows. (b) A 1936 photograph of the building provided the documentation to restore its historic appearance. (c) Glass fiber reinforced plastic (GFRP) was chosen as a substitute material, and samples were made in a variety of colors and textures to obtain the best match for the missing and damaged terra cotta. (d) This photo taken after restoration shows that the GFRP replacements successfully blend in with the original terra cotta. Photo (d): Blamonet at English Wikipedia.

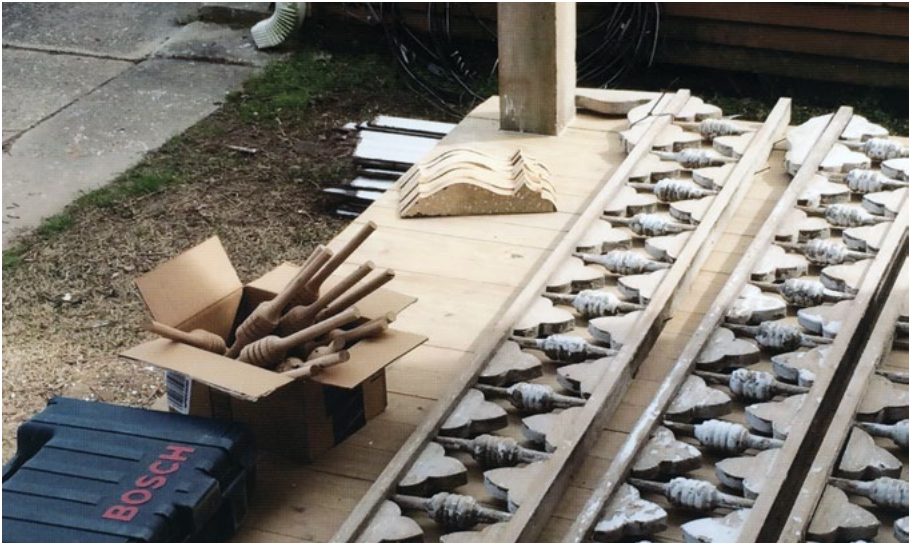
[5] New wood trim pieces were milled to match the few remaining historic features to replace those that were missing.

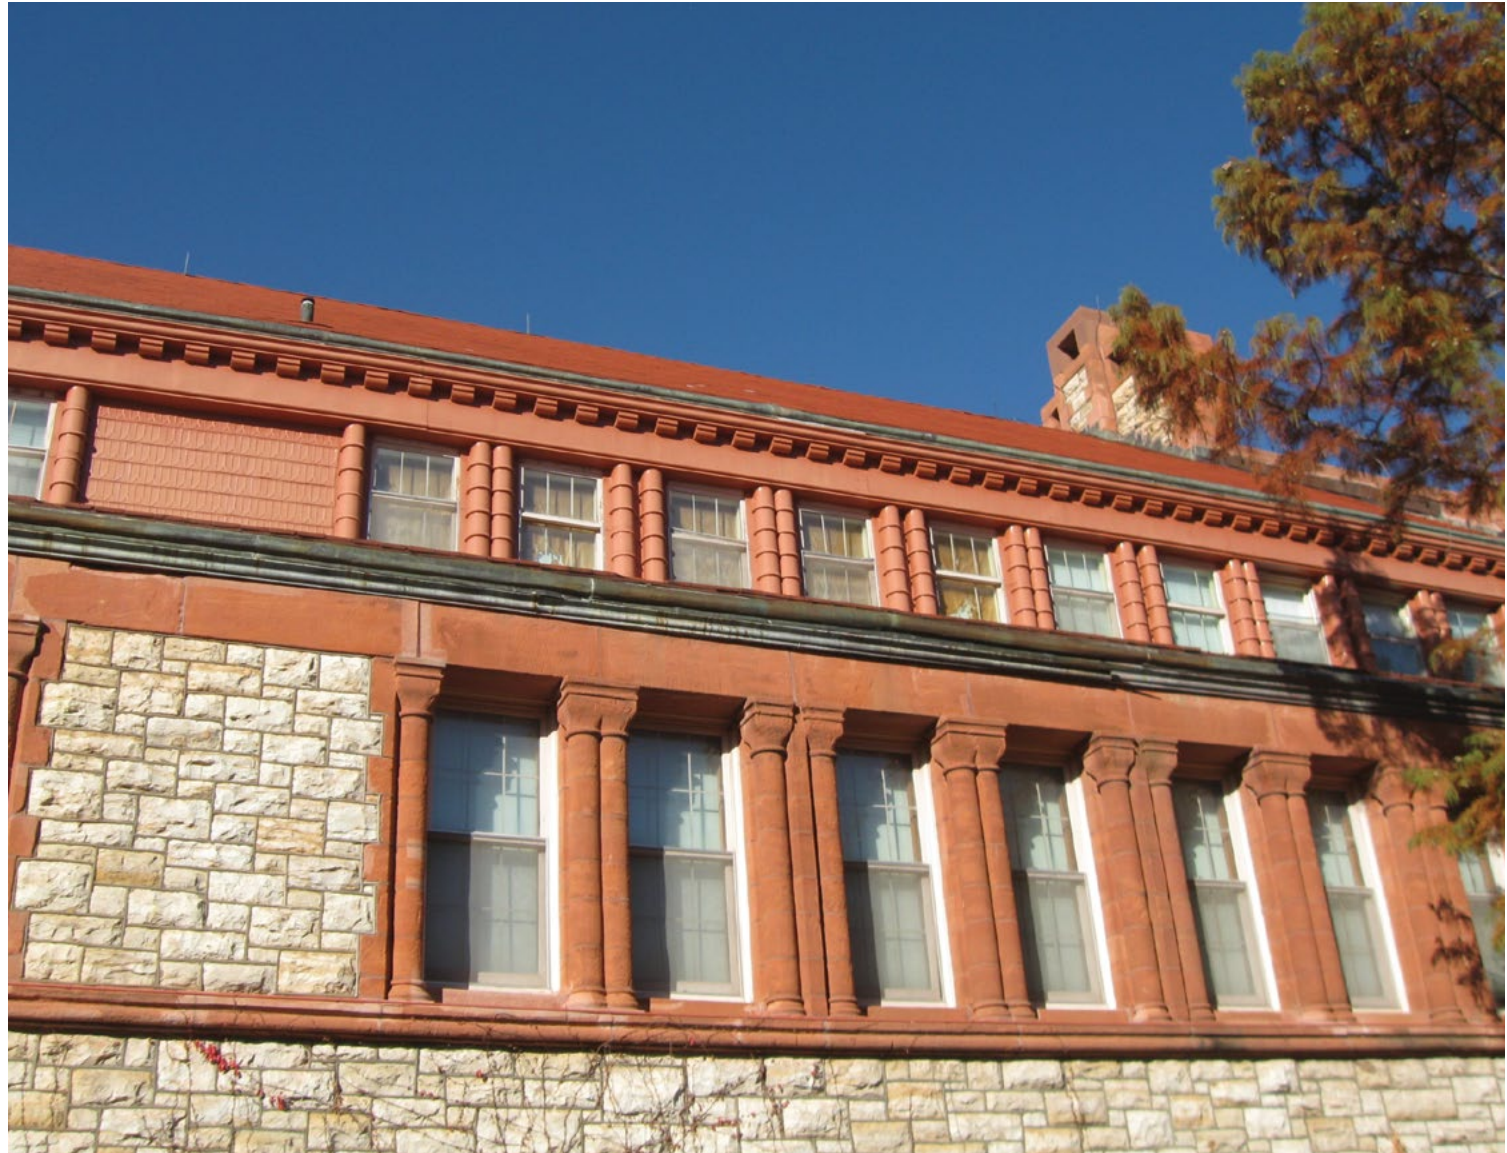
[6] Preliminary work before starting restoration revealed that the columns and the decorative shingles ornamenting the top floor of this historic building were fabricated of metal to imitate the red sandstone used elsewhere on the building.

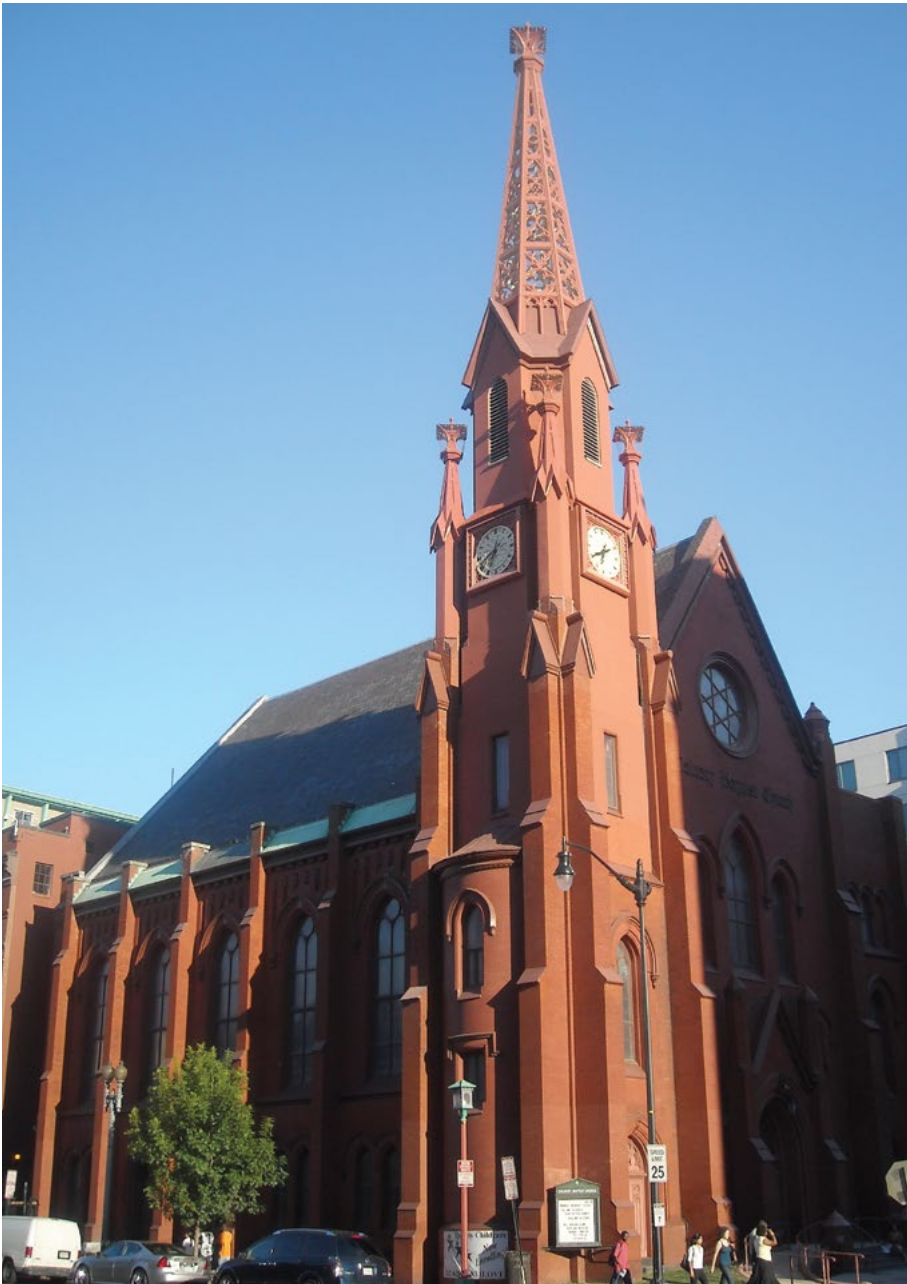
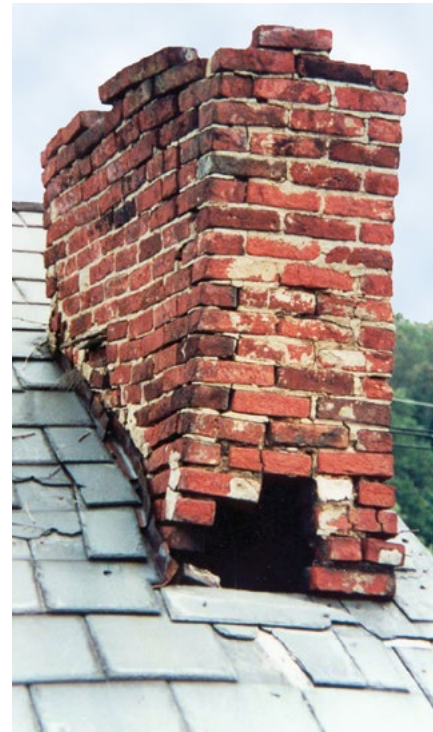
[7 a-b] This crumbling chimney was restored to its historic appearance using matching bricks.

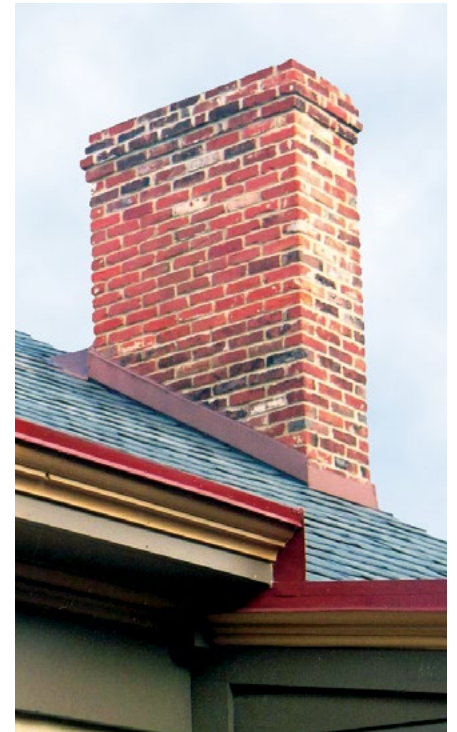
[8] The missing steeple of this historic church was replaced with a new steeple made of a substitute material that, from the street below, closely resembles the original steeple. *Photo: en.Wikipedia.*

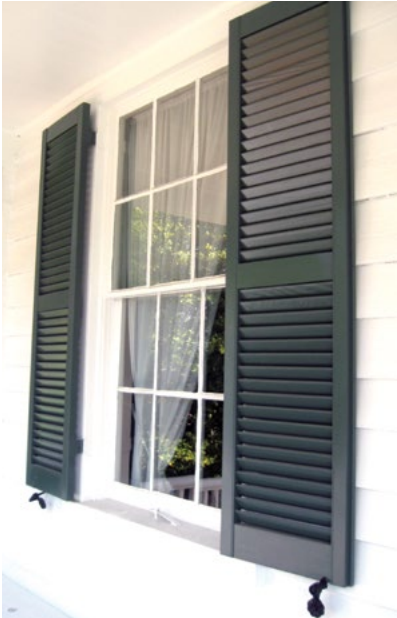
[9] Historic window and shutter hardware such as that shown here should be retained and repaired in a restoration project.

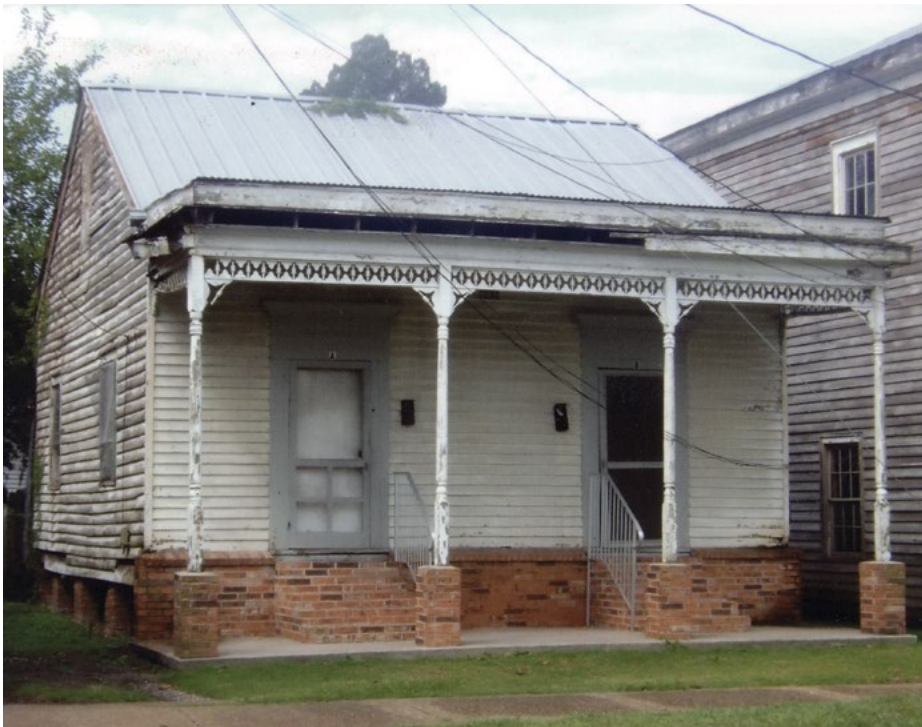
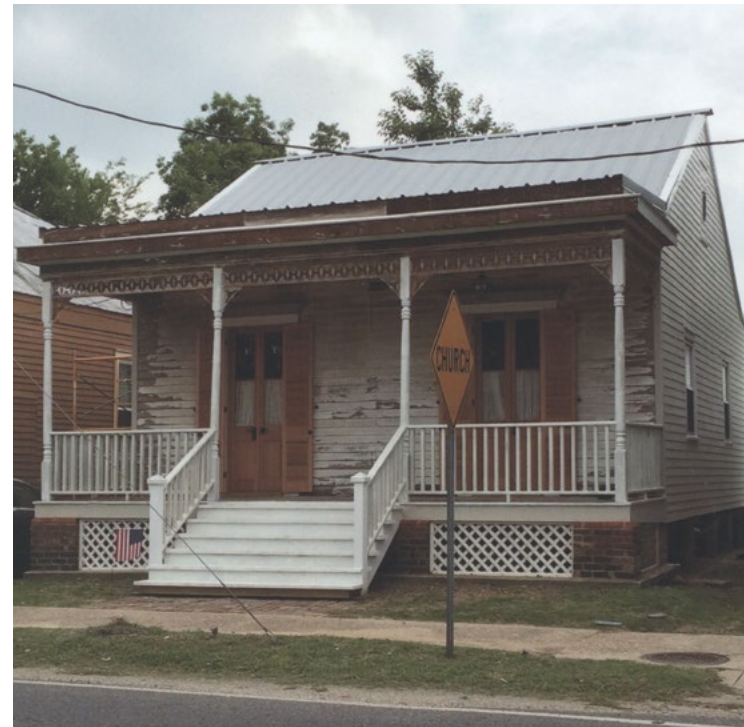
## ENTRANCES AND PORCHES

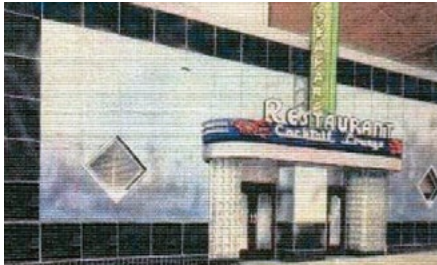
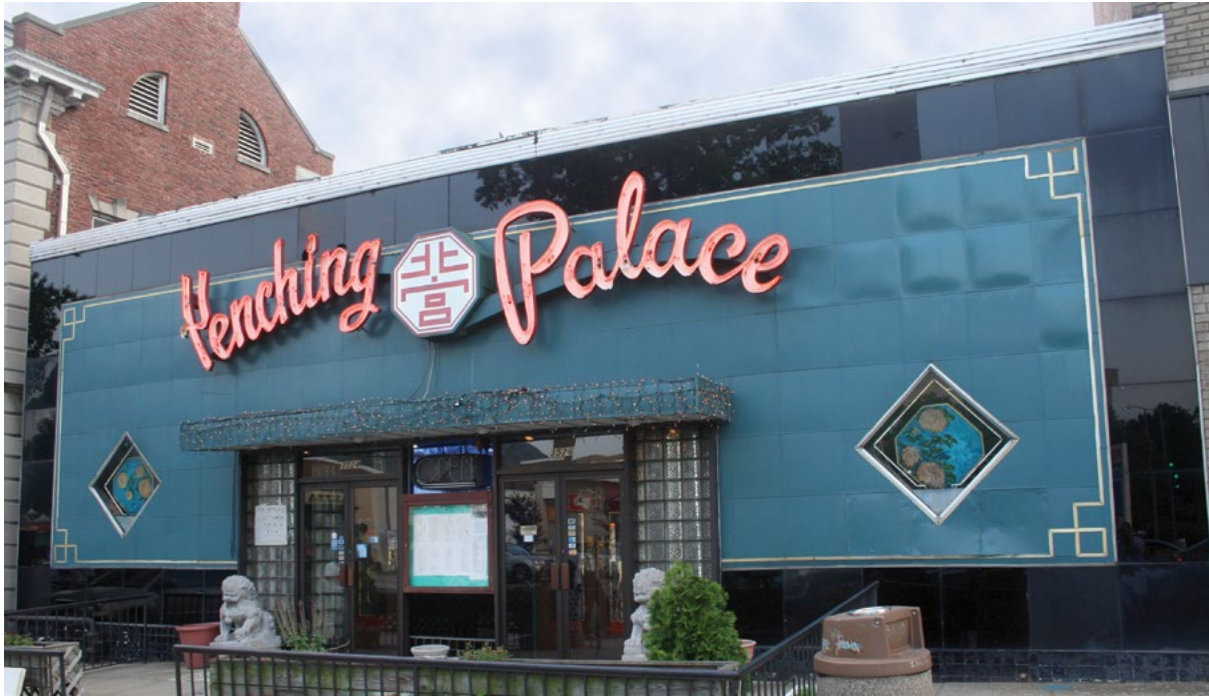
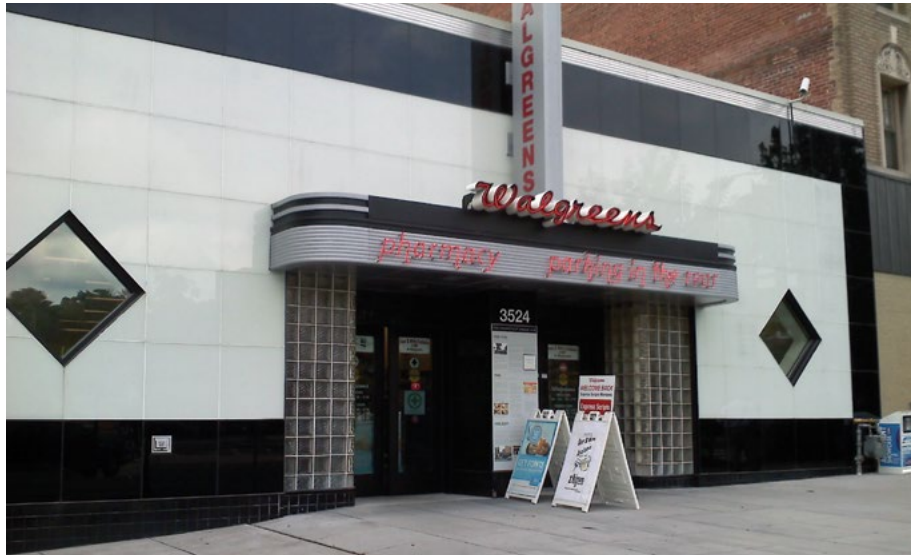
[11] (a) Some of the materials on the front of this historic building had been previously replaced, but the façade retained its essential distinctive features and design. (b) A vintage postcard of the building (far left) provided sufficient documentation to restore the façade to its historic 1945 appearance, using spandrel glass as a replacement for the original Carrara glass (c). Photo (b): Courtesy Kelsey & Associates.

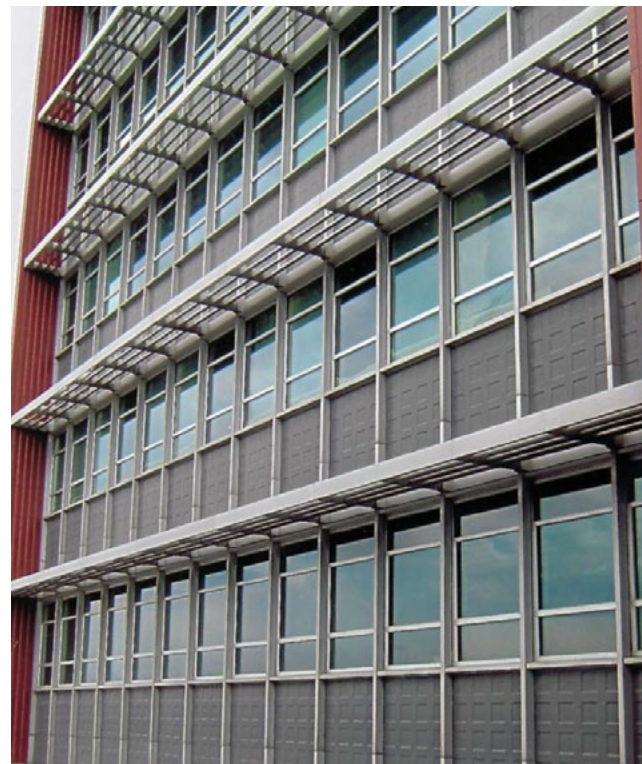
[12] This historic curtain wall features a distinctive variety of panel types which must be repaired or replicated in a restoration project if any are damaged or missing.

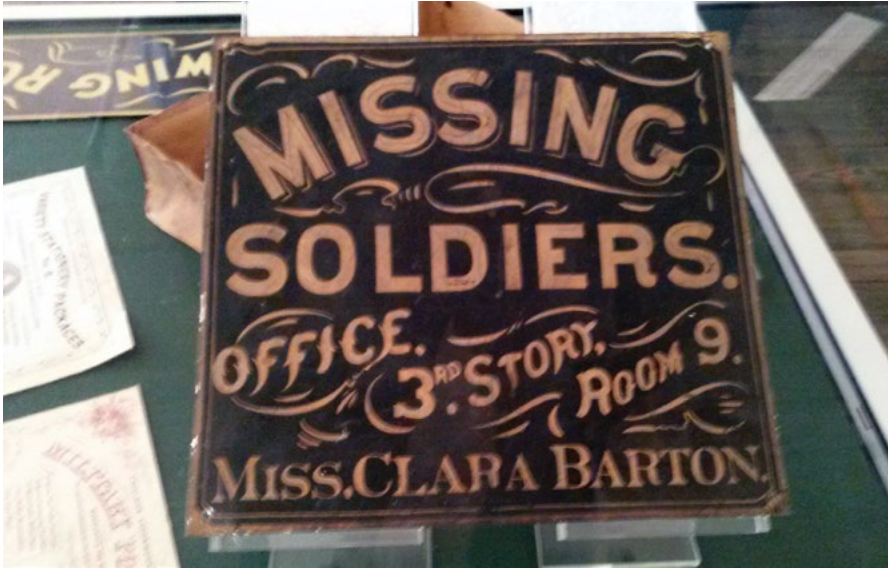
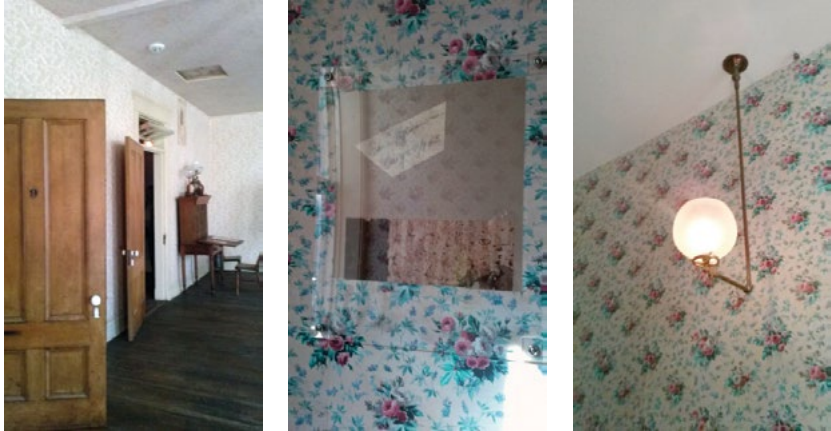
[13] (a) In the 1990s the Missing Soldier's Office—established by Clara Barton at the end of the Civil War—was discovered still extant on the third floor of a building in Washington, DC, that was slated for demolition. The office was restored to its historic appearance using physical and documentary evidence. The original numeral '9' is still on the door to the office, and wall paper was reproduced from scraps found on the walls (b-d).

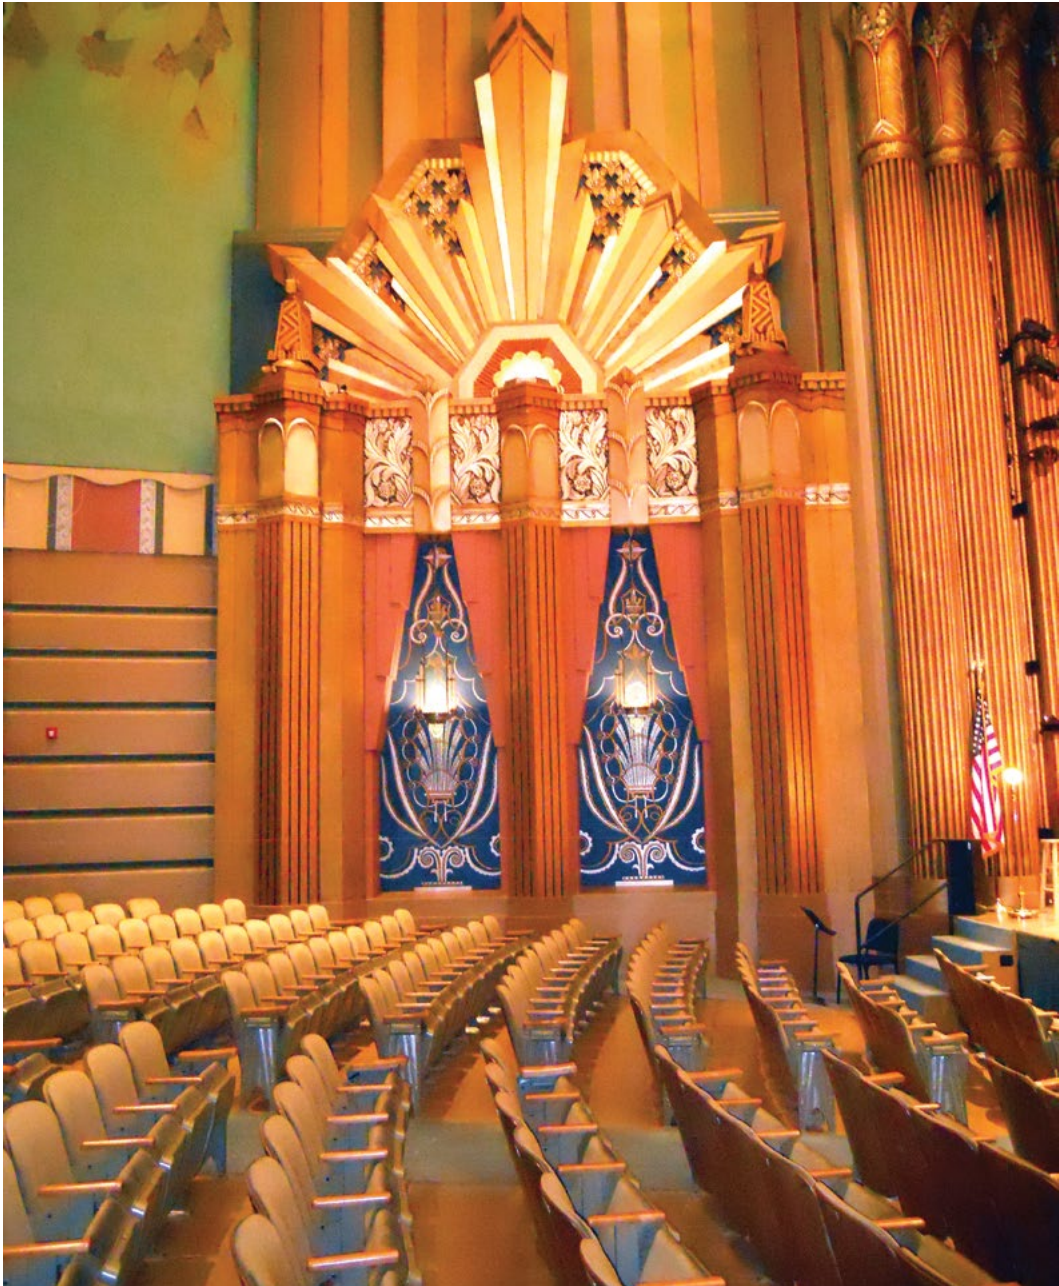
[14] When the 1931 Fox Theater in Spokane, WA, was rehabilitated as a performing arts center, the auditorium was restored to its original Art Deco splendor.

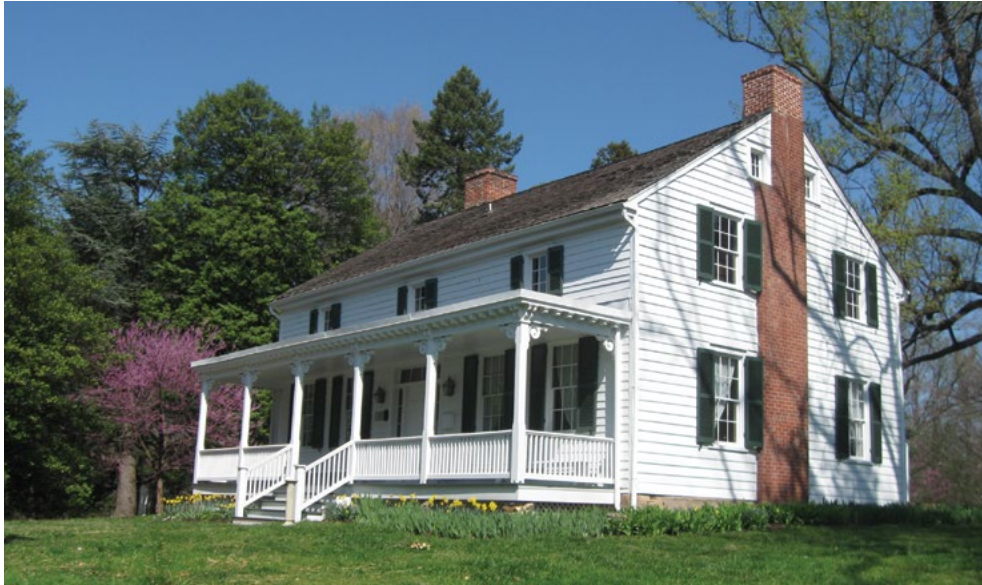
[15] (a) Cherry Hill House and Farm (c. 1845) in Falls Church, VA, was the site of encampments during the Civil War. Outbuildings on the property, such as the corn crib (b) in the foreground which was the source of provisions for the soldiers, are important in interpreting its role during the war.

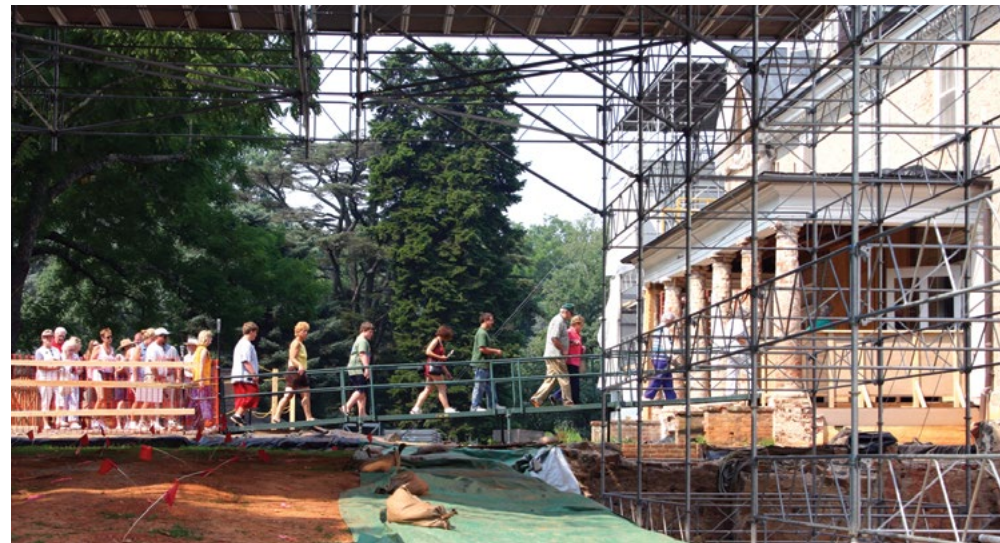
**SETTING (DISTRICT / NEIGHBORHOOD)**

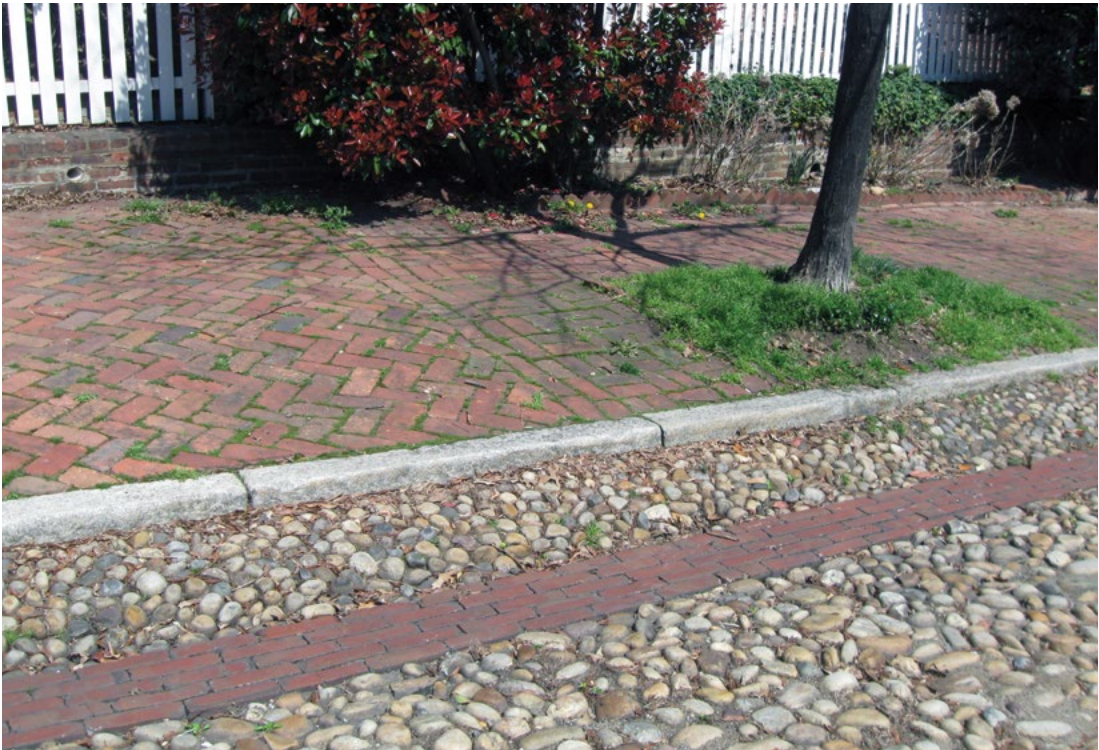
[17 a-b] The cobblestone street, brick sidewalks, and stone stoops of these houses are important restoration-period features of the late 18th-through the 19th-century restoration period of this historic district.

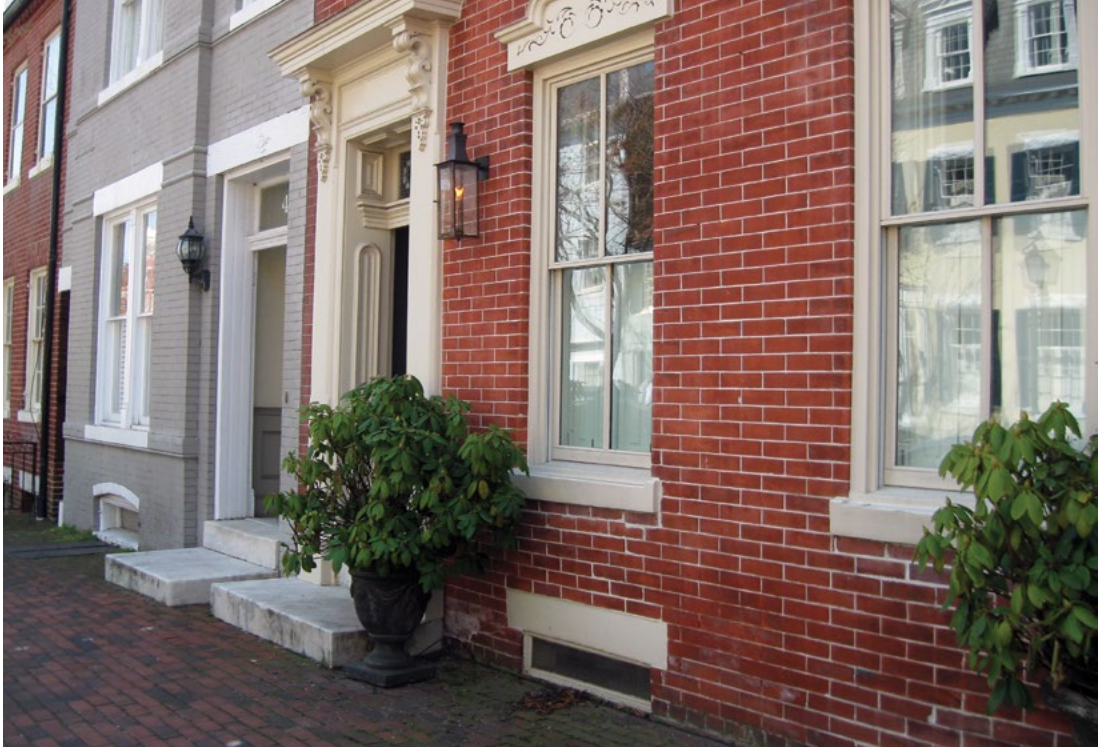
<b>RECOMMENDED</b>	<b>NOT RECOMMENDED</b>
<p><i>Protecting and maintaining</i> features from the restoration period in the setting through regularly-scheduled maintenance and grounds and landscape management.</p>	<p>Failing to protect and maintain materials in the setting on a cyclical basis so that deterioration of buildings and landscape features results.</p> <p>Removing restoration-period building or landscape features in the setting, such as porches, fencing, walkways, or plant material.</p>
<p>Installing protective fencing, bollards, and stanchions in a setting, when necessary for security, that are as unobtrusive as possible.</p>	<p>Installing protective fencing, bollards, and stanchions in a setting, when necessary for security, without taking into consideration their location and visibility so that they negatively impact the historic character of the setting.</p>
