## **HISTORICAL COMMISSION SPECIAL MEETING AGENDA**

**7:00 PM - Monday, August 08, 2022**

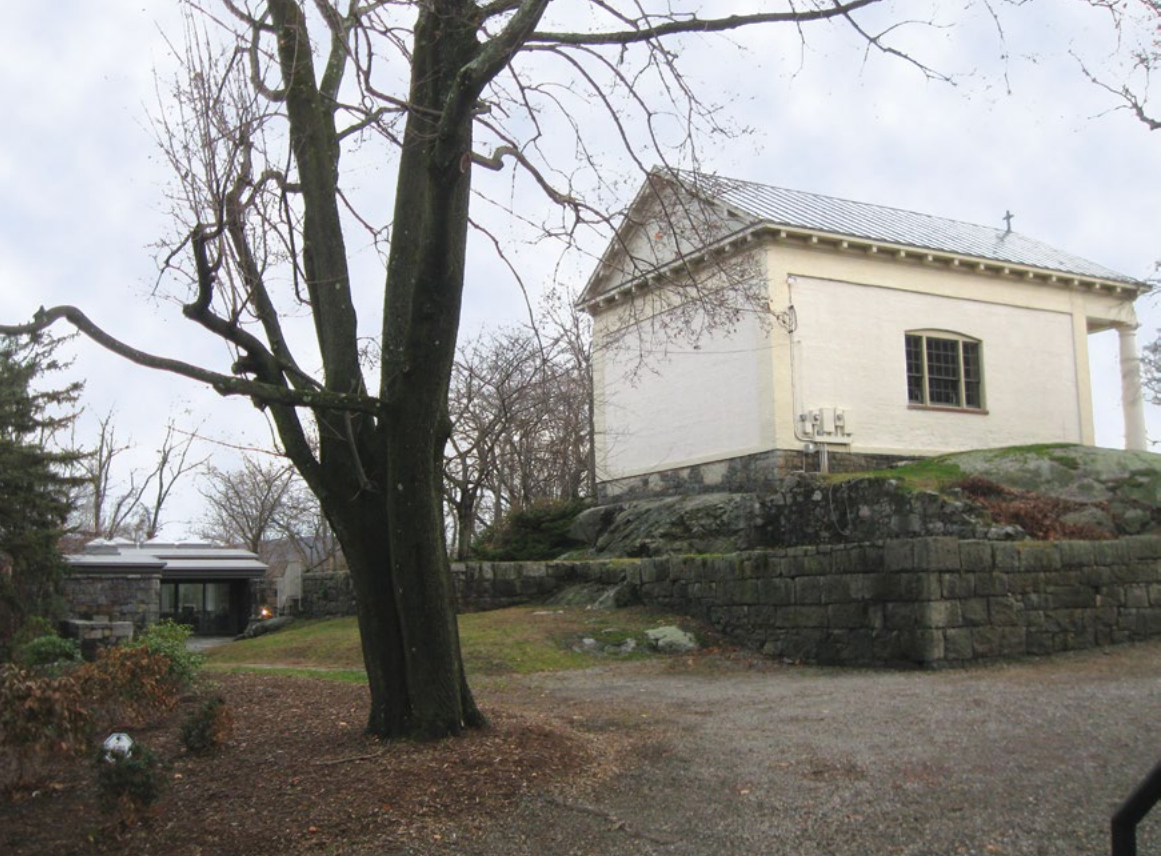
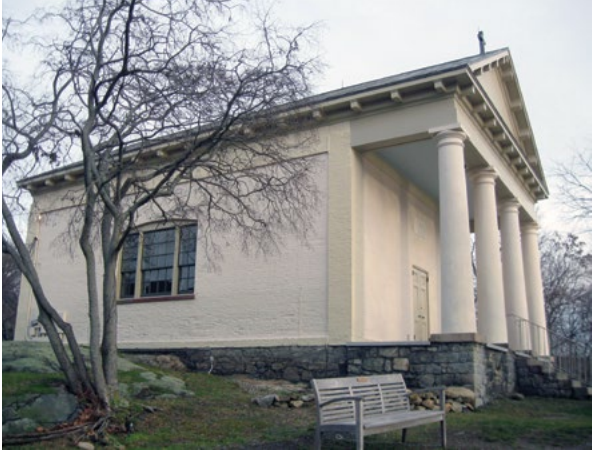
[18 a-b] The historic Chapel of Our Lady in Cold Spring, NY, is situated on a rocky promontory overlooking the Hudson River. Installing an accessible ramp would greatly compromise the character of the building and the site. However, an audio-visual program available in a separate building—located where it would not impact the character of the site, such as this small pavilion at the rear of the property—could provide visitors otherwise unable to access the Chapel an opportunity to experience the site.

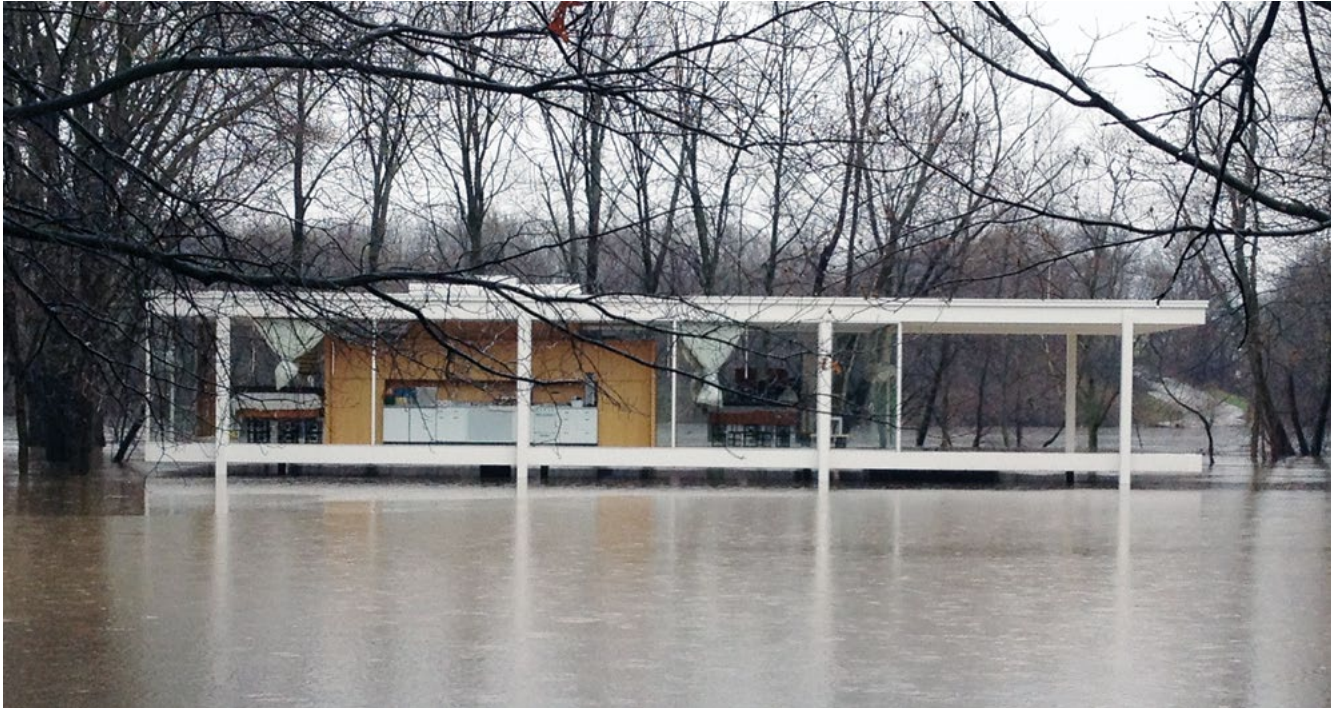
[19] The 1951 Mies van der Rohe-designed Farnsworth House, Plano, IL, was built close to the Fox River, which is increasingly prone to floods. To preserve the house in its original location, historic preservation architects and engineers continue to explore ways to protect it from the flooding, including a possible system that would lift the house above the flood waters and lower it back to the ground. *Photo: Courtesy Farnsworth, A Site of the National Trust for Historic Preservation.*

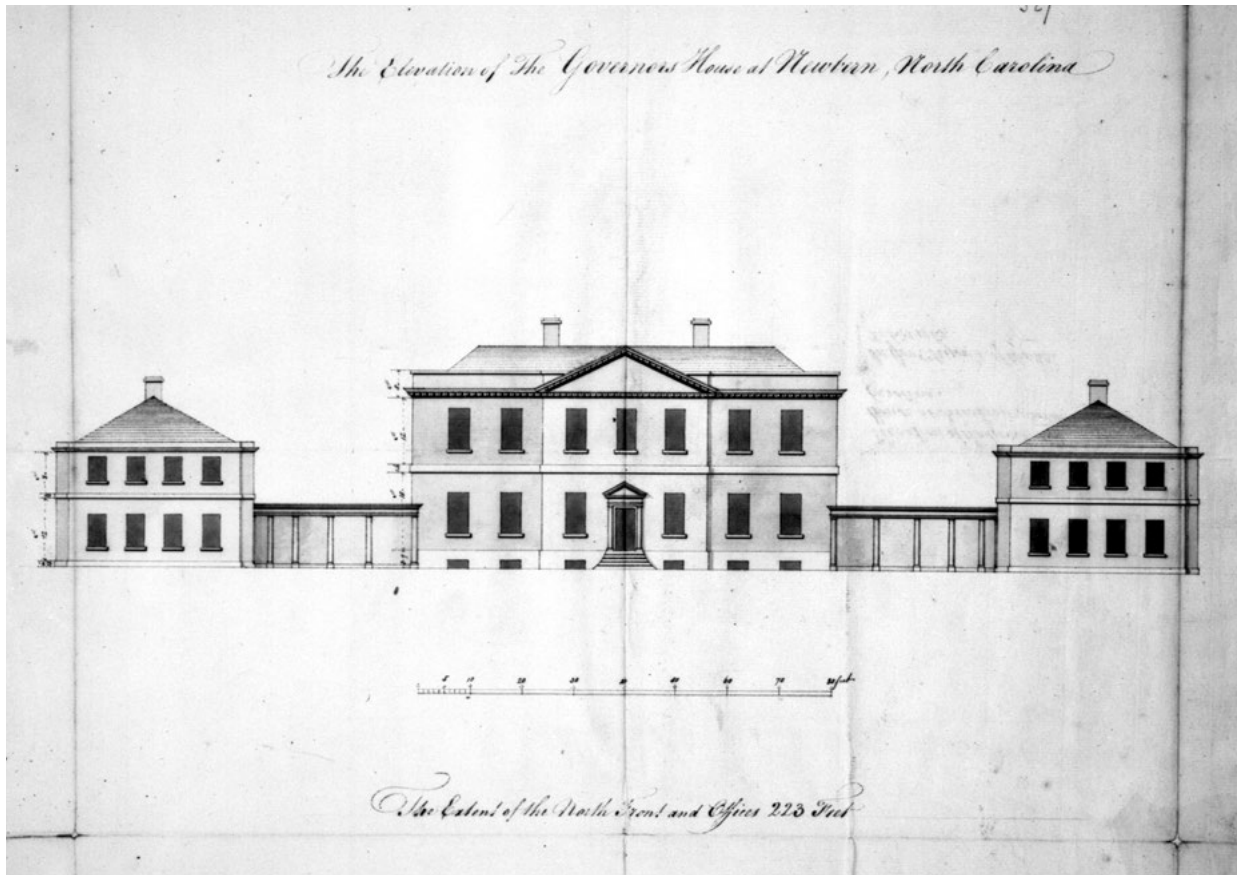
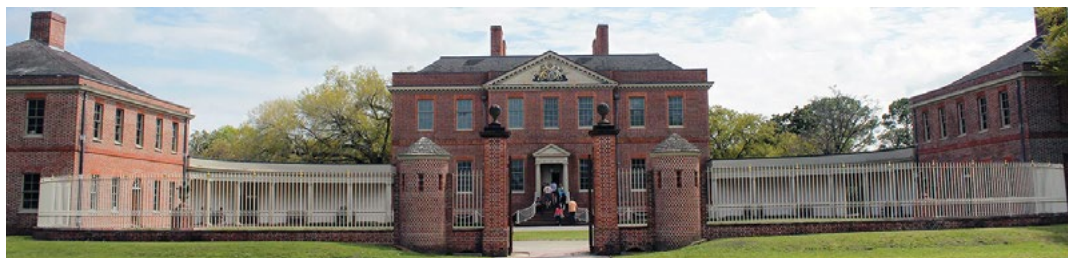
[1 a-b] Tyron Palace, New Bern, NC, was designed by John Hawks in 1767 for Governor William Tyron. It was completed in 1770, but destroyed by fire in 1798. The palace was reconstructed in 1959 based on the original plans, and on its original foundation, which was found 5 feet below the street, with the help of the 1767 drawing. Photo: Courtesy Tyron Palace, New Bern, NC. Drawing: Courtesy of the State Archives of North Carolina.

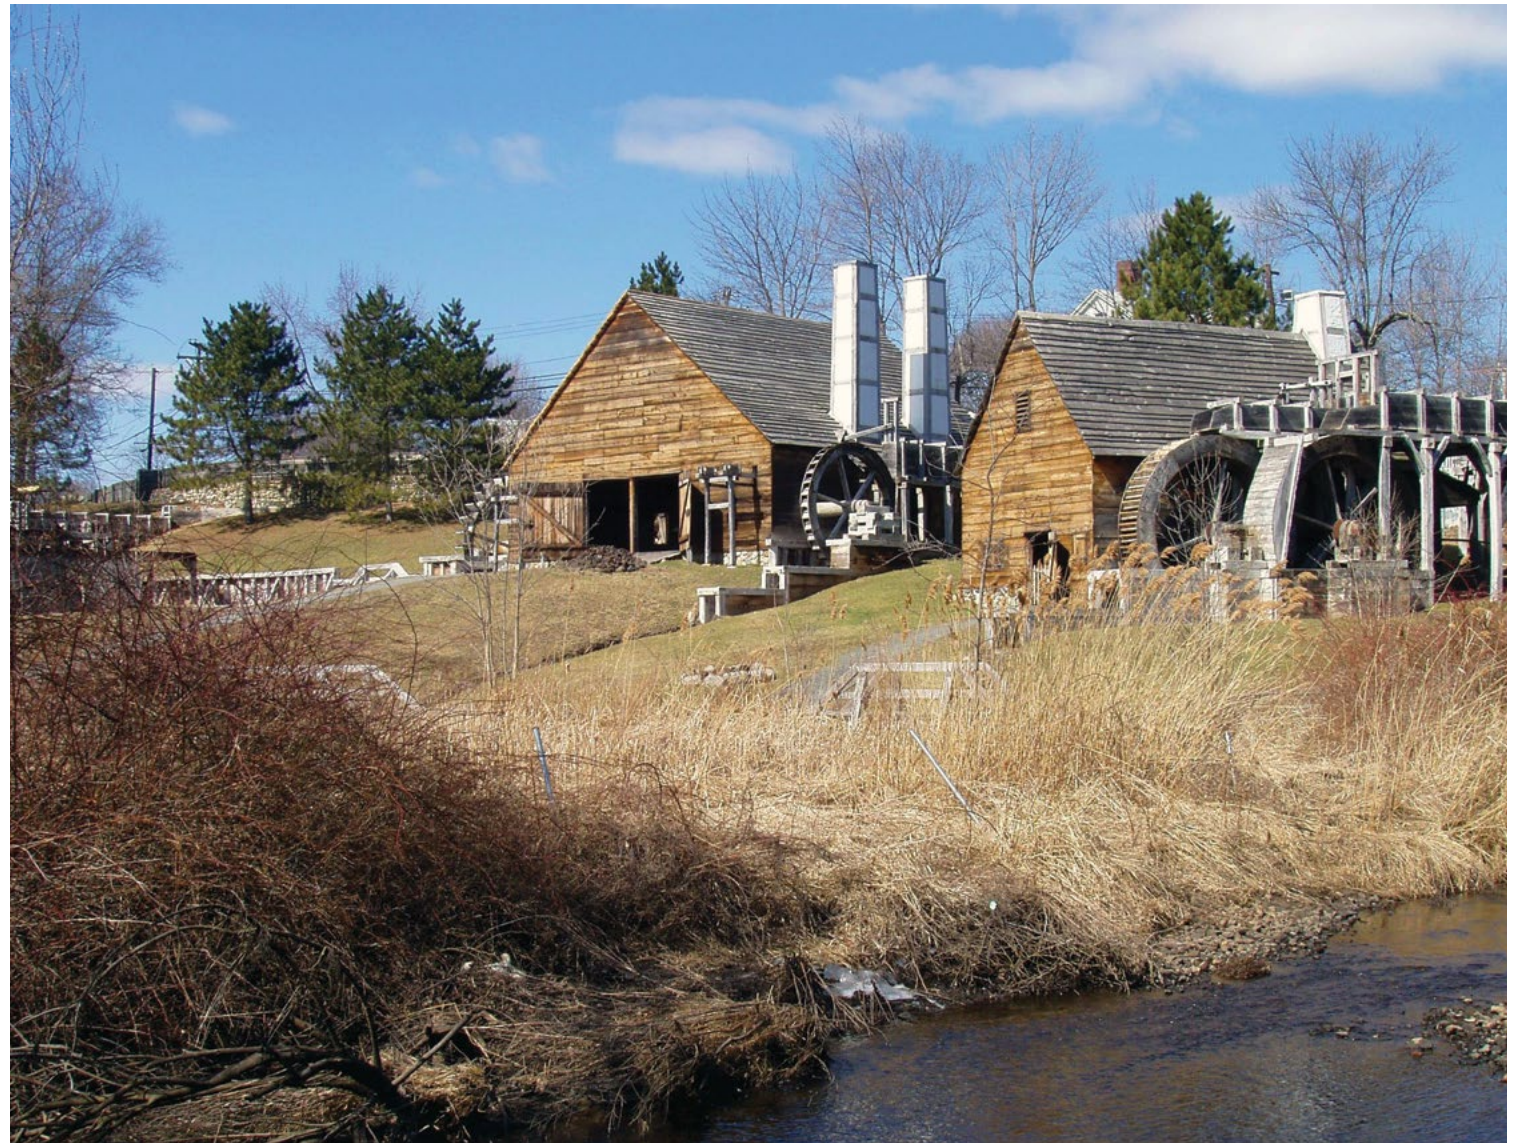
[2] The Saugus Iron Works, Saugus, MA, a National Historic Site, was active from 1646 to about 1670 and was the first integrated iron works in North America. The forge and mill (shown here) are part of the site which was reconstructed based on archeological research and historic documents and opened in 1954. *Photo: Daderot at the English language Wikipedia.*

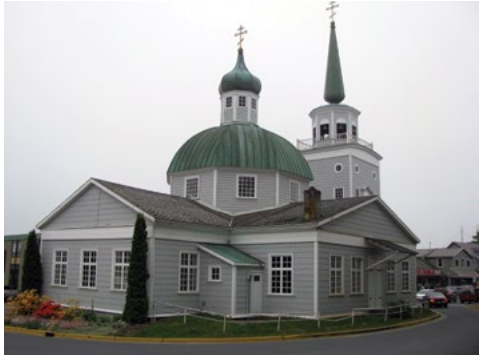
**BUILDING EXTERIOR**

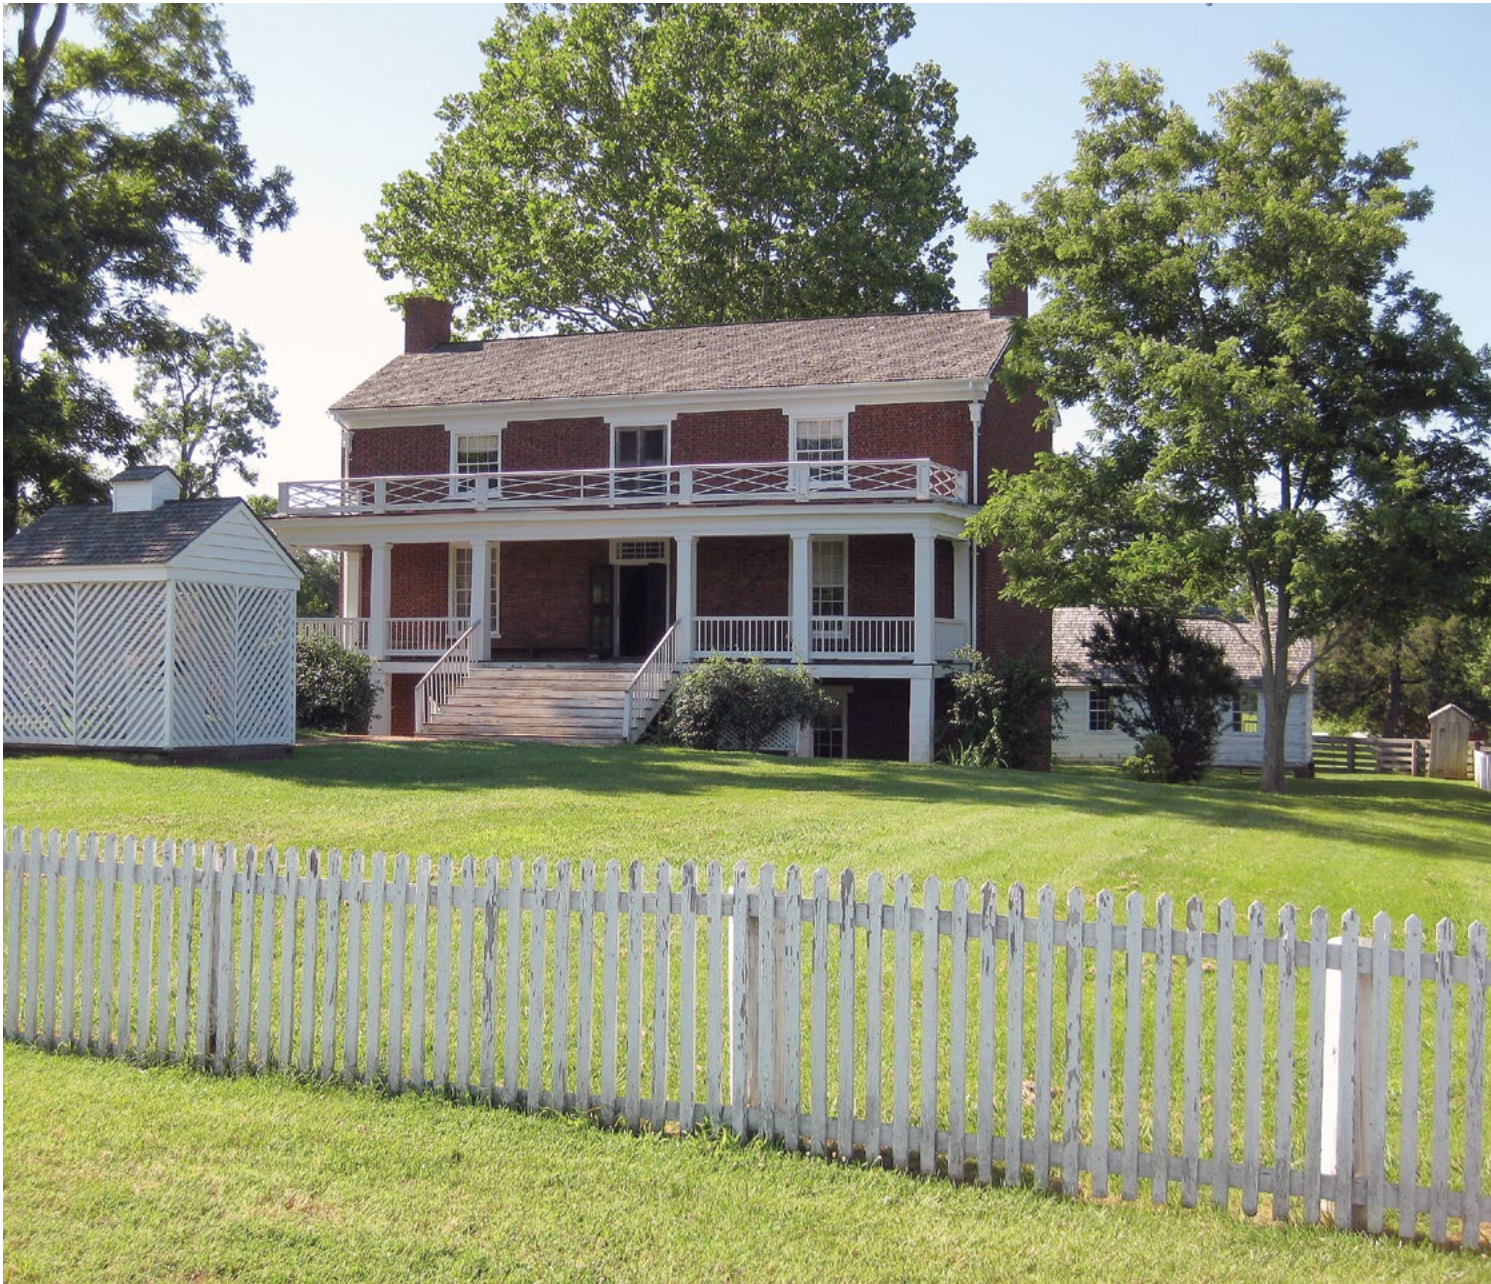
[4] The McLean House, where Robert E. Lee surrendered to Ulysses S. Grant, is located on the site of the battlefield—now part of Appomattox Courthouse National Historical Monument (VA). Several years after the end of the Civil War, measured drawings were made of the house before it was dismantled to be moved to Washington, DC, where it was to be reconstructed as a tourist attraction. This scheme never came to fruition, and the dismantled pieces gradually disappeared. The house was accurately reconstructed in 1949 on the original site based on the measured drawings.

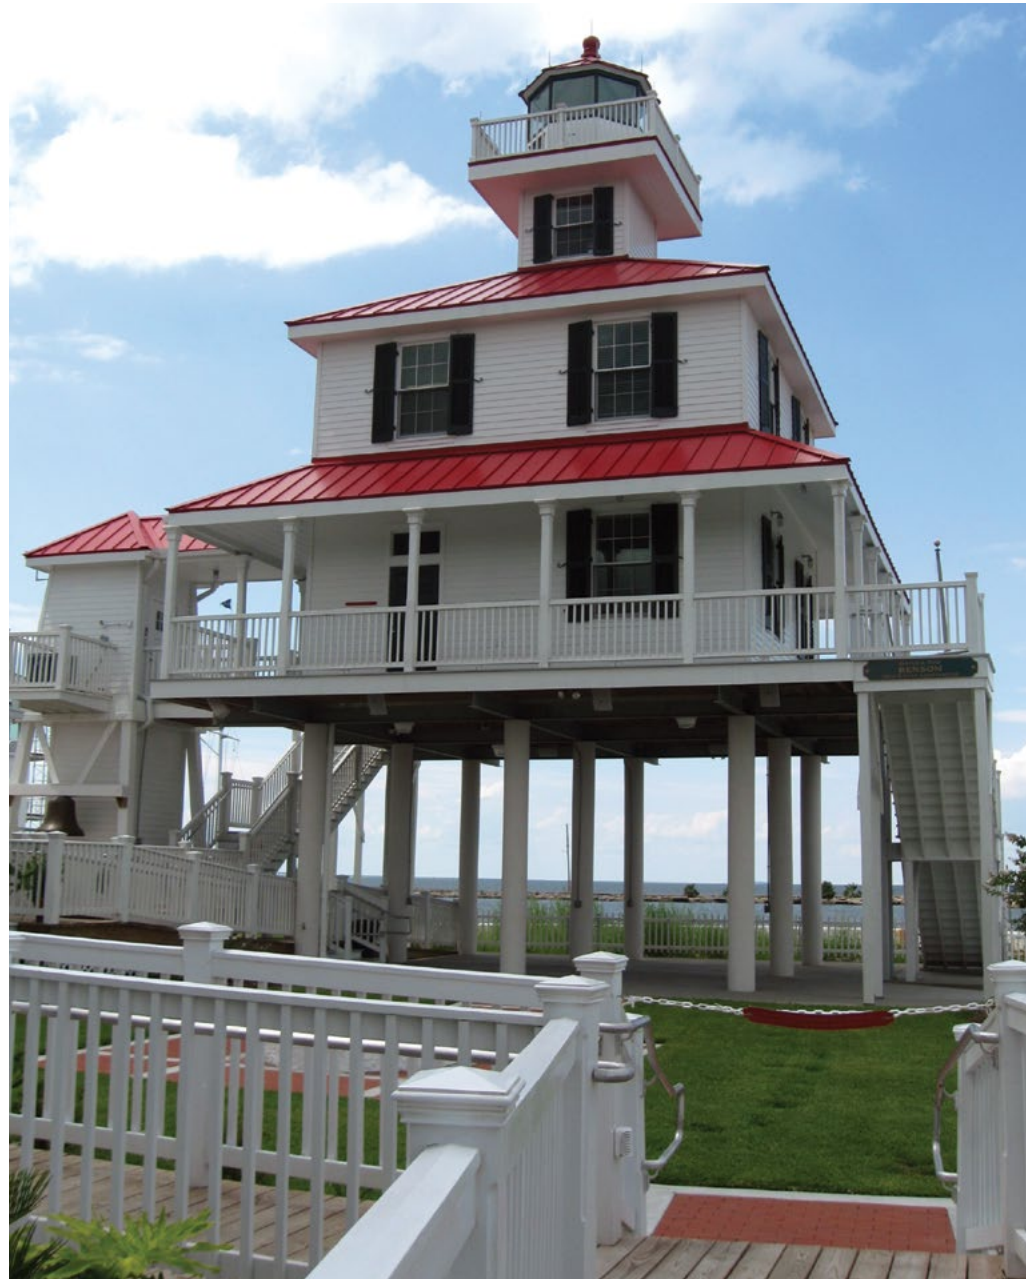
[6] This lighthouse on Lake Ponchartrain in New Orleans was reconstructed after the historic 1890 lighthouse was destroyed by Hurricane Katrina.

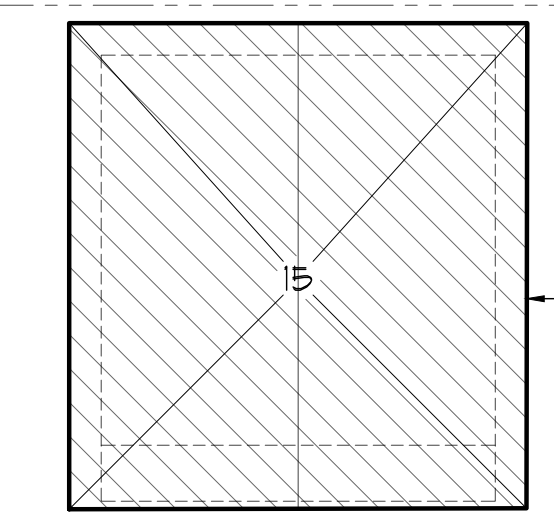
(E)SHED OVER & REMOVED AND  
REPLACED w/ NEW STRUCTURE.  
ROOF DIAGONAL HATCH  
INDICATES WHERE STRUCTURE WILL  
BE AFFECTED, REMOVED.  
CALCULATIONS PROVIDED TO THE  
LEFT.

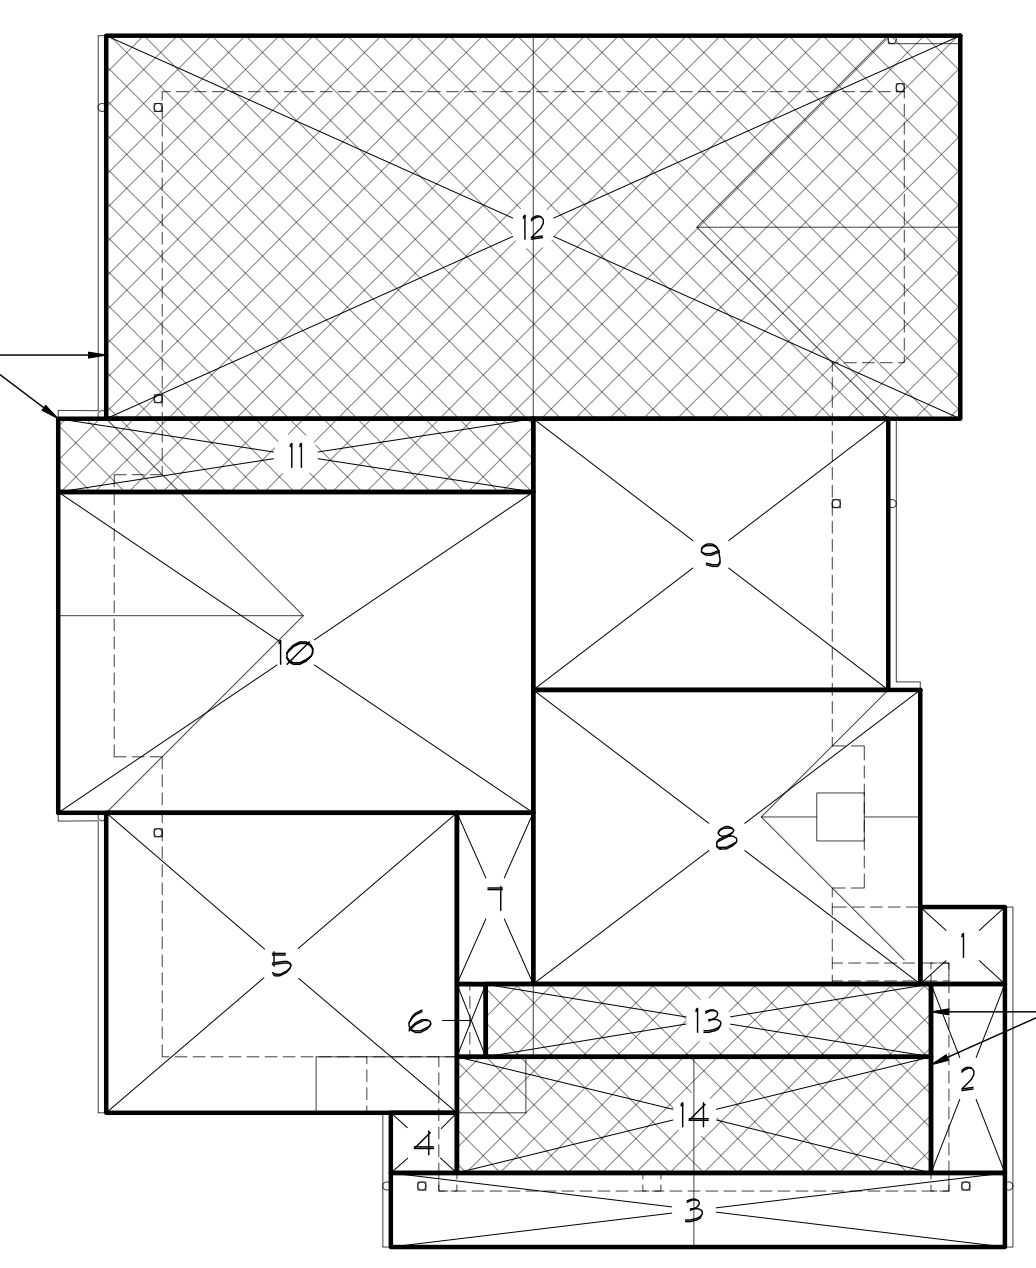
EXISTING ROOF  
FRAMING THIS PORCH  
AREA TO REMAIN.  
CROSS HATCH  
INDICATES WHERE NEW  
CEILING FRAMING AT  
COVERED PORCH AND  
FINISH WILL BE  
VAULTED.  
CALCULATIONS  
PROVIDED TO THE  
LEFT.

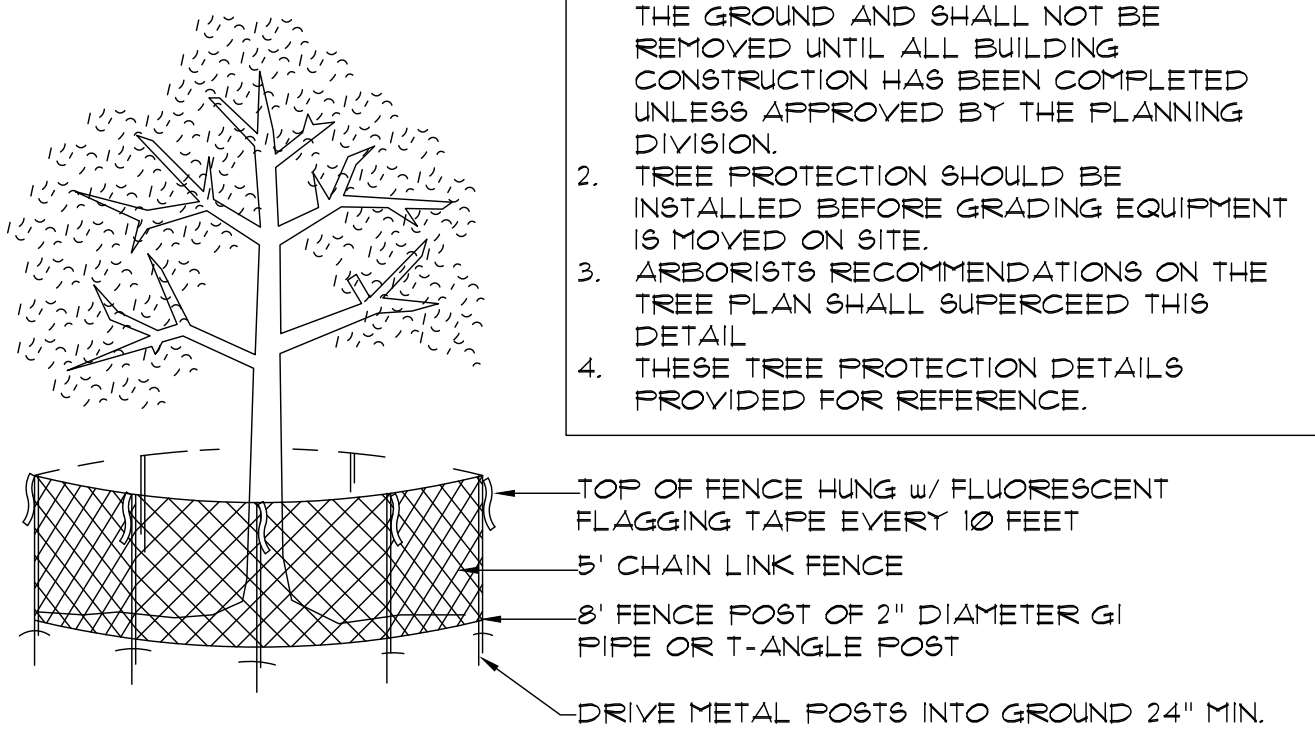
- ALL TREE PROTECTION FENCING SHALL BE CHAIN LINK AND A MINIMUM OF FIVE FEET IN HEIGHT WITH POSTS DRIVEN INTO THE GROUND AND SHALL NOT BE REMOVED UNTIL ALL BUILDING CONSTRUCTION HAS BEEN COMPLETED UNLESS APPROVED BY THE PLANNING DIVISION.
- TREE PROTECTION SHOULD BE INSTALLED BEFORE GRADING EQUIPMENT IS MOVED ON SITE.
- ARBORIST'S RECOMMENDATIONS ON THE TREE PLAN SHALL SUPERCEDE THIS DETAIL.
- THESE TREE PROTECTION DETAILS PROVIDED FOR REFERENCE.

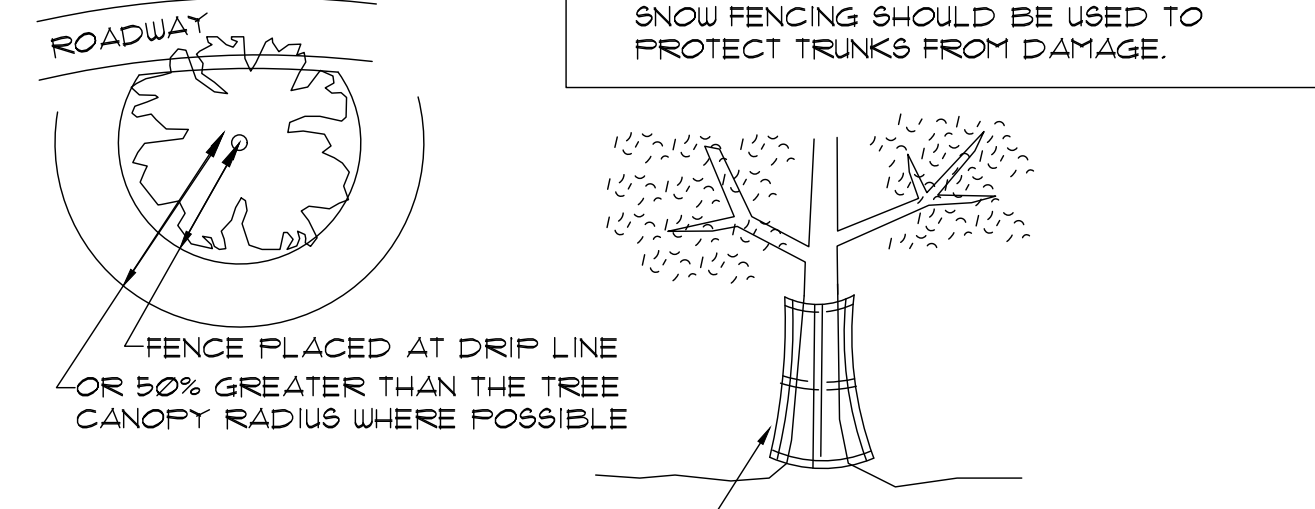
**2 TREE PROTECTION**  
NO SCALE

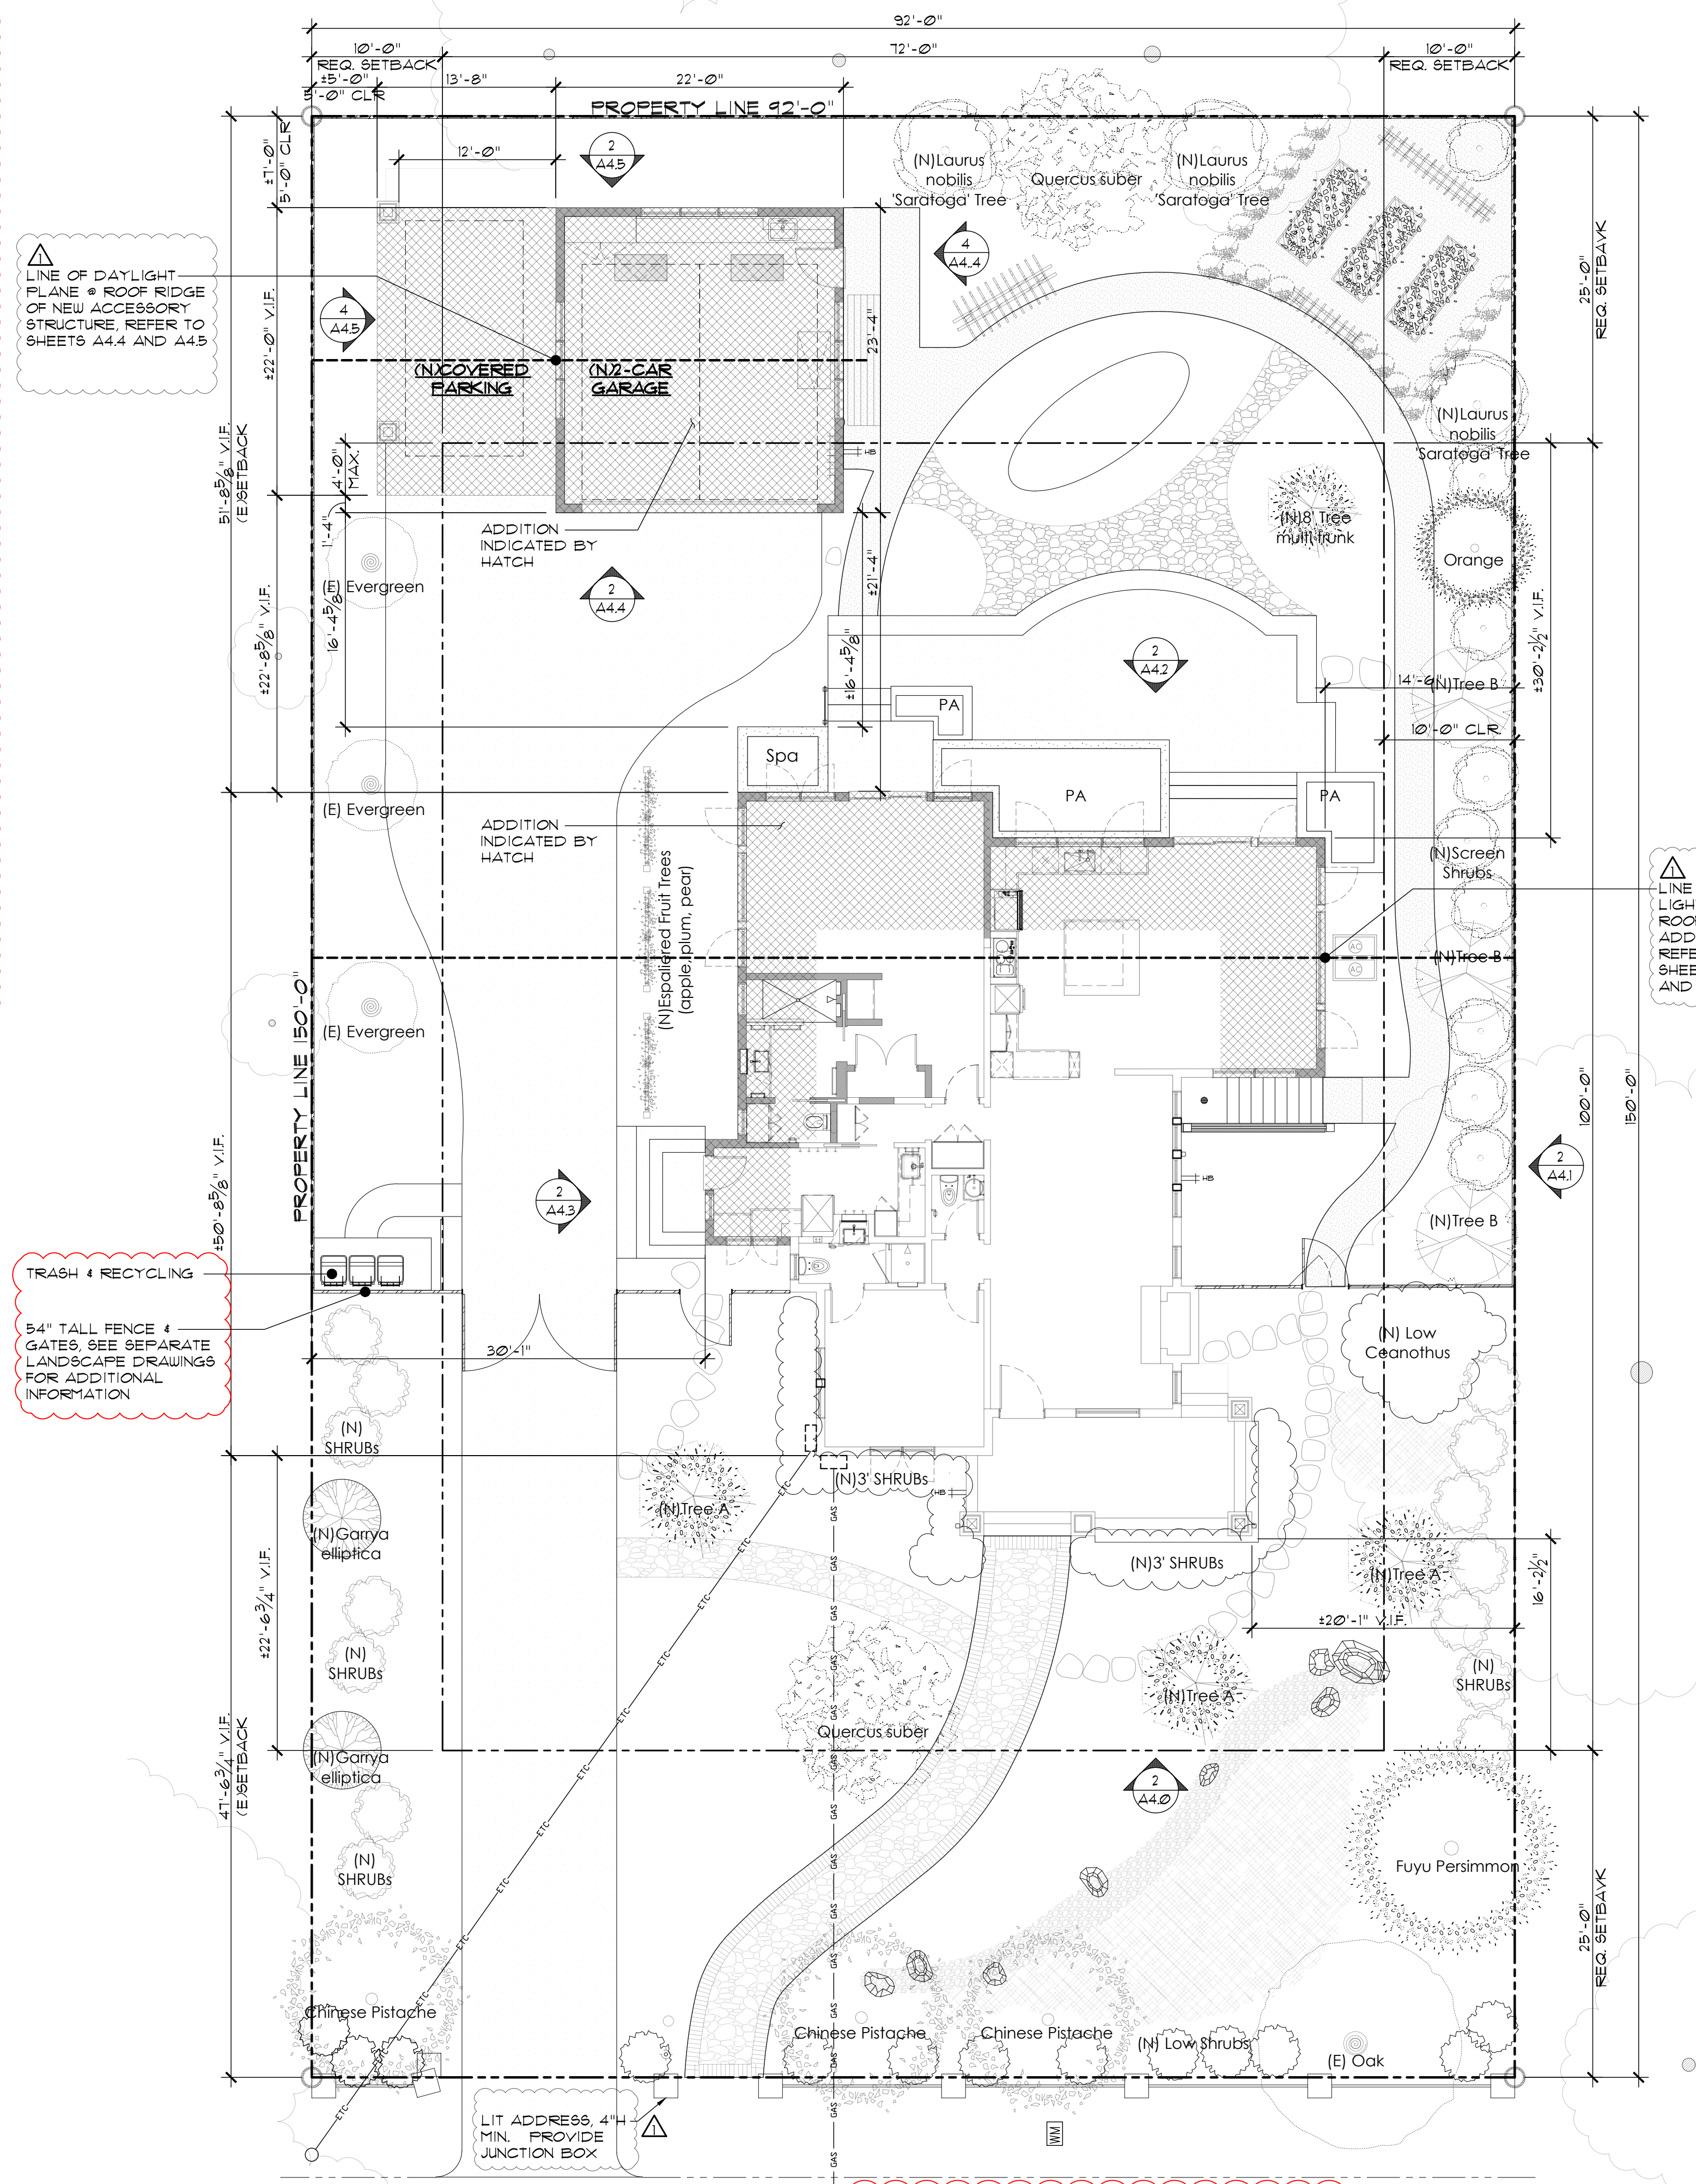
- PROPERTY LINE
- SETBACK LINE OR LINE OF EASEMENT
- OUTLINE OF RESIDENCE FOOTPRINT
- UTILITY LINE - UNDER GROUND
- (E)(OH)--- UTILITY LINE - OVERHEAD
- FENCE & DRAINAGE EASEMENT, FENCE / GATE
- AREA OF (E) RESIDENCE
- AREA OF RESIDENCE TO BE REMODELED.
- AREA OF ADDITION
- D.S.
- DOWNSPOUT CONNECTED TO UNDERGROUND DRAINAGE PIPING
- TREE INVENTORY SYMBOL (NUMBER)

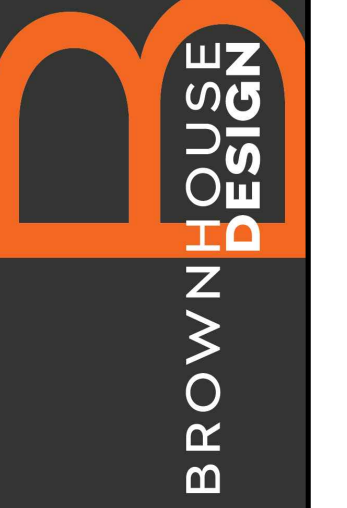
DESIGNER: BROWNHOUSE DESIGN, INC. 101 MAIN ST. LOS ALTOS, CA 94022  
ARCHITECT OF RECORD: DAVID BARNA, ARCHITECT 270 PROMISE WAY HOLLISTER, CA 95023

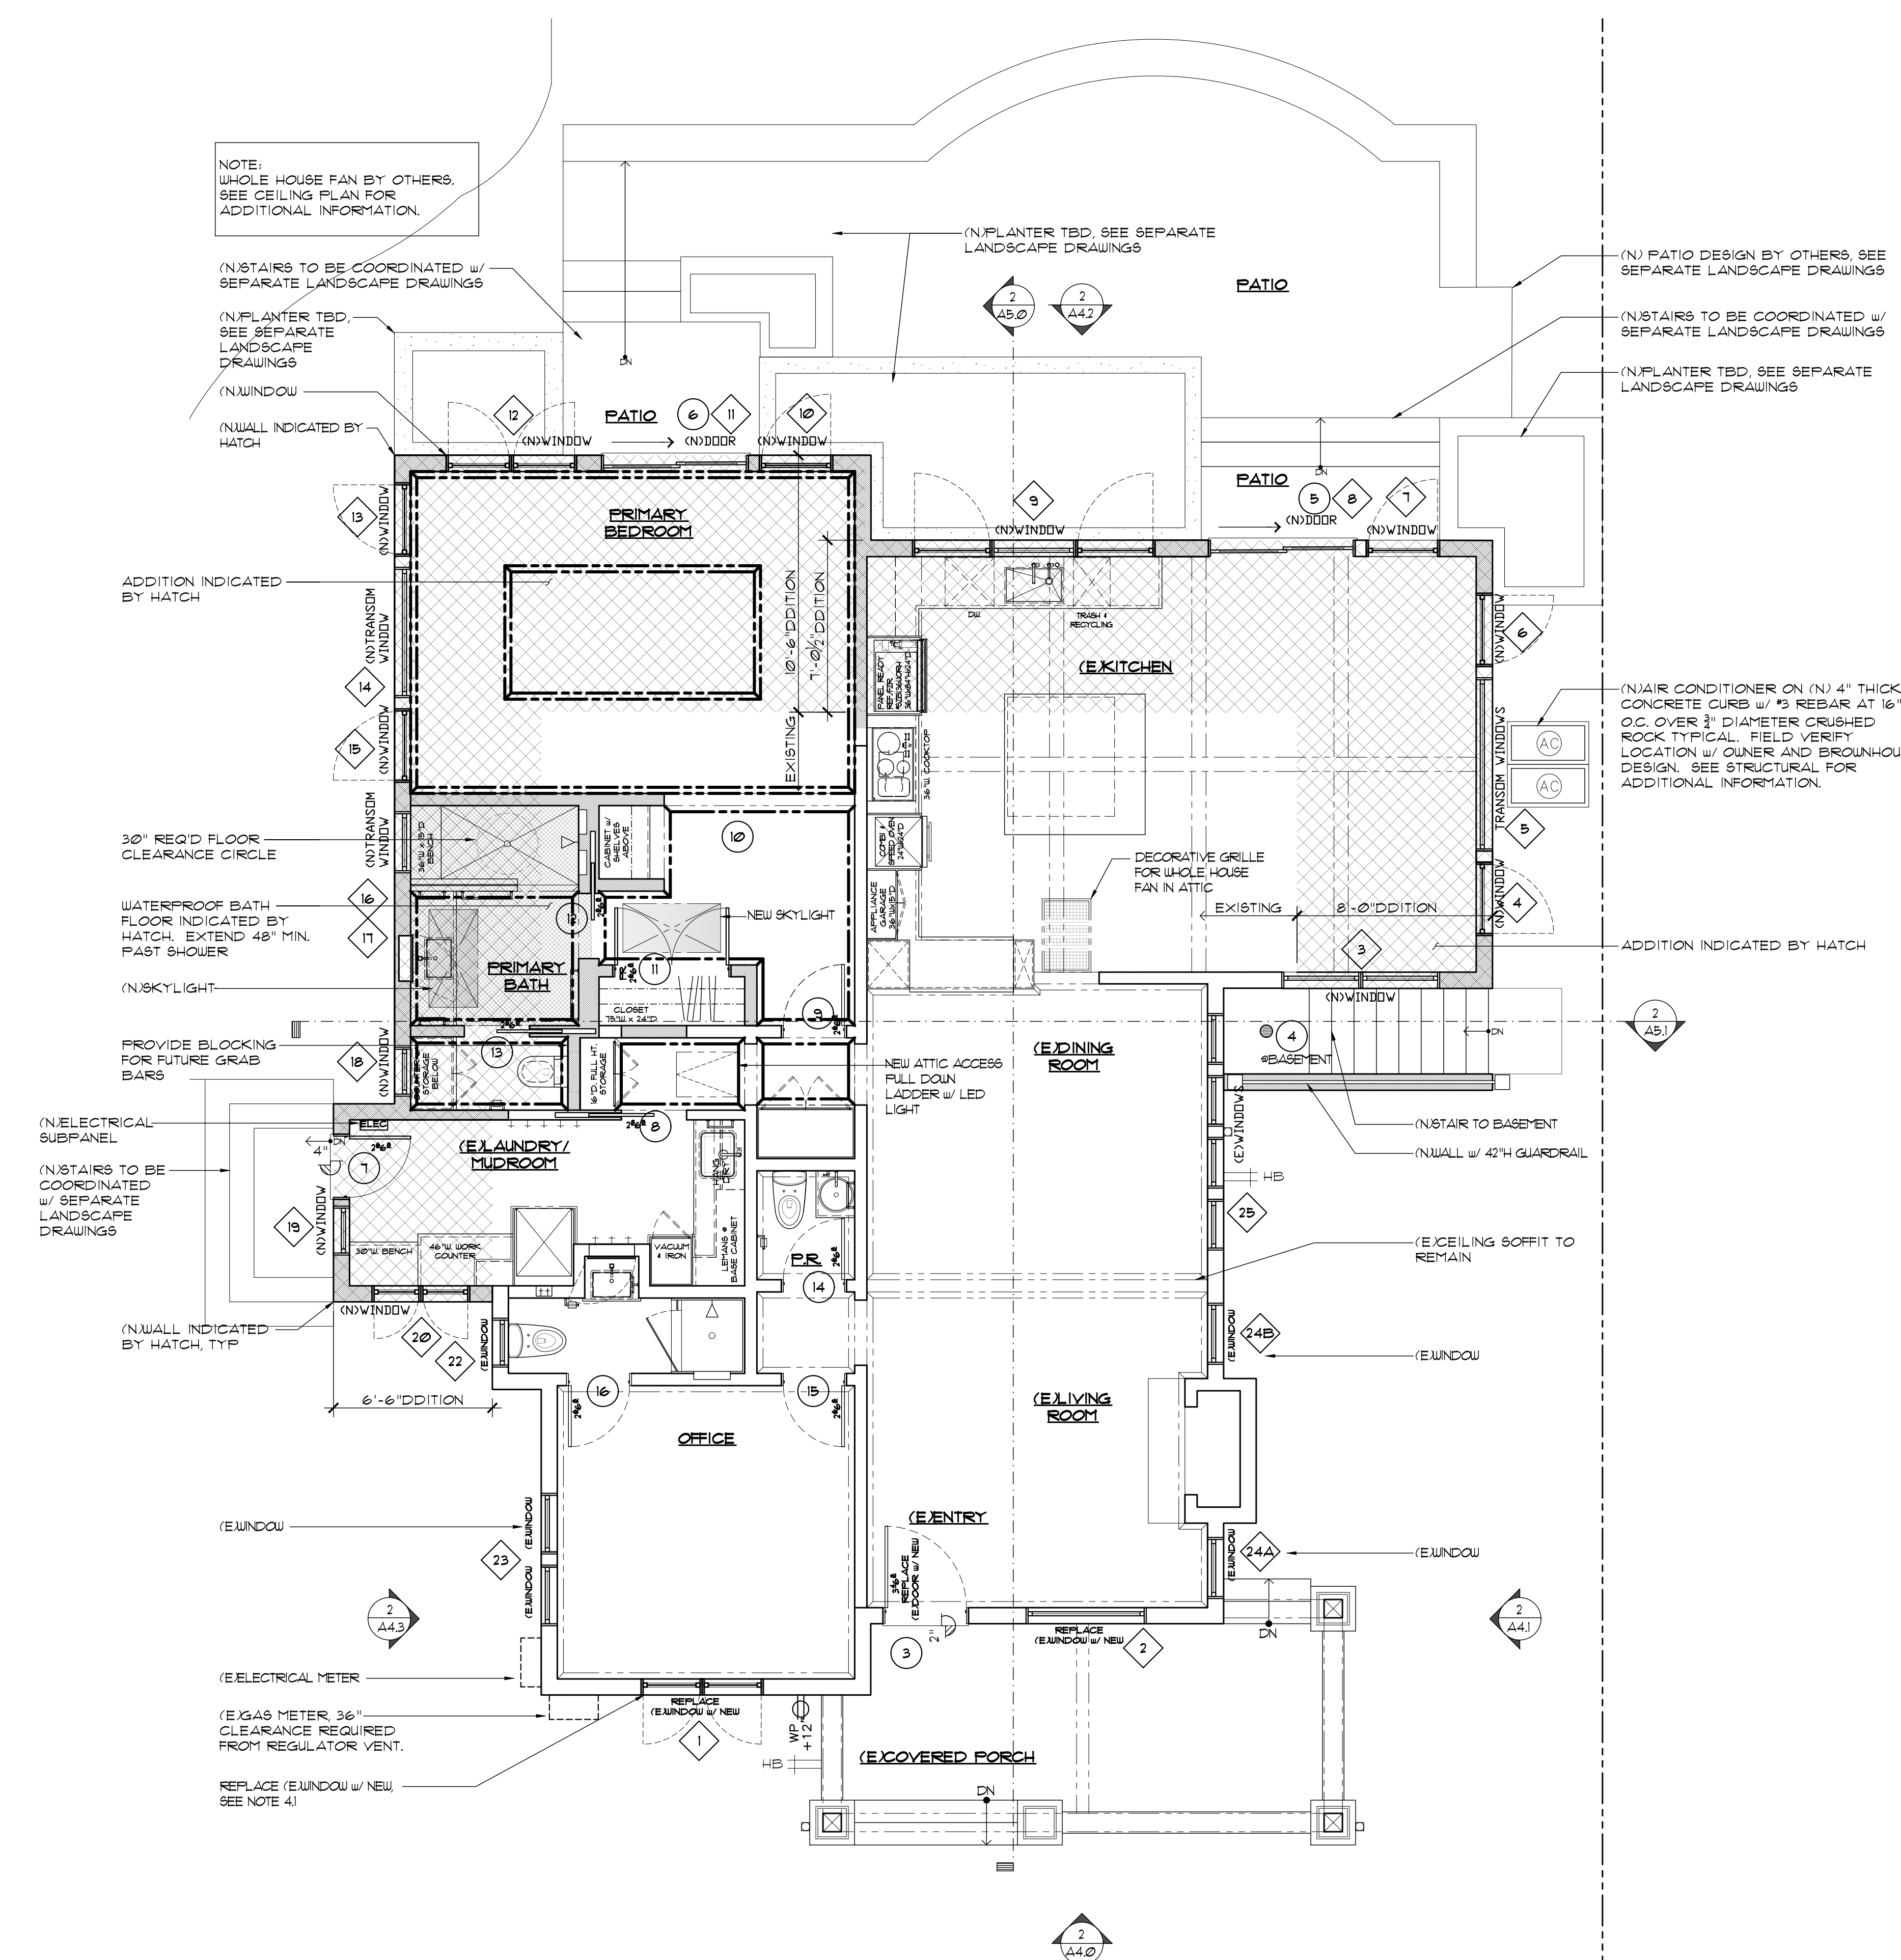
NOTE: WHOLE HOUSE FAN BY OTHERS. SEE CEILING PLAN FOR ADDITIONAL INFORMATION.

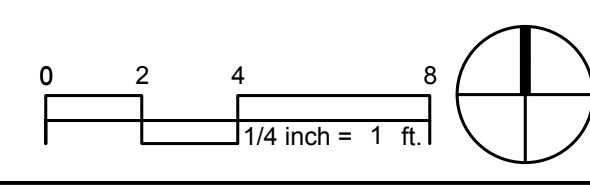
### FLOOR PLAN DEMOLITION NOTES
