## **HISTORICAL COMMISSION SPECIAL MEETING AGENDA**

**7:00 PM - Monday, August 08, 2022**

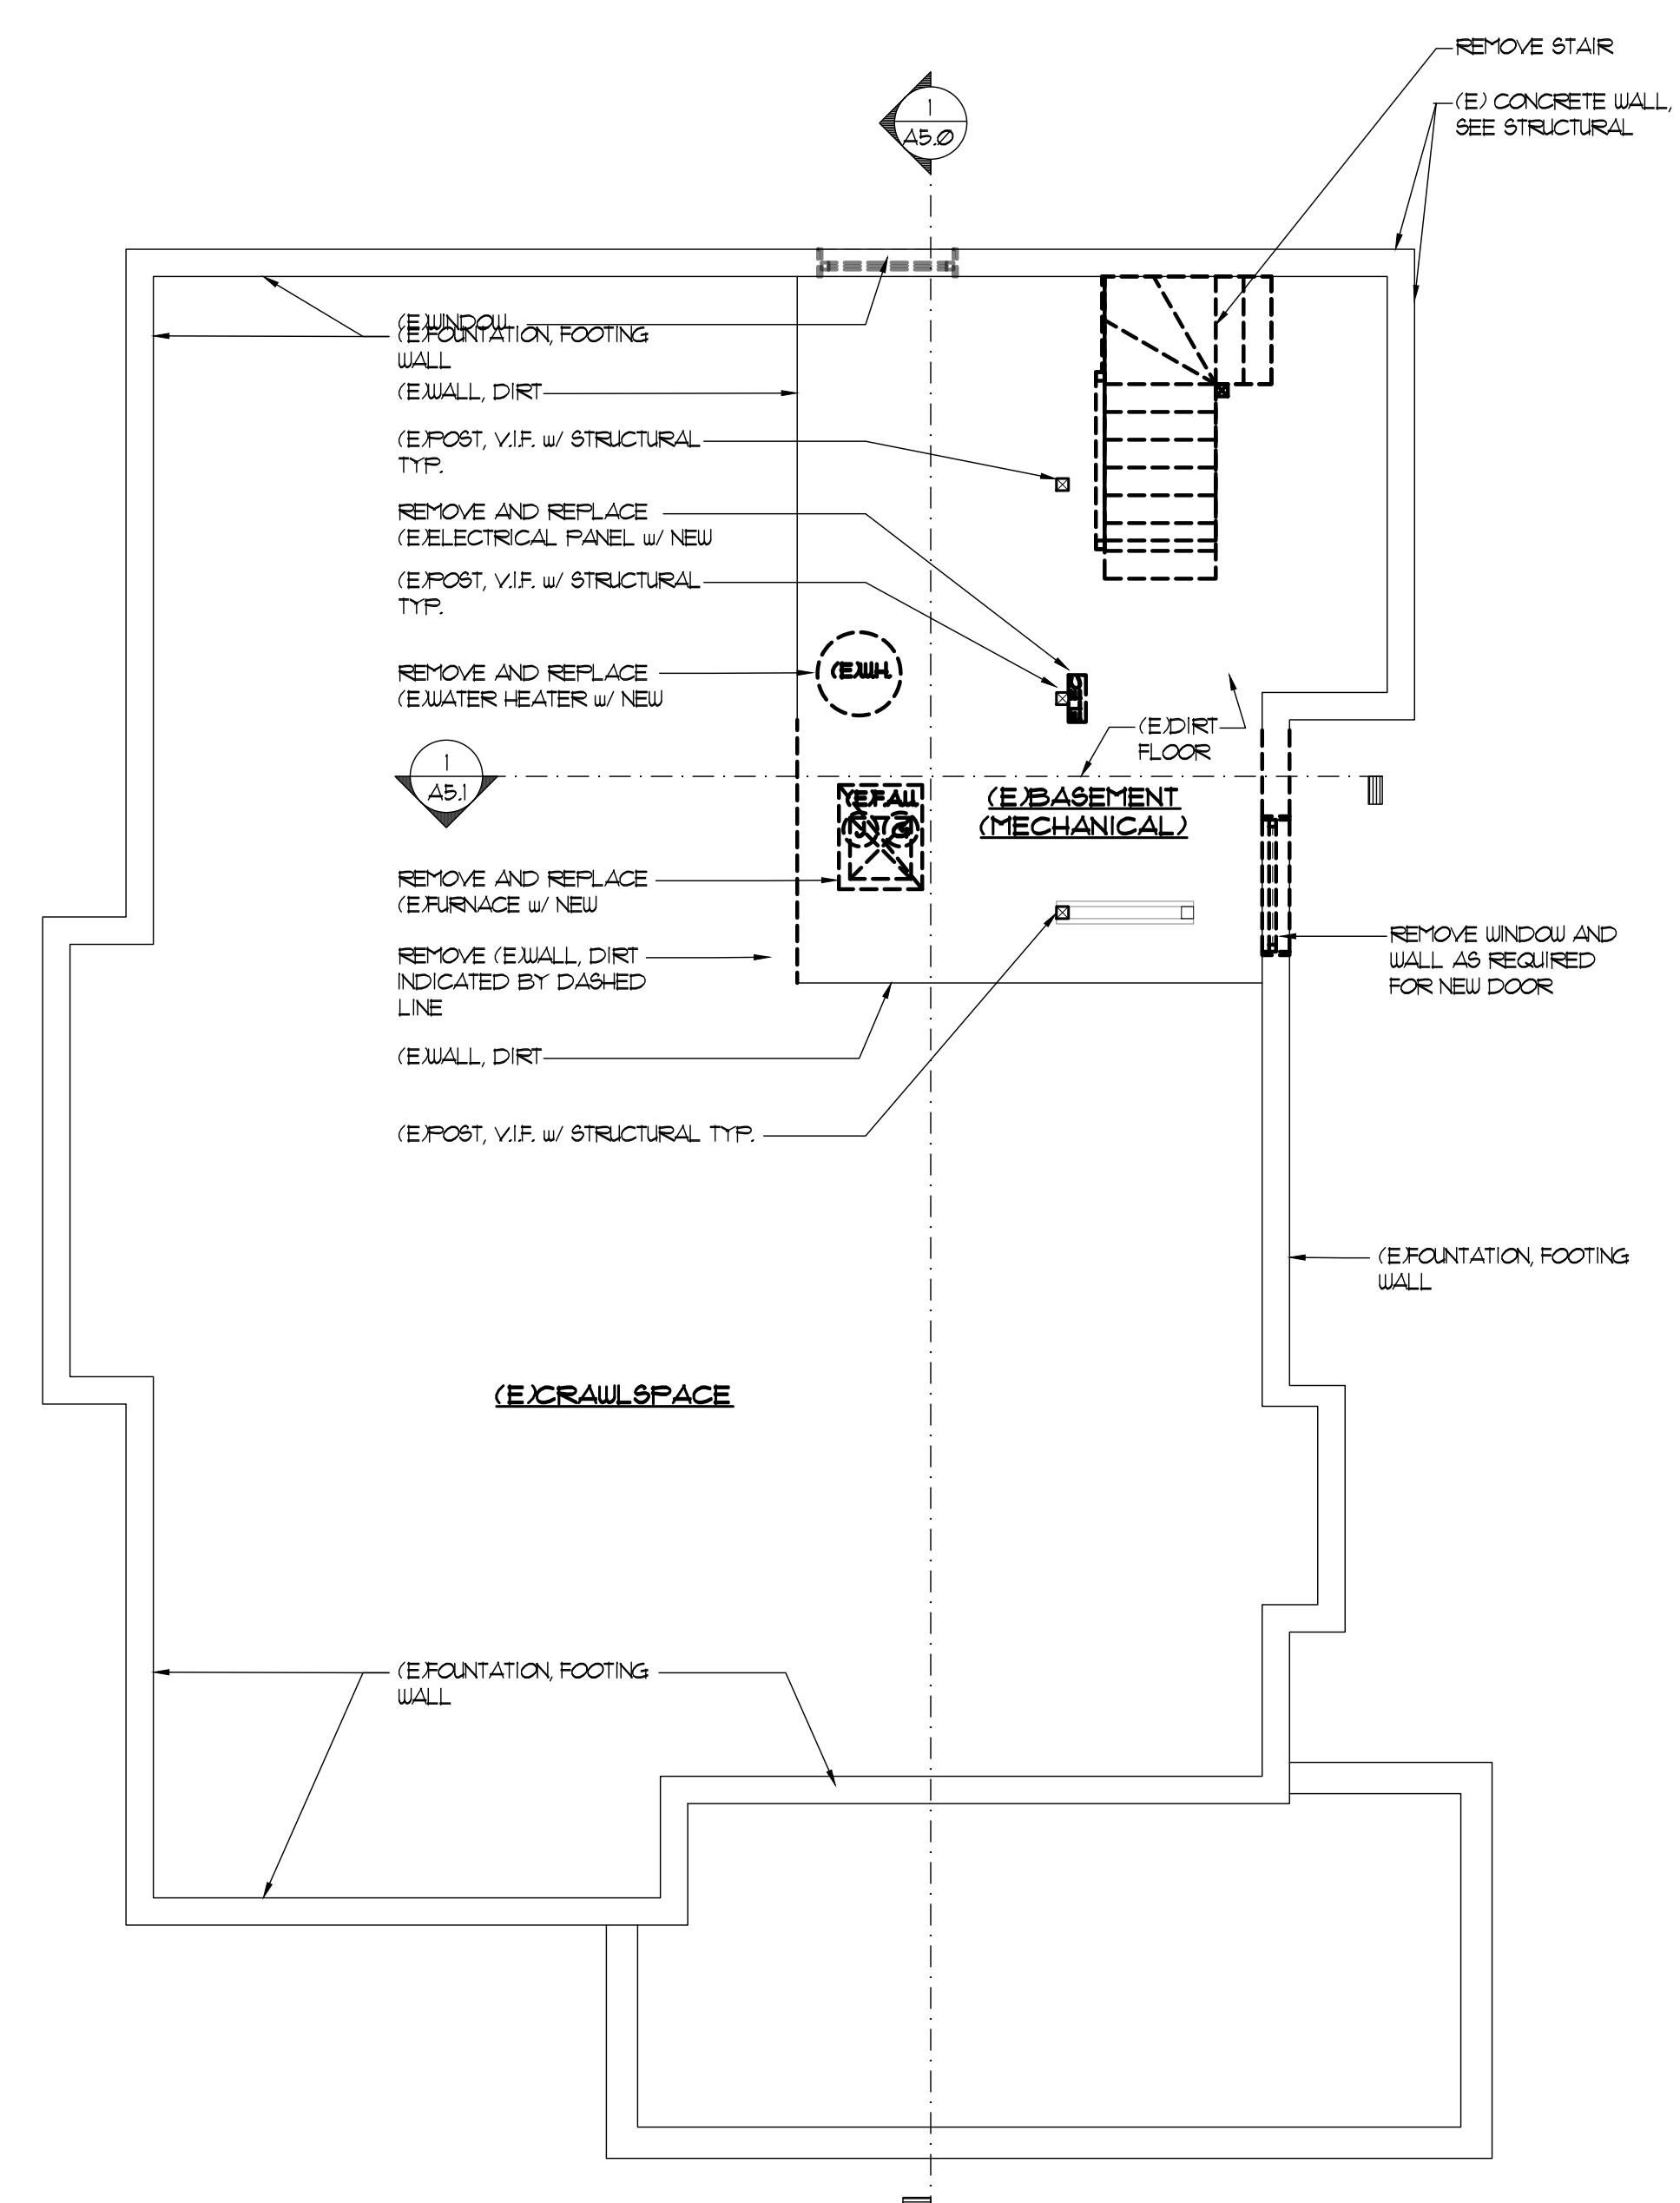
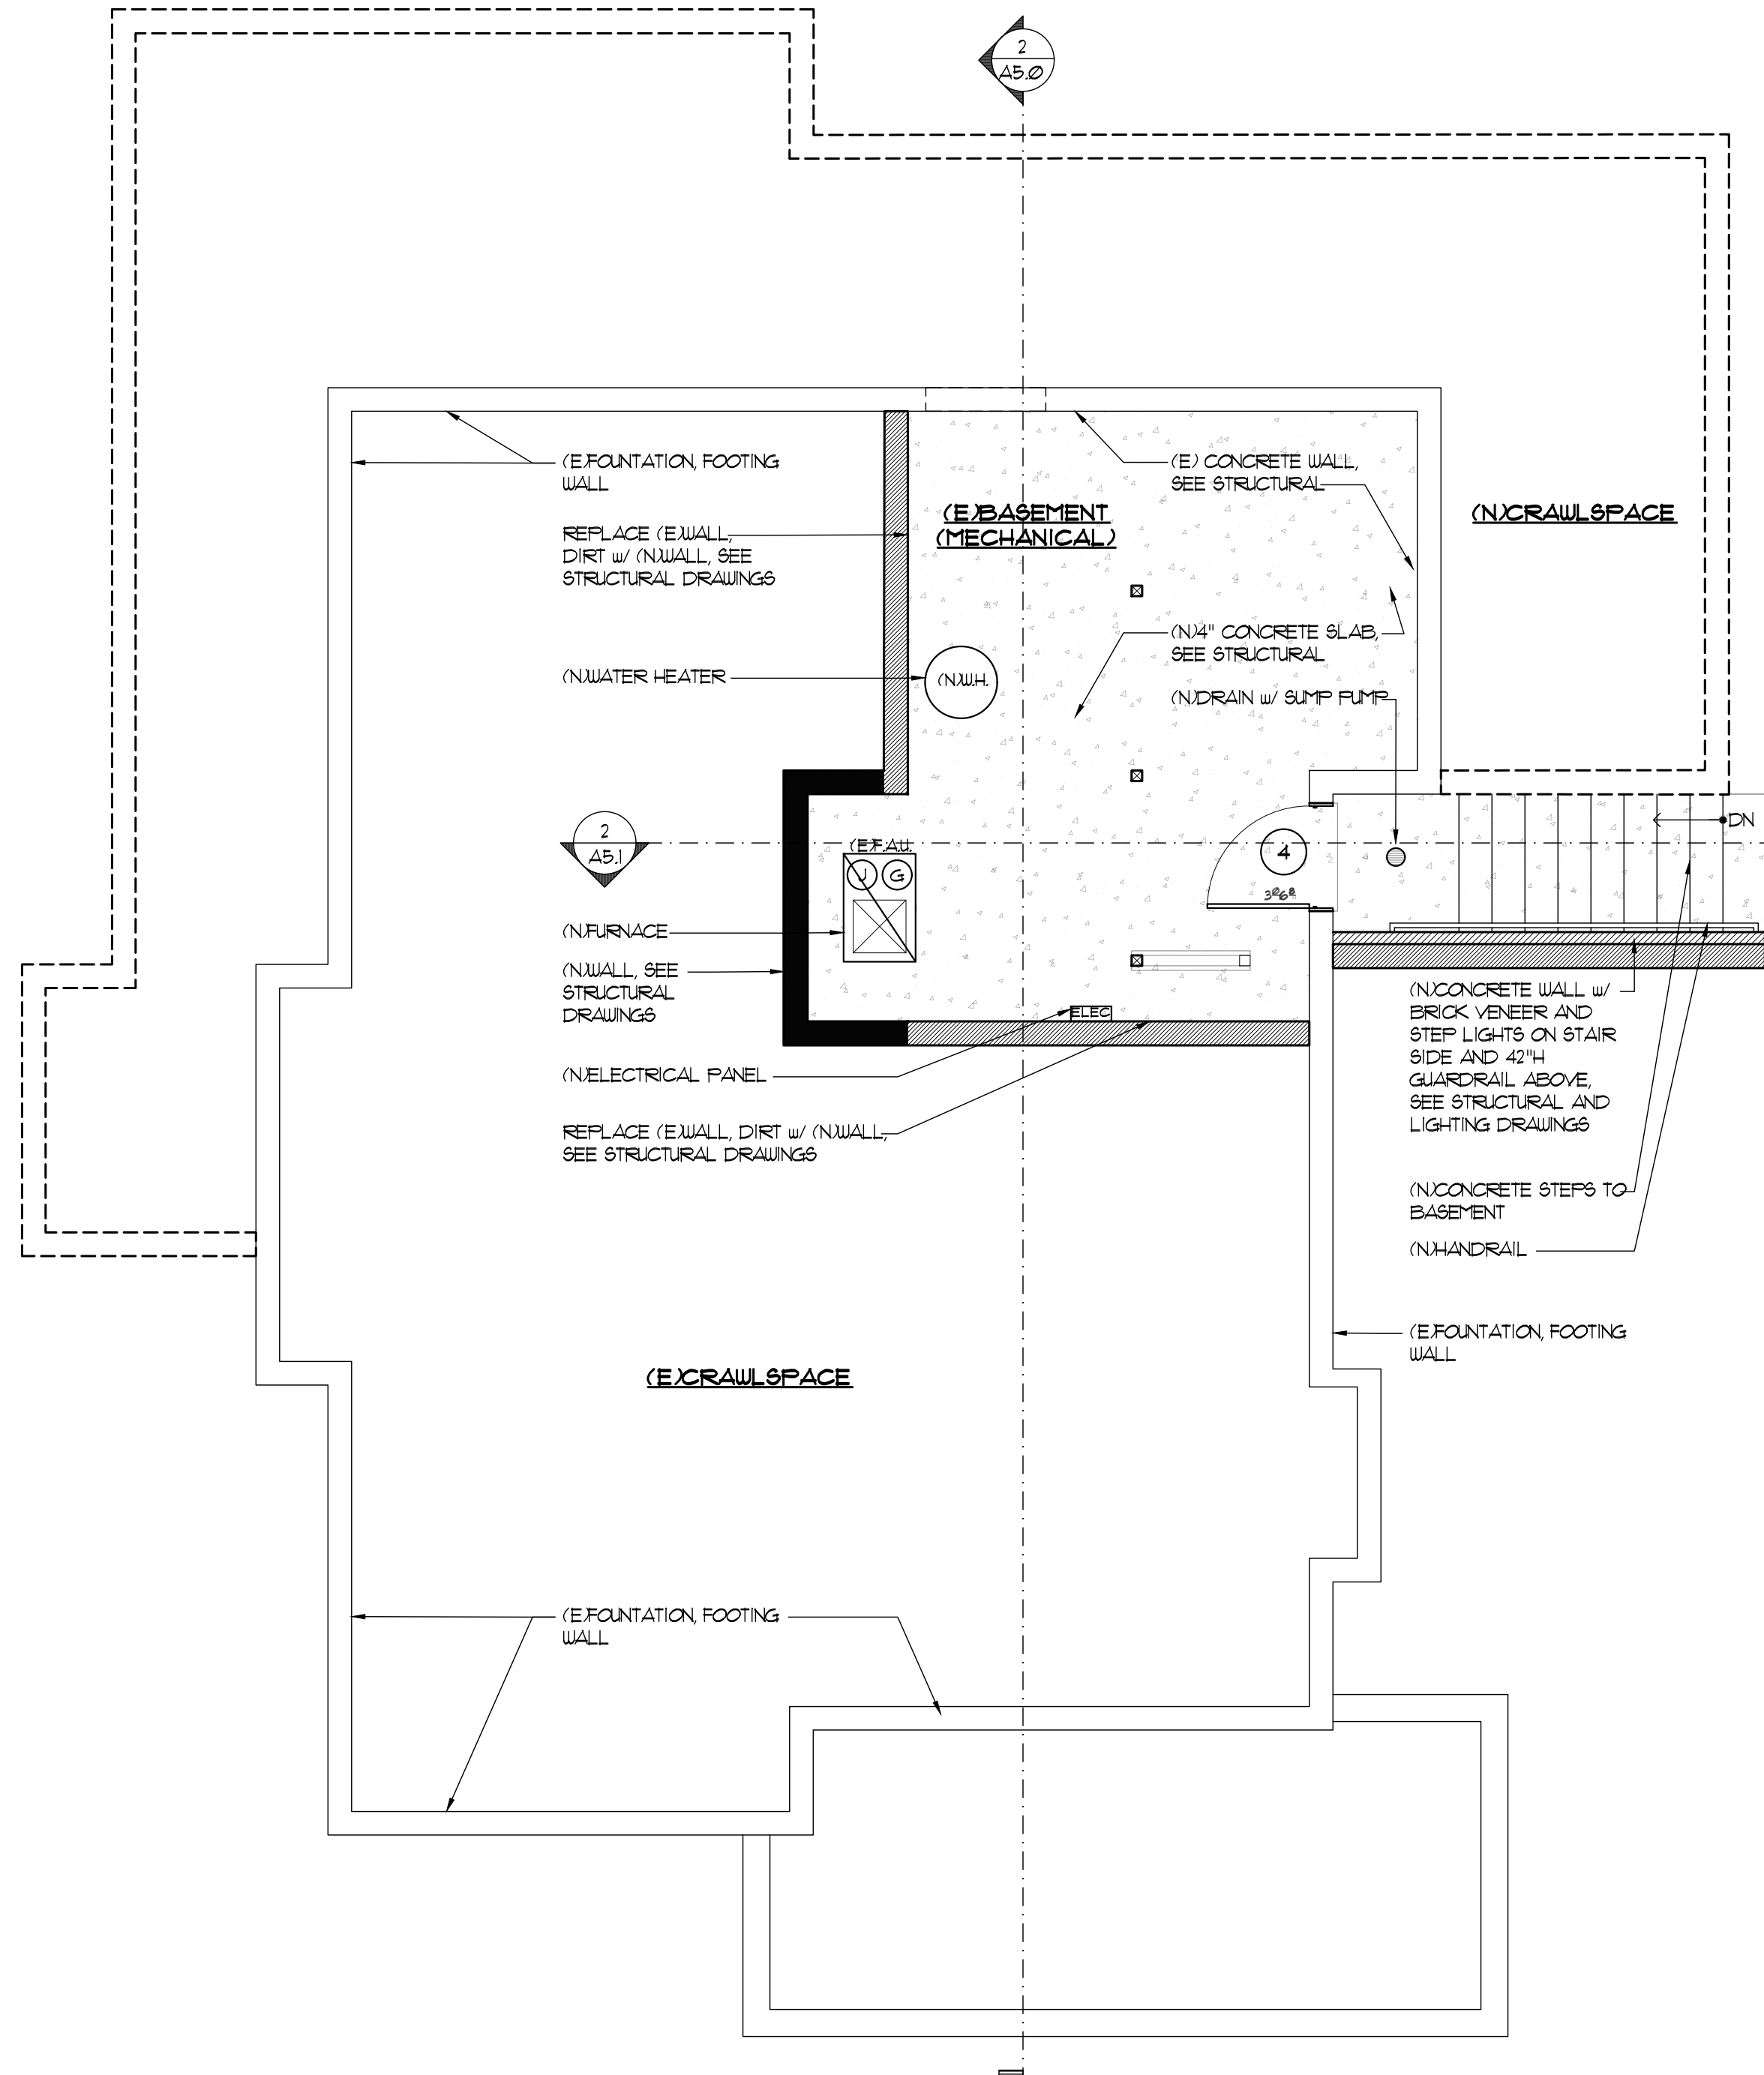
**BASEMENT EXISTING/DEMOLITION FLOOR PLAN**  
SCALE: 1/4" = 1'-0"

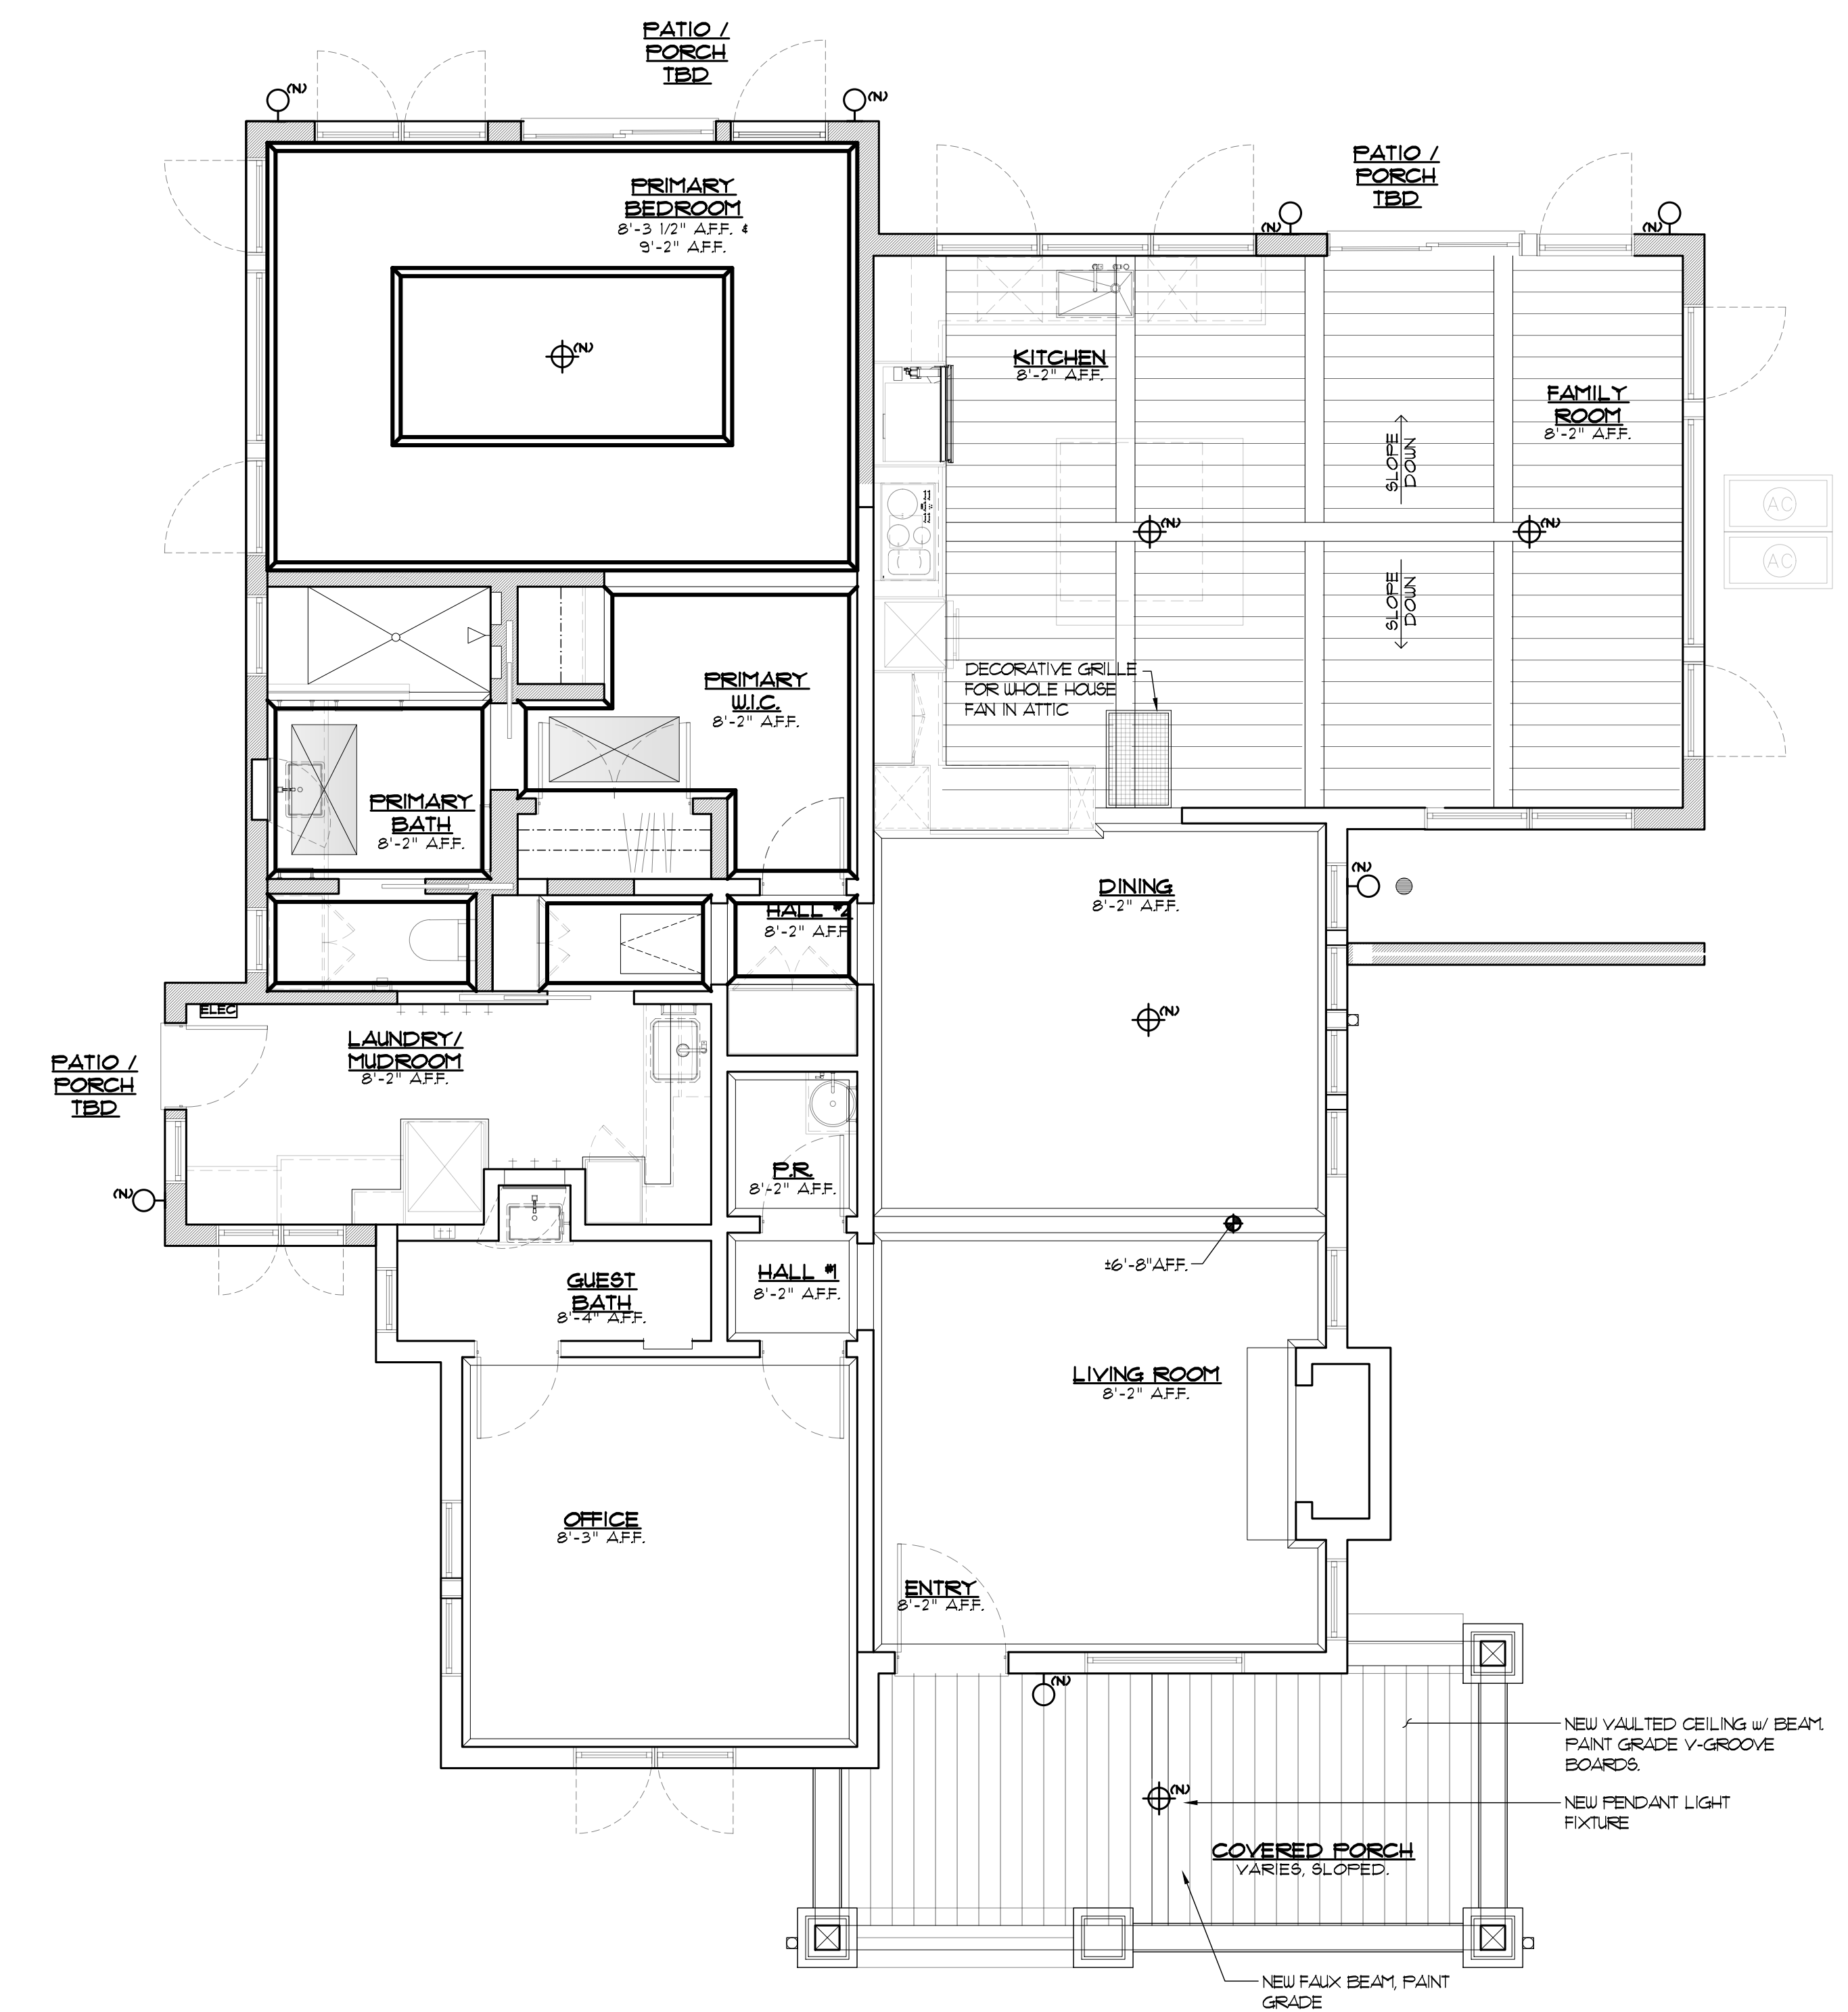
**CEILING PLAN NOTES**

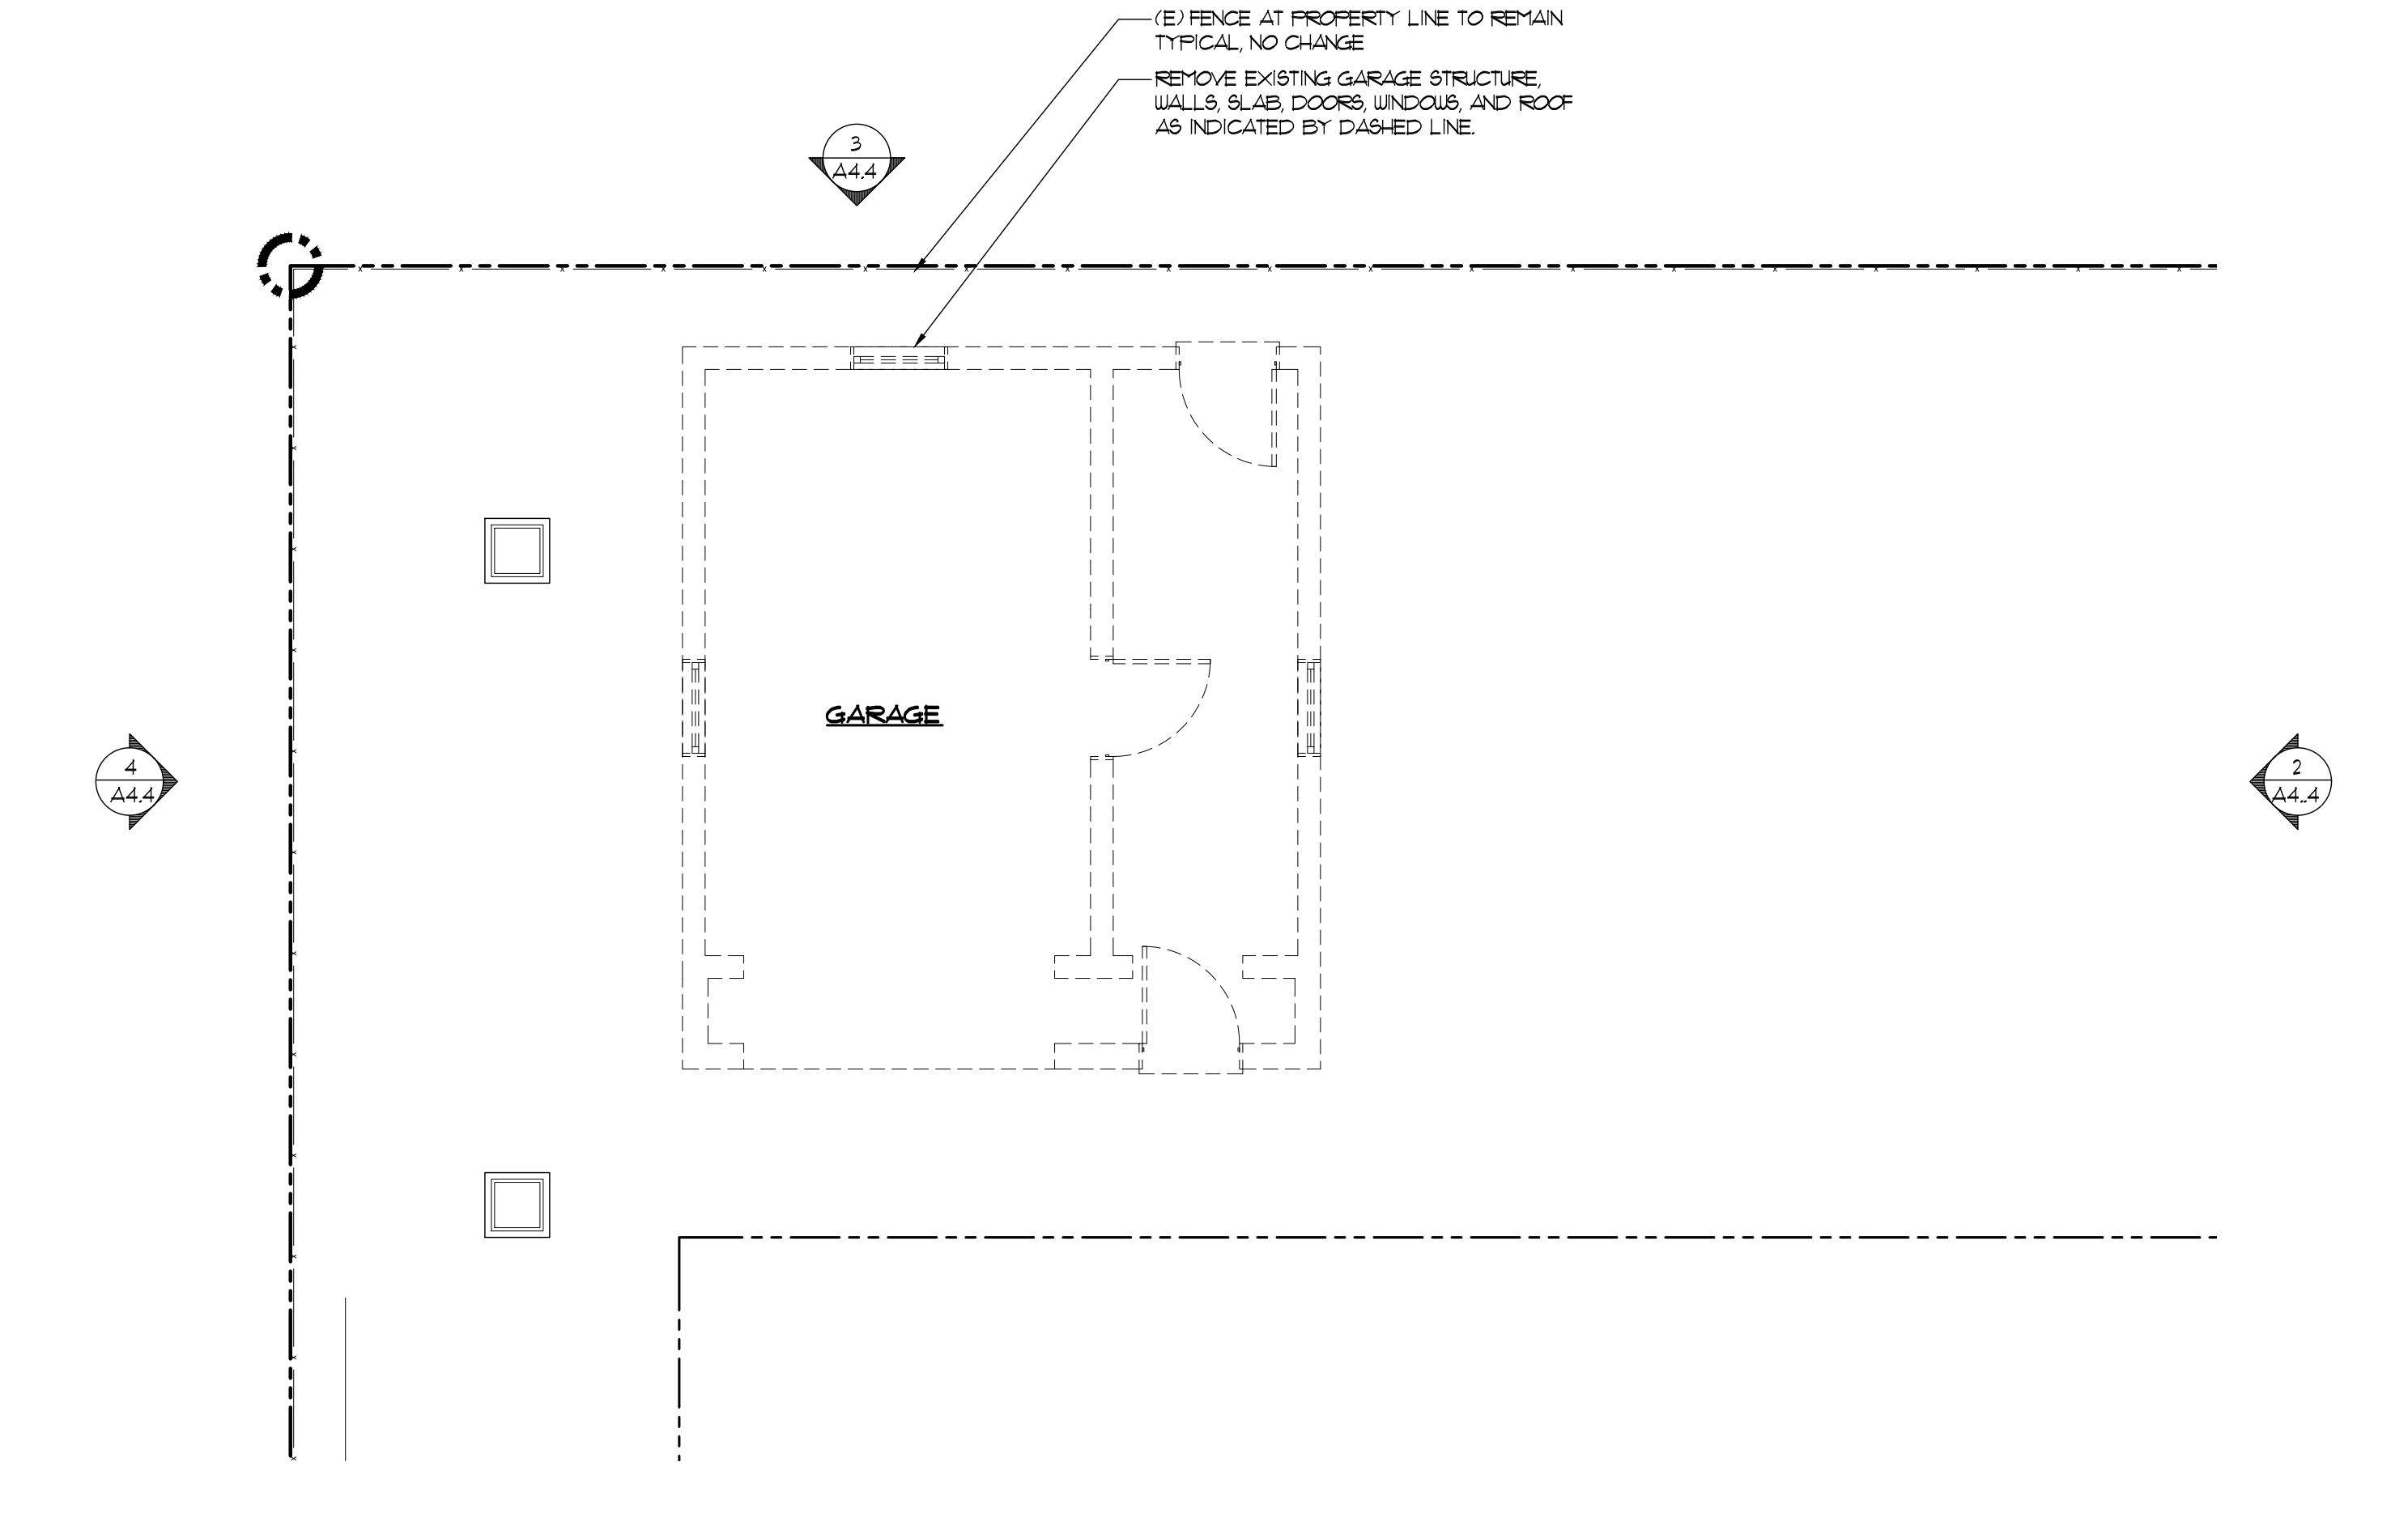
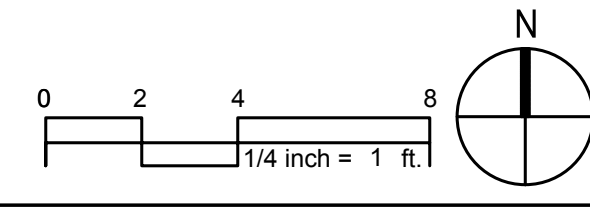
**2 DETACHED GARAGE NEW/PROPOSED CEILING PLAN**  
SCALE: 1/4" = 1'-0"

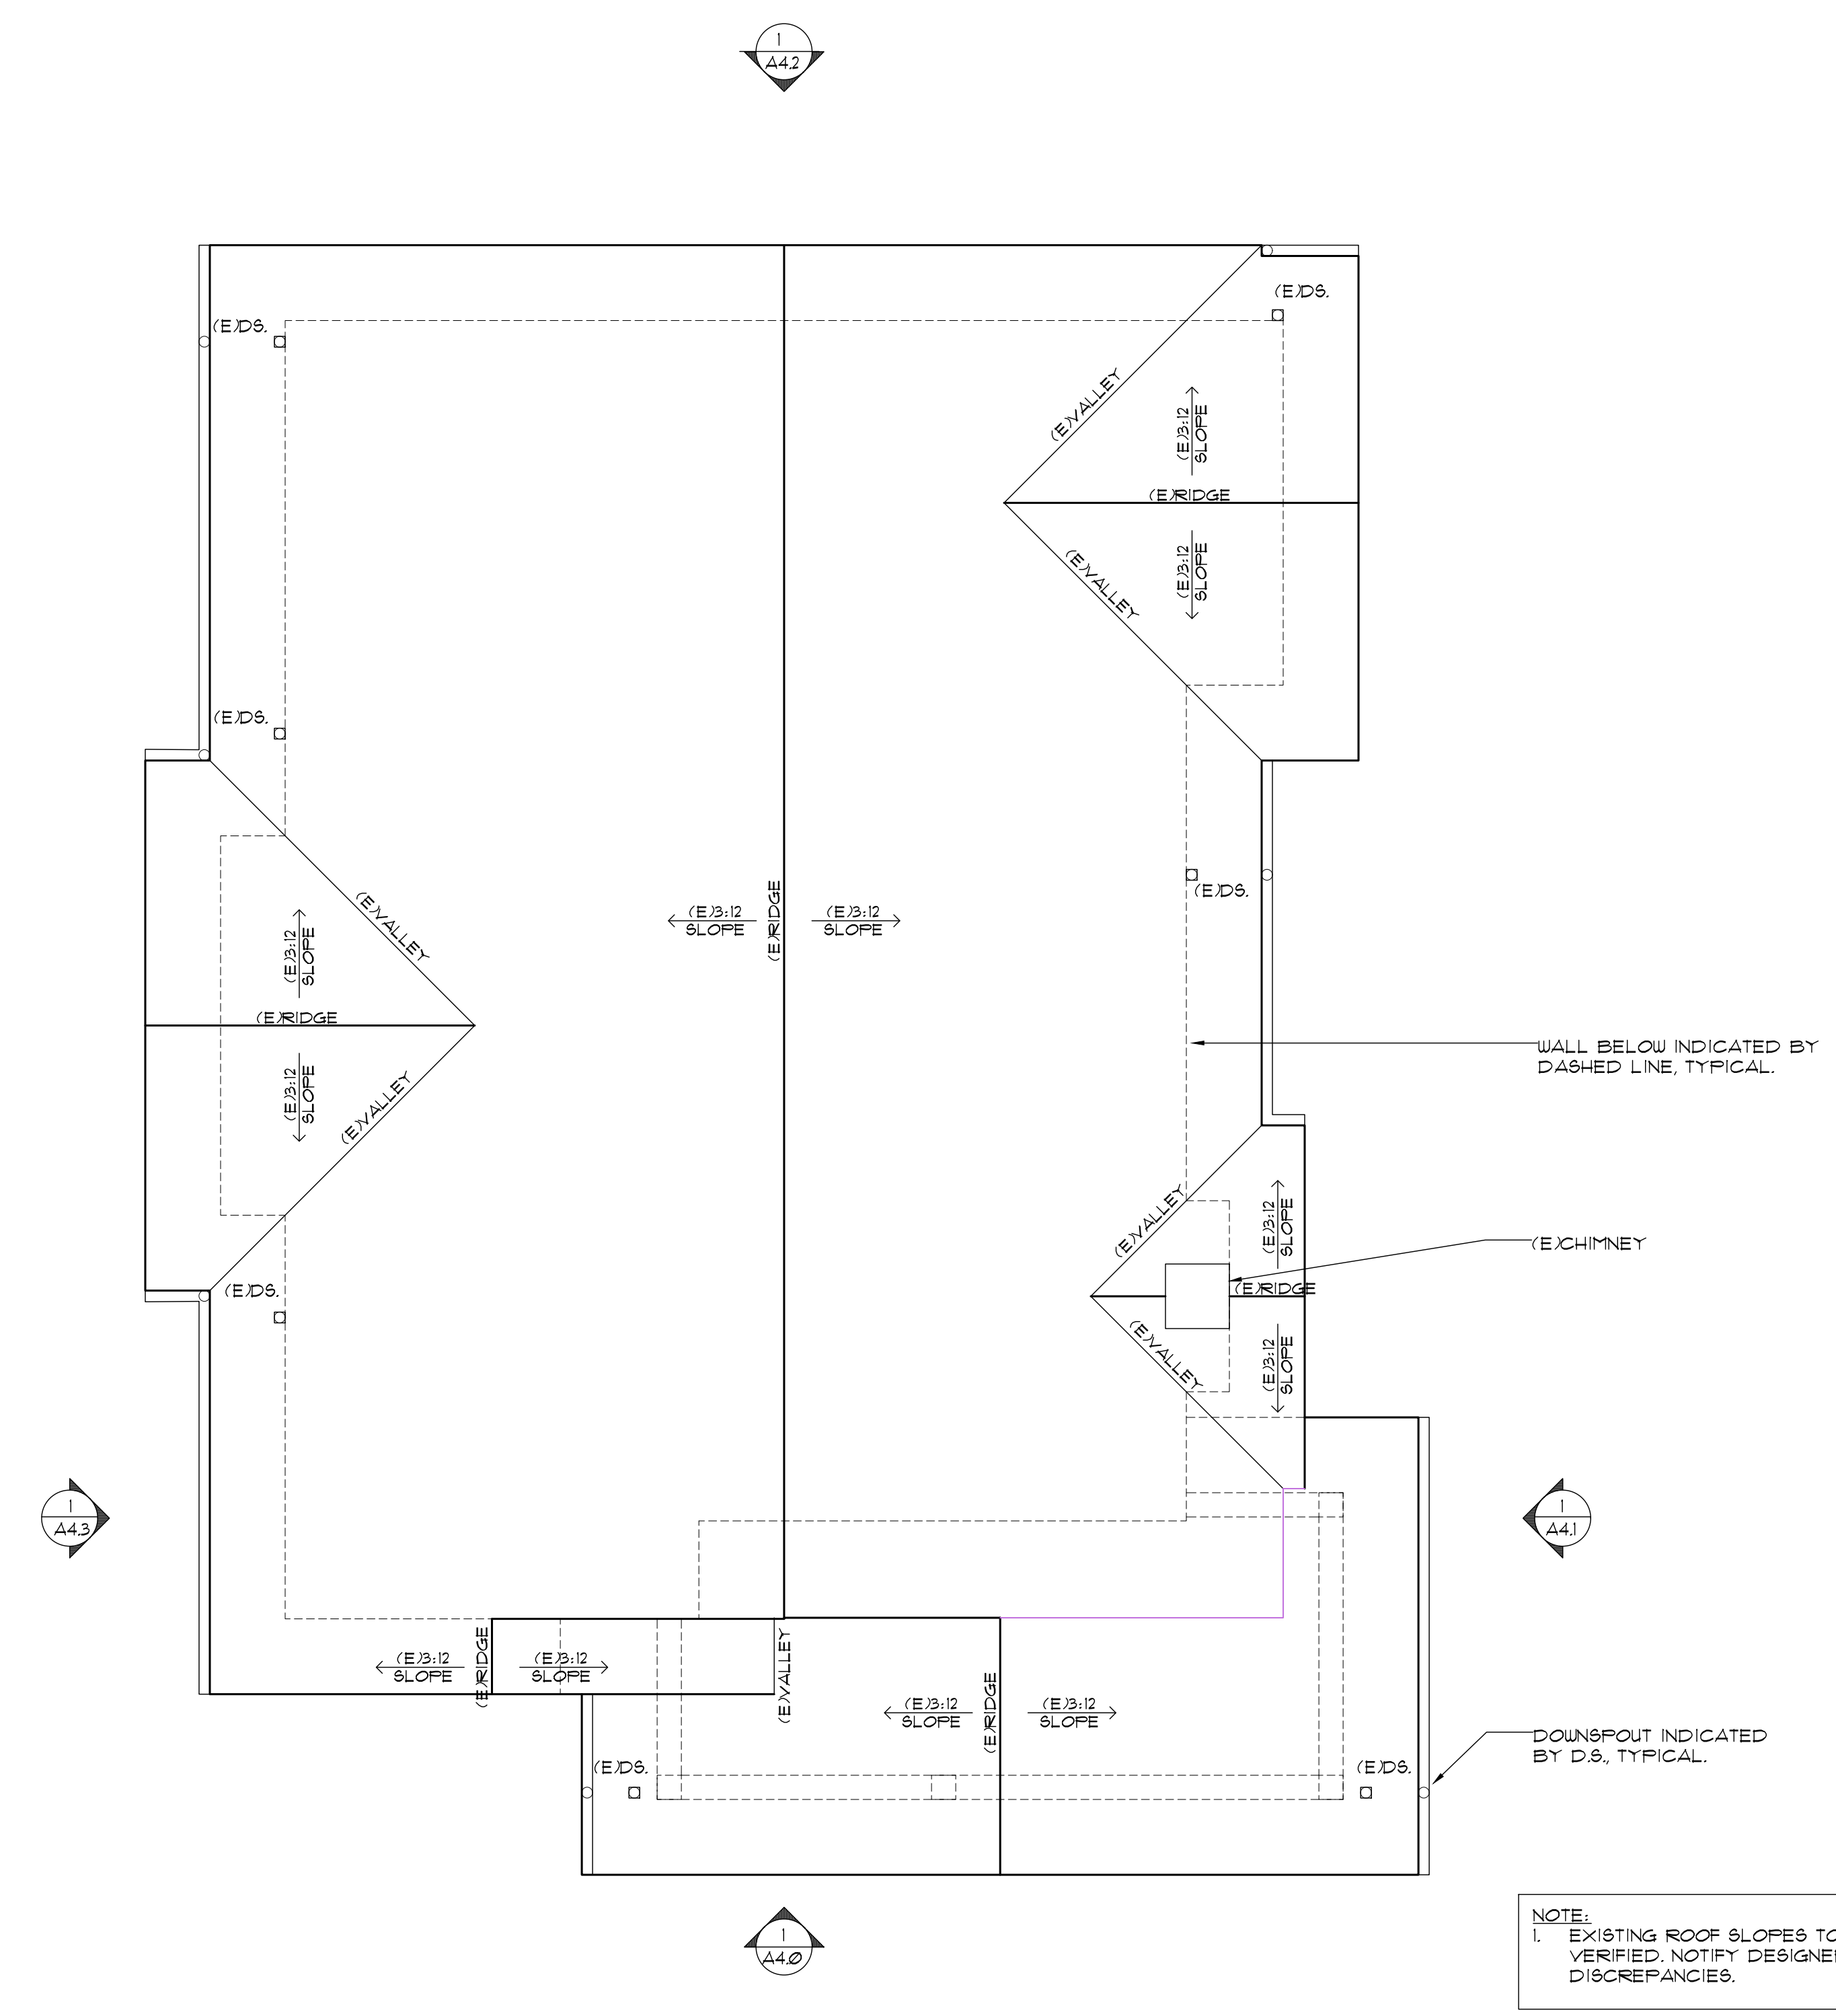
**MAIN HOUSE**  
**EXISTING/DEMOLITION ROOF PLAN**  
SCALE: 1/4" = 1'-0"

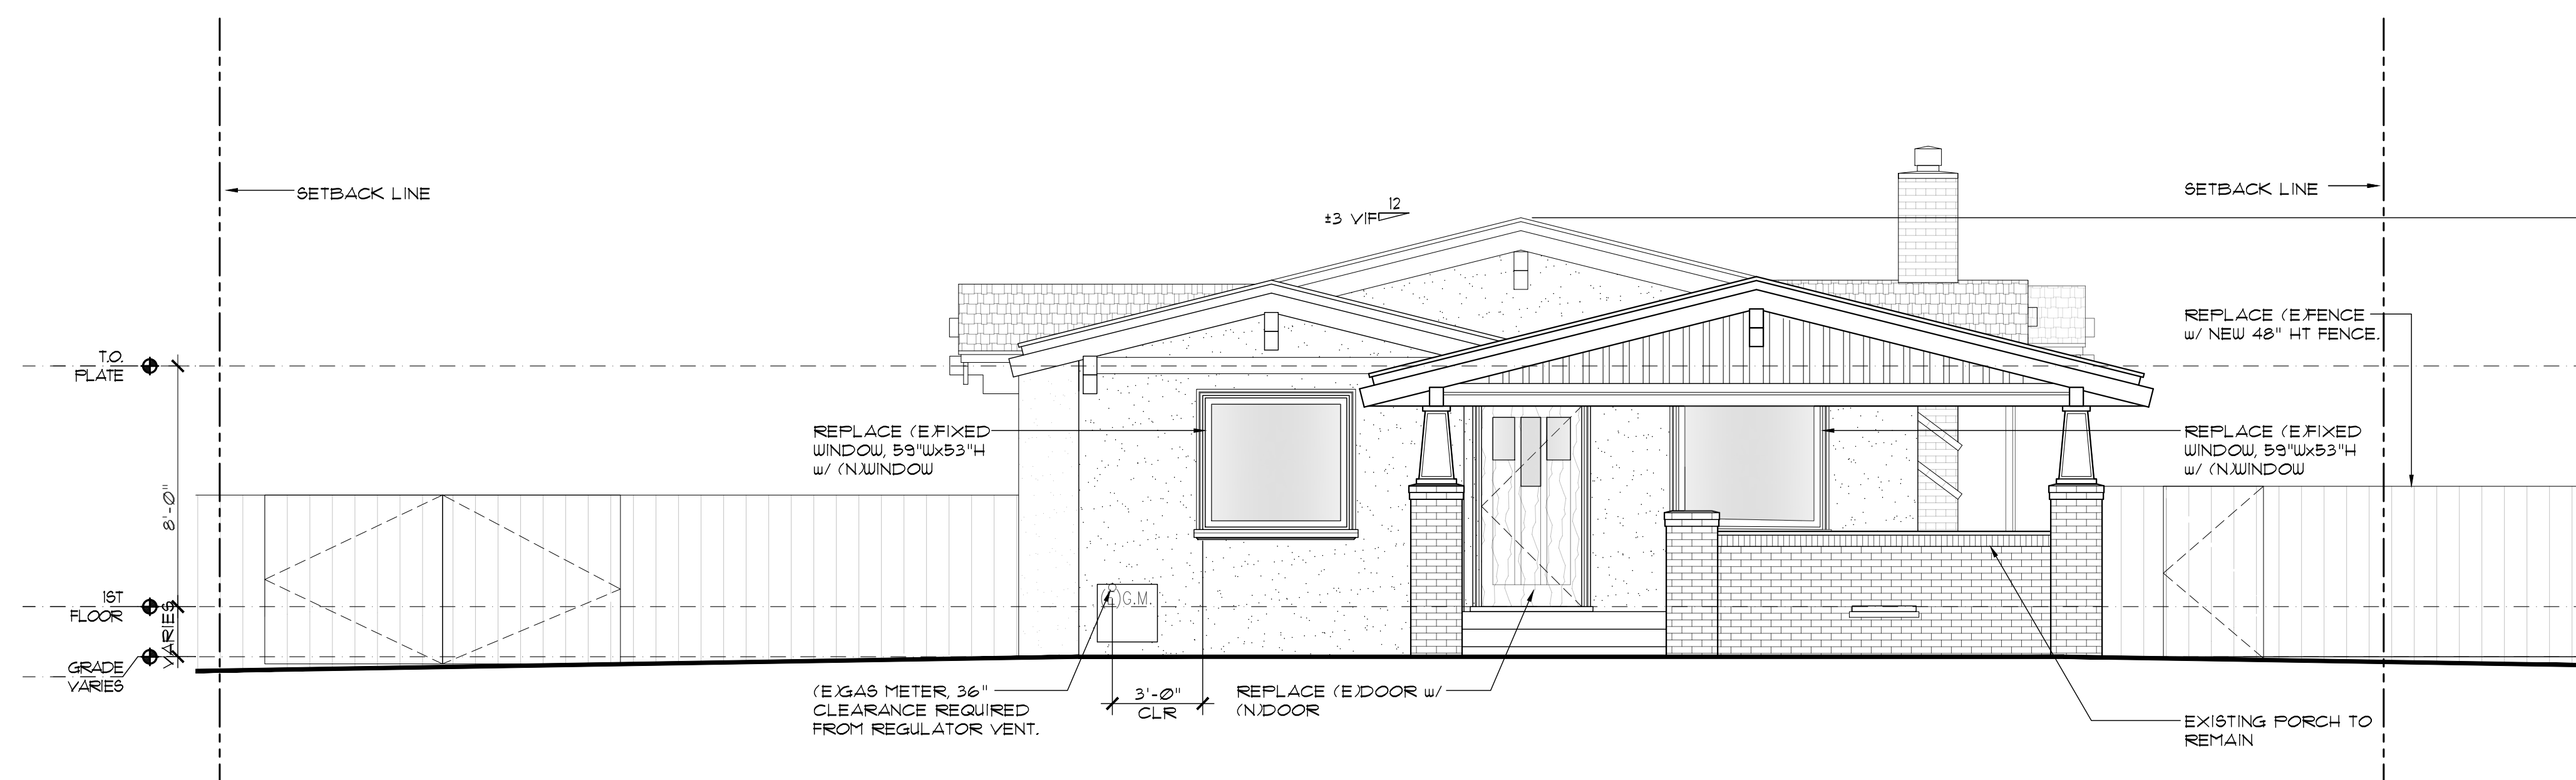
**MAIN HOUSE  
FRONT ELEVATION, SOUTH -EXISTING/DEMOLITION**

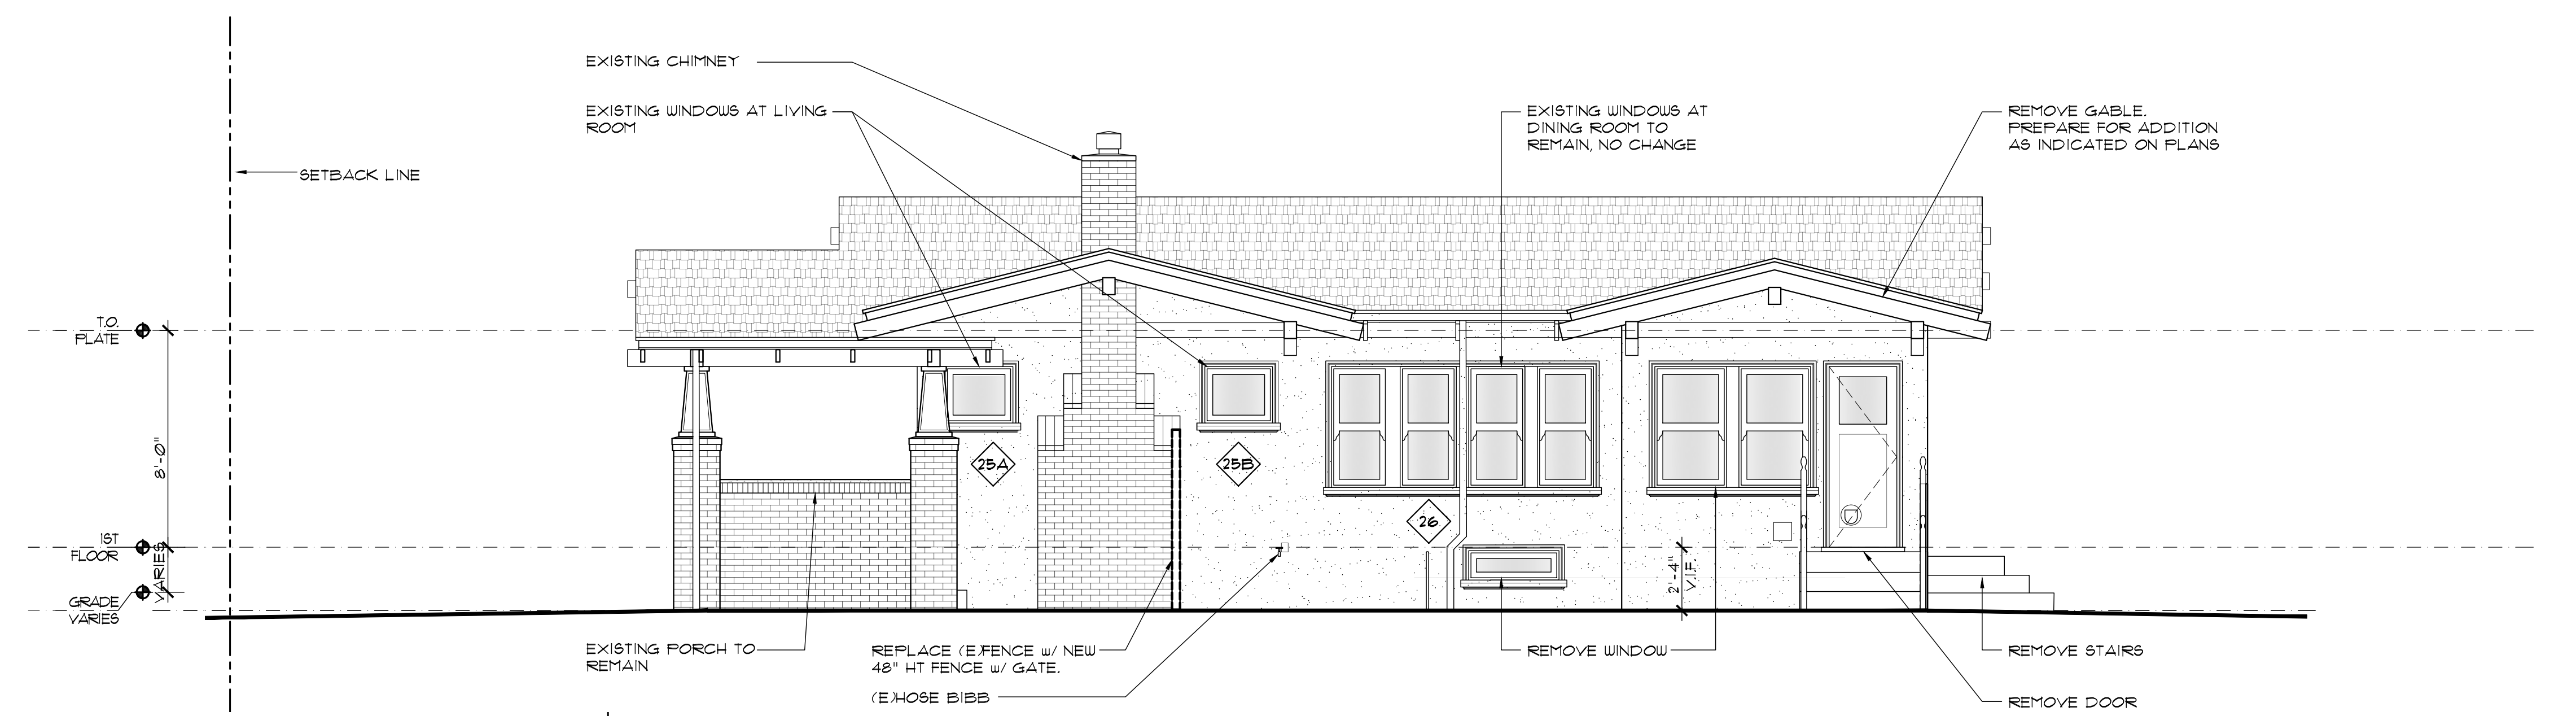
**MAIN HOUSE  
RIGHT SIDE ELEVATION, EAST -EXISTING/DEMOLITION**
