## **HISTORICAL COMMISSION SPECIAL MEETING AGENDA**

**7:00 PM - Monday, August 08, 2022**

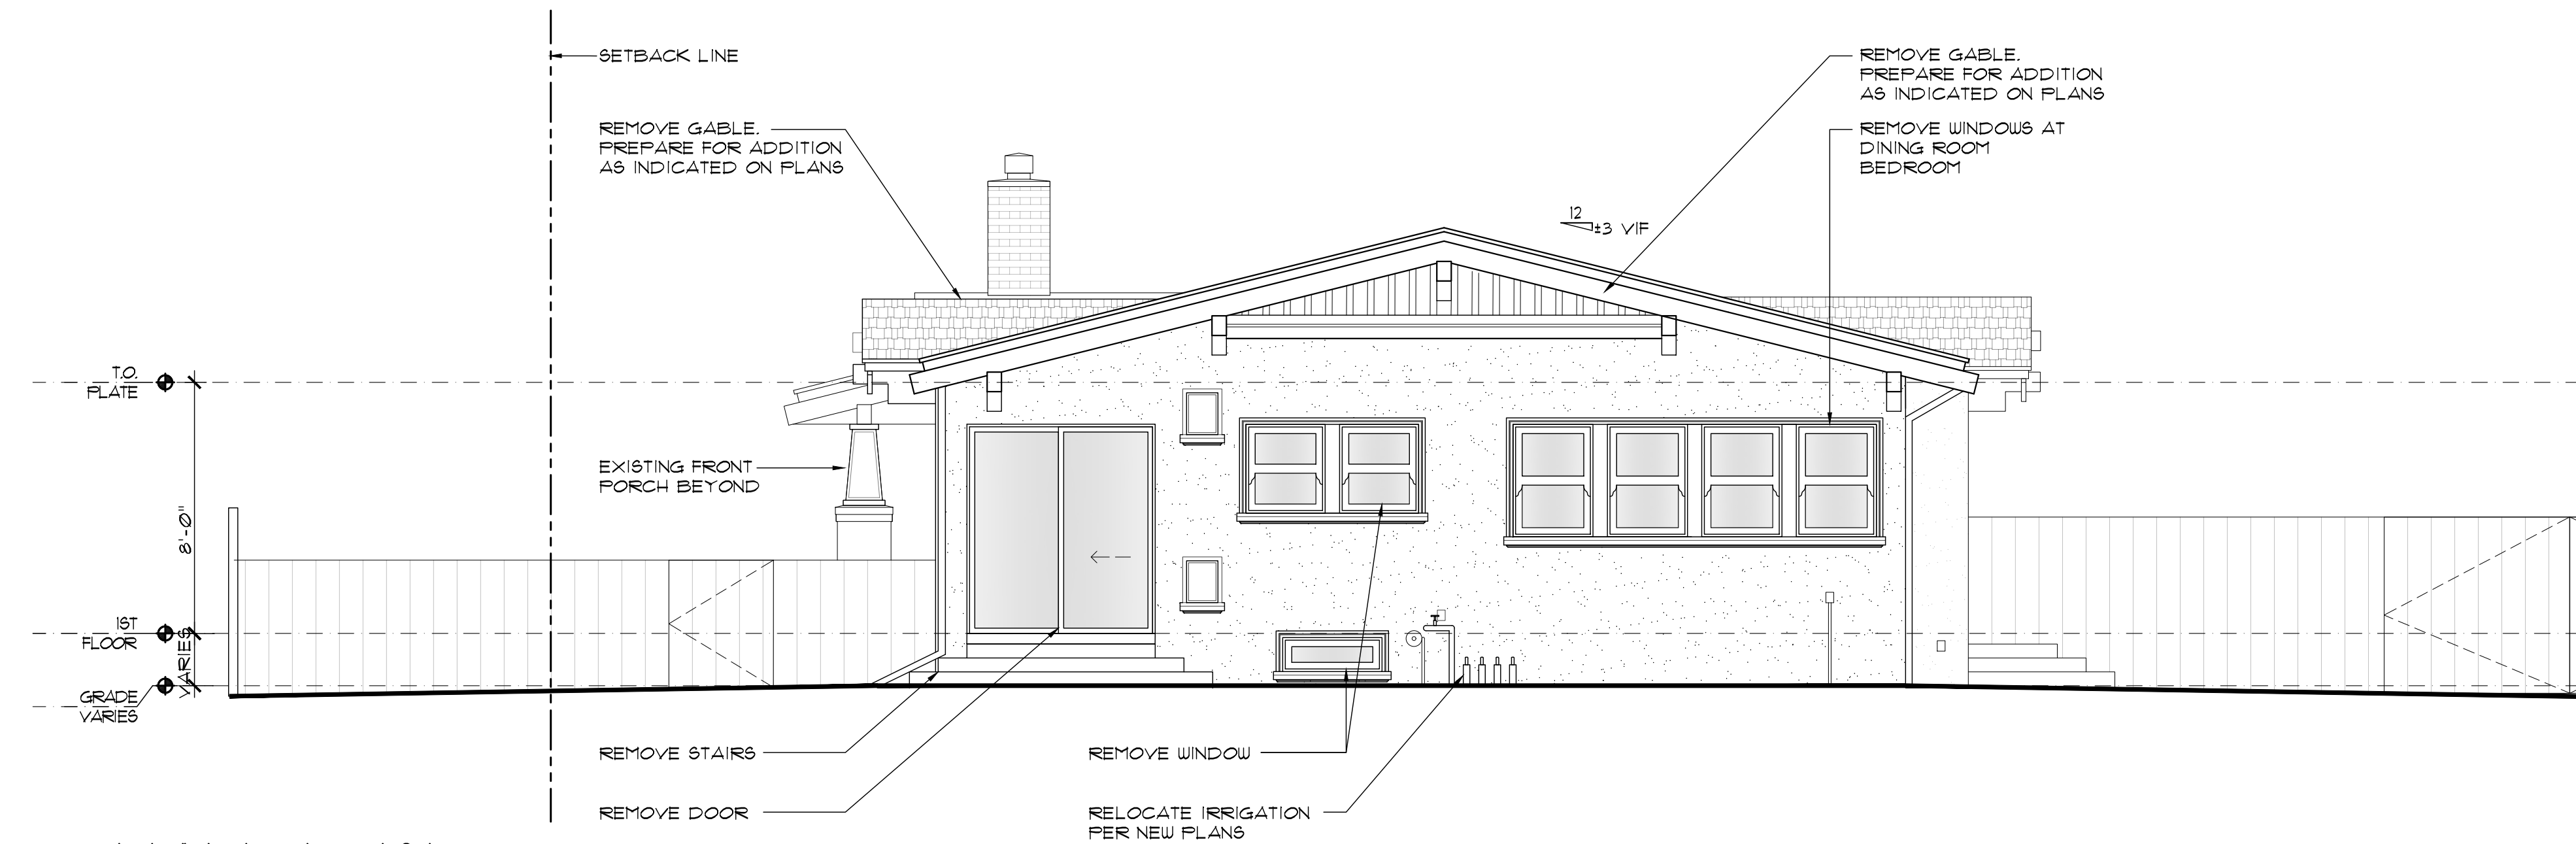
**MAIN HOUSE  
REAR ELEVATION, NORTH -EXISTING/DEMOLITION**  
SCALE: 1/4" = 1'-0"

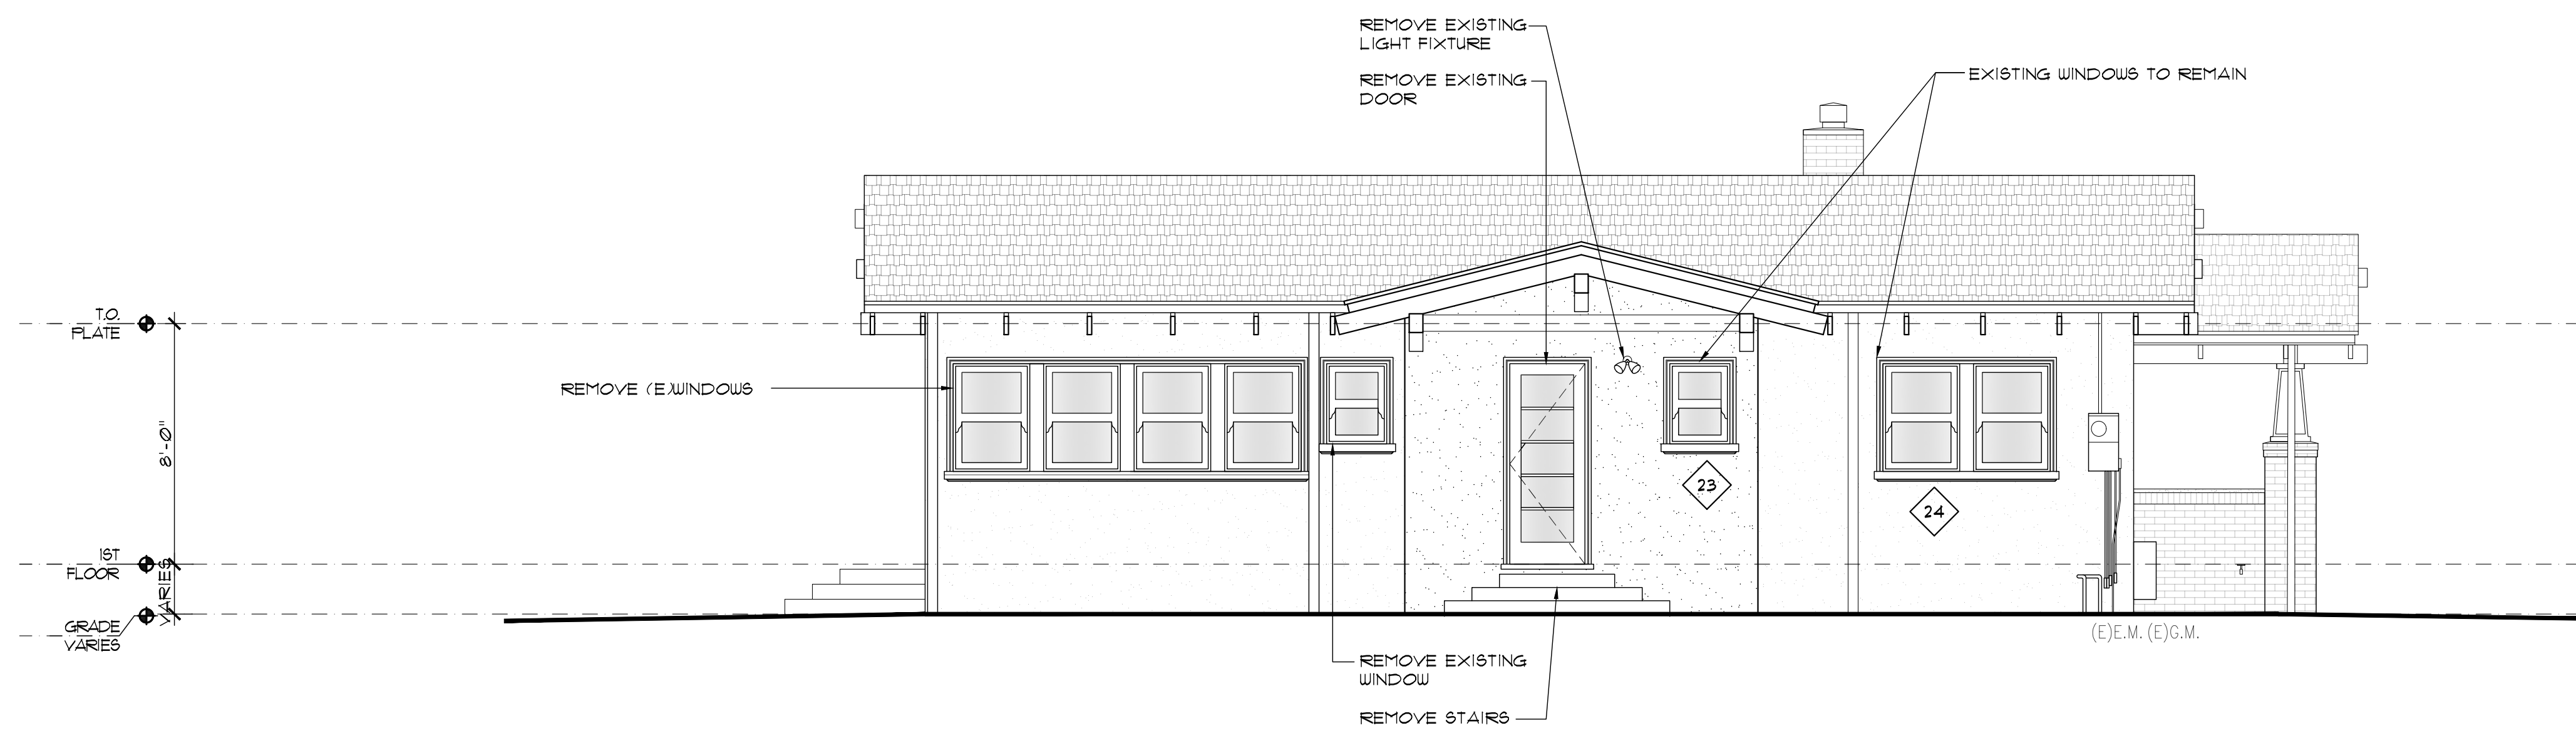
**1 MAIN HOUSE LEFT SIDE ELEVATION, WEST -EXISTING/DEMOLITION**  
SCALE: 1/4" = 1'-0"

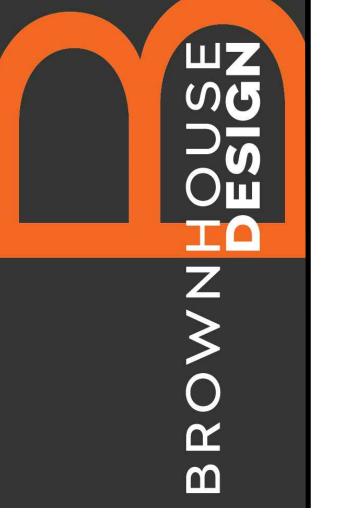
DESIGNER:  
BROWNHOUSE DESIGN, INC.  
101 MAIN ST. LOS ALTOS, CA 94022

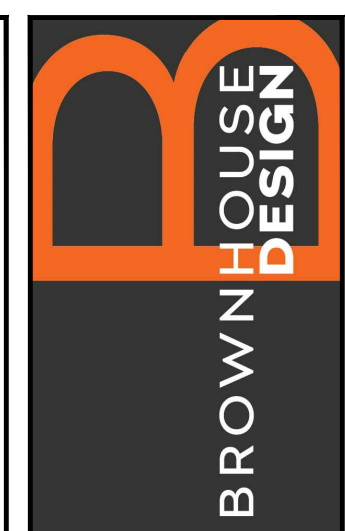
DESIGNER:  
BROWNHOUSE DESIGN, INC.  
164 MAIN ST., LOS ALTOS,  
CA 94022

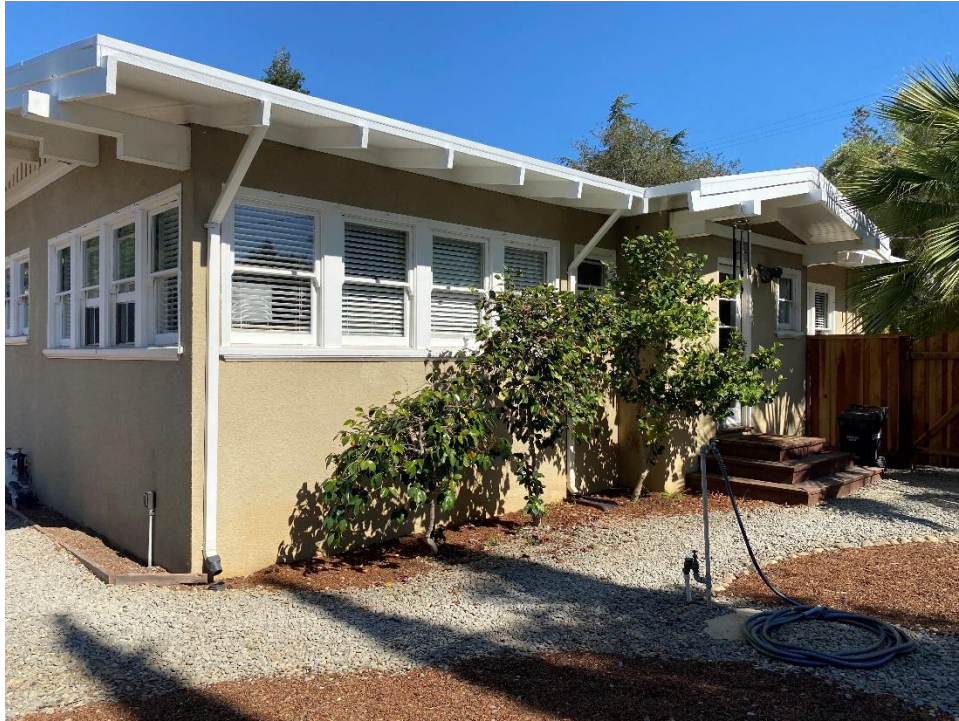
**Figure 31. West elevation, facing southeast.**

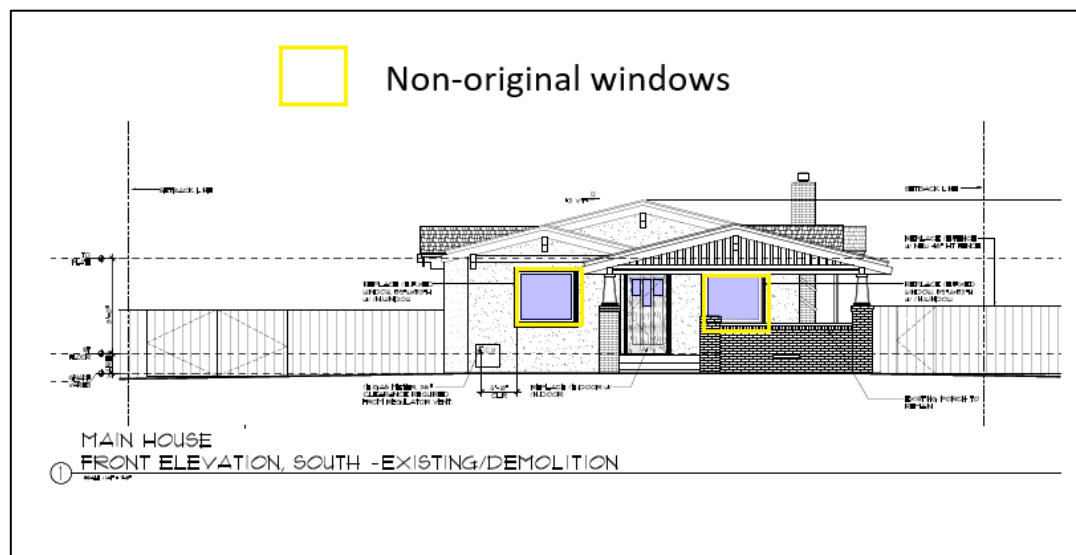
Figure 39. Primary façade (south elevation) showing the non-original windows outlined in yellow (Brownhouse Design; dated 5/27/2022).

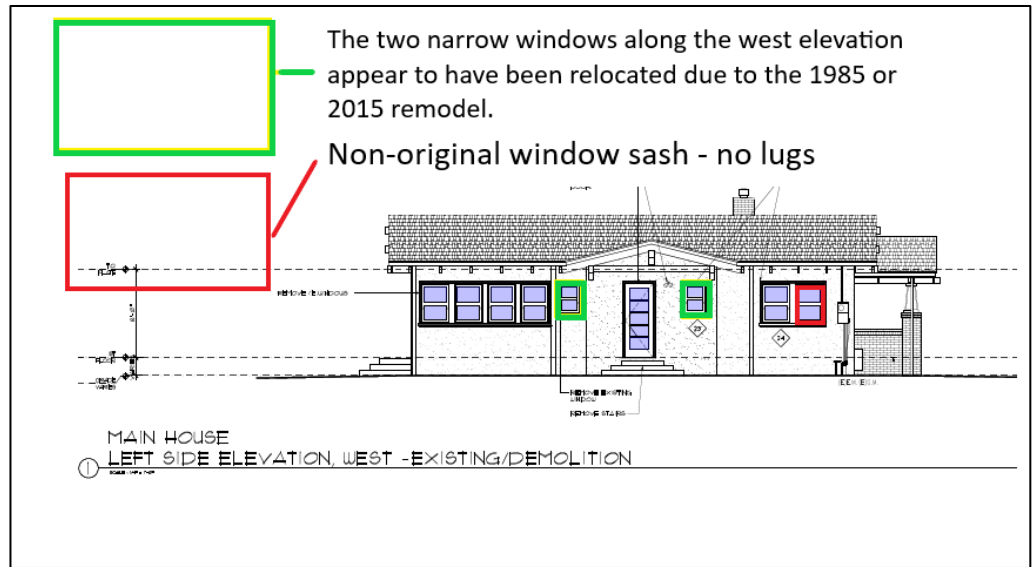
Figure 42. West elevation showing a non-original window sash (outlined in red) and two narrow wood windows (outlined in green) that appear to have been relocated due to remodeling (Brownhouse Design; dated 5/27/2022).

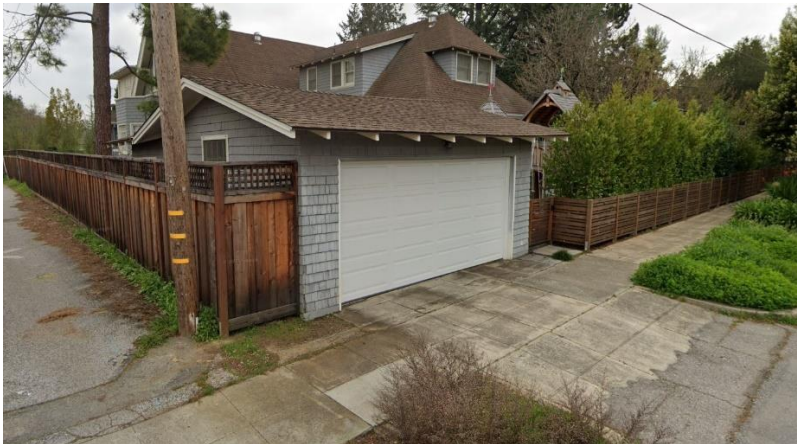
Interactive Resources  
Project No. 2021-053

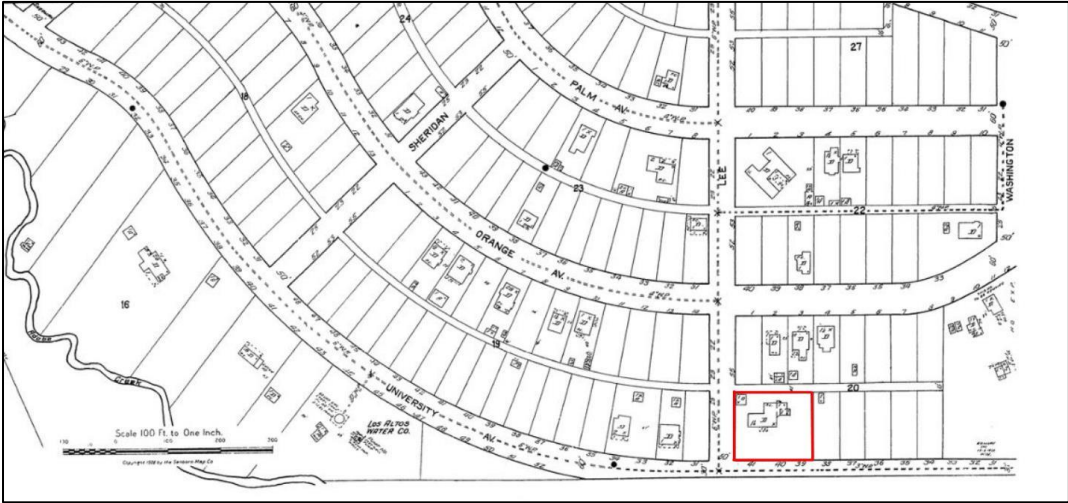
Figure 1 – 1926 Sanborn Fire Insurance Map of the vicinity showing the property

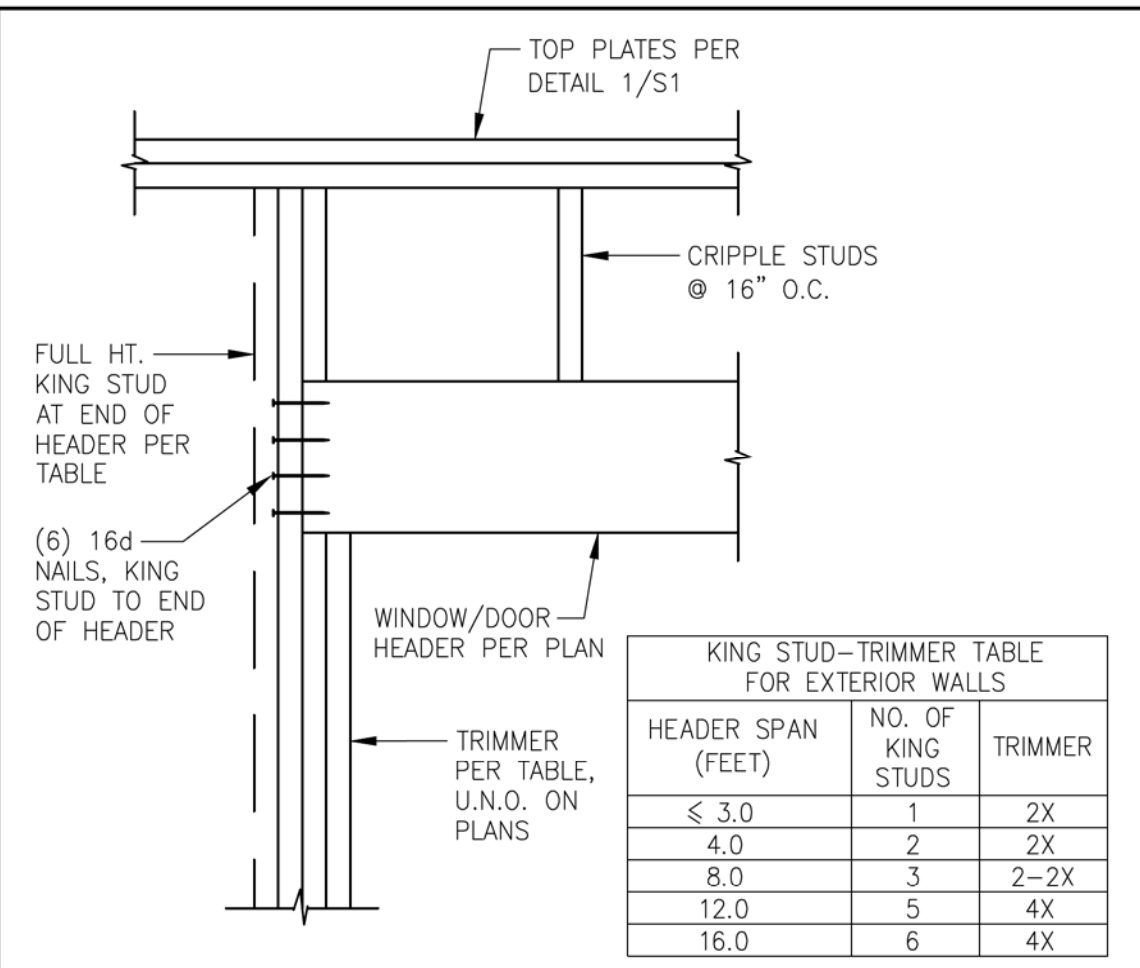
KING STUD-TRIMMER TABLE FOR EXTERIOR WALLS. Columns: HEADER SPAN (FEET), NO. OF KING STUDS, TRIMMER. Rows: <= 3.0 (1, 2X), 3.0-4.0 (2, 2X), 4.0-8.0 (3, 2-2X), 8.0-12.0 (5, 4X), 12.0-16.0 (6, 4X).

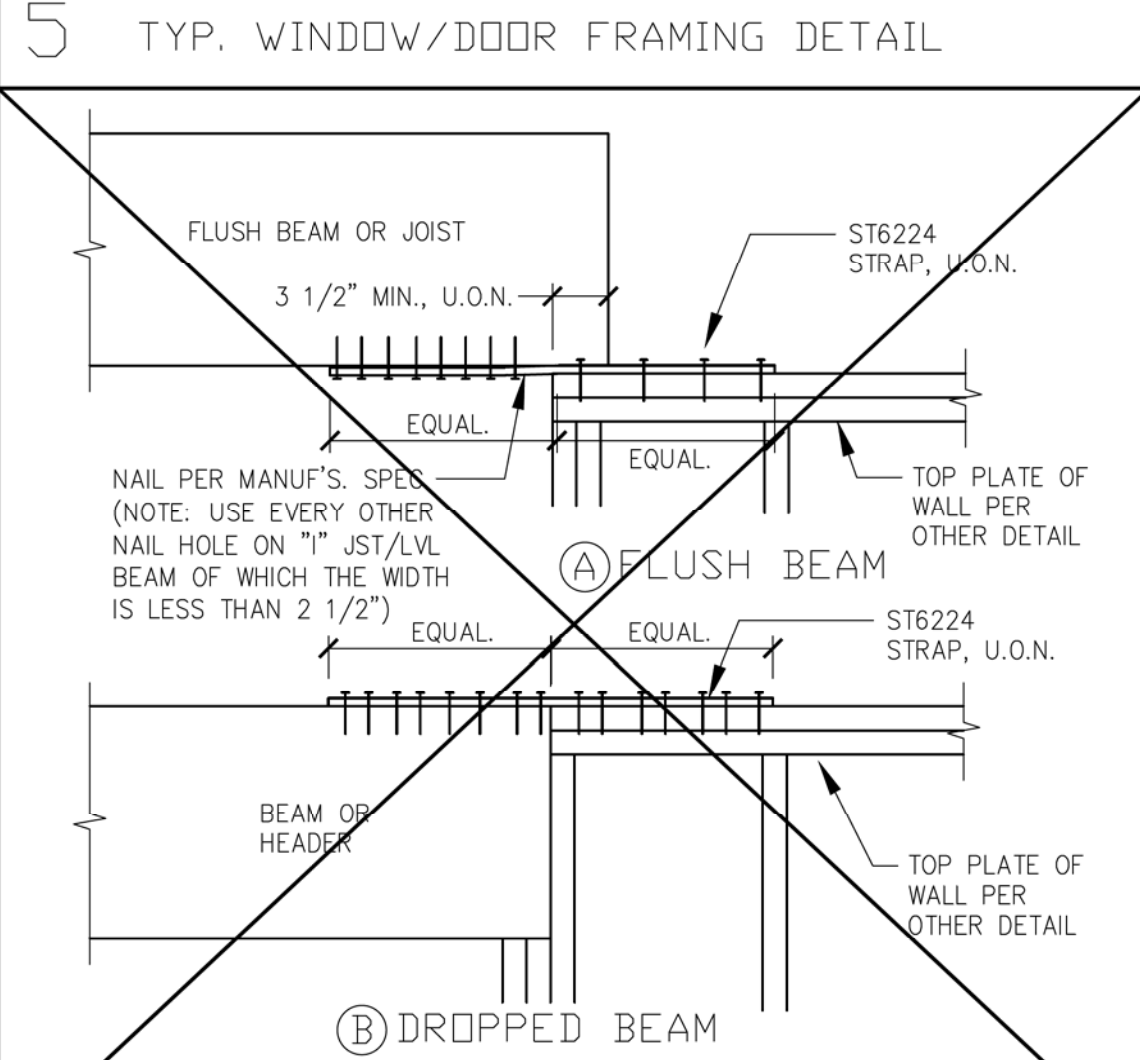
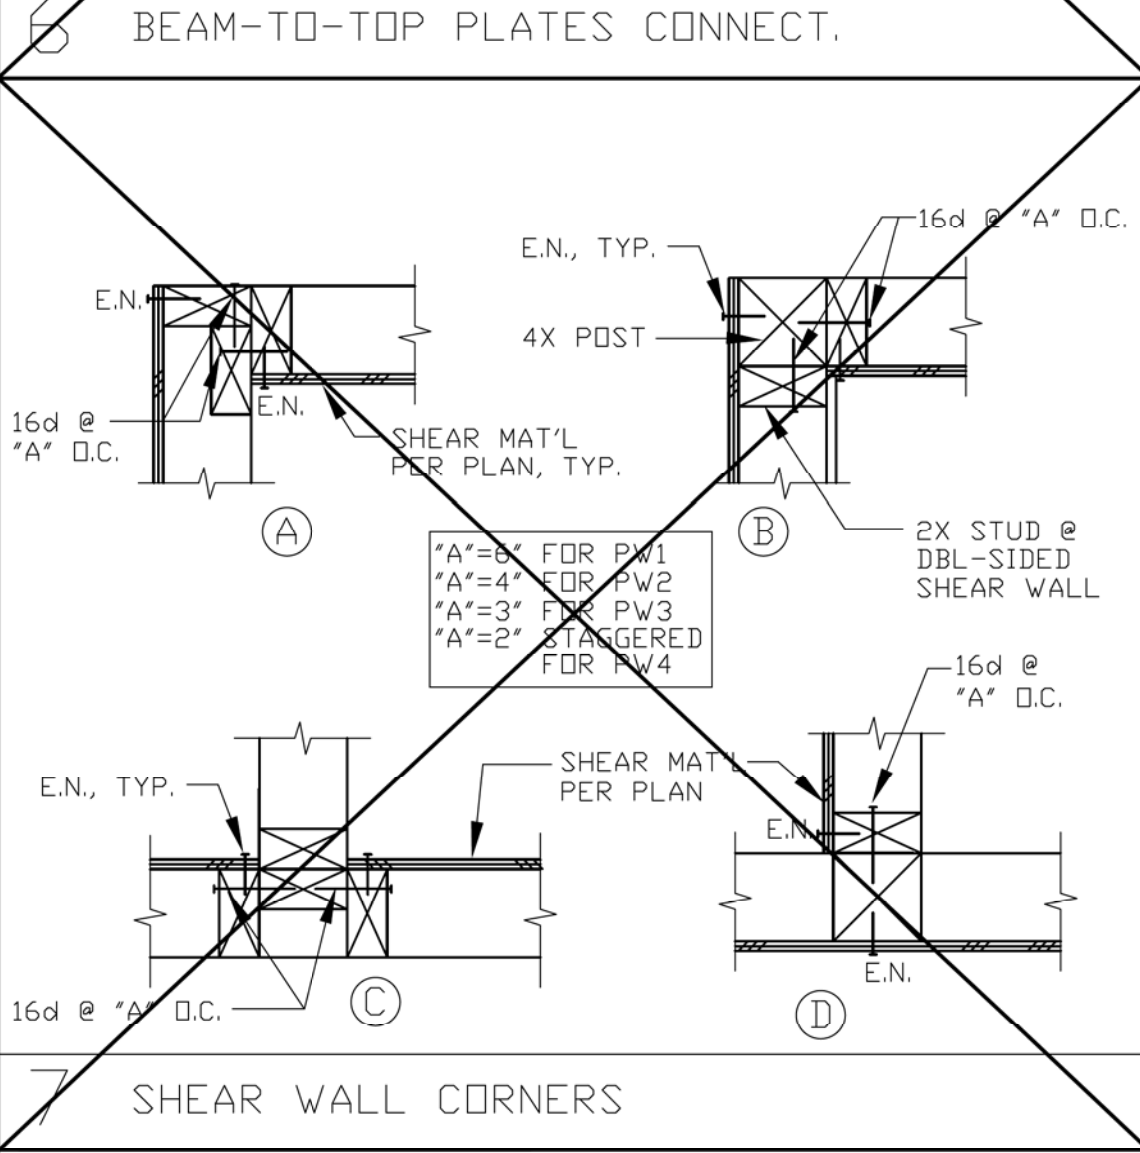
SHEET INDEX table with columns S1 (STRUCTURAL NOTES/ DETAILS), S2 (STRUCTURAL DETAILS), and S3 (ROOF FRAMING AND FOUNDATION PLANS).

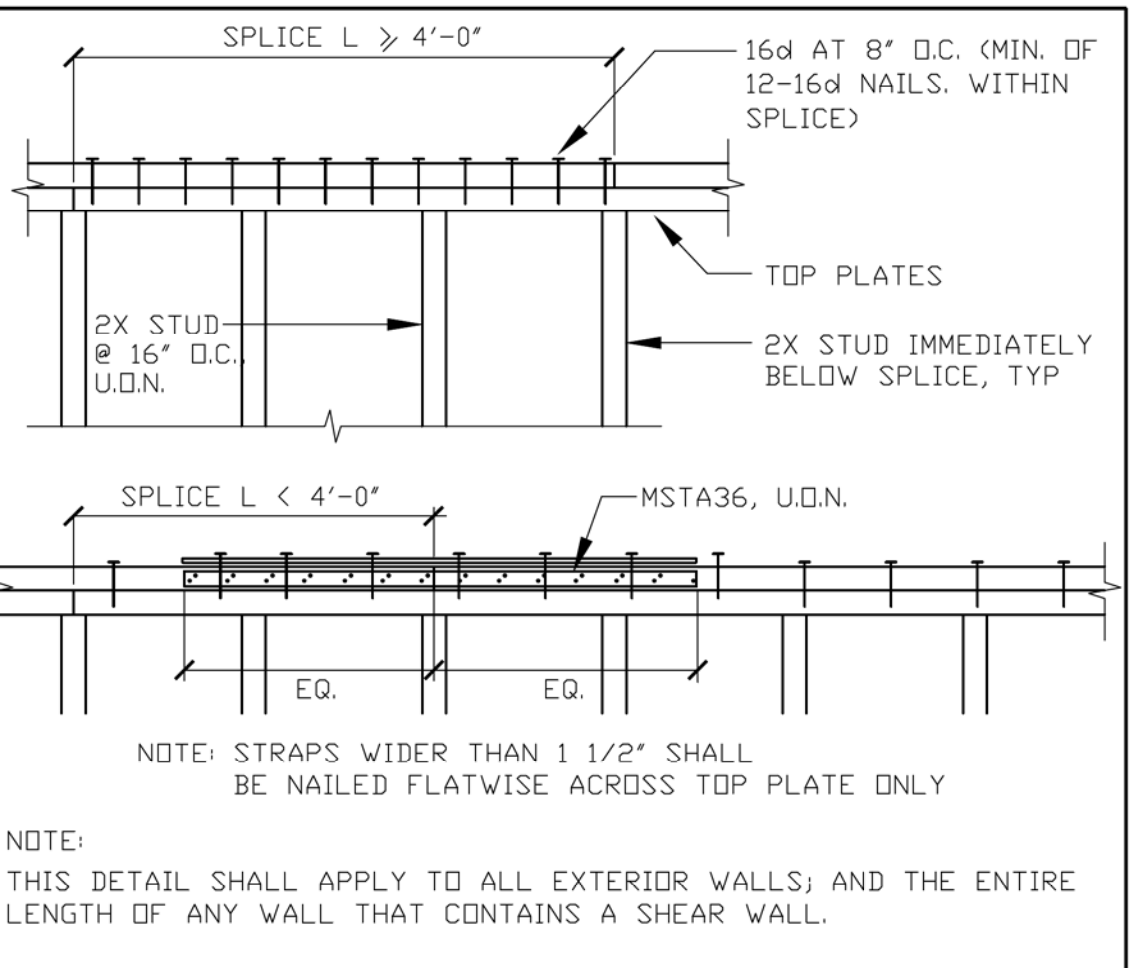
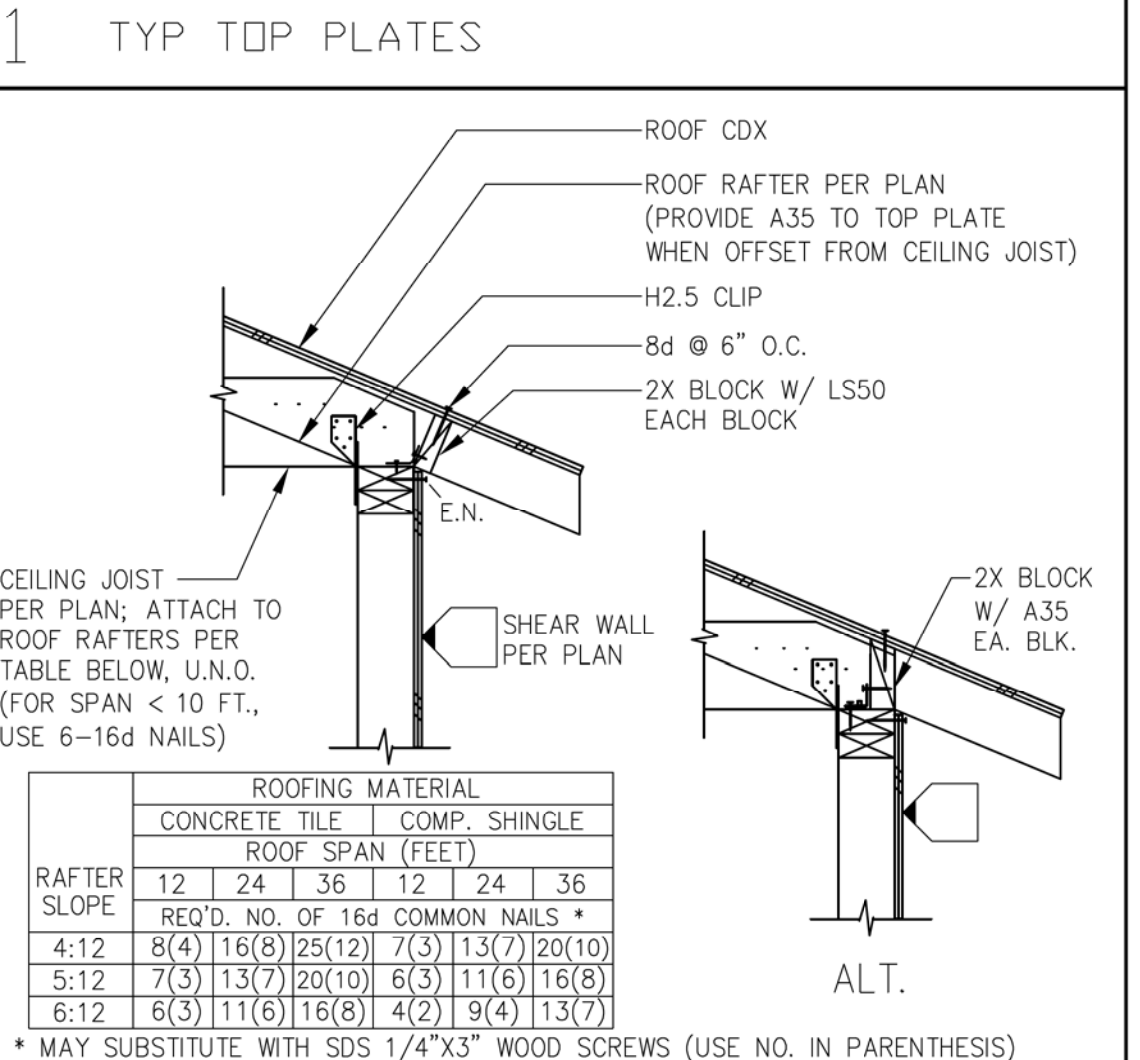
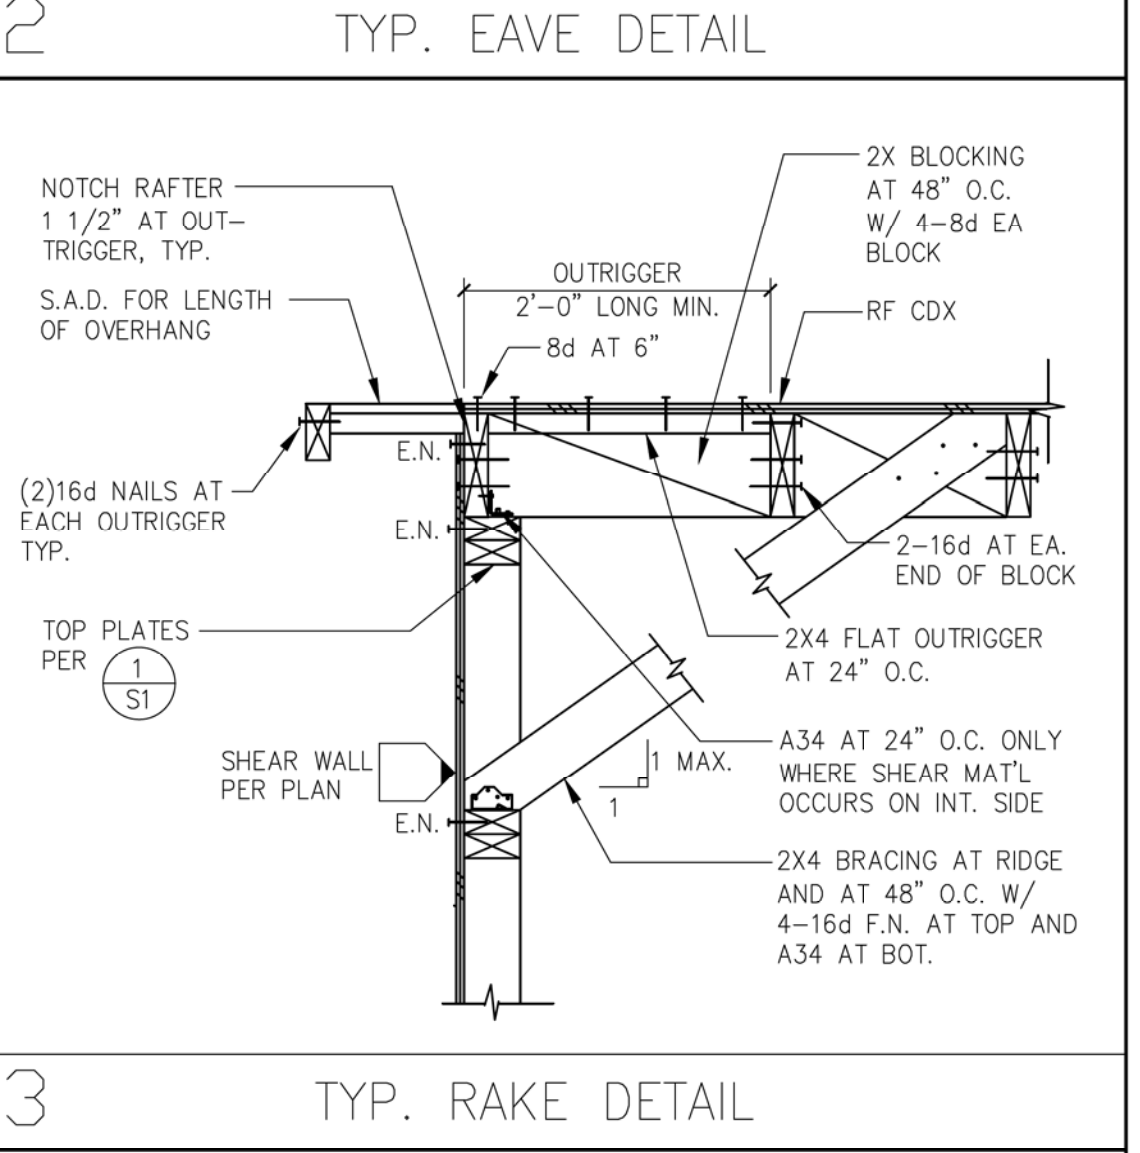
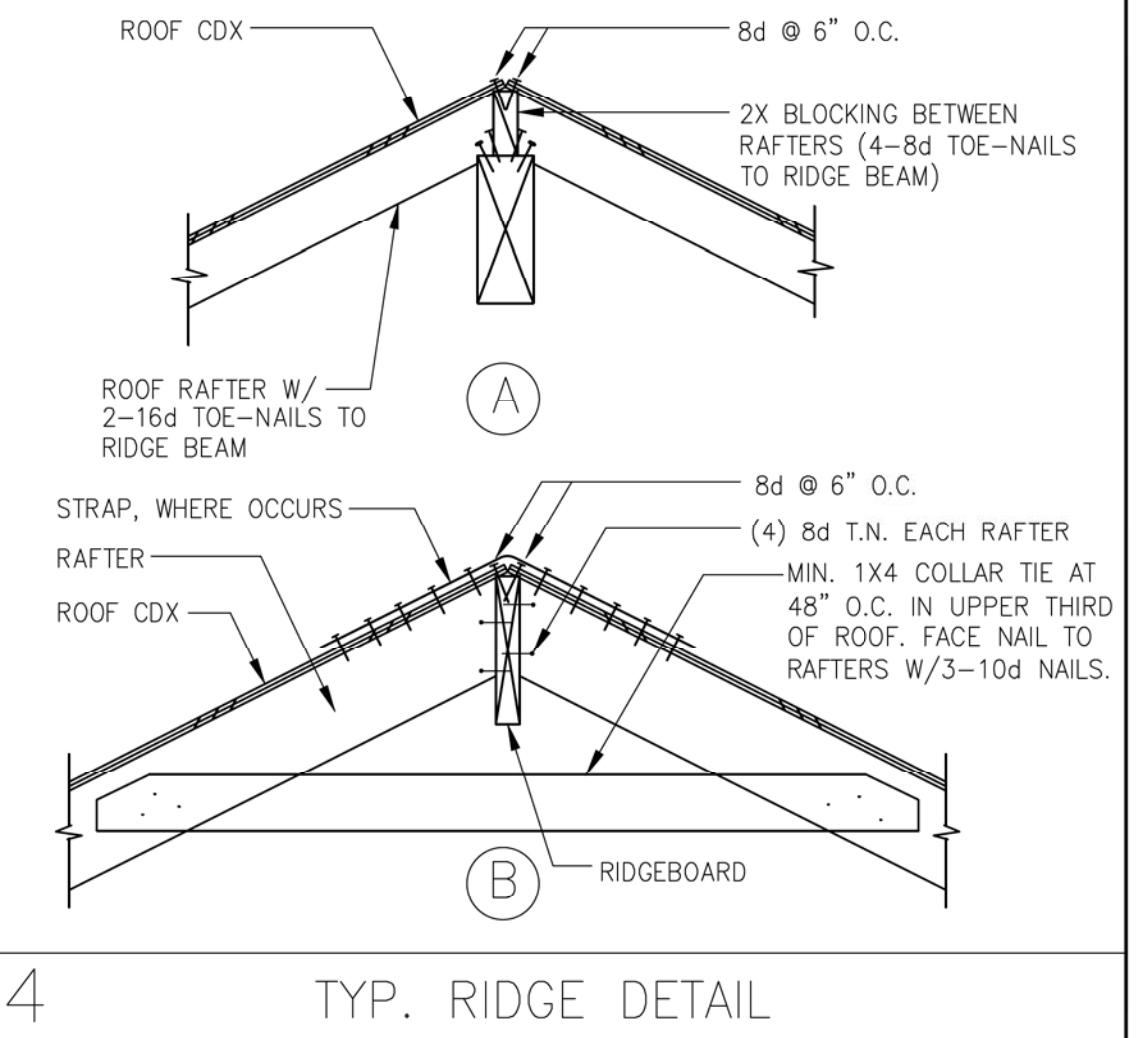
REVISIONS table with columns NO., DATE, and REVISIONS.

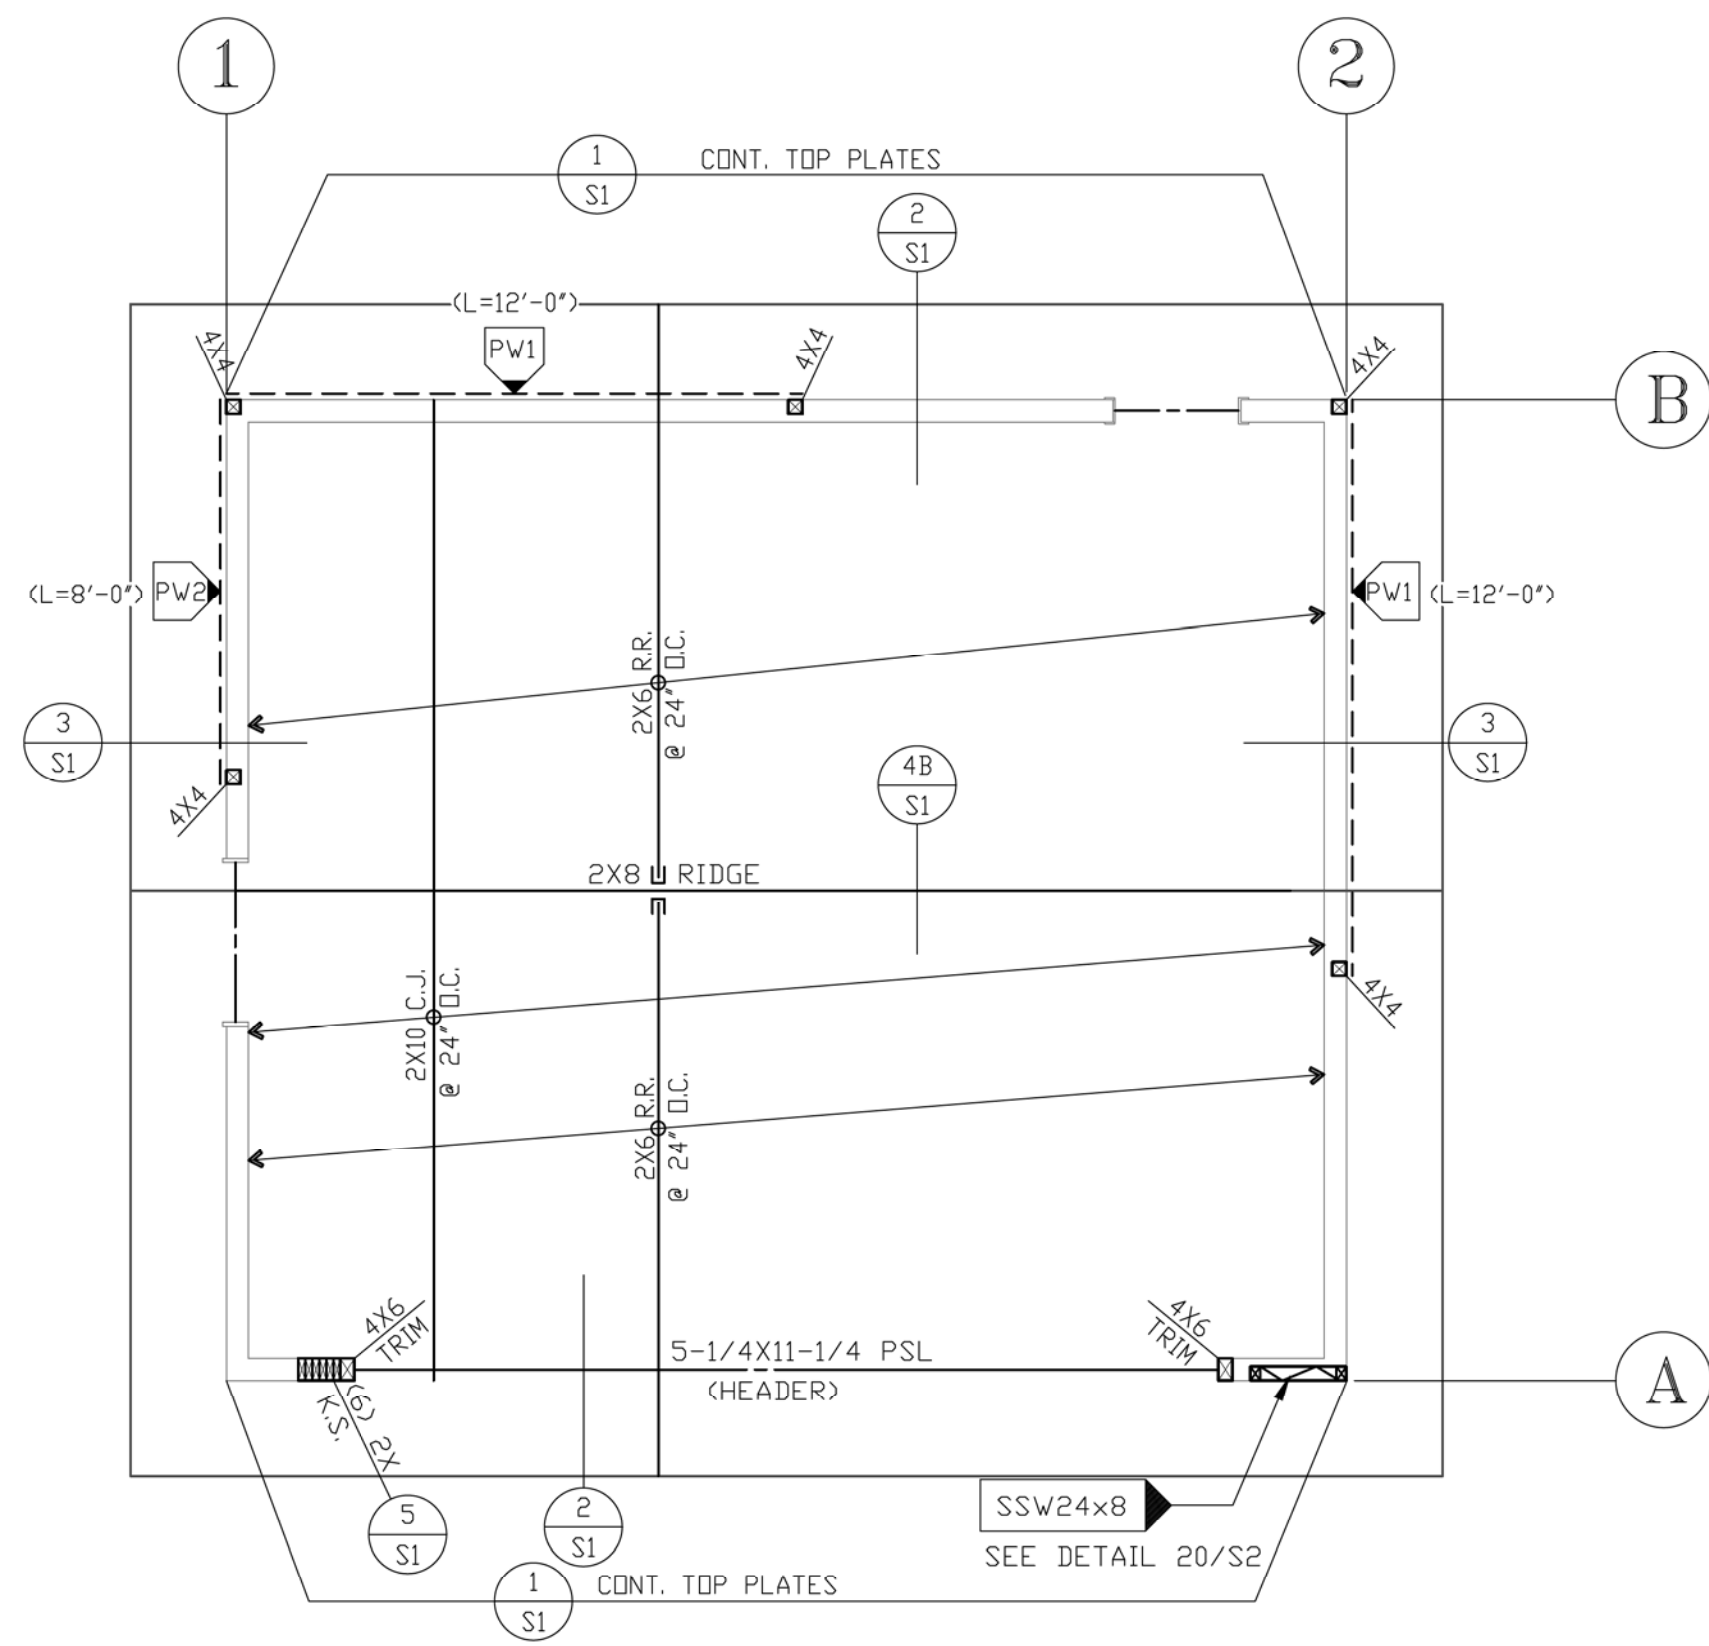
**PARTIAL ROOF FRAMING NOTES:**

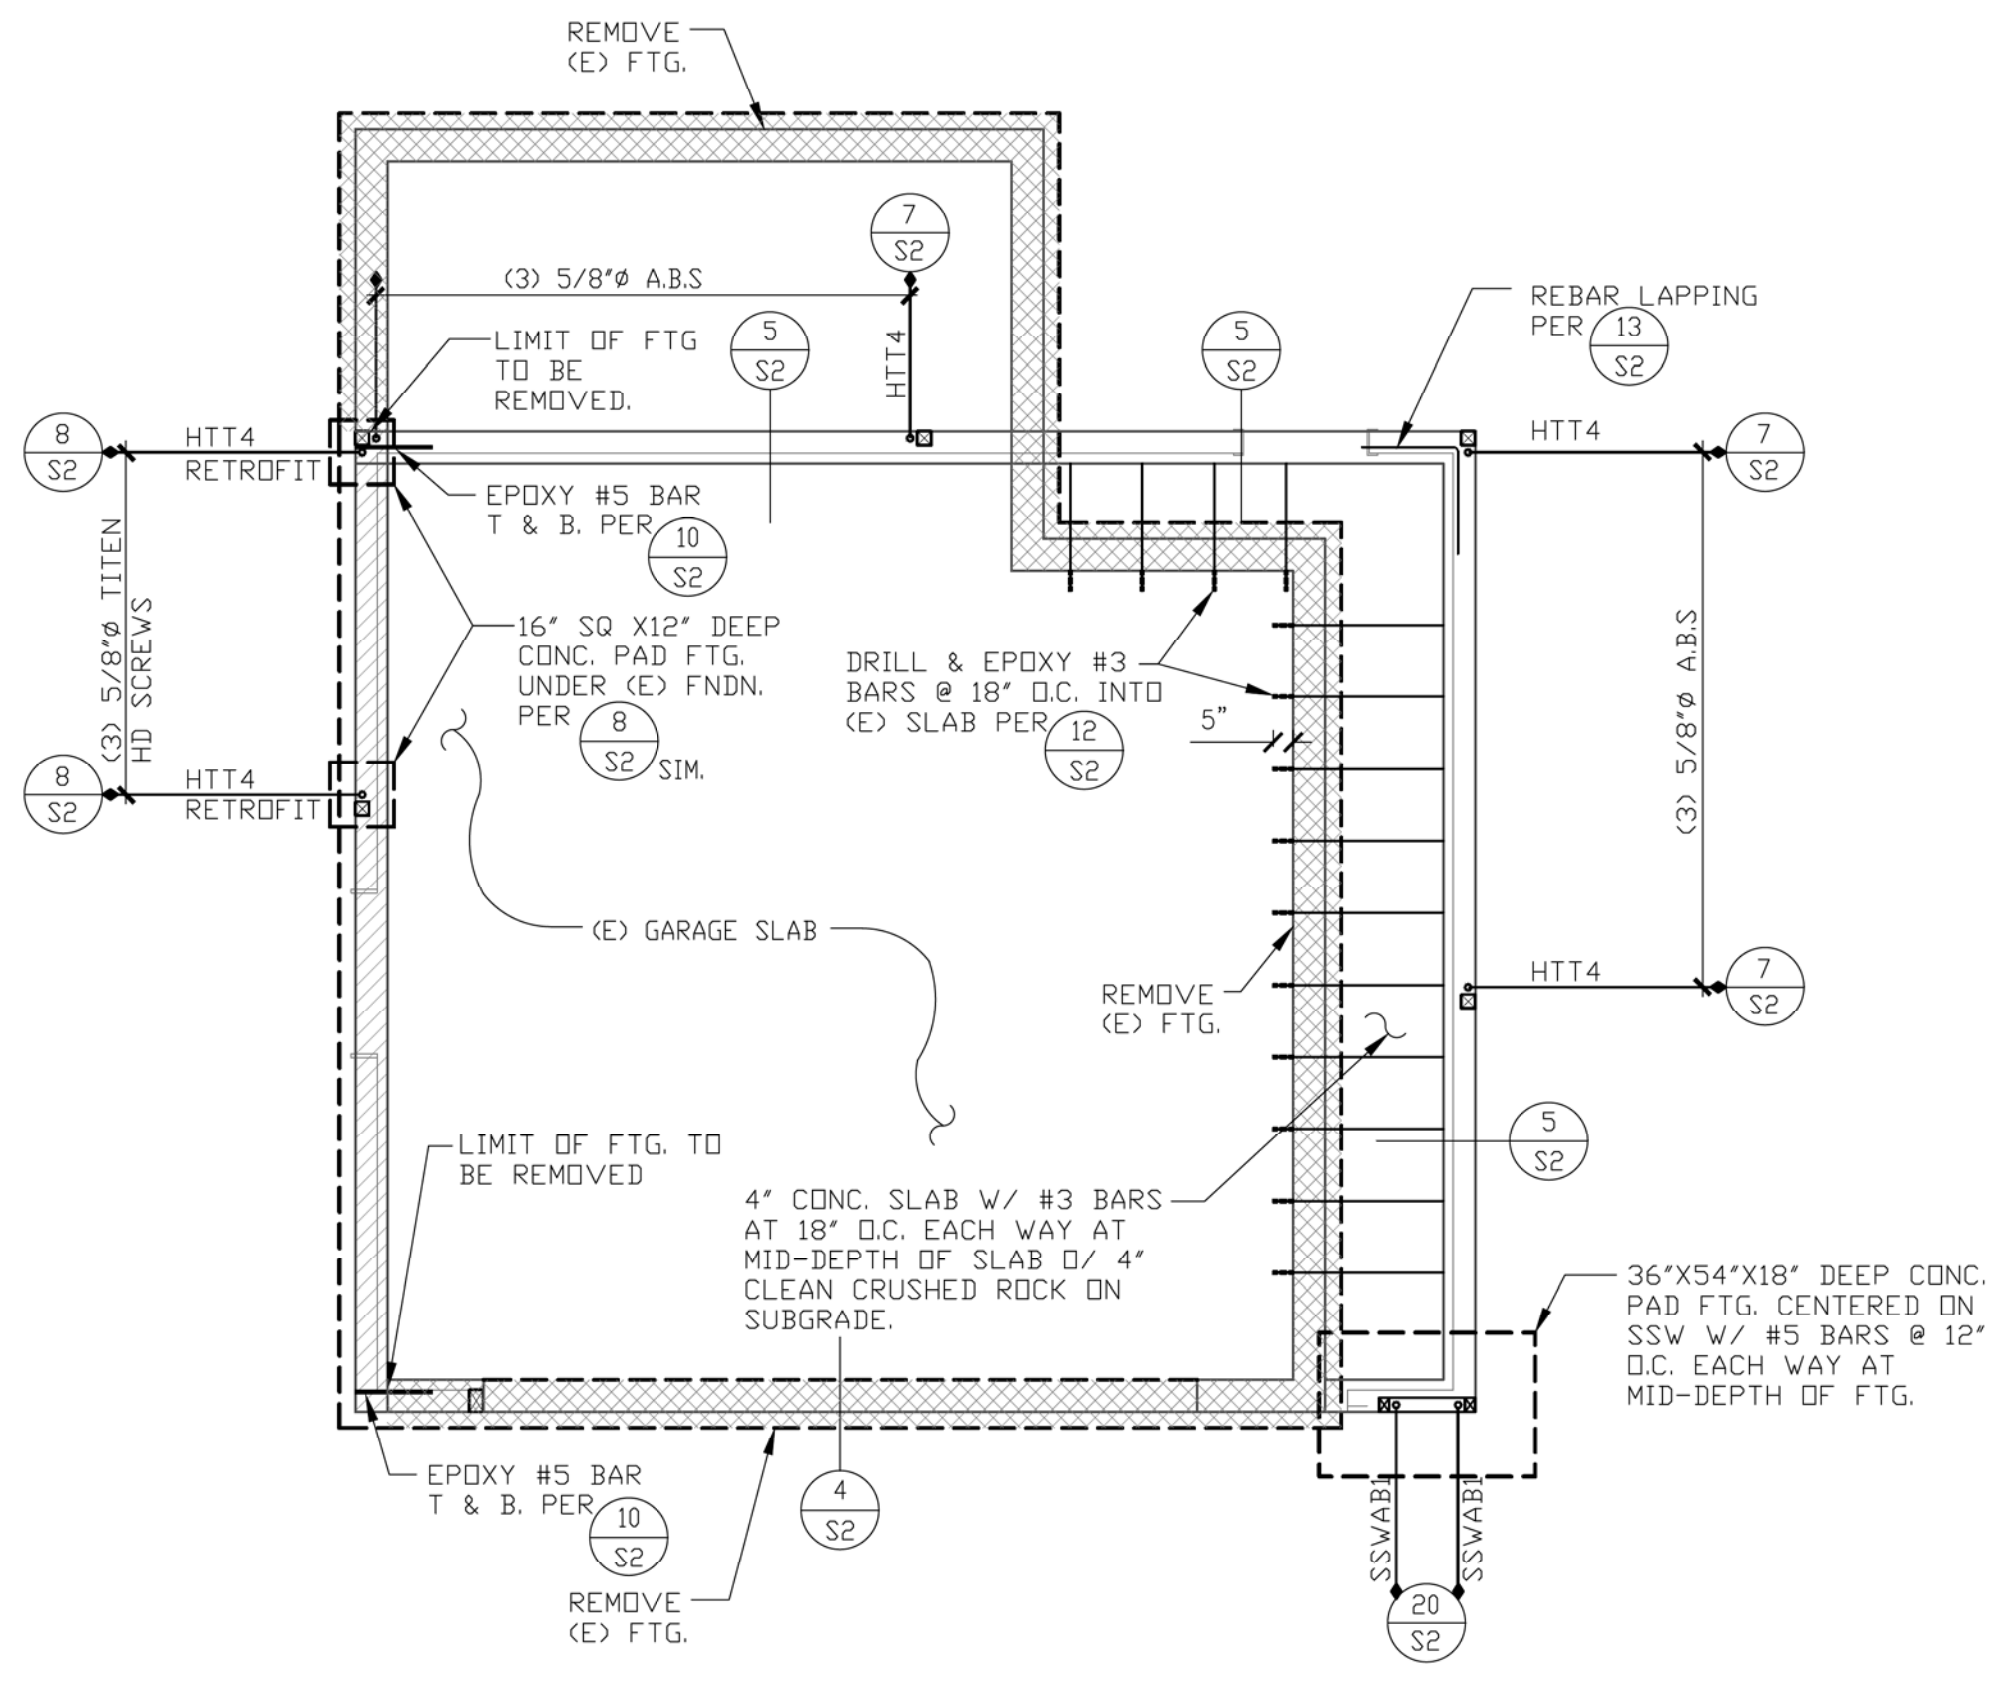
**ROOF FRAMING PLAN**

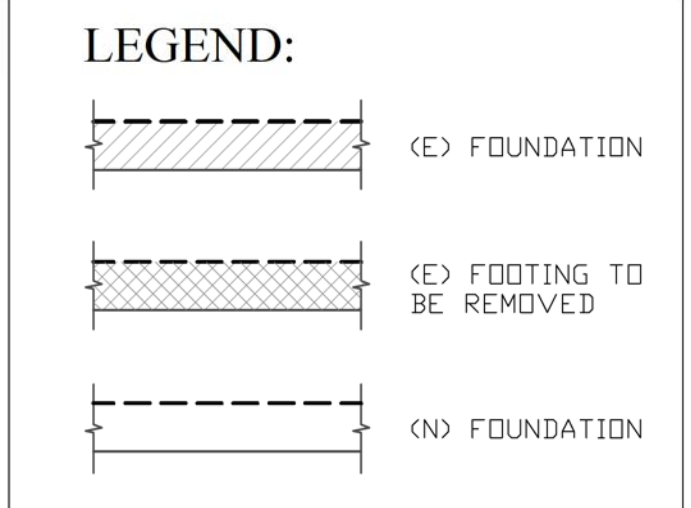
NO.	DATE	REVISIONS	BY
