URBAN FORESTRY COMMISSION SPECIAL MEETING AGENDA

2. Recommendation to City Council: Existing Trees as they relate to the Downtown Parking Lot Improvement Project - **action item**

CITY PARKING LOT IMPROVEMENTS
218 CHURCH STREET
SANDPOINT, IDAHO

CITY PARKING LOT IMPROVEMENTS 2025

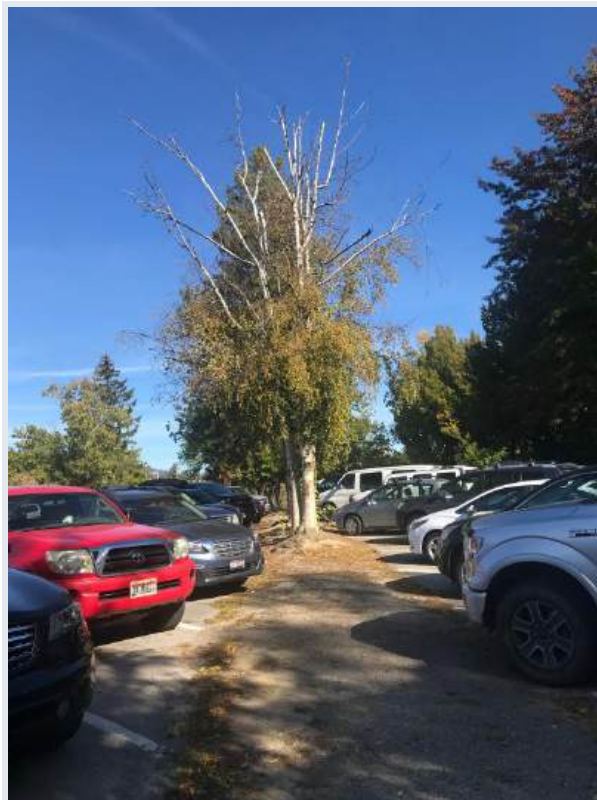
IMG_2708.jpg
9/29/2018

Tree Information	
Tree Id:	7766
Latin Name:	Betula papyrifera
Common Name:	Paper Birch
Cultivar:	
Genus:	Betula
Code:	BEPA
Status:	Alive
Year Planted:	
DBH:	25
DBH Range:	24-30in
Tree Height:	
Number of Stems:	Multiple Stems
Condition:	Dead / Dying

Percent Dieback:	50-75%
Crown Class:	Co-Dominant
Clearance Conflicts:	None
Observations:	Crown Dieback
Stock Type:	
Tree Comments:	Tree in serious decline
Family:	Betulaceae
Has Ecobenefits:	Yes
Last Modified:	09/29/2018
Upload ID:	upld_5818ec7cd30a8
User - Upload:	
Last Inspection:	
Next Inspection:	
Inspection Cycle:	
Crown Light Exposure:	
Archived:	No
Tree Protection Zone(TPZ):	
Critical Root Zone(CRZ):	
TPZ Ratio:	
CRZ Ratio:

Management Needs	
Primary Maintenance:	Large Tree (routine)
Secondary Maintenance:	Remove
Wires:	No Lines
Watch This Tree? :	Yes
Maintenance Comments:	Remove. Serious decline. Not aesthetically pleasing in popular lot.
Organization:	Sandpoint
User:	SP_sdrinkard

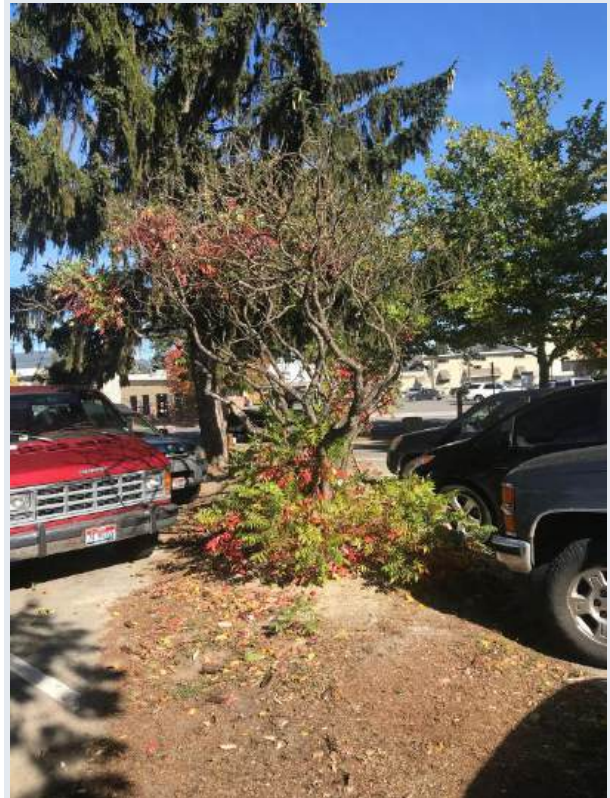
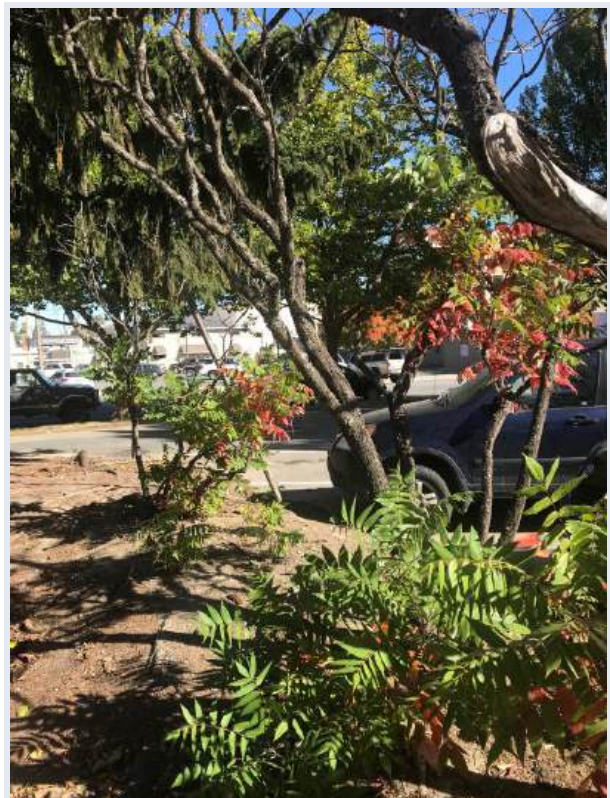
Tree Id:	7770
Latin Name:	Rhus spp
Common Name:	Sumac
Cultivar:	
Genus:	Rhus
Code:	RHSP
Status:	Alive
Year Planted:	
DBH:	3
DBH Range:	3-6in
Tree Height:	
Number of Stems:	Multiple Stems
Condition:	Poor - Major Problems

Percent Dieback:	25-50%
Crown Class:	Overtopped
Clearance Conflicts:	None
Observations:	Nutrient Deficiency, Poor Location, Poor Structure, Serious Decline, Crown Dieback
Stock Type:	
Tree Comments:	There are three "shrub trees" in a row. Perhaps Sumac is species, but in any case there is significant "crown" dieback. Don't really belong if they cannot be trained to be one trunk trees.
Family:	Anacardiaceae
Has Ecobenefits:	Yes
Last Modified:	09/30/2018
Upload ID:	upld_5818ec7cd30a8
User - Upload:	
Last Inspection:	
Next Inspection:	
Inspection Cycle:	
Crown Light Exposure:	
Archived:	No
Tree Protection Zone(TPZ):	
Critical Root Zone(CRZ):	
TPZ Ratio:	
CRZ Ratio:

Most Recent Changes to this Tree
SP_sdrinkard set Maintenance Comments="Remove and replant with appropriate tree." on Sep 29, 2018 at 4:50pm
SP_sdrinkard set Secondary Maintenance="Remove" on Sep 29, 2018 at 4:49pm
SP_sdrinkard set Secondary Maintenance="Prune-structural, Remove" on Sep 29, 2018 at 4:49pm
SP_sdrinkard set Primary Maintenance="Small Tree (immediate)" on Sep 29, 2018 at 4:49pm
SP_sdrinkard set Tree Comments="There are three "shrub trees" in a row. Perhaps S..." on Sep 29, 2018 at 4:48pm
SP_sdrinkard set Observations="Crown Dieback, Nutrient Deficiency, Poor Location,..." on Sep 29, 2018 at 4:46pm
SP_sdrinkard set Observations="Crown Dieback, Nutrient Deficiency, Poor Location,..." on Sep 29, 2018 at 4:46pm
SP_sdrinkard set Observations="Crown Dieback, Nutrient Deficiency, Poor Structure" on Sep 29, 2018 at 4:46pm
SP_sdrinkard set Observations="Crown Dieback, Poor Structure" on Sep 29, 2018 at 4:46pm

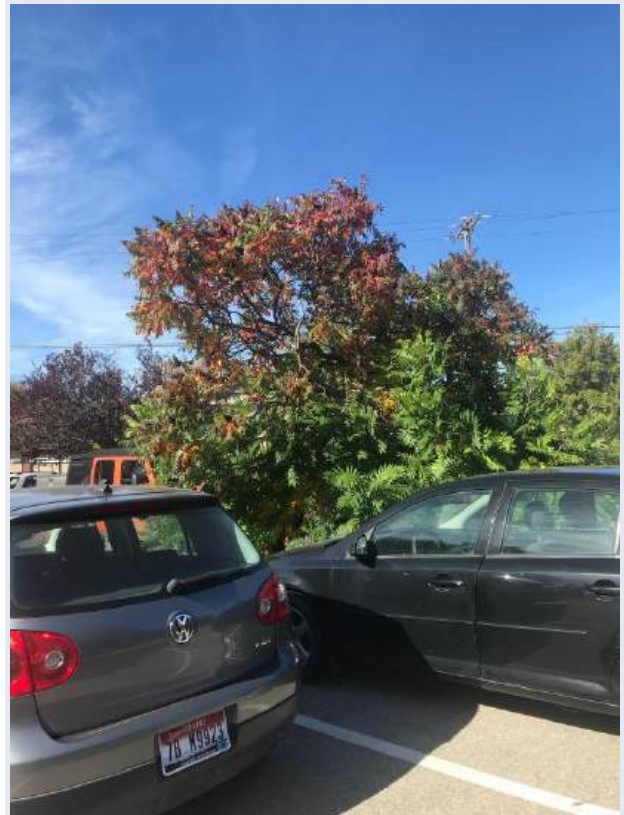
Tree Id:	7763
Latin Name:	Rhus spp
Common Name:	Sumac
Cultivar:	
Genus:	Rhus
Code:	RHSP
Status:	Alive
Year Planted:	
DBH:	3
DBH Range:	3-6in
Tree Height:	
Number of Stems:	Multiple Stems
Condition:	Fair - Minor Problems
Percent Dieback:	25-50%
Crown Class:	Overtopped
Clearance Conflicts:	None

Observations:	Improperly Pruned, Poor Location, Poor Structure
Stock Type:	
Tree Comments:	Not sure that this is a sumac. In any case it needs to be heavily pruned for tree shape or removed.
Family:	Anacardiaceae
Has Ecobenefits:	Yes
Last Modified:	09/29/2018
Upload ID:	
User - Upload:	
Last Inspection:	
Next Inspection:	
Inspection Cycle:	
Crown Light Exposure:	
Archived:	No
Tree Protection Zone(TPZ):	
Critical Root Zone(CRZ):	
TPZ Ratio:	
CRZ Ratio:

Management Needs	
Primary Maintenance:	Small Tree (routine/train)
Secondary Maintenance:	Prune-structural, Remove, Remove Suckers
Wires:	No Lines
Watch This Tree? :	Yes
Maintenance Comments:	Train to be single trunk tree or remove.
Organization:	Sandpoint
User:	SP_sdrinkard

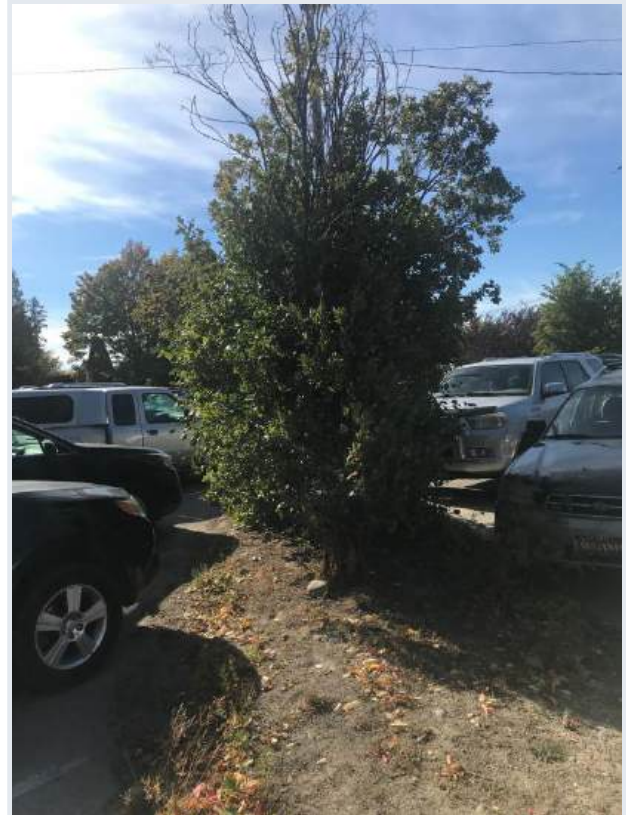
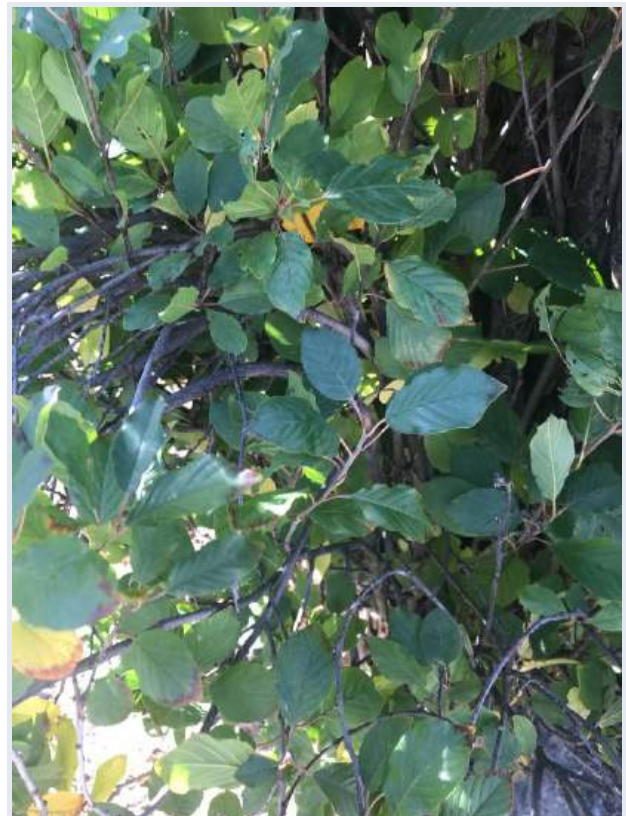
Tree Information	
Tree Id:	7761
Latin Name:	Other
Common Name:	Other
Cultivar:	
Genus:	Other
Code:	
Status:	Alive
Year Planted:	
DBH:	
DBH Range:	
Tree Height:	3
Number of Stems:	Multiple Stems
Condition:	Fair - Minor Problems
Percent Dieback:	25-50%
Crown Class:	Overtopped
Clearance Conflicts:	None

Observations:	Improperly Pruned, Poor Location, Poor Structure
Stock Type:	
Tree Comments:	This is tree turned shrub. Not sure at this time is species.
Family:	
Has Ecobenefits:	No
Last Modified:	12/19/2022
Upload ID:	
User - Upload:	
Last Inspection:	
Next Inspection:	
Inspection Cycle:	
Crown Light Exposure:	Three sides of the crown are exposed to light.
Archived:	No
Tree Protection Zone(TPZ):	
Critical Root Zone(CRZ):	
TPZ Ratio:	
CRZ Ratio:

Management Needs	
Primary Maintenance:	Remove Tree
Secondary Maintenance:	Remove
Wires:	No Lines
Watch This Tree? :	Yes
Maintenance Comments:	Need to replace with a single trunk tree that doesn't "hide" areas of the lot.
Organization:	Sandpoint
User:	SP_sdrinkard

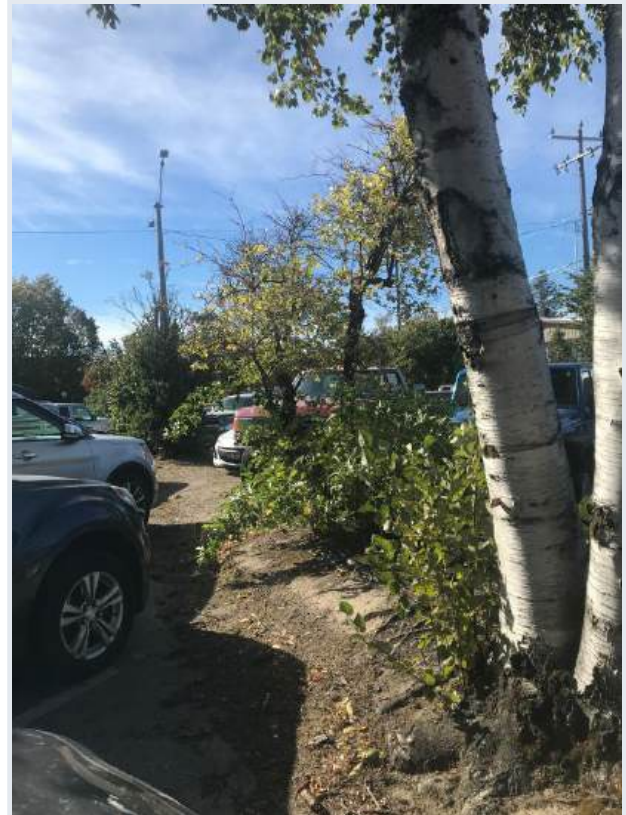
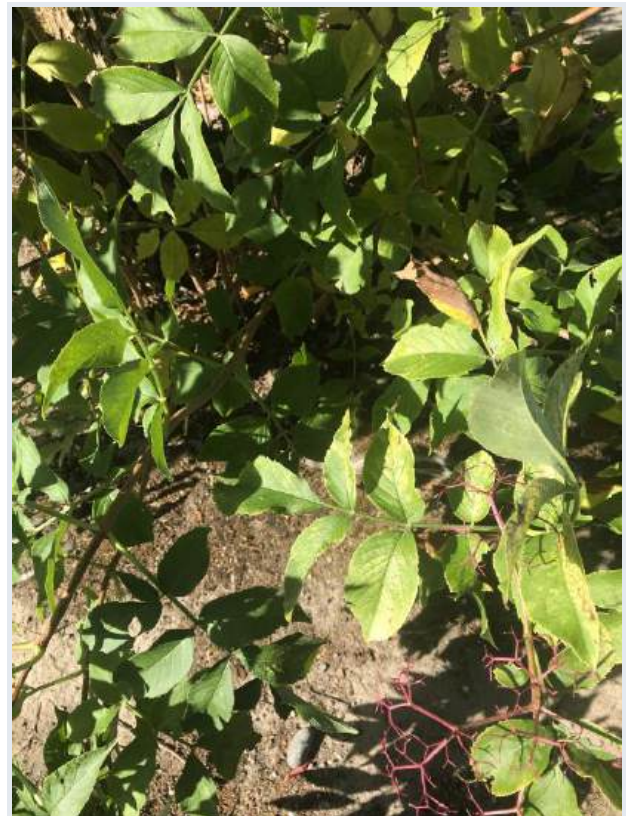
Tree Id:	
Latin Name:	Betula papyrifera
Common Name:	Paper Birch
Cultivar:	
Genus:	Betula
Code:	BEPA
Status:	Alive
Year Planted:	
DBH:	4
DBH Range:	3-6in
Tree Height:	
Number of Stems:	
Condition:	Poor - Major Problems
Percent Dieback:	50-75%
Crown Class:	Overtopped
Clearance Conflicts:	None
Observations:	Poor Location
