CITY OF  
**TUMWATER**

**HISTORIC PRESERVATION COMMISSION  
MEETING AGENDA**

**Thursday, March 12, 2026  
6:30 PM**

### Davis-Meeker Oak

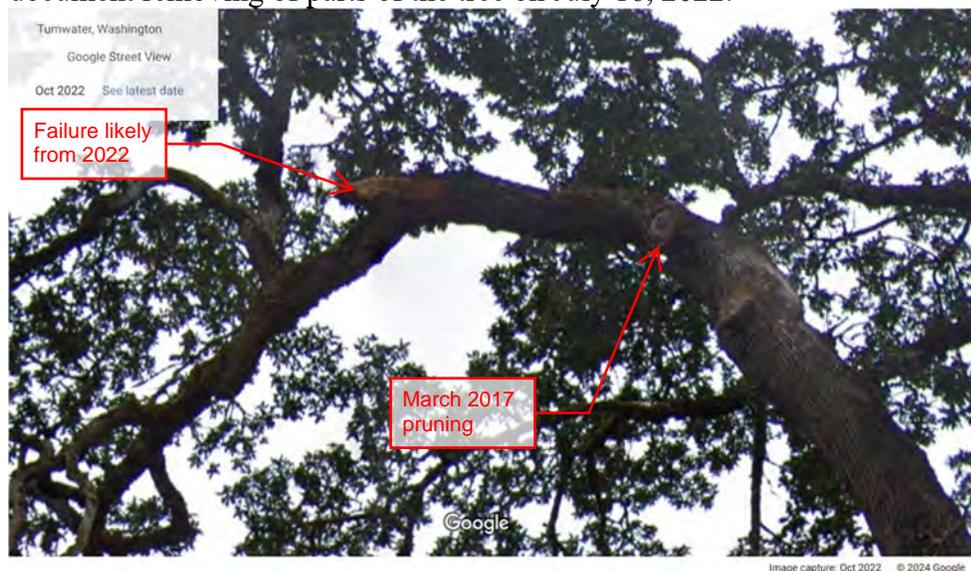
- There is a relatively recent branch failure, likely from 2022. Google street view shows the torn branch first appearing in October 2022. City of Tumwater records document removing of parts of the tree on July 16, 2022.

**Figure 4 October 2022 view of branch over Old Highway 99.**

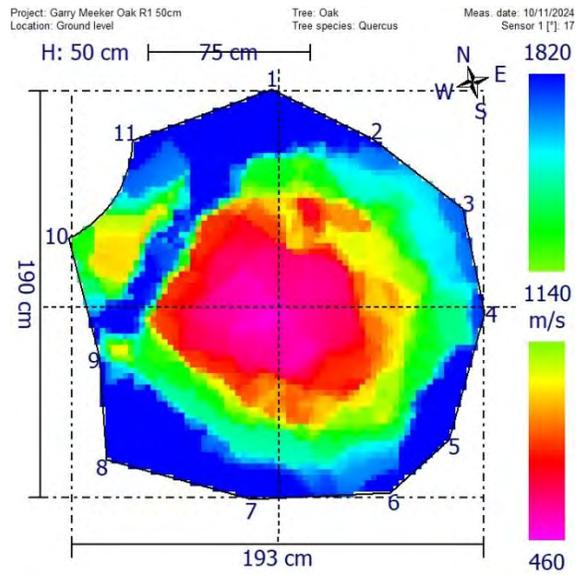
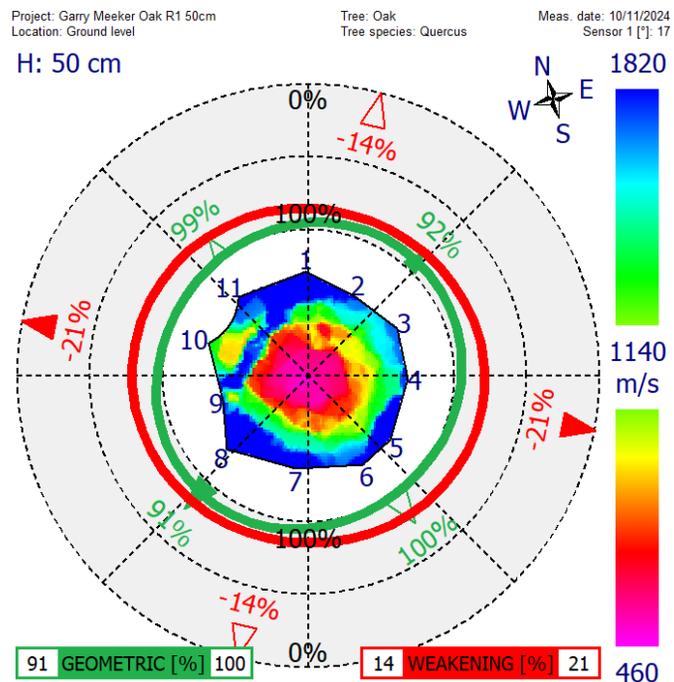
At this level there is significant compromised wood throughout the stem. The wood decay fungi that is affecting this tree has created a significant amount of compromised wood.

At this level there is between 14% and 21% strength loss depending on direction.

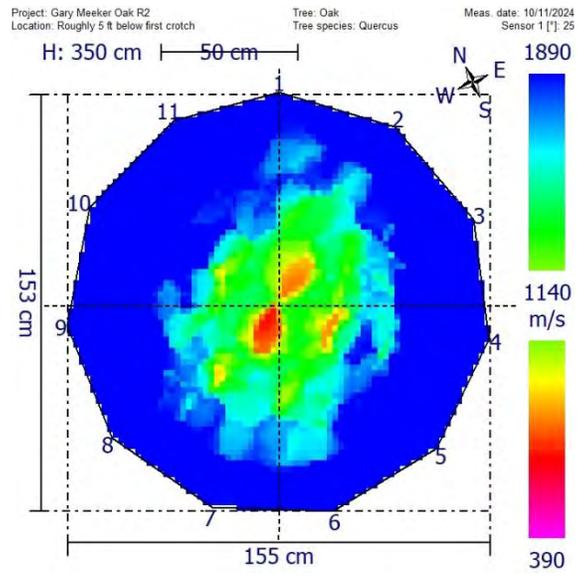
At this level there is a small amount of compromised wood in the center of the stem. The green indicates where the co-dominant inclusion is causing a weak attachment point.

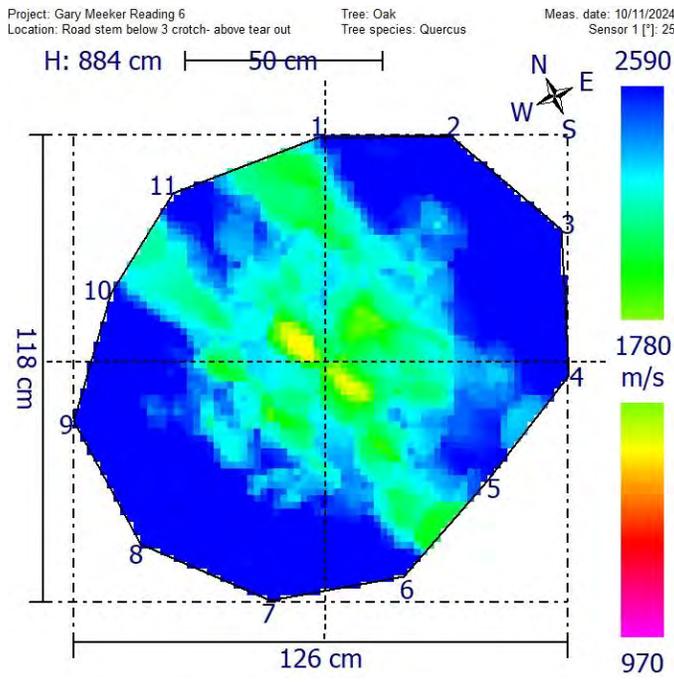
At this level there is included bark throughout the center of the stem, where the three stems connect.

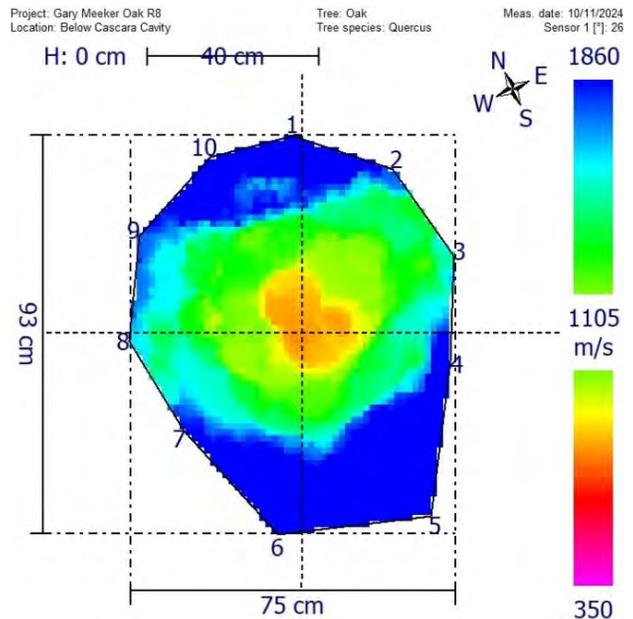
At this level there is less dense wood in the center of the stem. The center yellow spot indicates where the cavity above extends too.

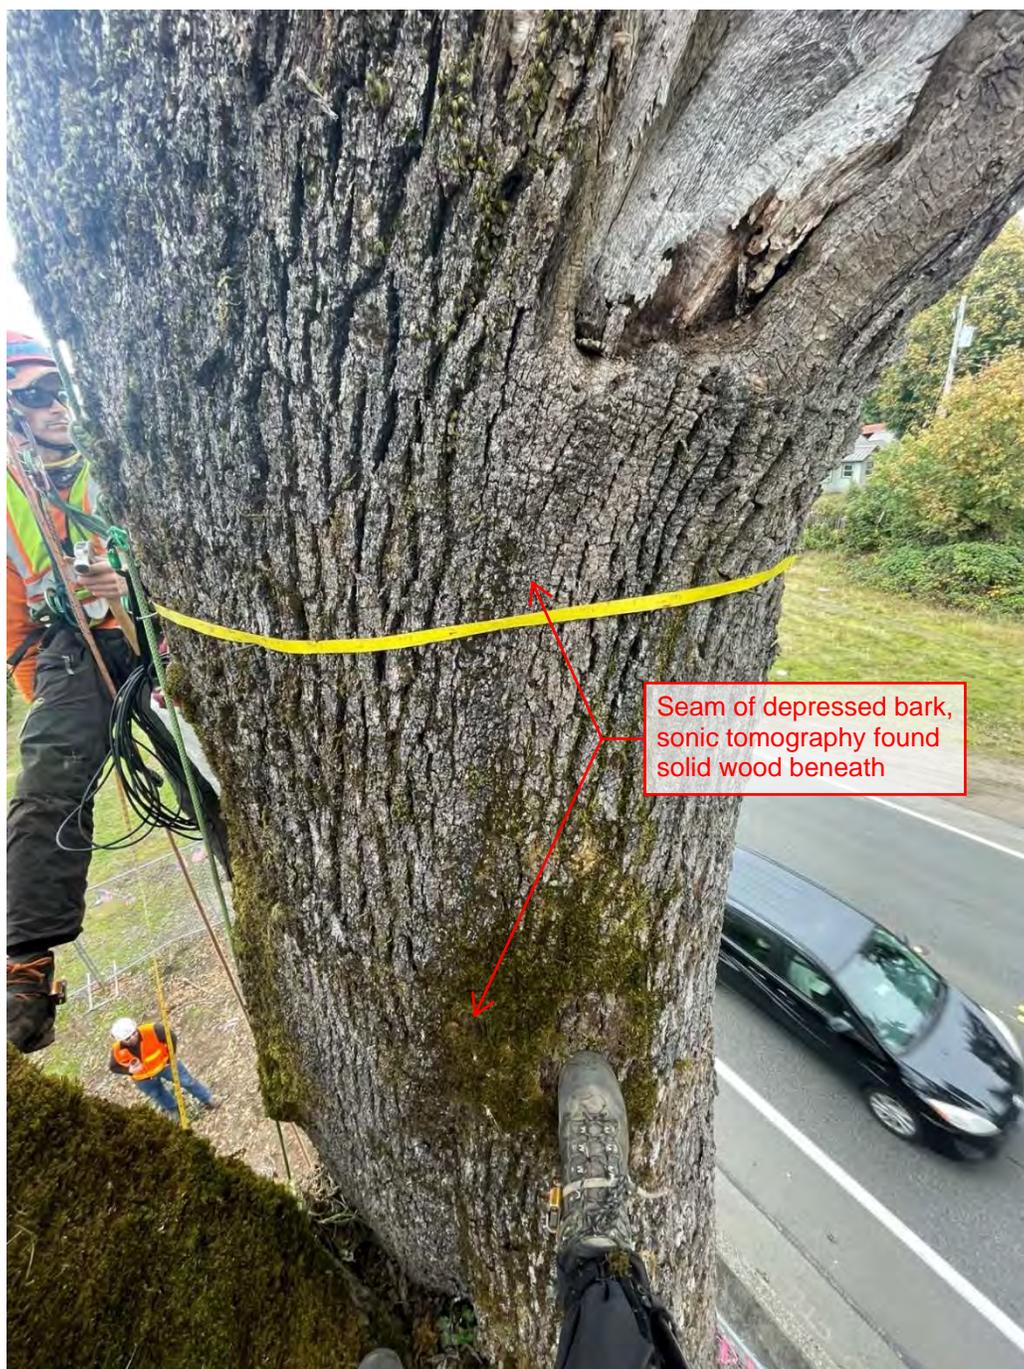
Figure 5 Seam below 2012 failure. Sonic tomography found solid wood down into codominant union.

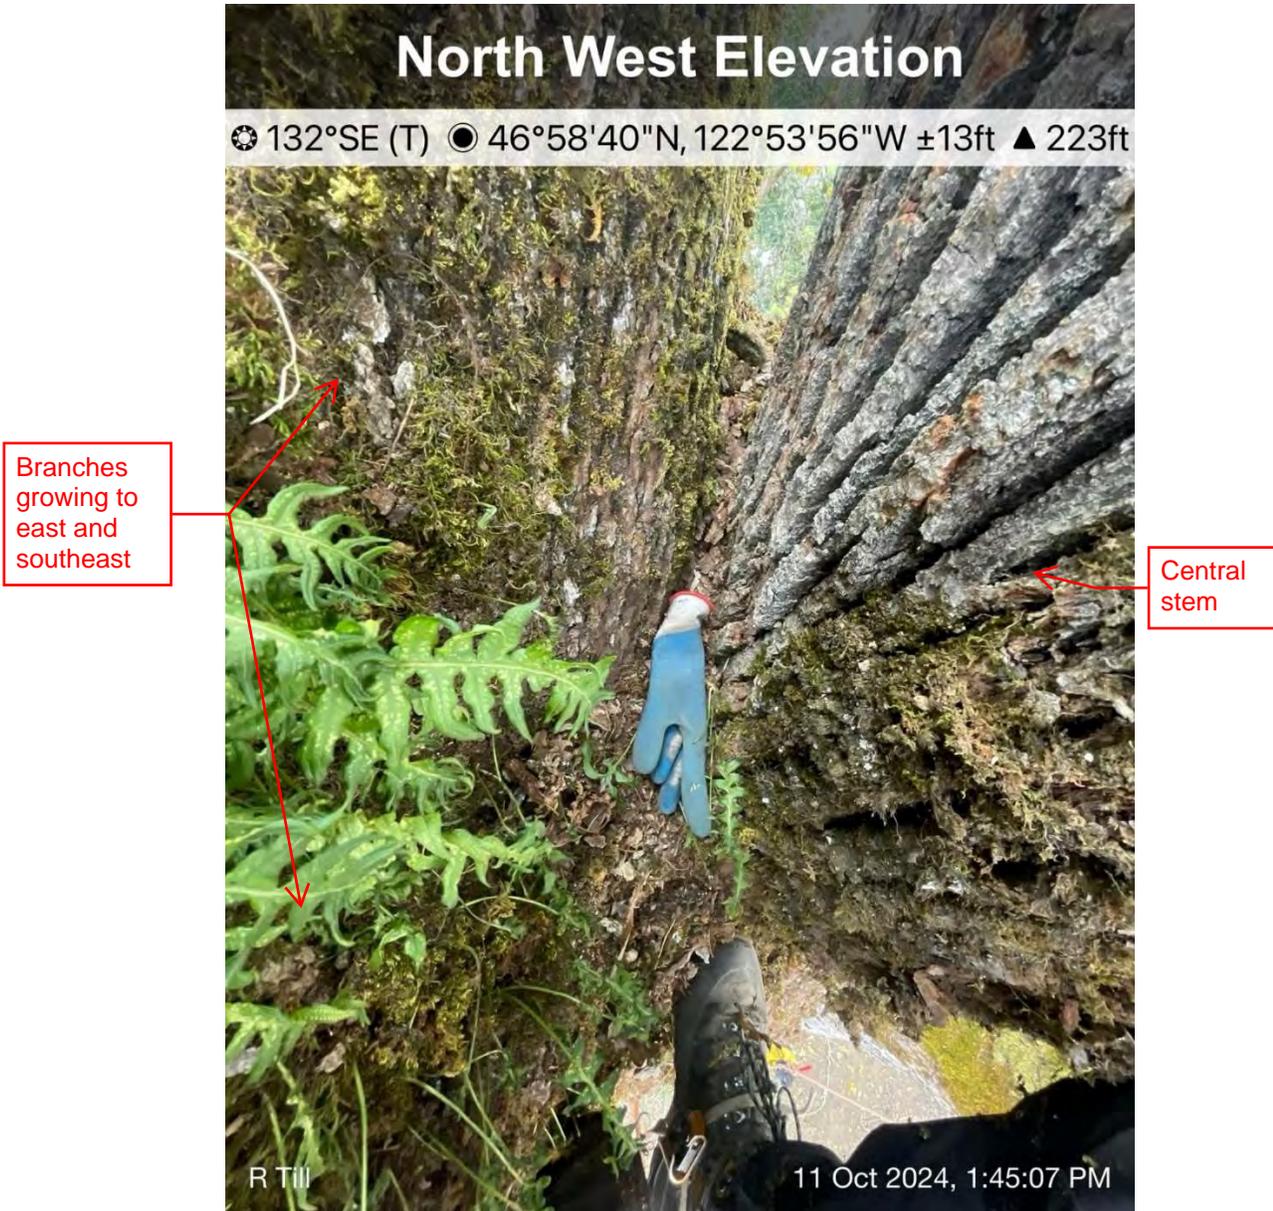
Figure 6 View directly down into second codominant union. Two stems over the road are on the left and central stem to the right. Union has included bark. Probing did encounter solid resistance beneath debris.

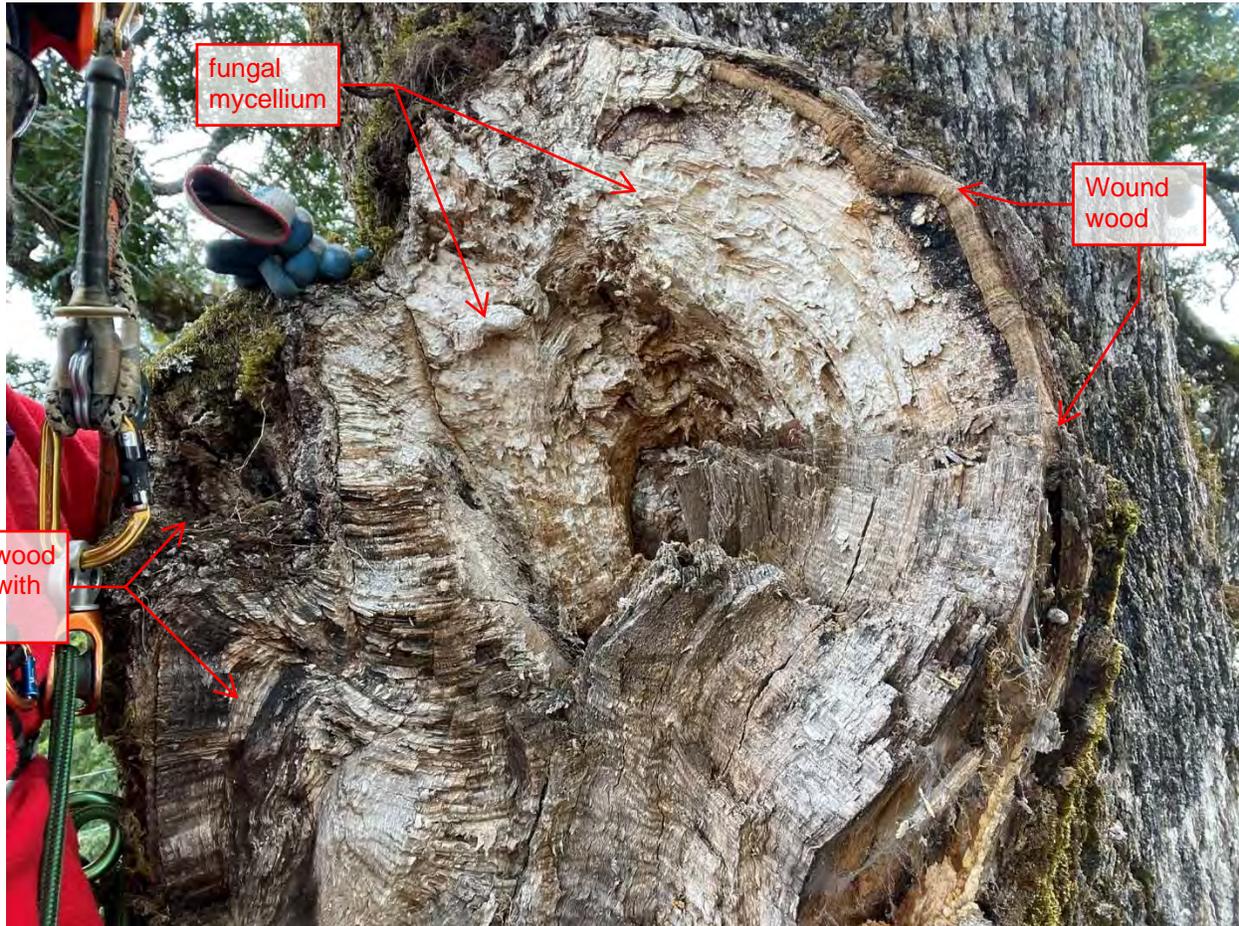
Figure 11 Wound wood on the top-right margin is positive response from tree. The fungal mycelium sampled from this location was identified as a *Stereum* species, which primarily consumes dead sap wood.

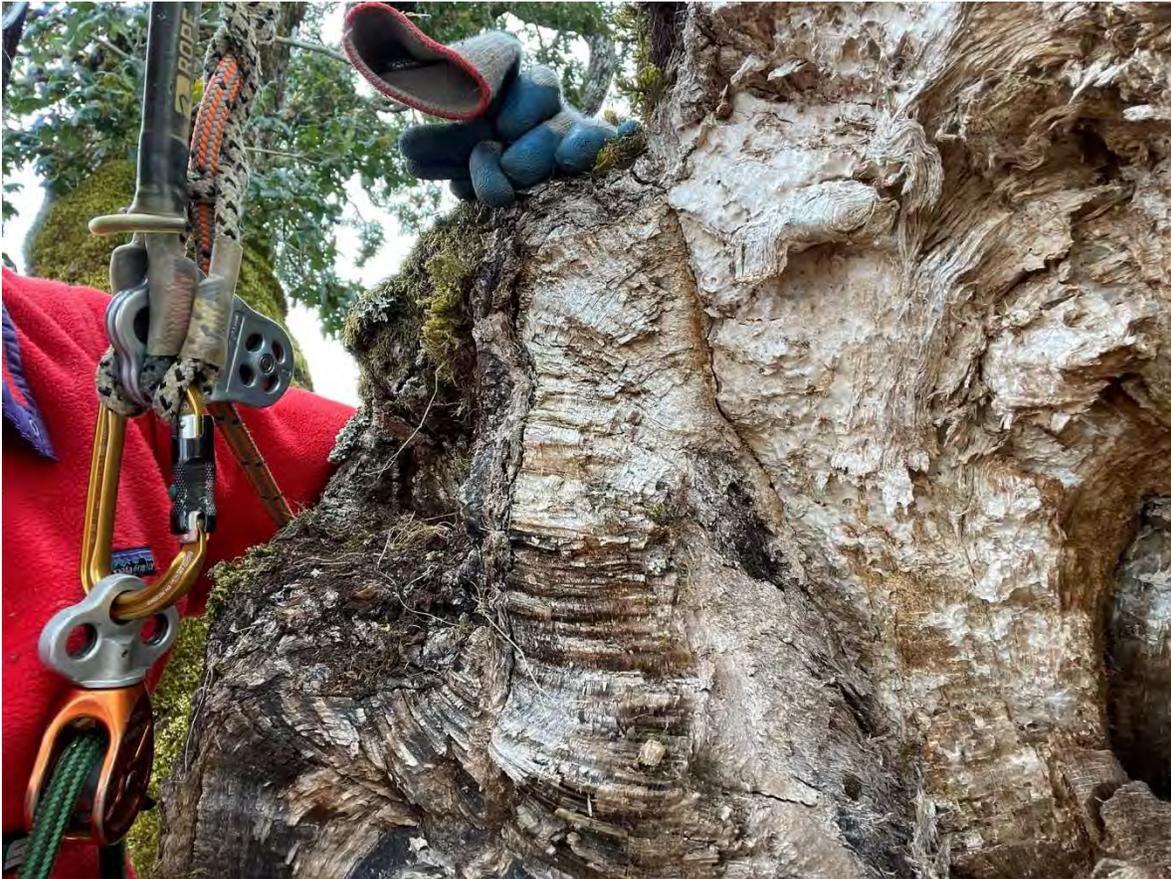
Figure 12 Left margin of 2023 failure and adjacent historic wound.

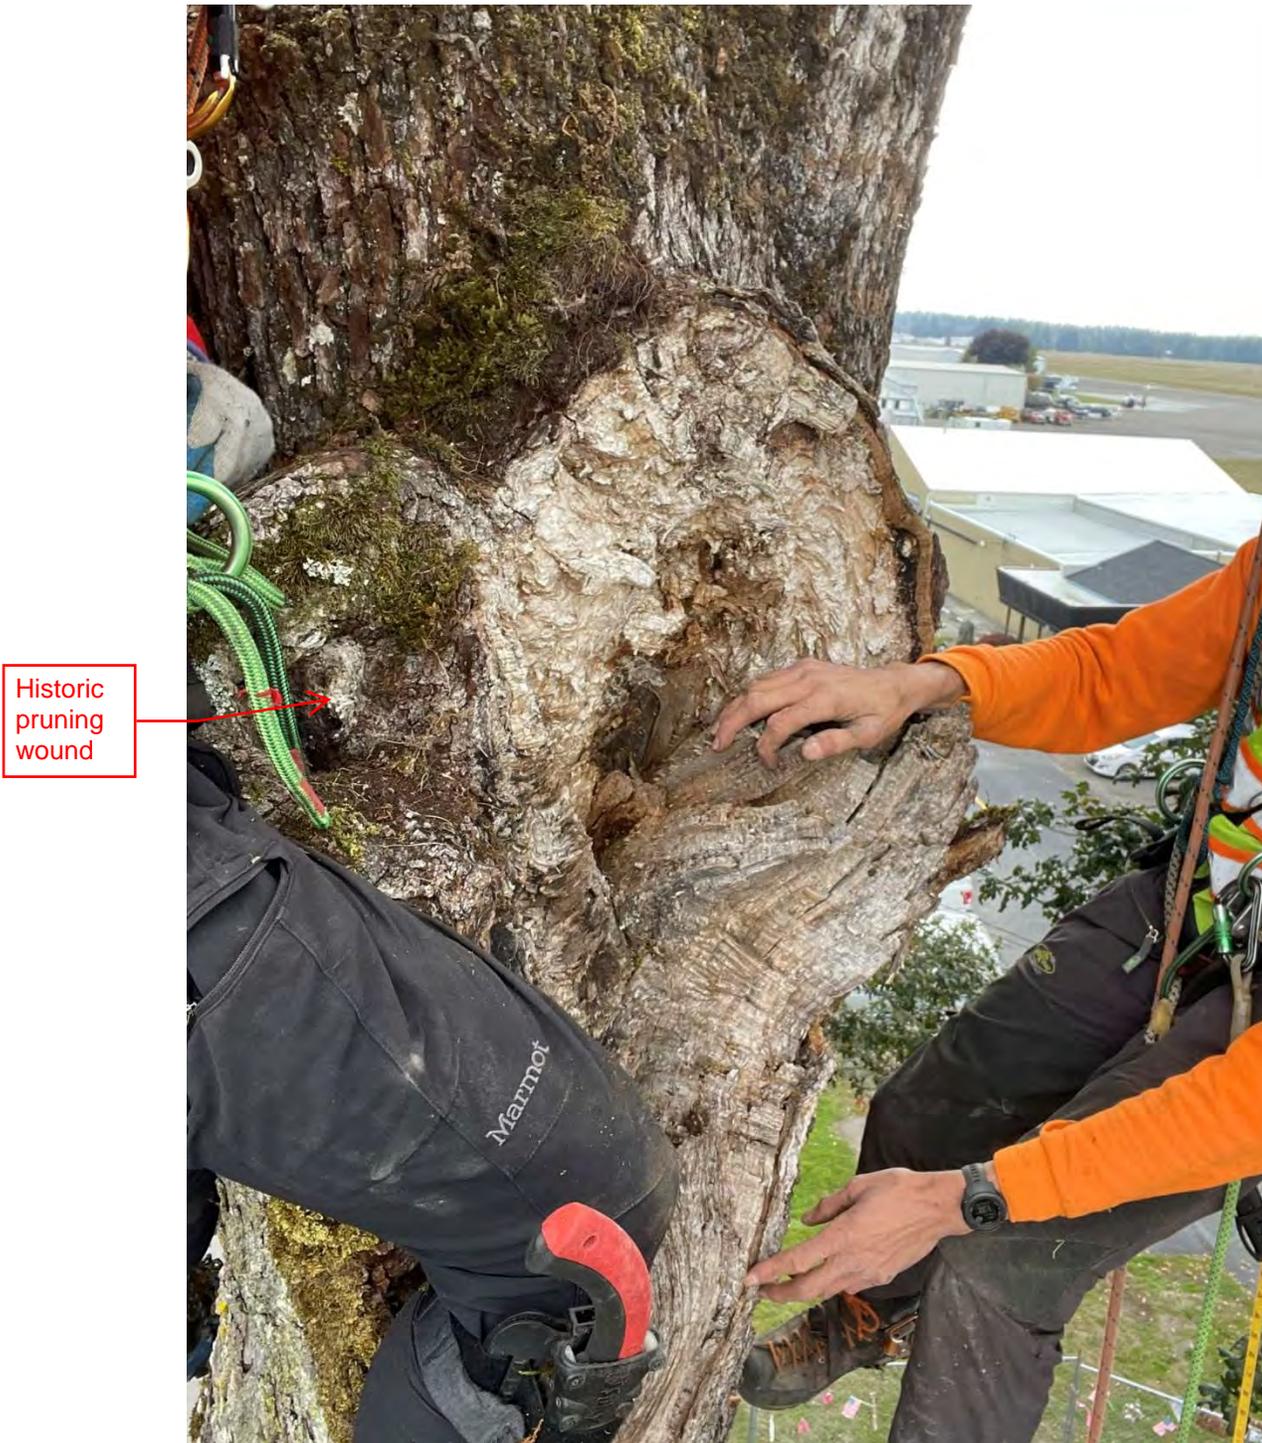
Figure 13 Additional view of 2023 failure and historic pruning wound.

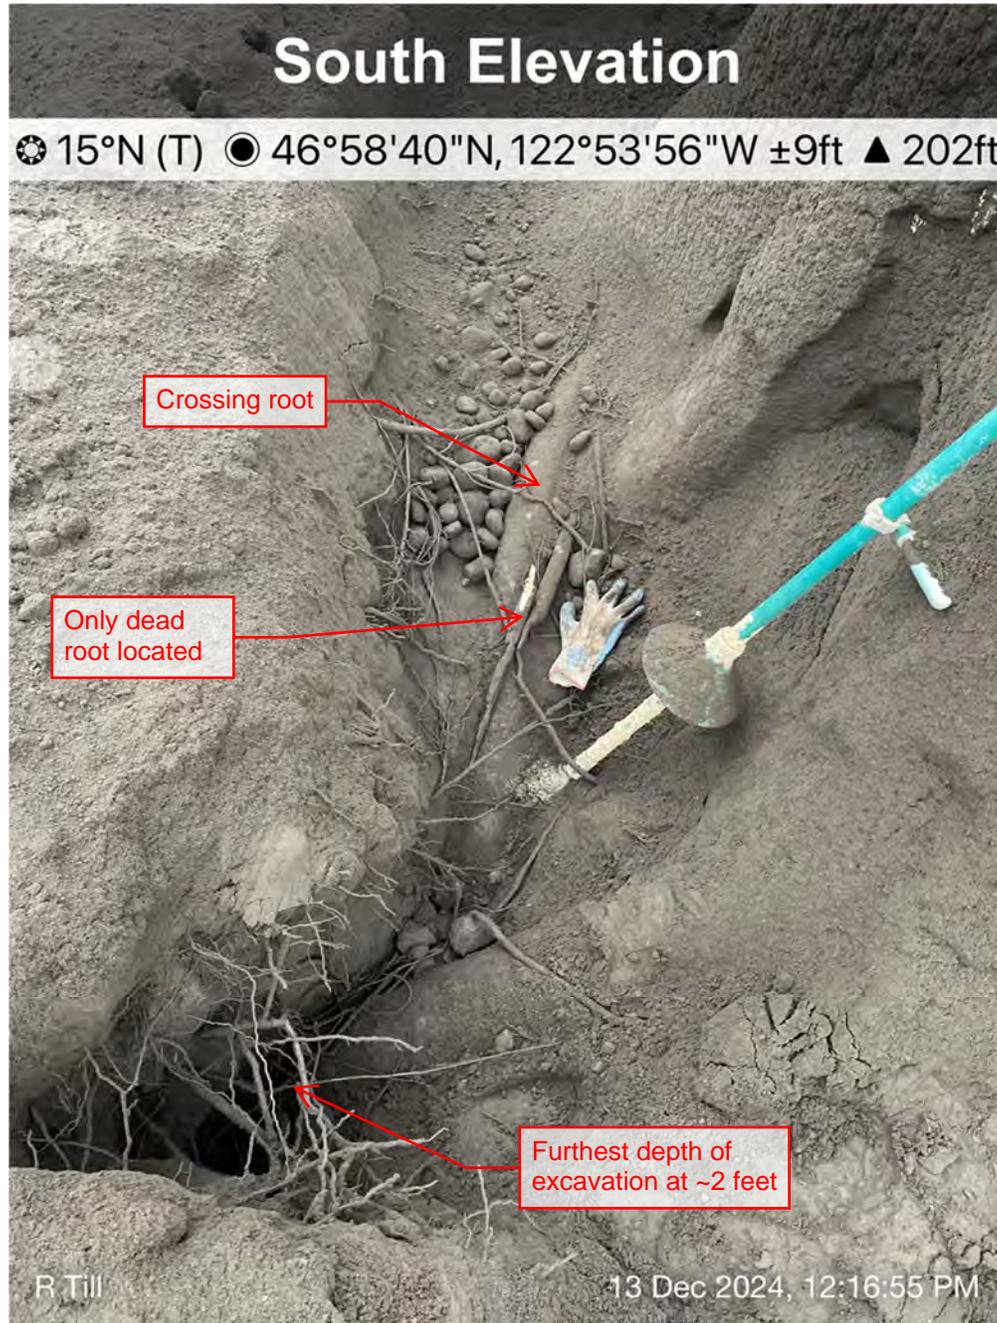
Figure 4 Traced one buttress root and did not locate any signs of concern. One, ~1-inch diameter dead root was located (visible to the left of the glove). One ~4-inch root crosses a primary buttress root, which could limit buttress root expansion.

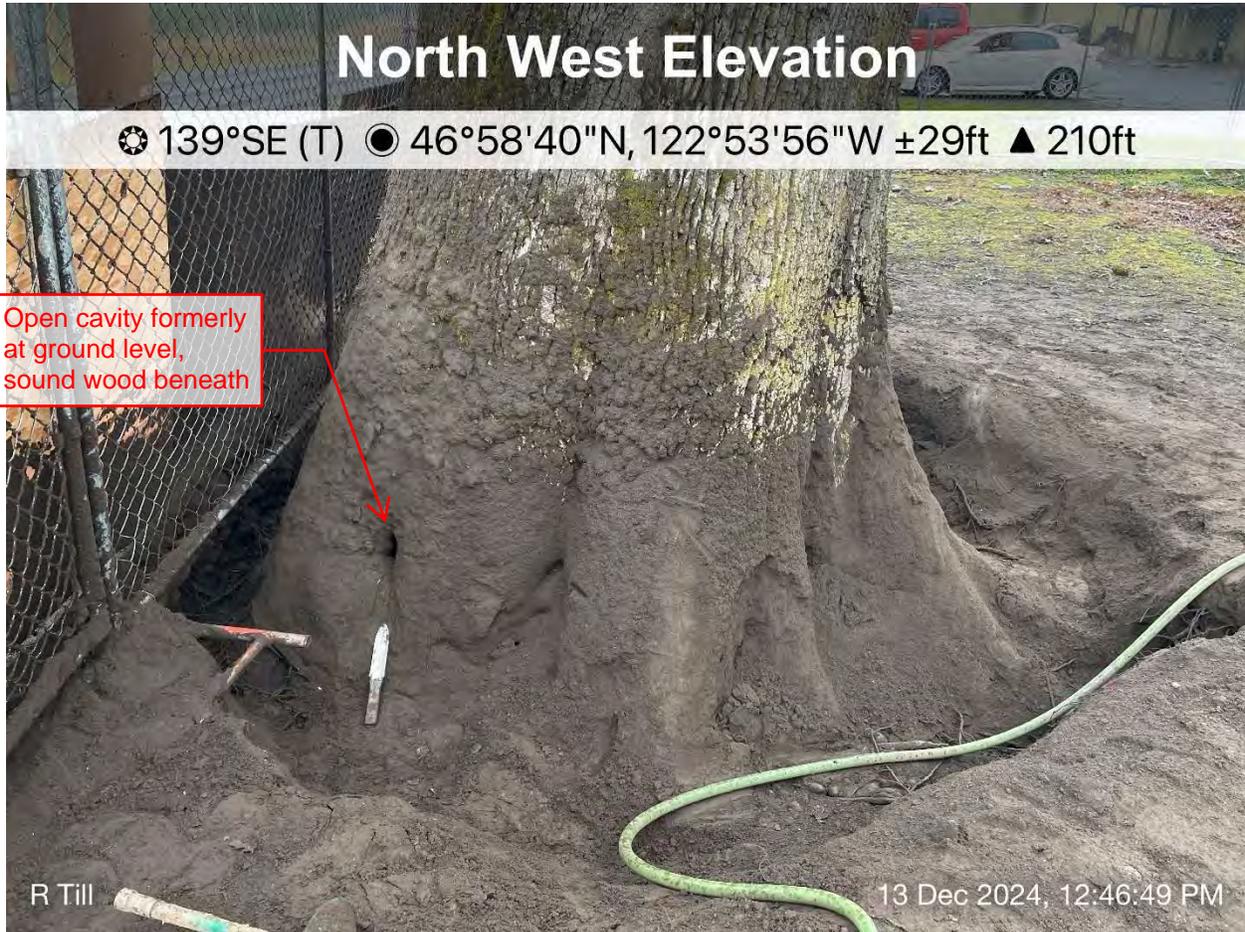
Figure 6 View from northwest. Wood below the cavity is sound. Hand inspected cavity and substantial wood present. Probes creases/sinuses between buttress lobes and did not identify signs of decay.
