City of Arkansas City

PLANNING COMMISSION MEETING AGENDA

**FACILITY EVALUATION REPORT
OF
PARIS PARK POOL
FOR THE CITY OF
ARKANSAS CITY, KANSAS
JUNE 8, 2021**

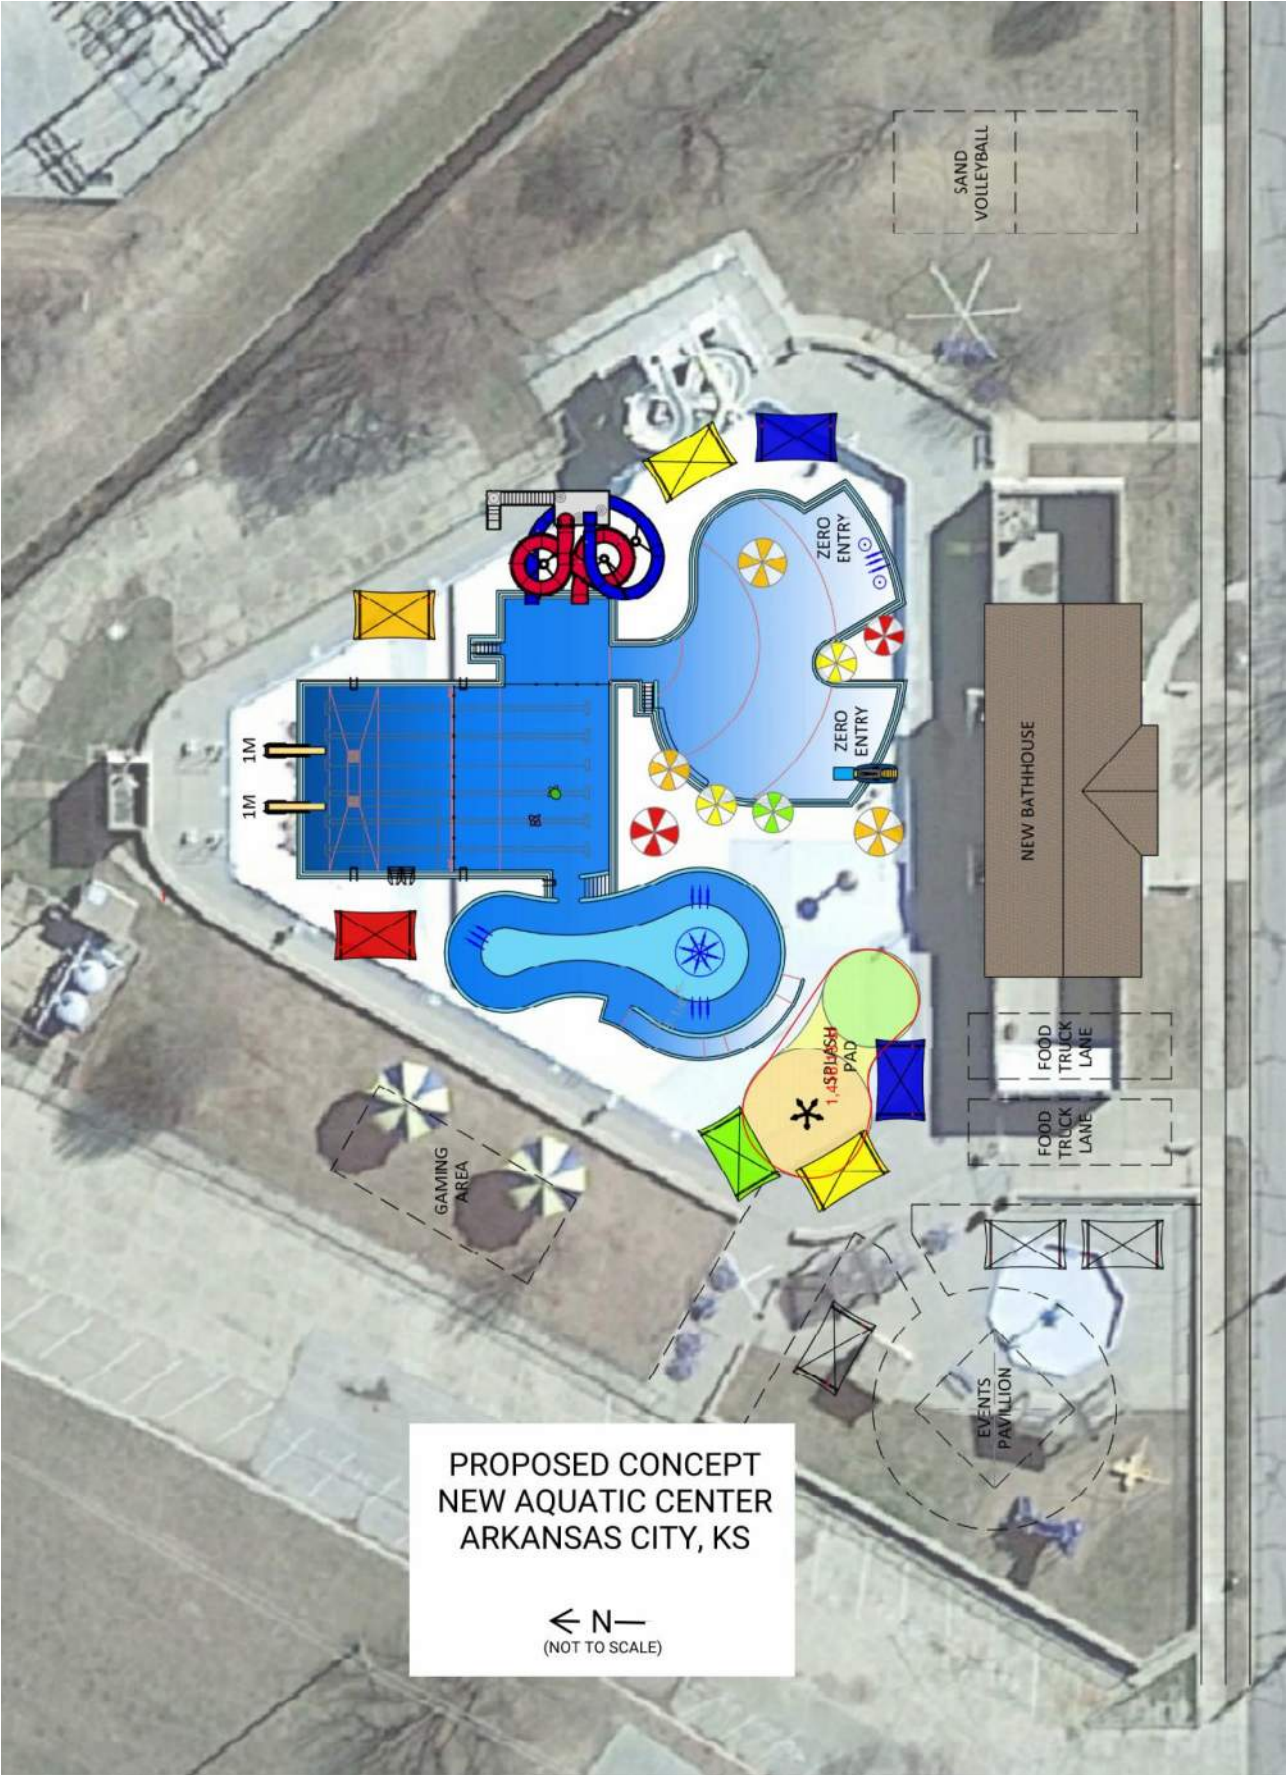
The proposed pool concept features:

- One multi-use swimming pool, about 9,200 sq ft of surface area, including:
 - A 3,300 square foot shallow play area small children and families with:
 - Beach entry
 - Deck sprays at beach entry
 - Tot slide
 - Shaded Mother's Bench
 - Underwater bench
 - 180-foot long by 8-foot-wide lazy river, with sprays.
 - Plunge pool for two waterslides; 20 to 25-foot slide tower.
 - 6 lane by 25 yard lap swim area.
 - Dive well with two 1-meter dive stands and climbing wall.
- 1,400 sq ft splash pad.
- About 18,000 sq ft of pool deck with lots of shade.
- New bathhouse and concessions building.
- Space for food truck concessions.
- Green areas for events pavilion, a variety of non-aquatics activities and family gathering areas.

A new pool facility is recommended, and this concept (see next page) is offered for the community and community leaders to consider.

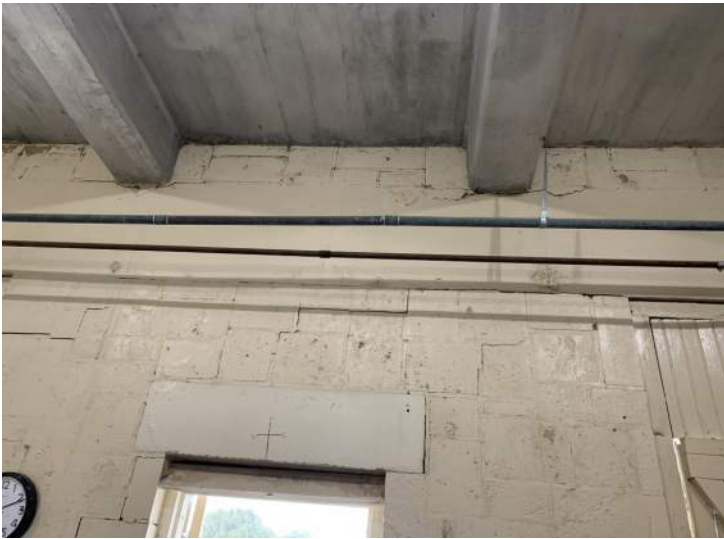
The bathhouse exhibits cracking in the masonry joints in numerous locations. The example to the left shows damage projecting from from the lintel at the doorway and damage around the connection points with the cast concrete roof structure. Note the displacement in the wall plane at the cracks. This damage reflects movement due to settlement. The damage may also have been exacerbated by past seismic activity or excessive wind damage. Water intrusion is also a factor as illustrated in photographs presented below.

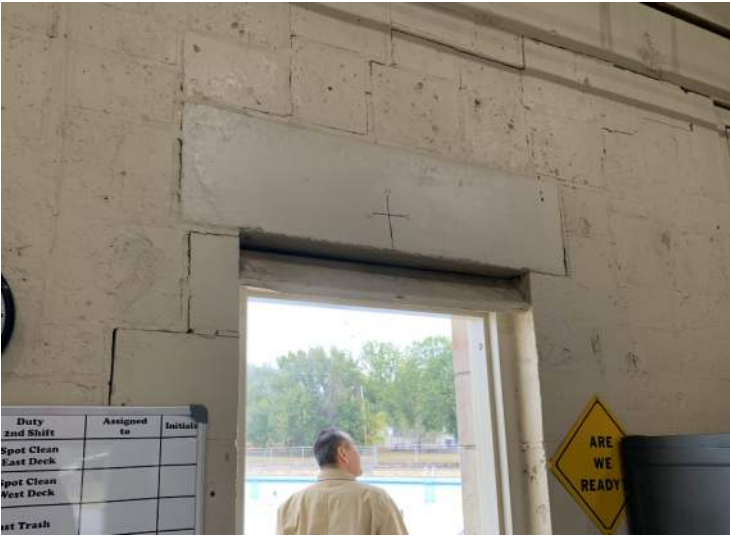
This is a close-up of the lintel from the previous photo.

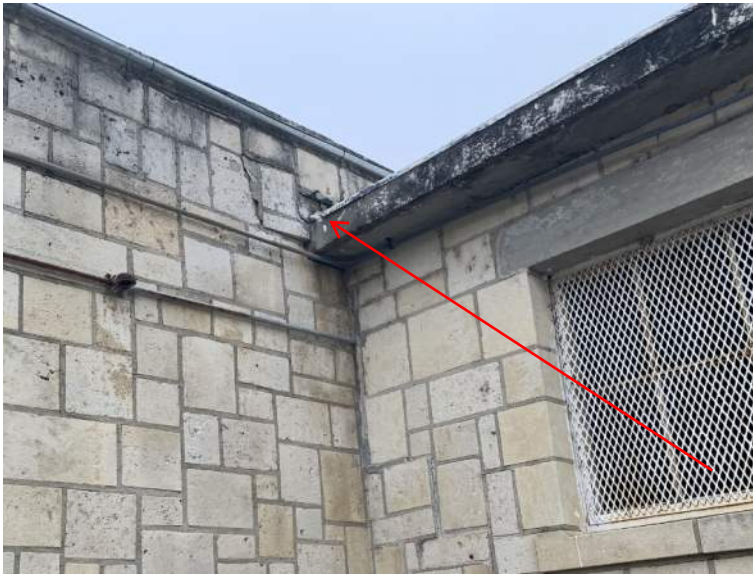
Another example of differential movement and rotation of the exterior wall, relative to the adjoining wall. This is in the southwest corner of men's changing area; wall on right is part of storage room on southwest corner.

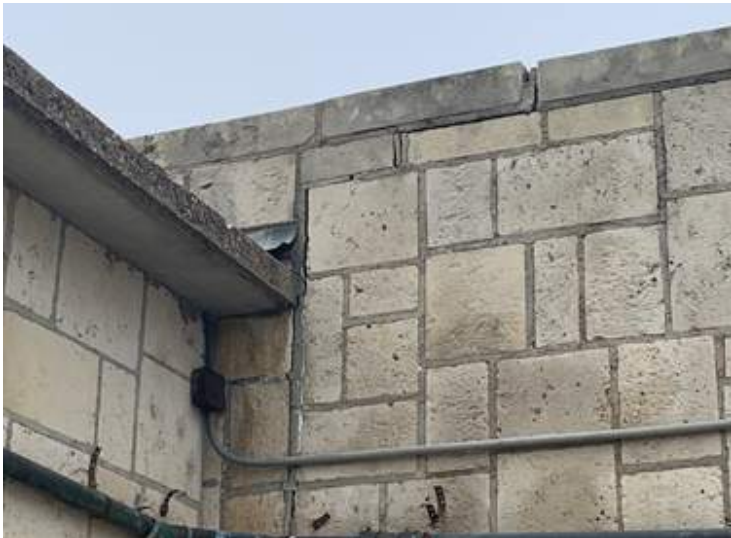
Damage due to settlement in the opposite (northeast) corner of the building from the previous photograph.

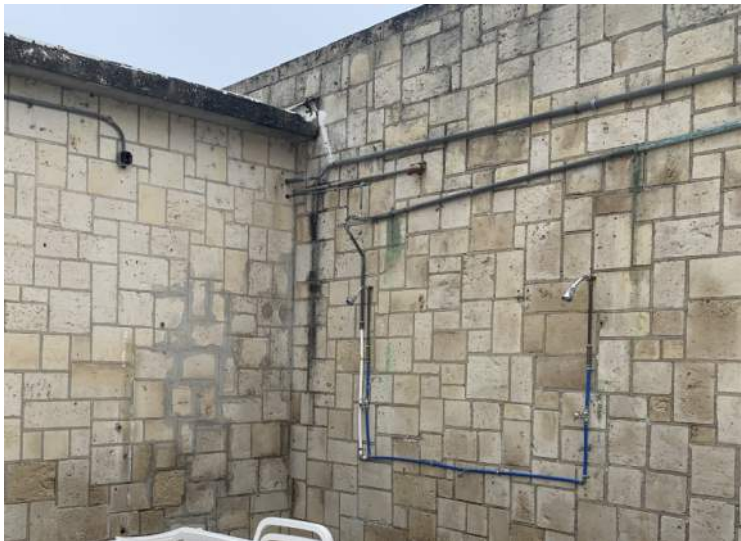
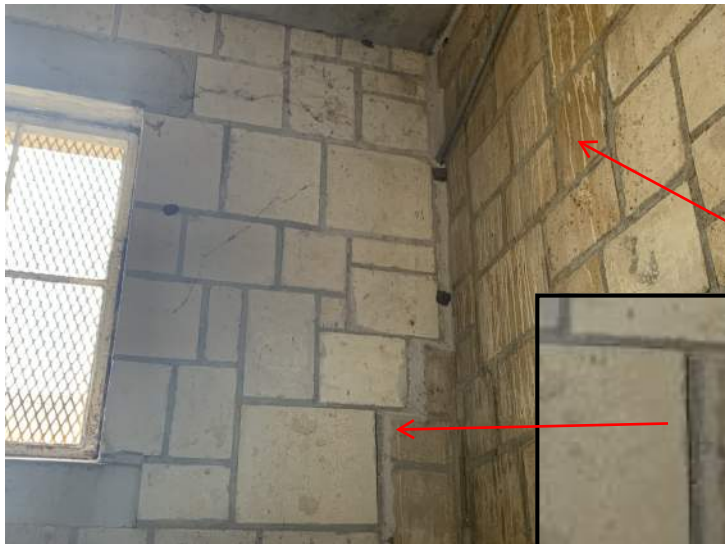
The next two photos show earlier tuck point repairs in the masonry joints to address cracking due to settlement.

Note a gap has opened up since the tuck point repair indicating continued movement in the structure. This is in the storage room on southwest corner of building.

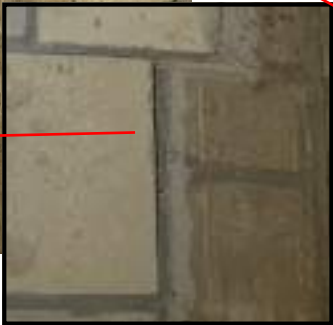
Streaking from water leakage is also evident on this wall.

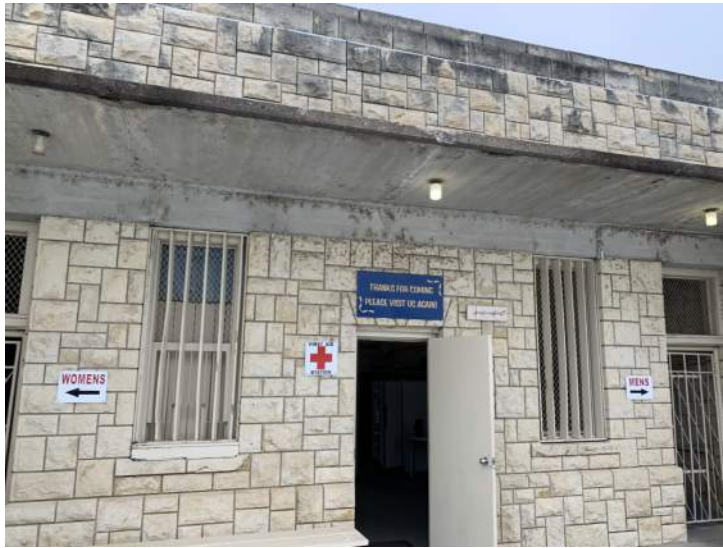
The concrete slab overhang shows cracking and distress most likely from water intrusion due to poor drainage. The dark patches along the the bottom side where the slab meets the wall may indicate mildew and potentially spalling of concrete. The slab exhibits lateral cracks extending through the width of the overhang.

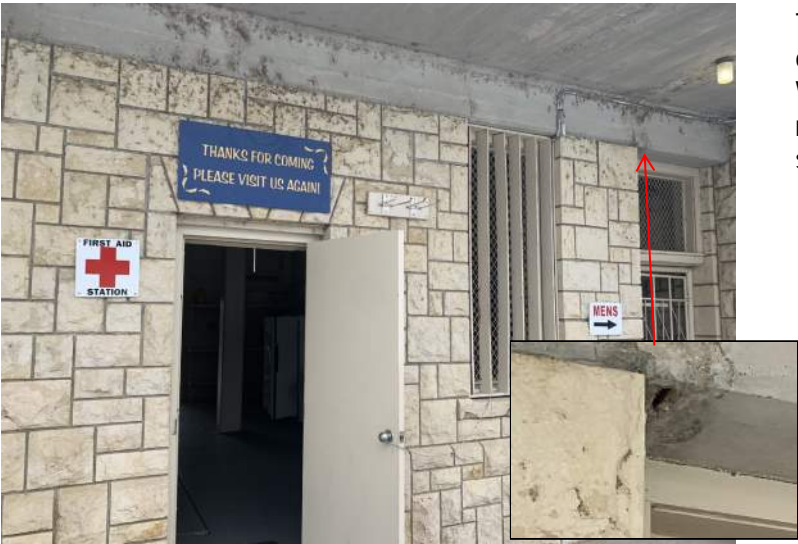
The most severe damage observed in this overhang is shown in the photo inset. Water intrusion has corroded the reinforcement causing the concrete to spall on the bottom of the member.

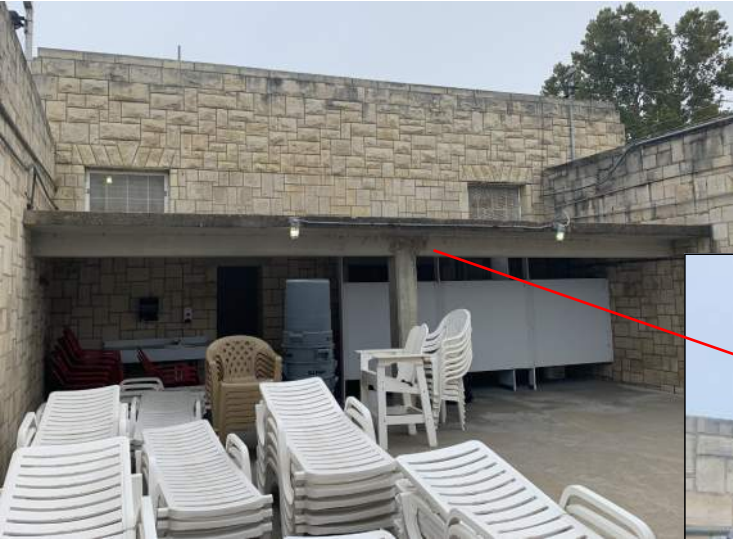
The roof overhang in the men's changing area show deterioration. Note the damage at the top of the center column and the cracking, spalling, and exposed reinforcement along the edge of slab.

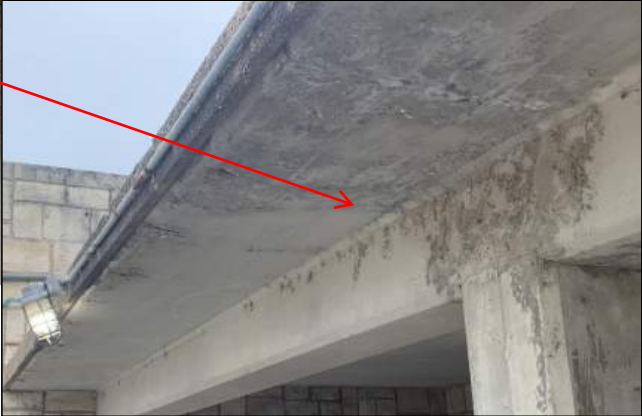
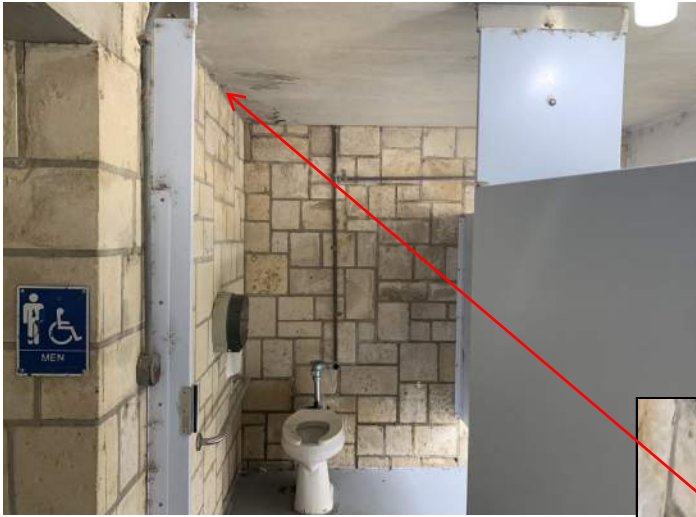
These photos were taken underneath the men's overhang where the roof meets wall. Note that water intrusion has caused delamination in the corner of the ceiling and in the lintel above the door. Cracking and efflorescence is also apparent in the bottom of slab. All of this damage is most likely contributable to poor drainage on the slab and lack of a sealing membrane layer on the top of concrete.

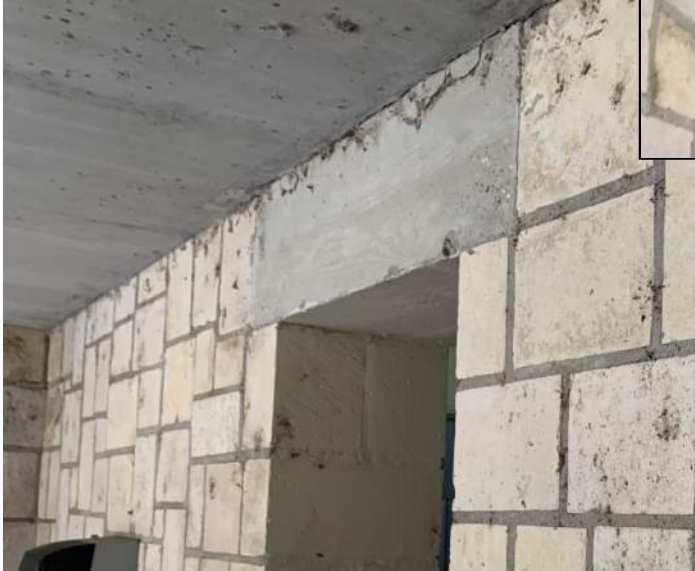
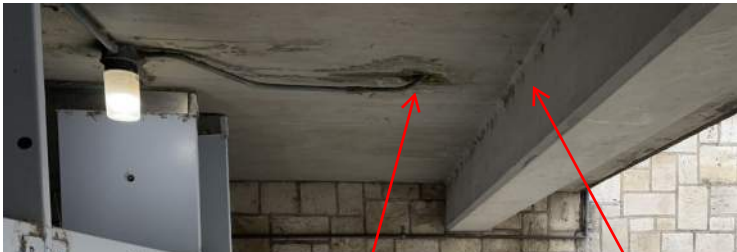
Also note the signs of water intrusion in the men's overhang. Note the efflorescence and mold around the electrical conduit penetration and the distress/ discoloration in where the slab meets the beam.

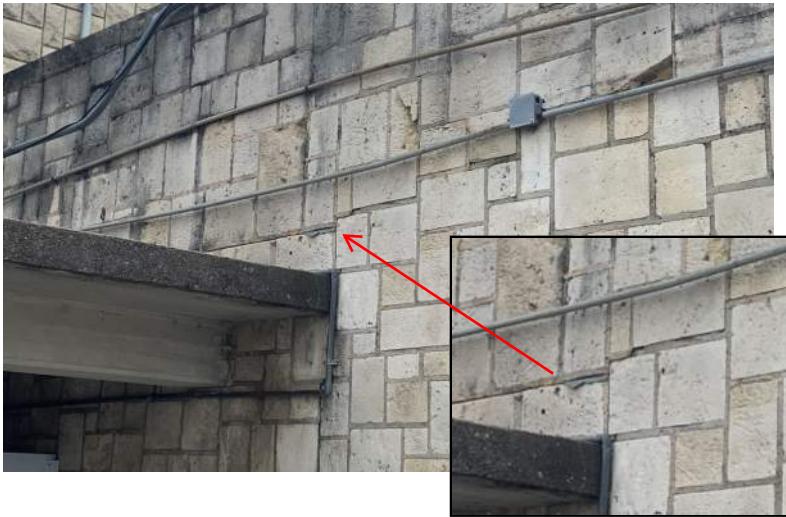
A remnant of what appears to be old flashing is also seen on the men's side. A crack extends in the mortar joint away from this line, indicating a point of weakness in the wall. It also suggests the original roof system was replaced by the current roof.

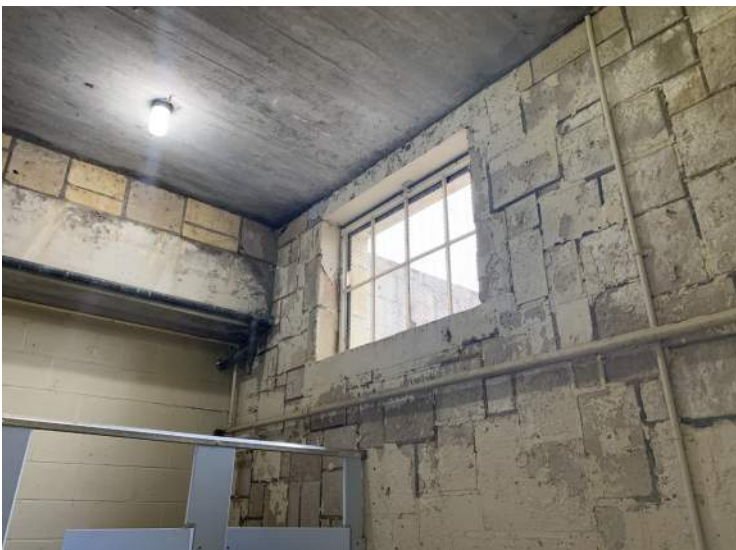
Deterioration from moisture intrusion is also evident in a number of locations. This is exhibited by the dark color of the mortar and the peeling paint.

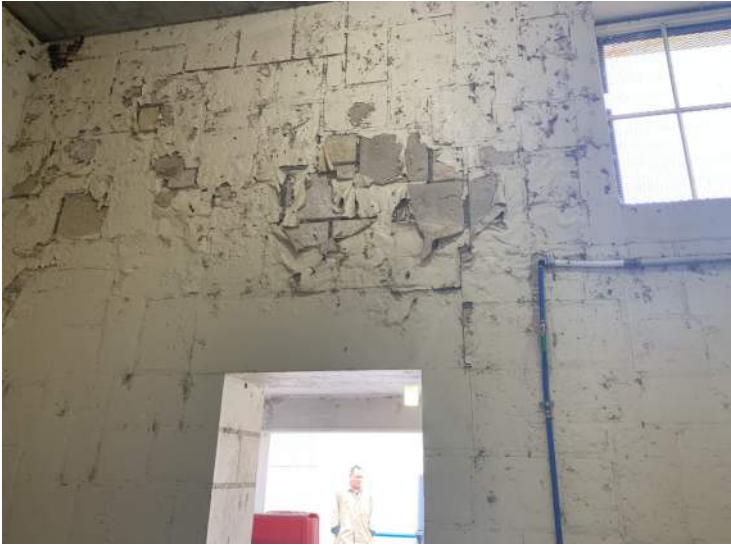
The type of paint applied has likely exacerbated the problem by trapping moisture in the block behind the paint. Again, the results of such intrusion are evident in peeling paint and discolored mortar.q

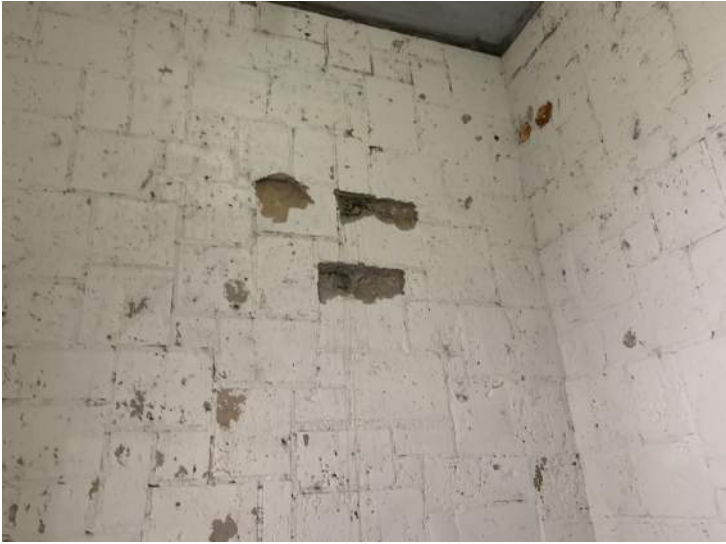
These conditions can also cause deterioration and delamination of the rock itself.wt

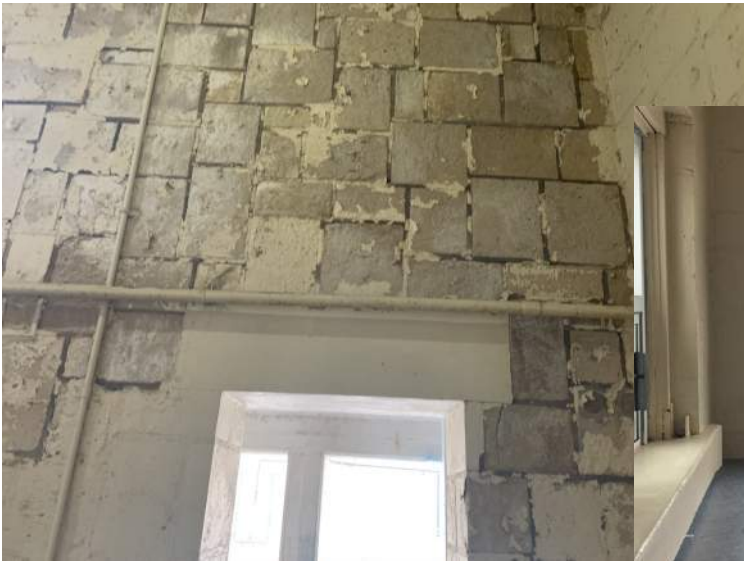
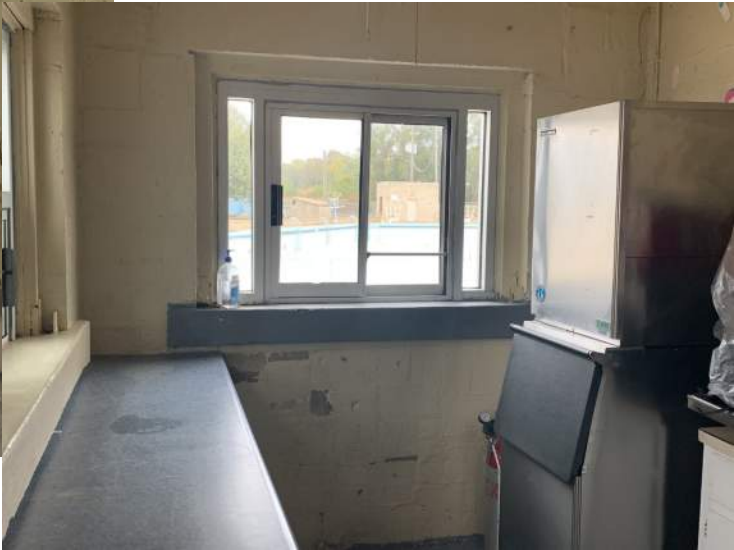
A couple more examples.

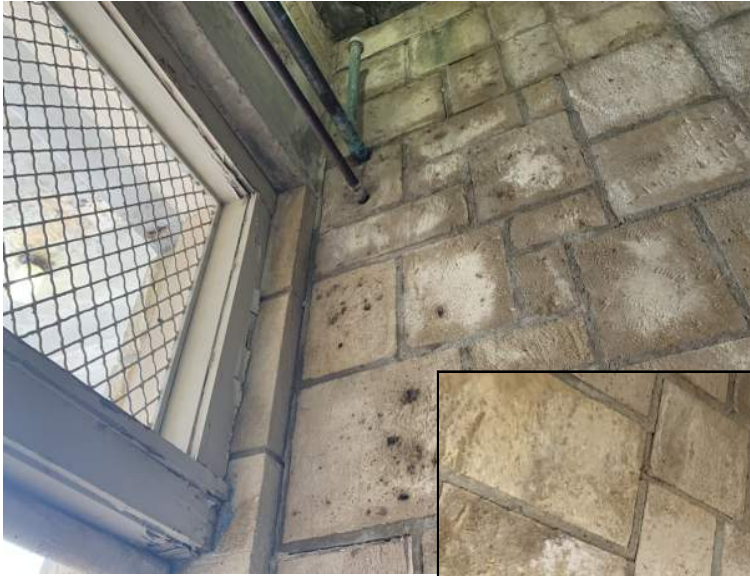
The casework around window openings and door frames needs attention. The age and environmental conditions have resulted in what appears to be some degree of wood rot.

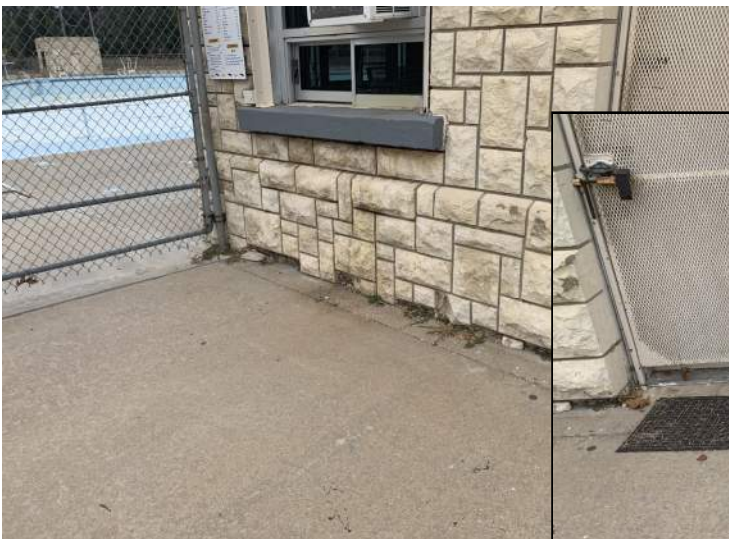
The bottom photos show deterioration in the bottom course of stone on the west end of the building. This condition is not observed elsewhere. This is attributed to poor drainage on the deck adjacent to the wall. The theory is water drains toward the wall, seeps into the stone, and--most likely due to freeze/thaw--has caused the rock to slowly disintegrate.

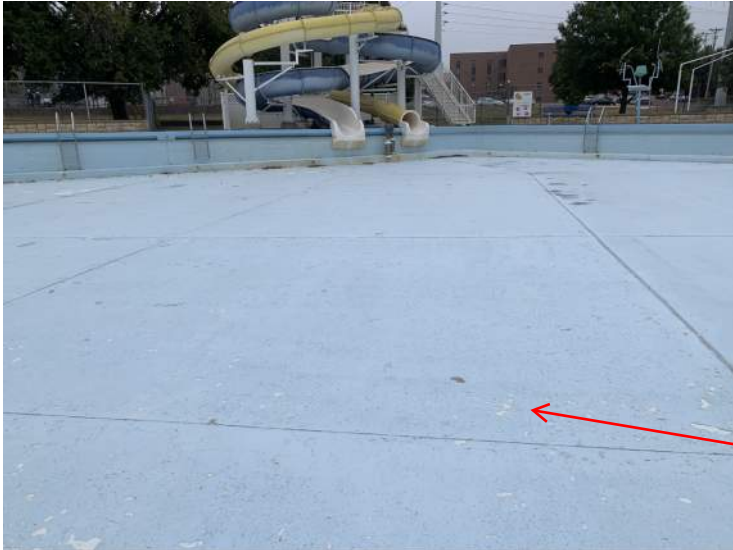
The floor built in 2002 is acceptable condition. No significant damage was observed around joints. A few cracks were observed in some of the slabs. The painted surface is in poor condition, exhibiting significant peeling.

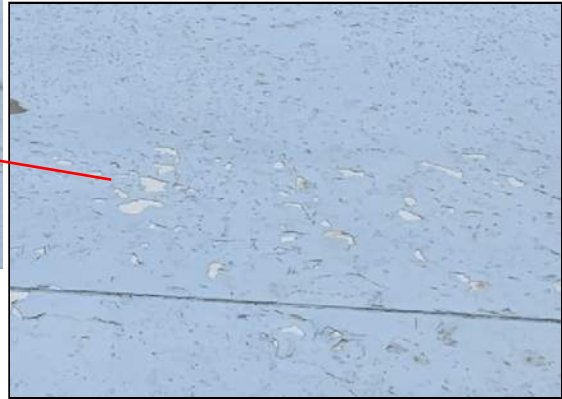
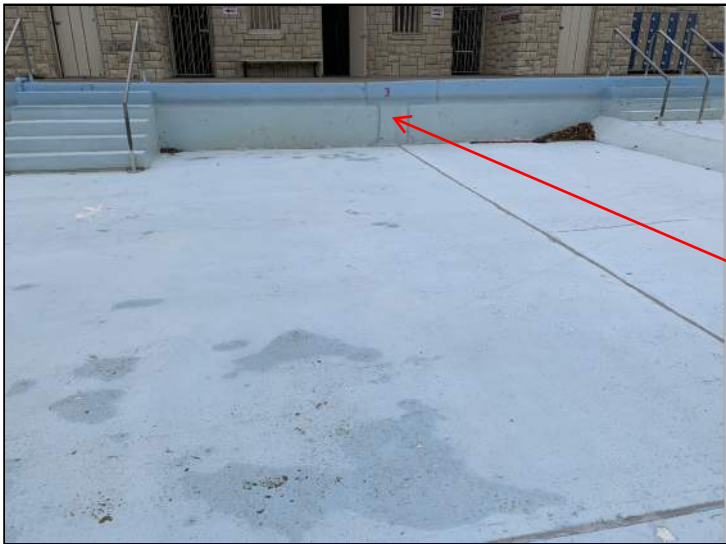
Note a patch made in the wall, presumably to replace piping.

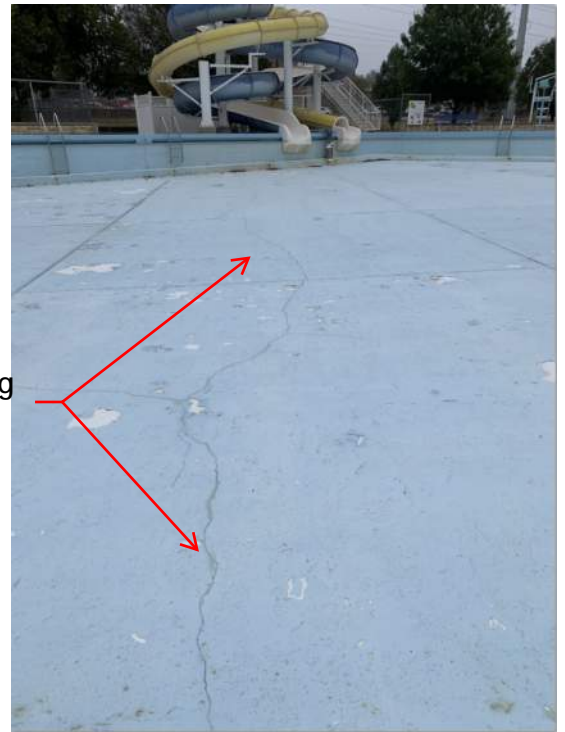
The dive well is in poor condition. The painted surface is deteriorated like the rest of the pool, but the paint may also be revealing deterioration cracking from the underneath concrete, as shown in the close-up below.

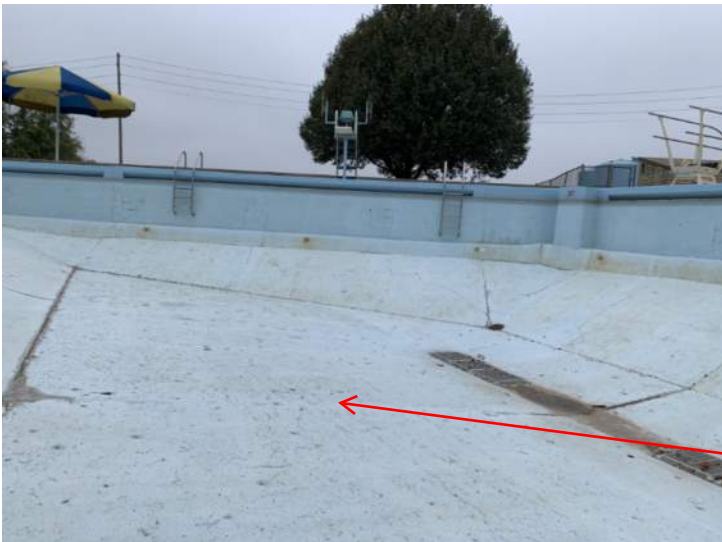
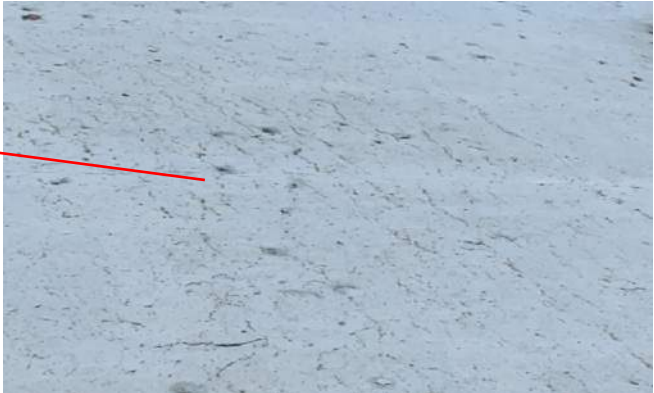
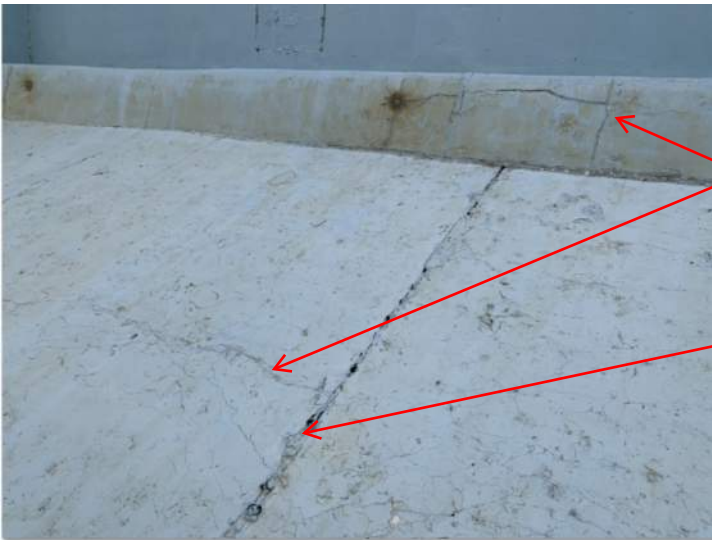
Extensive cracking

Damaged joints

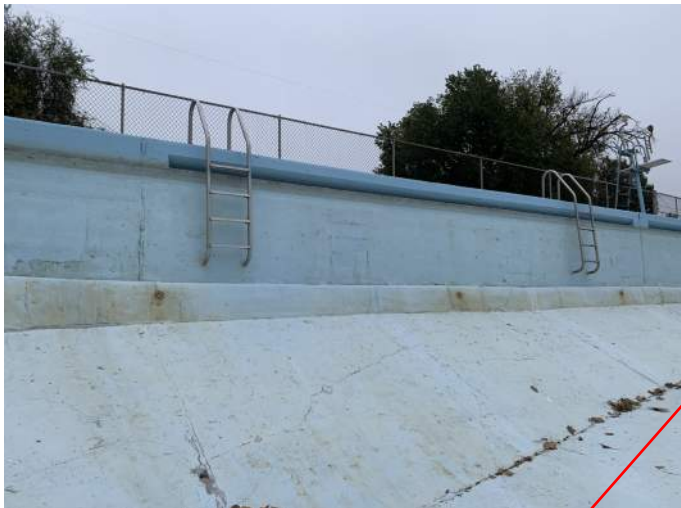
Pool walls and gutter appear in fair condition, given the age. There are numerous patches observed in the walls, presumably from filling in old light niches and wall returns. Note the supply piping encased in concrete at the base of wall. Typically, this is a re-model solution for replacing the return (supply) piping while minimizing impact to the existing pool

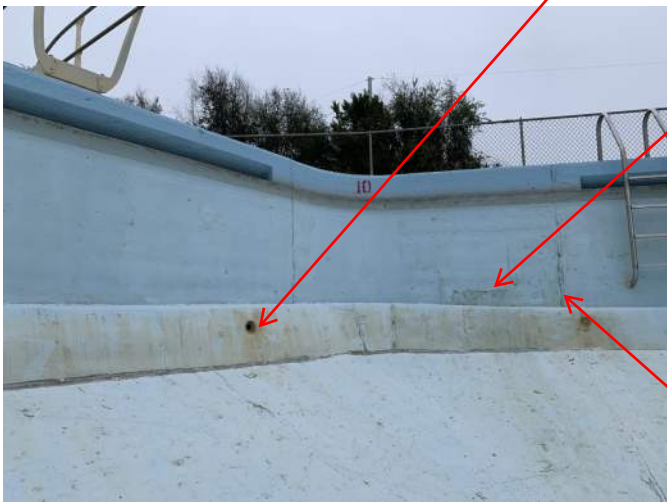
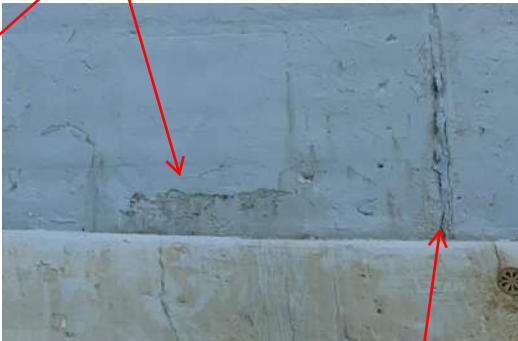
Cracking in dive well wall suggests water penetration.

Appearance of joint suggests movement in the wall system.

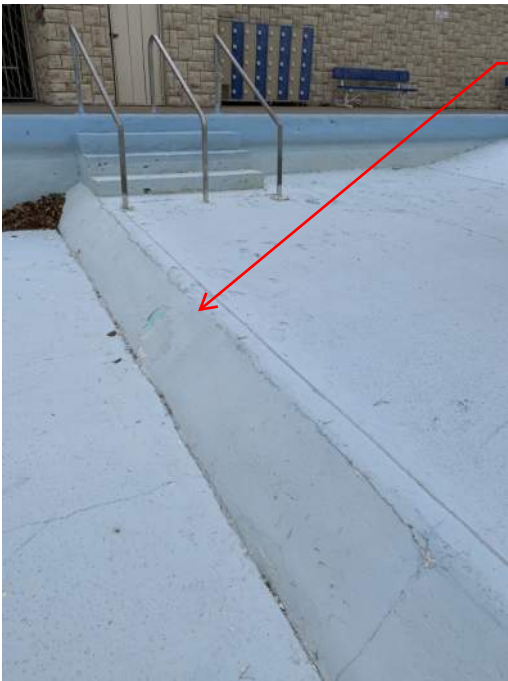
Severe drop-off is dangerous for non-swimmers. Modern code does not allow slopes greater than 8% (1:12) slopes in shallow (<5 feet) depth.

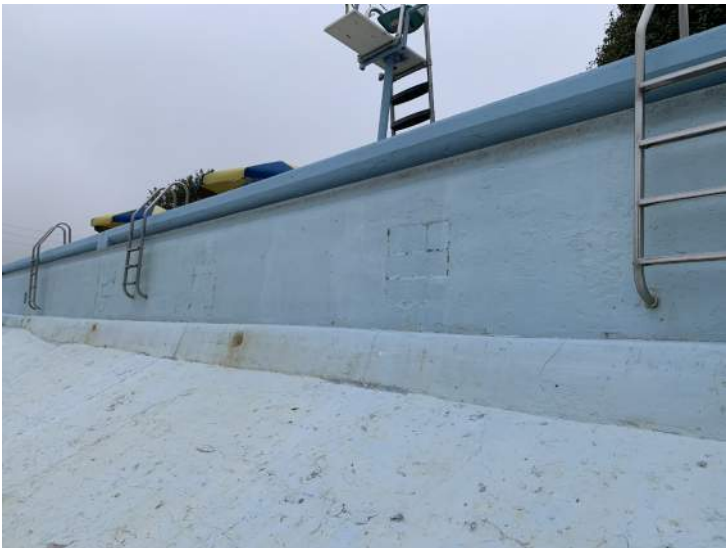
Slope appears to be about 12% (1:8) which is steeper than allowed by current codes. Code allows 8% (1:12) in water 5 feet or less deep.

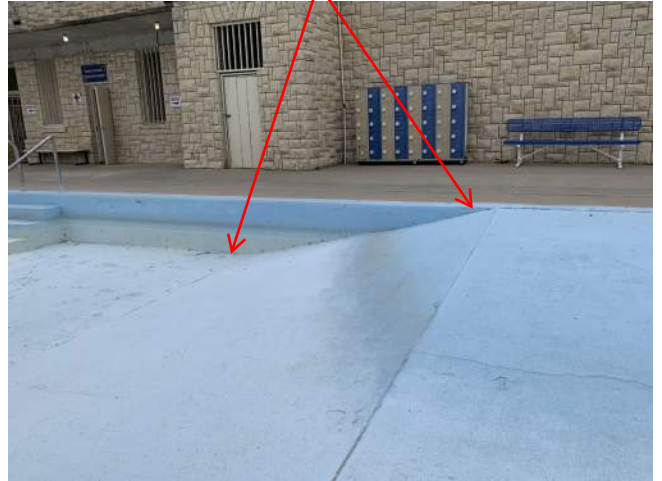
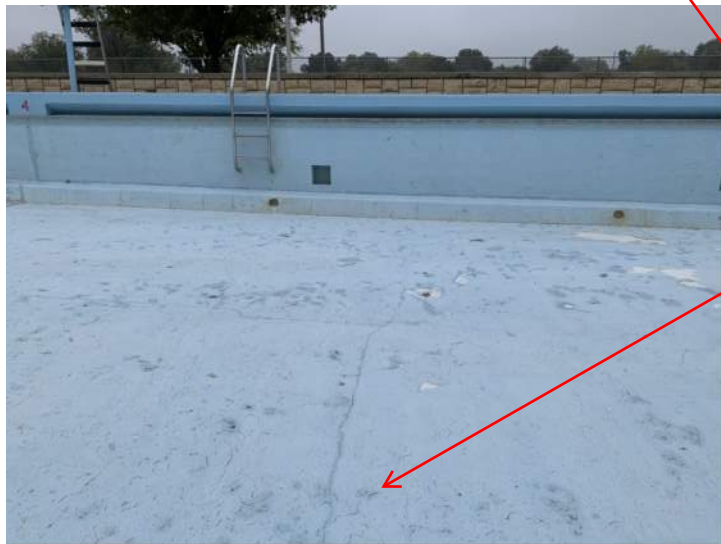
Note cracking in 18-year old deck

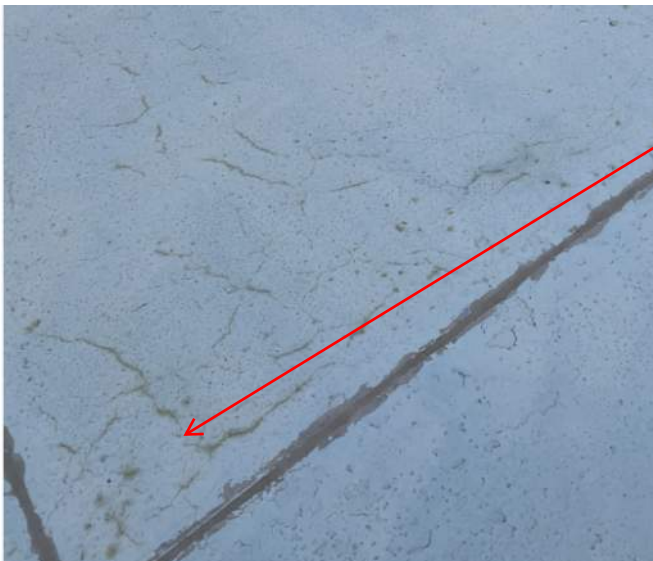
Deterioration cracking forming around joints. This indicates damage from freeze-thaw. Water penetrates joint and adjacent concrete in winter and cracking occurs when water freezes. This was observed in 18-year old floor slab.

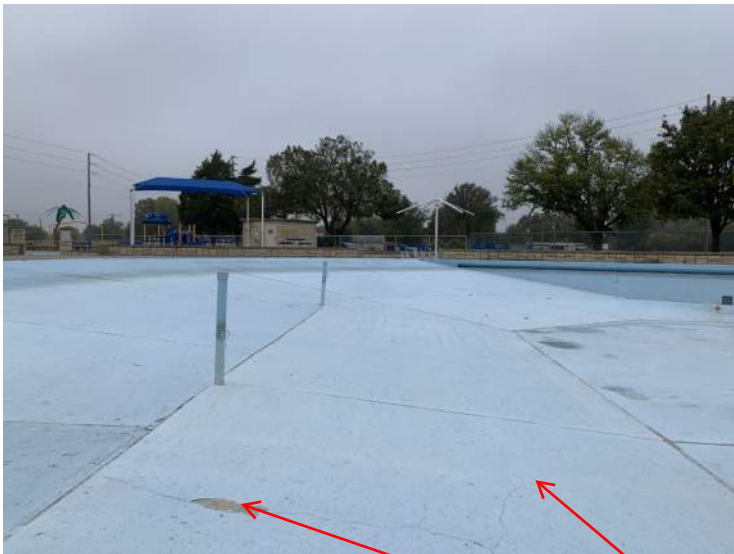
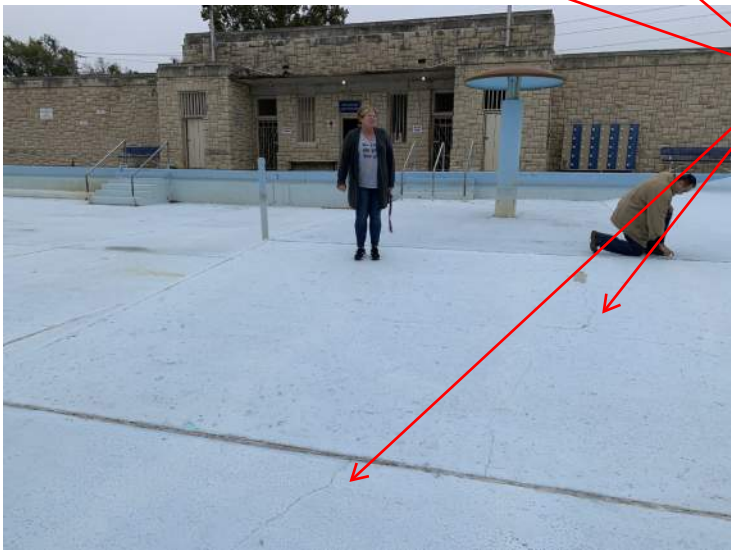
Note cracking and delamination in 36-year old beach slab.

Note cracking and delamination in 36-year old beach slab. Cracks likely formed at time of construction, but appear have gotten progressively wider with time.

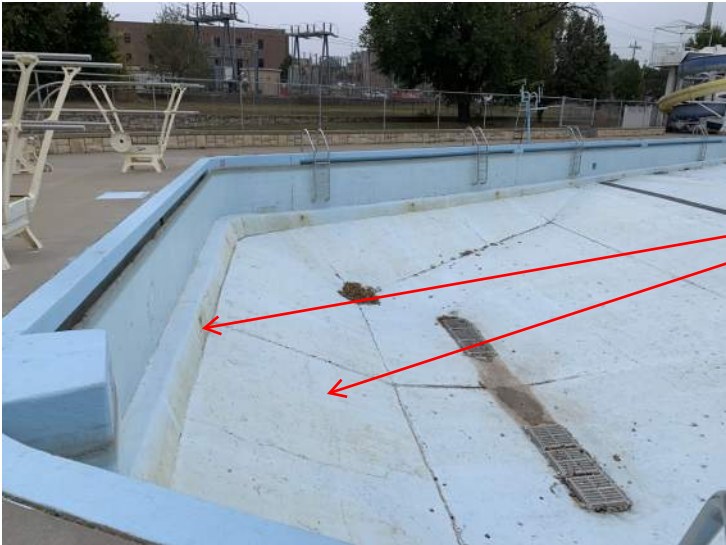
Depth at plummet (end of board) and depth at backwall of dive well may not meet current code. This is a liability and life safety issue.

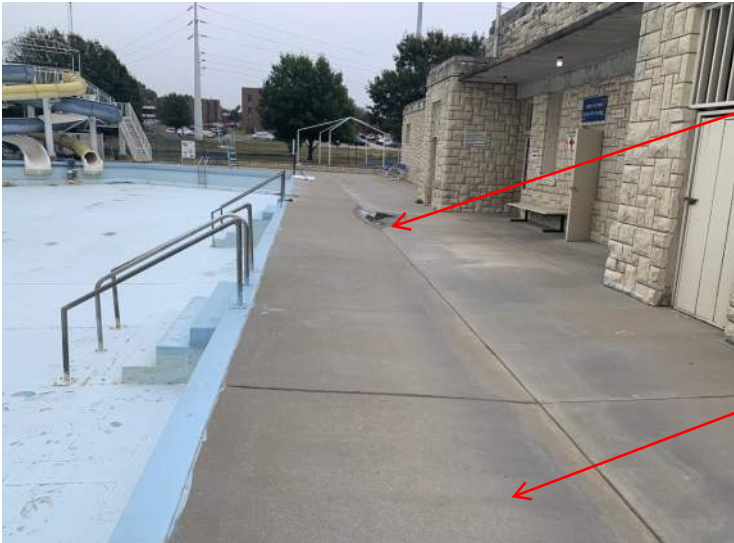
Ponding water is a concern when the facility is in operation.

Pool deck is in generally good condition.

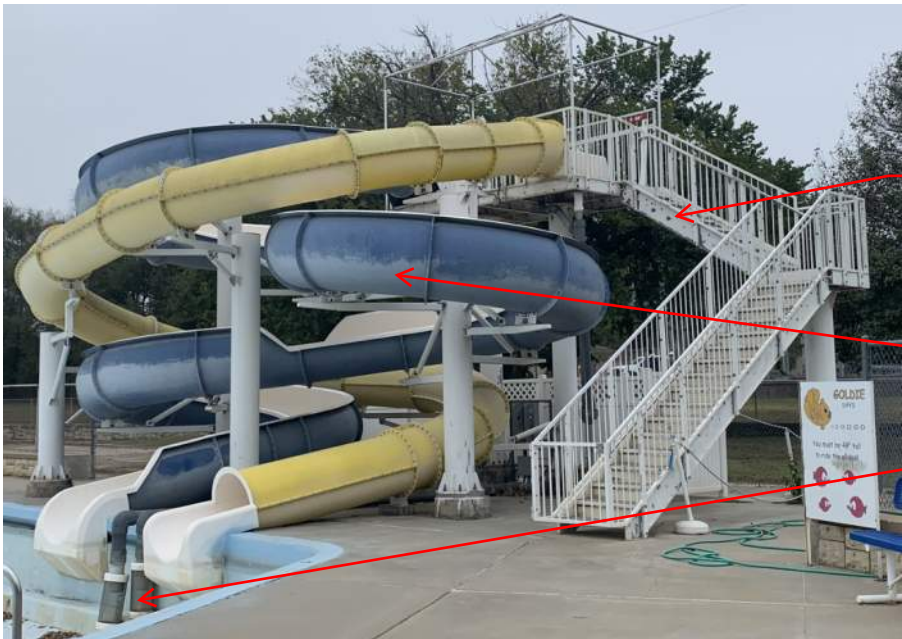
Water slide tower and stairs appear in acceptable condition. Some peeling paint is apparent. No significant rust was observed.

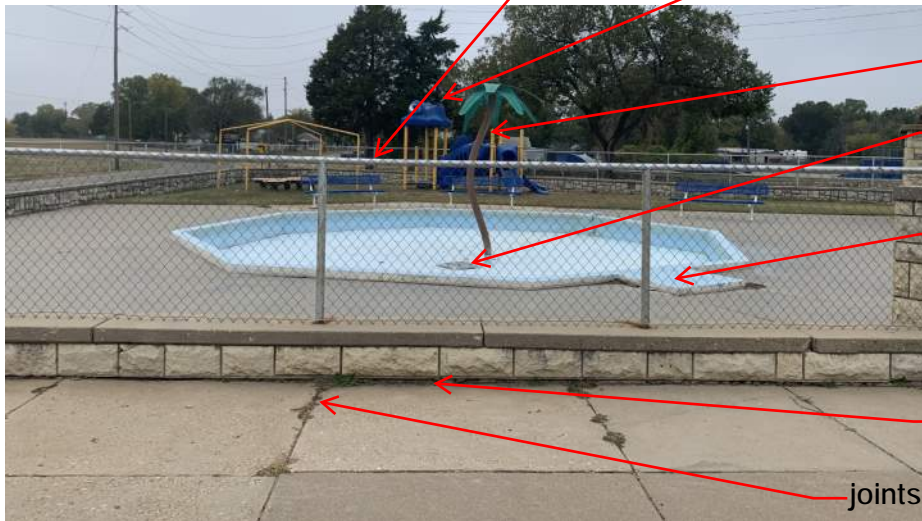
spray element installed in 2002

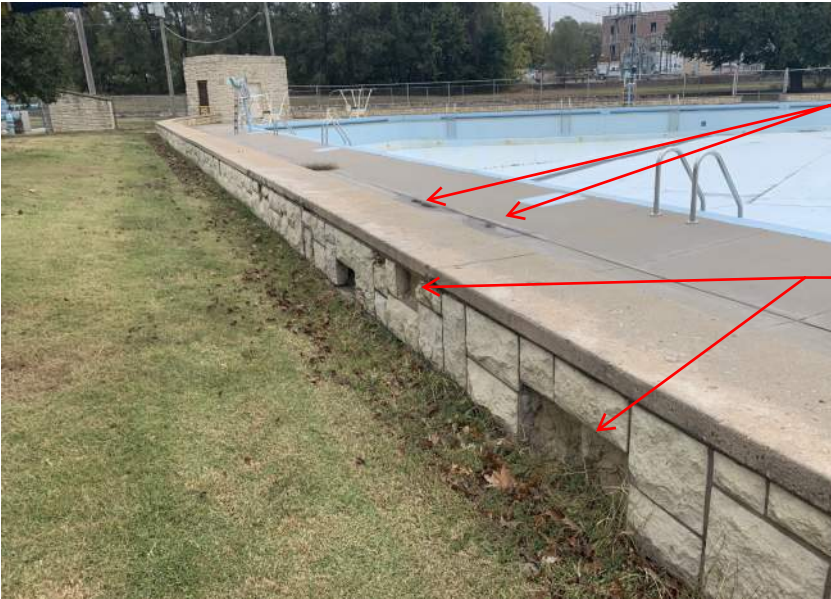
Standing water is a concern when the facility is in operation.

Deteriorated rock masonry due to water intrusion and subsequent freeze/thaw damage.

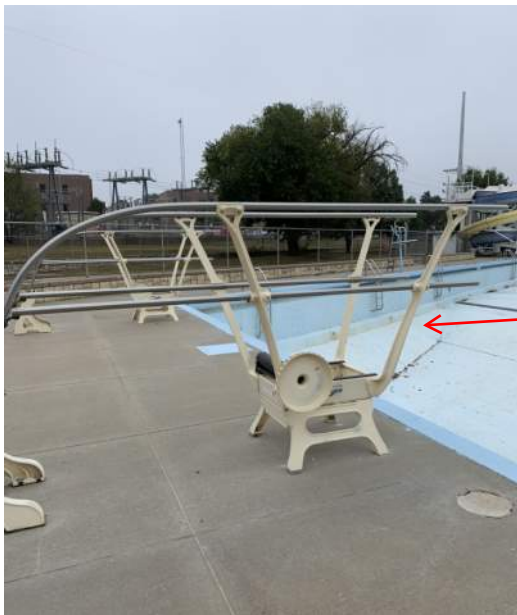
Dive stands appear in good condition

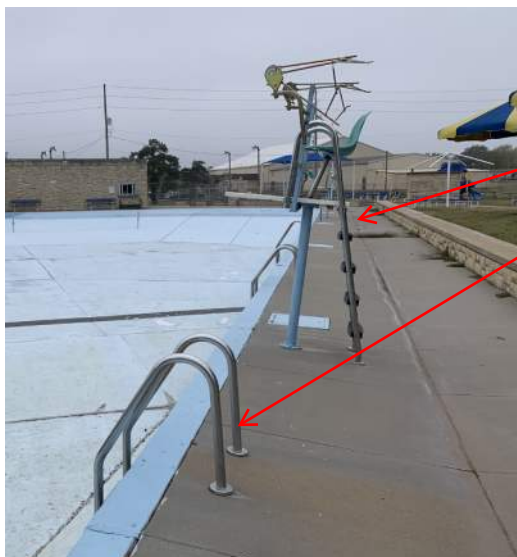
Life guard chairs and ladders appear in good condition
